| <b>Name of the Project</b> | <b>:</b> | <b>VISUAL INSPECTION OF ROB 437</b> |
| <b>Location</b> | <b>:</b> | <b>NEAR ALLURU RAILWAY STATION (Km 202/16-18)</b> |
| <b>Date of Inspection</b> | <b>:</b> | <b>29<sup>th</sup> NOVEMBER, 2019</b> |

## VISUAL INSPECTION OF ROAD OVER BRIDGE

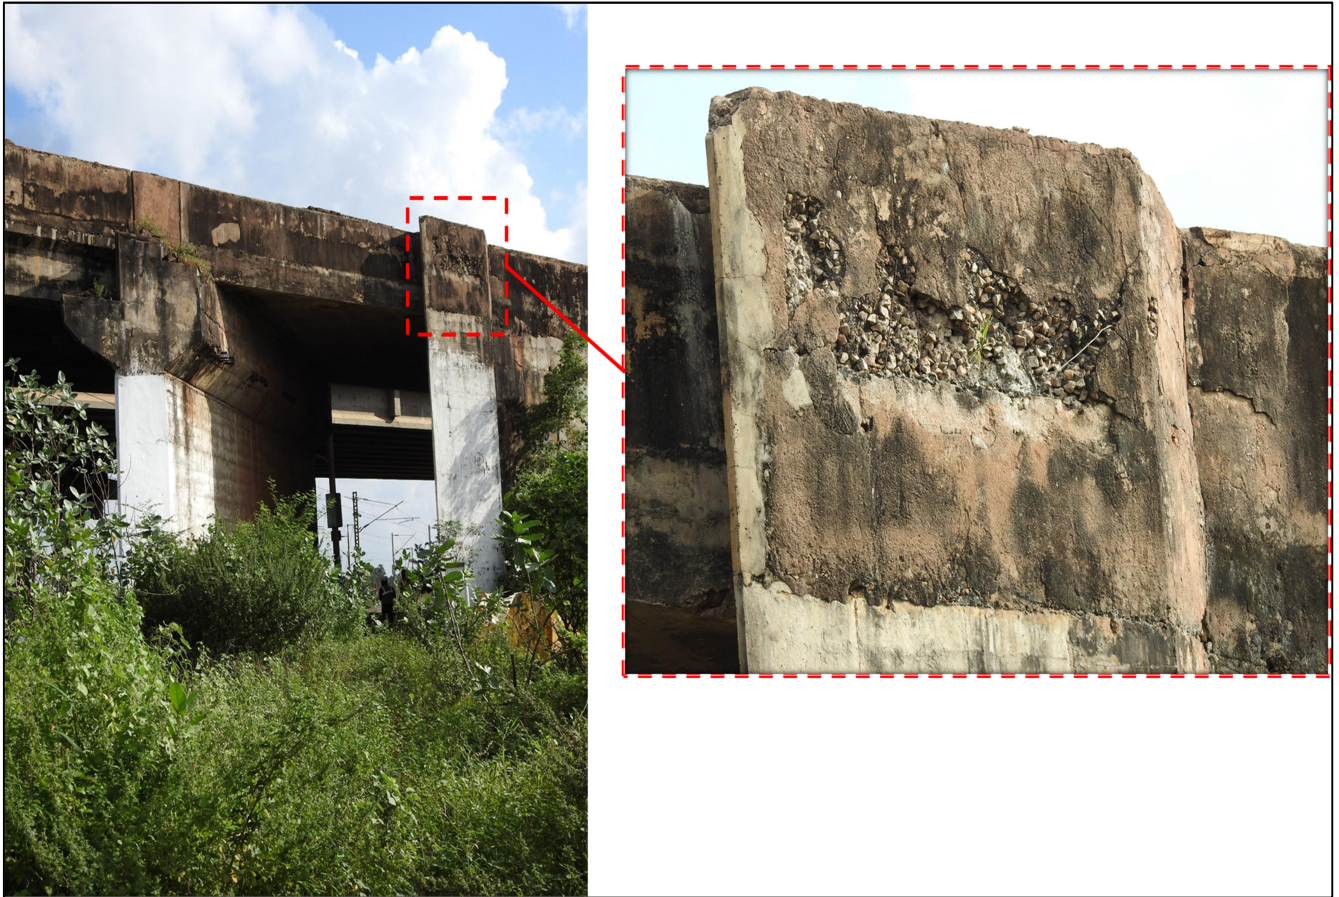
| PART 2 STRUCTURAL SYSTEM OF THE BRIDGE | | | |
|---|---|---|---|
| | Condition (Crack, Settlement, Scour, Tilting, Steel Corrosion, Strains and other damages etc...) | Distresses Found | Cracks & Spalling Observed (Refer Fig-4 & 7) |

**Fig 4:** Spalling and reinforcement exposed in abutment

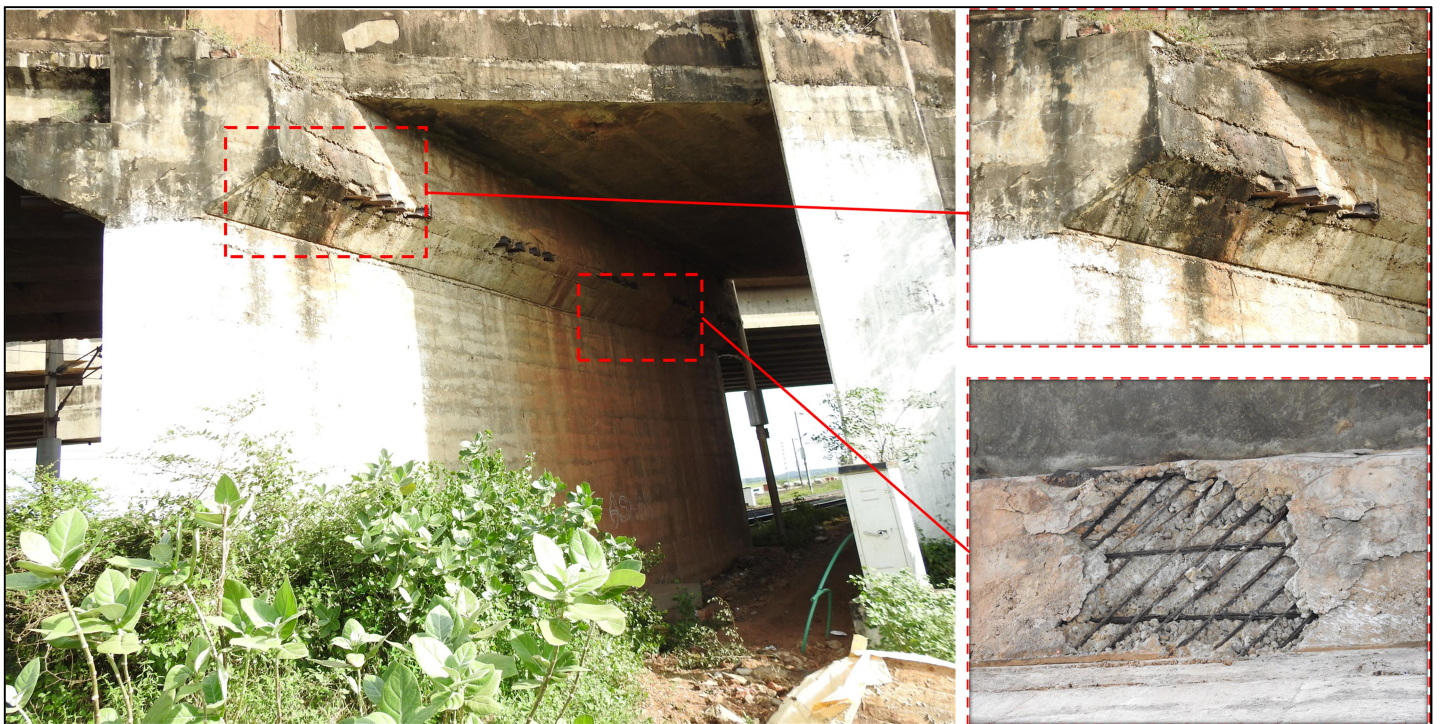
| PART 2 STRUCTURAL SYSTEM OF THE BRIDGE | | | |
|---|---|---|---|
| | Type (Shape) | Wall Type | Spalling, Cracks, Reinforcement exposure and Leaching observed at Pier. |
| | Pier Cap Material | RCC | .... (Refer Fig-5 & 8) |

**Fig 5** Spalling & Reinforcement exposed at Pier-1

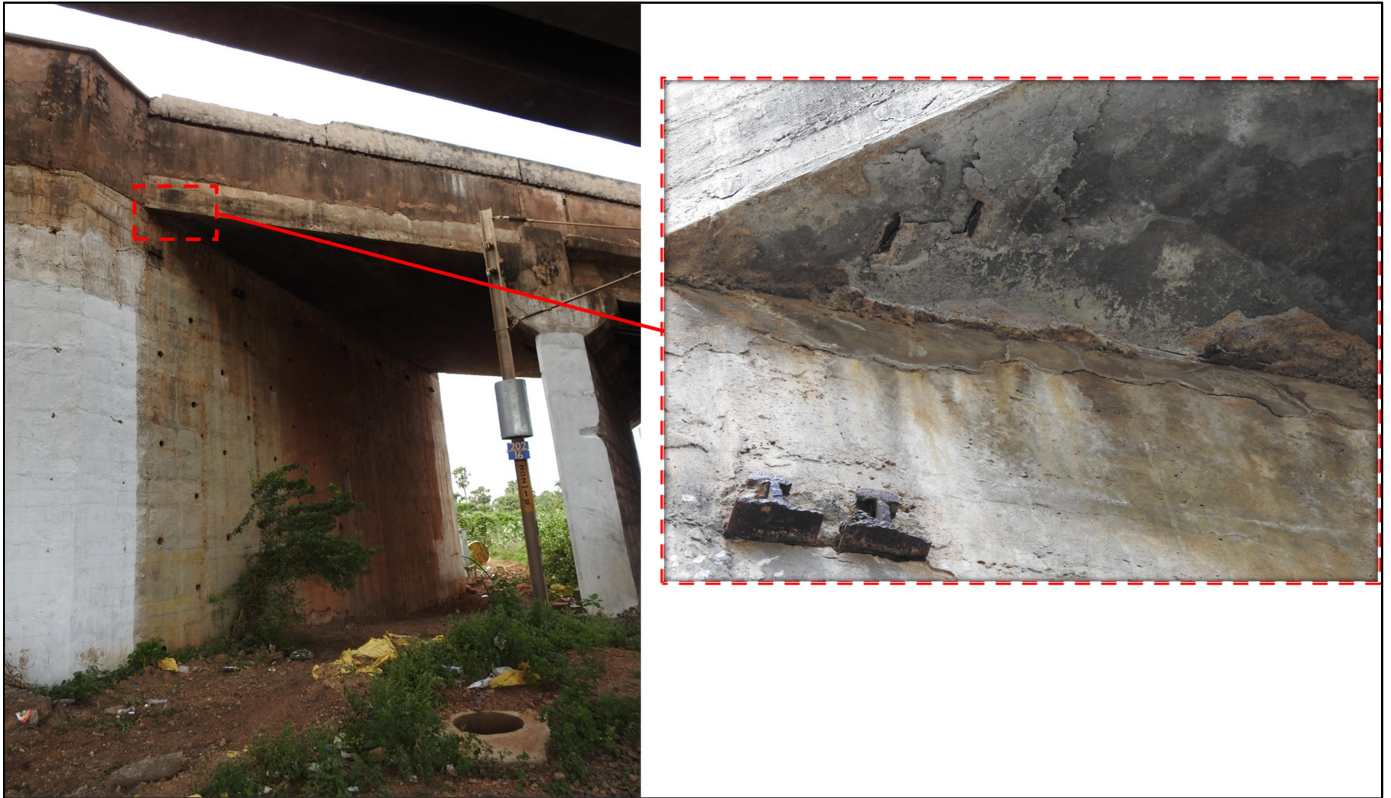
**Fig 6:** Reinforcement exposure at slab and Corroded Rail sections (Shuttering Support) at Abutment

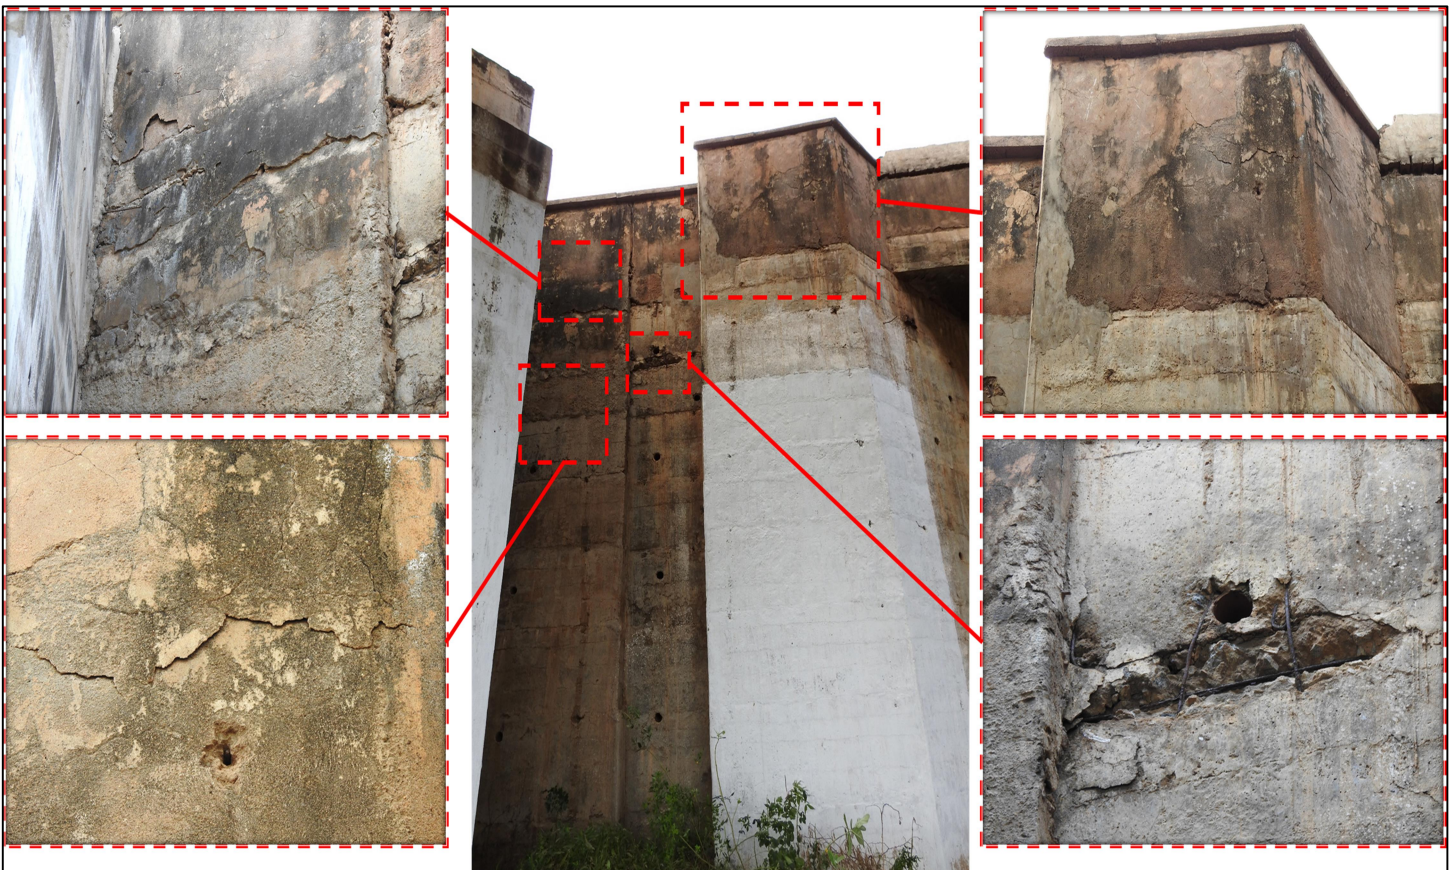
**Fig 7:** Distresses observed at Retaining Walls & Abutment

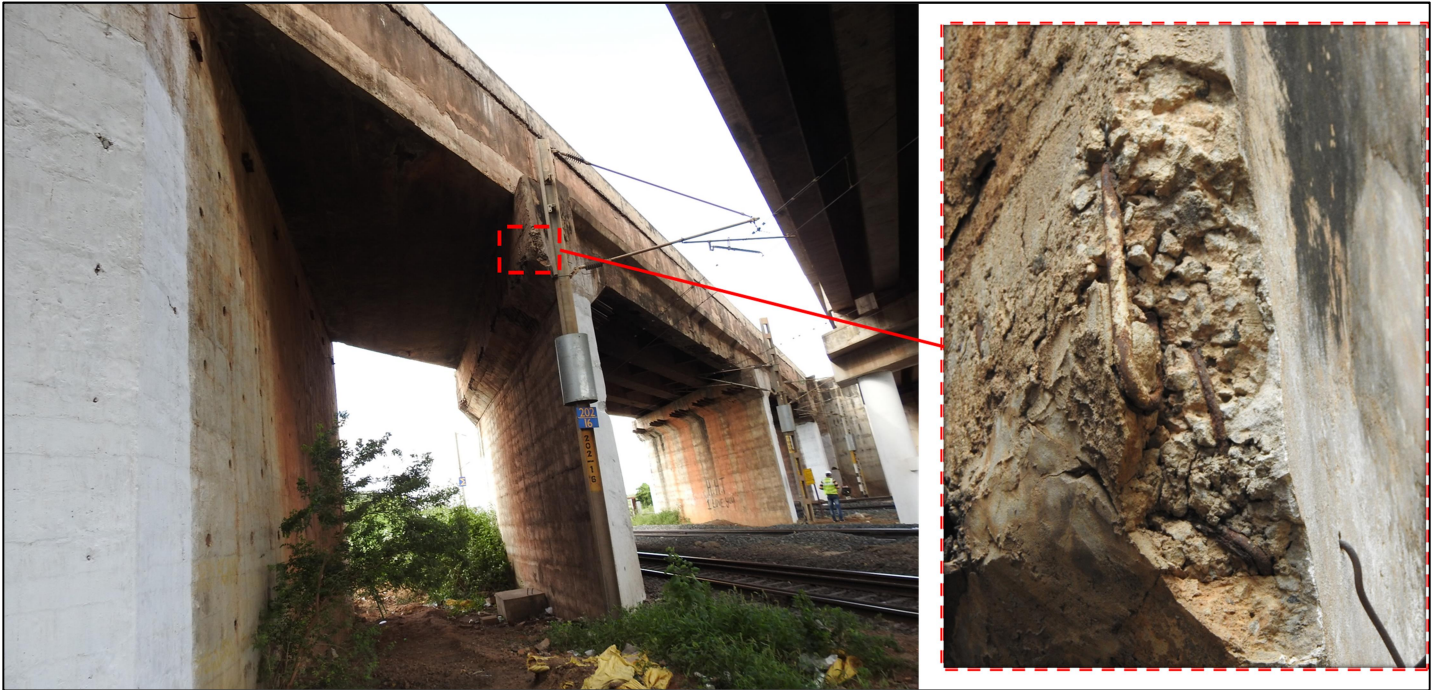
**Fig 8:** Spalling & Reinforcement exposed at Pier

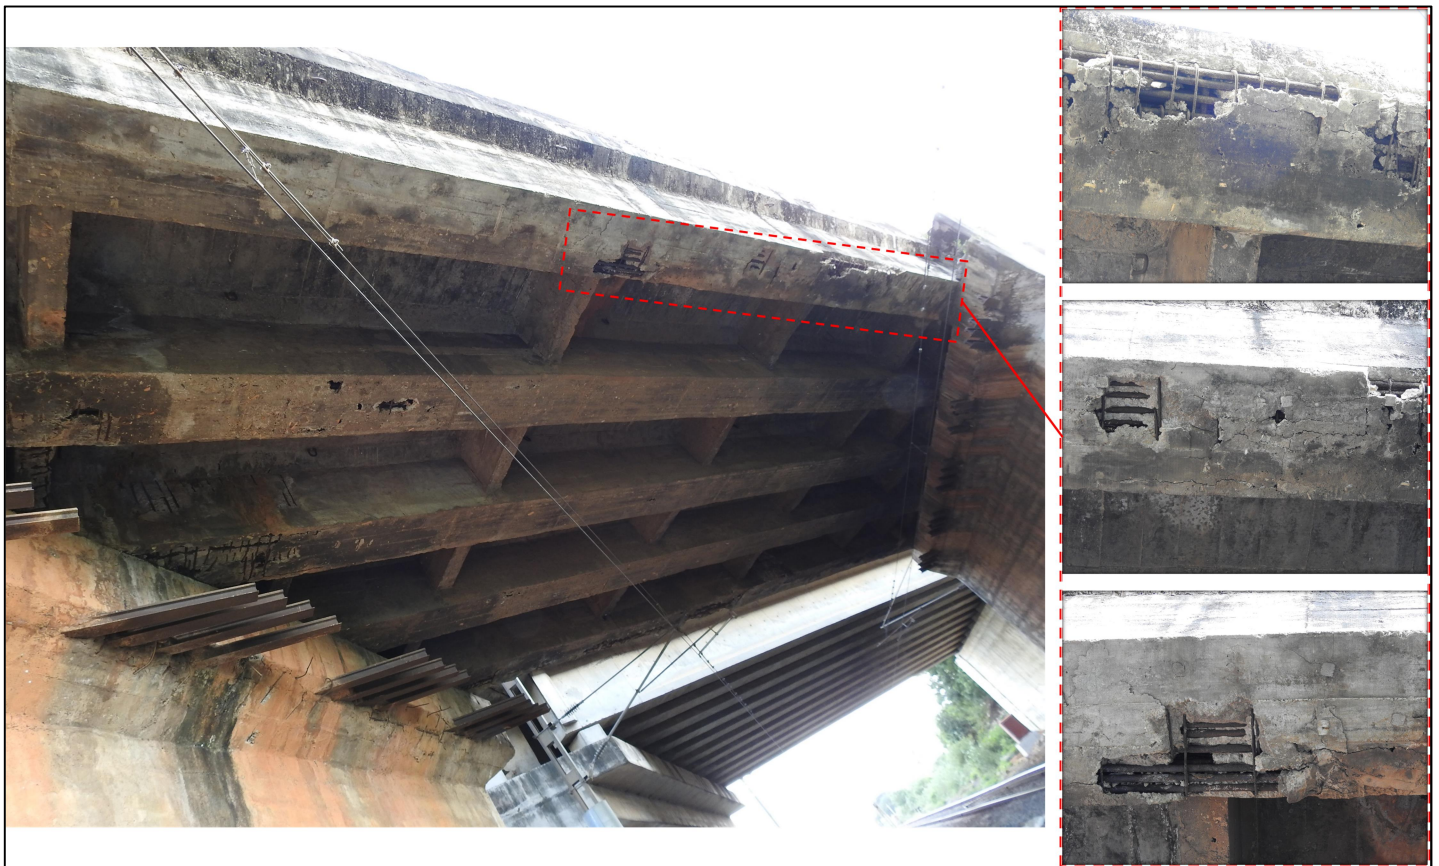
| | Condition of Girder | Severe Distresses<br>Found | Severe Spalling, Reinforcement exposure and<br>Corrosion observed<br>Deflection is observed in exterior girder<br>(Refer Fig- 9, 11, 12, 14, 16 & 17) |

**Fig 9:** Severe Spalling & Reinforcement exposure at exterior girder of Span-2

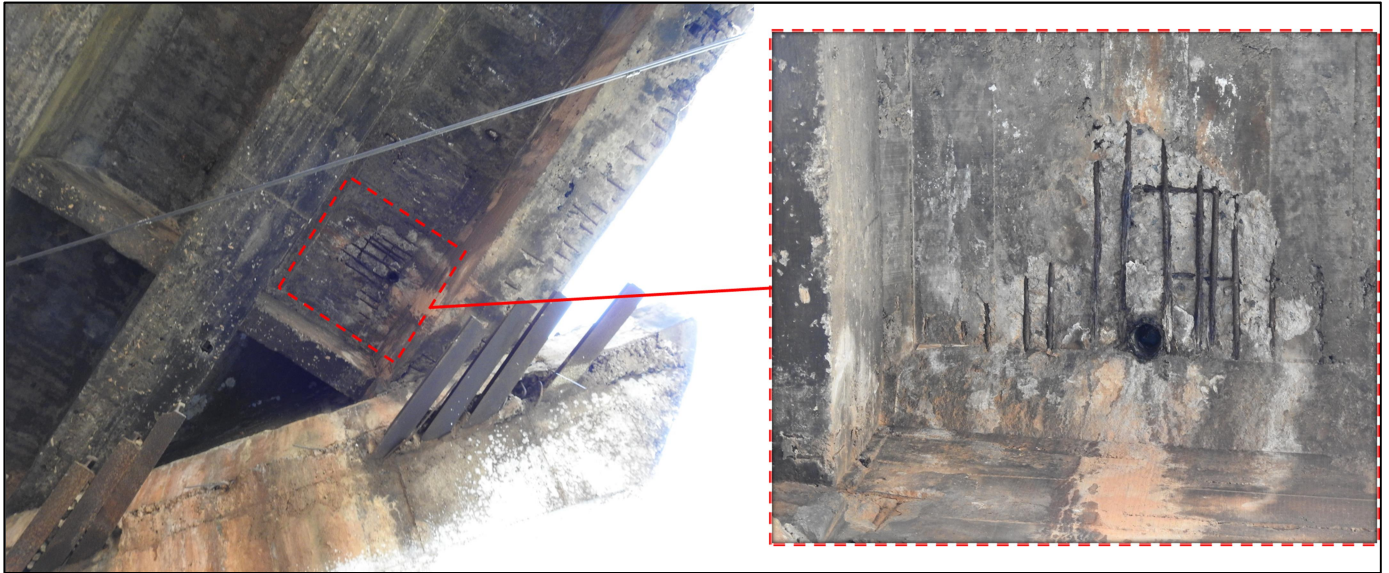
| | Condition of Slab from Bottom | | Spalling & Reinforcement exposure has been<br>Observed. (Refer Fig-10 & 15) |

**Fig 10:** Spalling & Reinforcement exposure in slab at drainage spout location

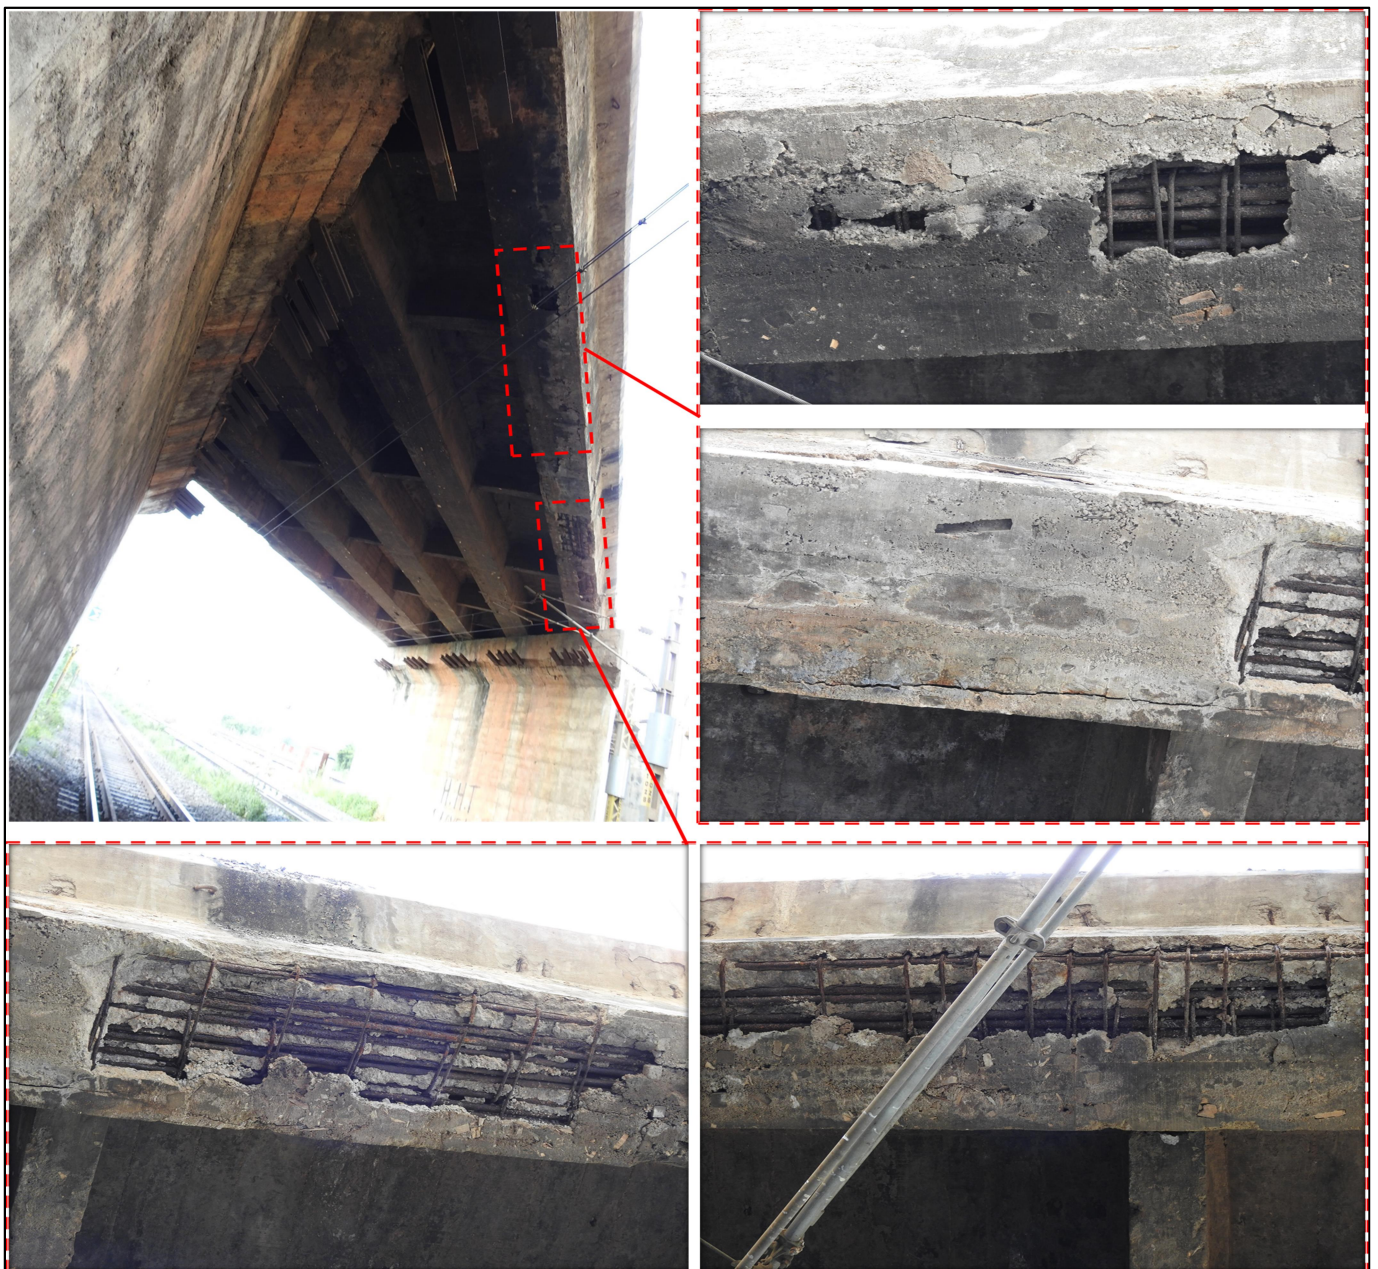
**Fig 11:** Severe Spalling & Reinforcement exposure at exterior girder of Span-3

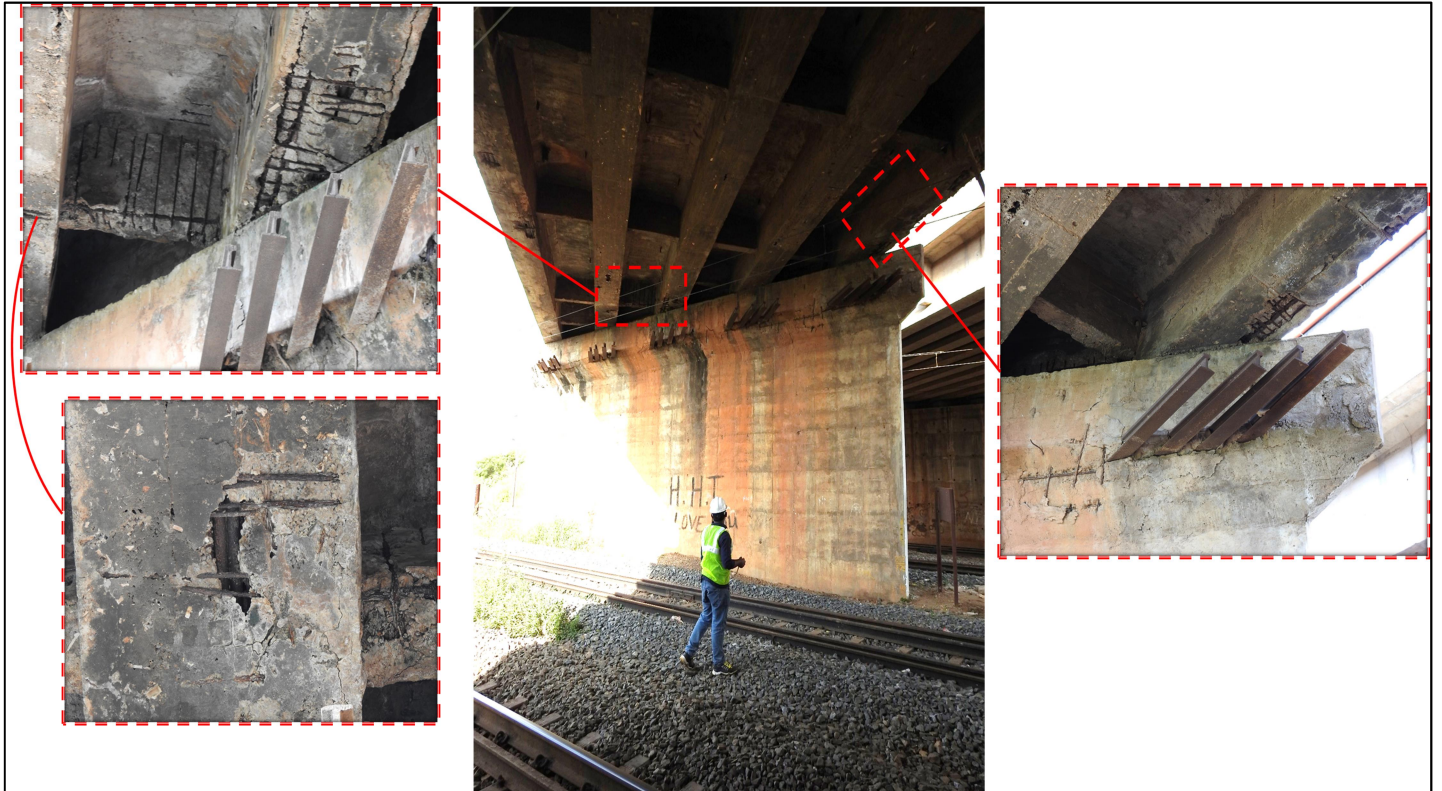
**Fig 12:** Severe Spalling & Reinforcement exposure at girder ends

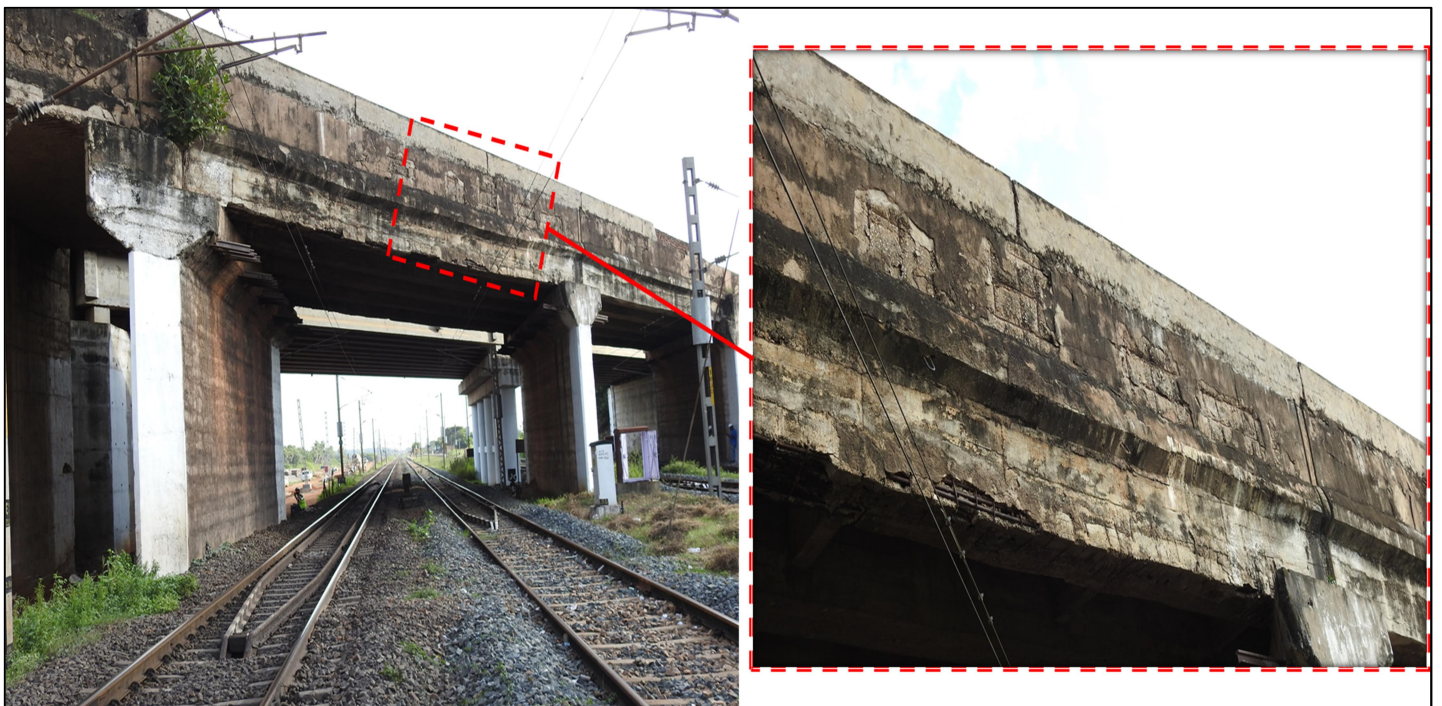
**Fig 13:** Spalling & Reinforcement exposure at exterior girder & parapet

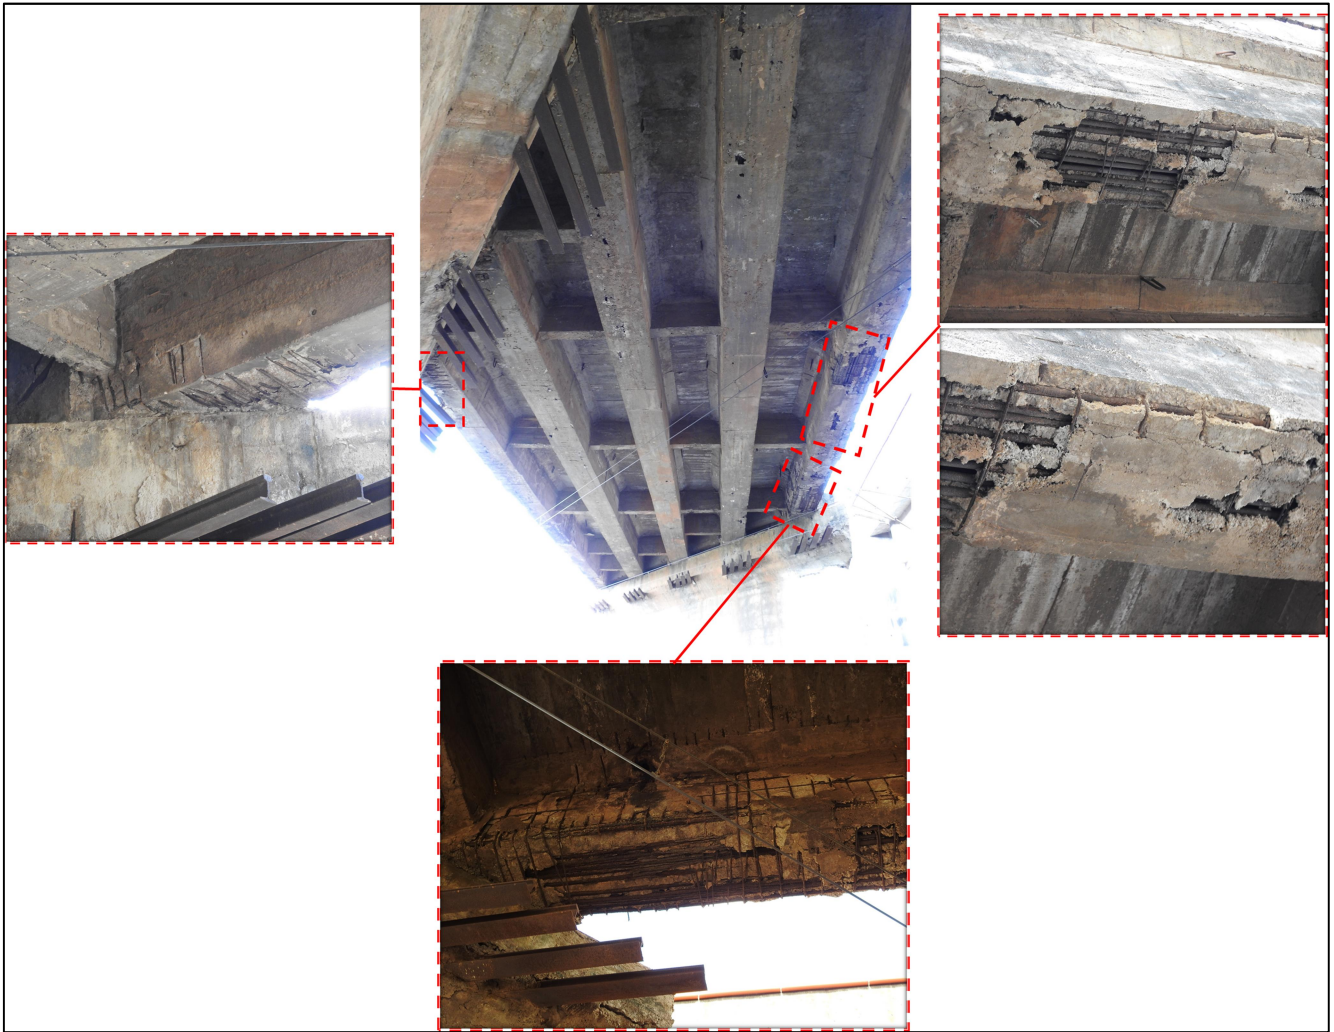
***Fig 14:*** Severe Spalling & Reinforcement exposure at girders

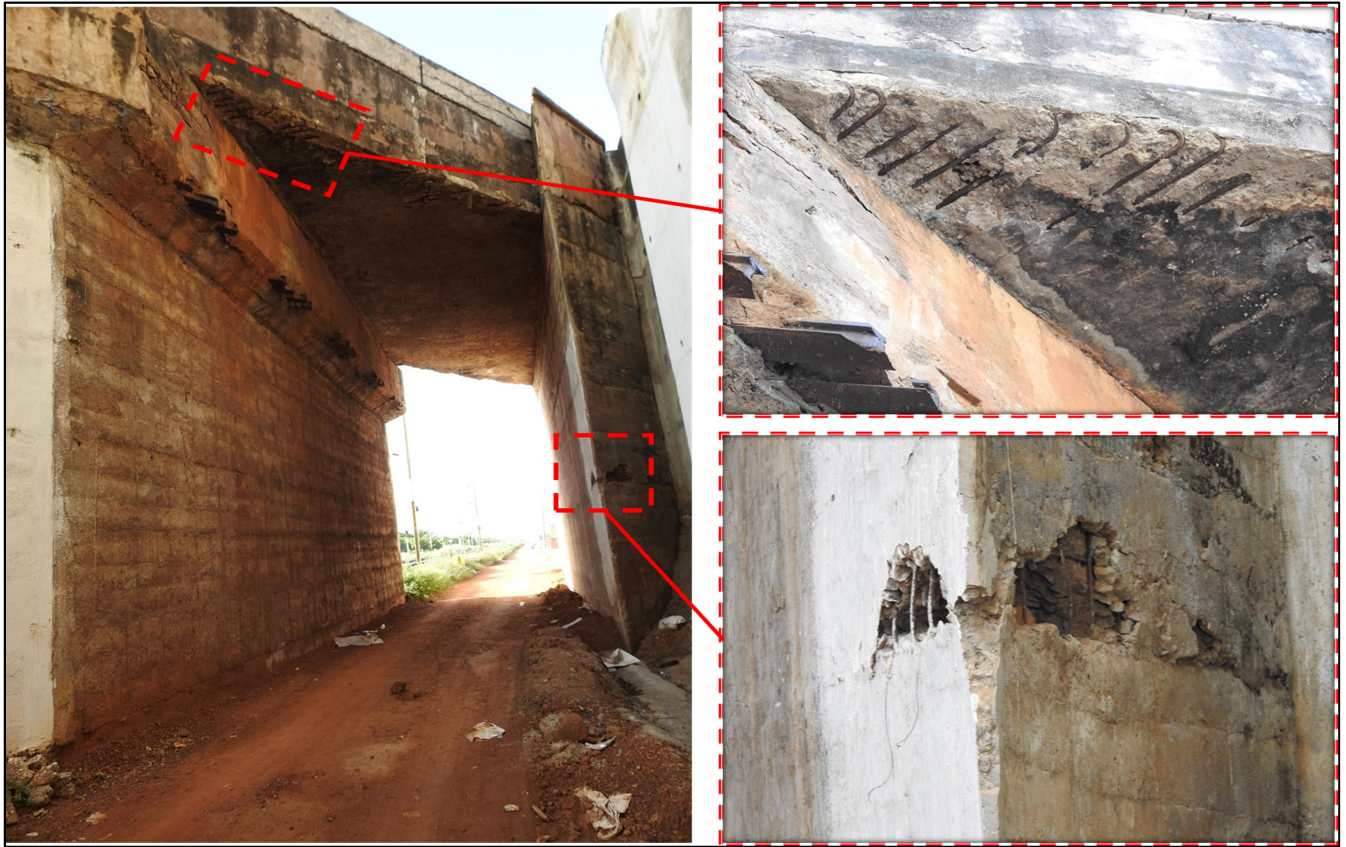
**Fig 15:** Spalling & Reinforcement exposure at Slab of Span-4 & Abutment

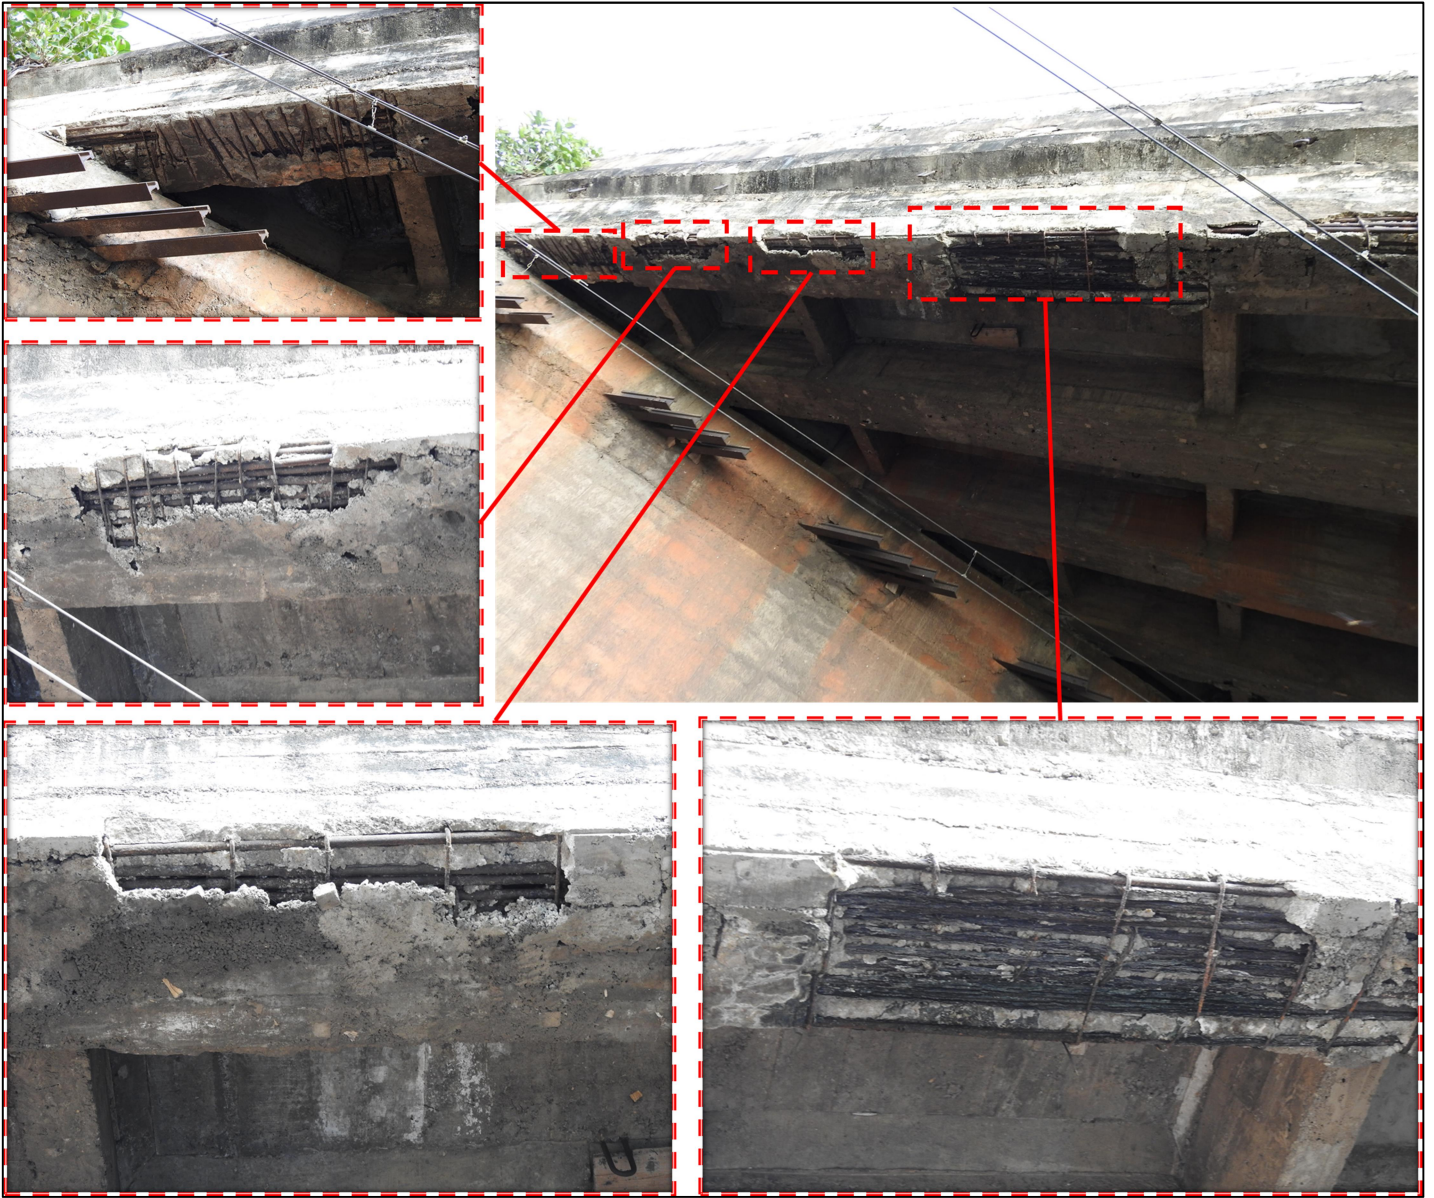
**Fig 16:** Severe Spalling & Reinforcement exposure at exterior girders

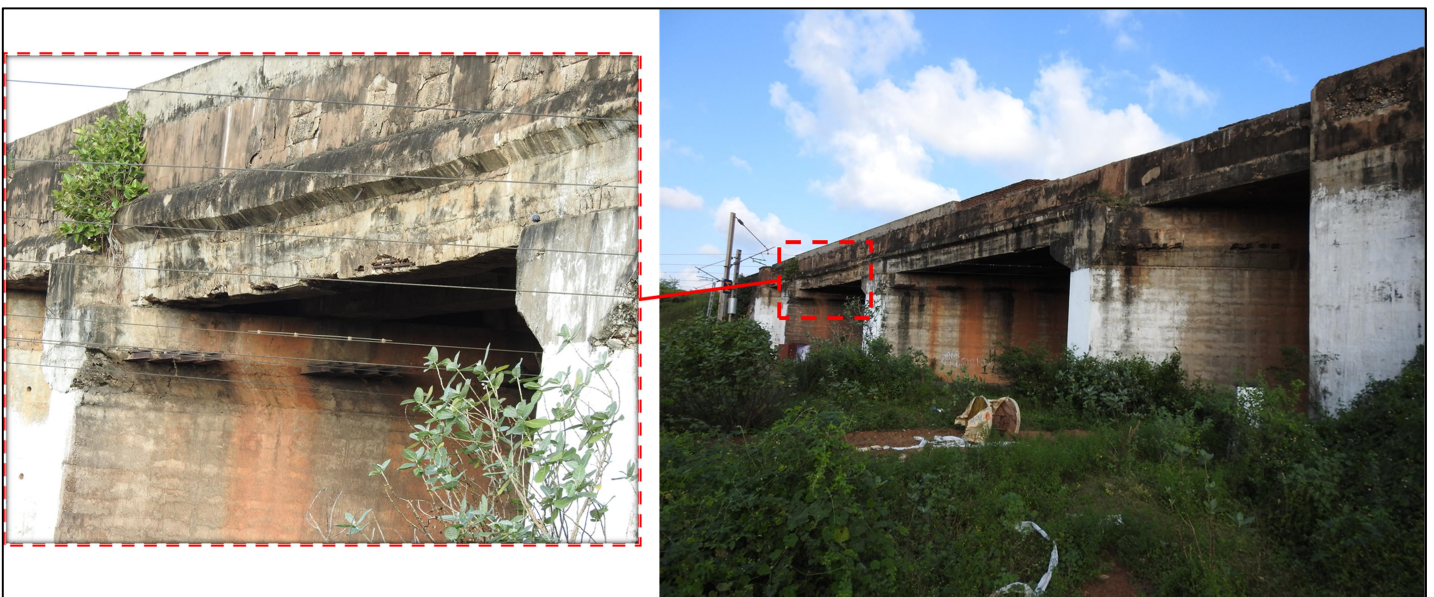
**Fig 17:** Deflection Observed at Exterior Girder of Span-3

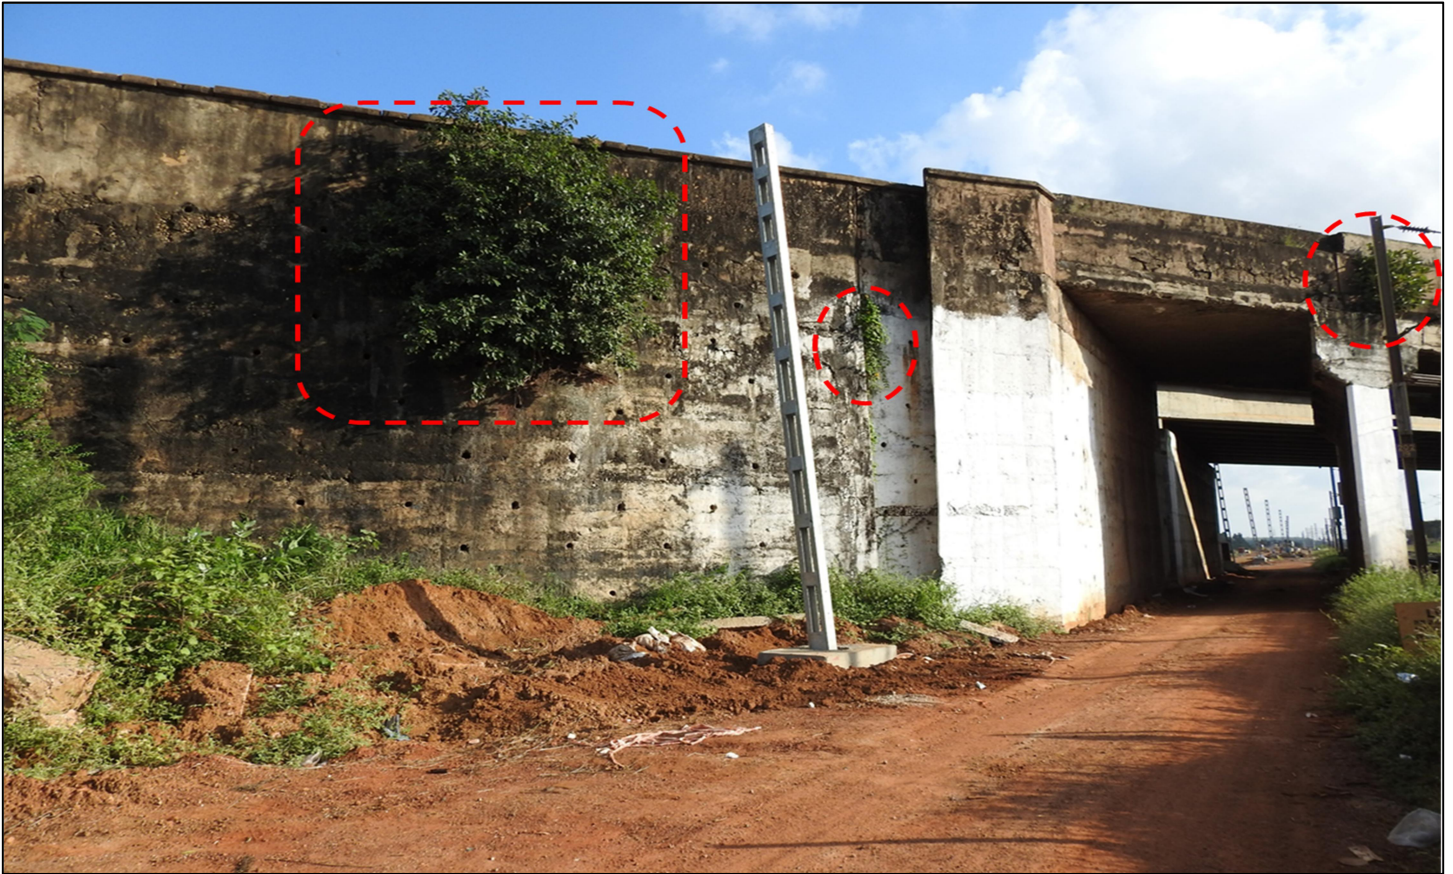
**Fig 18:** Vegetation at Pier cap & Abutment Retaining Walls

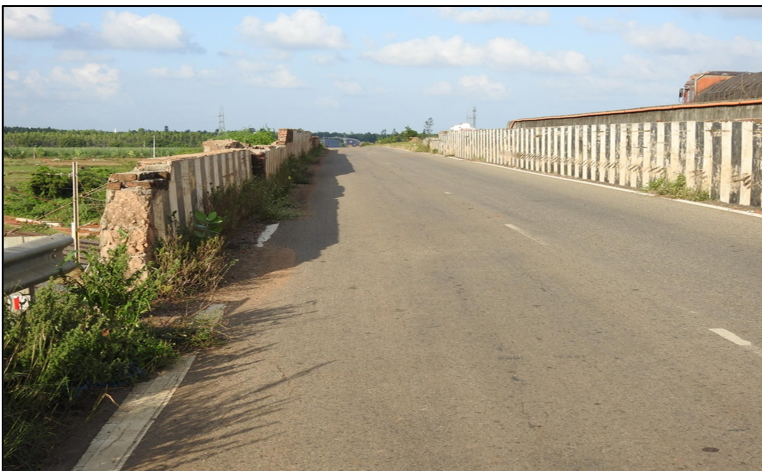
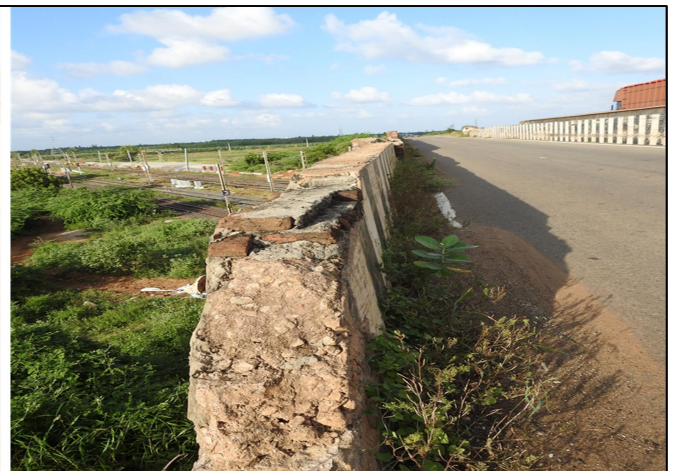
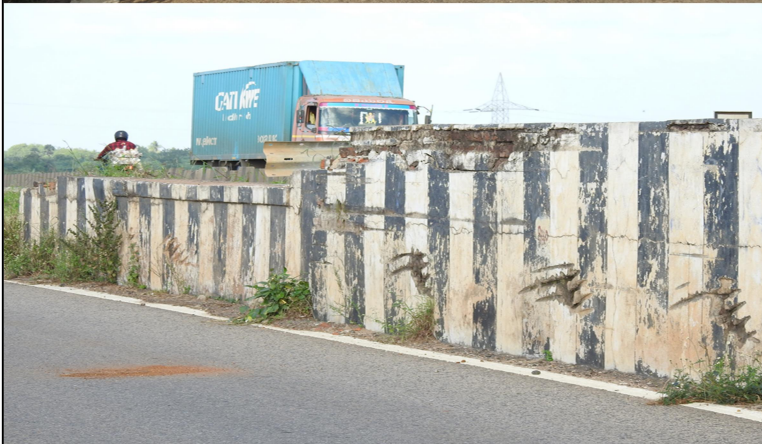
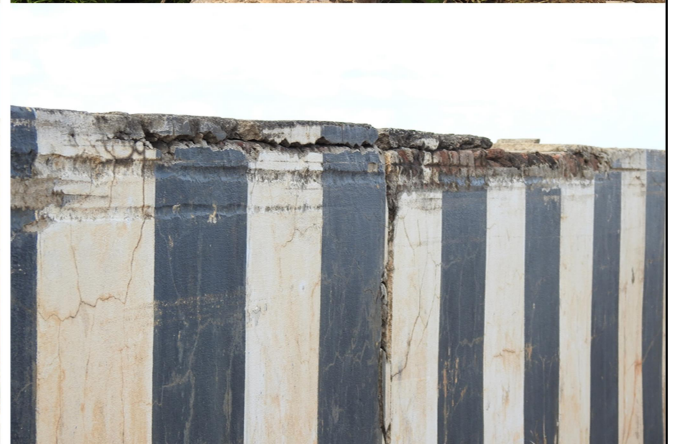
| | Condition of Flooring/Wearing<br>Coat | Fair | ...(Refer Fig-19) |

| Condition of Wall/Railing | Spalling is observed (Refer Fig-19) |

**Fig 19:** Top View/ Condition of Road surface and Crash Barrier
