**Name of the Project** : **VISUAL INSPECTION OF ROB No. 459A  
NEAR KAZIPET RAILWAY STATION**

**Location** : **Near Kazipet Railway Station**

**Date of Inspection** : **28<sup>th</sup> NOVEMBER, 2019**

## **VISUAL INSPECTION OF ROAD OVER BRIDGE**

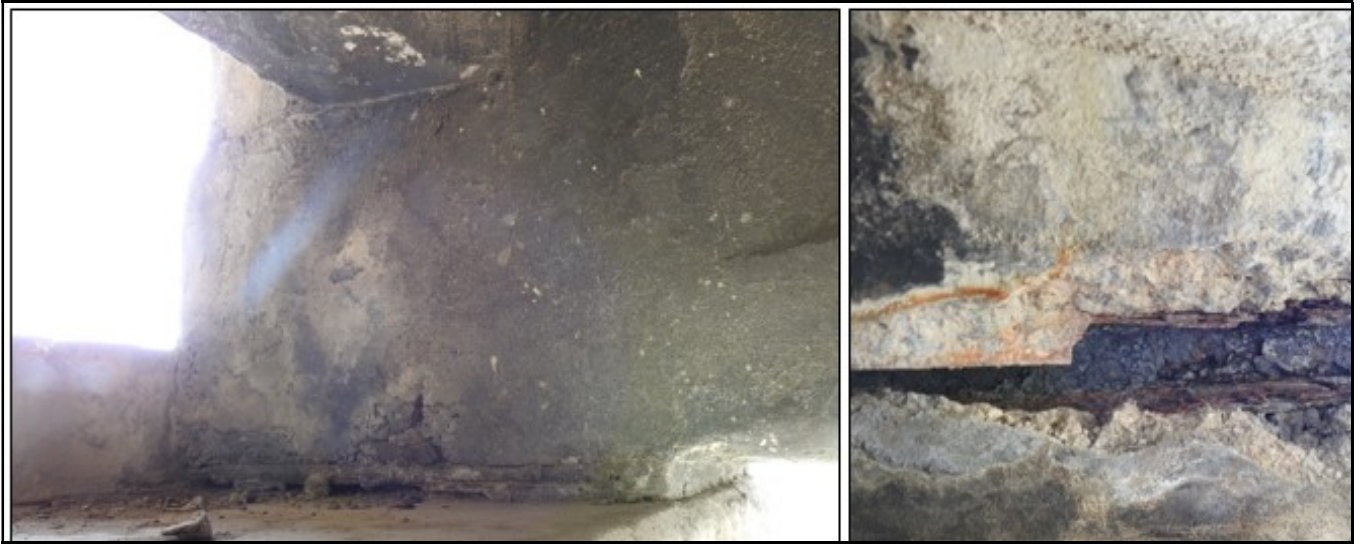
| | General condition<br>(Check Corrosion, cleanliness, seizing of plates silting, accumulations of dirt in case of submersible bridges) | Corrosion observed | 2) Elastomeric bearings are observed at span 2 and 3<br>3) Metallic plate bearings are corroded (Refer Fig-3, 4) |

Fig.3 : Metallic plate Bearings corrosion observed at span 1 and 4

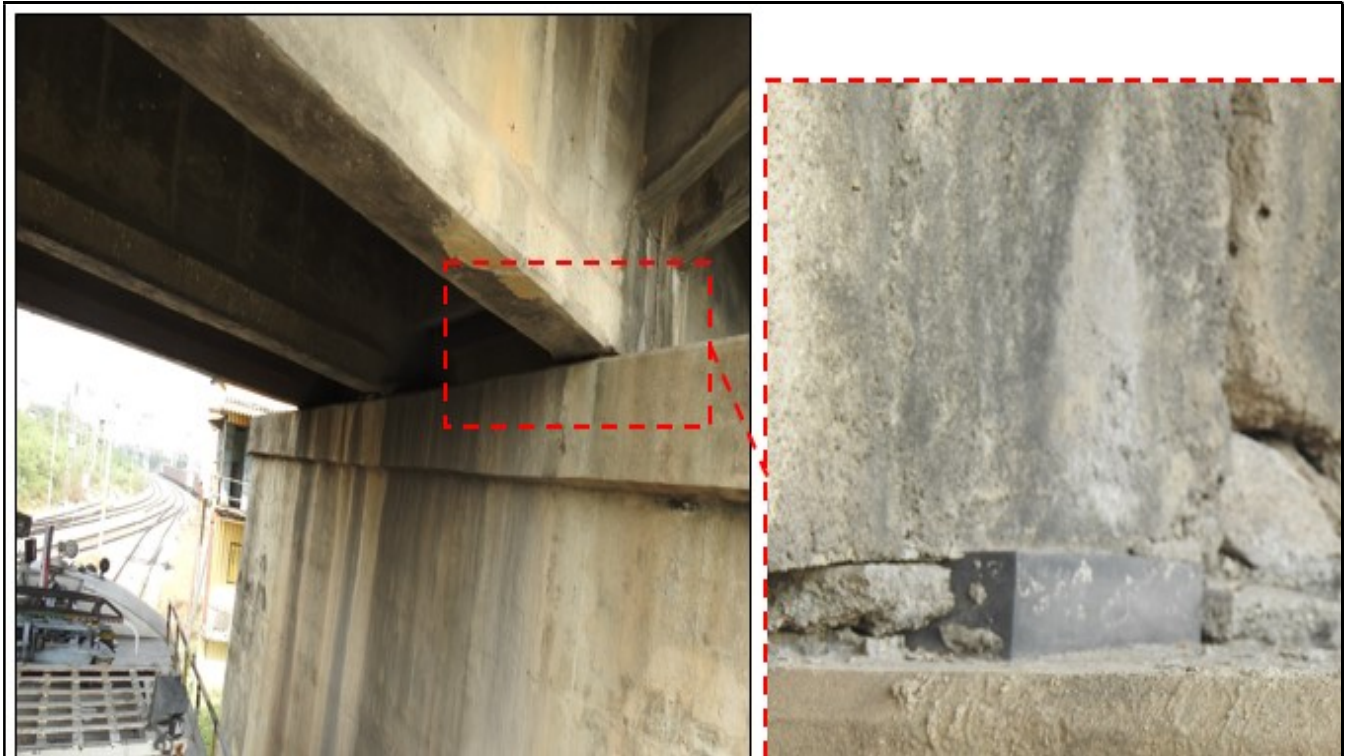
| | Condition of Secondary Girder | | Cracks and patch work has been observed (Refer Fig-4) |

Fig.4 : Elastomeric Bearings observed at span 2 & 3

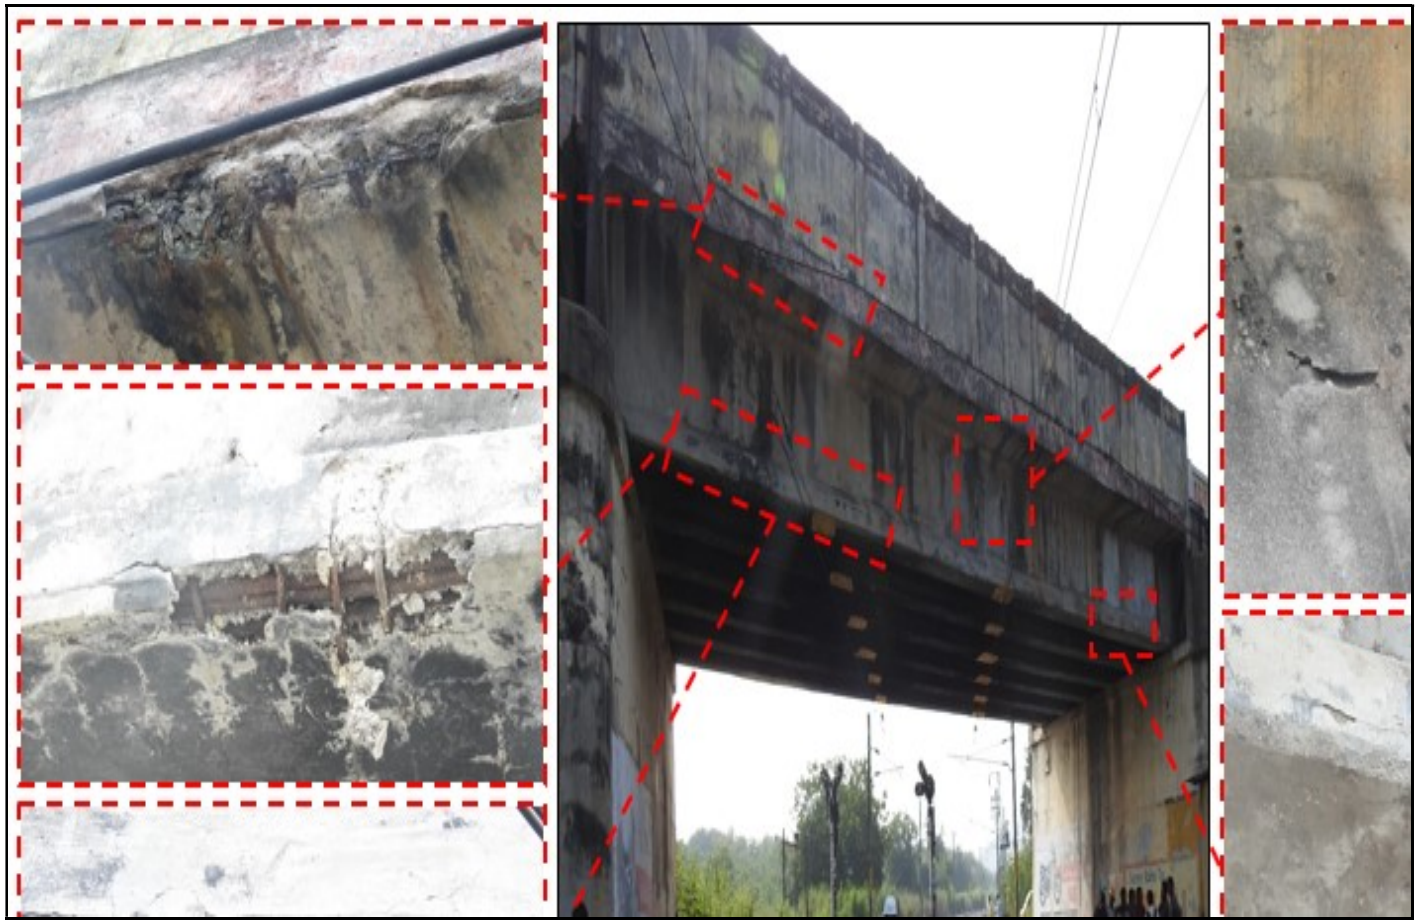
| | Condition of Girder | | Spalling and cracks and Reinforcement exposed (Refer Fig-5,8,9) |

Fig.5 : Patch work, Reinforcement exposed and Structural Cracks at Span-1

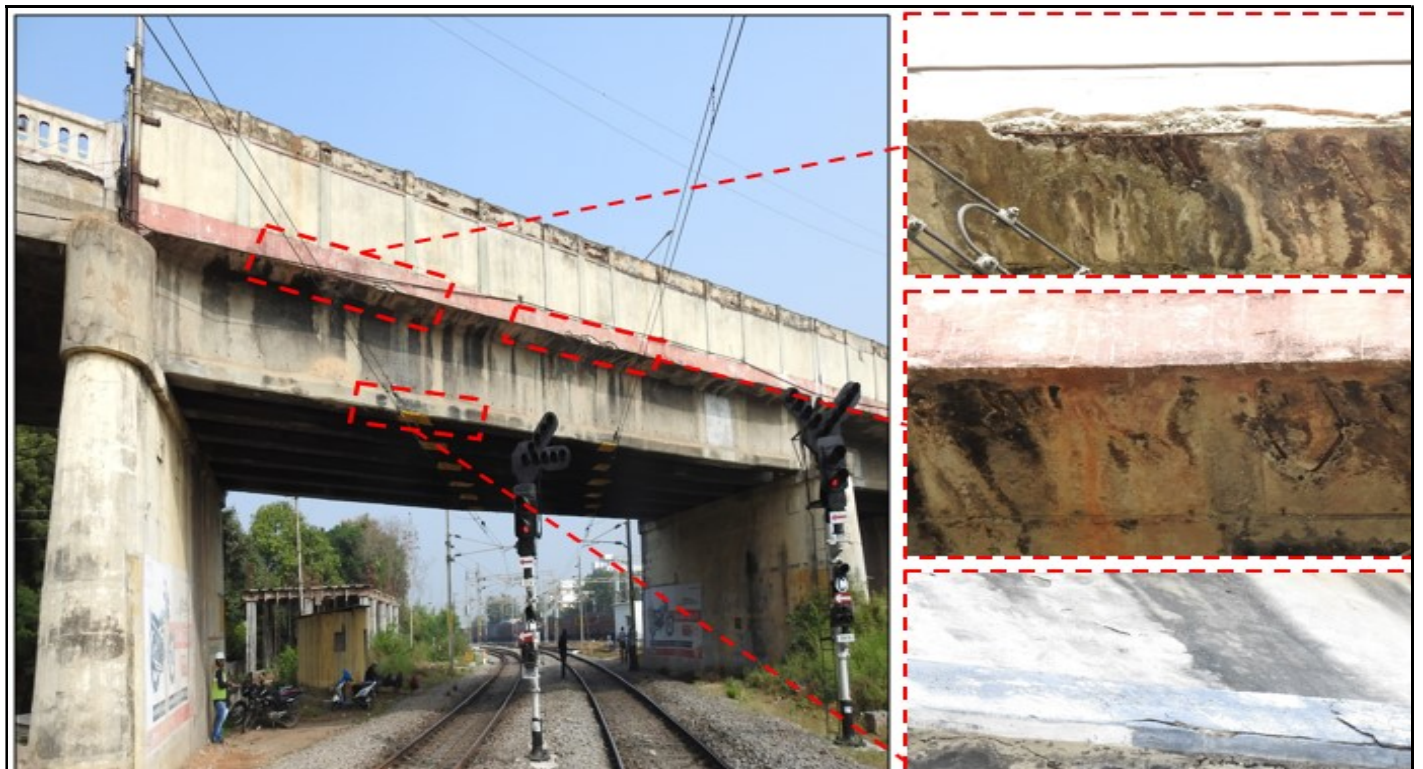
| | Condition of Slab from Bottom | | Spalling & Reinforcement exposure has been observed. (Refer Fig-6,8) |

Fig.6 : Spalling, Cracks, leaching and Reinforcement exposed is observed at Main girder of span-1 and overhanging portion of slab.

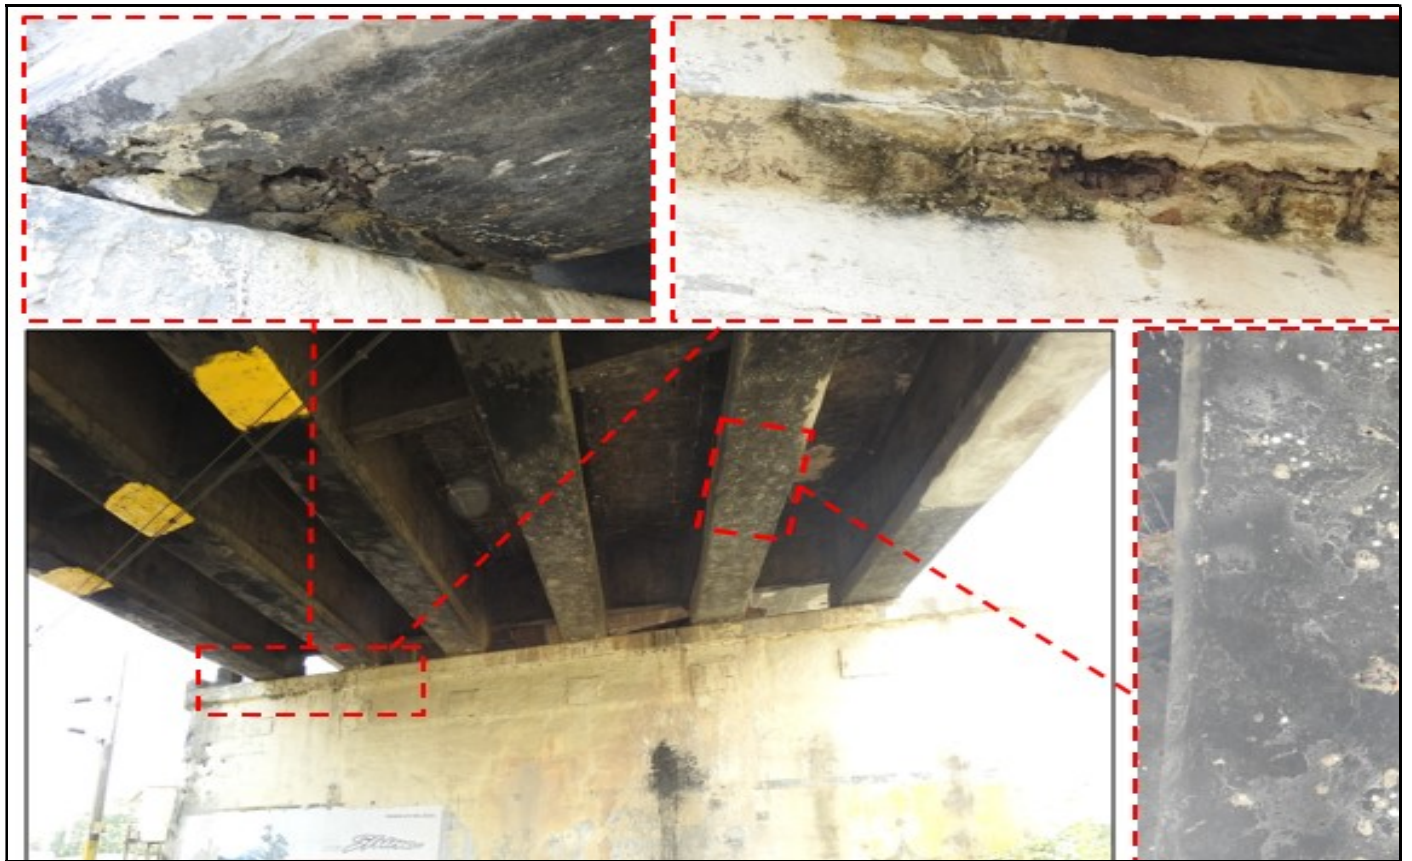
| PART 2 STRUCTURAL SYSTEM OF THE BRIDGE | | | |
|---|---|---|---|
| | Type (Shape) | Wall type | Spalling and reinforcement exposure is observed at pier cap (Refer Fig.7) |

Fig.7 : Reinforcement exposed and Spalling is observed at pier cap and main girder of Span 1.

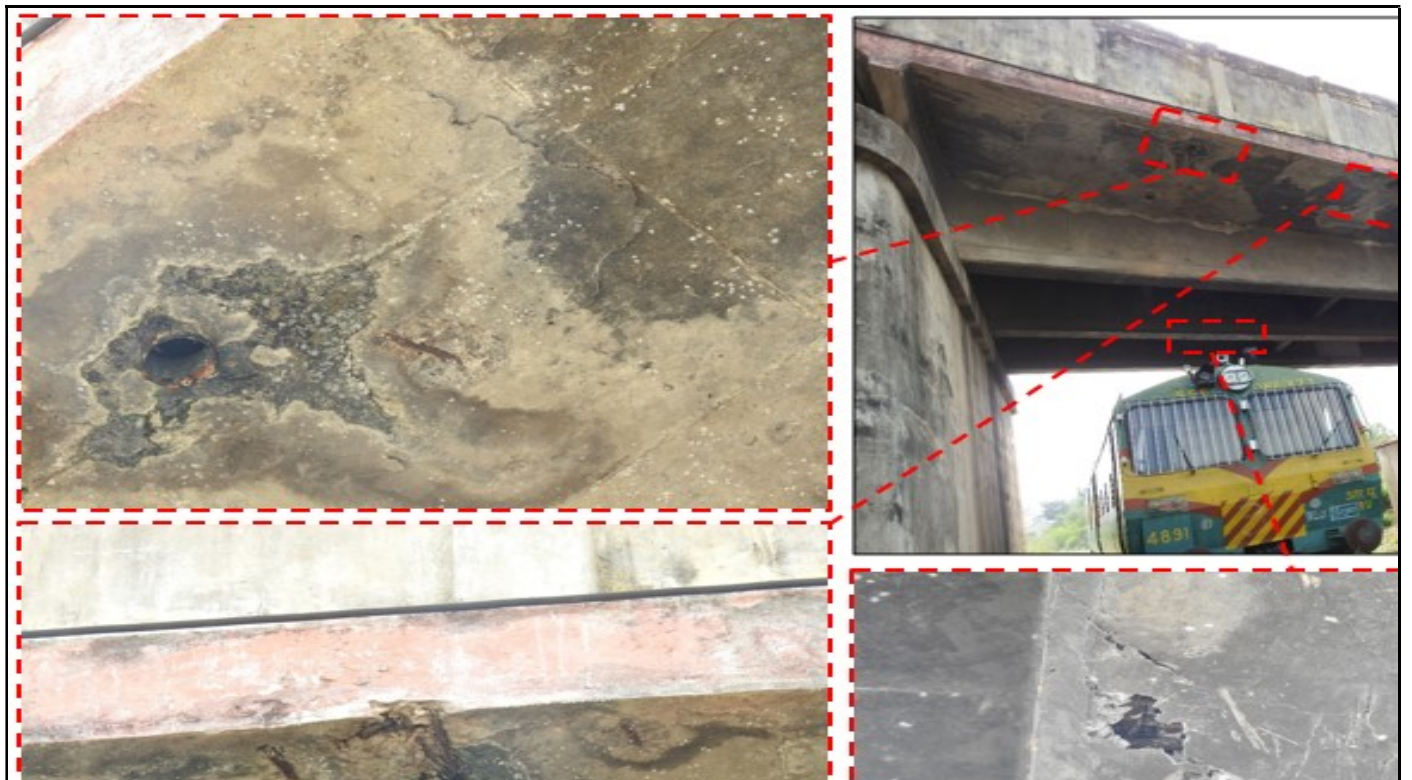
Fig.8 : Reinforcement exposed and Spalling is observed at overhang slab portion and Main girder of Span-2.

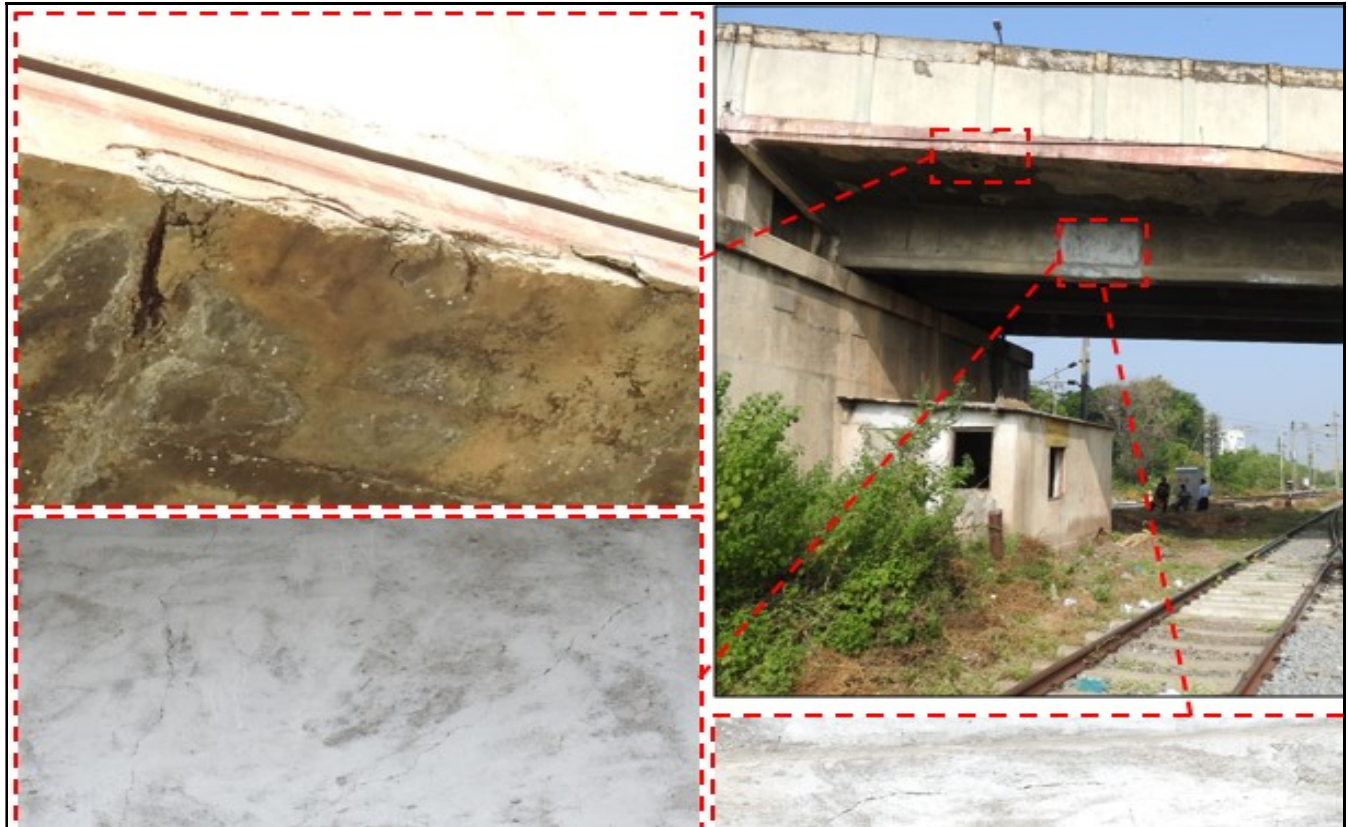
Fig.9 : Cracks, patch work and Spalling is observed at main girder and overhang slab of Span-2.

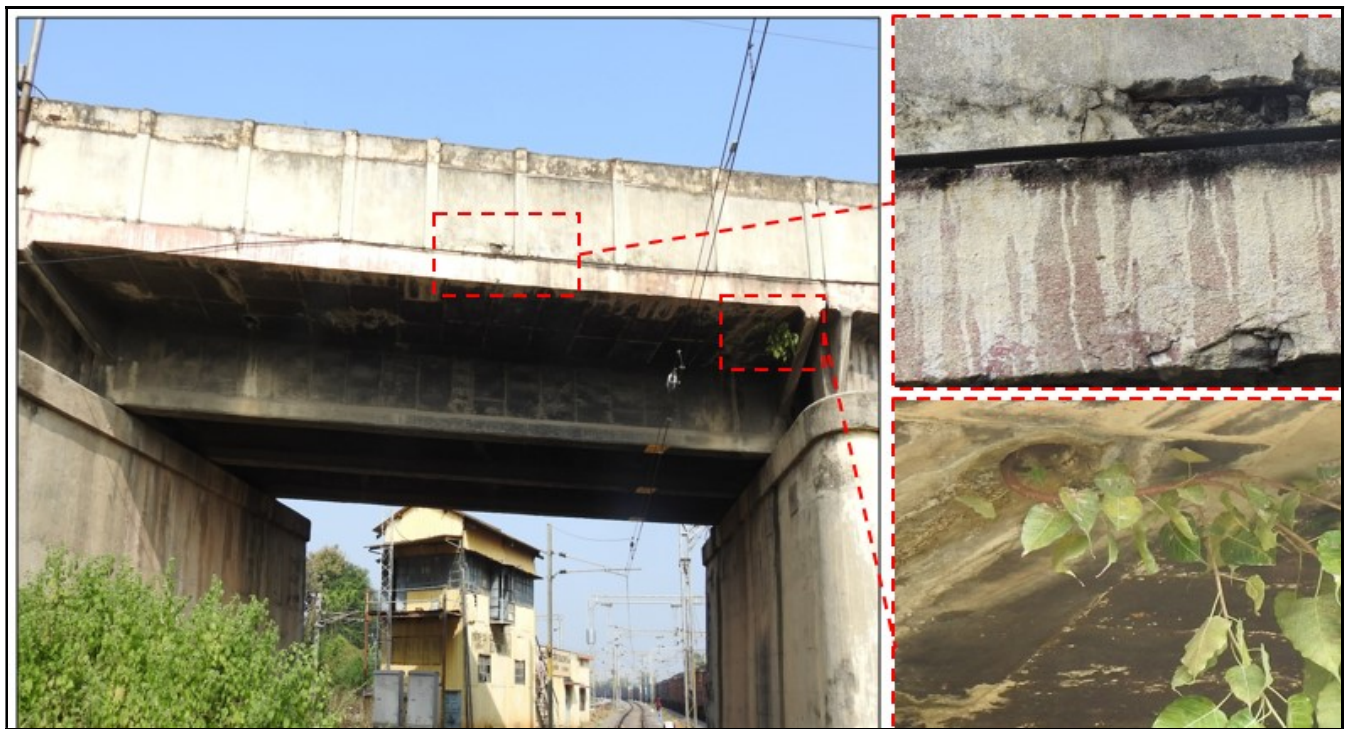
Fig.10 : Spalling and vegetation observed in span 3 .

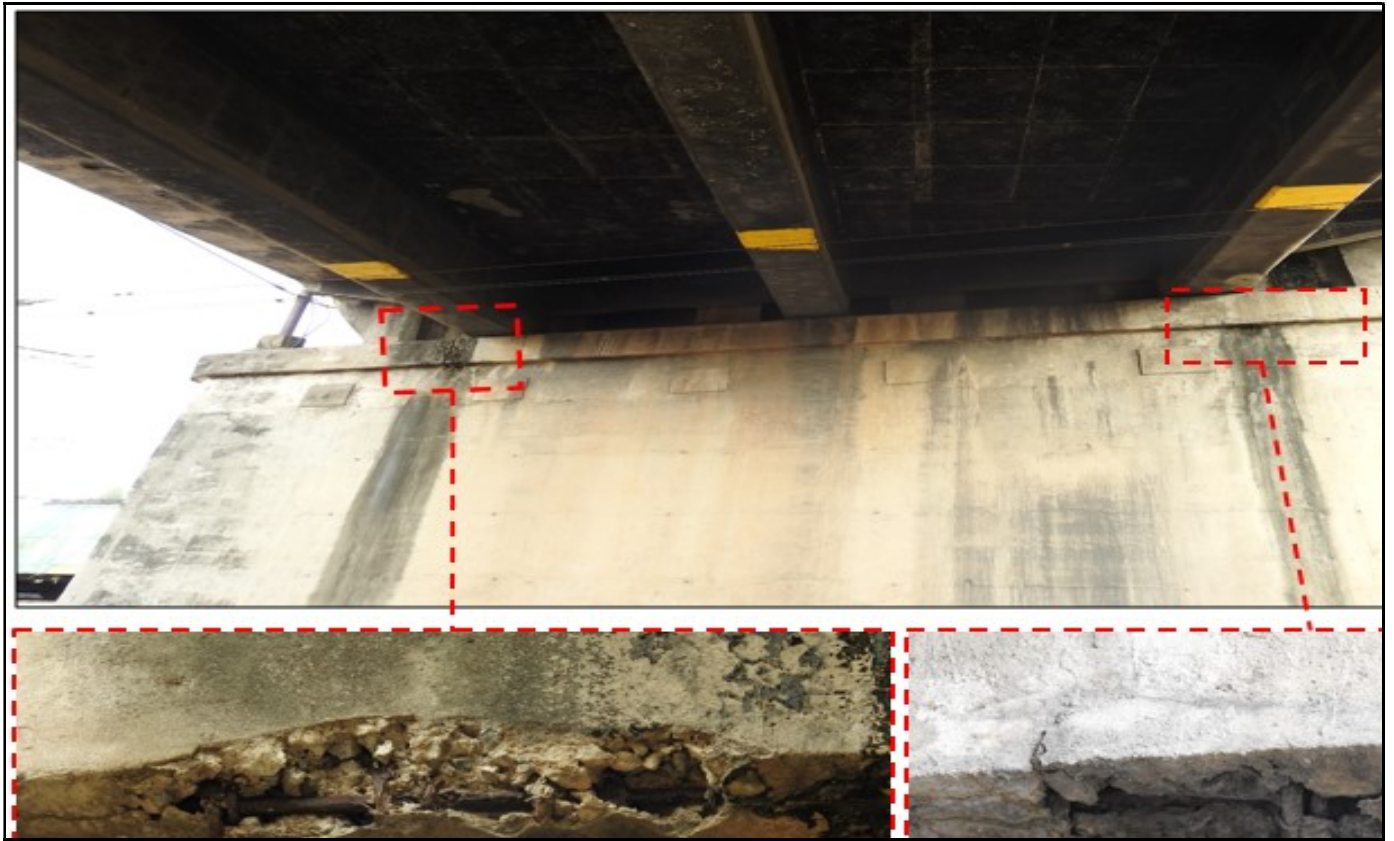
Fig.11 : Reinforcement exposed, spalling and cracks observed at pair-3 .

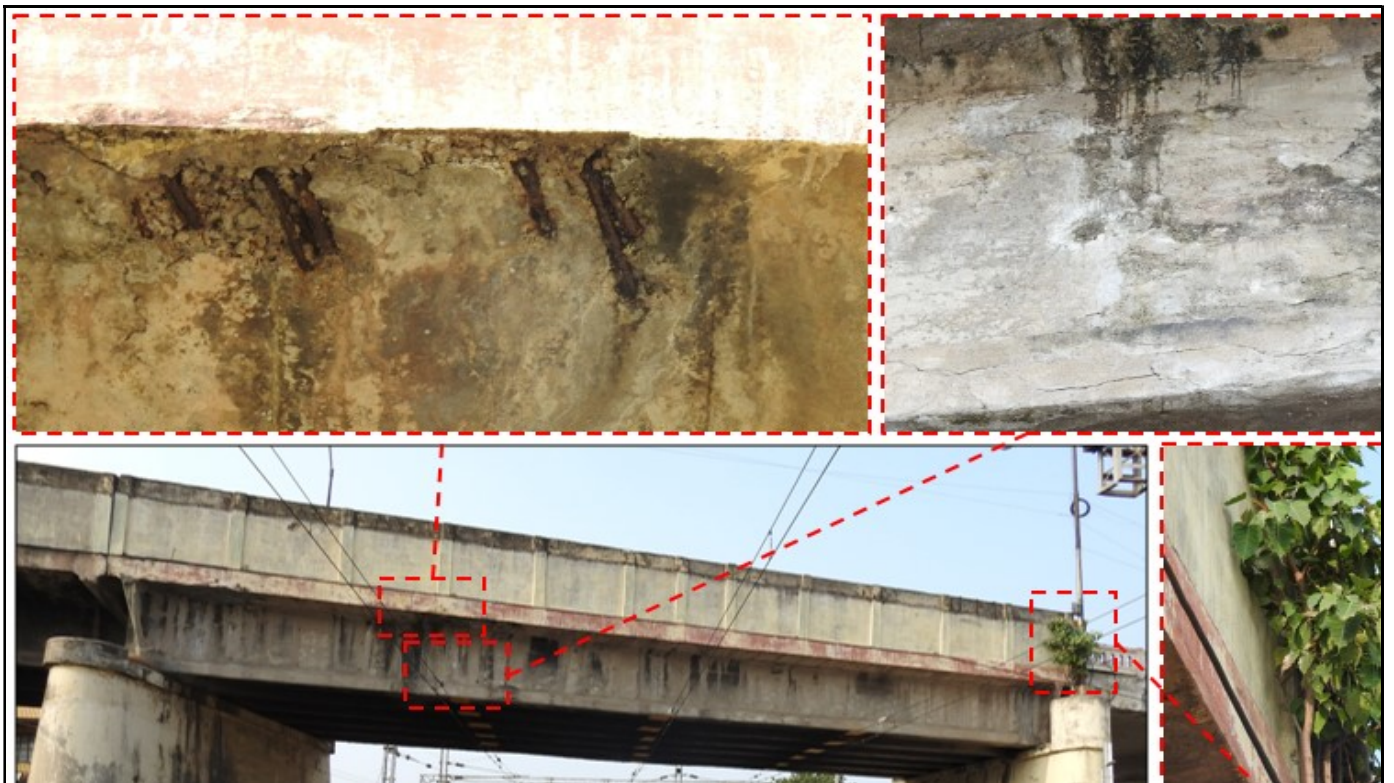
Fig.12 : Reinforced exposed, cracks and vegetation observed at overhang slab portion of span-4 .

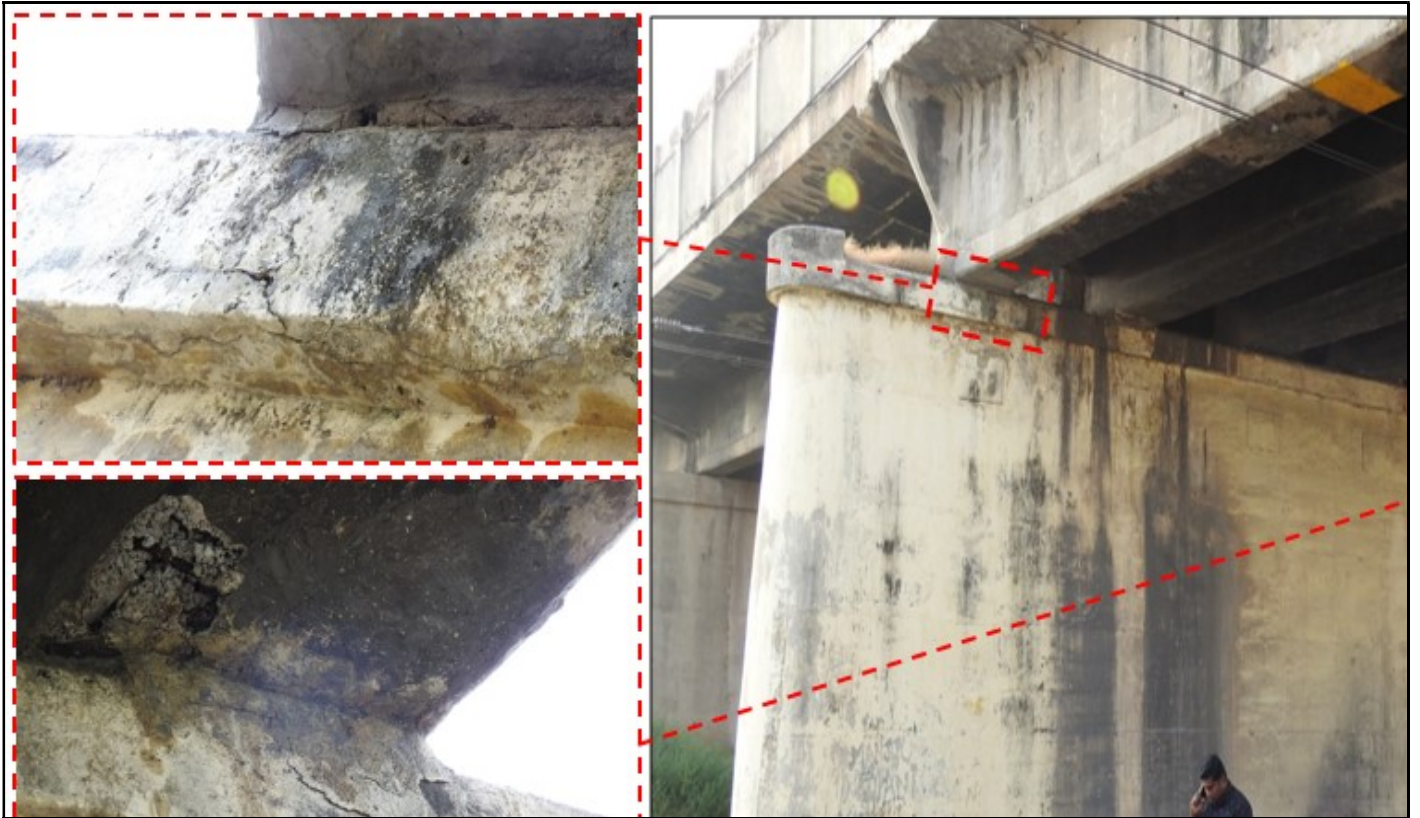
Fig.13 : Spalling , cracks and Reinforcement exposed observed at Pier cap and girder joint of Pier-4 .

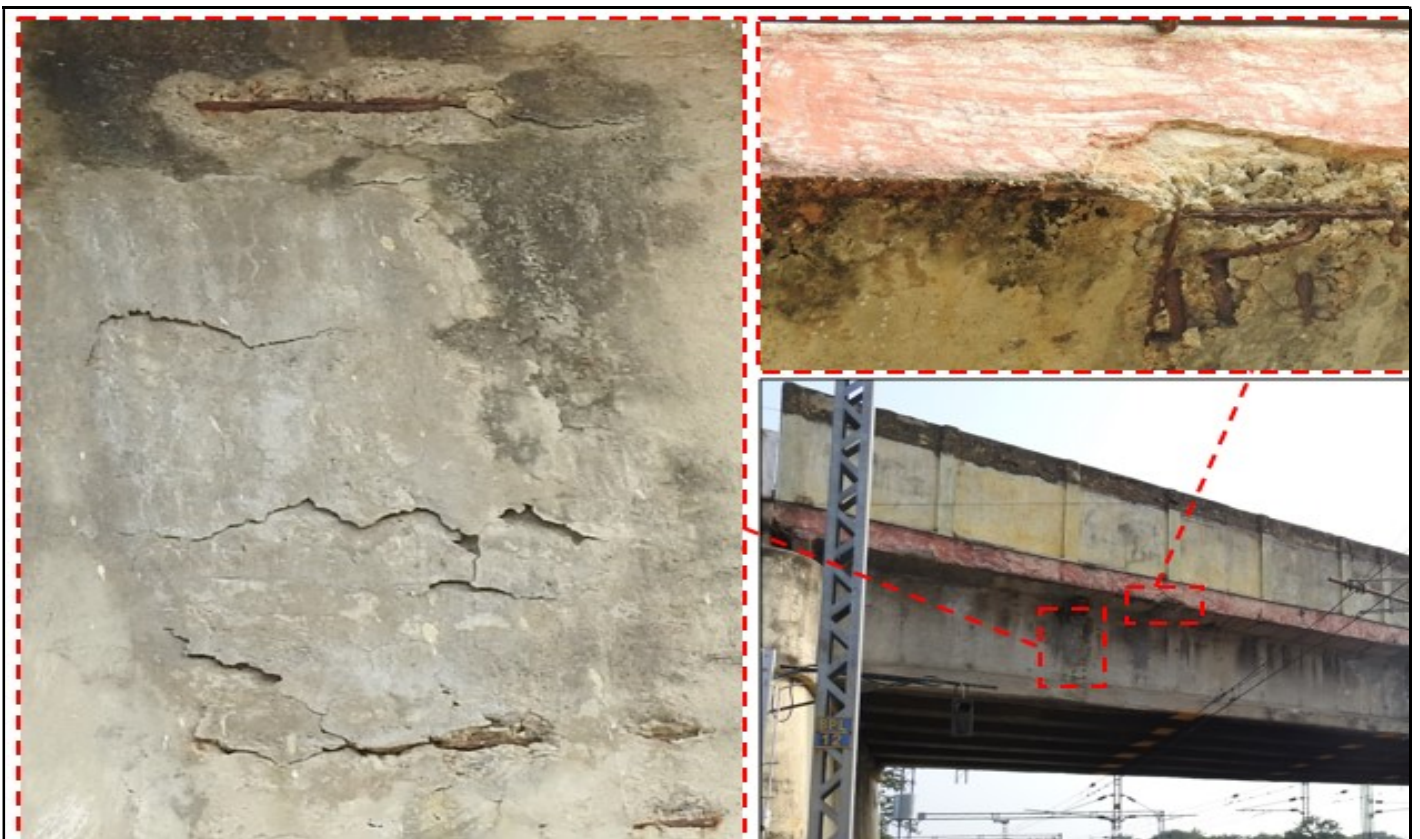
Fig.14 : Spalling and Reinforcement exposed observed at span-4 overhang slab portion .

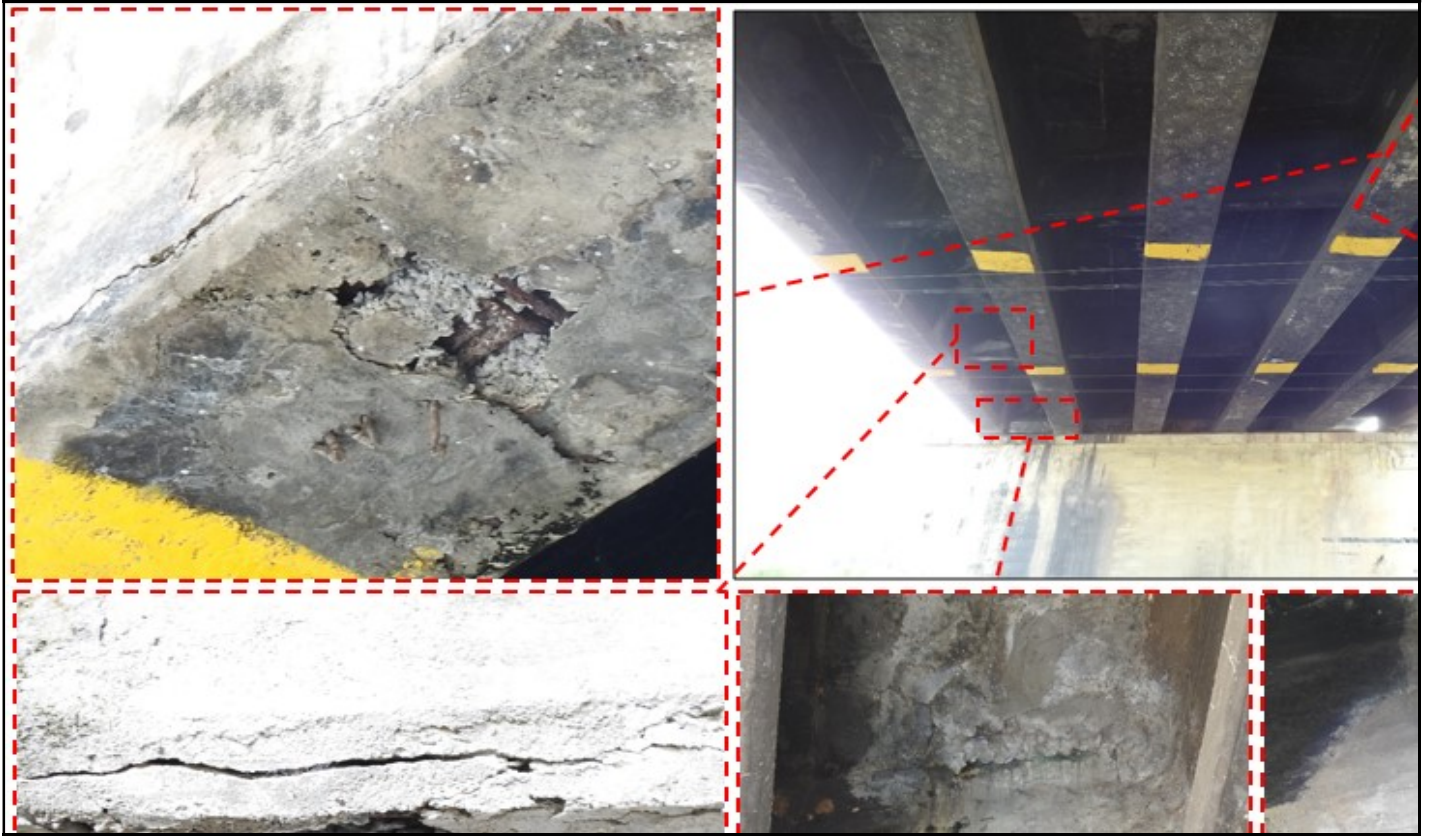
Fig.15 : Reinforcement exposed , Spalling , leaching and patch work observed at main & Secondary girders of span-4 .

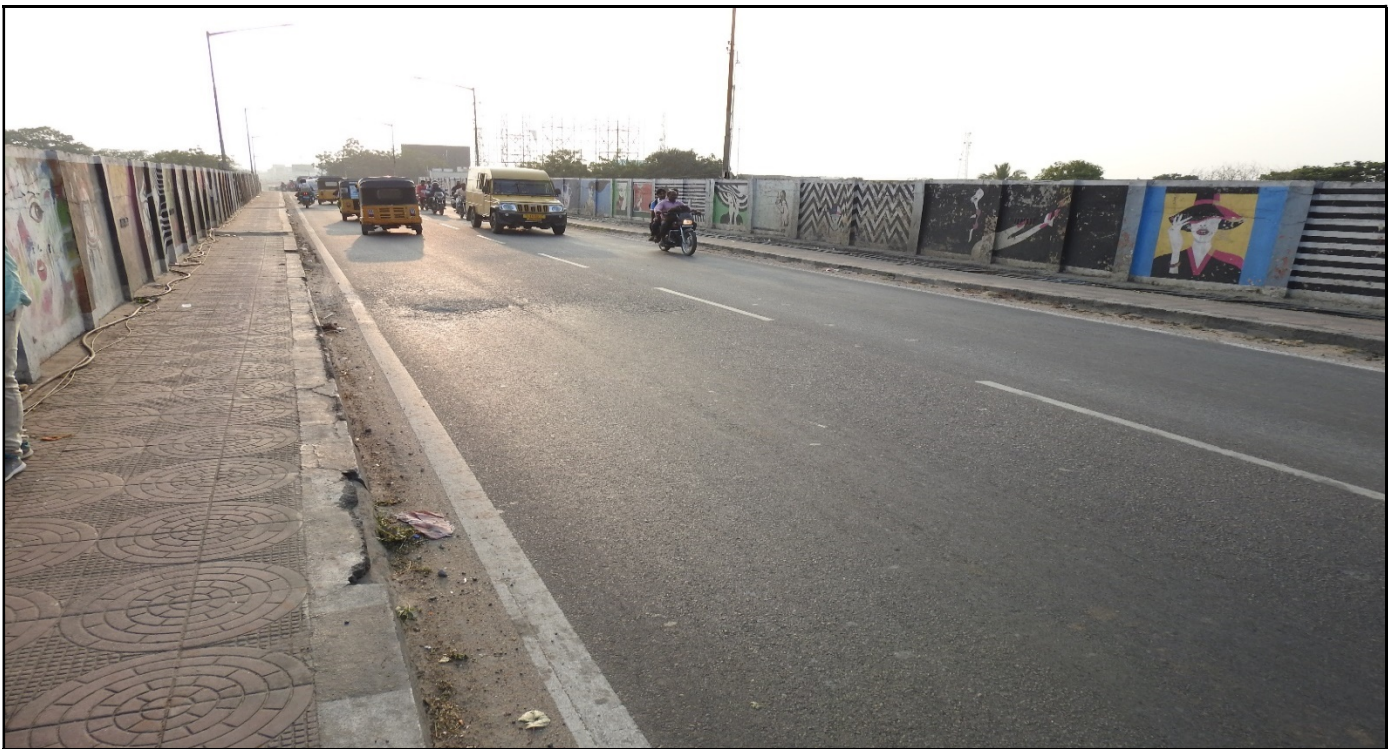
| | Condition of Wall/Railing | | No hitting damages observed. |

Fig.16 : Road surface, Parapet wall
