| <b>Name of the Project</b> | <b>:</b> | <b>VISUAL INSPECTION OF ROB-378</b> |
| <b>Location</b> | <b>:</b> | <b>NEAR MALLIAL</b> |
| <b>Date of Inspection</b> | <b>:</b> | <b>30<sup>th</sup> NOVEMBER, 2019</b> |

### VISUAL INSPECTION OF ROAD OVER BRIDGE

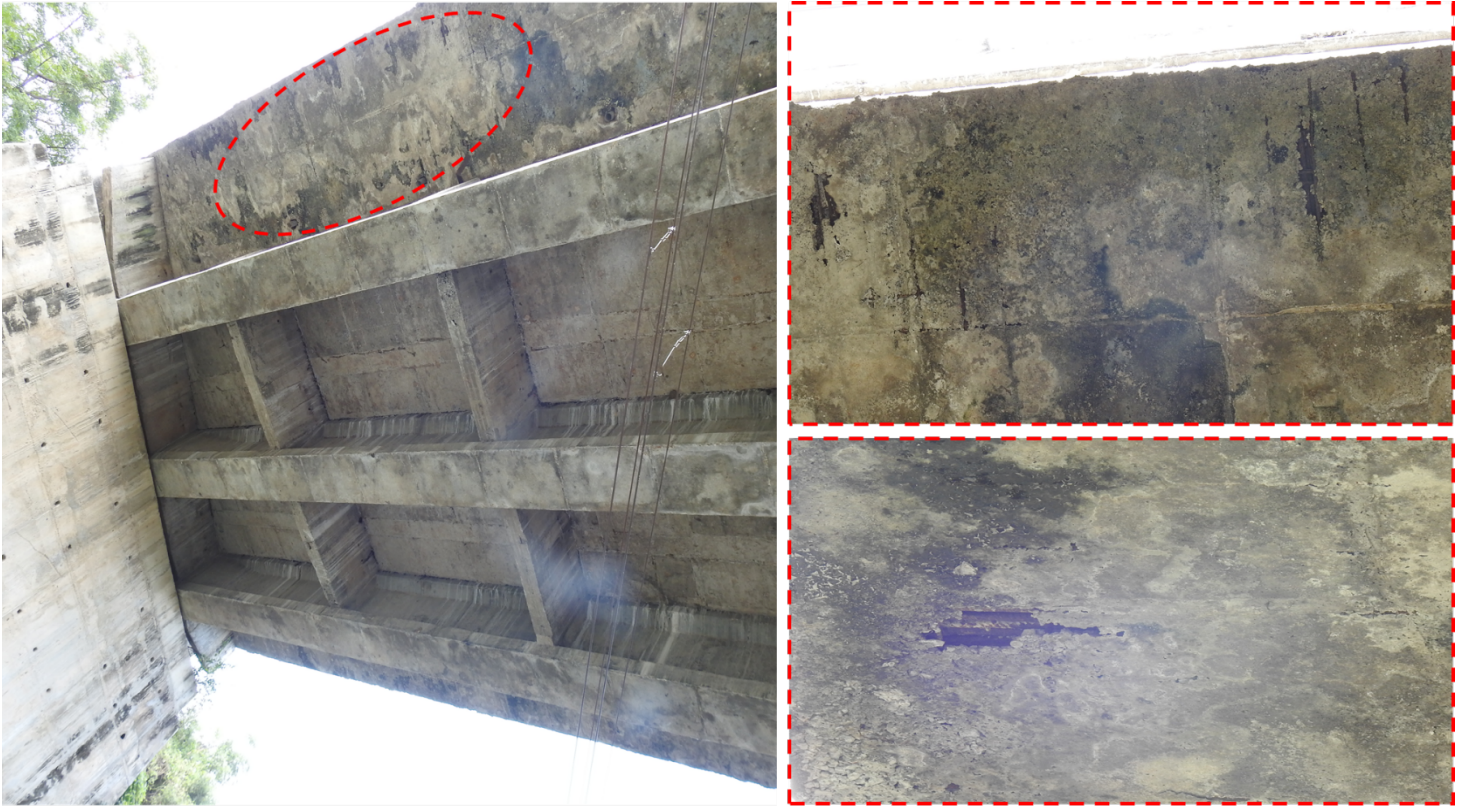
| | Condition of Slab from Bottom | | Leaching and Reinforcement visible due to less cover at overhang portion of slab. |

**Fig 4: Reinforcement visible at overhang portion of slab**

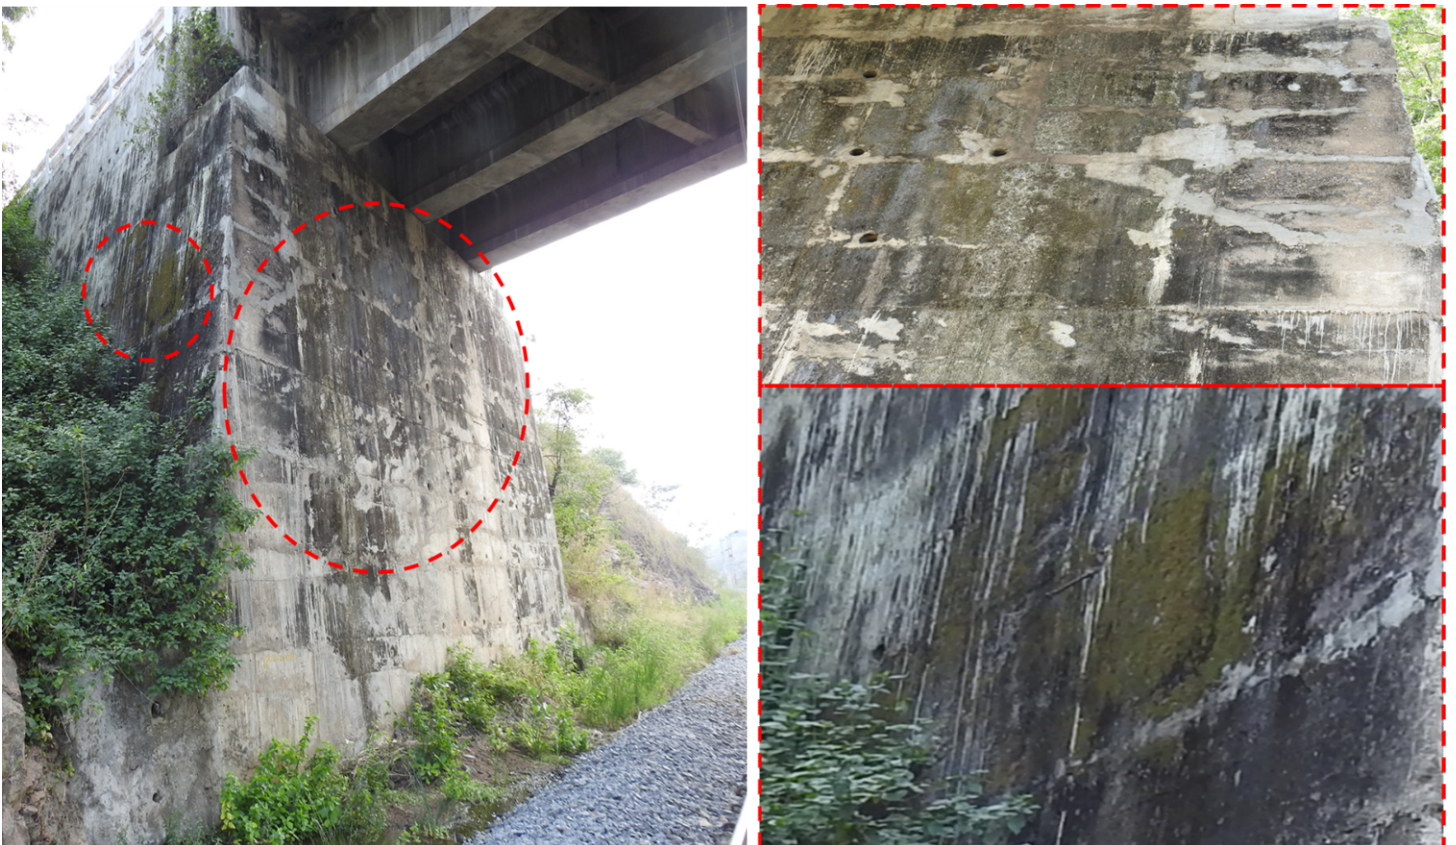
| | | | Notes |
|---|---|---|---|
| | Condition (Crack, Settlement, Scour, Tilting, Steel Corrosion, Strains and other damages etc...) | Leaching observed. | Leaching and algae formation observed (Refer Fig-5) |

**Fig 5: Leaching and algae formation observed at Abutment**

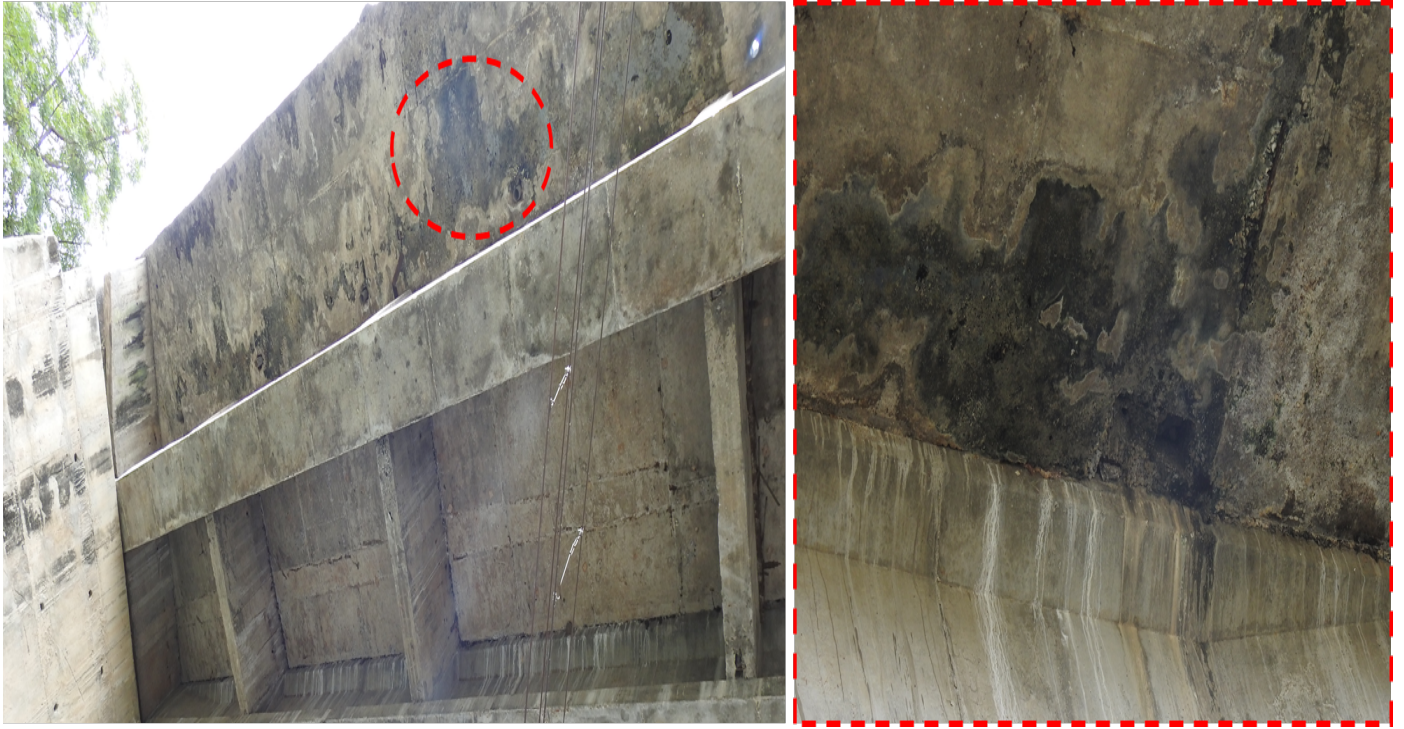
**Fig 6:** Leaching observed at overhang portion of Slab

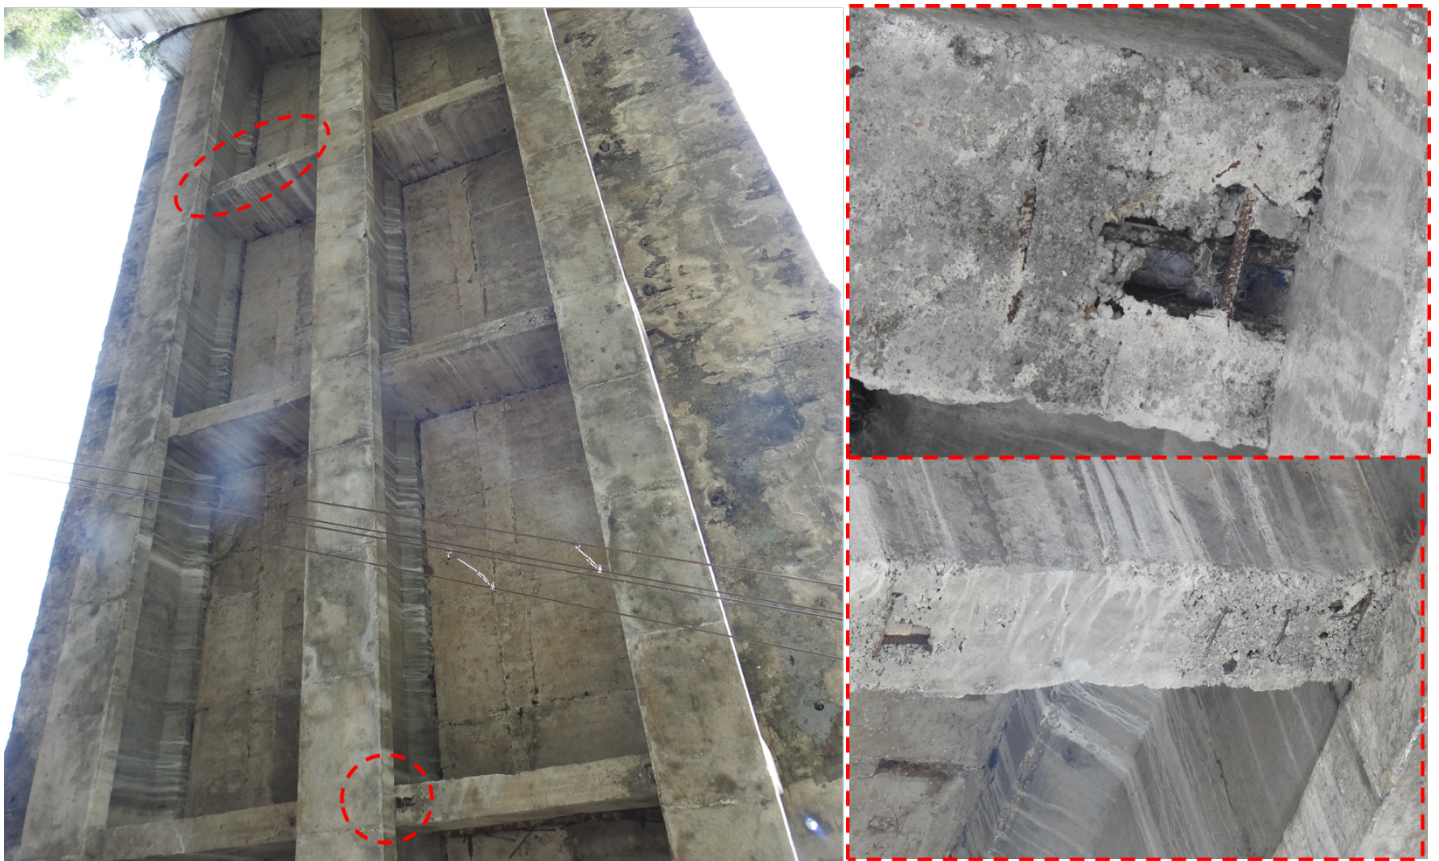
| | Condition of Secondary Girder | | Reinforcement visible. (Refer Fig-7) |

**Fig 7:** Reinforcement visible at Cross girders

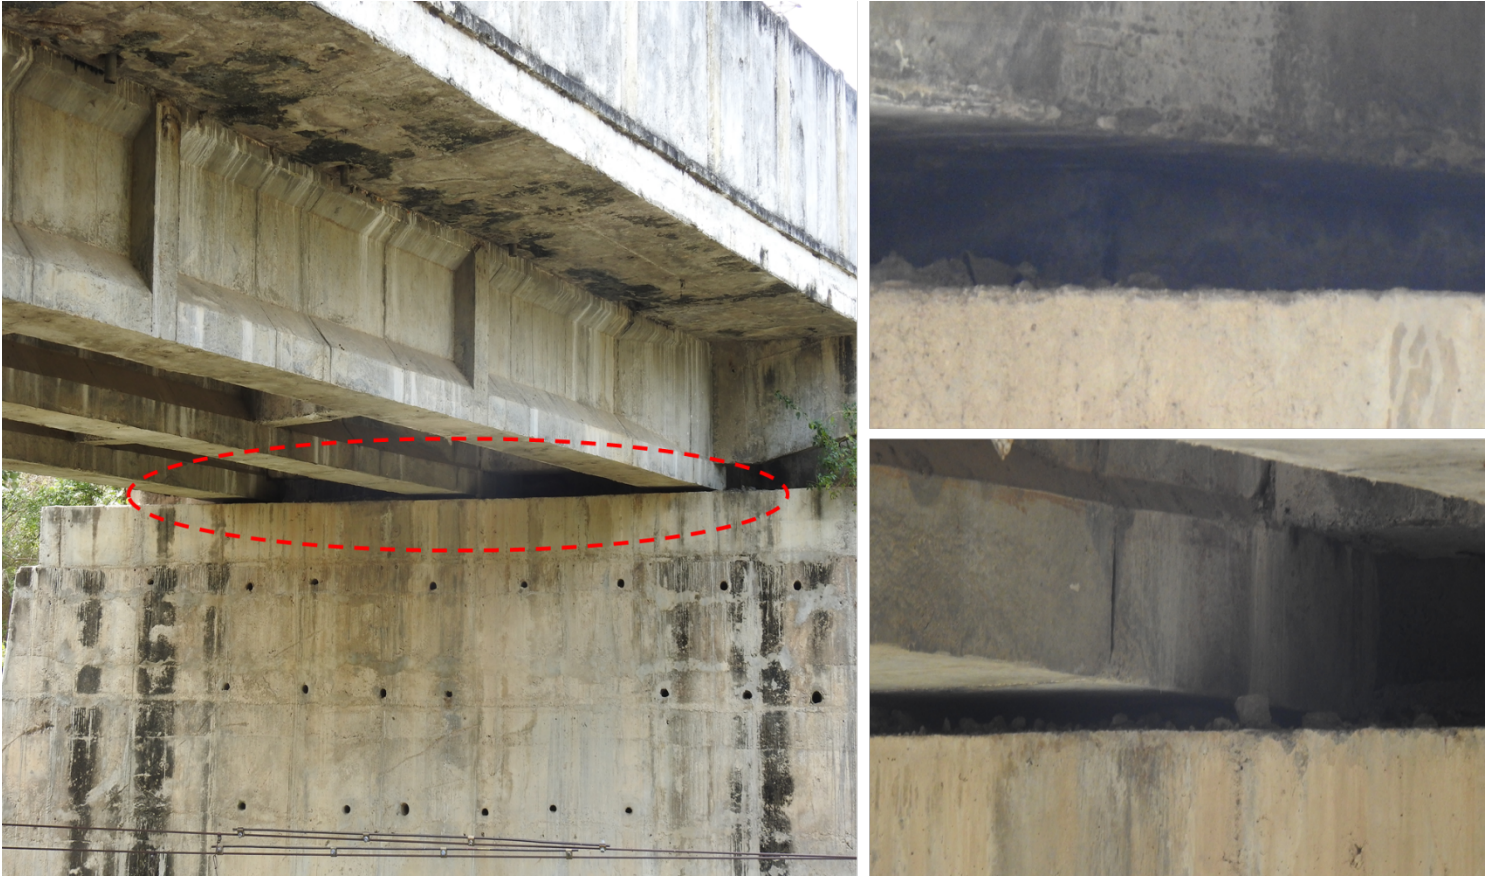
**Fig 8:** Bearing details

| | General condition (Check Corrosion, cleanliness, seizing of plates silting, accumulations of dirt in case of submersible bridges) | | Bearings distressed (Refer Fig-8) |

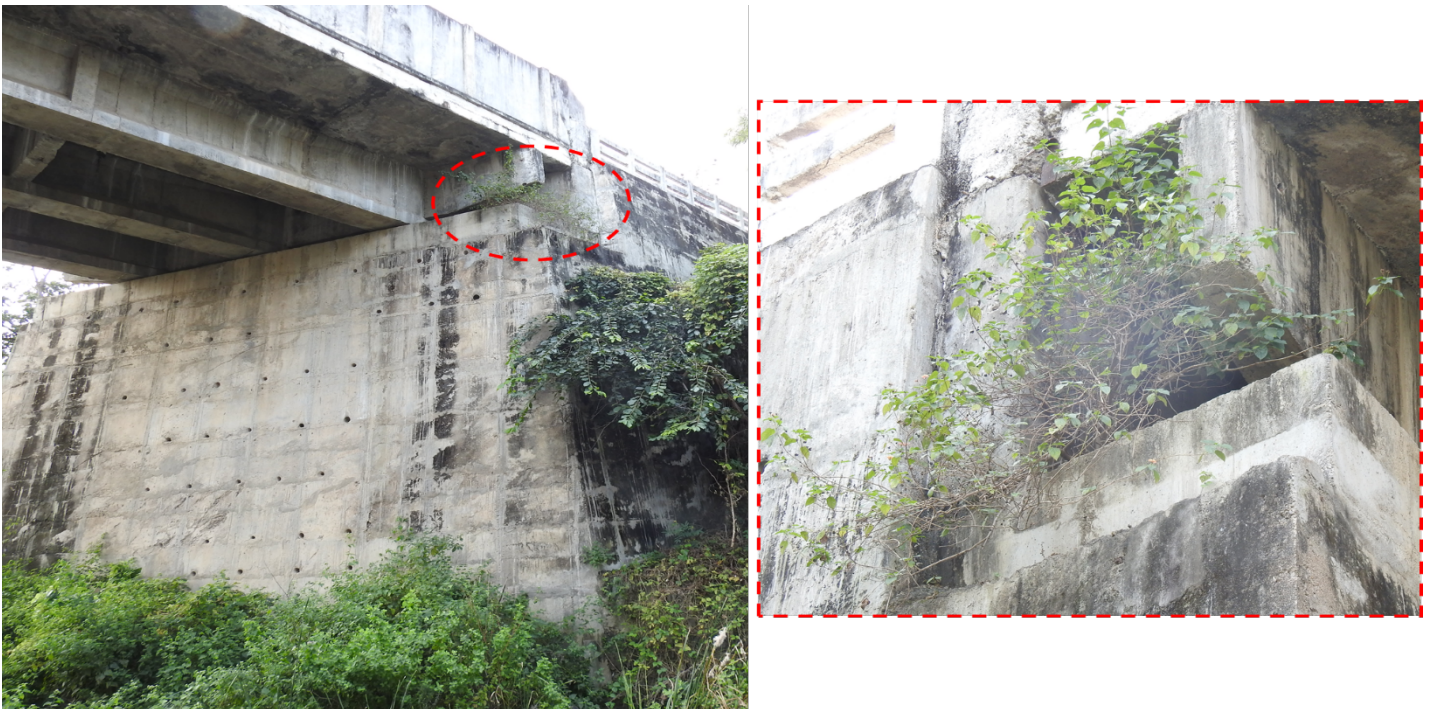
**Fig 9:** Vegetation observed at abutments

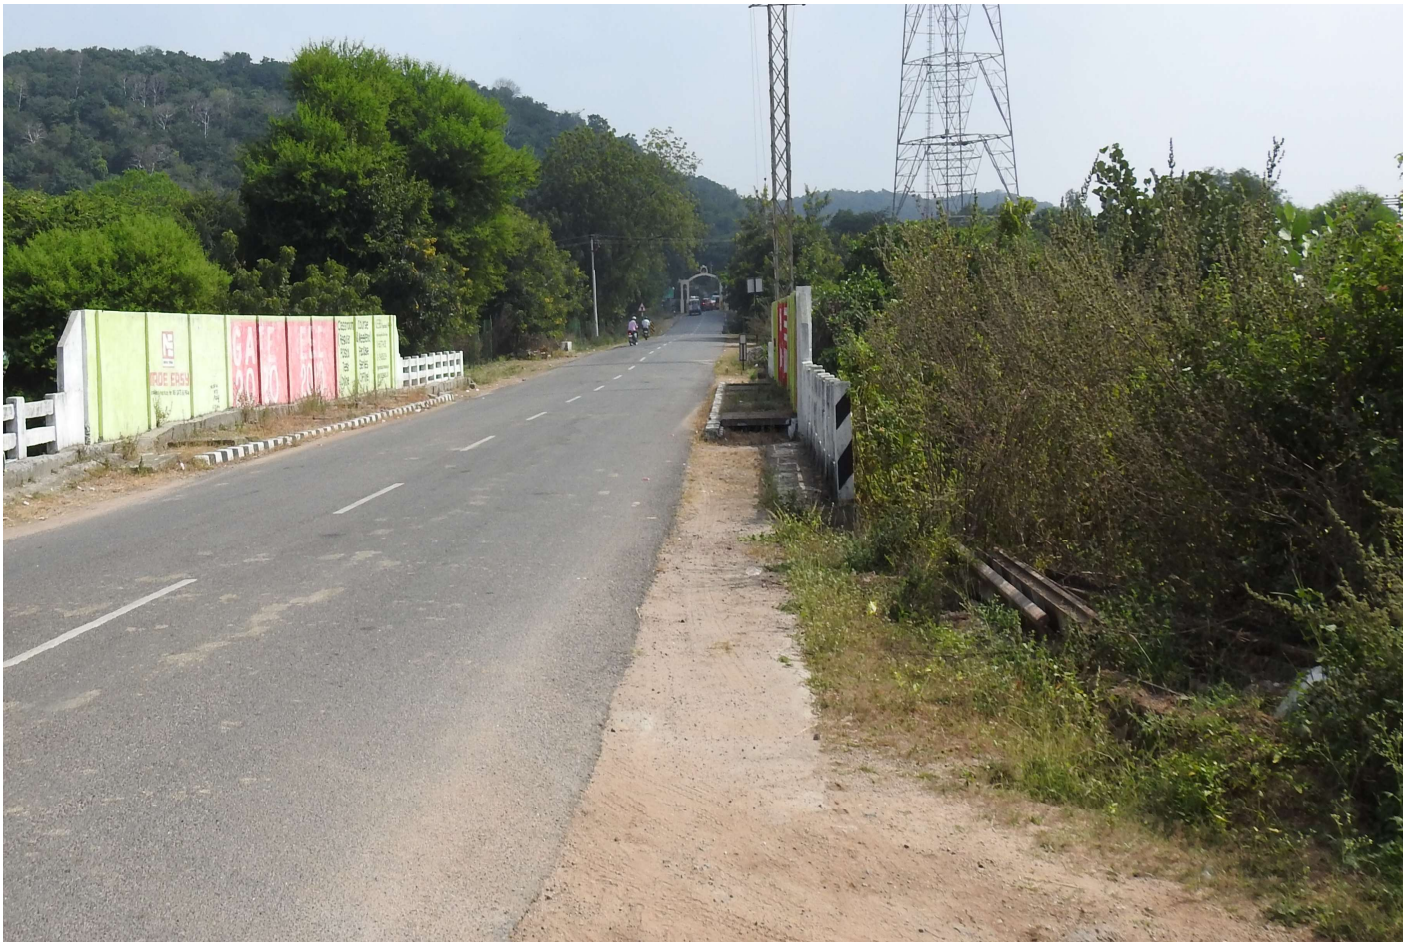
***Fig 10: Road surface & Parapet wall***

| | Condition of Flooring/Wearing Coat | | Fair condition (Refer Fig-10) |
| | Condition of Wall/Railing | | No Accidental hit marks are observed on wall (Refer Fig-10) |
