# STRUCTURAL HEALTH ASSESSMENT & REHABILITATION OF ROB

Mettuguda (254B)

February | 2020

| <b>Name of the Project</b> | <b>:</b> | <b>VISUAL INSPECTION OF ROB - (254B)</b> |

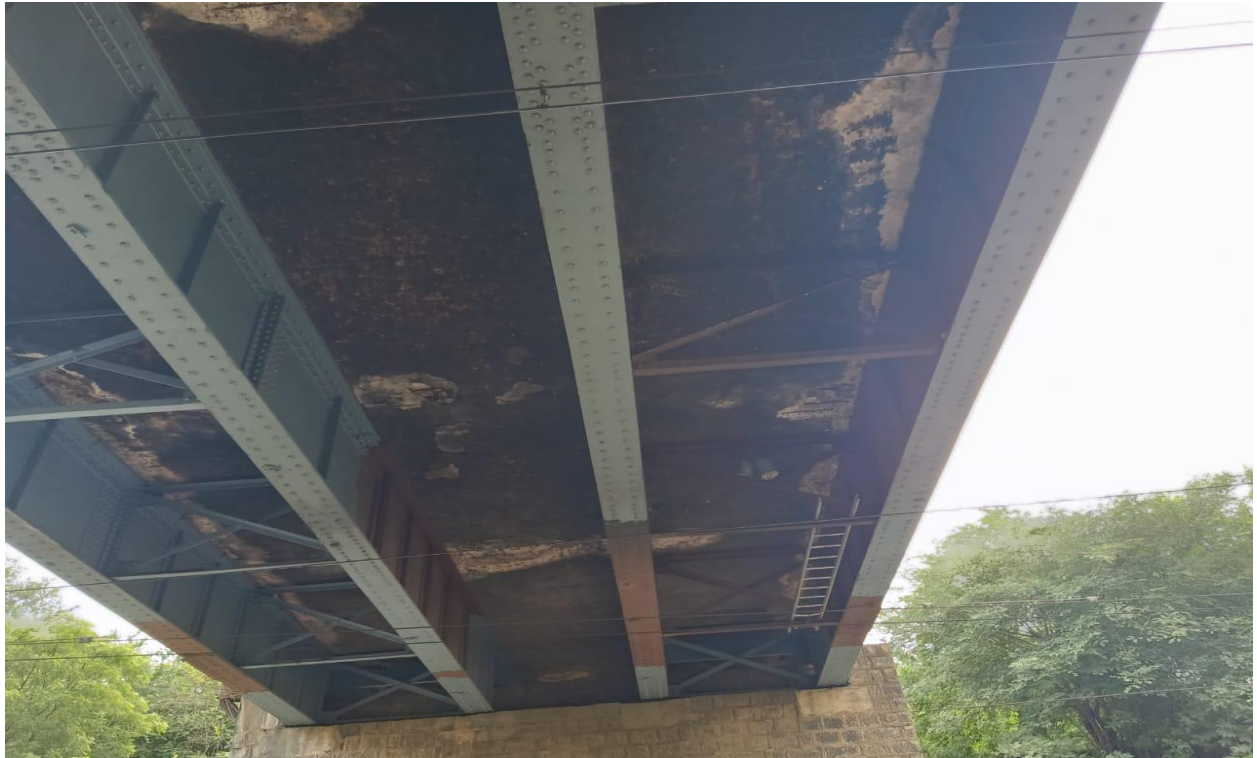
**Fig:2** Bottom view of Slab

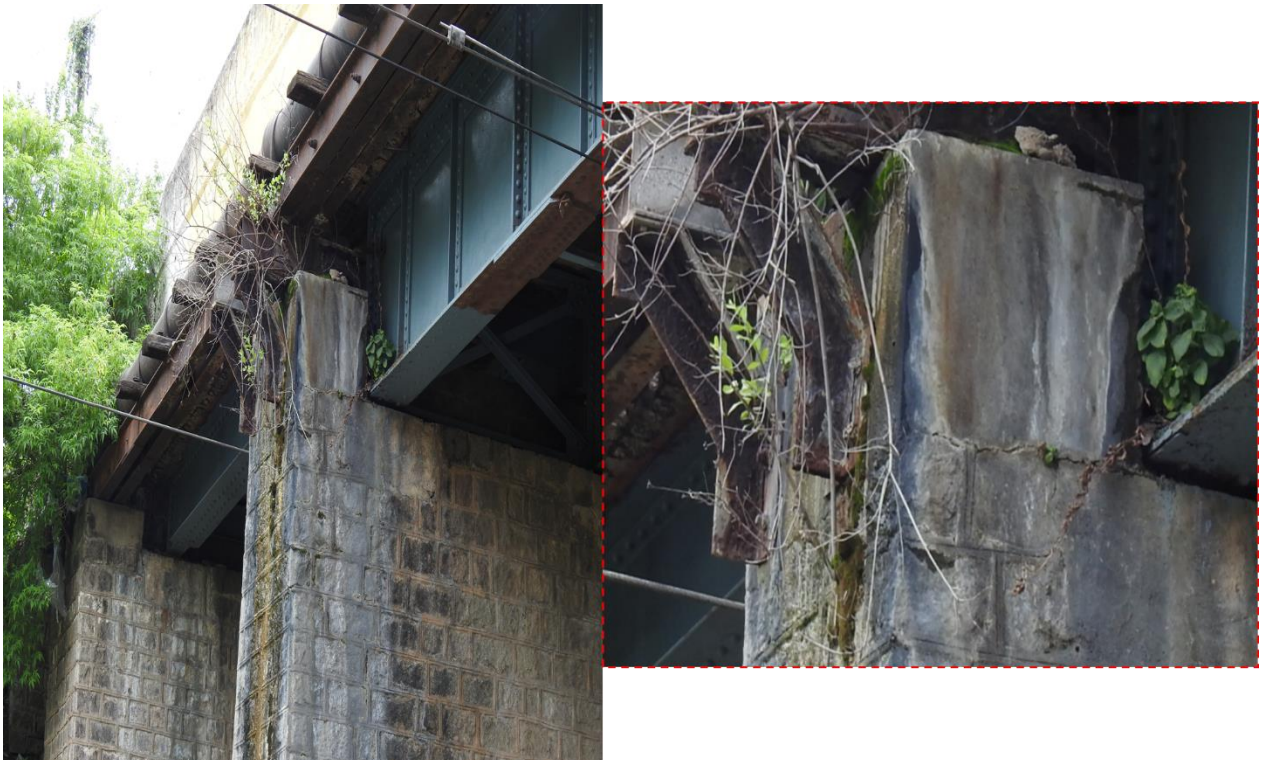
| 1.2 STRUCTURAL SYSTEM OF THE BRIDGE | | | |
|---|---|---|---|
| | Type (Shape) | wall | Leaching and Algae formation and vegetation growth has been observed on piers. |

| 1.3 SURVEY OF SIGNS OF DISTRESS, DEFORMATION IN BRIDGES | | | |
|---|---|---|---|
| | Cracking in RCC components | Pier cap | cracks are observed at pier cap ( <i>Refer Fig:11</i> ) & Pier ( <i>Refer Fig:3</i> ) |

**Fig: 3** Vegetation, algae growth, leaching and cracks observed at Piers

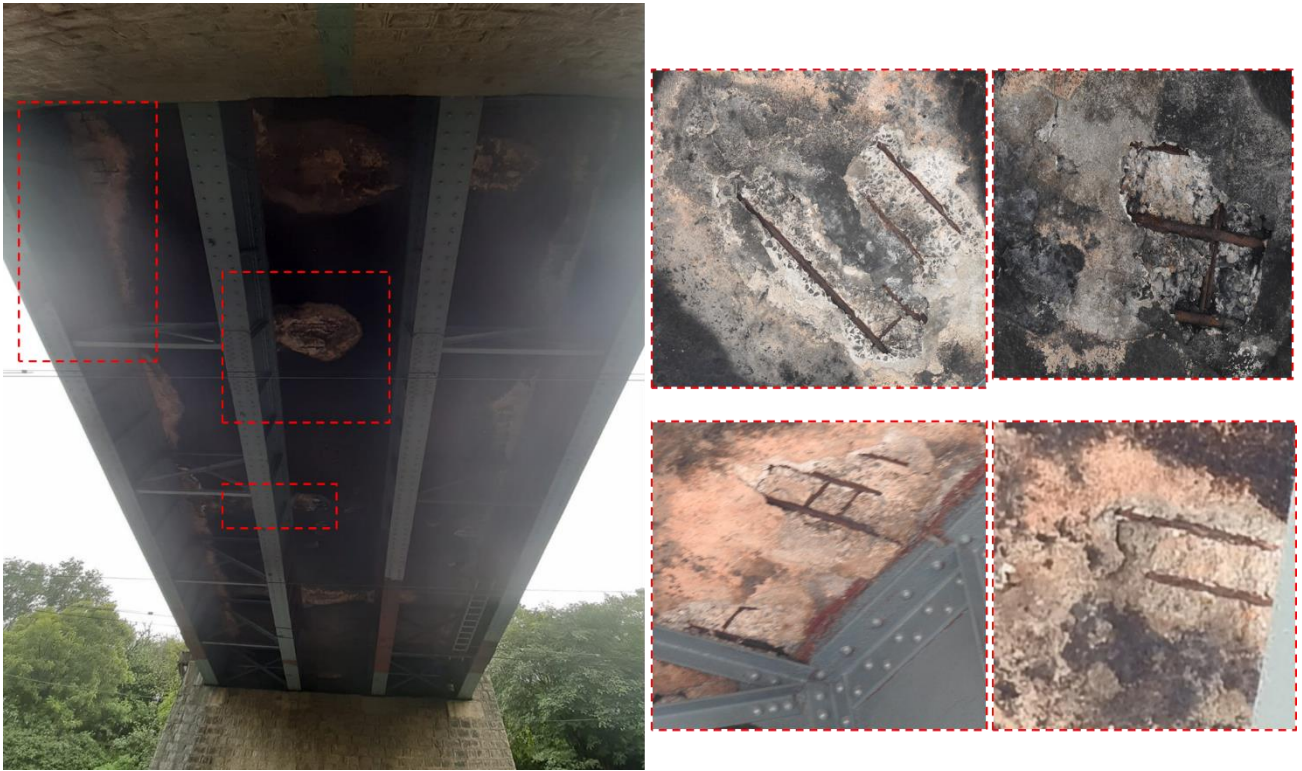
| | Condition of Slab from Bottom | Distresses Found | Spalling & Reinforcement exposure has been Observed. (Refer Fig:4, 5) |

| 1.3 SURVEY OF SIGNS OF DISTRESS, DEFORMATION IN BRIDGES | | | |
|---|---|---|---|
| | Spalling | Slab | Spalling is observed in Slabs. ( <i>Refer Fig:4, 5</i> ) |

**Fig: 4** Exposed reinforcement observed in span 2

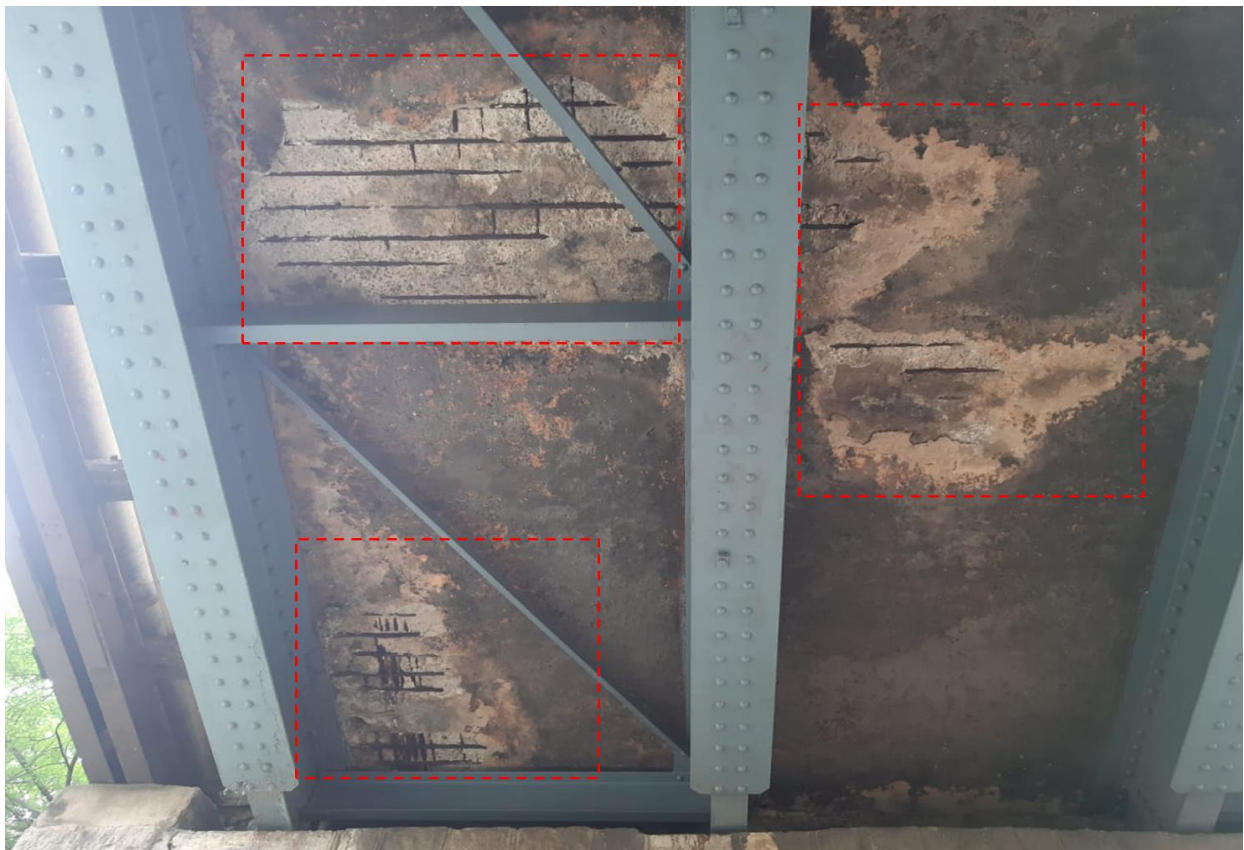
**Fig: 5** Exposed reinforcement observed in span 3

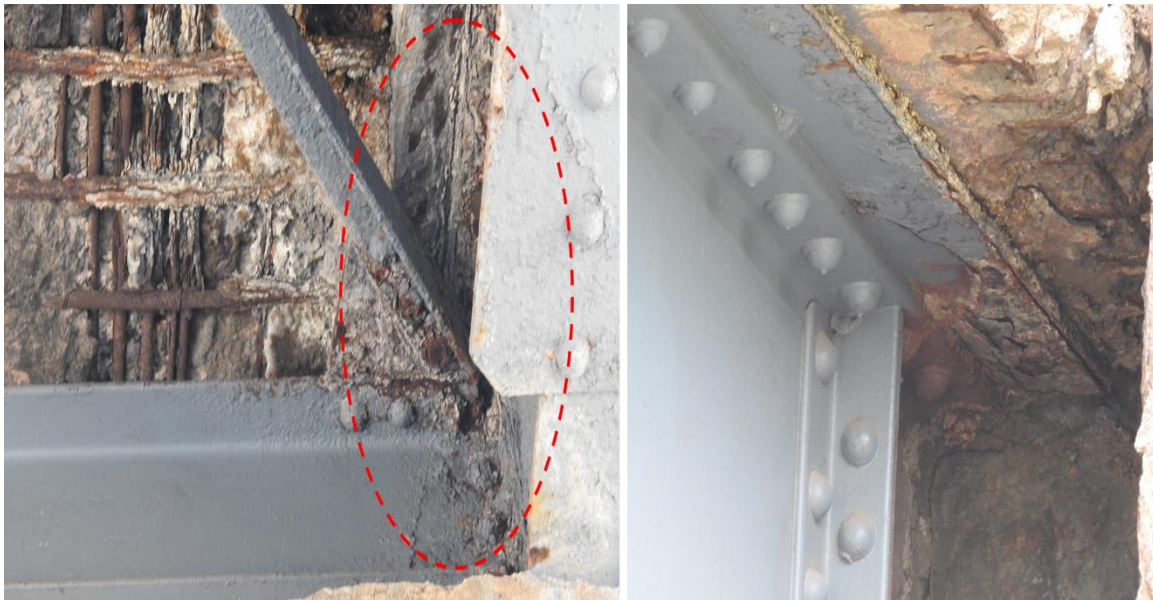
| | Condition of Girder | Distresses Found | corrosion is observed in along steel concrete joint (Refer Fig:6) |

| 1.3 SURVEY OF SIGNS OF DISTRESS, DEFORMATION IN BRIDGES | | | |
|---|---|---|---|
| | Corrosion | Girder | Corrosion is observed at steel concrete joints of ( <i>Refer Fig:6</i> ) |

**Fig: 6** Corrosion observed at steel concrete joint, severe damage observed at rivet head

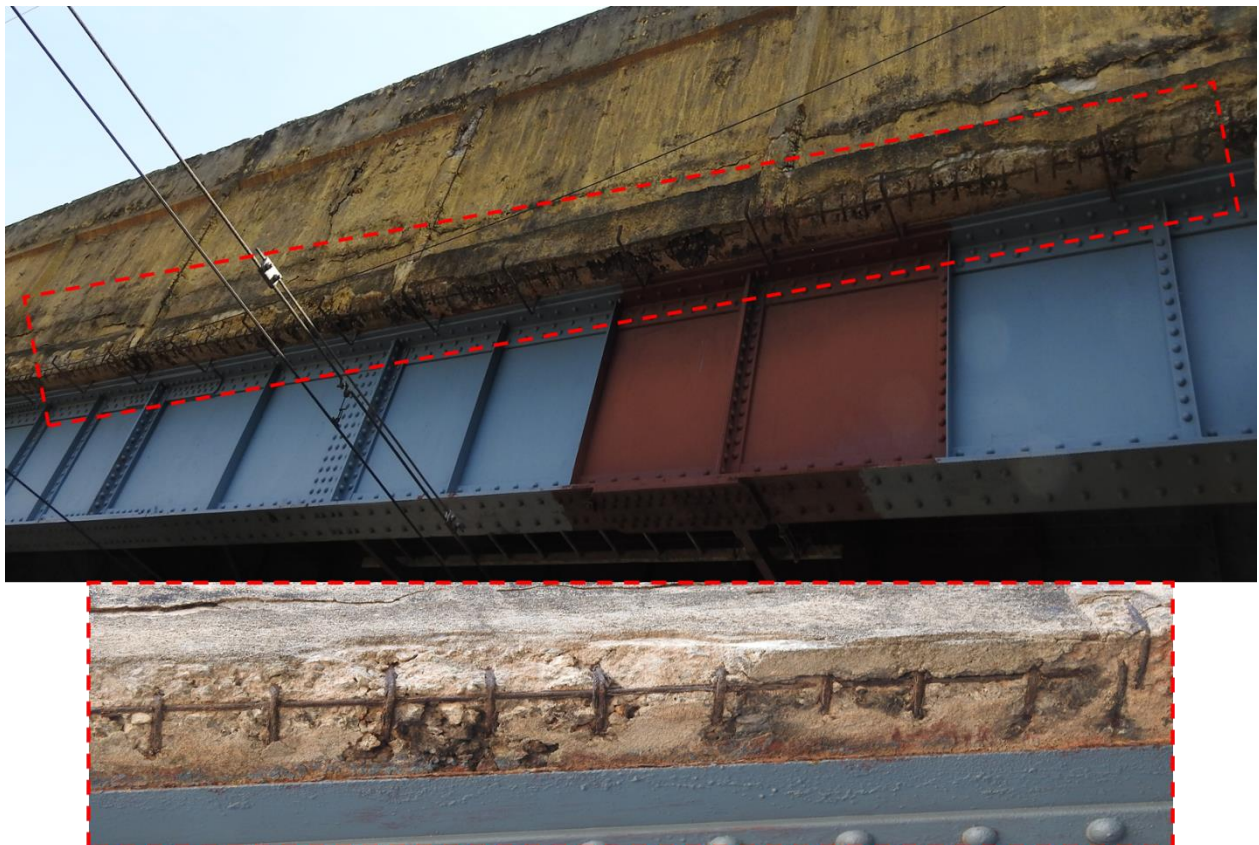
| 1.3 SURVEY OF SIGNS OF DISTRESS, DEFORMATION IN BRIDGES | | | |
|---|---|---|---|
| | Reinforcement Exposure | Slab | Reinforcement Exposure is observed in Slabs ( <i>Refer Fig:4,5,7</i> ) |

**Fig: 7** Spalling and reinforcement exposed at overhang portion of slab due to less cover

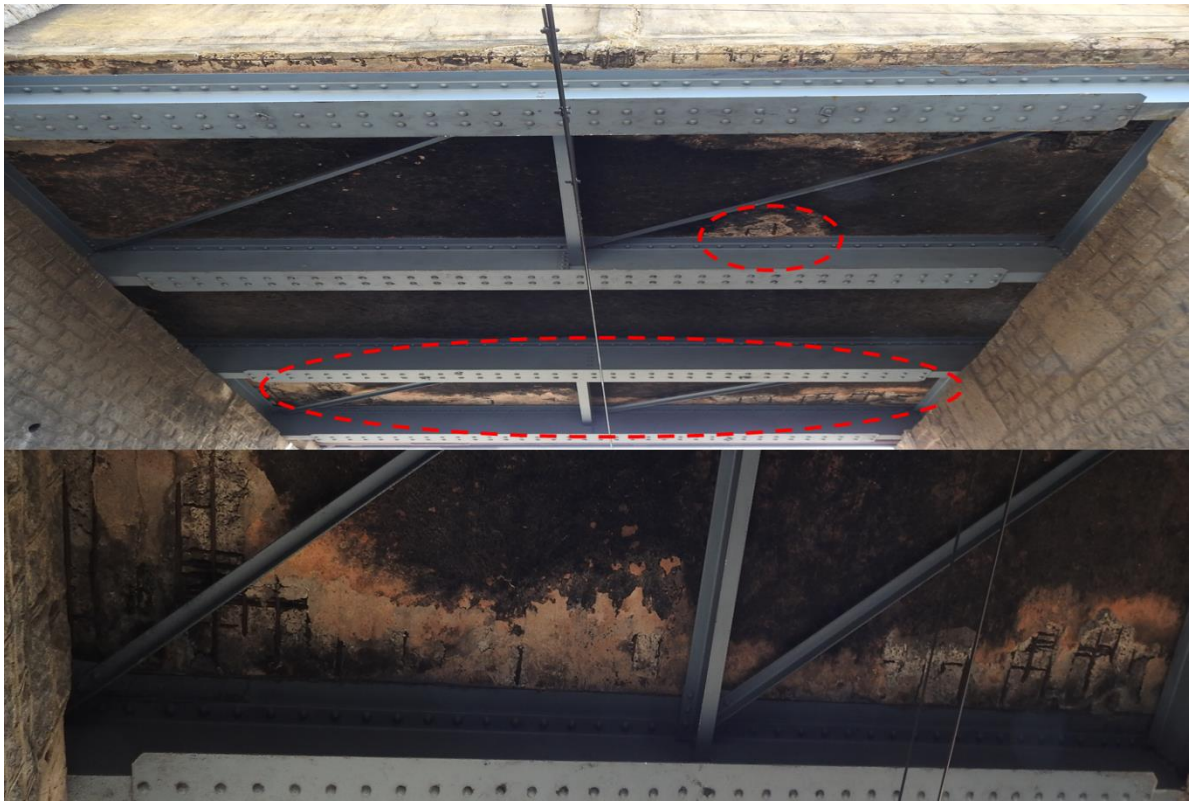
**Fig: 8** Spalling and reinforcement exposed at span 1

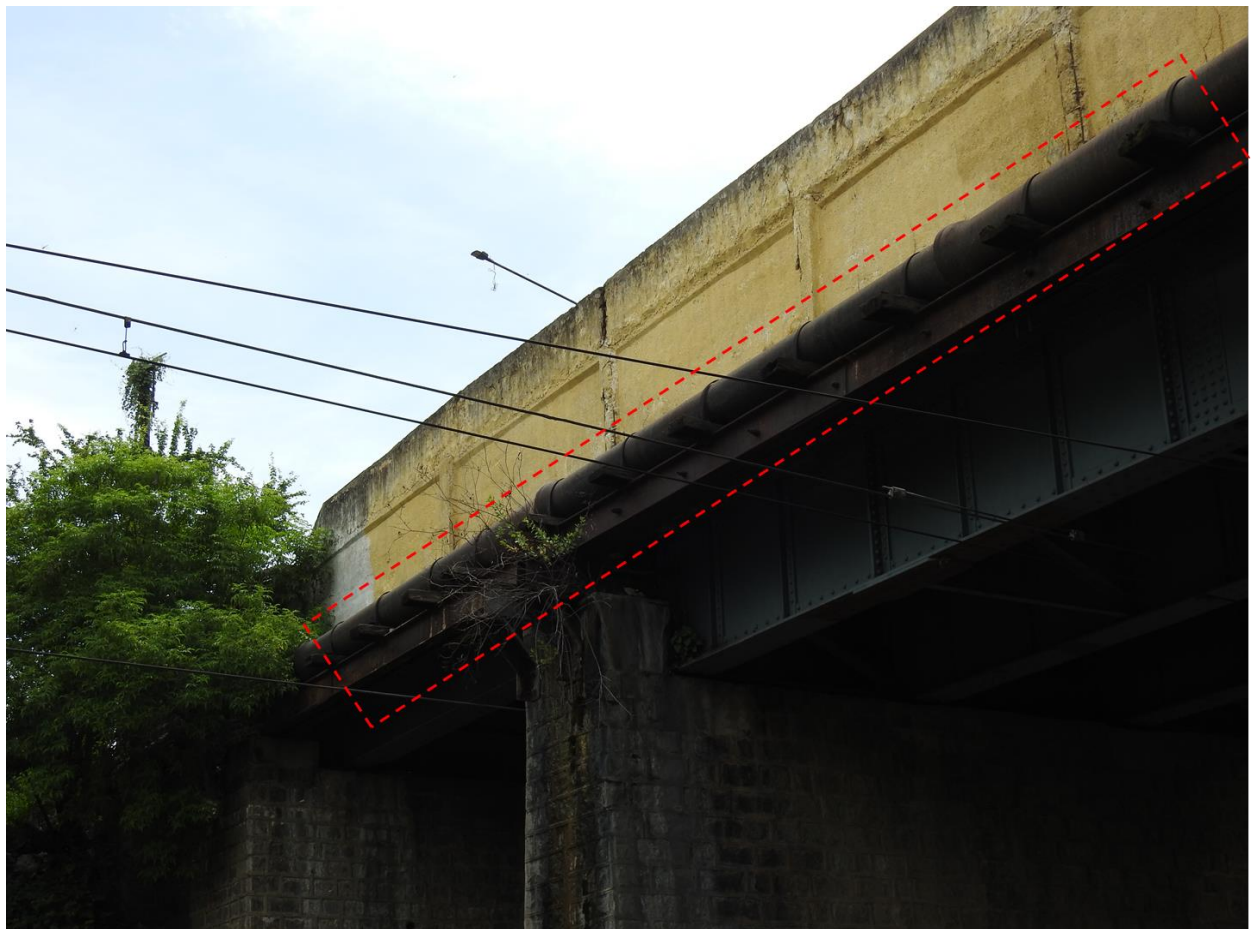
**Fig: 9** Additional load of utility is observed

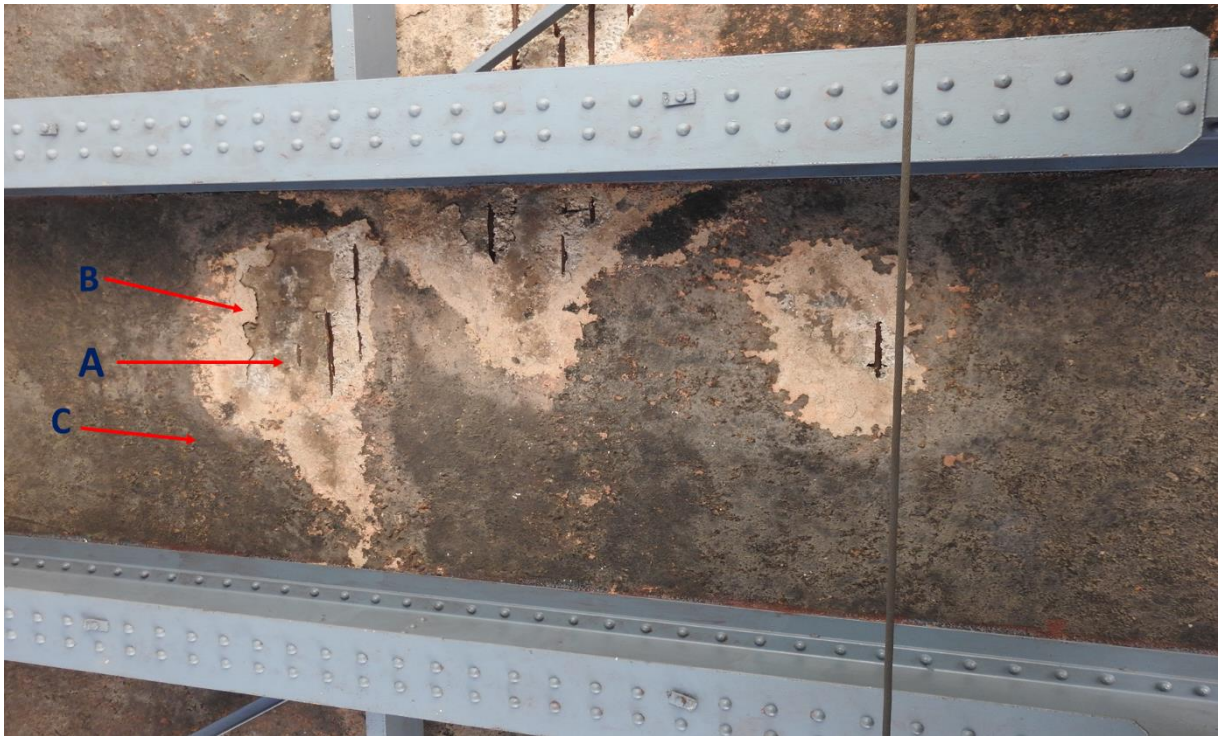
**Fig: 10** Patch work observed (A- original concrete, B-old patch work, C-new patch work)

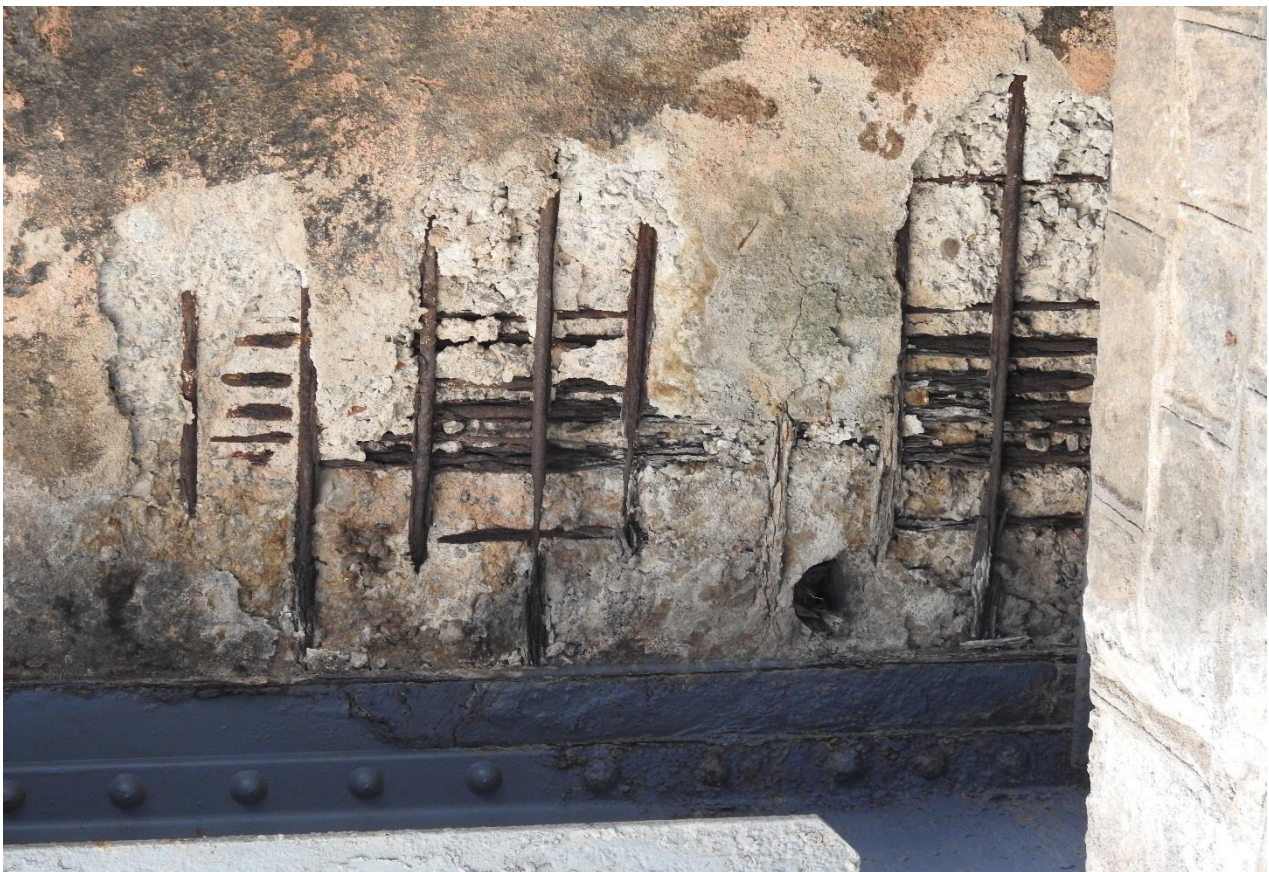
**Fig: 11** Reinforcement exposed due to Congested steel, caused no vibrations resulting voids.

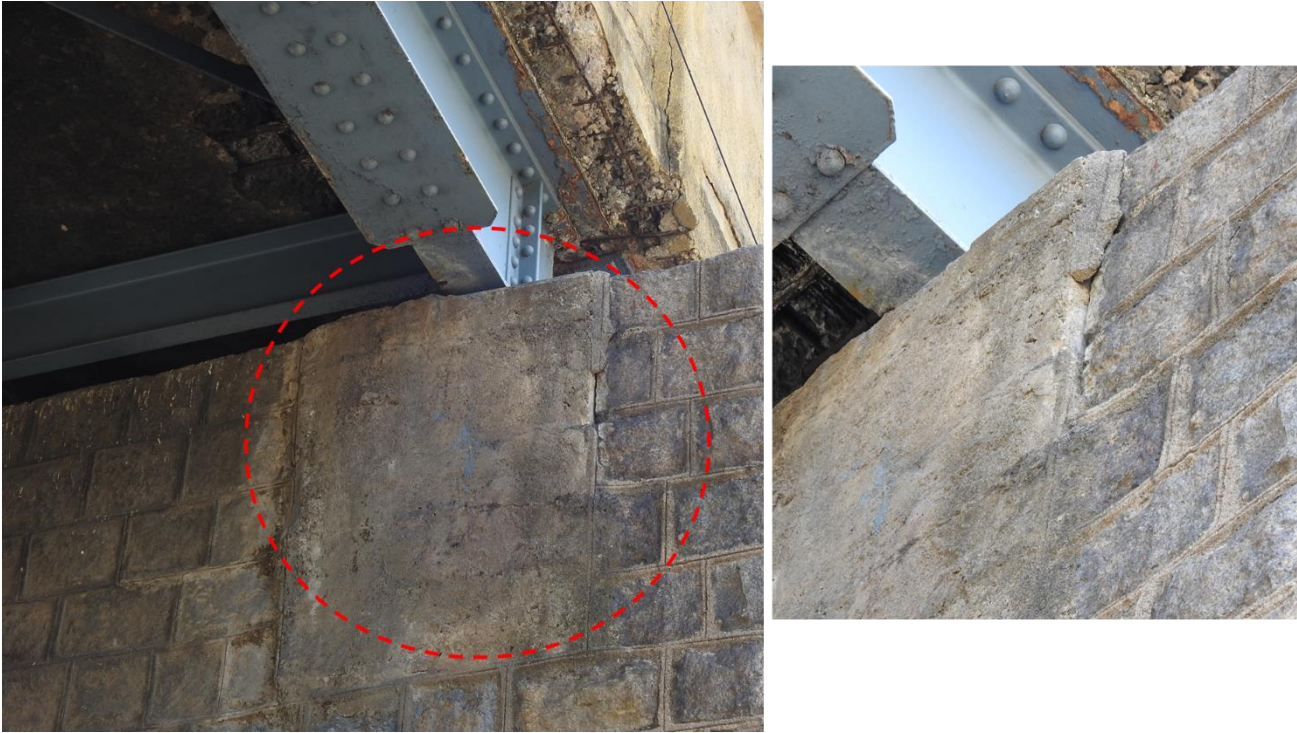
**Fig: 12** pointing failure observed at bed block

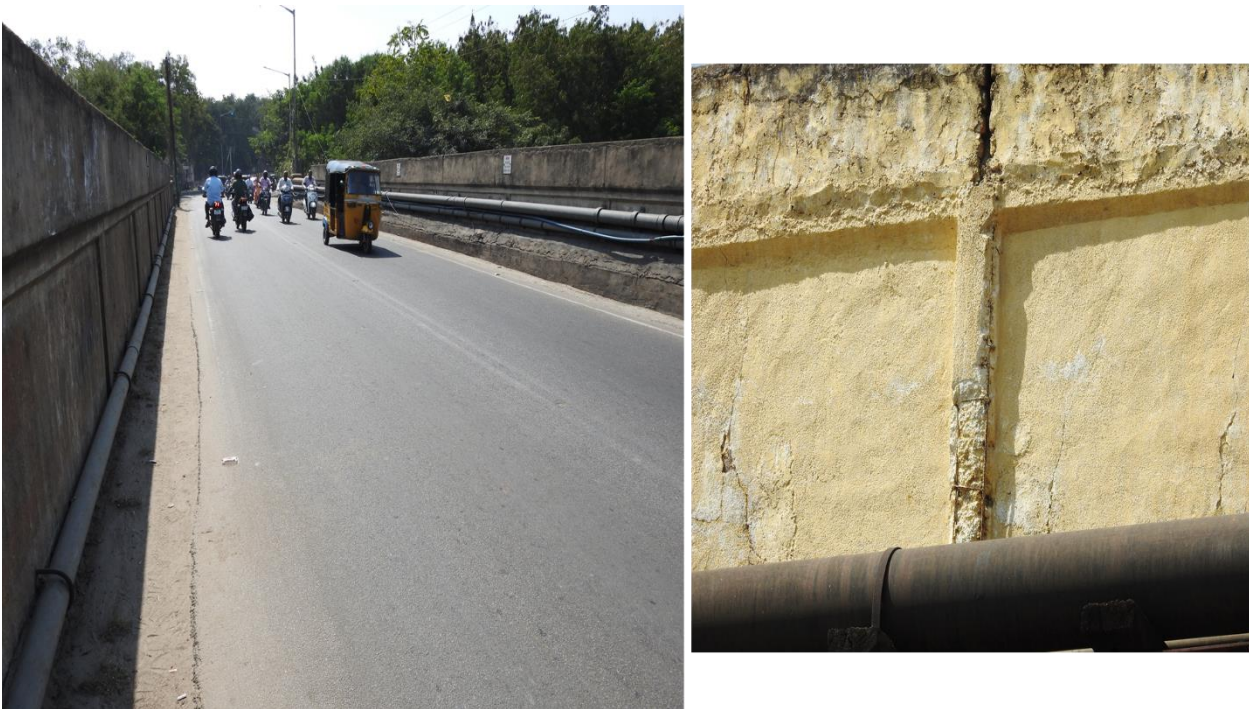
**Fig: 13** Wearing coat and parapet wall

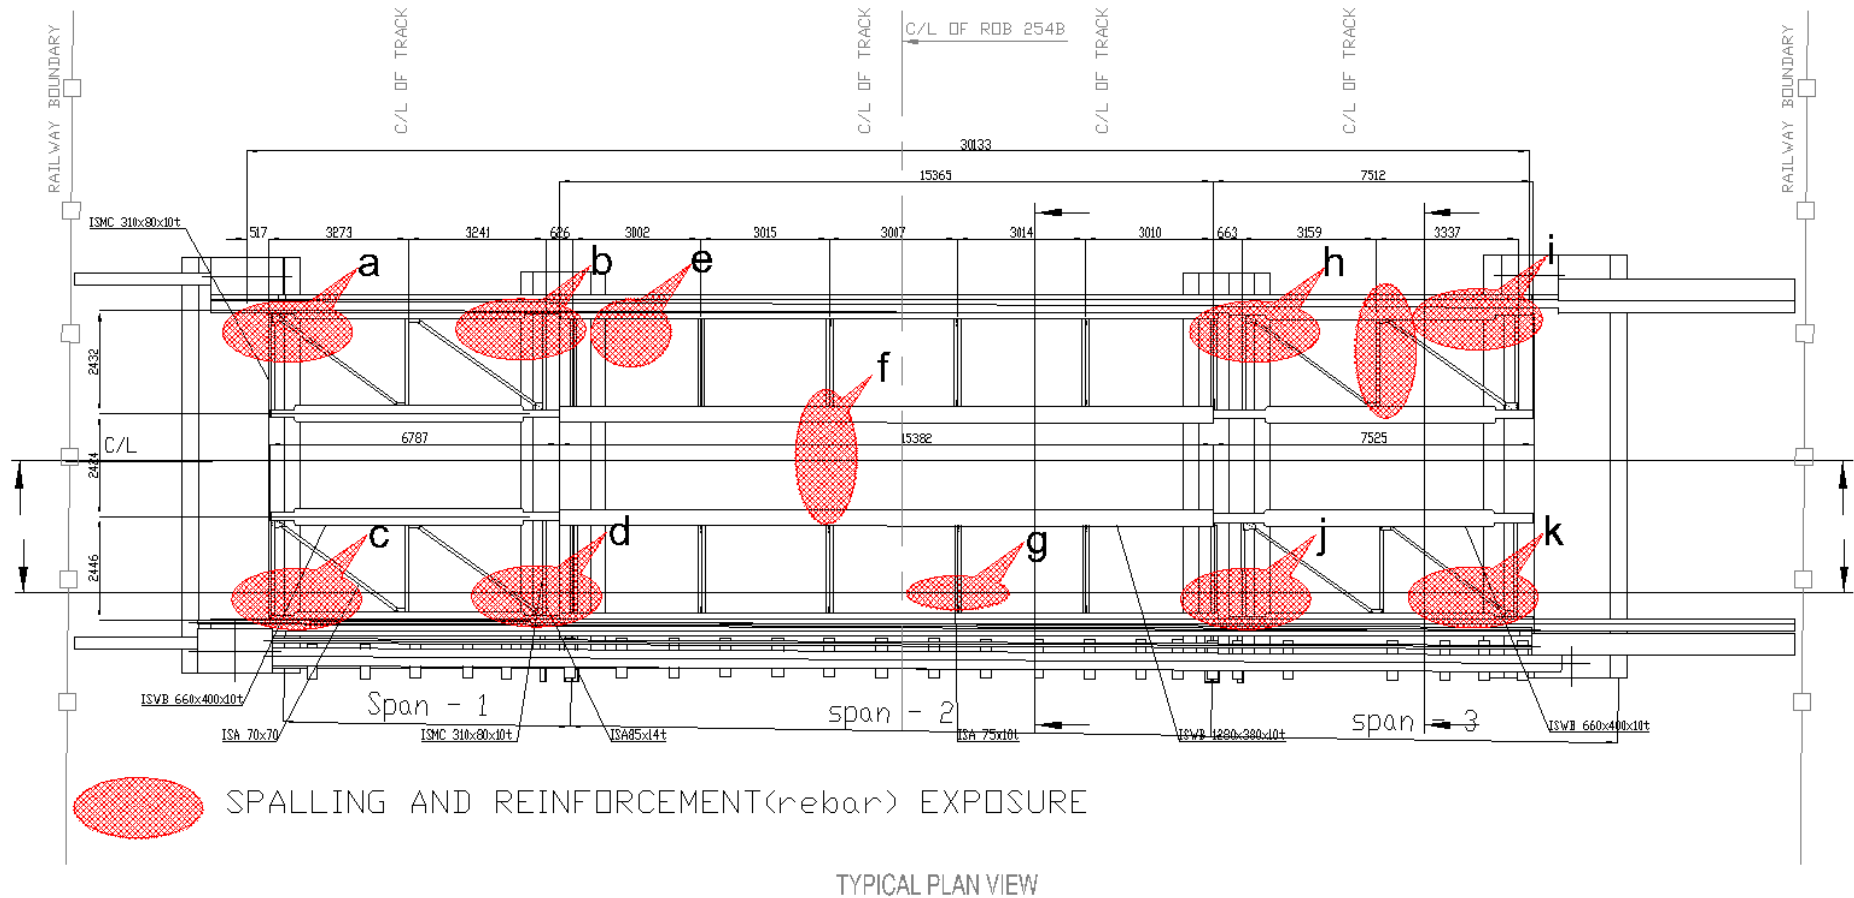
**Fig 14:** Bottom view of slab deck with reinforcement exposed (damaged) locations

During the detailed visual observation, is made of Deck slab on the above said locations and the following observations are made, excessive spalling was noticed in span 1, 2 & 3 in majority of the deck slab is effected with dampness, rebar corrosion and cracks were noticed at the steel concrete joints.

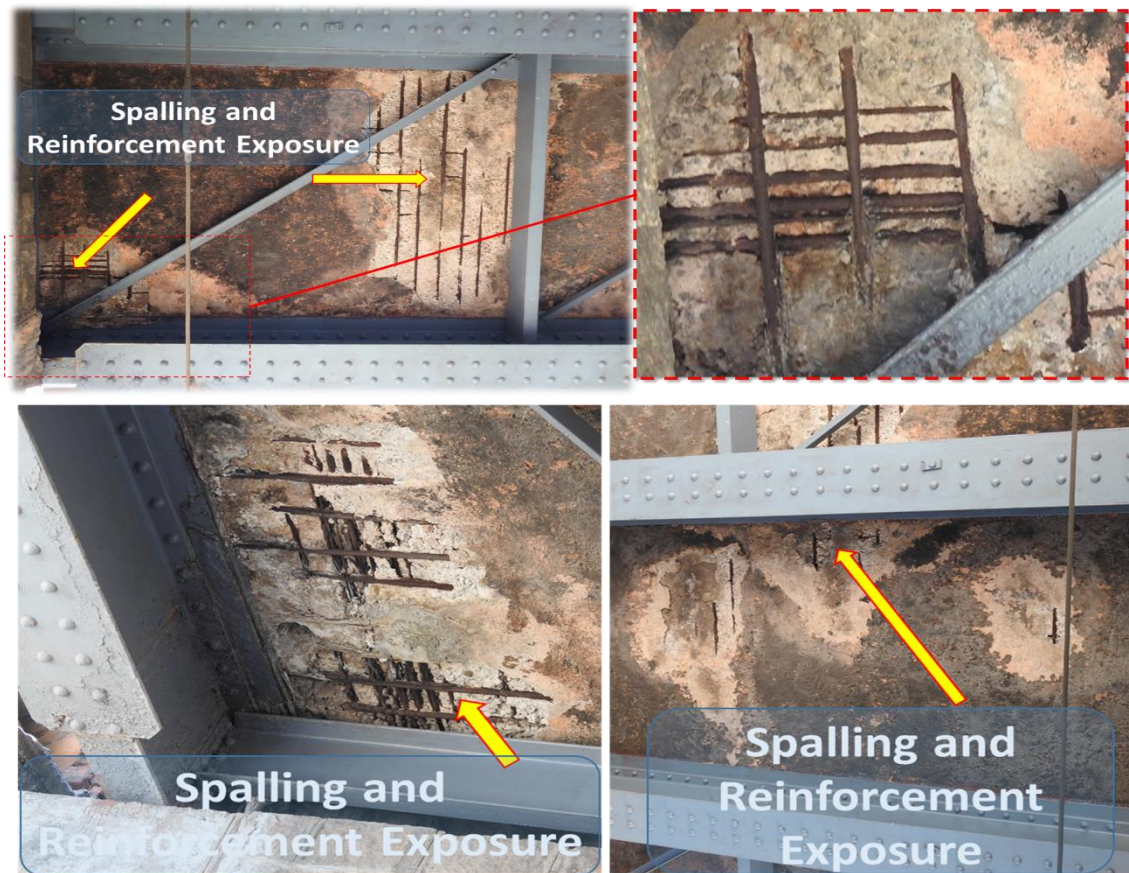
**Fig 15:** Damage locations identified in span 1 at “a, b, c & d”

- Remove all loose and spalling concrete and expose the corroded reinforcement wherever possible by careful chipping.
- Carryout thorough sand blasting using dry coarse sand or by grinding.

- Fix 8 mm dia PVC nozzles at all honey combed areas and wherever cavities exist. At all other vulnerable areas drill 12/14 mm dia hole to a depth of 50 to 75 mm and fix 8 mm PVC nozzles.

- Now drill 12/14 mm dia holes at a spacing of 500 mm c/c to a depth of 50 mm and fix 8 mm dia shear connectors using polyester resin grout.
- Fix 50 mm x 50 mm x 4 mm Geo grid tied to the exposed reinforcement / shear connectors.

- Carryout 40 to 50 mm thick shot - creating to underside of slab etc, using a mix proportion of 1: 2: 2 (cement: sand: aggregate).
- Now carryout cement injection grouting through the nozzles in sequential manner until rejection.

- Carryout curing for 7 days.

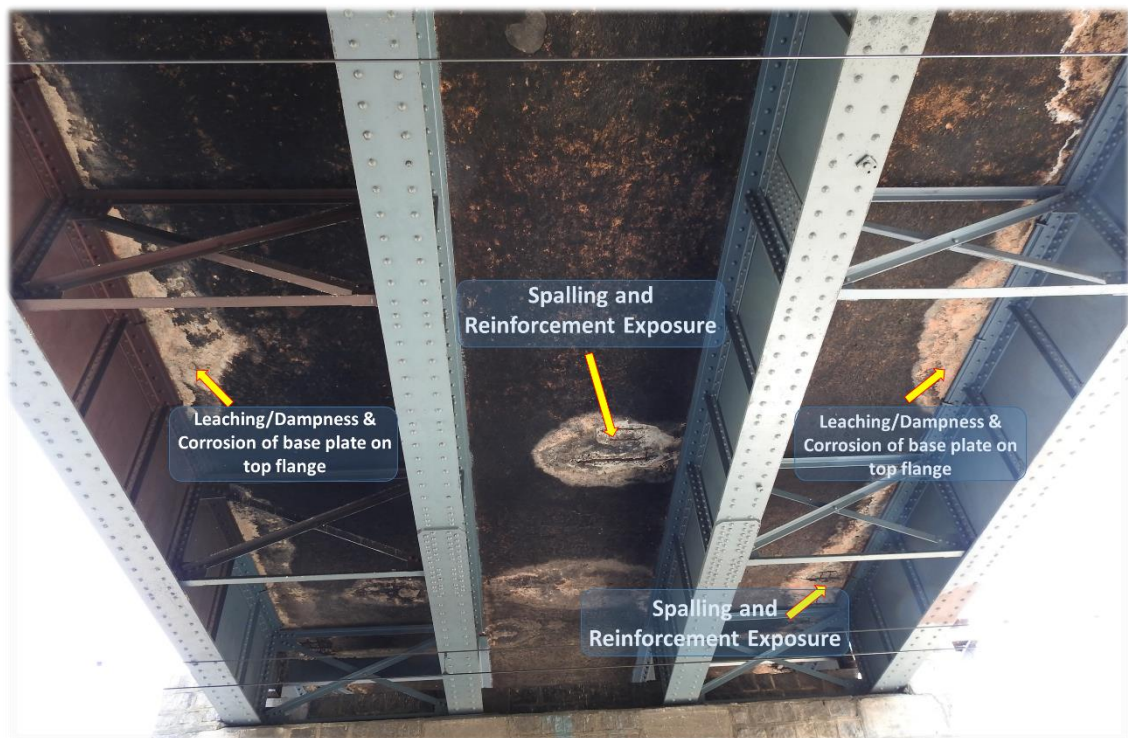
**Fig 16:** Damage locations identified in span 2 at “e, f & g”

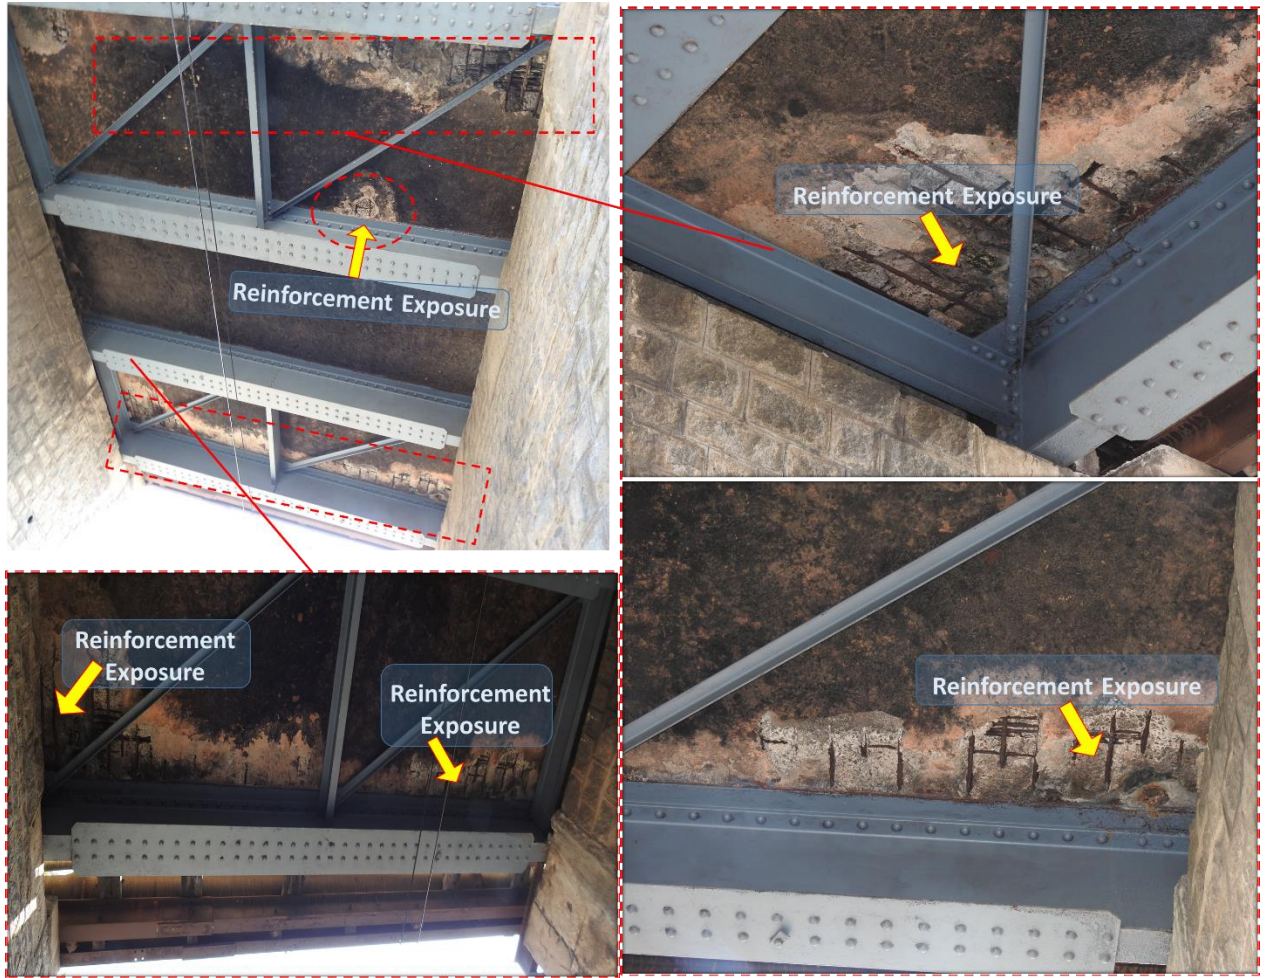
**Fig 17:** Damage locations identified in span 3 at “h, l, j & k”

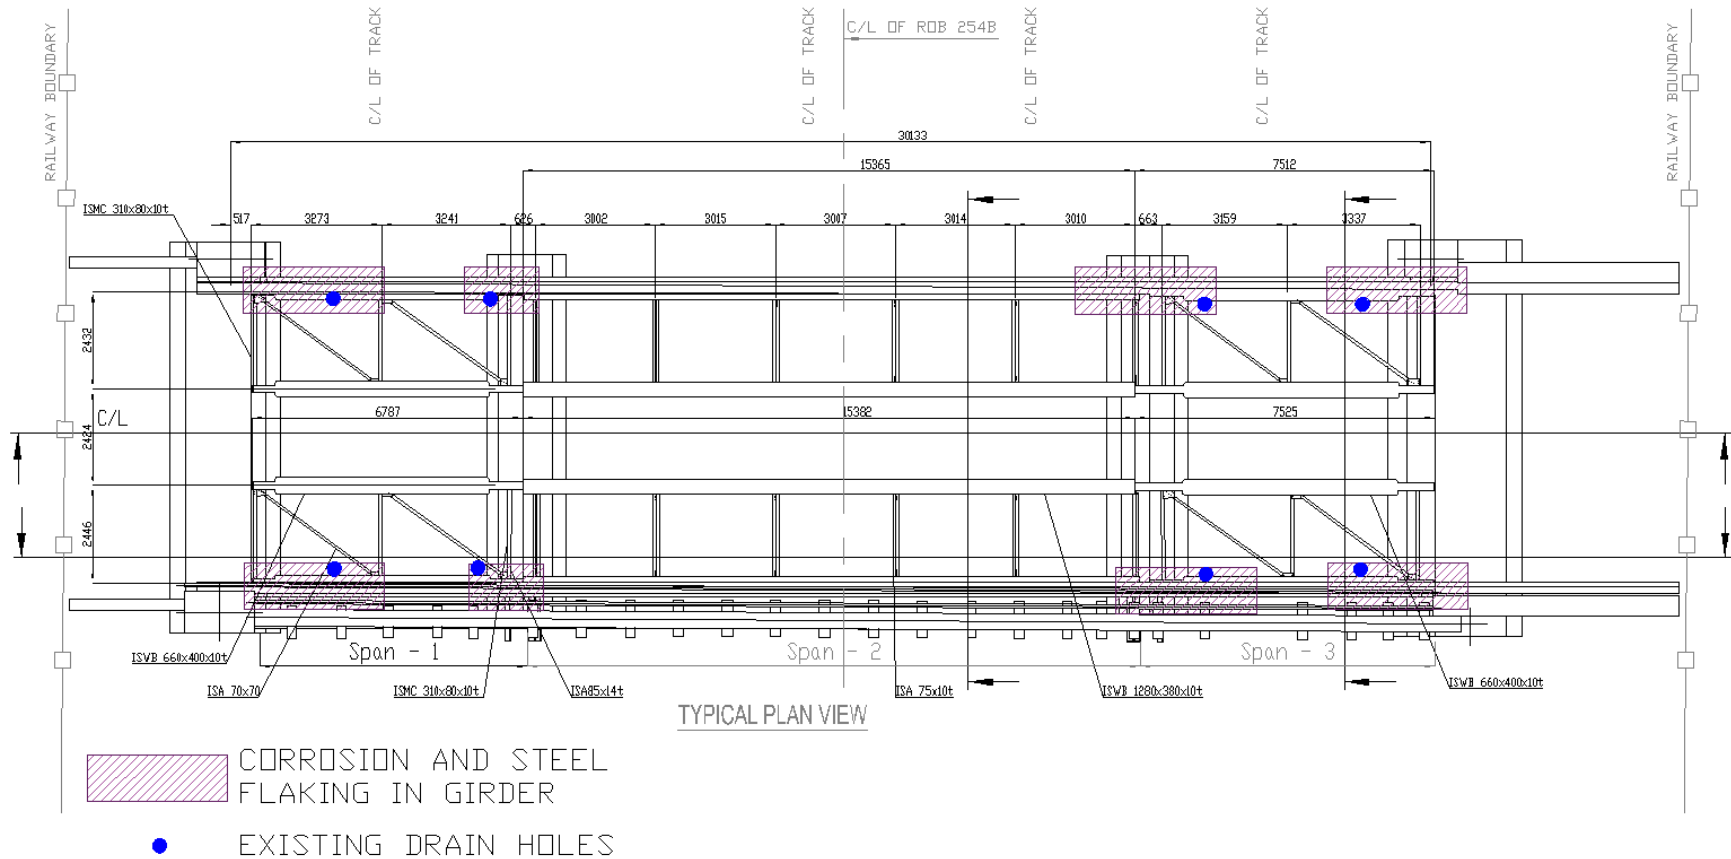
**Fig 18:** Bottom view of slab deck with Steel girder exposed (damaged) locations

A detailed visual observation is made on steel girders on the above said locations and the following observations are made, excessive corrosion and steel flaking was noticed in span 1, & 3 near drain holes and supports. Near steel concrete joints cover plate on the girders and angular bracing members connected with rivets are damaged.

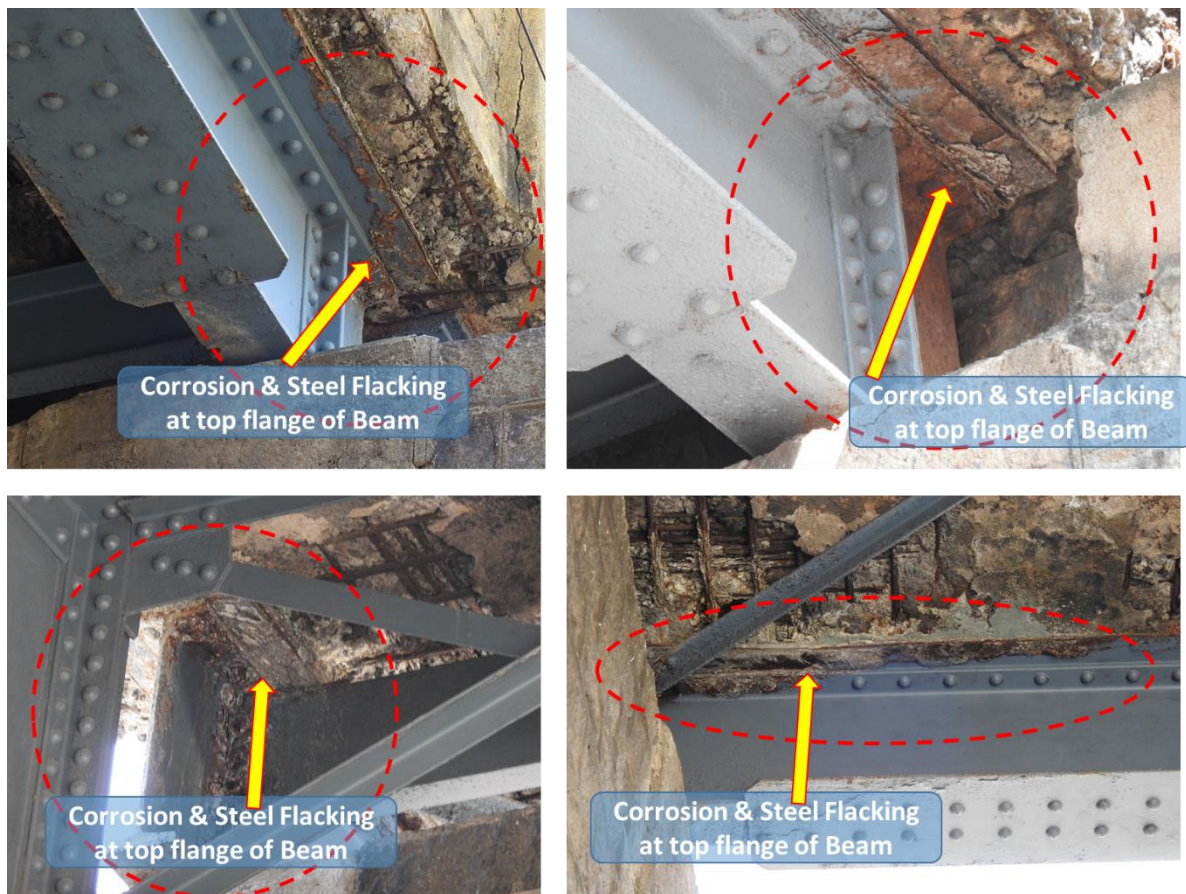
### Corrosion and steel flaking observed near support

**Fig 19:** Damaged locations identified in span 1 and 3

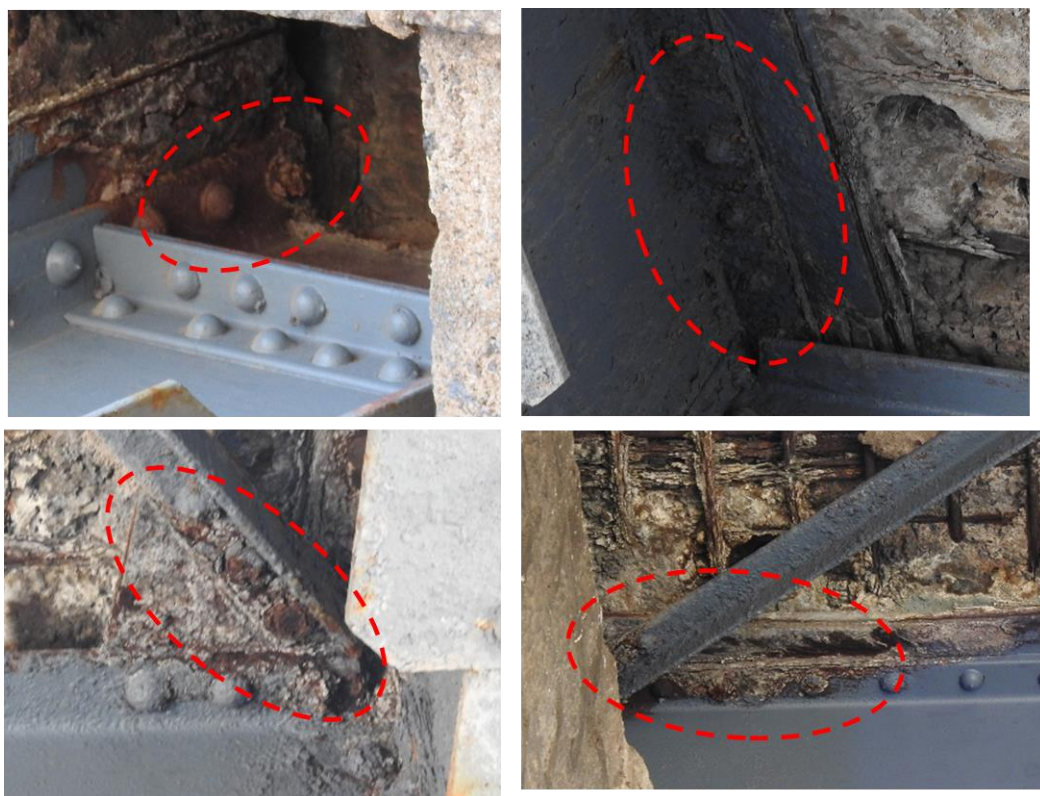
**Fig 20:** Rivet Damaged locations identified in span 1 and 3

The procedure for repairing flange corrosion in riveted girders involves the following, Remove heads of rivets that are to be replaced by bolts. Remove the underside heads for bottom flanges and the topside heads for top flanges. For top flange rivet removal, fit clamps to the underside to prevent rivets falling out.

- i. Prepare the flange surface for cover plating by removing all loose rust and dirt and by grinding where necessary to create a smooth surface. Fill any deep pitting ( $>1\text{mm}$  deep) or any area of unevenness to create a flat surface for seating the cover plate.
- ii. Position the packer plates and cover plate, holding them in place with clamps.
- iii. Progressively remove rivets to be replaced and fit and tension replacement bolts. Note that no more than 10% of rivets, evenly distributed along the member, are to be removed at any one time.
- iv. Seal open interfaces to new steel where required. Fill exposed rivet head holes on the top flange to prevent collection of water.
- v. Prepare for and paint new steelwork and areas of existing steelwork to the extent.

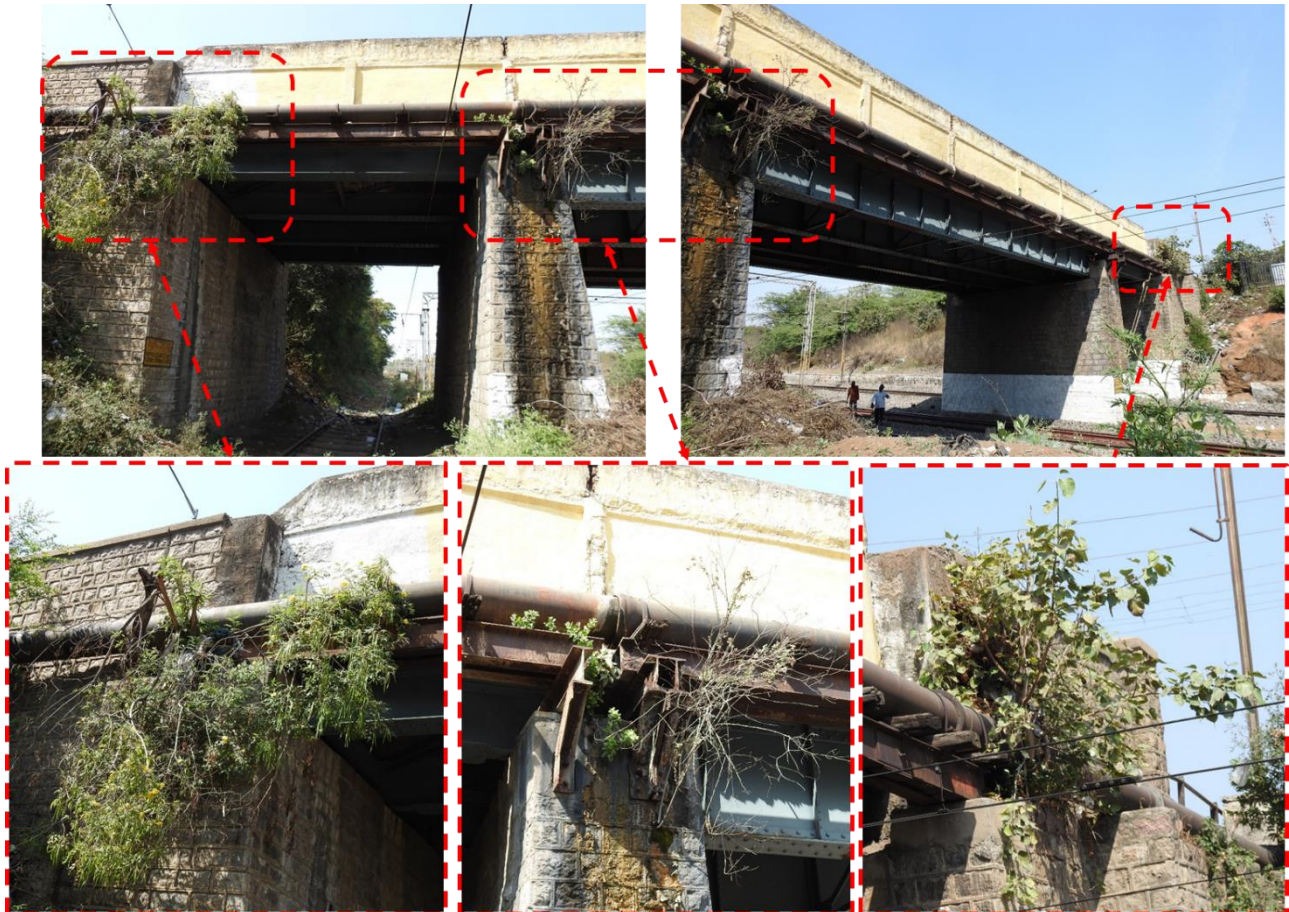
**Fig 24:** Vegetation observed on the top of the pier (abutment wall)

Various components of a bridge, namely deck surface, curbs and sidewalks, expansion joints, pier caps, abutment caps, trusses and their web members, lower flanges of beams and girders, wind bracings and drains shall be thoroughly cleaned of accumulated dust, debris and other foreign materials at regular intervals. This is to prevent deterioration of the bridge, which will therefore preserve the bridge components in their intended conditions resulting in increased service life of the bridge as well as provide safety and comfort to the road users. Areas which have been cleaned shall be ensure freedom from accumulated sand, gravel, dirt, and other foreign materials. Vegetation grown on the components

of bridges shall be removed. In addition, vegetation near the bridge that might affect the normal performance of the bridge, such as free flow of water under the bridge, etc. shall be removed.

These shall be removed from the components of the bridges as well as from near the bridges if it is found that they affect the soundness of the structure in course of time.
