## 1. VISUAL INSPECTION REPORT

| <b>Name of the Project</b> | : VISUAL INSPECTION OF FOB AT MALKAJGIRI RAILWAY STATION |
| <b>Location</b> | : MALKAJGIRI RAILWAY STATION |
| <b>Date of Inspection</b> | : 4 <sup>th</sup> March 2020. |

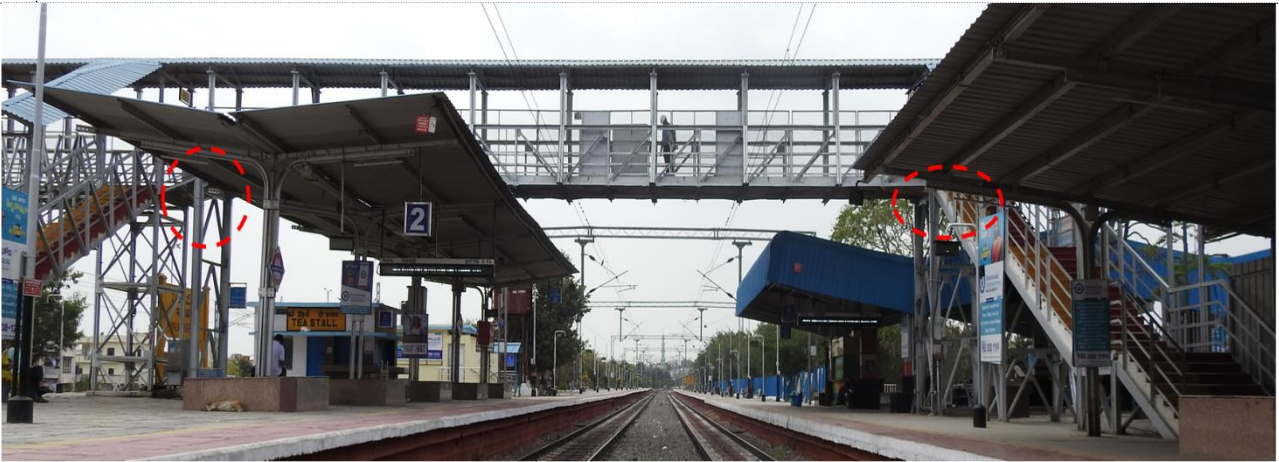
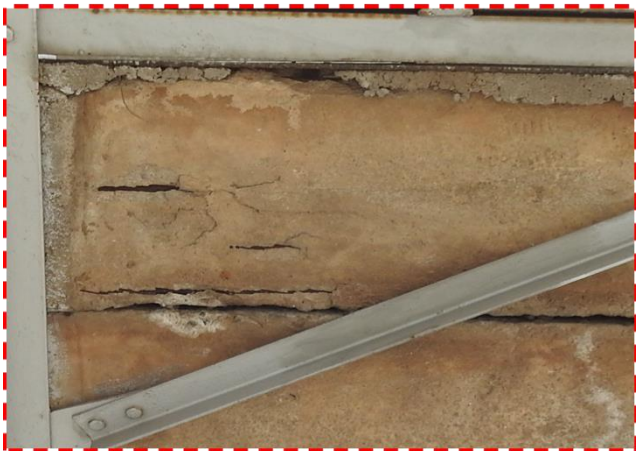
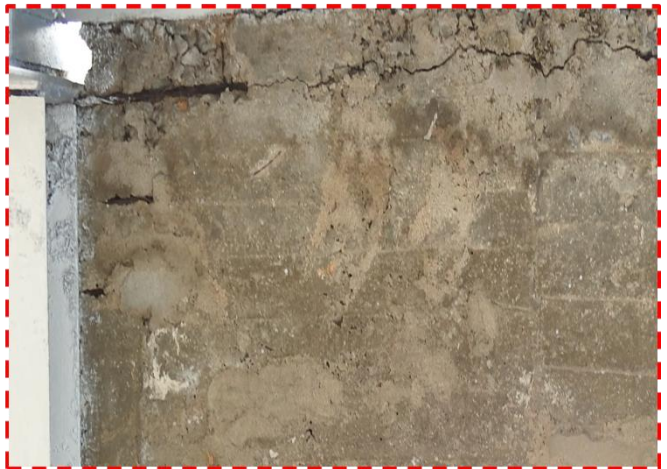
- a. ✓ Spalling and Reinforcement exposure of RCC slab observed along the 1<sup>st</sup> span of FOB

Spalling and reinforcement exposure in span 1

| SURVEY OF SIGNS OF DISTRESS, DEFORMATION IN BRIDGES | | | |
|---|---|---|---|
| | Spalling | Floor slab and staircase slab | spalling and exposed reinforcement is observed at the bottom of slab in span 1,3 and at stair case 2,3 slab. (Refer <b>Part 1.4 – 1.4(a)</b> ) |

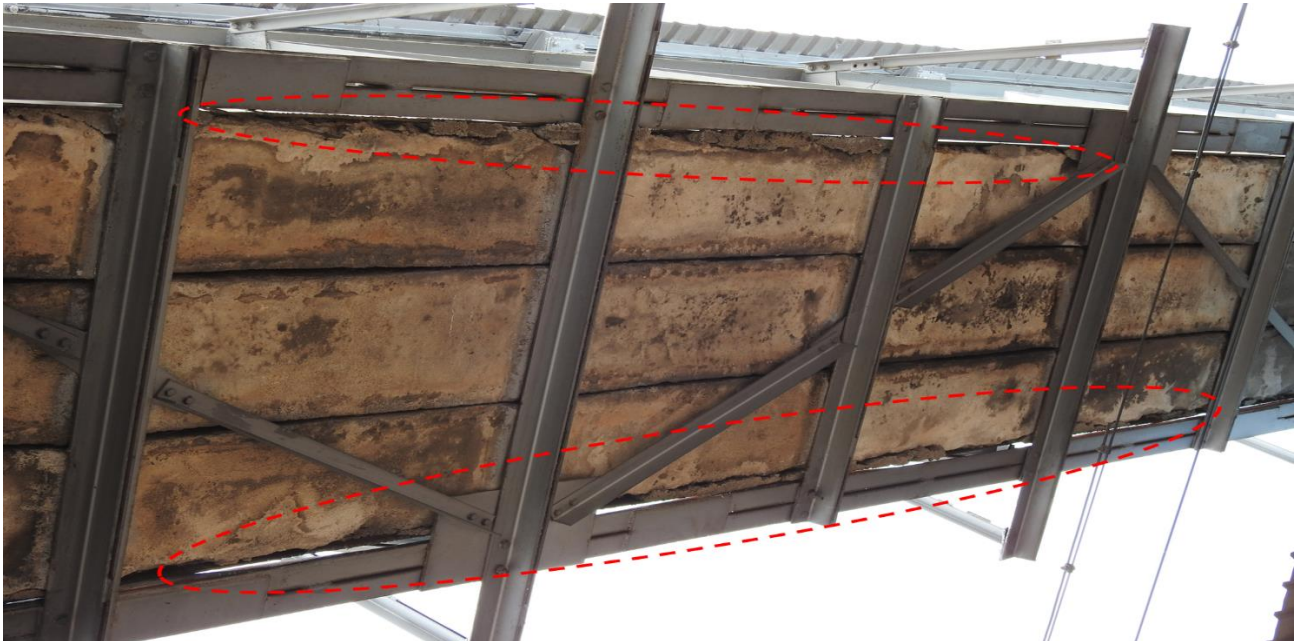
Spalling at bottom chord and slab panels connecting joint

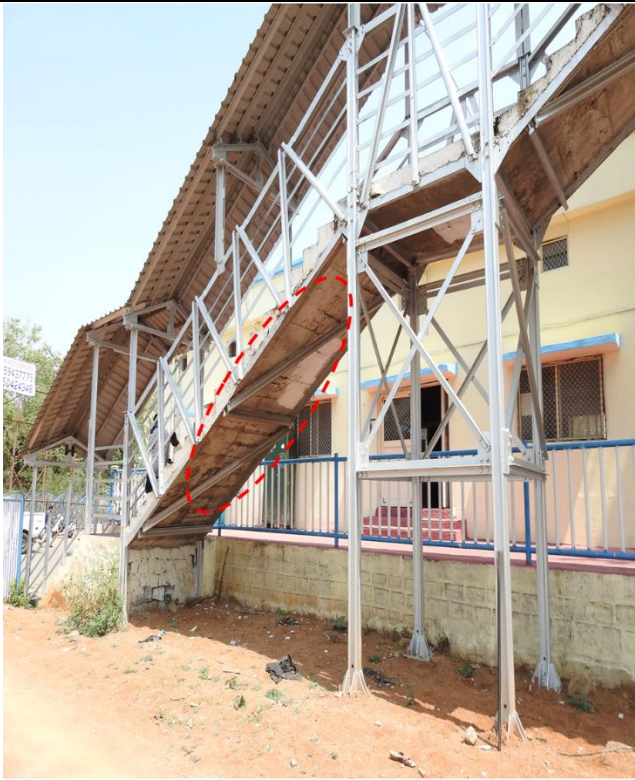
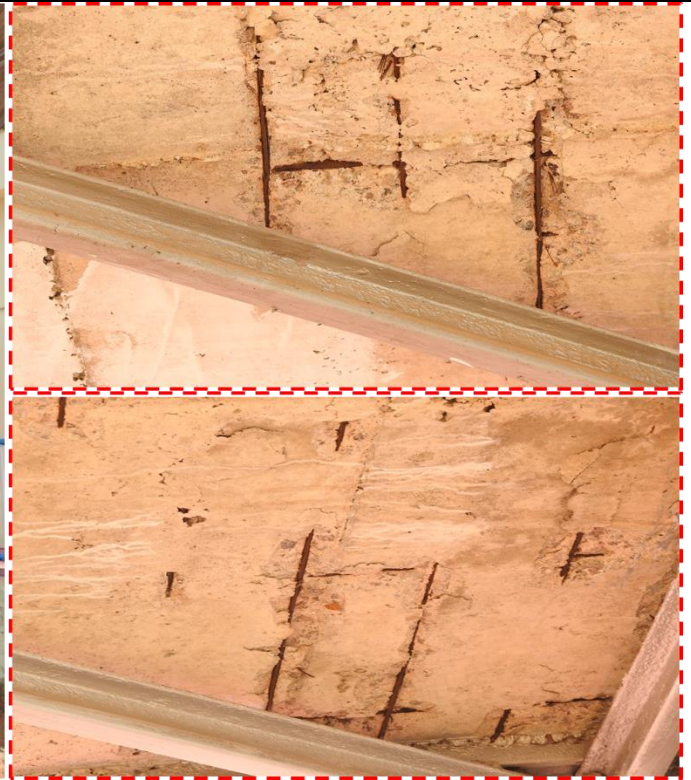
Spalling at stair case 3

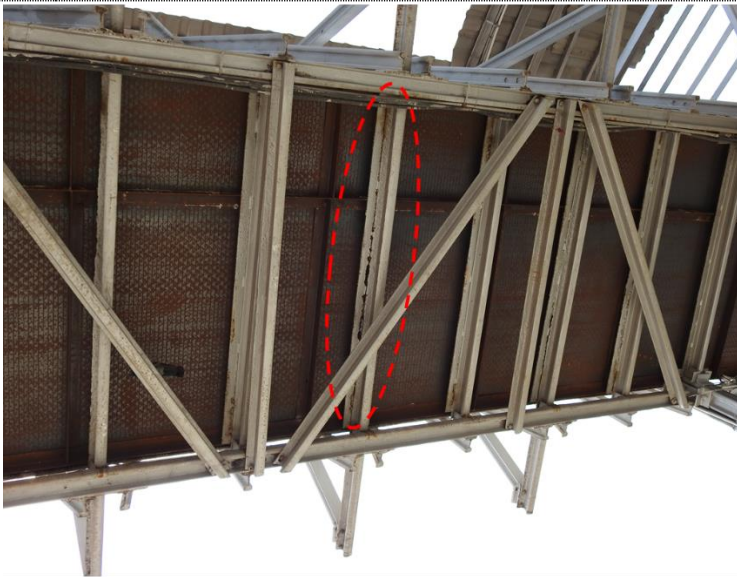
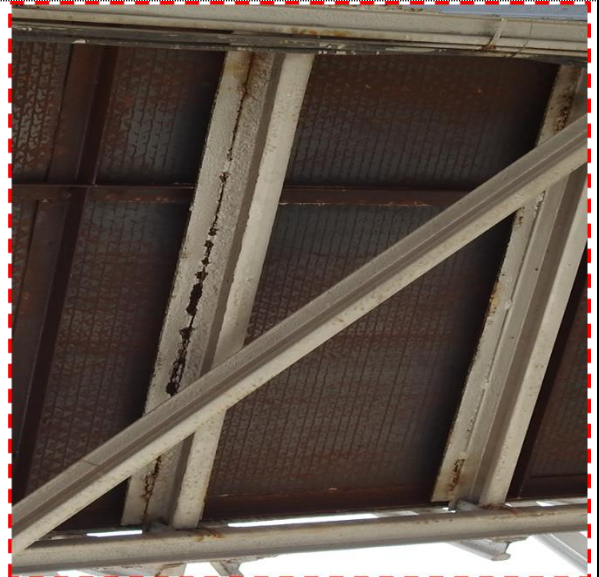
b. ✓ Slight Corrosion is observed floor beams of span 2

Slight Corrosion of Floor beams

| SURVEY OF SIGNS OF DISTRESS, DEFORMATION IN BRIDGES | | | |
|---|---|---|---|
| | Extent of Corrosion | Floor beams | Slight corrosion is observed at floor beams of span 2 (Refer <b>Part 1.4 – 1.4(b)</b> ) |

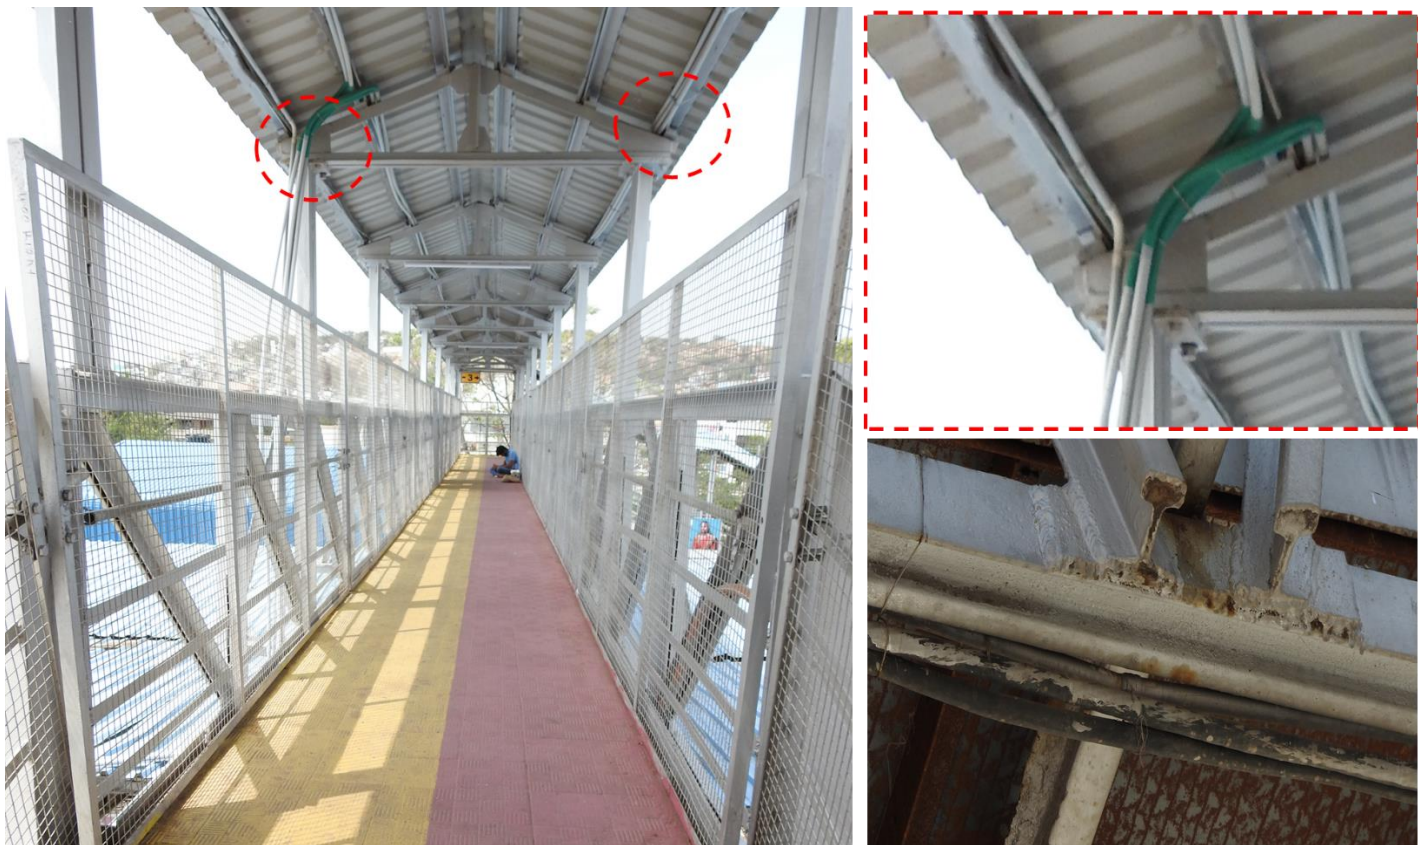
| PART 1.2 IDENTIFICATION OF LOADS ON BRIDGE | | | |
|---|---|---|---|
| | b) Cables | Yes | Cables are protected with 1-inch dia HDPE pipe of 2 nos. and 1-inch PVC pipes of 5 nos. (Refer <b>fig :1</b> )<br>King post roof supported with 65 x 65 x 8 mm angles are used (Refer <b>fig: 1</b> ).<br>Steel Metal Sheet is used for Roof (Refer <b>fig :1</b> ) |
| | b) Provision of protective screen for passengers | Yes | Chain link fence made of galvanized wire of 2 mm gauge and 2mm galvanized sheet is used above OHE line on both side of gangway is used for protection. (Refer <b>fig :1</b> ) |

| PART 1.3 STRUCTURAL SYSTEM OF THE BRIDGE | | | |
|---|---|---|---|
| | Element of roof truss section | Angle sections | Span of roof truss is supported with 65 x 65 x 8 mm double angle sections which are rested on Top chord members.<br>(Refer <b>fig :1</b> ) |

**Fig 1:** Cables, Roof truss, Flooring and Protective screen

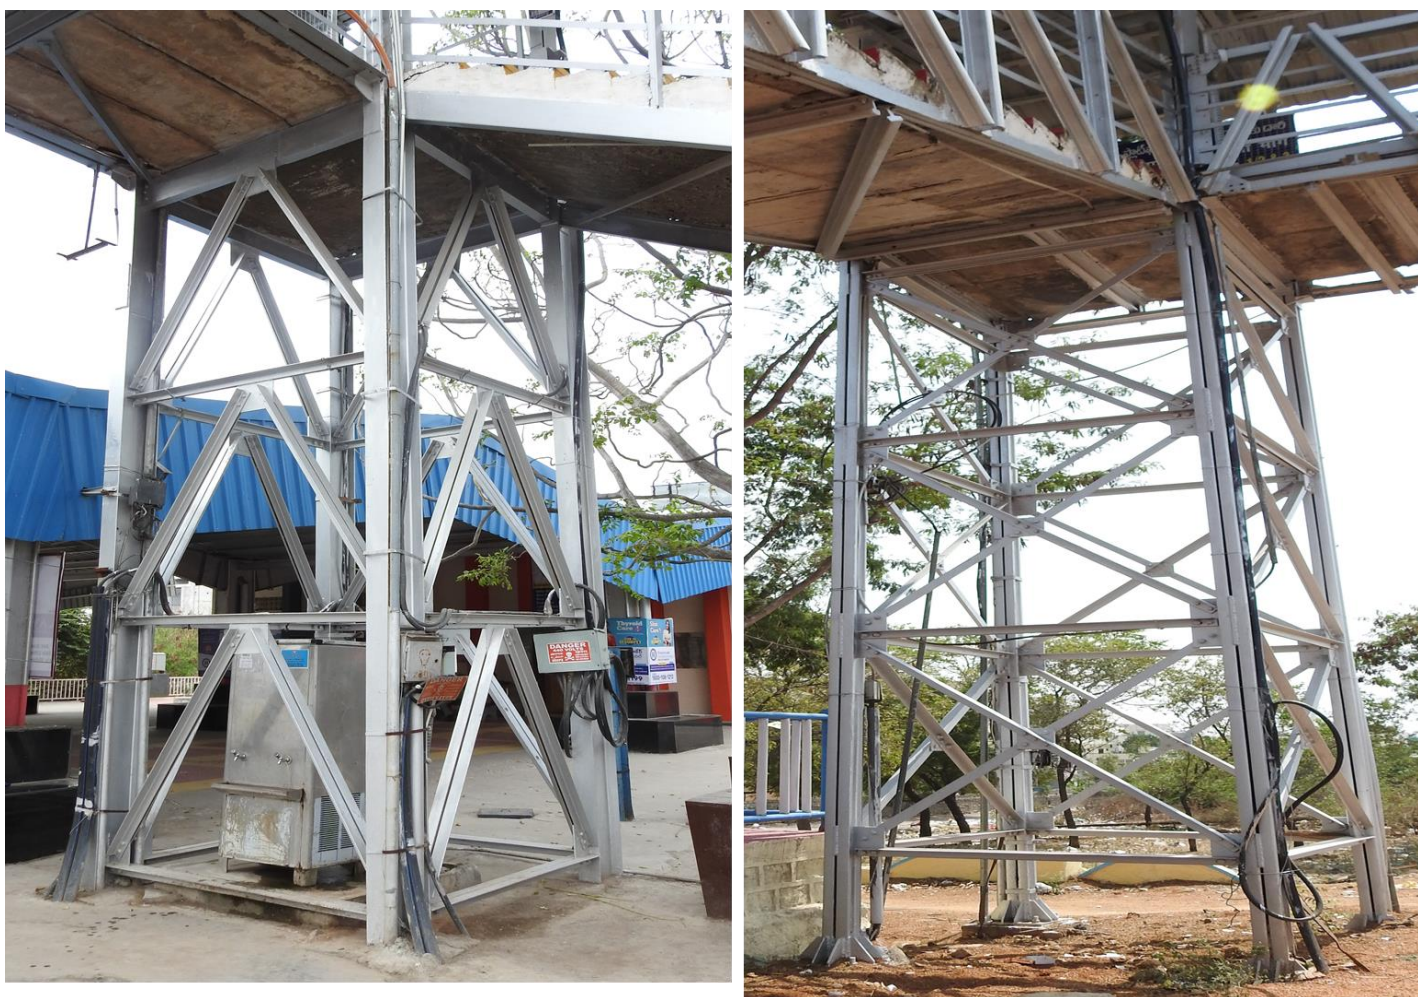
| PART 1.3 STRUCTURAL SYSTEM OF THE BRIDGE | | | |
|---|---|---|---|
| | Type/Shape of Column section | I – Section, Rail section | Span 1:<br>FOB is supported on vertical column of ISMB 300 with bracings of 65 x 65 x 8mm double angle sections. (Refer <b>fig :2</b> )<br>Span 2,3,4:<br>FOB is supported on vertical column of Built up rail section of 130x130 mm with 2 Rail sections of 60 x 130 x 60 mm (Head x Height x Base) with bracings of 65 x 65 x 8mm angle sections (Refer <b>fig :2</b> ) |

**Fig 2:** Trestles details

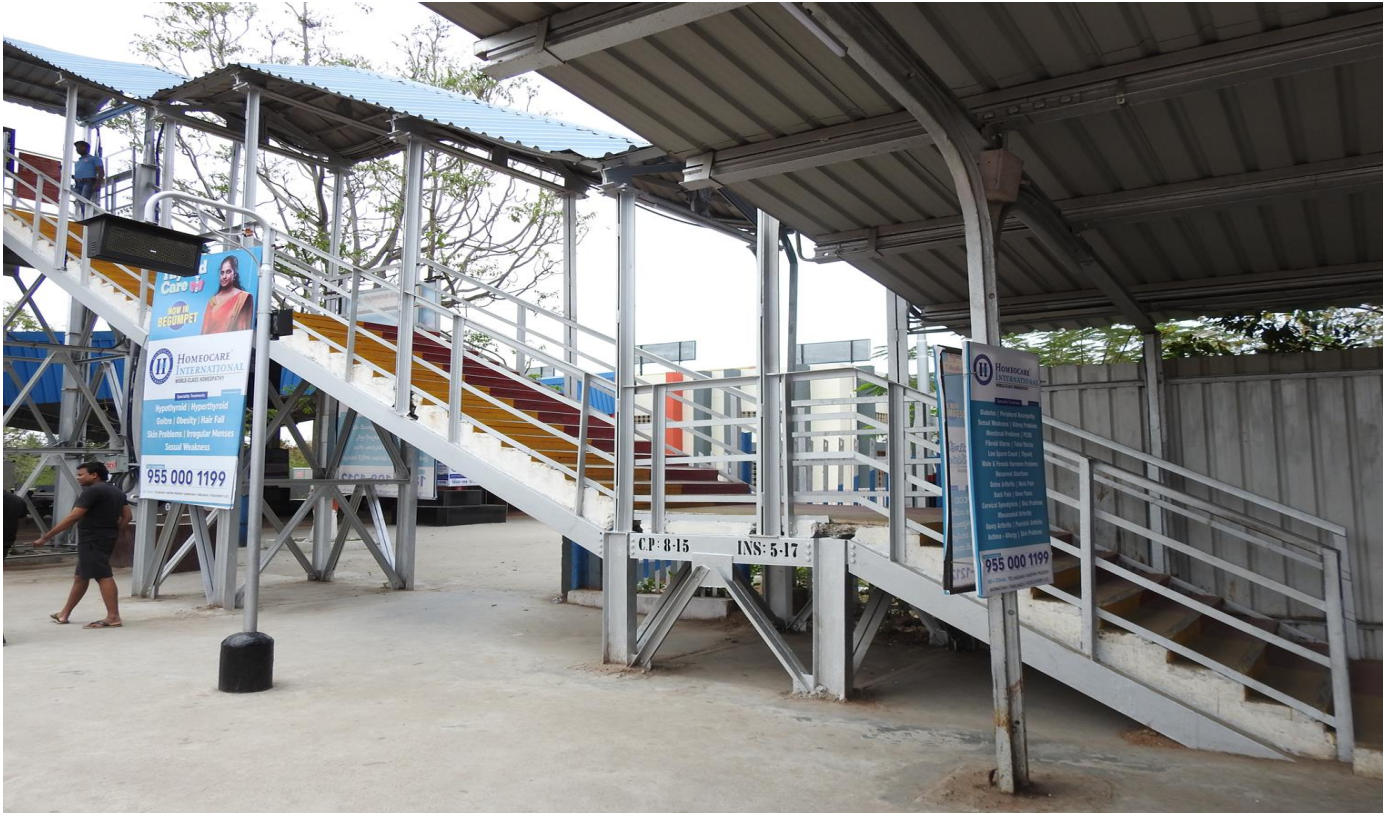
| | Number of Staircase | 3 no's | Staircase steps are observed as RCC slab, Steps are supported on stringer beams of ISMB 250 section, horizontal members of ISMB 150 and diagonal bracings with 65 x 65 x 8mm angle sections.<br>(Refer <b>fig :7</b> ) |
| | Type of Parapet Railing | Steel railing | Staircase is provided with railing on both sides of 1.2m height using 75 x 75 x 8 mm double angle sections and 50 x 6 mm MS flats are used.<br>(Refer <b>fig :7</b> ) |

**Fig 7:** Staircase details

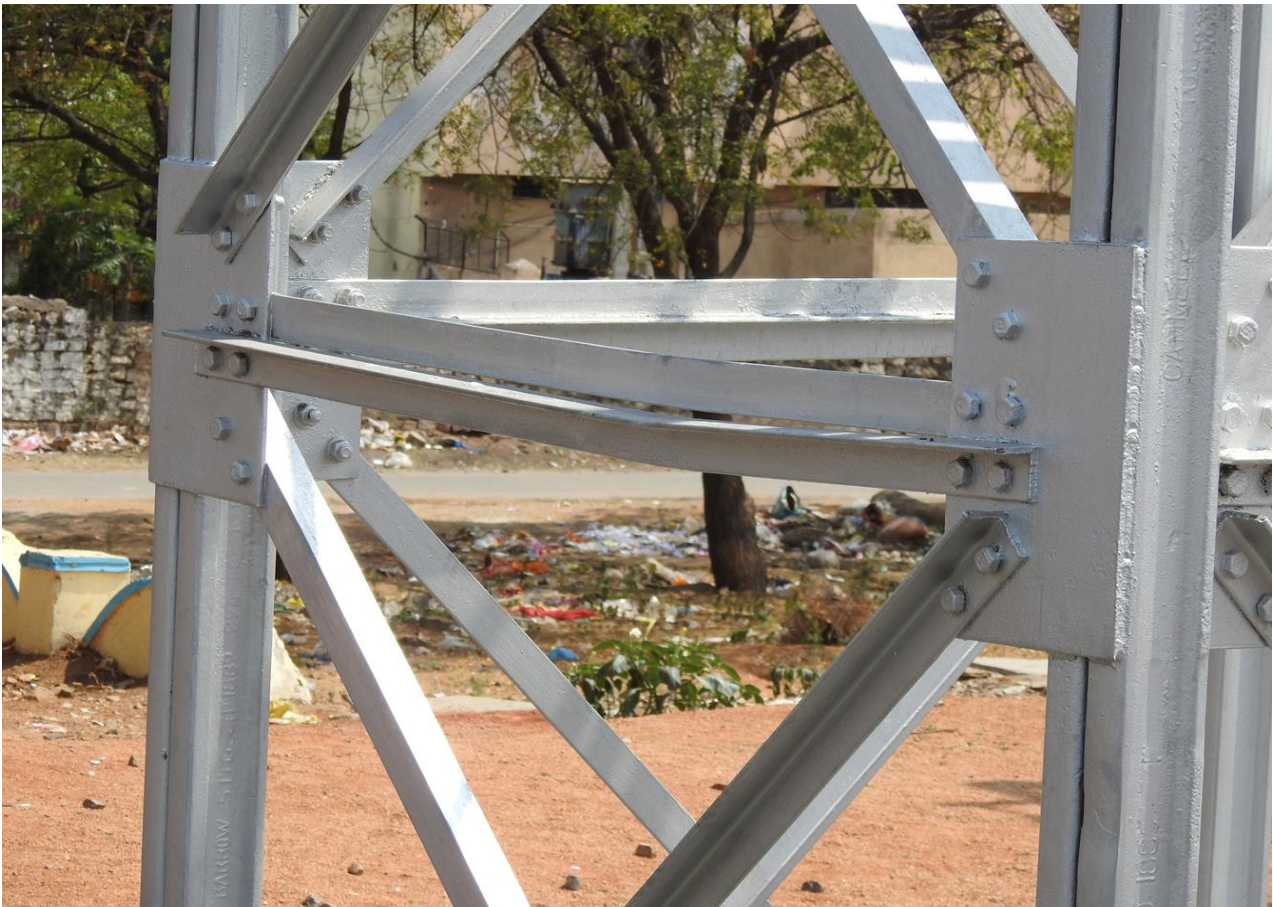
**Fig 8:** Deformation of bracings at trestle 4

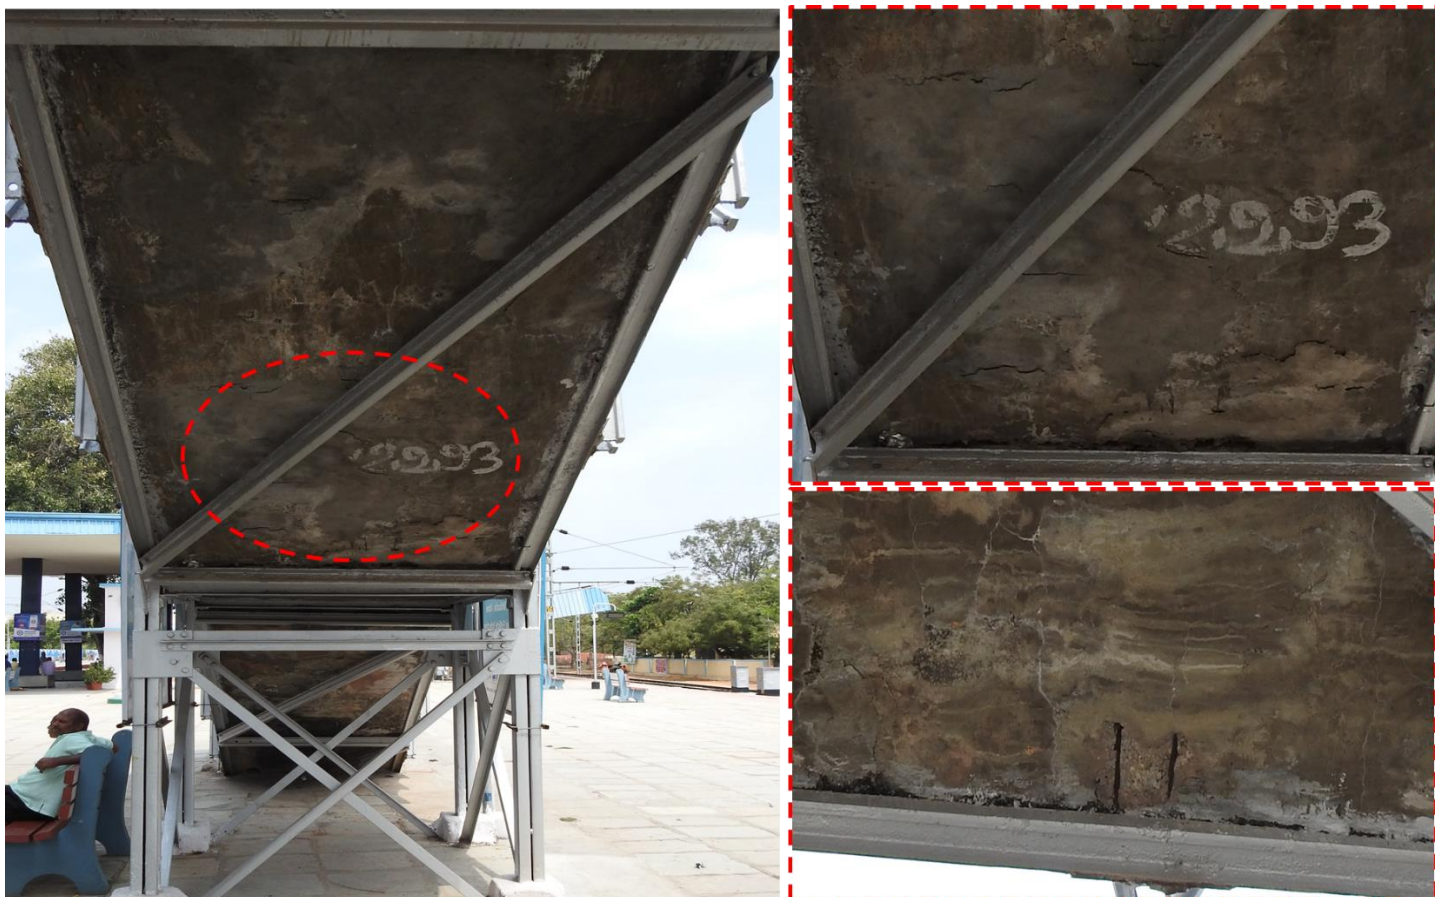
**Fig 9:** Patch work observed at staircase 2
