## 1. VISUAL INSPECTION REPORT

| <b>Name of the Project</b> | : | VISUAL INSPECTION OF FOB AT FALAKNUMA RAILWAY STATION |
| <b>Location</b> | : | FALAKNUMA RAILWAY STATION |
| <b>Date of Inspection</b> | : | 3 <sup>rd</sup> March 2020 |

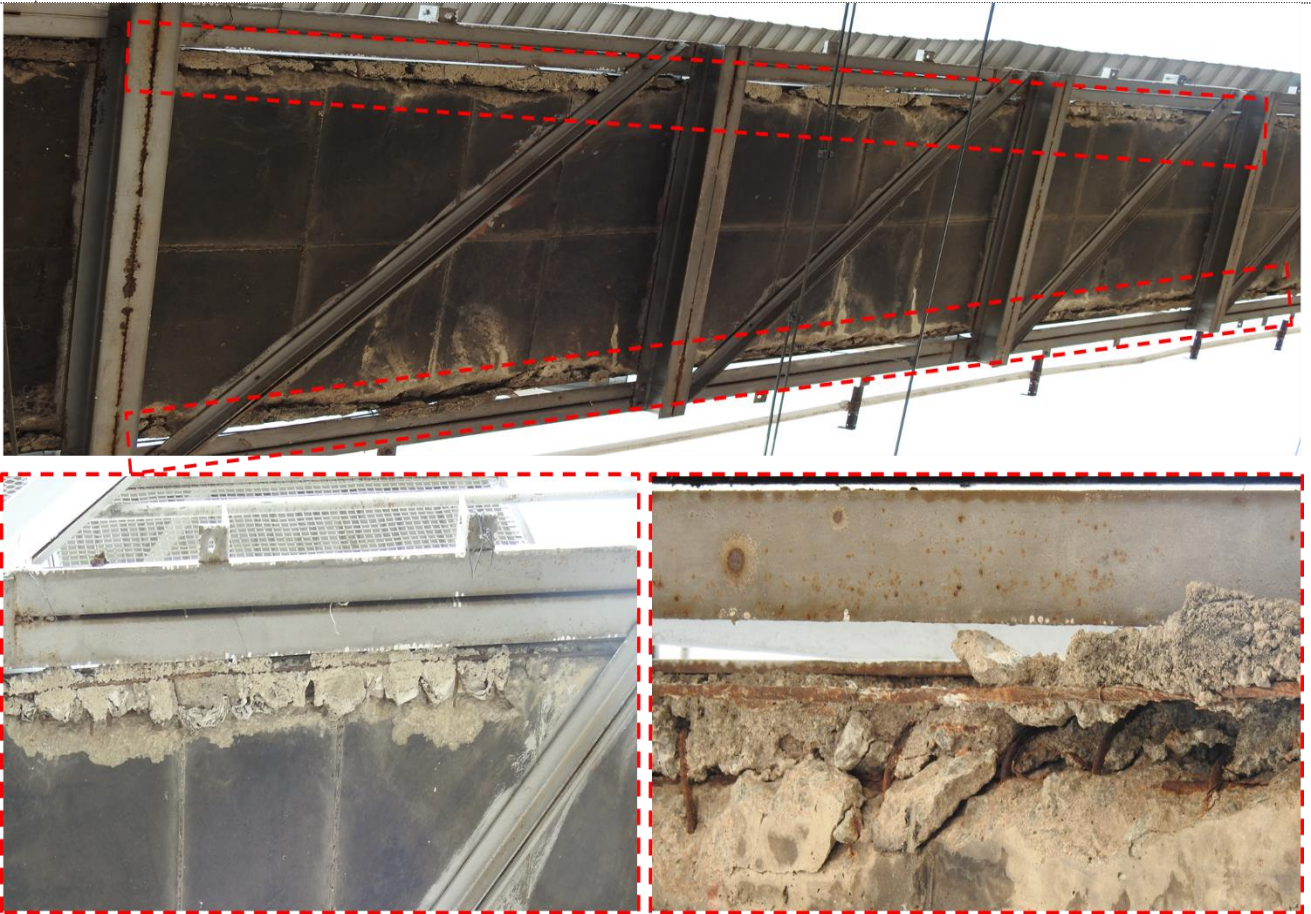
- a. ✓ Spalling and Reinforcement exposure of RCC slab observed along the 1<sup>st</sup> span of FOB

Spalling and reinforcement exposure

| SURVEY OF SIGNS OF DISTRESS, DEFORMATION IN BRIDGES | | | |
|---|---|---|---|
| | Spalling | RCC slab | spalling and exposed reinforcement is observed at the bottom of slab in span 1 and at stair case slab. (Refer <b>Part 1.4 – 1.4(a)</b> ) |

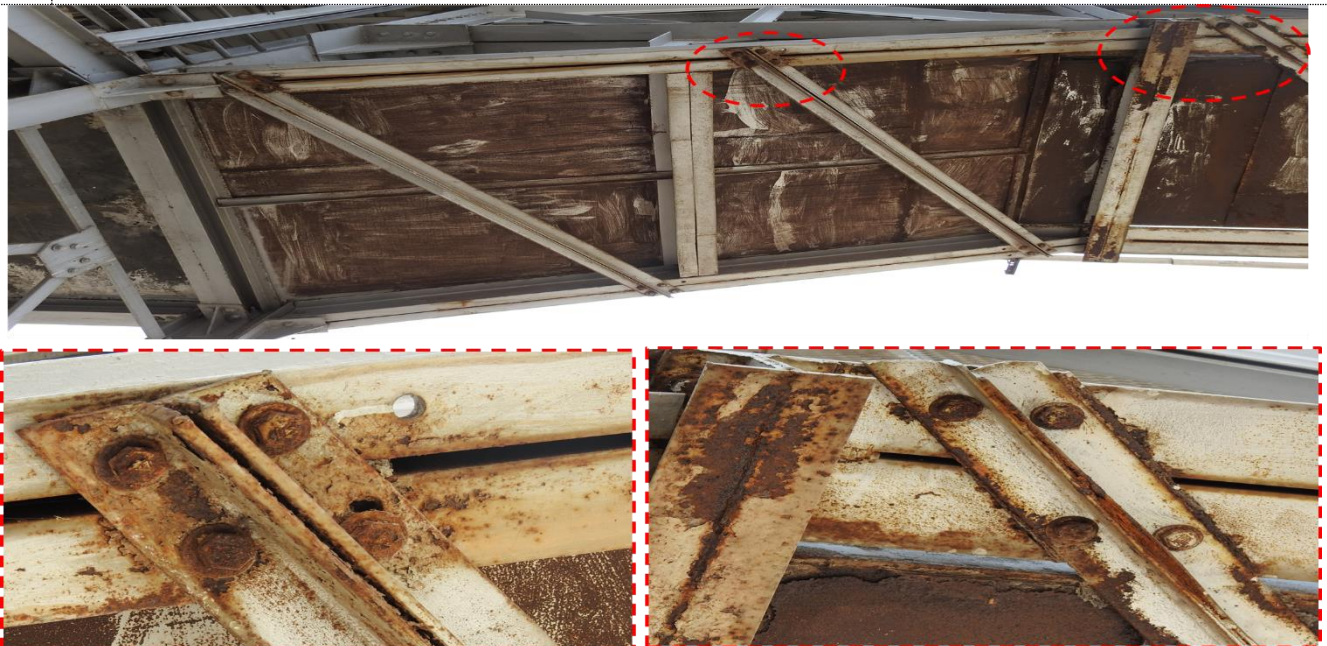
- b. ✓ Corrosion is observed in joints of Floor beams and bottom main chord member and slight corrosion is observed at stringer beam joints

Corrosion observed in Floor beams joints of span 2

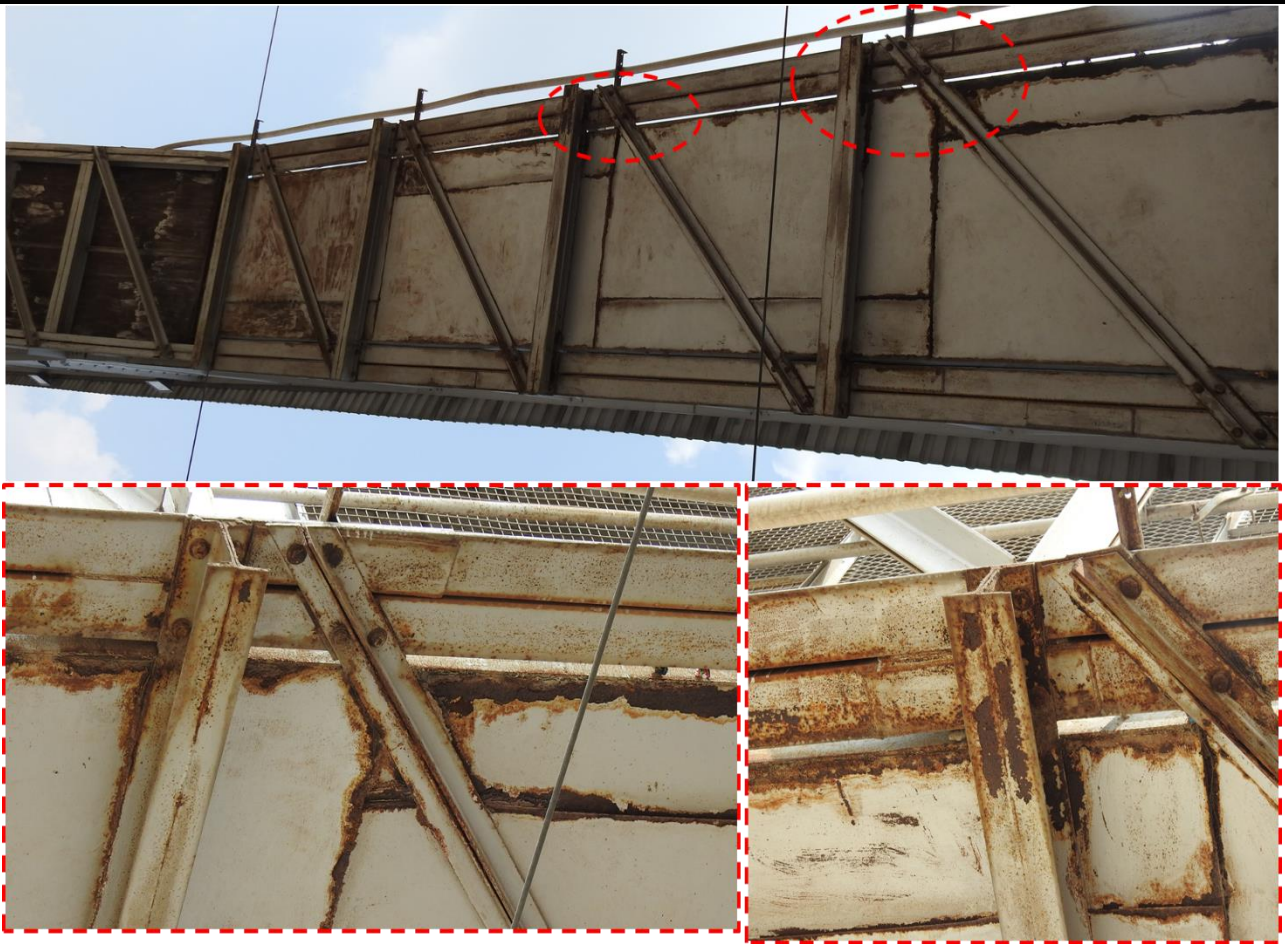
Corrosion of floor beam joints of span 3

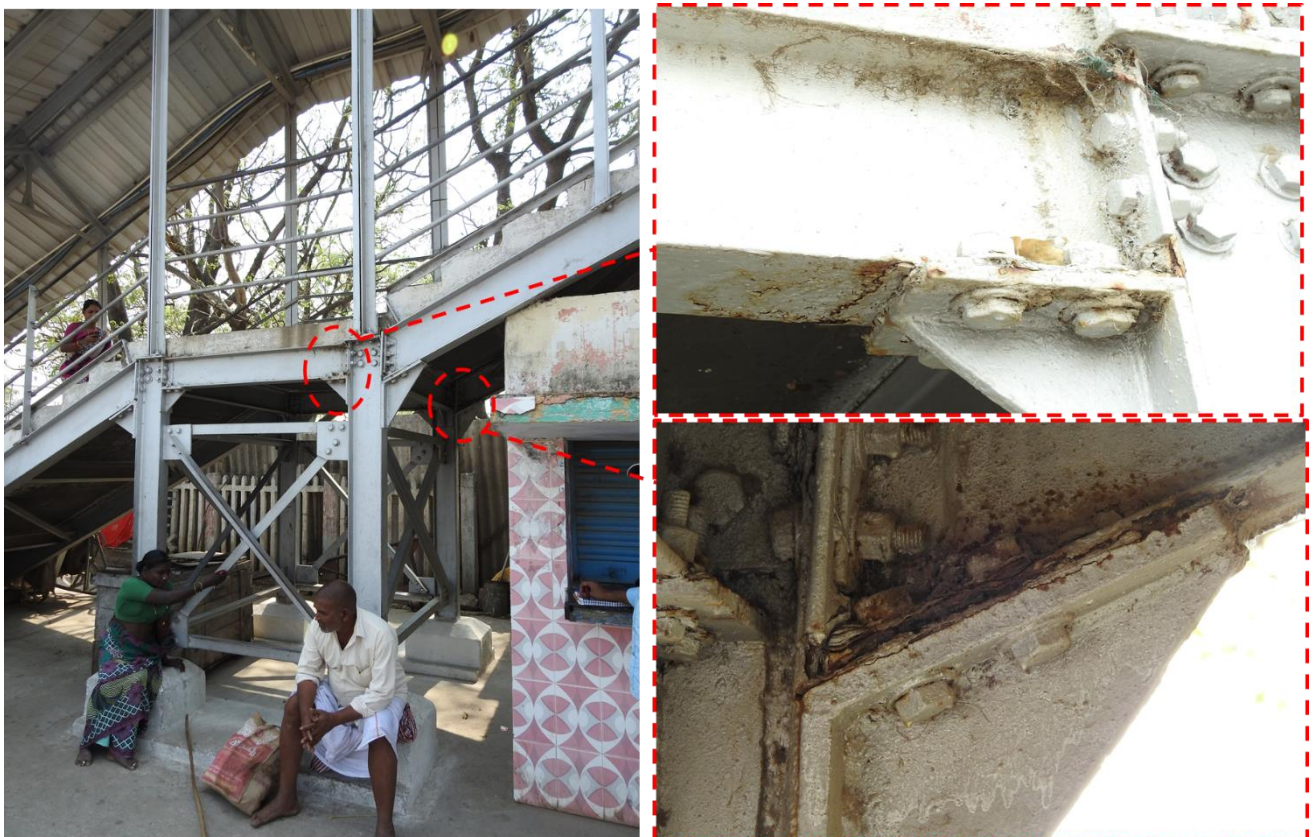
Corrosion at mid landing beam column joint.

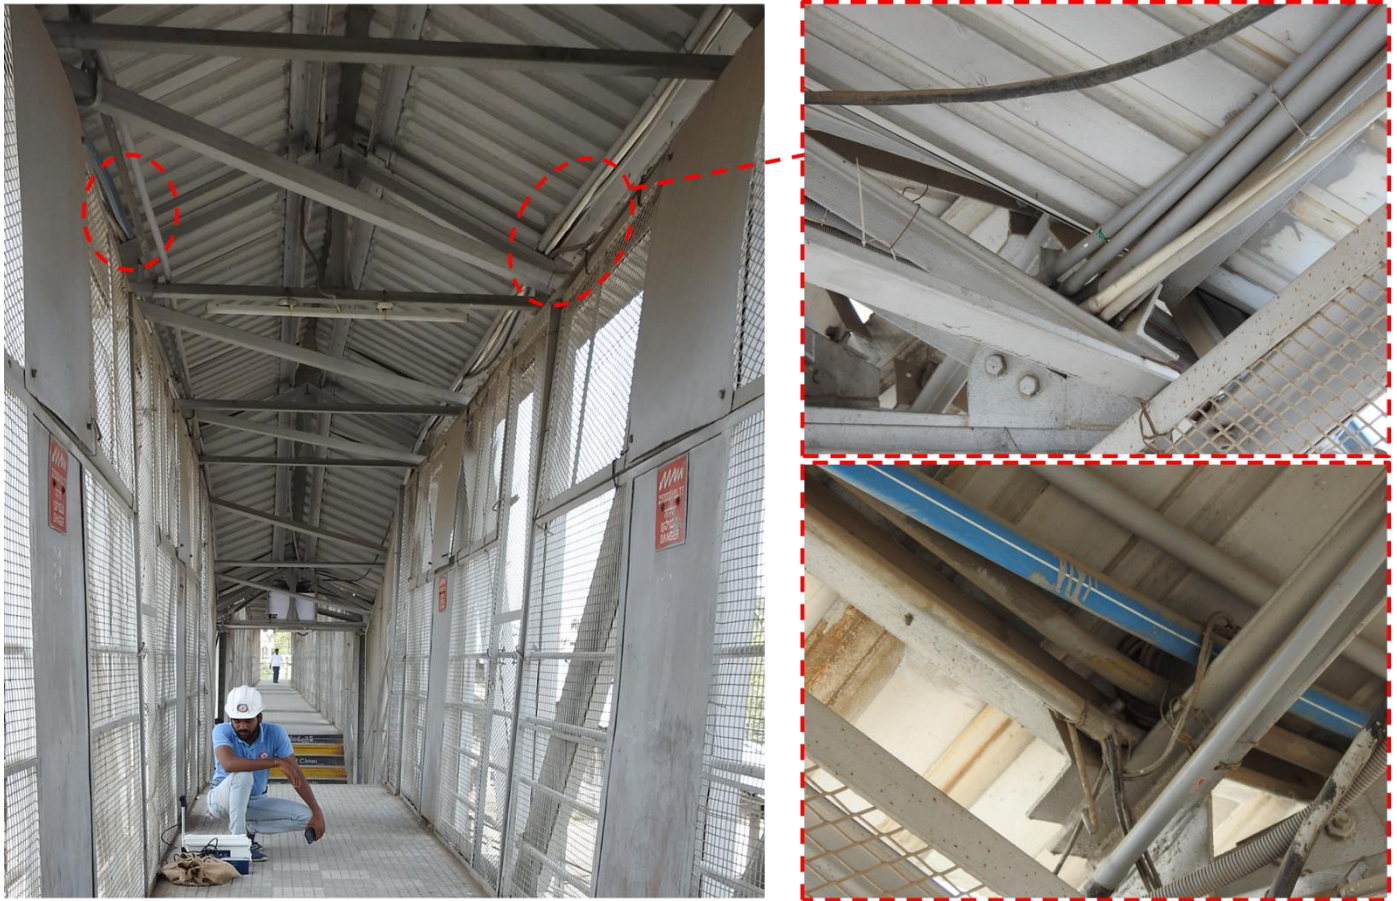
**Fig 1:** Cables, Roof truss, Flooring and Protective screen

| PART 1.2 IDENTIFICATION OF LOADS ON BRIDGE | | | |
|---|---|---|---|
| | b) Cables | Yes | Cables are protected with 1-inch and 2-inch dia HDPE pipe of 2 nos. and 1-inch PVC pipes of 6 nos and (Refer <b>fig :1</b> ) King post supported with 65 x 65 x 8 mm angles are used (Refer <b>fig: 1</b> ).<br>Steel Metal Sheet is used for Roof (Refer <b>fig :1</b> ) |
| | b) Provision of protective screen for passengers | Yes | Chain link fence made of galvanized wire of 2 mm gauge and 2mm galvanized sheet is used above OHE line on both side of gangway is used for protection. (Refer <b>fig :1</b> ) |

| PART 1.3 STRUCTURAL SYSTEM OF THE BRIDGE | | | |
|---|---|---|---|
| | Element of roof truss section | Angle sections | Span of roof truss is supported with 65 x 65 x 8 mm double angle sections which are rested on Top chord members.<br>(Refer <b>fig :1</b> ) |

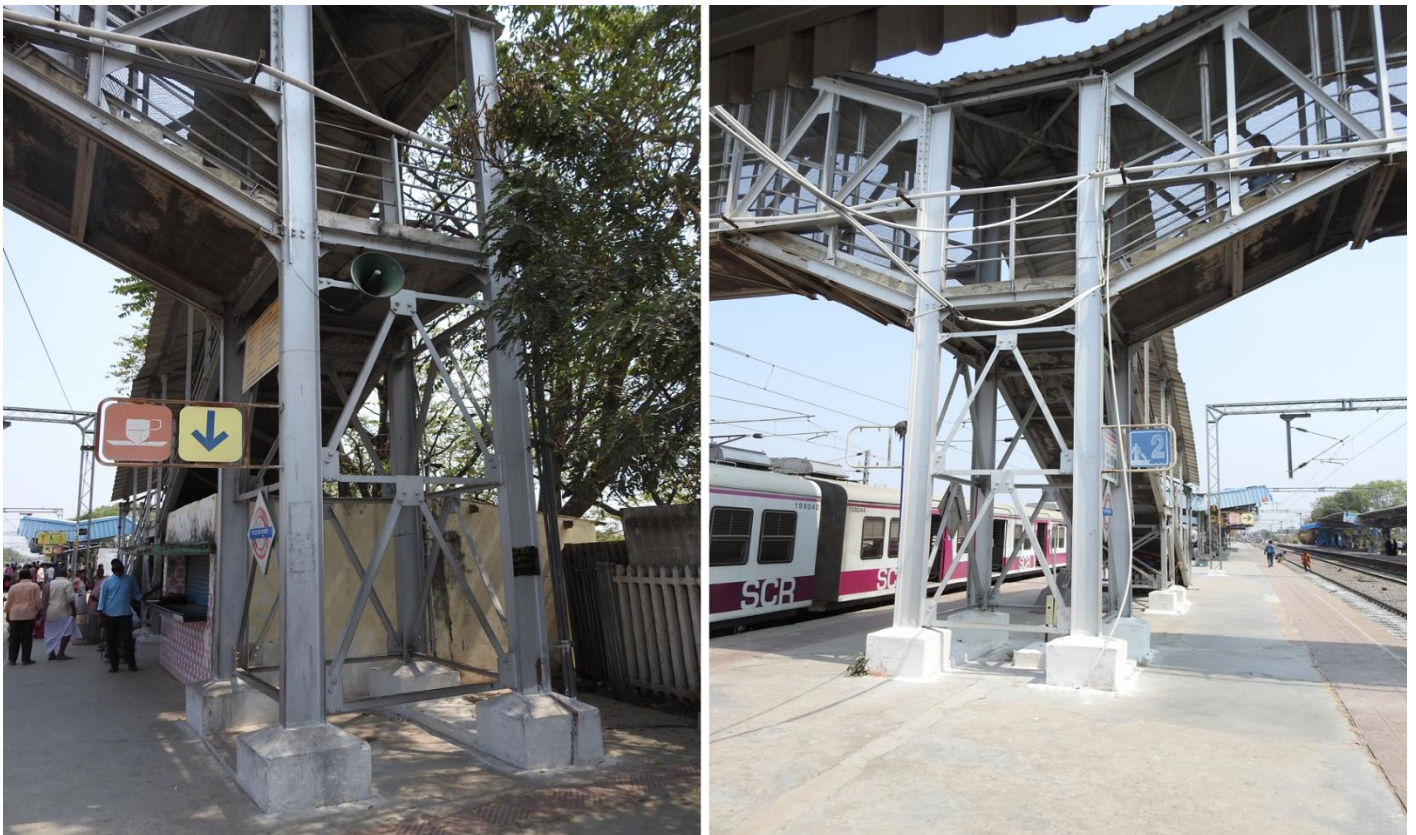
**Fig 2:** Trestles details

| PART 1.3 STRUCTURAL SYSTEM OF THE BRIDGE | | | |
|---|---|---|---|
| | a) No of Bolts and size | Not visible, filled with concrete | Trapezoidal Concrete encasement is observed below vertical supports<br>(Refer <b>fig :2</b> ) |

| | Type/Shape of Column section | I – Section | FOB is supported on vertical column of Four - ISMB 300. (Refer <b>fig :2</b> ) |

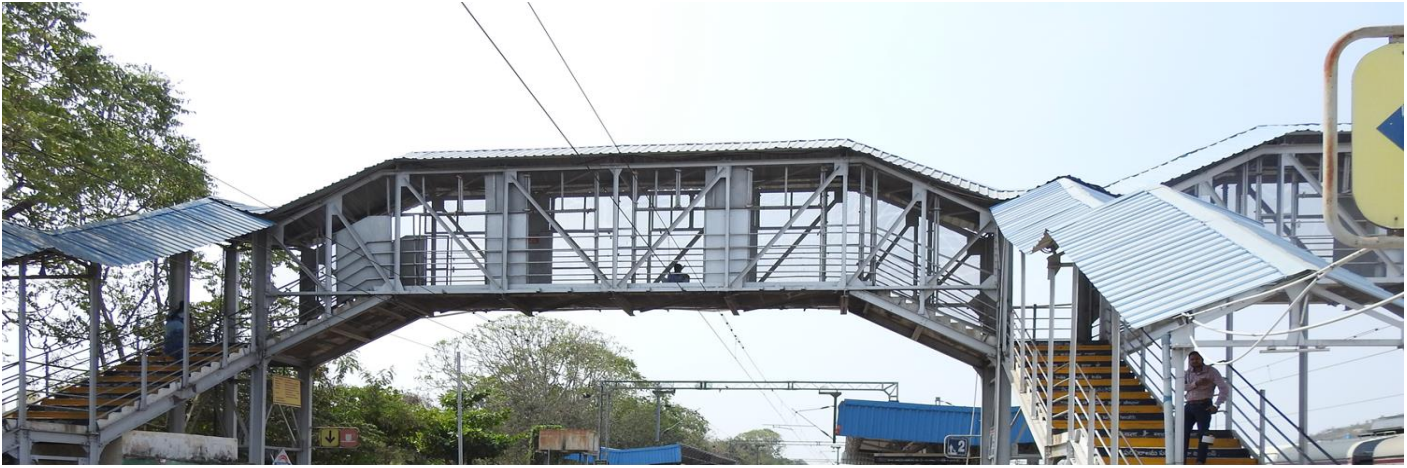
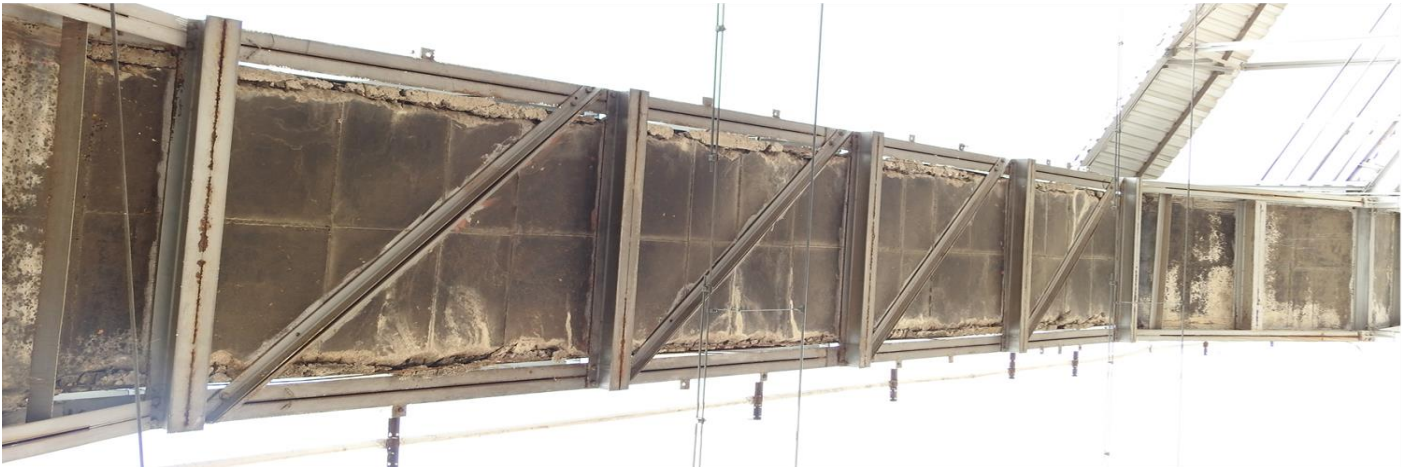
**Fig 3:** Front view and bottom view of span 1

| | Height of Truss (H) | 3 m | a. Top and bottom chord members 150 x150 x12 mm of double angle sections.<br>b. 90 x 90 x 10 mm double angle sections are used as bracing members<br>c. ISMC 150 Double Channels are used as Floor beams supported by 65 x 65 x 8 mm angle sections to transfer load from slab to roof truss.(Refer <b>fig :3</b> ) |

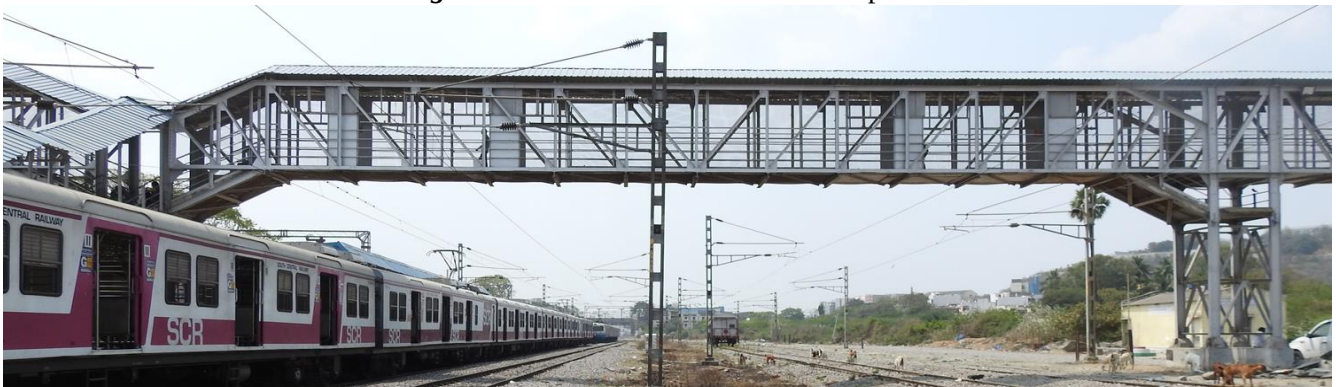
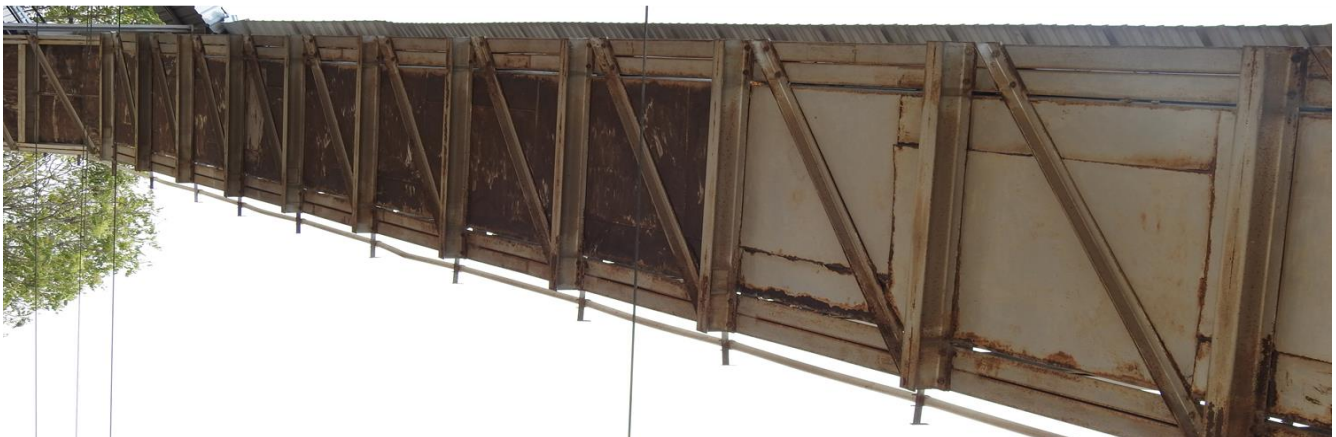
**Fig 4:** Front view and bottom view of span 2

| SURVEY OF SIGNS OF DISTRESS, DEFORMATION IN BRIDGES | | | |
|---|---|---|---|
| | Rust straining | Bottom chord members | Rusting is observed at all over the bottom chord members of FOB. (Refer <b>Part 1.4 – 1.4(b), Fig 4</b> ) |

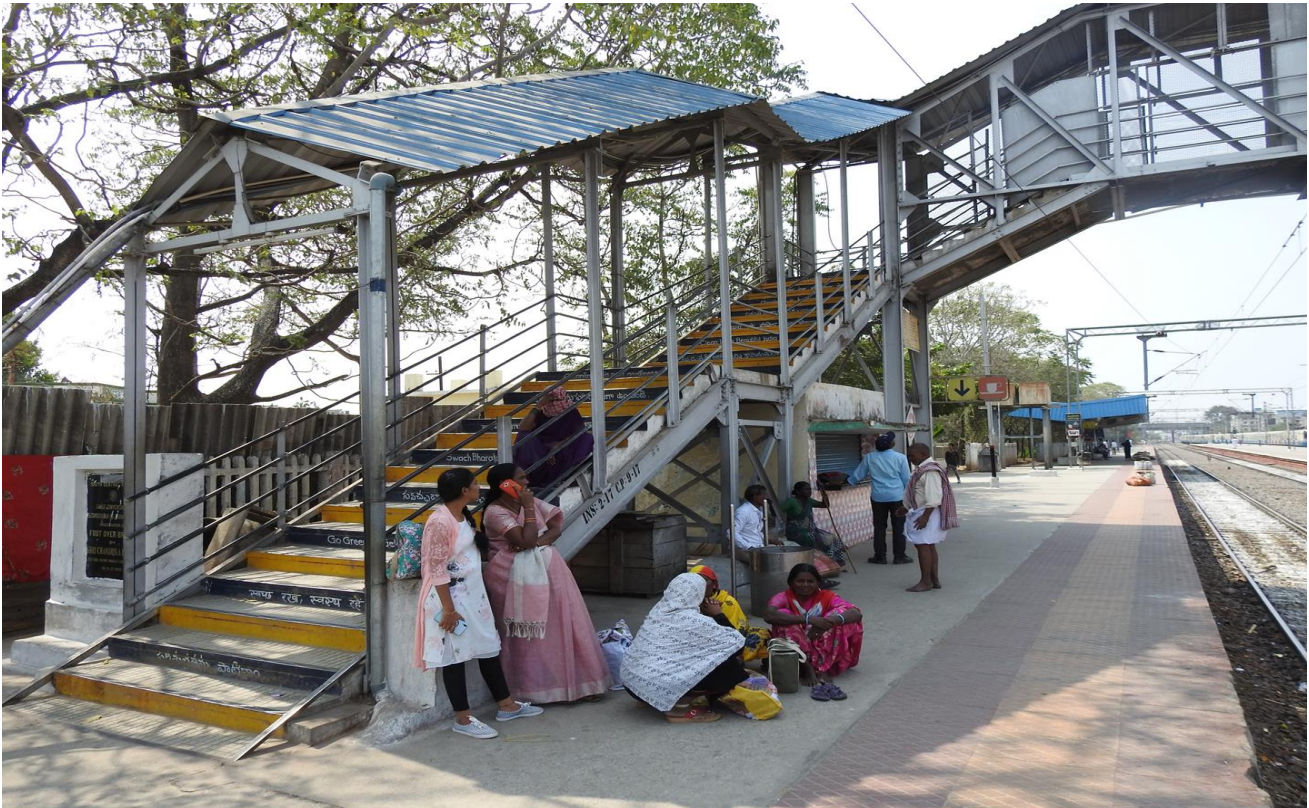
**Fig 6:** Staircase details

| | Number of Staircase | 3 no's | Staircase steps are observed as RCC slab, Steps are supported on stringer beams of ISMB 250 section, horizontal members of ISMB 150 and diagonal bracings with 65 x 65 x 8mm angle sections.<br>(Refer <b>fig :6</b> ) |
| | Type of Parapet Railing | Steel railing | Staircase is provided with railing on both sides of one-meter height using 65 x 65 x 8 mm double angle sections and 35 mm dia MS pipes are used. (Refer <b>fig :6</b> ) |
