| <b>Name of the Project</b> | <b>:</b> | VISUAL INSPECTION OF FOB AT PEDDAVADLAPUDI RAILWAY STATION |
| <b>Date of Inspection</b> | <b>:</b> | 21 <sup>st</sup> October 2019 |

## VISUAL INSPECTION OF STEEL FOOT OVER BRIDGE

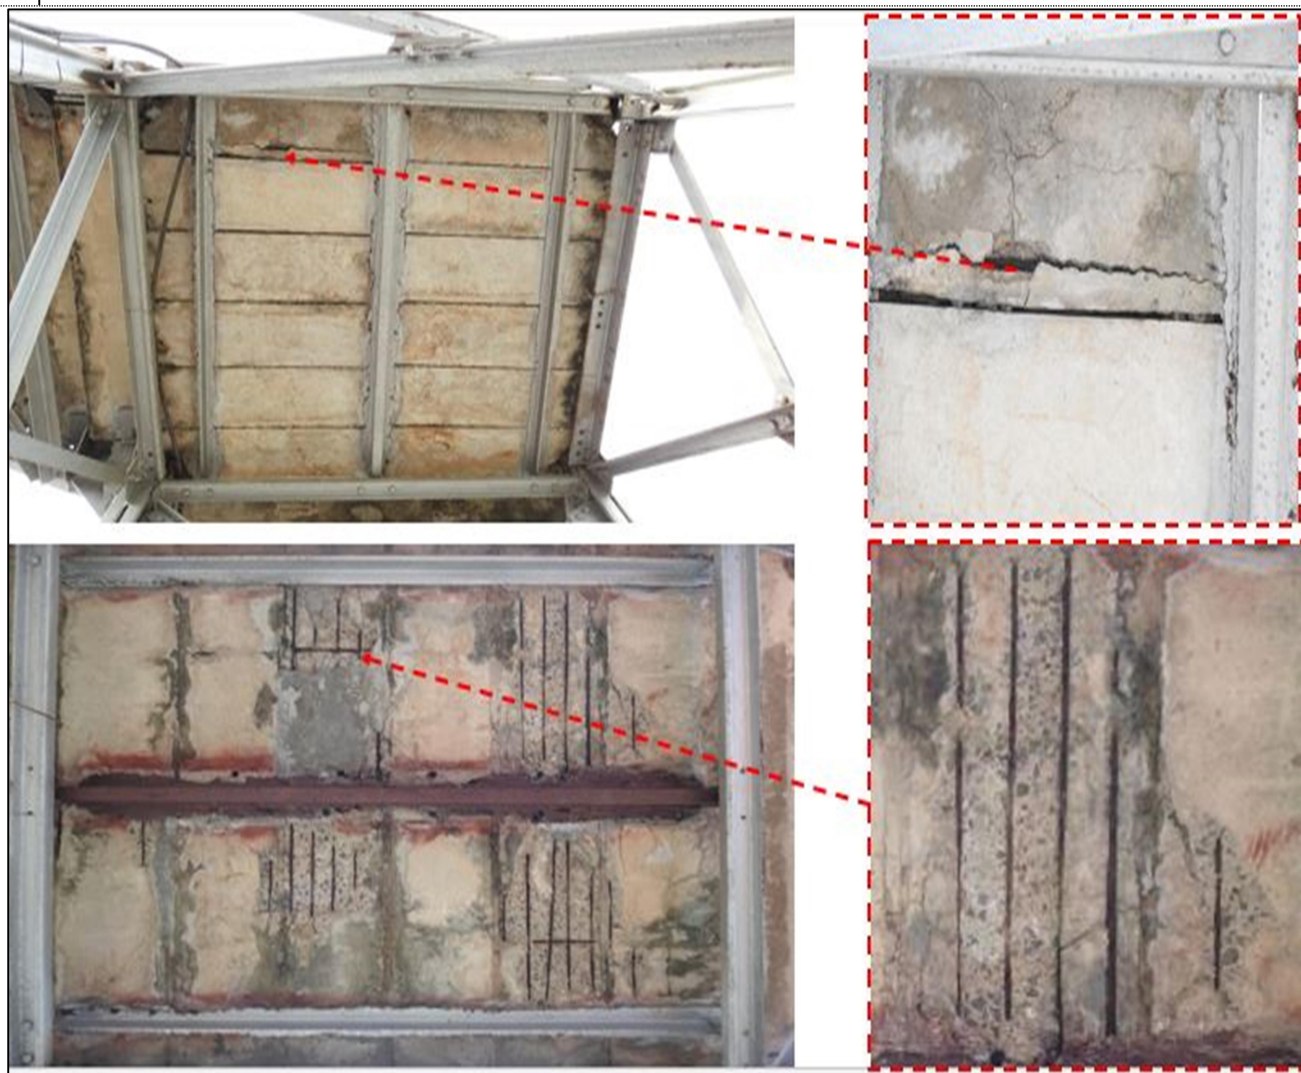
- 4.1 ✓ Exposed reinforcement is observed at Staircase Landing slab panels at plat form 1 and 2.

a).Exposed reinforcement is observed on staircase Landing slab at plat form 1 and 2

| PART 4 SURVEY OF SIGNS OF DISTRESS, DEFORMATION IN BRIDGES | | | |
|---|---|---|---|
| | Spalling | Slab panels, Stair case | Spalling and reinforcement exposure is observed in Precast RCC panels of Stair Case and Landings (Refer <b>Part 4.1</b> ) |

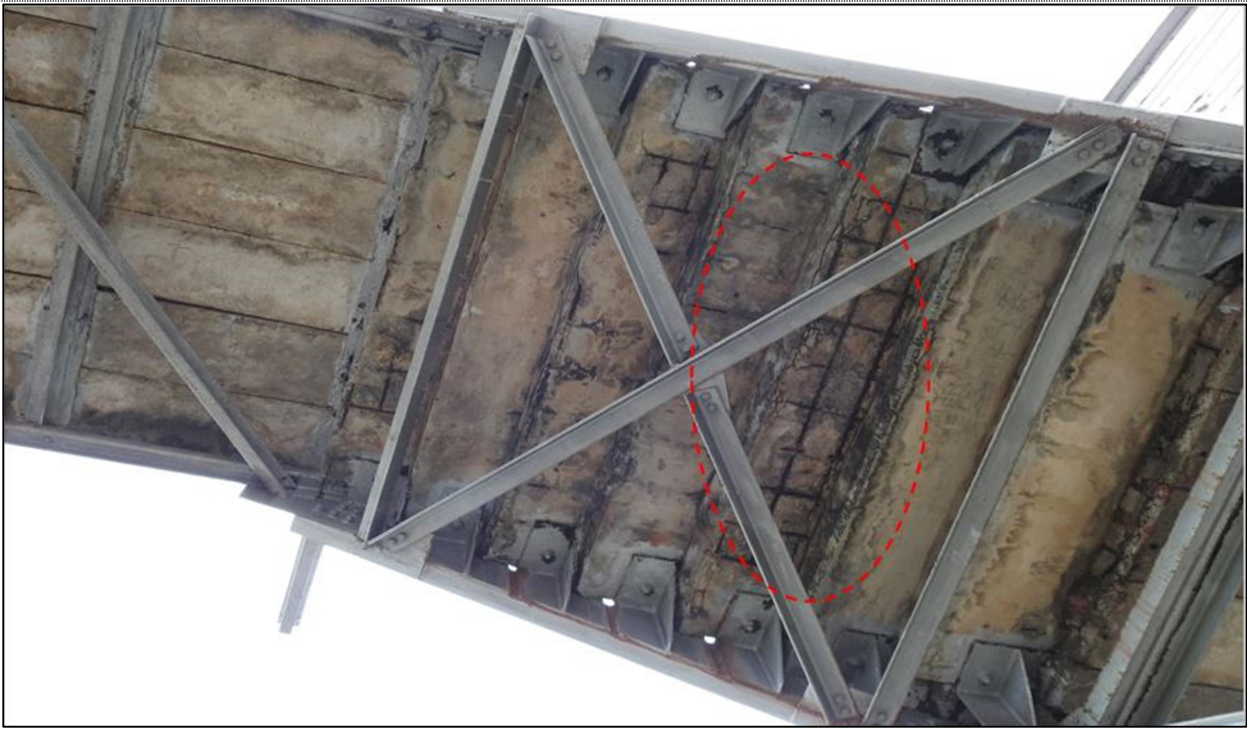
**b.** Reinforcement exposed at Stair Case flight of Clear span

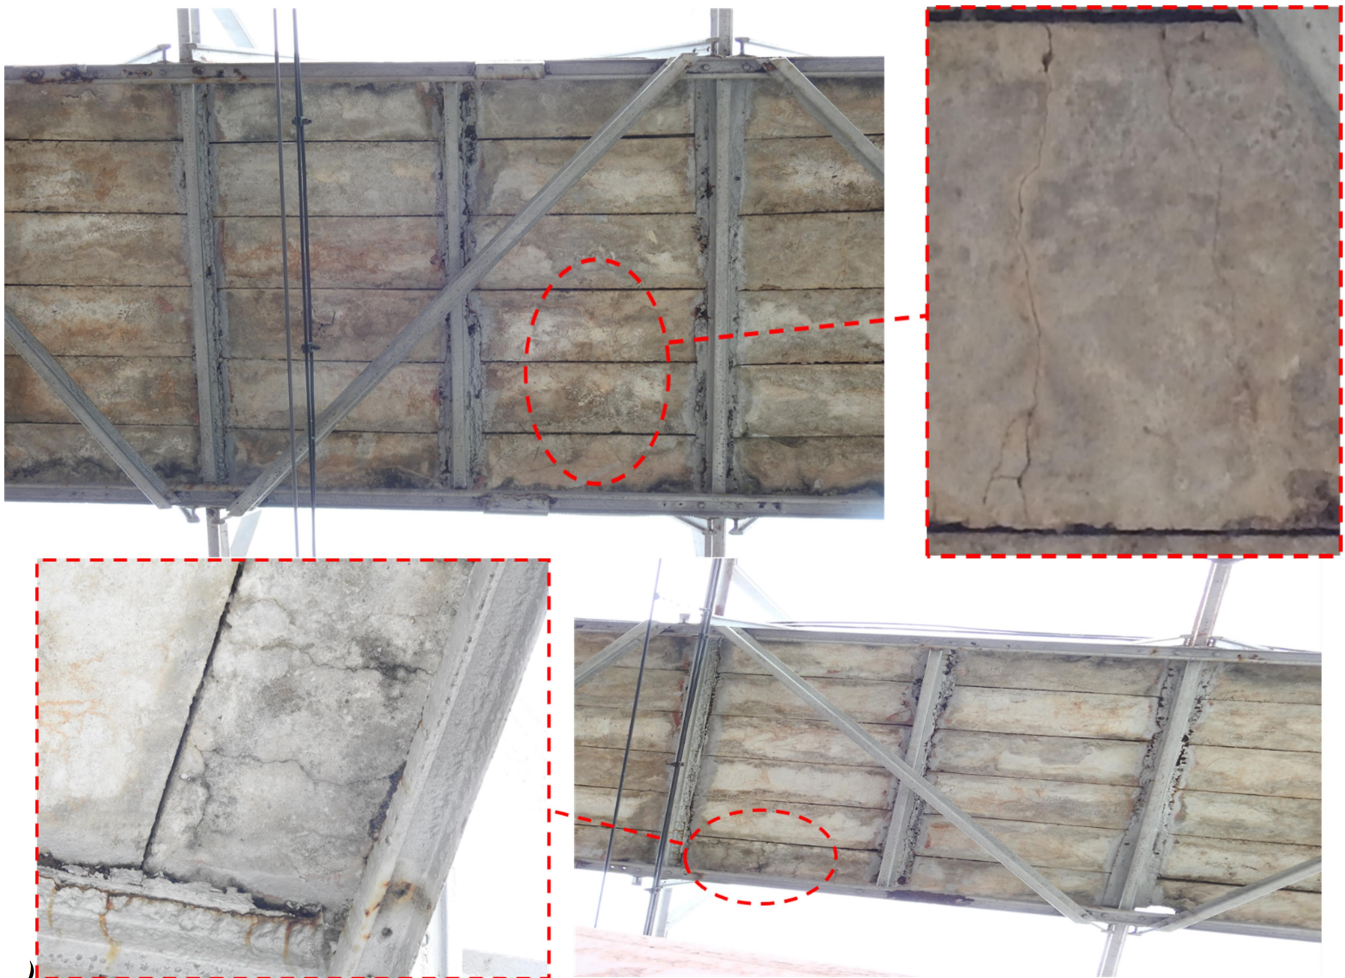
4.2      ✓ Cracks are observed at bottom of the span and below the stair case

**a)** Cracks observed at Span-1 & Span 2

| PART 4 SURVEY OF SIGNS OF DISTRESS, DEFORMATION IN BRIDGES | | | |
|---|---|---|---|
| | Cracking in RCC components | slab panels | cracks are observed in Pre-cast RCC panels (Refer <b>Part 4.2</b> ) |

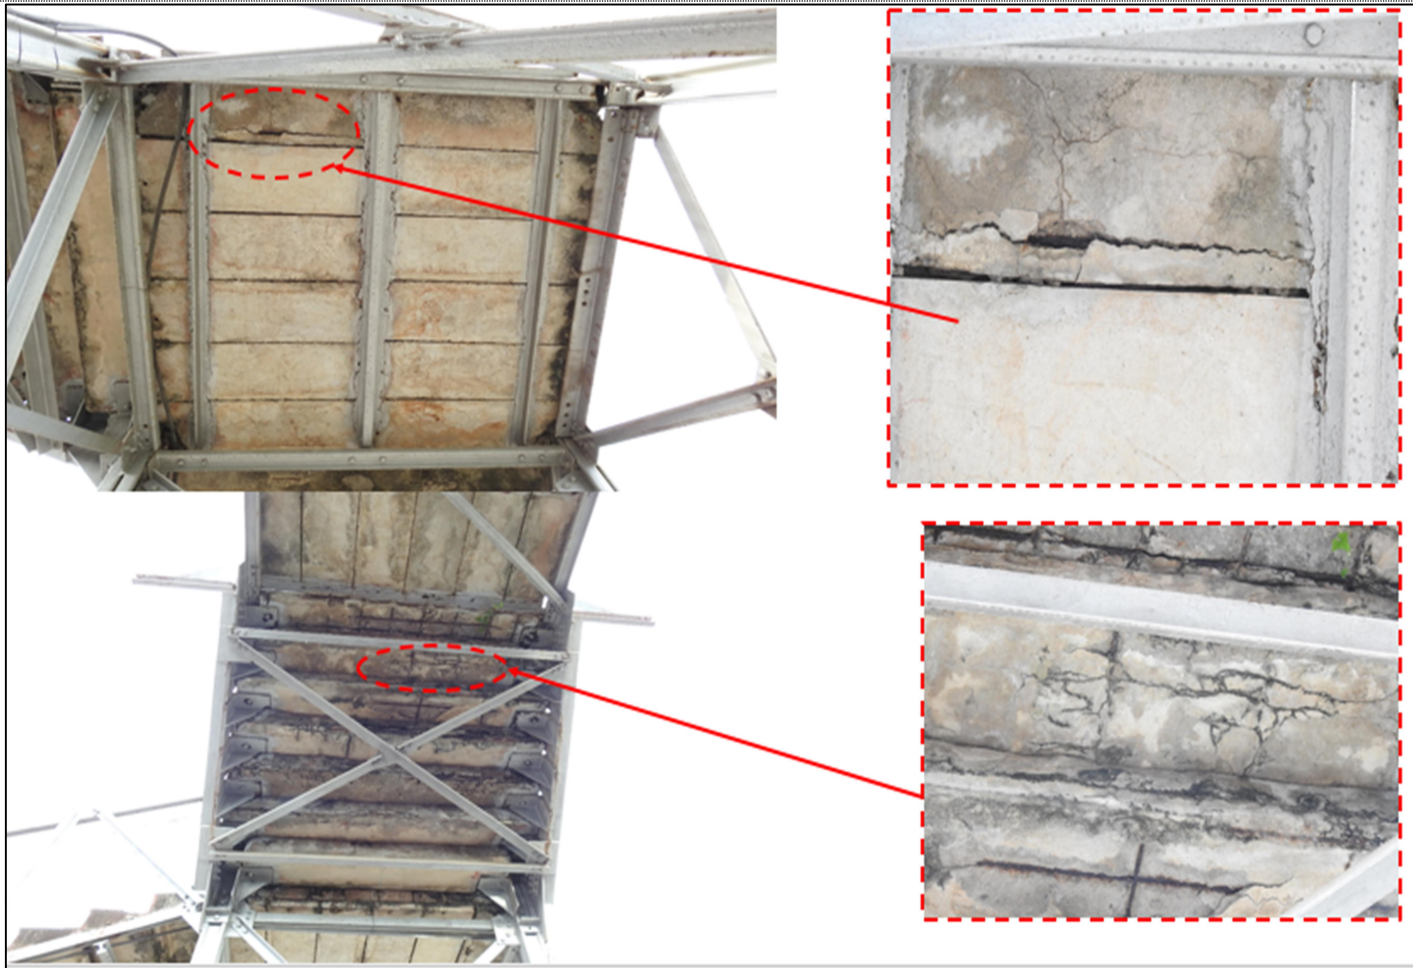
*b) Spalling and Cracks Observed at Stair case 2*

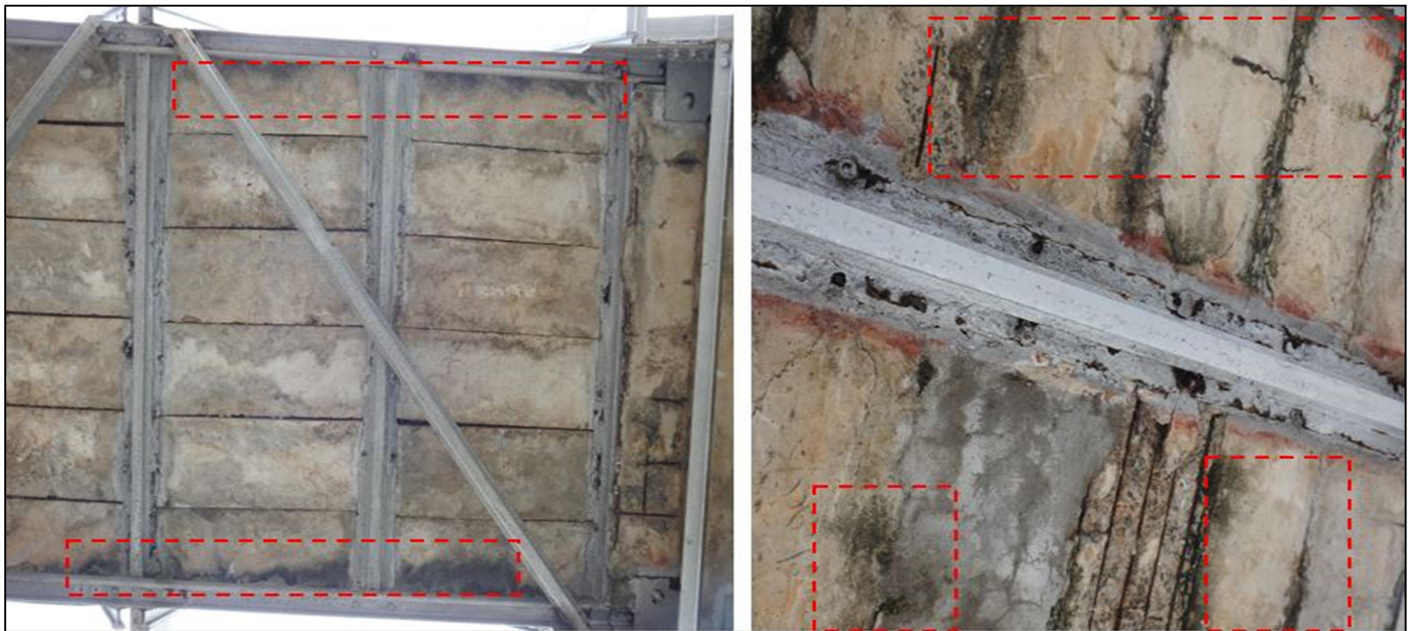
*c) Leaching and water seepage is observed at slab panels*

| PART 4 SURVEY OF SIGNS OF DISTRESS, DEFORMATION IN BRIDGES | | | |
|---|---|---|---|
| | Water seepage | Slab panels | water seepage is observed at slab panels (Refer <b>Part 4.2 c</b> ) |

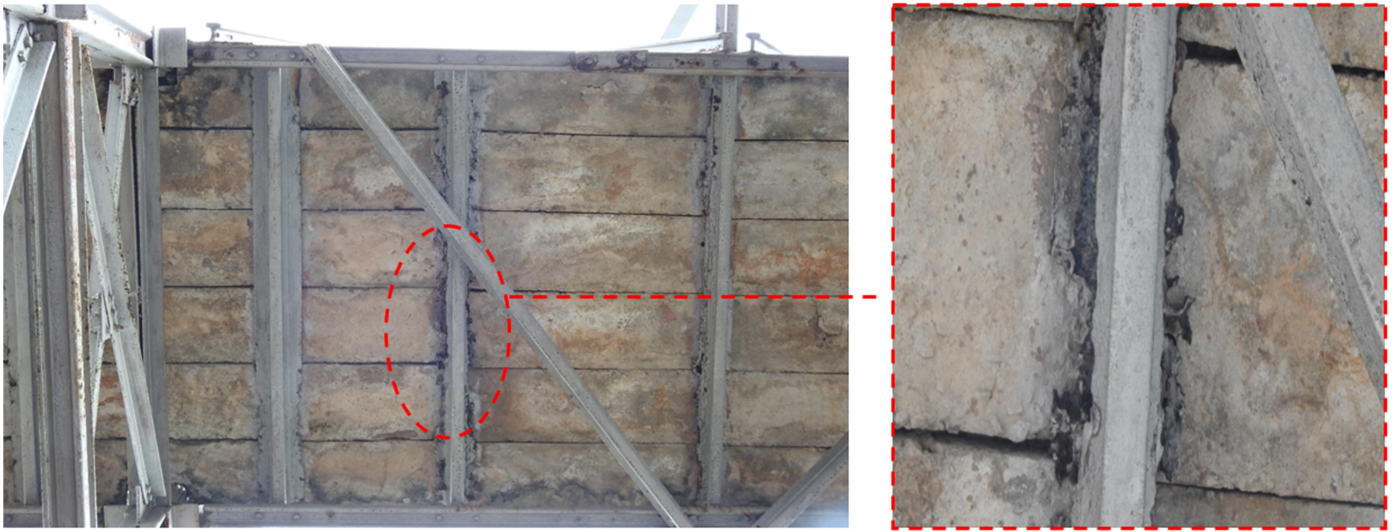
a) Corrosion of Floor Beams at Span-2

| PART 4 SURVEY OF SIGNS OF DISTRESS, DEFORMATION IN BRIDGES | | | |
|---|---|---|---|
| | Extent Of Corrosion | Floor beams, bottom chord | Corrosion of floor beam is observed in both spans of FOB. (Refer <b>Part 4.3</b> ) |

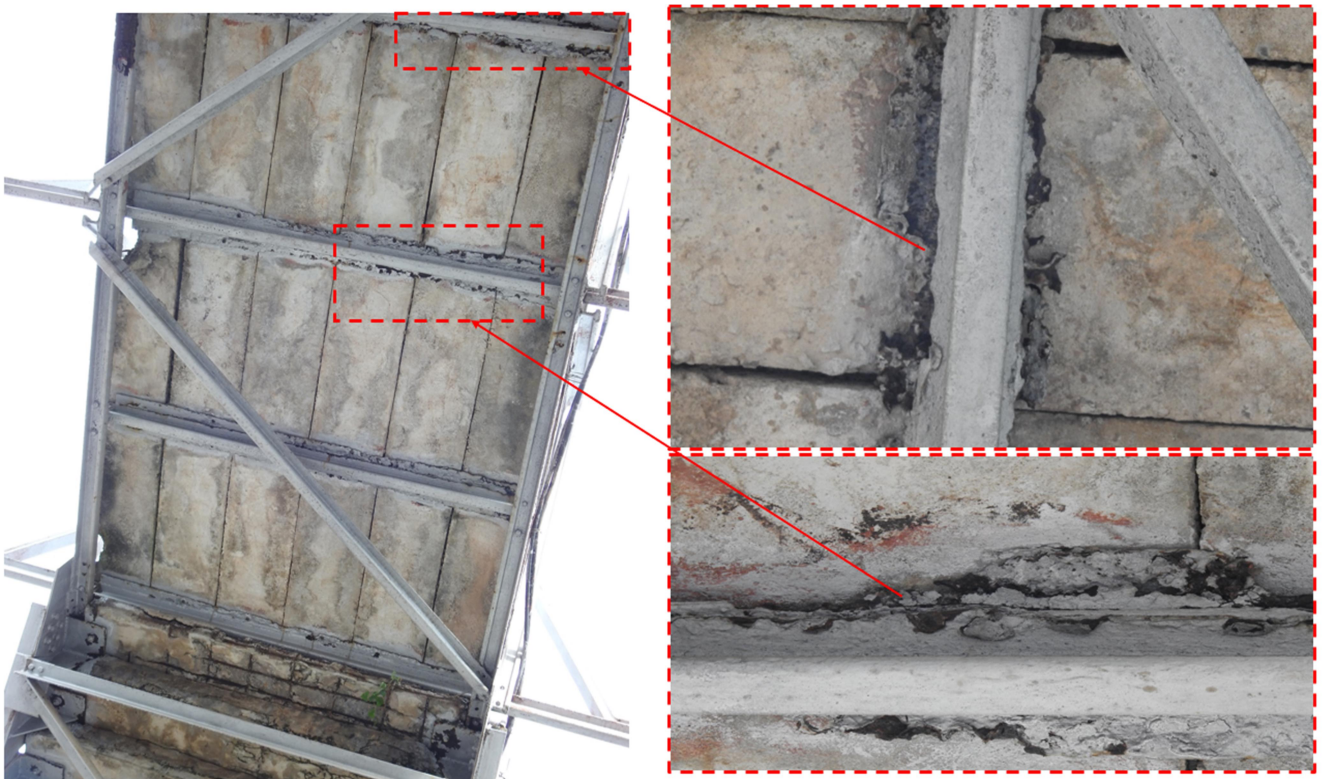
b) Corrosion of Floor Beams at Span-2

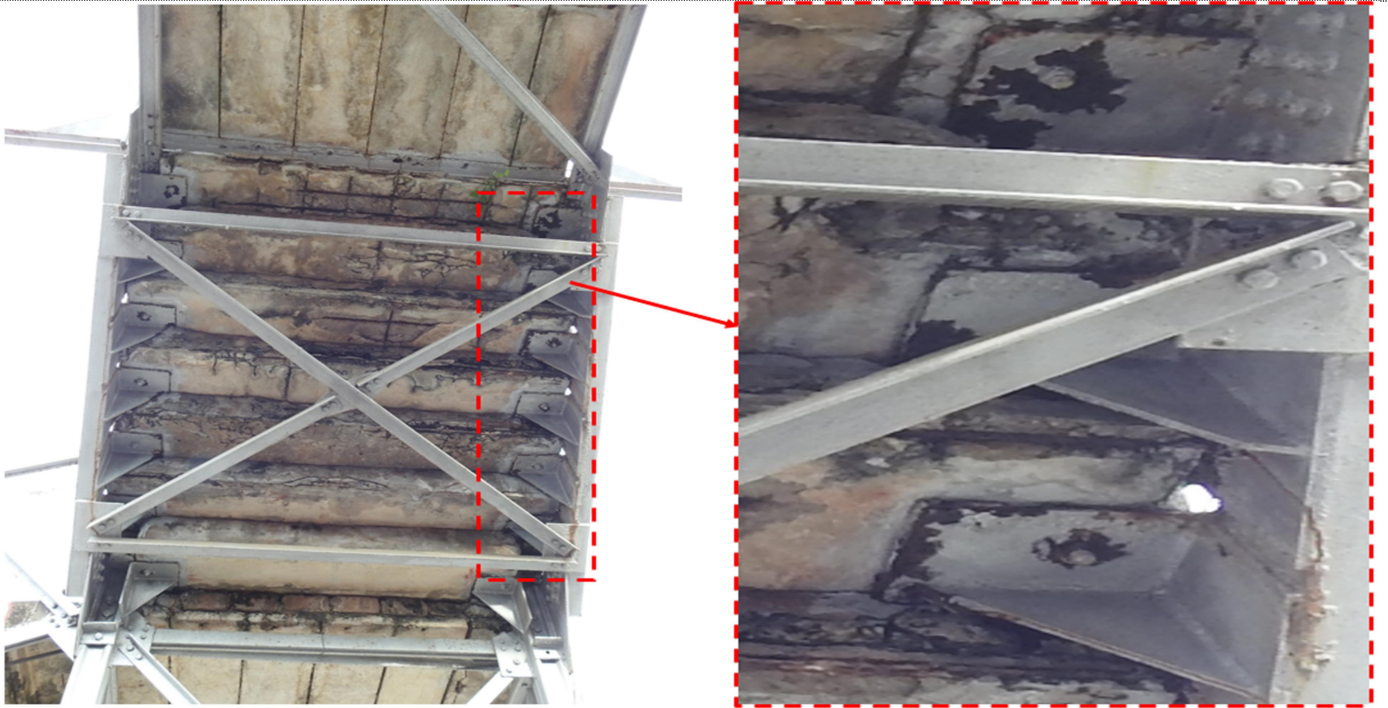
c) Corrosion at Cleat Angles of Stair Case

| PART 4 SURVEY OF SIGNS OF DISTRESS, DEFORMATION IN BRIDGES | | | |
|---|---|---|---|
| | Corrosion in Gusset plate | Cleat angles | Corrosion is observed on Cleat angles of Staircase(Refer <b>Part 4.3</b> ) |

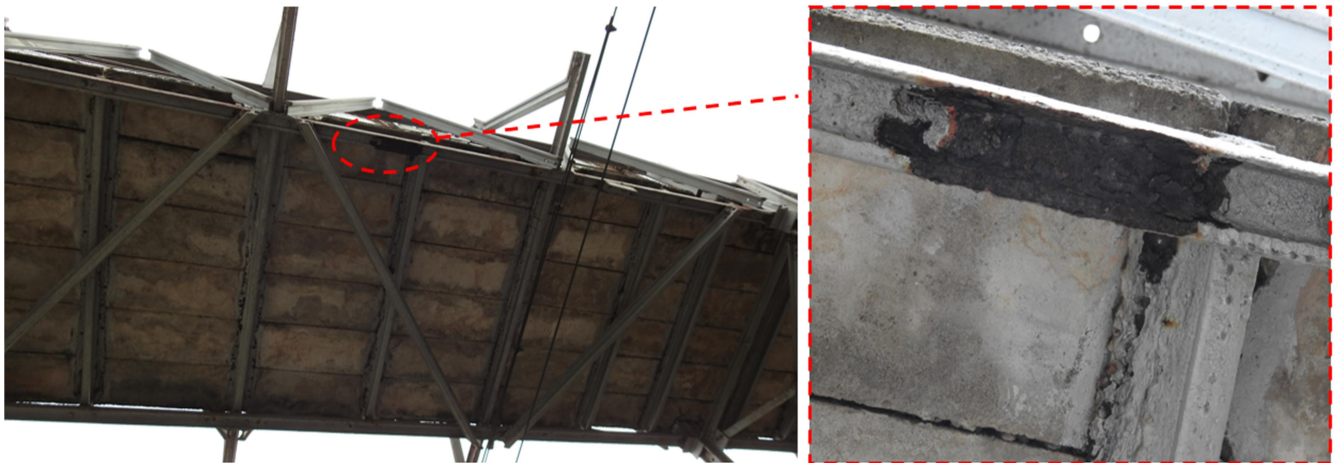
d) Corrosion of Bottom chord in Span 2

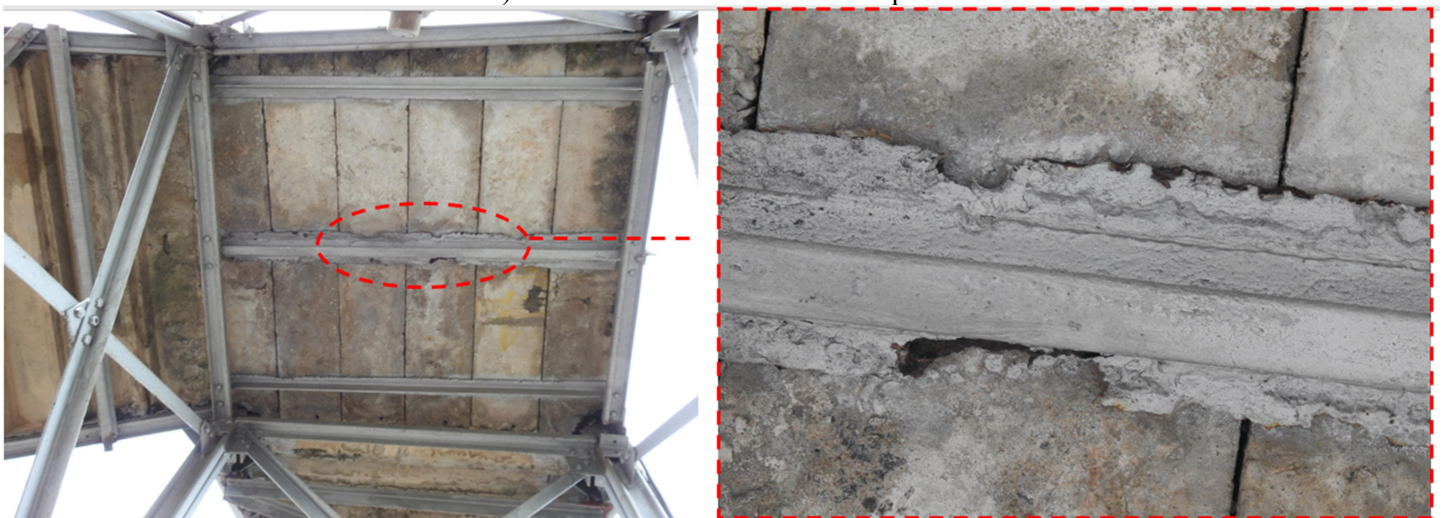
e) Corrosion of Floor beam at landing

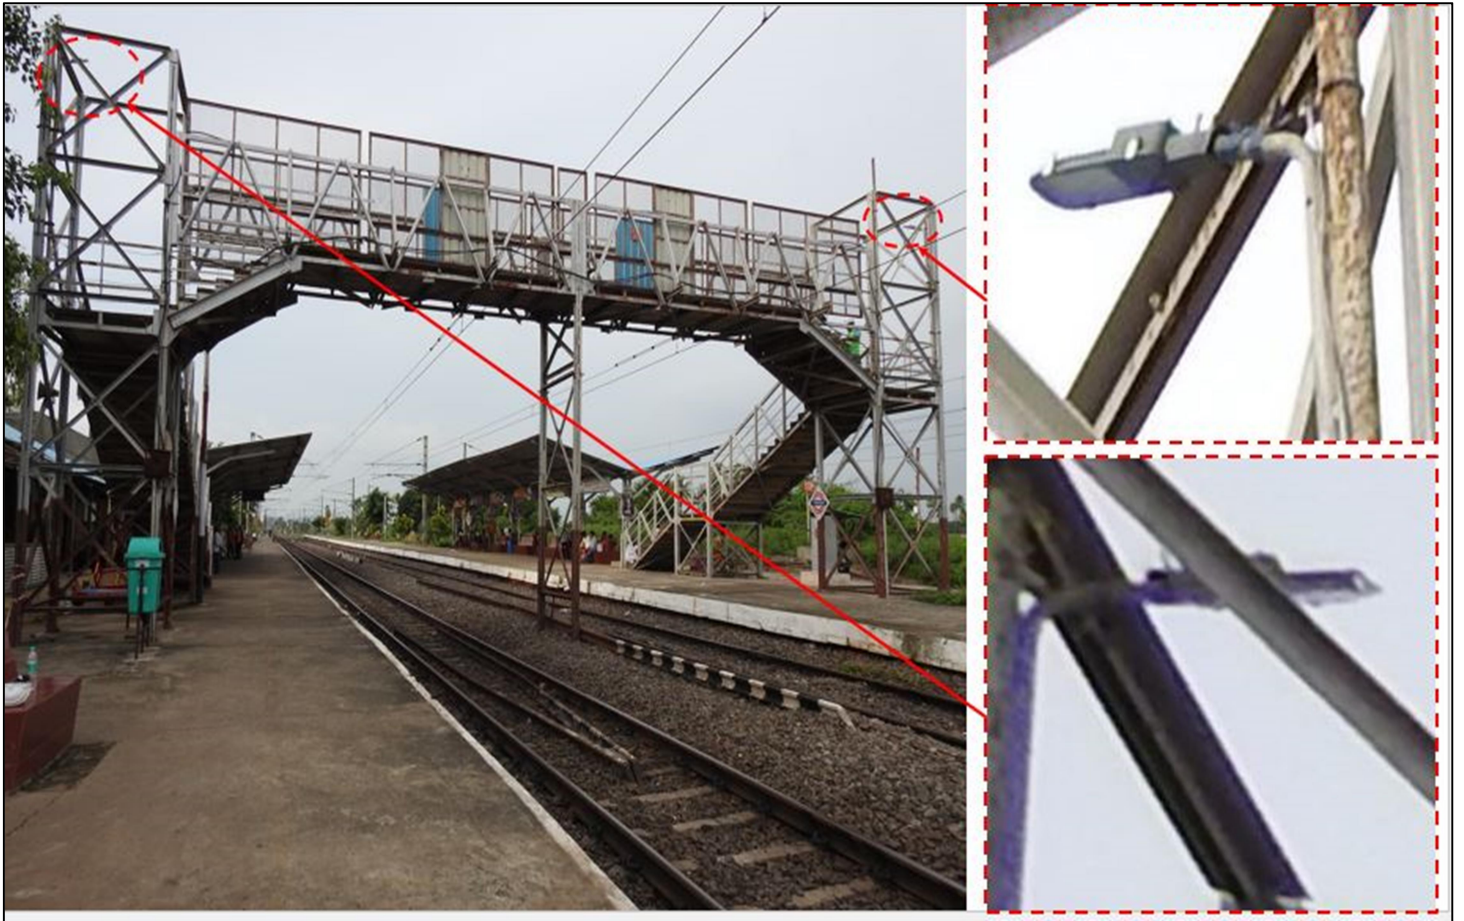
| | | Yes/No | Photo ID |
|---|---|---|---|
| | e) load of advertising hoarding, Light post | Yes | Light post with 50 mm dia. GI pipe is supported on Trestle railing at both corners of FOB.( Refer <b>fig :1</b> ) |

**Fig 1:** Light Post attached to landing Trestles Pf. 1

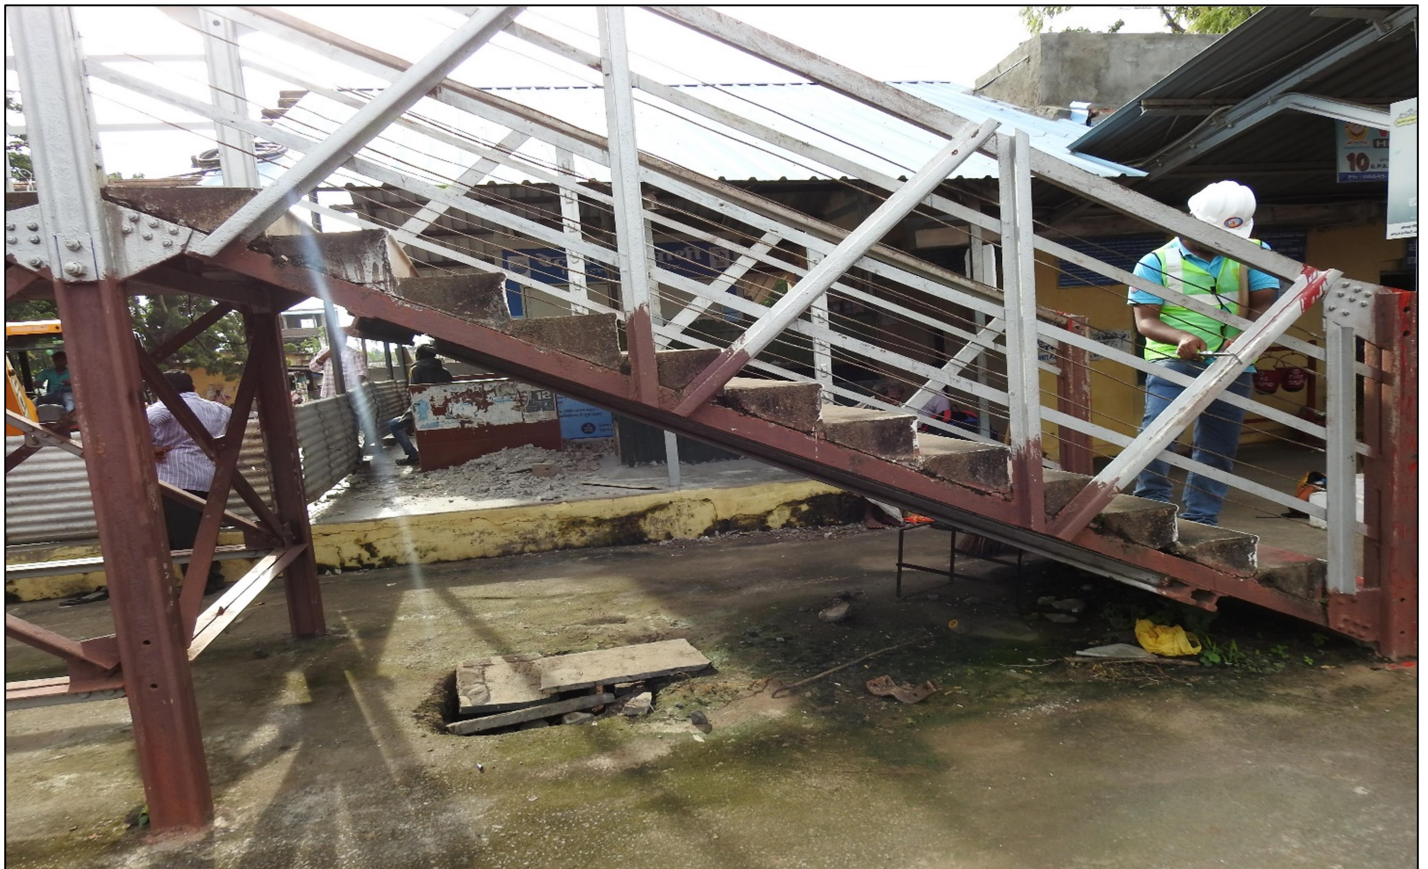
**Fig 2:** Red oxide coating observed at FOB

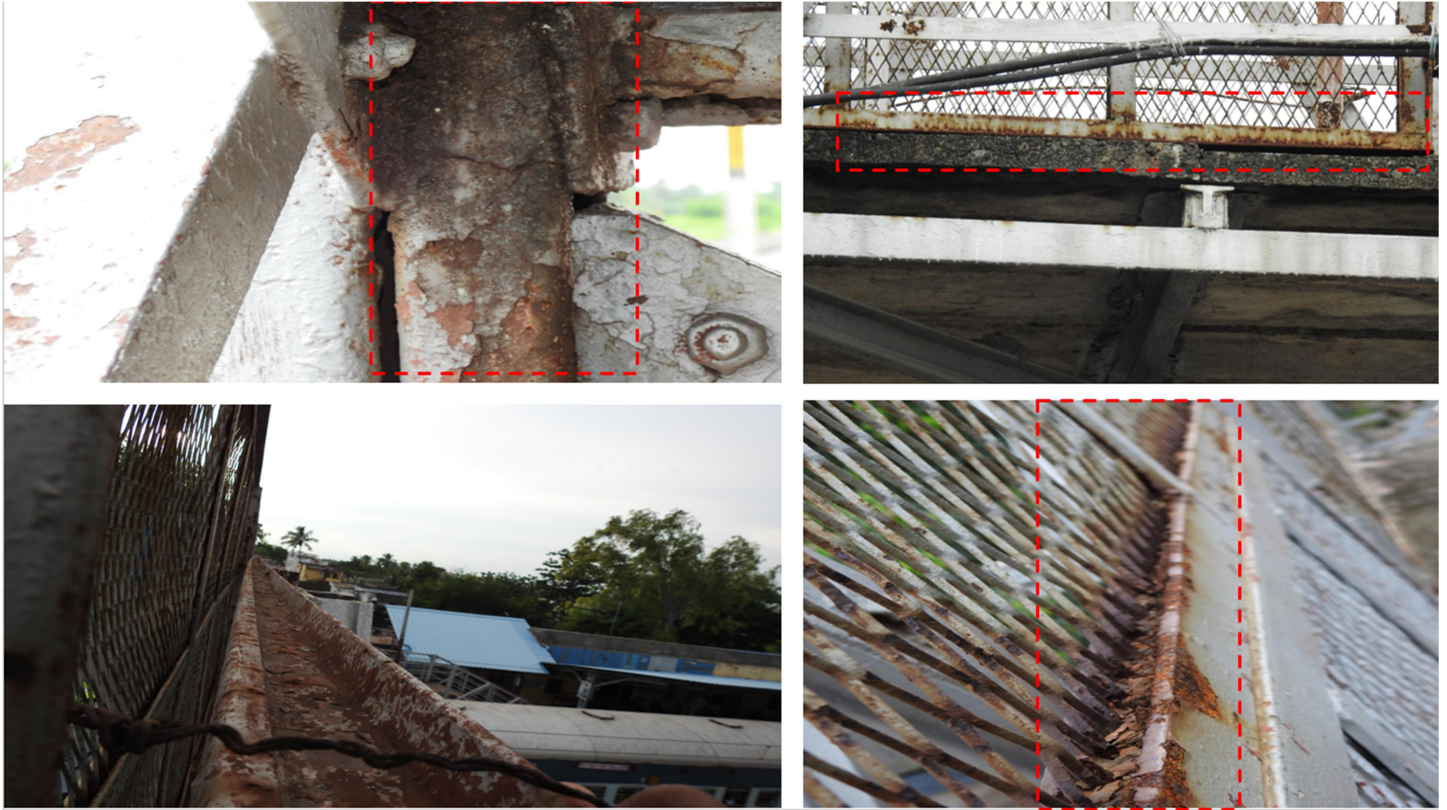
| PART 4 SURVEY OF SIGNS OF DISTRESS, DEFORMATION IN BRIDGES | | | |
|---|---|---|---|
| | Rust straining | Chord members, joints | Rusting is observed at all the joints of FOB& Top chord member (Refer <b>Fig.3</b> ) |

**Fig 3:** Rusting observed at steel joint & Top chord

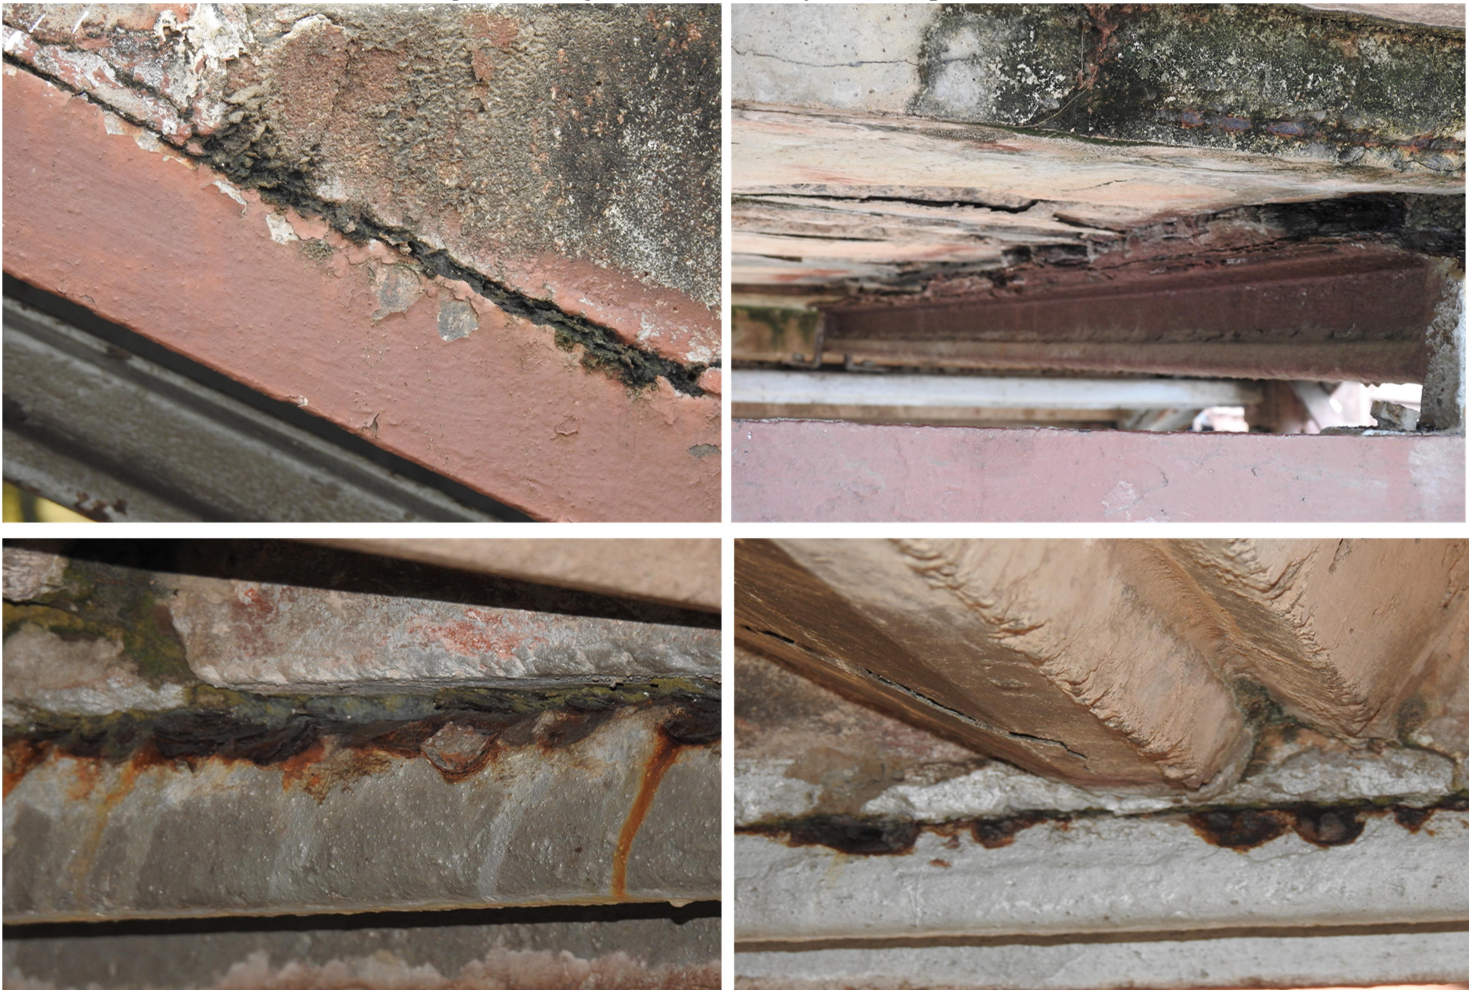
**Fig 4:** Corrosion is observed at Stringer beam joint

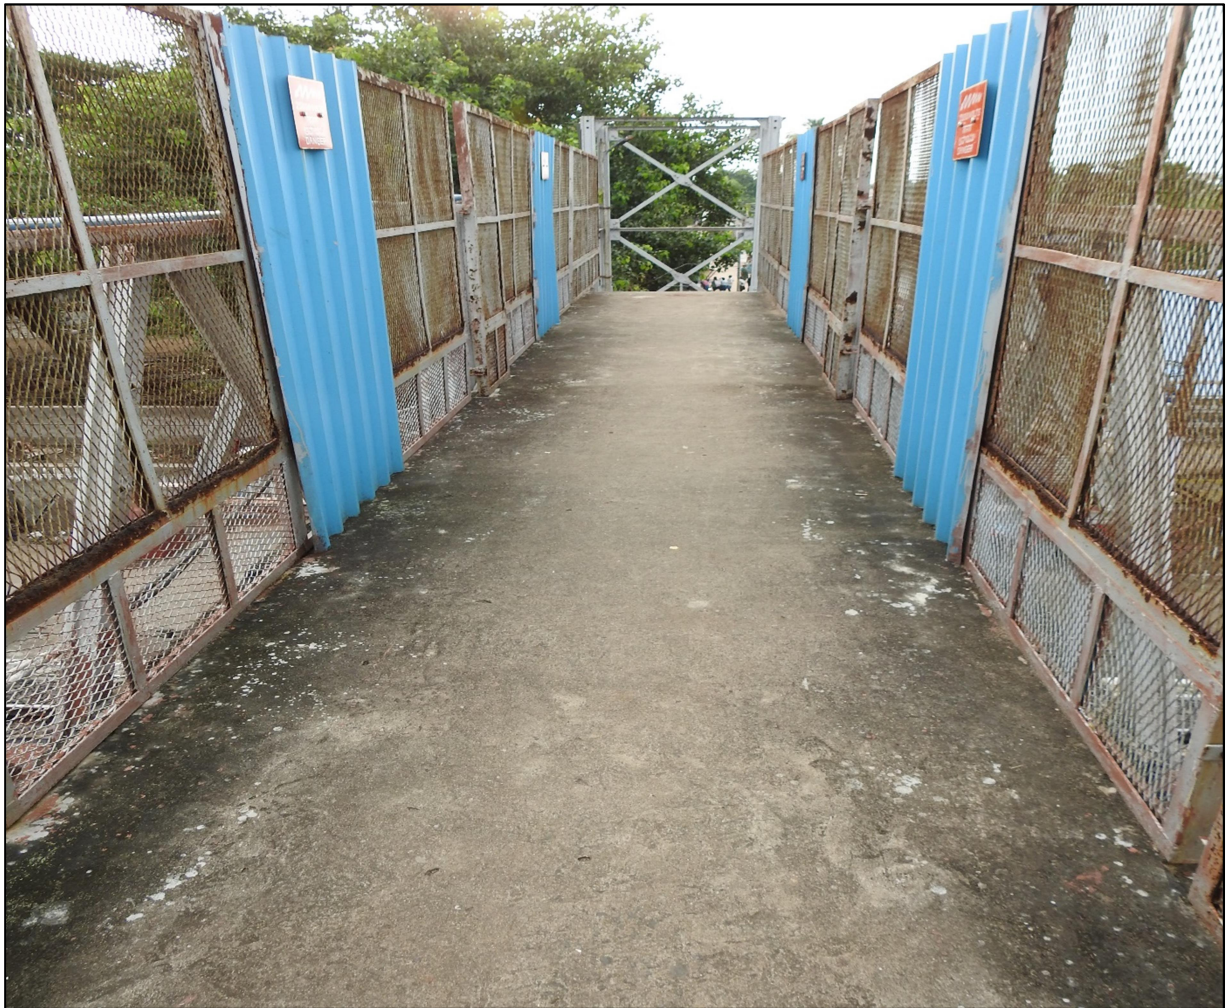
| | | Yes/No | Photo ID |
|---|---|---|---|
| | a) Additional wearing coat on Floor | Yes | Plain Cement concrete layer is used for flooring (Refer <b>fig :5</b> ). |
| | b) Provision of protective screen for passengers | Yes | XPM mesh of 2 mm gauge and 2mm galvanized sheet is used above OHE line on both side of gangway is used for protection (Refer <b>fig :5</b> ) |

**Fig 5:** Path Way, Protective screen of FOB

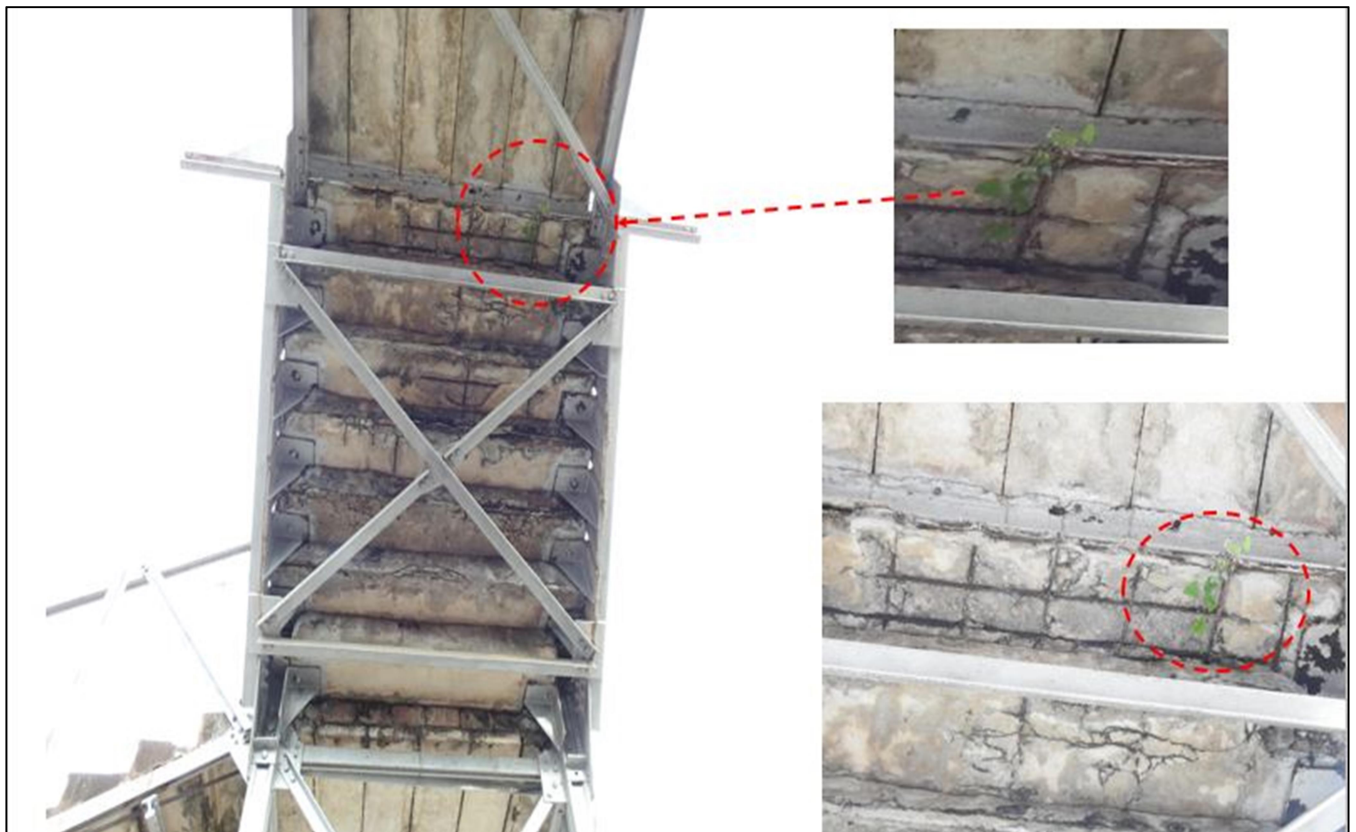
**Fig 6:** Vegetation growth at FOB

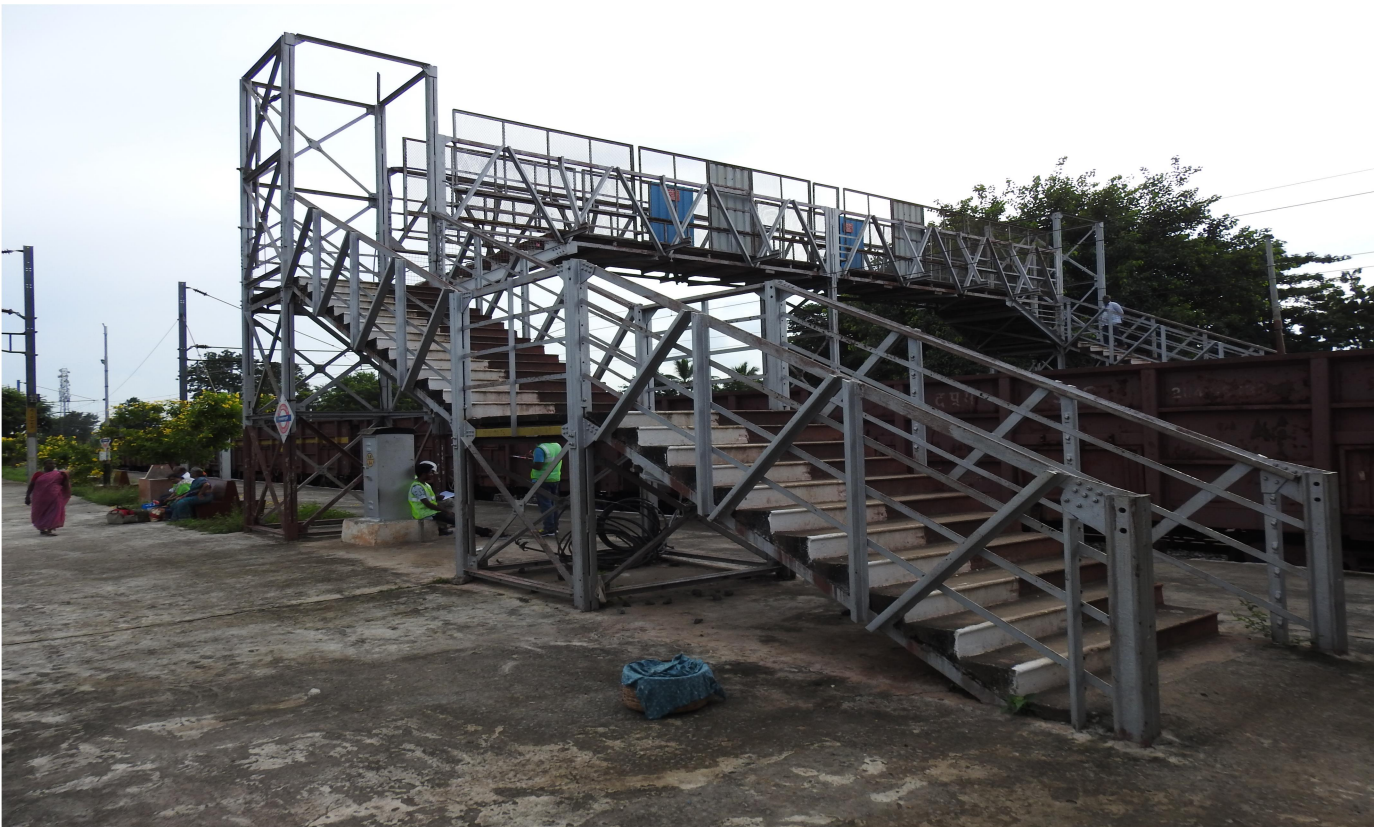
| | Type of Parapet Railing | Steel railing | a. Staircase is provided with railing on both sides of 50 x 80 x 80 mm Rail section and 50 x 8 mm M.S flats are used. (Refer <b>fig :8</b> ) |

**Fig 8:** Railing, Trestle of FOB

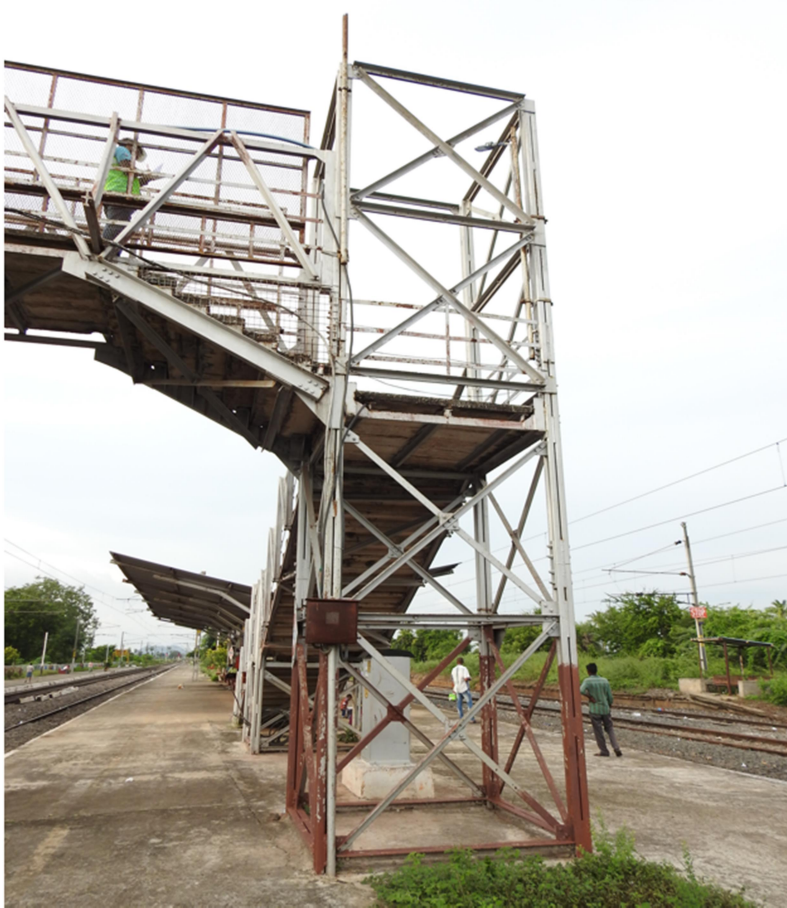
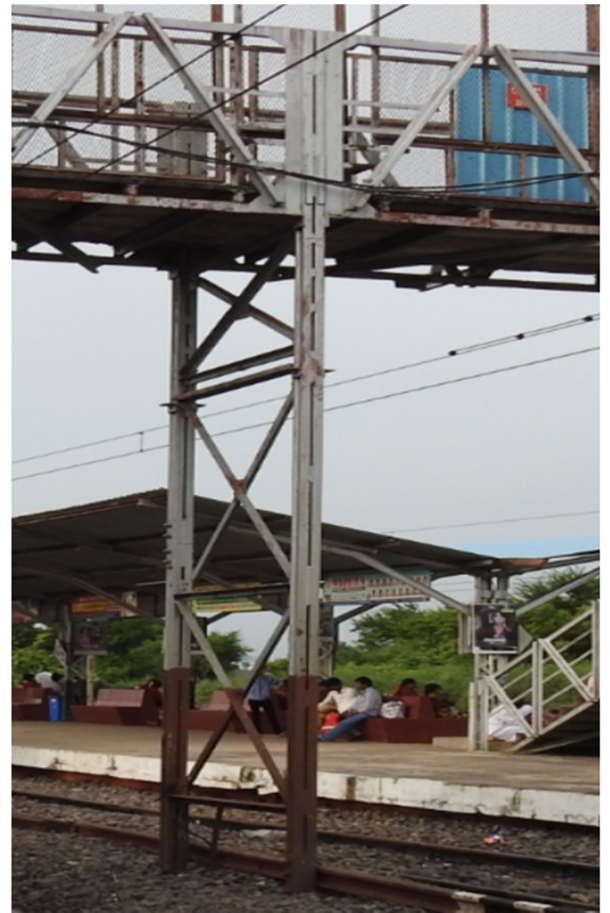
| PART 3 STRUCTURAL SYSTEM OF THE BRIDGE | | | |
|---|---|---|---|
| | Type/Shape of Column section | Bull Headed Rail | a. FOB is supported on vertical column of 2 Bull Headed Rail section 65 x 130 x 65, with bracings of 65 x 65 x 10 mm angle section(Refer <b>fig :9</b> )<br>b. Trestles 1 and 3 have 4 columns whereas Trestles 2 (Stanchion) has only 2 columns.<br>c. Staircase landing is supported by Trestle column of 2 Rail section 65 x 130 x 65, with bracings of 65 x 65 x 10 mm angle section |

***Fig 9:*** Trestle and Stanchion of FOB
