## Third Party Audit of ROB's and FOB's of SCR

### INSPECTION OF FOB AT NAMPALLY RAILWAY STATION

**Final Report**  
SEPTEMBER | 2020

| Name of the Project | : | VISUAL INSPECTION OF FOB/ PF-2 - PF-6 AT HYDERABAD RAILWAY STATION |

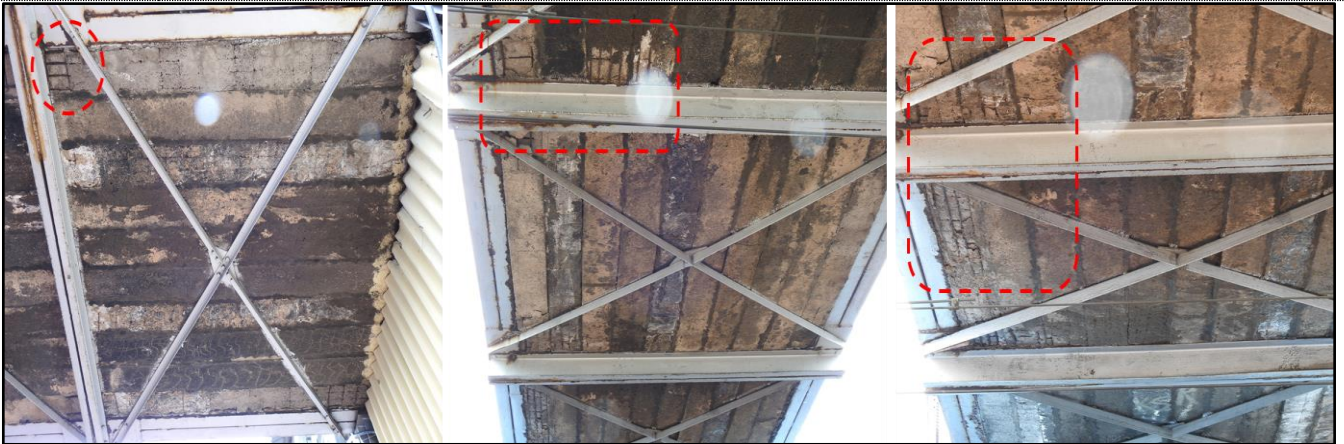
**A**

- ✓ Spalling and reinforcement exposed in precast RCC slab panels and joints.
- ✓ Corrosion is observed in Tie angular sections, Gusset plates and bracing along steel – concrete joint on both sides of FOB
- ✓ Leaching is observed between slab panels joints.

Spalling and leaching effect observed at bottom of slab panels

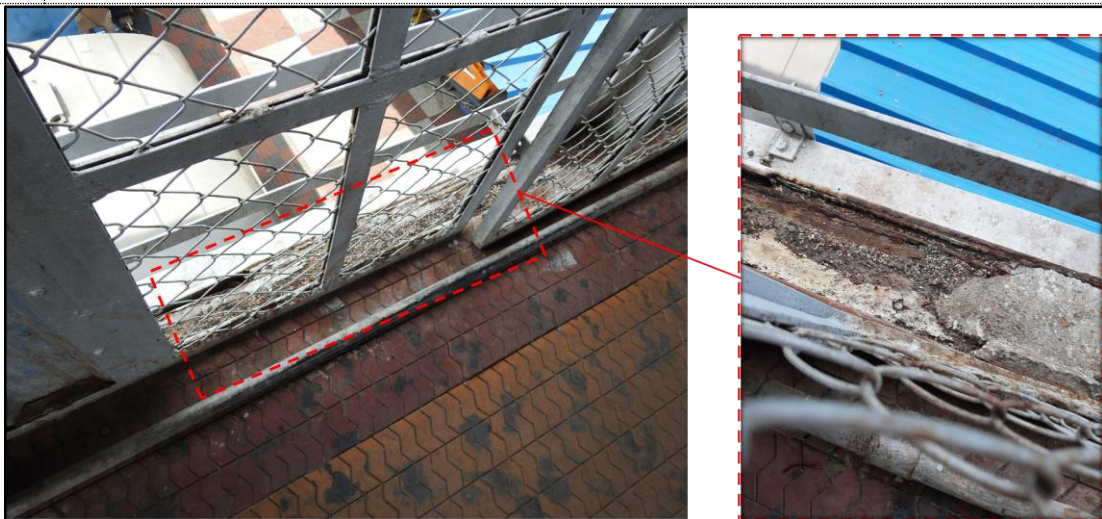
**B**

- ✓ Major Corrosion is observed along the length of steel concrete joint on both sides
- ✓ Inclined bracing and gusset plates are also corroded near base slab

Major Corrosion observed at main girders along the span

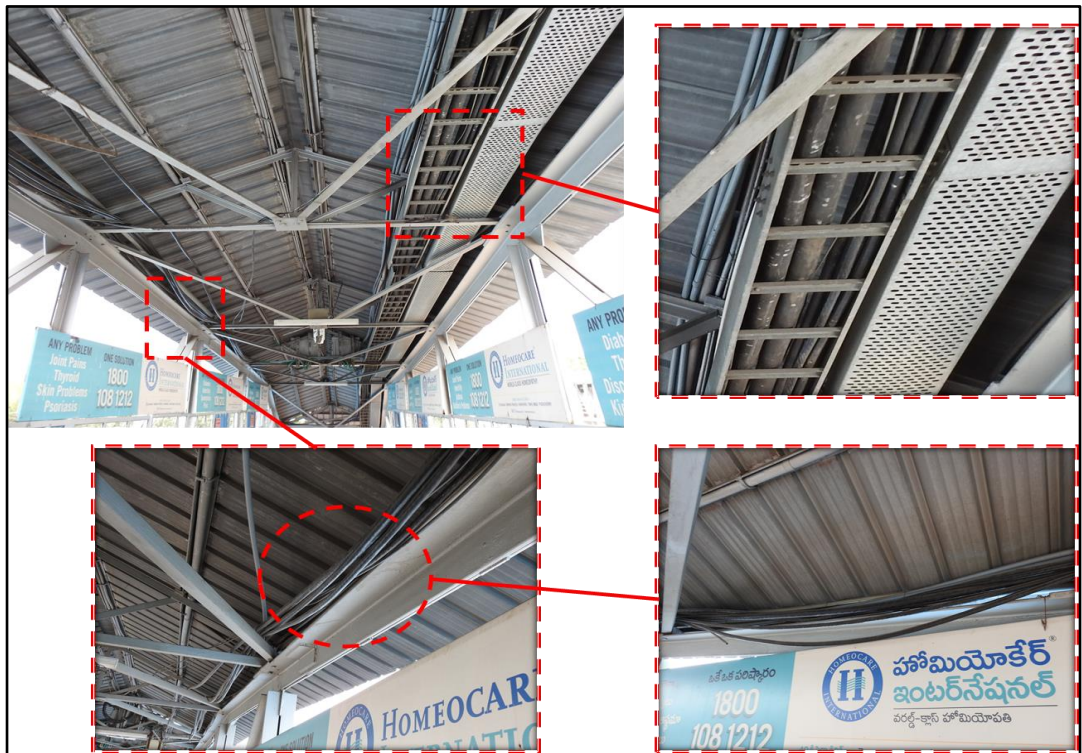
**Fig 1.1:** Cables

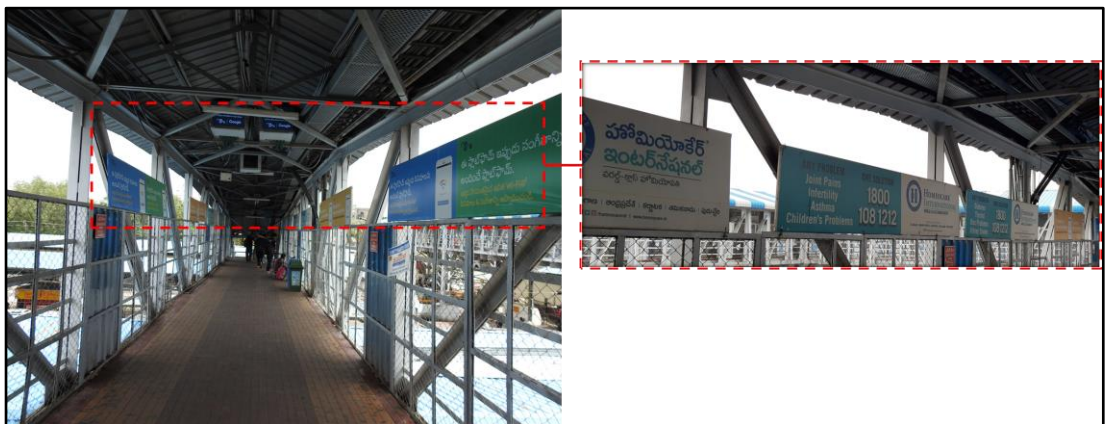
**Fig 1.2:** Advertising hoardings in FOB

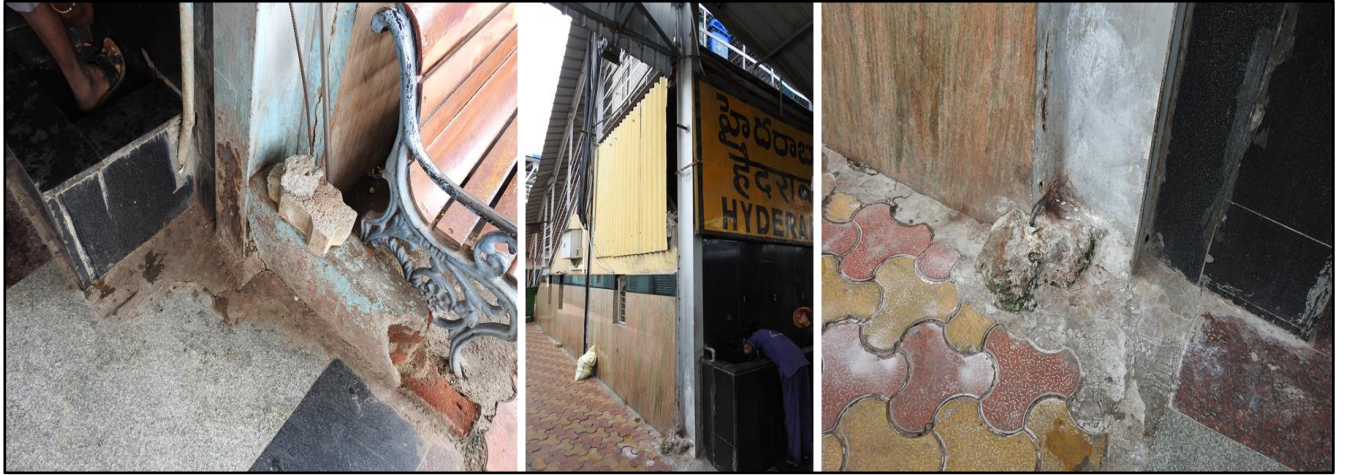
| 1.3 STRUCTURAL SYSTEM OF THE BRIDGE | | | |
|---|---|---|---|
| a | <b>Foundation</b> | | Not visible at site (Refer <b>fig :1.4</b> ) |

**Fig 1.4:** Column is merged in platform flooring

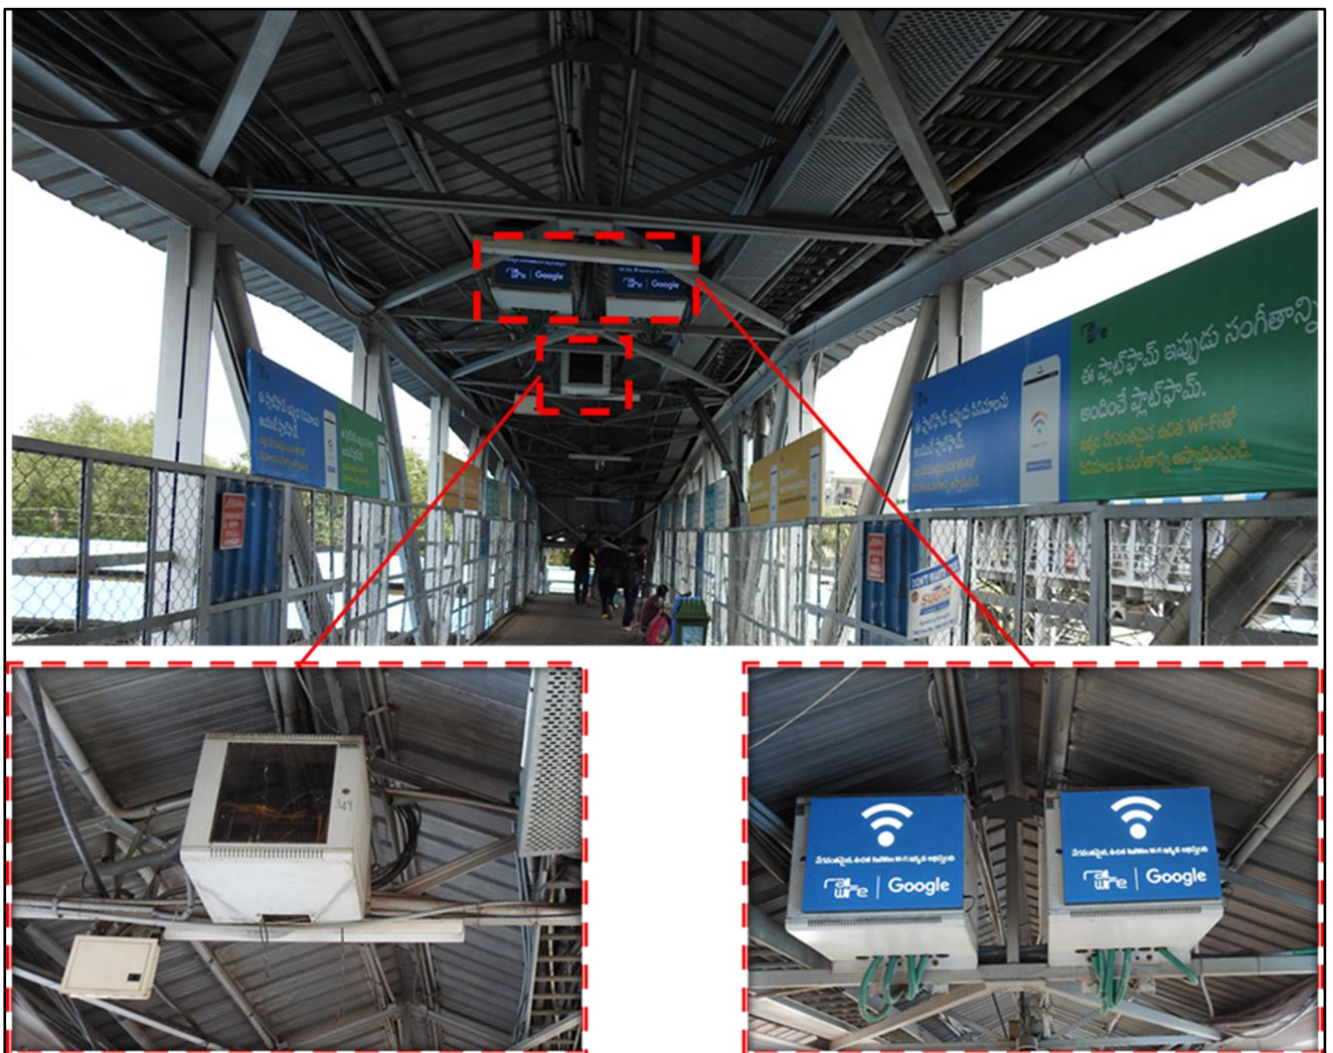
**Fig 1.5:** Utilities load on roof truss (Ethernet boxes)

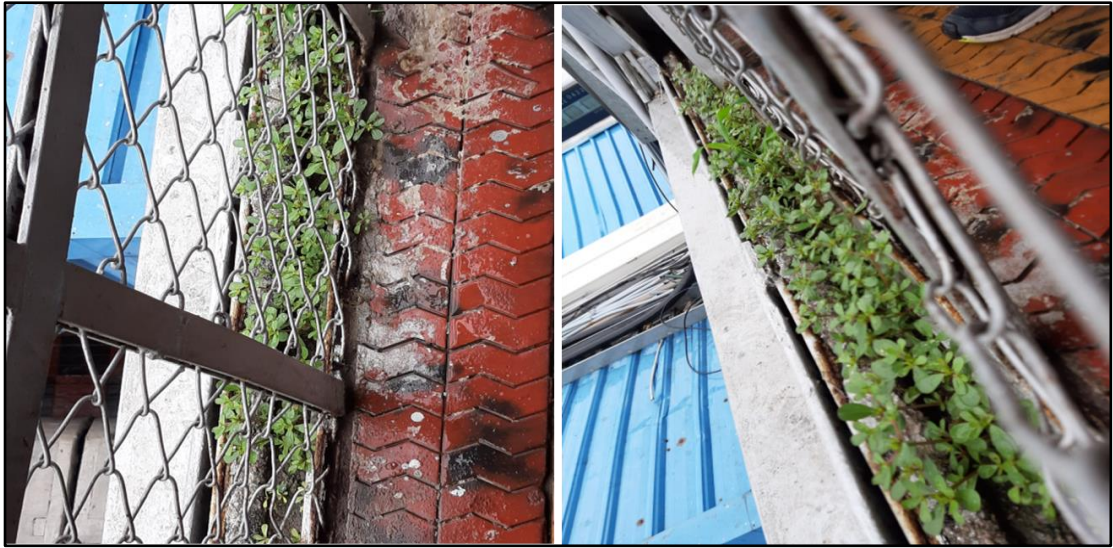
**Fig 1.9:** Vegetation growth on main girder

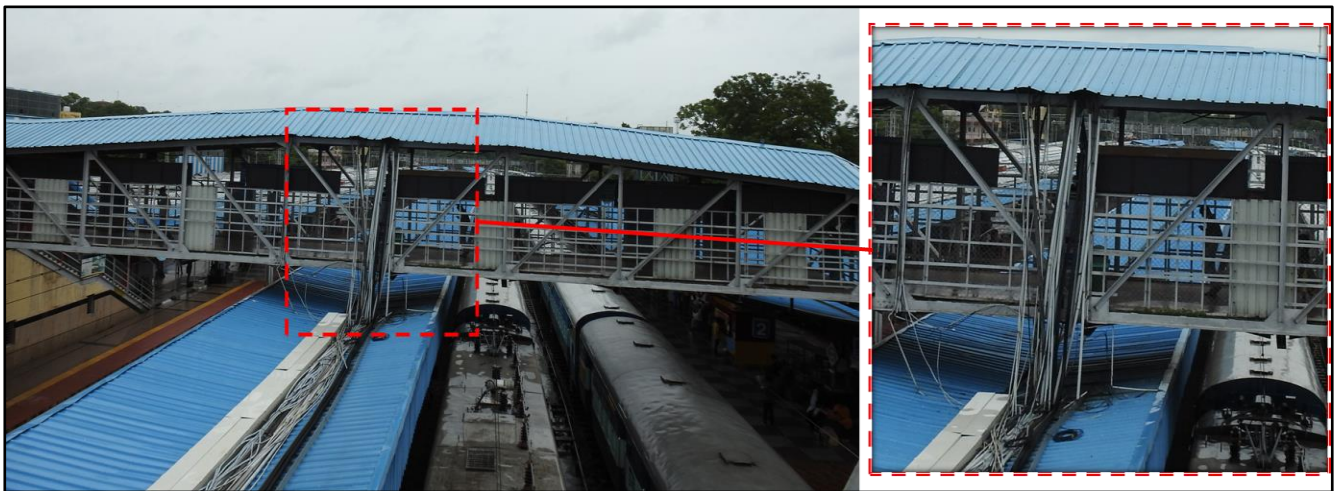
**Fig 1.10:** Running of Cables into FOB

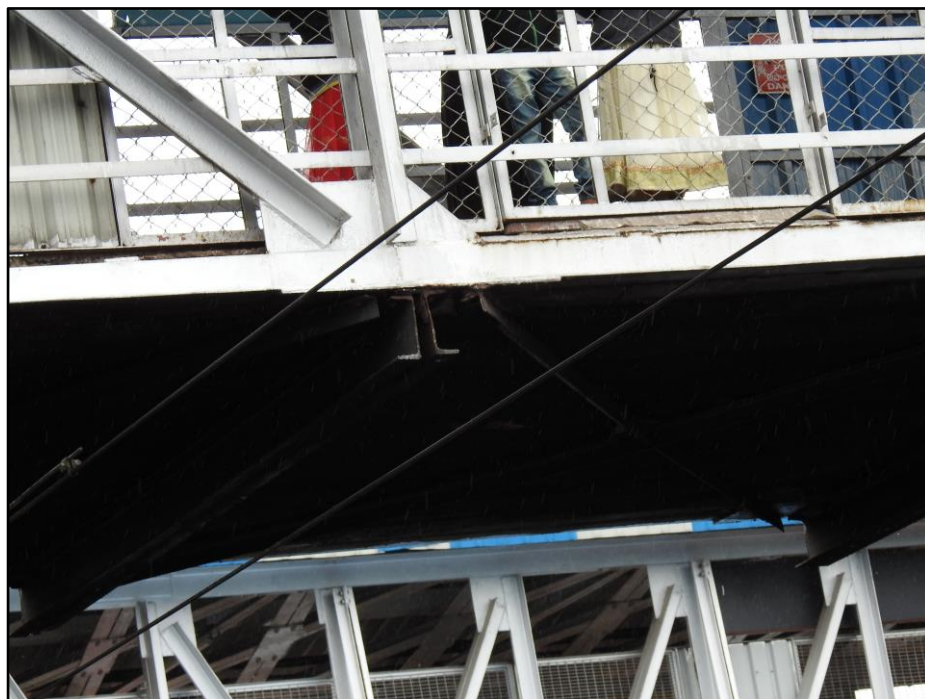
| SIGNS OF DISTRESS, DEFORMATION IN BRIDGES | | | |
|---|---|---|---|
| | Extent Of Corrosion | In Tie member | a. Distressing is observed in bottom Tie members along steel column joints<br>b. Spacers in between secondary girders are completely distressed |

**Fig 1.11:** Secondary girders joints have severely deteriorated

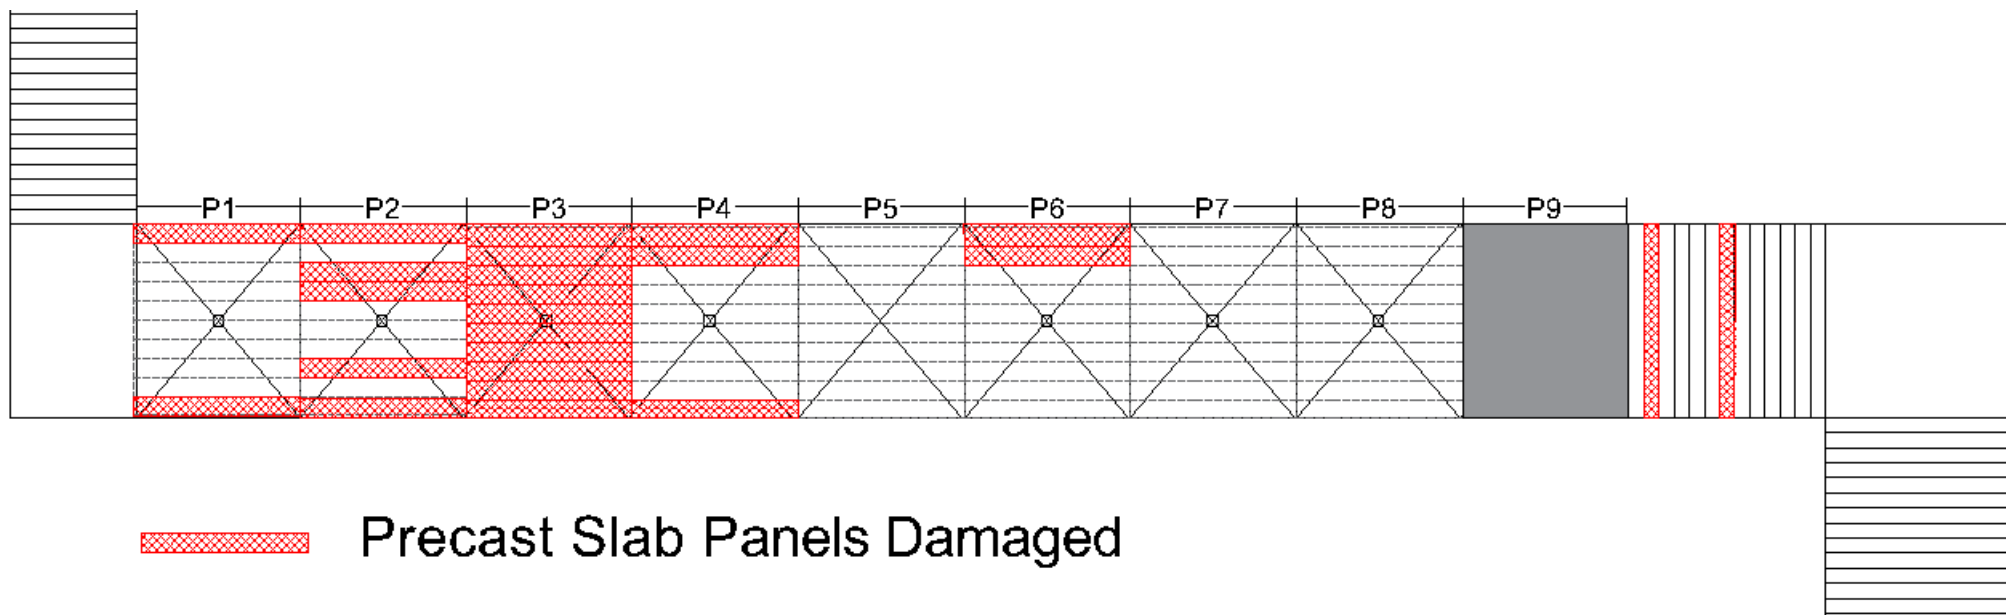
**Fig 3.1:** Bottom view of FOB with pre-cast panels damaged locations

- FOB pre-cast slab panels on the above said locations and the following observations are made, excessive spalling, rebar corrosion and cracks in pre-cast slab panels majority of the cracks were noticed at the steel concrete joints. Cracks and reinforcement exposure is observed in almost in all pre-cast slab panels of FOB as shown in below figures. All the pre-cast slab are to be replaced with new pre-cast slab panels. (Locations are marked in figures below).
- Algae formation and vegetation is observed along steel concrete joint on outer surface at deck level. Staircase 2 precast slab panels are deteriorated reinforced is exposed in flights and staircase RCC landing slab at deck level. (Photographs of the same can be see in **fig 3.2-3.10**)

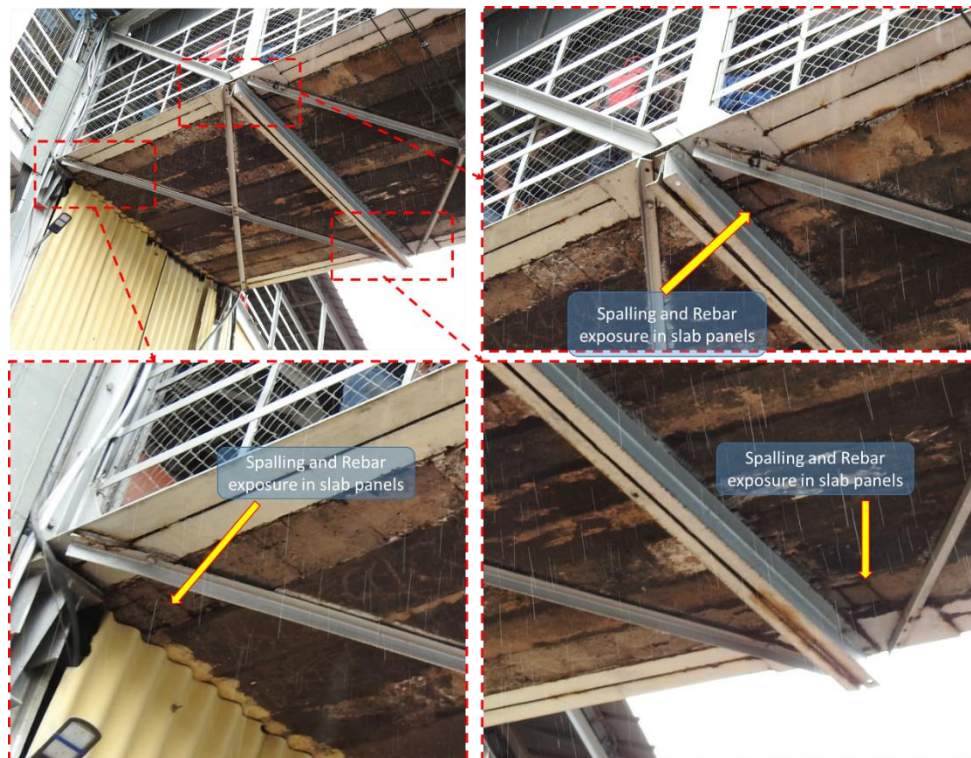
**Fig 3.2:** Damage locations identified in “P1”

**Methodology for patching:** Hand applied Mortar (Patching) repair is performed to restore small areas where sound concrete is damaged by spalling, scaling and/or impact. This method of repair is generally applied using trowel and require minimum or formworks. The patch thickness is limited to a maximum of 100 mm depth of hollow surface. Hand applied Mortar repair is classified into two types considering defective area and surface. Hand applied Mortar

- a) **Type - A** is applicable to surfaces without exposed rebar is having defective widths of up to 300mm and depths of up to 50 mm.
- b) **Type - B** is for surfaces with exposed rebar, with defective widths between 300 mm and 600 mm, and up to 100 mm depths.

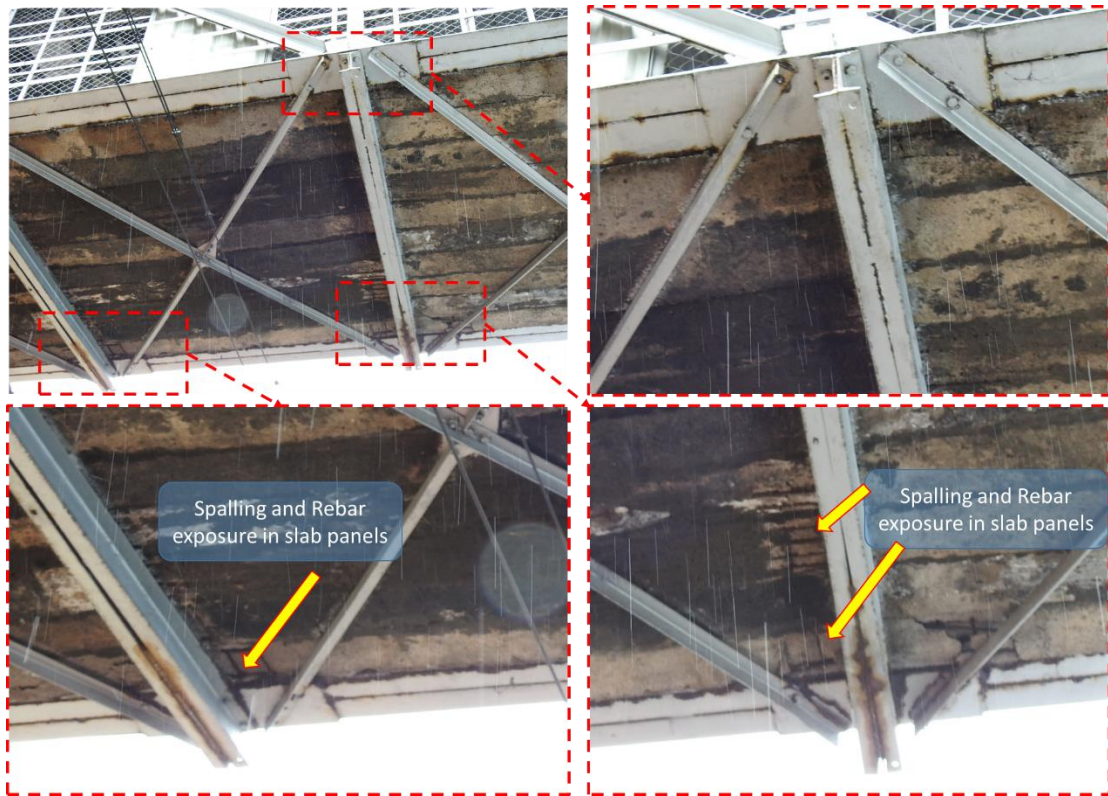
**Fig 3.3:** Damage locations identified in “P2”

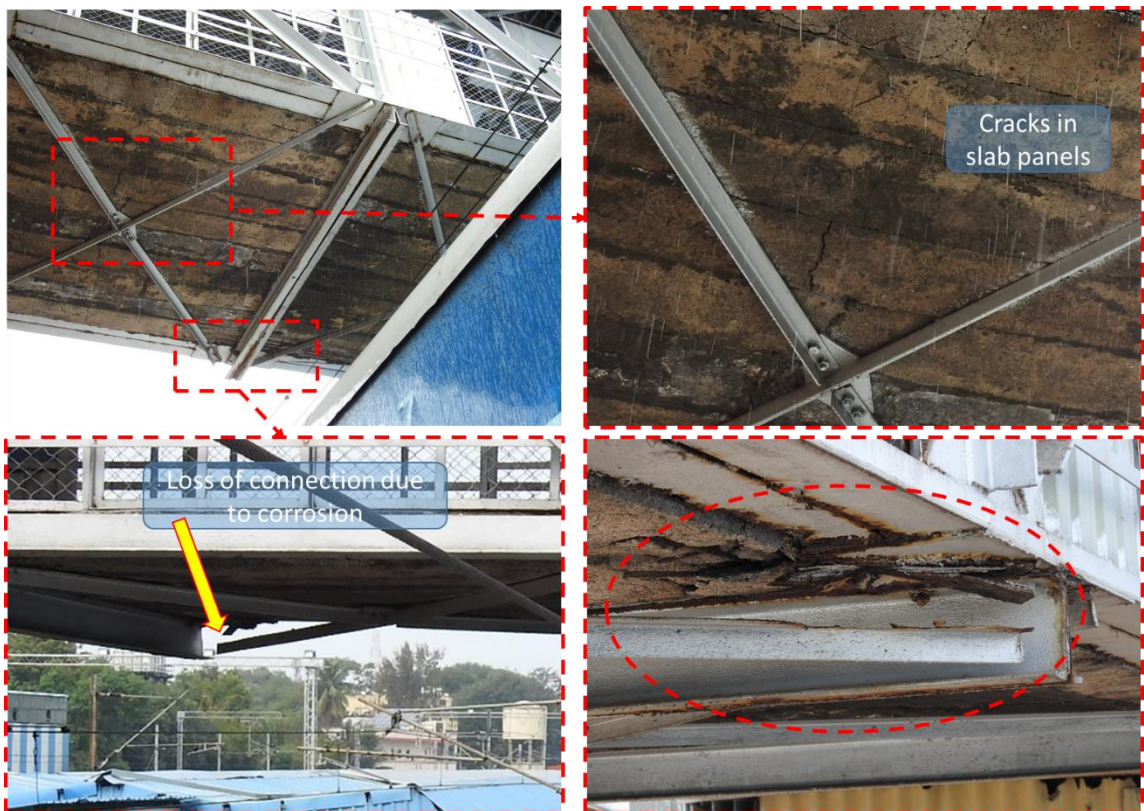
**Fig 3.4:** Damage locations identified in “P3”

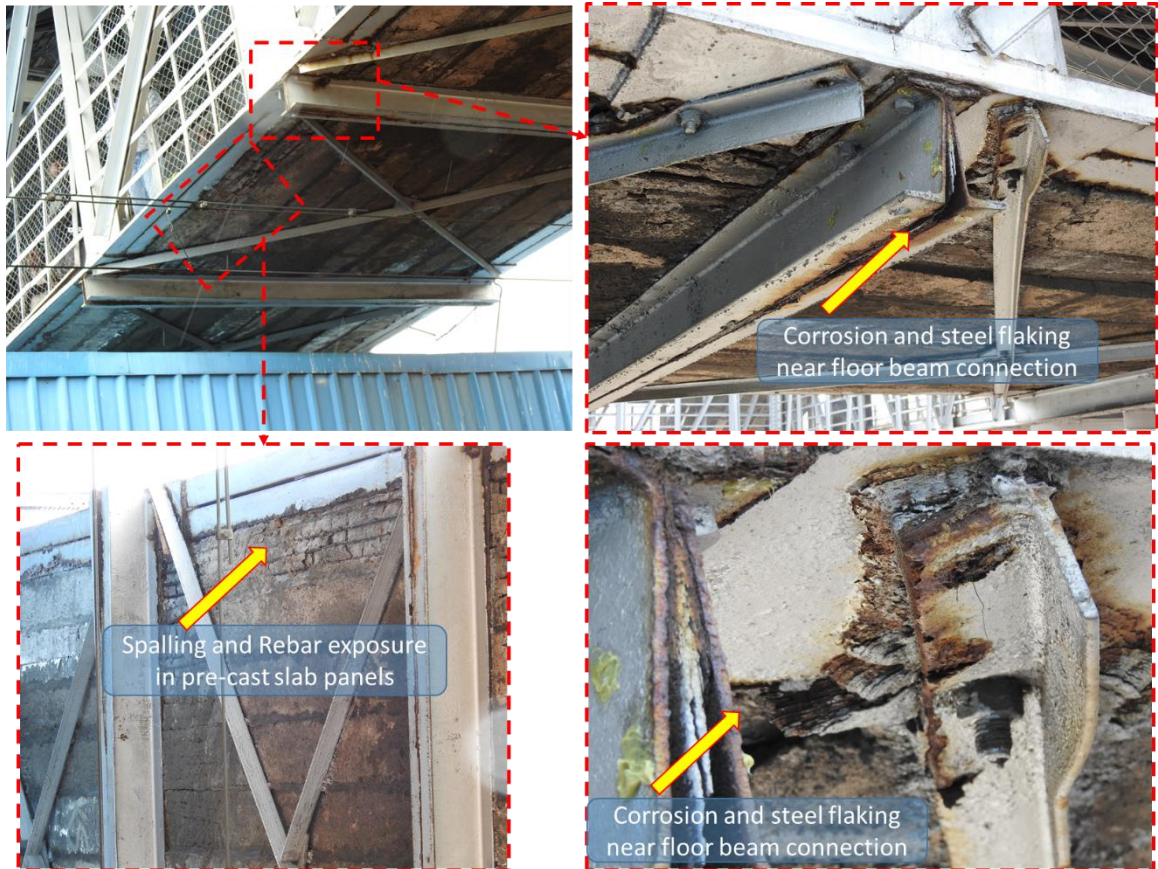
**Fig 3.5:** Damage locations identified in “P4”

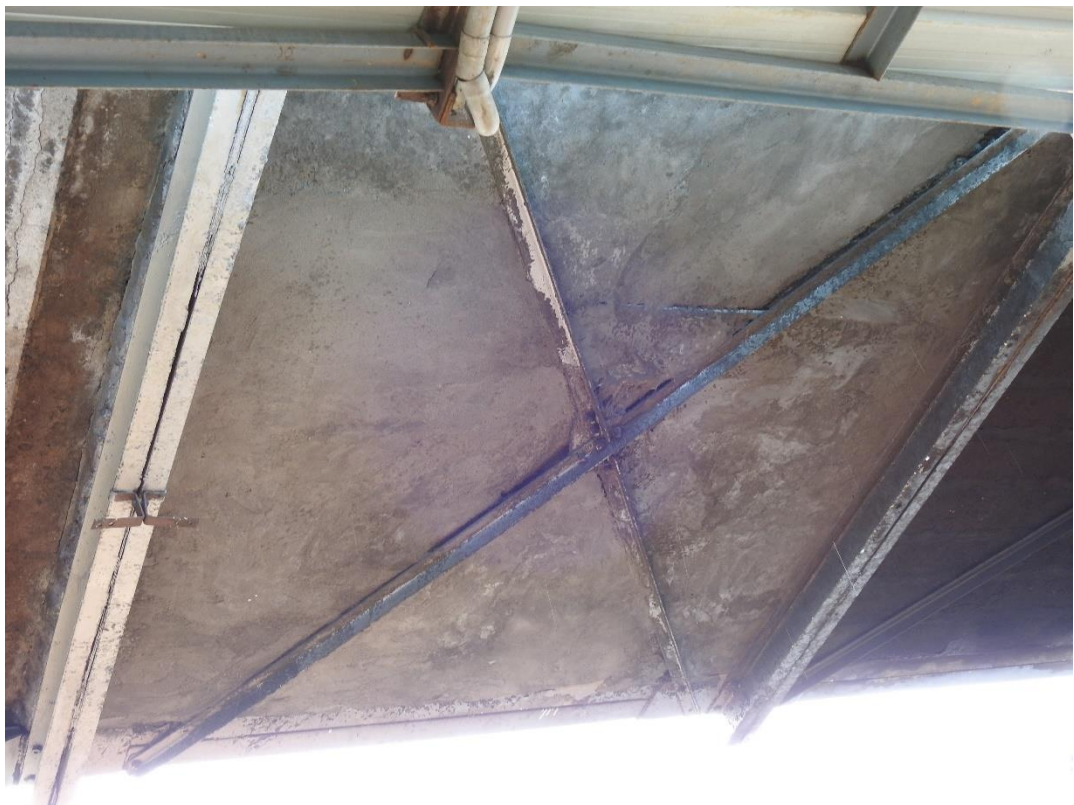
**Fig 3.6:** pre-cast panels protected with cement mortar from bottom “P9”

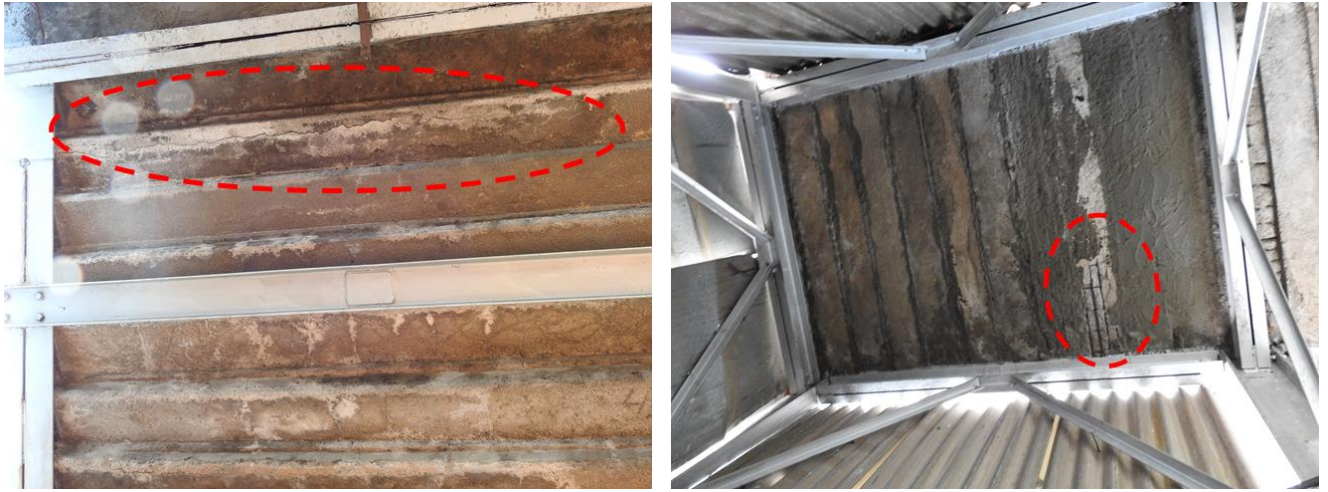
Reinforced cement concrete Slab at Deck level and some precast panels in staircase are observed with exposed rebar in many locations. *(Photographs of the same can be see in **fig:32.3.3**)*

**Fig 3.7:** Rebar exposure under staircase

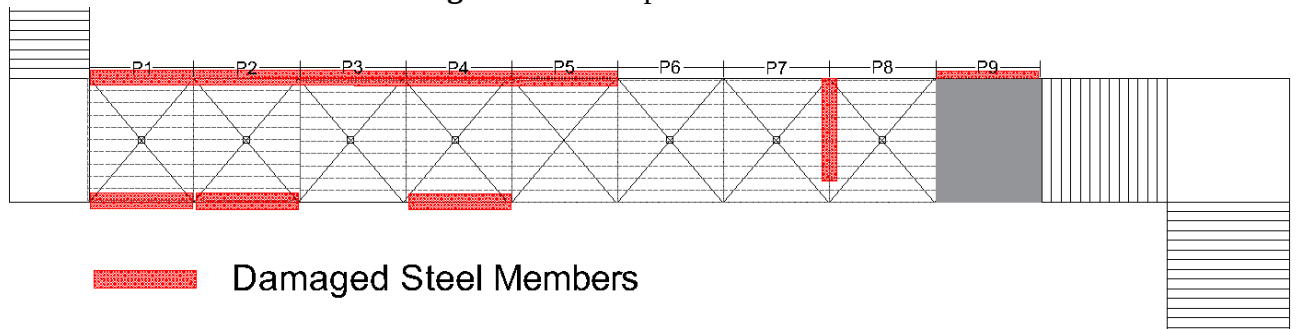
**Fig 3.8:** Bottom view of FOB with bottom chord member and floor beam damaged locations

- If the paint condition is identified as Grade-1, aluminum paint shall be applied with a similar shade.
- Where condition of paint is evaluated as Grade-2 special anticorrosion paint shall be applied to restrict corrosion from progressing further.

- When the condition of the member is observed to be in Grade – 3, which might have occurred due to environmental conditions or age of the structure. In such cases section loss is calculated by using caliper where it is accessible and UPV at one accessible location. The first step in dealing with corrosion is to measure the section loss in the member. The member may be measured using calipers or other appropriate methods for totally exposed sections.

- a. Section Loss < 15% - Clean the Surface and Apply the anticorrosion protective coat.
  - b. Section Loss 15% - 40% Repair the member as per design.

- c. Section Loss > 40% - Replace the member

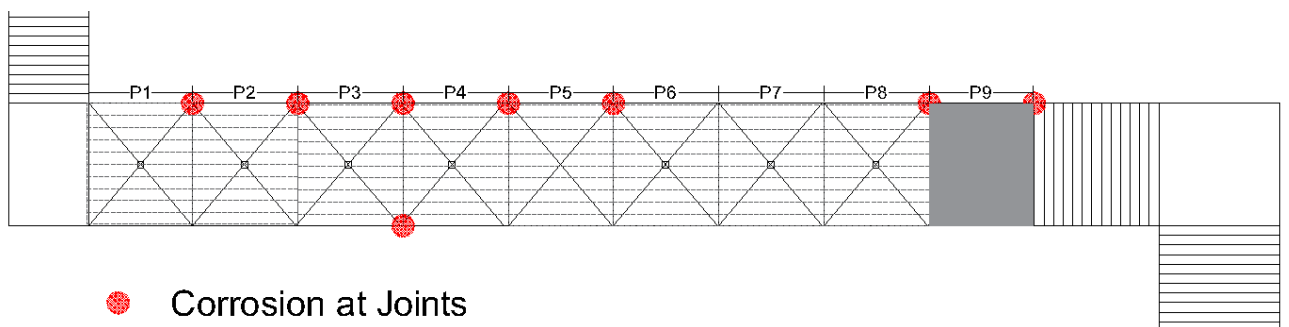
**Fig 3.9:** Bottom view of FOB with bottom chord member, floor beam and bracing connection damaged locations

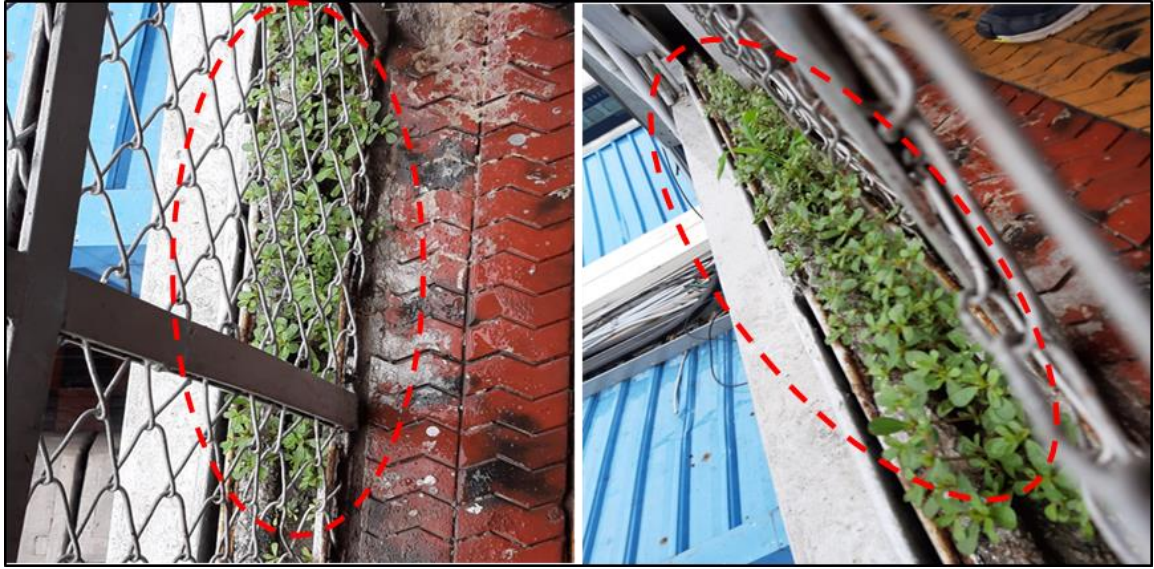
**Fig 3.10:** Vegetation and debris accumulated on top of bridge

- **Methodology for cleaning:** Generally foreign material are deposited or accumulated on bridge deck and in several bridge components which can deteriorate the bridge if proper action is not taken, so we support cleaning.
- **Debris removal:** The surface areas of a FOB should be cleaned and washed by brushing with fresh water or using high-pressure water blasting, including Deck slab top, sides along steel concrete joint on either side of deck, Supporting Railing and connecting staircase.
- **Vegetation removal:** Vegetation growth shall be removed from the components of the FOB, and near the FOB. *(Photographs of the same can be see in **fig3.10:**)*
