# Third Party Audit of ROB's and FOB's Of SCR

## INSPECTION OF FOB AT KHAIRTHABAD RAILWAY STATION

**Final Report**  
SEPTEMBER | 2020

| <b>Name of the Project</b> | : | INSPECTION OF FOB/ PF-1 - PF-2 AT KHAIRTABAD RAILWAY STATION |

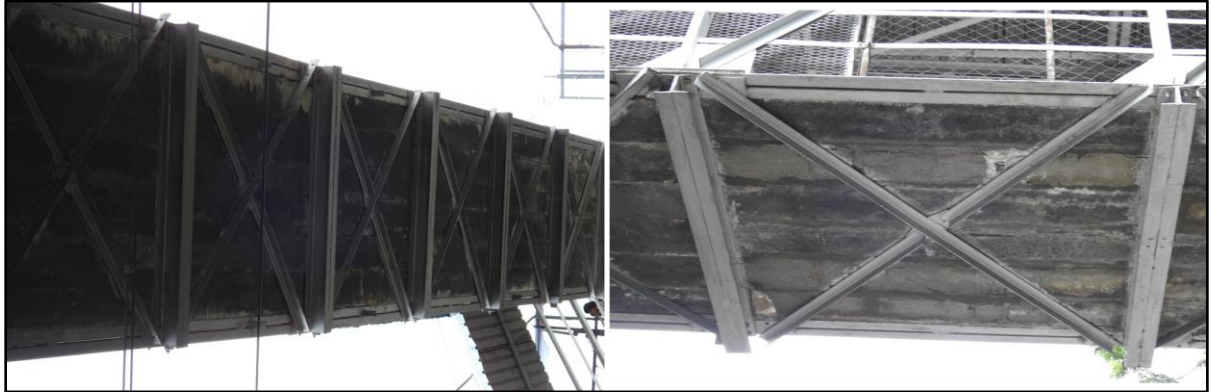
a

- ✓ Leaching effect and cracks are observed in Pre-cast RCC Slab panel at joints.
- ✓ Corrosion is observed in Tie Angular sections, Gusset plates and bracings along steel - concrete joint on both sides of FOB.
- ✓ Rusting is observed in Truss bracing members along the length of FOB near steel concrete joint.

Leaching effect and minor cracks observed in Pre-cast slab panels

| SIGNS OF DISTRESS, DEFORMATION IN BRIDGES | | | |
|---|---|---|---|
| | Cracking in RCC components | Slab panels | Minor cracks are observed in Pre-casted RCC slab panels |

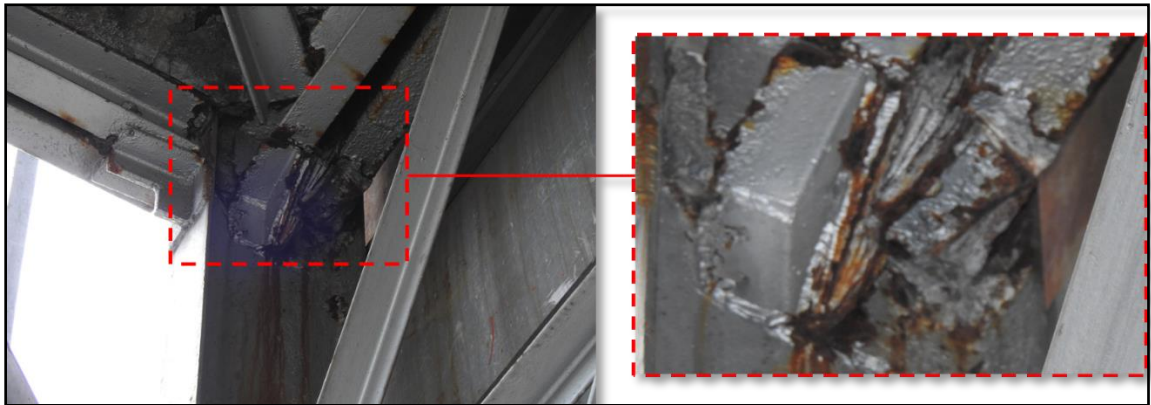
b

- ✓ Distressing of Cleat angle is observed at Beam – Column joint
- ✓ Rusting is observed at all beam Column joints.

Distressing of Cleat angle is observed at Beam – Column Joint

| SIGNS OF DISTRESS, DEFORMATION IN BRIDGES | | | |
|---|---|---|---|
| | Extent of Corrosion | PF – 2 Beam column joints | Distressing is observed at Beam – Column joint |

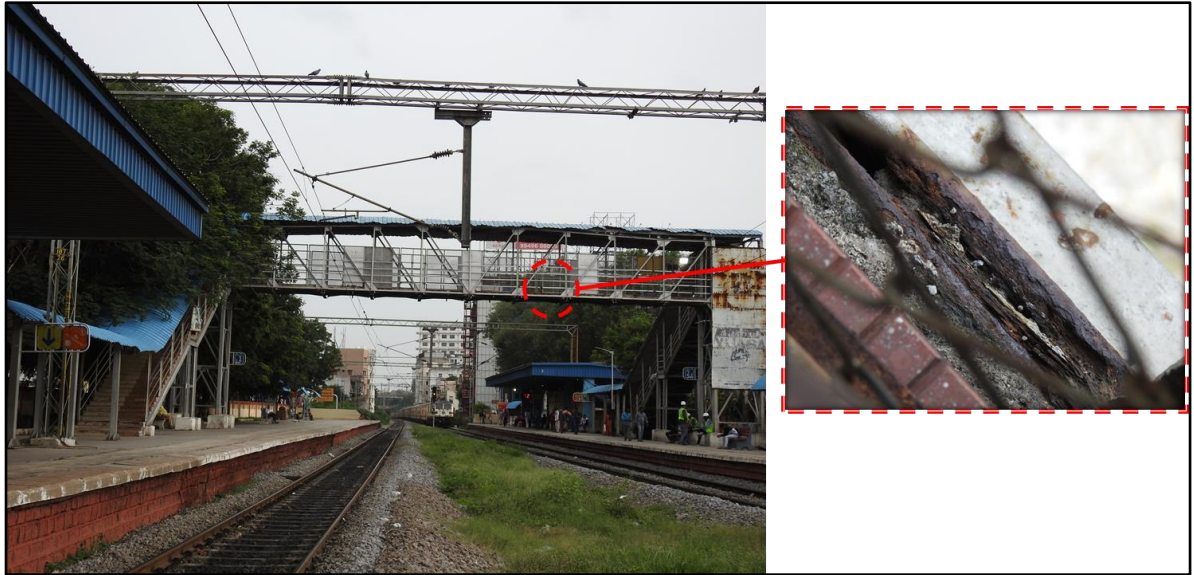
**Fig 1.9:** Corrosion at concrete-steel joint along the span

| SIGNS OF DISTRESS, DEFORMATION IN BRIDGES | | | |
|---|---|---|---|
| | Corrosion at steel-Concrete joint | | Major corrosion is observed at steel concrete joint along (Refer <b>Fig 1.9</b> ) |

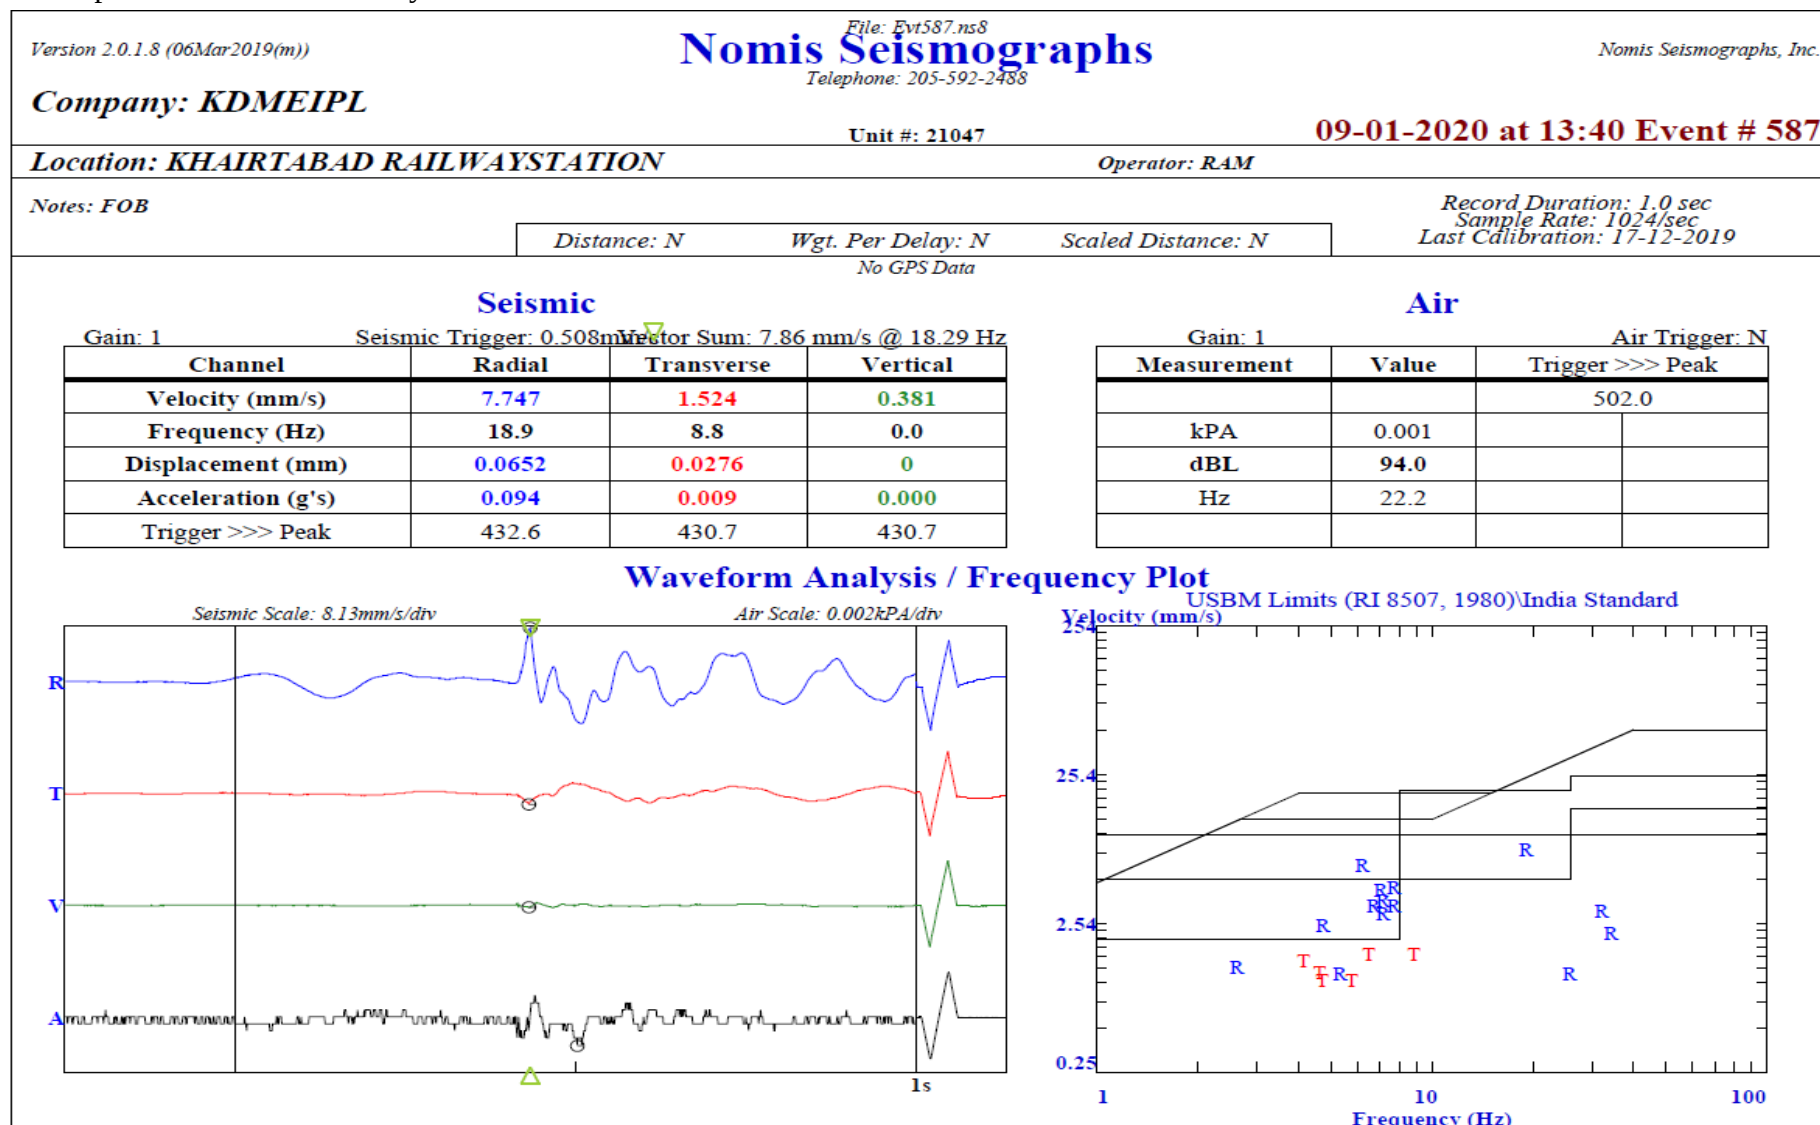
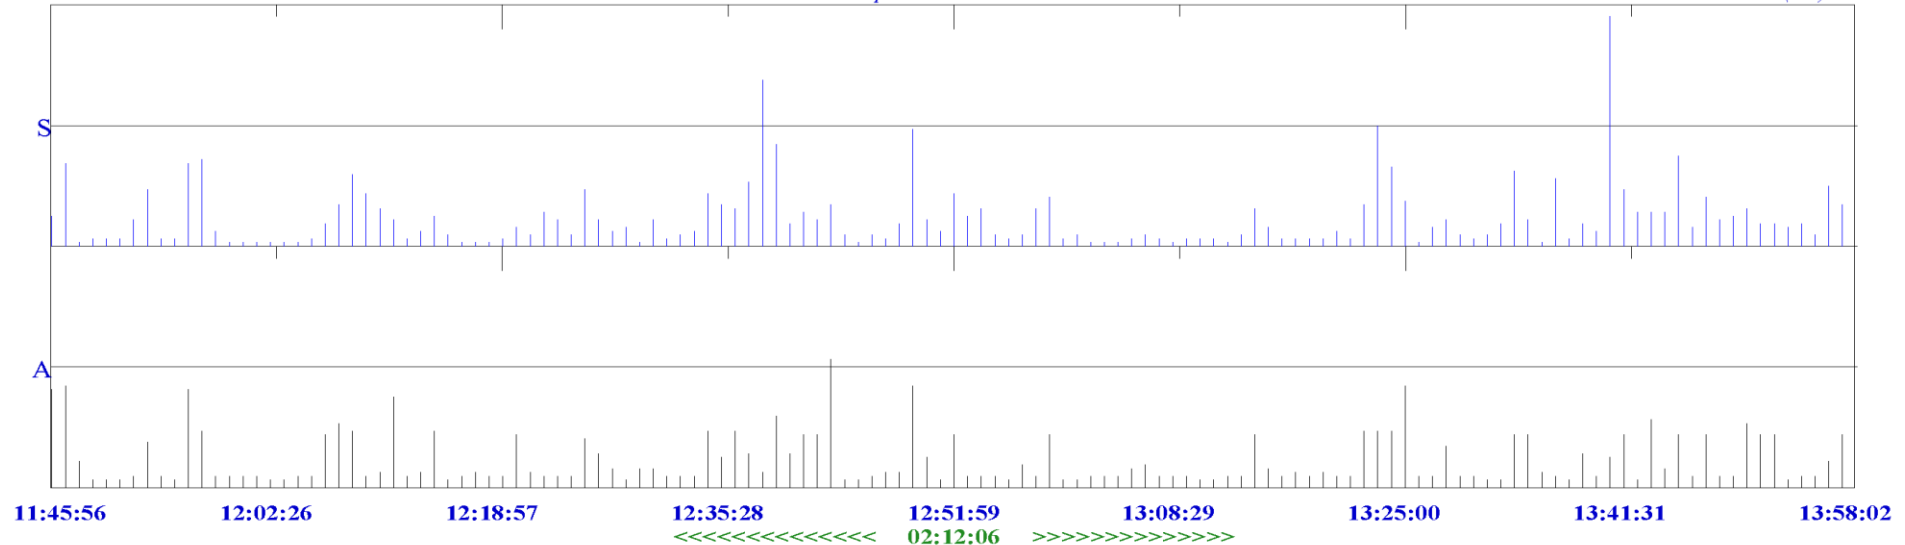
Based on the vibration analysis carried out the structure is undergoing more vibrations than permissible. (Frequency observed is 1134 cpm and maximum amplitude observed during the test time of complete 3hrs is 0.0652 mm).

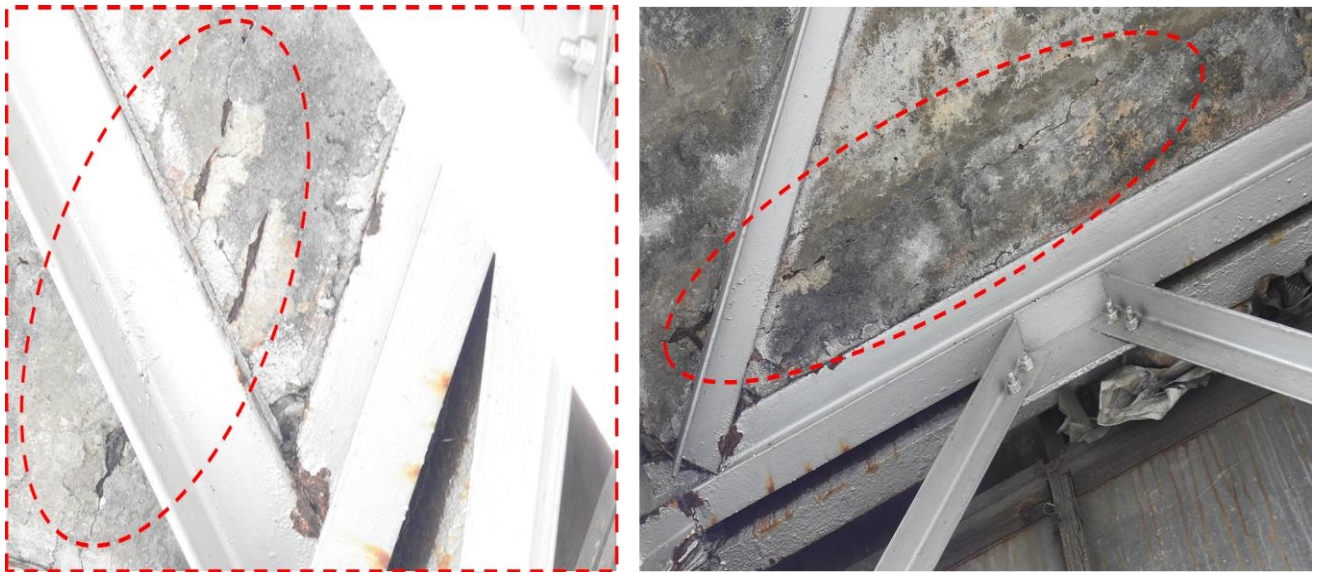
**Fig 3.2:** Spalling and cracks observed at precast panels

Reinforced cement concrete Slab at Deck level and some precast panels in staircase are observed with exposed rebar in many locations. *(Photographs of the same can be see in **fig 3.2**)*

**Methodology for patching:** Hand applied Mortar (Patching) repair is performed to restore small areas where sound concrete is damaged by spalling, scaling and/or impact. This method of repair is generally applied using trowel and require minimum or formworks. The patch thickness is limited to a maximum of 100 mm depth of hollow surface. Hand applied Mortar repair is classified into two types considering defective area and surface. Hand applied Mortar

- a) **Type - A** is applicable to surfaces without exposed rebar is having defective widths of up to 300mm and depths of up to 50 mm.
- b) **Type - B** is for surfaces with exposed rebar, with defective widths between 300 mm and 600 mm, and up to 100 mm depths.

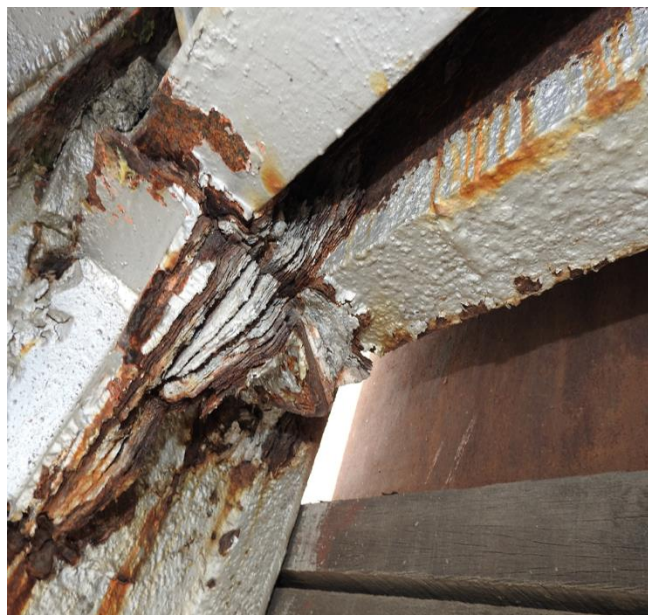
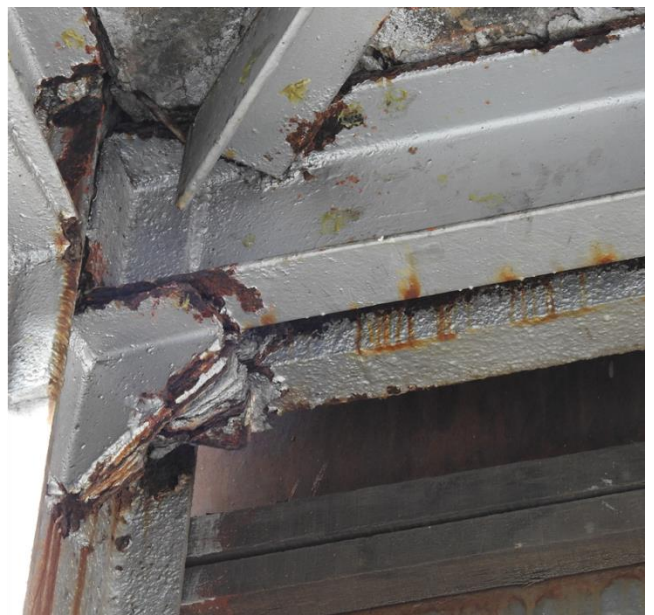
**Fig 3.4** Corrosion of cleat angle at beam column joint

- a) Slight corrosion is observed at all the joints between truss and slab (above slab).
- b) Major corrosion is observed a few concrete steel joints (below slab).
- c) Minor cracks are observed at bottom of pre-cast slab panels.
- d) Extreme corrosion of cleat angle at beam column joint.

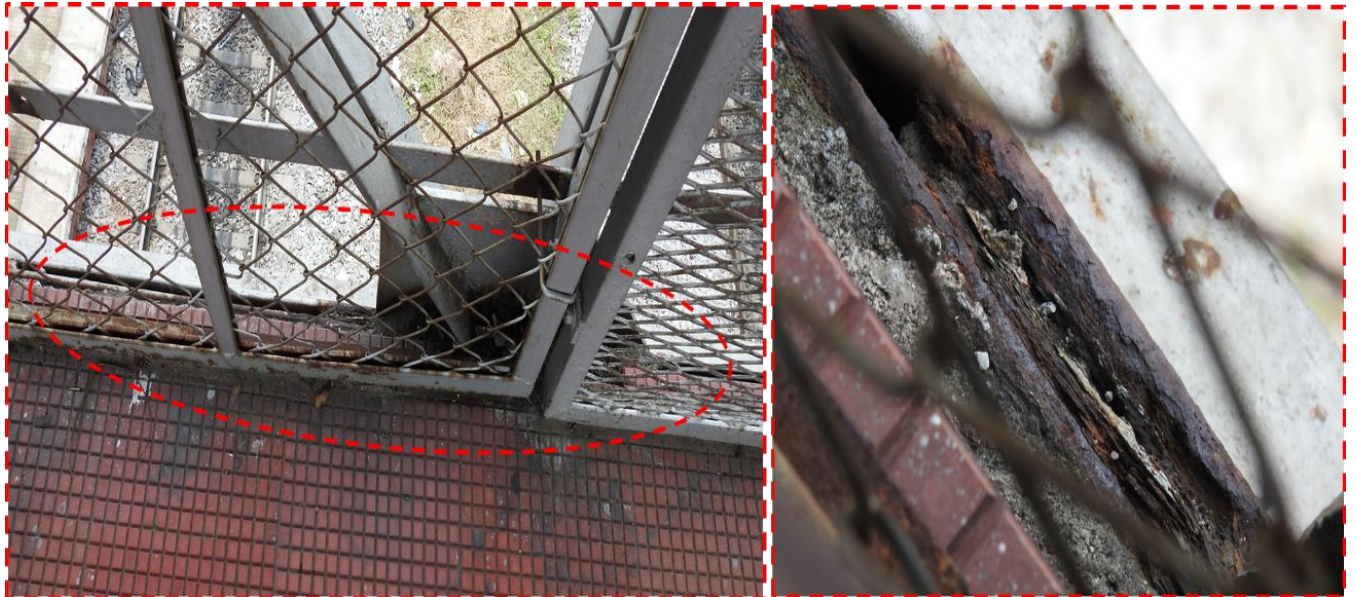
**Fig 3.6** corrosion in bottom chord at steel concrete joint

- Structural members are in fair condition, displaying mild corrosion for top chord members, verticals, diagonals, and gusset plates, moderate corrosion for bottom chord members and staircase stringer beam along steel concrete joint (locations are marked in figures below).
- Severely corroded cleat angle connecting mid landing and column. (*Photographs of the same can be see in fig 3.2-3.6*)

- If the paint condition is identified as Grade-1, aluminum paint shall be applied with a similar shade.

- Where condition of paint is evaluated as Grade-2 special anticorrosion paint shall be applied to restrict corrosion from progressing further.
- When the condition of the member is observed to be in Grade – 3, which might have occurred due to environmental conditions or age of the structure. In such cases section loss is calculated by using caliper where it is accessible and UPV at one accessible location. The first step in dealing with corrosion is to measure the section loss in the member. The member may be measured using calipers or other appropriate methods for totally exposed sections.
  - a. Section Loss < 15% - Clean the Surface and Apply the anticorrosion protective coat.
  - b. Section Loss 15% - 40% Repair the member as per design.
  - c. Section Loss > 40% - Replace the member.
