# Third Party Audit of ROB's and FOB's of SCR

**INSPECTION OF FOB AT BIBINAGAR RAILWAY STATION**

**Final Report**  
SEPTEMBER | 2020

| <b>Name of the Project</b> | : | VISUAL INSPECTION OF FOB/ PF-1 - PF-2 AT BIBINAGAR RAILWAY STATION |

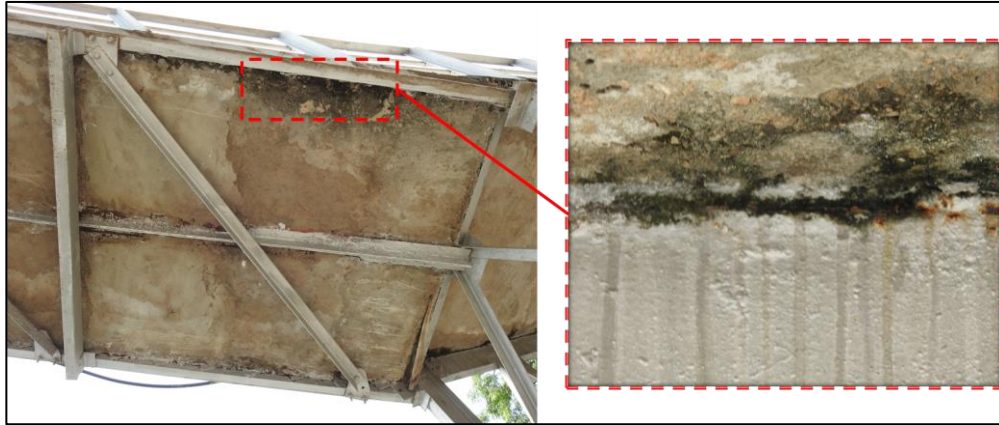
- a. ✓ Dampness on edge of the staircase slab and formation of the algae

Dampness and formation of algae observed

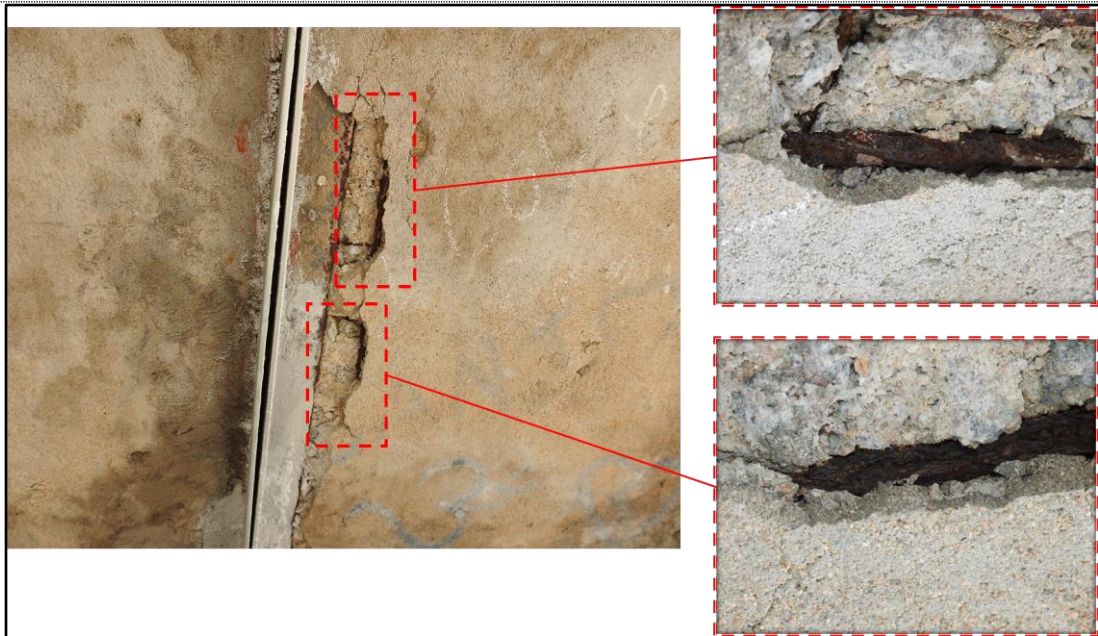
- b. ✓ Spalling and highly corroded reinforcement is observed in flight of staircase at PF-1

Spalling and corrosion on reinforcement

| SIGNS OF DISTRESS, DEFORMATION IN BRIDGES | | | |
|---|---|---|---|
| | Spalling | At staircase | Spalling is observed in flight-2 of PF-1 (Refer <b>part 1.4a – 1.4b</b> ) |

- ii. Replacement of severely corroded splice joints, gusset plate and sacrificial plate.
  - iii. Patchwork with modified concrete at bottom of staircase 1.

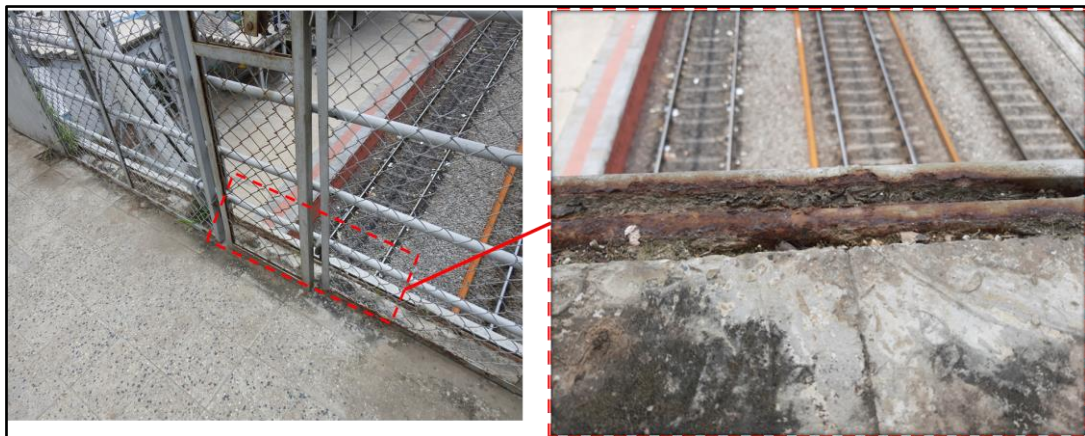
- c. ✓ Main angular sections of truss are highly corroded at certain locations along the concrete slab

Corrosion at bottom chord members

- **Based on visual inspections and its interpretations following recommendations can be made:**
  - i. Anti-corrosive treatment for Grade-1 and Grade-2 highlighted corrosive members like floor beams, top chord, and bottom chord.

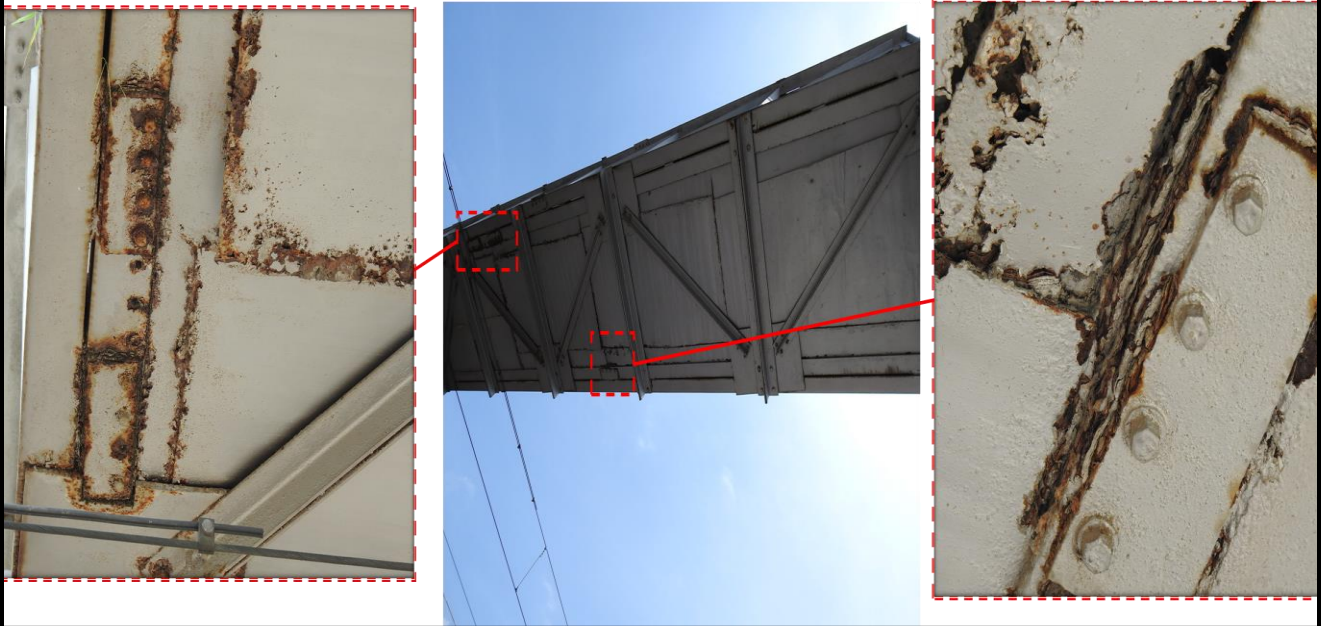
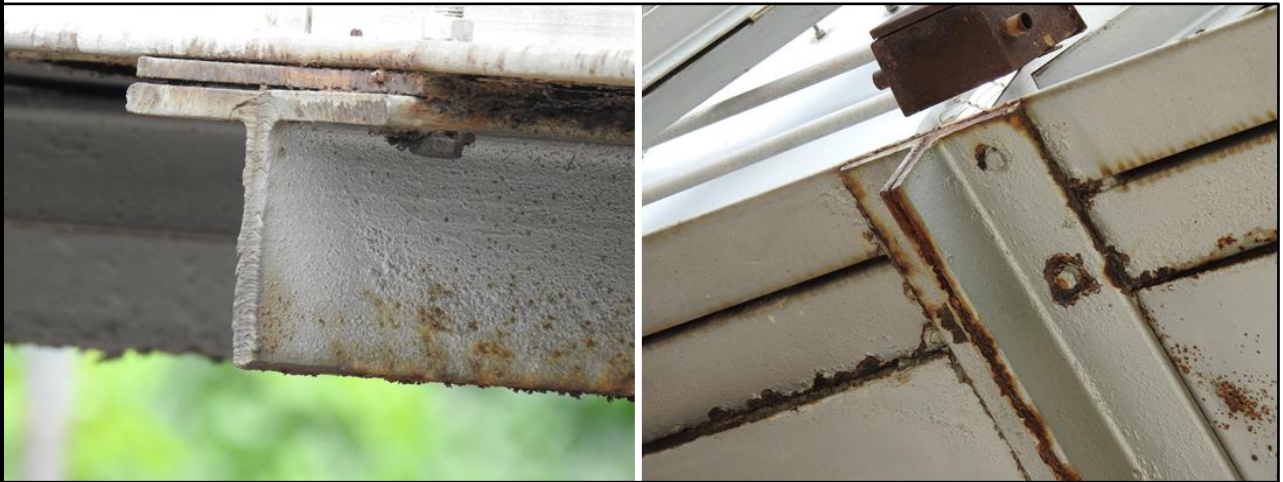
- d. ✓ Highly corrosion is observed at bottom slab joints (Gusset plate, angular section)

Corrosion observed at gusset plate and floor beams

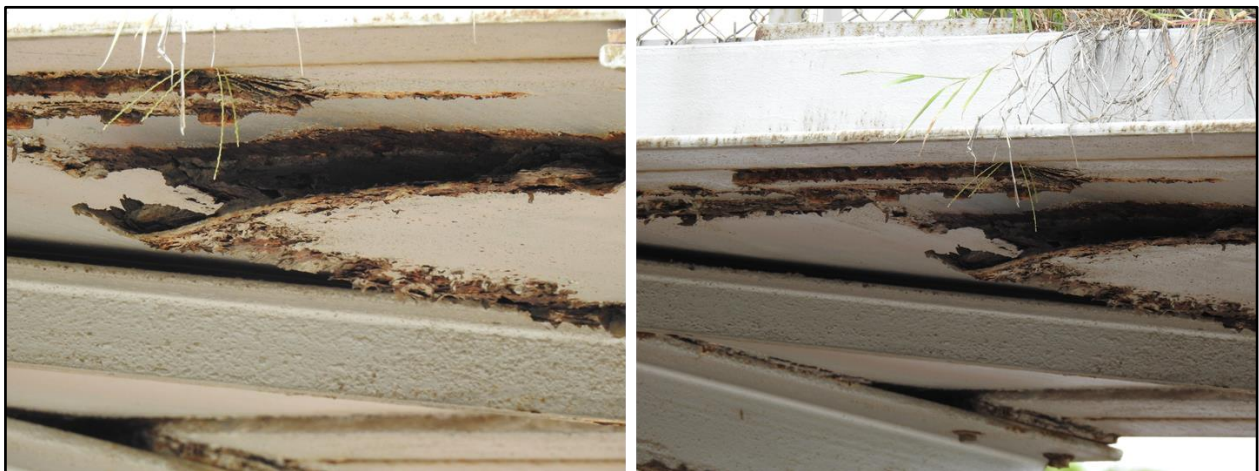
- e. ✓ High corrosion is observed in sacrificial plate

Corrosion of sacrificial plate

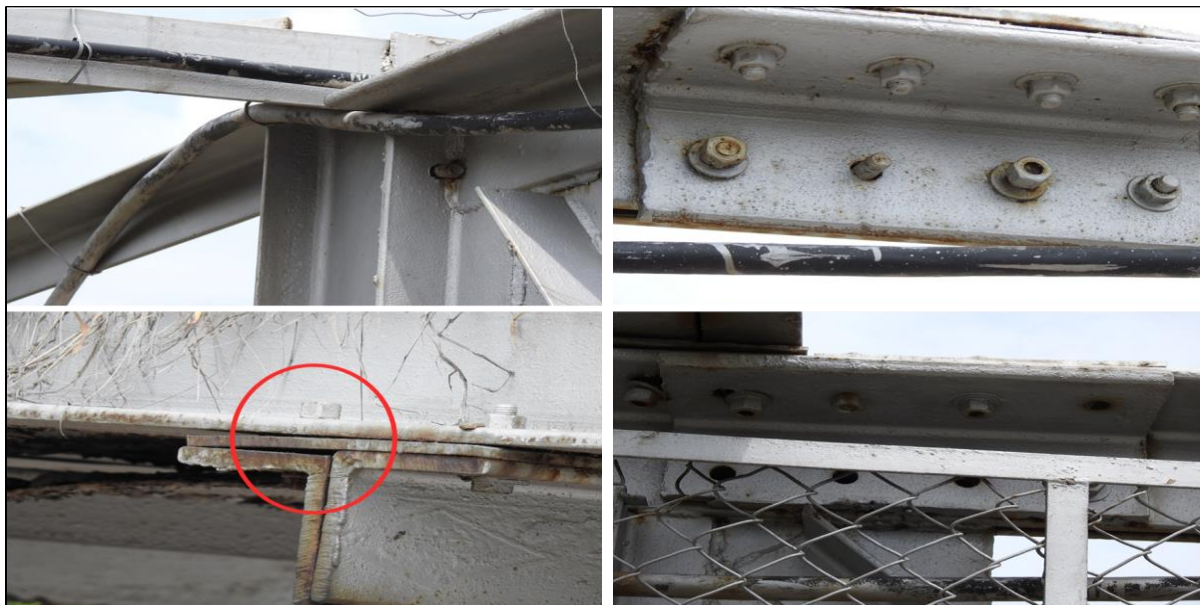
f. ✓ Slipped and missing bolts observed at certain location of FOB

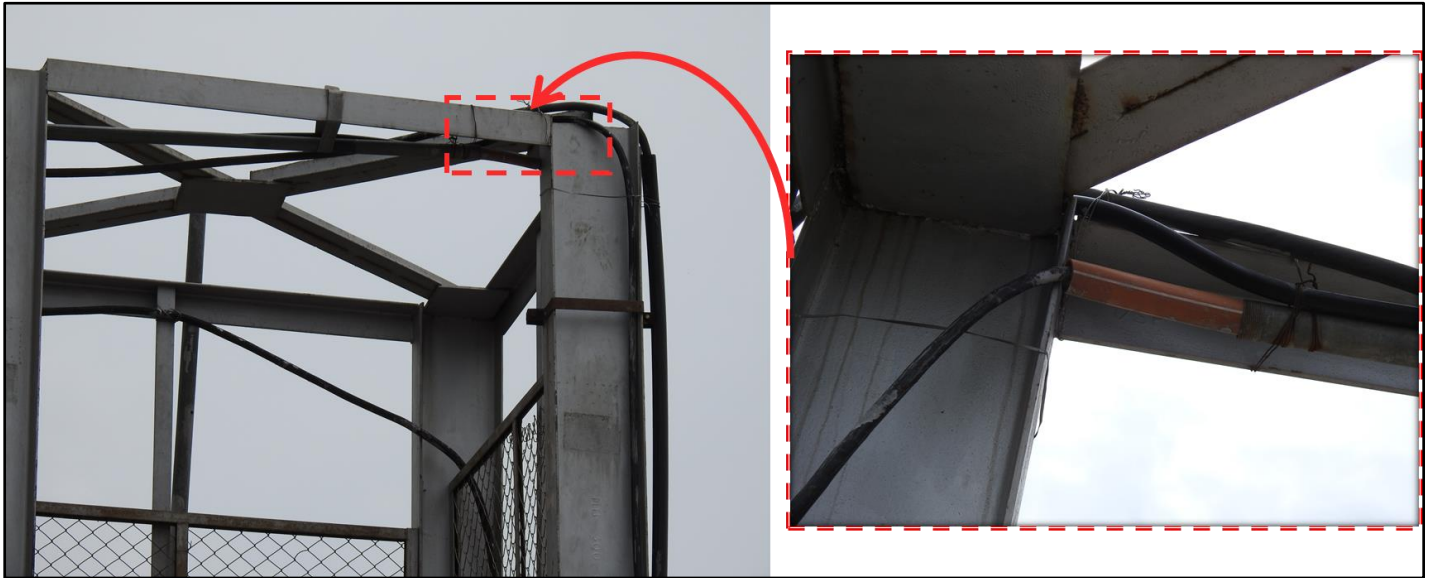
| 1.2 IDENTIFICATION OF LOADS ON BRIDGE | | |
|---|---|---|
| b) Cables | Yes | Cables are protected with 1-inch dia HDPE pipe and 2-inch GI pipe (Refer <b>fig :1.1</b> ) |

**Fig 1.1:** Electrical Cables

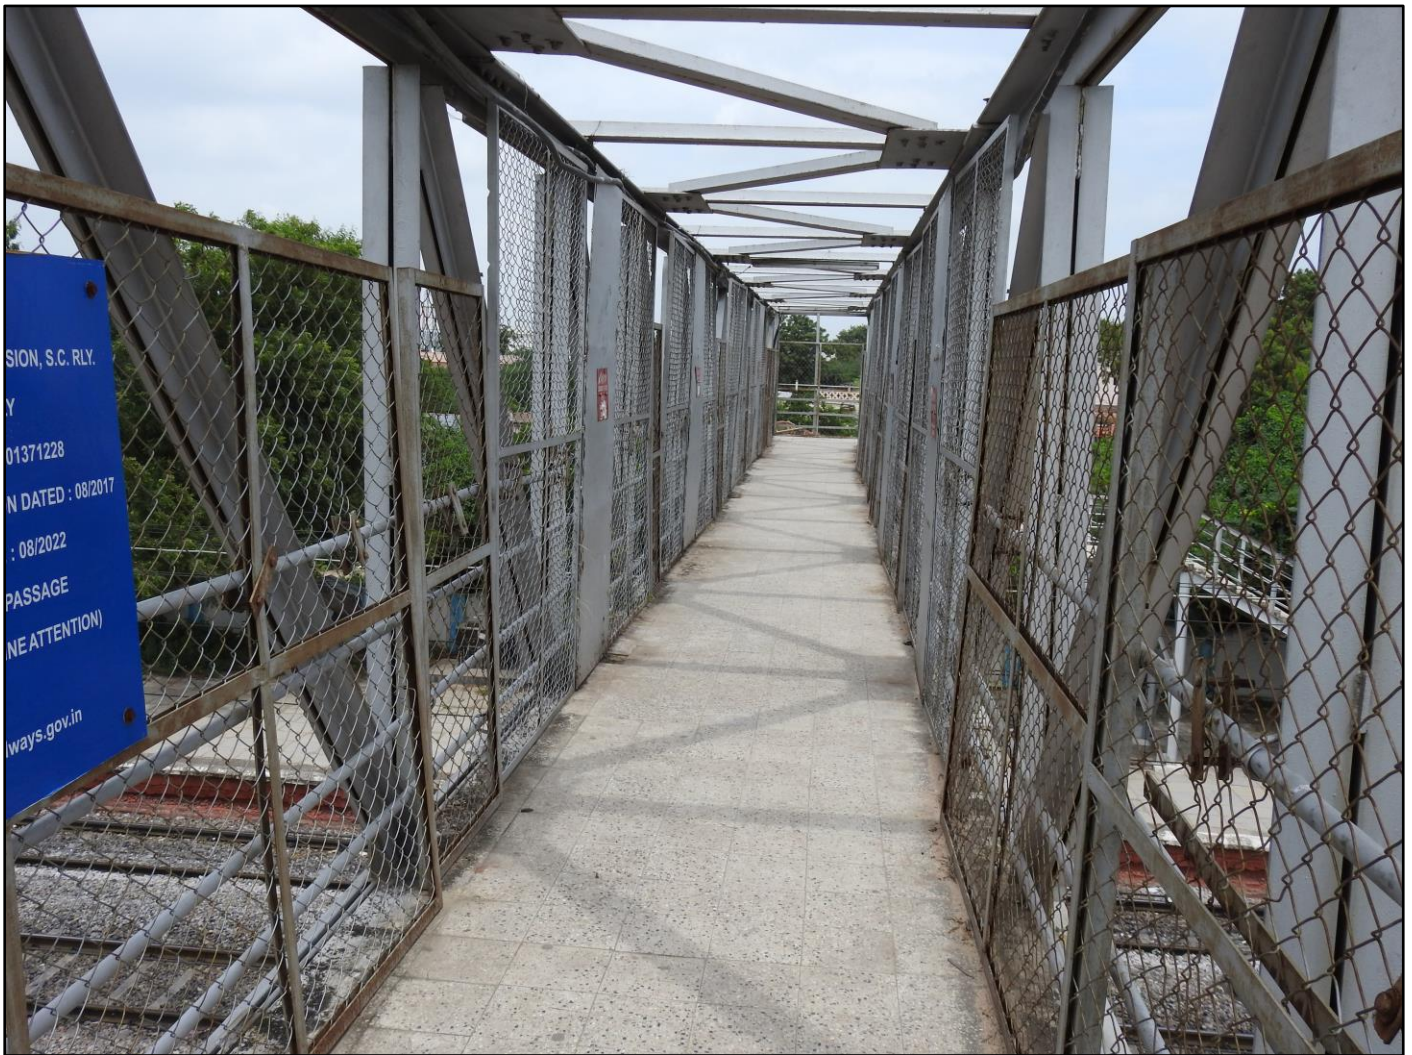
| 1.2 IDENTIFICATION OF LOADS ON BRIDGE | | |
|---|---|---|
| b) Provision of protective screen for passengers | Yes | Chain link fence made of Galvanized wire of 2 mm gauge and 2 mm Galvanized sheet is used above OHE Line on both side of pathway is used for Protection. Mesh frame is supported with angular and MS flats. (Refer <b>fig :1.2</b> ) |

**Fig 1.2:** Protective screening mesh for passenger and flooring and roof elements

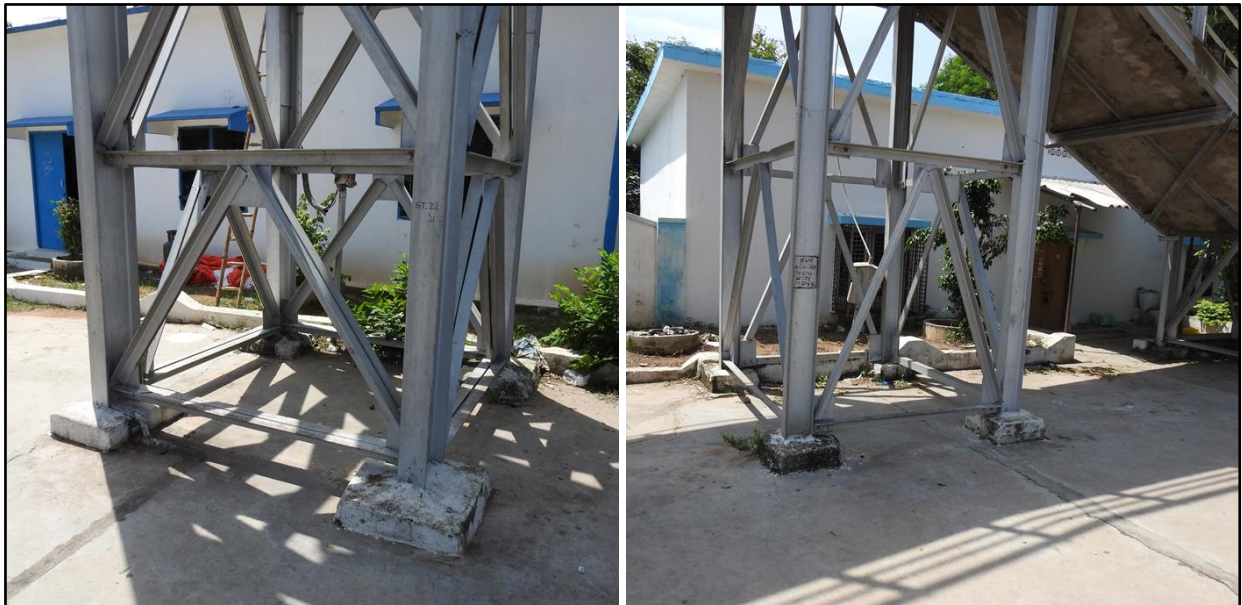
| 1.3 STRUCTURAL SYSTEM OF THE BRIDGE | | |
|---|---|---|
| Type of Pedestal | Concrete | Concrete encasement is provided to trestles at bottom on platform level of dimensions 650x 550 mm for ISMB 300 and 450x480mm for ISMB 200 (Refer <b>fig :1.3</b> ) |

**Fig 1.3:** Trestles and their protection with concrete encasement

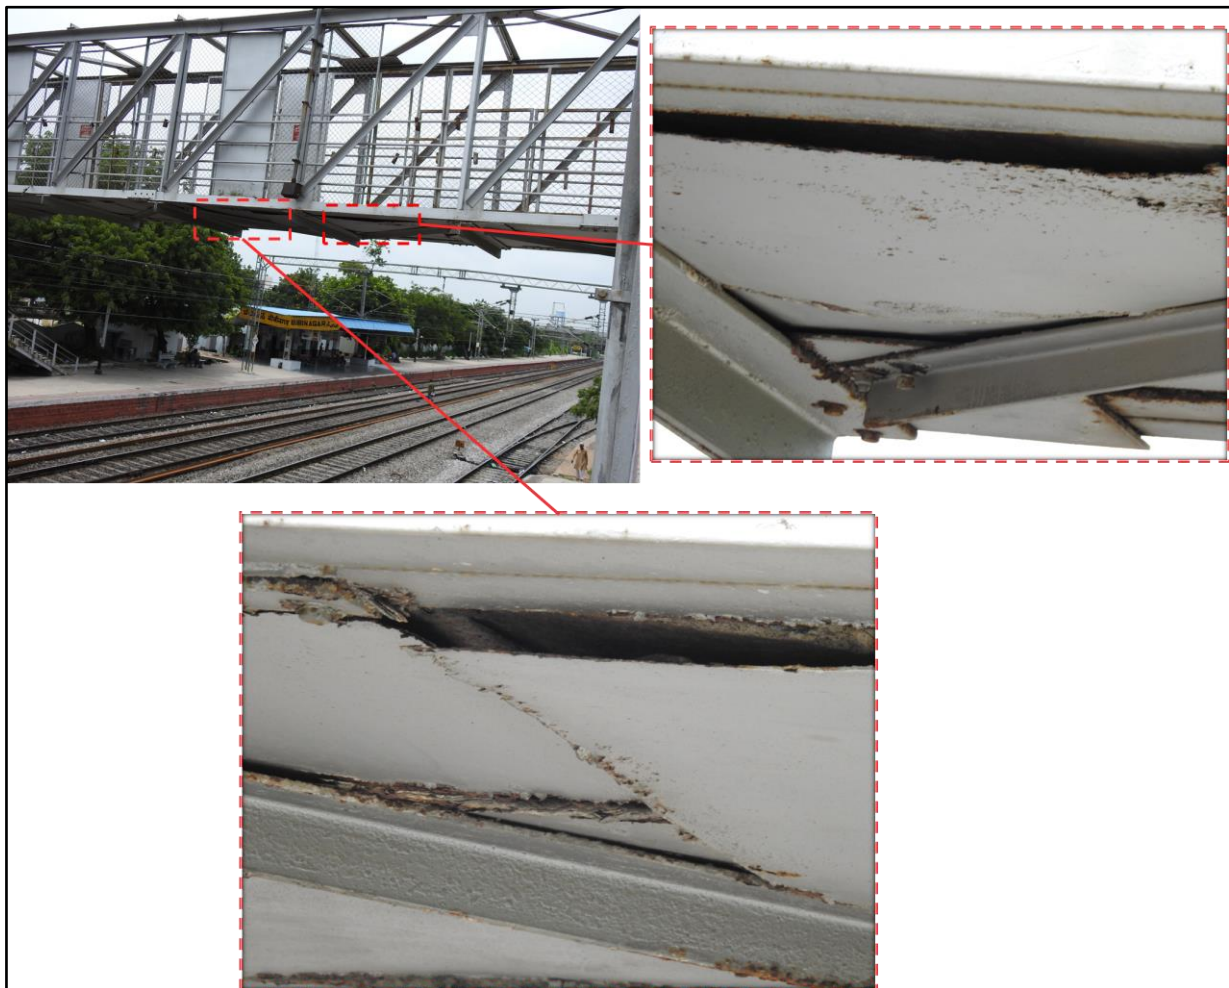
| SIGNS OF DISTRESS, DEFORMATION IN BRIDGES | | | |
|---|---|---|---|
| | Extent of Corrosion | Slab bottom | Medium and highly corrosion is observed at the joints of the bottom slab (Refer <b>fig:1.4,1.5,1.7</b> ) |

**Fig 1.4:** Corrosion of sacrificial plate

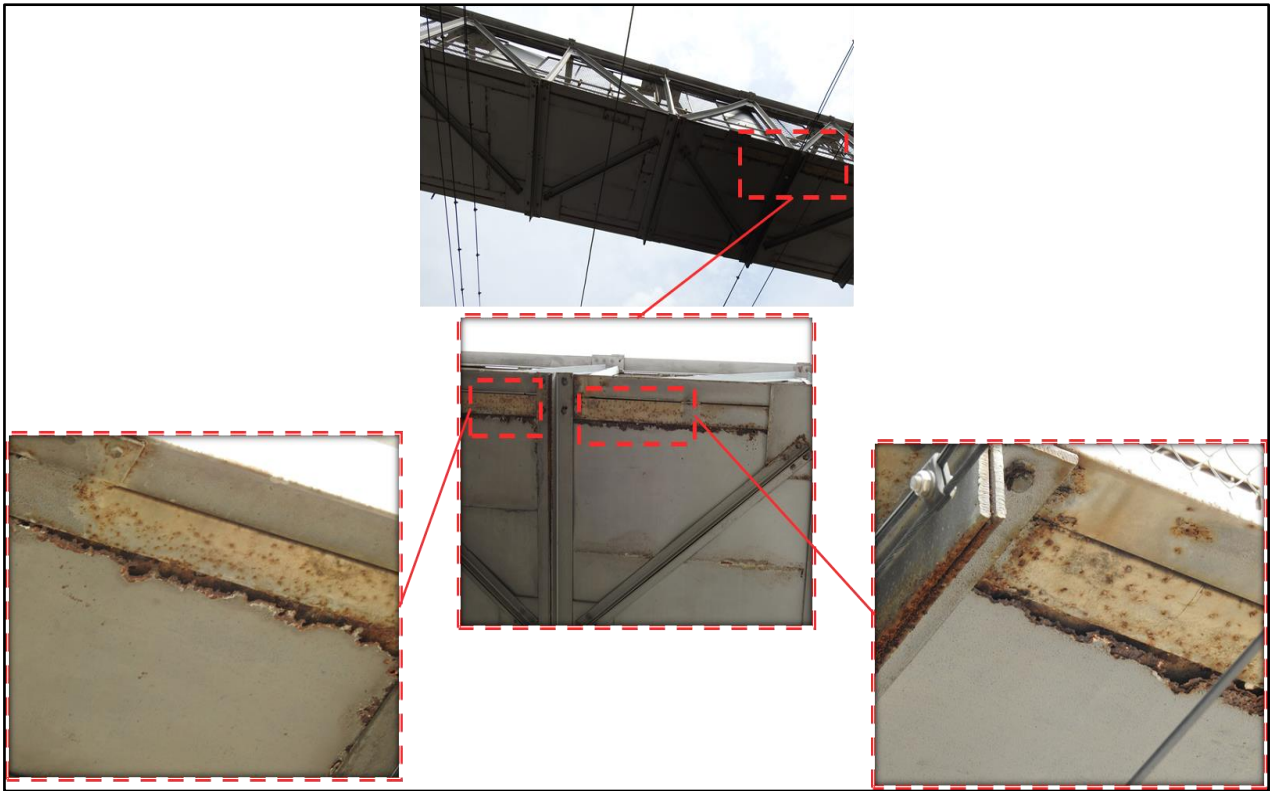
**Fig 1.5:** Corrosion of sacrificial plate, bottom chord members and mild corrosion observed at floor beams

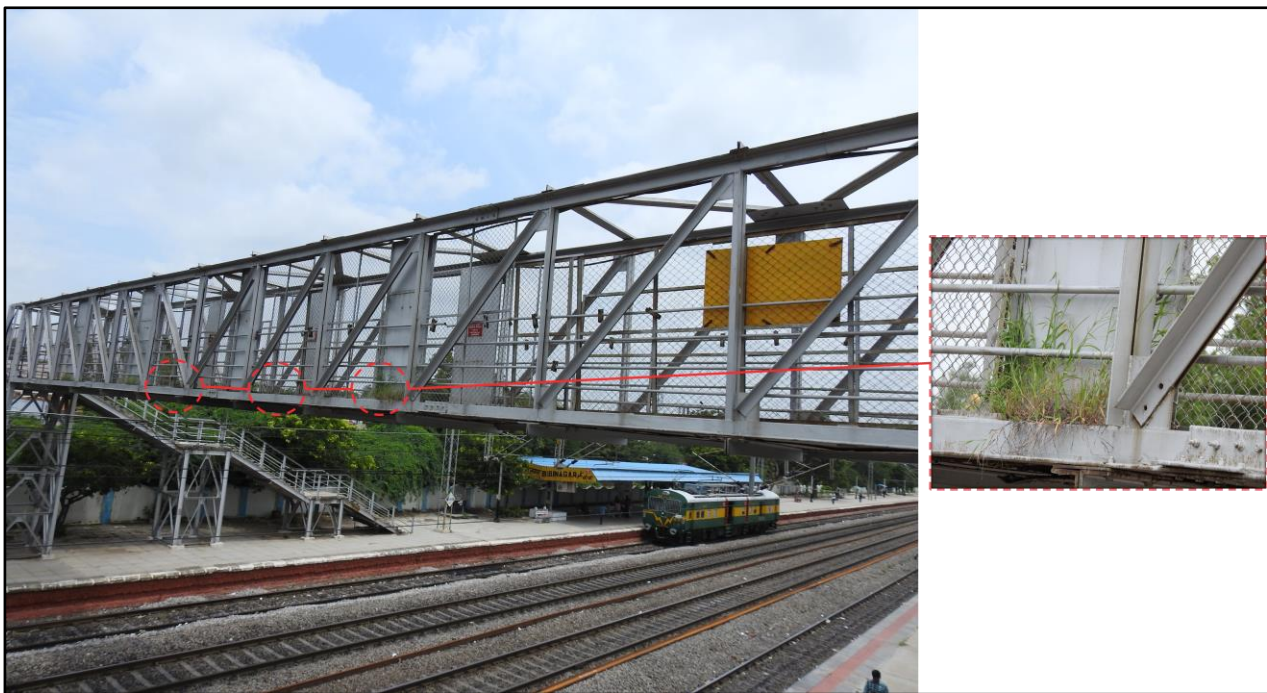
**Fig 1.6:** Vegetation at truss level and shape of truss

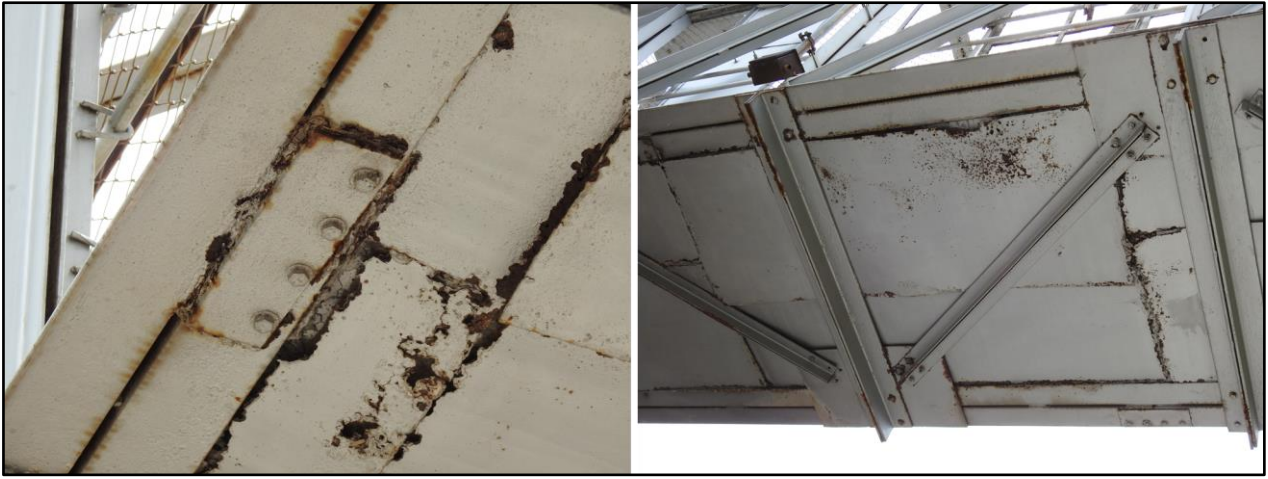
| SIGNS OF DISTRESS, DEFORMATION IN BRIDGES | | | |
|---|---|---|---|
| | Corrosion in Gusset plate | Slab bottom | Slight corrosion at the bottom of the slab (Refer <b>fig:1.7</b> ) |

**Fig 1.7:** Corrosion observed at bottom chord members along the span of FOB

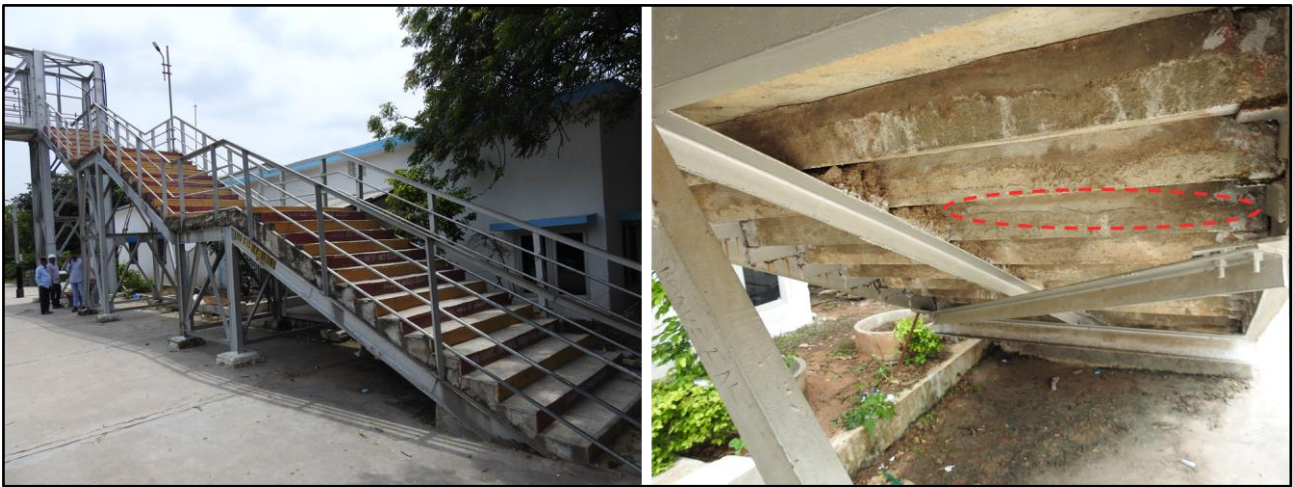
| SIGNS OF DISTRESS, DEFORMATION IN BRIDGES | | | |
|---|---|---|---|
| | Cracking in RCC components | | Minor cracks are observed on precast slab panels on flight-1 of PF-1 (Refer <b>fig:1.8</b> ) |

**Fig 1.8:** View of staircase and cracks in Pre-cast RCC panels in staircase at PF-1

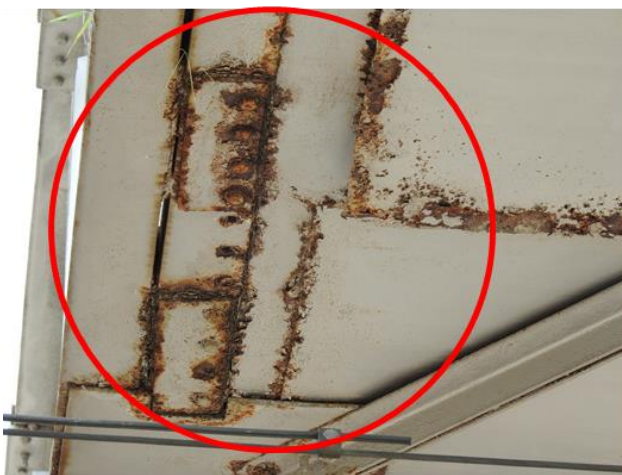
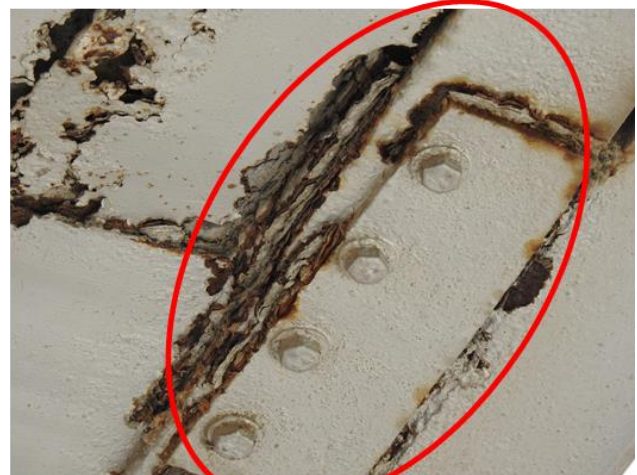
**Fig 2.2:** Locations of Splice joint and bottom chord Deteriorations

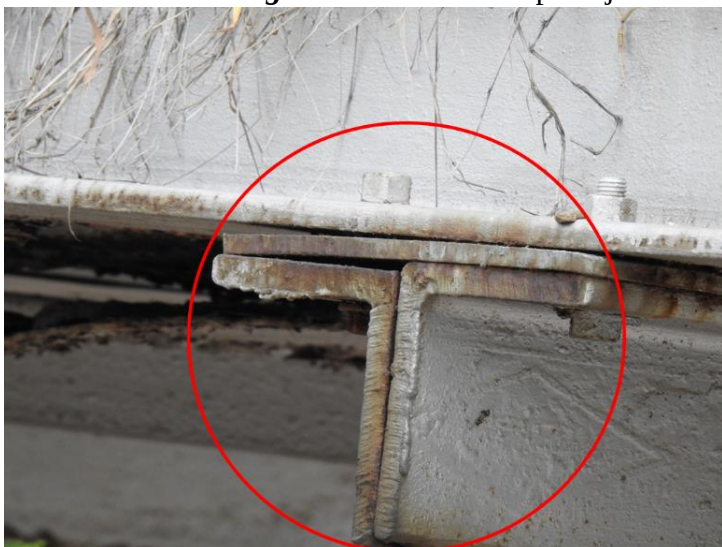
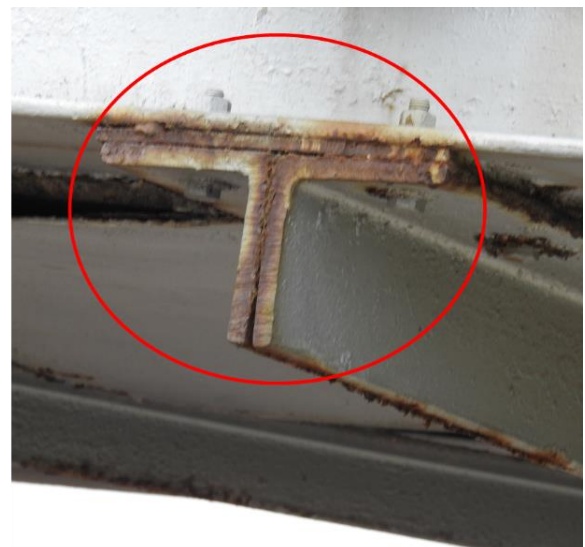
**Fig 2.3:** Locations of floor beam Deterioration

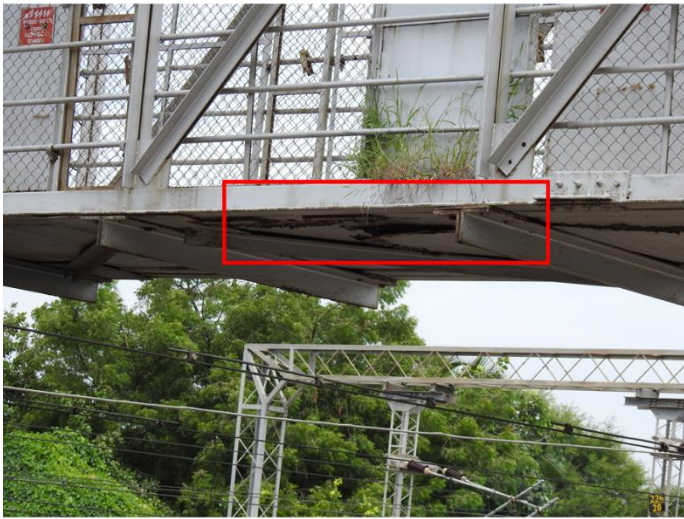
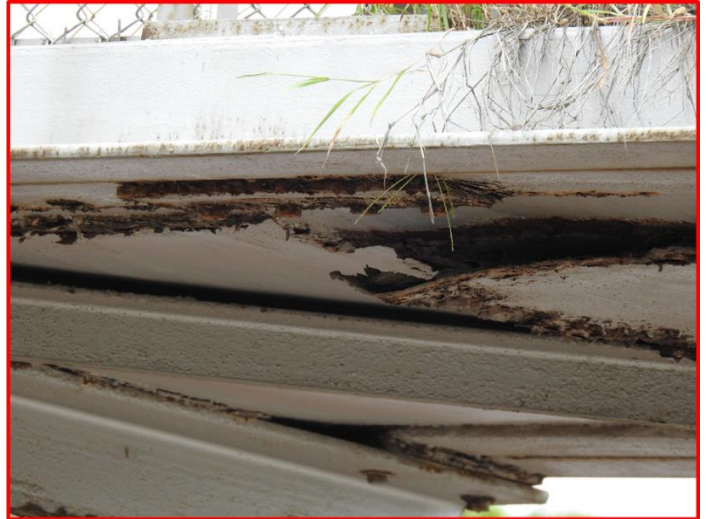
**Fig 2.4:** Locations of Sacrificial plate Deteriorations

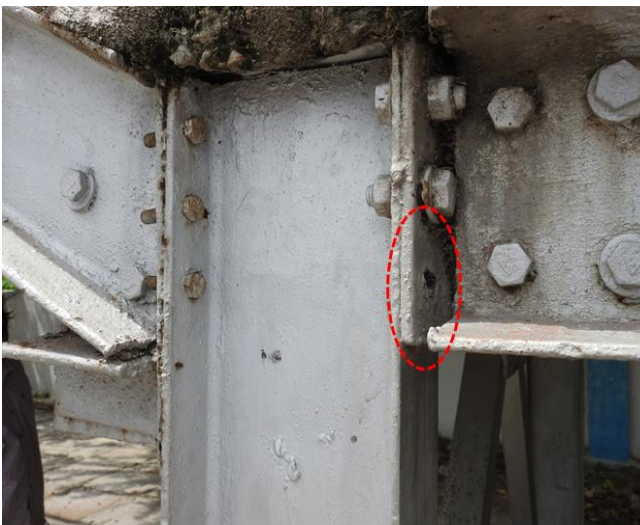
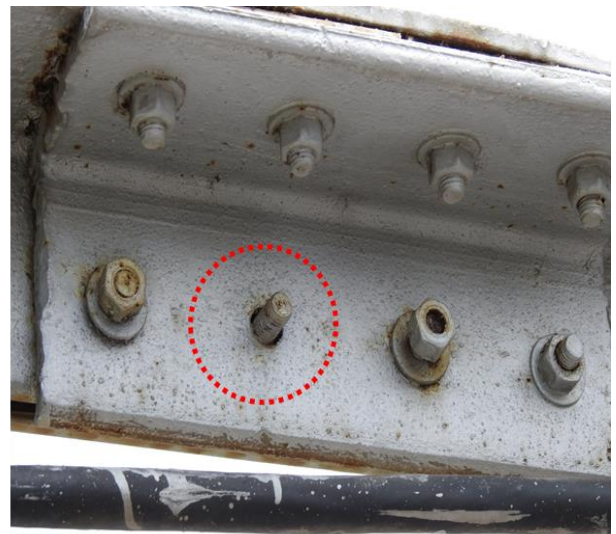
**Fig: 2.5** missing of bolts at mid land at staircase stinger beam

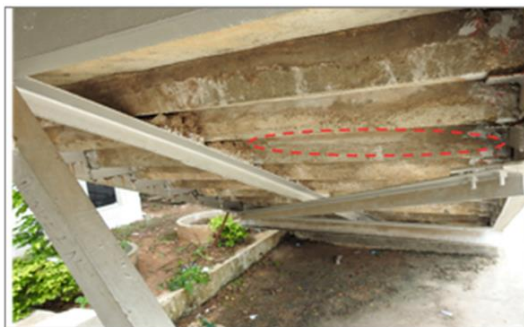
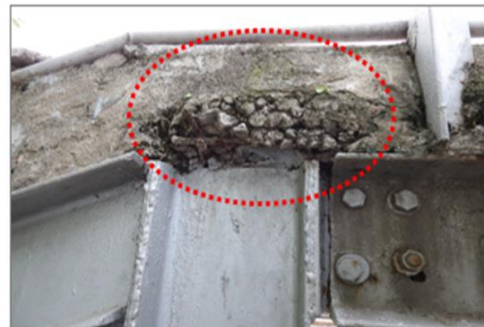
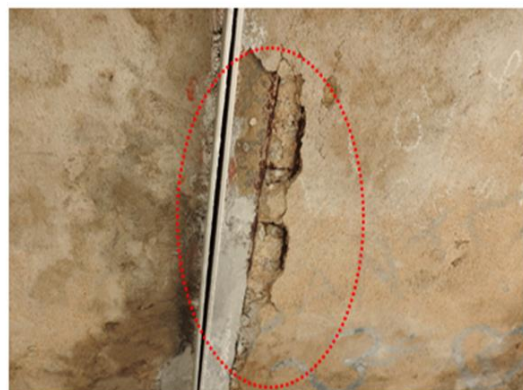
Reinforced cement concrete Slab at Deck level and some precast panels in staircase are observed with exposed rebar in many locations. (*Photographs of the same can be see in fig 2.6*)

**Fig: 2.6** spalling, Reinforcement exposure and cracks is observed at staircase 1

**Methodology for patching:** Hand applied Mortar (Patching) repair is performed to restore small areas where sound concrete is damaged by spalling, scaling and/or impact. This method of repair is generally applied using trowel and require minimum or formworks. The patch thickness is limited to a maximum of 100 mm depth of hollow surface. Hand applied Mortar repair is classified into two types considering defective area and surface. Hand applied Mortar
