## Third Party Audit of ROB's and FOB's of SCR

### INSPECTION OF FOB AT WIRUR RAILWAY STATION

**Final Report**  
SEPTEMBER | 2020

| <b>Name of the Project</b> | : | VISUAL INSPECTION OF FOB/ PF-1 - PF-2 AT WIRUR RAILWAY STATION |

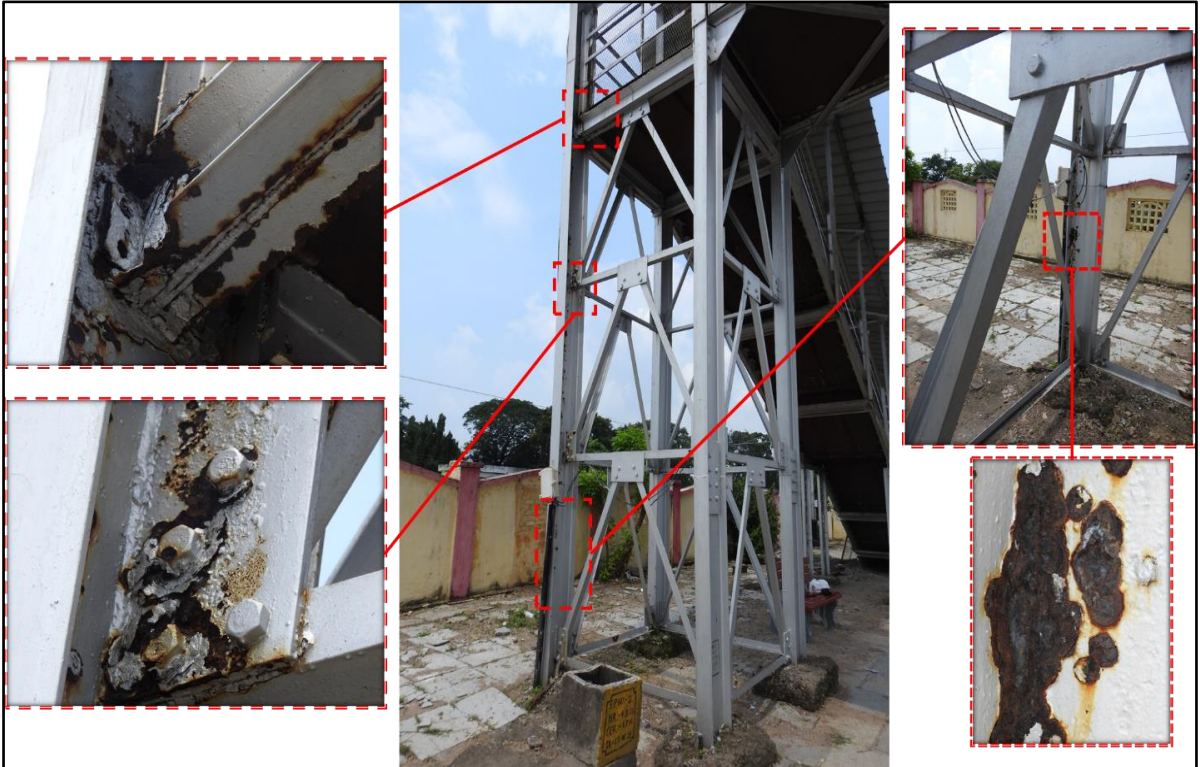
- a. ✓ Major corrosion observed in stringer beam, gusset plate and in Trestles at PF-2.

Corrosion Major corrosion observed

| SIGNS OF DISTRESS, DEFORMATION IN BRIDGES | | | |
|---|---|---|---|
| | Corrosion in Gusset plate | Trestles bracings | Corrosion is observed in Gusset plates.<br>(Refer <b>Part -1.4(a)</b> ) |

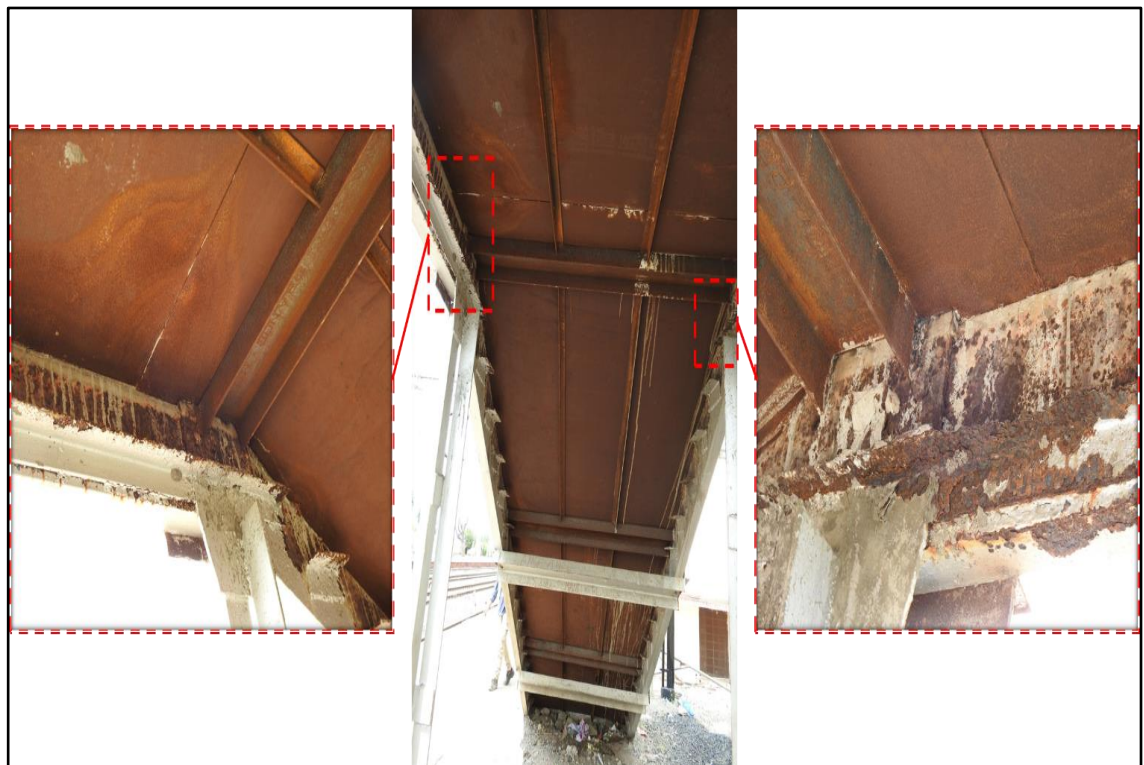
- b. ✓ Corrosion is observed in staircase landing which is supported on channel section at PF-2

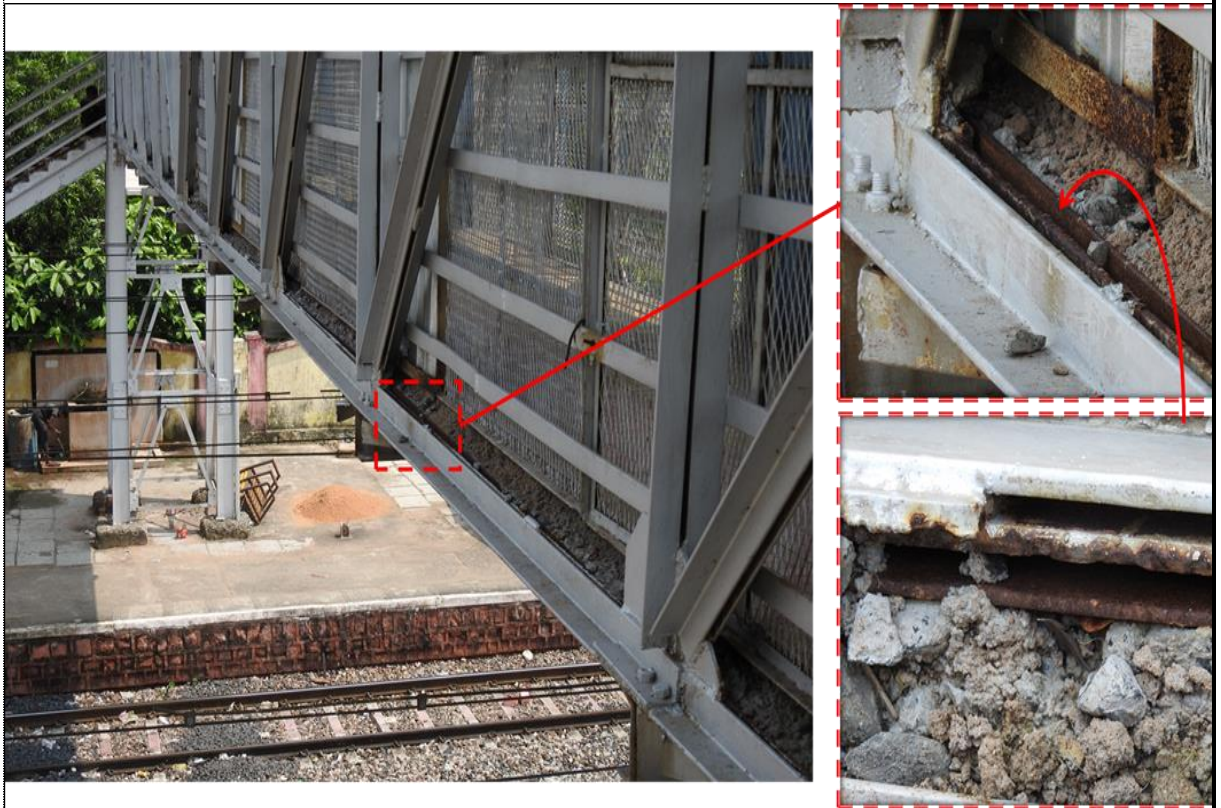
c. Corrosion is observed in bottom chord member (Double angular section) near steel concrete joint

Corrosion is observed at steel concrete joint

| SIGNS OF DISTRESS, DEFORMATION IN BRIDGES | | | |
|---|---|---|---|
| | Corrosion at steel-Concrete joint | Bottom main chord member | Corrosion is observed at steel concrete joint.<br>(Refer <b>Part - 1.4(c)</b> ) |

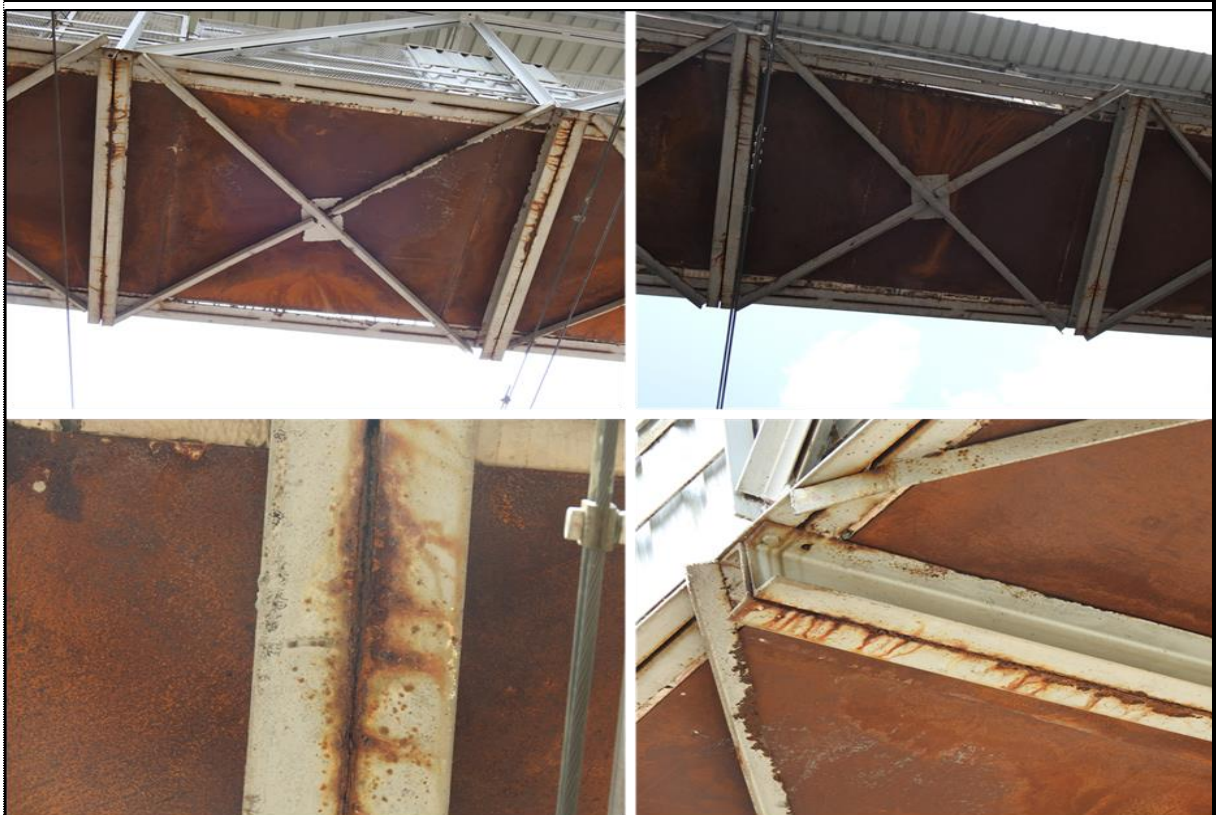
d. Corrosion of sacrificial plates is observed all over the slab bottom and corrosion observed in floor beams

Corrosion is observed in floor beams

| SIGNS OF DISTRESS, DEFORMATION IN BRIDGES | | | |
|---|---|---|---|
| | Rust straining | Sacrificial plate | Corrosion is observed at all over the bottom of slab and bottom of staircase of FOB.<br>(Refer <b>Part - 1.4(d)</b> ) |

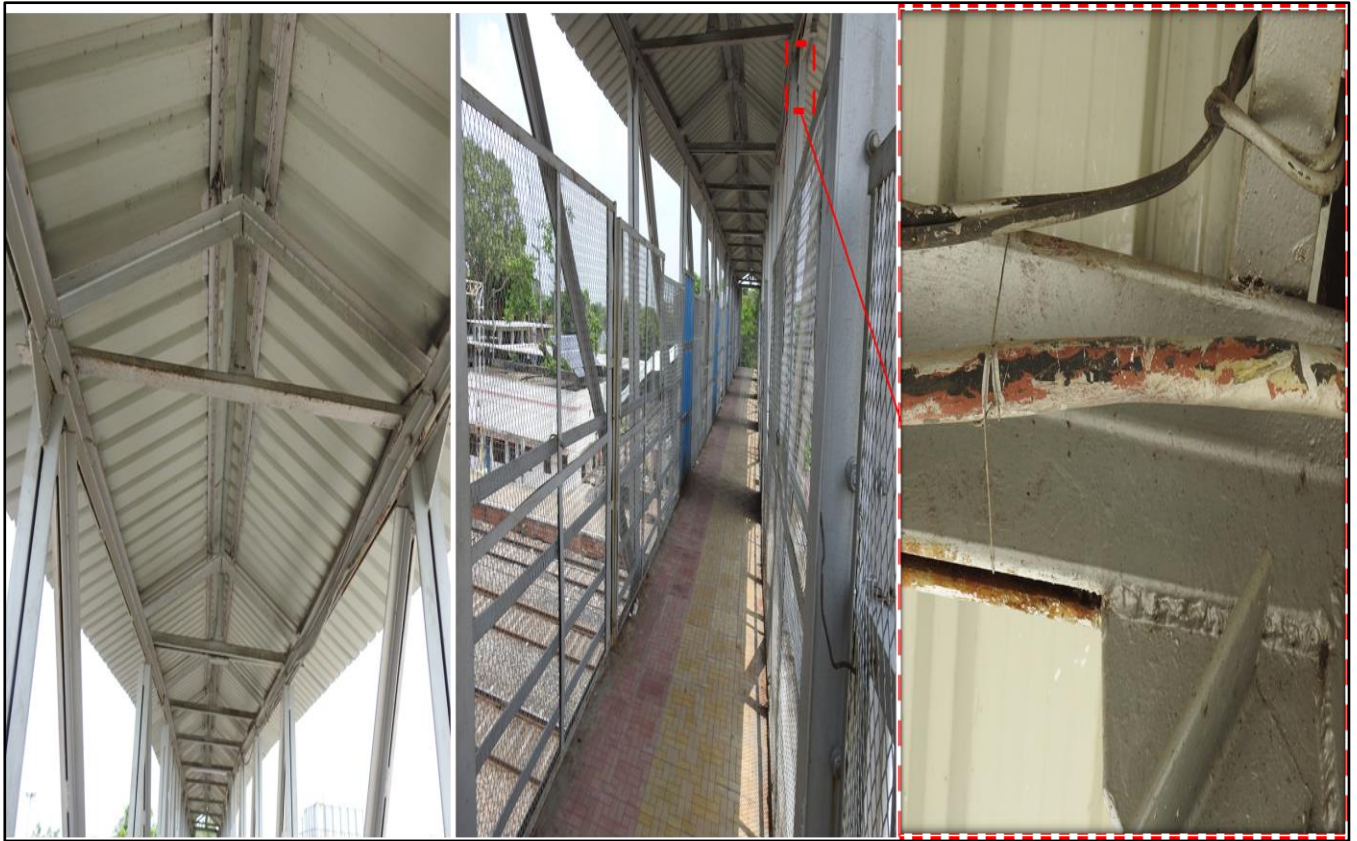
**Fig 1.1:** Cables, Roof truss, Flooring and Protective screen

| 1.2 IDENTIFICATION OF LOADS ON BRIDGE | | | |
|---|---|---|---|
| | b) Cables | Yes | Cables are protected with 1-inch dia HDPE pipe (Refer <b>fig :1.1</b> ) |
| | b) Provision of protective screen for passengers | Yes | Chain link fence made of galvanized wire of 2 mm gauge and 2mm galvanized sheet is used above OHE line on both side of gangway is used for protection. (Refer <b>fig :1.1</b> ) |

| 1.3 STRUCTURAL SYSTEM OF THE BRIDGE | | | |
|---|---|---|---|
| | Element of roof truss section | Angular sections | Span of roof truss is supported with 65 x 65 x 6 mm angular and supported on 75 x 75 x 10 mm main top chord members. (Refer <b>fig :1.1</b> ) |

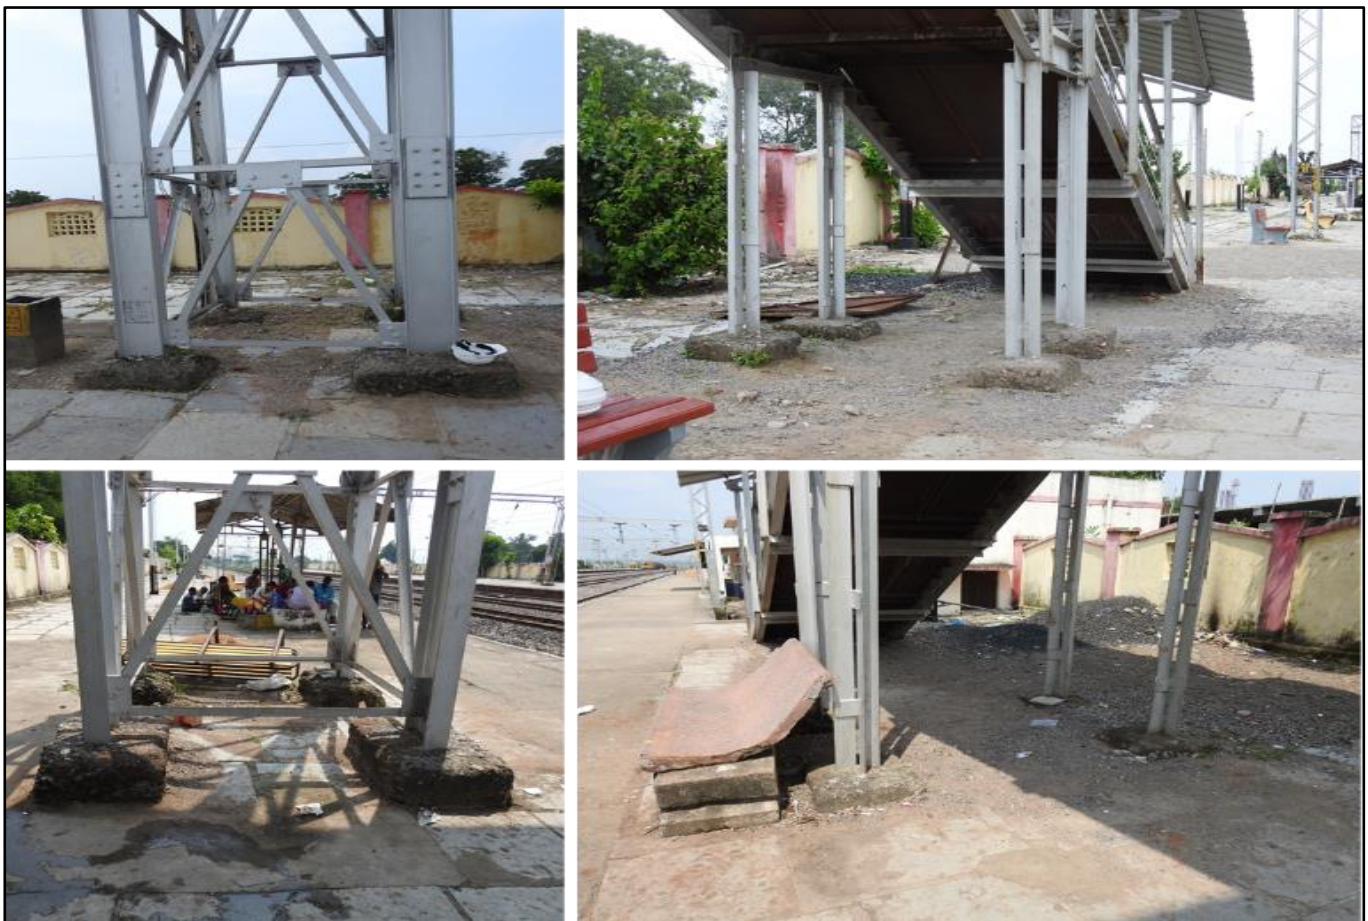
**Fig 1.2:** Trestles details

| 1.3 STRUCTURAL SYSTEM OF THE BRIDGE | | | |
|---|---|---|---|
| | Trestles Connection Details | | Concrete encasement is observed below vertical supports (Refer <b>fig :1.2</b> ) |

| | Type/Shape of Column section | I – Section | FOB is supported on vertical column of Four - ISMB 300. (Refer <b>fig :1.2</b> ) |

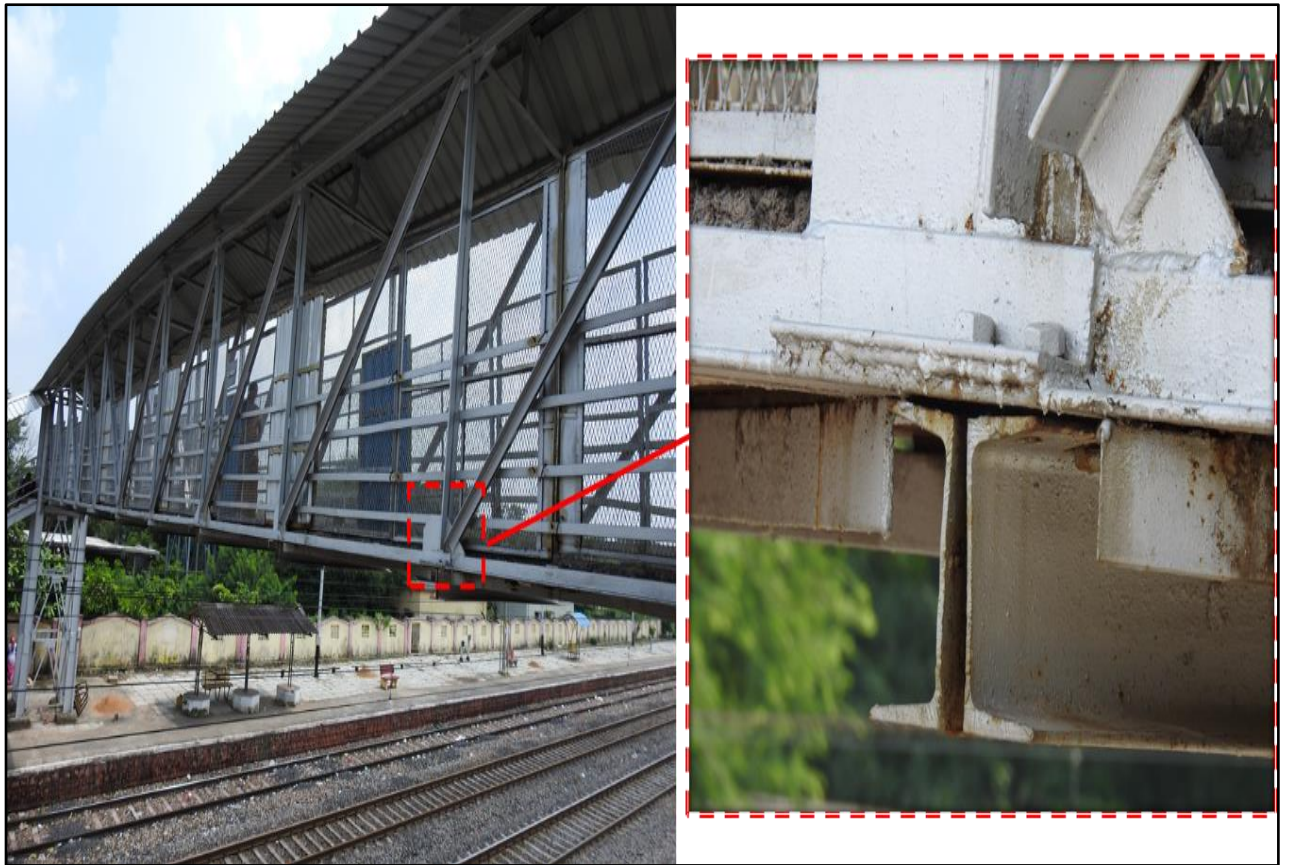
**Fig 1.3:** Top and bottom chord members, bracings and floor beams

| | Height of Truss (H) | 2.95 m at mid span,<br>2.08 m at supports | a. Top and bottom chord members 75 x75 x10 mm double angular section.<br>b. 65 x 65 x 6 mm double angular are used as bracing members<br>c. 10 mm thick gusset plate is used for welded joint.<br>ISMC 150 Double Channel are used as floor beams supported with 65 x 65 x 8 mm angular section to transfer load from slab to roof truss.(Refer <b>fig :1.3</b> ) |

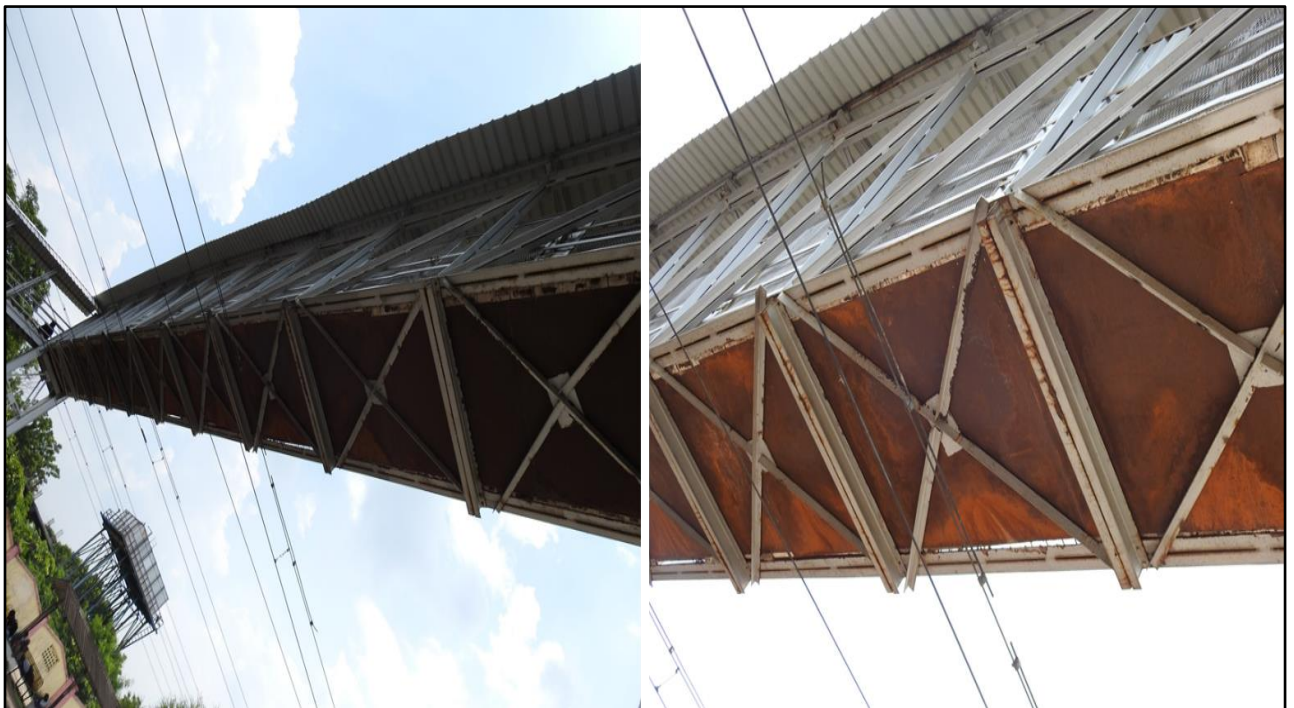
**Fig 1.4:** Bottom view of FOB

| | Material of Slab | RCC | a. Cast in site slab is used for floor slab of 100mm thick, cast in situ slab is supported with sacrificial plate which is connected to on secondary girder and bracings from bottom<br>b. Chequered tile flooring is laid on the top of the slab (Refer <b>fig :1.4</b> ) |

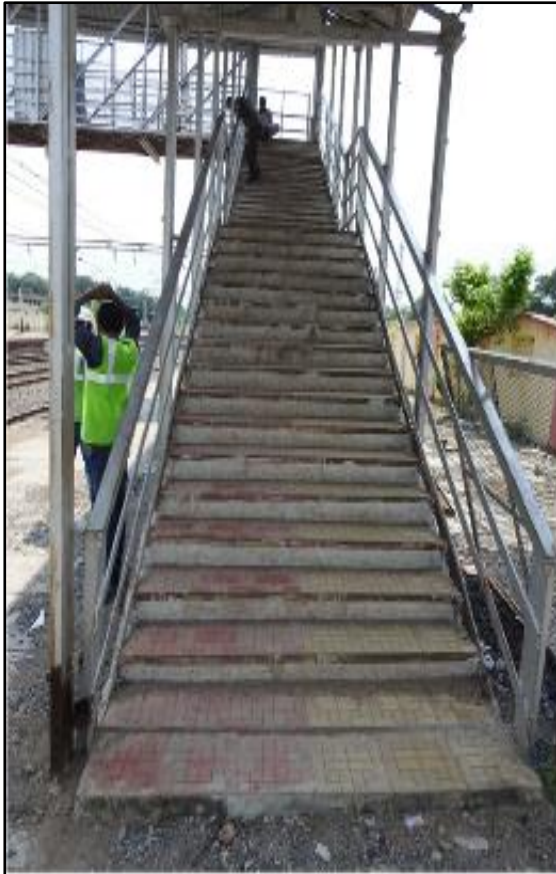
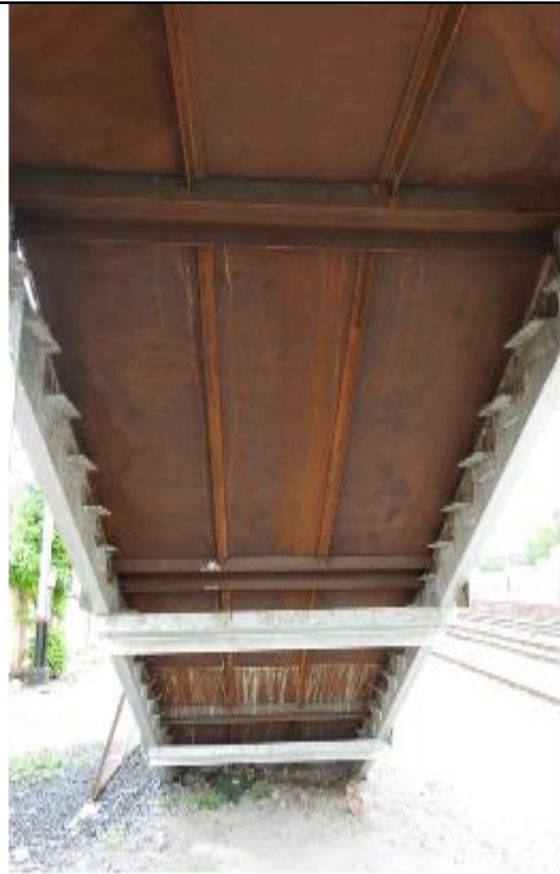
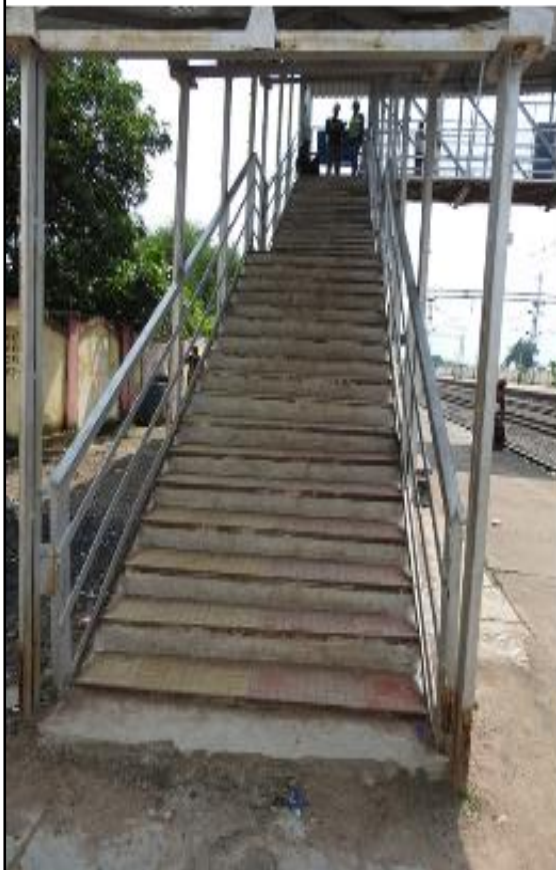
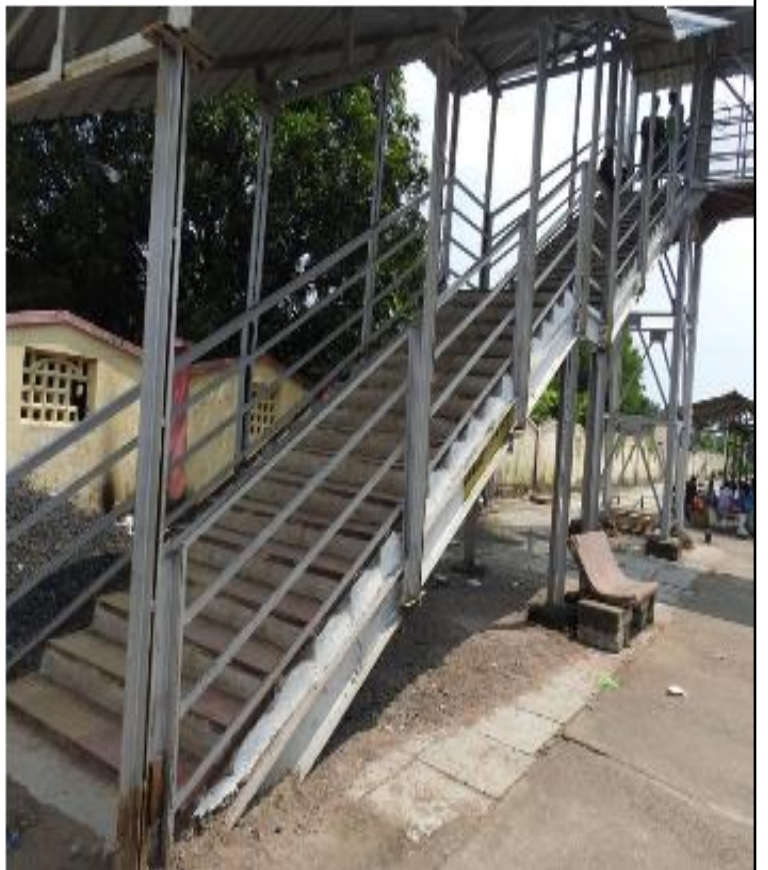
***Fig 1.5:*** Staircase details and bottom view

| | Number of Staircase | 2 no's | Staircase steps are observed as cast in site slab of size 300 x 100 mm used. Steps are supported on ISMC 250 channel using sacrificial plate. Staircase landing of 1.6 m wide is supported on vertical and horizontal channels members.<br>Roof of staircase is supported with 65 x 65x 6 mm double angular section. (Refer <b>fig :1.5</b> ) |

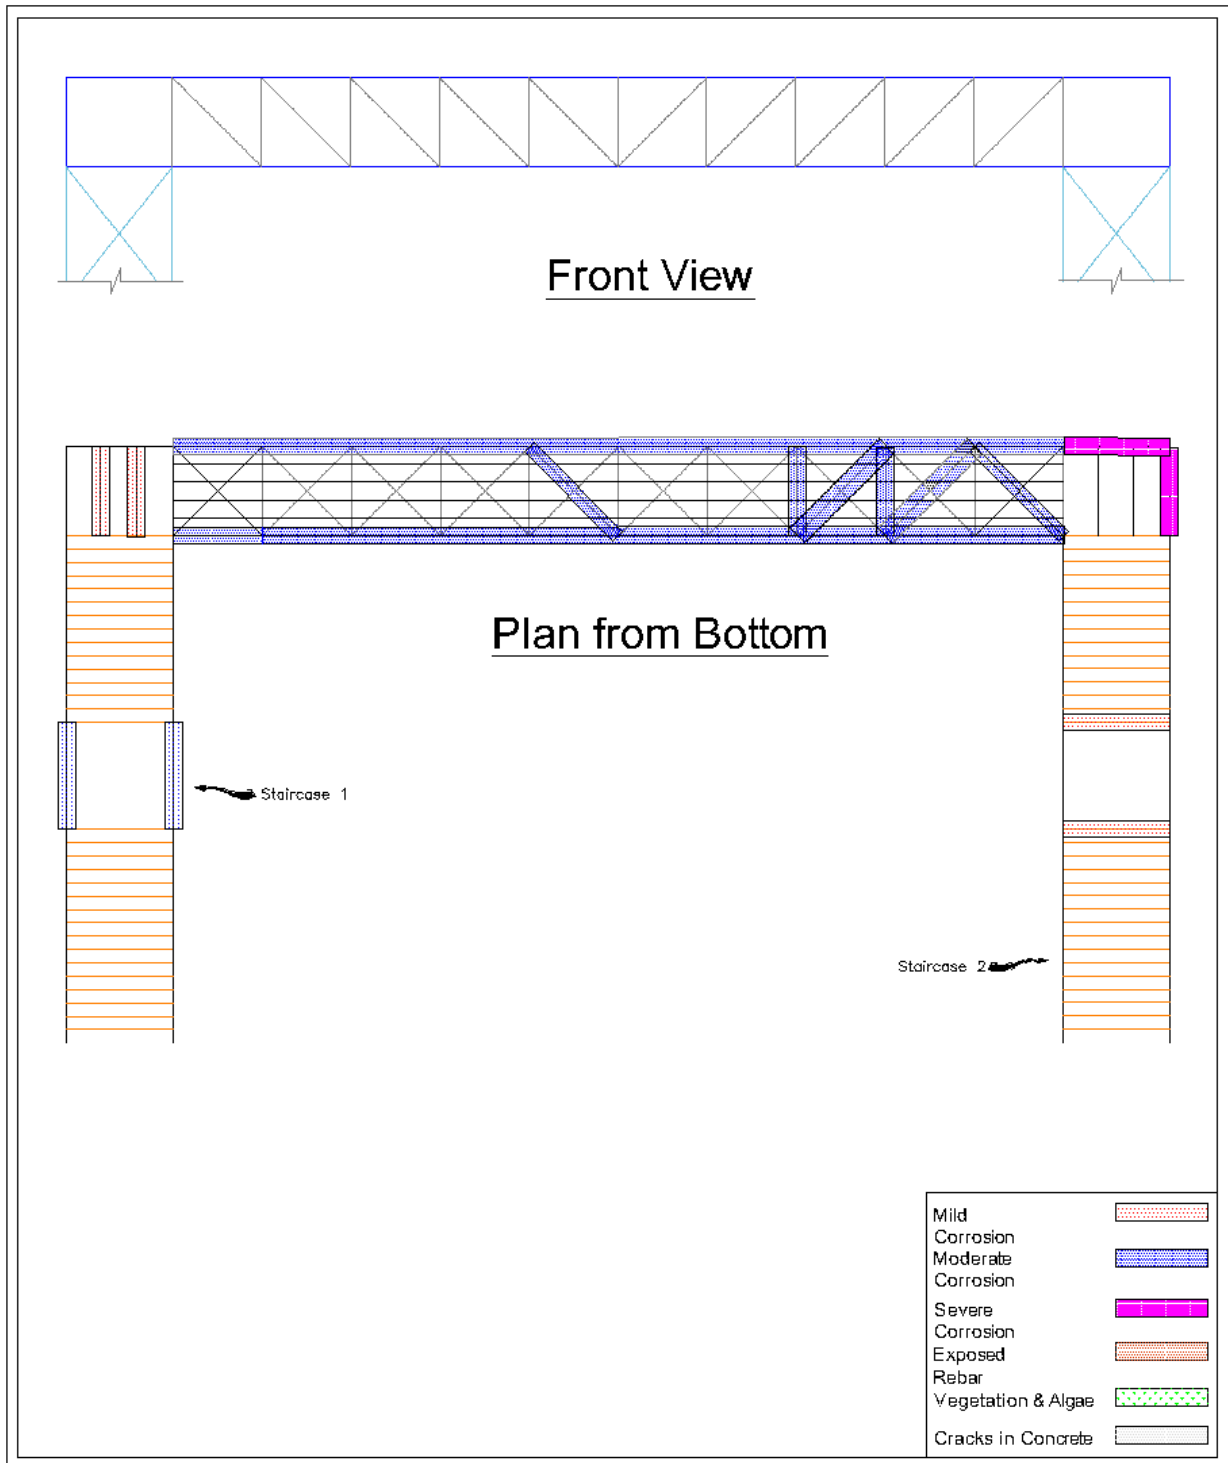
**Fig: 2.1** locations of deteriorations and view of FOB from bottom

- Structural members are in fair condition, displaying mild corrosion for top chord members, verticals, diagonals, and moderate corrosion for bottom chord members along steel concrete joint and floor beams and severe corrosion at staircase stringer beam. Sacrificial plate is also corroded (*Photographs of the same can be see in **fig 2.2-2.6***)

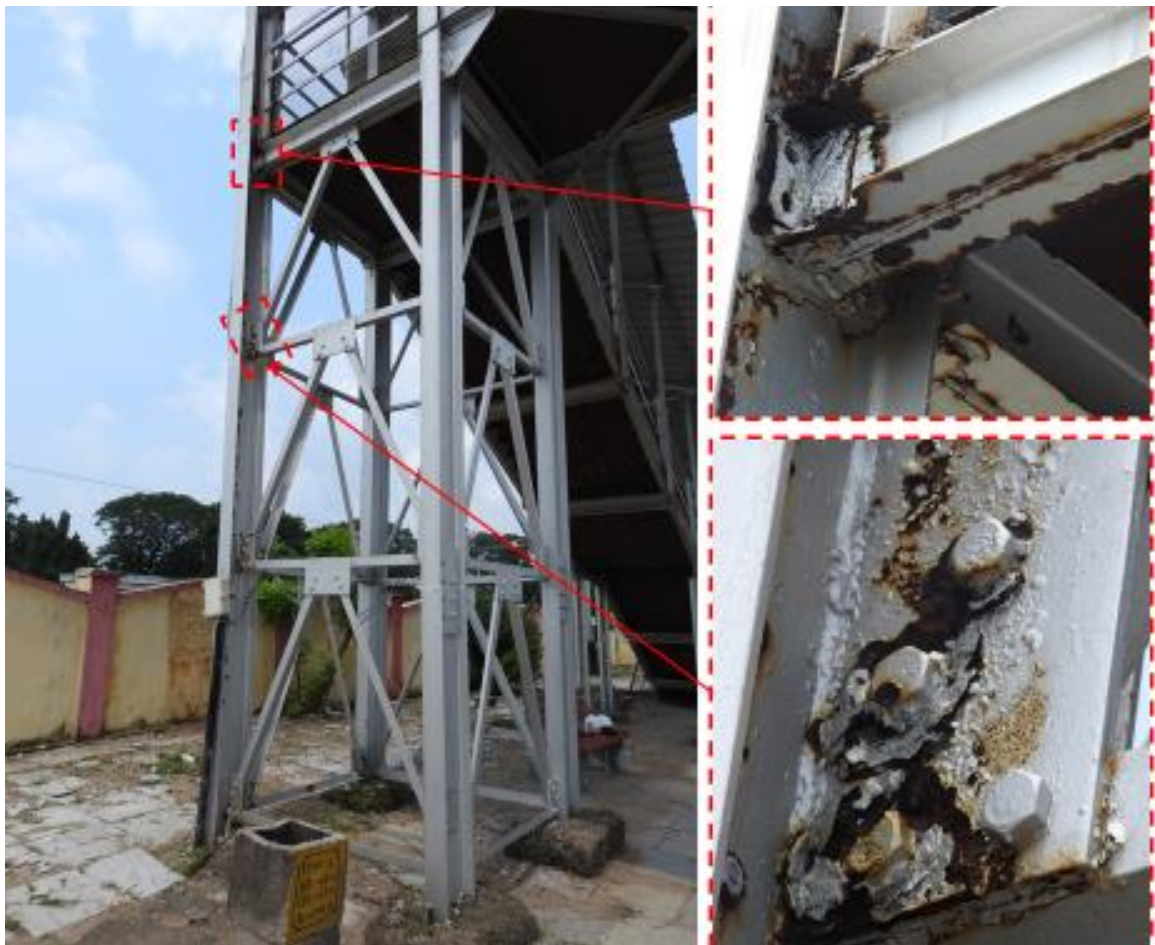
**Fig: 2.2** Corrosion in floor beam at beam column joint

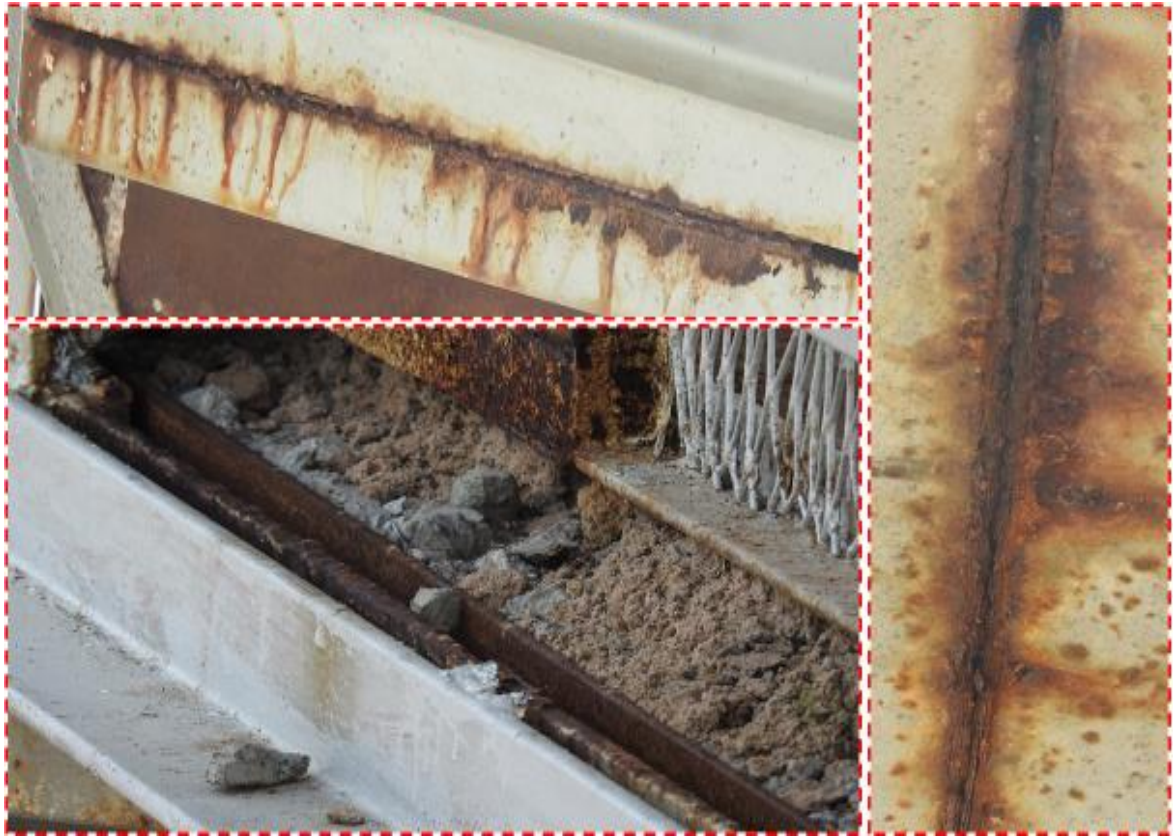
| Span 1 | Mild Corrosion | Moderate Corrosion | Sever Corrosion | Remark |
|---|---|---|---|---|
| Bottom Chord | | ✓ | | |

**Fig: 2.3** Corrosion at bottom chord members and floor beams

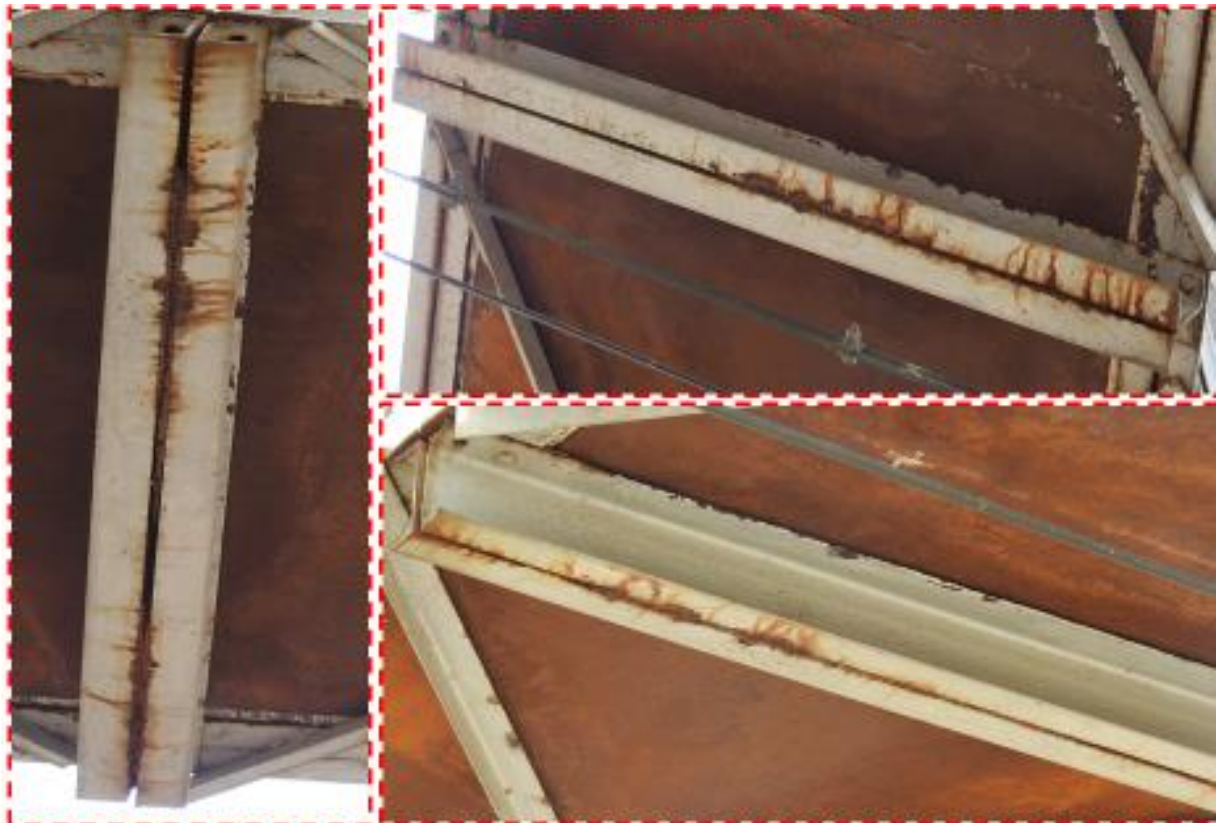
**Fig: 2.4** corrosion at floor beams

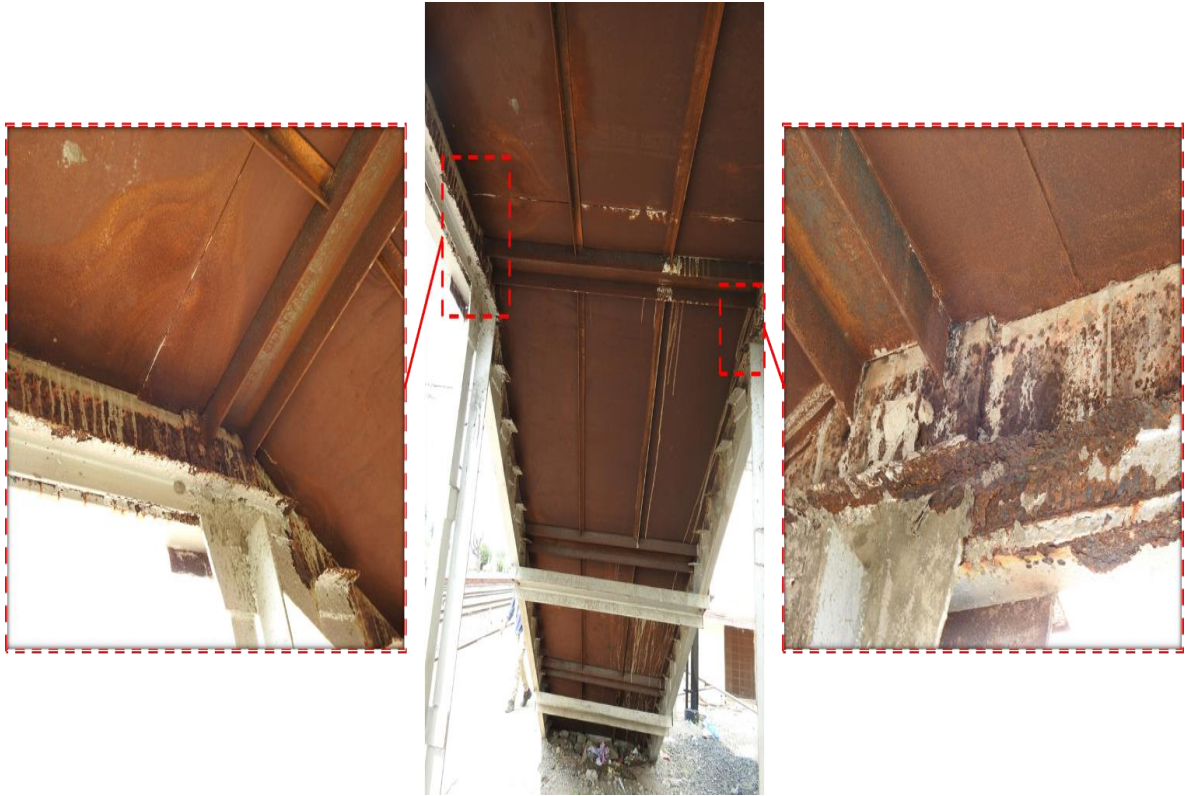
**Fig: 2.5** Corrosion of staircase stringer beam
