## Third Party Audit of ROB's and FOB's of SCR

### INSPECTION OF FOB AT LAKDIKAPUL RAILWAY STATION

**Final Report**

| <b>Name of the Project</b> | : | VISUAL INSPECTION OF FOB/ PF-1 - PF-2 AT LAKDIKAPUL RAILWAY STATION |

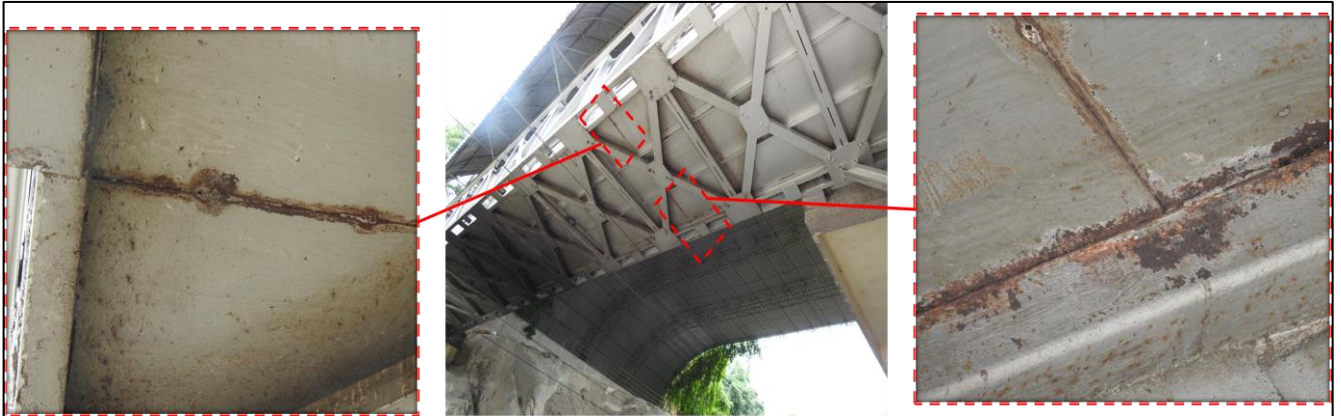
**a**

✓ Slight corrosion is observed between two sacrificial plate joints

Corrosion observed at sacrificial plates

| SIGNS OF DISTRESS, DEFORMATION IN BRIDGES | | | |
|---|---|---|---|
| | Rust straining | Sacrificial plate | Corrosion is observed at bottom slab of FOB<br>(Refer <b>Part 1.4-a</b> ) |

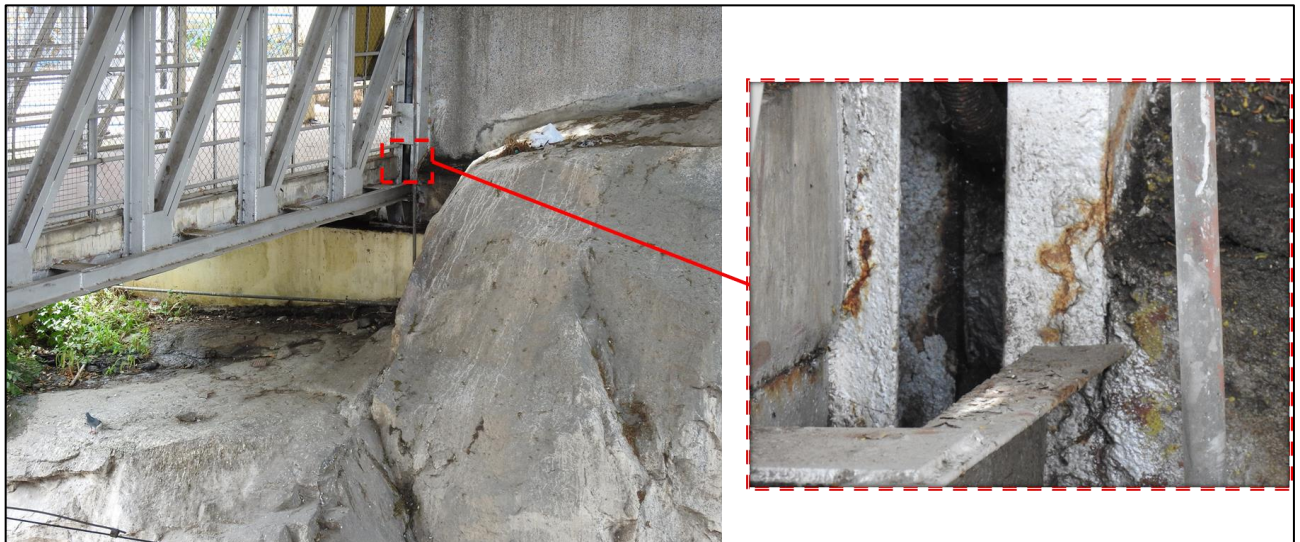
**b**

✓ Mild Corrosion is observed at Trestles (Double channel section) at PF-2

Corrosion observed in Double channel section

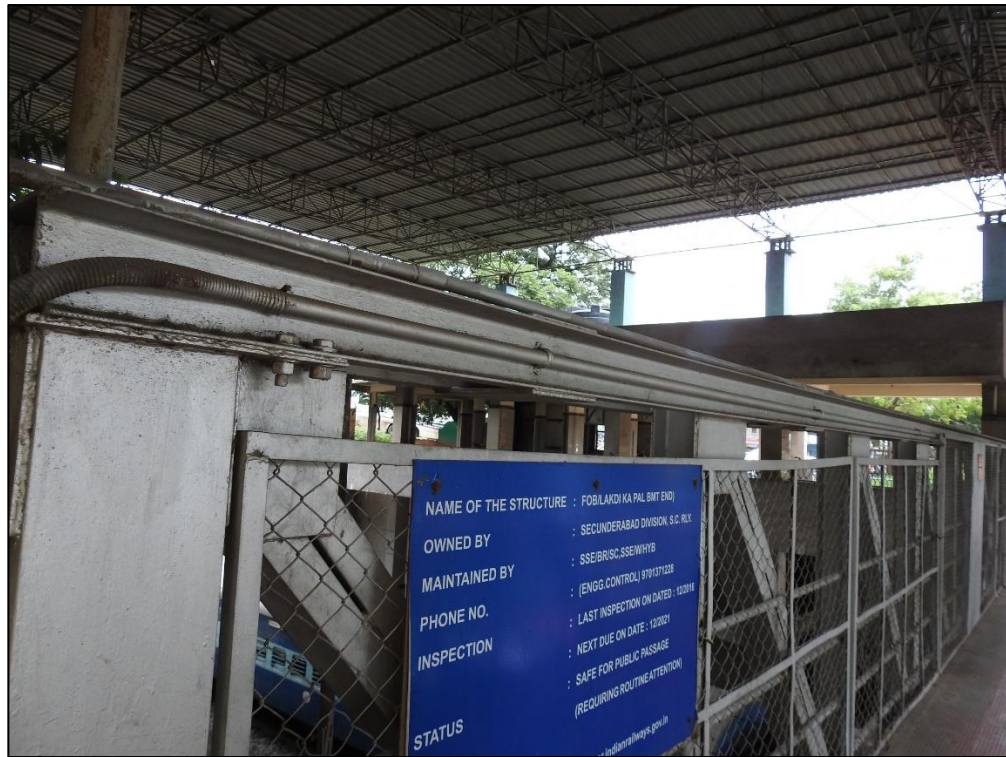
| 1.2 IDENTIFICATION OF LOADS ON BRIDGE | | | |
|---|---|---|---|
| | b) Provision of protective screen for passengers | Yes | Chain link fence made of Galvanized wire of 2 mm gauge and 2 mm Galvanized sheet is used above OHE Line on both side of pathway is used for Protection. Mesh frame is supported with angular and MS flats.<br>(Refer <b>fig :1.1</b> ) |

**Fig 1.1:** Electrical Cables and Protective screening mesh for passengers

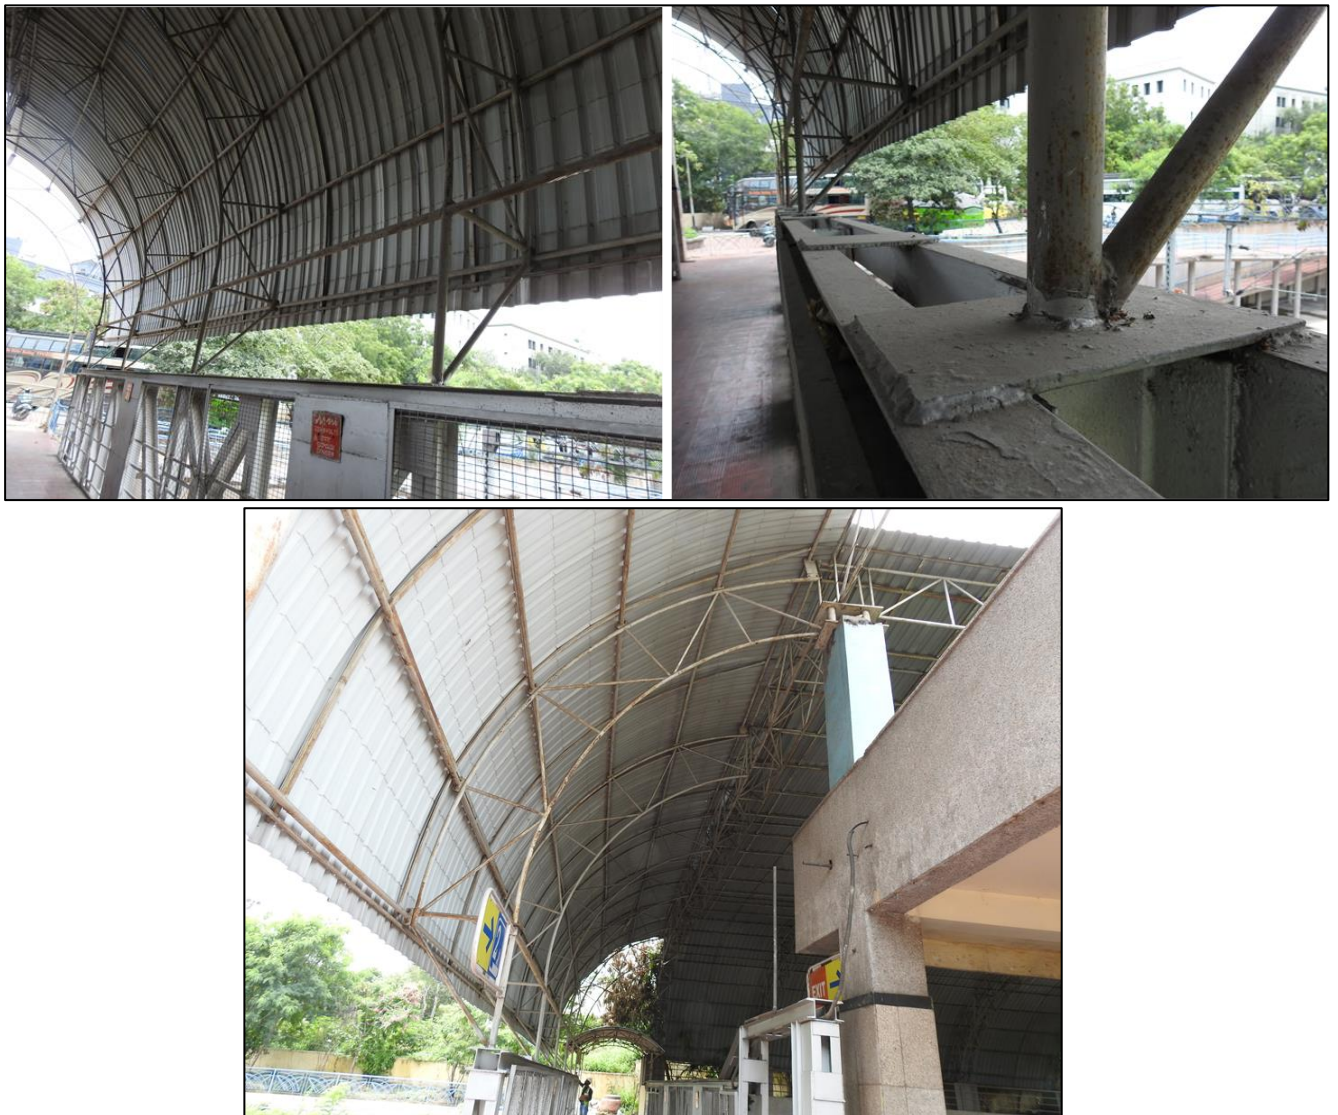
| | 1.3 STRUCTURAL SYSTEM OF THE BRIDGE | | |
|---|---|---|---|
| | Element of roof truss section | circular truss supported with hollow pipes | 2-inch circular truss with plate welded to top chord members. (Refer <b>fig :1.2</b> ) |

**Fig 1.2:** Roof Sheet and Roof truss

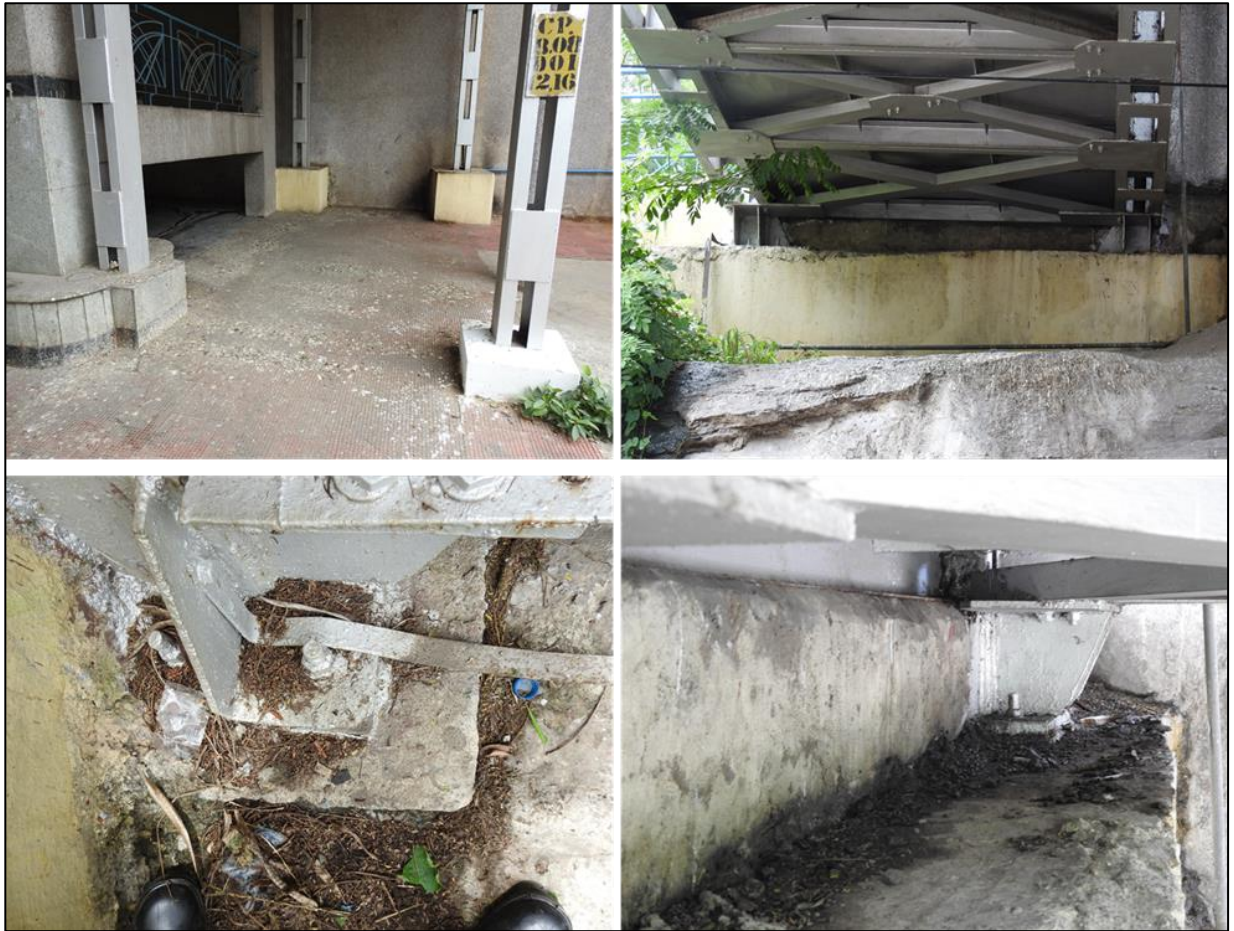
| | 1.3 STRUCTURAL SYSTEM OF THE BRIDGE | | |
|---|---|---|---|
| | Type of Pedestal | Concrete | Concrete encasement is observed below vertical supports (Refer <b>fig :1.3</b> )<br>By performing cover test, reinforcement in pedestal can be identified (Refer <b>fig :1.3</b> ) |

**Fig 1.3:** Trestles and their protection with concrete encasement

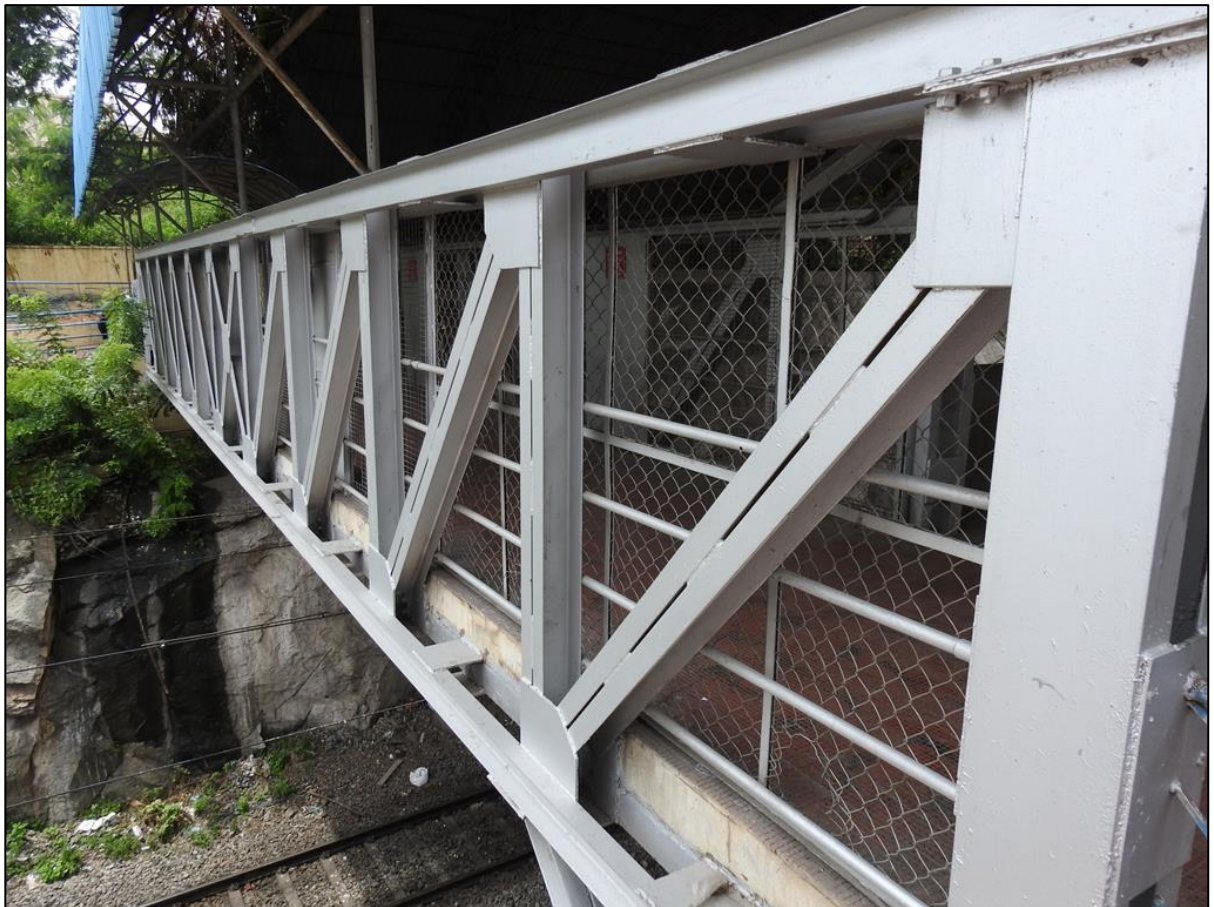
| | No of Floor beams/bracings for span | 10 no's | d. one end of fob is anchored to the stone (Refer <b>fig :1.4</b> ) |

**Fig 1.4:** Top and bottom main chord members with vertical and diagonal bracings

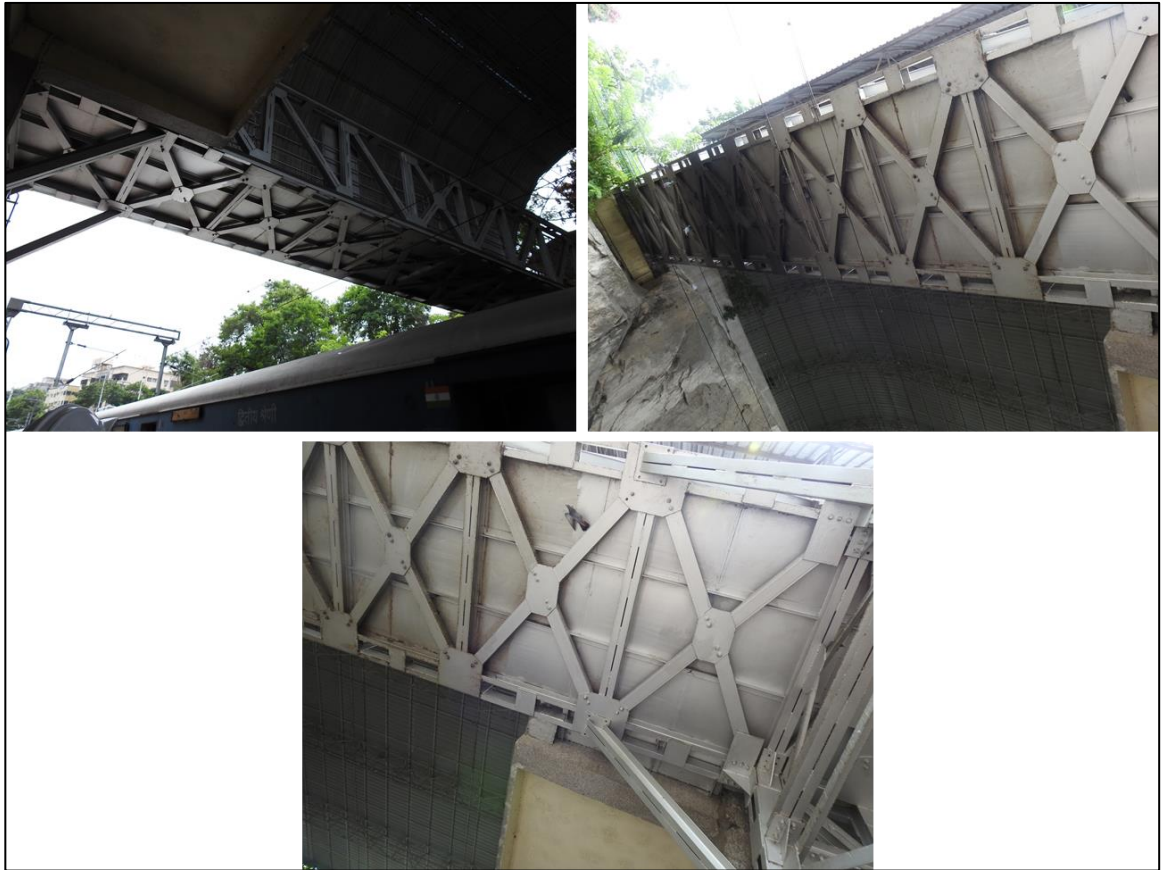
| | Condition of Slab from Bottom | Slabs supported with Sacrificial plate | c. RCC slab is supported by Floor beams of ISMC150 (Refer <b>fig :1.5</b> ) |

**Fig 1.5:** Slab is supported with sacrificial plate

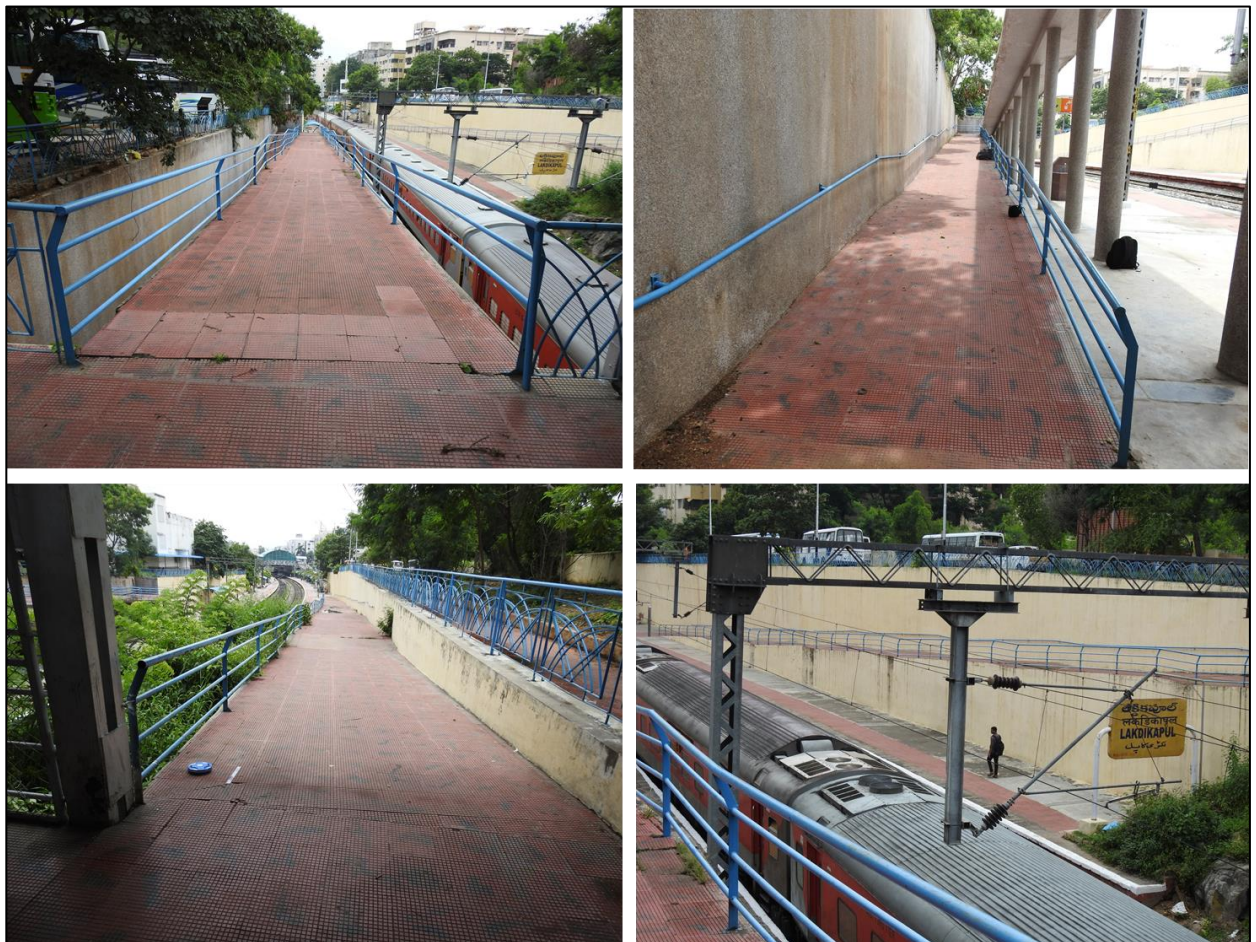
| | Width of ramp | 2.3 m | Ramp is supported with RCC slab at a length of 49.54 m at PF-1 and 60 m at PF-2. |
| | Type of Parapet Railing | Steel railing | Stair case is provided with Railing on both sides of one-meter height using Hollow Circular sections. (Refer <b>fig :1.6</b> ) |

**Fig 1.6:** Ramp on PF-1 and PF-2

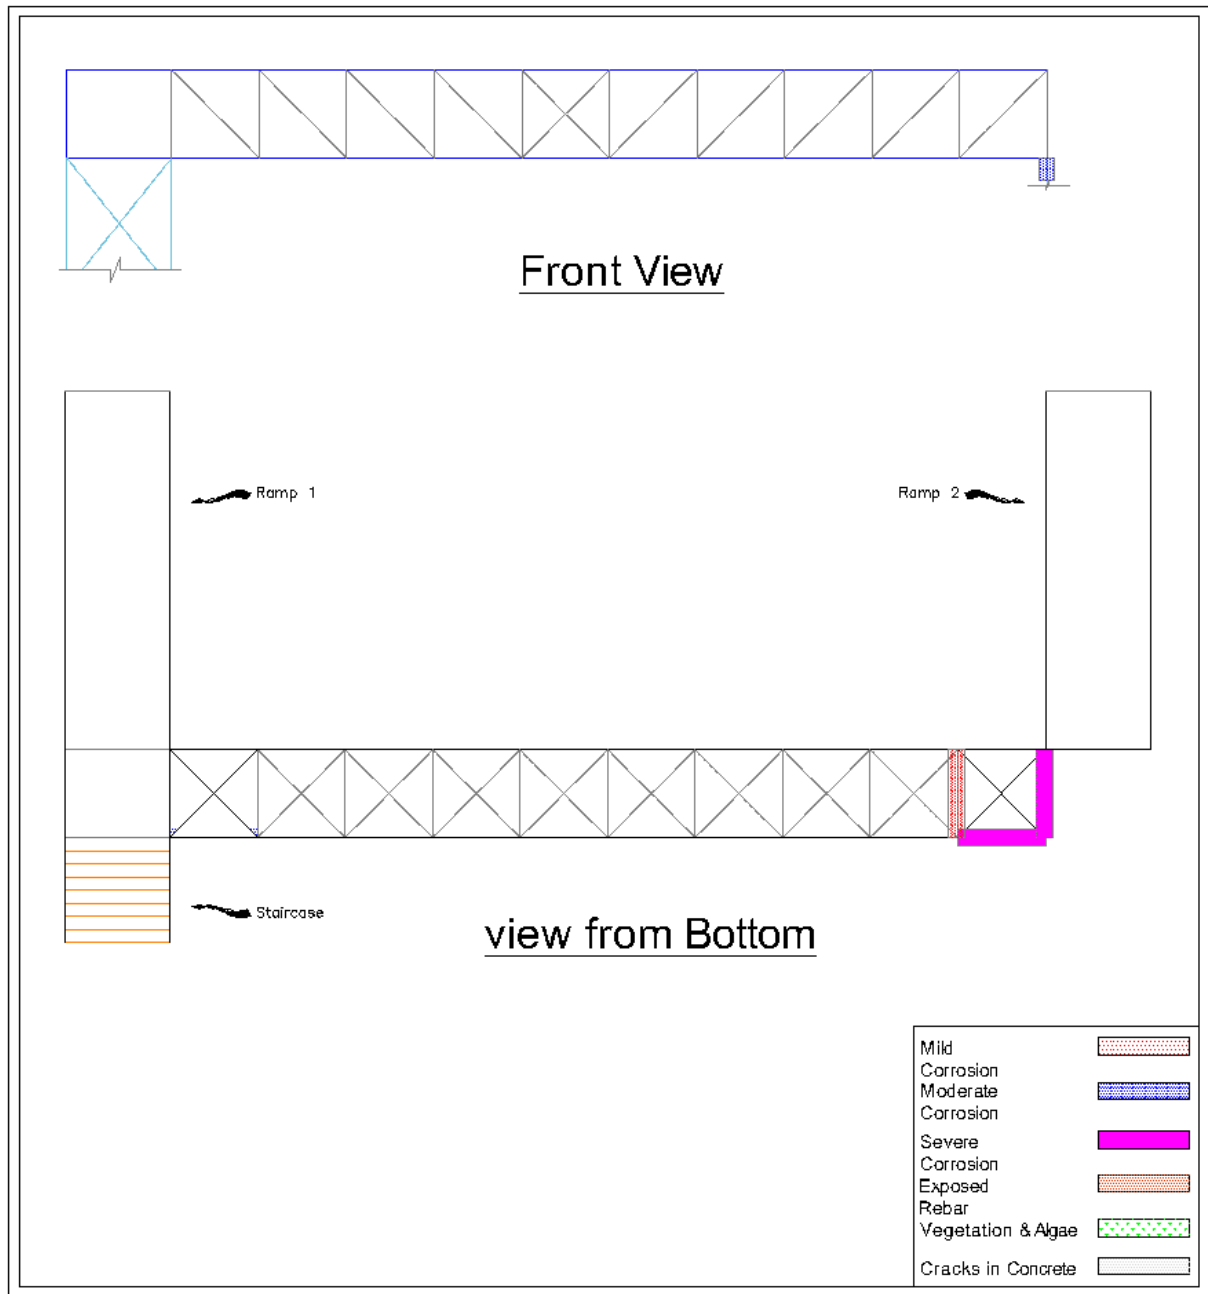
**Fig 2.1:** Location of corrosion and rusting of members of FOB

- Structural members are in fair condition, displaying mild corrosion for top chord members, verticals, diagonals, and gusset plates, bottom chord members along steel concrete joint and on

the Sacrificial plate is also corroded in some locations. Severe corrosion at gusset plate near (Locations are marked in figures below).

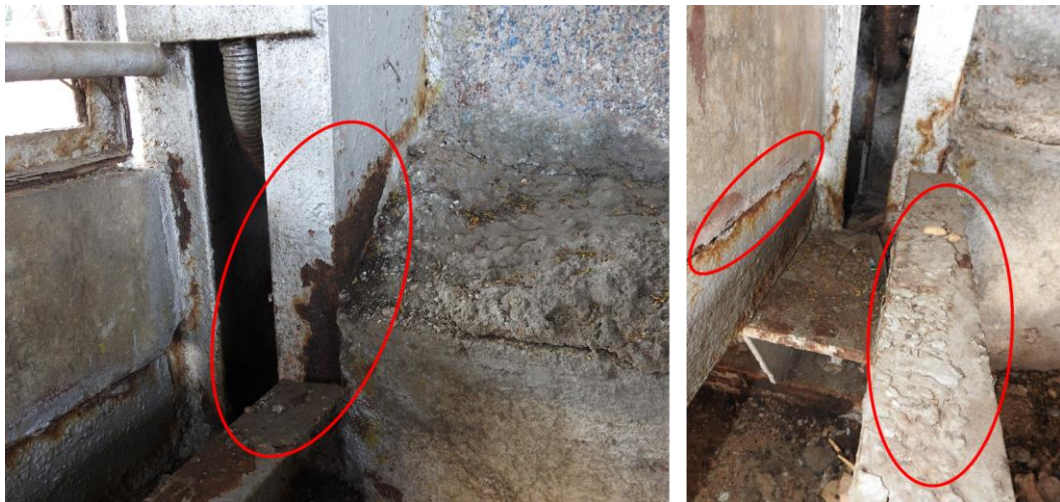
- Severe corrosion is observed in bottom chord near ramp 2. Effective thickness is decreased due to corrosion. (Photographs of the same can be see in **fig 2.2-2.3**)

**Fig 2.2:** Corrosion of vertical member, gusset plate and at steel concrete joint

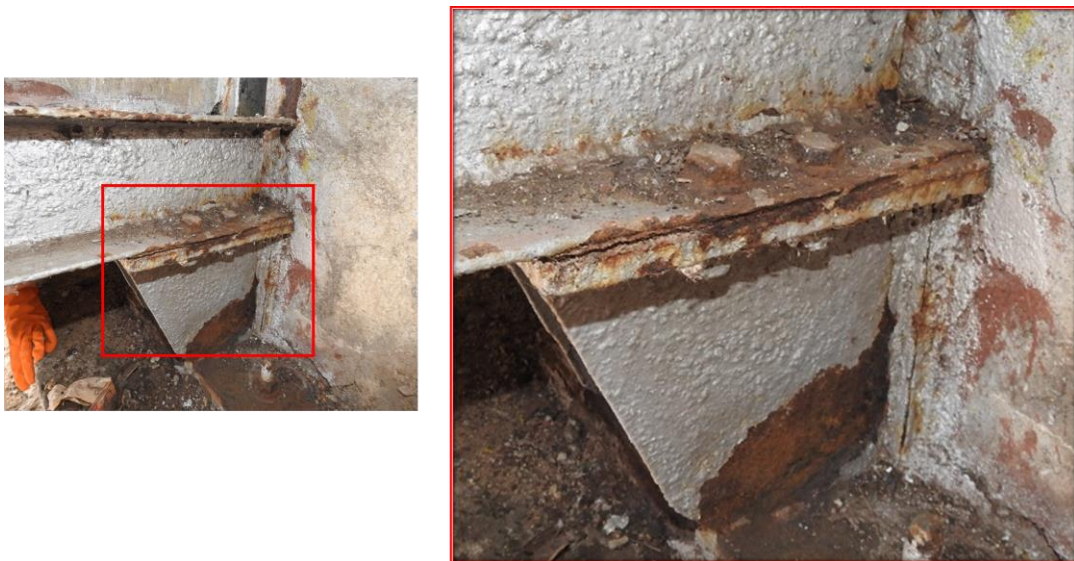
**Fig 2.3:** Corrosion of bottom chord and gusset plate

- **Based on visual inspections and its interpretations following recommendations were made:**
  - a) Cleaning of debris immediately to avoid deterioration of concrete and steel members.
  - b) Anti-corrosion treatment for Grade-1 and Grade-2 highlighted corrosive members.
  - c) Replacement of gusset plate and bottom chord members or severely corroded members near ramp 2. (*See fig 2.3*)
