## Third Party Audit of ROB's and FOB's of SCR

### INSPECTION OF FOB AT SIRPUR RAILWAY STATION

**Final Report**  
SEPTEMBER | 2020

| <b>Name of the Project</b> | <b>:</b> | VISUAL INSPECTION OF FOB/ PF-1 - PF-2 AT SIRPUR TOWN RAILWAY STATION |

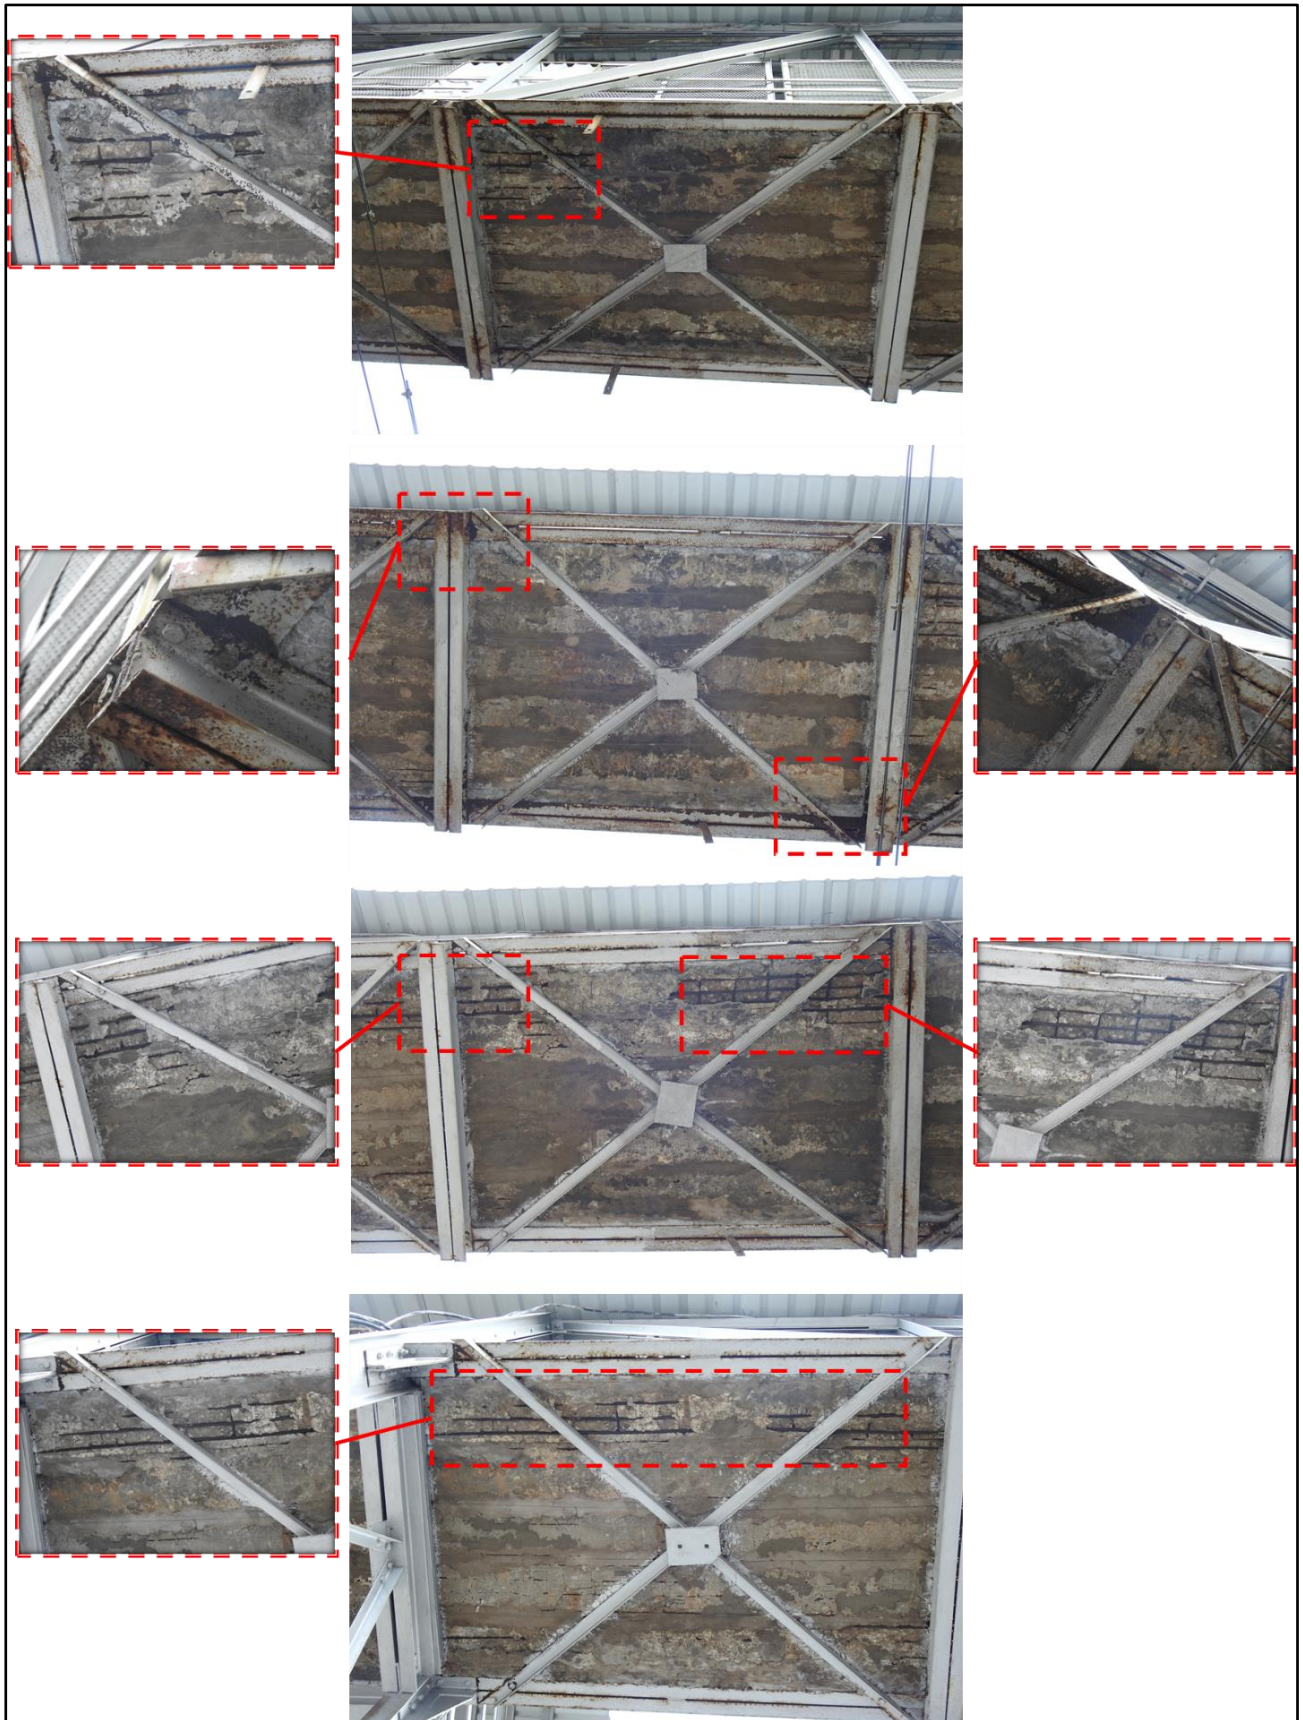
- a. ✓ Reinforcement exposure of RCC slab panels and corrosion observed along the span of FOB

Reinforcement exposure and corrosion

| SIGNS OF DISTRESS, DEFORMATION IN BRIDGES | | | |
|---|---|---|---|
| | Spalling | Bottom of RCC slab panels and bottom slab panels of staircase | Major spalling and exposed reinforcement is observed at the bottom of slab panels of staircase and pathway. (Refer <b>Part 1.4 – 1.4(a) and fig: 1.4</b> ) |

- iii. Replacement of damaged pre-cast slab panels which are severely deteriorated.
  - iv. Patch work for exposed reinforcement in flights of staircase 1 and staircase 2.

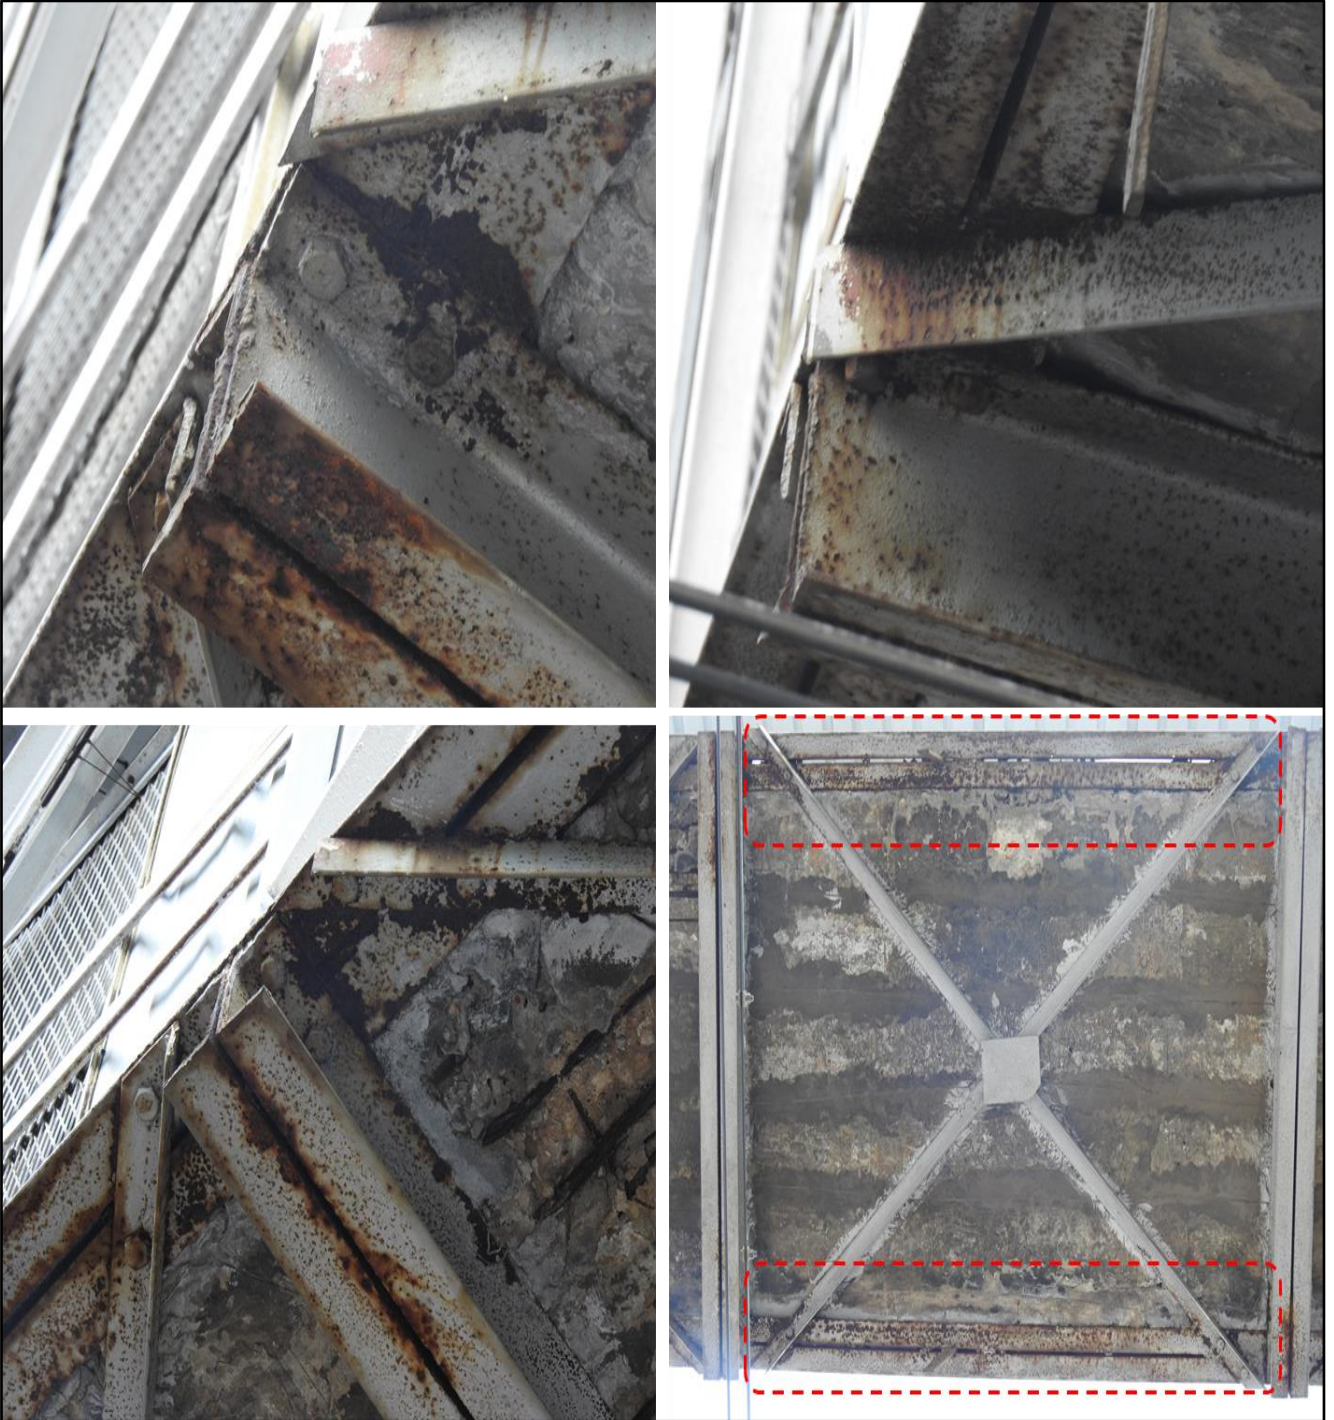
- b. ✓ Corrosion is observed in joints of Floor beams and bottom main chord member and slight rusting is observed at bottom of main bottom double angle sections along the length of FOB

Corrosion observed in Floor beams joints

| SIGNS OF DISTRESS, DEFORMATION IN BRIDGES | | | |
|---|---|---|---|
| | Rust straining | Bottom main chord members | Rusting is observed at all over the bottom main chord members of FOB. (Refer <b>Part 1.4 – 1.4(b)</b> ) |
| | Extent of Corrosion | Gusset plate connecting Floor beams and bottom main chord member | Spacers in between Floor beams are distressed.<br>Major corrosion is observed at gusset plate connecting Floor beams and main chord members (Refer <b>Part 1.4 – 1.4(b)</b> ) |

- i. Cleaning of debris immediately to avoid deterioration of concrete and steel members.
  - ii. Anti-corrosion treatment for Grade-1 and Grade-2 highlighted corrosive members.

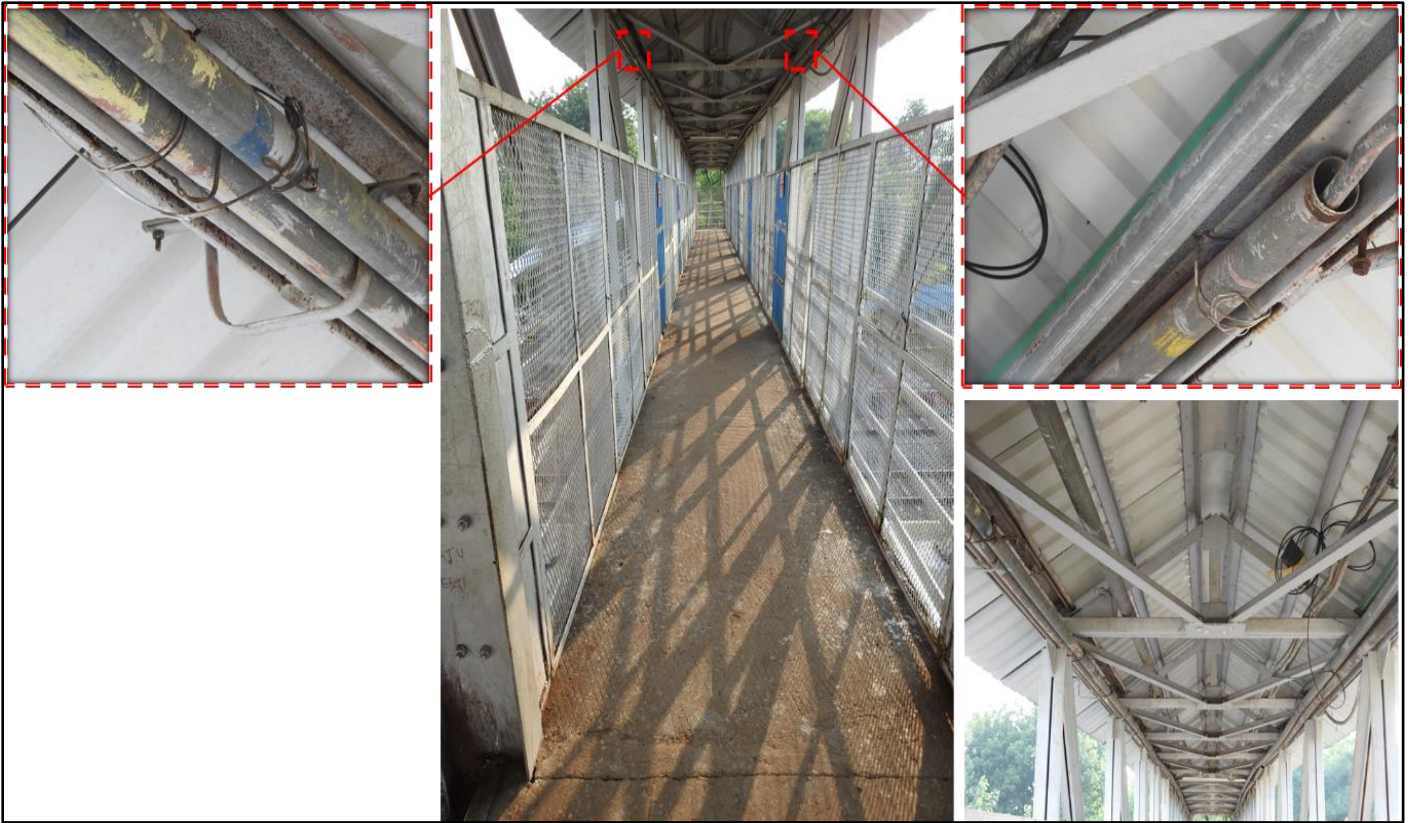
**Fig 1.1:** Cables, Roof truss, Flooring and Protective screen

| 1.2 IDENTIFICATION OF LOADS ON BRIDGE | | | |
|---|---|---|---|
| | b) Cables | Yes | Cables are protected with 1-inch dia HDPE pipe and five-inch Galvanized pipes (Refer <b>fig :1.1</b> )<br>King post supported with 65 x 65 x 6 mm angles are used (Refer <b>fig: 1.1</b> ).<br>Steel Metal Sheet is used for Roof (Refer <b>fig :1.1</b> ) |
| | b) Provision of protective screen for passengers | Yes | Chain link fence made of galvanized wire of 2 mm gauge and 2mm galvanized sheet is used above OHE line on both side of gangway is used for protection. (Refer <b>fig :1.1</b> ) |

| 1.3 STRUCTURAL SYSTEM OF THE BRIDGE | | | |
|---|---|---|---|
| | Element of roof truss section | Angle sections | Span of roof truss is supported with 65 x 65 x 6 mm angular and supported on 80 x 80 x 8 mm main top chord members. (Refer <b>fig :1.1</b> ) |

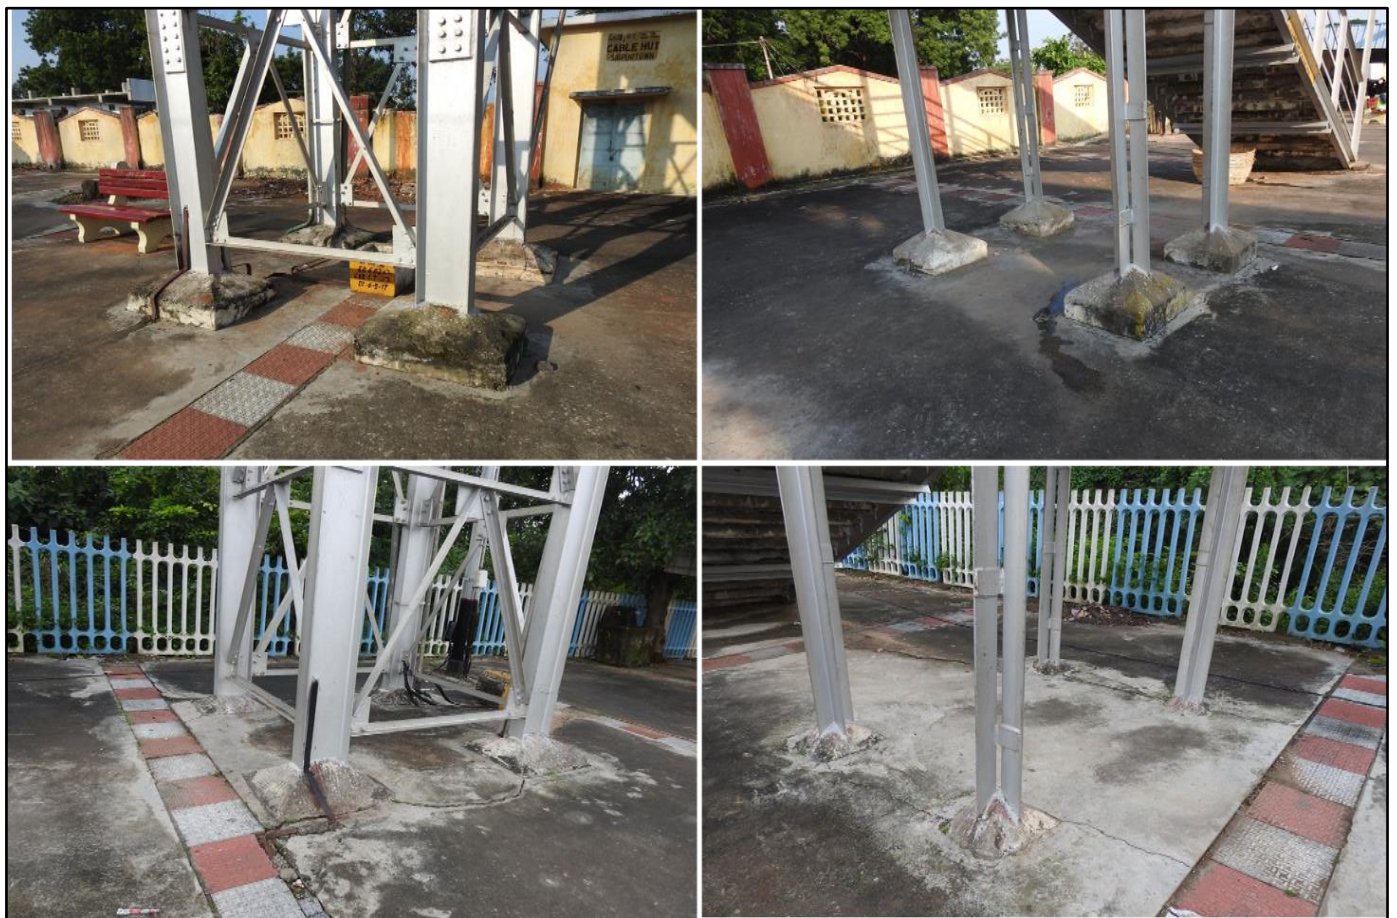
**Fig 1.2:** Trestles details

| 1.3 STRUCTURAL SYSTEM OF THE BRIDGE | | | |
|---|---|---|---|
| | Trestles Connection Details | | Trapezoidal Concrete encasement is observed below vertical supports (Refer <b>fig :1.2</b> ) |

| | Type/Shape of Column section | I – Section | FOB is supported on vertical column of Four - ISMB 300. (Refer <b>fig :1.2</b> ) |

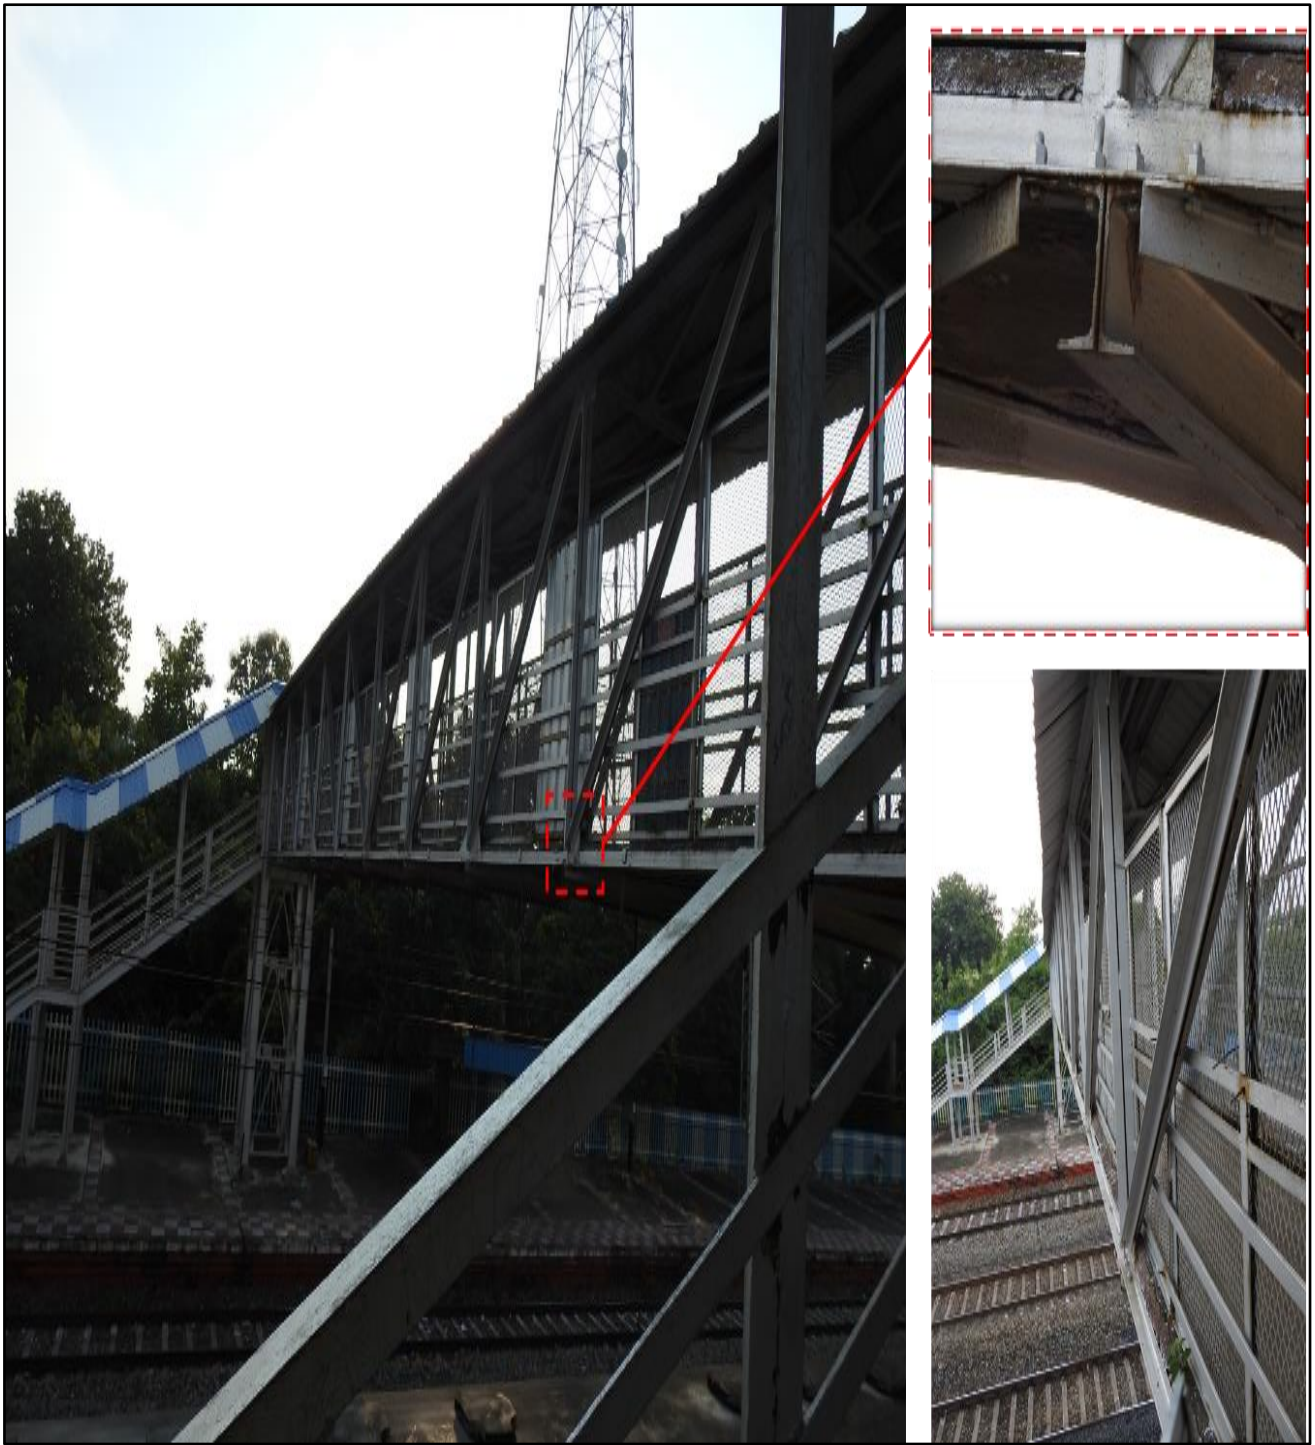
***Fig 1.3:*** Top and bottom chord members, bracings and Floor beams

| | Type/Shape of Secondary Girder /Bracings | Double Channel sections and angle sections | ISMC 150 Double Channels are used as Floor beams supported by 65 x 65 x 6 mm angle sections to transfer load from slab to roof truss.(Refer <b>fig :1.3</b> ) |

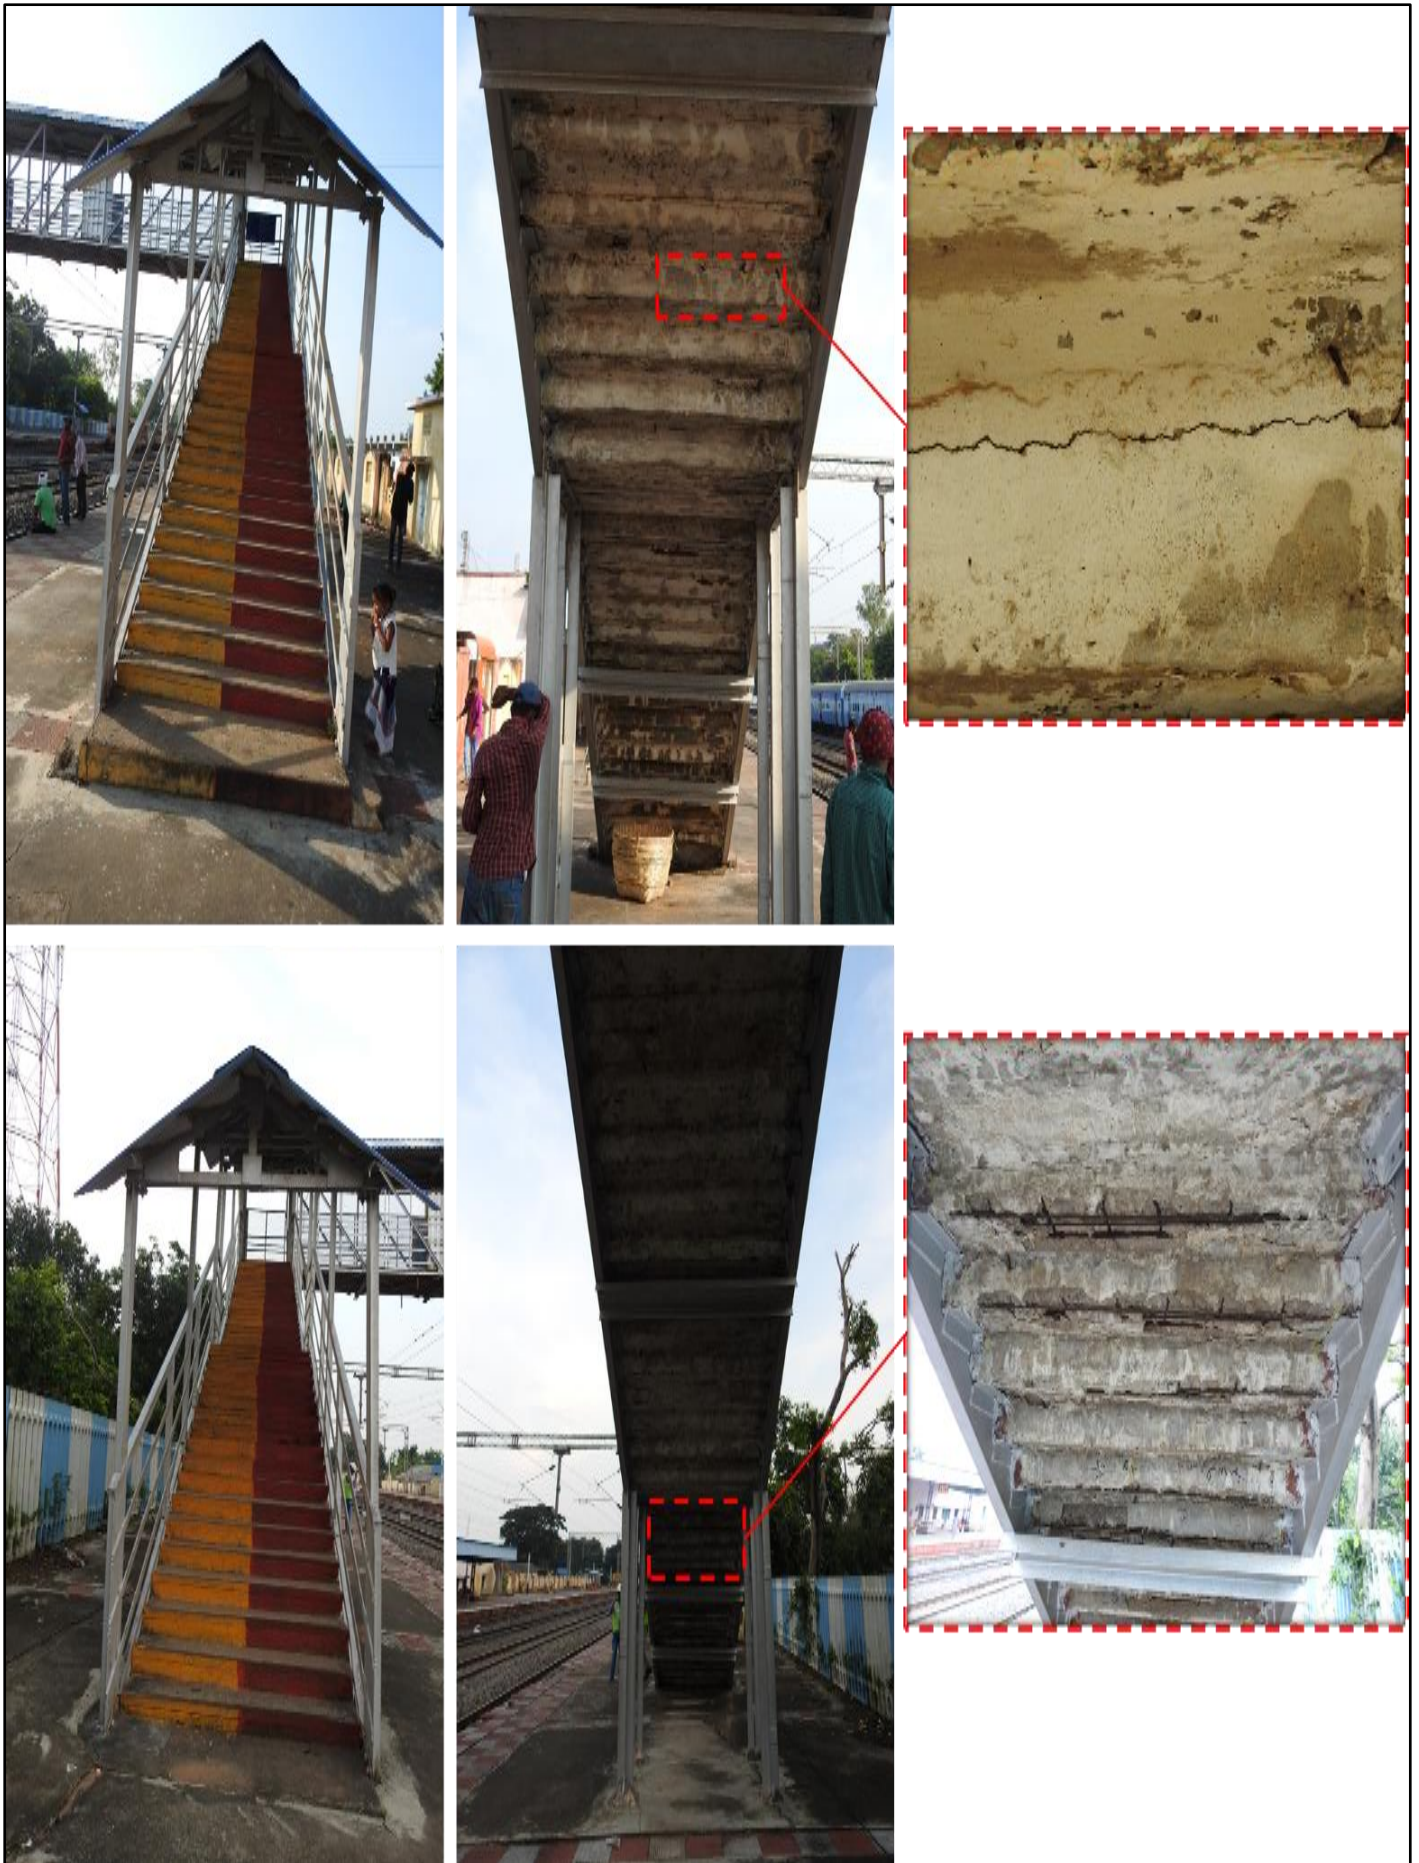
**Fig 1.4:** Staircase details, cracks and reinforcement exposure

| | Number of Staircase | 2 no's | Staircase steps are observed as RCC slab panels of size 300 x 100 mm used. Steps are on ISMC 250 channel using cleat angle. Staircase landing of 1.8 m wide is supported on vertical and horizontal channels members. Roof of staircase is supported with 75 x 75x 6 mm double angle sections. (Refer <b>fig :1.4</b> ) |

| SIGNS OF DISTRESS, DEFORMATION IN BRIDGES | | | |
|---|---|---|---|
| | Cracking in RCC components | RCC slab panels of staircase | cracks are observed in bottom of staircase (Refer <b>fig: 1.4</b> ) |

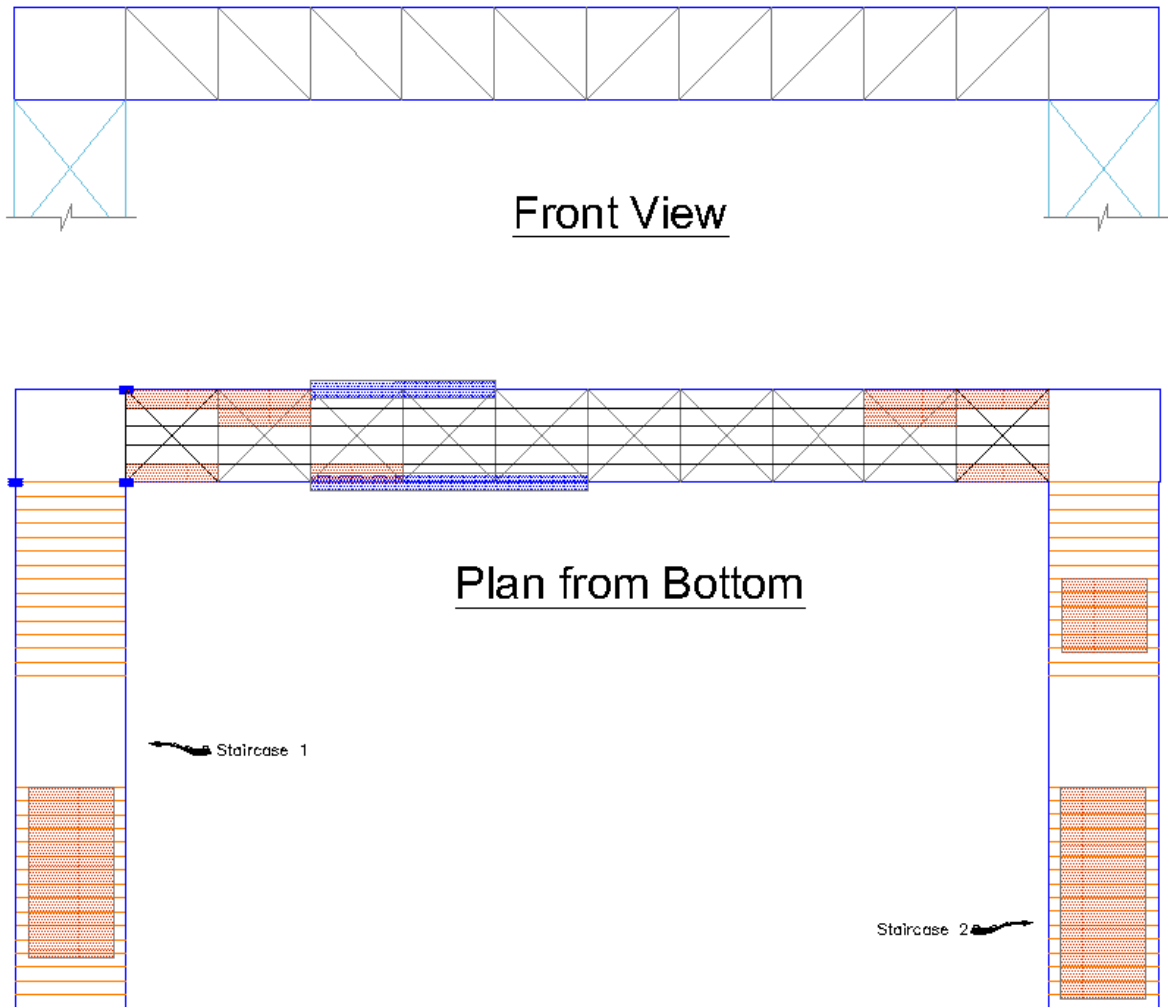
**Fig: 2.1** Bottom view of FOB with deteriorated locations

- Structural members are in fair condition, displaying mild corrosion for top chord members, verticals, diagonals, and gusset plates, moderate corrosion for bottom chord members, floor beam and staircase stinger beam along steel concrete joint. Exposed rebar in pre-cast slab panels (locations are marked in figures below).
- Staircases precast slab panels are deteriorated reinforced is exposed in flights and staircase RCC landing slab at deck level. (Photographs of the same can be see in **fig 2.2-2.4**)

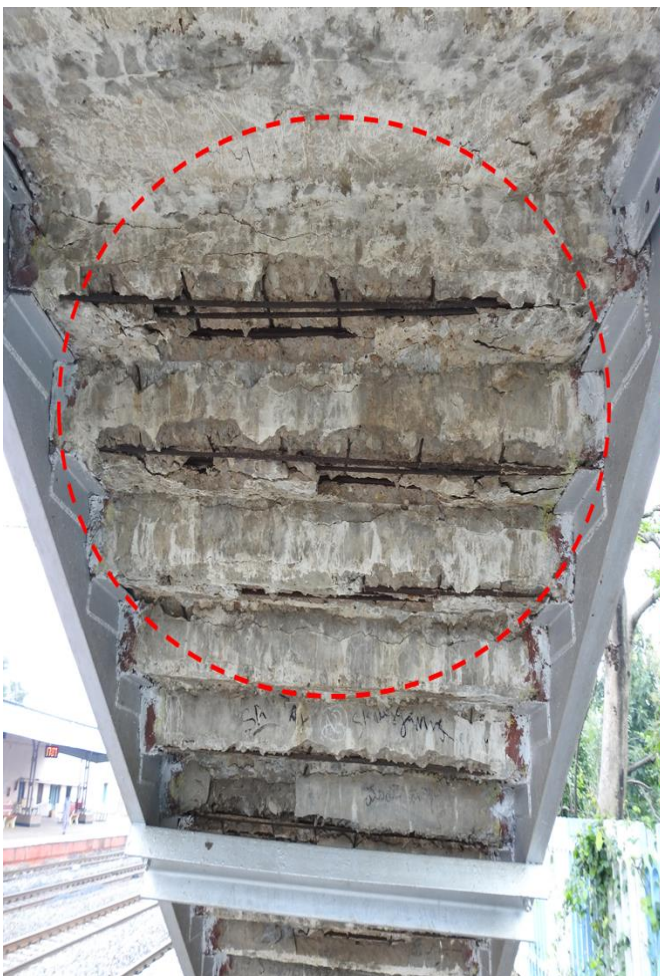
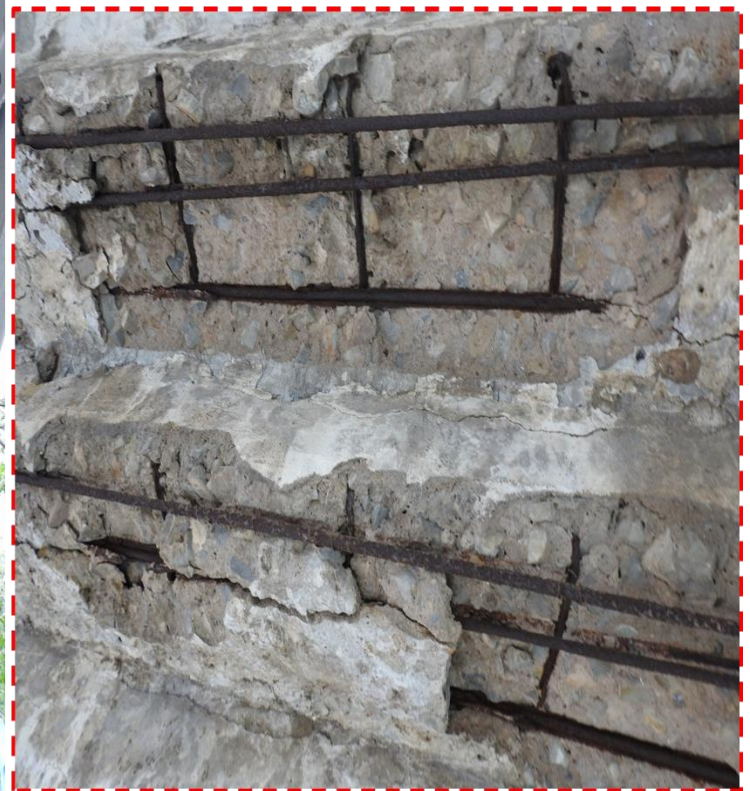
**Fig: 2.4** spalling at Staircase 2 flight

Reinforced cement concrete Slab at Deck level and some precast panels in staircase are observed with exposed rebar in many locations. (*Photographs of the same can be see in fig 2.4*)

**Methodology for patching:** Hand applied Mortar (Patching) repair is performed to restore small areas where sound concrete is damaged by spalling, scaling and/or impact. This method of repair is generally applied using trowel and require minimum or formworks. The patch thickness is limited to a maximum of 100 mm depth of hollow surface. Hand applied Mortar repair is classified into two types considering defective area and surface. Hand applied Mortar

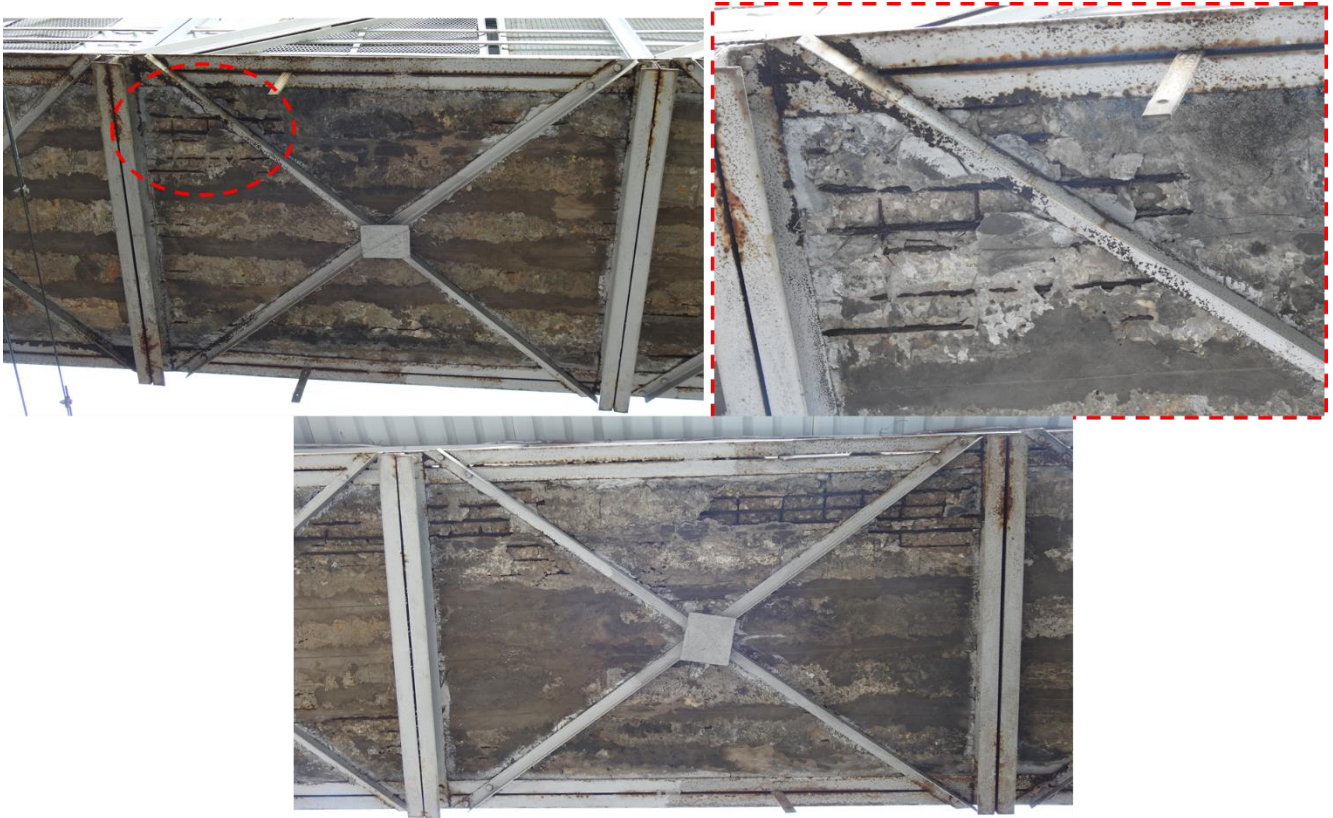
**Fig: 2.5** Spalling and Reinforcement exposure at bottom of slab panels

- **Visual inspection of Sirpur town railway station fob has been conducted on 23<sup>rd</sup> October 2019, following observations were made**
  - i. Spalling and reinforcement exposed observed in bottom of slab panels of staircase and pathway of FOB.
