## Third Party Audit of ROB's and FOB's of SCR

**INSPECTION OF FOB AT MAHABUBABAD RAILWAY STATION**

**Final Report**  
**SEPTEMBER | 2020**

| <b>Name of the Project</b> | <b>:</b> | VISUAL INSPECTION OF FOB/ PF-1 - PF-2 AT MAHABUBABAD RAILWAY STATION |

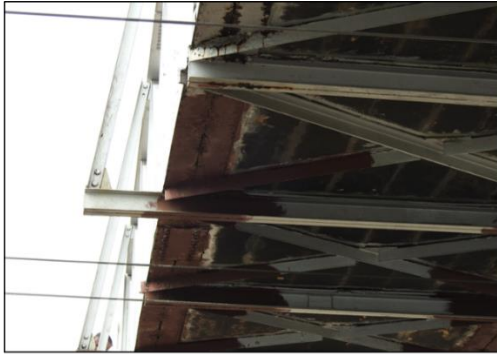
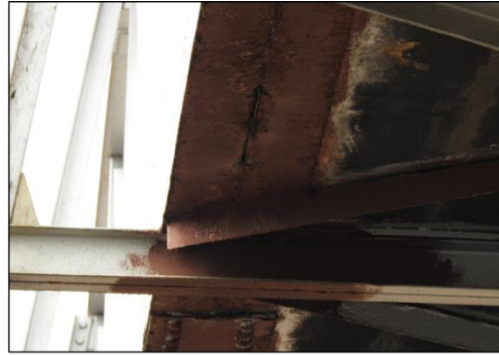
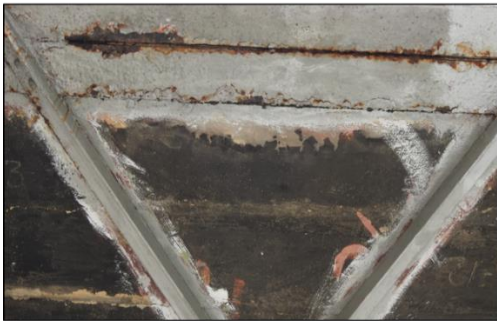
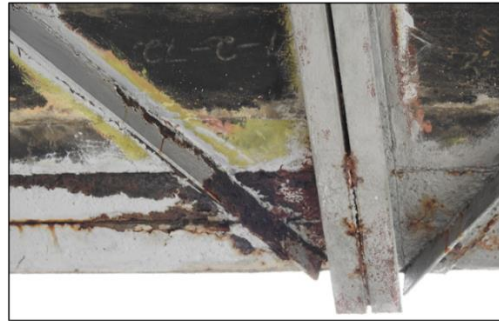
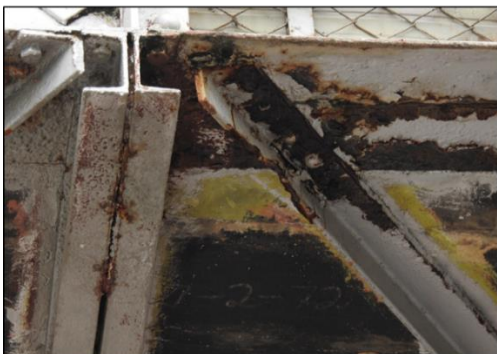
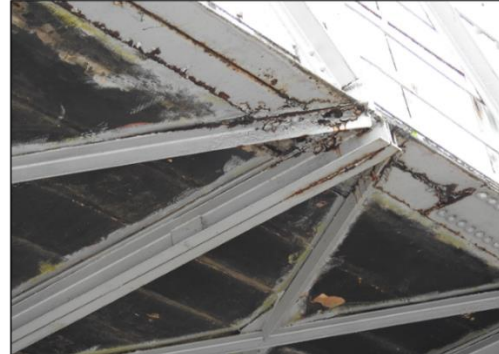
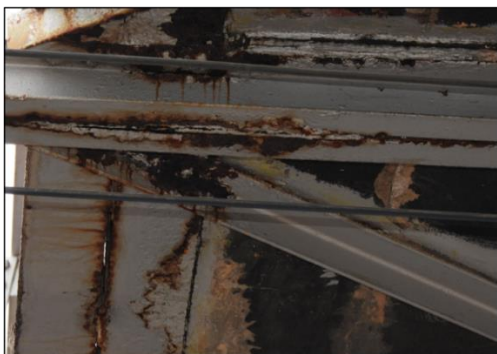
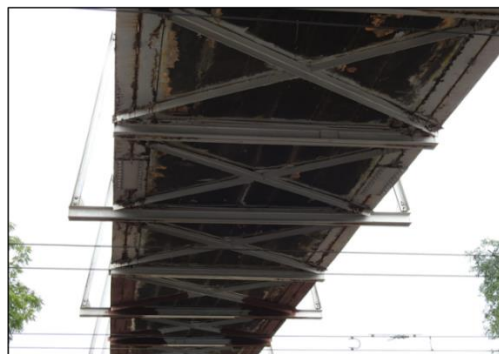
- ✓ Highly corrosion is observed at bottom slab joint (Gusset plate, Angle sections)

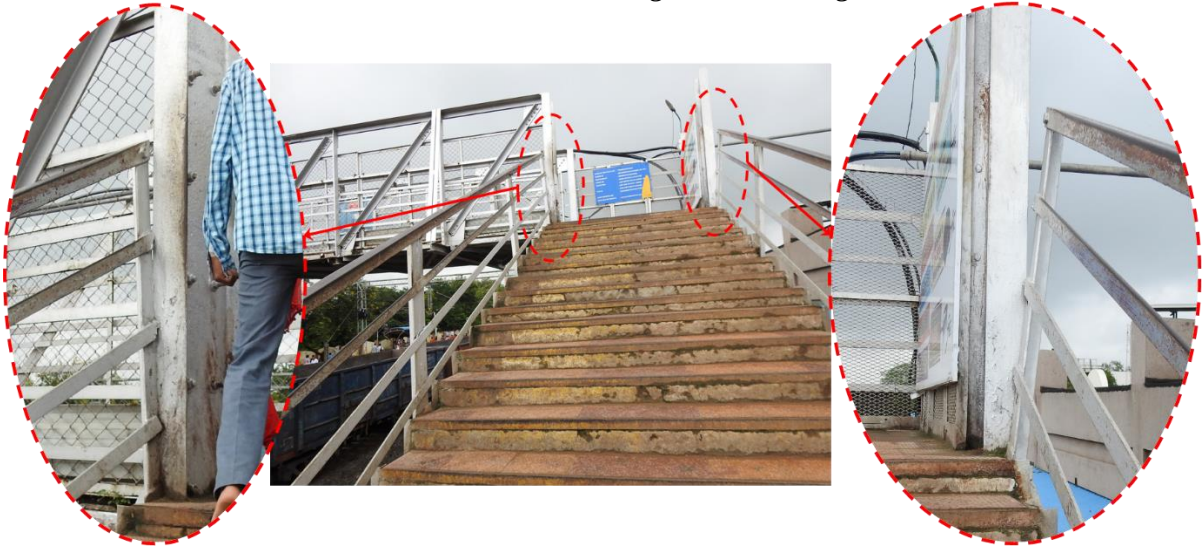
- ✓ On Platform 1 Staircase Railing connection as been lost on 2<sup>nd</sup> Flight and sliding is observed in site on both sides of staircase Railing as shown in figure.

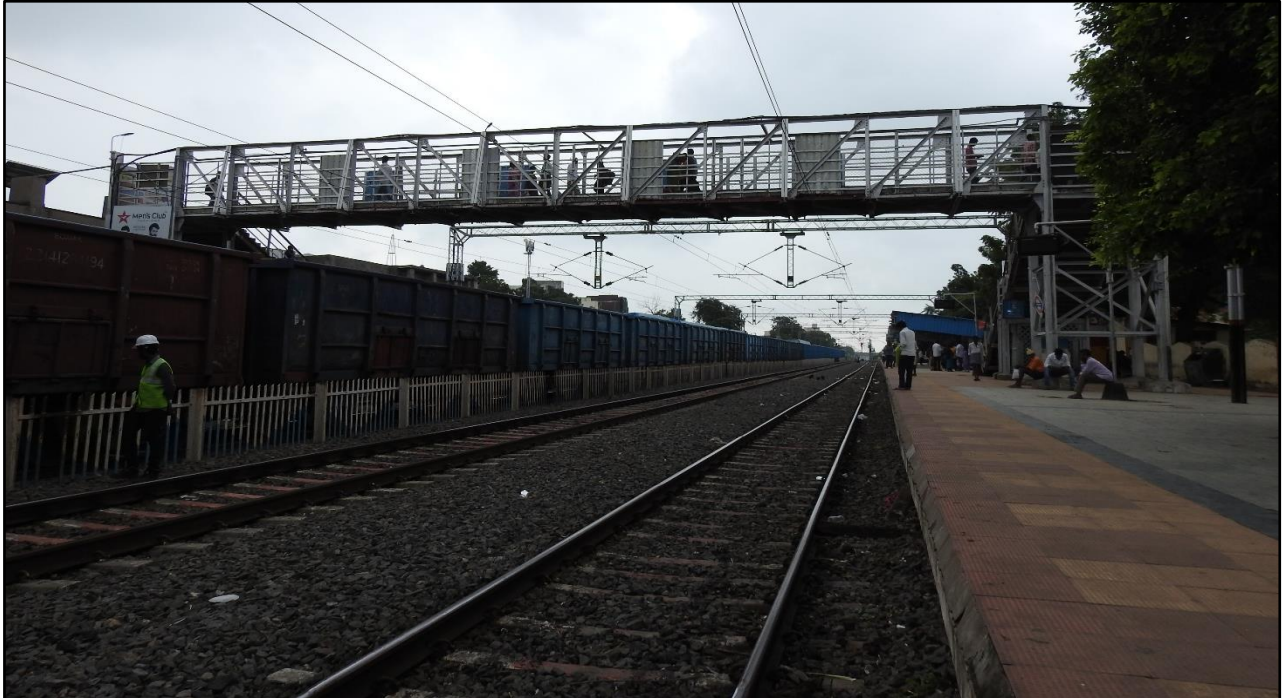
| | Girder/Truss Support Condition | Ridged connection | c) 10 mm thick, gusset plate used for welded joint. (Refer <b>fig: 1.1</b> )<br>d) 2/ISMC 150 Double channel Sections are used as Floor beams, supported with 2/75 x 75 x 8 mm inclined support to top Chord member. 65 x 65 x 8 mm Angle sections are used for inclined bracings of pathway. Floor beams are connected to bottom chord Member using Revit's and Bracing are connected using welding. (Refer <b>fig :1.1&amp;1.6</b> ) |

**Fig 1.1:** Front view of FOB towards Khammam Junction

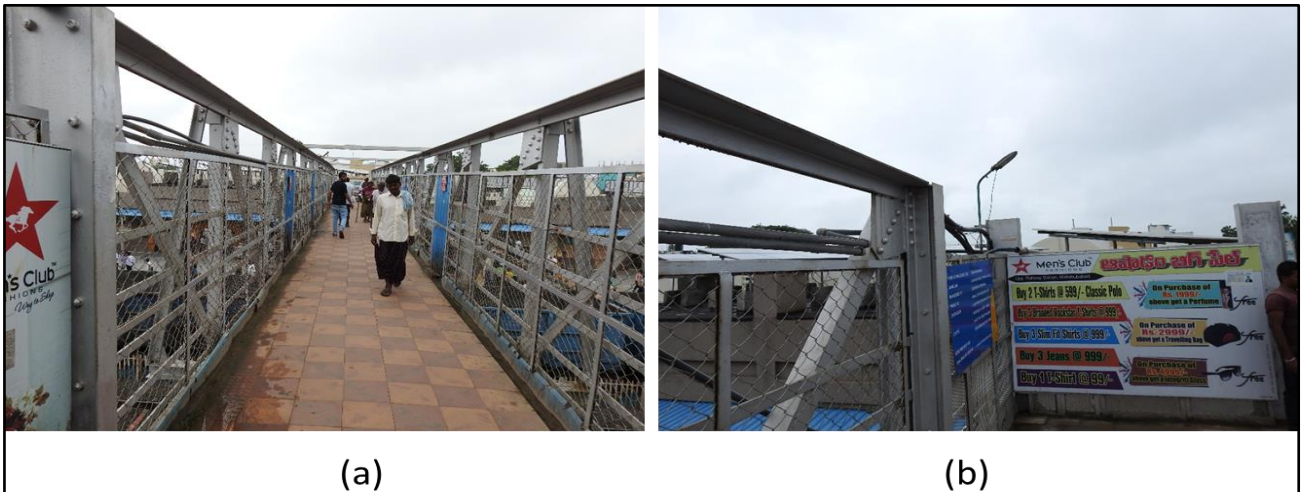
| PART 1.2 IDENTIFICATION OF LOADS ON BRIDGE | | |
|---|---|---|
| b) Cables | Yes | Cables are protected are supported to Main truss (Refer <b>fig: 1.3</b> ) |
| b) Provision of protective screen for passengers | Yes | Chain link fence made of galvanized wire of 2 mm gauge and 2mm galvanized sheet is used above OHE line on both side of gangway is used for protection. (Refer <b>fig :1.3</b> ) |

**Fig 1.3:** Advertising board supported by vertical column members and main truss

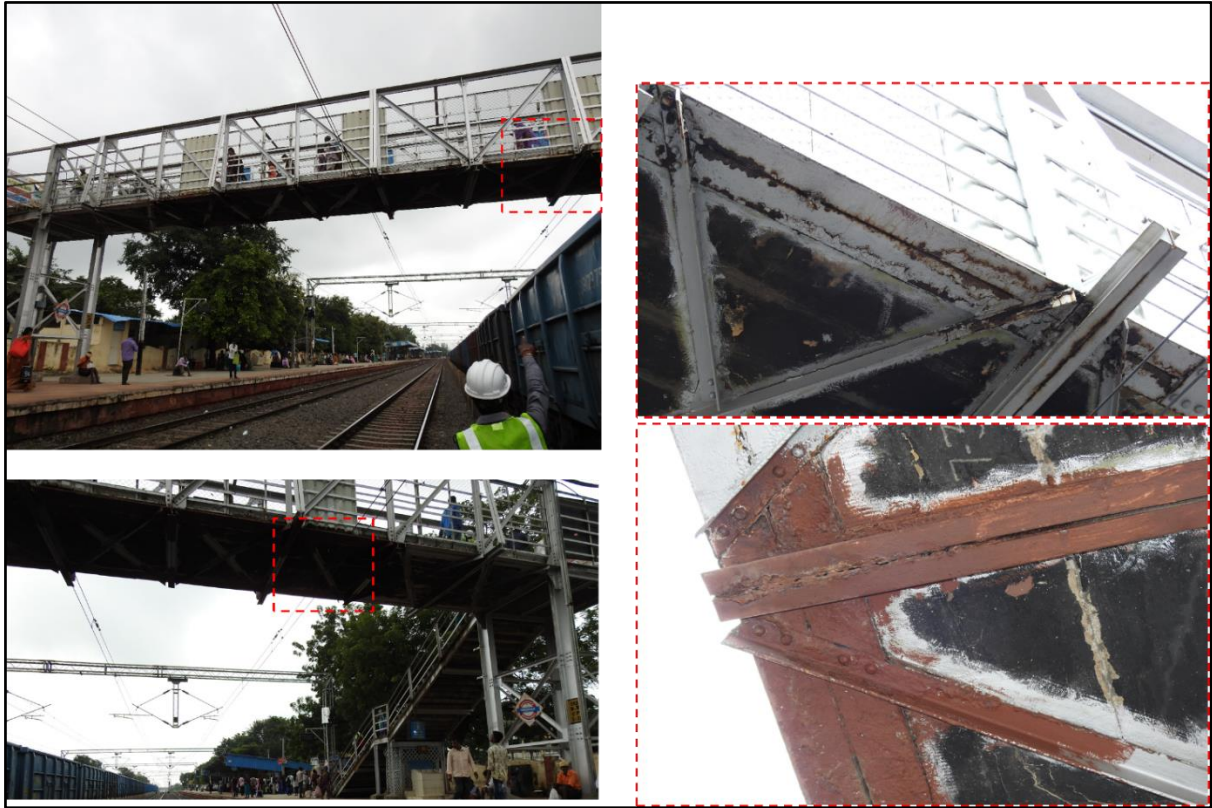
**Fig 1.6:** Red oxide has been applied at corroded joints and member

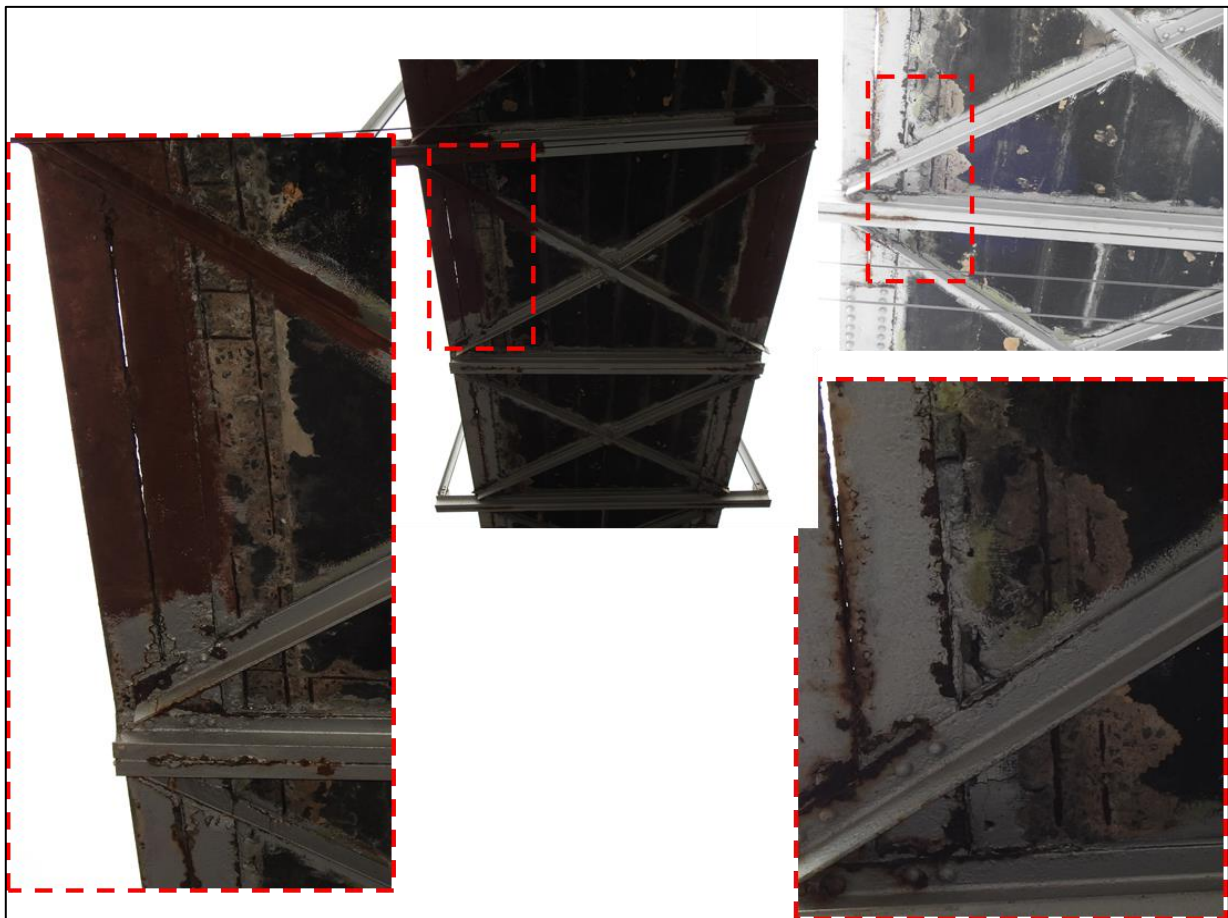
**Fig 1.7:** Spalling is observed in Floor slab from bottom

Reinforced cement concrete Slab at Deck level and some precast panels in staircase are observed with exposed rebar in many locations. (Photographs of the same can be seen in **fig 1.6-1.8**)

**Methodology for patching:** Hand applied Mortar (Patching) repair is performed to restore small areas where sound concrete is damaged by spalling, scaling and/or impact. This method of repair is generally applied using trowel and require minimum or formworks. The patch thickness is limited to a maximum of 100 mm depth of hollow surface. Hand applied Mortar repair is classified into two types considering defective area and surface. Hand applied Mortar

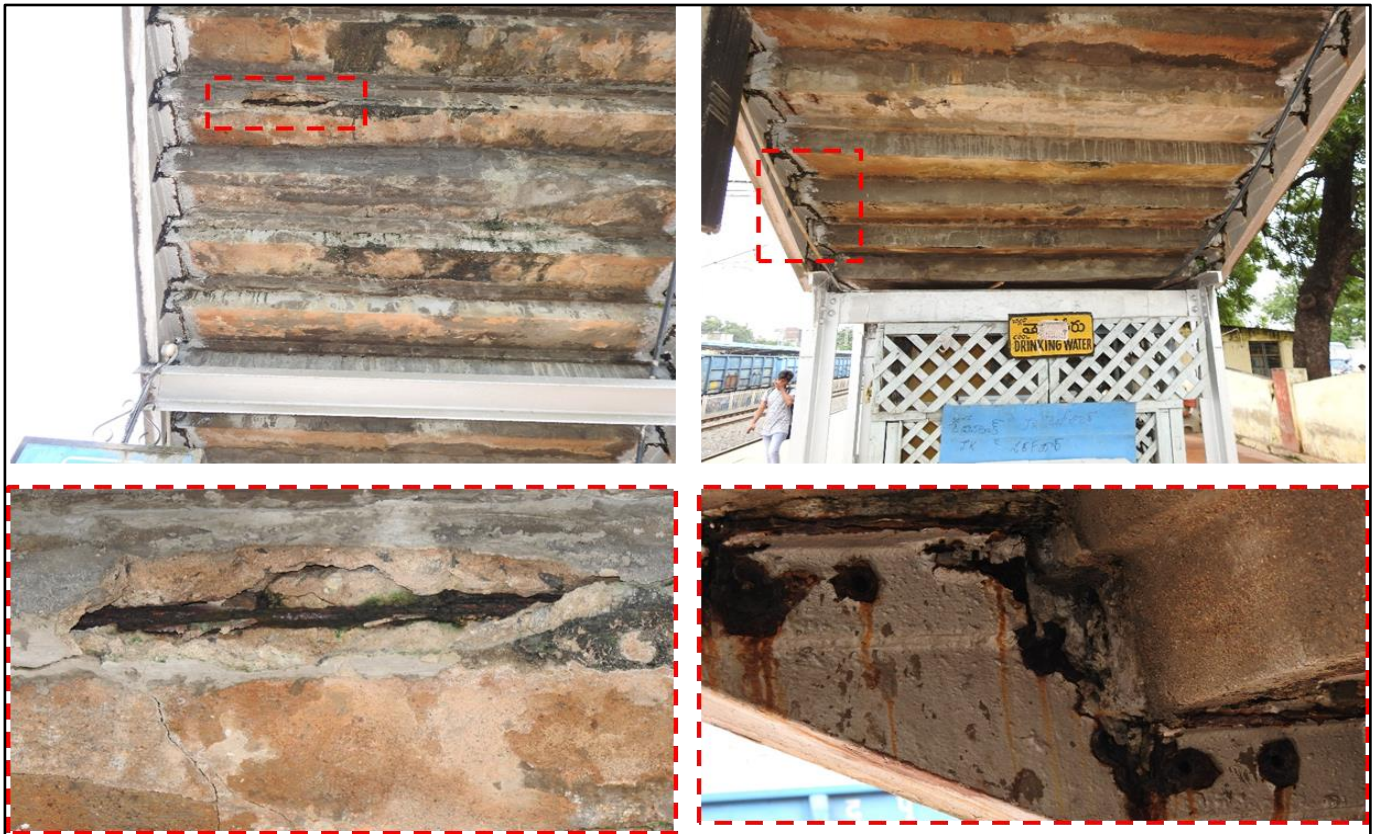
**Fig 1.8:** Spalling is observed in underneath of staircase

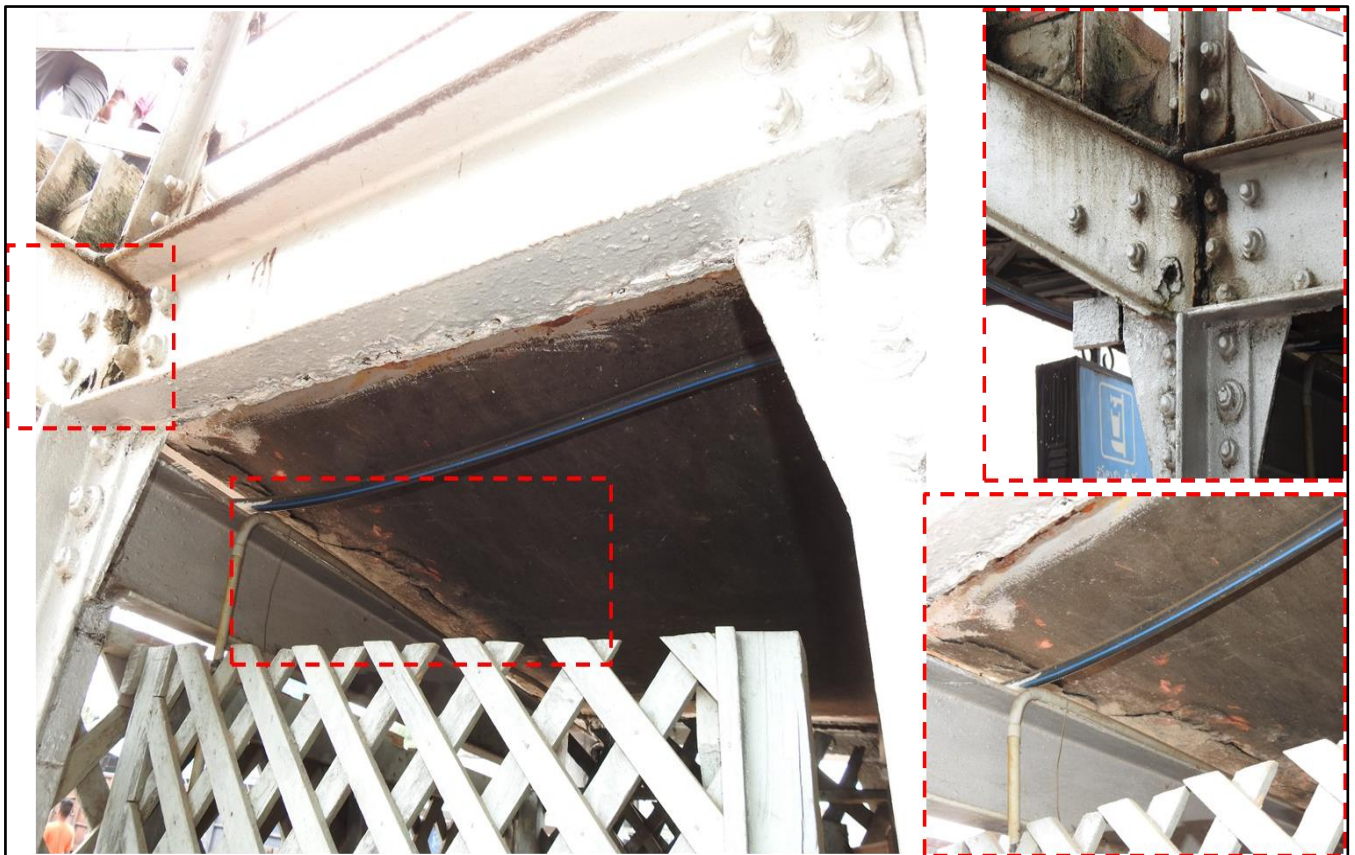
**Fig 1.9:** cracks are observed on landing floor slab from bottom

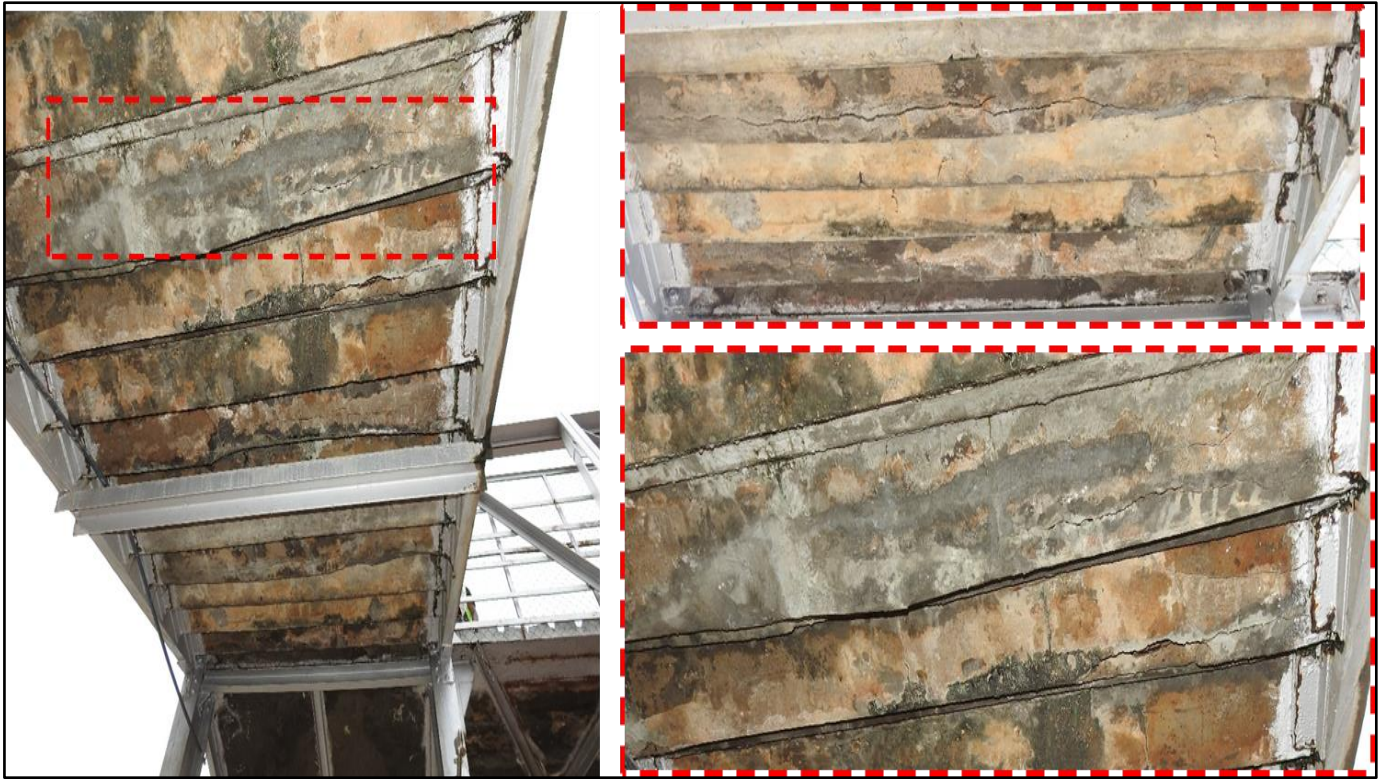
***Fig 1.10:*** cracks are observed on landing of staircase from bottom

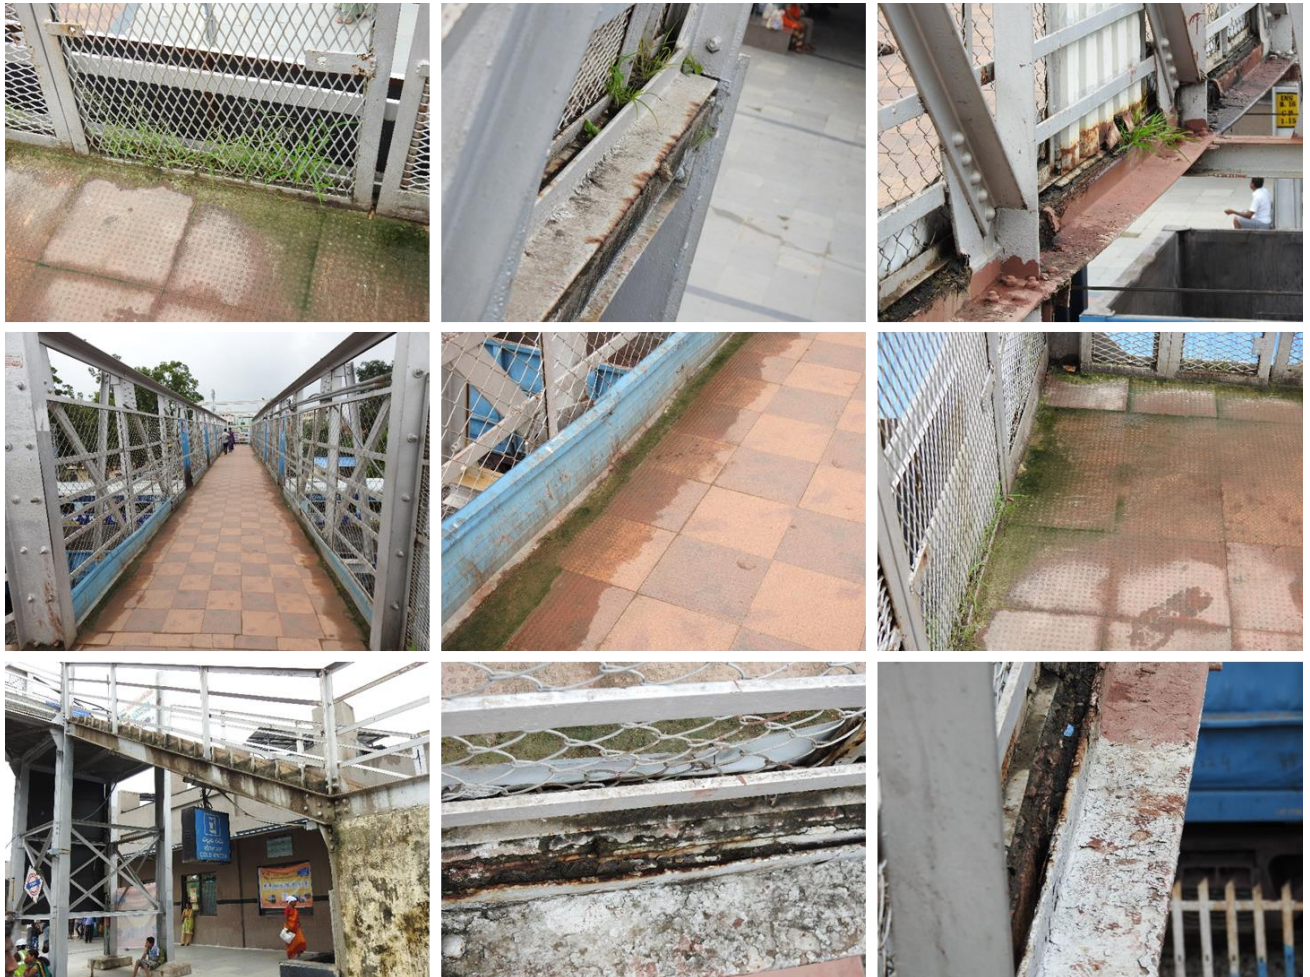
**Fig 2.1:** Algae and vegetation on the pathway

**Debris removal:** The surface areas of a FOB should be cleaned and washed by brushing with fresh water or using high-pressure water blasting, including Deck slab top, sides along steel concrete joint on either side of deck, Supporting Railing and connecting staircase.

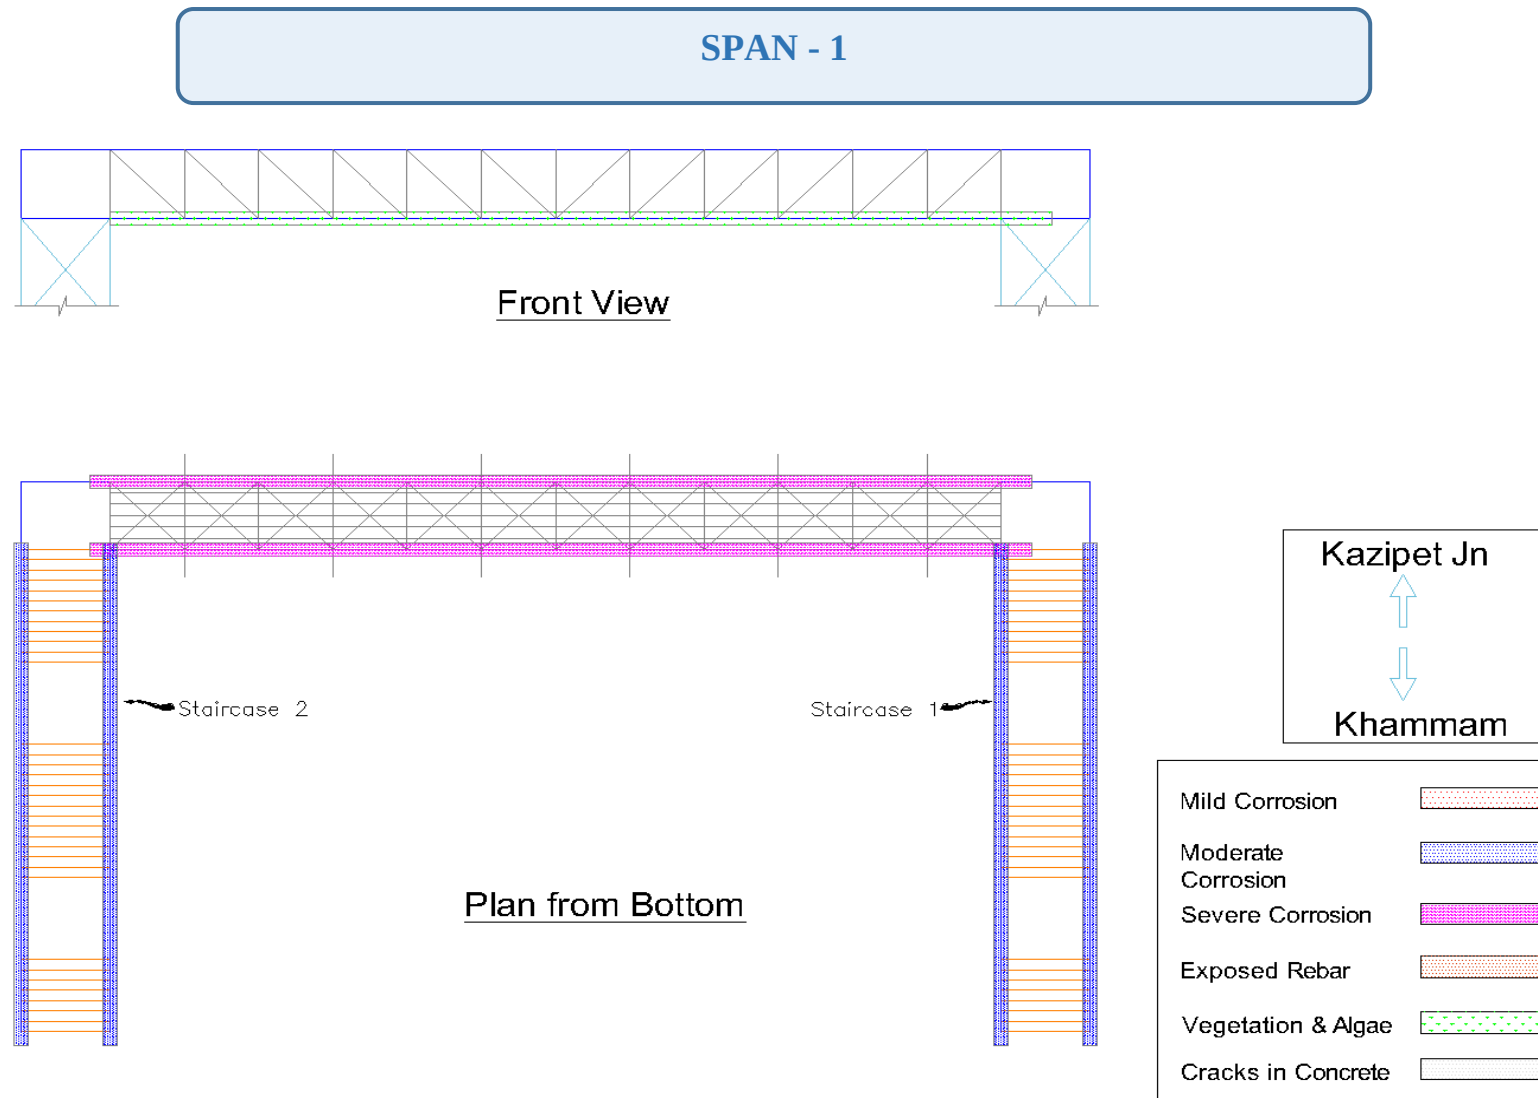
**Fig 2.2:** Locations of Deteriorations

- Bottom chord and bottom lateral bracing members are severely corroded. (Photographs of the same can be seen in **fig: 1.4-1.7, 2.3**)
- Staircase stringer beams are having moderate corrosion. (Photographs of the same can be seen in **fig 2.4**)
- Algae and Vegetation is observed along steel concrete joint on outer surface at deck level. Carryout removal and cleaning as per Annexure 1a. (Photographs of the same can be seen in **fig 2.1**)
- In Majority of RCC Pre-cast slab panels spalling of concrete cover, cracking and reinforcement exposure is higher. (Photographs of the same can be seen in **fig 1.6-1.8, 2.4**)

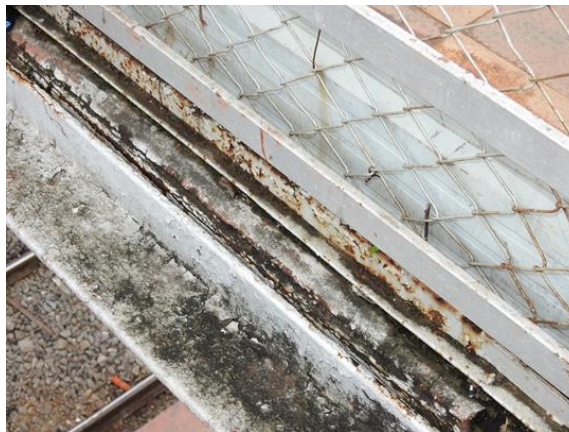
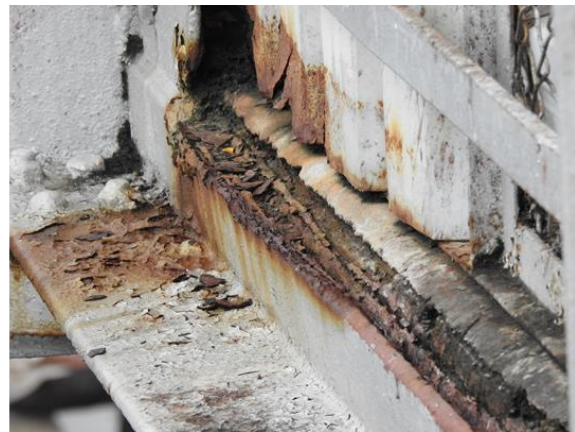
**Fig 2.3:** Bottom chord members are severely corroded along steel concrete joint

- a. Section Loss < 15% - Clean the Surface and Apply the anticorrosion protective coat.
  - b. Section Loss 15% - 40% Repair the member as per design.

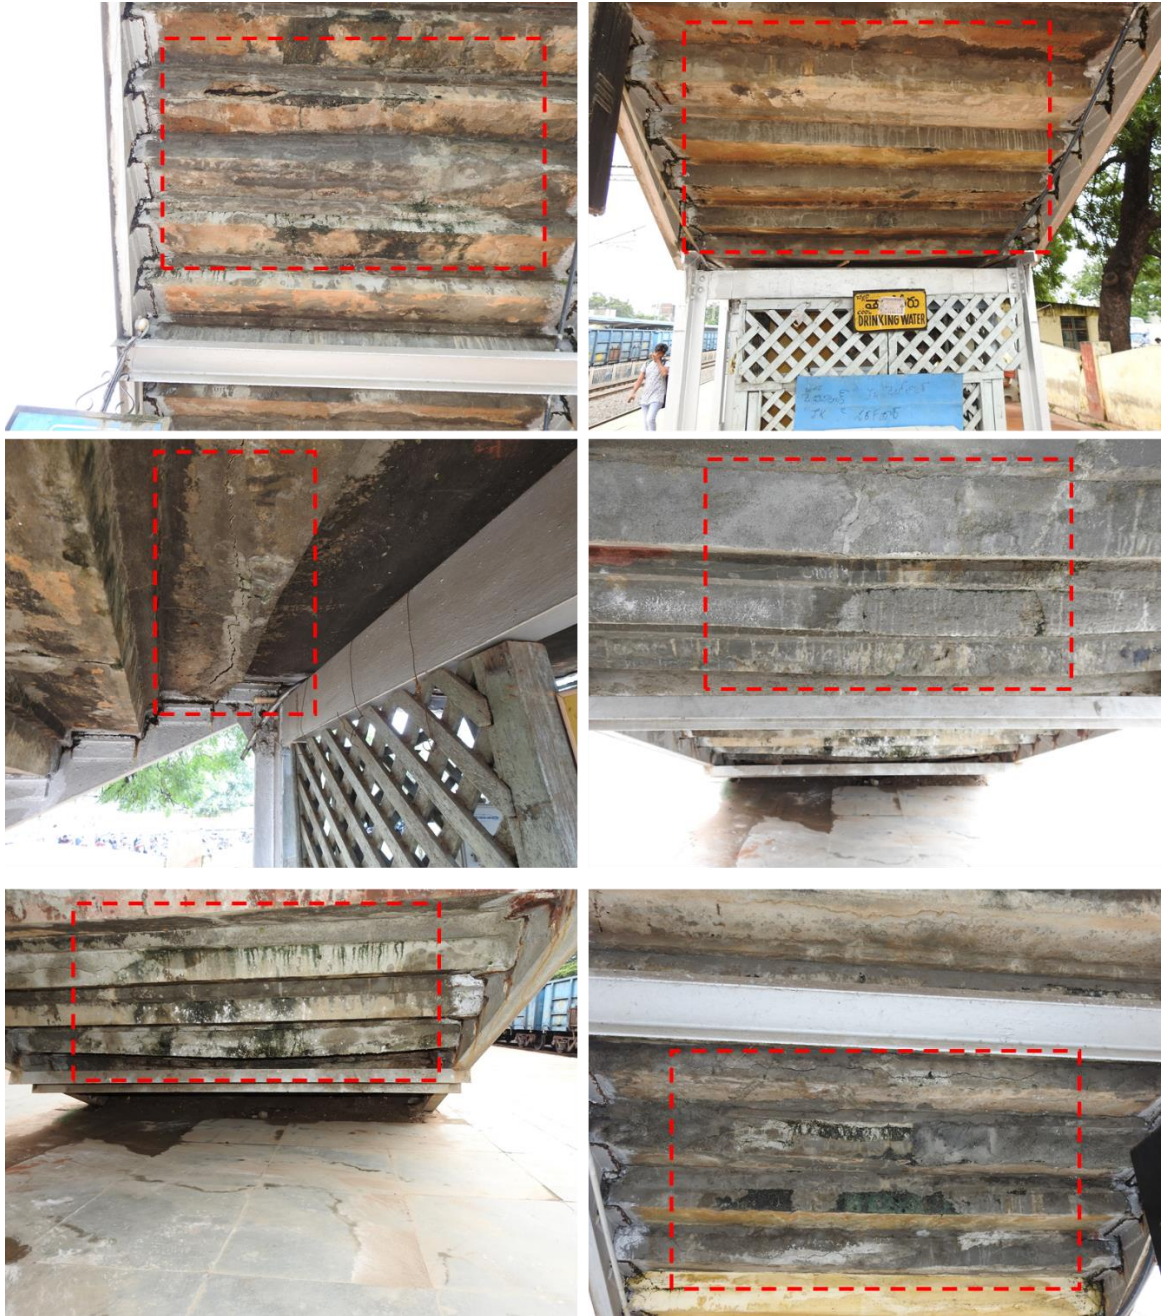
**Fig 2.4:** Cracking and splitting of concrete in both staircase pre-cast RCC panels
