## Third Party Audit of ROB's and FOB's of SCR

### INSPECTION OF FOB AT MANCHIRYAL RAILWAY STATION

**Final Report**

SEPTEMBER | 2020

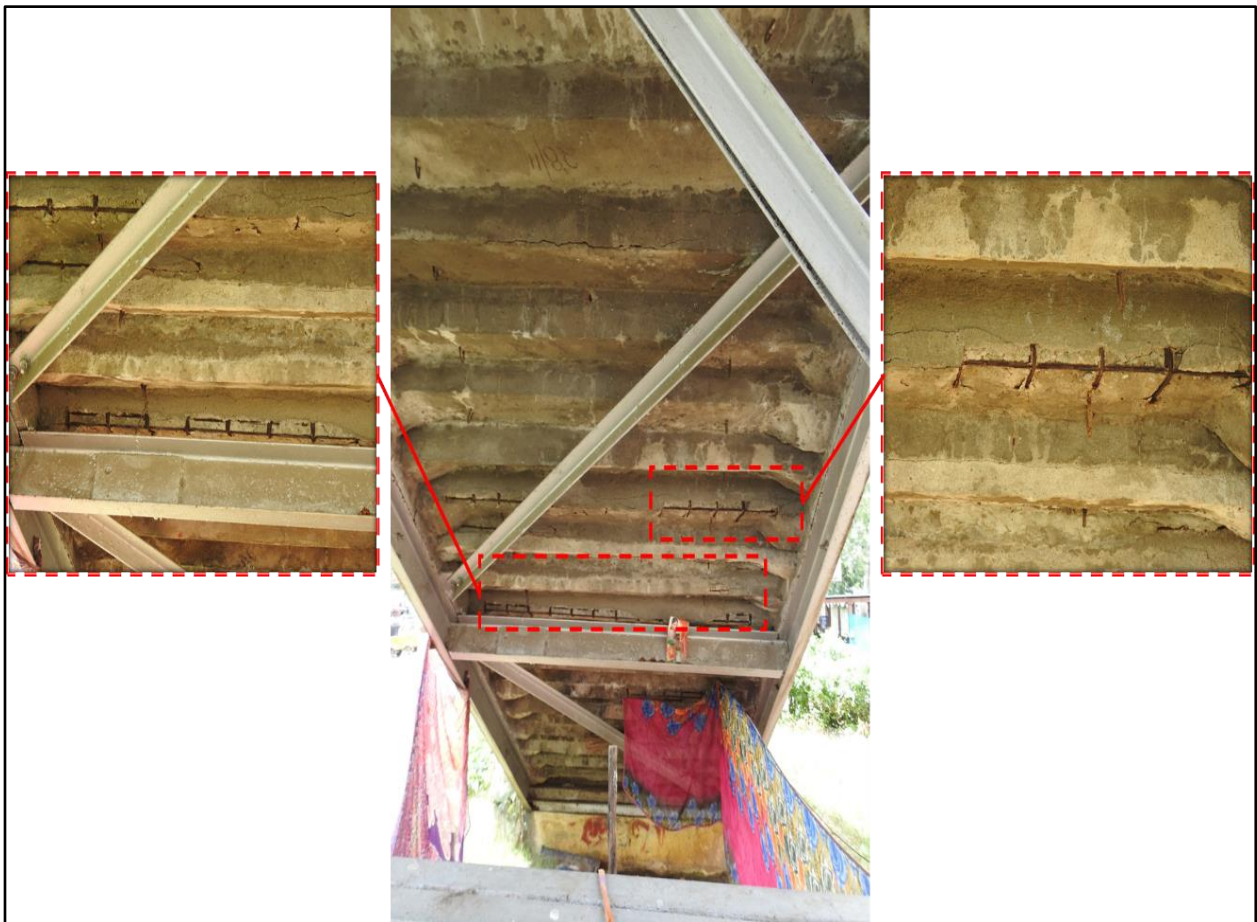
- 1.4(a) ✓ Exposed reinforcement is observed on Pre-cast RCC slab panels of staircase at bottom which is connecting Circulating area to PF-1.

Reinforcement exposed slab panels

| SIGNS OF DISTRESS, DEFORMATION IN BRIDGES | | | |
|---|---|---|---|
| | Spalling | Stair case | Spalling and reinforcement exposure is observed in some precast RCC panels connecting circulating area to PF-1 staircase. (Refer <b>Part 1.4 – 1.4(a)</b> ) |

Reinforced cement concrete Slab at Deck level and some precast panels in staircase are observed with exposed rebar in many locations.

**Methodology for patching:** Hand applied Mortar (Patching) repair is performed to restore small areas where sound concrete is damaged by spalling, scaling and/or impact. This method of repair is generally applied using trowel and require minimum or formworks. The patch thickness is limited to a maximum of 100 mm depth of hollow surface. Hand applied Mortar repair is classified into two types considering defective area and surface. Hand applied Mortar

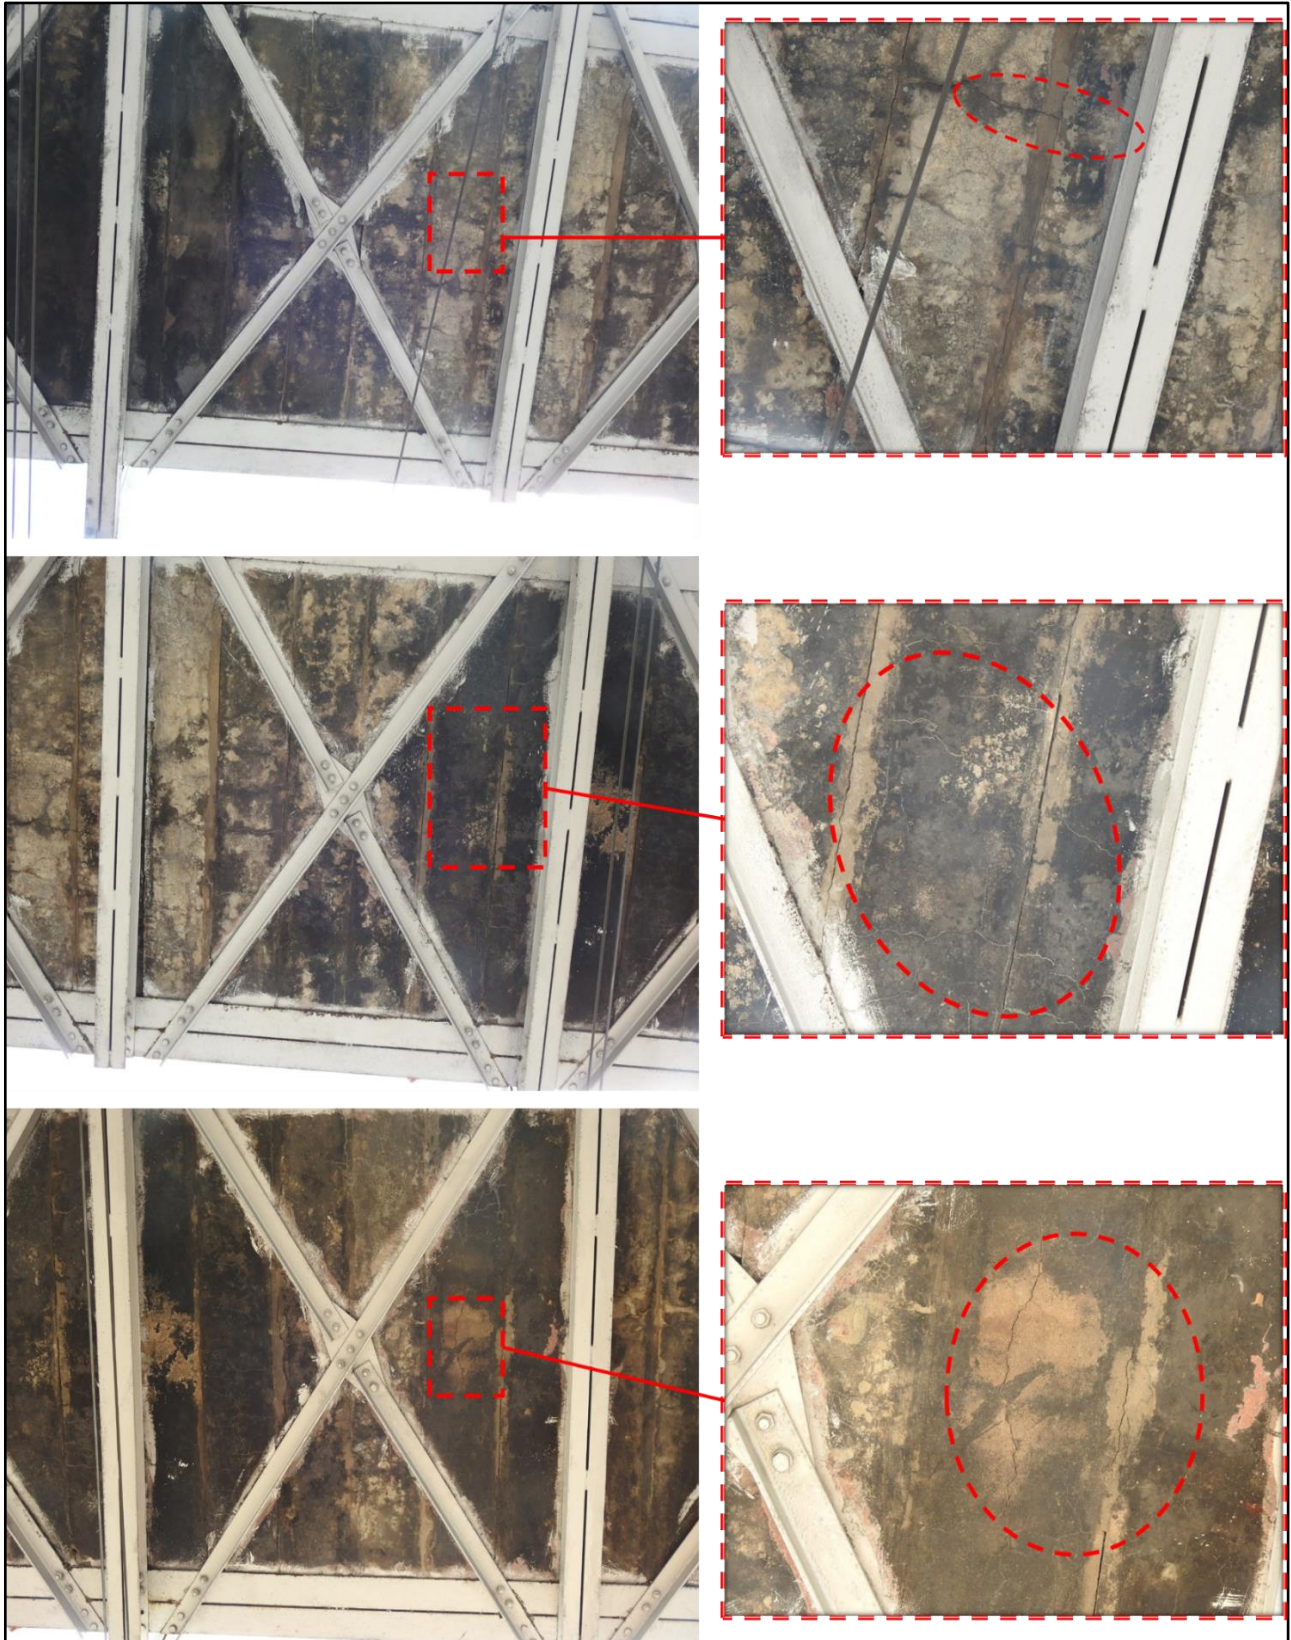
1.4(b) Leaching effect and Cracks are observed on Pre-cast slab panels on 1<sup>st</sup> span of FOB (PF-1 – PF-2).

Leaching and Cracks in Pre-cast panels of 1<sup>st</sup> span

| SIGNS OF DISTRESS, DEFORMATION IN BRIDGES | | | |
|---|---|---|---|
| | Cracking in RCC components | Slab Panels | cracks are observed in Pre-cast RCC slab panels (Refer <b>Part 1.4 – 1.4(b)</b> ) |

- b) Anti-corrosion treatment for Grade-1 and Grade-2 highlighted corrosive members, floor beams and bottom chord member in span-2
  - c) Replacement of damaged or deteriorated slab panels in span-1 and span-2.

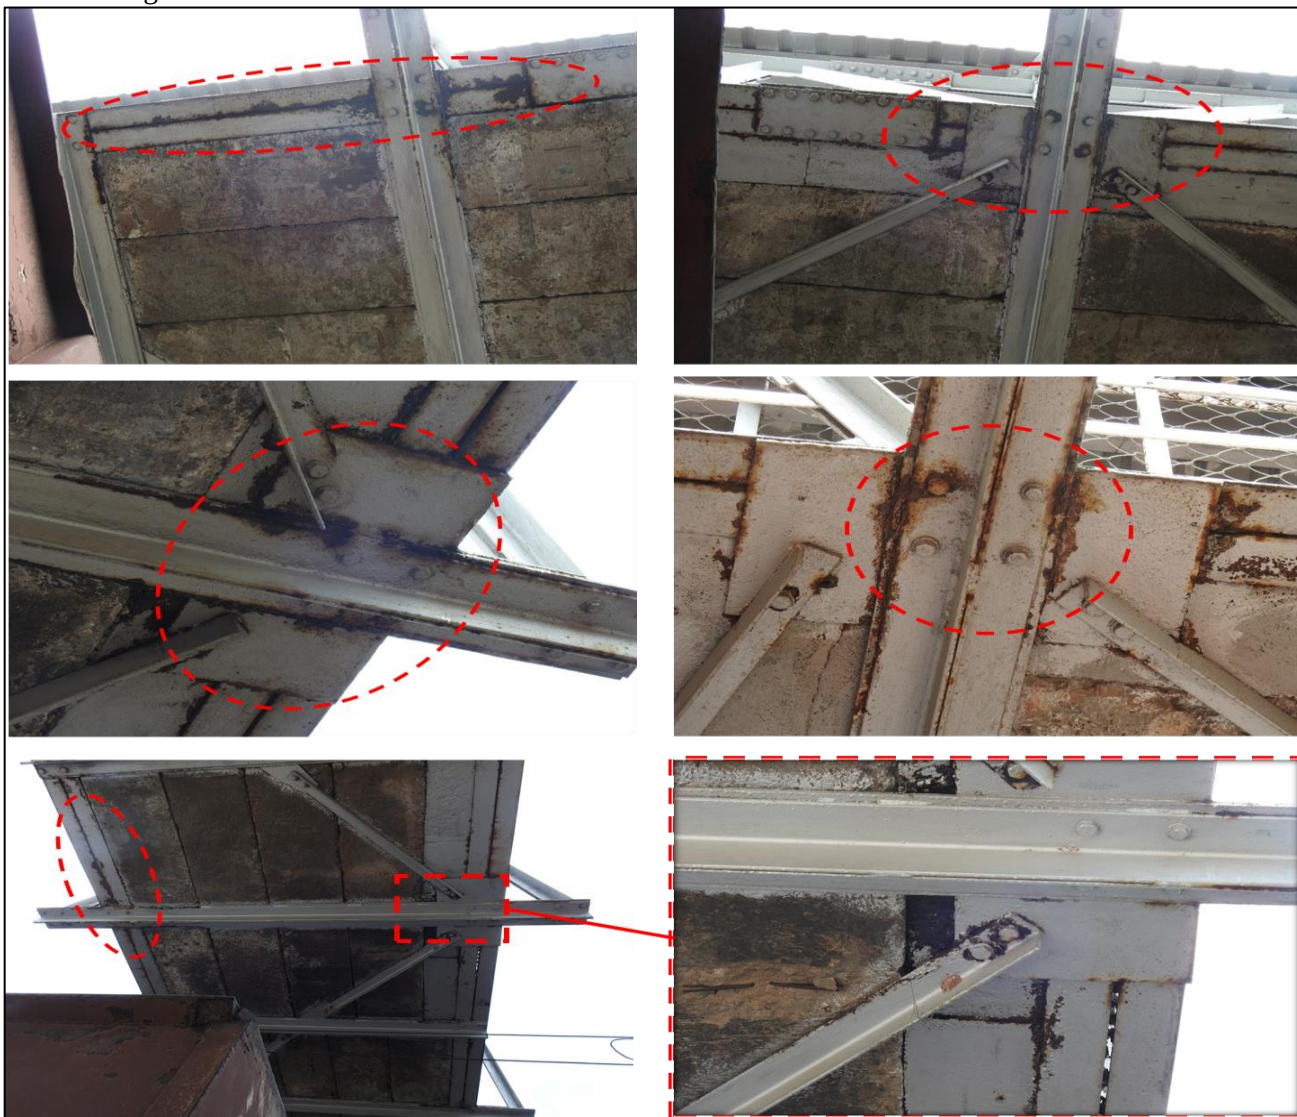
1.4(c) Corrosion is observed at gusset plate joints and bottom main chord double angle section of 2<sup>nd</sup> span of FOB and vegetation is also observed.

(a) Corrosion in gusset plate joints and bottom main chord double angle section

| SIGNS OF DISTRESS, DEFORMATION IN BRIDGES | | | |
|---|---|---|---|
| | Rust straining | Bottom main Chord members | Rusting is observed at all the joints of FOB (Refer <b>Part 1.4 – 1.4(c) and 1.4(d)</b> ) |
| | Corrosion in Gusset plate | Bottom of the slab | Rusting is observed on Gusset plates (Refer <b>Part 1.4 – 1.4(c)</b> ) |

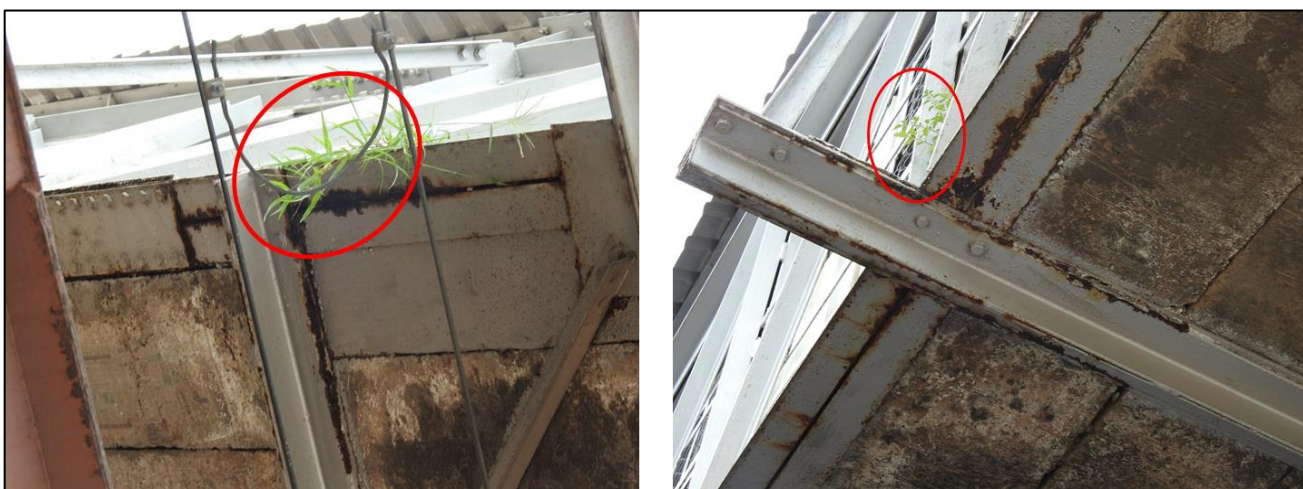
(b) Vegetation

- **Based on visual inspections and its interpretations following recommendations were made:**
  - a) Cleaning of debris and vegetation immediately to avoid deterioration of concrete and steel members.

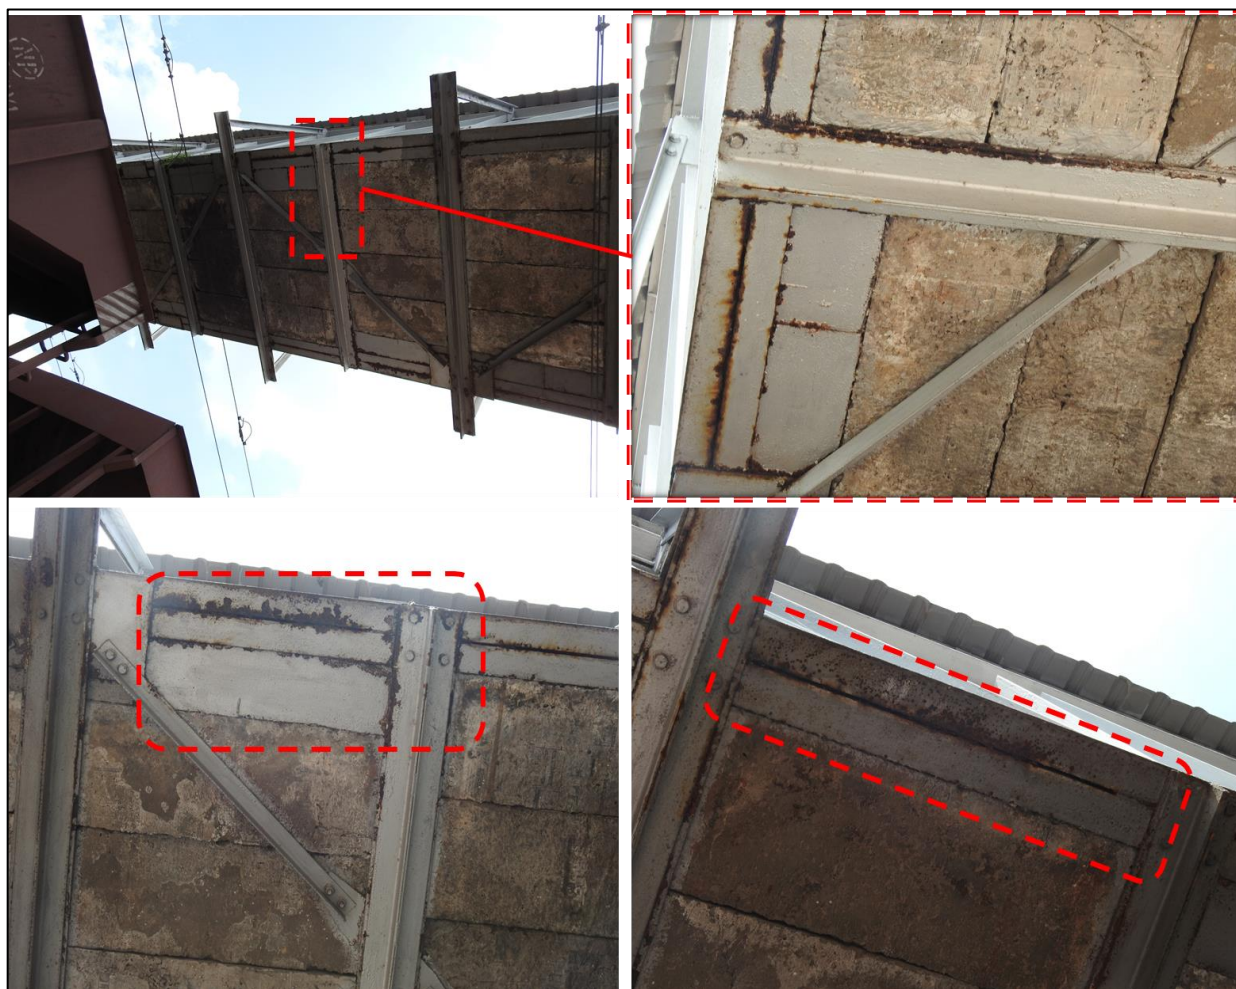
1.4(d) Corrosion of Floor beam is observed in 2<sup>nd</sup> span and Slight rusting of bottom main chord angle section

Corrosion of Floor beam and rusting of Chord members

| SIGNS OF DISTRESS, DEFORMATION IN BRIDGES | | | |
|---|---|---|---|
| | Extent of Corrosion | In Floor beam | Corrosion of floor beam is observed in 2 <sup>nd</sup> span of FOB. (Refer <b>Part 1.4 - 1.4(d)</b> ) |

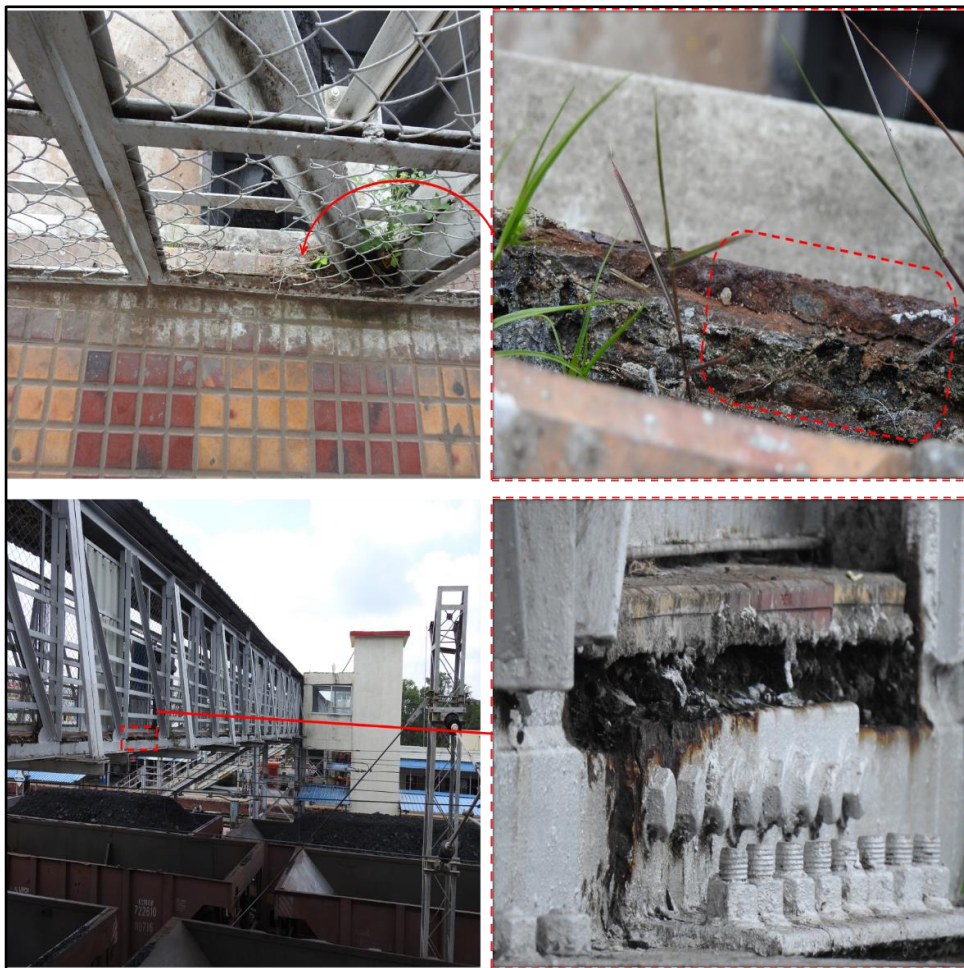
**Fig 1.6:** Corrosion is also observed at steel concrete joint

| SIGNS OF DISTRESS, DEFORMATION IN BRIDGES | | | |
|---|---|---|---|
| | Corrosion at steel-Concrete joint | | Corrosion is observed at steel concrete joint. (Refer <b>fig: 1.6</b> ) |

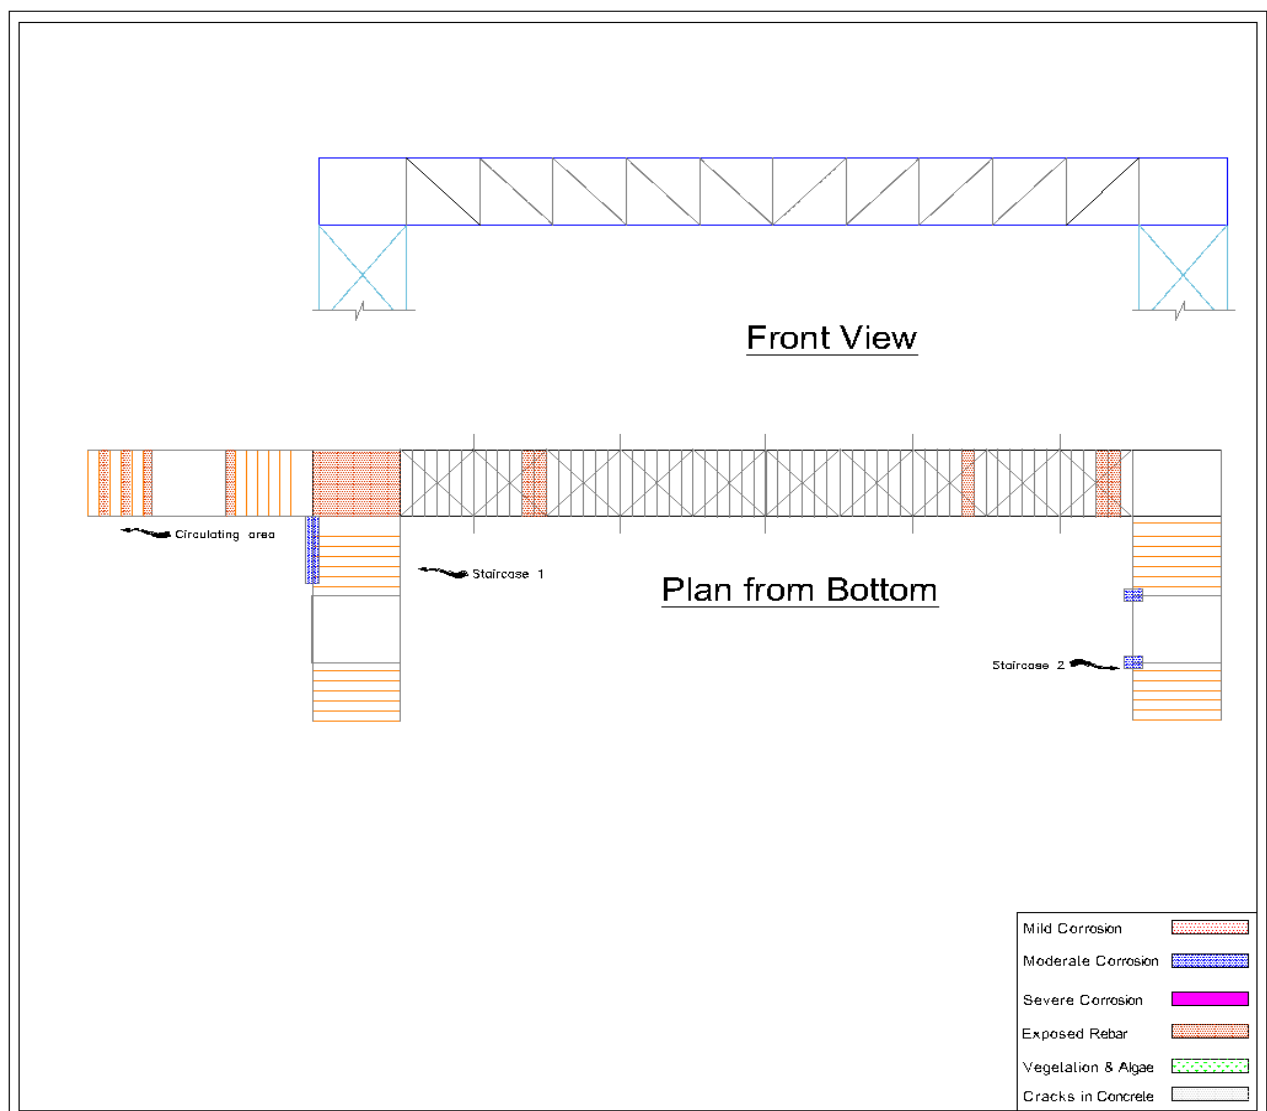
**Fig 2.1:** locations of deterioration and bottom view of span-1

- Structural members are in fair condition, displaying mild corrosion for top chord members, verticals, diagonals, gusset plates, bottom chord members, and moderate corrosion for staircase stringer beam along steel concrete joint. (Locations are marked in figures below).
- Circulating area Staircase precast slab panels are deteriorated reinforced is exposed in flights and staircase RCC landing slab at deck level cracks are observed in pre-cast slab panels along the pathway of span-1. (Photographs of the same can be see in **fig 2.2-2.3**)

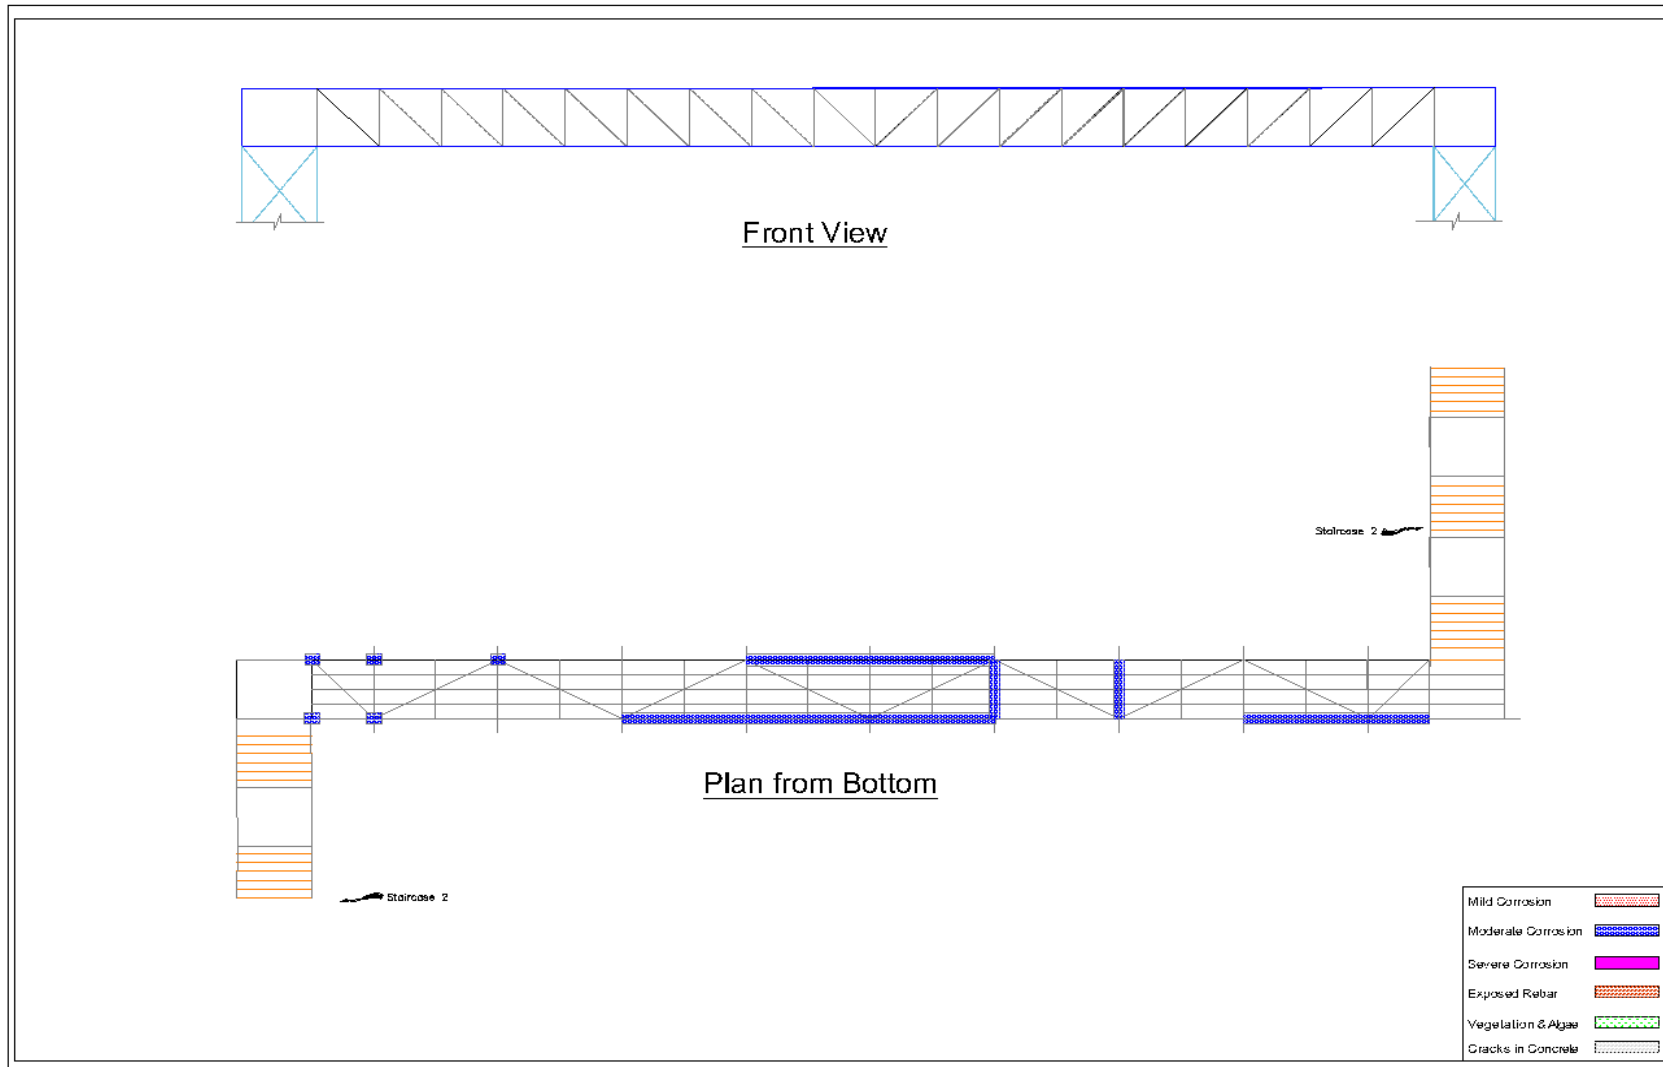
**Fig 2.4:** Locations of deteriorations and bottom view of span-2

- Structural members are in fair condition, displaying mild corrosion for top chord members, verticals, diagonals, gusset plates and moderate corrosion for bottom chord members along steel concrete joint. (Locations are marked in figures below) (Photographs of the same can be seen in **fig 2.5**)
