## Third Party Audit of ROB's and FOB's of SCR

### INSPECTION OF FOB AT RAGHAVAPURAM RAILWAY STATION

**Final Report**  
SEPTEMBER | 2020

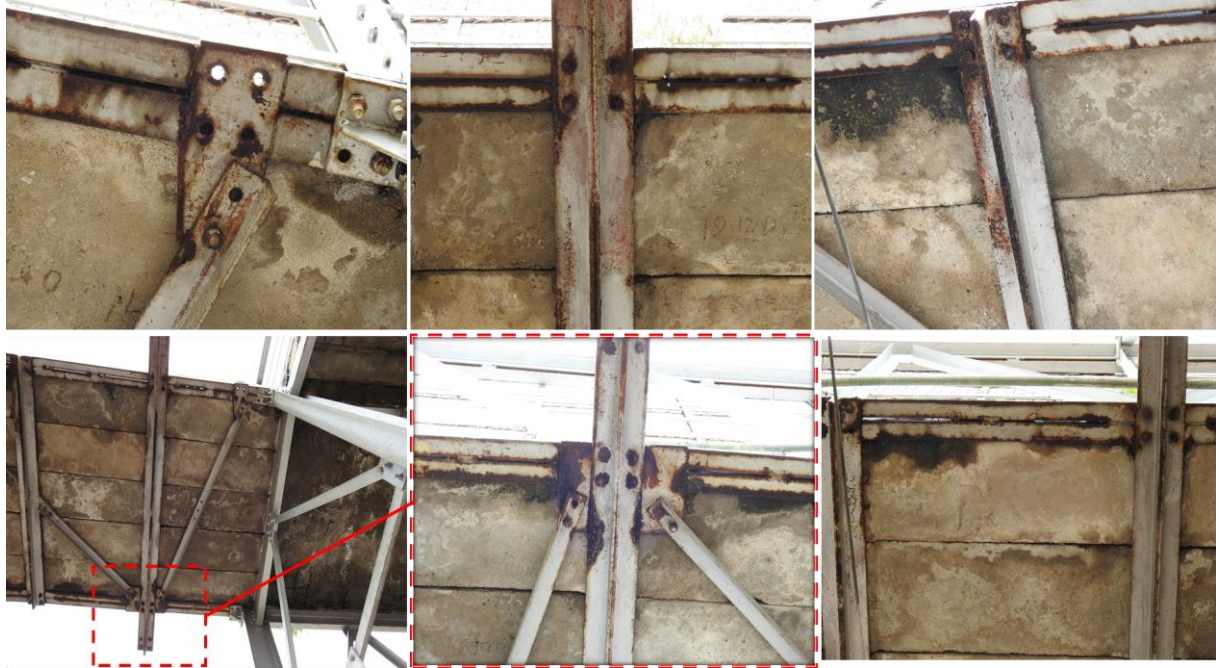
**a**

- ✓ Corrosion is observed in bottom of main chord member ( Double angle section) and gusset plate joints connecting floor beam

Reinforcement exposed and leaching of slab panels

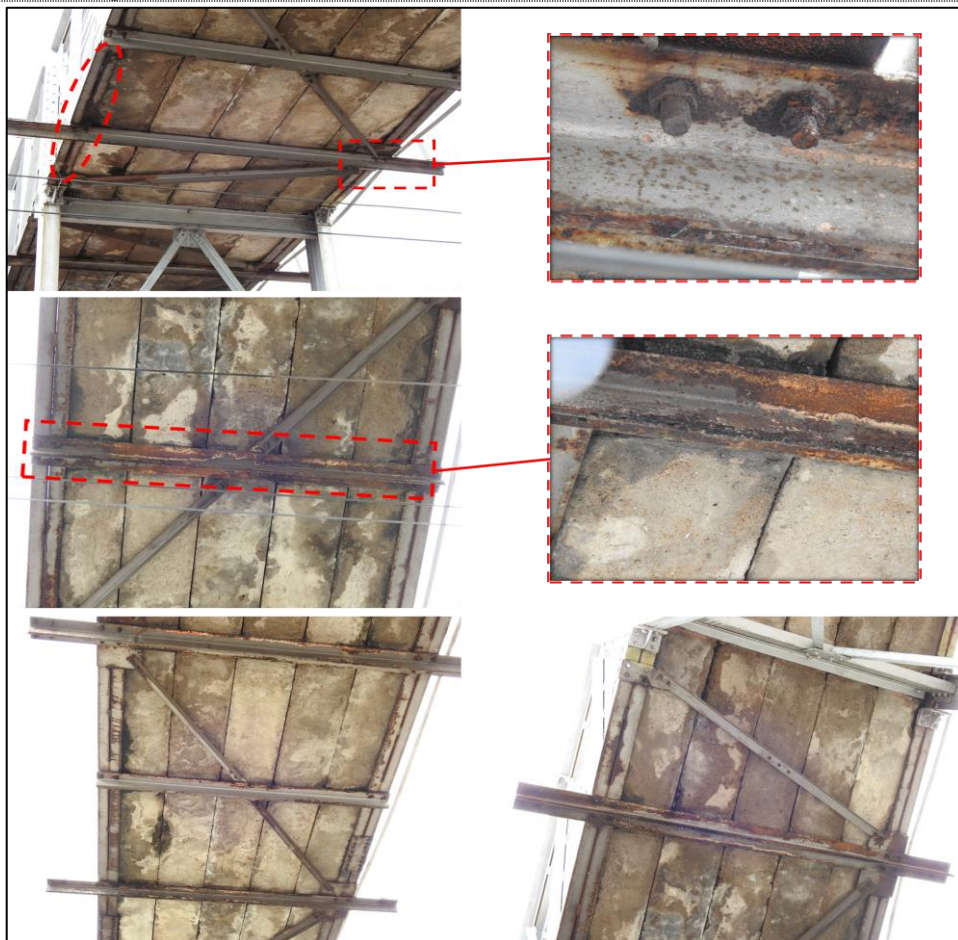
**b**

- ✓ Corrosion is observed in the floor beams and in the bottom chord members of 3<sup>rd</sup>, 4<sup>th</sup> and 5<sup>th</sup> span in FOB

Corrosion of floor beams

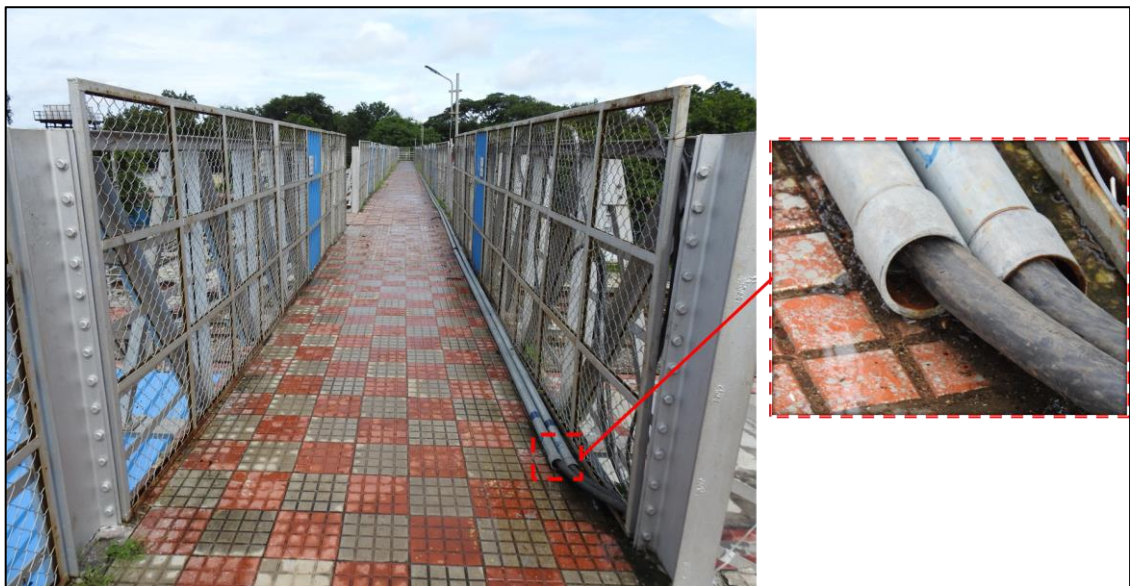
| 1. 2 IDENTIFICATION OF ADDITIONAL LOADS ON BRIDGE | | | |
|---|---|---|---|
| | a) Pipeline – Utilities | No | No pipelines are observed at roof level. Two GI pipes of 2-inch dia with cables running on the floor.<br><br>a. Cables are protected with 2-inch Gi pipe.<br>b. No advertising boards are provided. (Refer <b>fig :1.1</b> ) |
| | a) Additional wearing coat on Floor | No | Only Chequered tiles are used for flooring (Refer <b>fig :1.1</b> ) |

**Fig 1.1:** Cables, Flooring and protective screen

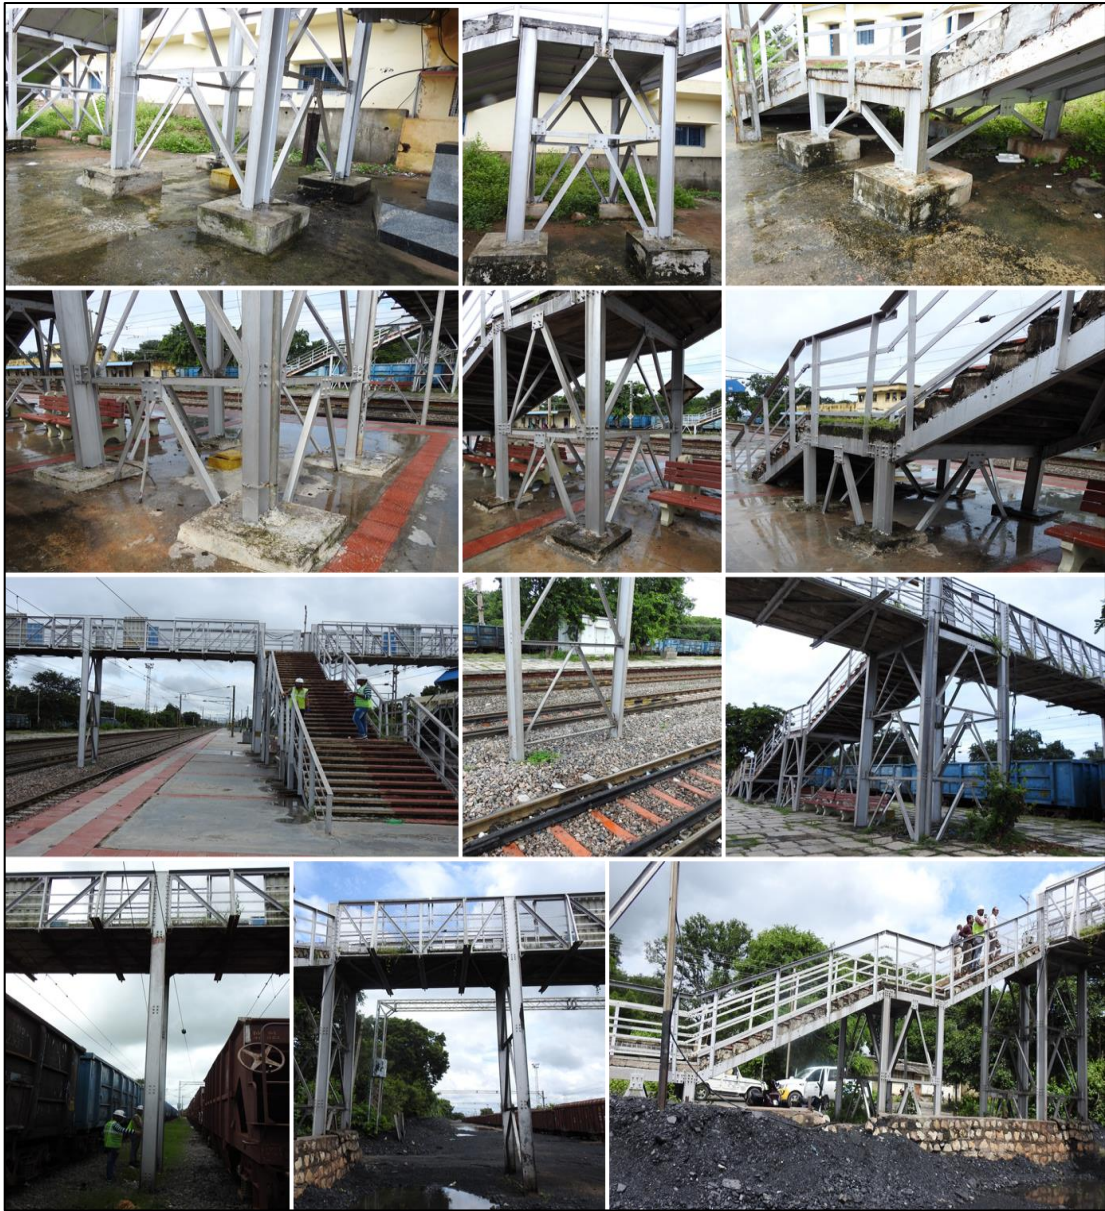
| 1.3 STRUCTURAL SYSTEM OF THE BRIDGE | | | |
|---|---|---|---|
| | Column – Trestles Connection Details | | Concrete encasement is observed below vertical supports. (Refer <b>fig :1.2</b> ) |

**Fig 1.2:** Trestles details

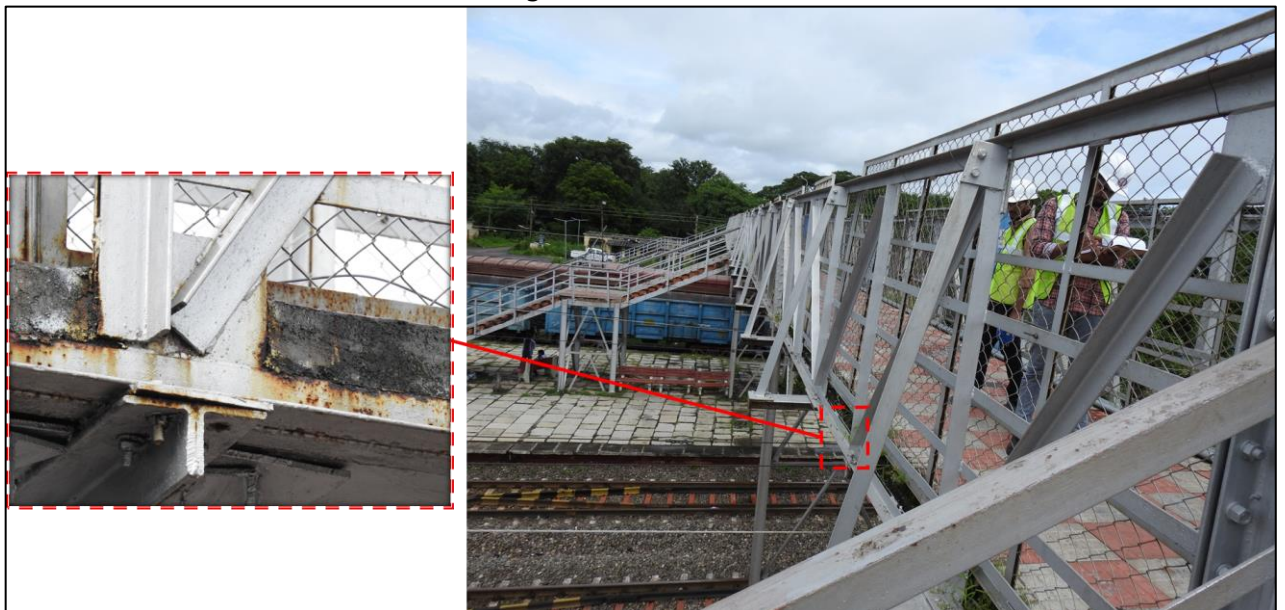
**Fig 1.3:** Main chord members, Floor beams, vertical and diagonal bracings

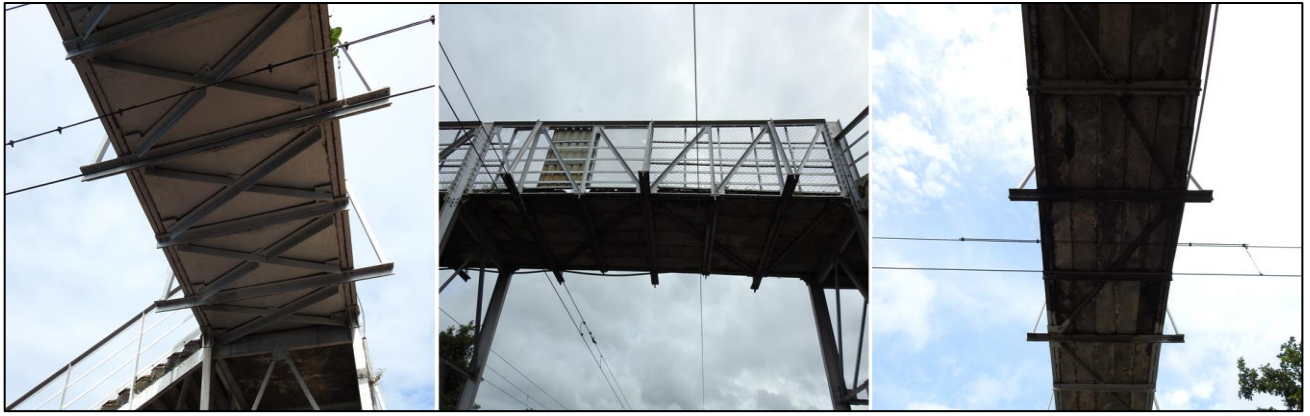
**Fig 1.4:** Bottom view of span 1, 3 and 5

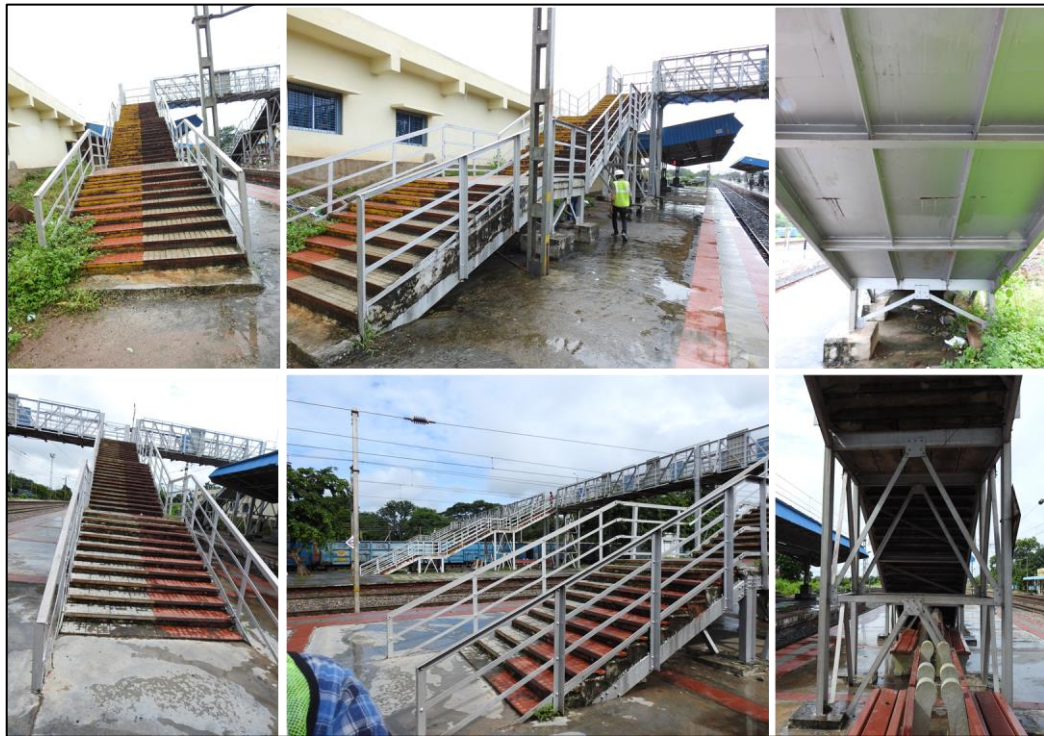
| | Number of staircases | 4 No's | a. Staircase steps are observed as cast in situ slab. Steps size of 300 x 100 mm are supported on ISMC 200 channel using sacrificial plate only at PF-1. Staircase landing of 2.54 m wide is supported on ISMC 250.<br>b. Staircase steps are observed as Precast slab panels. Steps size of 300 x 100 mm are supported on ISMC 200 channel using ISA 75 x 75 x 8 mm angle section connected to ISMC 150. Staircase landing of 2.54 m wide is supported on ISMC 250. (Refer <b>fig :1.5</b> ) |

**Fig 1.5:** Staircase details

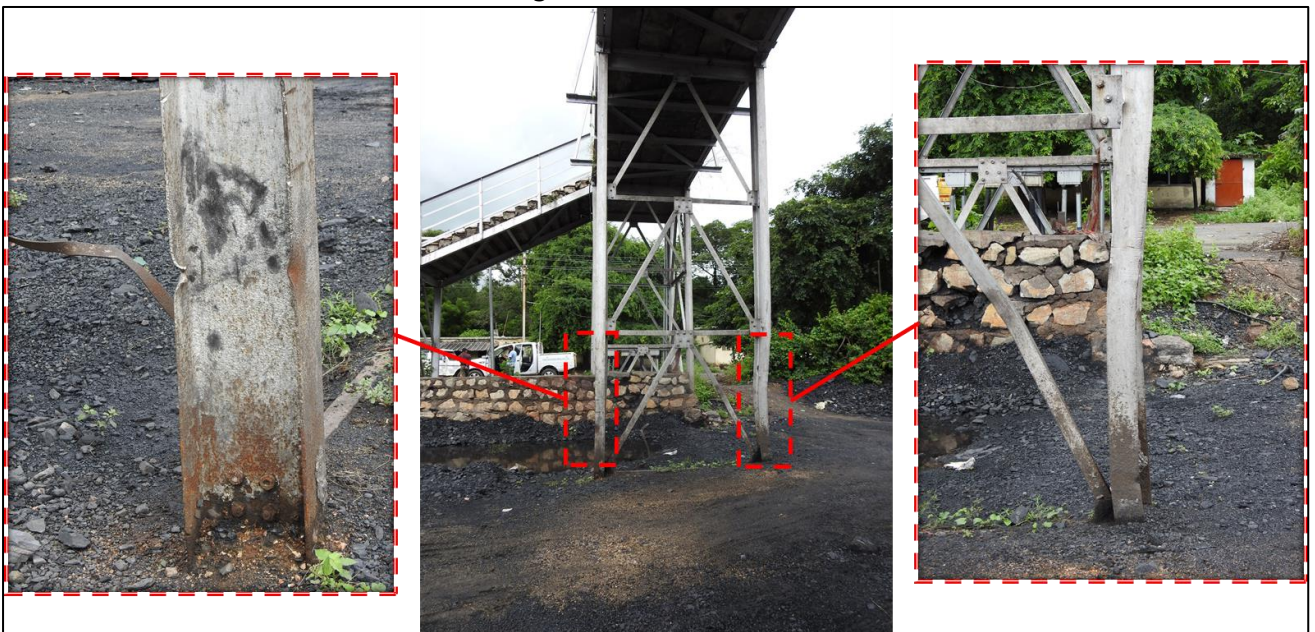
| 1.1 GENERAL INFORMATION AND OBSERVATION | | |
|---|---|---|
| m | Damages due to accidental hitting, Grazing Marks | Yes (Damage due to accidental hitting)<br>(Refer <b>fig :6</b> ) |

**Fig 1.6:** Accidental damage observed at stanchions

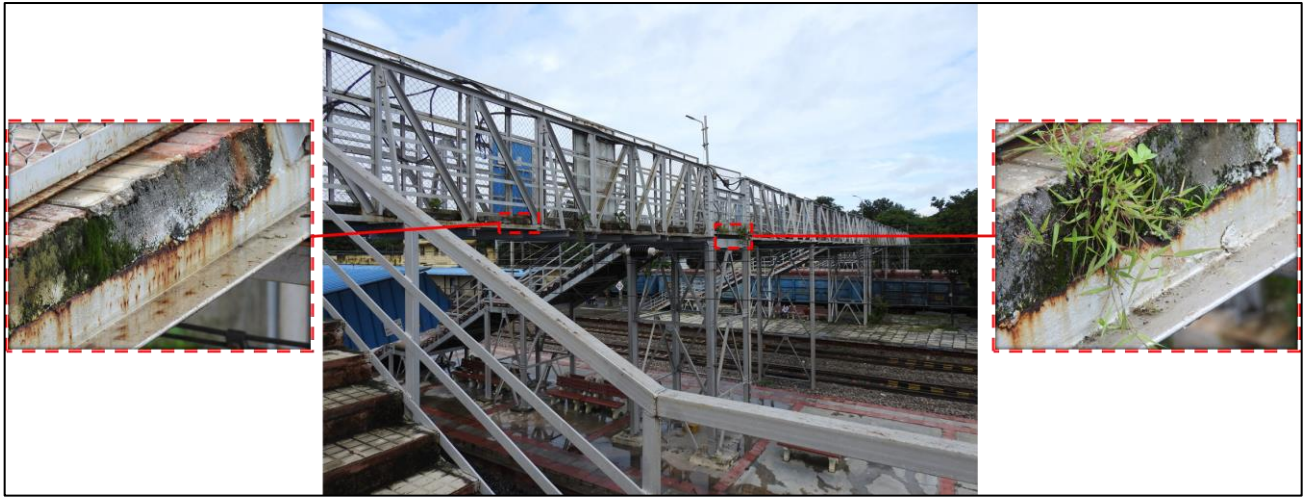
| SIGNS OF DISTRESS/DEFORMATION IN BRIDGES | | | |
|---|---|---|--|
| Corrosion at steel-Concrete joint | | Corrosion is observed at steel concrete joint. (Refer <b>fig :1.7</b> ) | |

***Fig 1.7:*** Corrosion and vegetation

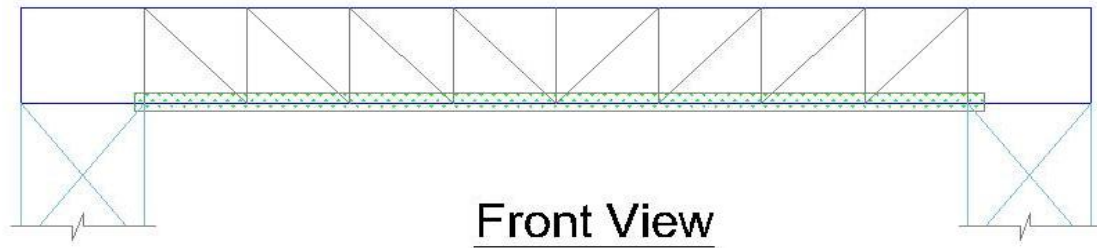
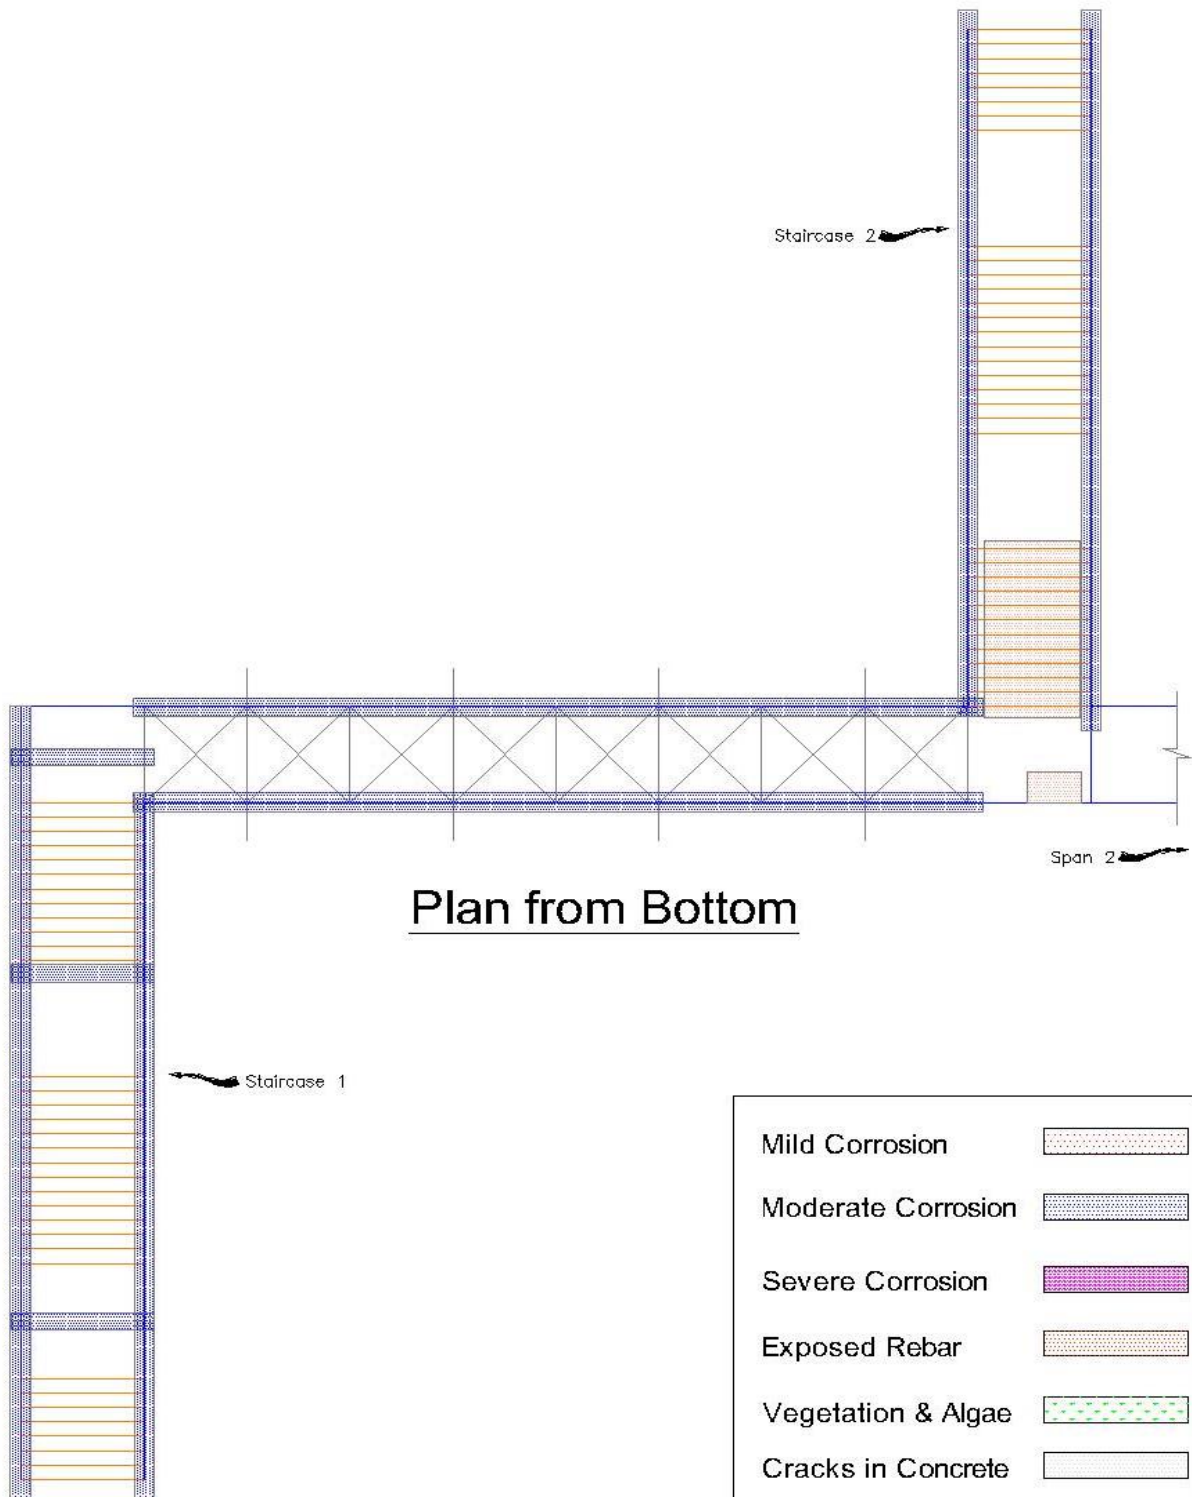
**Fig 2.1:** Locations of Deteriorations in Span 1

- Structural members are in fair condition, displaying mild corrosion for top chord members, verticals, diagonals, and gusset plates, moderate corrosion for bottom chord members, and staircase stringer beam along steel concrete joint and on the Sacrificial plate is also corroded (locations are marked in figures below).
- Algae formation and vegetation is observed along steel concrete joint on outer surface at deck level and on staircase 2 mid landing.

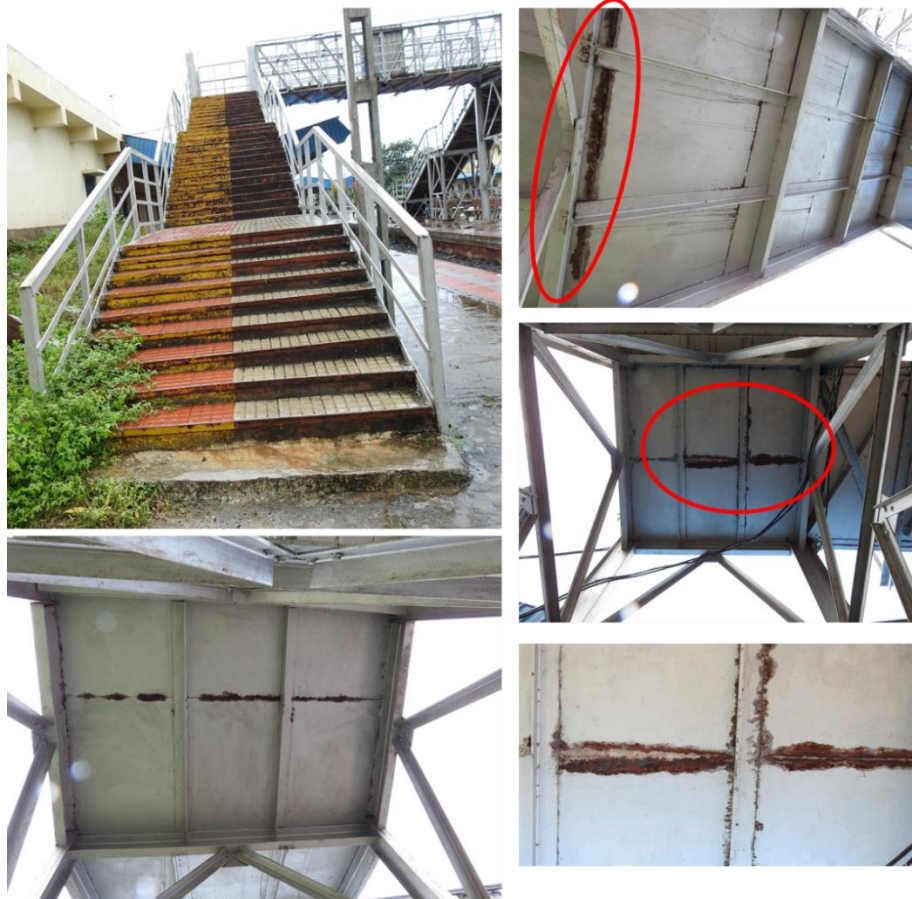
Staircase 2 precast slab panels are deteriorated reinforced is exposed in flights and staircase RCC landing slab at deck level. (Photographs of the same can be seen in **fig 2.2-2.4**)

**Fig 2.2:** Locations of deteriorations in Staircase 1 from bottom

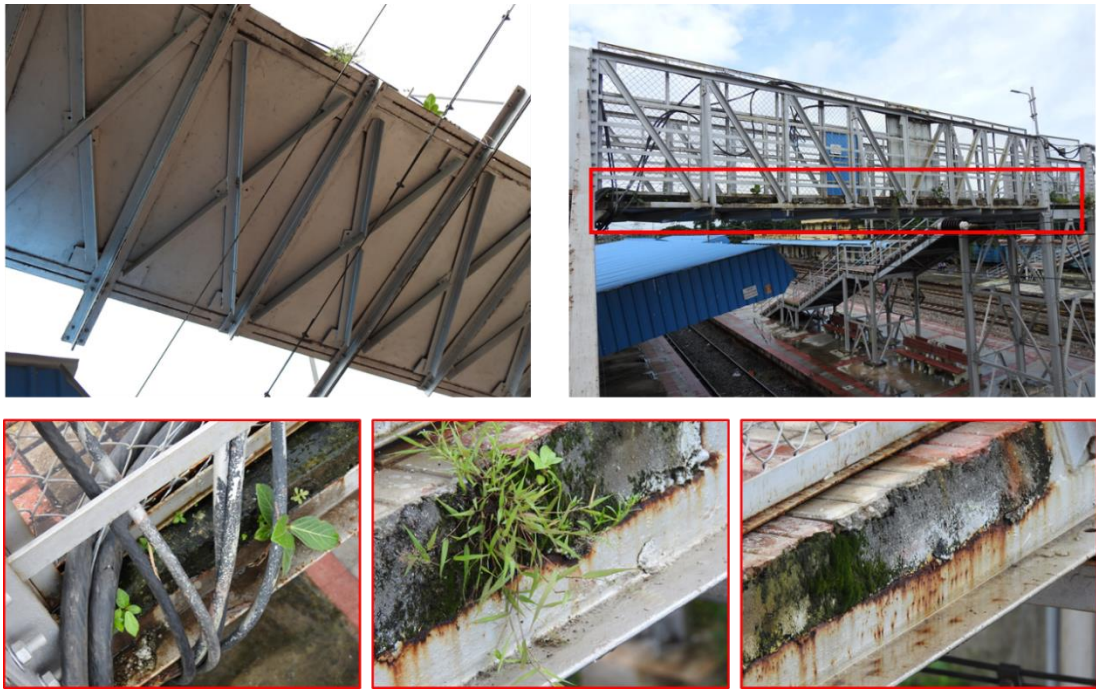
**Fig 2.3:** Deteriorations of bottom chord and Vegetation at deck level

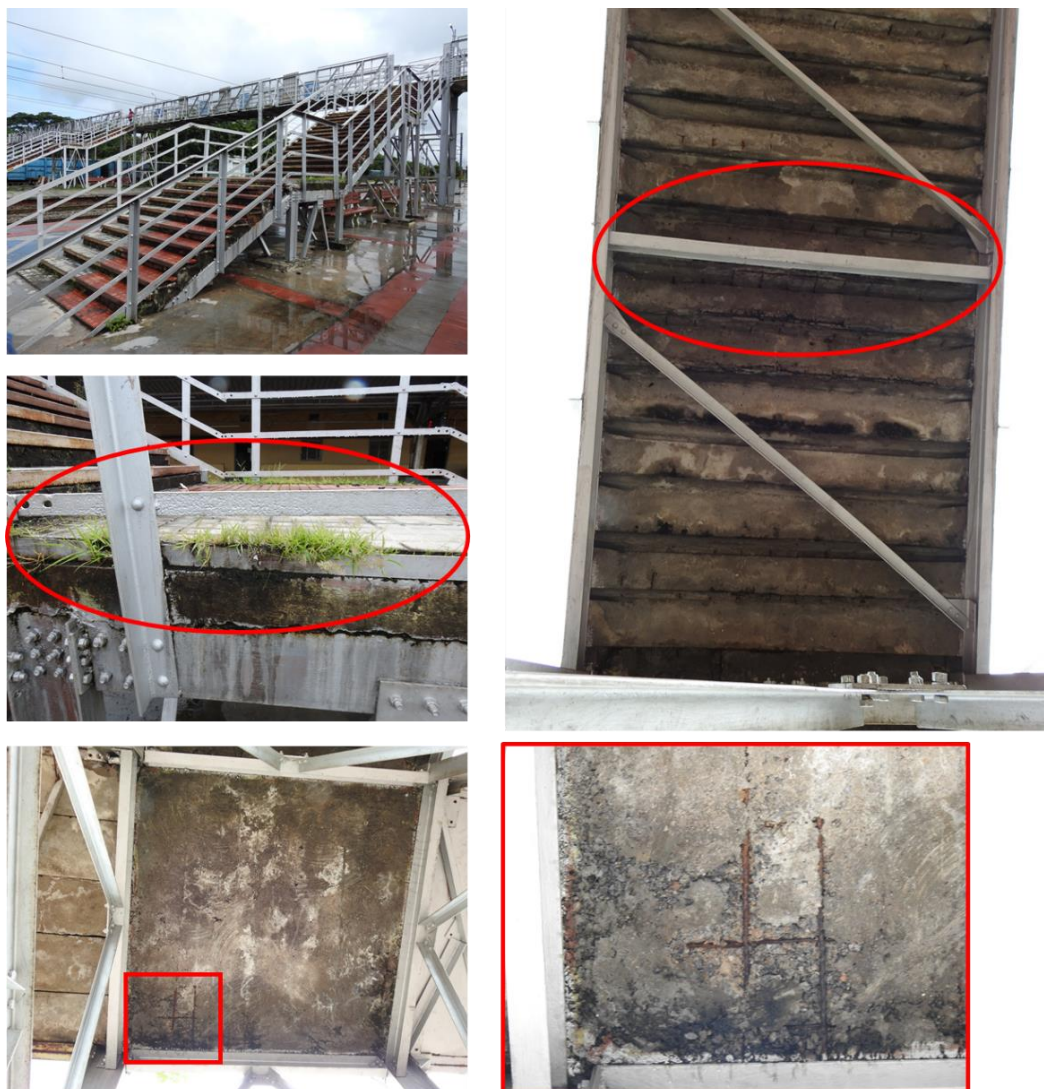
Reinforced cement concrete Slab at Deck level and some precast panels in staircase are observed with exposed rebar in many locations. *(Photographs of the same can be see in **fig 2.4**)*

**Fig 2.4:** Locations of Deteriorations in Staircase 2 from bottom

**Methodology for patching:** Hand applied Mortar (Patching) repair is performed to restore small areas where sound concrete is damaged by spalling, scaling and/or impact. This method of repair is generally applied using trowel and require minimum or formworks. The patch thickness is limited to a maximum of 100 mm depth of hollow surface. Hand applied Mortar repair is classified into two types considering defective area and surface. Hand applied Mortar

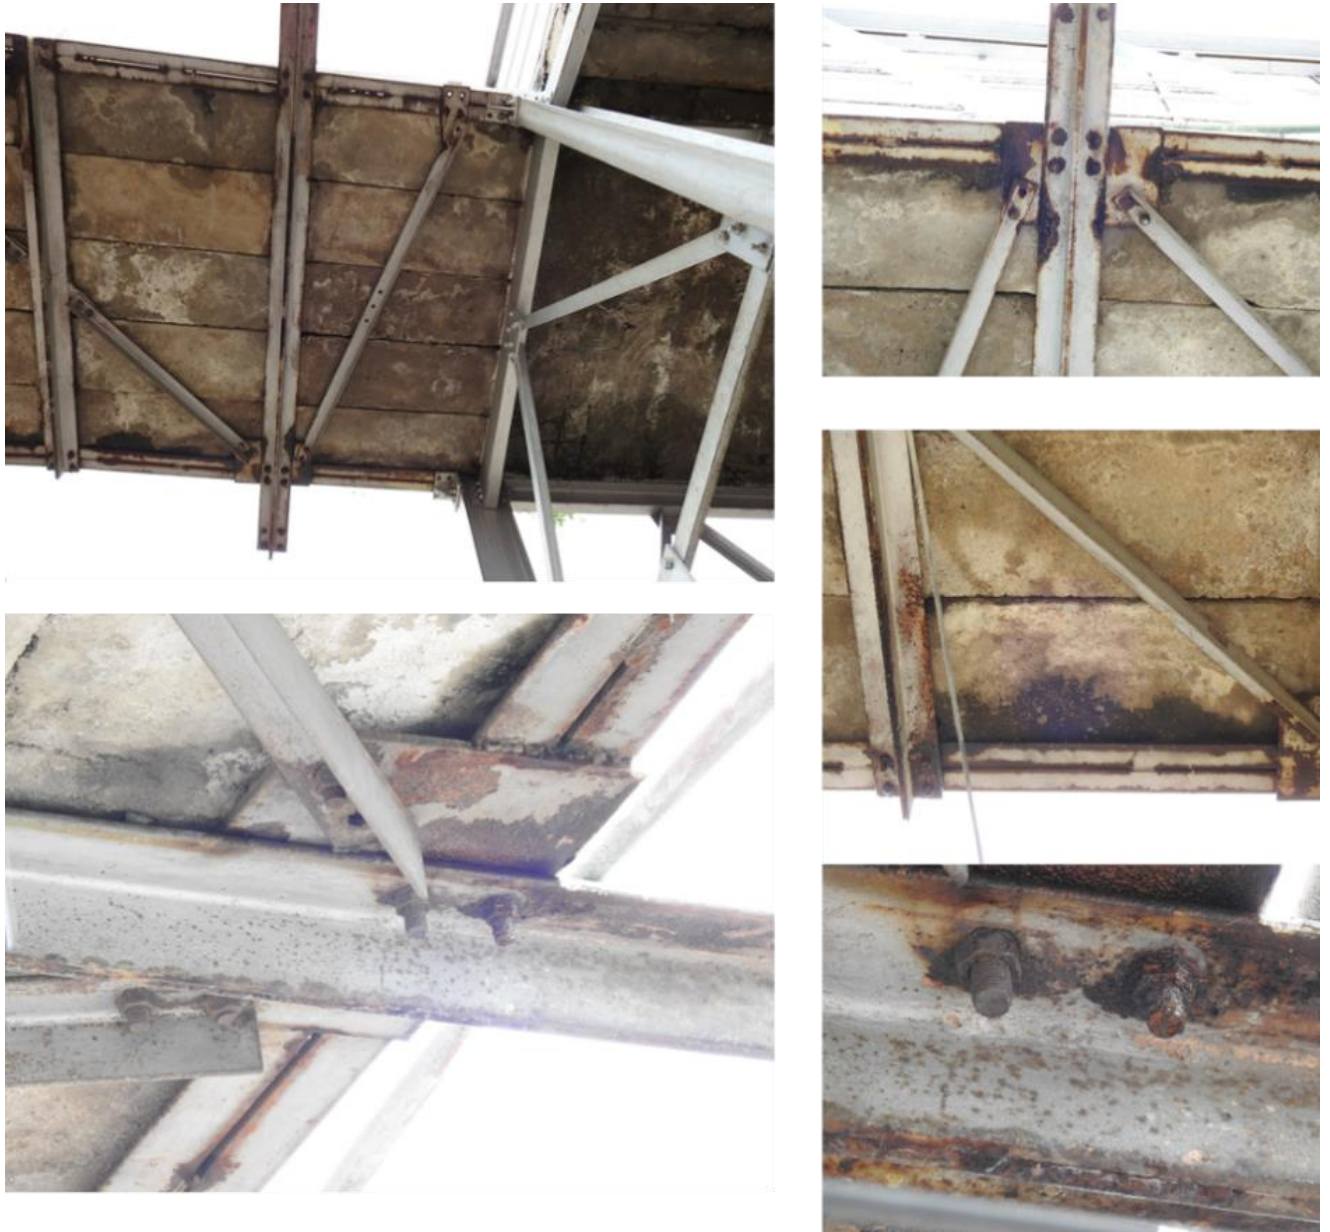
- Structural members are in fair condition, displaying mild to severe corrosion.
  - Algae formation and vegetation is observed along steel concrete joint on outer surface at deck level along the span.
- Bolts and nuts are missing in some locations. (Photographs of the same can be see in **fig 2.6, 2.7**)

**Fig 2.6:** Deterioration locations of steel members at slab deck level in span 2

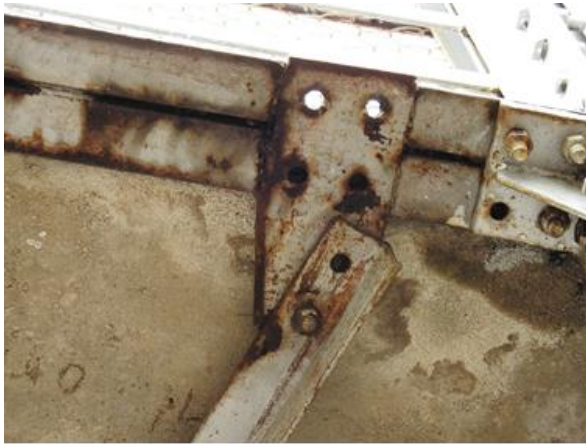
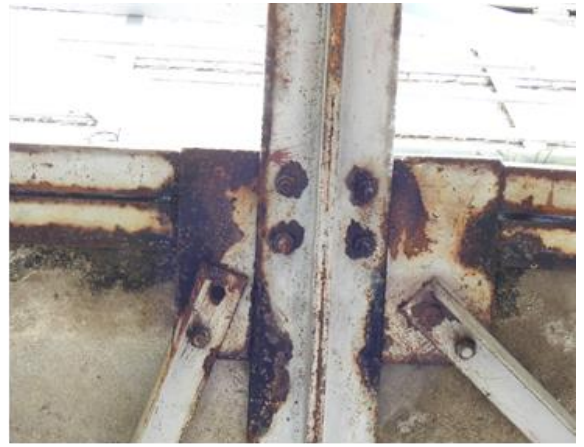
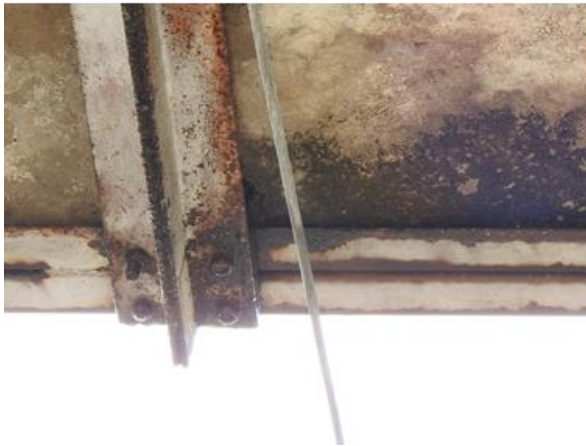
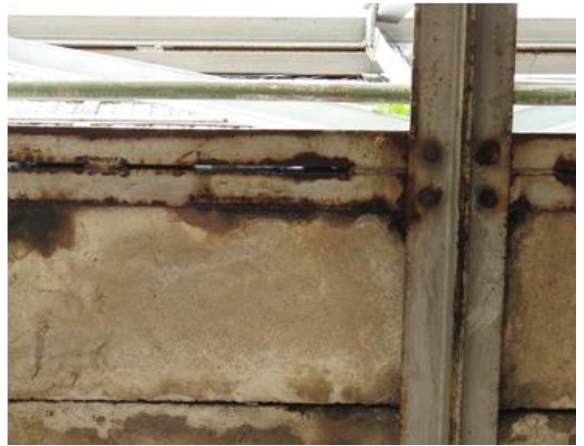
**Fig 2.7:** Some locations of Missing bolts and nuts in span 2

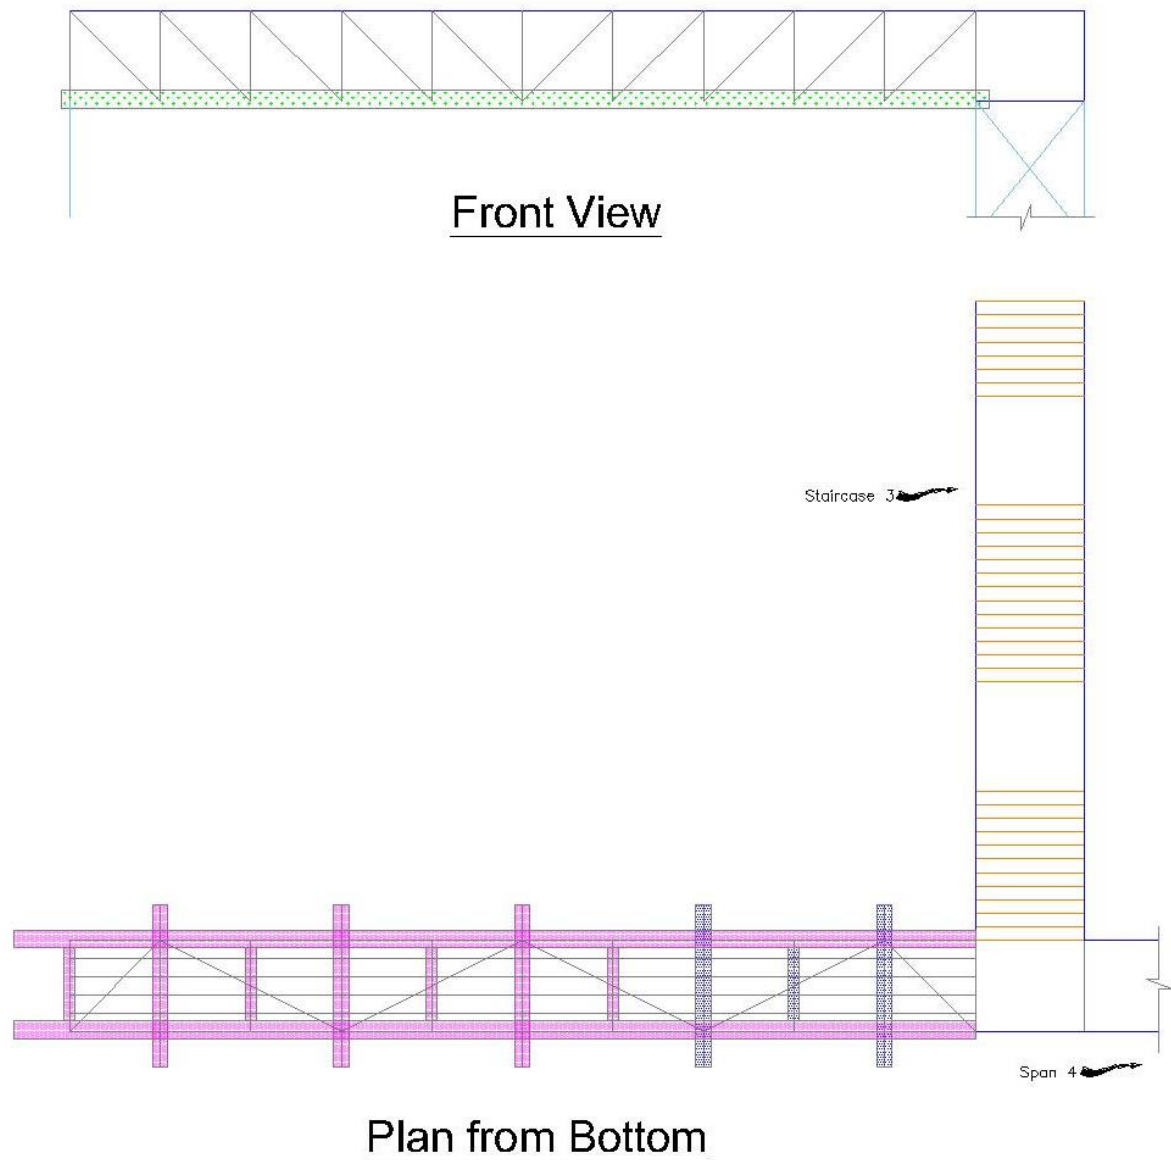
**Fig 2.8:** Locations of Deteriorations in Span 3 and staircase 3

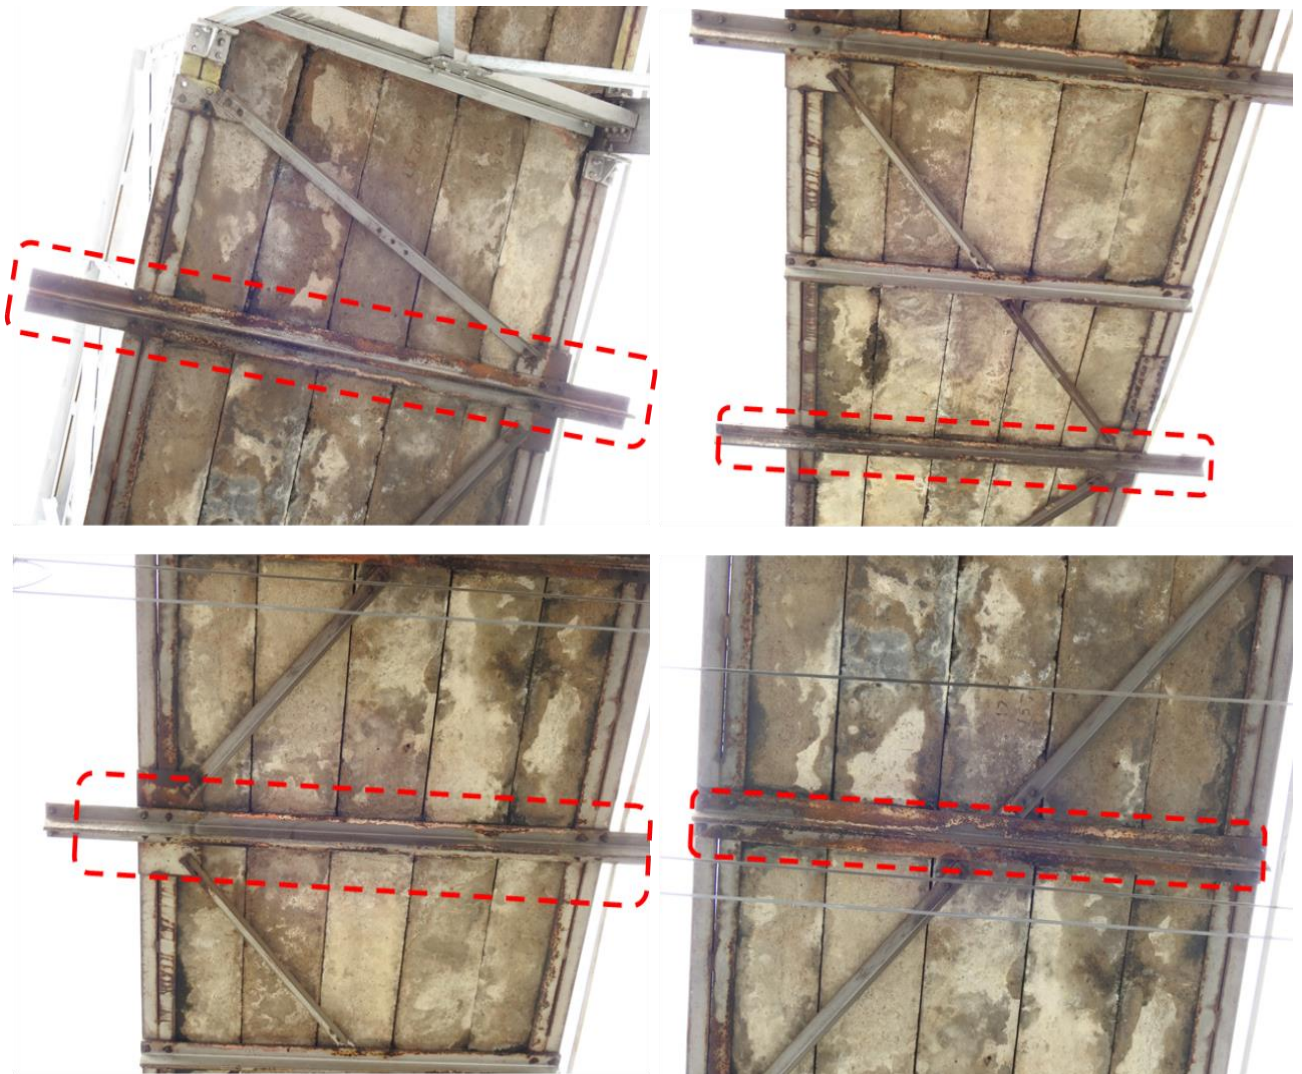
- Mild corrosion to sever corrosion for all structural members in FOB.
- Algae formation and vegetation is observed along steel concrete joint on outer surface at deck level and on staircase 3 mid landing. (Photographs of the same can be see in **fig:2.9, 2.10**)

**Fig 2.9:** sever corrosion of floor beam in span 3

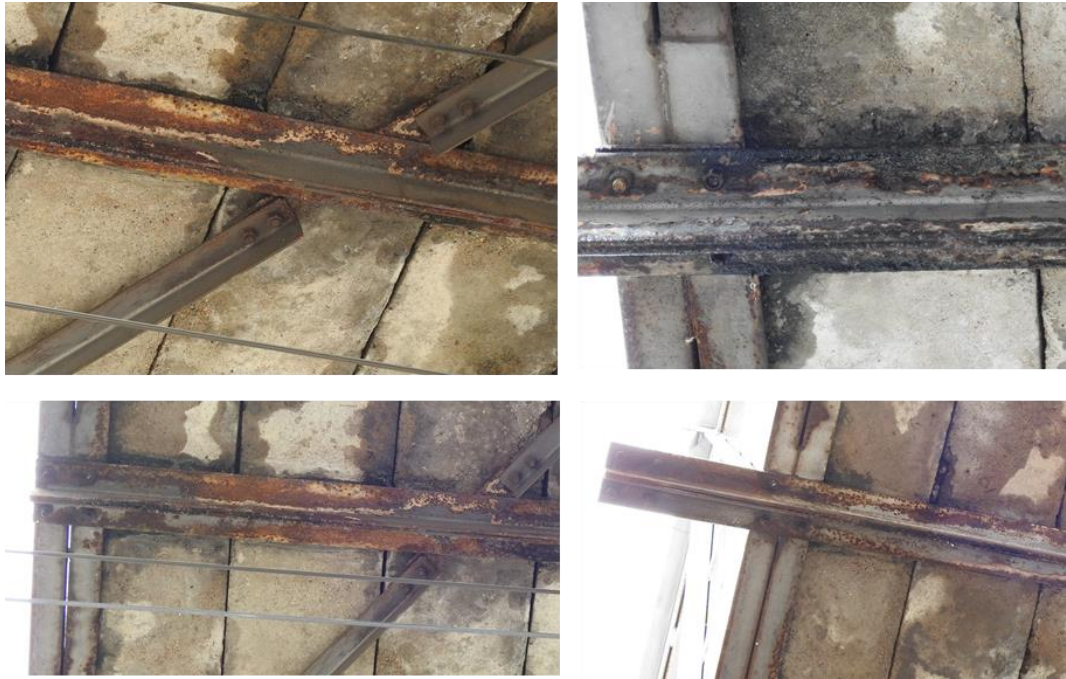
***Fig 2.10:*** Locations of deterioration of bolted connections in span 3

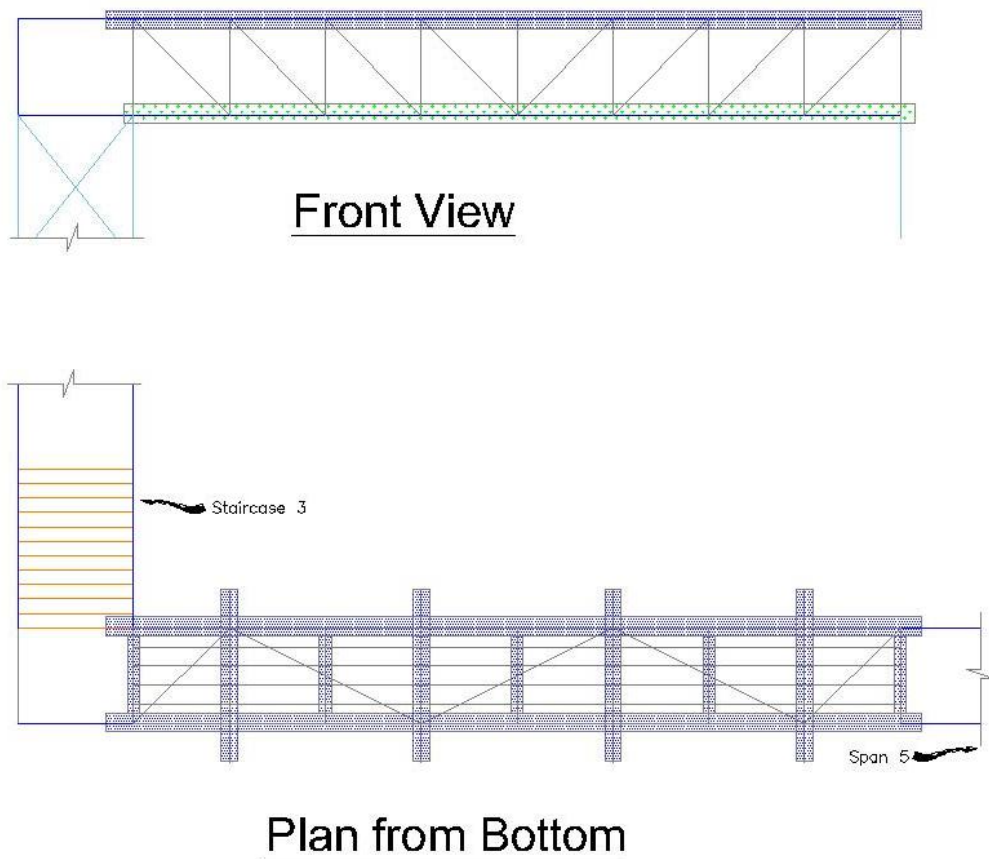
**Fig 2.11:** Locations of Deteriorations in Span 4

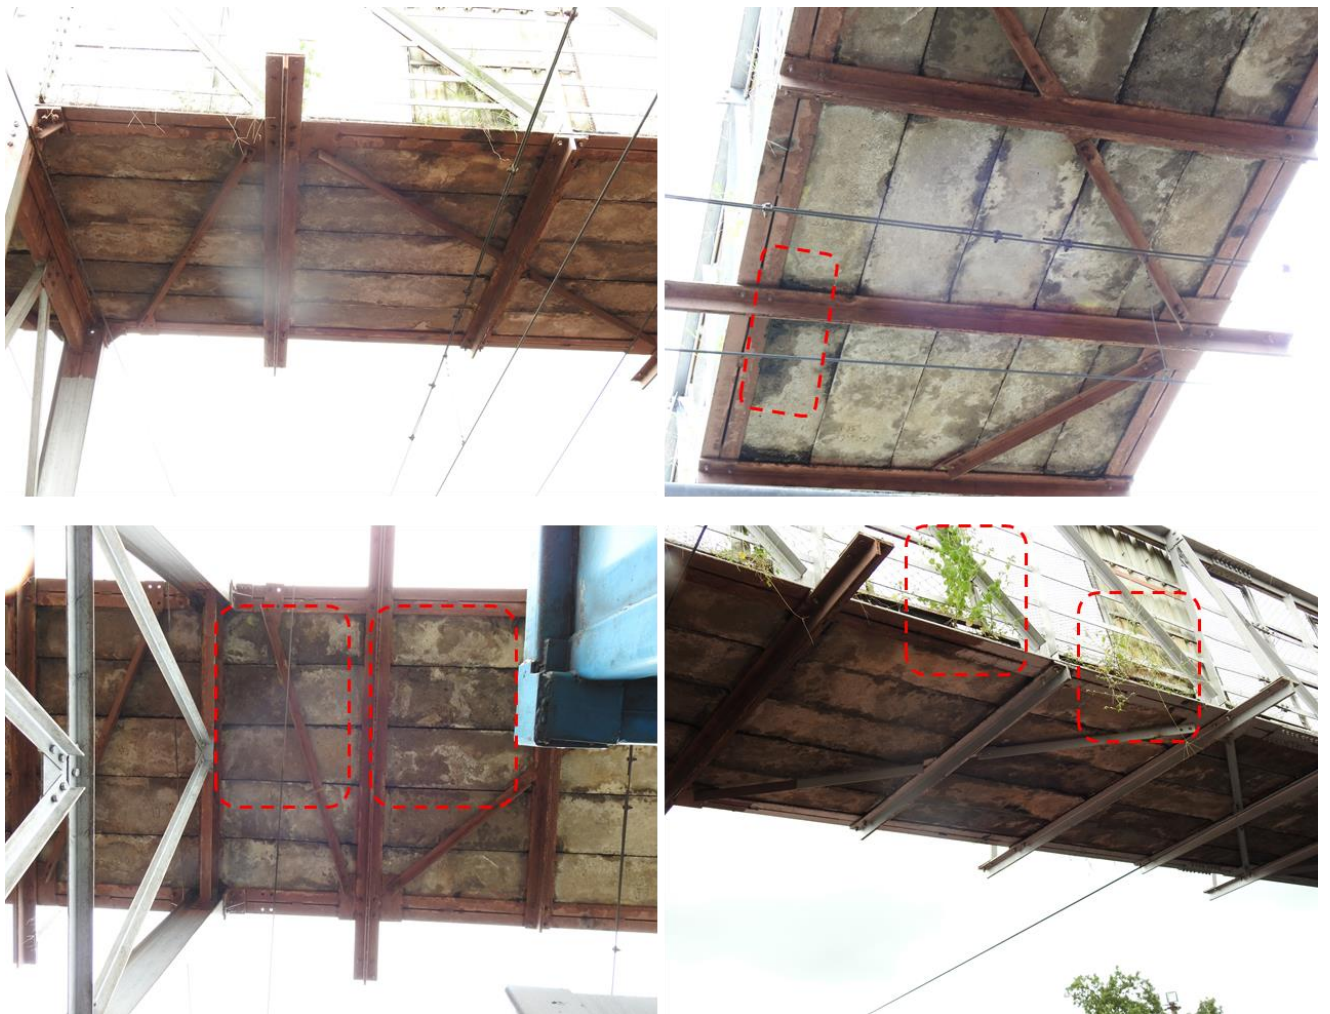
- Mild corrosion to sever corrosion for all structural members in FOB.
- Algae formation and vegetation is observed along steel concrete joint on outer surface at deck level (*Photographs of the same can be see in **fig 2.12***)
- Floor beams and gusset plate are painted with red oxide paint.

**Fig 2.12:** Locations of corrosion and vegetation in span 4

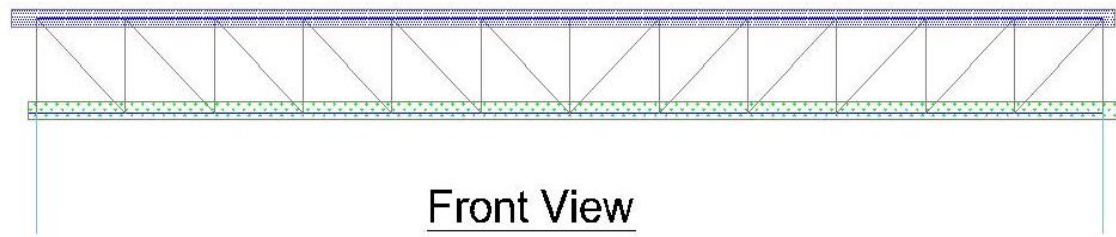
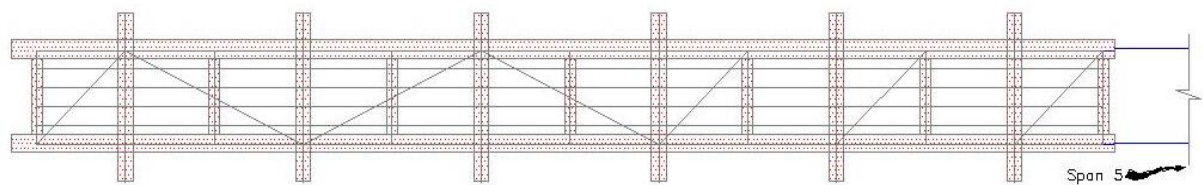
**Fig 2.13:** Locations of Deteriorations in Span 5

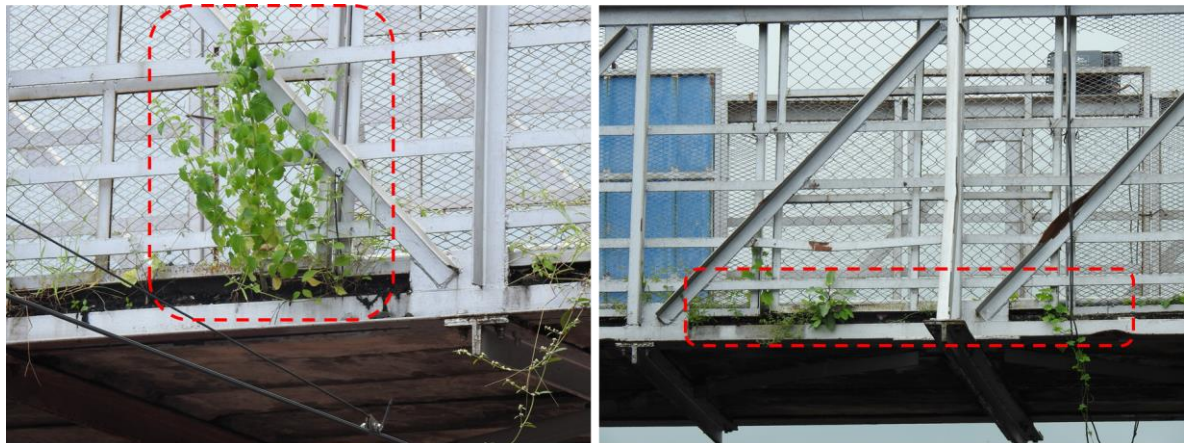
**Fig 2.14:** vegetation observed near bottom chord member
