## Third Party Audit of ROB's and FOB's of SCR

### INSPECTION OF FOB AT RAGHAVAPURAM RAILWAY STATION

**Final Report**  
SEPTEMBER | 2020

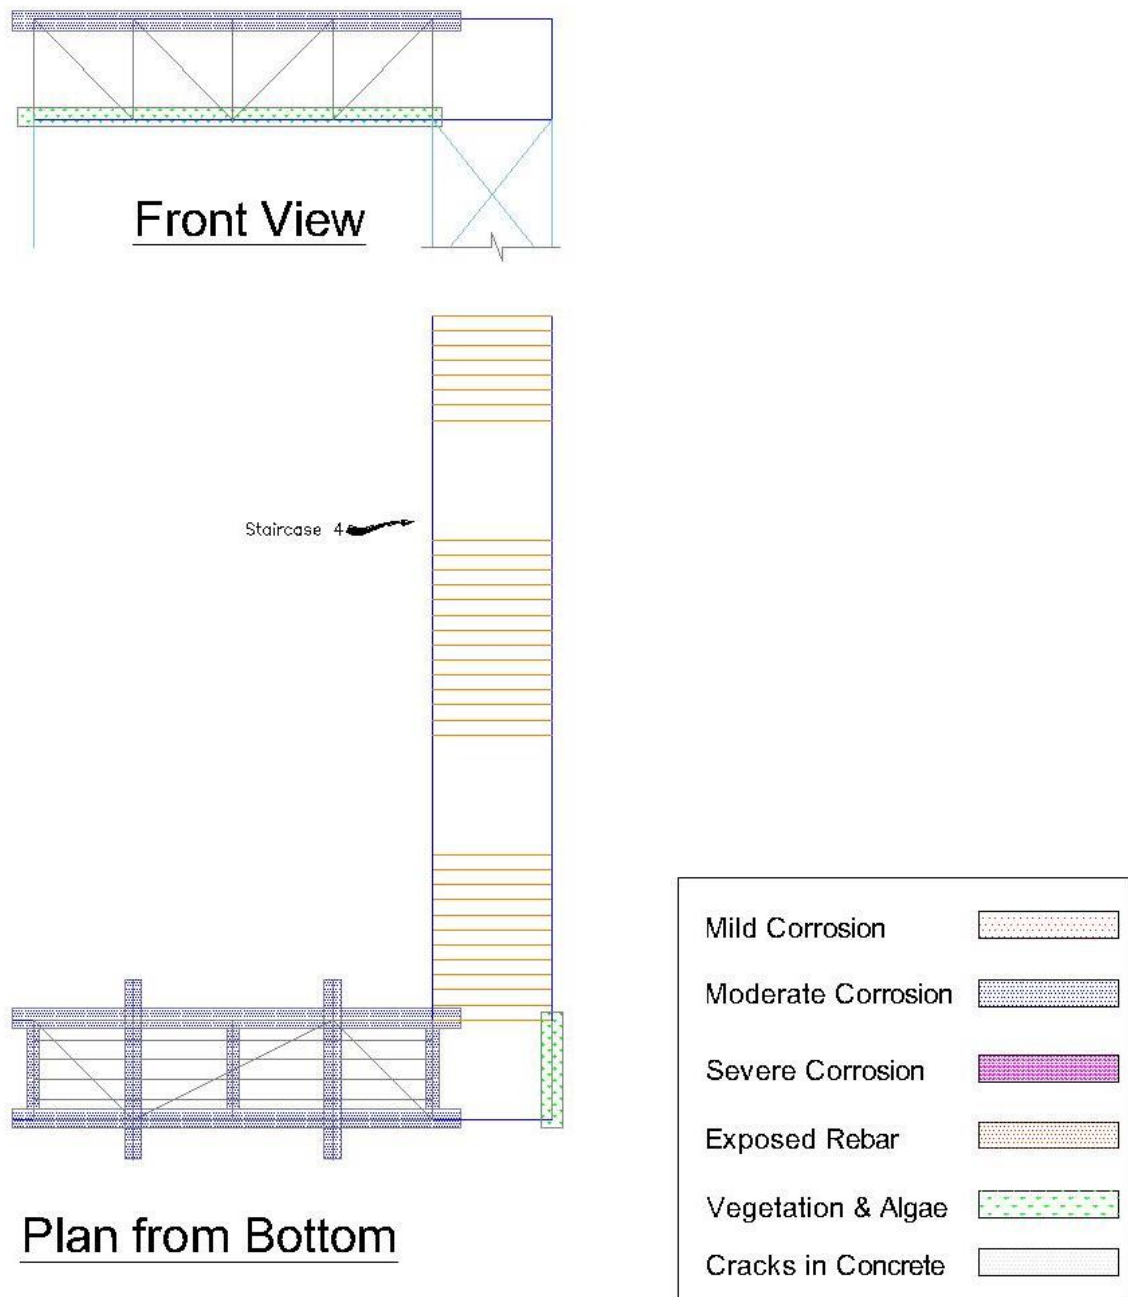
**Fig 2.15:** Locations of Deteriorations in Span 6

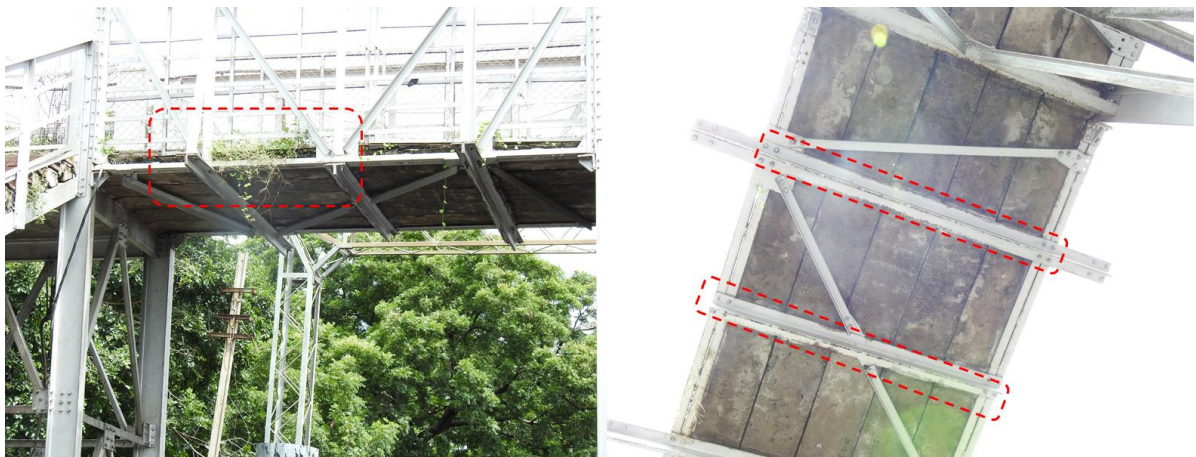
- Algae formation and vegetation is observed along steel concrete joint on outer surface of deck level (*Photographs of the same can be see in **fig 2.16-2.18**.*

**Fig 2.16:** vegetation and slight corrosion at floor beam

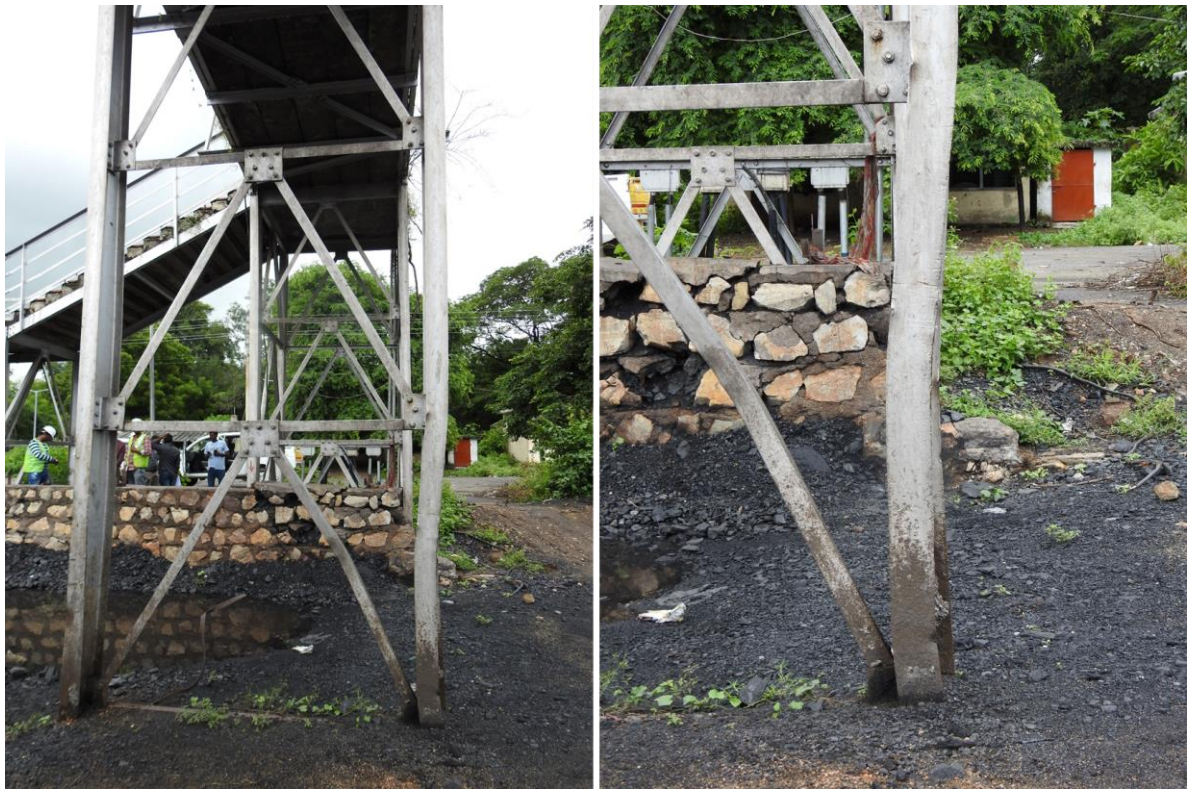
**Fig 2.17:** Deformed column due to accidental hitting

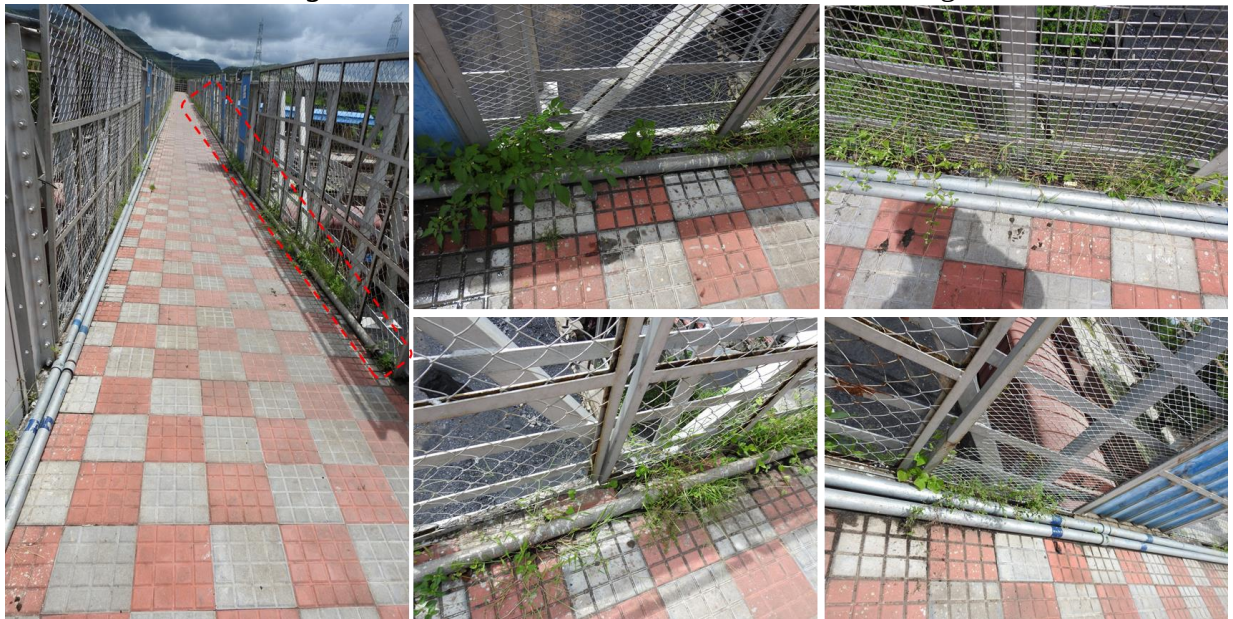
**Fig 2.18:** vegetation is observed on pathway of gangway
