# Third Party Audit of ROB's and FOB's of SCR

## INSPECTION OF FOB AT MADIRA RAILWAY STATION

**Final Report**  
SEPTEMBER | 2020

| <b>Name of the Project</b> | <b>:</b> | VISUAL INSPECTION OF FOB/ PF-1 - PF-2 AT MADIRA RAILWAY STATION |

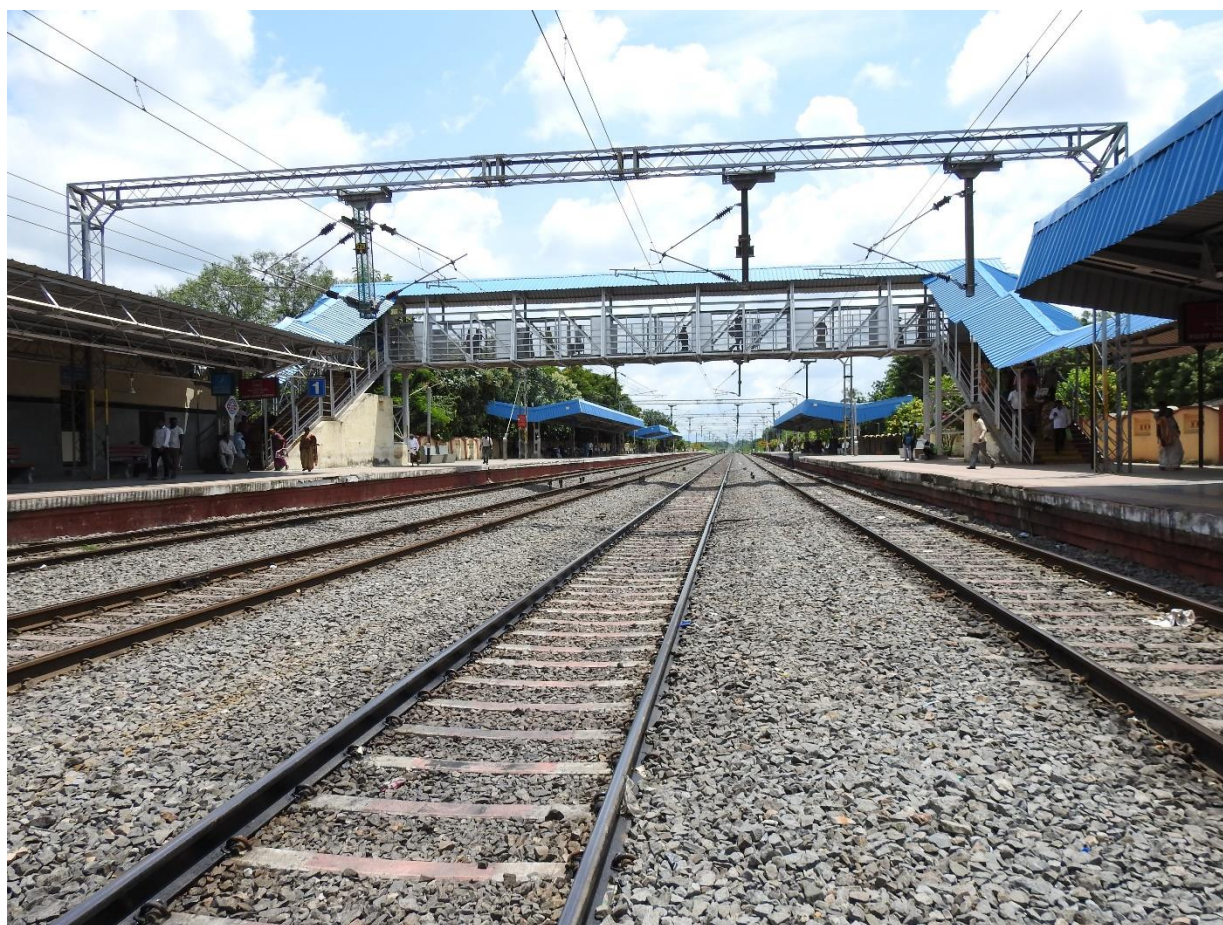
| PART 3 STRUCTURAL SYSTEM OF THE BRIDGE | | | |
|---|---|---|---|
| | Type /Shape of Truss Section | N- type | a) Main Chord members 2/150 x 100 x 12 mm Double Angle section.<br>b) 100 x 100 x 12 mm angles are used vertical and inclined bracings.<br>c) 10 mm thick, gusset plate used for welded joint. (Refer <b>fig : 1.1</b> ) |

**Fig 1.1:** Front view of FOB towards Vijayawada Junction

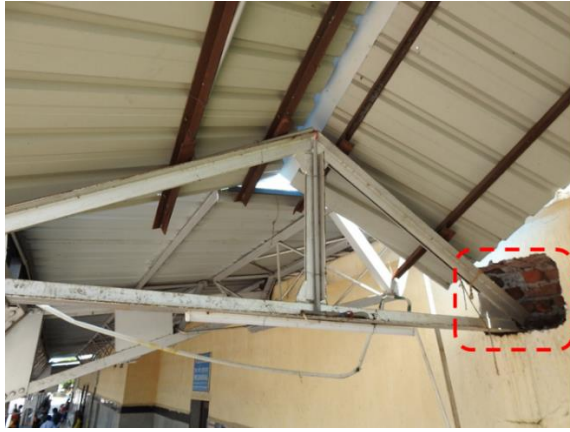
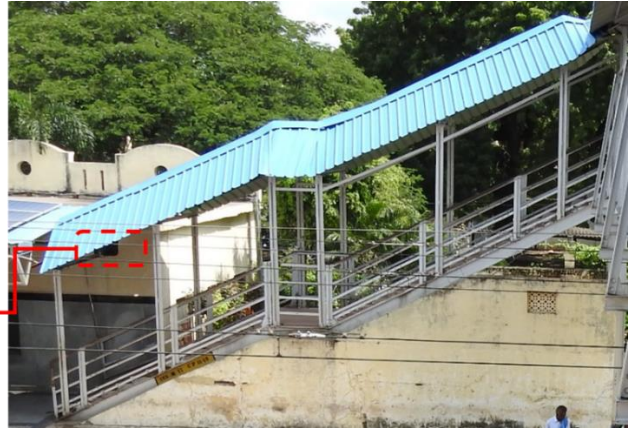
**Fig 1.2:** Staircase Roof truss on platform-1 one end is supported on Masonry wall

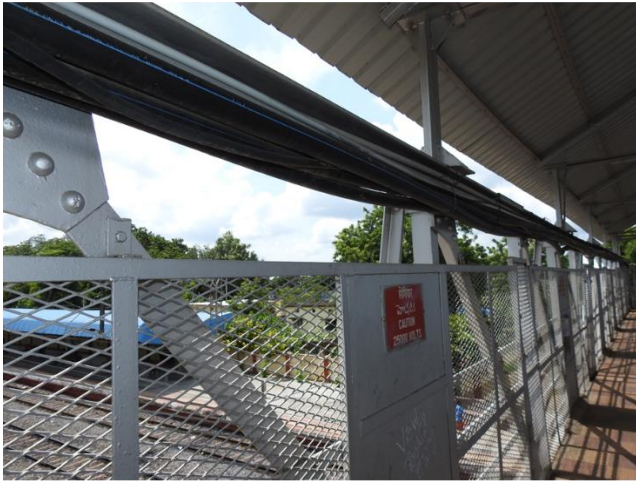
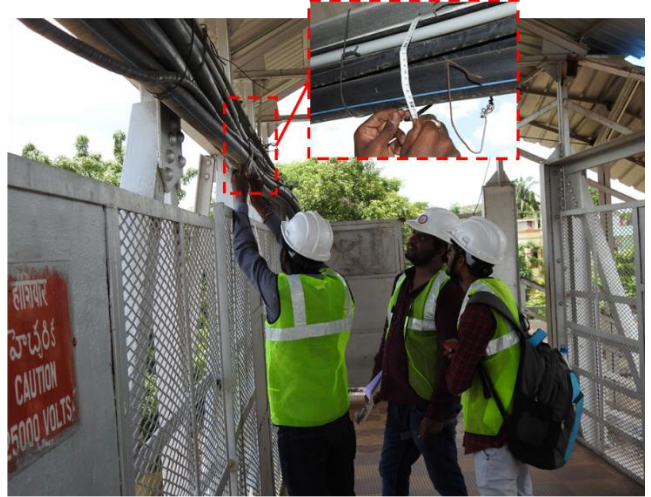
| PART 2 IDENTIFICATION OF LOADS ON BRIDGE | | | |
|---|---|---|---|
| | b) Cables | Yes | Set of Cables are running along the length of FOB, Approximate circumference of cables is 500 mm (Refer <b>fig : 1.3</b> ) |

**Fig1.3:** Bunch of Cables are running along the length of FOB, Approximate circumference is 500 mm

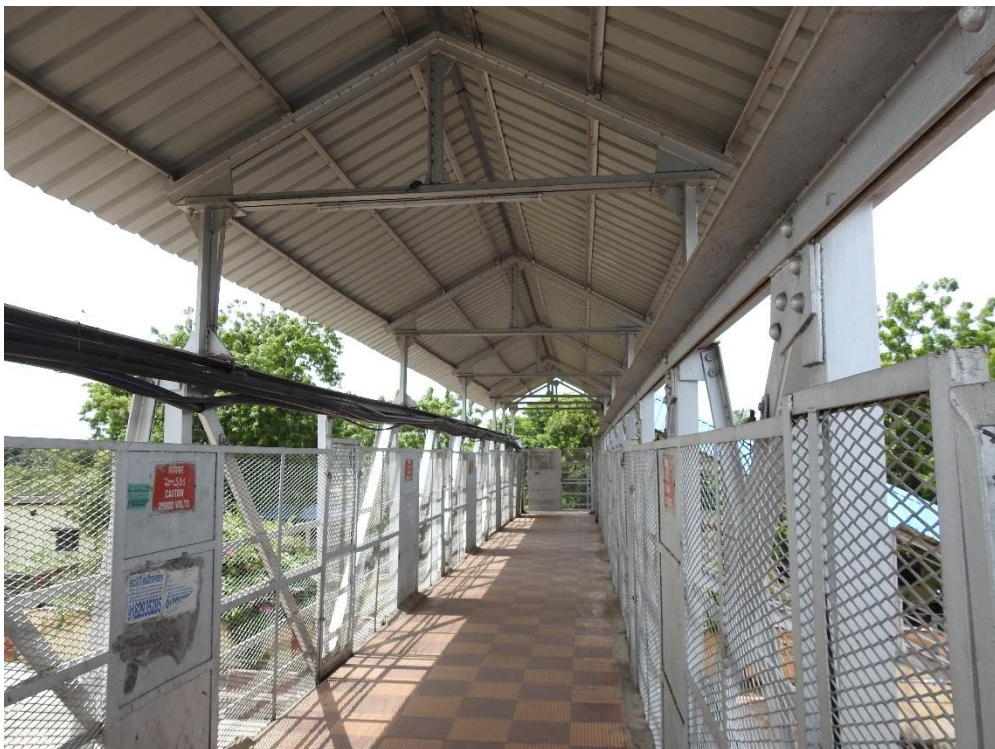
| PART 2 IDENTIFICATION OF LOADS ON BRIDGE | | | |
|---|---|---|---|
| | c) Roof Truss | Yes | 2/65 x 65 x 8 mm Angles are used (Refer <b>fig : 1.4</b> ) |
| | d) Roof Sheet | Yes | Corrugated Galvanized Sheet is used for Roof n(Refer <b>fig : 1.4</b> ) |
| | a) Additional wearing coat on Floor | No | Only Chequered tiles used for Flooring (Refer <b>fig : 1.4</b> ) |
| | b) Provision of protective screen for passengers | Yes | Fence made of Galvanized wire of 2 mm gauge and 2 mm Galvanized sheet is used above OHE Line on both side of Pathway is used for passengers Protection. (Refer <b>fig : 1.4</b> ) |

| PART 3 STRUCTURAL SYSTEM OF THE BRIDGE | | | |
|---|---|---|---|
| | Element of roof truss section | King post Angle | 2/65 x 65 x 8 mm King post Angle sections are used for roof truss supported on 2/150 x 100 x 12mm Top Chord Members using welded joints. (Refer <b>fig : 1.4</b> ) |

**Fig 1.4:** Pathway of FOB

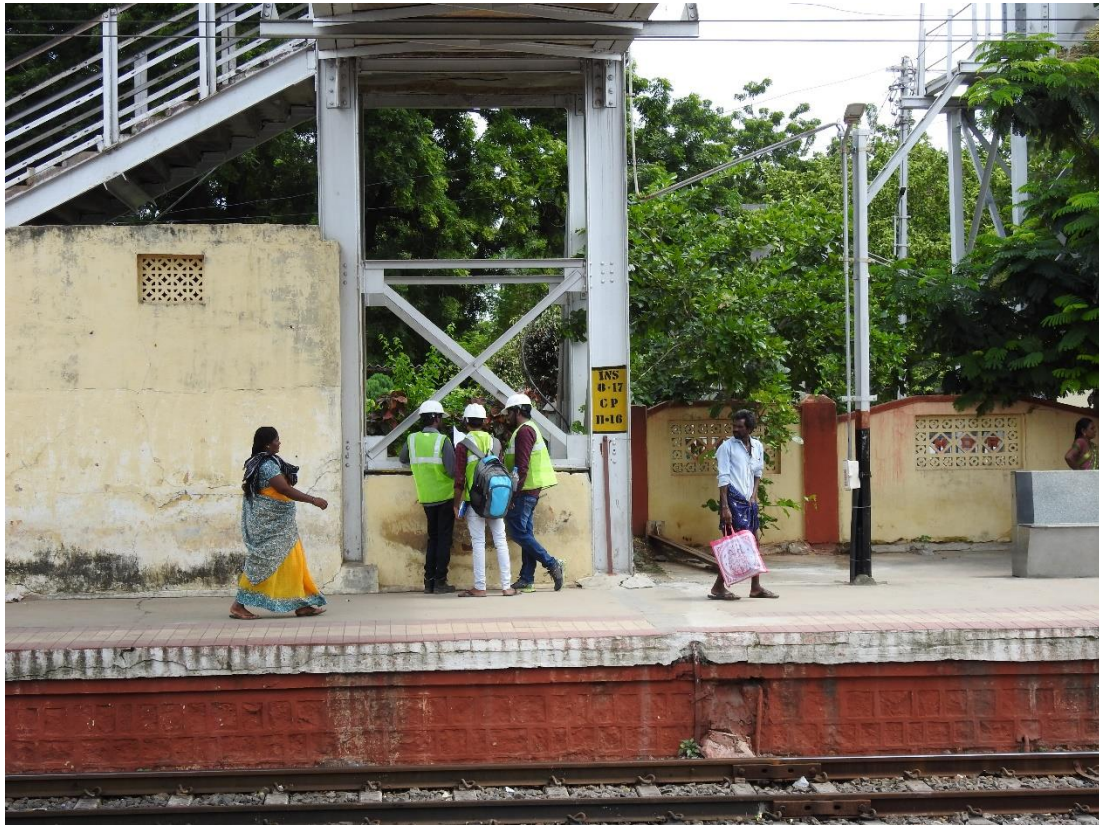
| PART 3 STRUCTURAL SYSTEM OF THE BRIDGE | | | |
|---|---|---|---|
| | Type of Material for Bottom Encasement | Concrete | Concrete encasement is used for protecting trestles from the corrosion on the platform (Refer <b>fig : 1.5</b> ) |

**Fig 1.5:** FOB is supported on four Trestles on either sides

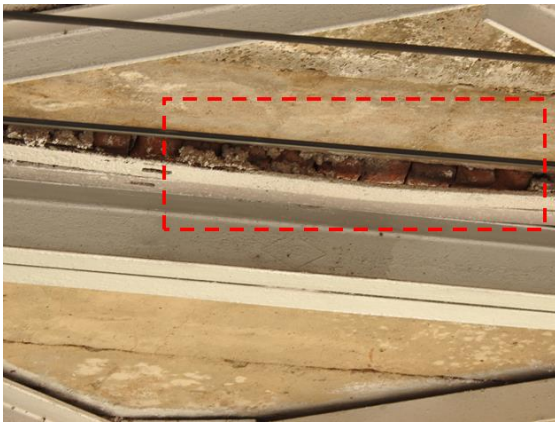
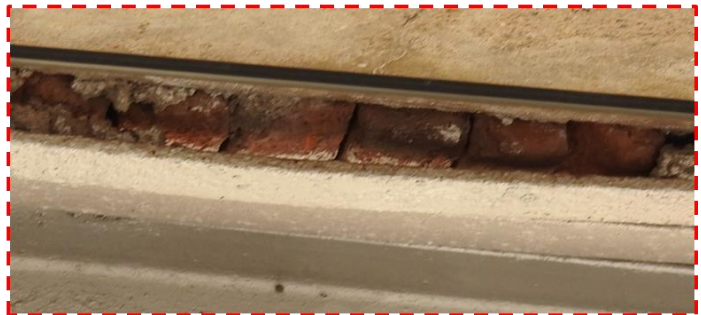
**Fig 1.6:** Bricks are used to fill the gap above floor beam

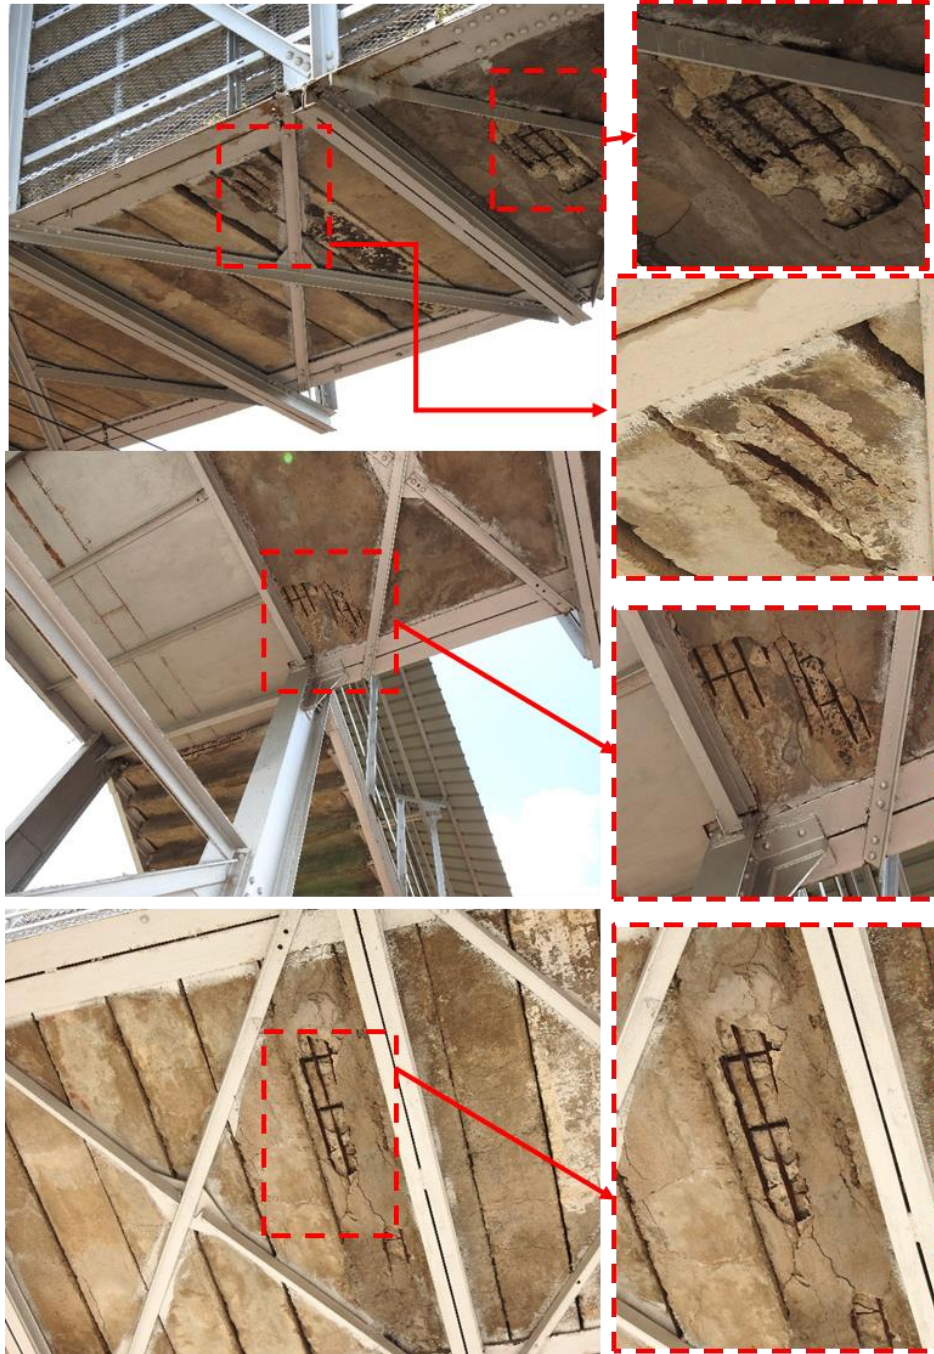
| | Shape of Floor beams /Bracings | Double Channels angle section | 2/ISMC 150 Double Angle Sections are used as Floor beams, supported with 75 x 75 x 8 mm inclined support to top Chord member. 65 x 65 x 8 mm angle sections are used for inclined bracings of pathway. Floor beams are connected to bottom chord Member using riveted connections and Bracing are connected using riveted and welding. (Refer <b>fig :1.7</b> ) |

**Fig 1.7:** Spalling is observed in Floor slab from bottom

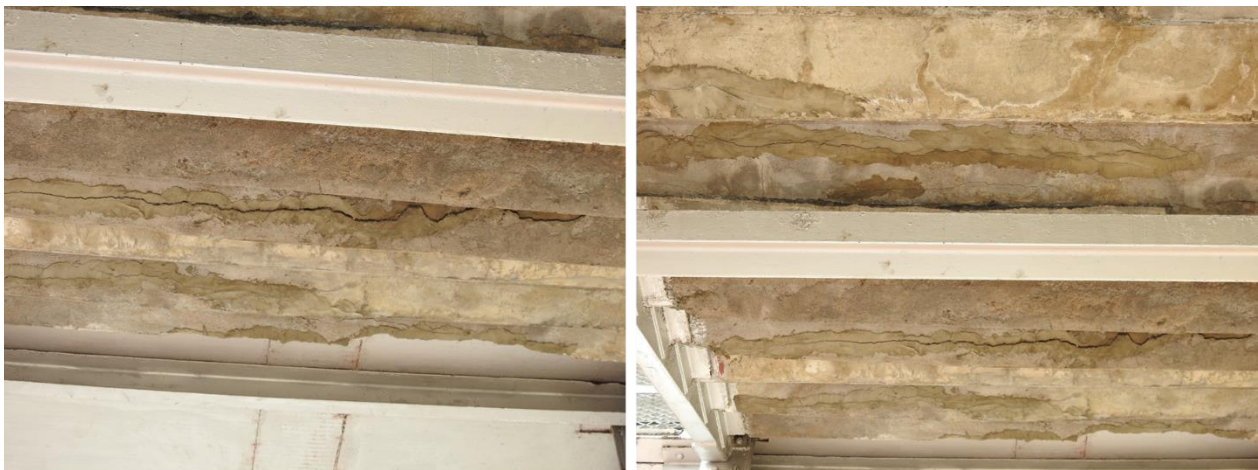
**Fig 1.8:** Cracks are observed in staircase steps from bottom

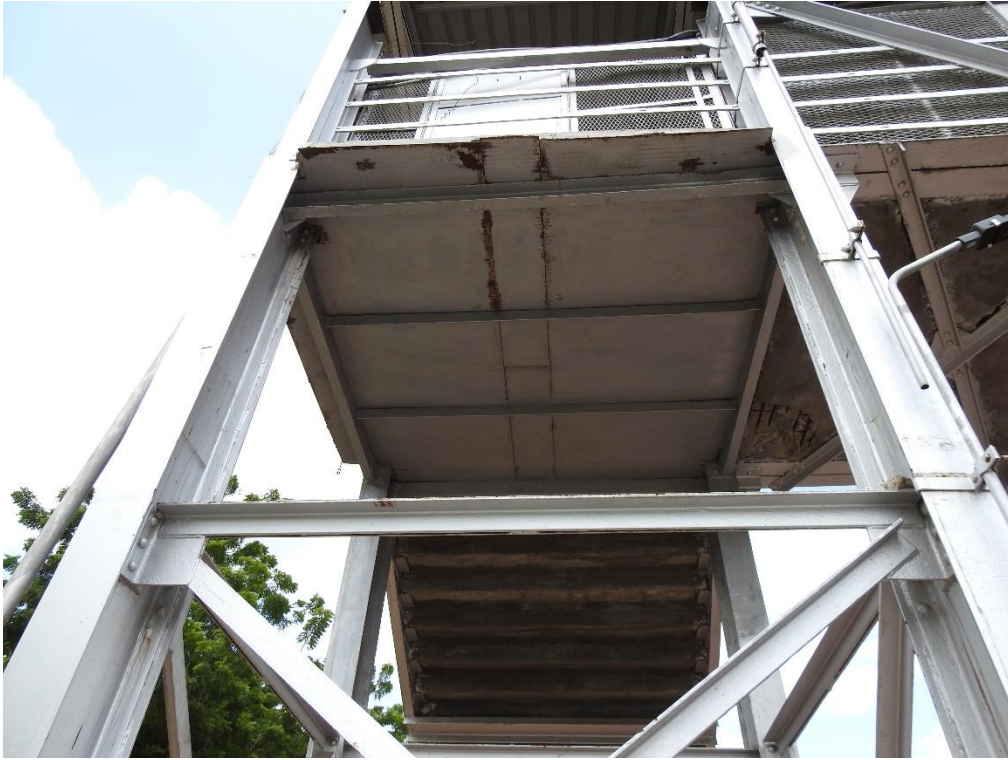
| | Material of Slab | Pre-cast slabs | a) Pre-cast Reinforced Concrete Slab panels are used for floor slab of 100 mm thick, Pre-cast RCC slab panels are resting on Angle chord members supported on Floor beams and Bracings from bottom. Chequered tile (25 mm thick) flooring is laid on the top of the Pre-cast slab panels. (Refer <b>fig : 1.7</b> )<br>b) Almost all the panels are having minor cracks and some of the slab panels are repaired.<br>c) Slab panels near to the platform 2 are distressed, spalling observed at the bottom of the slabs and reinforcement is exposed and corroded. (Refer <b>fig :1.7</b> )<br>d) Bricks are used to fill the gap above floor beam<br>e) Pathway on trestles<br>Plat form 1 is repaired with cement motor<br>Platform 2 is supported by sacrificial plate. (Refer <b>fig :1.9</b> ) |
| | Number of Staircase | 2 No's | a) Staircase steps are observed as Pre-cast RCC slab panels of size 300 x 100. Steps are supported on ISMC 250 Channel using cleat Angles. Staircase Landing of 1.56 m wide is supported on Vertical Angle and Horizontal Channel Members. (Refer <b>fig :1.8</b> )<br>b) Staircase is repaired at bottom with cement motor. (Refer <b>fig :1.8</b> )<br>c) Reinforcement is exposed and corroded. (Refer <b>fig: 1.7</b> )<br>d) At platform 2, under the staircase there is room, which is of debris. (Refer <b>fig :1.9</b> ) |

***Fig1.9:*** Pathway on trestles on platform 2, under the staircase there is room, which is of debris.

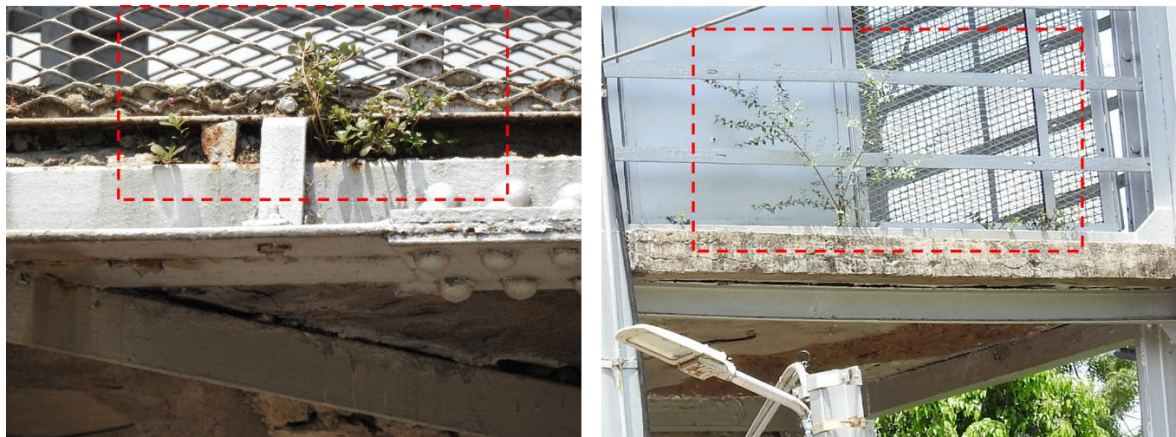
- **Methodology for cleaning:** Generally foreign material is deposited or accumulated on bridge deck and in several bridge components which can deteriorate the bridge if proper action is not taken, so we support cleaning.
- **Debris removal:** The surface areas of a FOB should be cleaned and washed by brushing with fresh water or using high-pressure water blasting, including Deck slab top, sides along steel concrete joint on either side of deck, Supporting Railing and connecting staircase.
- **Vegetation removal:** Vegetation growth shall be removed from the components of the FOB, and near the FOB. *(Photographs of the same can be seen in **fig: 2.1**)*

**Fig 2.1:** Locations of Vegetation growth and debris

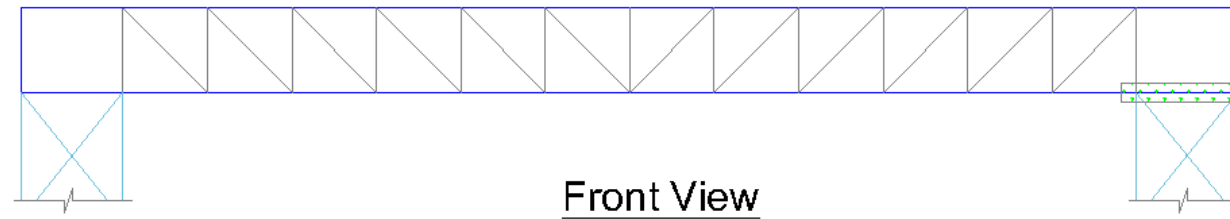
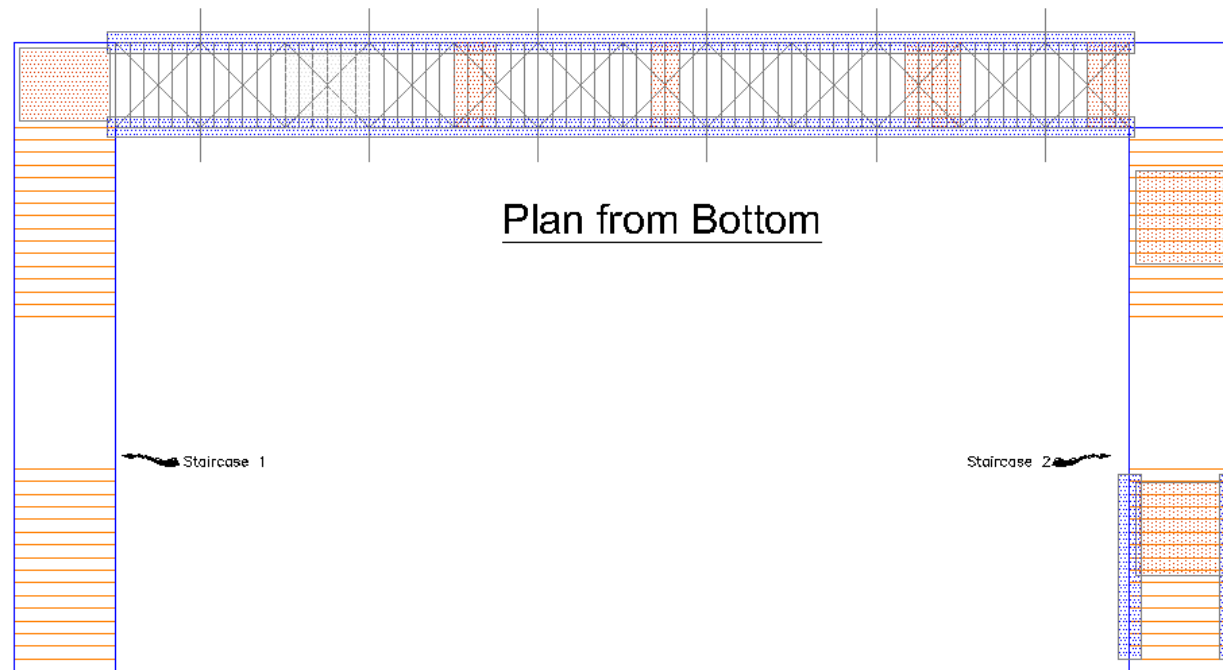
**Fig 2.2:** Locations of different elemental Deteriorations

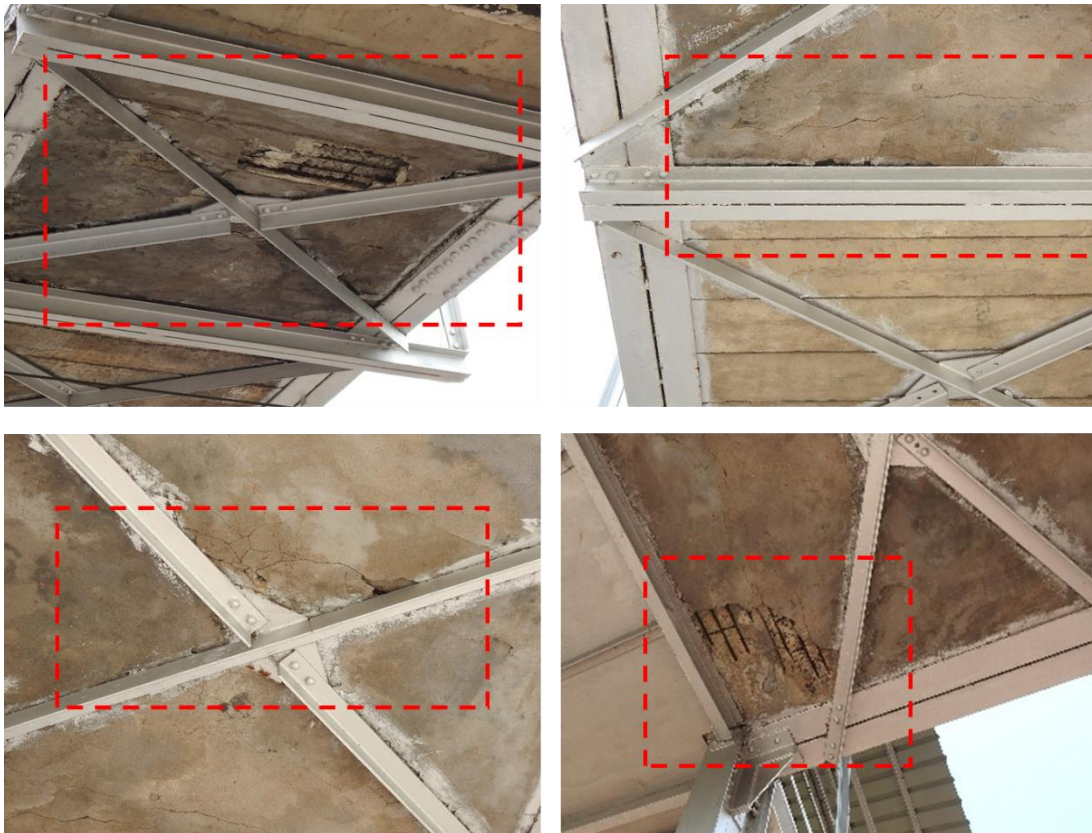
Reinforced cement concrete Slab at Deck level and some precast panels in staircase are observed with exposed rebar in many locations. *(Photographs of the same can be see in **fig 2.3-2.6**)*

**Fig 2.3:** Surface cracks and spalling are observed in repaired slab

**Methodology for patching:** Hand applied Mortar (Patching) repair is performed to restore small areas where sound concrete is damaged by spalling, scaling and/or impact. This method of repair is generally applied using trowel and require minimum or formworks. The patch thickness is limited to a maximum of 100 mm depth of hollow surface. Hand applied Mortar repair is classified into two types considering defective area and surface. Hand applied Mortar

- i. Anti-corrosive treatment for Grade-1 and Grade-2 highlighted corrosive members like floor beams, top chord and bottom chord. Carryout structural repairs to all Steel members as per Annexure 1c.
- ii. Replacement of precast slab panels in slab level and staircase where reinforcement is exposed and corroded.

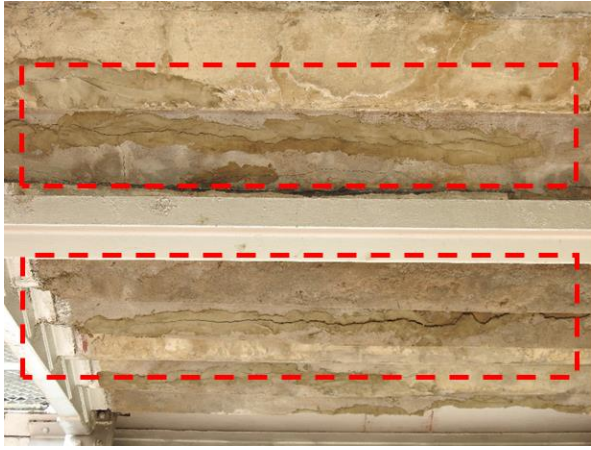
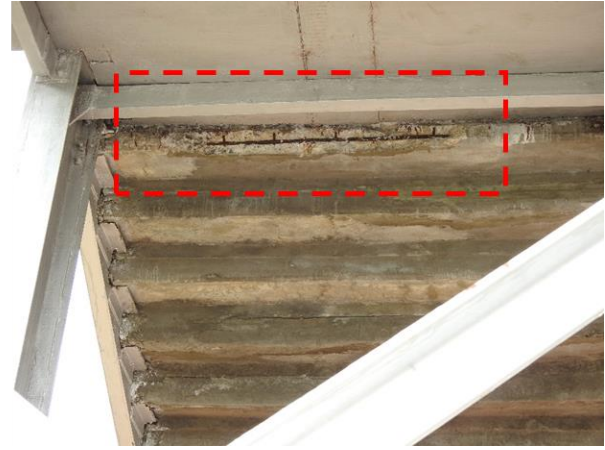
**Fig 2.4:** Spalling and cracking is observed in repaired panels of staircase 2

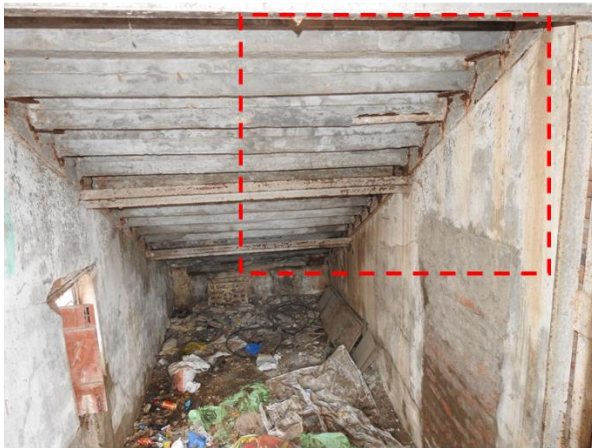
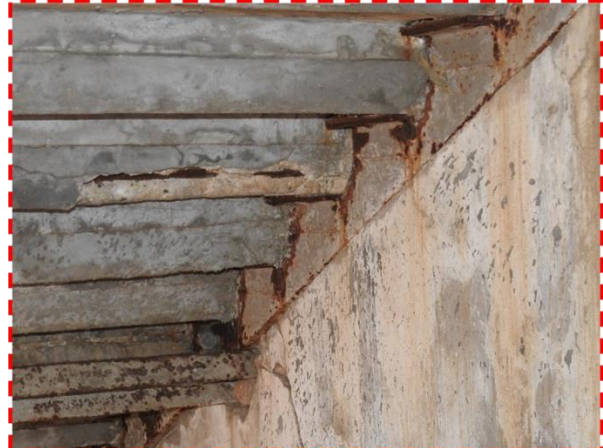
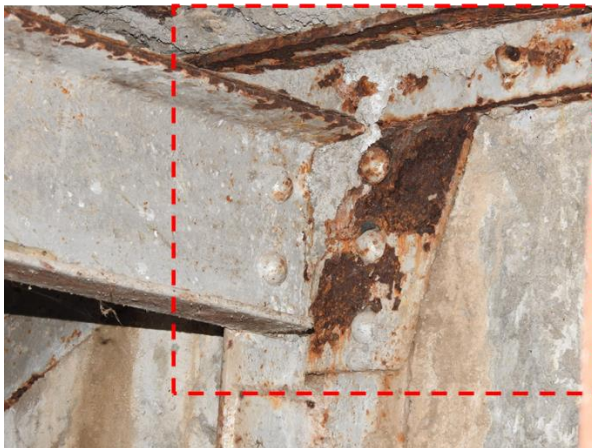
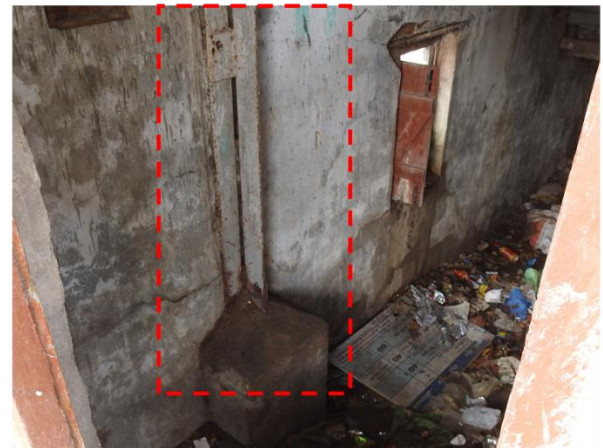
- Structural members are in fair condition, mild and moderate corrosion is observed in steel members.
- Staircase stringer beam is severely corroded. (Photographs of the same can be seen in **fig 2.5**)
- Vegetation is observed along steel concrete joint on outer surface at deck level. Carryout removal and cleaning as per Annexure 1a. (Photographs of the same can be seen in **fig 2.1**)
- In Majority of RCC Pre-cast slab panels spalling of concrete cover, cracking and reinforcement exposure is high. (Photographs of the same can be seen in **fig 2.3-2.6**)

**Fig 2.5:** Locations of Deteriorations in staircase first flight from bottom

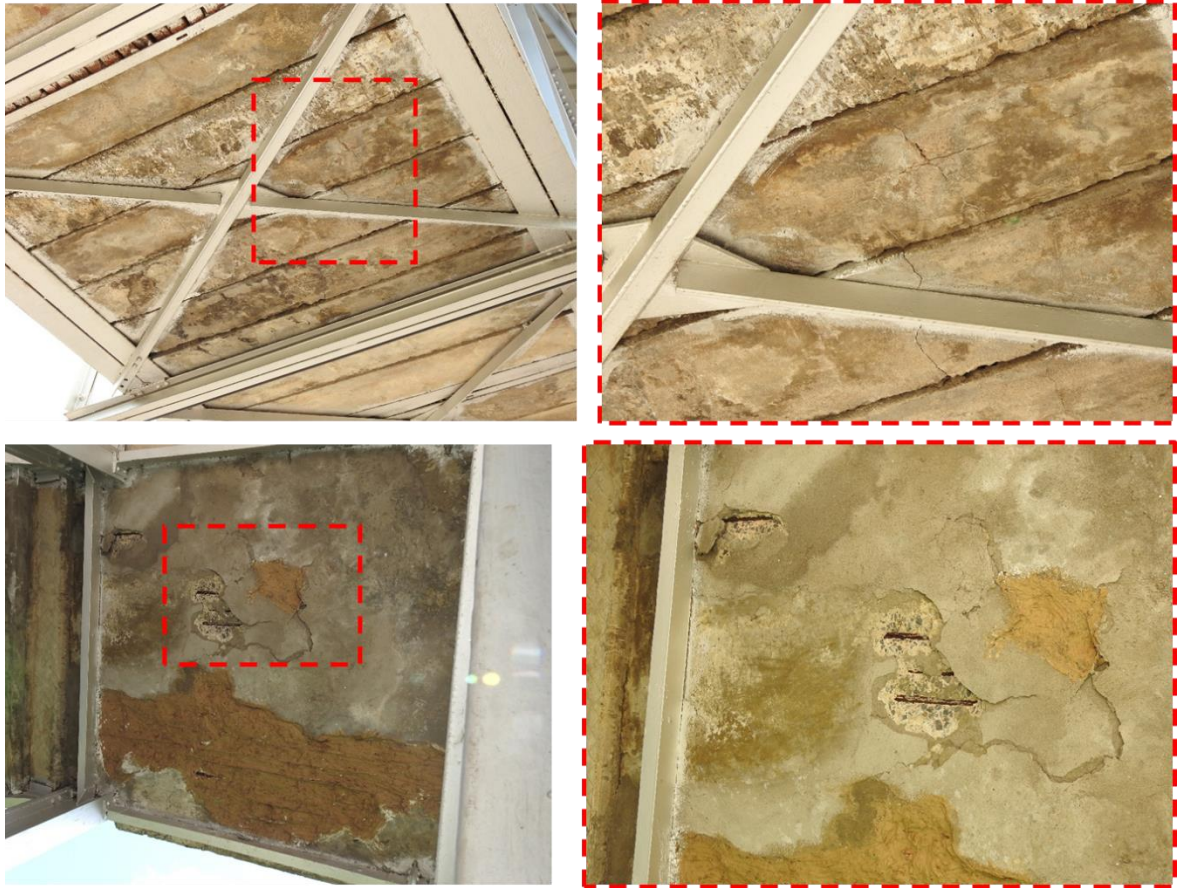
**Fig 2.6:** Cracks and spalling at bottom of slab
