## Third Party Audit of ROB's and FOB's of SCR

### INSPECTION OF FOB AT KAZIPET RAILWAY STATION

**Final Report**  
SEPTEMBER | 2020

| <b>Name of the Project</b> | <b>:</b> | VISUAL INSPECTION OF FOB/ PF-1 - PF-3 AT KAZIPET RAILWAY STATION |

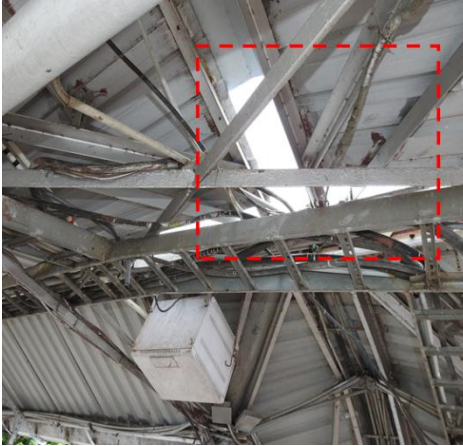
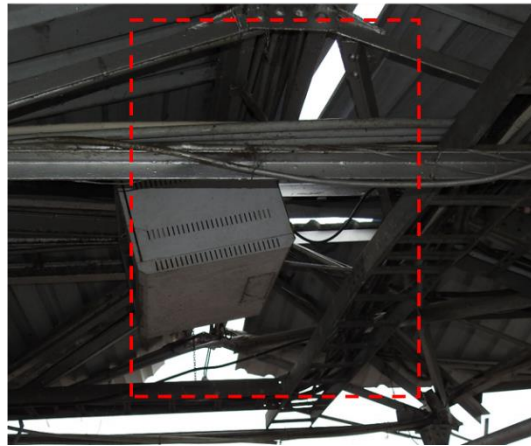
- ✓ Roof metal sheet is missing near staircase 2 on FOB

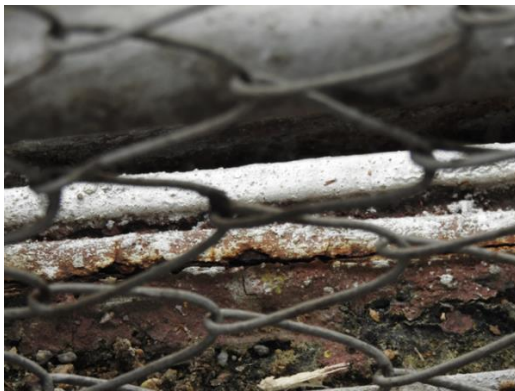
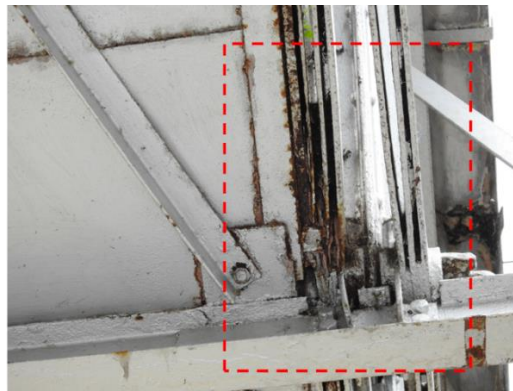
- ✓ **Condition:** Deteriorated M.S. Steel plates and pin joints are corroded in Bottom chord
- ✓ Bottom Chord members (M.S. Steel plates) are more prone to corrosion as rainwater on floor slab comes in contact with it and also due to dust/debris accumulation between the plates which retains the moisture leading to accelerated corrosion.

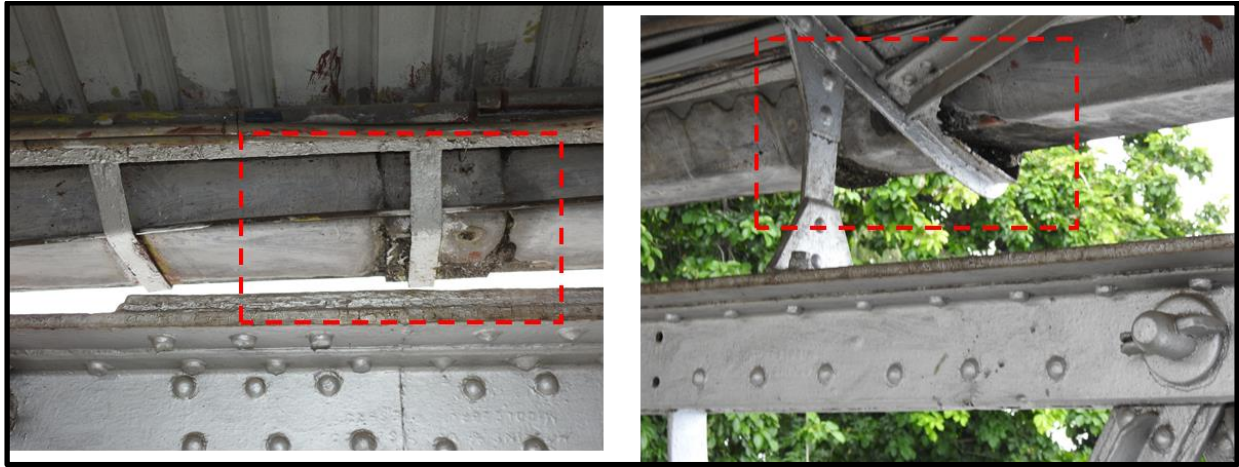
**Fig1.5:** Organic growth near top cord

- i. Foreign material and Vegetation growth shall be removed from the components of the FOB. Carryout removal and cleaning as per Annexure 1a.
  - ii. Anti-corrosive treatment for Grade-1 and Grade-2 highlighted corrosive members like floor beams, top chord and bottom chord.

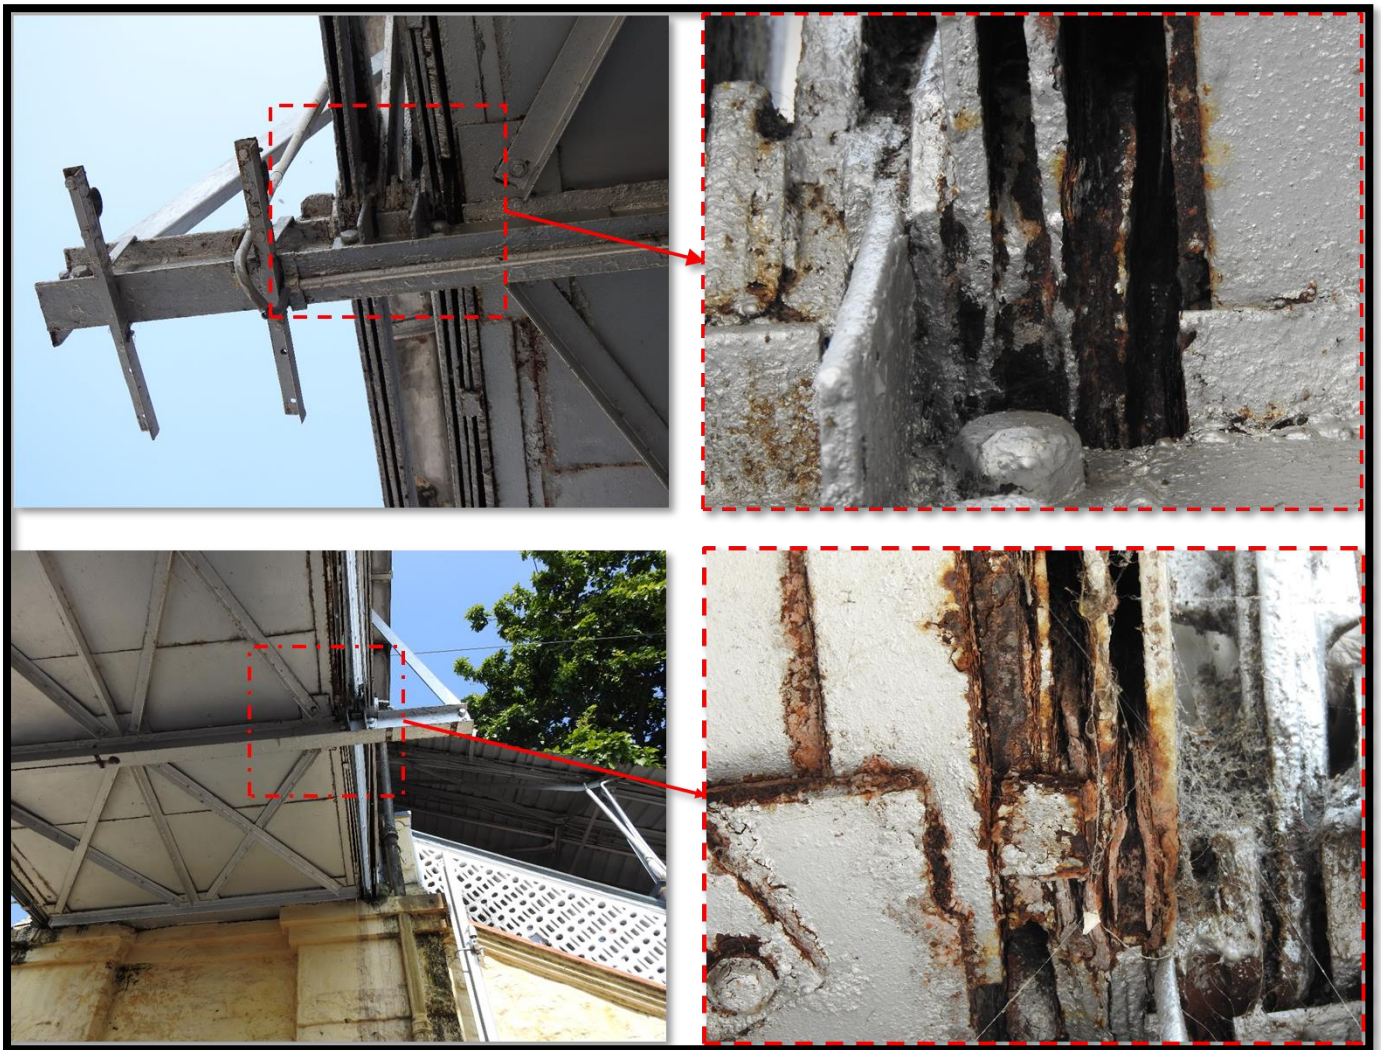
| Defects | Location | Notes |
|---|---|---|
| Corrosion in Gusset plate | Floor level | Corrosion is observed at bottom of Main plates ( <b>Fig 1.6</b> ) |
| Corrosion at steel-Concrete joint | | Major corrosion is observed near pin joints at bottom of FOB ( <b>Fig 1.6</b> ) |

**Fig 1.6:** Severe corrosion in main plates at bottom of FOB.

- When the condition of the member is observed to be in Grade – 3, which might have occurred due to environmental conditions or age of the structure. In such cases section loss is calculated by using caliper where it is accessible and UPV at one accessible location. The first step in dealing with corrosion is to measure the section loss in the member. The member may be measured using calipers or other appropriate methods for totally exposed sections.

- i. Section Loss < 15% - Clean the Surface and Apply the anticorrosion protective coat.
  - ii. Section Loss 15% - 40% Repair the member as per design.

- iii. Section Loss > 40% - Replace the member.

- iii. Replacement of severely corroded splice joints, gusset plate and sacrificial plate.  
Carryout structural repairs to all Steel members as per Annexure 1b.

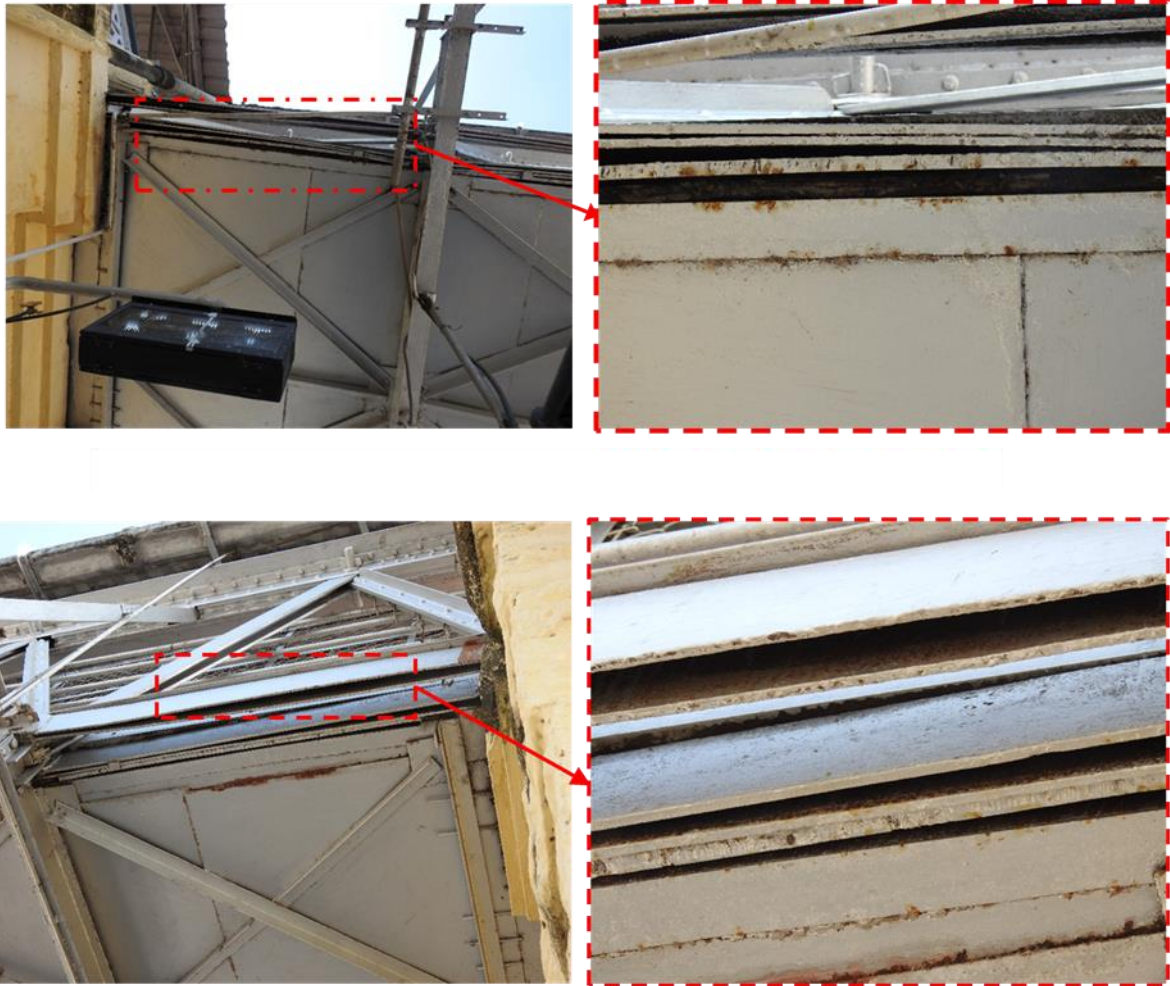
***Fig 1.7:*** Bending of bottom main plates

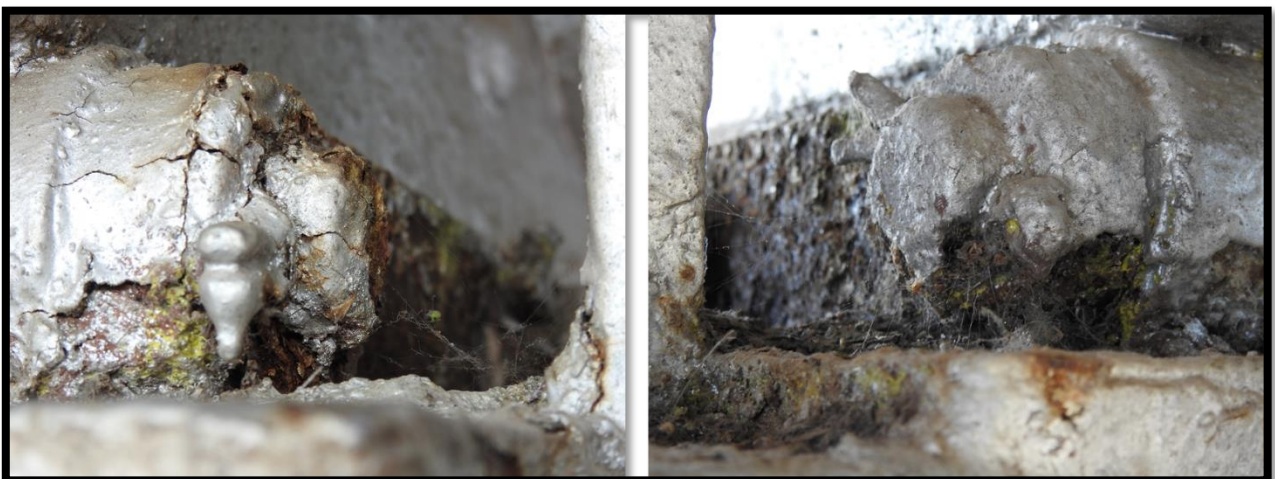
***Fig 1.8:*** Corrosion of rollers near staircase 3

- If the paint condition is identified as Grade-1, aluminum paint shall be applied with a similar shade.
- Where condition of paint is evaluated as Grade-2 special anticorrosion paint shall be applied to restrict corrosion from progressing further.

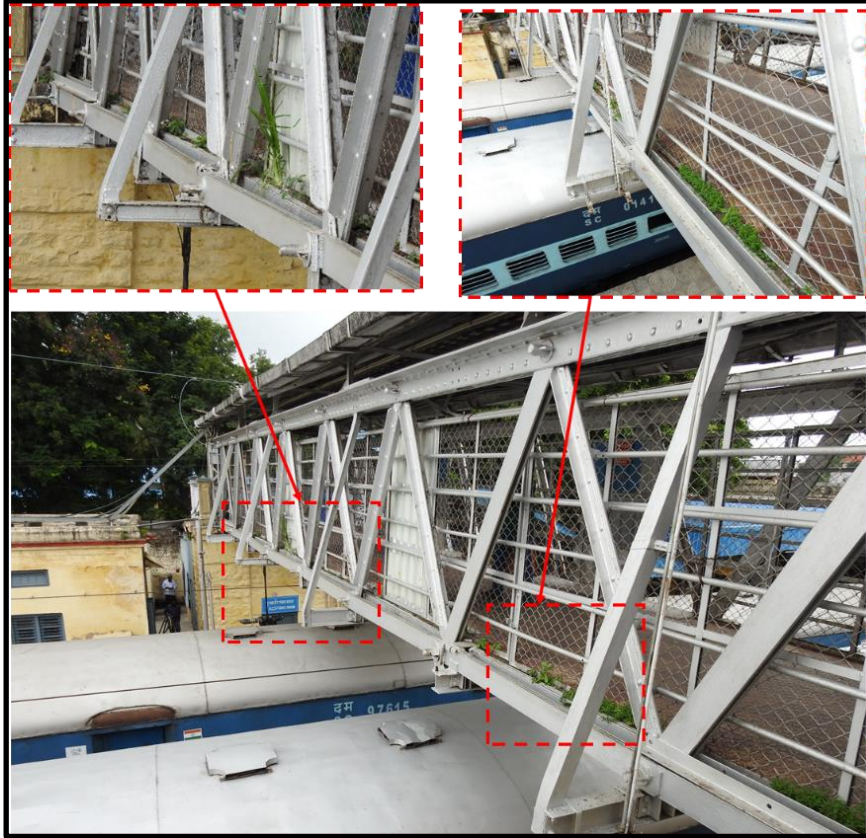
| Defects | Location | Notes |
|---|---|---|
| Water seepage | | Organic growth is observed ( <b>Fig 1.9</b> ) |

**Fig 1.9:** Vegetation on both sides of FOB at bottom

- **Methodology for cleaning:** Generally, foreign material are deposited or accumulated on bridge deck and in several bridge components, which can deteriorate the bridge if proper action is not taken, so we support cleaning.
- **Debris removal:** The surface areas of a FOB should be cleaned and washed by brushing with fresh water or using high-pressure water blasting, including Deck slab top, sides along steel concrete joint on either side of deck, Supporting Railing and connecting staircase.
- **Vegetation removal:** Vegetation growth shall be removed from the components of the FOB, and near the FOB. (Photographs of the same can be see in **fig:1.9, 2.1**)

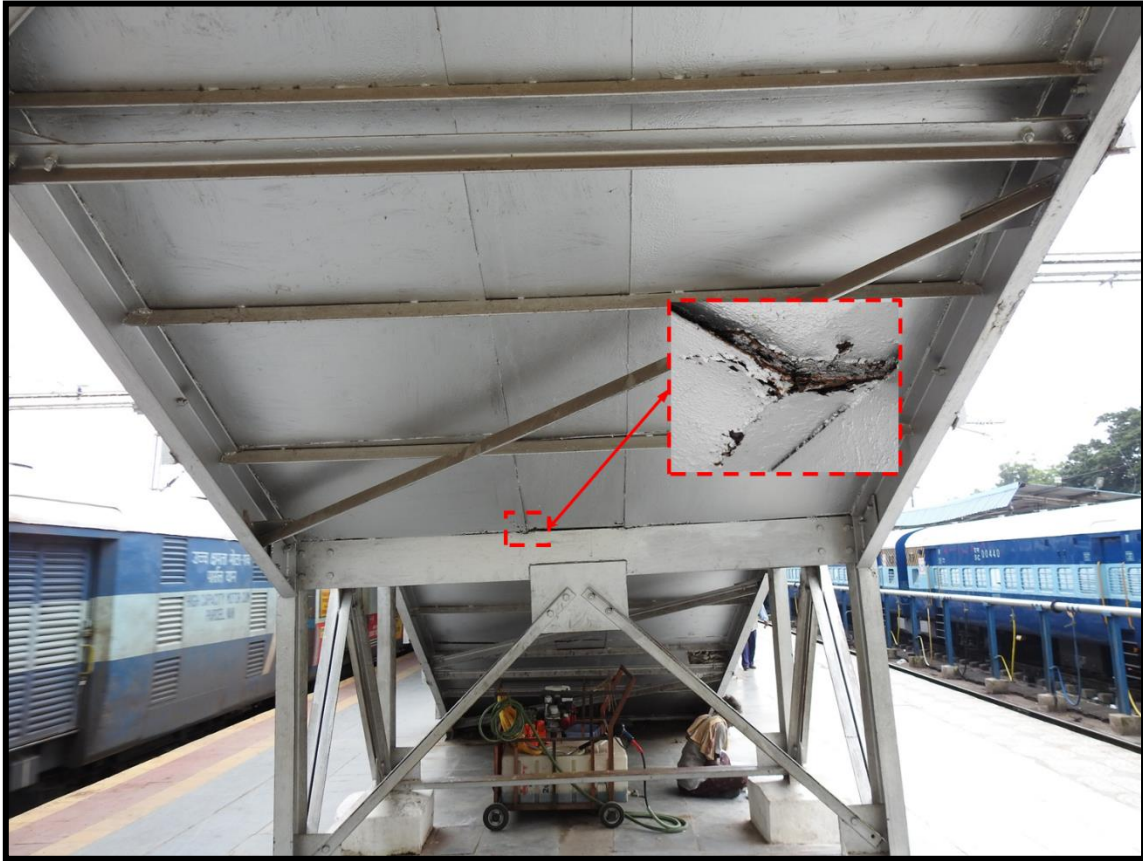
**Fig 1.11:** Bottom view of Staircase 3 from platform 2

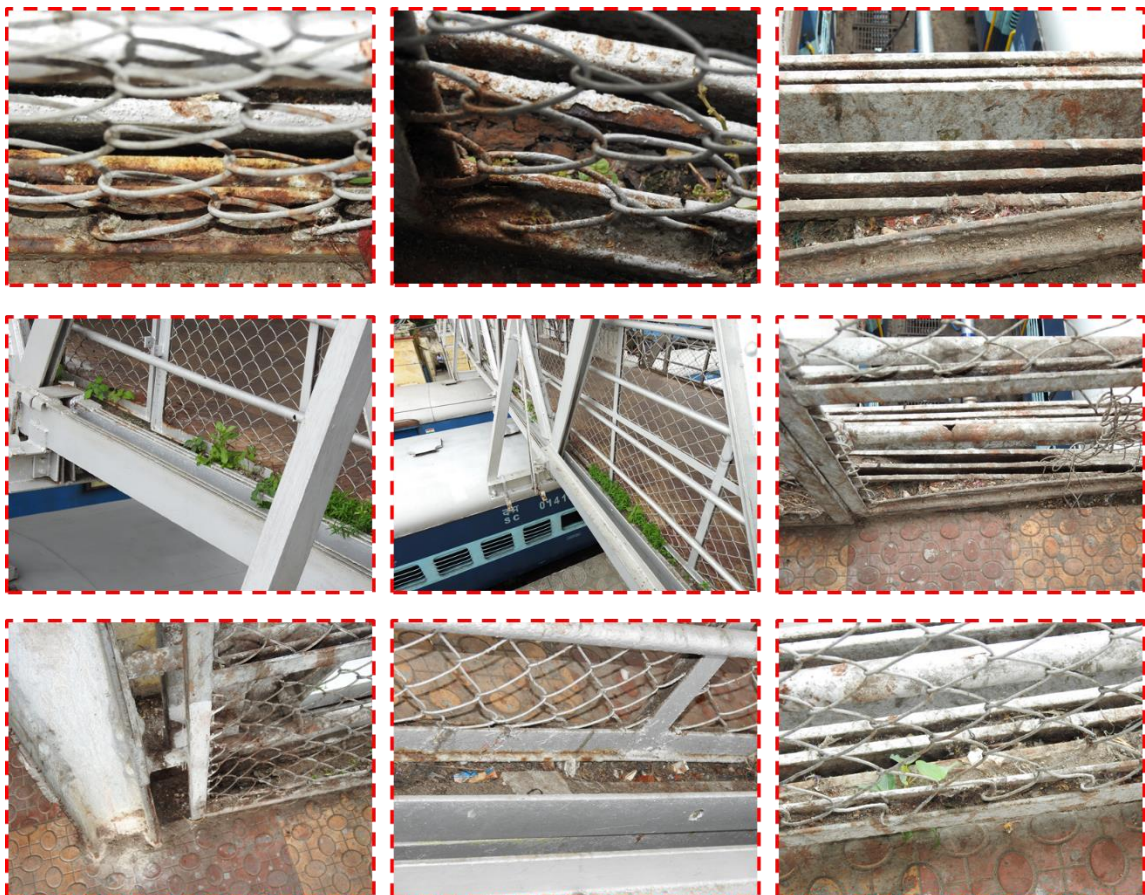
**Fig 2.1:** Locations of Vegetation growth and debris

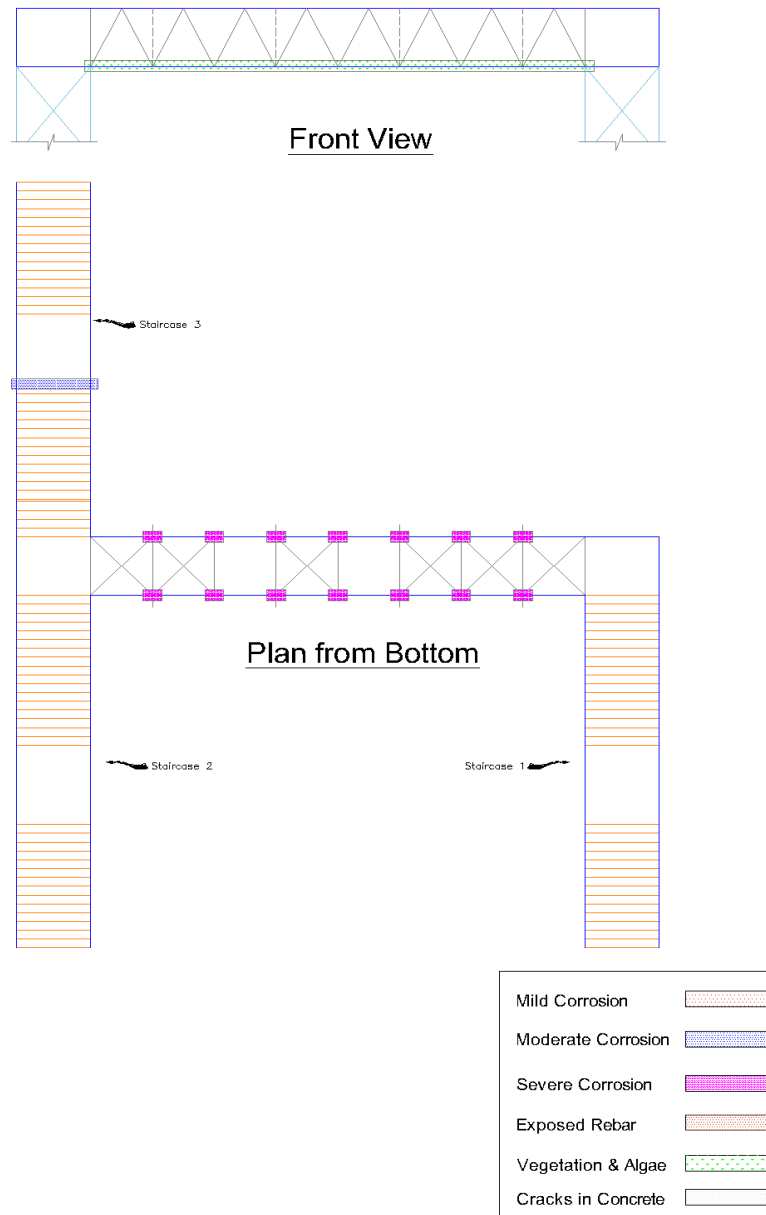
**Fig 2.2:** Locations of Deteriorations

**Table 2.1:** Grading of corrosion in span 1

| Span 1 | Mild Corrosion | Moderate Corrosion | Sever Corrosion | Remark |
| Floor Beams/ Cross Girders | ✓ | | | |
| Bottom Chord (Plates) | | | ✓ | |
| Top Chord | | ✓ | | |
| Bottom Pin Joint | | | ✓ | |
| Sacrificial plate | | ✓ | | |

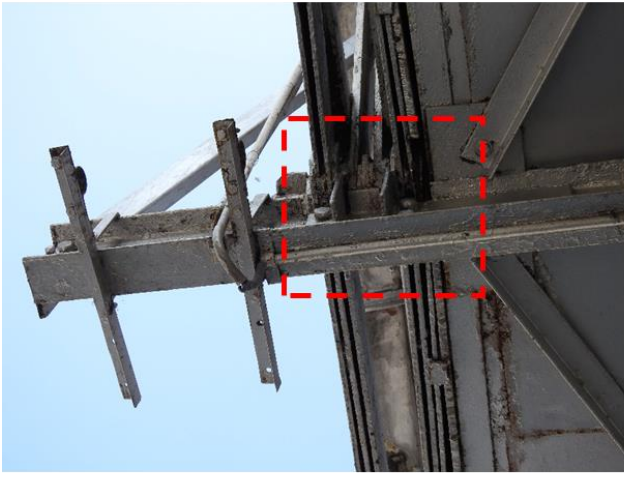
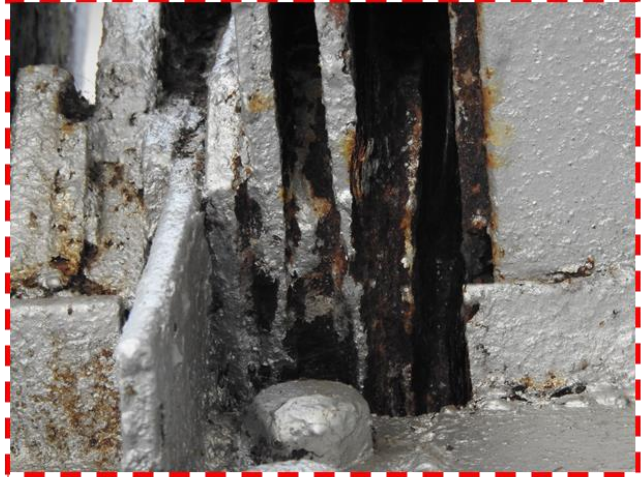
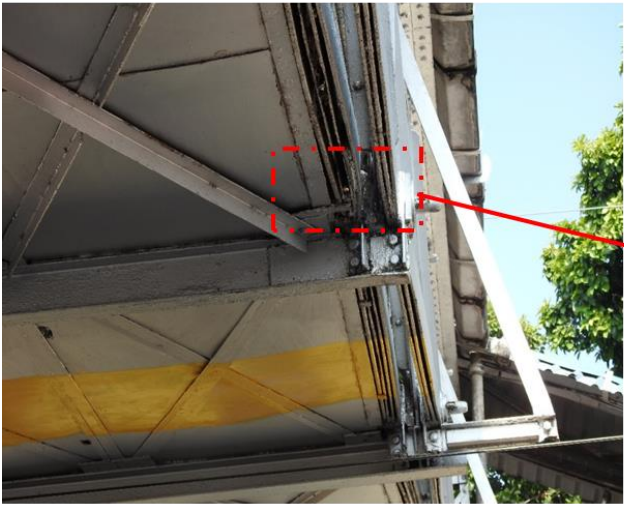
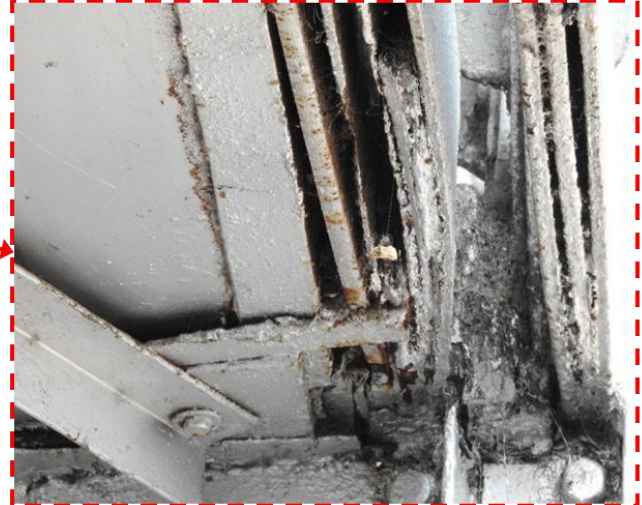
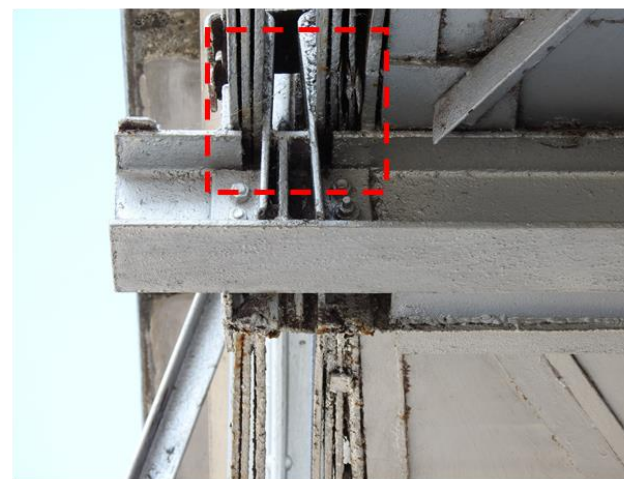
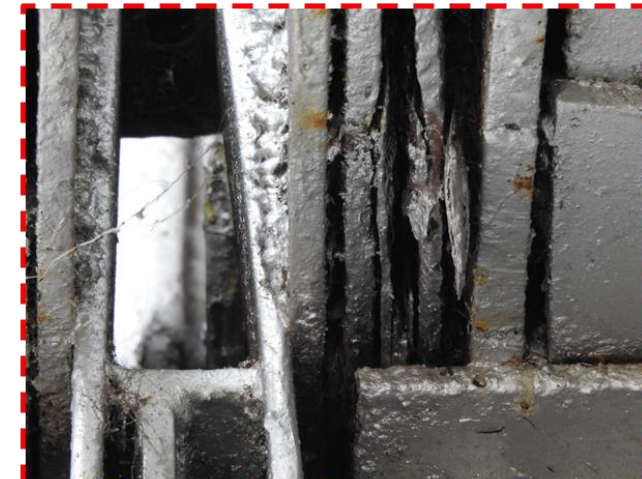
**Fig 2.3:** Locations of Severe corrosion and bulging of joints on deck from bottom

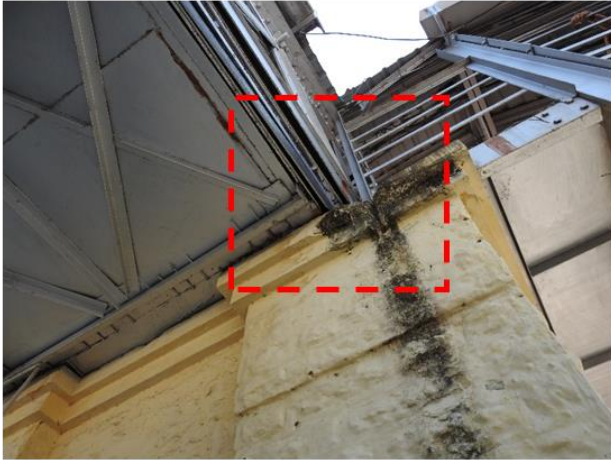
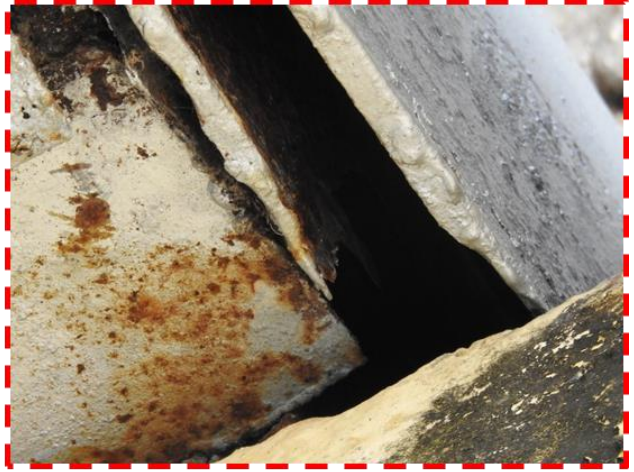
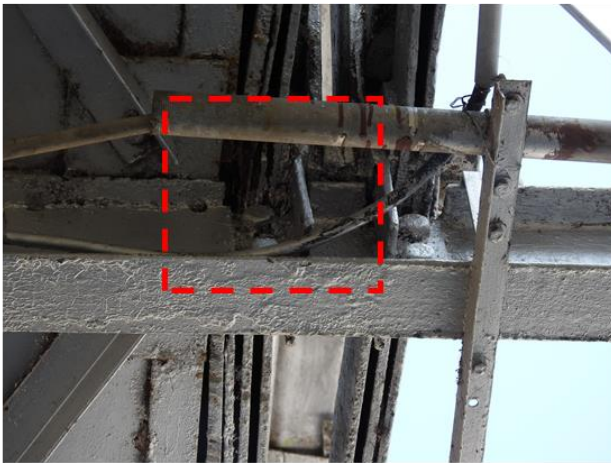
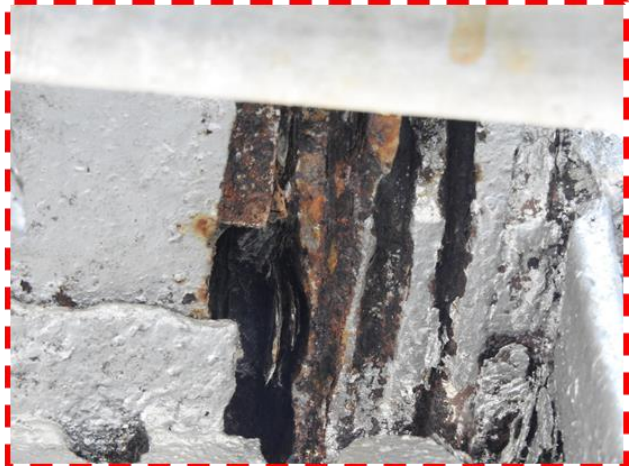
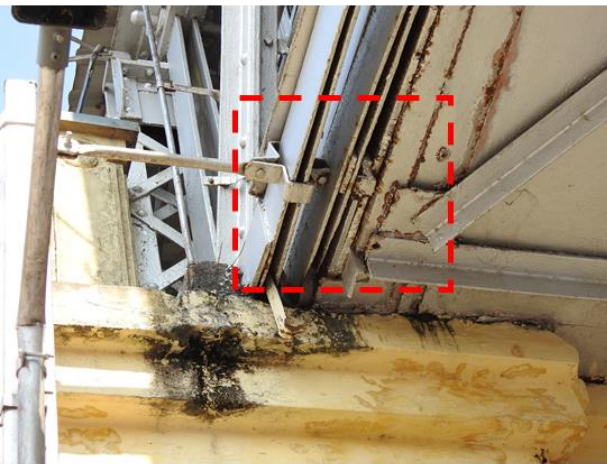
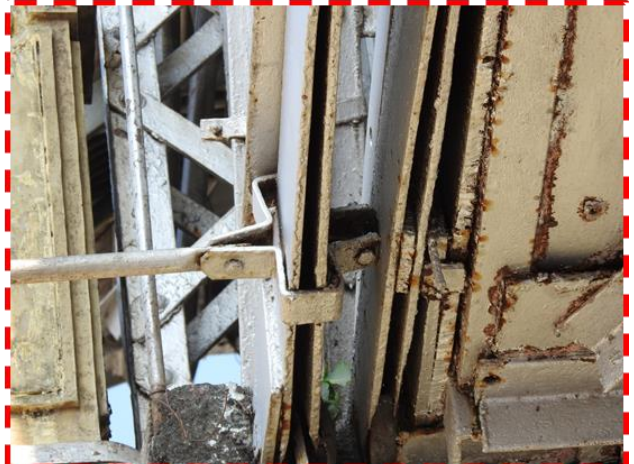
**Fig 2.4:** Locations of Severe corrosion on deck from bottom

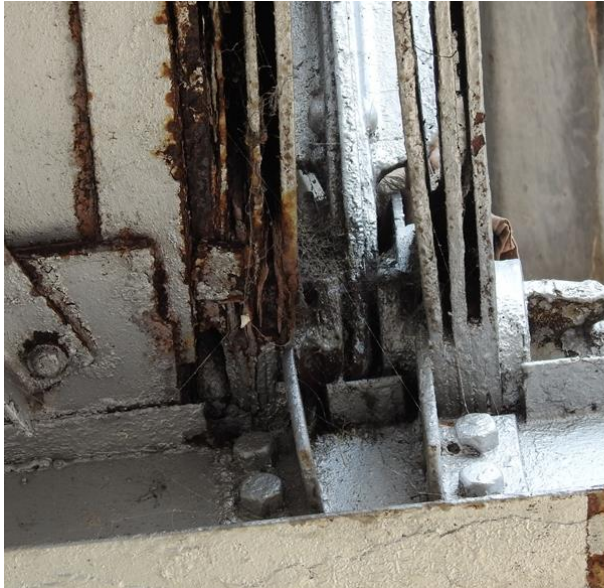
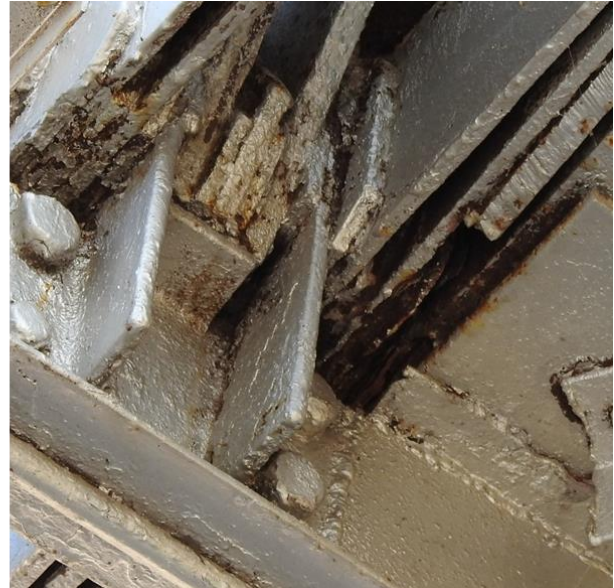
***Fig 2.5:*** Locations of Severe corrosion on deck from bottom
