# Third Party Audit of ROB's and FOB's of SCR

## INSPECTION OF FOB AT ELURU RAILWAY STATION

**Final Report**  
SEPTEMBER | 2020

| <b>Name of the Project</b> | : | VISUAL INSPECTION OF FOB/ PF-1 - PF-2<br>AT ELURU RAILWAY STATION |

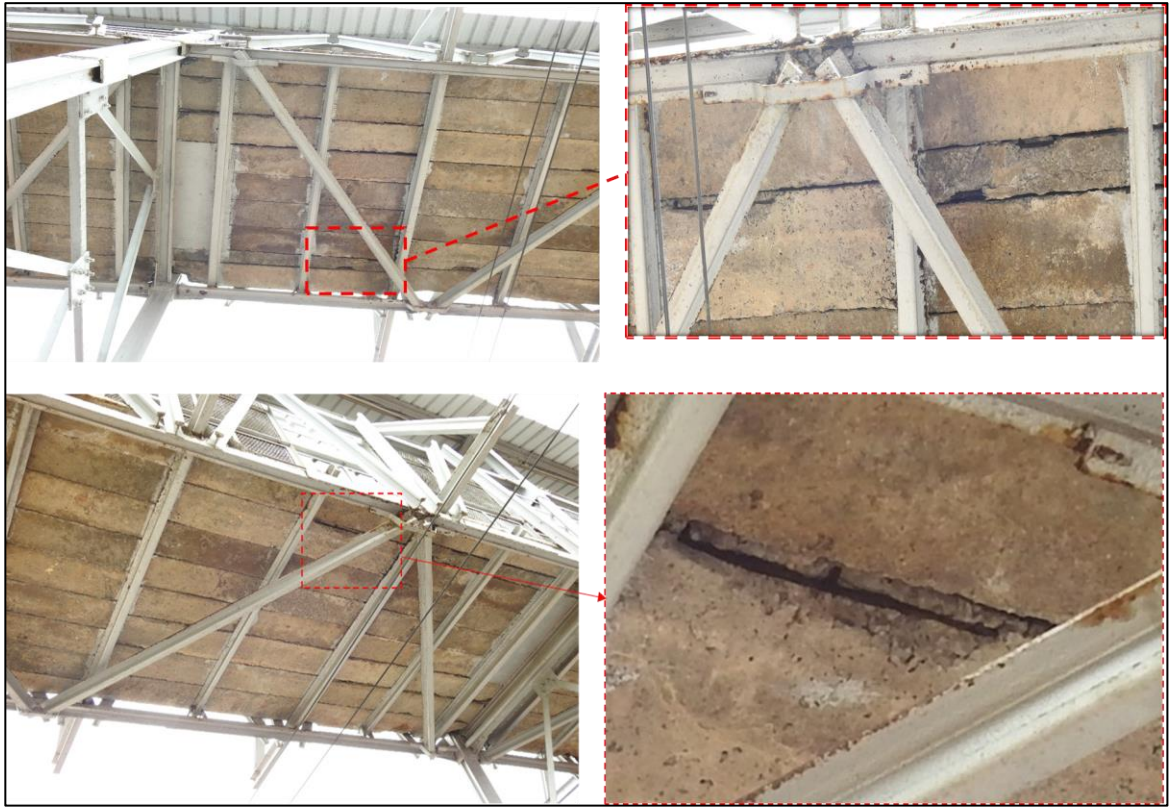
- ✓ Exposed reinforcement is observed on Pre-cast RCC slab panels of Span 1, Span 2 and staircase panels.

(a) Exposed reinforcement and corrosion of rebar

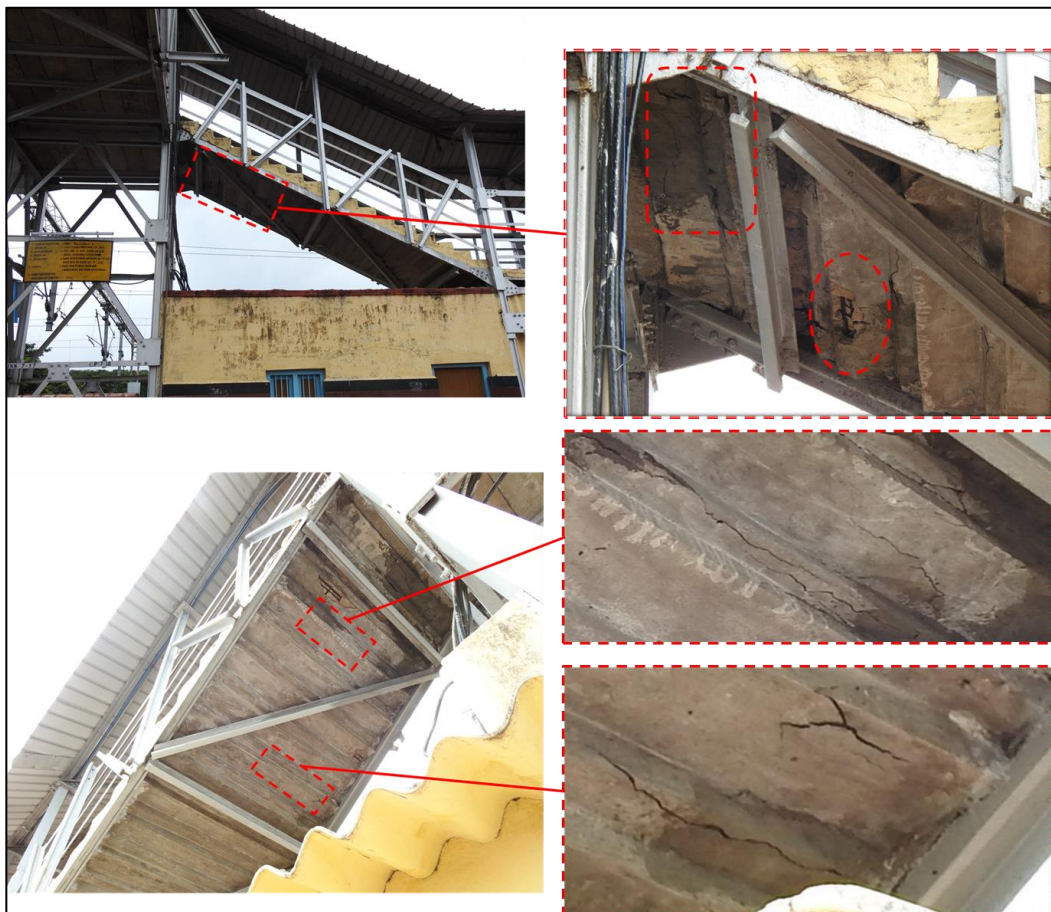
(b) Exposed reinforcement and cracks in staircase panels

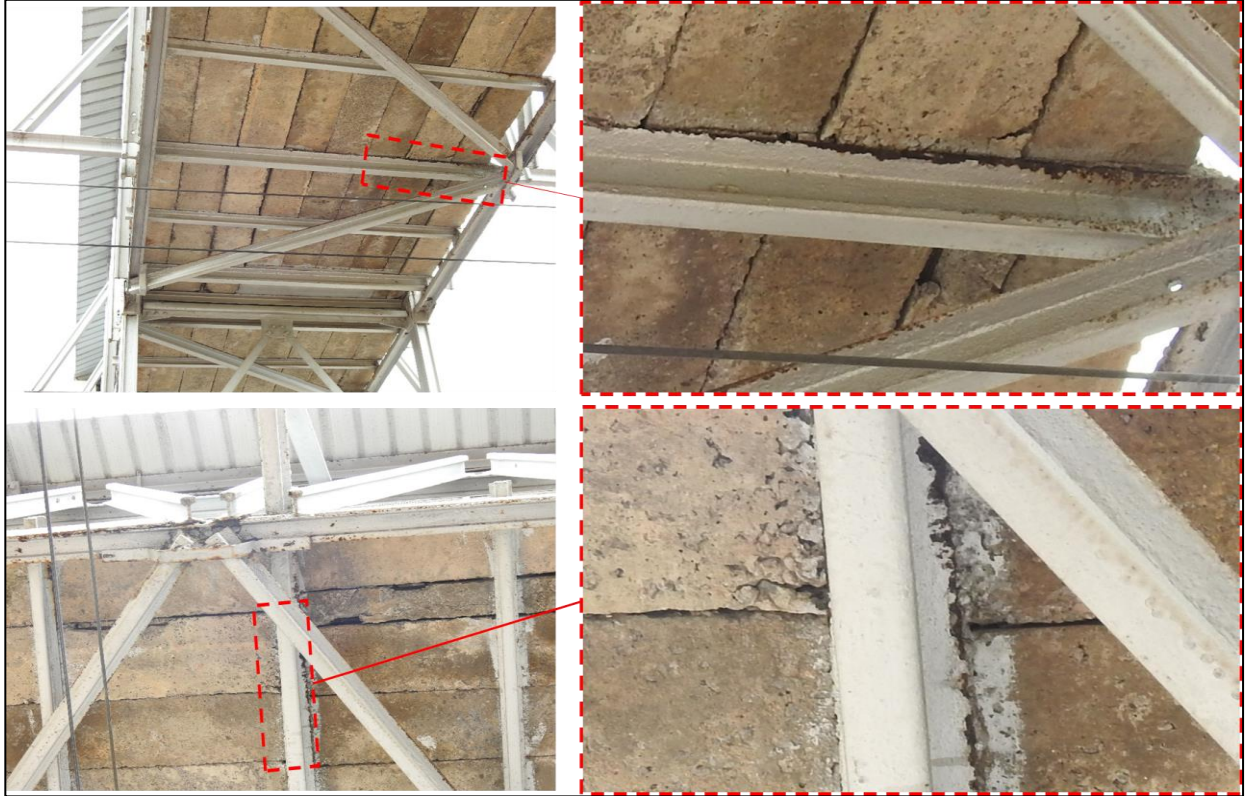
✓ Loss of Effective thickness is observed in floor beams, bottom bracings joints due to corrosion.

(a) Corrosion observed at floor beams

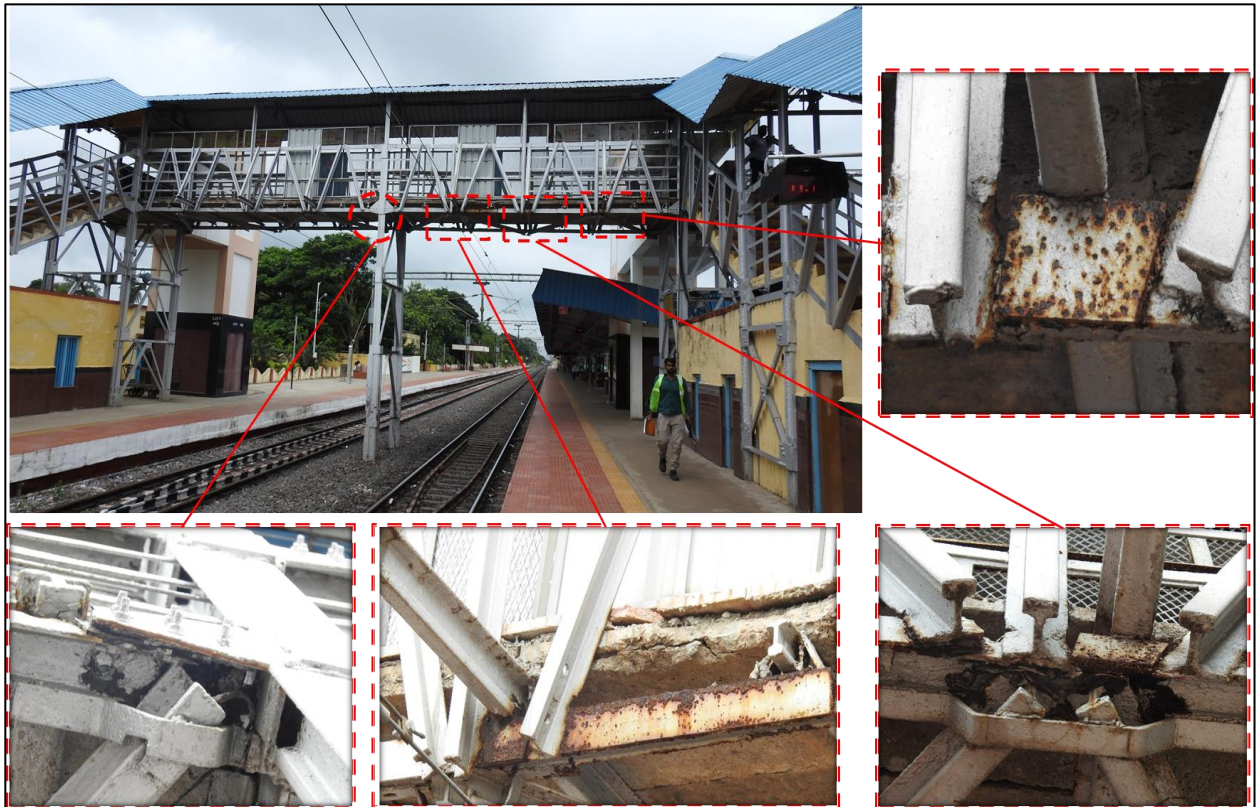
(b) Corrosion observed at Bottom chord and bracings joints.

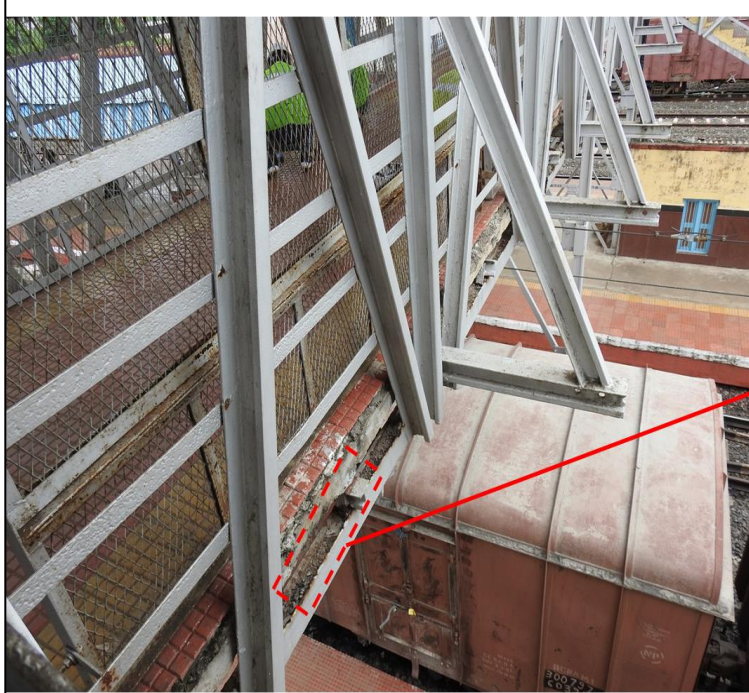
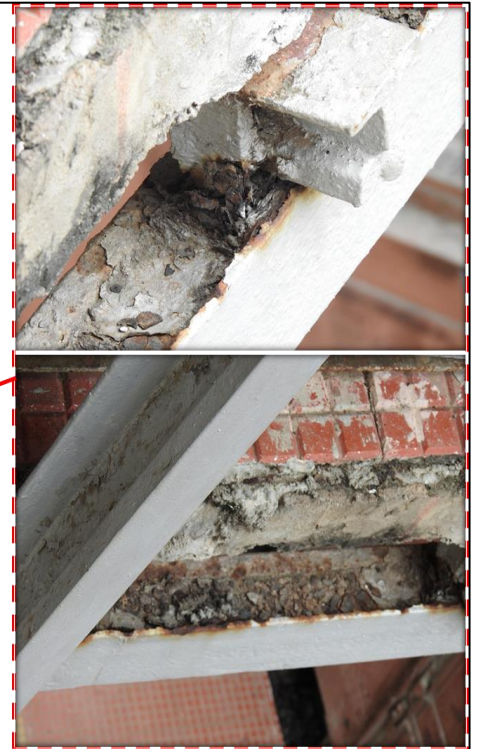
(c) Corrosion at Bottom chord

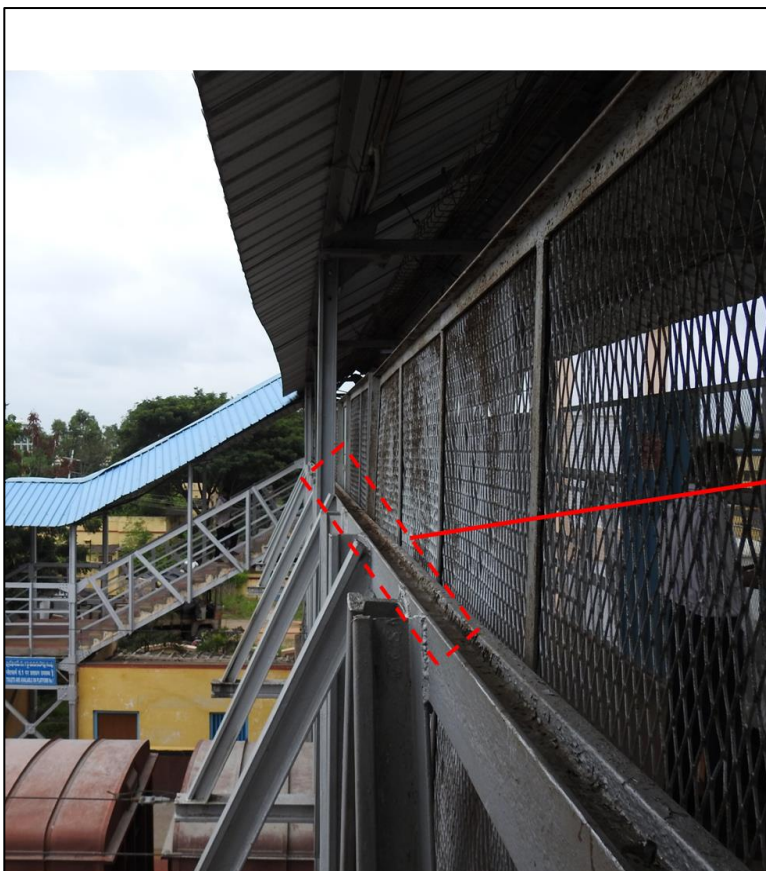
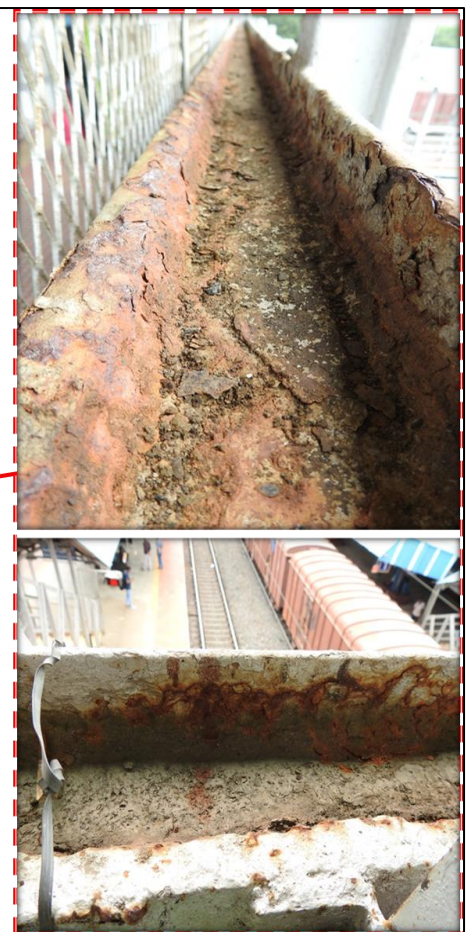
(d) Corrosion at top chord

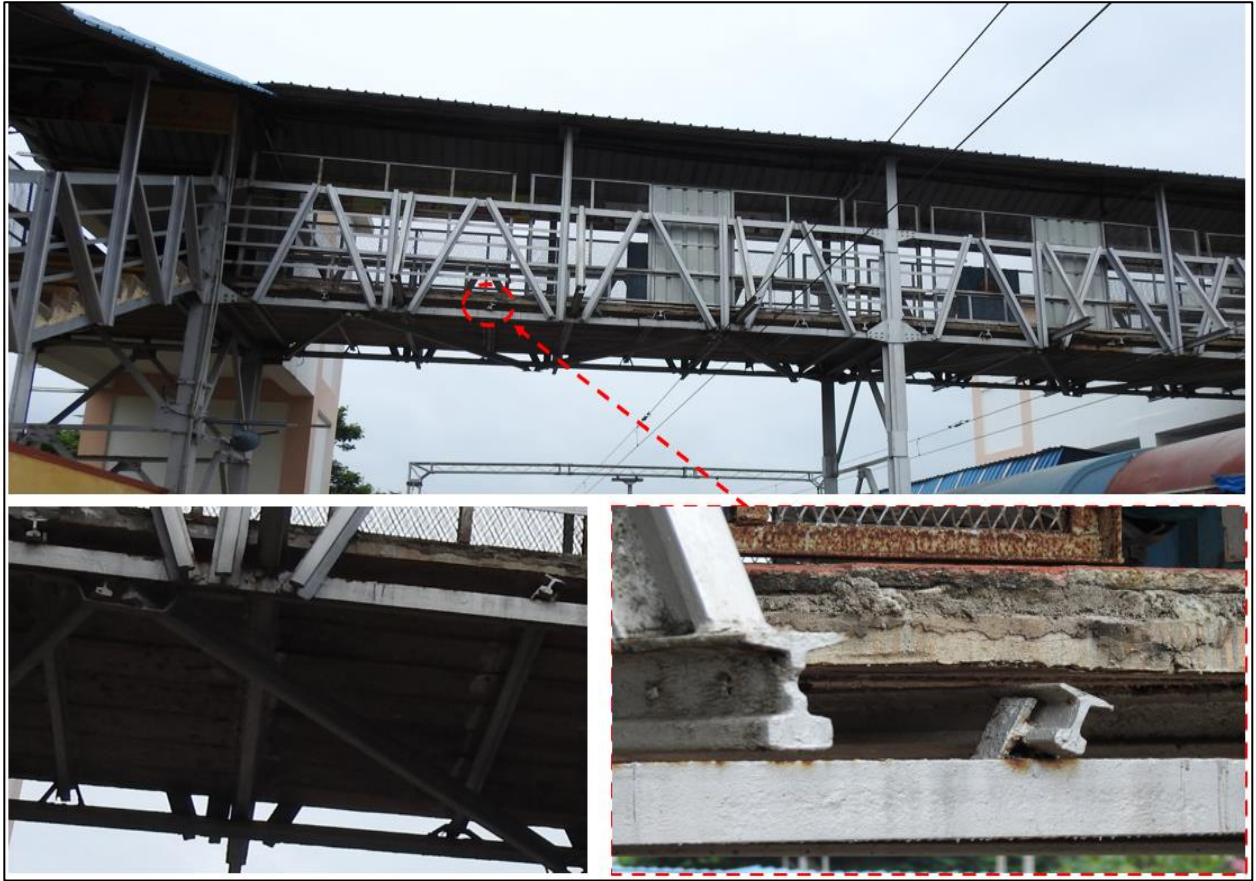
(a) Deformations in floor beam of span 1

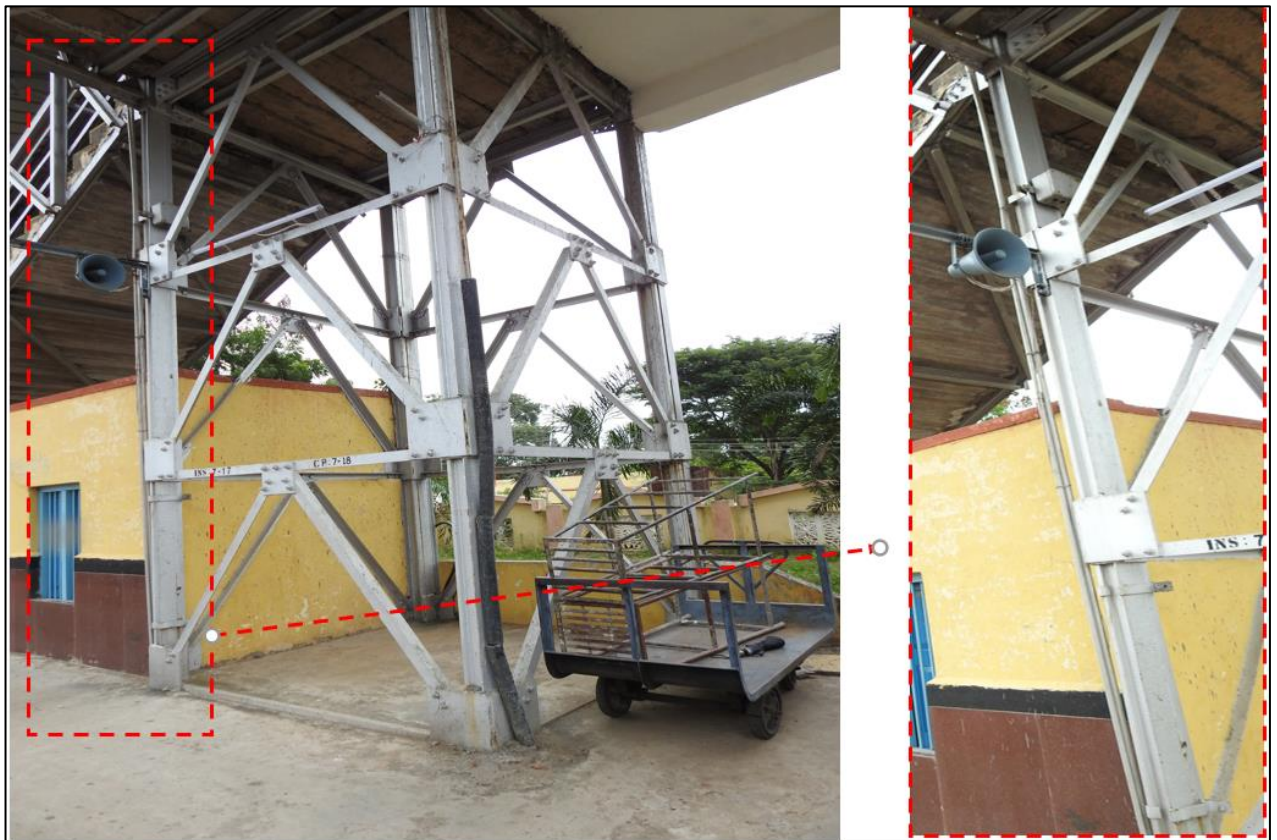
(b) Deformation observed in Trestle-1 column

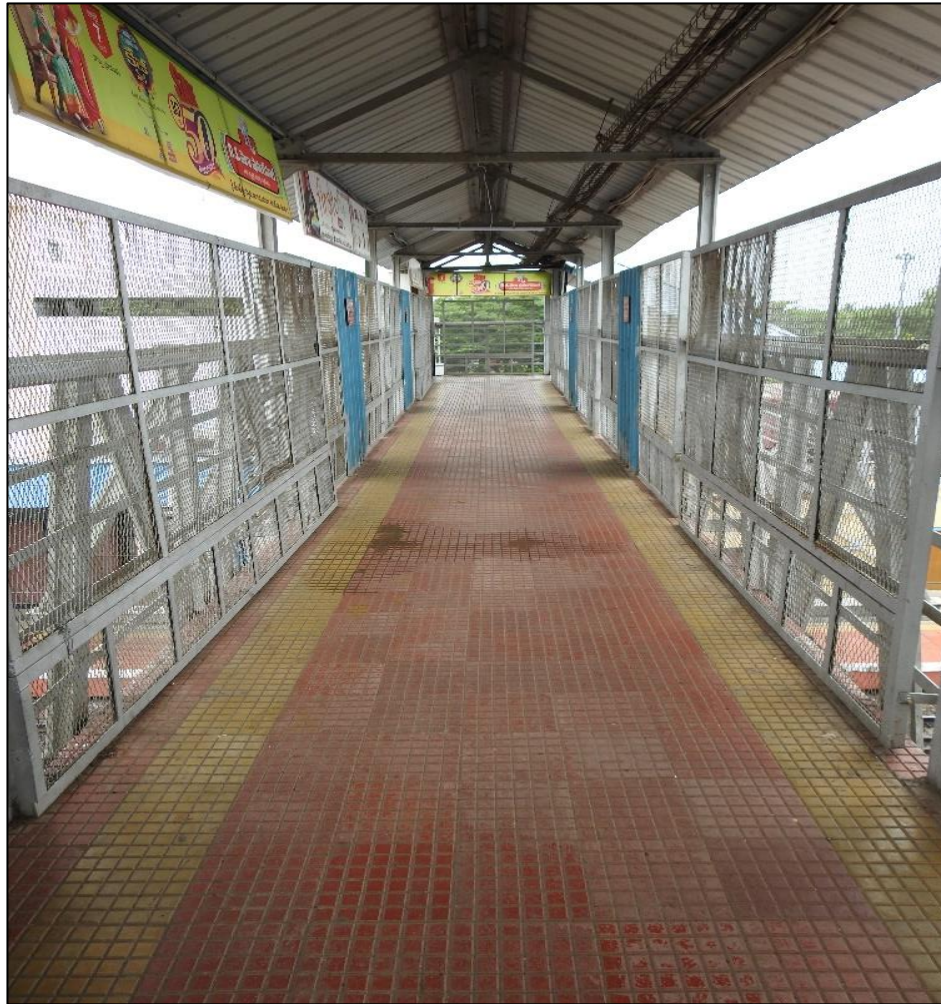
| PART 1.2 IDENTIFICATION OF LOADS ON BRIDGE | | | |
|---|---|---|---|
| | a) Additional wearing coat on Floor | Yes | Only Chequered tiles used for Flooring (Refer <b>fig :1.2</b> ) |
| | b) Provision of protective screen for passengers | Yes | Fence made of galvanized wire of 2 mm gauge and 2 mm galvanized sheet is used above OHE Line on both side of pathway is used for passengers Protection. (Refer <b>fig :1.2</b> ) |

**Fig 1.2:** FOB span 1 & 2 pathway, Roof Truss, Chequered tiles, protective screen and Hoardings

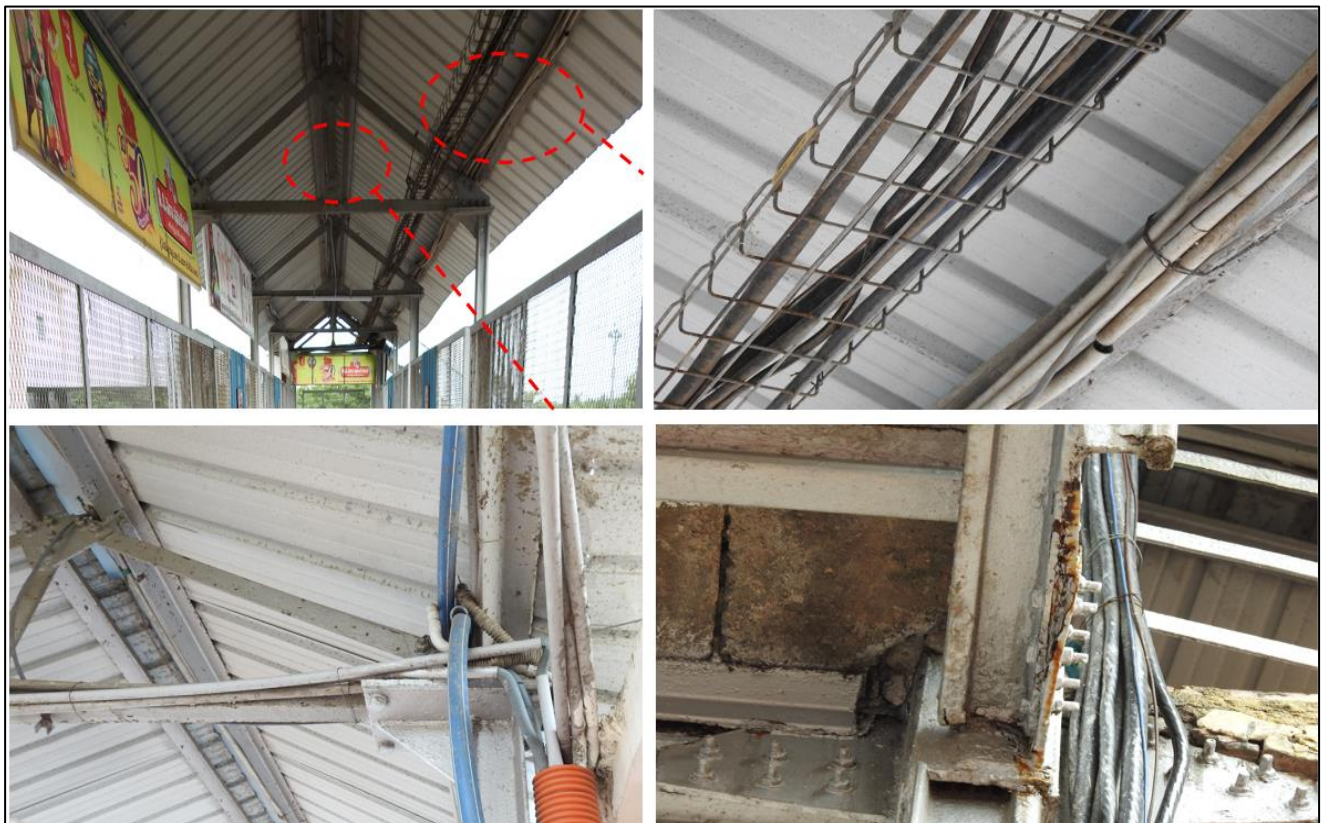
| PART 1.2 IDENTIFICATION OF LOADS ON BRIDGE | | | |
|---|---|---|---|
| | b) Cables | Yes | a. Cables are protected with 1-inch HDPE pipe of 2 No's, 1.5-inch HDPE pipe of 1 No's, 1-inch PVC pipe of 9 No's and 1-inch GI pipe of 2 No's supported on Roof Truss. (Refer <b>fig :1.3</b> )<br>b. King post of 65 x 65 x 10 mm Angles are used as Roof truss (Refer <b>fig :1.2</b> )<br>c. Coagulated Metal Sheet is used for Roof (Refer <b>fig: 1.2</b> )<br>d. Advertising boards are provided (Refer <b>fig: 1.3</b> ) |

**Fig 1.3:** Additional loads of HDPE, PVC pipes

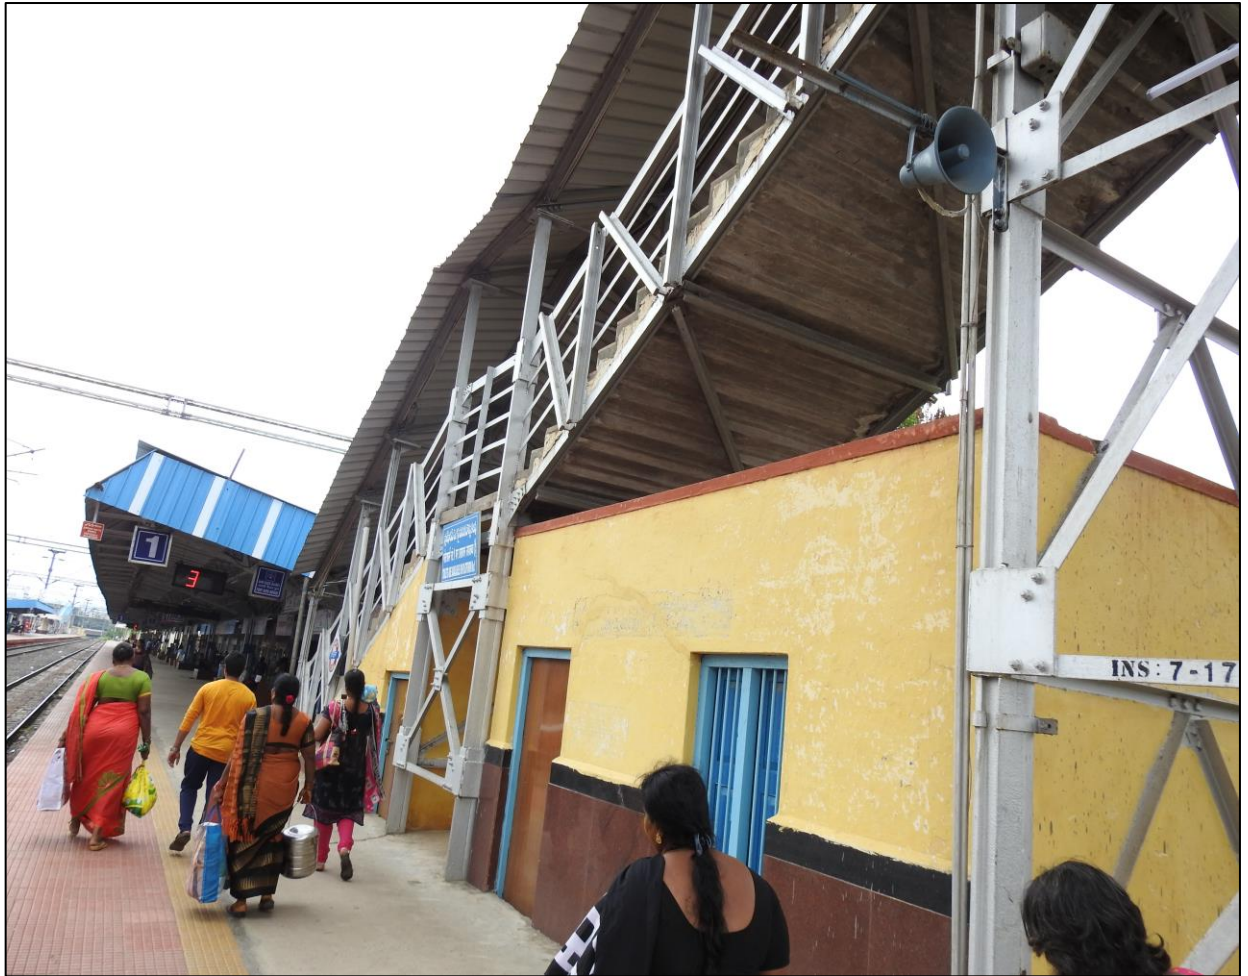
| | Number of Staircase | 2 No's | Staircase is observed as Precast RCC Slab panels supported on 60 x 110 x 110mm Rail tie beam and 60 x 110 x 110mm Rail Stringer beam on both sides of staircase. (Refer <b>fig :1.6</b> ) |

**Fig 1.6:** Under staircase not inspected due to existing room

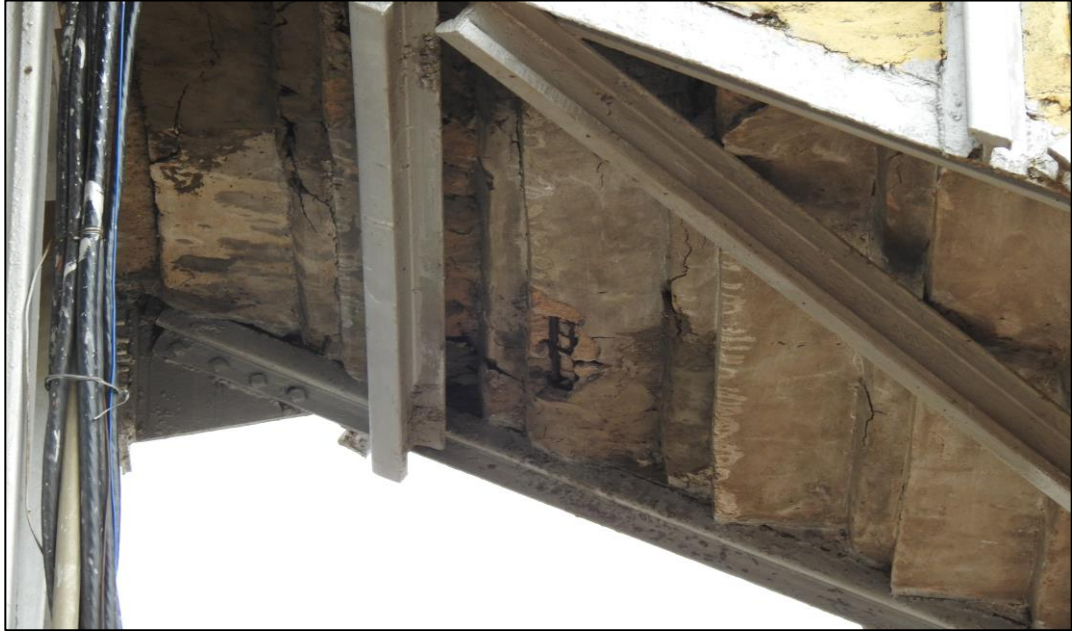
**Fig 1.8:** Patch work is observed at PF-2 stair case flight slab panels

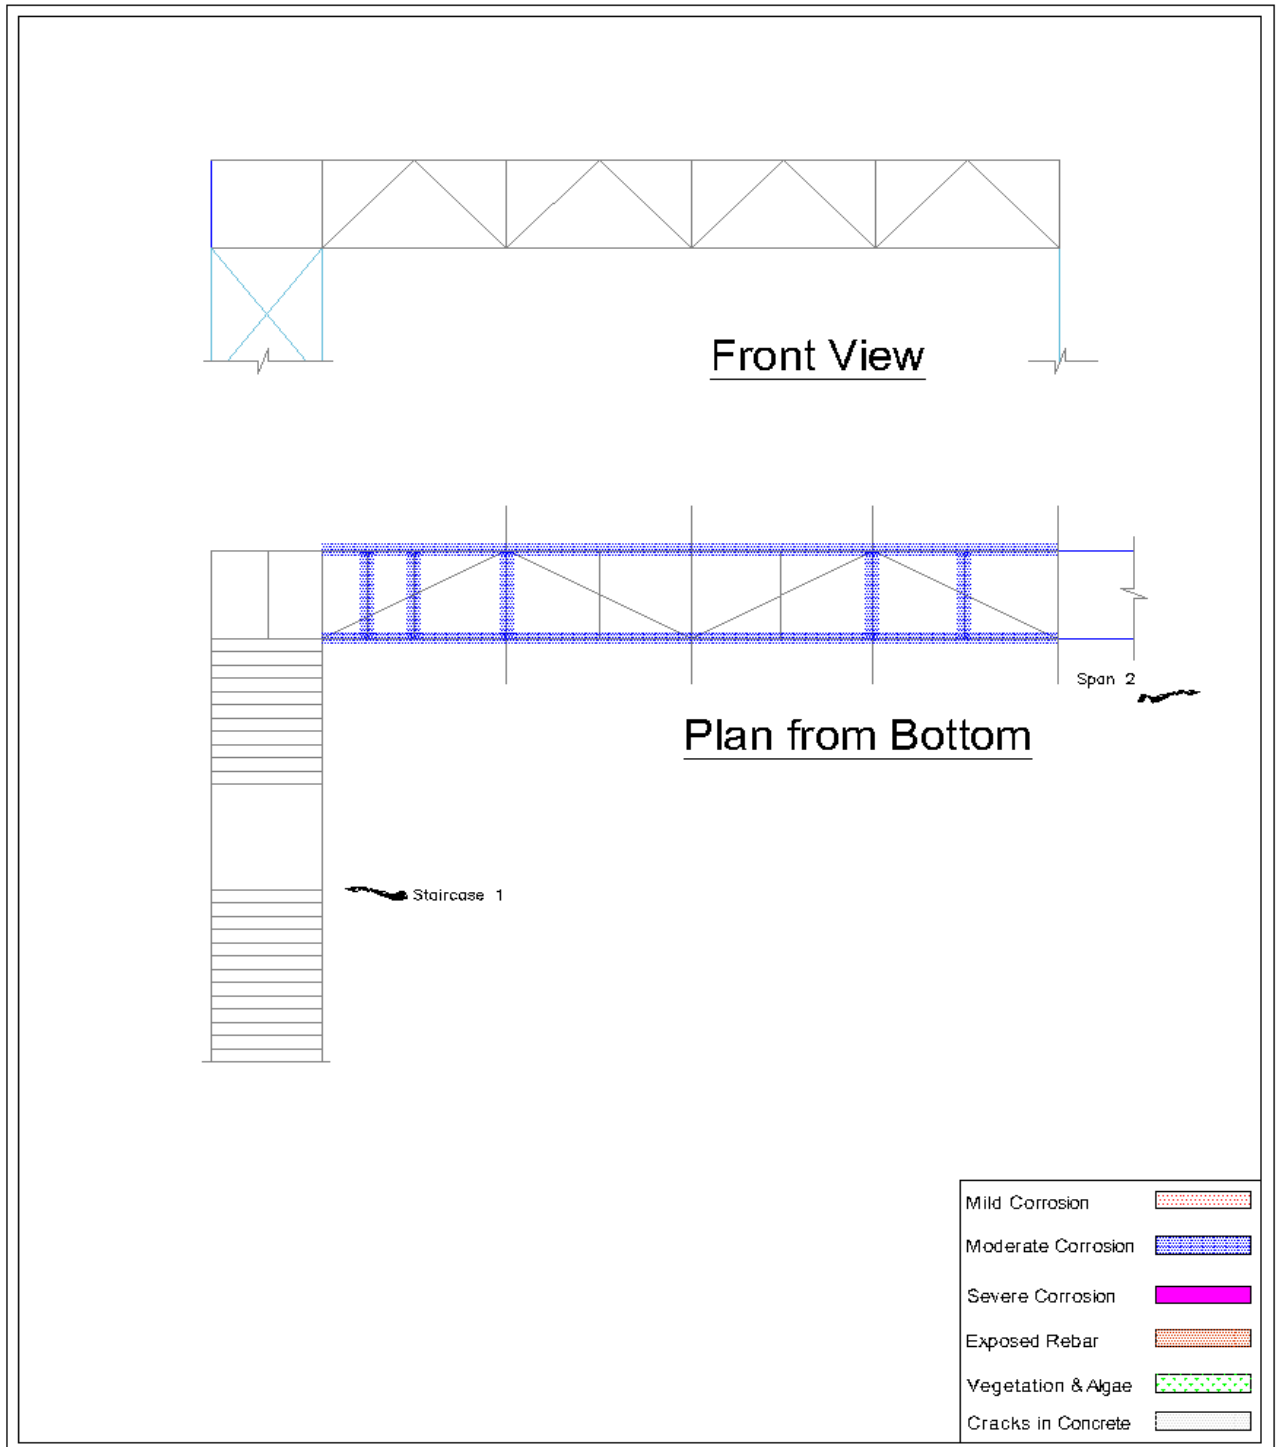
**Fig 2.1:** locations of deteriorations and bottom view of span-1

- Structural members are in fair condition, displaying mild corrosion for top chord members, verticals, diagonals and staircase stinger beam. Moderate corrosion for bottom chord members, (locations are marked in figures below).
- Slight deformation is observed in floor beam joint connecting bottom chord and moderate corrosion near joint connecting floor beam to bottom chord and gusset plate at beam column joint. Cracks are observed in pre-cast slab panels in staircase -1 flight. (Photographs of the same can be see in **fig 2.2-2.8**)

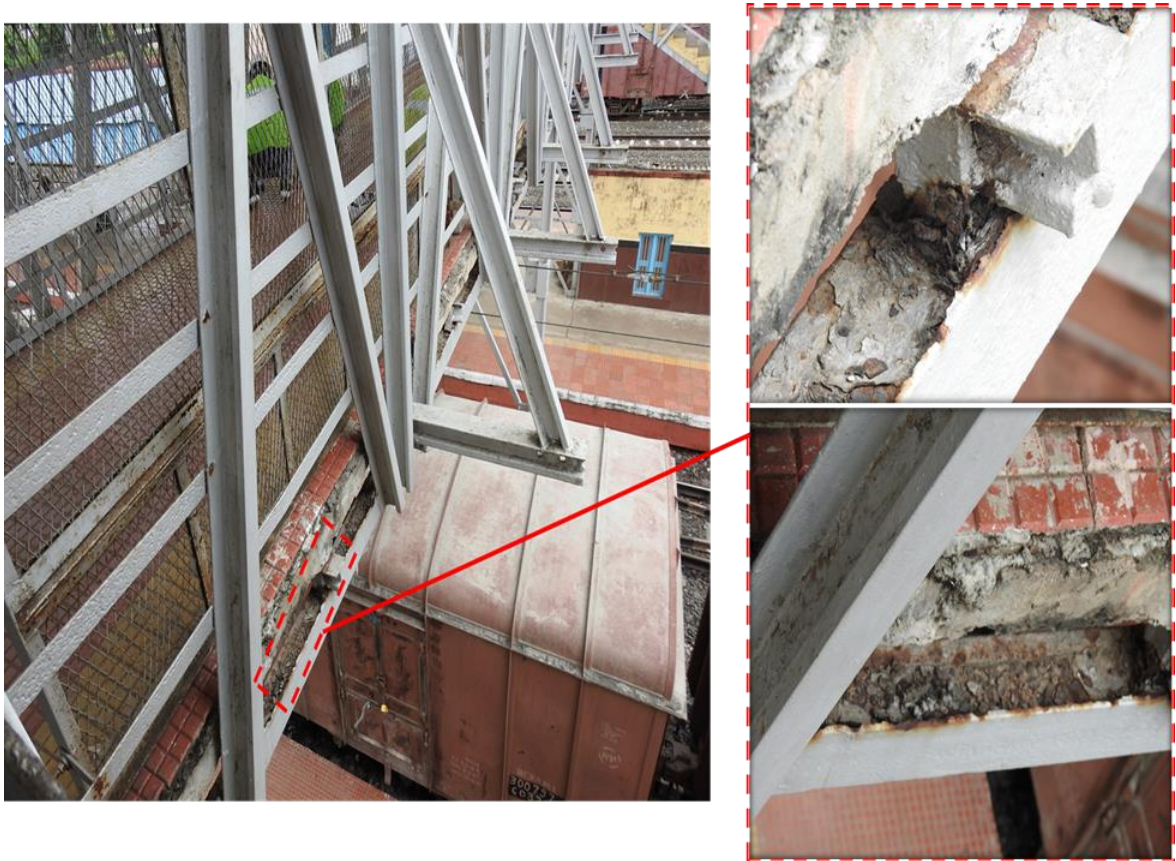
**Fig 2.2:** Corrosion of bottom chord member

- If the paint condition is identified as Grade-1, aluminum paint shall be applied with a similar shade.
- Where condition of paint is evaluated as Grade-2 special anticorrosion paint shall be applied to restrict corrosion from progressing further.

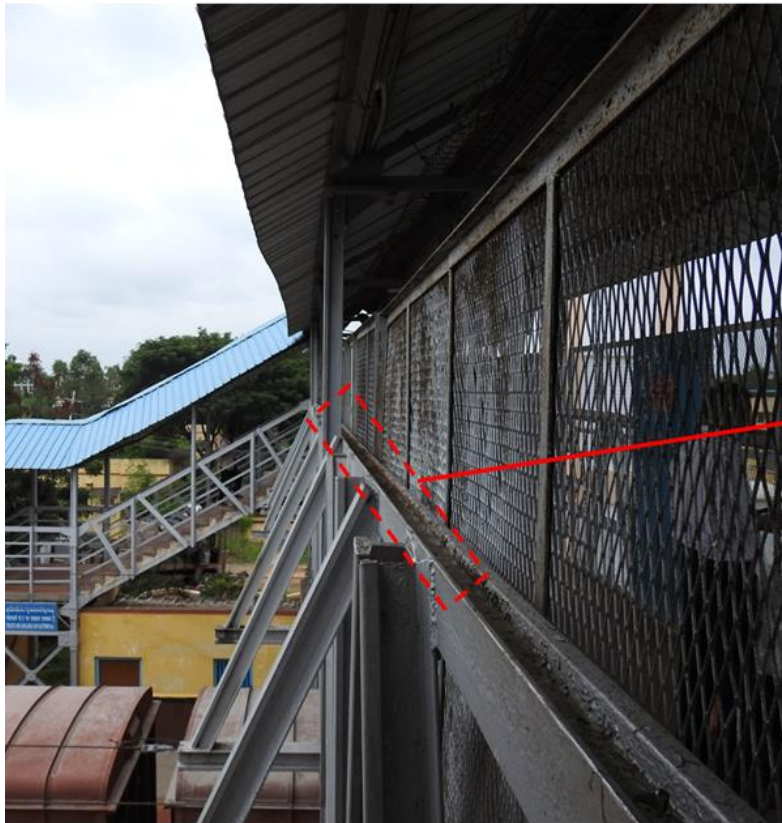
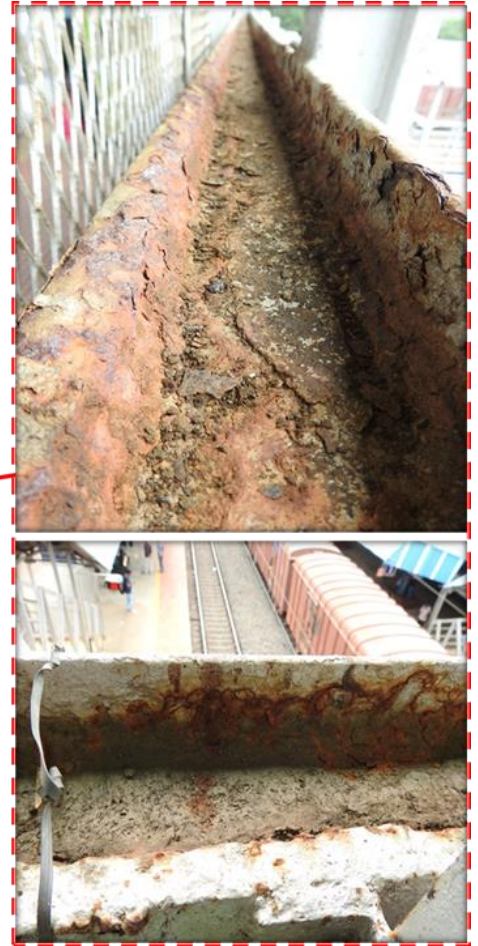
**Fig 2.3:** Corrosion of top chord member

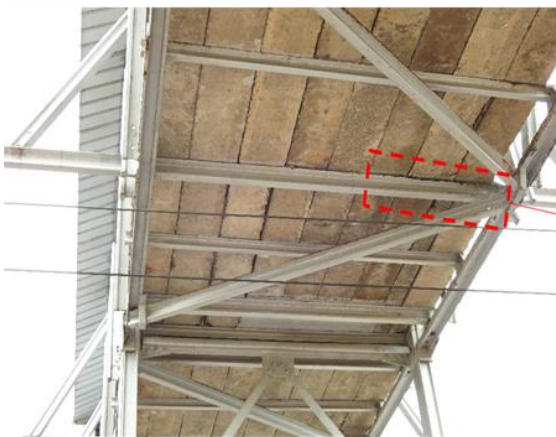
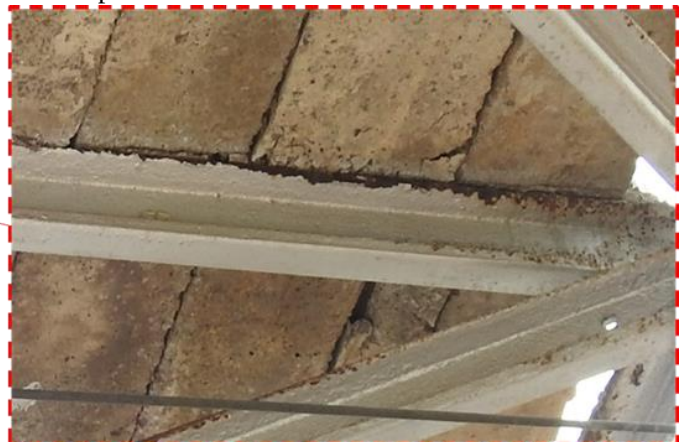
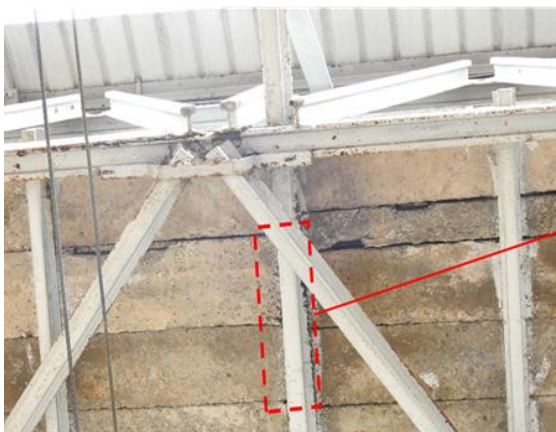
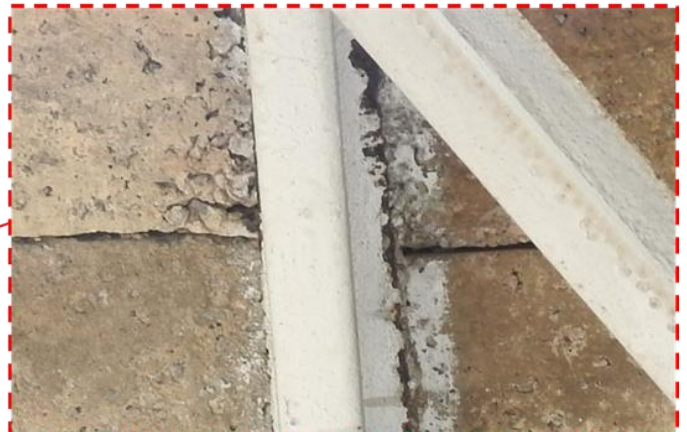
**Fig 2.4:** Corrosion of floor beams

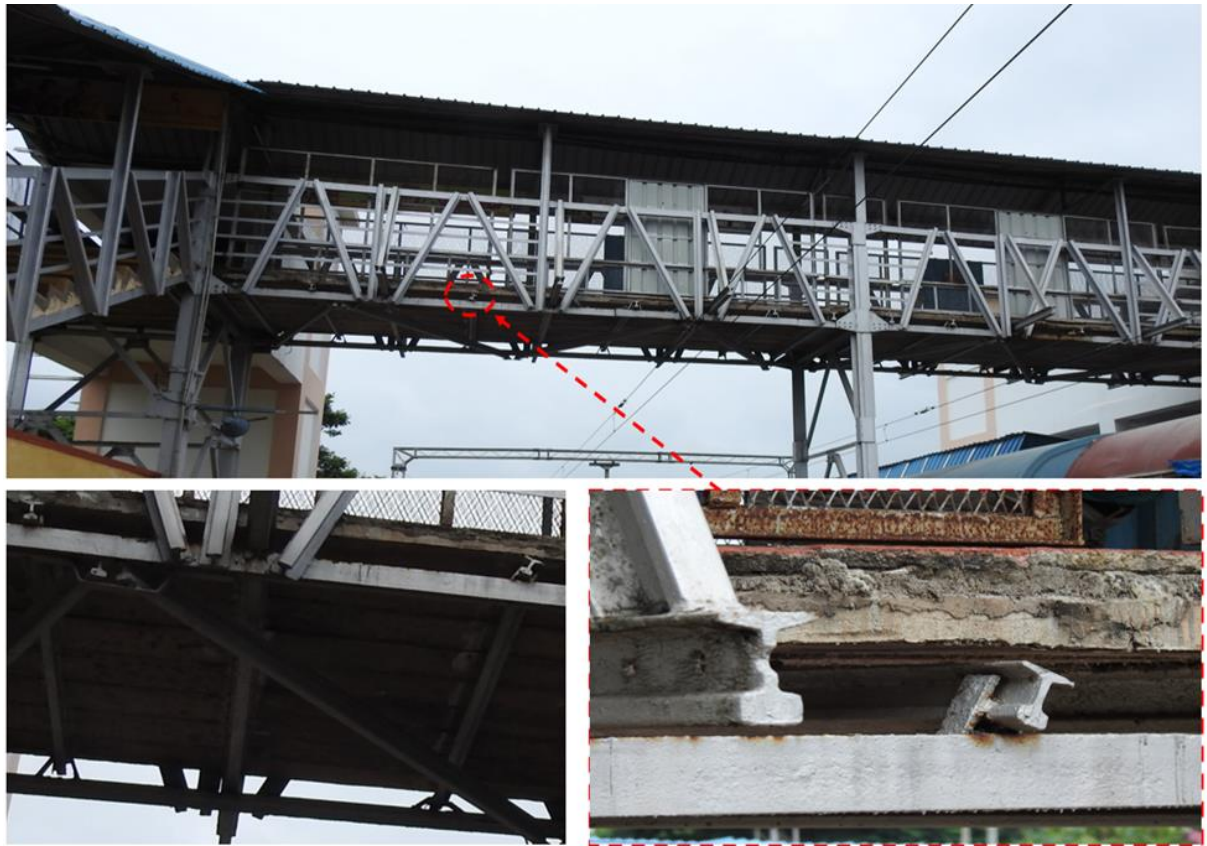
**Fig 2.5:** Deformation in floor beam connecting bottom chord

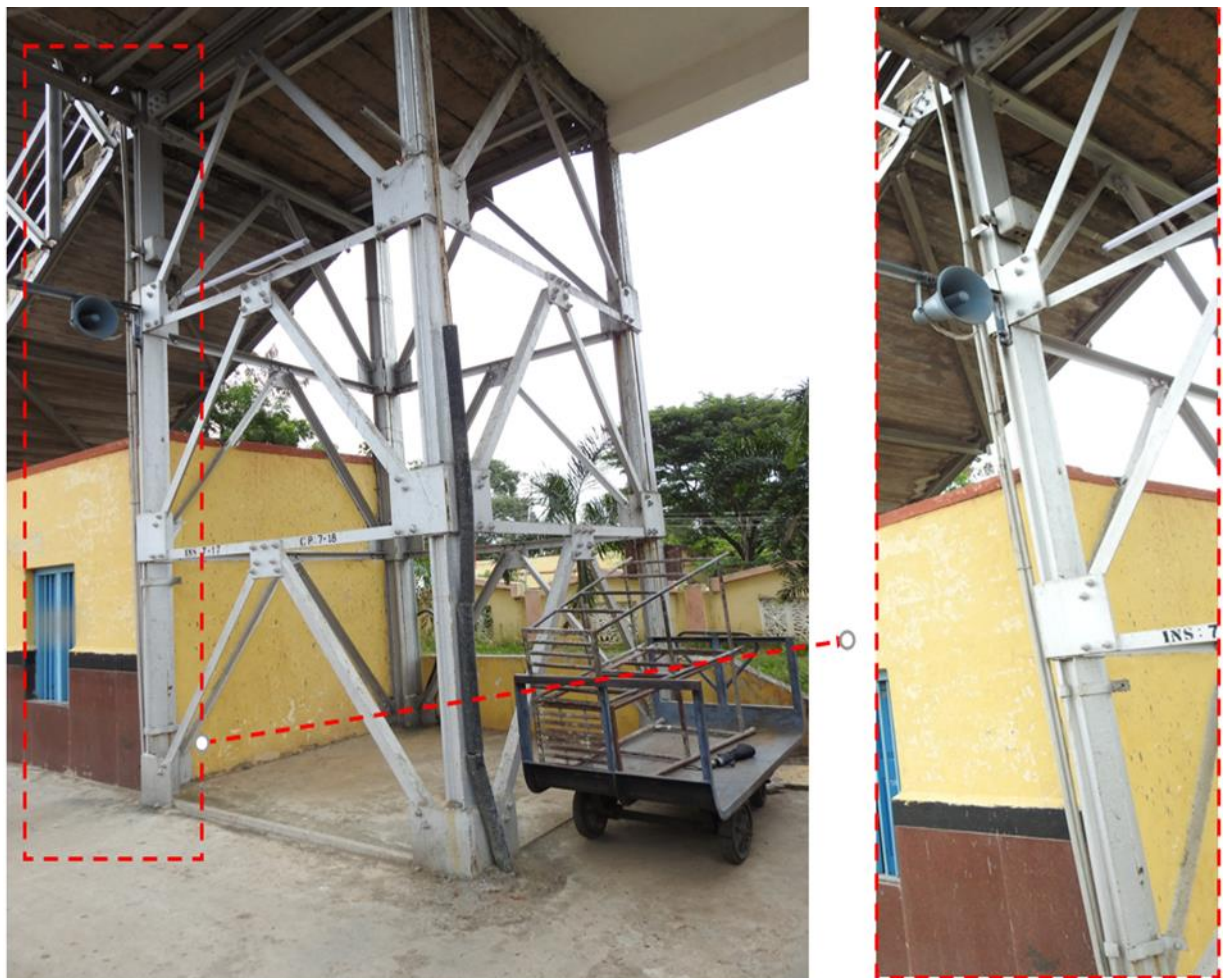
**Fig 2.6:** deformation in trestle at staircase-1

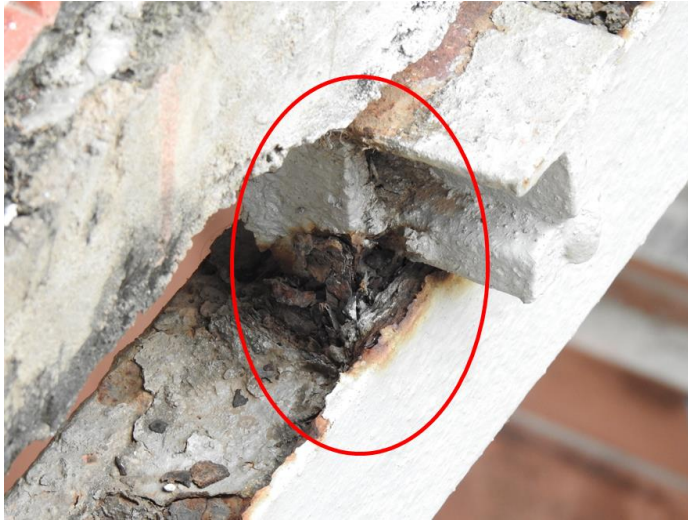
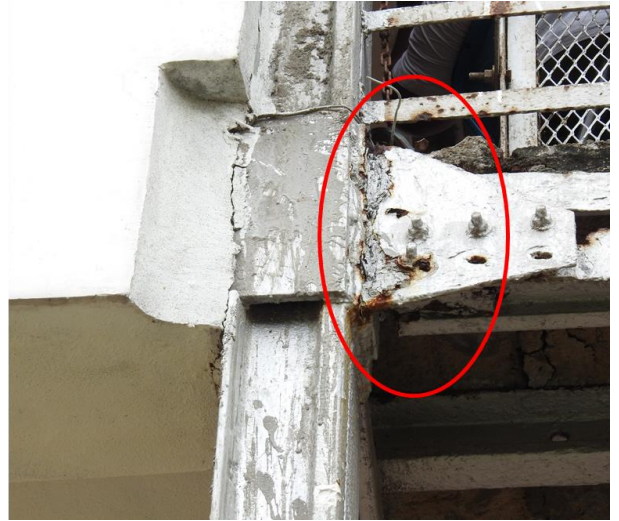
**Fig 2.7:** Corrosion at joints

- b) Anti-corrosion treatment for Grade-1 and Grade-2 highlighted corrosive members like floor beam joints and gusset plate in span-1.
  - c) Replacement of damaged members or severely corroded members in span -2, verticals, diagonals and bottom chord connecting welded joint. (see **fig:2.10**)

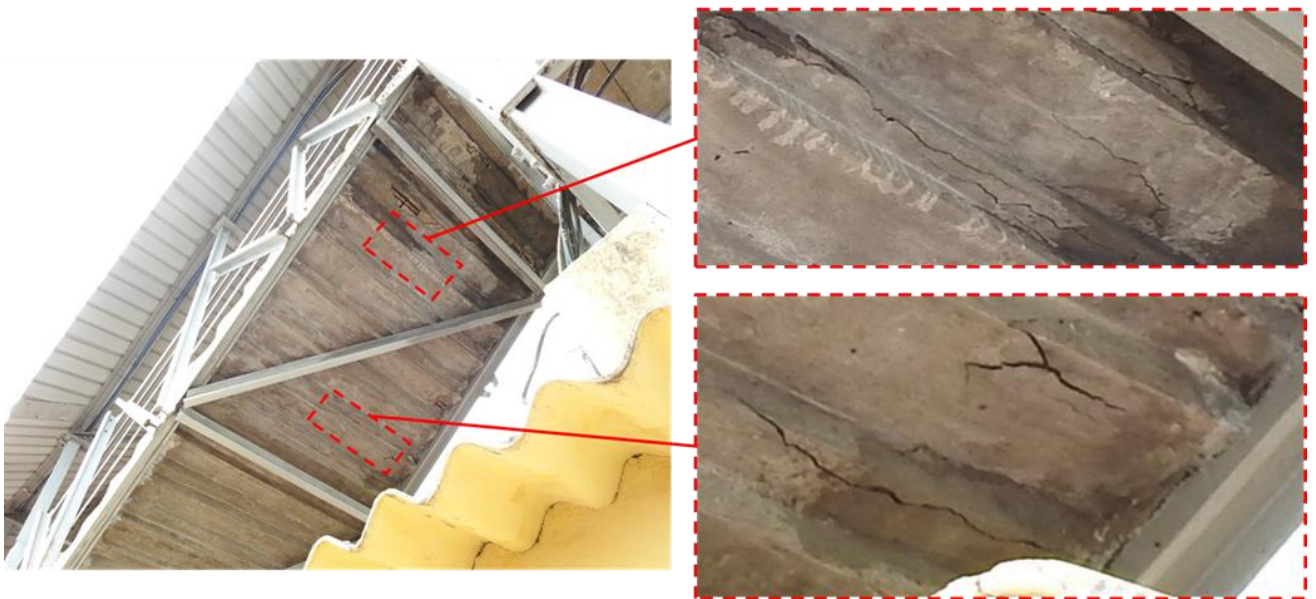
Reinforced cement concrete Slab at Deck level and some precast panels in staircase are observed with exposed rebar in many locations. *(Photographs of the same can be see in **fig2.8** & **fig 2.11**)*

**Fig 2.8:** Cracks are observed in staircase-1 panels

**Methodology for patching:** Hand applied Mortar (Patching) repair is performed to restore small areas where sound concrete is damaged by spalling, scaling and/or impact. This method of repair is generally applied using trowel and require minimum or formworks. The patch thickness is limited to a maximum of 100 mm depth of hollow surface. Hand applied Mortar repair is classified into two types considering defective area and surface. Hand applied Mortar
