# Third Party Audit of ROB's and FOB's of SCR

## INSPECTION OF FOB AT ELURU RAILWAY STATION

**Final Report**  
SEPTEMBER | 2020

| <b>Name of the Project</b> | : | VISUAL INSPECTION OF FOB/ PF-1 - PF-2<br>AT ELURU RAILWAY STATION |

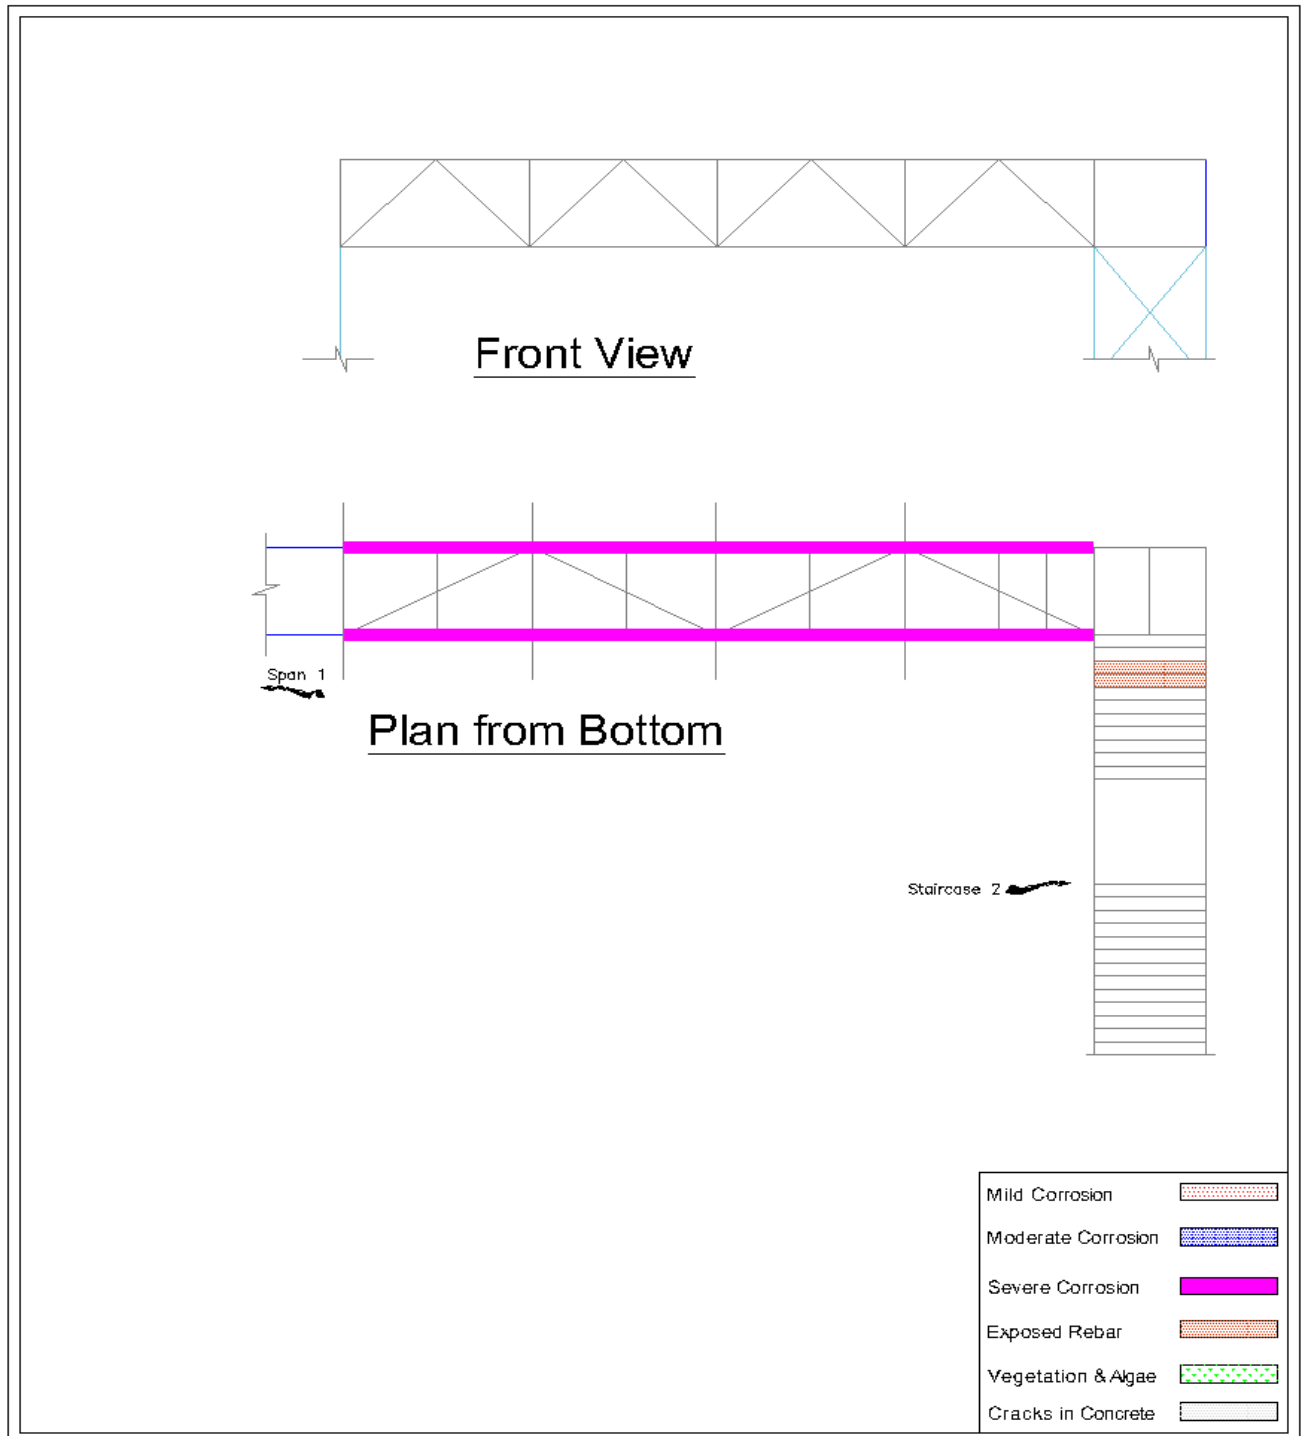
**Fig 2.9:** locations of deteriorations and bottom view of span-2

- Structural members are in fair condition, displaying mild corrosion for top chord members and staircase stinger beam. Severe corrosion at joints connecting verticals, diagonals, floor beams to bottom chord members. (Locations are marked in figures below).
- Cracks are observed in pre-cast slab panels in staircase -2 flight (*Photographs of the same can be see in fig 2.10,2.11*)

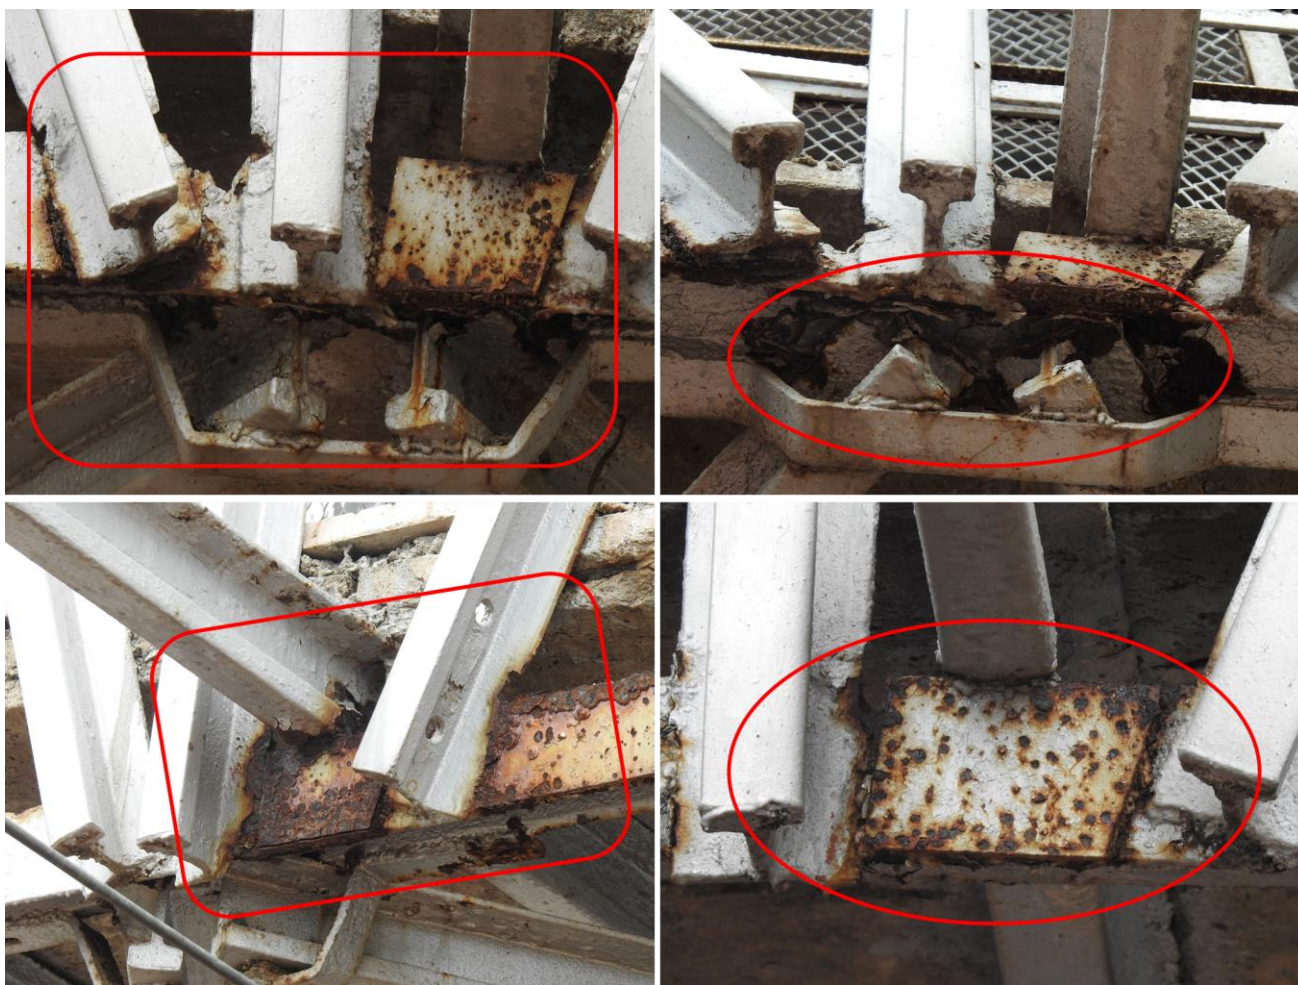
**Fig 2.10:** corrosion of bottom chord, diagonal and vertical joints

- b) Anti-corrosion treatment for Grade-1 and Grade-2 highlighted corrosive members like floor beam joints and gusset plate in span-1.
  - c) Replacement of damaged members or severely corroded members in span -2, verticals, diagonals and bottom chord connecting welded joint. (see **fig:2.10**)

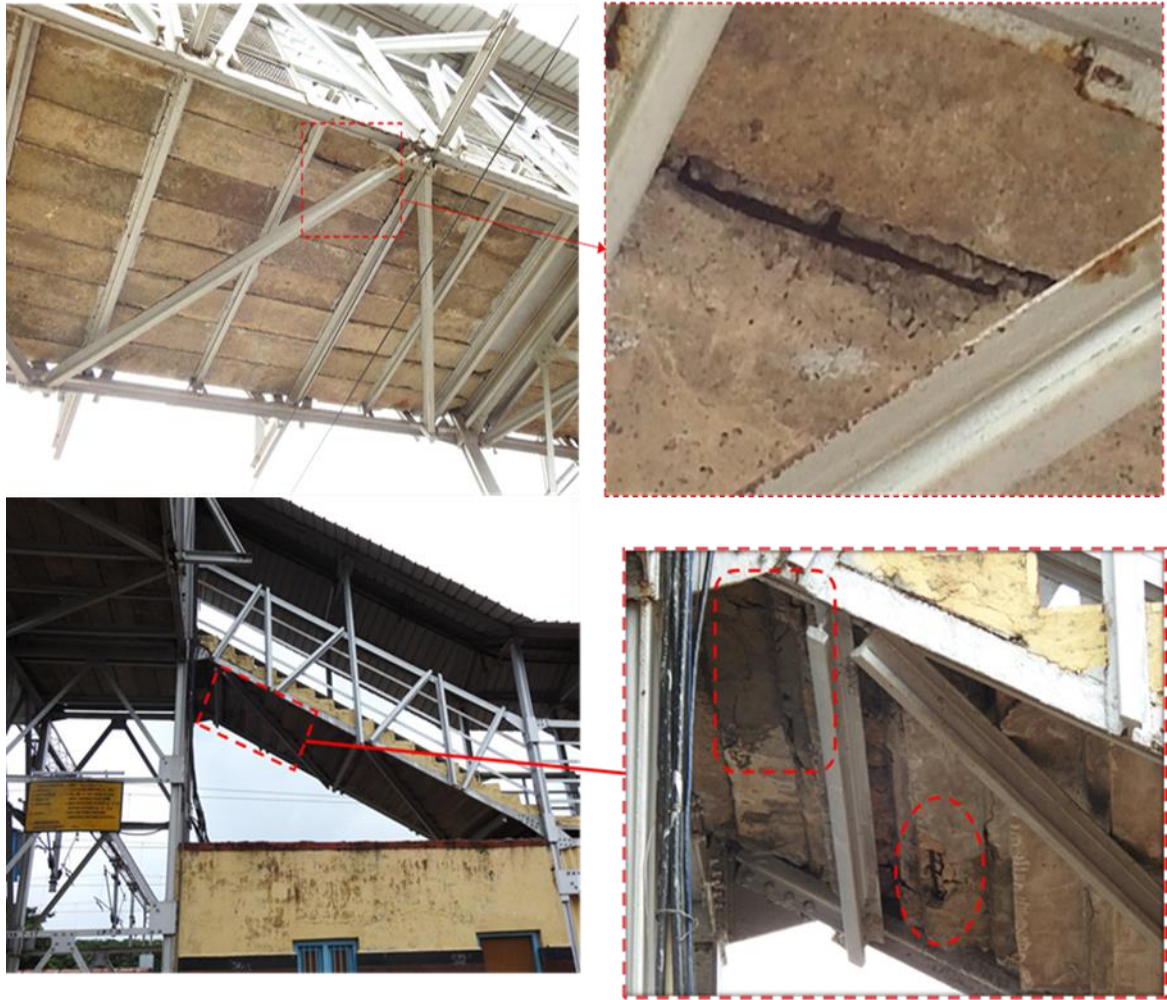
Reinforced cement concrete Slab at Deck level and some precast panels in staircase are observed with exposed rebar in many locations. *(Photographs of the same can be see in **fig2.8** & **fig 2.11**)*

**Fig 2.11:** Reinforcement exposed in panels

**Methodology for patching:** Hand applied Mortar (Patching) repair is performed to restore small areas where sound concrete is damaged by spalling, scaling and/or impact. This method of repair is generally applied using trowel and require minimum or formworks. The patch thickness is limited to a maximum of 100 mm depth of hollow surface. Hand applied Mortar repair is classified into two types considering defective area and surface. Hand applied Mortar
