# Third Party Audit of ROB's and FOB's of SCR

## INSPECTION OF FOB AT KRISHNA CANAL RAILWAY STATION

**Final Report**  
SEPTEMBER | 2020

| <b>Name of the Project</b> | : | VISUAL INSPECTION OF FOB/ PF-1 - PF-4 AT KRISHNA CANAL RAILWAY STATION |

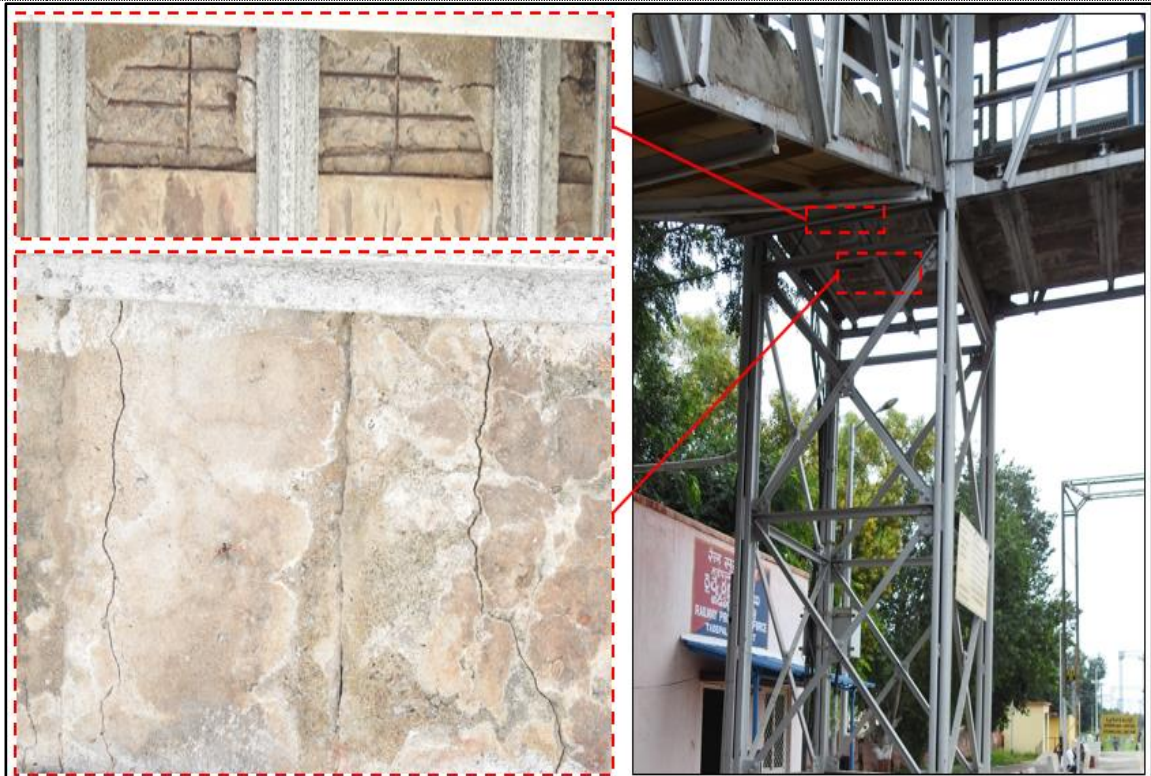
a) Reinforcement exposed and cracks on bottom of slab panels (Staircase 1 Main landing)

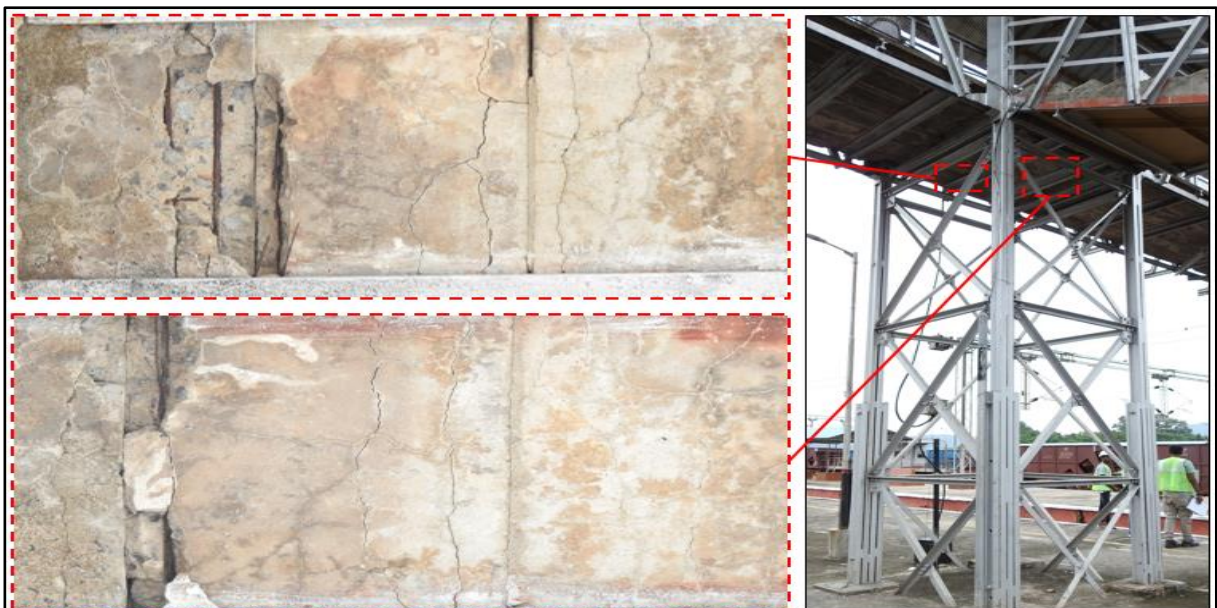
b) Reinforcement exposed and cracks on bottom of slab panels (Staircase 2 - Main landing)

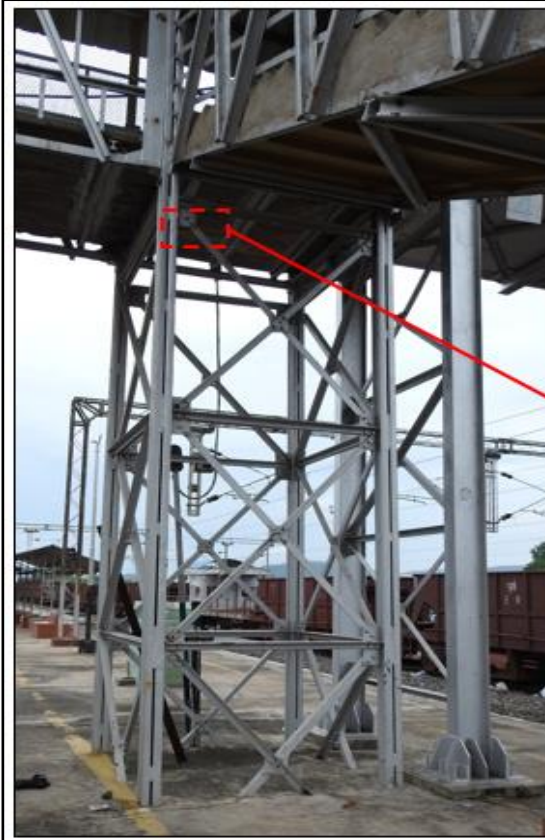
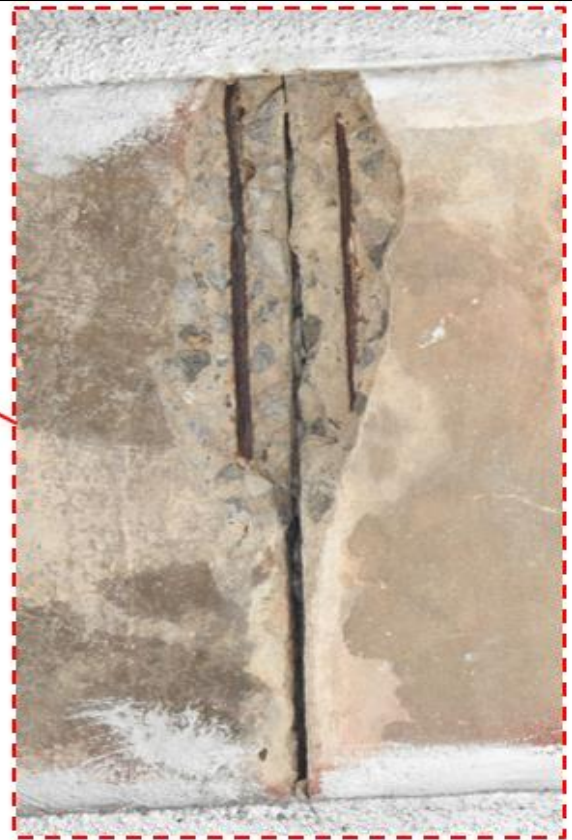
c) Reinforcement exposed on bottom of slab panels (Staircase 3 - Main landing)

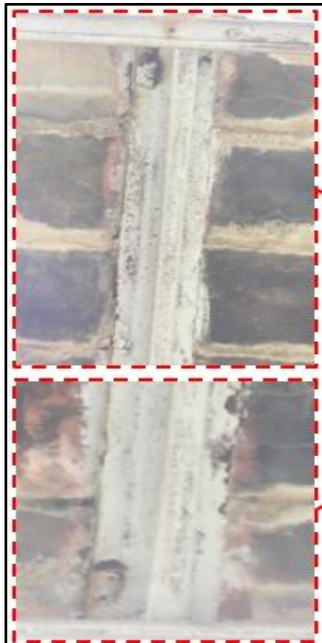
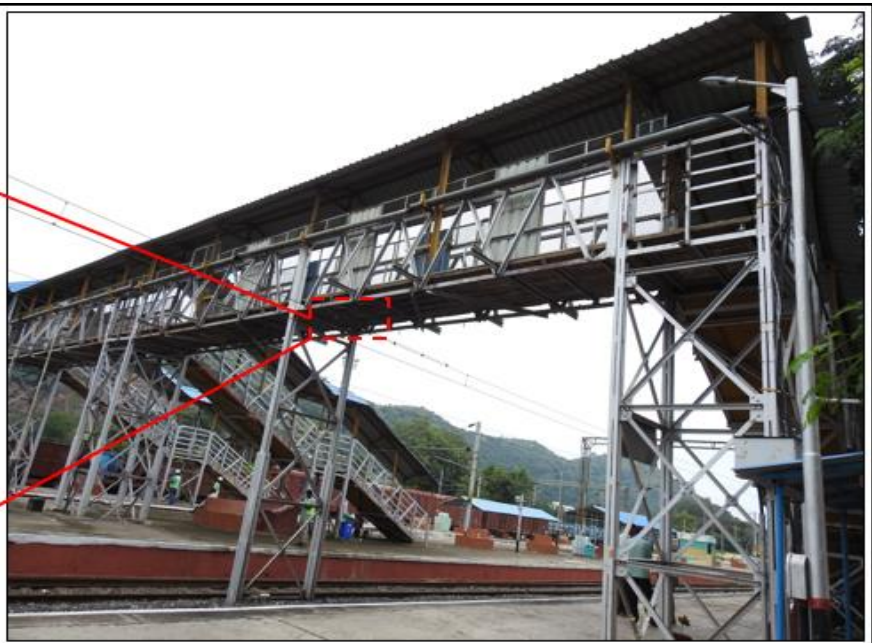
a) Corrosion observed at floor beams on Span-1

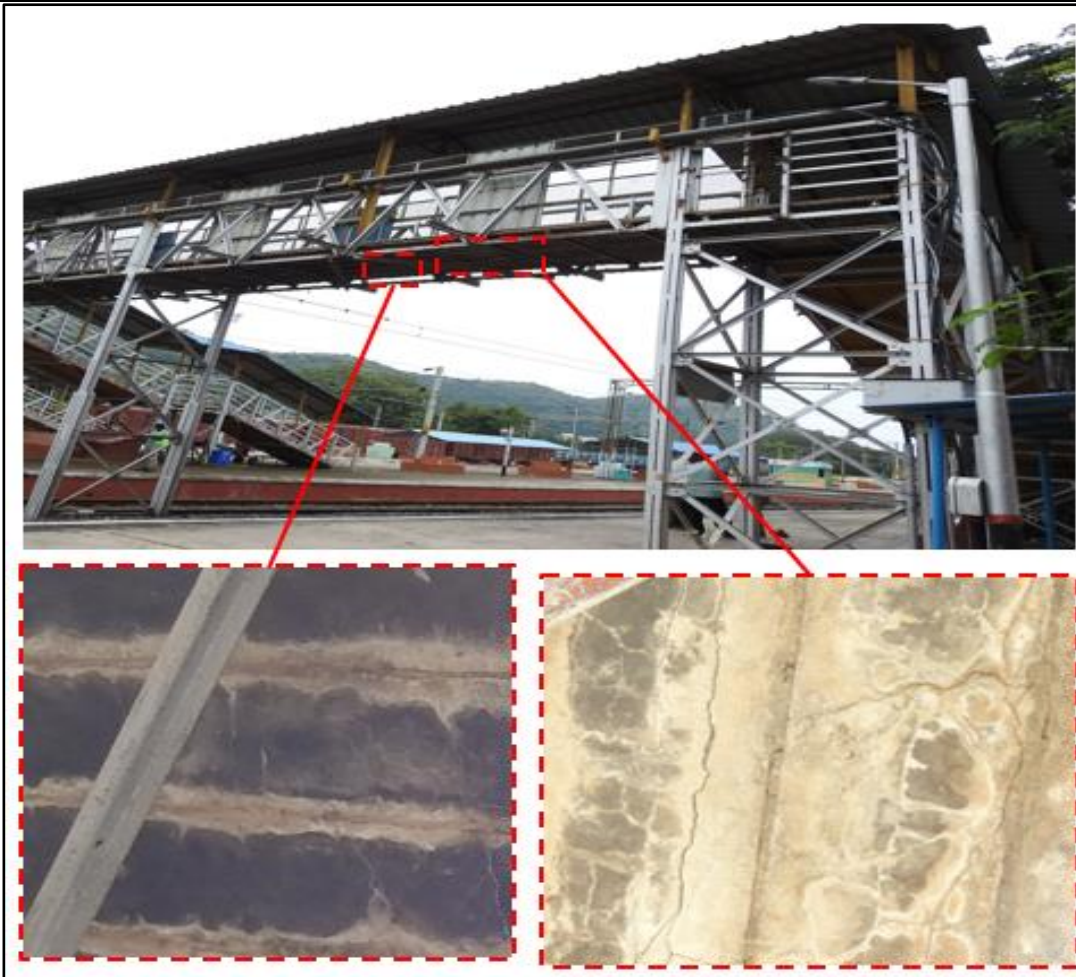
b) Cracks and Leaching at slab panels on Span-1

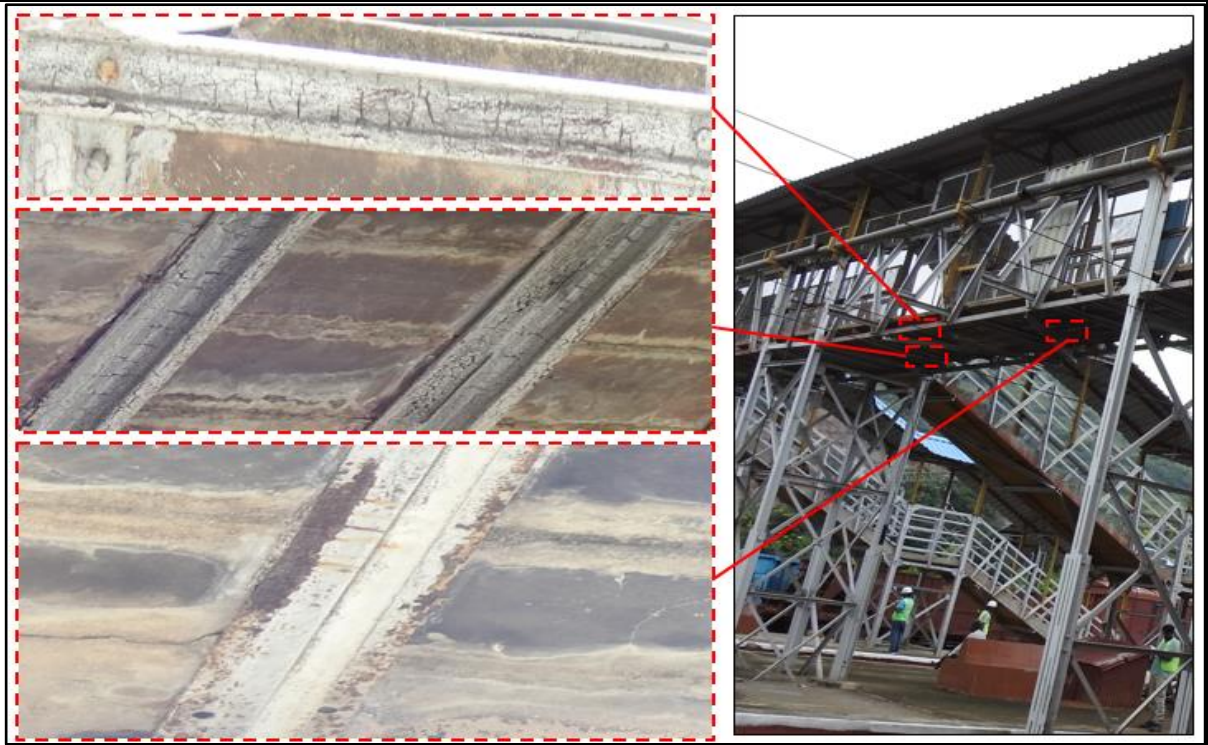
d) Cracks and Leaching at slab panels on Span-2

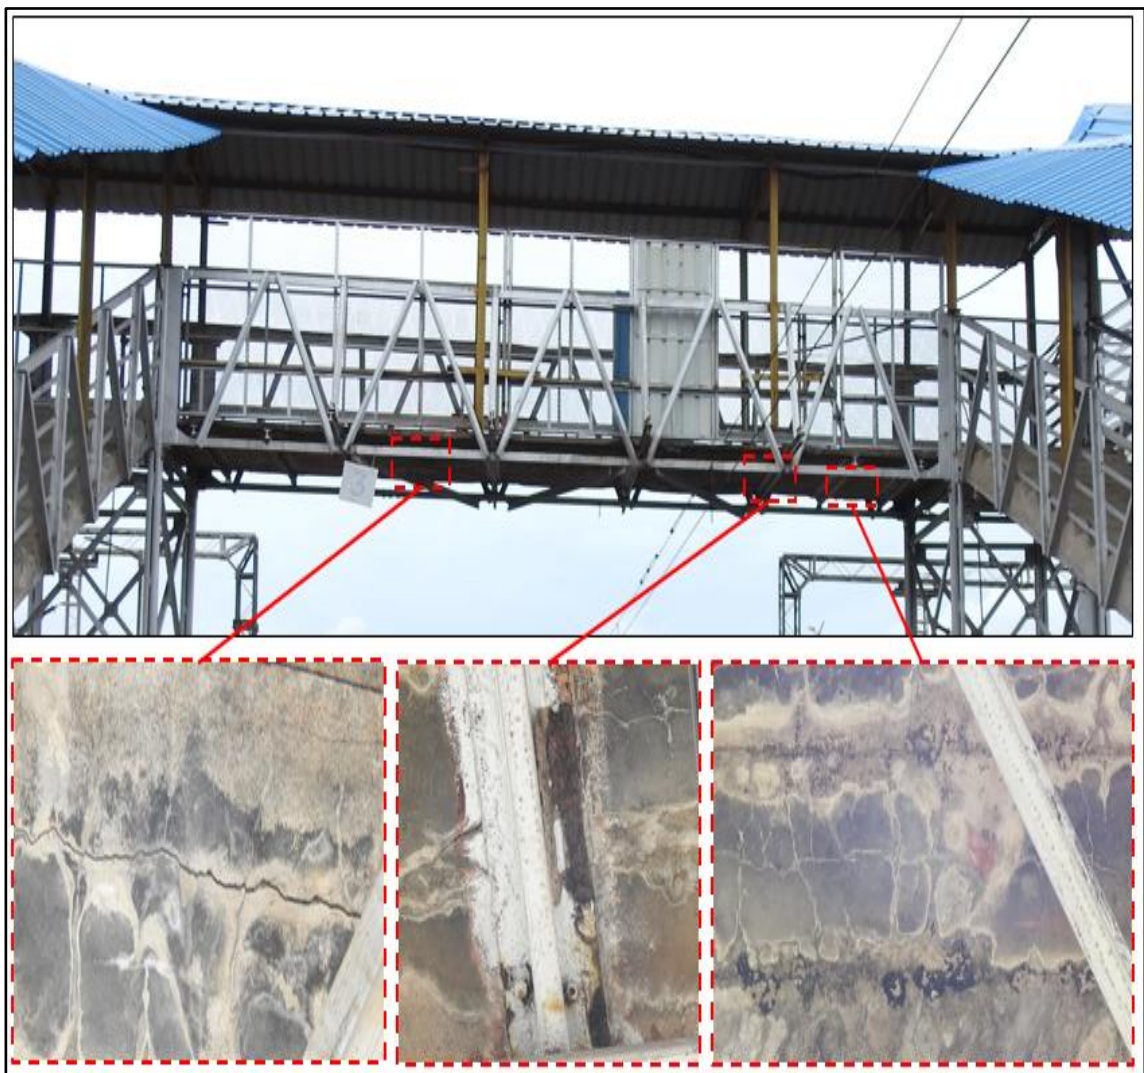
e) Cracks, Corrosion and Leaching at slab panels on Span-3

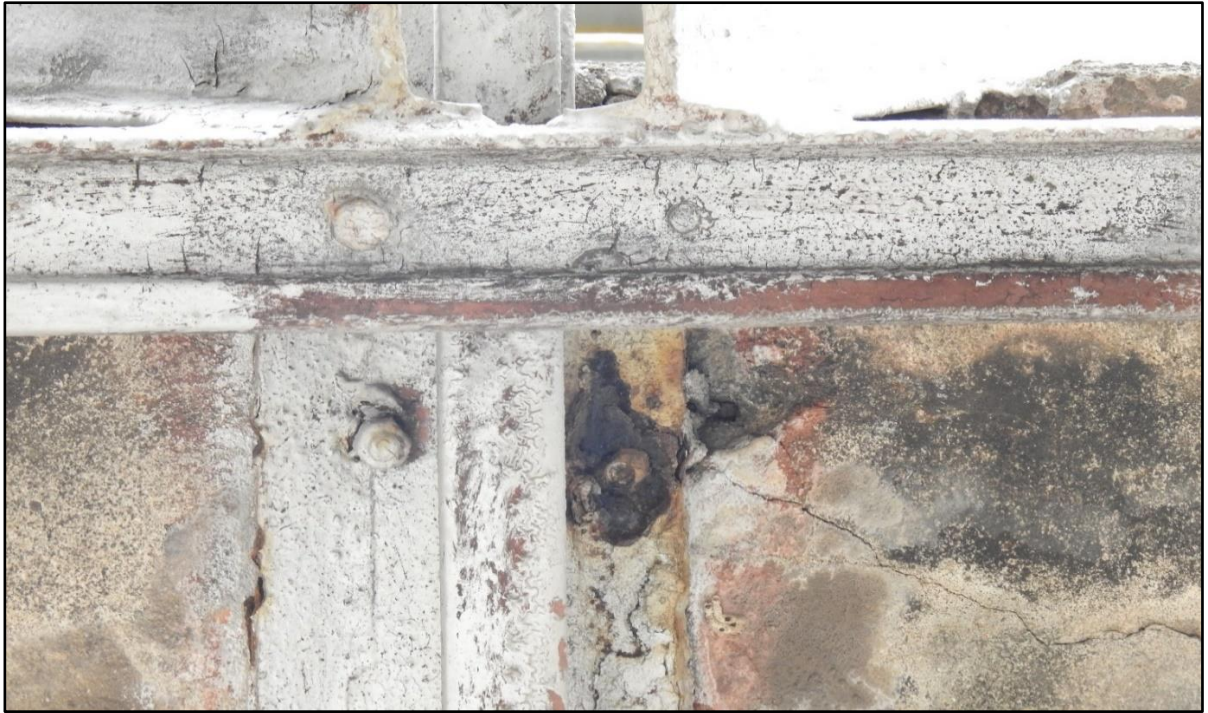
f) Corrosion observed at Floor beam and bottom chord bolt connection

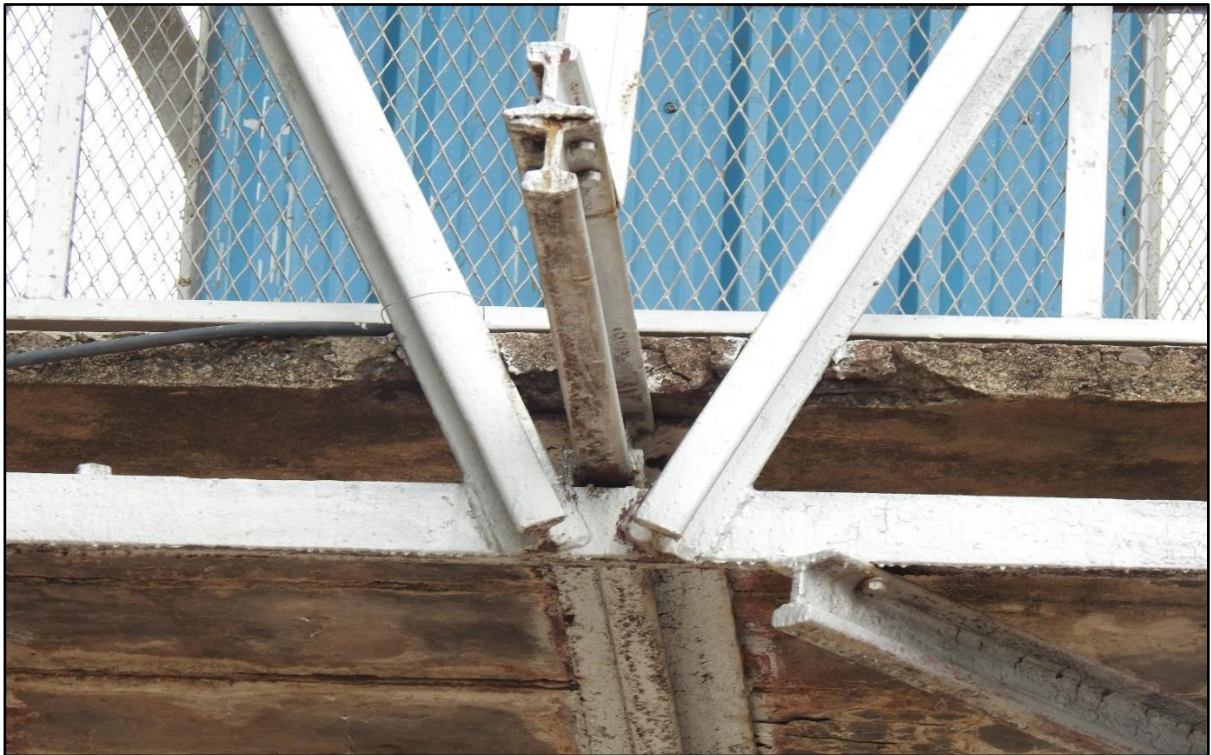
g) corrosion observed at Floor beam and bottom chord

| SIGNS OF DISTRESS, DEFORMATION IN BRIDGES | | | |
|---|---|---|---|
| | Rust straining | | Rusting is observed at steel concrete joint along length of FOB(Refer <b>part ( 1.4(b) g)</b> ) |
| | Corrosion at steel-Concrete joint | | Rusting is observed at steel concrete joint along length of FOB(Refer <b>part (1.4(b) g)</b> ) |

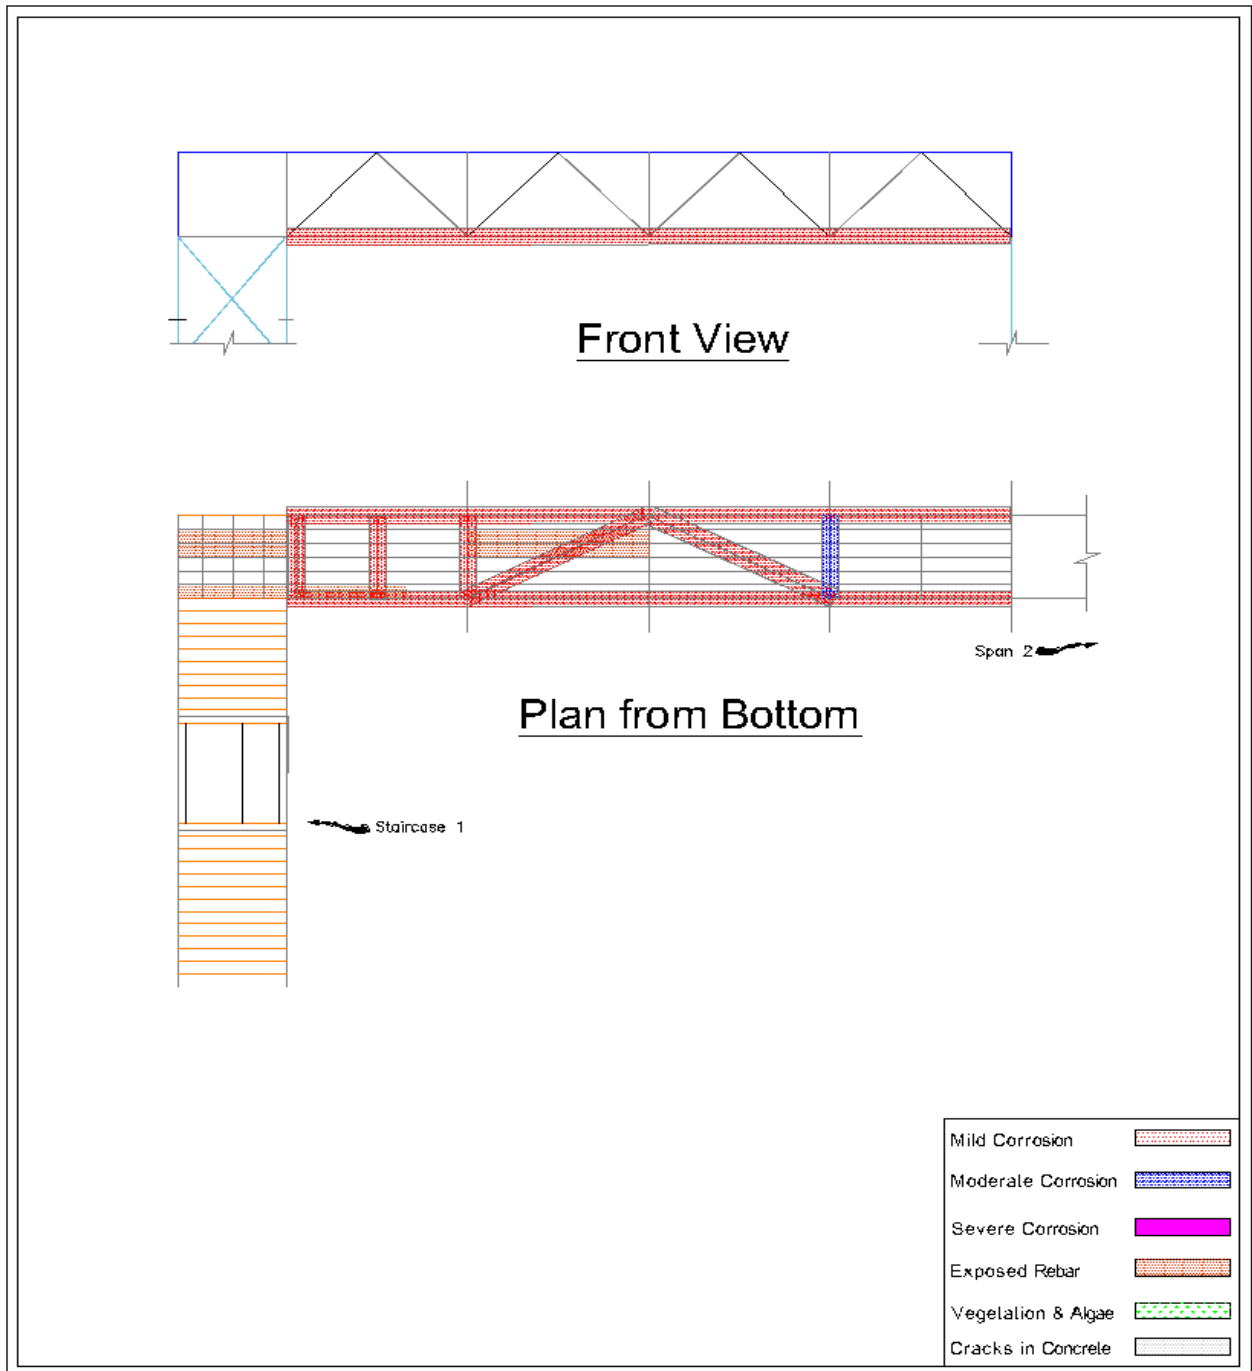
**Fig 2.1** locations of deterioration and bottom view of span-1

- Structural members are in fair condition, displaying mild corrosion for top chord members, verticals, diagonals, gusset plates and staircase stringer beam along steel concrete joint moderate corrosion for bottom chord members (locations are marked in figures below).
- Precast slab panels are deteriorated reinforced is exposed in pathway and staircase main landing. (Photographs of the same can be see in **fig 2.2-2.3**)

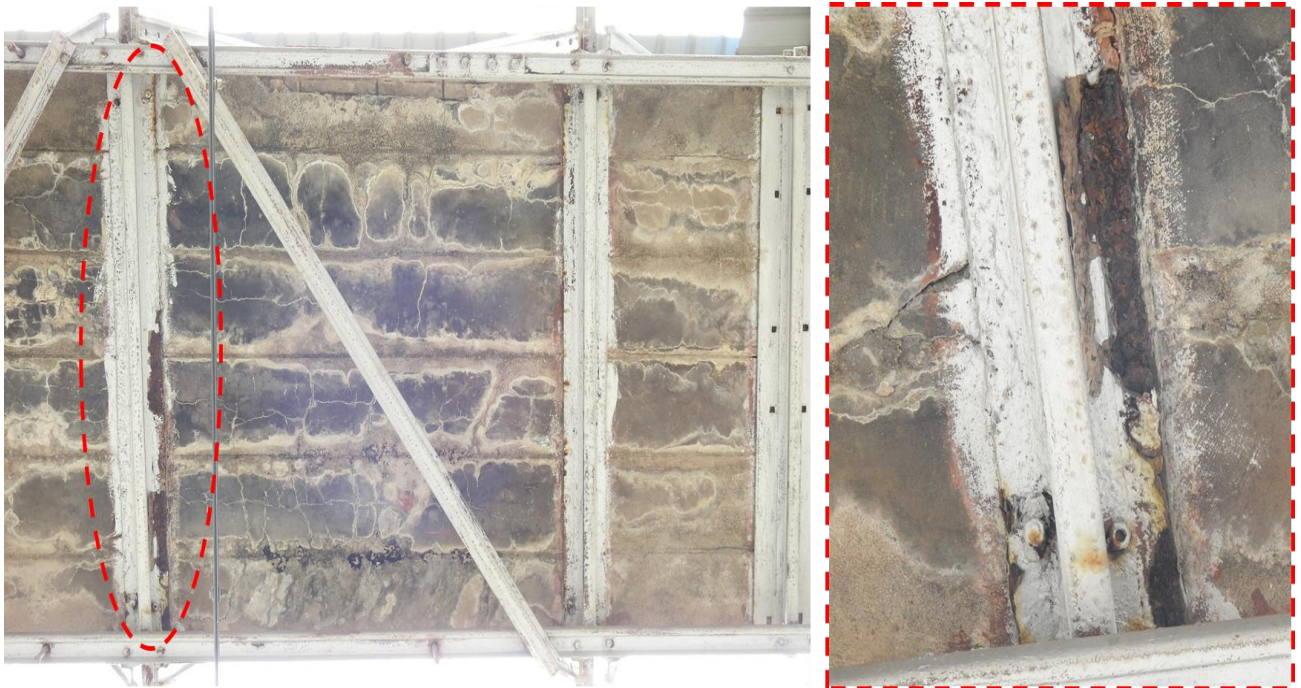
**Fig 2.2:** Corrosion of floor beam members in span-1

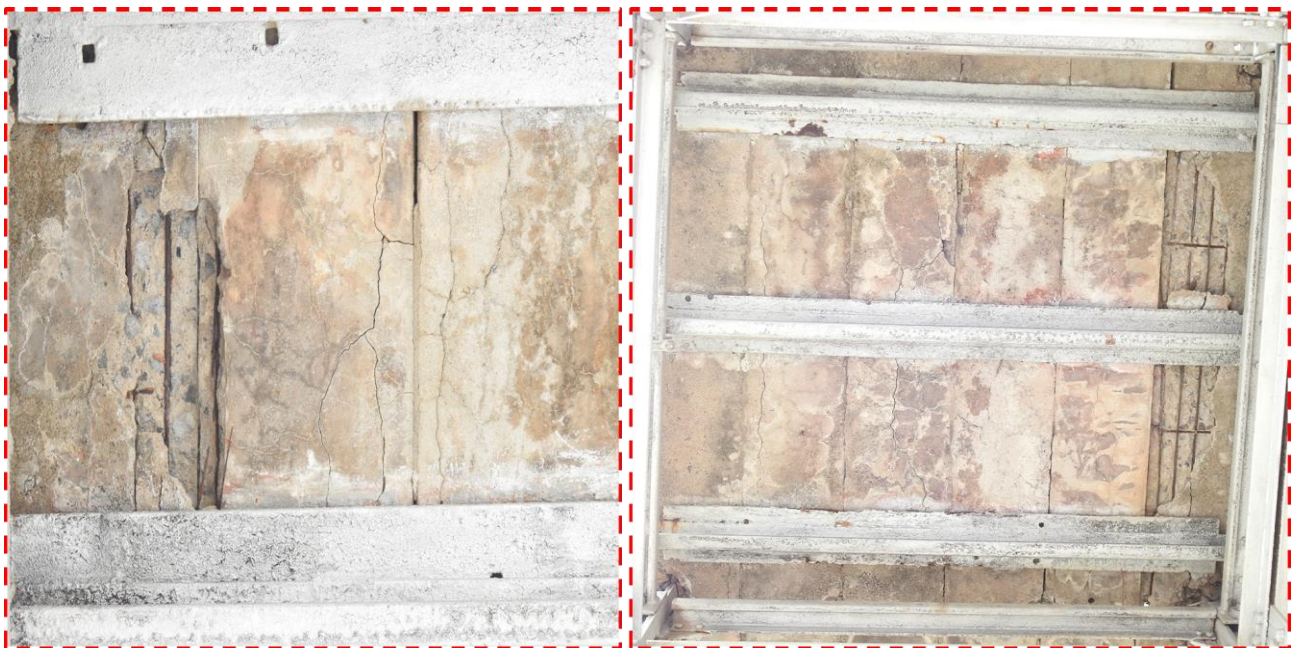
**Fig 2.3:** Exposed reinforcement at main landing in staircase-1

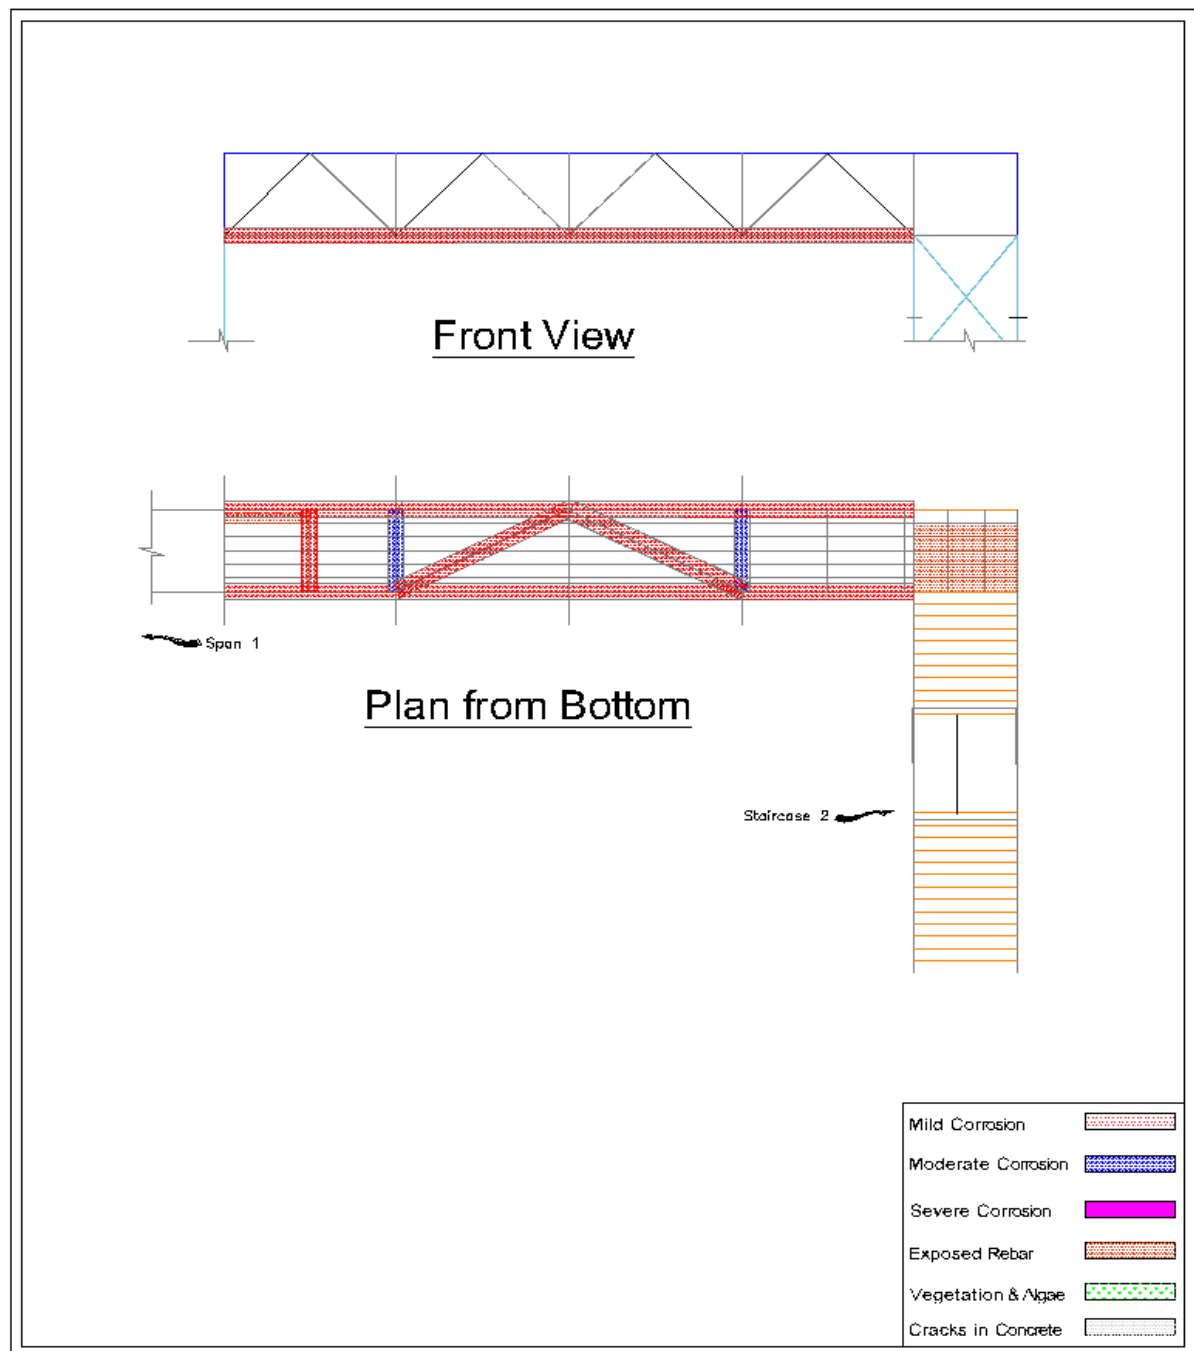
**Fig 2.4** locations of deterioration and bottom view of span-2

- Structural members are in fair condition, displaying mild corrosion for top chord members, verticals, diagonals, gusset plates and staircase stringer beam along steel concrete joint moderate corrosion for bottom chord members (locations are marked in figures below).
- Precast slab panels are deteriorated reinforced is exposed in pathway and staircase main landing. (Photographs of the same can be see in **fig 2.5,2.6**)

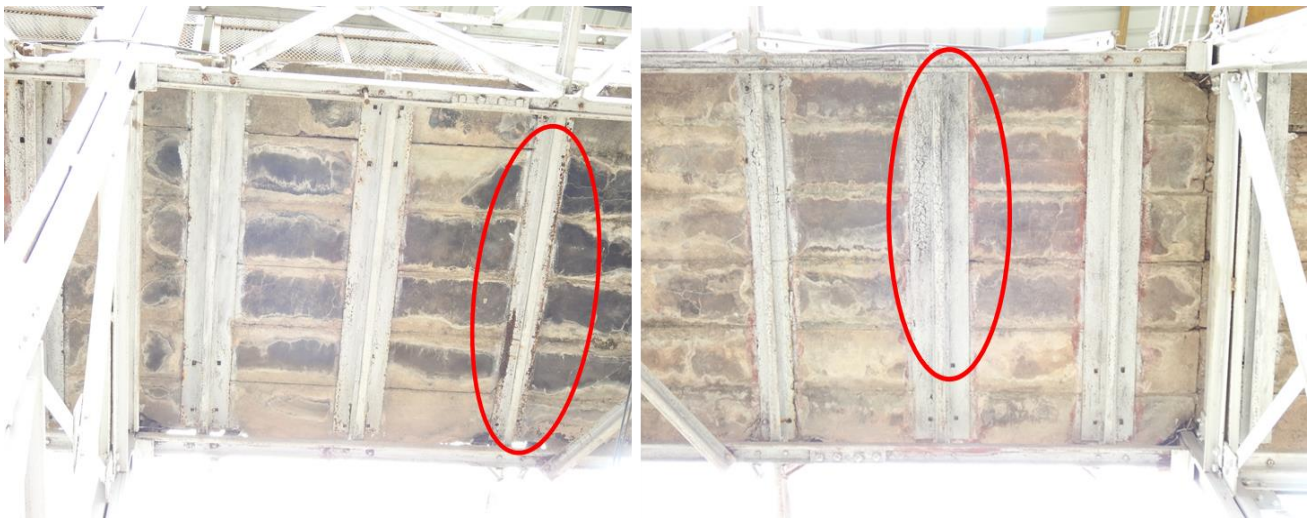
**Fig 2.5:** Corrosion of floor beam members in span-2

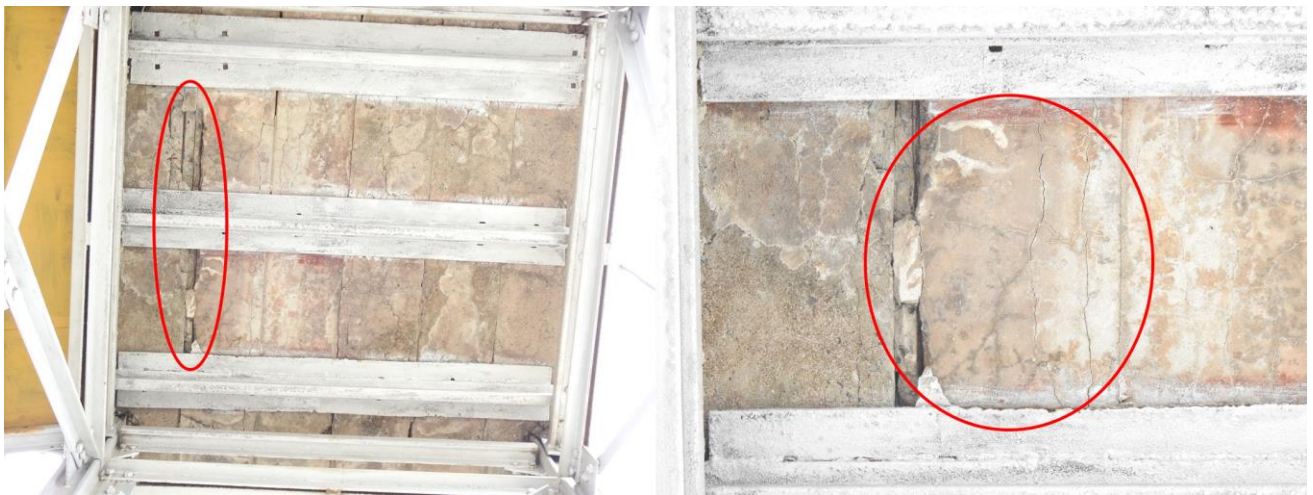
**Fig 2.6:** Exposed reinforcement at main landing in staircase-2

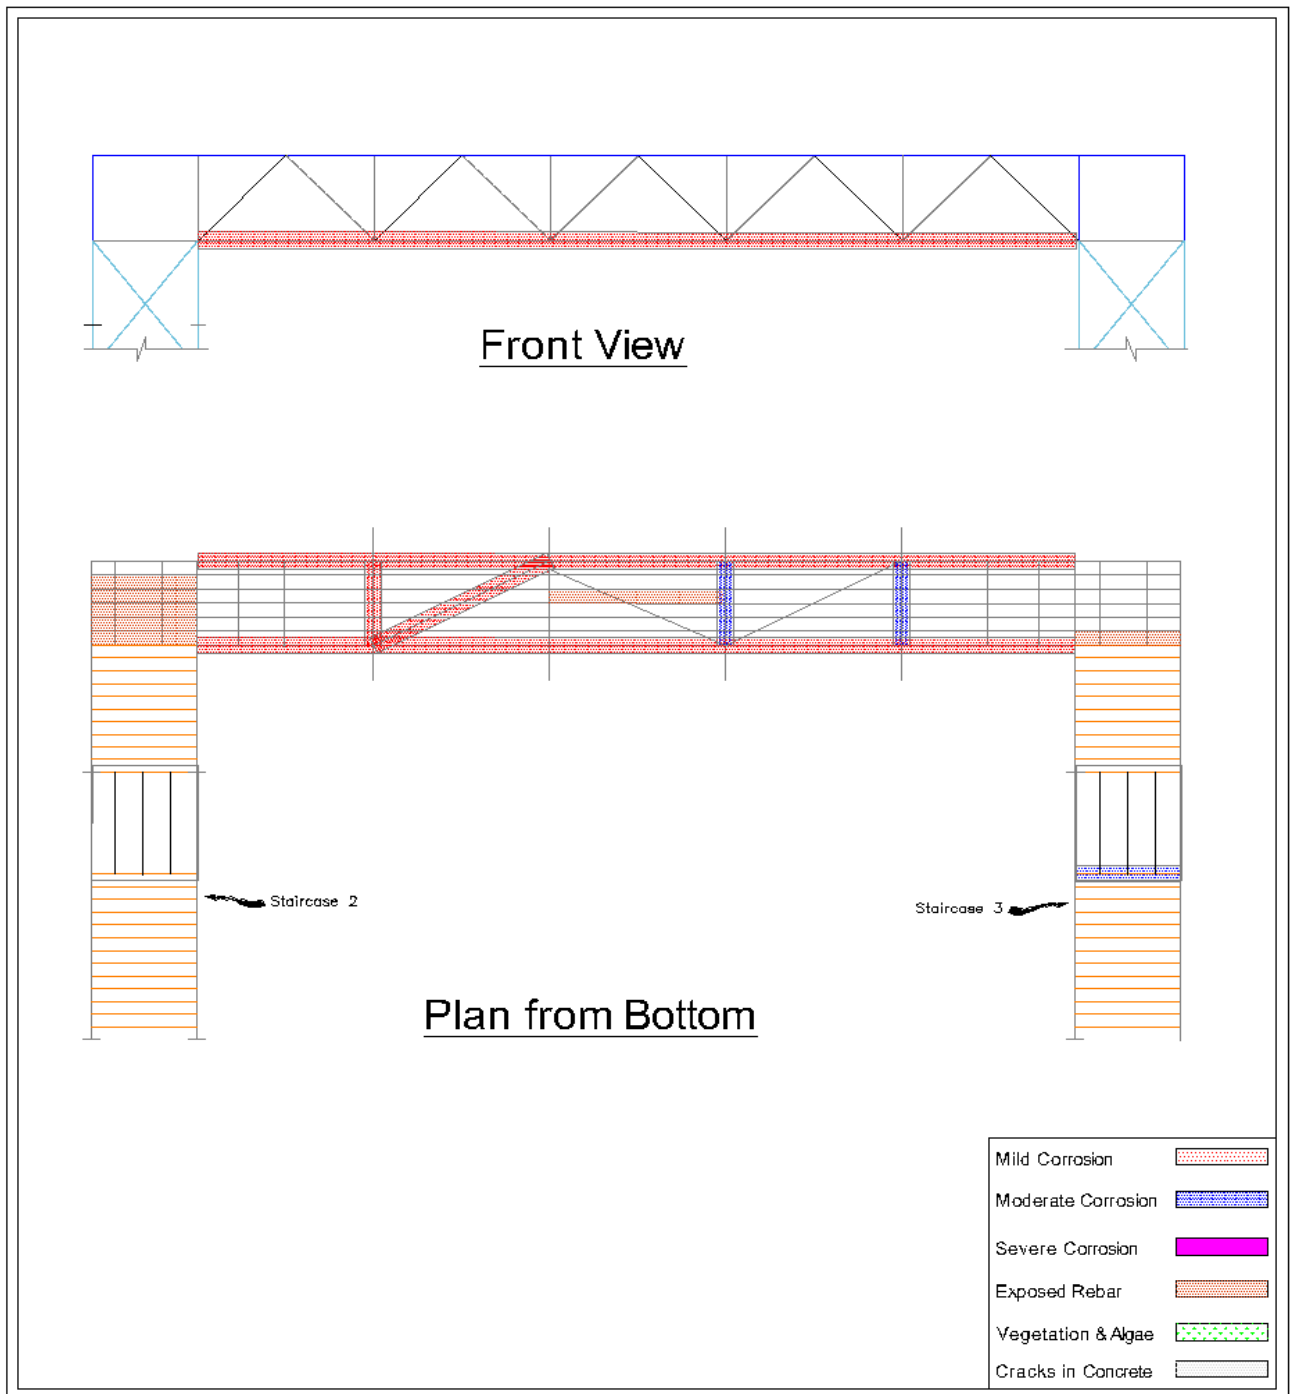
**Fig 2.7** locations of deterioration and bottom view of span-3

- Structural members are in fair condition, displaying mild corrosion for top chord members, verticals, diagonals, gusset plates and staircase stringer beam along steel concrete joint moderate corrosion for bottom chord members (locations are marked in figures below).
- Precast slab panels are deteriorated reinforced is exposed in pathway and staircase main landing. (Photographs of the same can be see in **fig 2.8,2.9**)

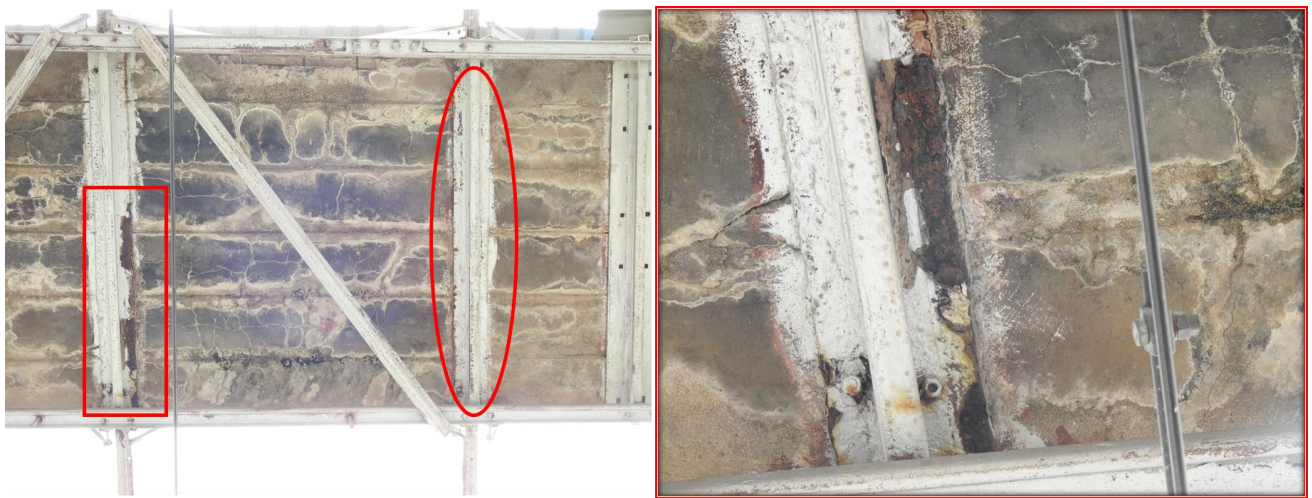
**Fig 2.8:** Corrosion of floor beam members in span-3

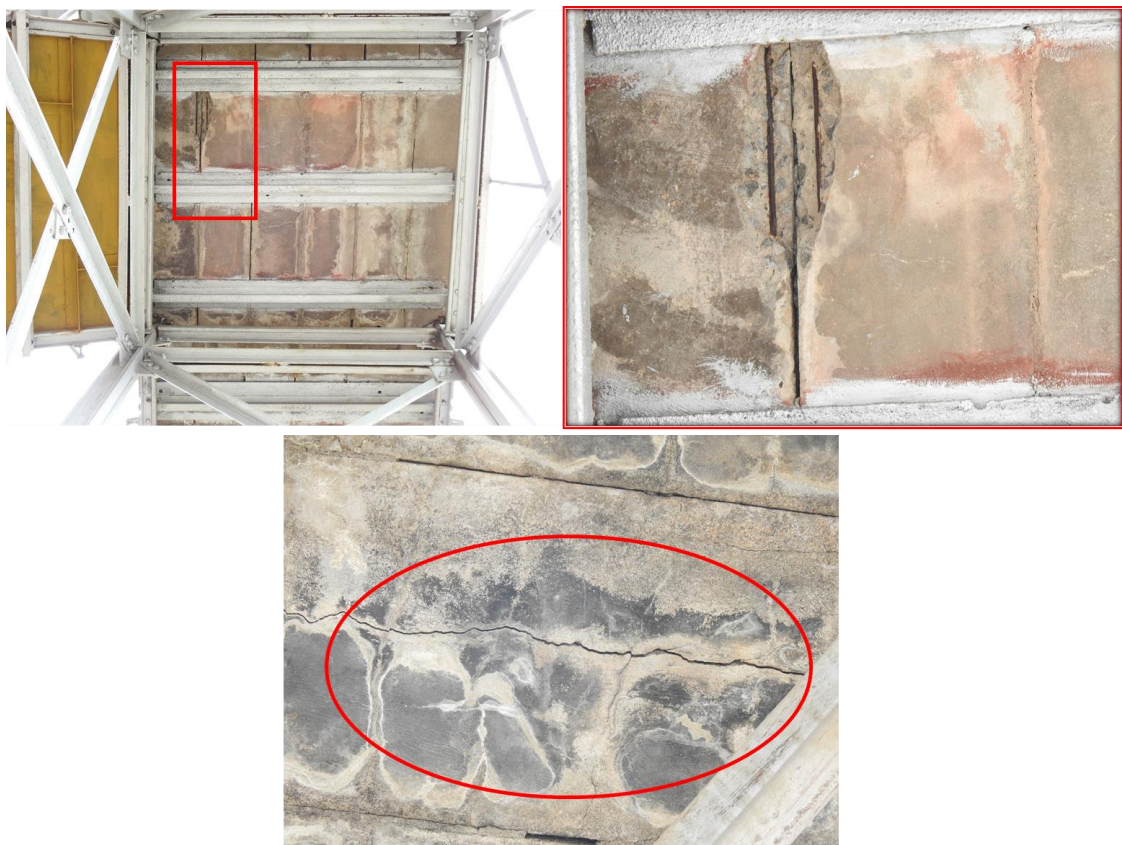
**Fig 2.9:** Exposed reinforcement at main landing and cracks in pathway slab panels in staircase-3
