# Third Party Audit of ROB's and FOB's of SCR

## INSPECTION OF FOB AT PEDDAVATLAPUDI RAILWAY STATION

**Final Report**  
SEPTEMBER | 2020

| <b>Name of the Project</b> | : | VISUAL INSPECTION OF FOB AT PEDDAVATLAPUDI RAILWAY STATION |

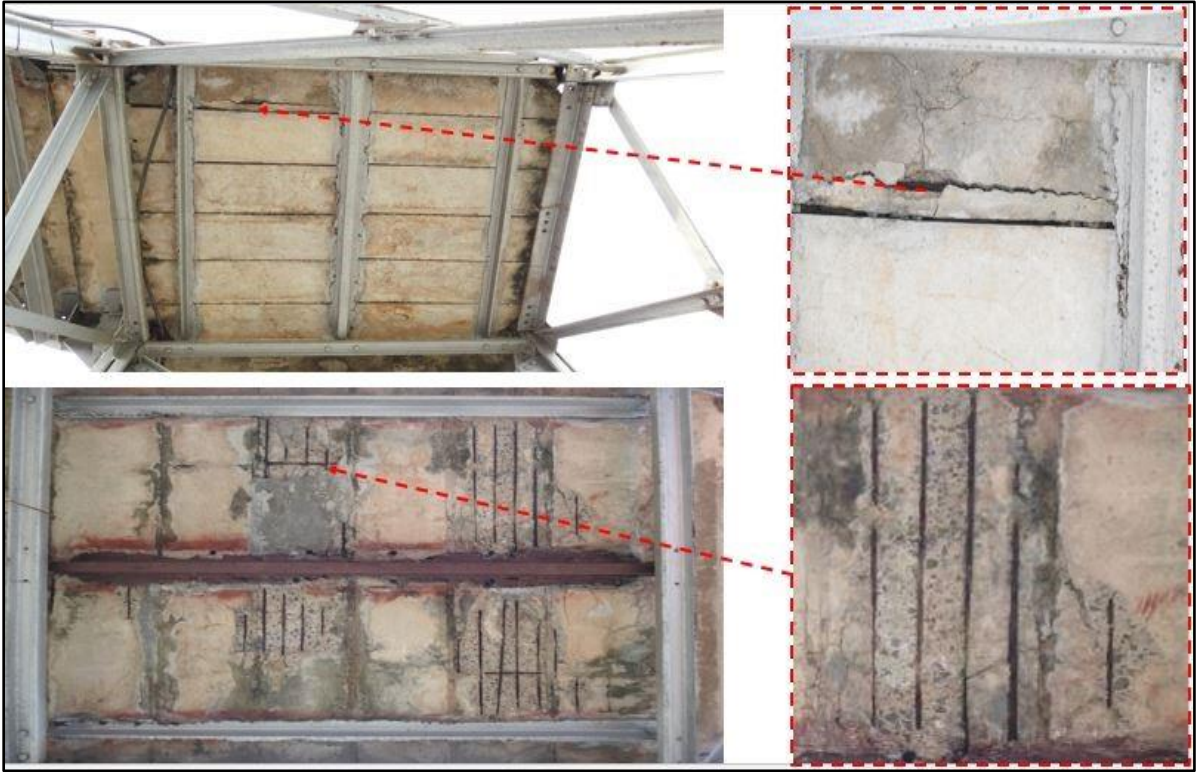
- ✓ Exposed reinforcement is observed at Staircase Landing slab panels at plat form 1 and 2.

Exposed reinforcement is observed on staircase Landing slab at plat form 1 and 2

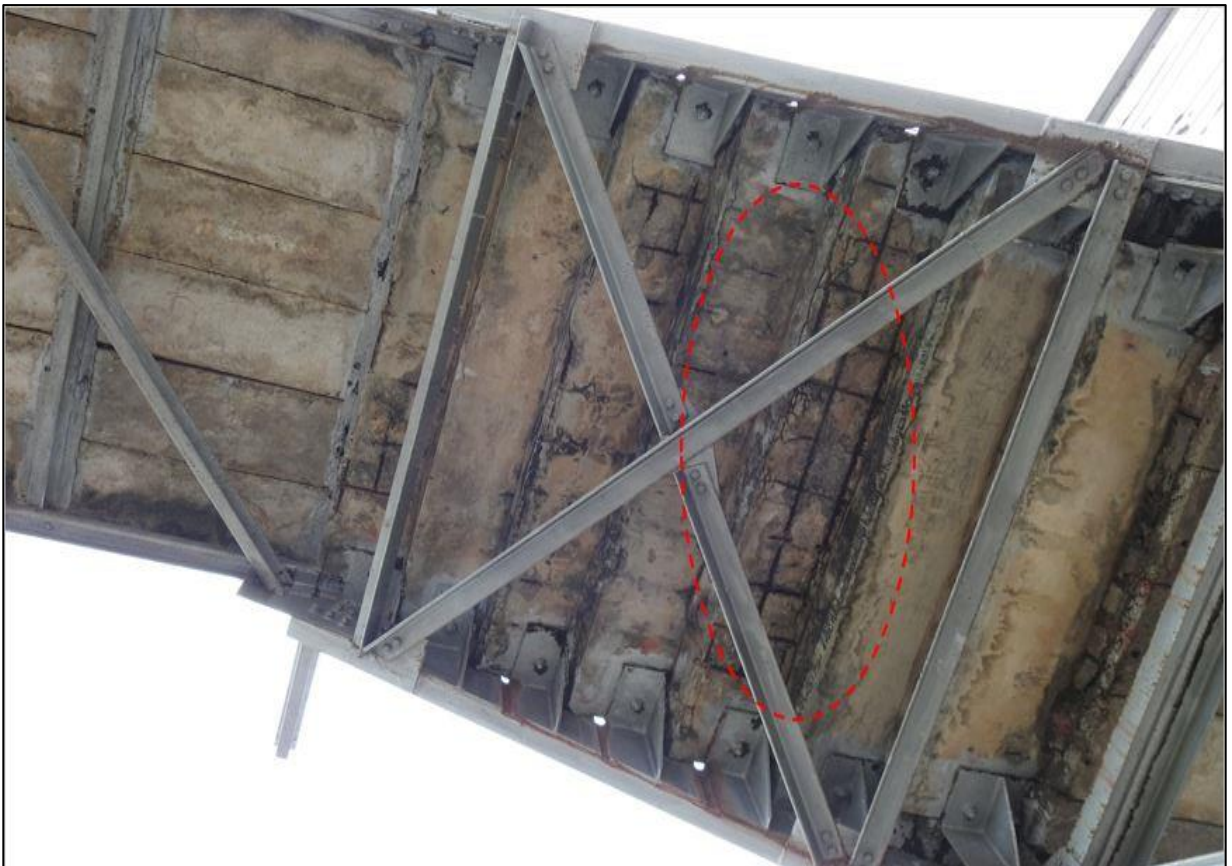
Reinforcement exposed at Stair Case flight of Clear span

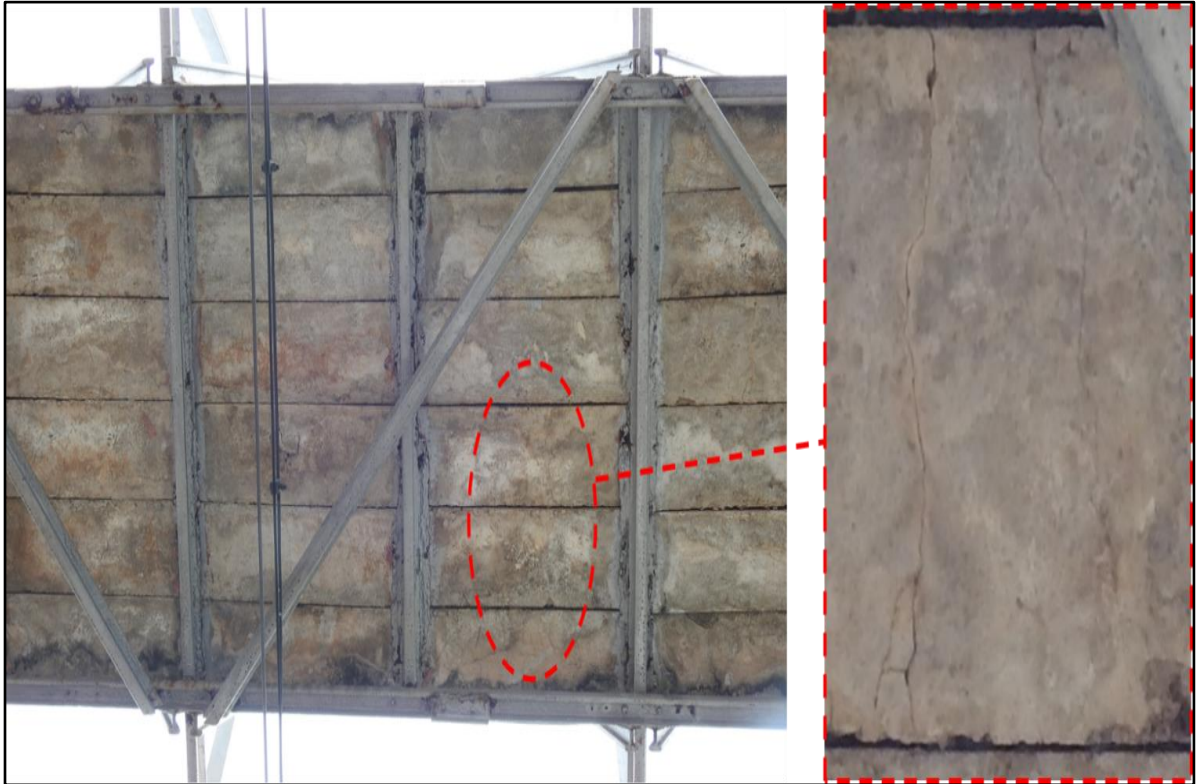
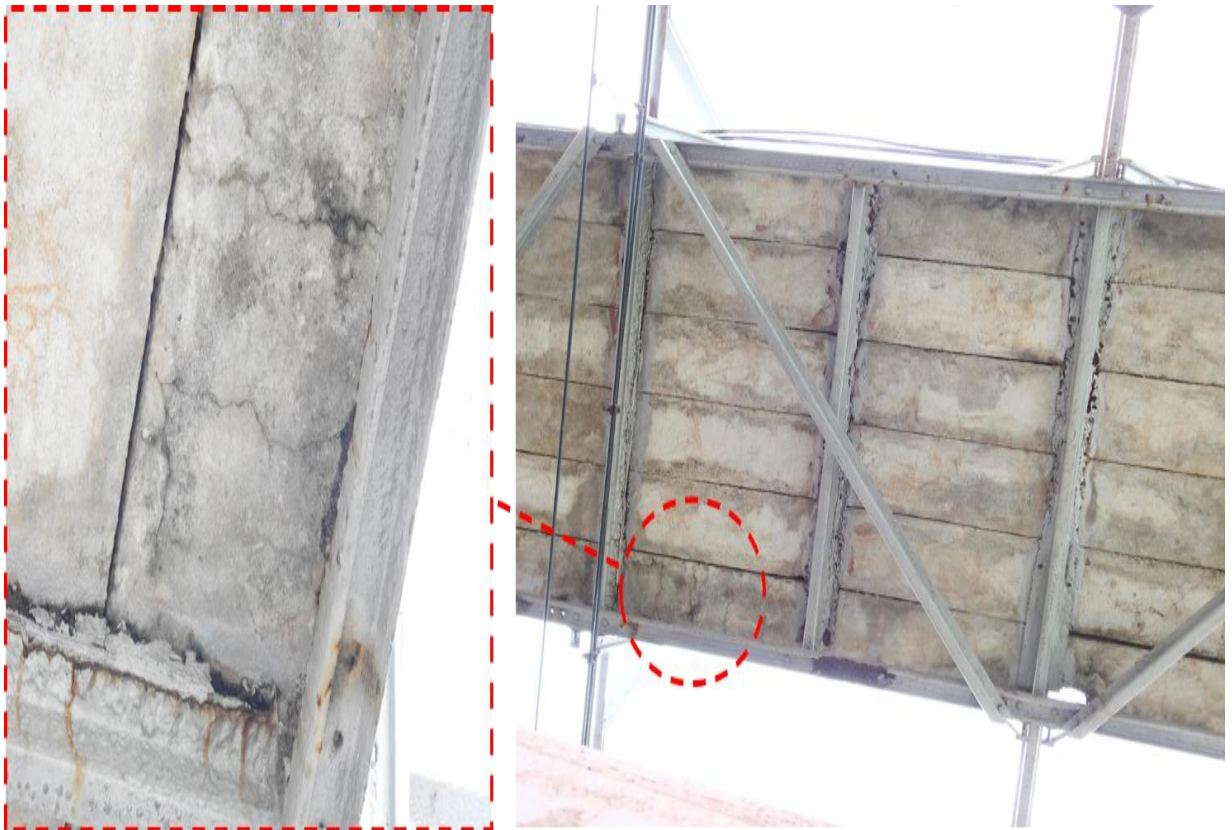
- ii. ✓ Cracks are observed at bottom of the span and below the stair case

a) Cracks observed at Span-1 & Span 2

| SIGNS OF DISTRESS, DEFORMATION IN BRIDGES | | | |
|---|---|---|---|
| | Cracking in RCC components | slab panels | cracks are observed in Pre-cast RCC panels (Refer <b>Part 1.4(b)</b> ) |

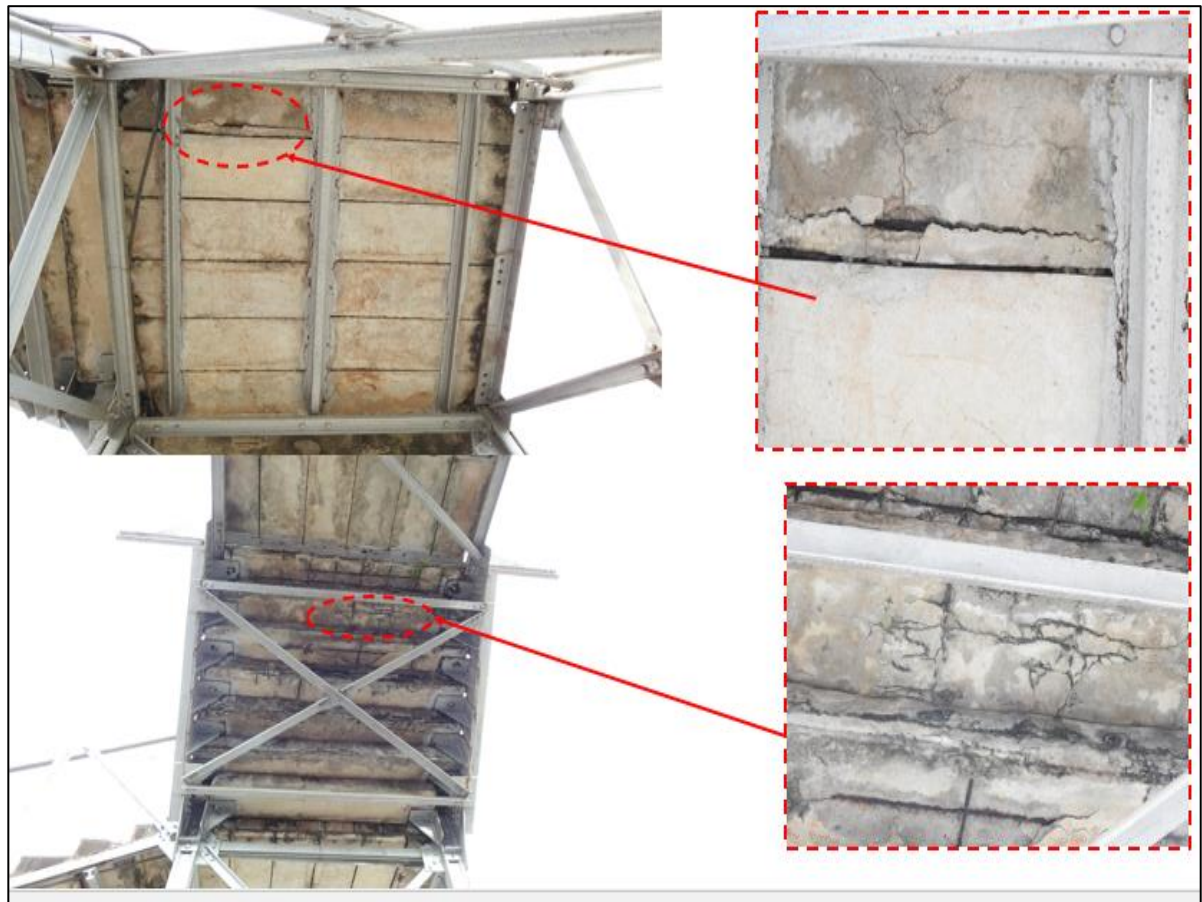
**b) Spalling and Cracks Observed at Stair case 2**

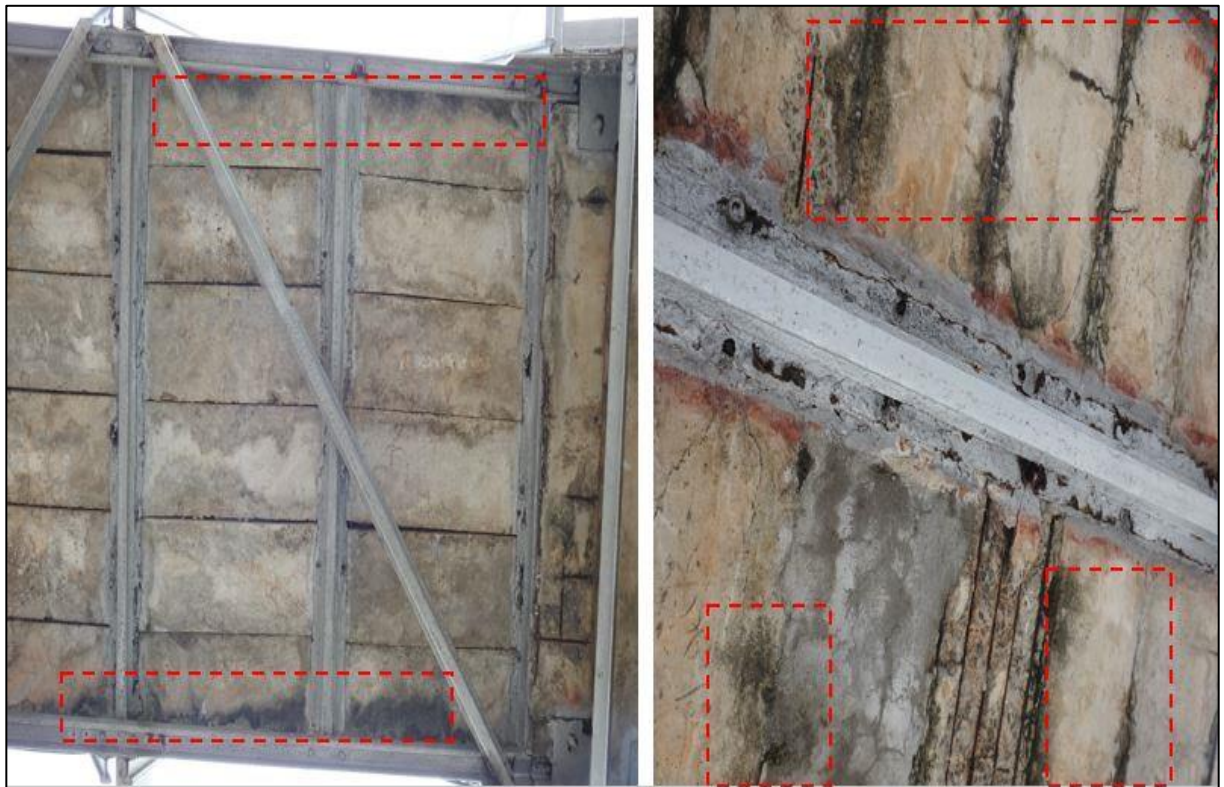
**c) Leaching and water seepage is observed at slab panels**

| SIGNS OF DISTRESS, DEFORMATION IN BRIDGES | | | |
|---|---|---|---|
| | Water seepage | Slab panels | water seepage is observed at slab panels (Refer <b>Part 1.4(b) c)</b> ) |

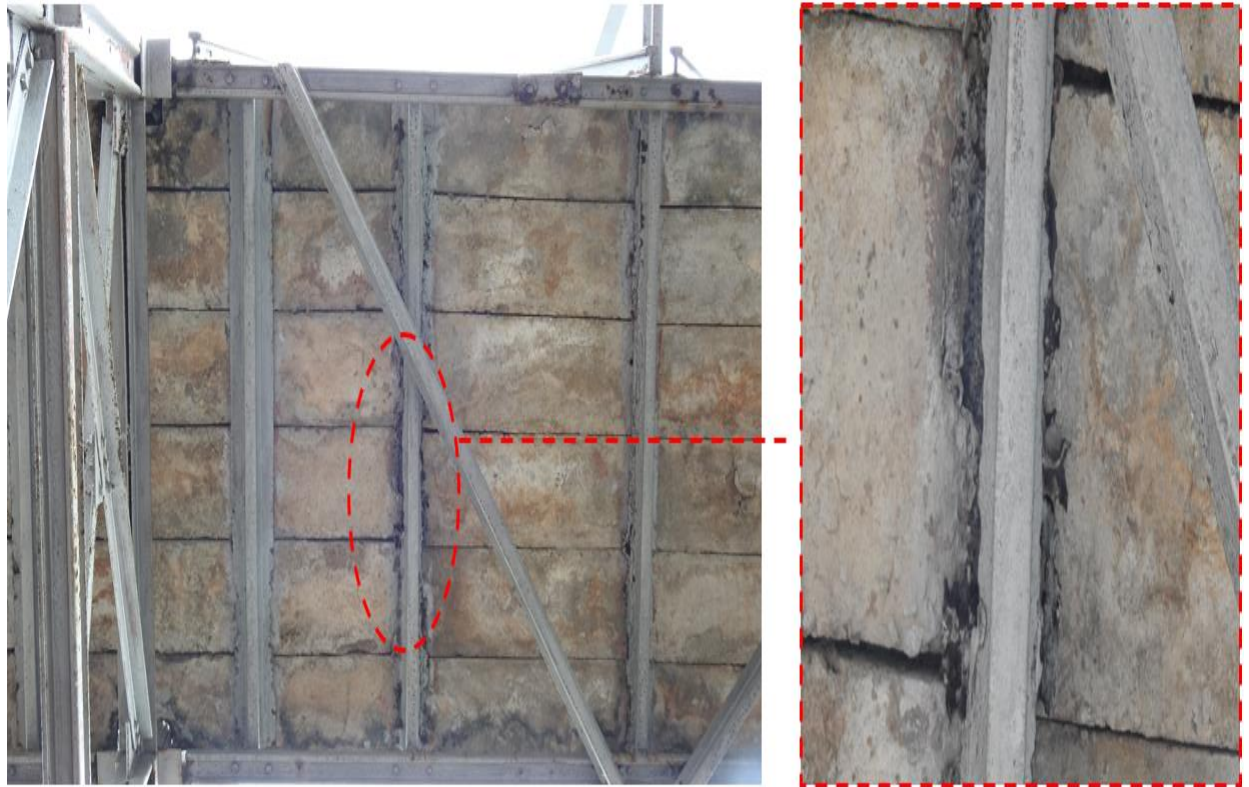
iii. Corrosion Observed at Floor beams, Bottom chord & Cleat angles

a) Corrosion of Floor Beams at Span-2

| SIGNS OF DISTRESS, DEFORMATION IN BRIDGES | | | |
|---|---|---|---|
| | Extent of Corrosion | Floor beams, bottom chord | Corrosion of floor beam is observed in both span of FOB. (Refer <b>Part 1.4(c)</b> ) |

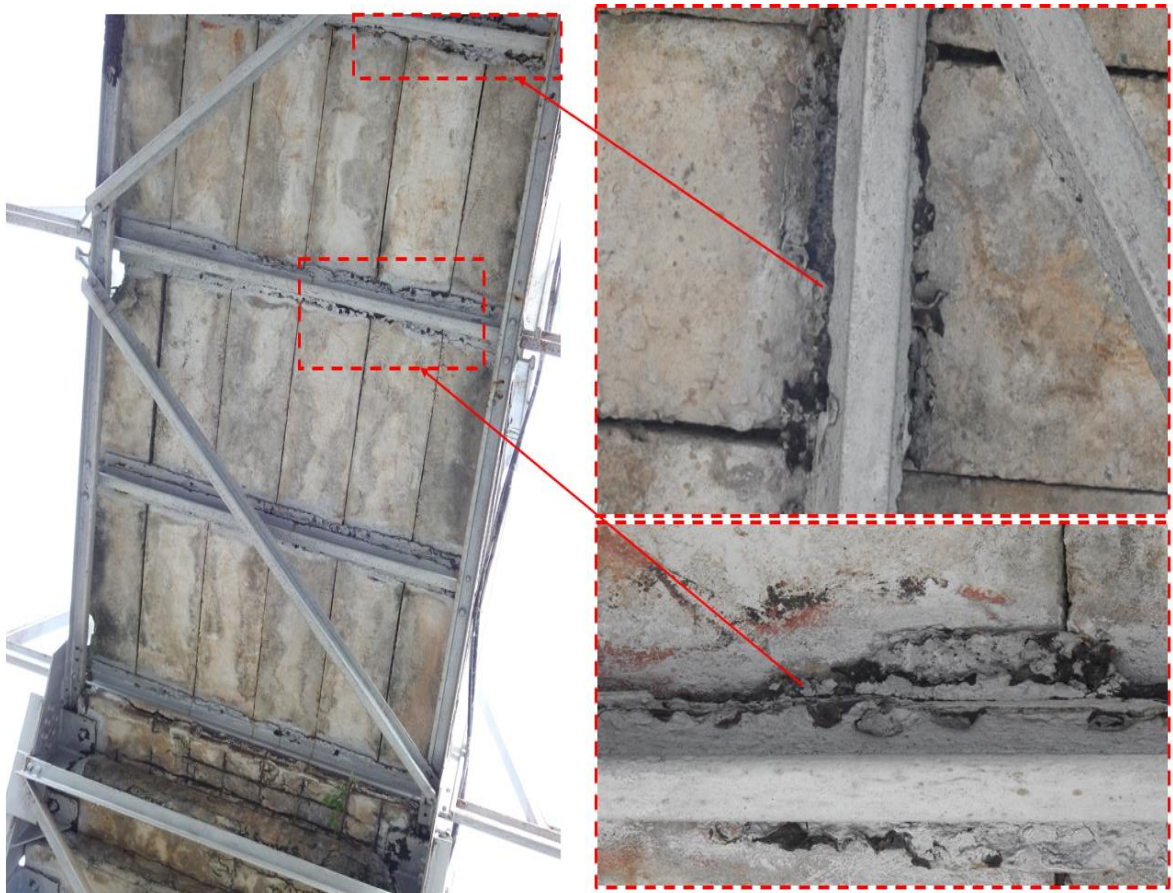
b) Corrosion of Floor Beams at Span-2

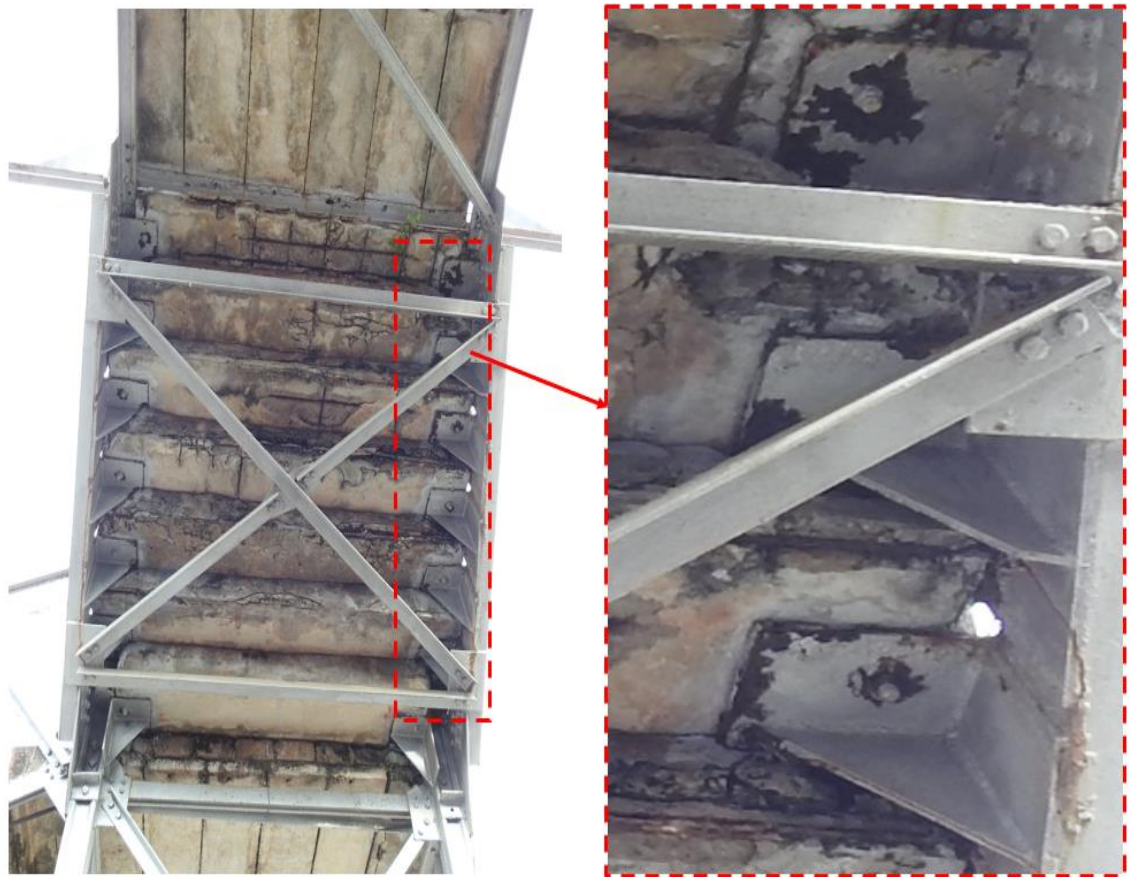
c. Corrosion at Cleat Angles of Stair Case

| SIGNS OF DISTRESS, DEFORMATION IN BRIDGES | | | |
|---|---|---|---|
| | Corrosion in Gusset plate | Cleat angles | Corrosion is observed on Cleat angles of clear span Staircase (Refer <b>Part 1.4(c)</b> ) |

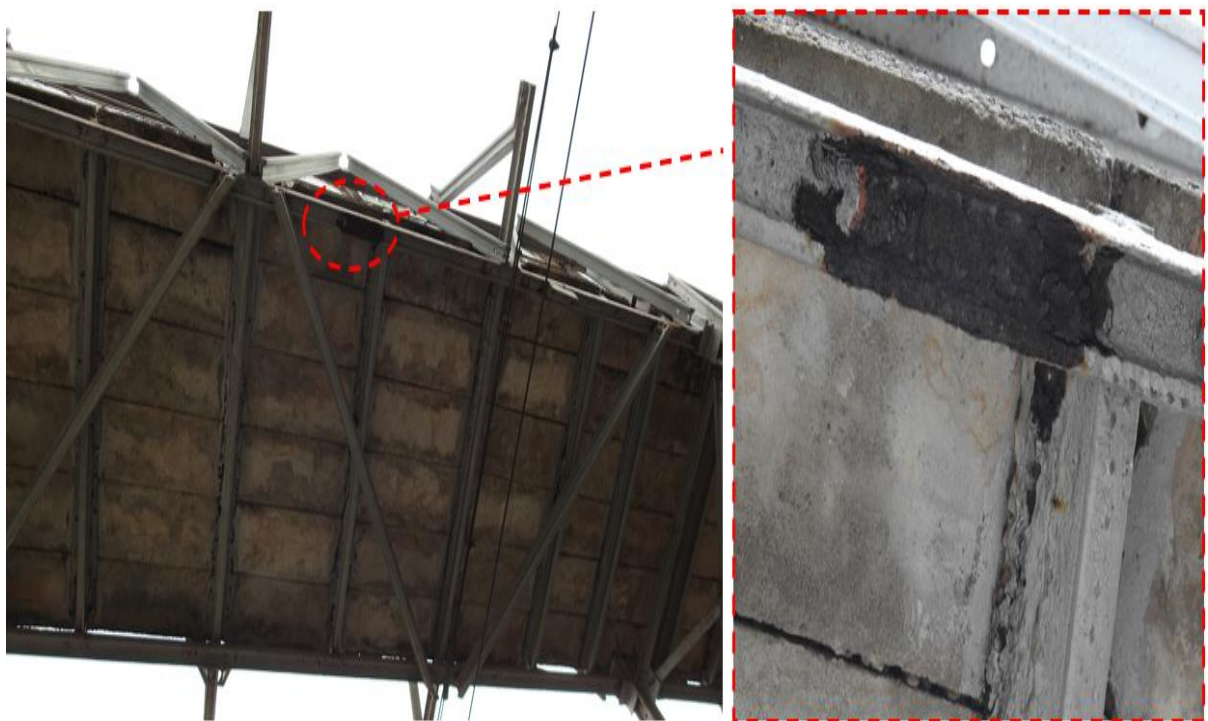
d)Corrosion of Bottom chord in Span 2

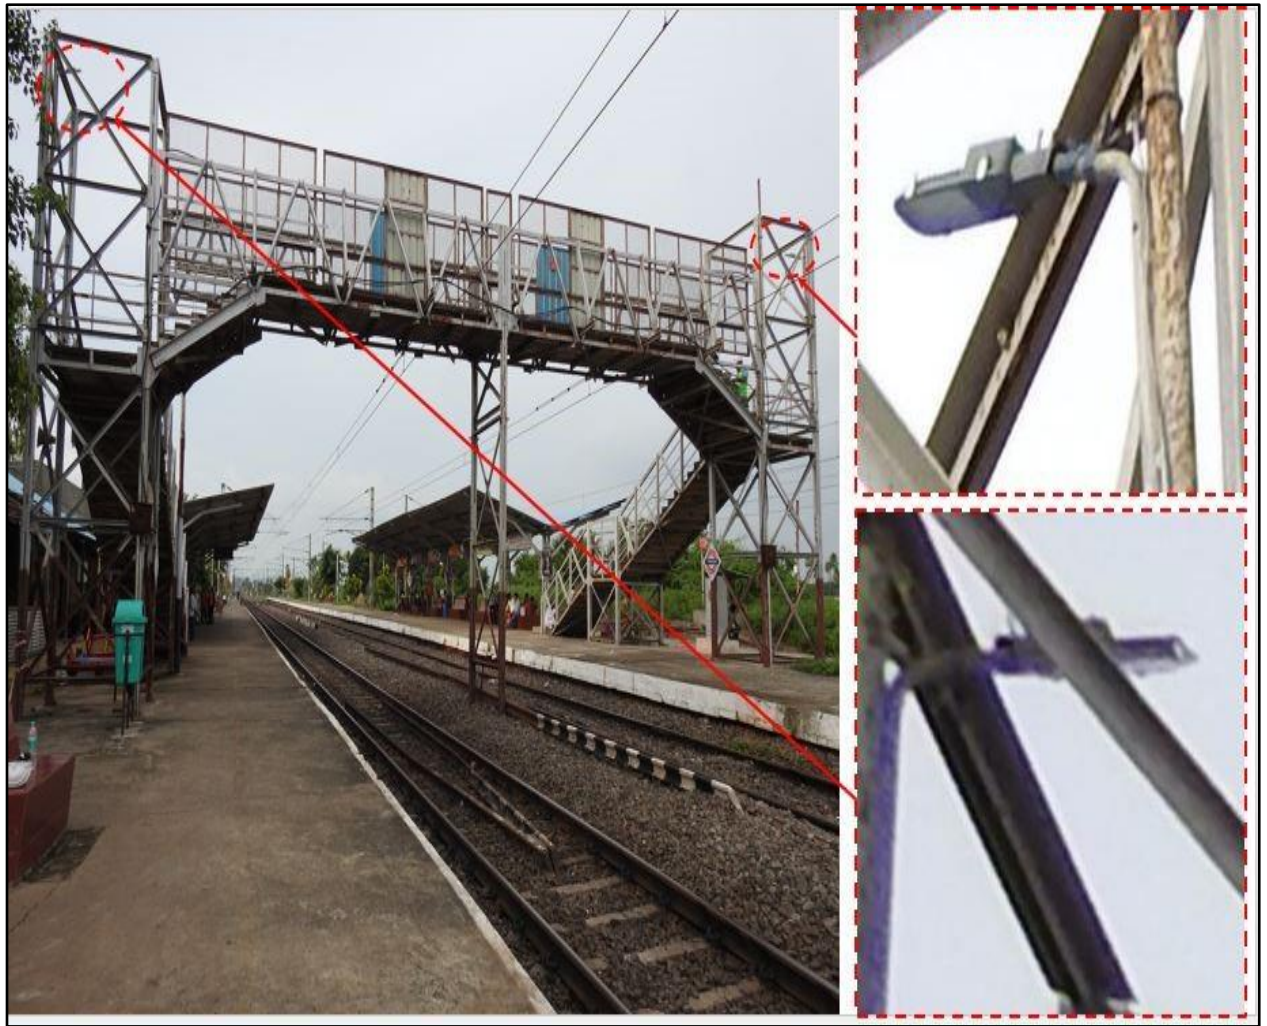
| 1.2 IDENTIFICATION OF LOADS ON BRIDGE | | | |
|---|---|---|---|
| | e) load of advertising hoarding | Yes | Light post with 50 mm dia. GI pipe is supported on Trestle railing at both corners of FOB.( Refer <b>fig :1.1</b> ) |

**Fig 1.1:** Light Post attached at Trestles 1 & 2

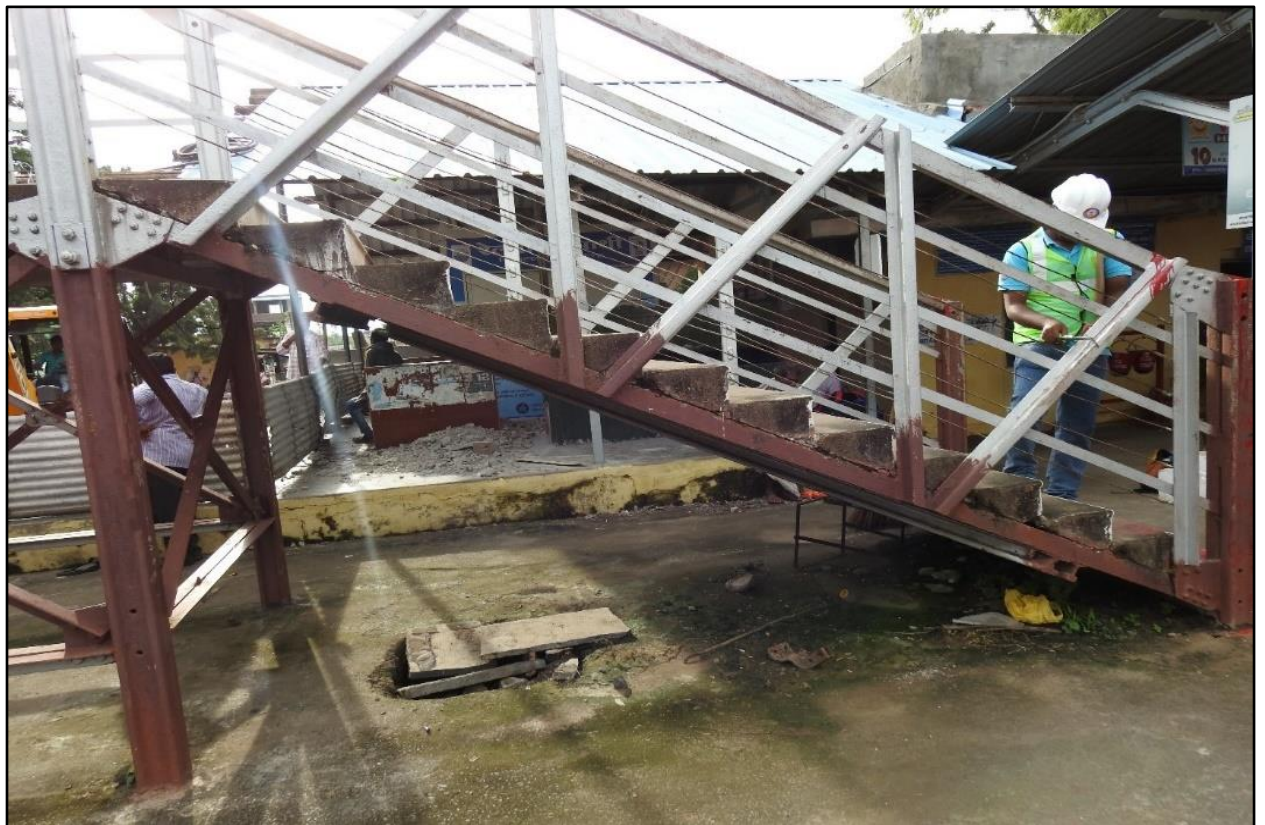
**Fig 1.2:** Red oxide coating observed at FOB

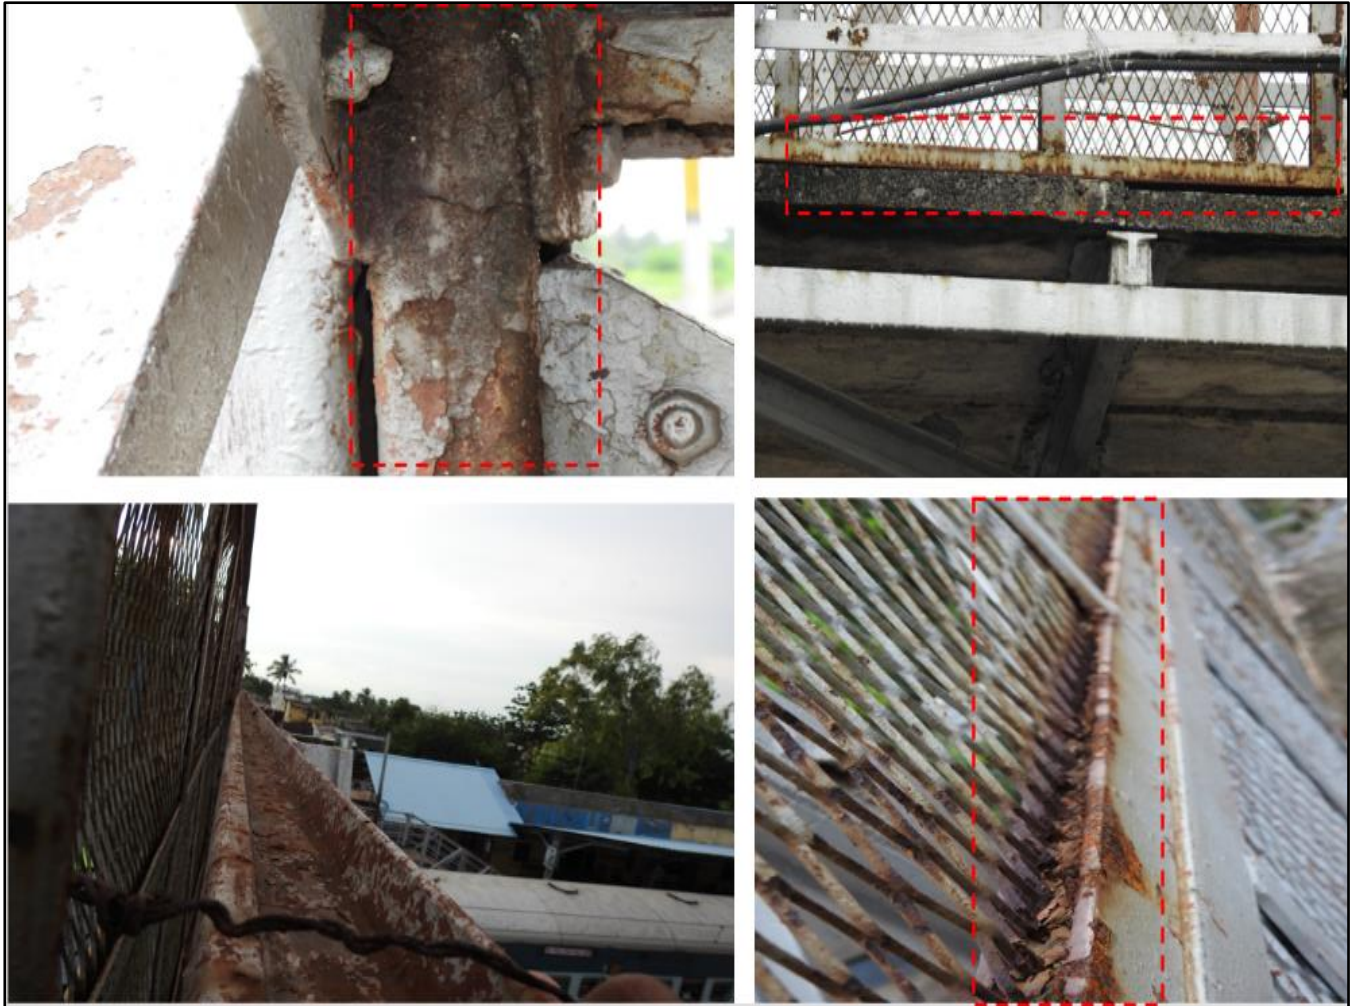
| SIGNS OF DISTRESS, DEFORMATION IN BRIDGES | | | |
|---|---|---|---|
| | Rust straining | Chord members, joints | Corrosion is observed at all the joints of FOB& Top chord member (Refer <b>Fig.1.3</b> ) |

**Fig 1.3:** Corrosion observed at steel joint & Top chord

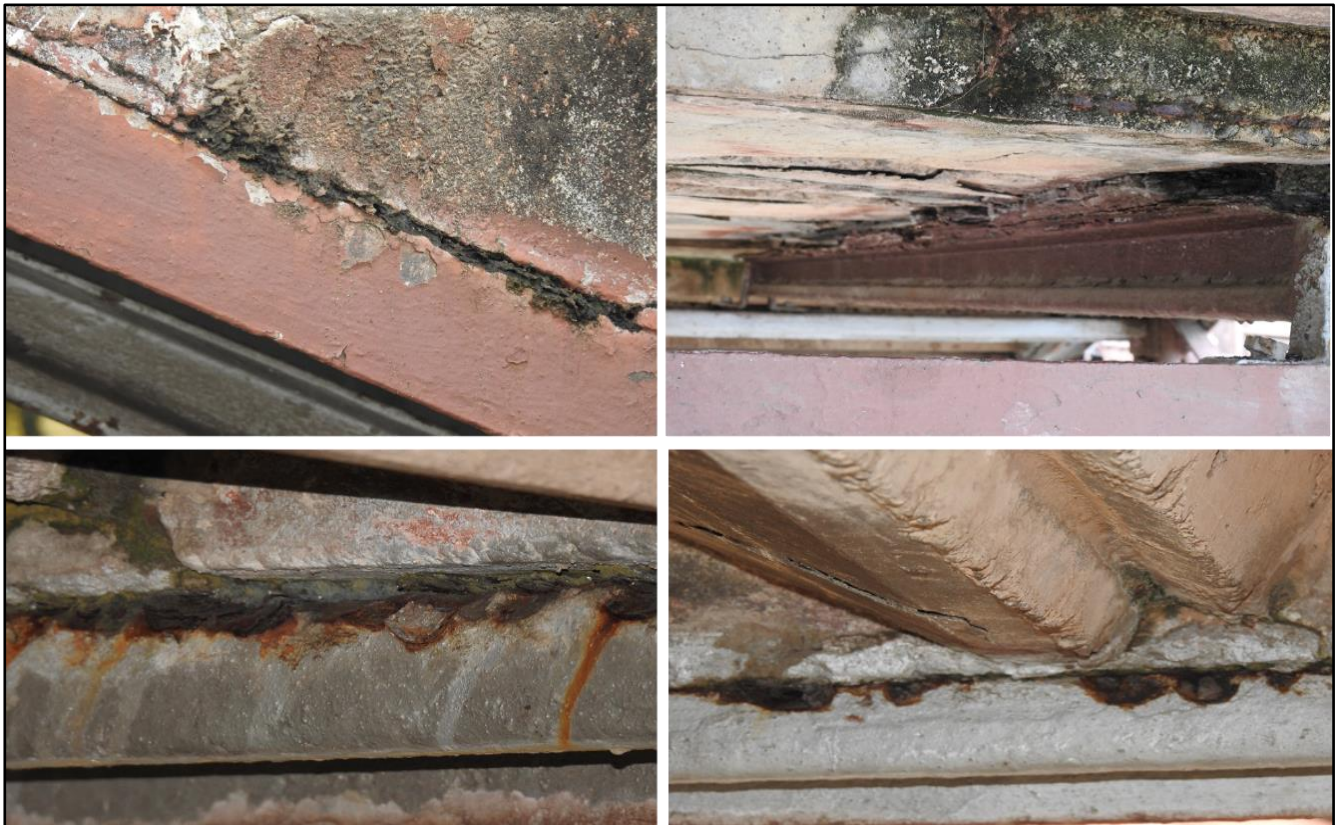
**Fig 1.4:** Corrosion is observed at Stringer beam joint

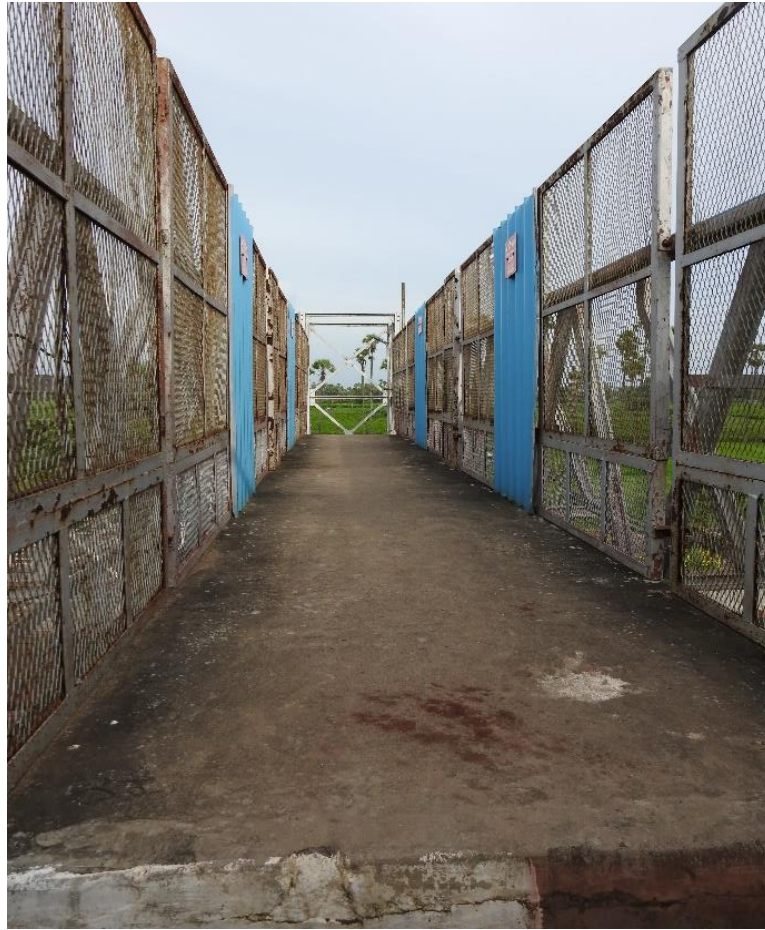
| 1.2 IDENTIFICATION OF LOADS ON BRIDGE | | | |
|---|---|---|---|
| | a) Additional wearing coat on Floor | Yes | Cement concrete layer is used for flooring (Refer <b>fig: 1.5</b> ). |
| | b) Provision of protective screen for passengers | Yes | Chain link fence made of galvanized wire of 2 mm gauge and 2mm galvanized sheet is used above OHE line on both side of gangway is used for protection (Refer <b>fig :1.5</b> ) |

**Fig 1.5:** Path Way, Protective screen of FOB

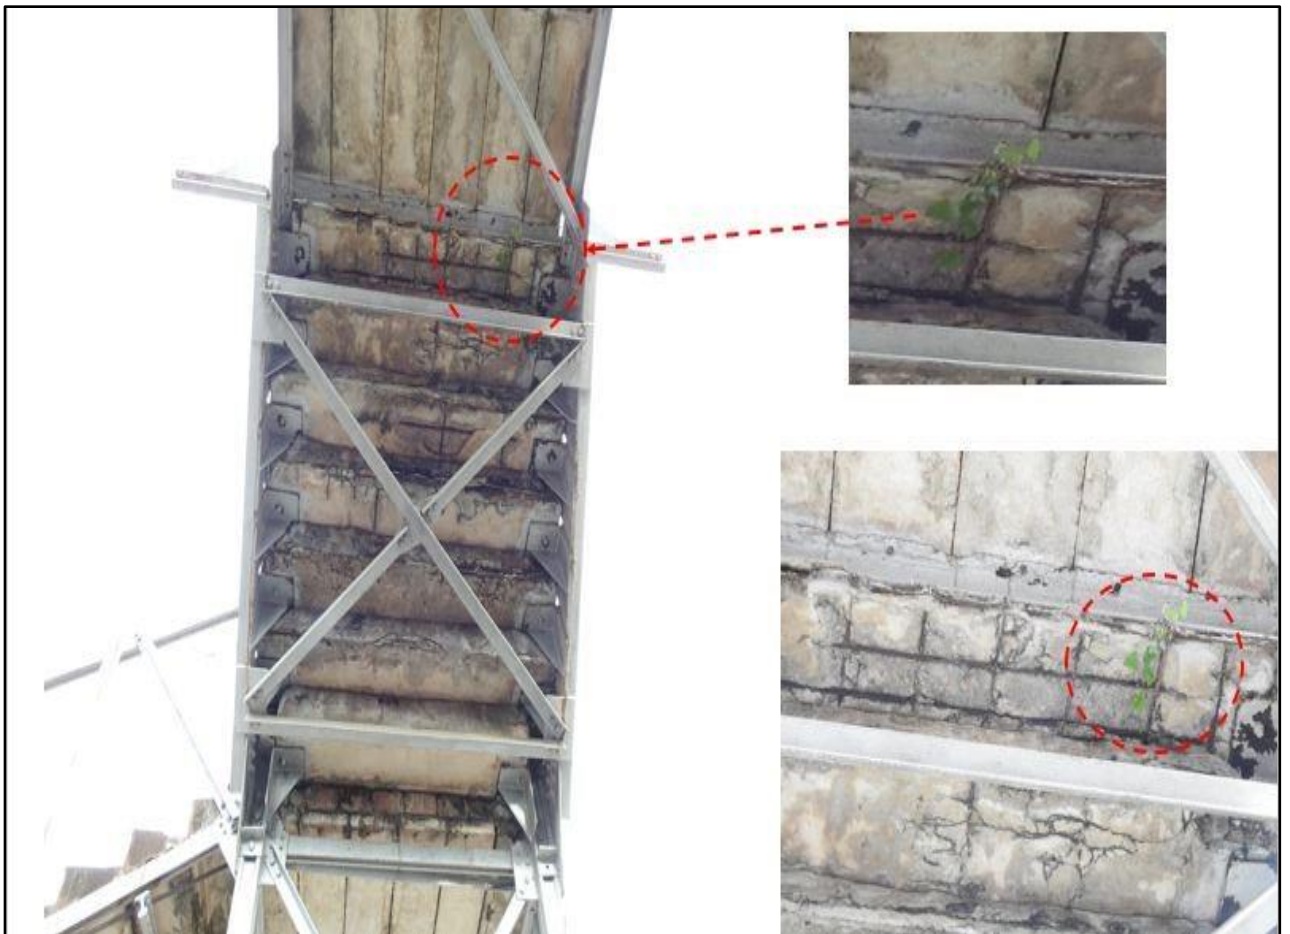
**Fig 1.6:** Vegetation growth at FOB

- **Methodology for cleaning:** Generally foreign material are deposited or accumulated on bridge deck and in several bridge components which can deteriorate the bridge if proper action is not taken, so we support cleaning.
- **Debris removal:** The surface areas of a FOB should be cleaned and washed by brushing with fresh water or using high-pressure water blasting, including Deck slab top, sides along steel concrete joint on either side of deck, Supporting Railing and connecting staircase.
- **Vegetation removal:** Vegetation growth shall be removed from the components of the FOB, and near the FOB.

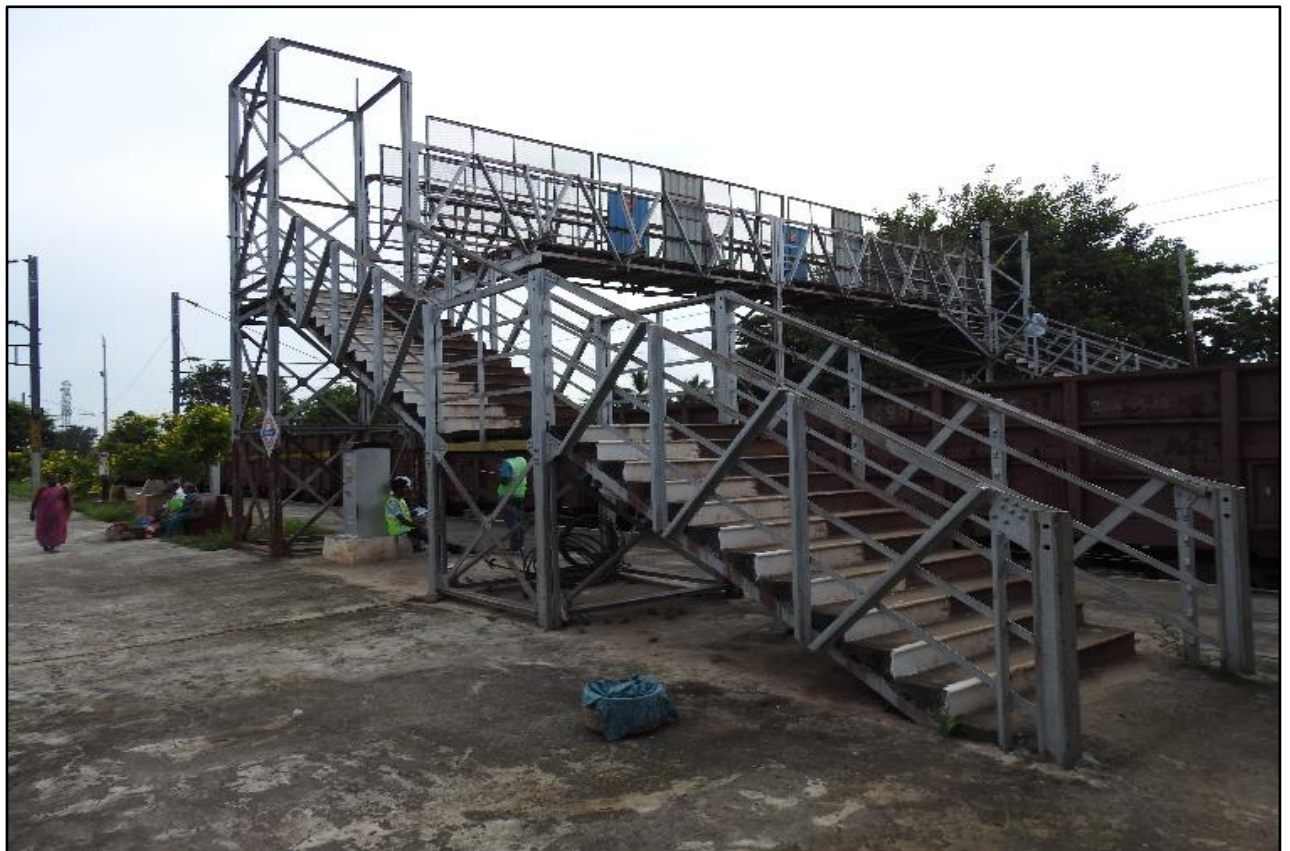
| | Number of Staircase | 2 no's | Staircase is observed as Precast RCC Slab panels supported on 50 x 80 x 80 Rail tie beam and 50 x 80 x 80 Rail section Stringer beam on both sides of stair case. (Refer <b>fig :1.8</b> ) |

**Fig: 1.8** Railing, Trestle of FOB

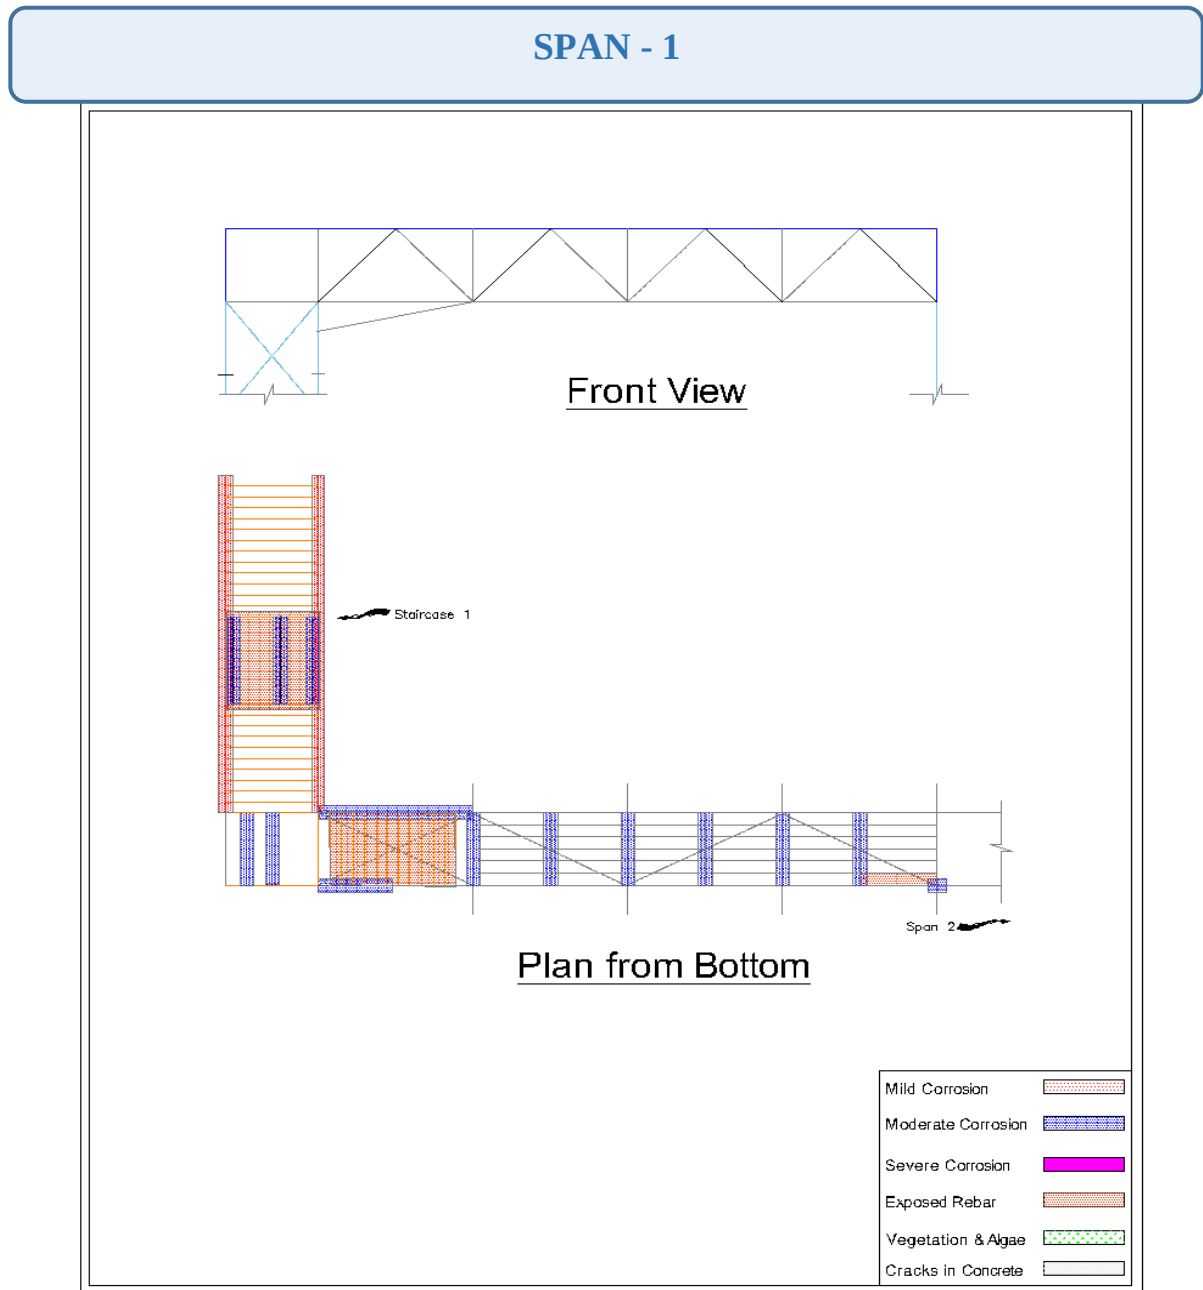
**Fig: 2.1** location of deterioration and view of span-1

- Structural members are in fair condition, displaying mild corrosion for top chord members, verticals, diagonals, and gusset plates, moderate corrosion for bottom chord members, and staircase stringer beam along steel concrete joint (locations are marked in figures below).

- Staircase 1 precast slab panels are deteriorated reinforced is exposed in mid landing and flights  
(Photographs of the same can be see in **fig2.3-2.7**)

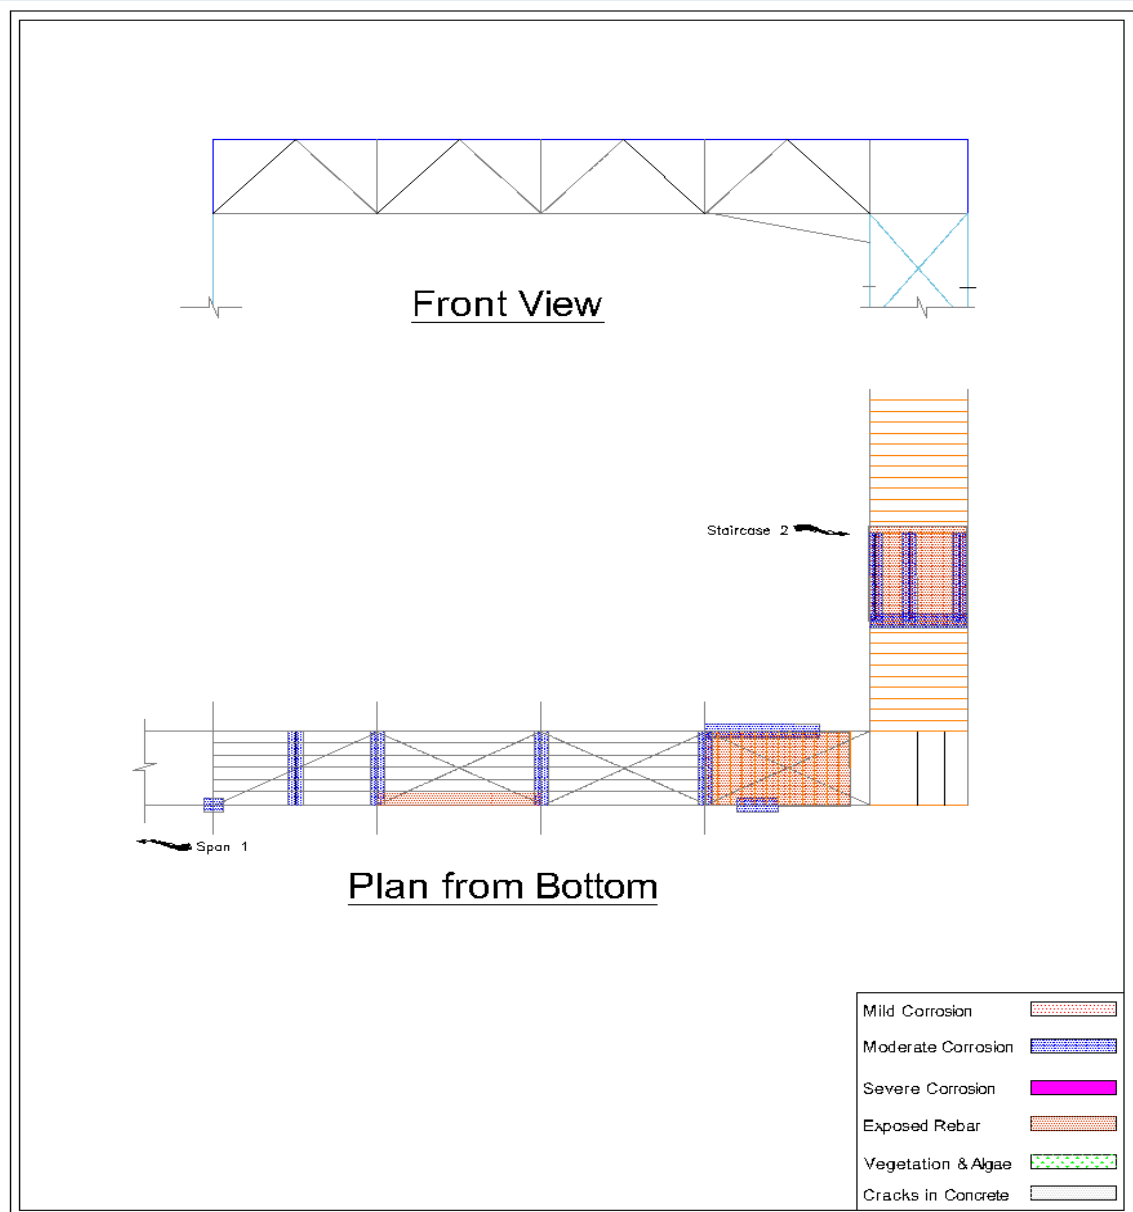
**Fig: 2.2** location of deterioration and view of span-2

- Structural members are in fair condition, displaying mild corrosion for top chord members, verticals, diagonals, and gusset plates, moderate corrosion for bottom chord members, and staircase stringer beam along steel concrete joint (locations are marked in figures below). Staircase 2 precast slab panels are deteriorated reinforced is exposed in mid landing and flights  
(Photographs of the same can be see in **fig2.3-2.7**)

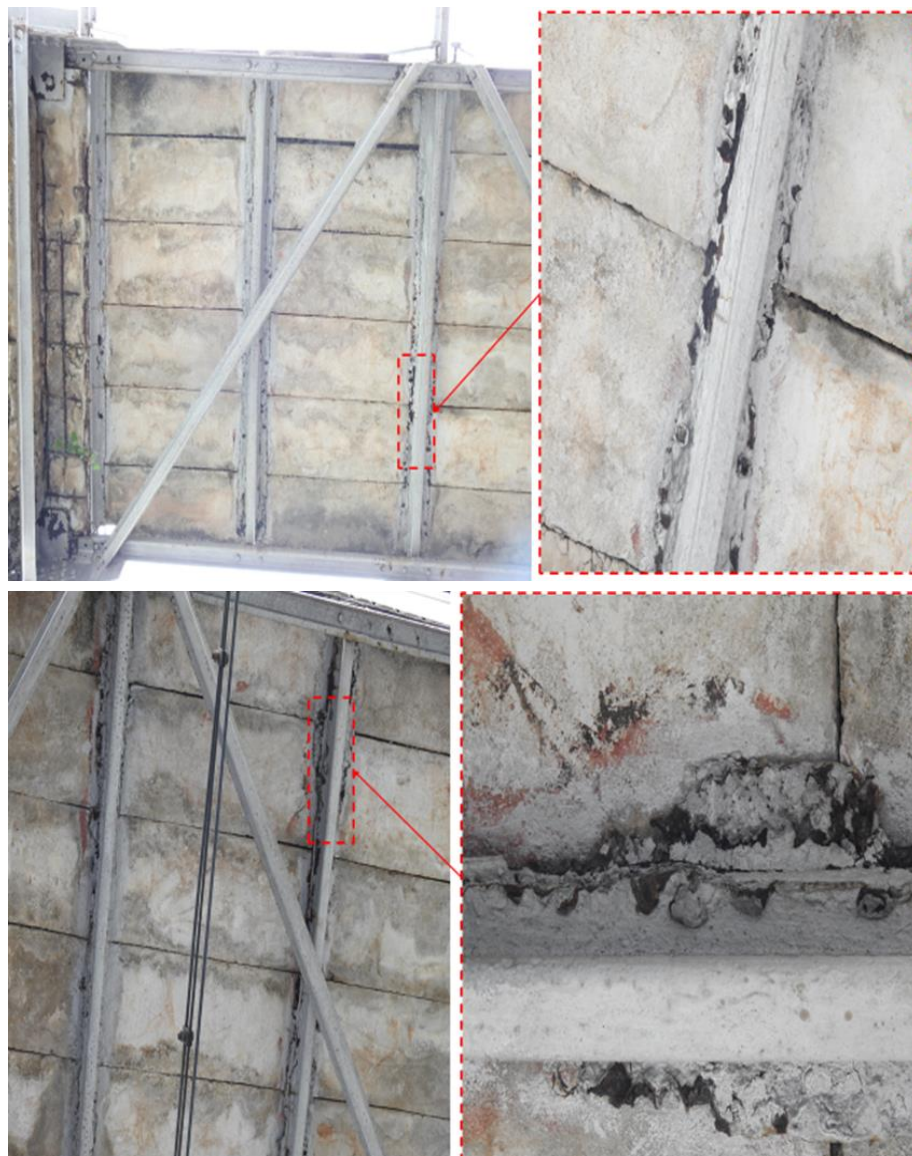
**Fig: 2.3** Corrosion observed in floor beams

- If the paint condition is identified as Grade-1, aluminum paint shall be applied with a similar shade.
- Where condition of paint is evaluated as Grade-2 special anticorrosion paint shall be applied to restrict corrosion from progressing further.
