# Third Party Audit of ROB's and FOB's of SCR

## INSPECTION OF FOB AT PEDDAVATLAPUDI RAILWAY STATION

**Final Report**  
SEPTEMBER | 2020

| <b>Name of the Project</b> | : | VISUAL INSPECTION OF FOB AT PEDDAVATLAPUDI RAILWAY STATION |

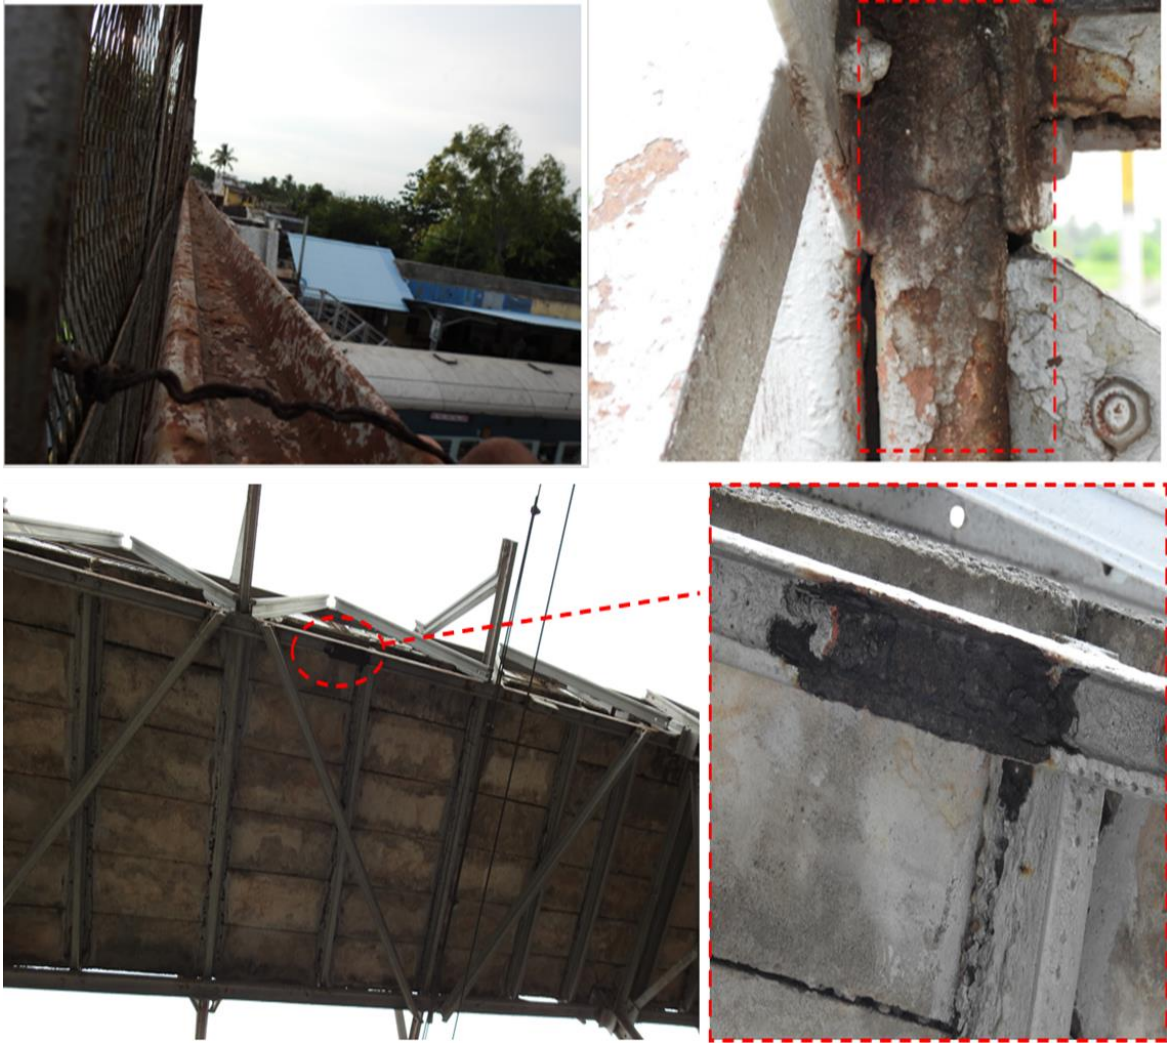
**Fig: 2.4** corrosion in top and bottom chord

- If the paint condition is identified as Grade-1, aluminum paint shall be applied with a similar shade.
- Where condition of paint is evaluated as Grade-2 special anticorrosion paint shall be applied to restrict corrosion from progressing further.

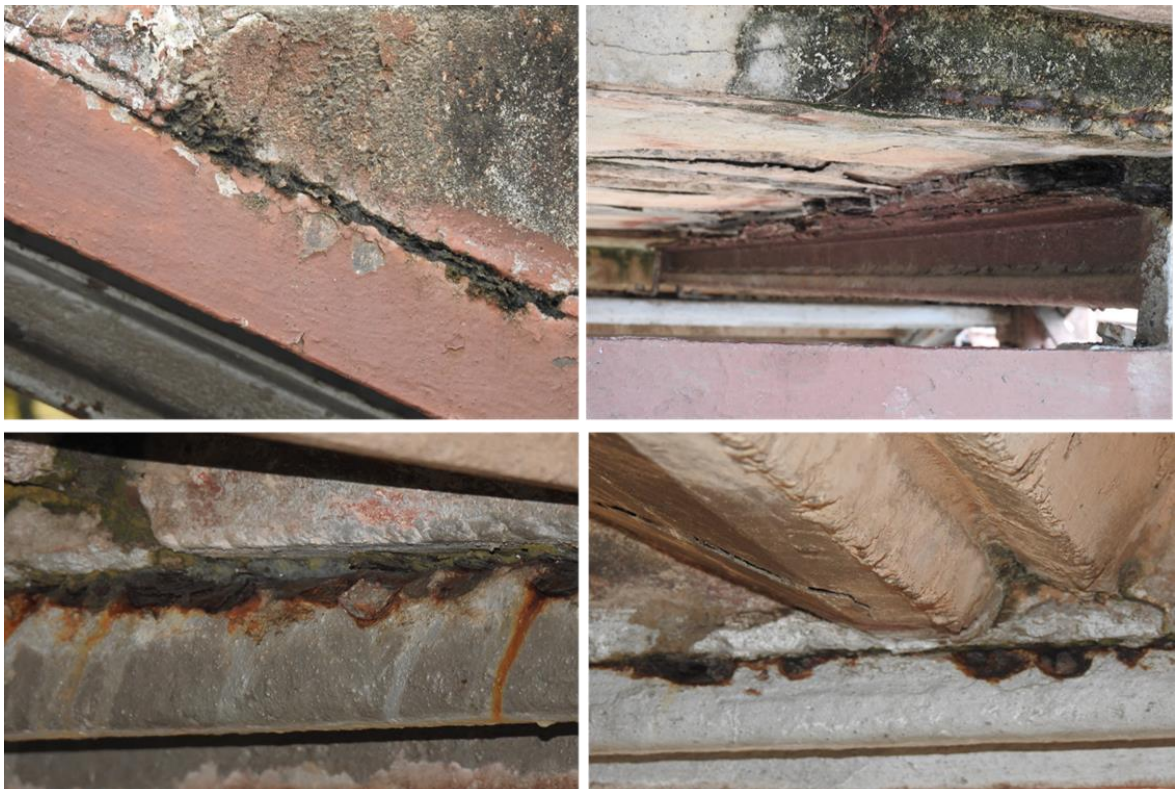
**Fig: 2.5** corrosion in staircase stinger beam near steel concrete joint

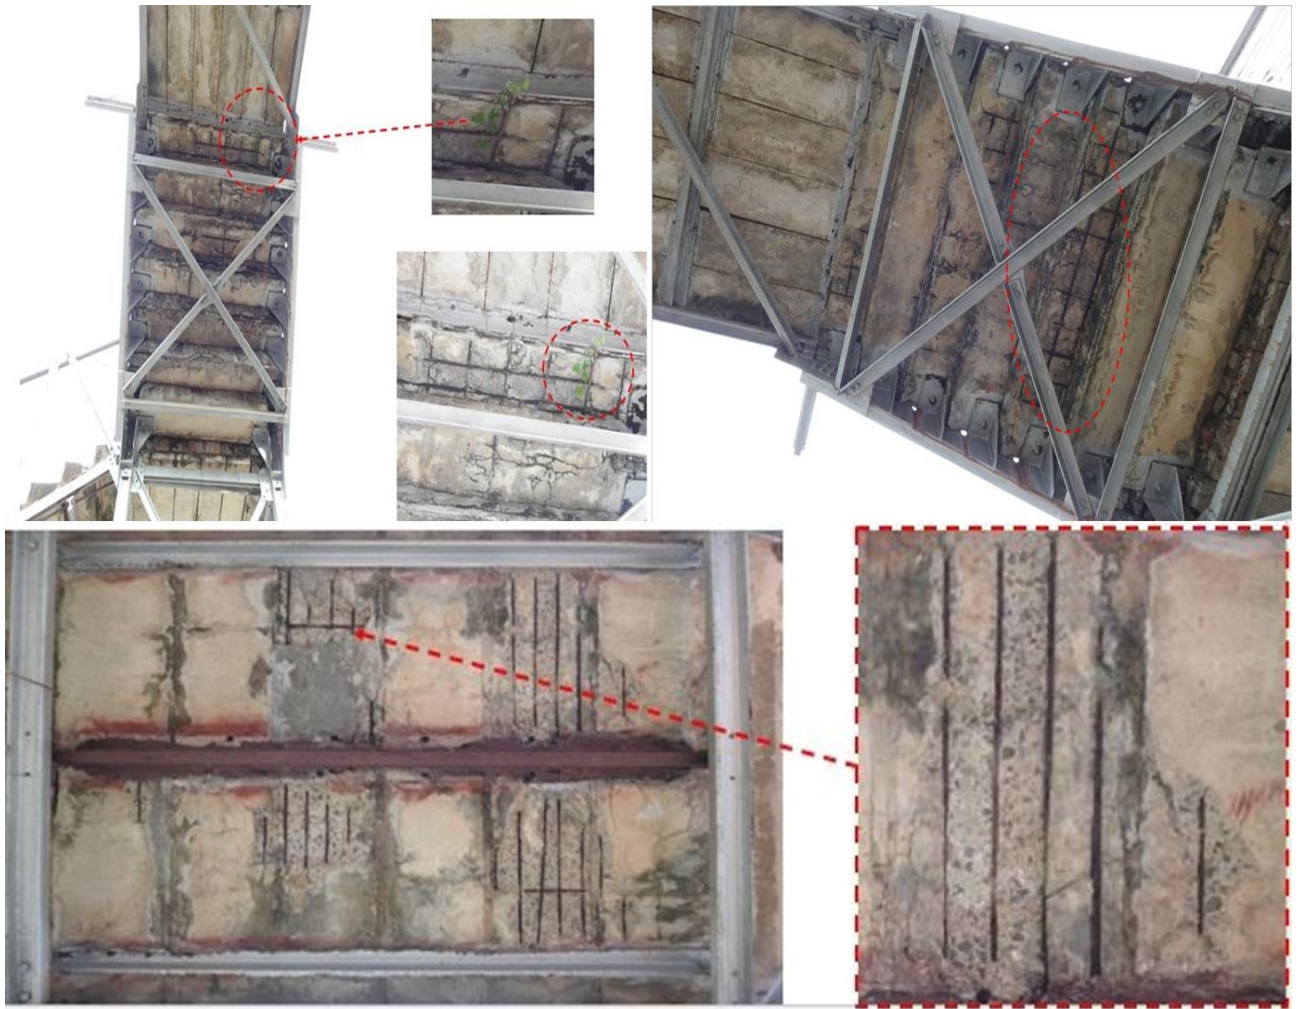
Reinforced cement concrete Slab at Deck level and some precast panels in staircase are observed with exposed rebar in many locations. (*Photographs of the same can be see in fig:2.6*)

**Fig: 2.6** damaged slab panels observed in mid landing and flight

**Methodology for patching:** Hand applied Mortar (Patching) repair is performed to restore small areas where sound concrete is damaged by spalling, scaling and/or impact. This method of repair is generally applied using trowel and require minimum or formworks. The patch thickness is limited to a maximum of 100 mm depth of hollow surface. Hand applied Mortar repair is classified into two types considering defective area and surface. Hand applied Mortar

- ii. Anti-corrosion treatment for Grade-1 and Grade-2 highlighted corrosive members.
  - iii. Replacement of pre-cast slab panels in staircase and pathway.

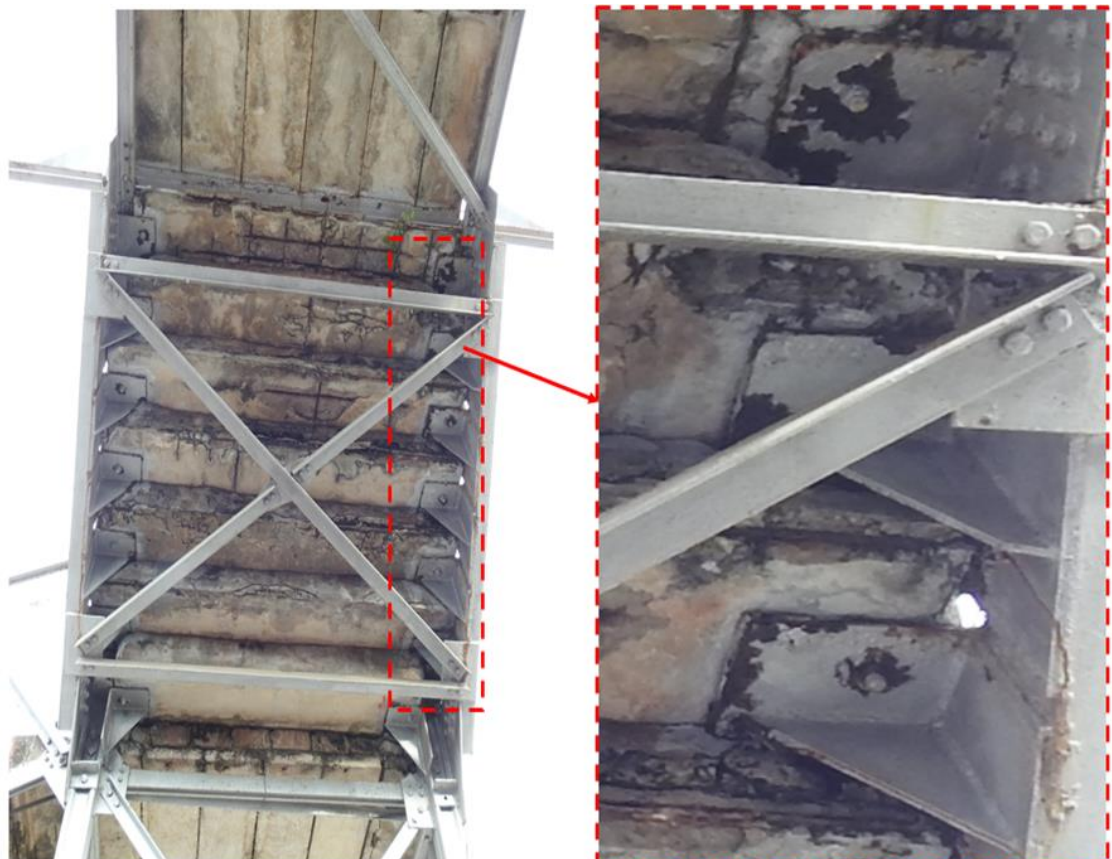
**Fig: 2.7** severely deterioration of cleat angle supporting staircase panels

- When the condition of the member is observed to be in Grade – 3, which might have occurred due to environmental conditions or age of the structure. In such cases section loss is calculated by using caliper where it is accessible and UPV at one accessible location. The first step in dealing with corrosion is to measure the section loss in the member. The member may be measured using calipers or other appropriate methods for totally exposed sections.
  - a. Section Loss < 15% - Clean the Surface and Apply the anticorrosion protective coat.
  - b. Section Loss 15% - 40% Repair the member as per design.
  - c. Section Loss > 40% - Replace the member.
