# Third Party Audit of ROB's and FOB's of SCR

## INSPECTION OF FOB AT TSUNDURU RAILWAY STATION

**Final Report**  
SEPTEMBER | 2020

| <b>Name of the Project</b> | : | VISUAL INSPECTION OF FOB/ PF-1 – PF-2 AT TSUNDURU RAILWAY STATION |

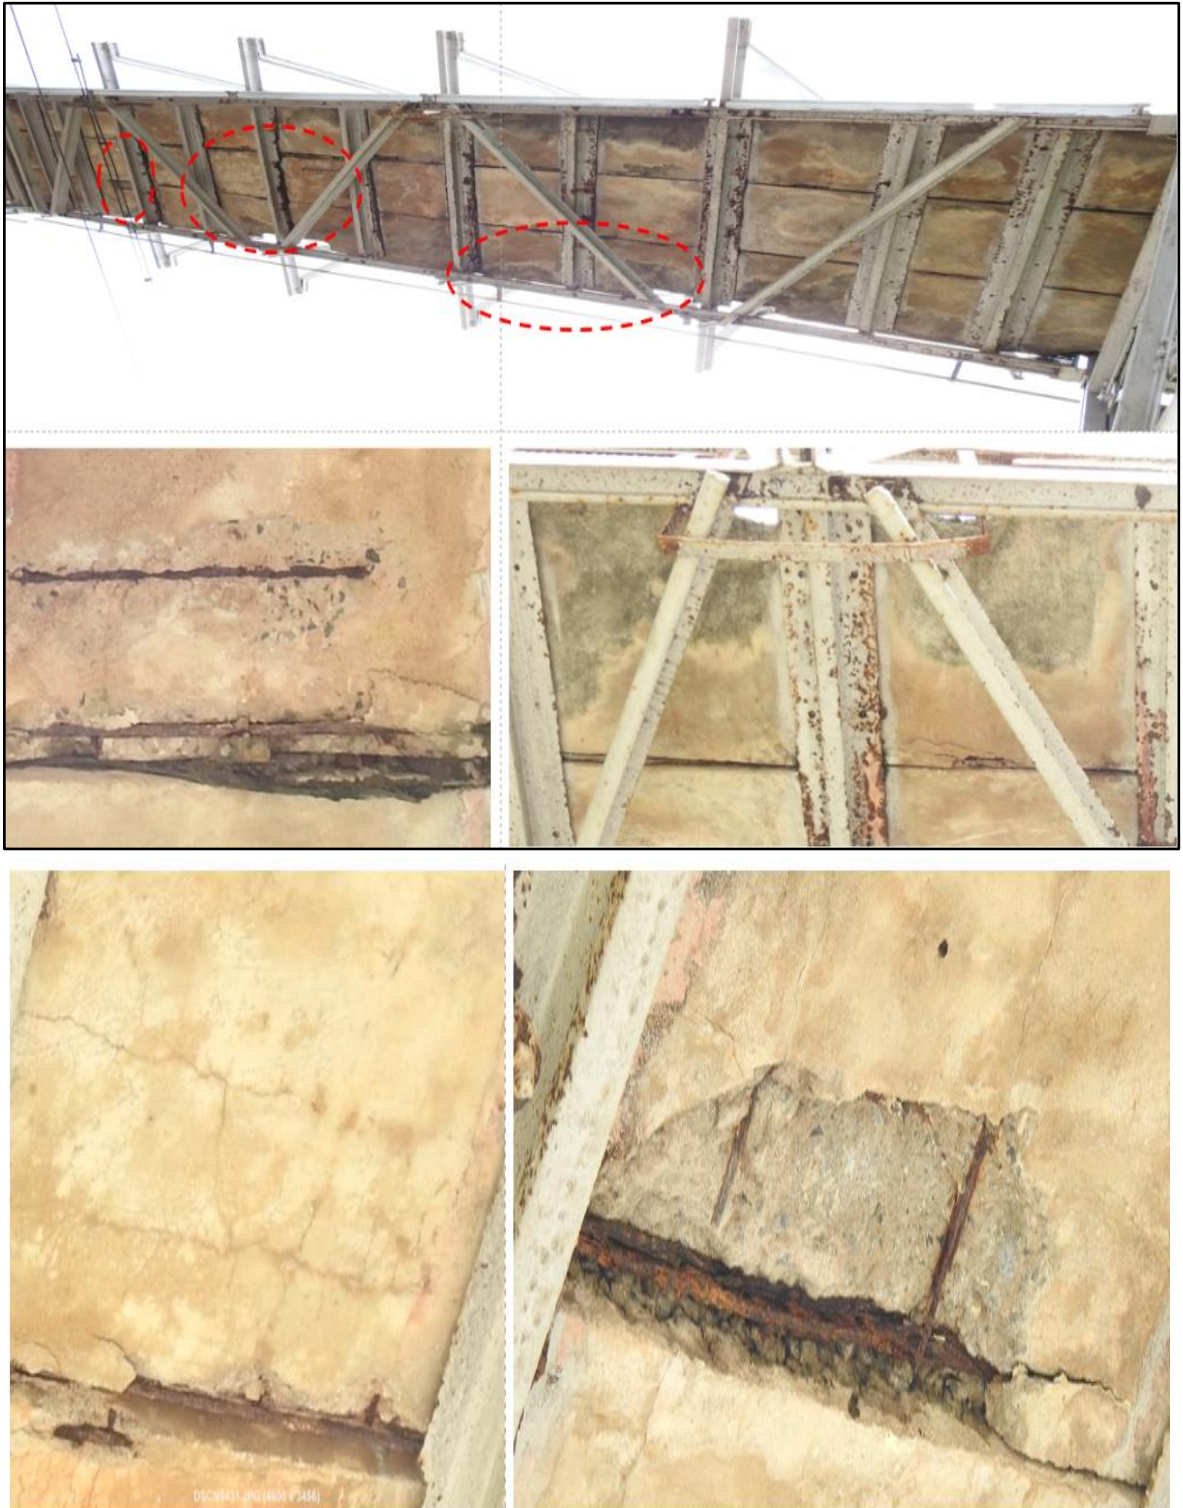
- i. ✓ Exposed reinforcement is observed on Pre-cast RCC slab panels of FOB.

a) Reinforcement exposed at slab panels of 1<sup>st</sup> span

| SIGNS OF DISTRESS, DEFORMATION IN BRIDGES | | | |
|---|---|---|---|
| | Cracking in RCC components | Slab Panels | cracks are observed in Pre-cast RCC slab panels ( <b>Refer part4 - 1.4(a) a,b</b> ) |
| | Spalling | Stair case | Spalling and reinforcement exposure is observed in some precast RCC panels of span1, 2 and landings of staircase. (Refer <b>Part 1.4 – 1.4(a)</b> ) |

Reinforced cement concrete Slab at Deck level and some precast panels in staircase are observed with exposed rebar in many locations. (Photographs of the same can be see in **fig 2.4**)

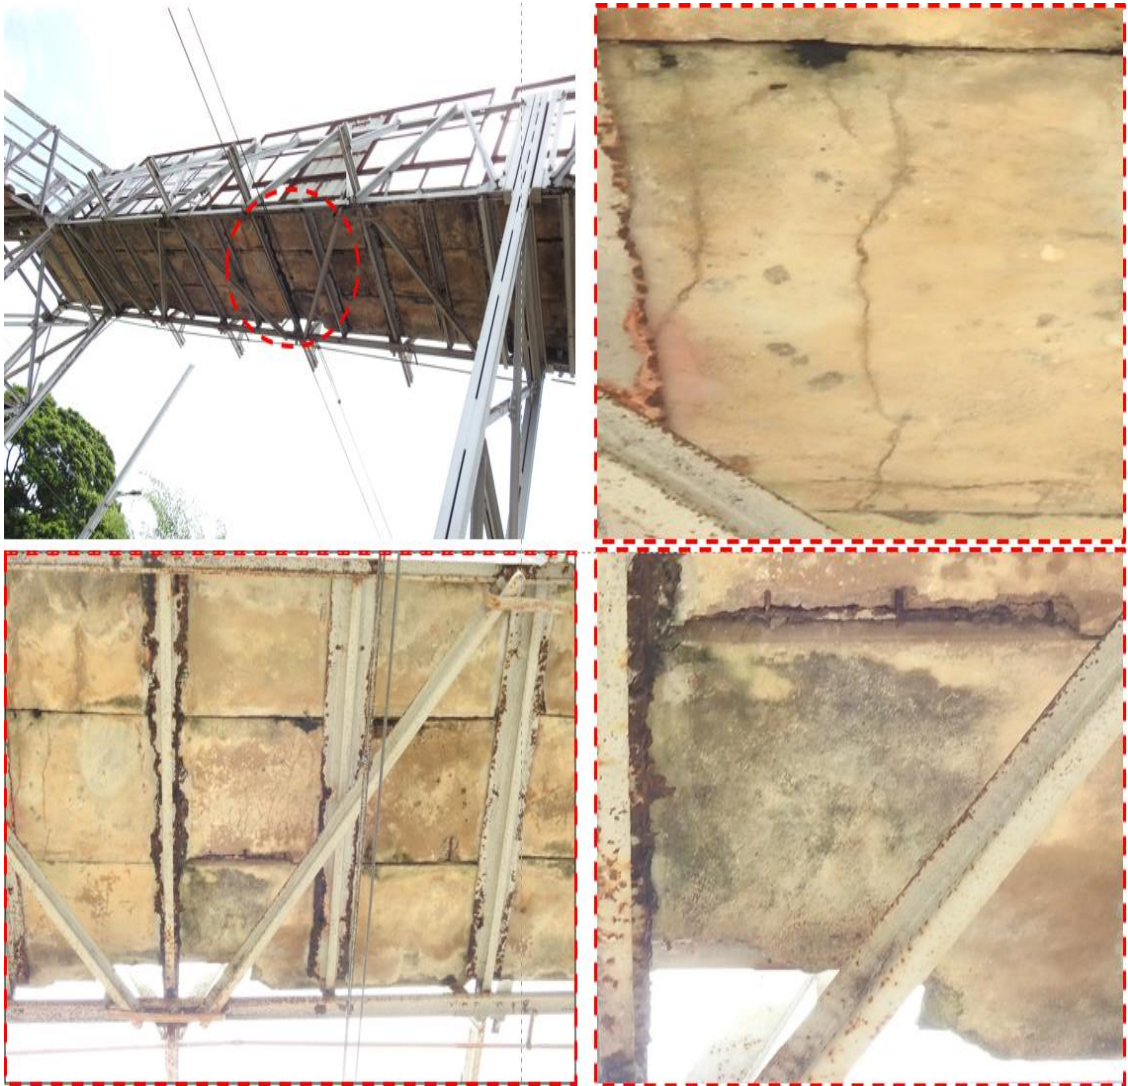
b) Reinforcement exposed at slab panels of 2<sup>nd</sup> span

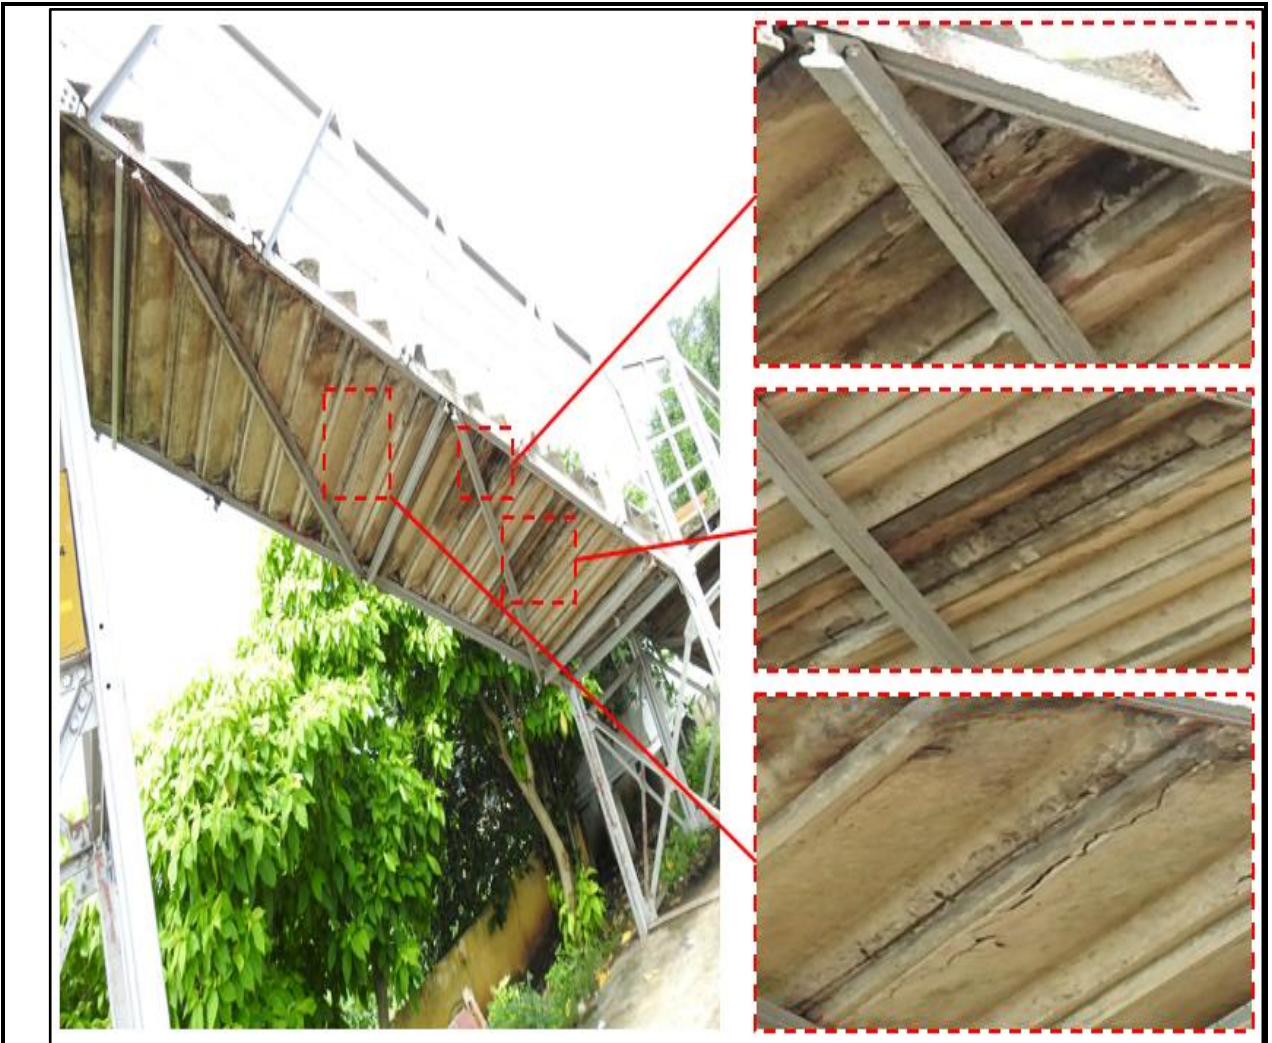
c) Reinforcement exposed slab panels on bottom of staircase-1

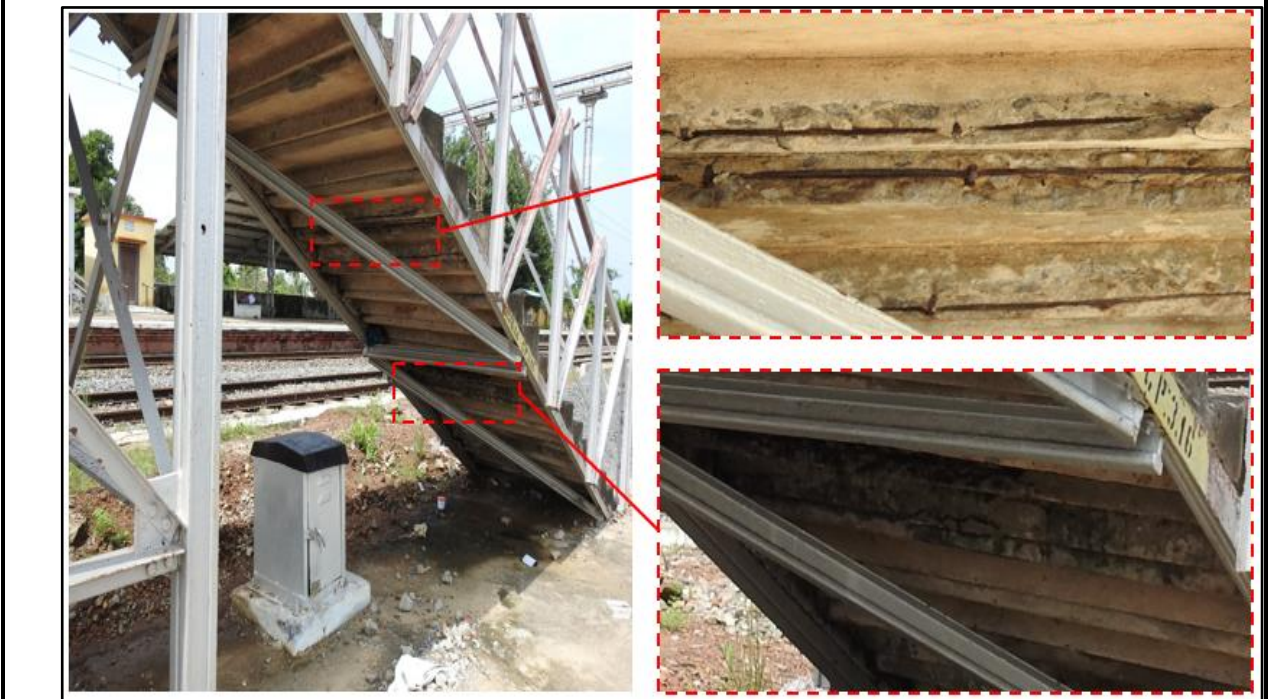
d) Reinforcement exposed slab panels on bottom of staircase-2

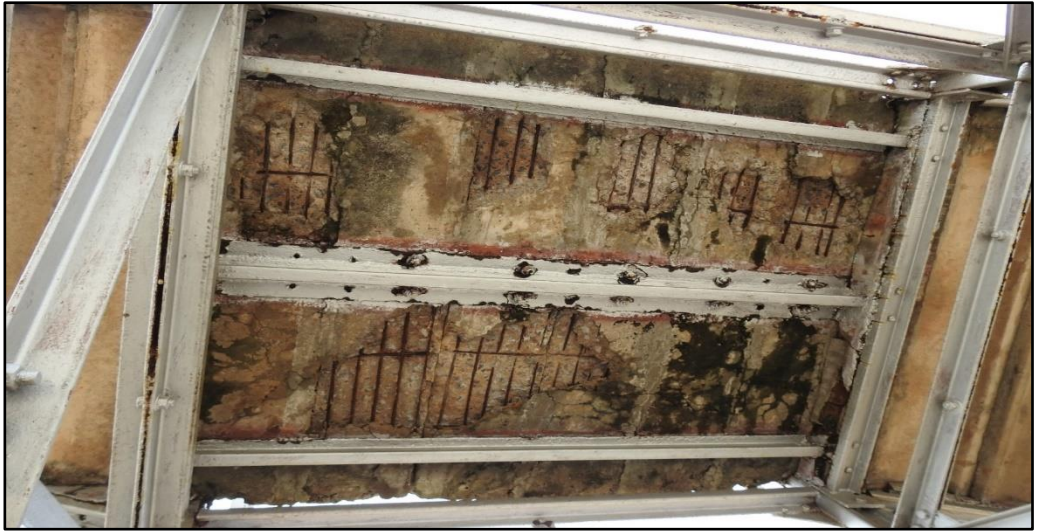
e) Spalling, Exposed Reinforcement and leaching observed in staircase 2 (Mid landing)

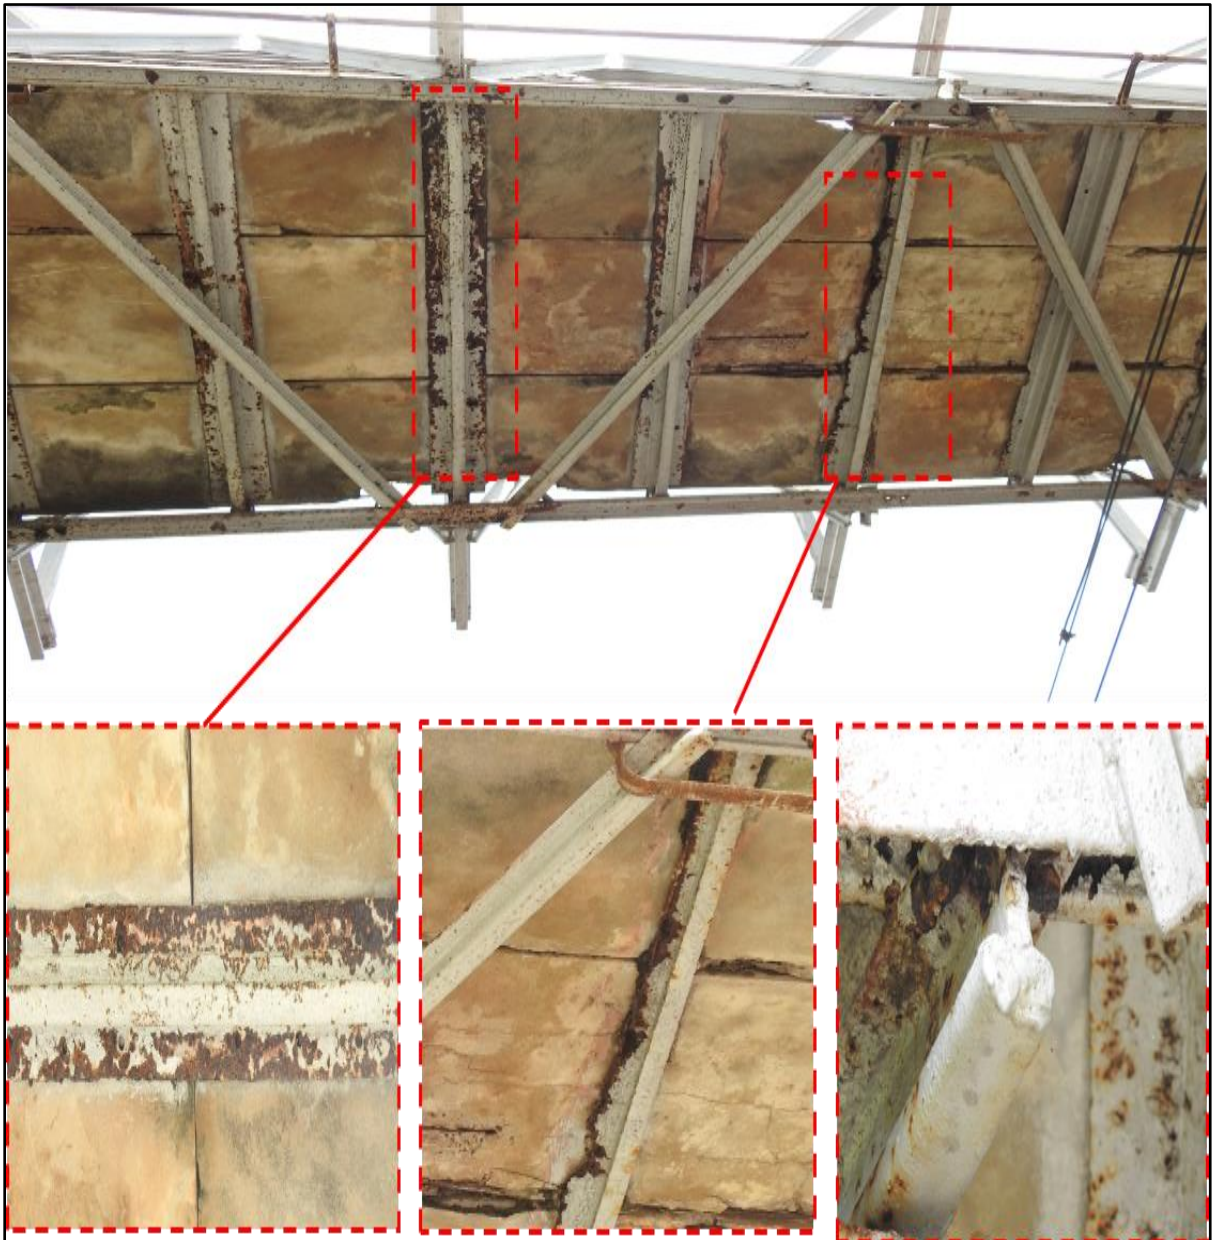
- ✓ Corrosion and Corrosion of Floor beams and Bottom chord, Stringer beam, bracings of FOB

a) Corrosion of Floor beams is observed in 1<sup>st</sup> span

| SIGNS OF DISTRESS, DEFORMATION IN BRIDGES | | | |
|---|---|---|---|
| | Extent of Corrosion | In Floor beam | Corrosion of floor beams is observed in 1 <sup>st</sup> and 2 <sup>nd</sup> span of FOB. (Refer <b>Part 1.4 – 1.4(b)</b> ) |

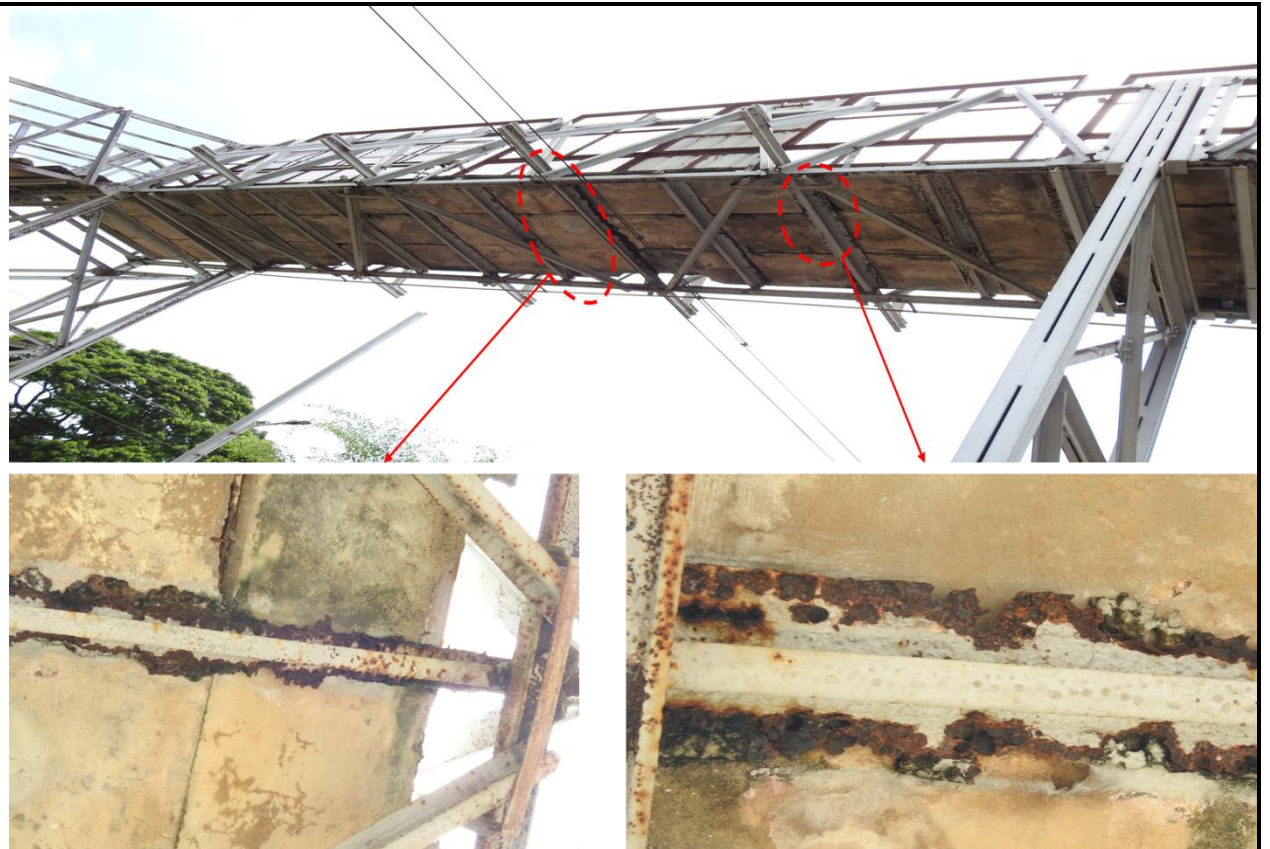
b) Corrosion of Floor beams is observed in 2<sup>st</sup> span

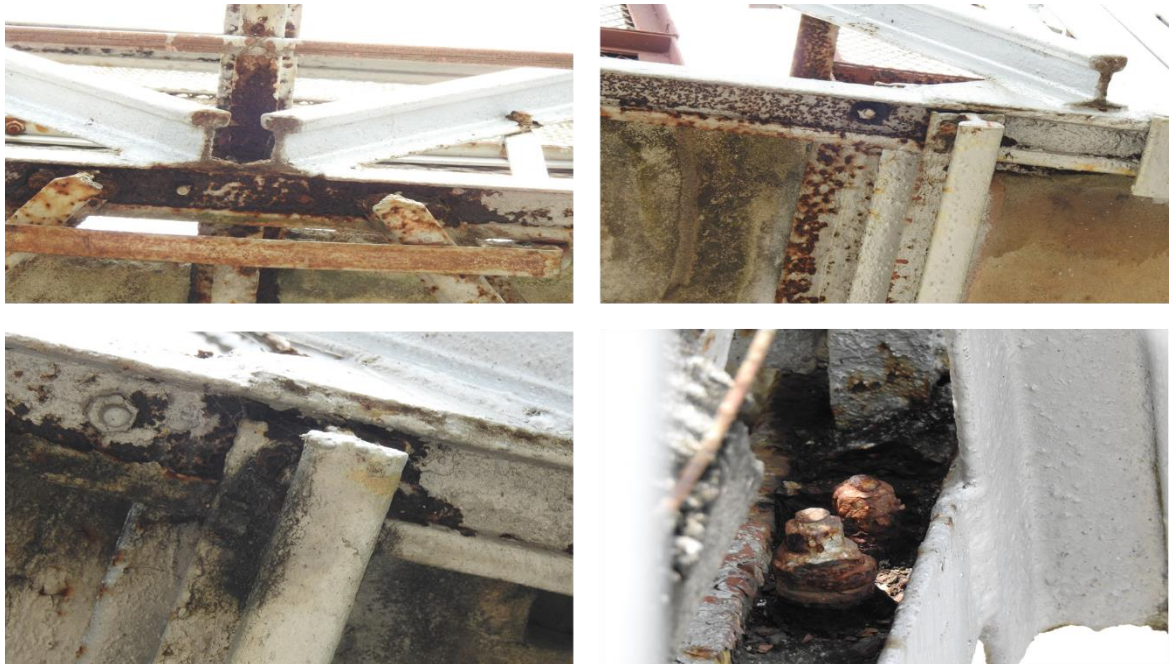
c) Corrosion of bottom chord

| SIGNS OF DISTRESS, DEFORMATION IN BRIDGES | | | |
|---|---|---|---|
| | Rust straining | Bottom main Chord members | Corrosion is observed at all the joints of FOB (Refer <b>Part 1.4 – 1.4(b)</b> ) |

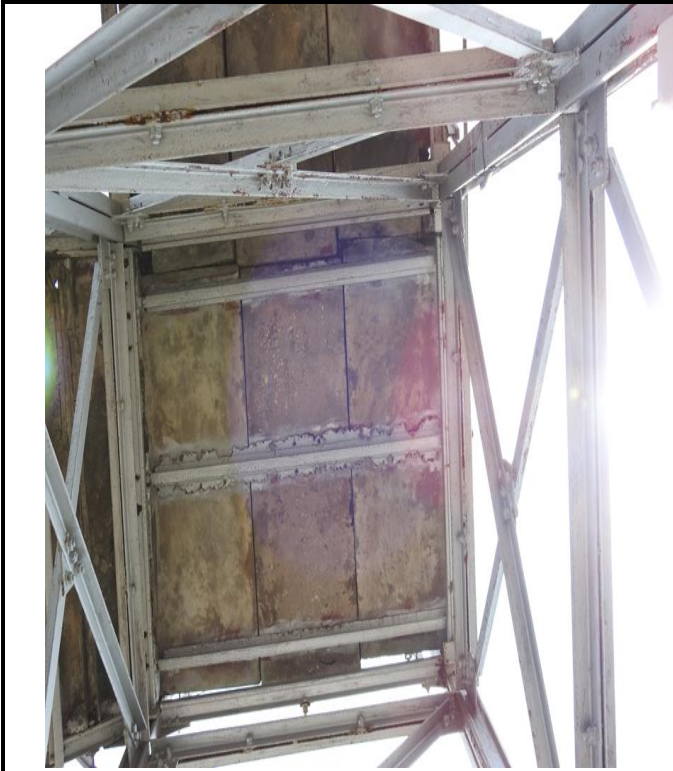
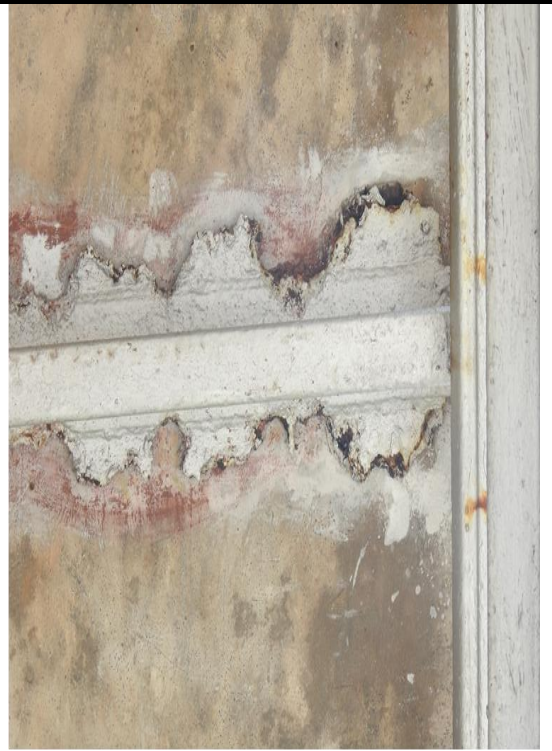
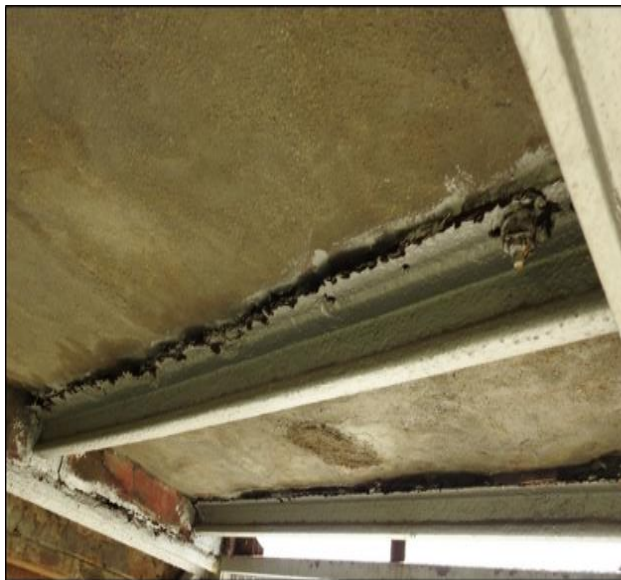
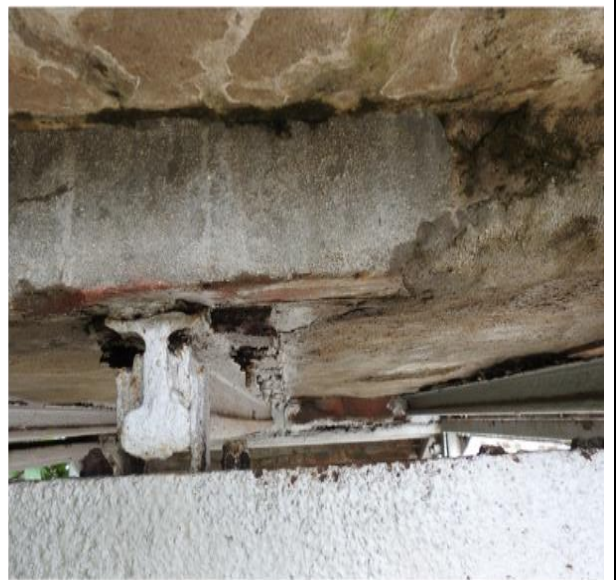
d) Corrosion of floor beam and Patch work observed at landing

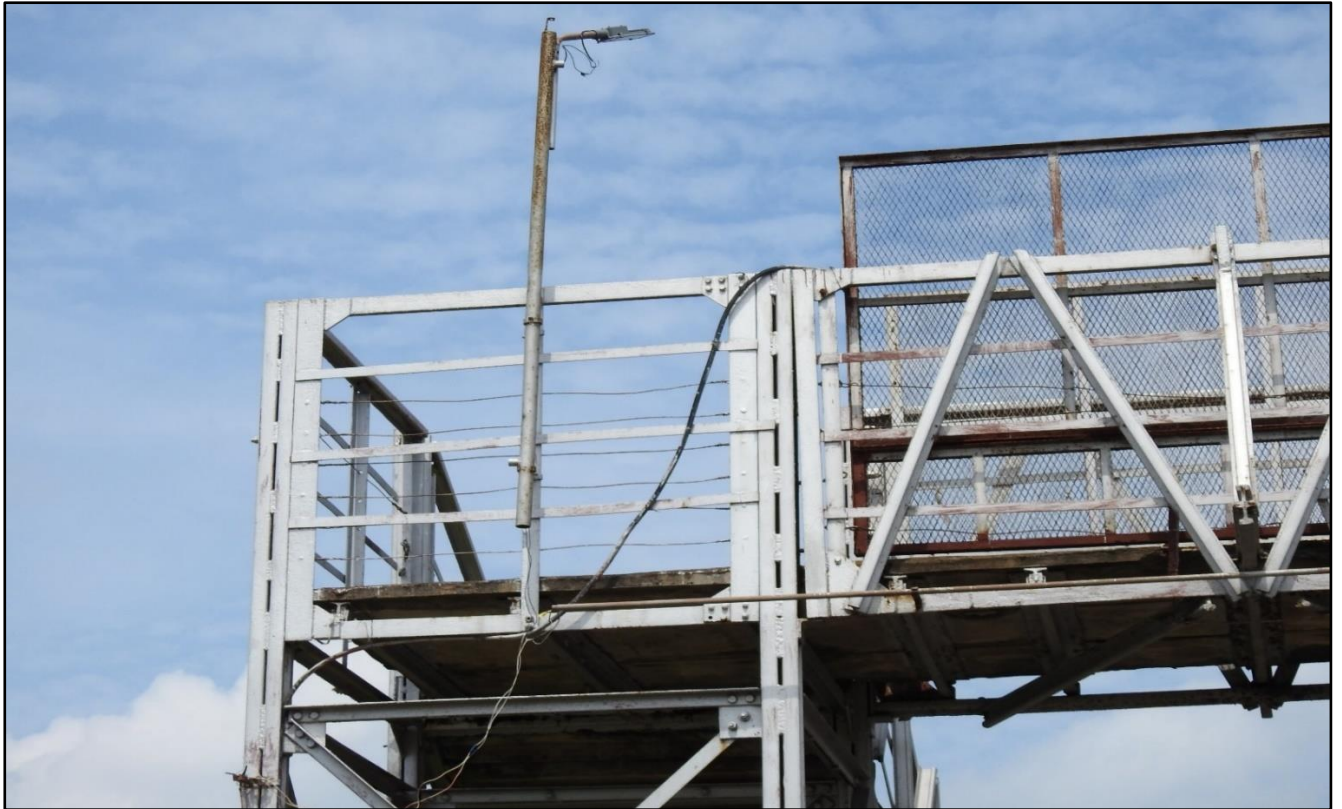
***Fig 1.1:*** Cables, Electric post and protective screen

| 1.2 IDENTIFICATION OF LOADS ON BRIDGE | | | |
|---|---|---|---|
| | e) load of advertising hoarding | Yes | Light post with 60 mm dia. GI pipe is supported on Trestle railing at both corners of FoB. (Ref <b>Fig. 1.1</b> ) |

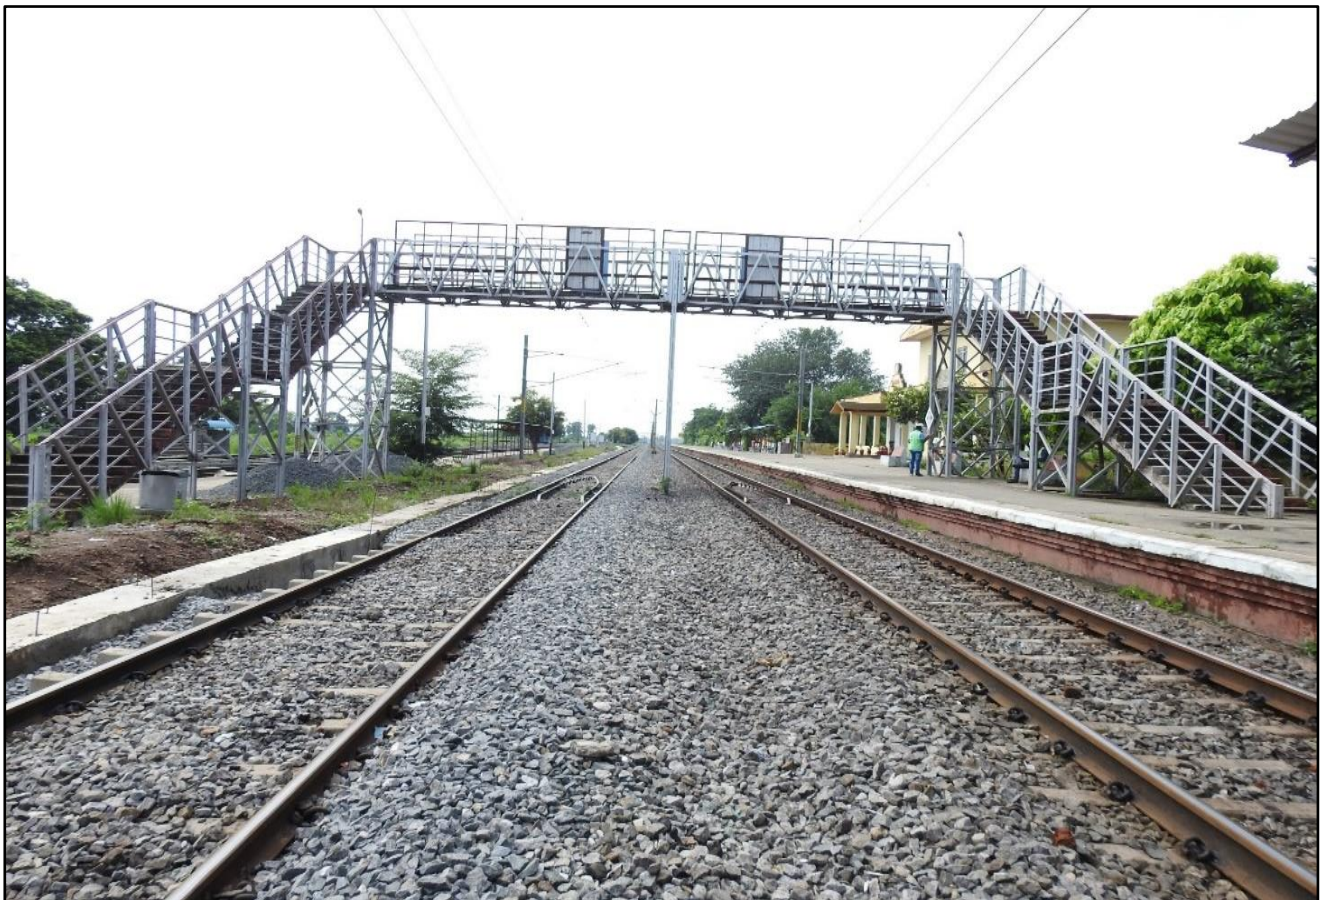
***Fig 1.2:*** FOB Front view

| 1.3 STRUCTURAL SYSTEM OF THE BRIDGE | | | |
|---|---|---|---|
| <b>d.</b> | <b>Steel Truss</b> | | a) Top and bottom Chord members are 50 x 80 x 80 (Head x Height x Base) Rail section. (Refer <b>fig :1.2</b> )<br>b) 50 x 80 x 80 Rail section are used as diagonal bracing members. |

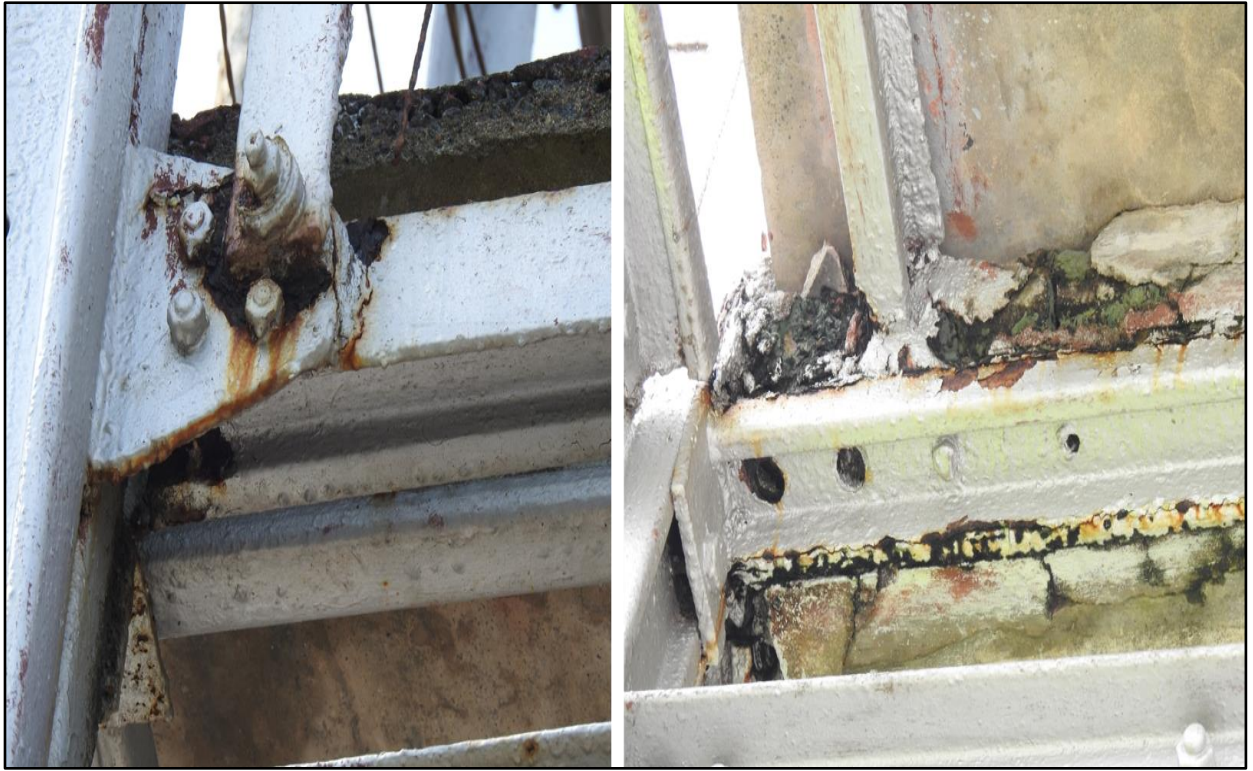
| SIGNS OF DISTRESS, DEFORMATION IN BRIDGES | | | |
|---|---|---|---|
| | Corrosion in Gusset plate | Bottom of the slab | Corrosion is observed on Gusset plates (Refer <b>Fig 1.7</b> ) |
| | Corrosion at steel-Concrete joint | Tie members of clear span | Corrosion is observed at steel concrete joint.(Refer <b>Fig 1.7</b> ) |

**Fig 1.7:** Corrosion is also observed at steel concrete joint gusset plate

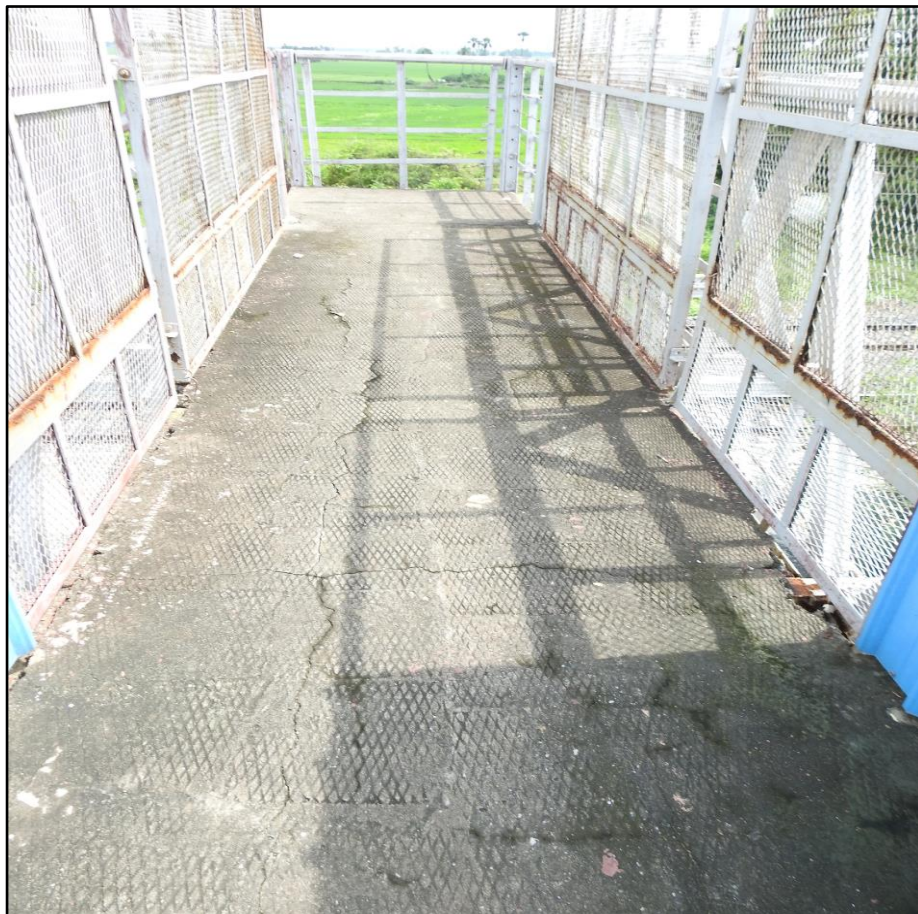
**Fig 1.8:** Path way, Protective screen

| 1.2 IDENTIFICATION OF LOADS ON BRIDGE | | | |
|---|---|---|---|
| | a) Additional wearing coat on Floor | Yes | Cement concrete layer is used for flooring (Refer <b>fig: 1.8</b> ). GI Pipe of 25 mm dia. connected to bottom chord. |
| | c) Type of Material used for mesh | Galvanized wire mesh | (Refer <b>fig :1.8</b> ) |

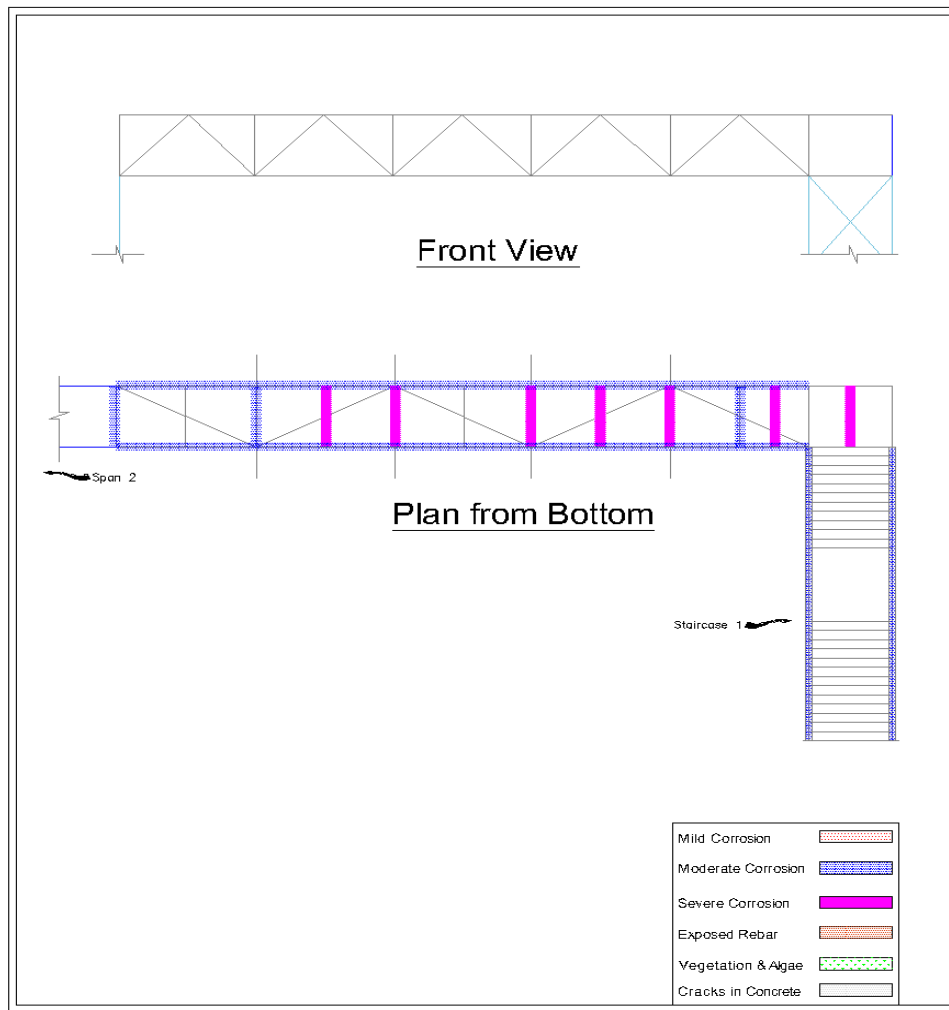
**Fig: 2.1** locations of deterioration and bottom view of span 1

- Structural members are in fair condition, displaying mild corrosion for top chord members, verticals, diagonals, and moderate corrosion for bottom chord members and staircase stringer beam along steel concrete joint and severe corrosion of floor beams (locations are marked in figures below).
- Reinforcement exposed in some precast slab panels are deteriorated in span 1 (*Photographs of the same can be see in fig2.2-2.6*)

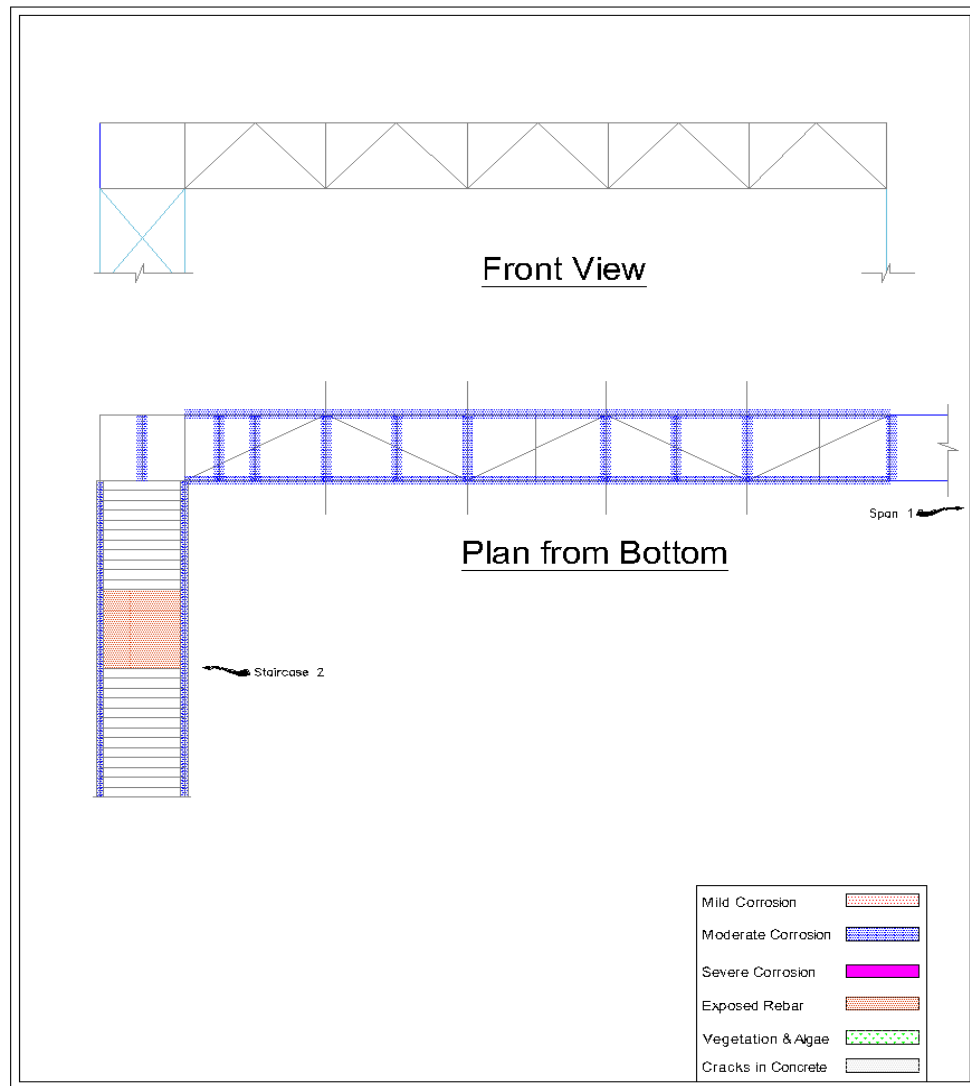
**Fig: 2.2** locations of deterioration and bottom view of span 2

- Structural members are in fair condition, displaying mild corrosion for top chord members, verticals, diagonals, and moderate corrosion for bottom chord members, floor beams and staircase stringer beam along steel concrete joint (locations are marked in figures below).
- Reinforcement exposed in some precast slab panels and staircase mid landing are deteriorated in span 2 (*Photographs of the same can be see in fig2.2-2.6*)

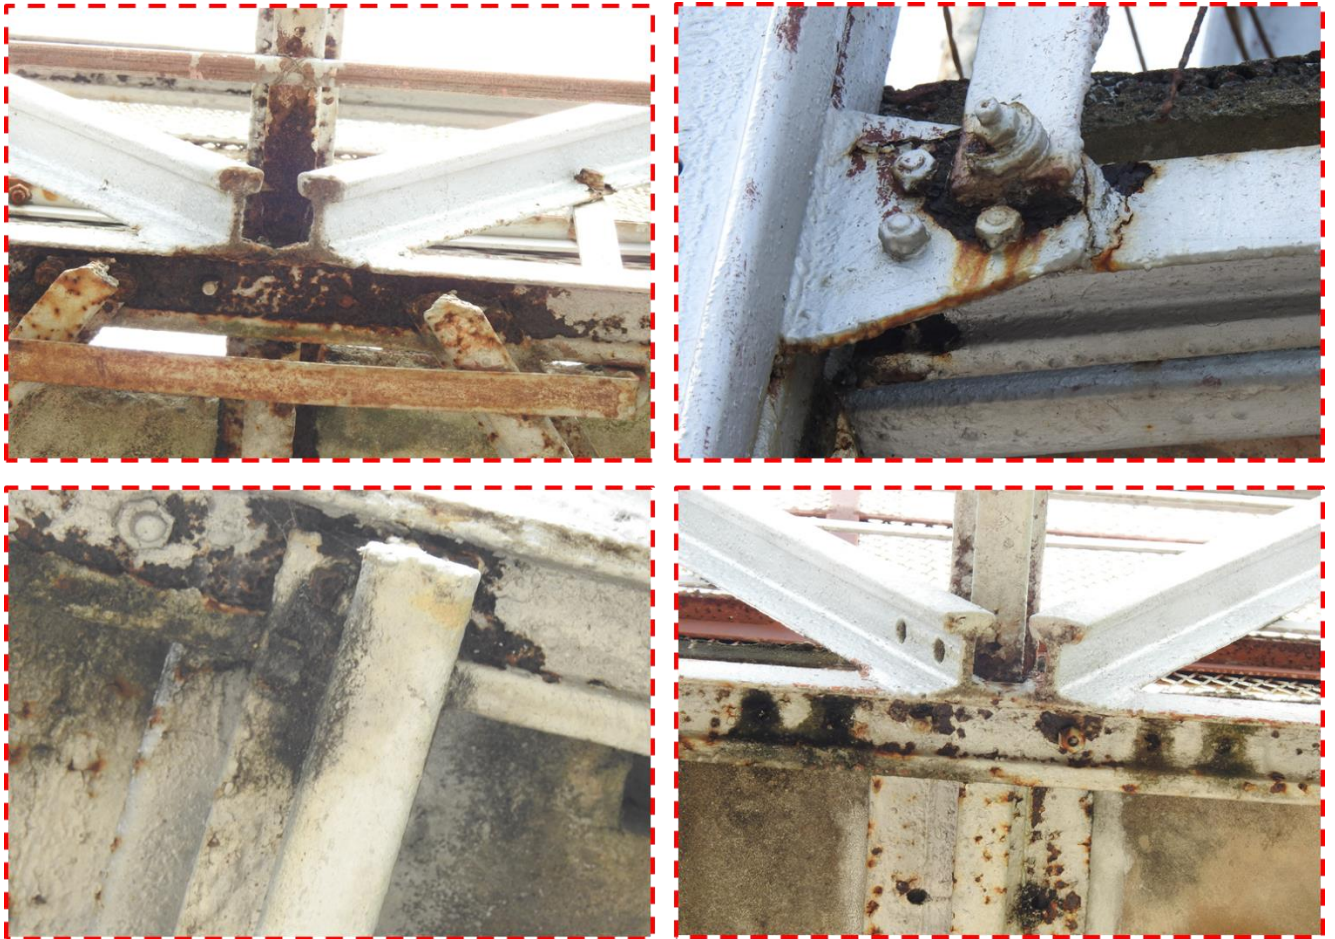
**Fig: 2.3** Corrosion at joints and bottom chord

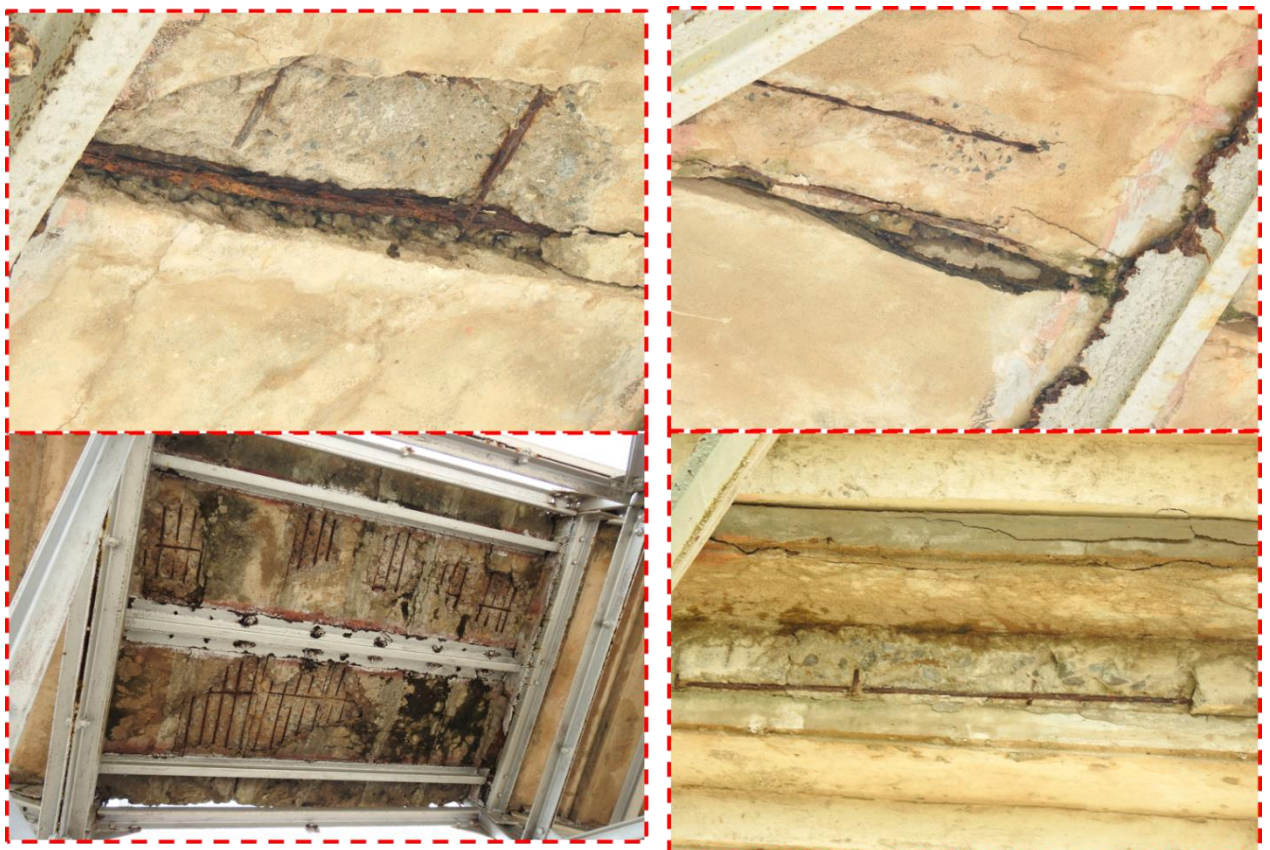
**Fig: 2.4** exposed reinforcement in pathway pre cast panels and staircase mid landing

**Methodology for patching:** Hand applied Mortar (Patching) repair is performed to restore small areas where sound concrete is damaged by spalling, scaling and/or impact. This method of repair is generally applied using trowel and require minimum or formworks. The patch thickness is limited to a maximum of 100 mm depth of hollow surface. Hand applied Mortar repair is classified into two types considering defective area and surface. Hand applied Mortar

- a) **Type - A** is applicable to surfaces without exposed rebar is having defective widths of up to 300mm and depths of up to 50 mm.
- b) **Type - B** is for surfaces with exposed rebar, with defective widths between 300 mm and 600 mm, and up to 100 mm depths.

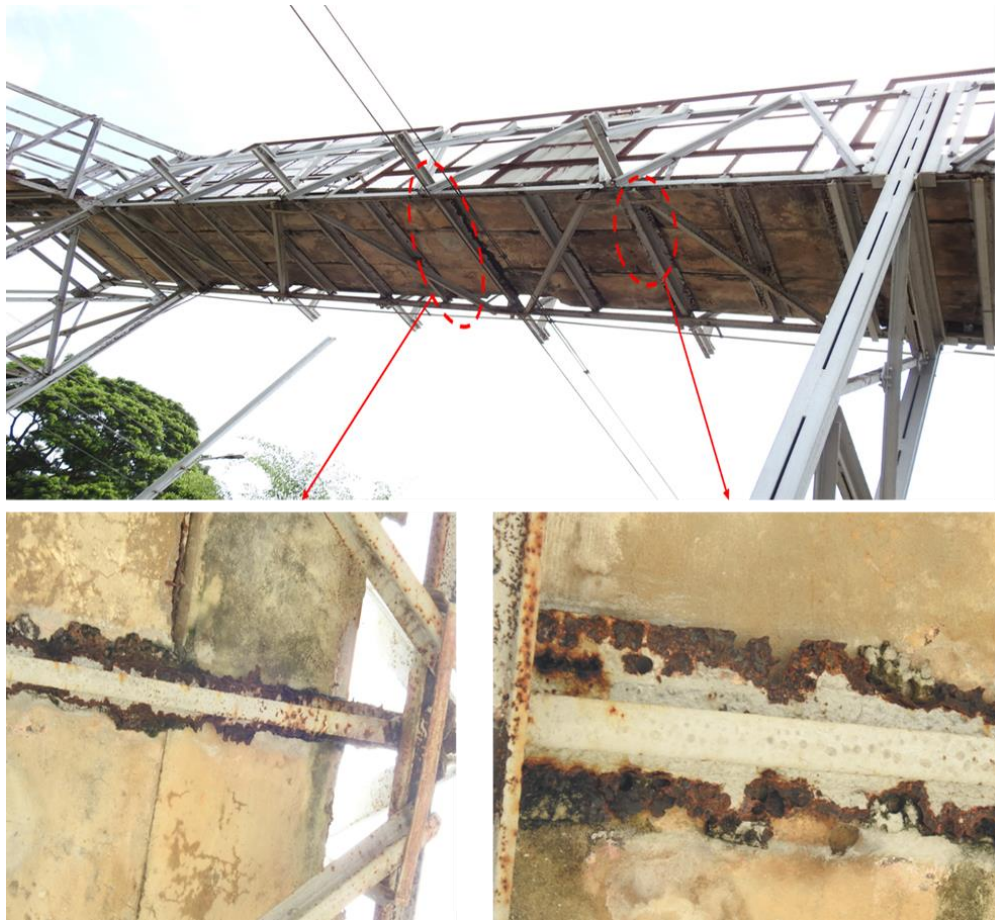
**Fig: 2.5** Corrosion of floor beams in span-1

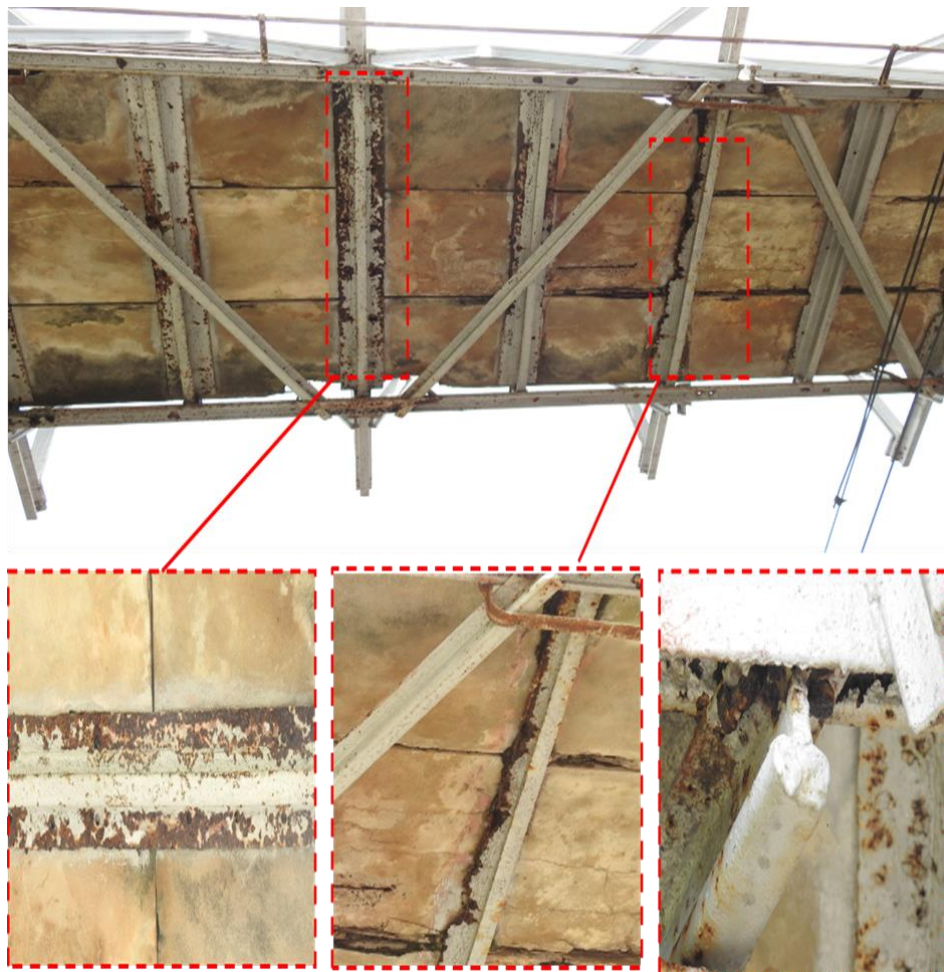
**Fig: 2.6** Corrosion of floor beams in span-2
