# Third Party Audit of ROB's and FOB's of SCR

## INSPECTION OF FOB AT MUSTABAD RAILWAY STATION

**Final Report**  
SEPTEMBER | 2020

| <b>Name of the Project</b> | : | VISUAL INSPECTION OF FOB AT MUSTABADA RAILWAY STATION |

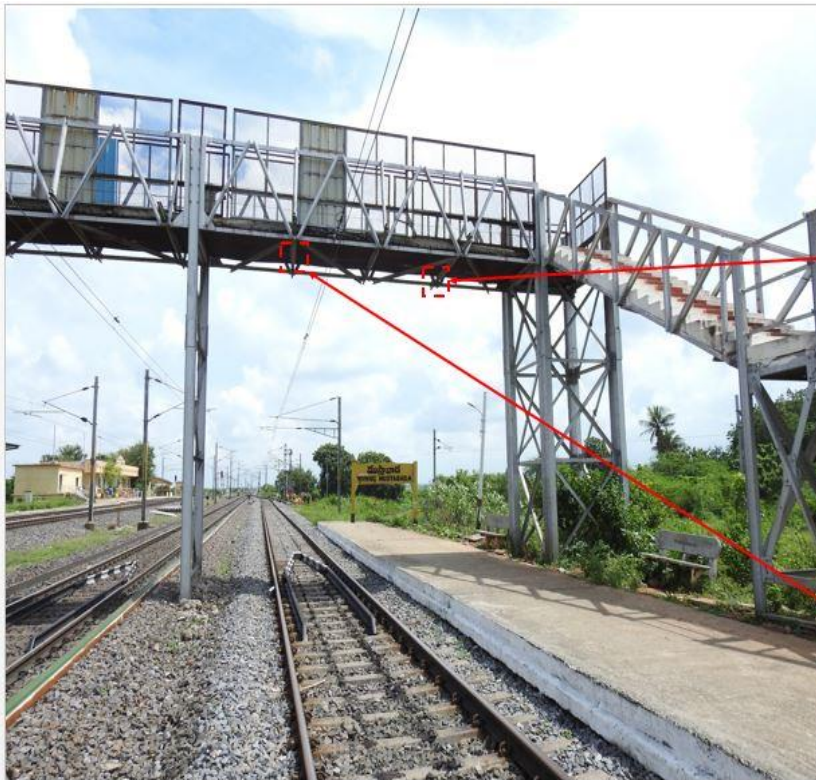
**i**      ✓ Corrosion is observed in floor Beams all over the FOB

a) Corrosion of floor beams at Span-1

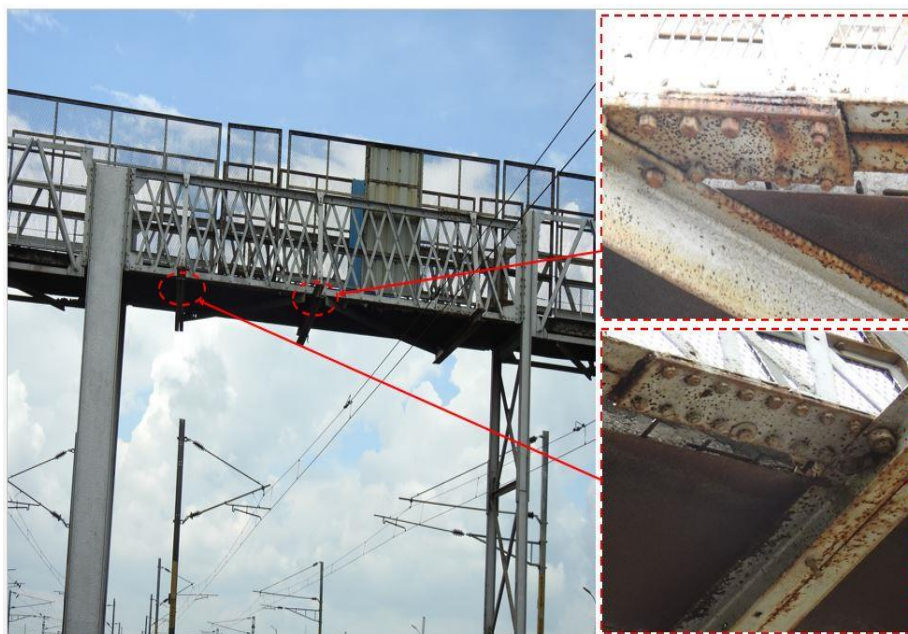
b) corrosion in splice joint at Span-2

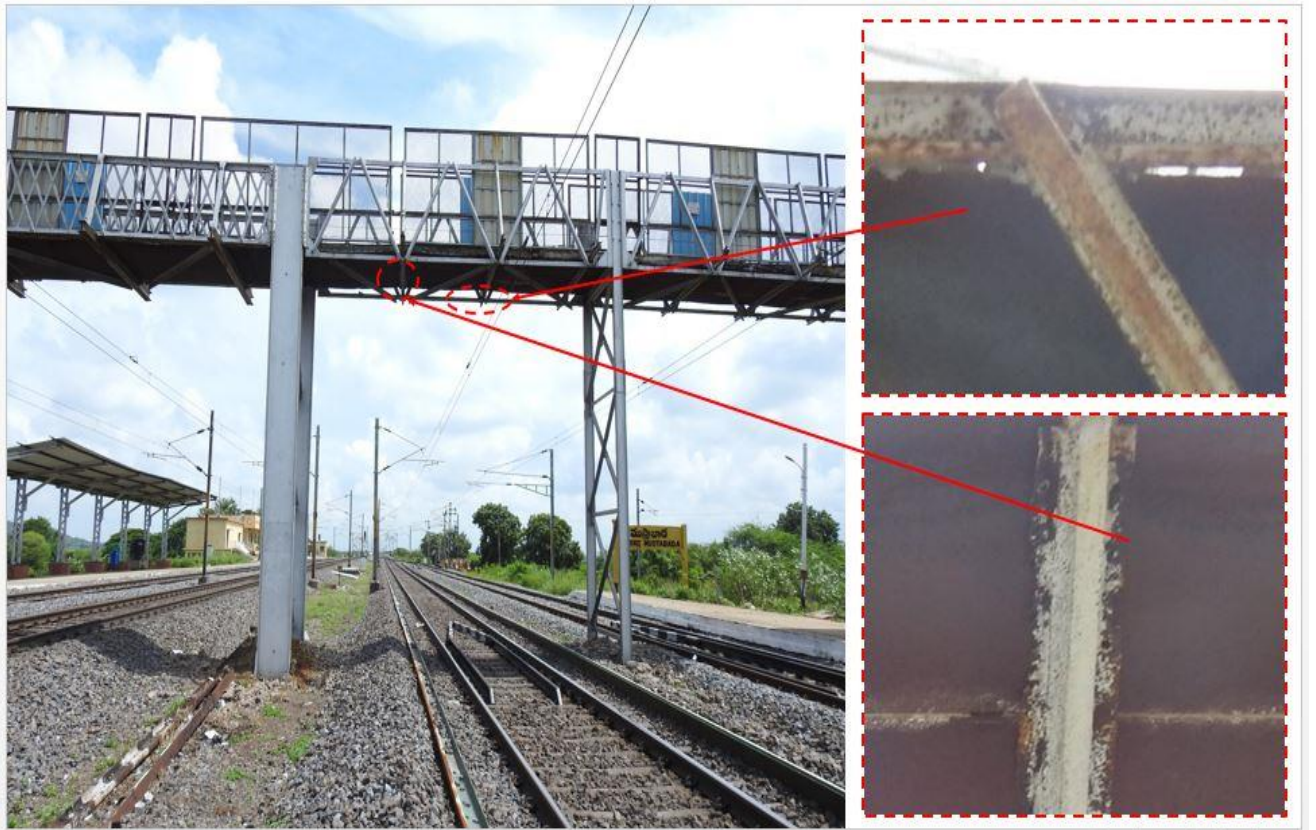
c) Corrosion in floor beams at Span-3

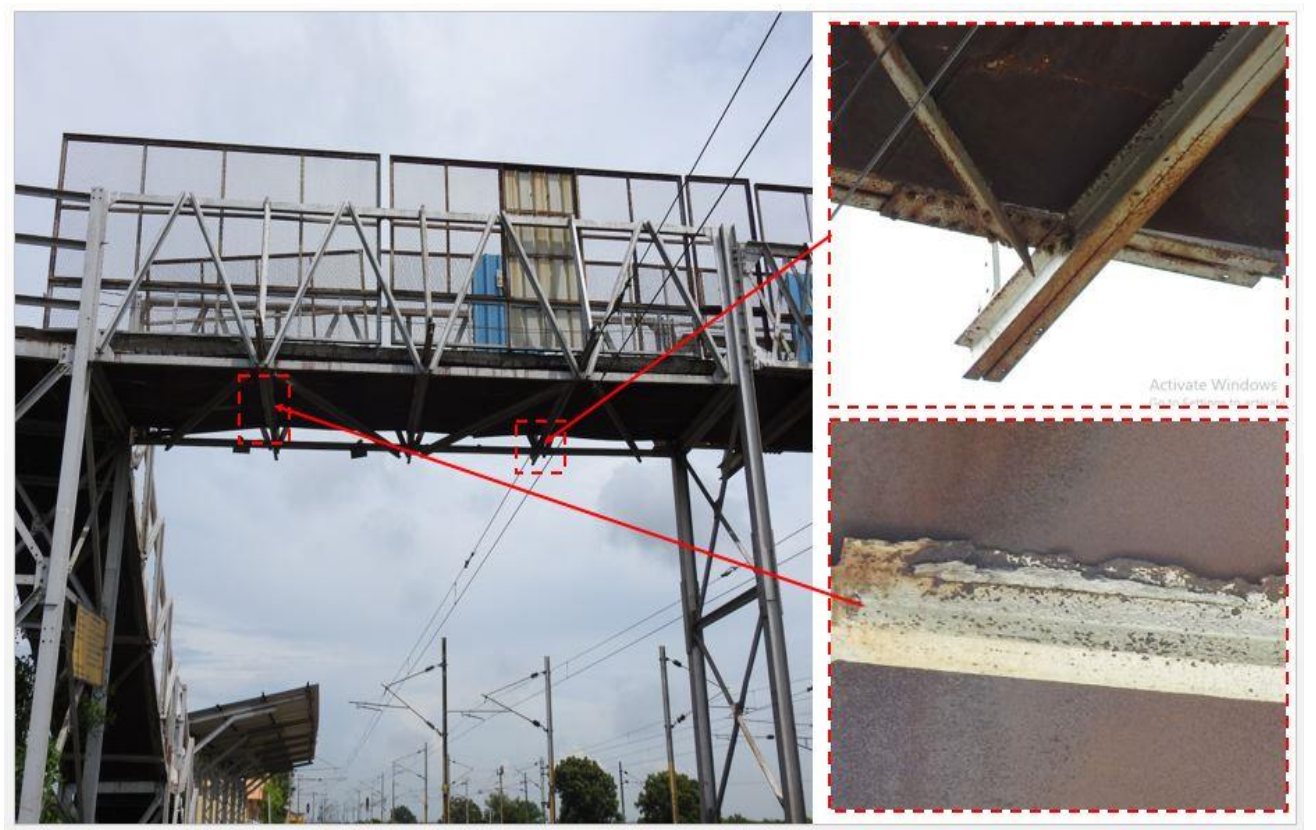
d) Corrosion in floor beams at Span-4

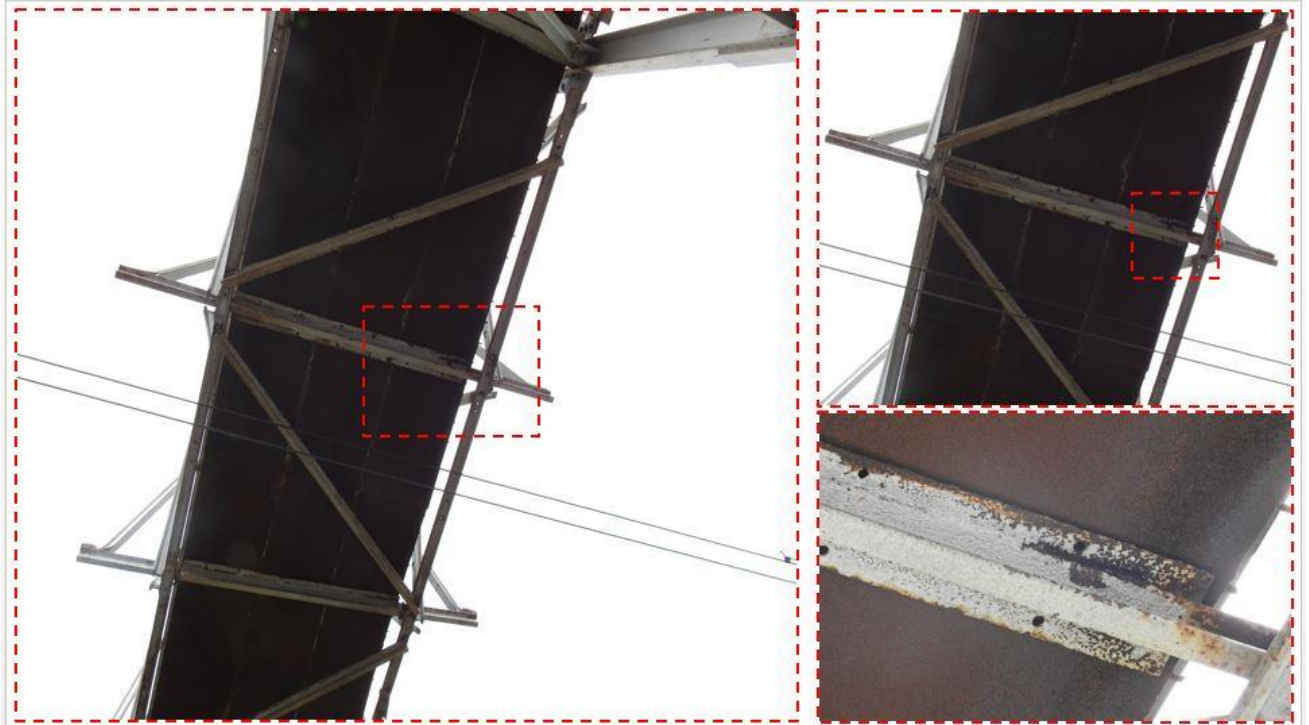
e) Corrosion in Joints

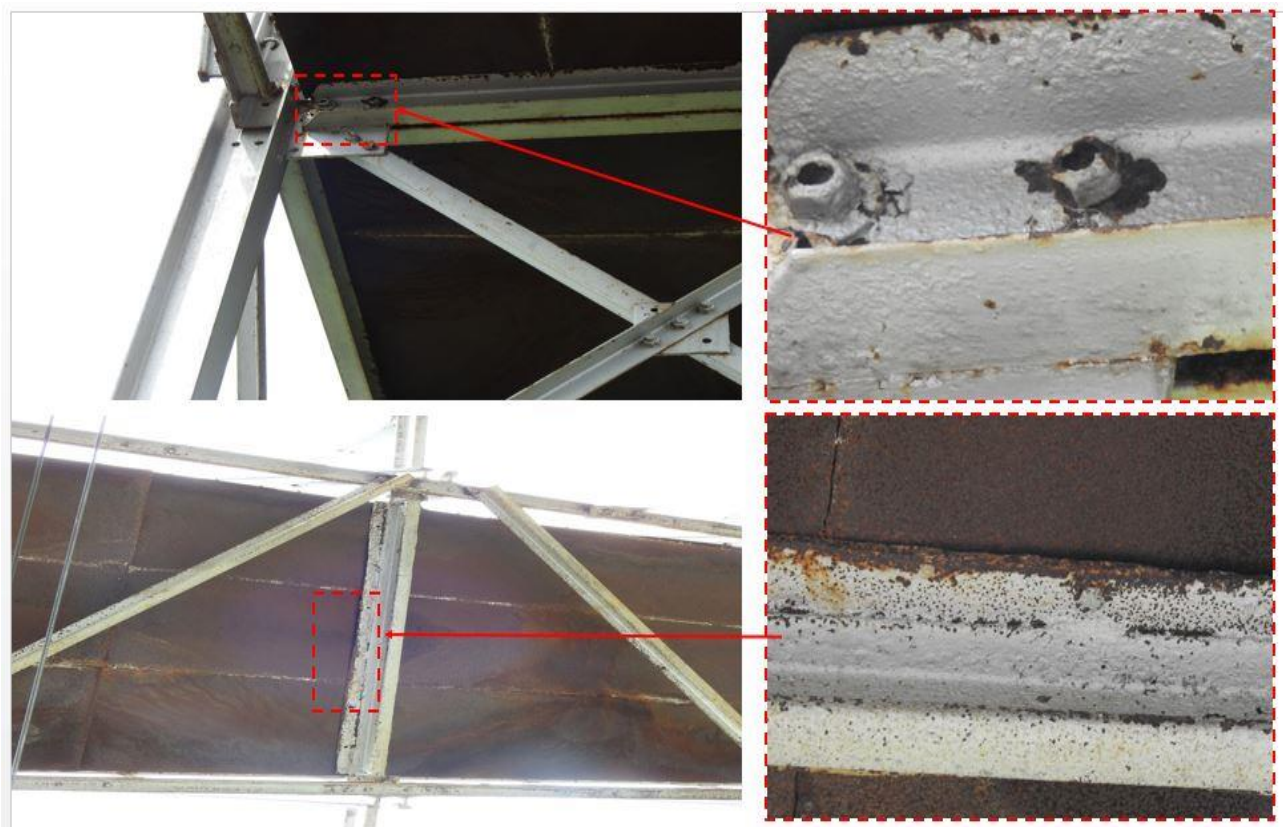
f) Corrosion at Floor Beam

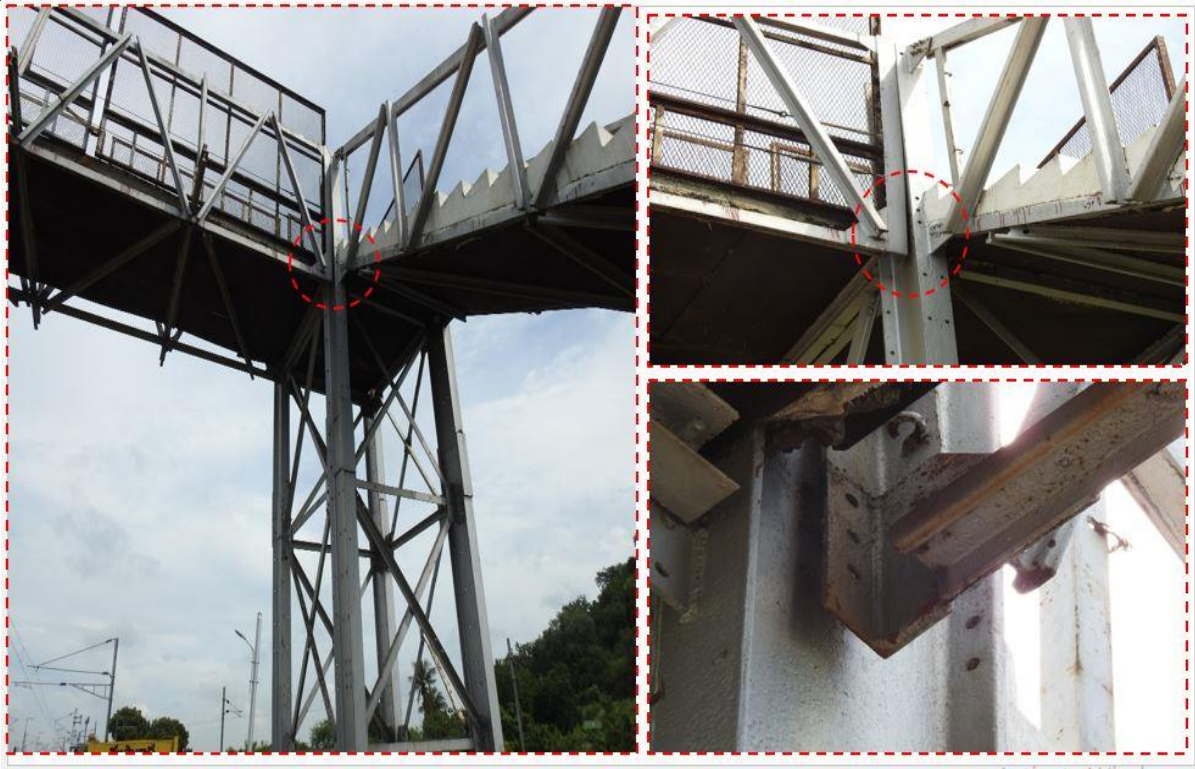
✓ Truss, Column joint connection failure is observed at span 4.

Connection failure at Stair Case-2

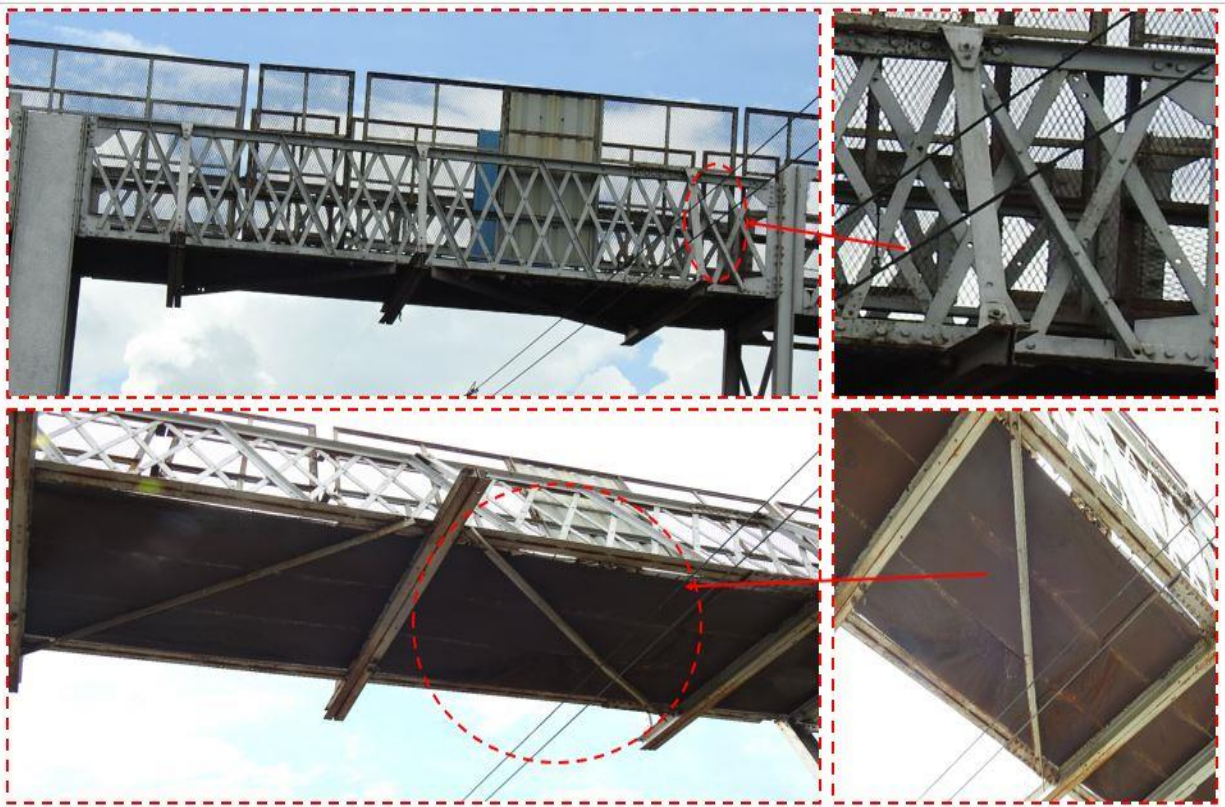
✓ Deformation observed at Diagonal member and Slab bottom lateral bracing.

Deformation in Diagonal members, Slab bottom lateral bracing

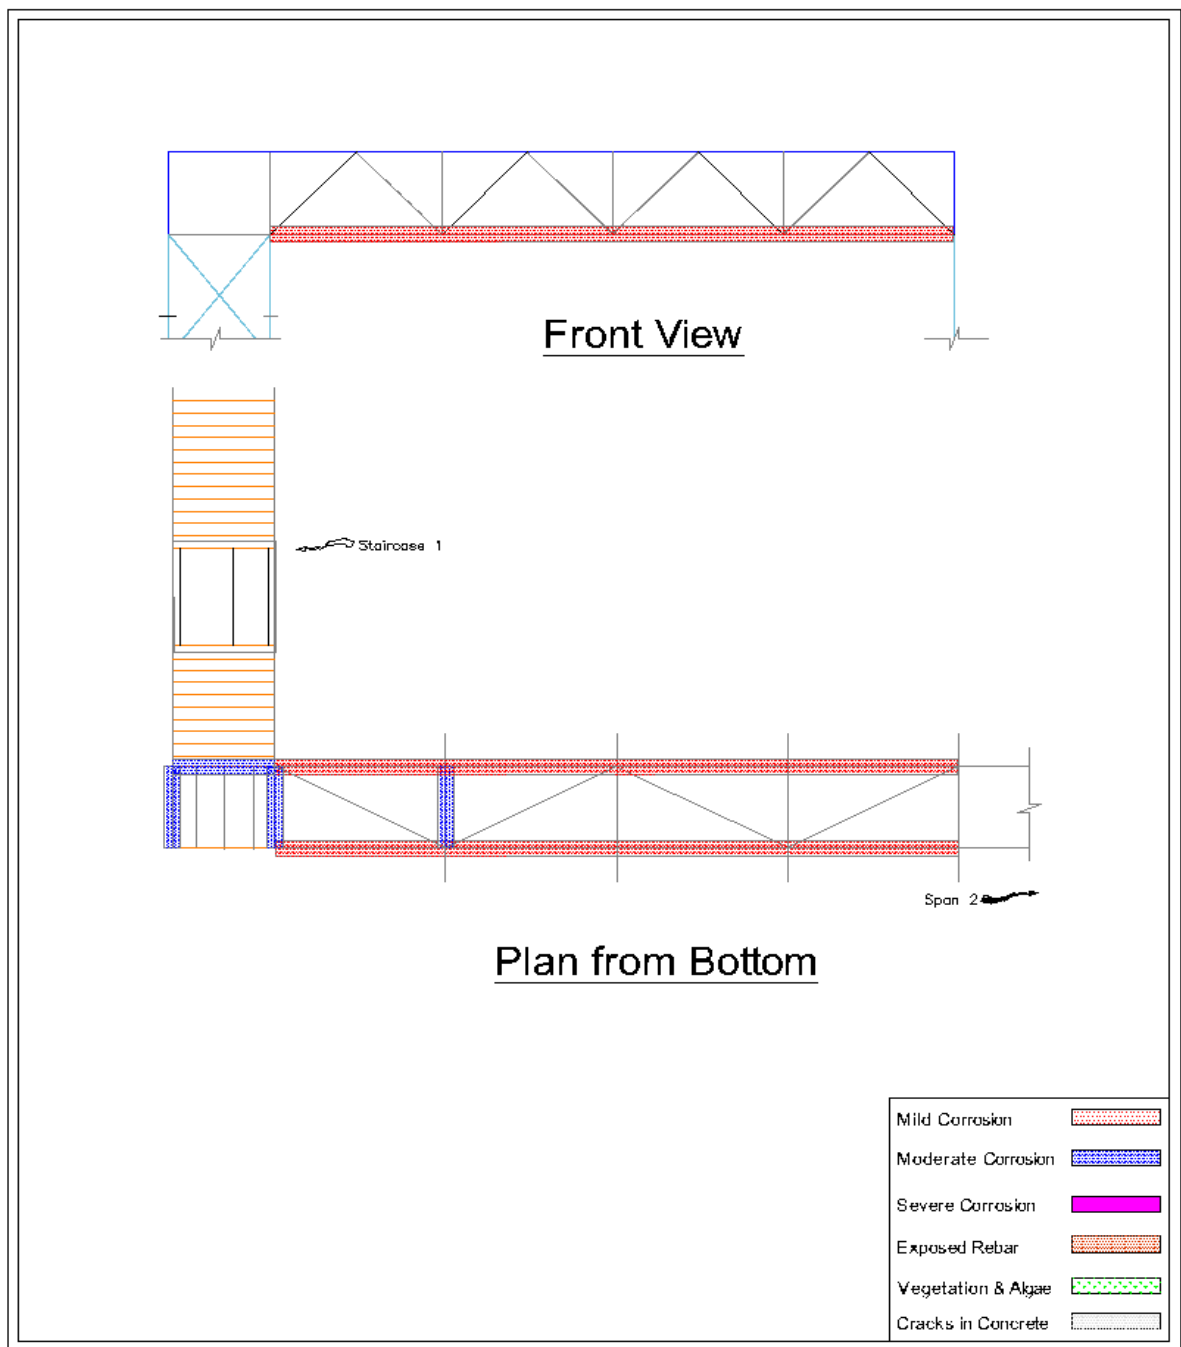
**Fig.2.1** Locations of deteriorations and bottom view of span-1

- Structural members are in fair condition, displaying mild corrosion for top chord members, verticals, diagonals, and gusset plates and bottom chord members. Moderate corrosion for floor beams (locations are marked in figures below). (Photographs of the same can be see in **fig2.2**)

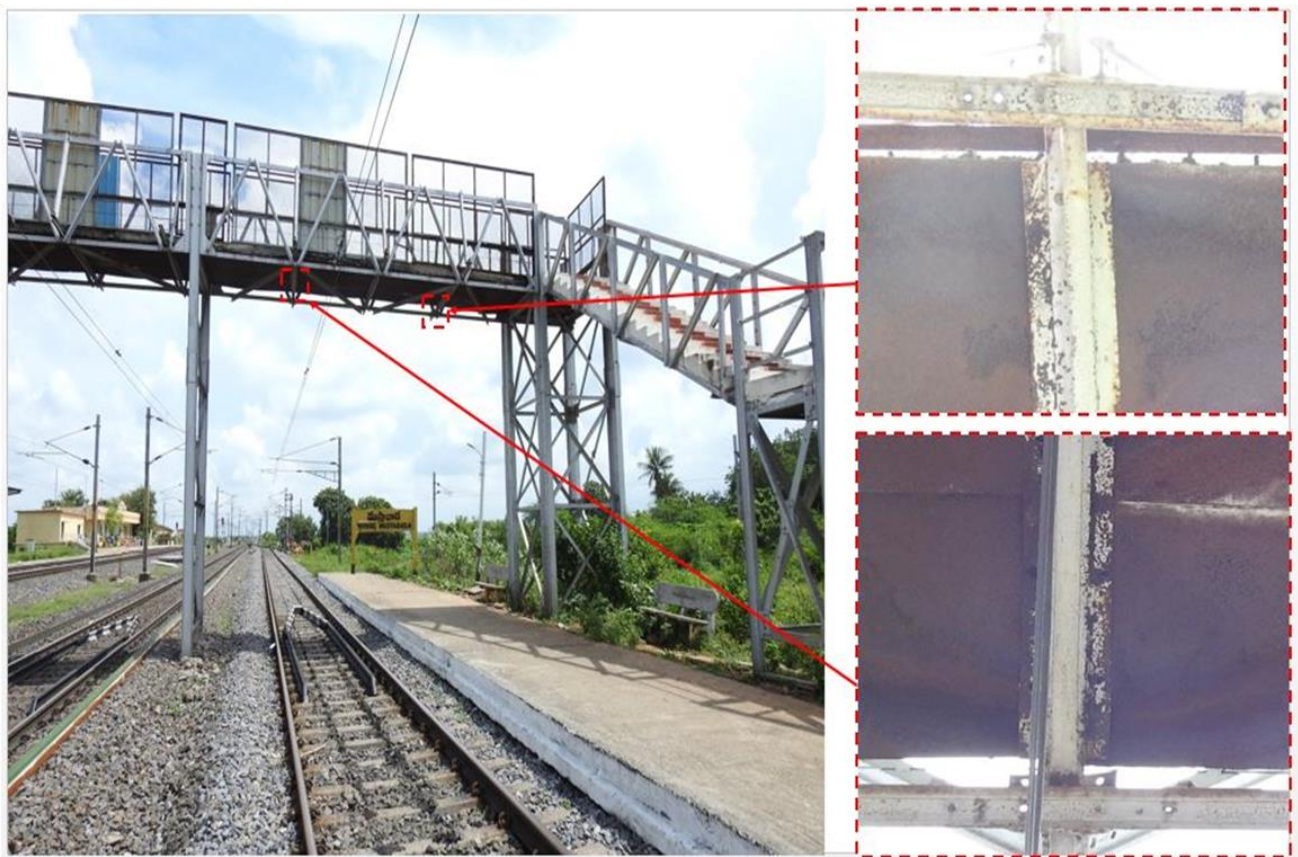
**Fig.2.2** Corrosion of floor beams at span-1

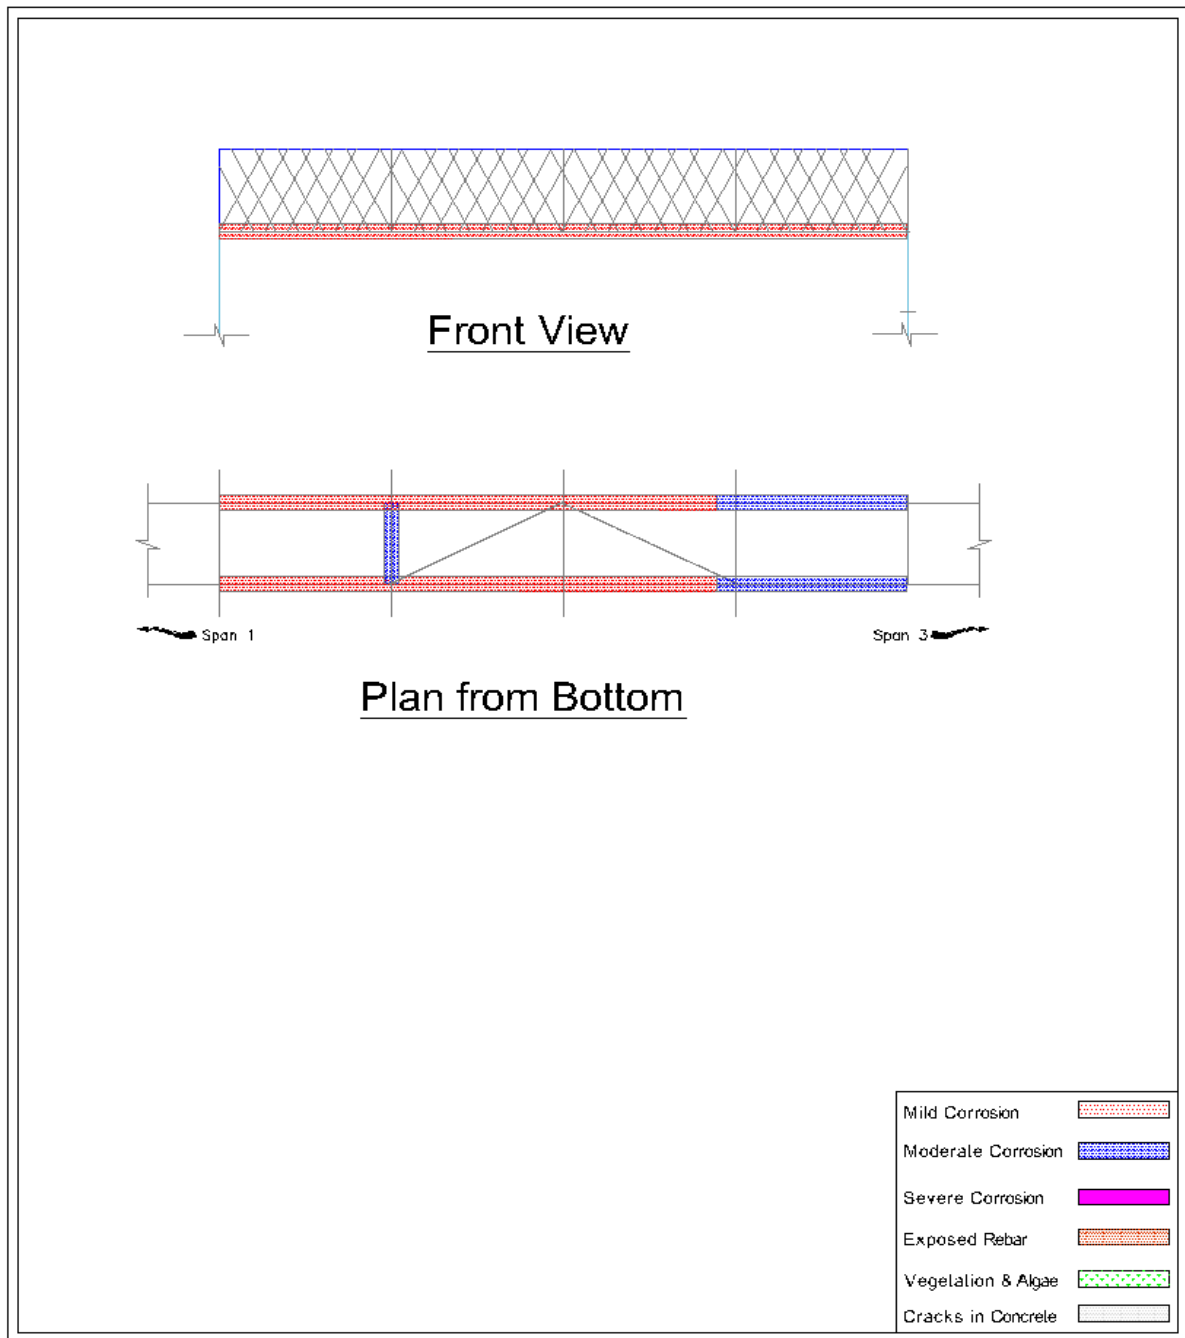
**Fig.2.3** Locations of deteriorations from bottom view of span-2

- Structural members are in fair condition, displaying mild corrosion for top chord members, verticals, diagonals, and gusset plates. Moderate corrosion for floor beams and bottom chord member. Moderate corrosion at splice joint. (Locations are marked in figures below). (Photographs of the same can be see in **fig2.4**)

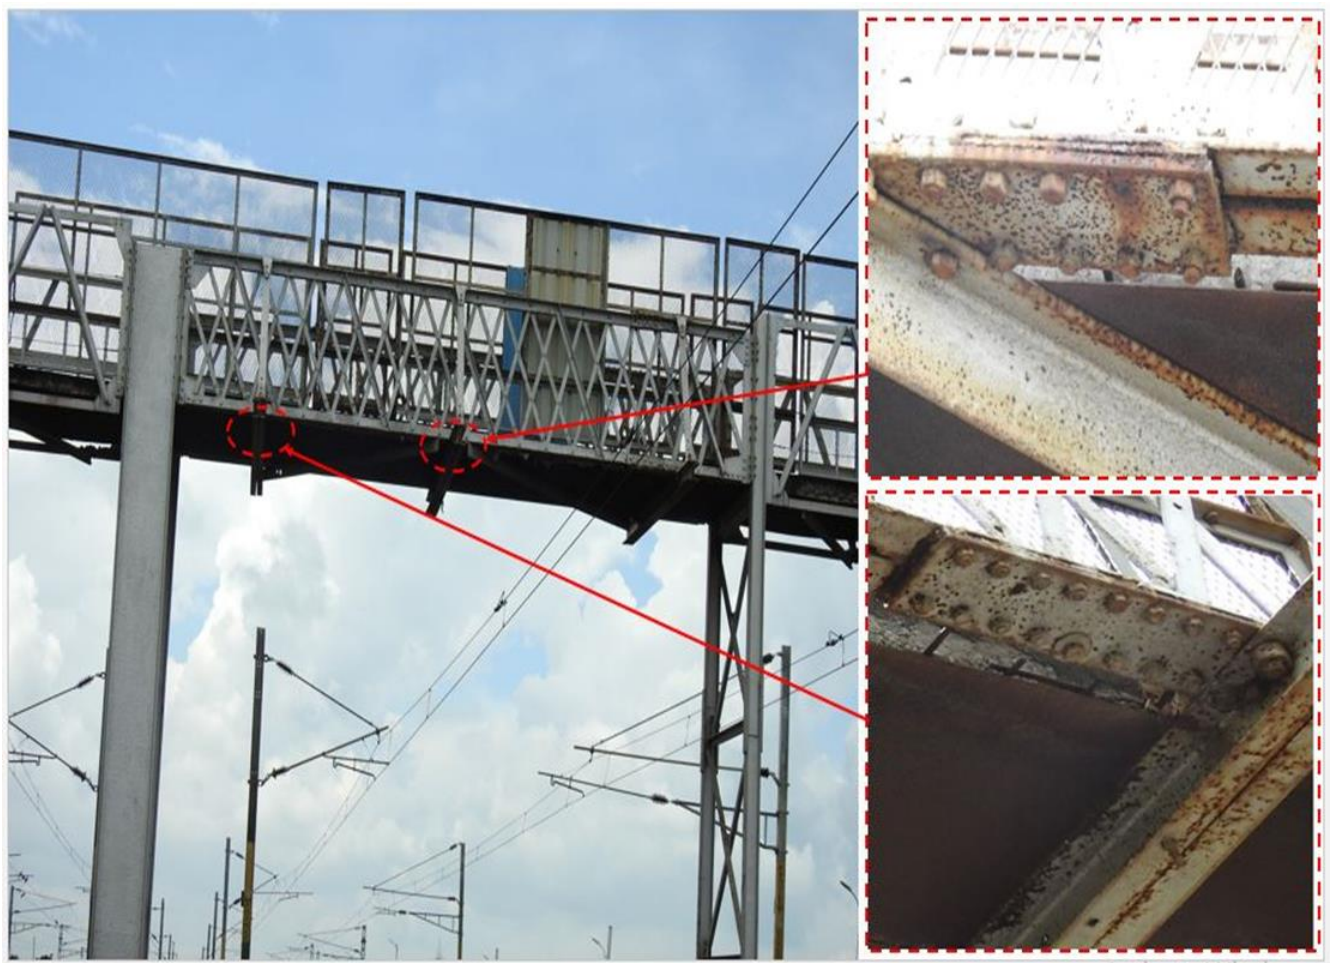
**Fig.2.4** Corrosion of floor beams and slice joint at span-2

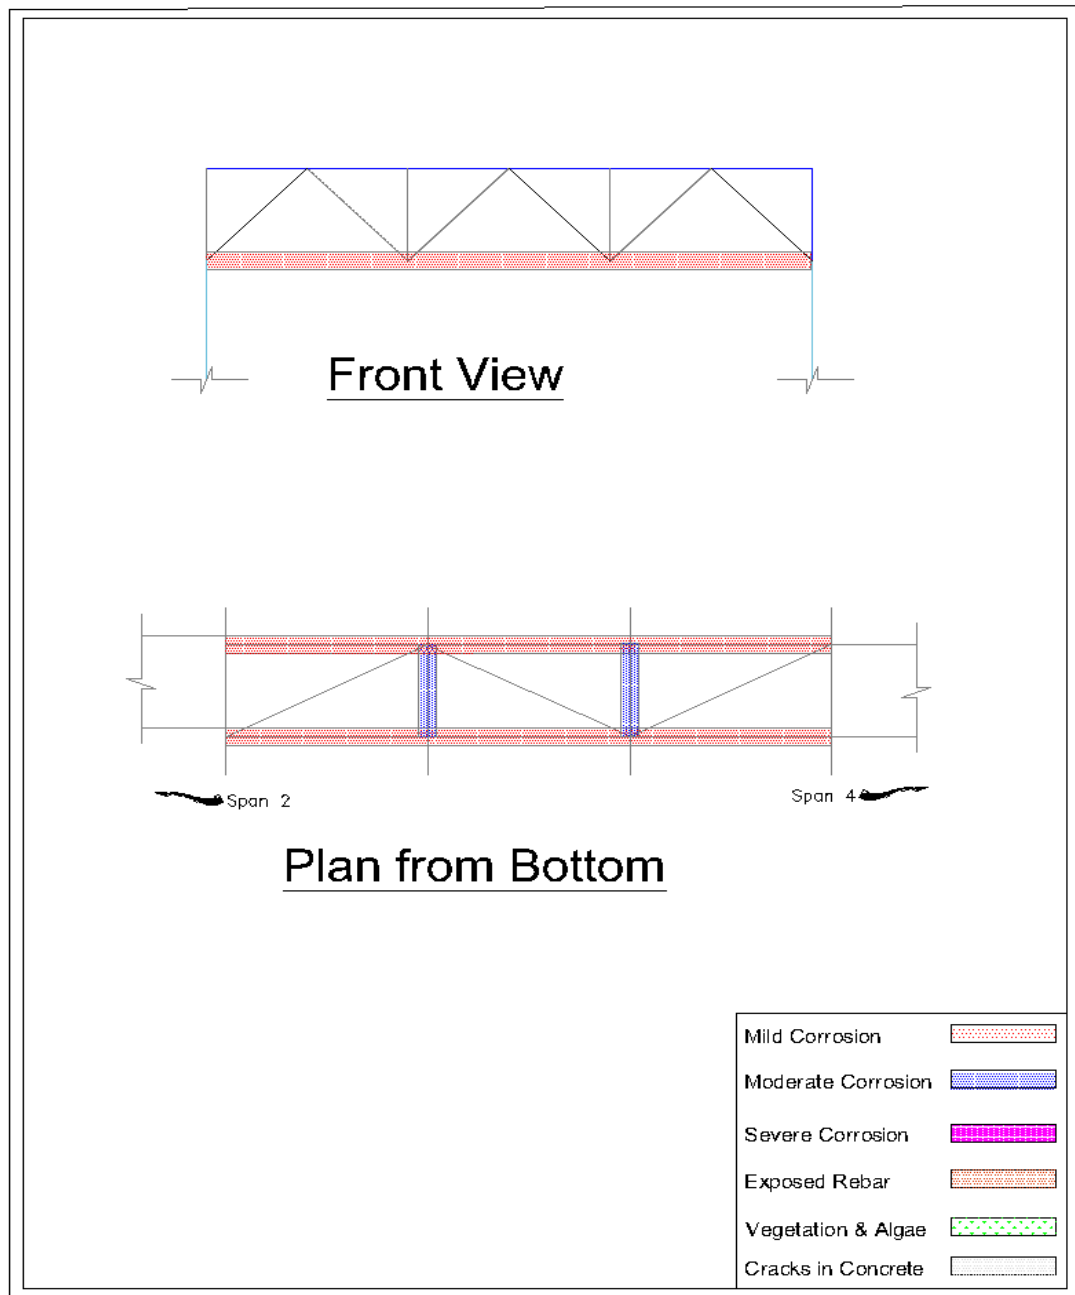
**Fig.2.5** Locations of deteriorations from bottom view of span-3

- Structural members are in fair condition, displaying mild corrosion for top chord members, verticals, diagonals, bottom chord member and gusset plates. Moderate corrosion for floor beams. (Locations are marked in figures below). (Photographs of the same can be see in **fig2.5**)

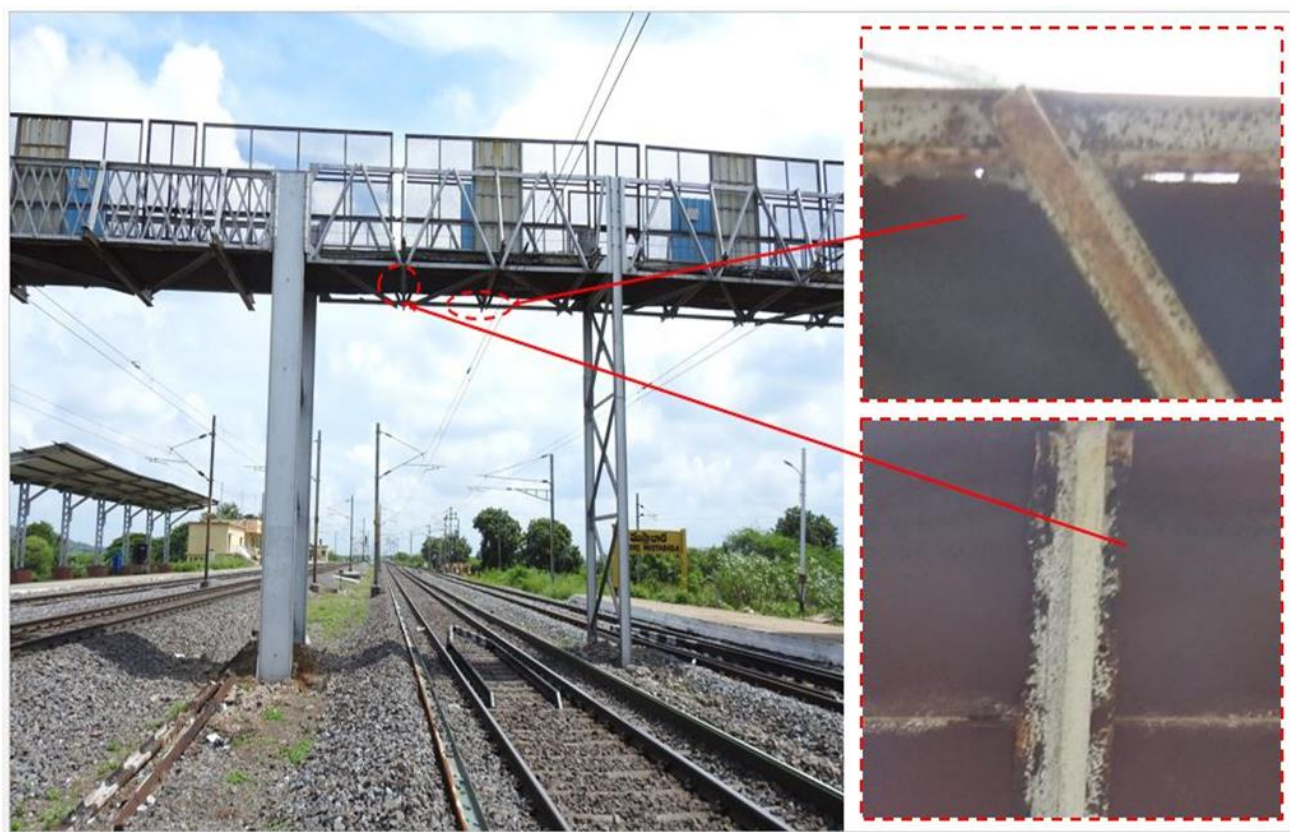
**Fig.2.6** Corrosion of floor beams at span-3

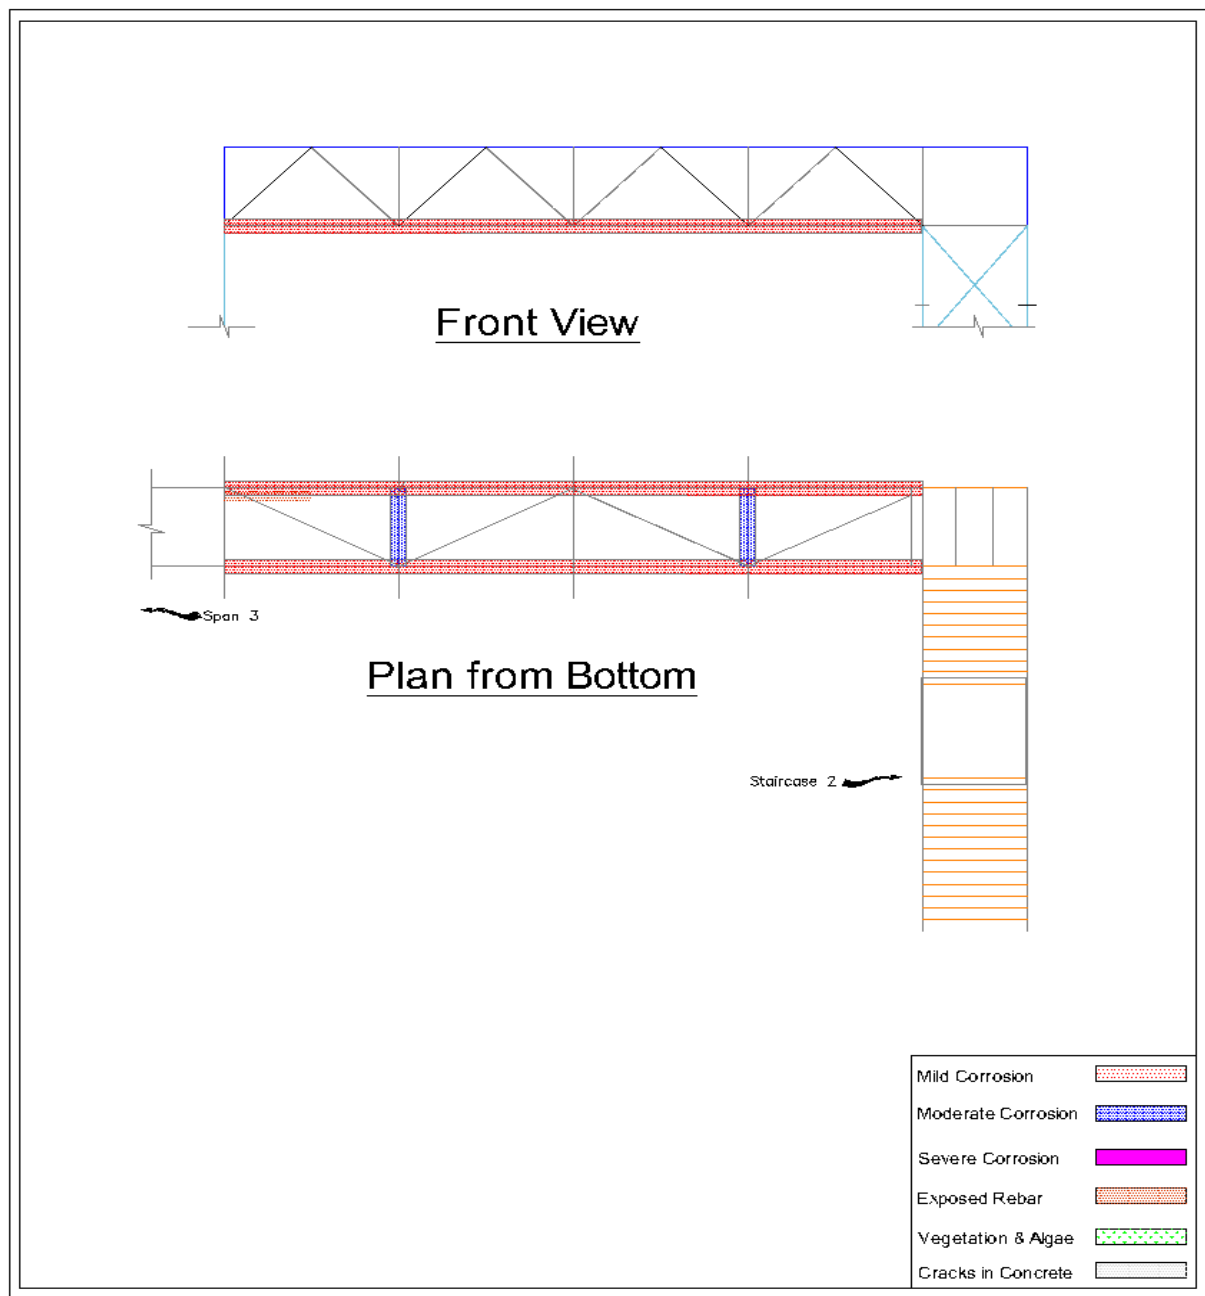
**Fig.2.7** Locations of deteriorations from bottom view of span-4

- Structural members are in fair condition, displaying mild corrosion for top chord members, verticals, diagonals, bottom chord member and gusset plates. Moderate corrosion for floor beams. (Locations are marked in figures below). (Photographs of the same can be see in **fig2.7**)

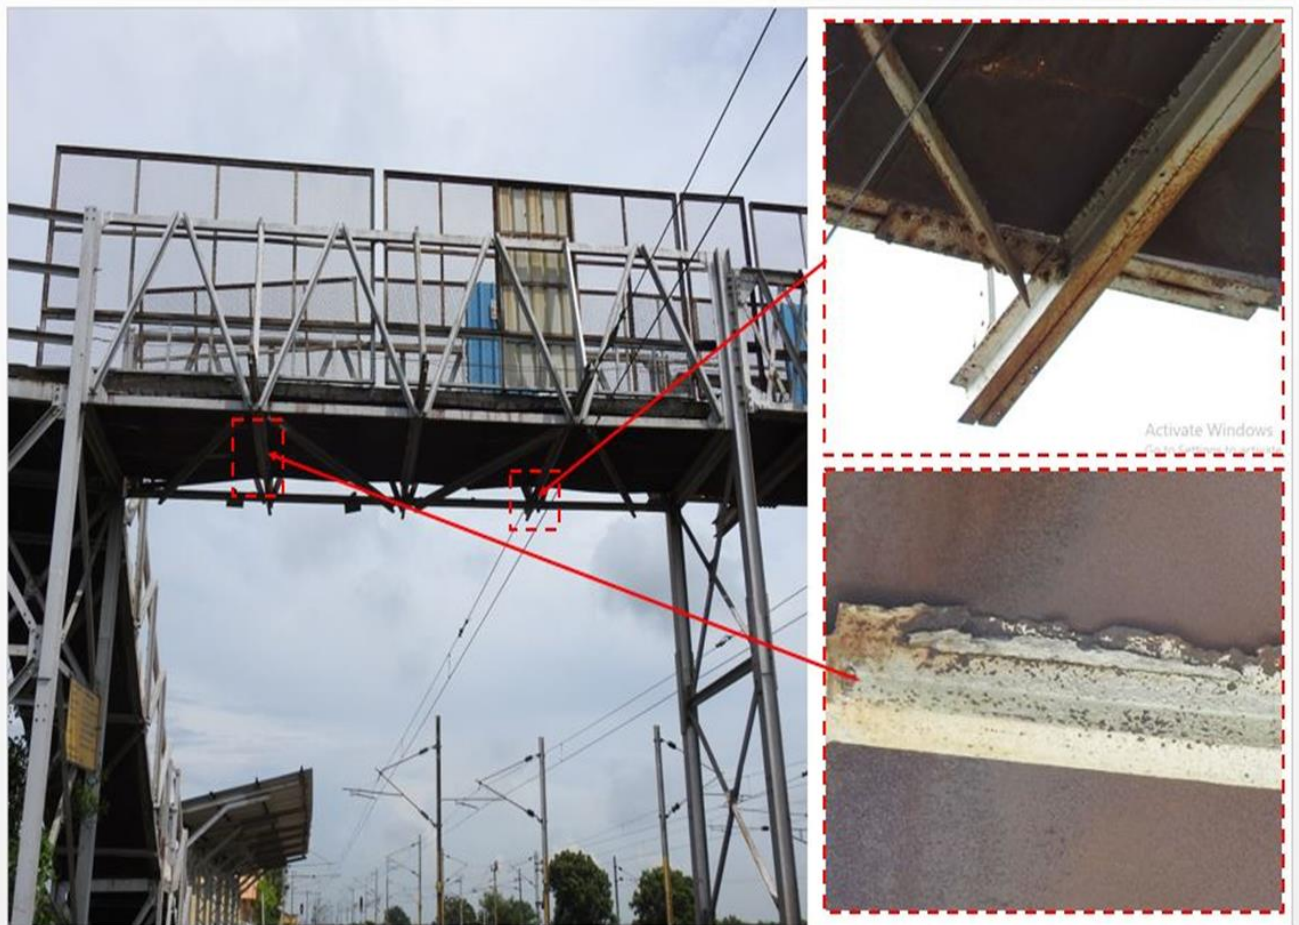
**Fig.2.8** Corrosion of floor beams at span-4

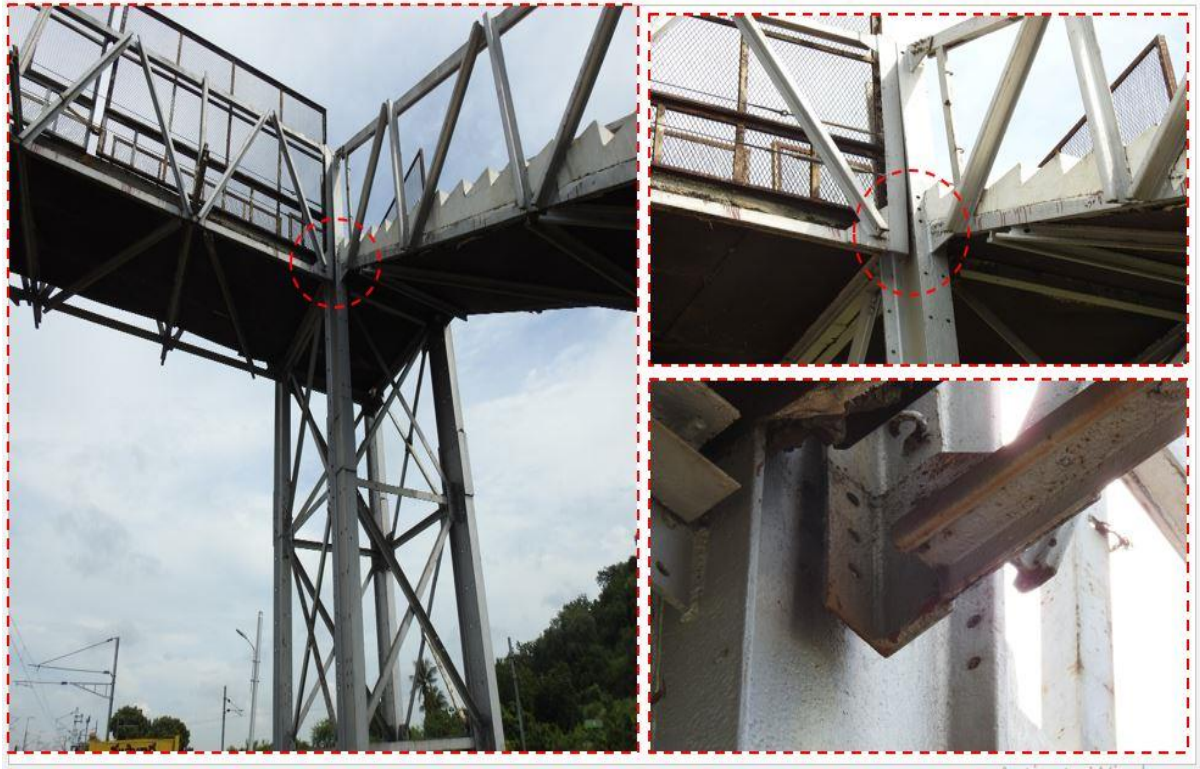
**Fig.2.9** Connection failure at Stair Case-2

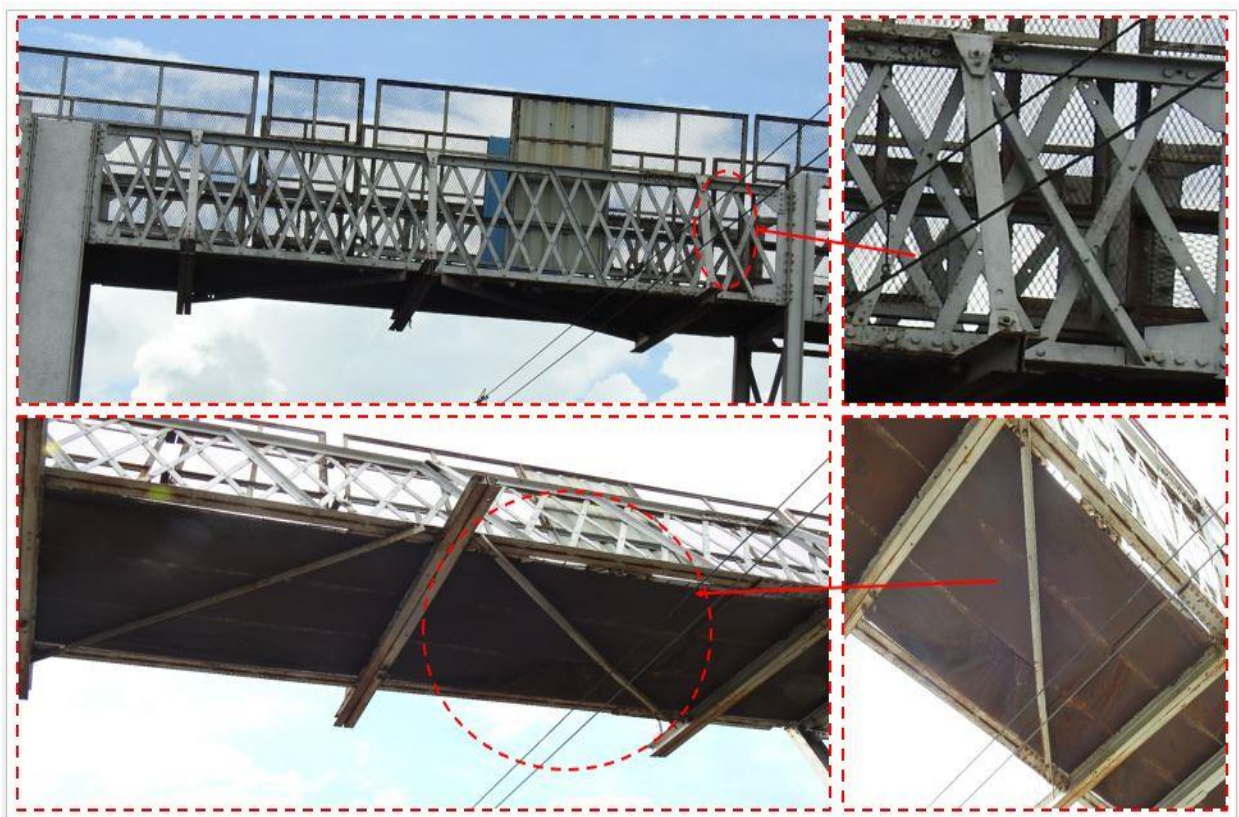
**Fig.2.10** Deformation in Diagonal members, Slab bottom lateral bracing
