## Third Party Audit of ROB's and FOB's of SCR

### INSPECTION OF FOB AT CHINNAGANJAM RAILWAY STATION

**Final Report**  
SEPTEMBER | 2020

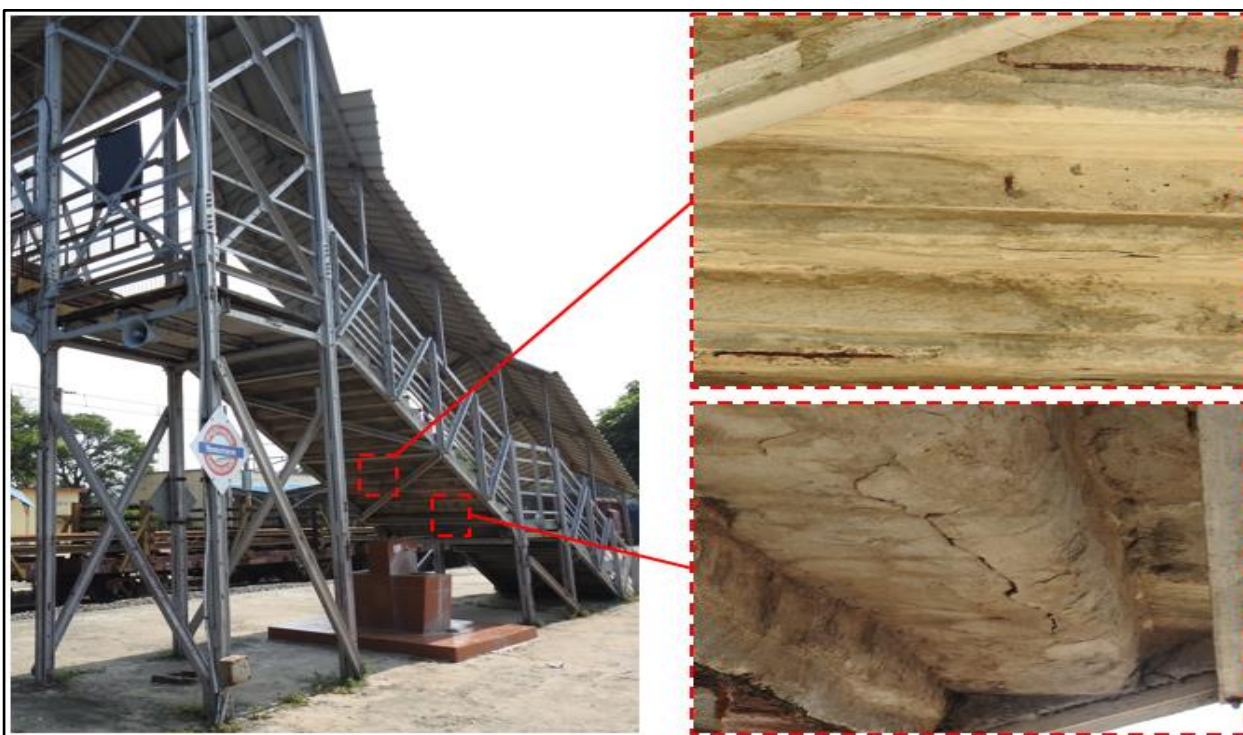
a) Cracks and reinforcement observed at Staircase 2 bottom

| SIGNS OF DISTRESS, DEFORMATION IN BRIDGES | | | |
|---|---|---|---|
| | Cracking in RCC components | Slab panels | Cracks are observed in Pre-cast RCC slab panels of stair case. (Refer <b>Part 1.4(a)</b> ) |
| | Spalling | | Spalling is observed in staircase-pre-cast panels. (Refer <b>Part 1.4(a)</b> ) |

- c) Replacement of damaged slab panels of staircase.
  - d) Replacement of severely corroded floor beams and cleat angles at staircase.

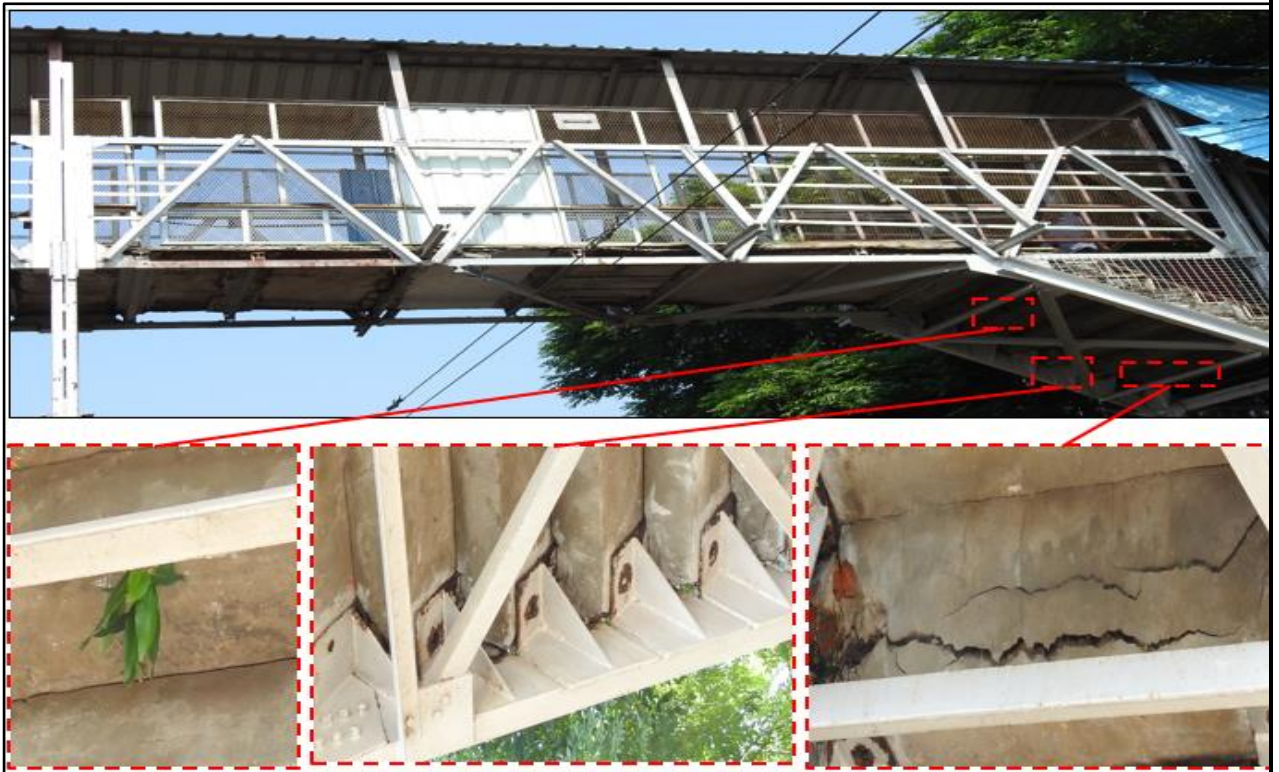
b) Vegetation, corrosion at cleat angles and cracks observed at pathway staircase Span 1

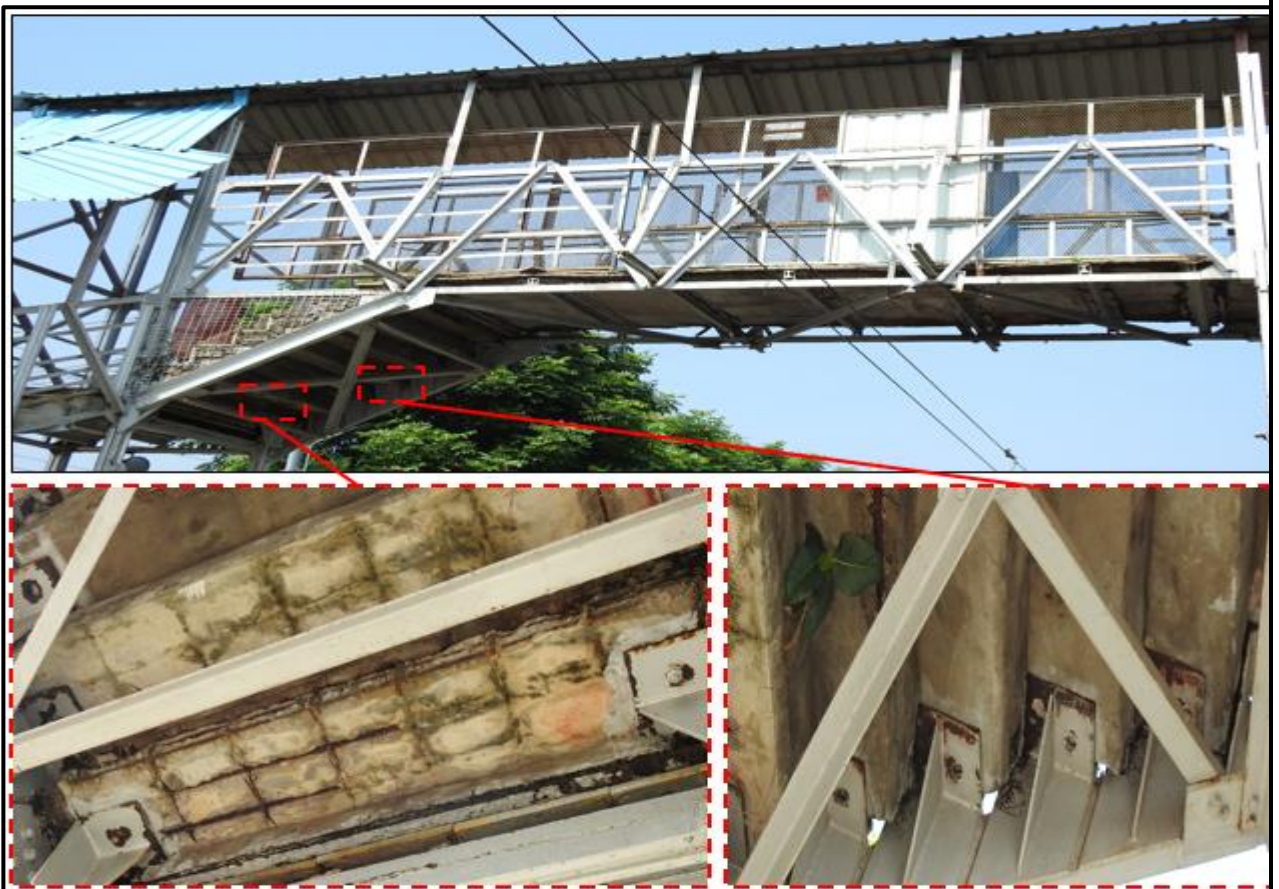
c) Vegetation , Reinforcement exposed and corrosion at cleat angles observed at pathway staircase Span 2

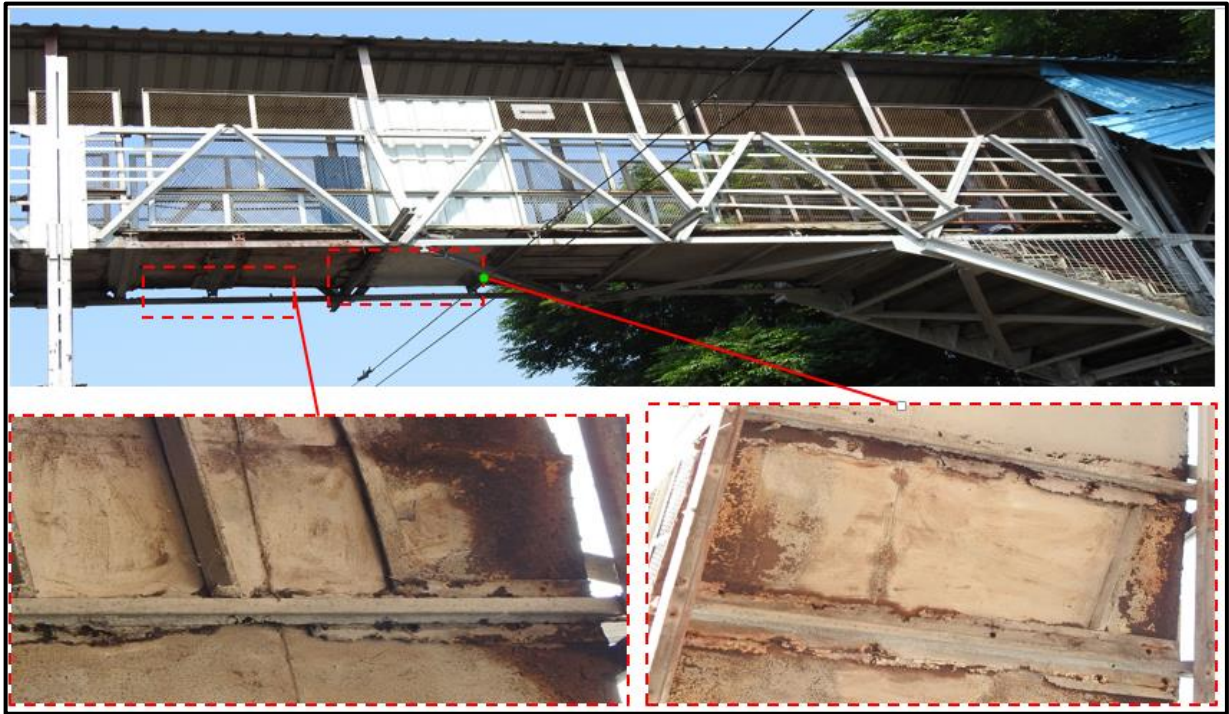
I. Corrosion observed at floor beams on Span-1

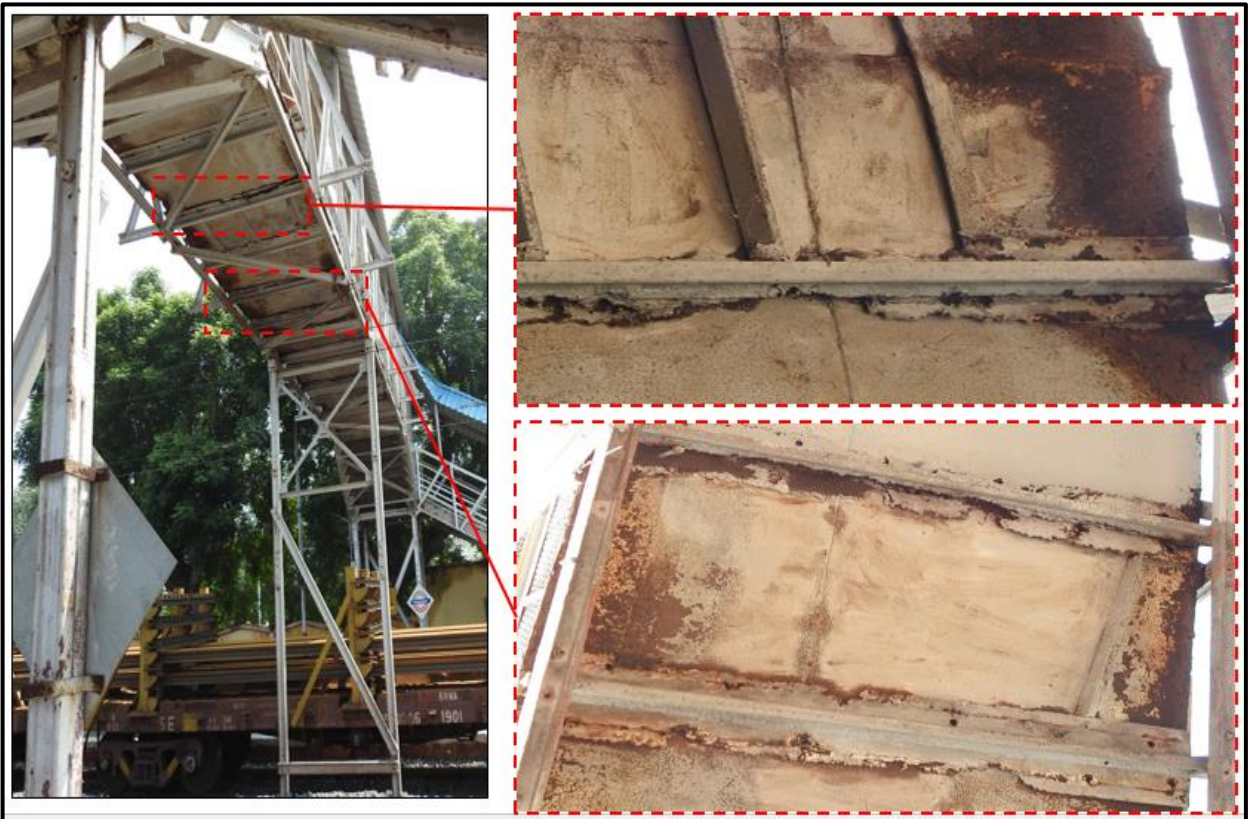
II. Corrosion observed at floor beams on Span-2

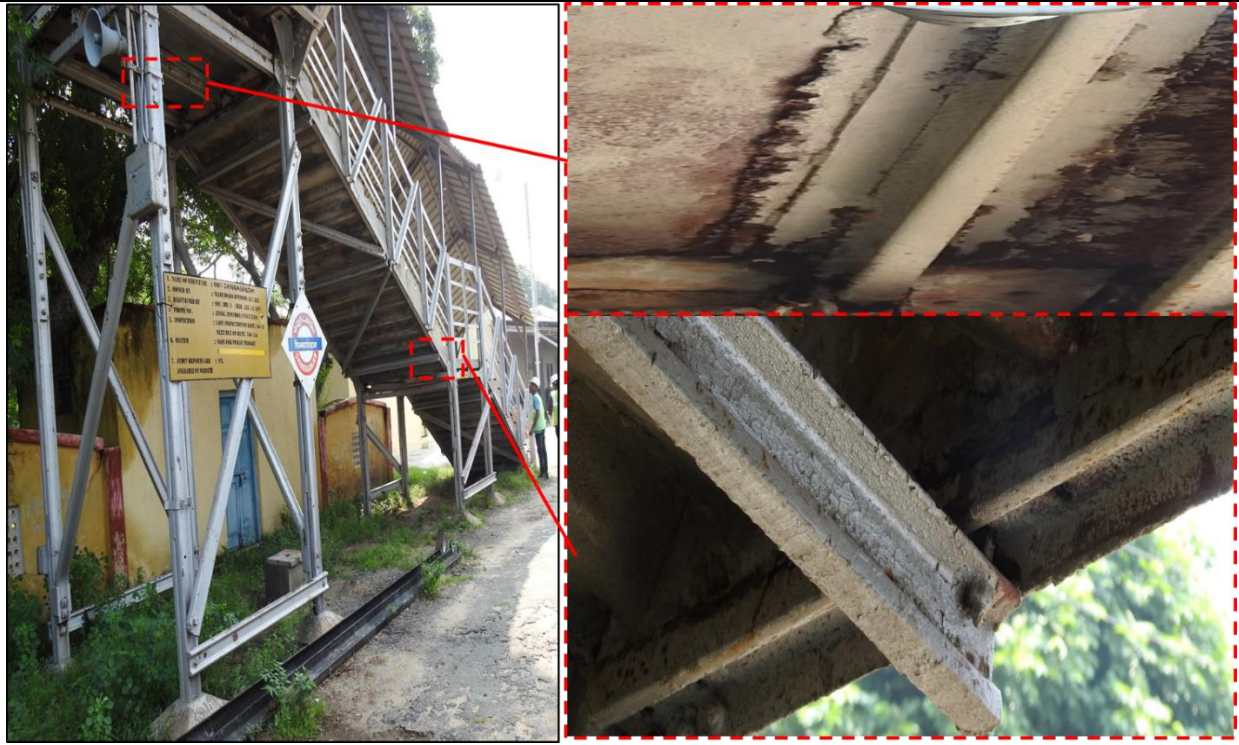
III. Corrosion observed at floor beams in landing and Stringer beams in Staircase 1

- a) Cleaning of debris immediately to avoid deterioration of concrete and steel members.
  - b) Anti-corrosion treatment for Grade-1 and Grade-2 highlighted corrosive members, stringer beams of Staircase.

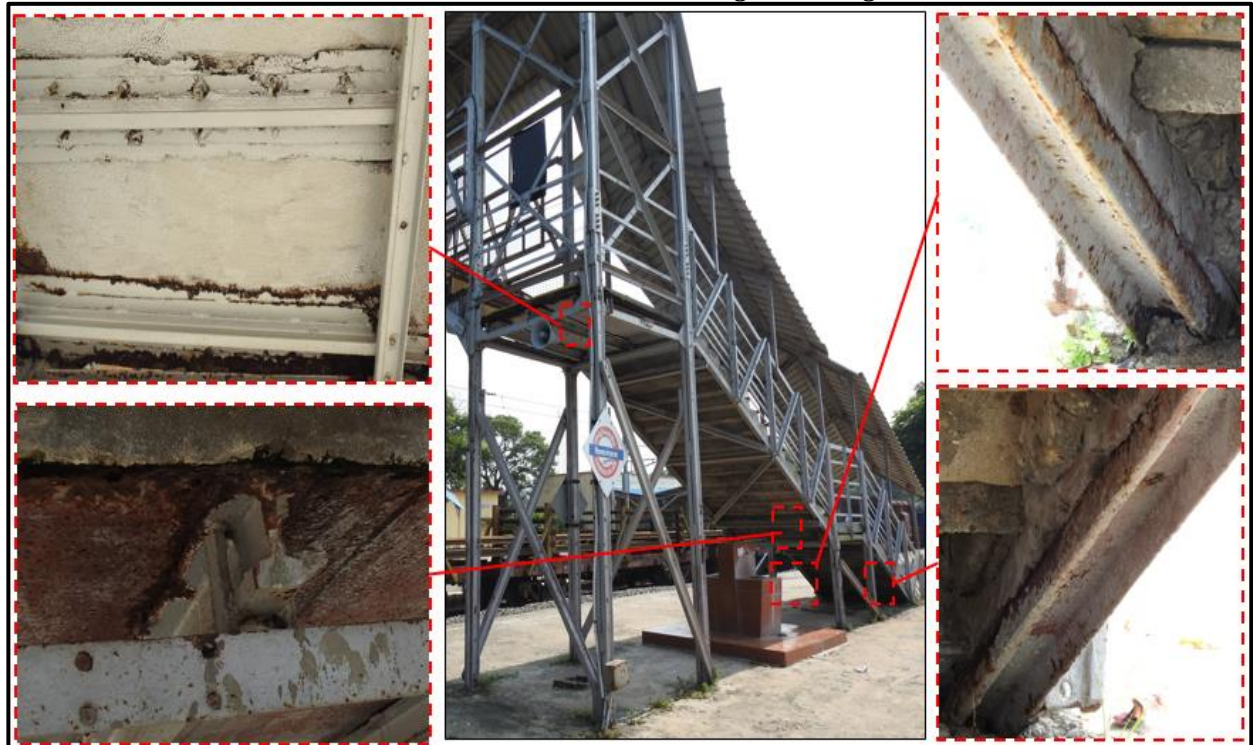
IV. Corrosion observed at floor beams in landing and Stringer beams in Staircase 2

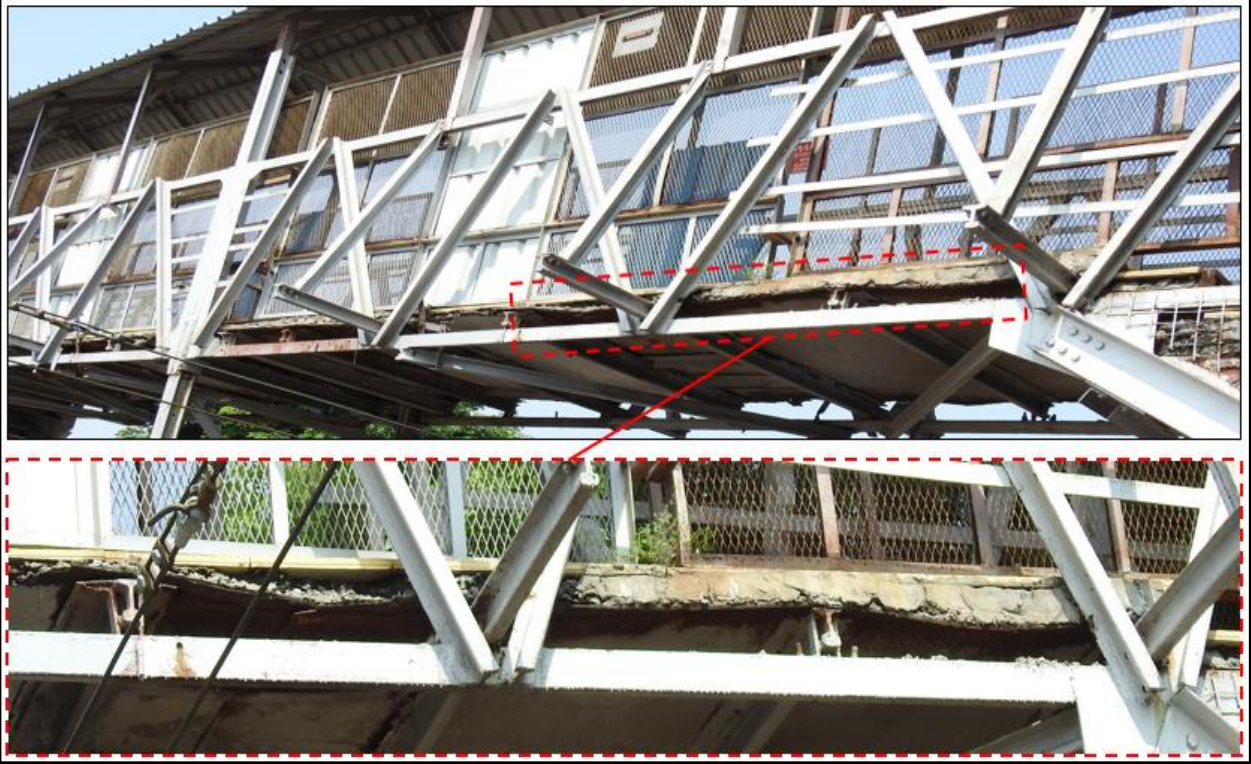
V. Deformation at slab panels on Span-1

| SIGNS OF DISTRESS, DEFORMATION IN BRIDGES | | | |
|---|---|---|---|
| | Deformation | Floor Slab, Staircase (PF-2) | Deformation is observed at Tie beam of Mid Landing and Floor Slab between floor beams. (Refer <b>Part 1.4(b)</b> ) |

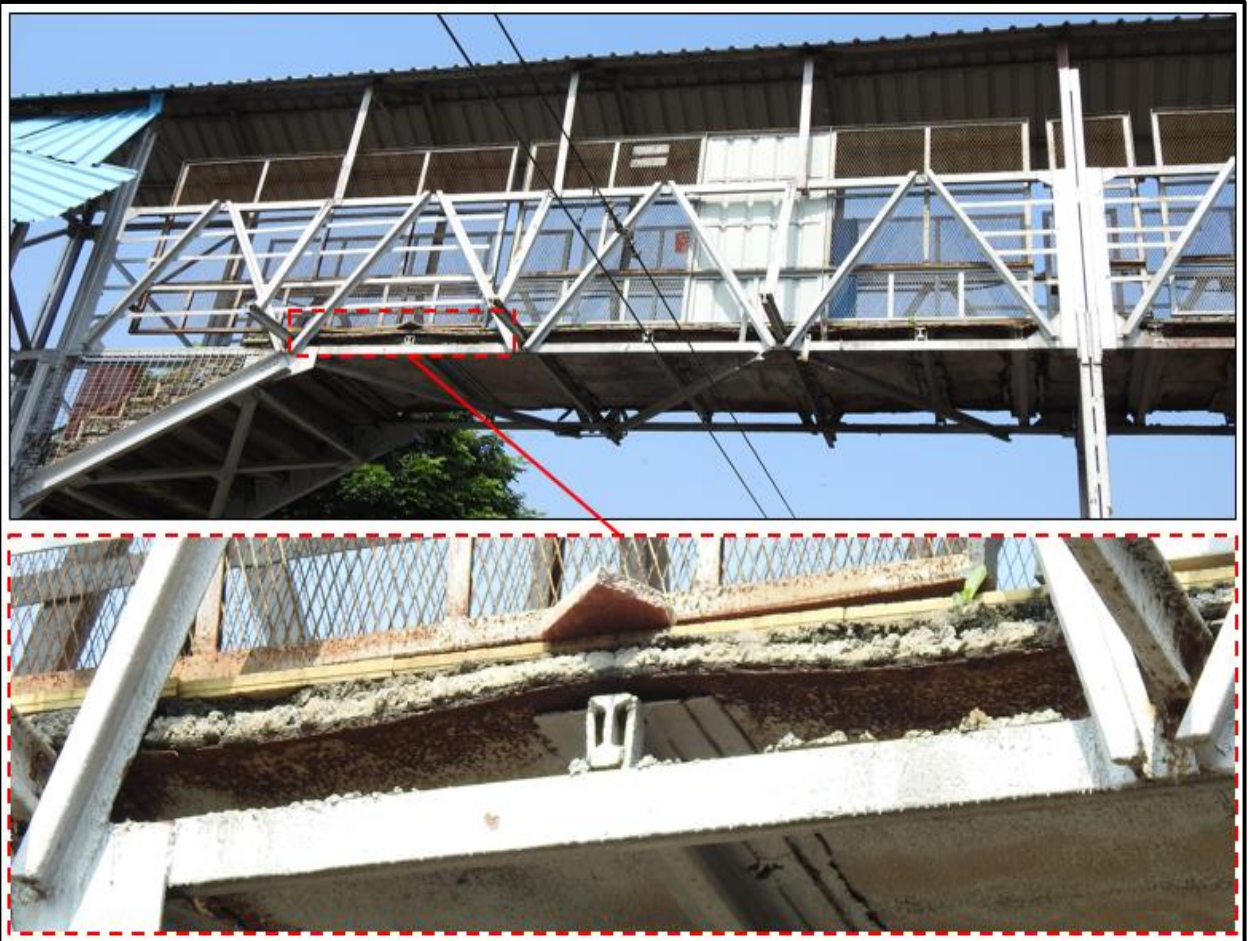
VI. Deformation at slab panels on Span-2

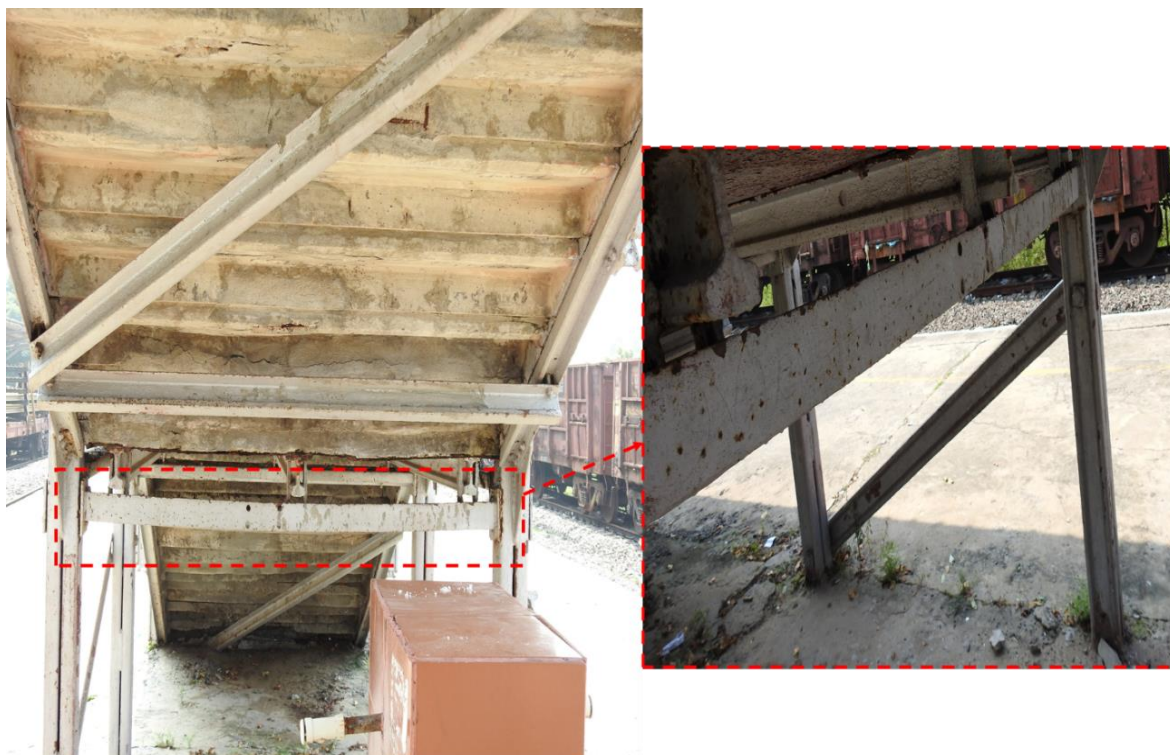
VII. Deformation of Tie beam at Staircase 2

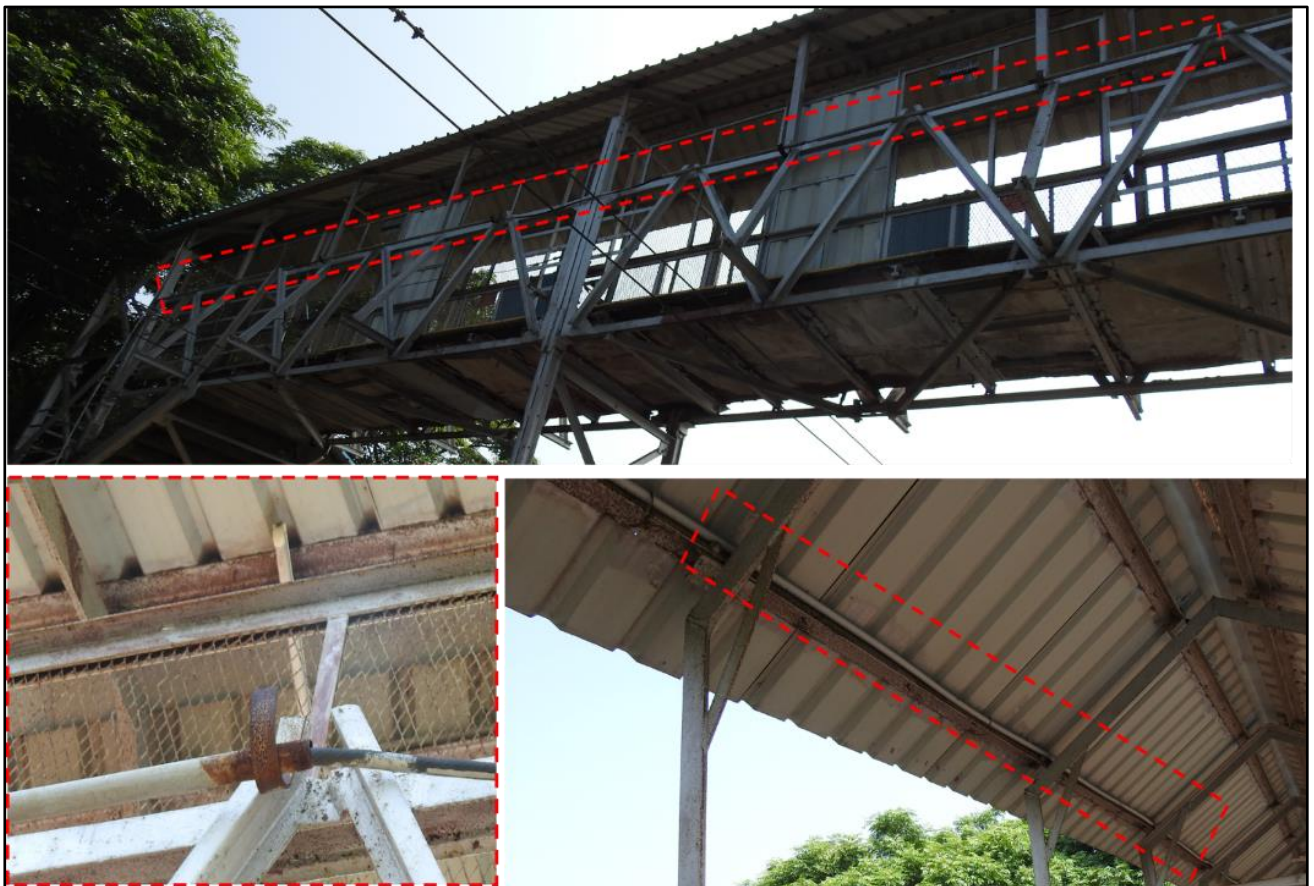
| PART 1.2 IDENTIFICATION OF LOADS ON BRIDGE | | | |
|---|---|---|---|
| | b) Cables | Yes | a. Cables are protected with 1-inch HDPE pipe, 1.5-inch GI pipe supported on Top Chord, 1-inch PVC pipe supported on Roof Truss. (Refer <b>fig :1.3</b> )<br>b. Common Rafter Truss of 75 x 75 x 6 mm Angles are used as Roof truss (Refer <b>fig :1.2</b> )<br>c. Steel Metal Sheet is used for Roof (Refer <b>fig : 1.2</b> ) |

**Fig 1.3:** Additional loads of HDPE, PVC pipes

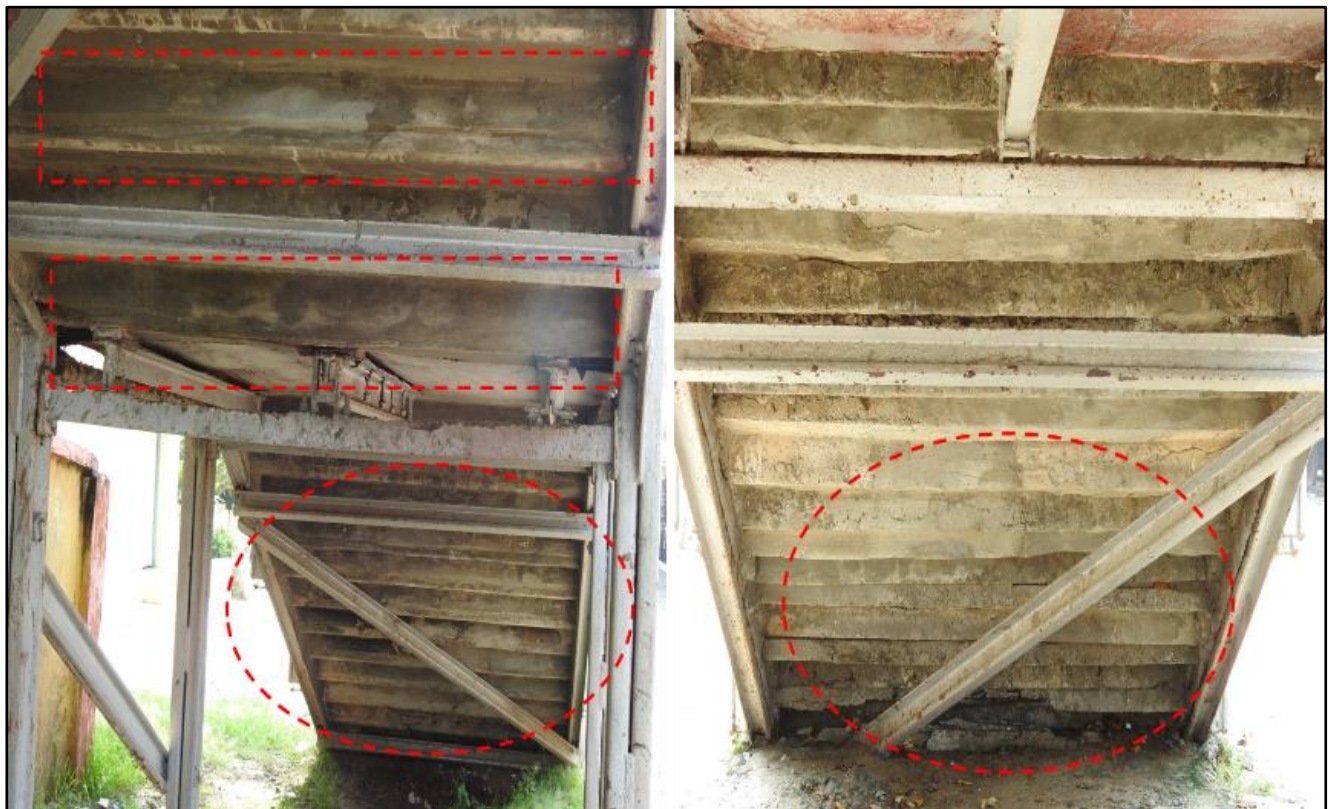
| | Number of Staircase | 2 no's | Staircase is observed as Pre cast RCC Slab panels supported on 50 x 80 x 80mm Rail tie beam and 50 x 80 x 80mm Rail Stringer beam on both sides of stair case. (Refer <b>fig : 1.5</b> ) |

**Fig 1.5:** Patch work is observed at PF- 2 stair case flight slab panels

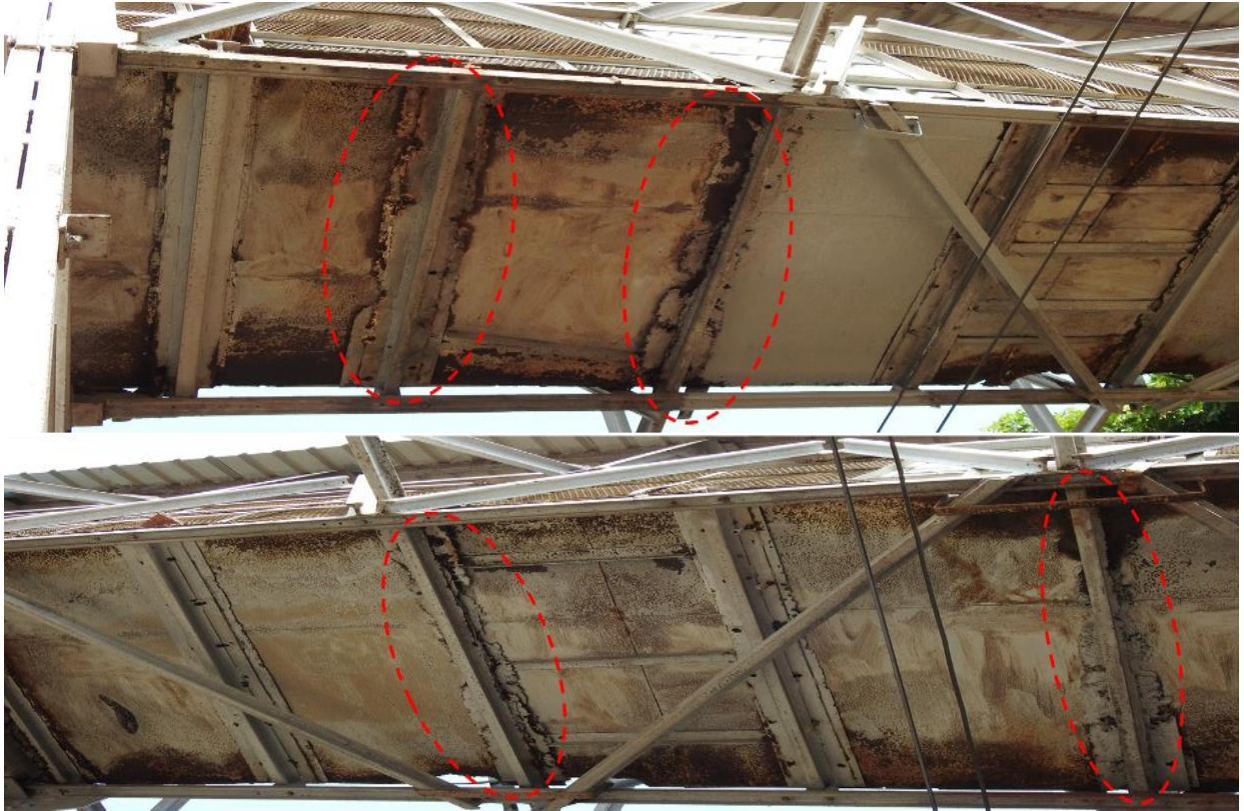
**Fig: 1.8** Corrosion of floor beams in Span 1 and Span 2

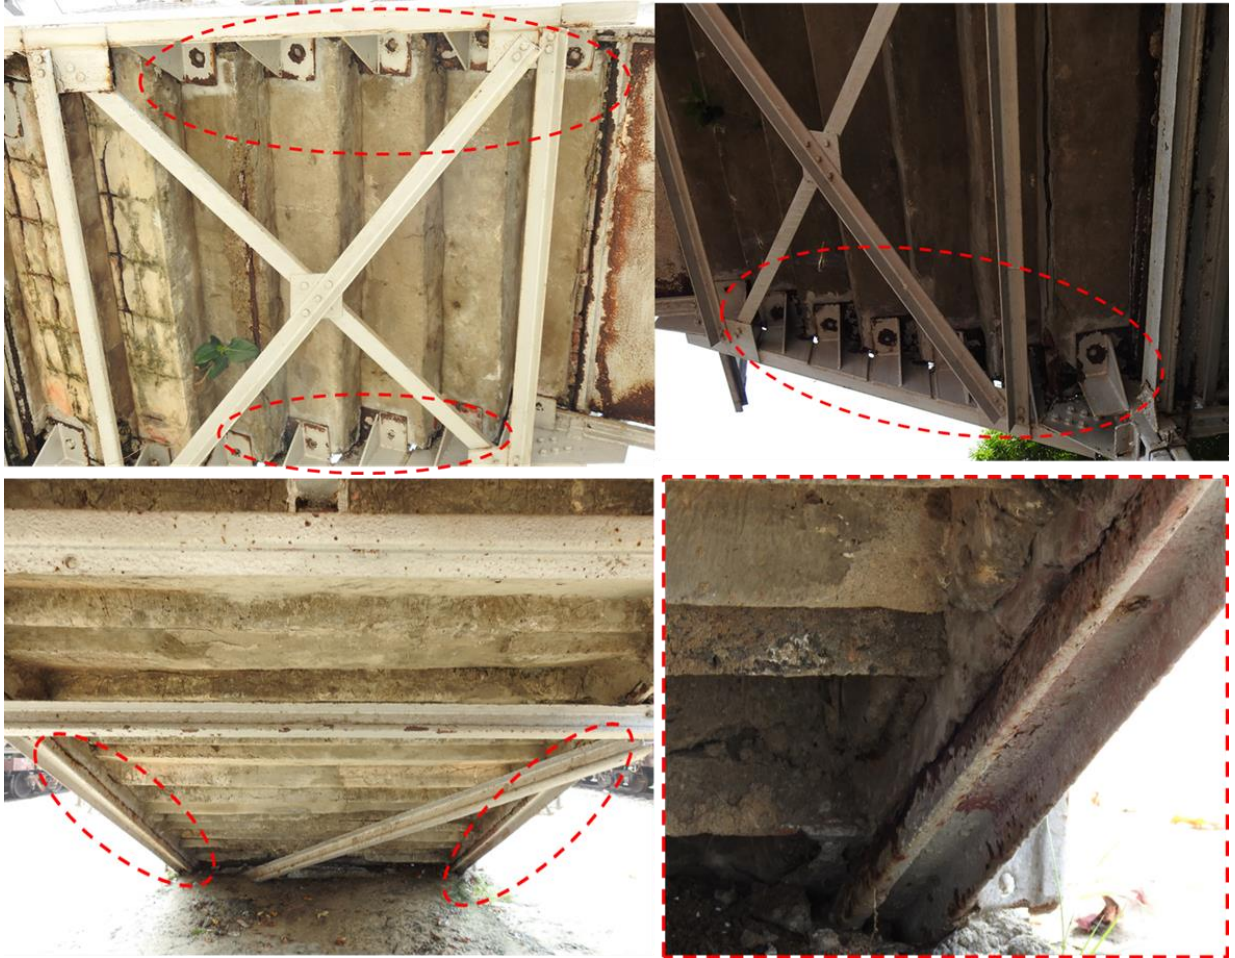
**Fig: 1.9** Corrosion of Cleat angles and Stringer beam

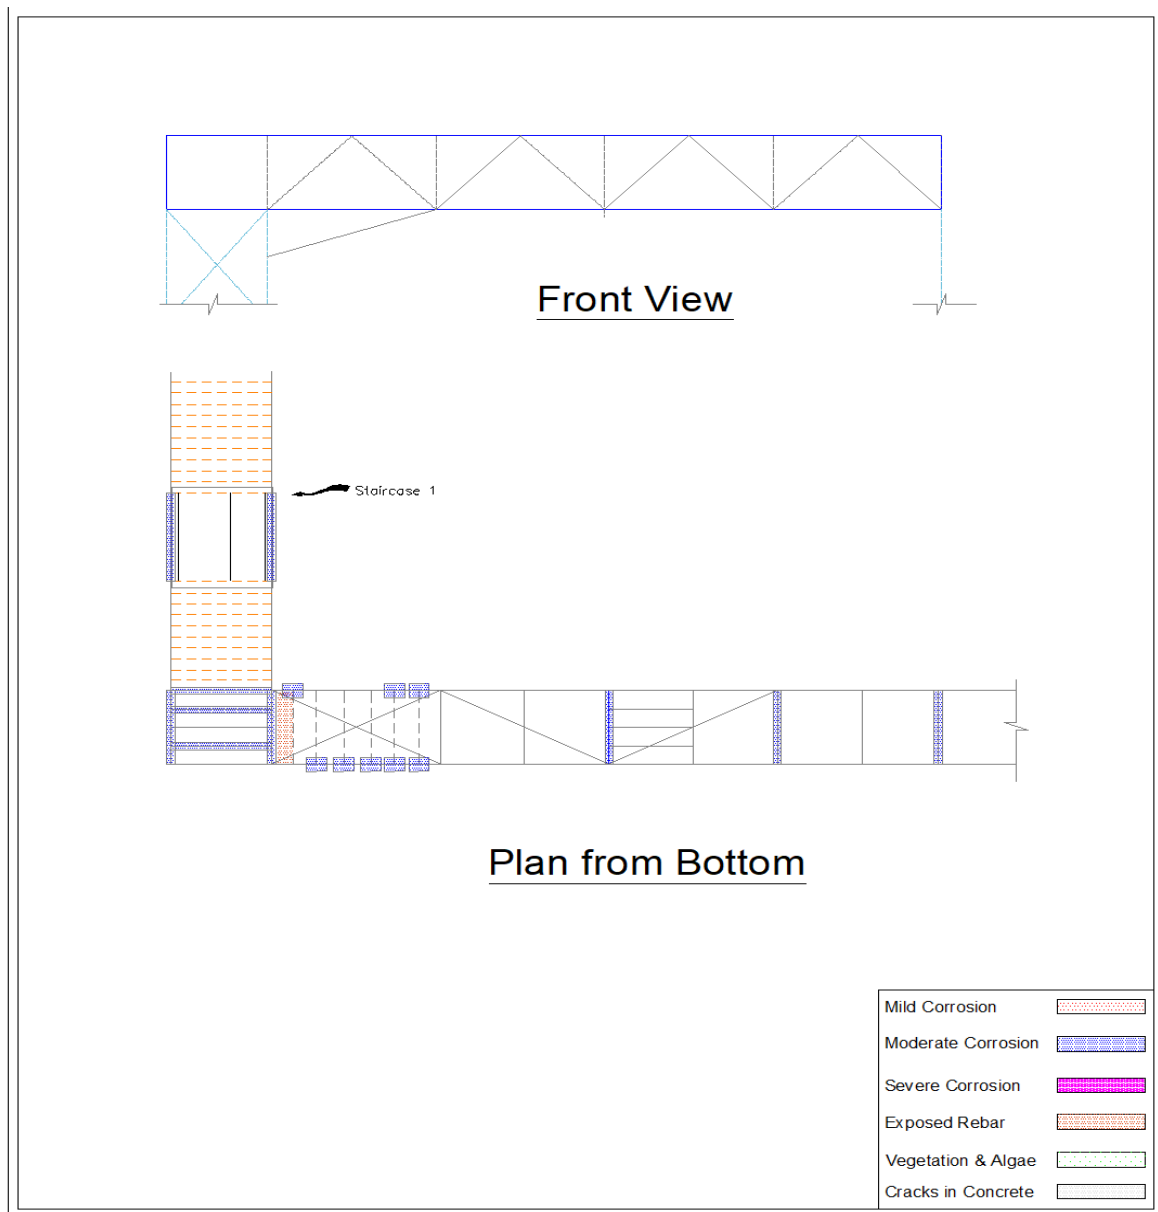
**Fig 2.1:** locations of deterioration and bottom view of span-1

- Structural members are in fair condition, displaying mild corrosion for top and bottom chord members, verticals, diagonals, moderate corrosion for floor beams Cleat angles supporting Pathway staircase. (Locations are marked in figures below).
- Algae formation is observed along steel concrete joint on outer surface at deck level. Precast slab panels are spalling of precast slab panels of pathway staircase at deck level. (Photographs of the same can be see in **fig2.2-2.3** )

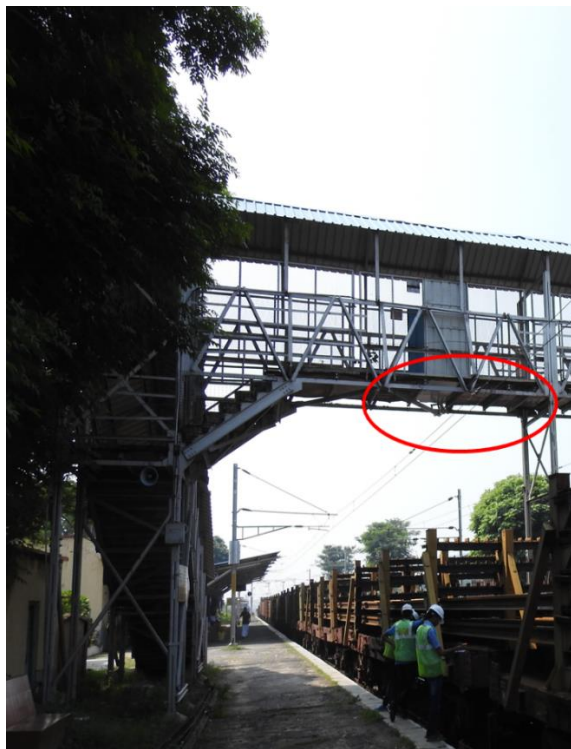
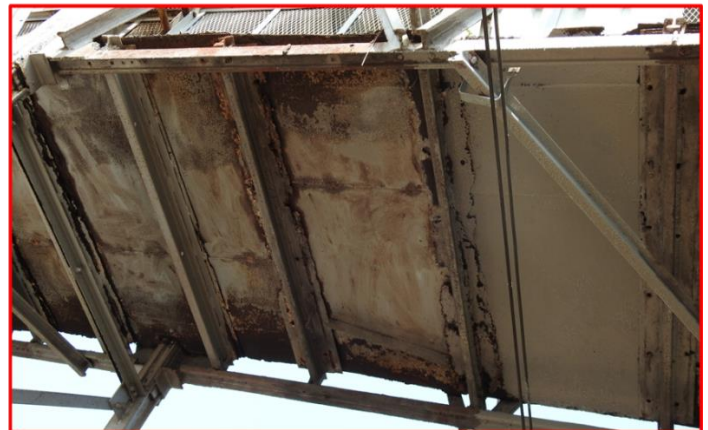
**Fig 2.2:** Corrosion of floor beams of span-1

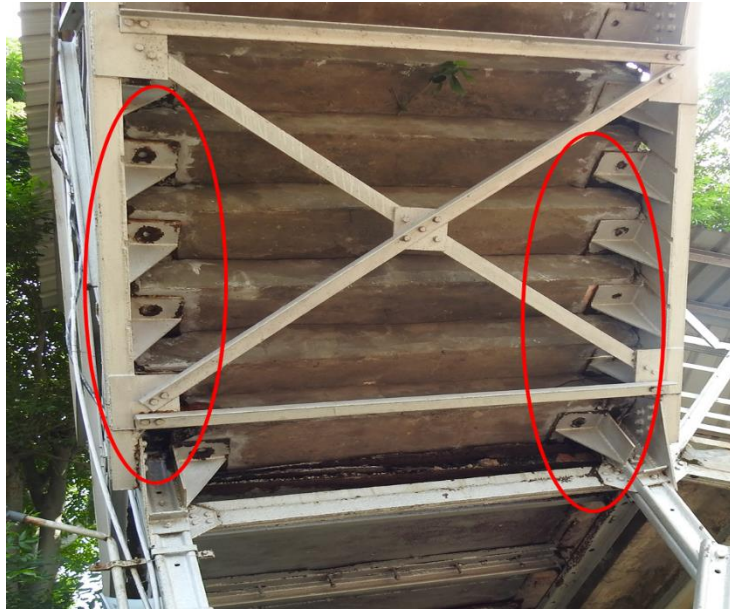
***Fig 2.3:*** Corrosion of Cleat angles along the staircase

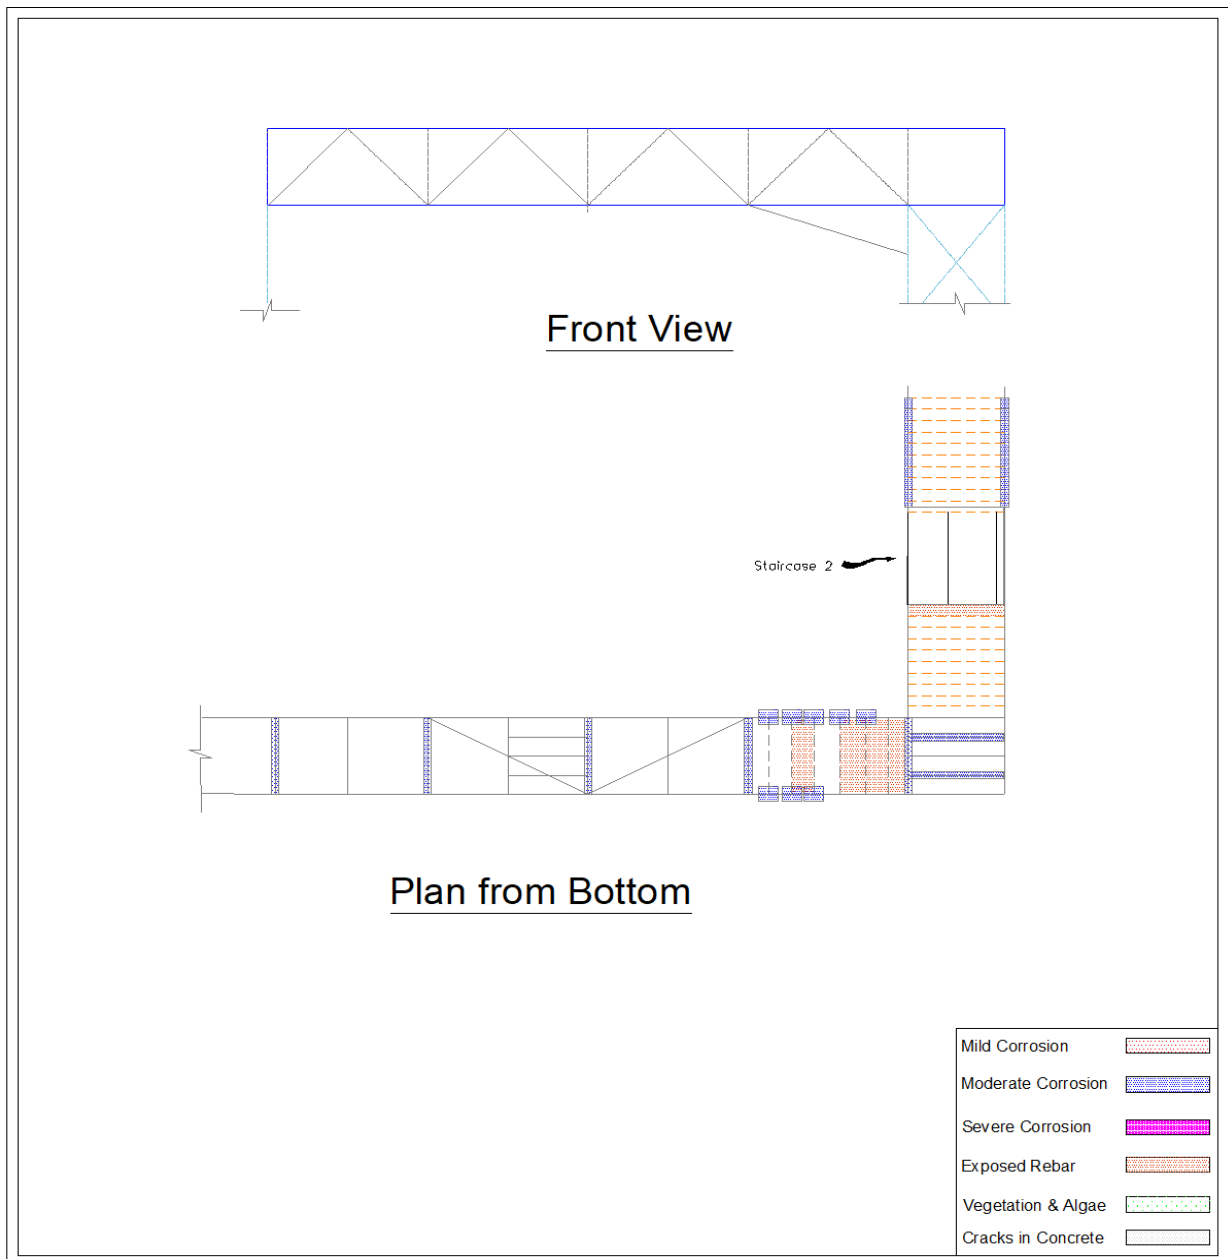
**Fig 2.4:** locations of deterioration and bottom view of span 2

- Structural members are in fair condition, displaying mild corrosion for top and bottom chord members, verticals, diagonals, moderate corrosion for floor beams Cleat angles supporting Pathway staircase. (Locations are marked in figures below).
- Algae formation is observed along steel concrete joint on outer surface at deck level. Precast slab panels are deteriorated reinforced is exposed in flights and pathway staircase at deck level. (Photographs of the same can be see in **fig2.5-2.7** )

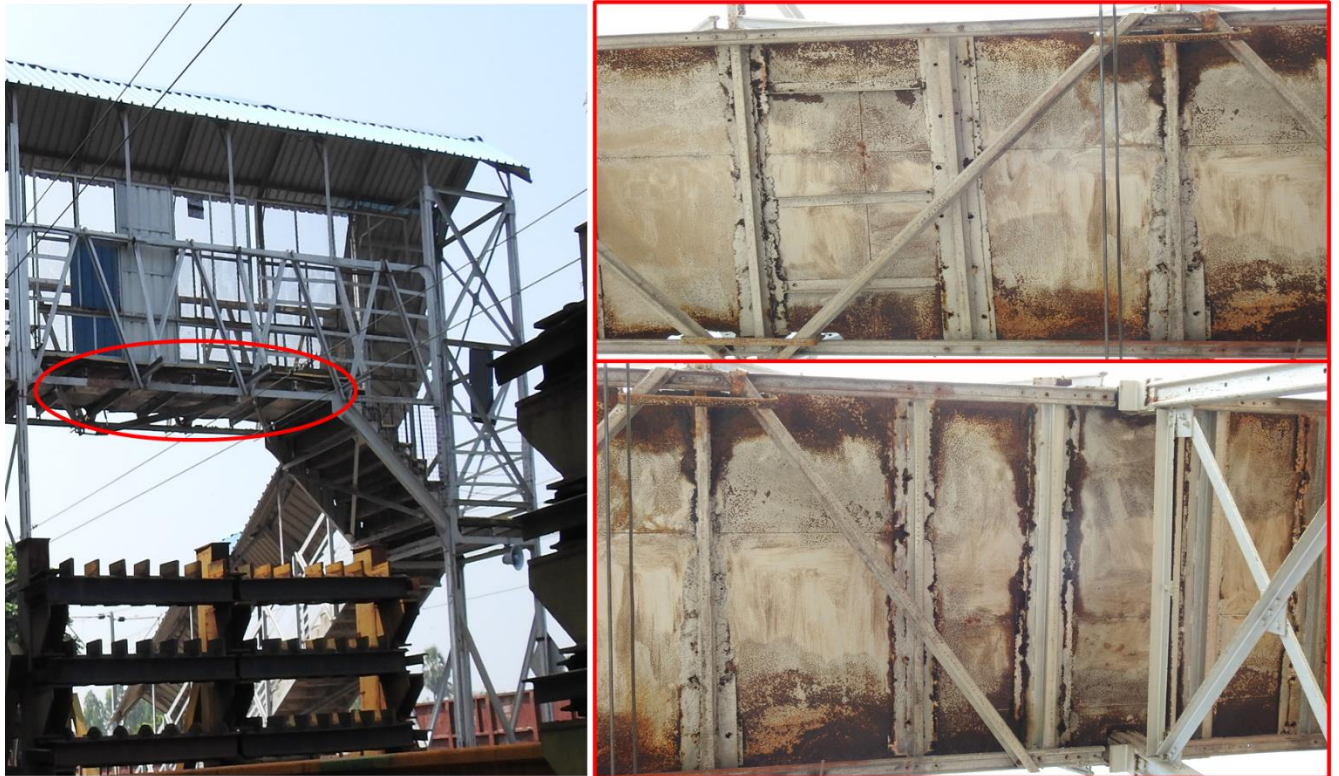
**Fig 2.5:** Corrosion of floor beams in span 2

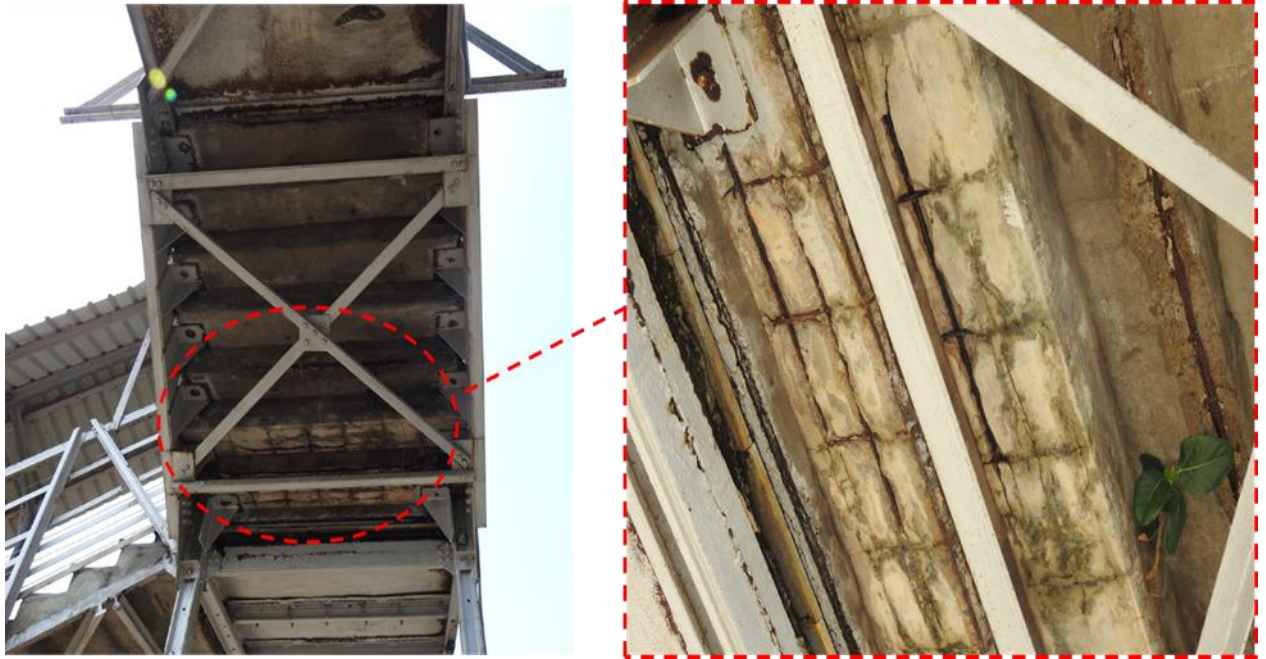
**Fig 2.6:** reinforcement exposure of pathway stair case

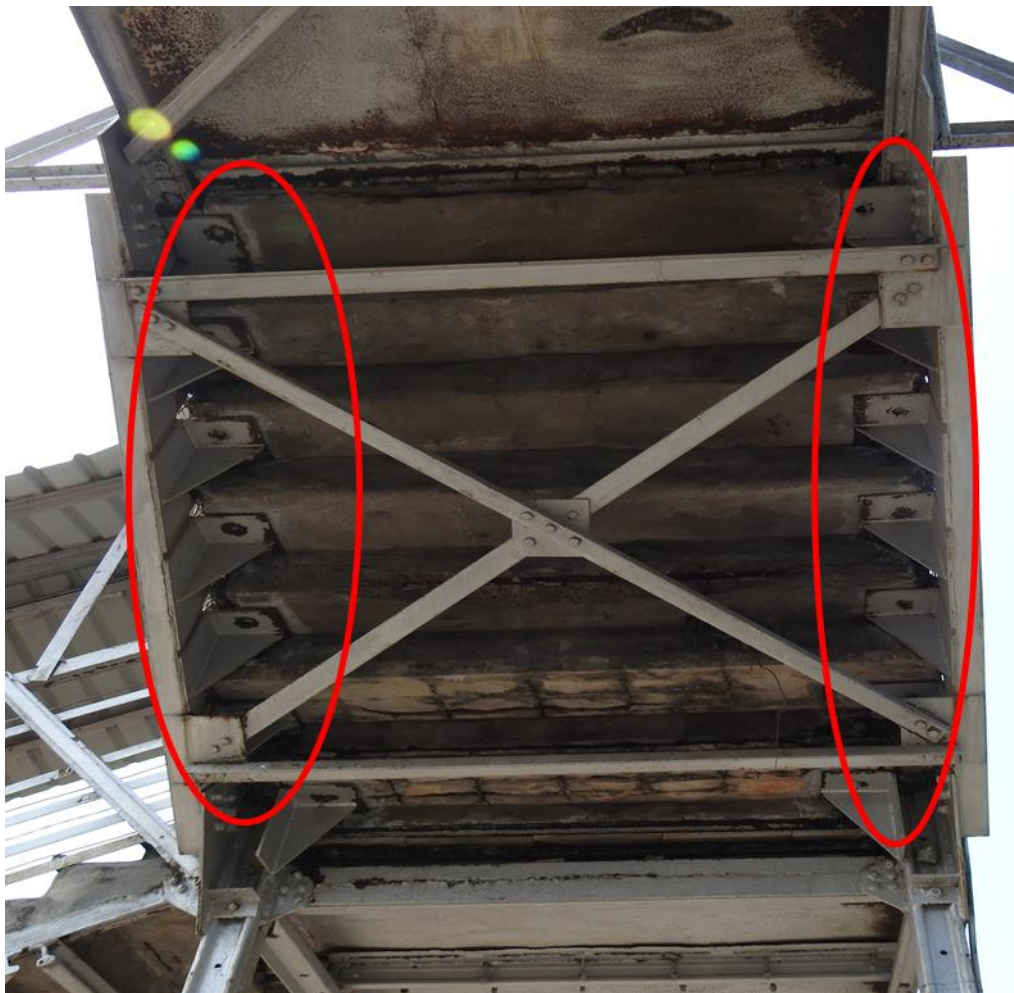
**Fig 2.7:** Corrosion of cleat angles of span 2
