# Third Party Audit of ROB's and FOB's of SCR

## INSPECTION OF FOB AT ANAKAPALLE RAILWAY STATION

**Final Report**  
SEPTEMBER | 2020

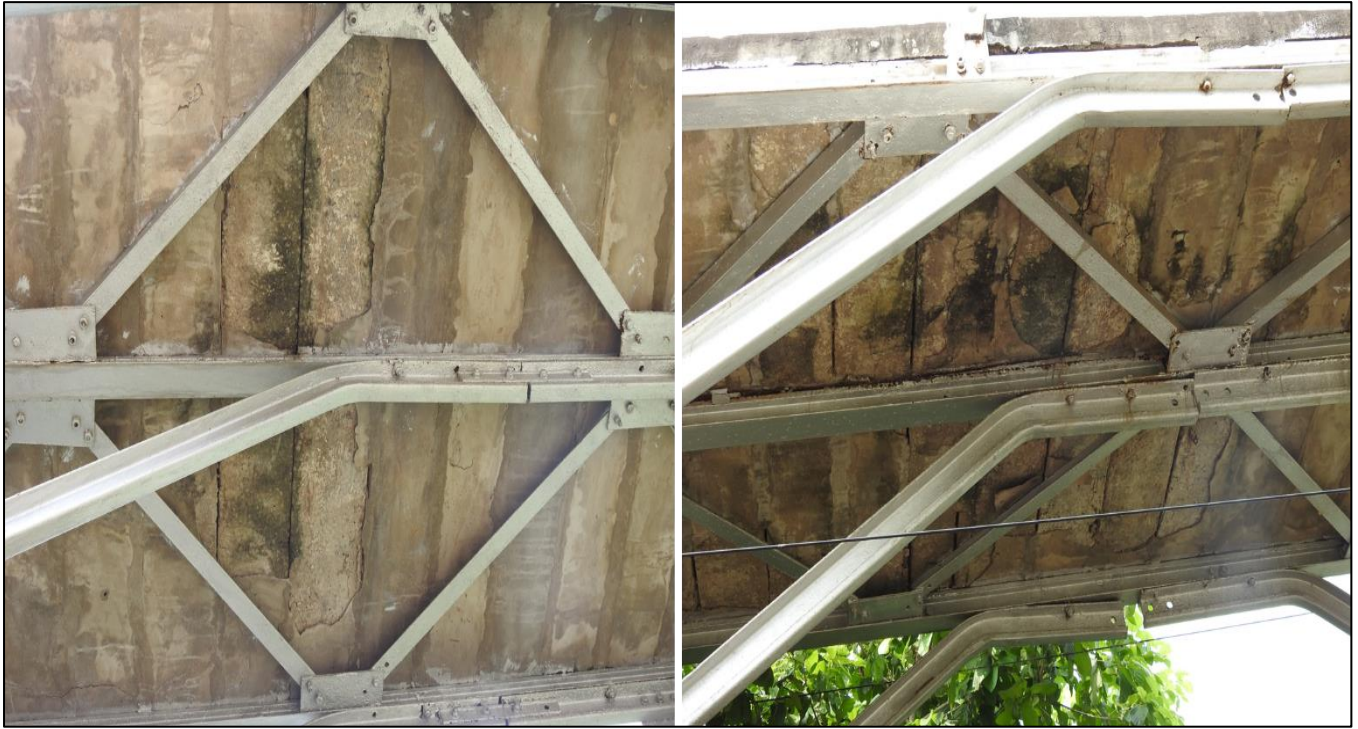
- i ✓ Exposed reinforcement is observed in span 1, 2, 3 and 7<sup>th</sup> span and spalling are observed ramp.

a) Reinforcement exposed slab panels

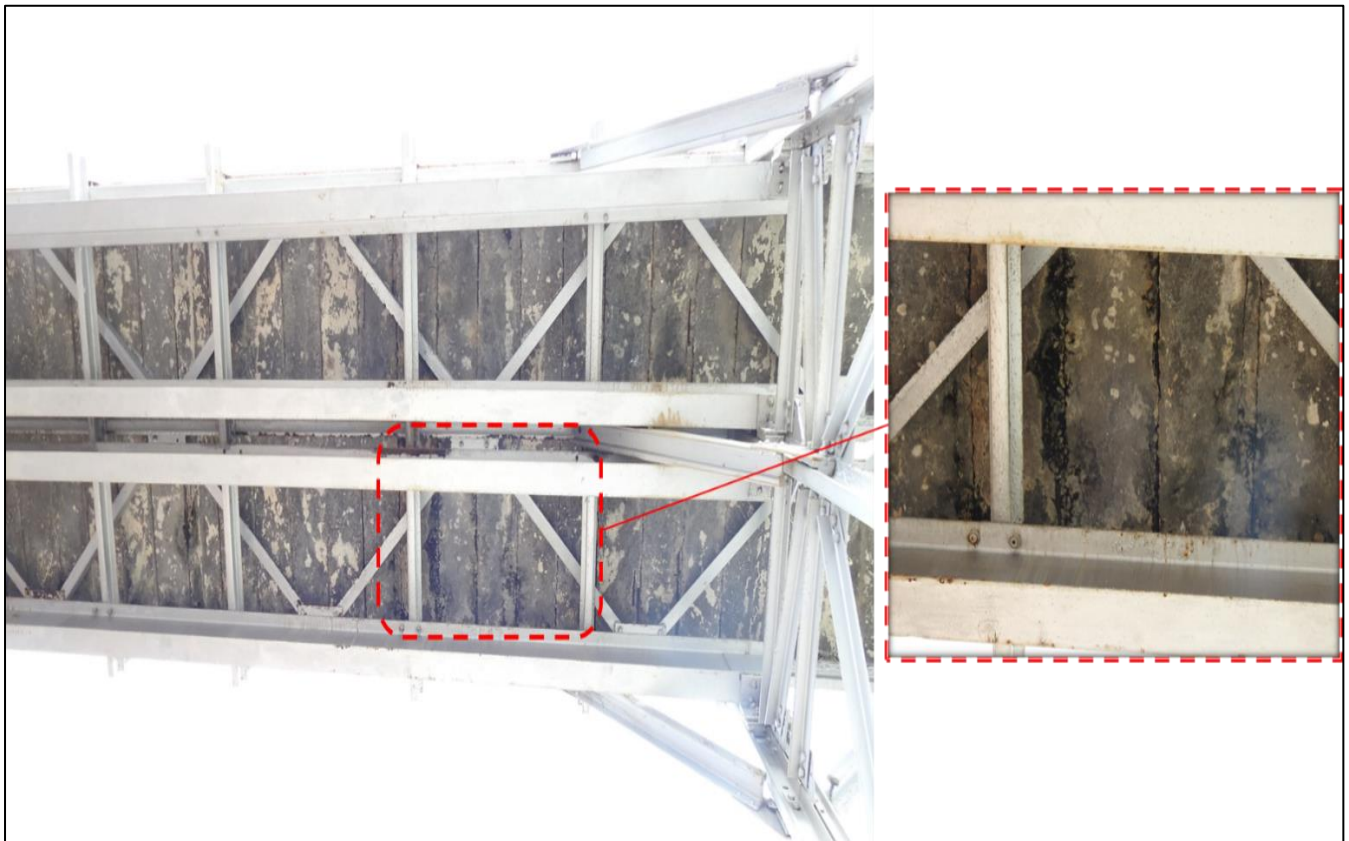
b) Spalling observed in ramp on both sides

| SIGNS OF DISTRESS, DEFORMATION IN BRIDGES | | | |
|---|---|---|---|
| | Spalling | Slab panels in ramp | Spalling is observed in ramp slab (Refer: <b>Part 1.4, Fig- b</b> ). |

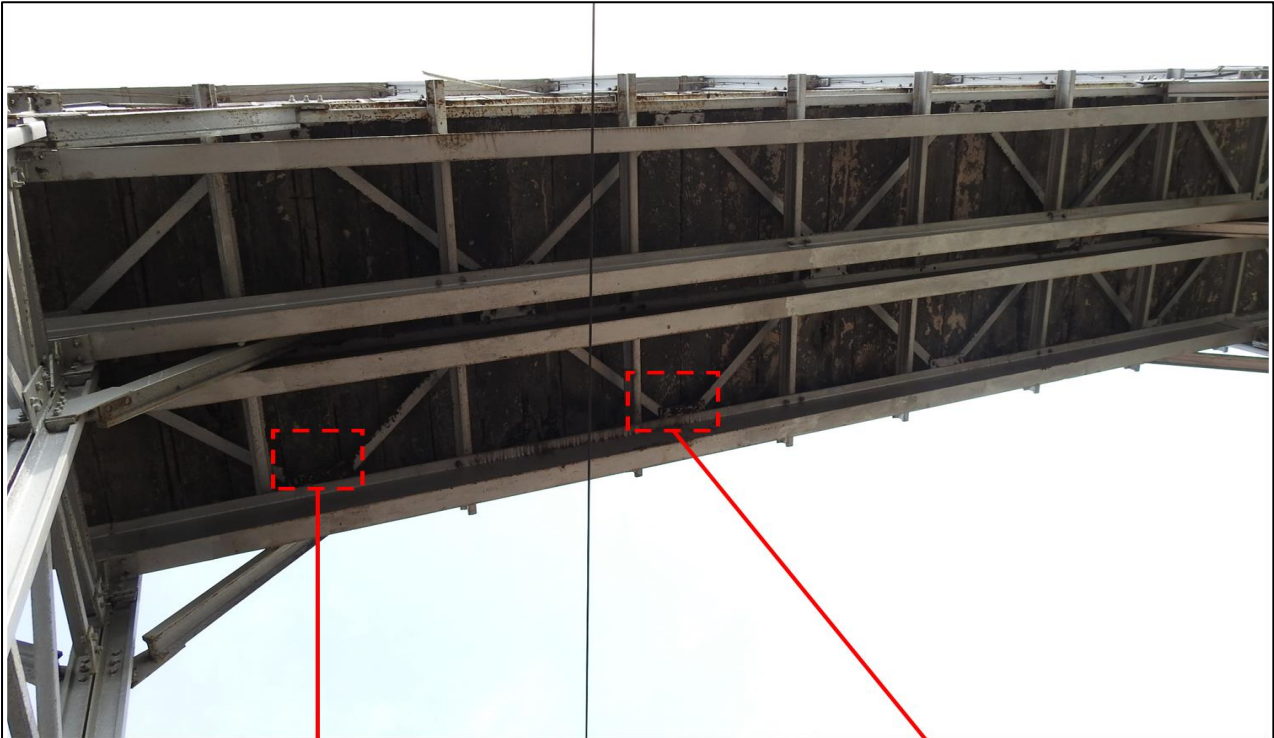
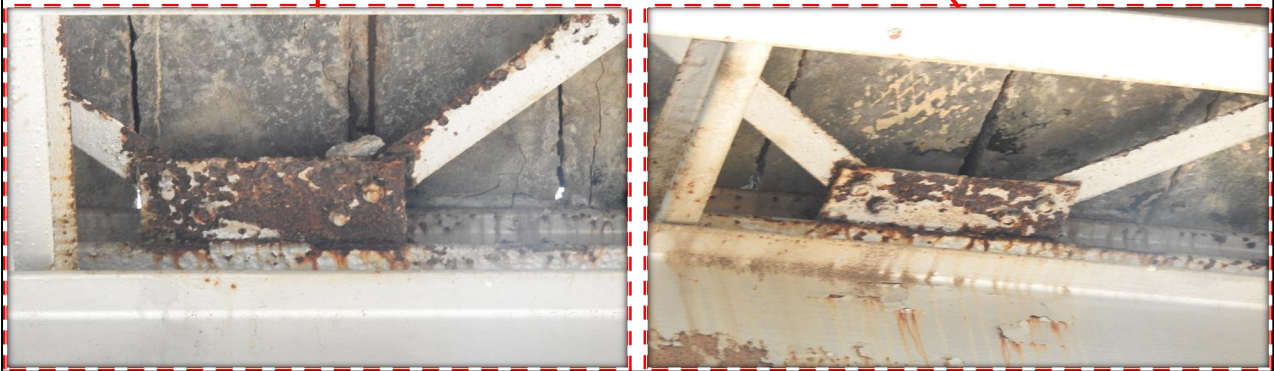
c) Leaching is observed in bottom Slab of FOB in span 1, 2 and 3

| SIGNS OF DISTRESS, DEFORMATION IN BRIDGES | | | |
|---|---|---|---|
| | Rust straining | Bottom chord | Slight rusting is observed at all the joints of FOB at floor level (Refer: <b>Part 1.4-ii, Fig- c</b> ). |

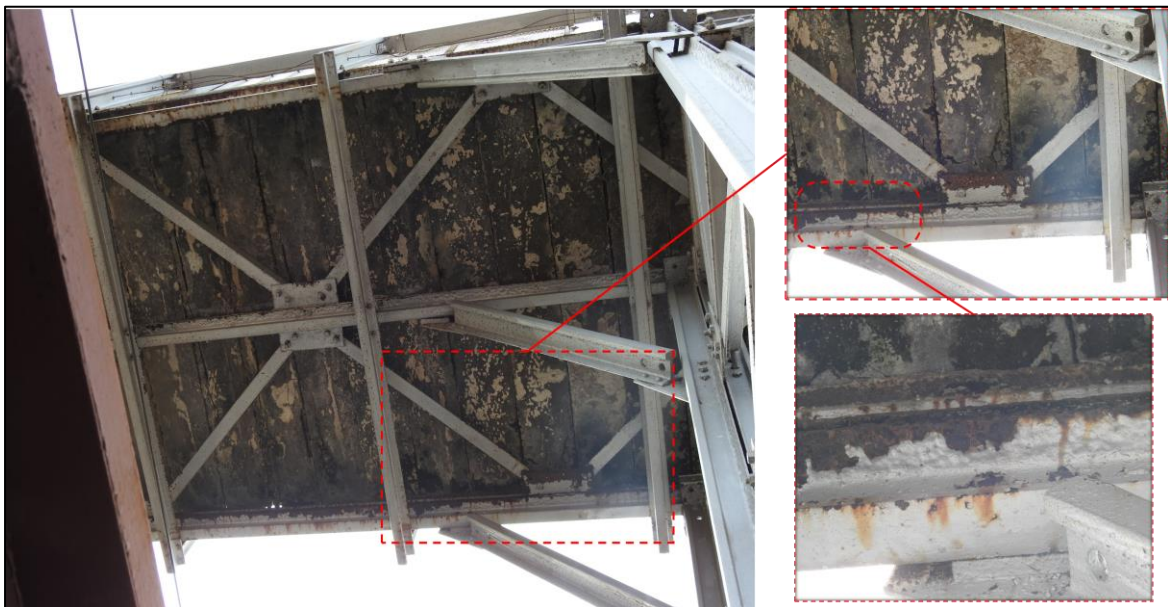
a) Corrosion of Gusset plate in 2<sup>nd</sup> Span of FOB

| SIGNS OF DISTRESS, DEFORMATION IN BRIDGES | | | |
|---|---|---|---|
| | Corrosion in Gusset plate | Span-2 <sup>nd</sup> , 4 <sup>th</sup> and 5 <sup>th</sup> | Corrosion is observed in gusset plate connecting bottom bracings (Refer: <b>Part 1.4-ii, Fig- a, b and d</b> ). |

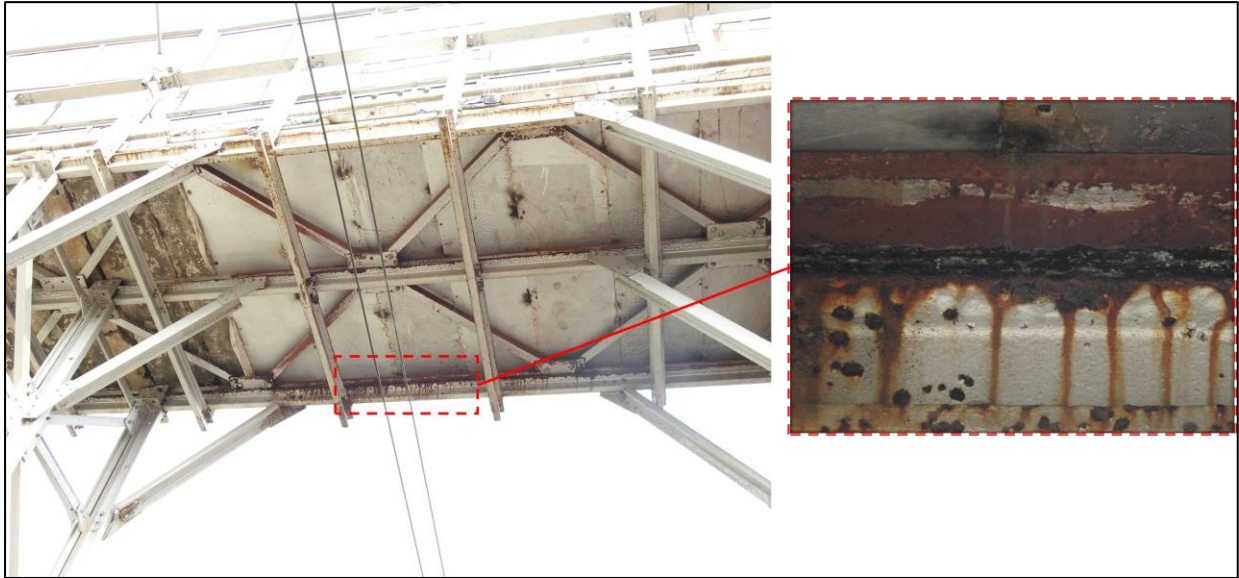
b) Corrosion of Gusset plate and bottom chord member in 3<sup>rd</sup> span of FOB

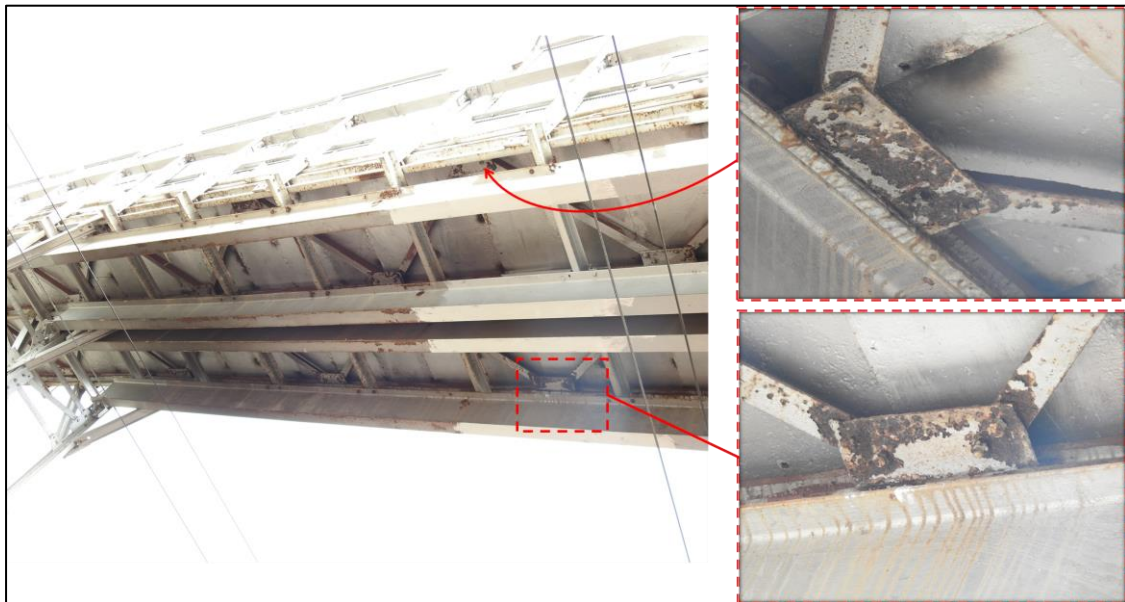
c) Corrosion of bottom chord member in 5<sup>th</sup> span of FOB

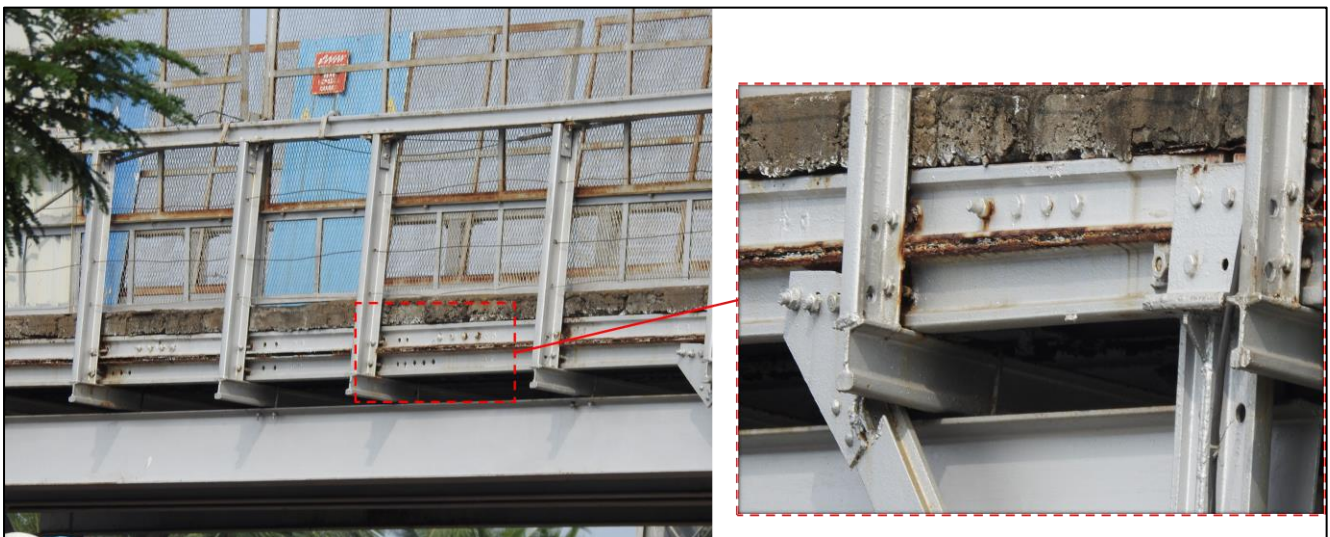
d) Corrosion of gusset plate connecting bottom bracings in 4<sup>th</sup> span of FOB

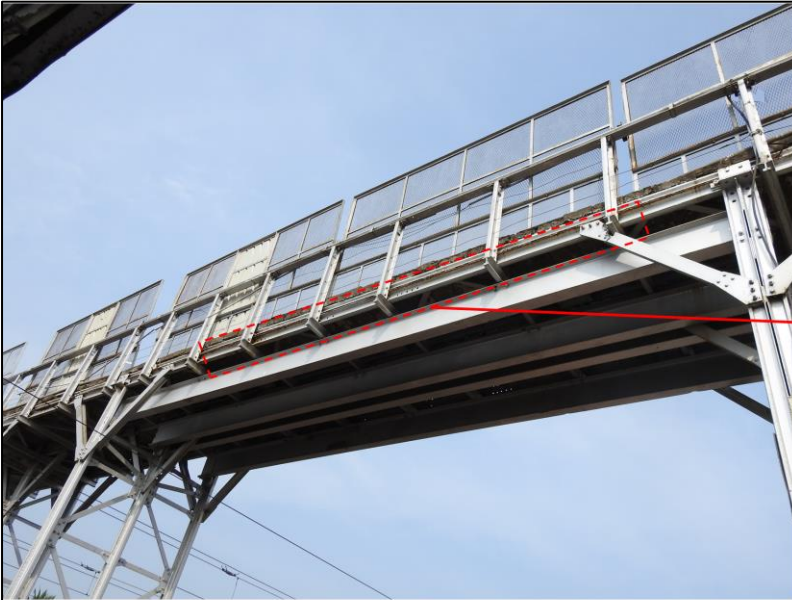
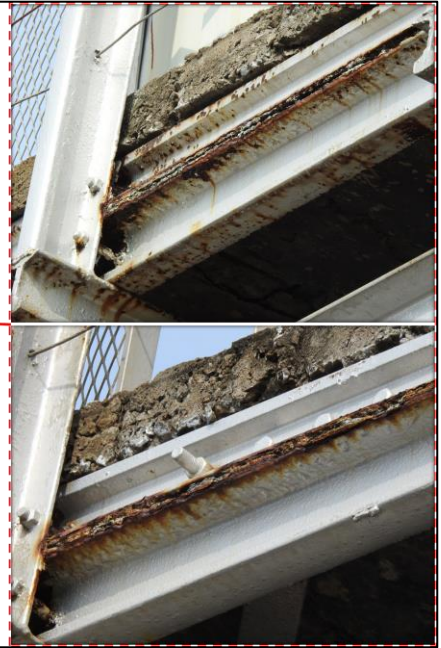
e) Corrosion observed in bottom chord

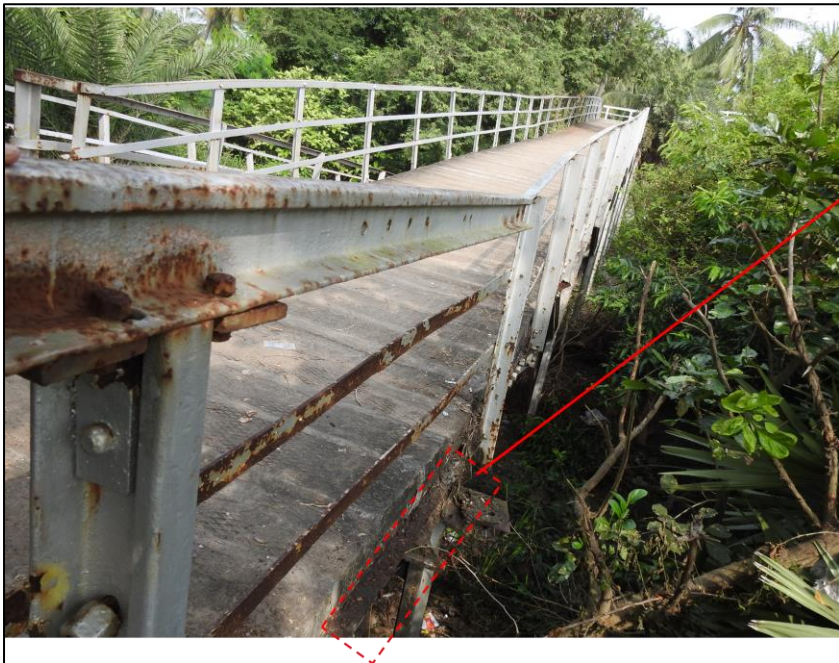
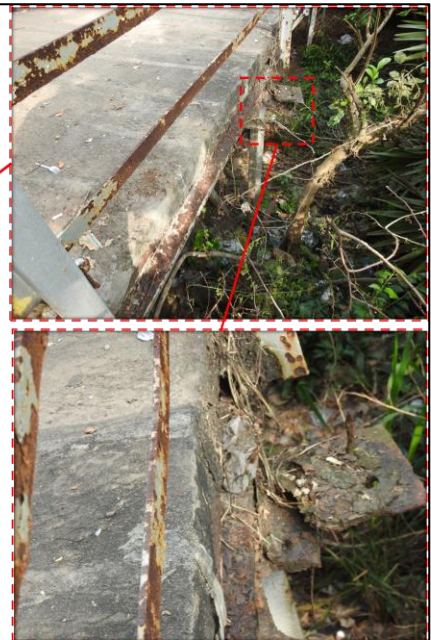
f) Corrosion observed in bottom chord

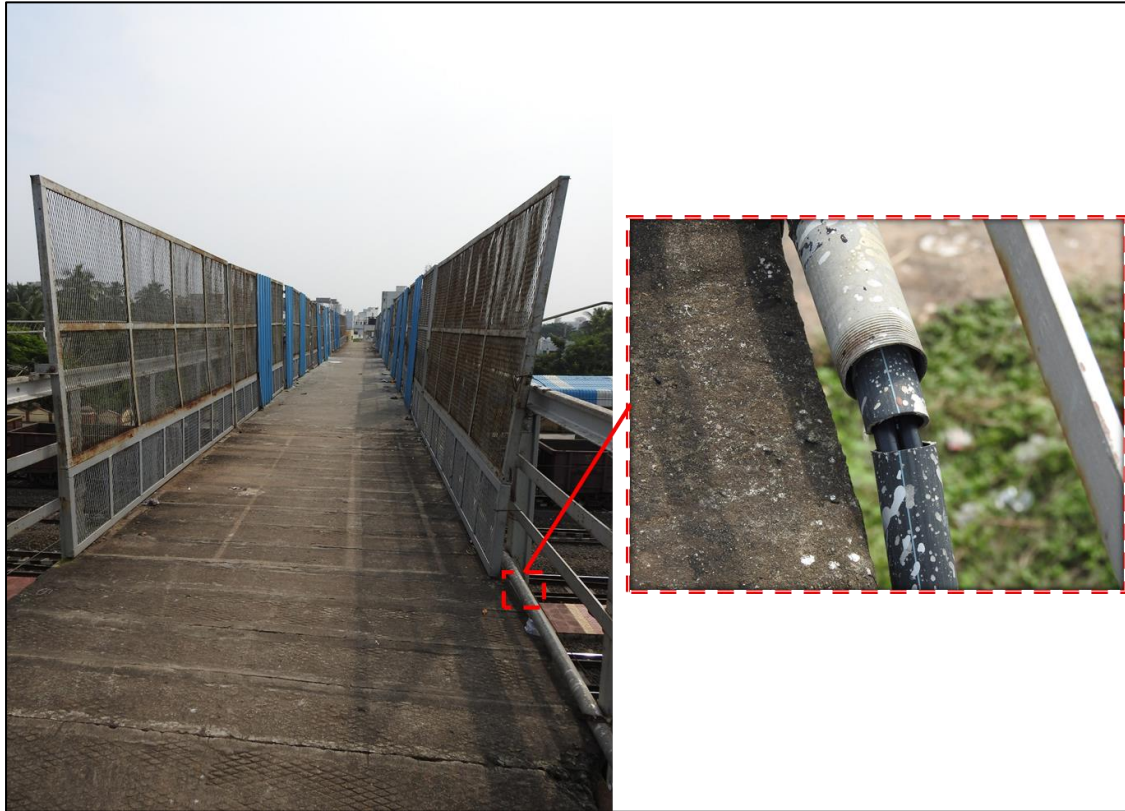
| 1.2 IDENTIFICATION OF LOADS ON BRIDGE | | | |
|---|---|---|---|
| | b) Cables | Yes | a. Cables are protected with 1.5-inch HDPE pipe.<br>(Refer <b>fig :1.2</b> )<br>b. GI Pipes of Dia-60mm is observed<br>c. No Roof Truss is provided. |
| | a) Additional wearing coat on Floor | No | Only RCC Slab is used as Flooring (Refer <b>fig :1.2</b> ) |

**Fig 1.2:** FOB pathway, protective screen, and cables on floor of pathway

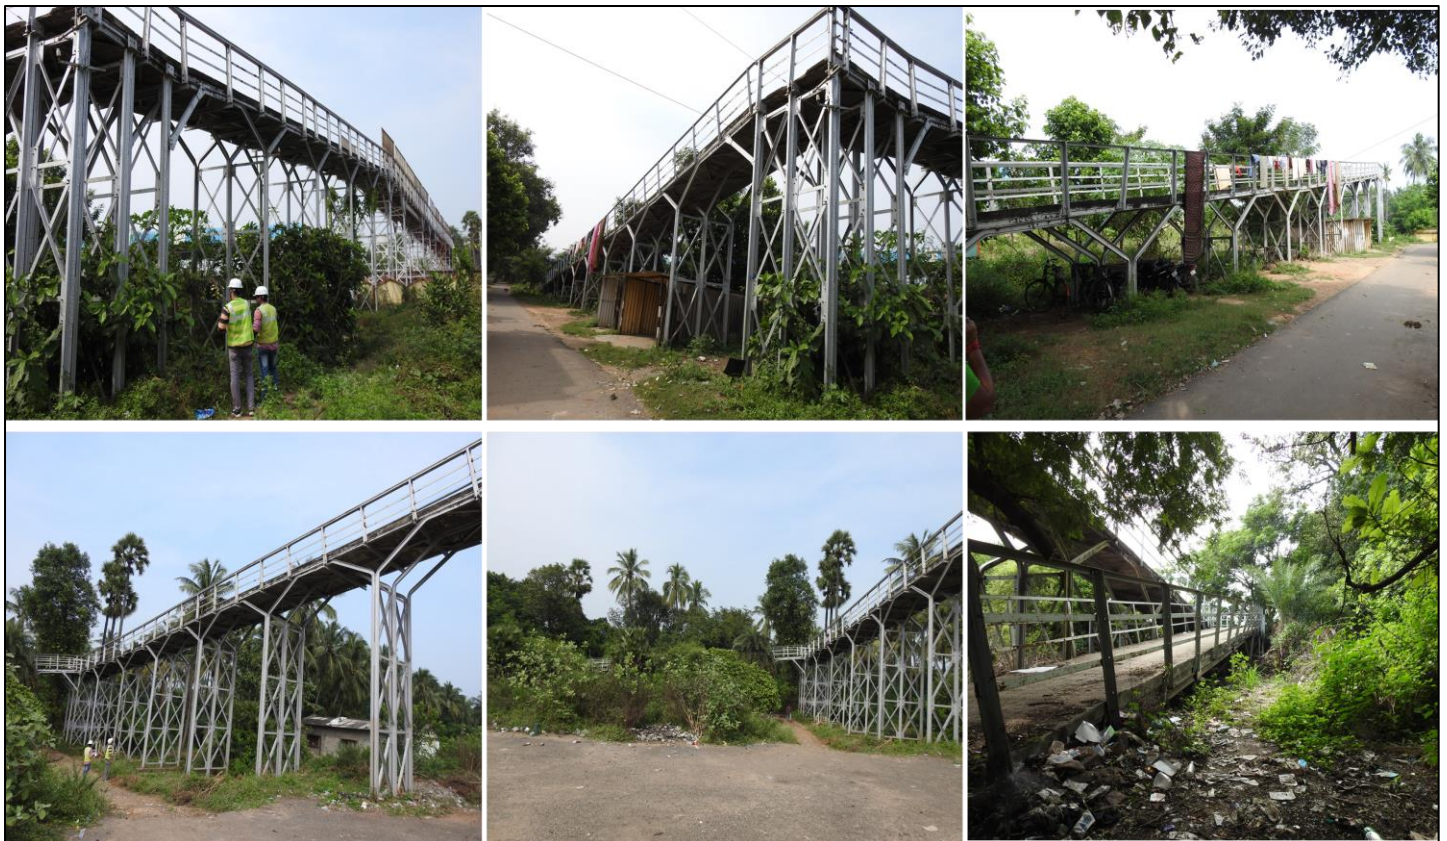
| | Material used for Ramp | Pre-cast RCC Slab Panel | Ramps is observed as Pre-cast RCC Slab panels supported on 55 x 110 x 110 (Head x Height x Base) Bottom chords on both sides and middle of the ramp. (Refer <b>fig 1.5</b> ) |

**Fig 1.5:** Ramp details both sides of FOB

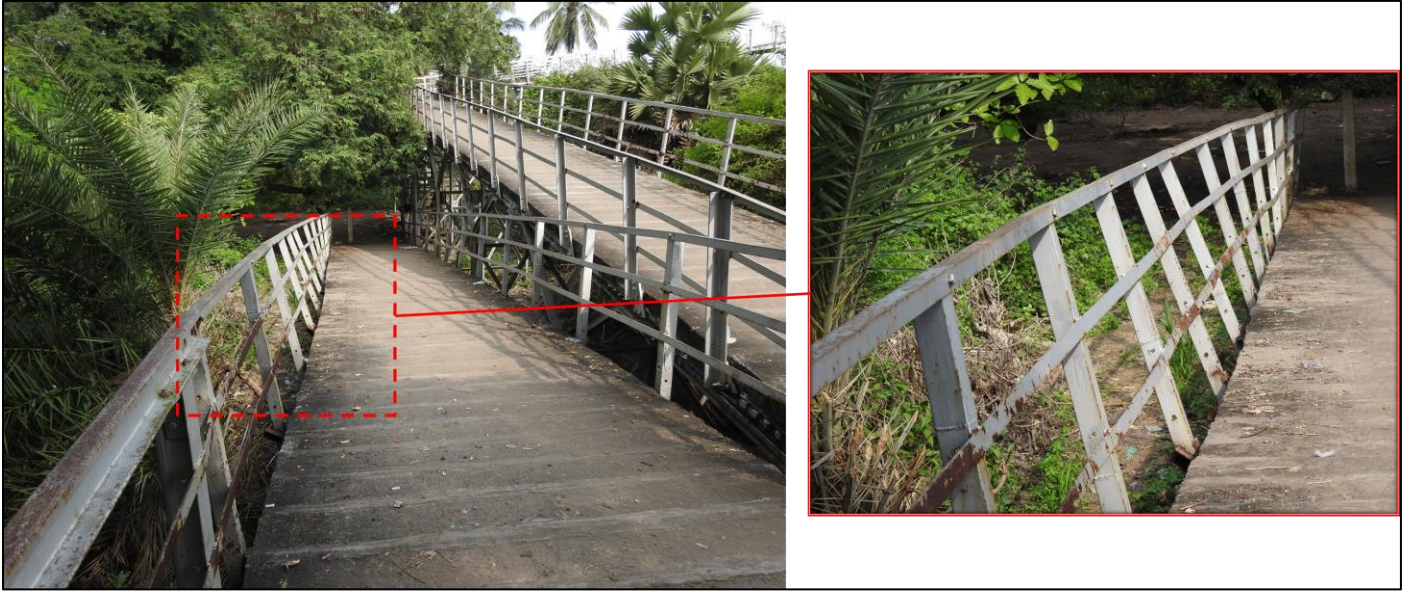
**Fig 1.6:** Damaged ramp railing

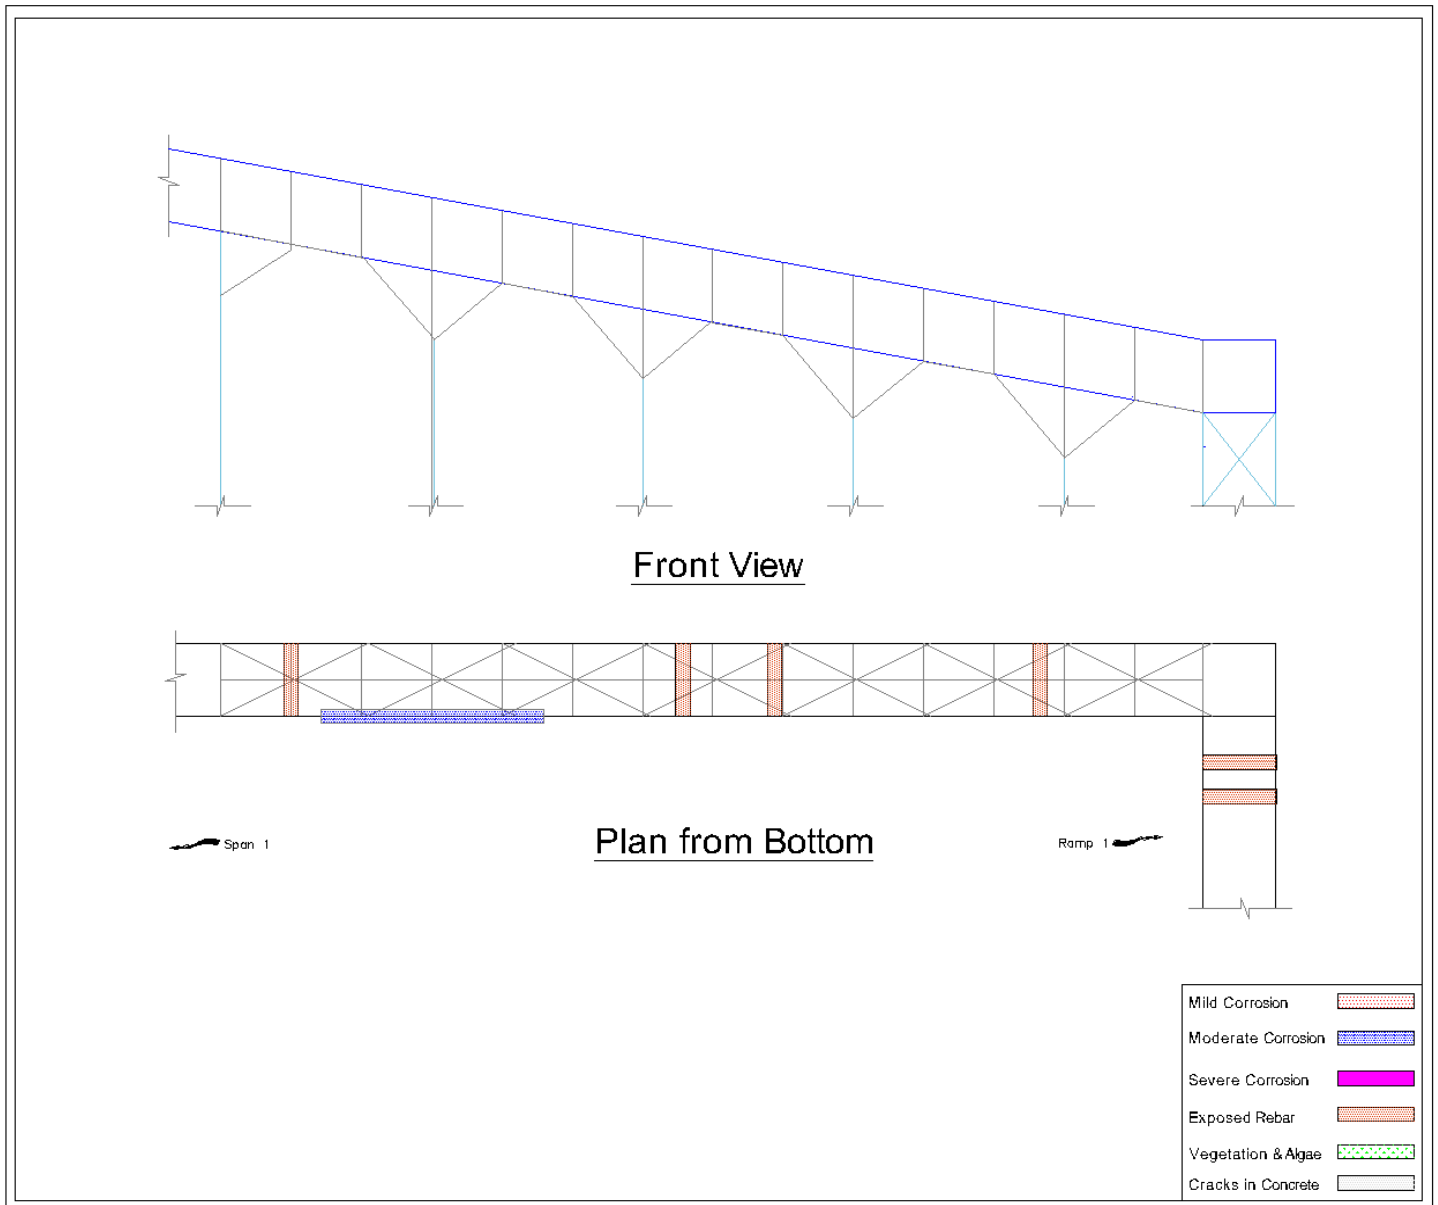
**Fig 2.1:** Locations of Deteriorations in Ramp -1

- Structural members are in fair condition, displaying mild corrosion for top chord members, verticals, diagonals, and gusset plates, moderate corrosion for bottom chord members and Ramp main stinger beam along steel concrete joint. (locations are marked in figures below).
- Algae formation observed on the pre-cast panels of ramp. Ramp precast slab panels are deteriorated reinforced is exposed in flights at deck level. (Photographs of the same can be see in **fig 2.2-2.3**)

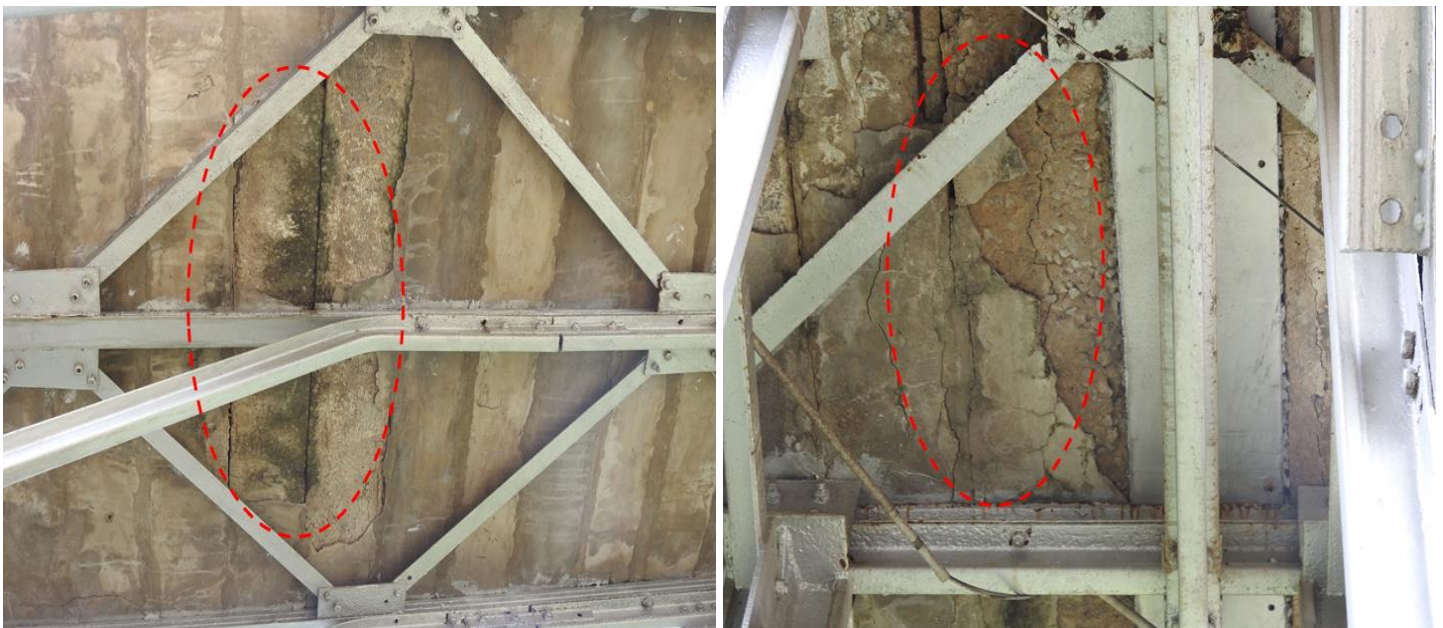
**Fig 2.2:** Algae and cracks in Ramp -1 pre-cast slab panels

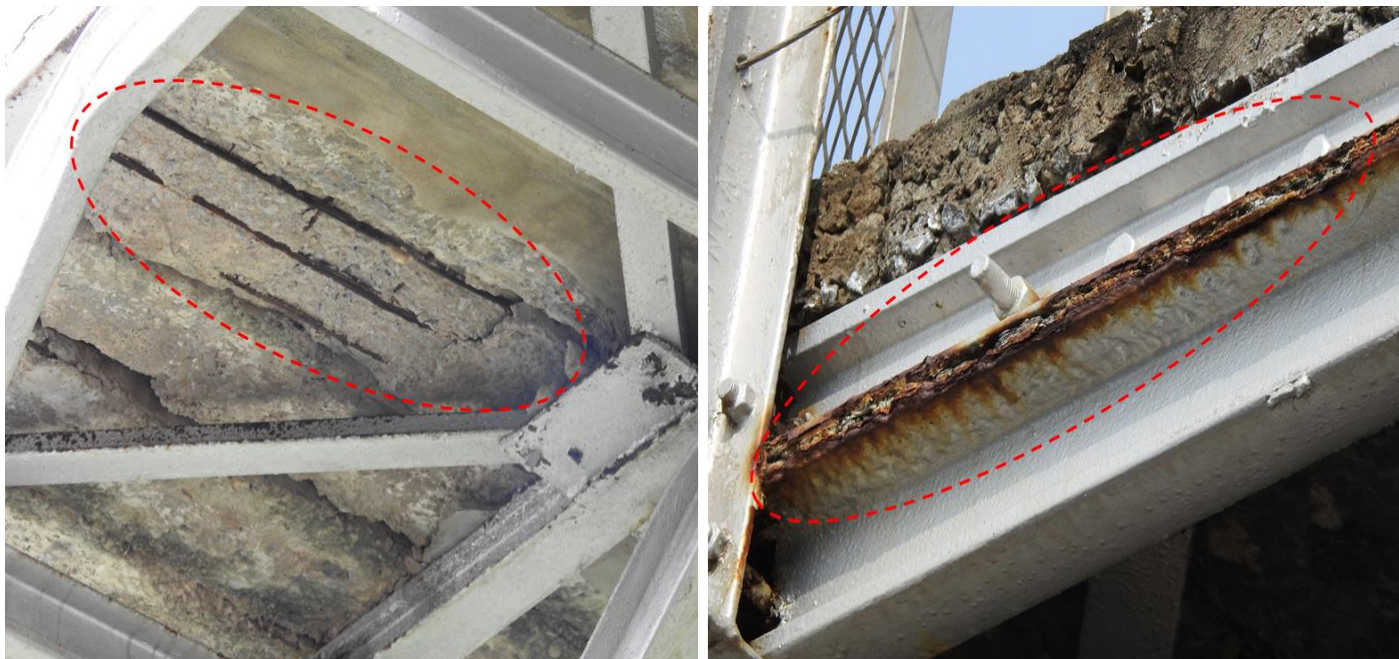
**Fig 2.3:** Exposed Reinforcement and moderate corrosion in bottom chord member

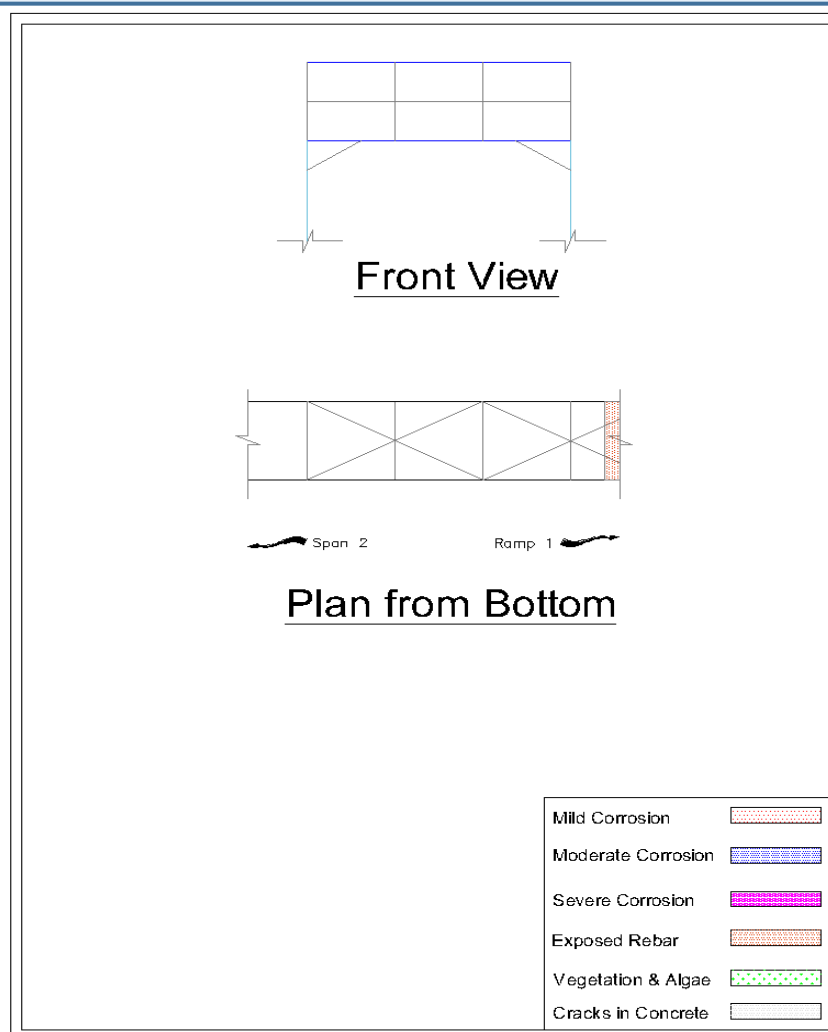
**Fig 2.4:** Locations of Deteriorations in Span-1

- Structural members are in fair condition, displaying mild corrosion for top chord members, verticals, diagonals, gusset plates, bottom chord members steel concrete joint. (locations are marked in figures below).
- Precast slab panels are deteriorated reinforced is exposed at deck level. (*Photographs of the same can be seen in **fig 2.5***)

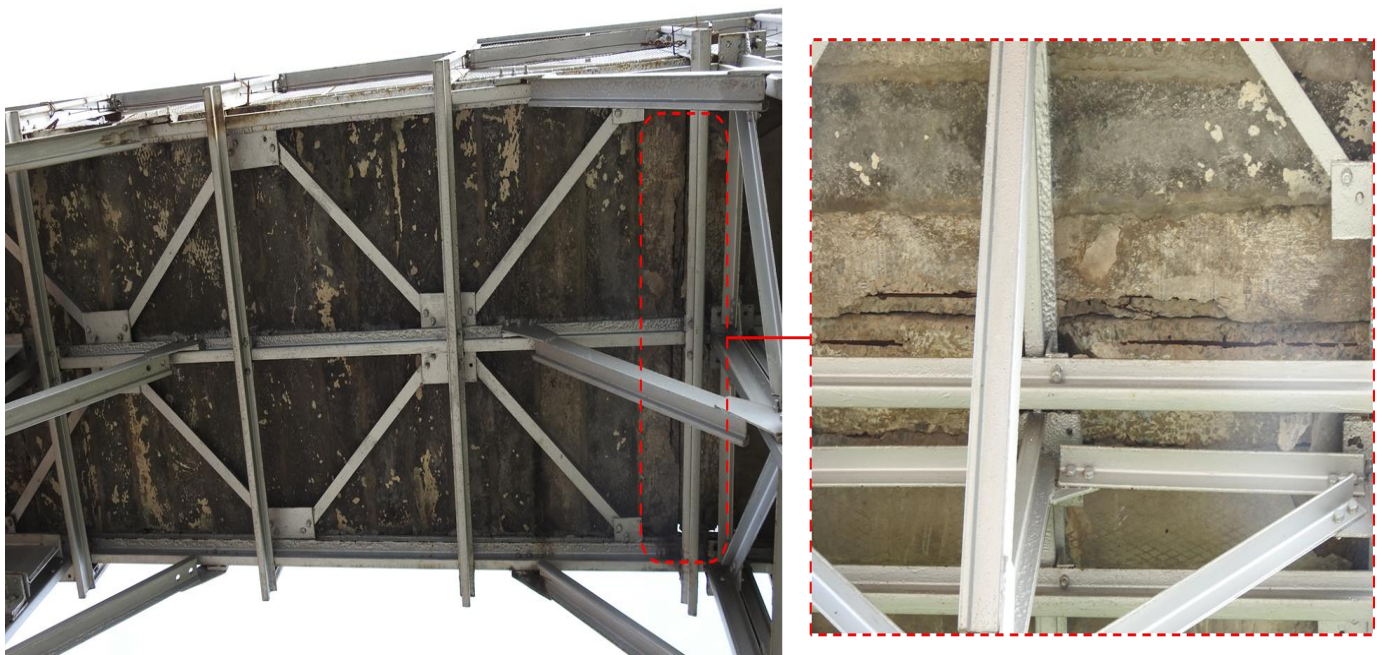
**Fig 2.5:** Exposed reinforcement in precast slab panels in span 1

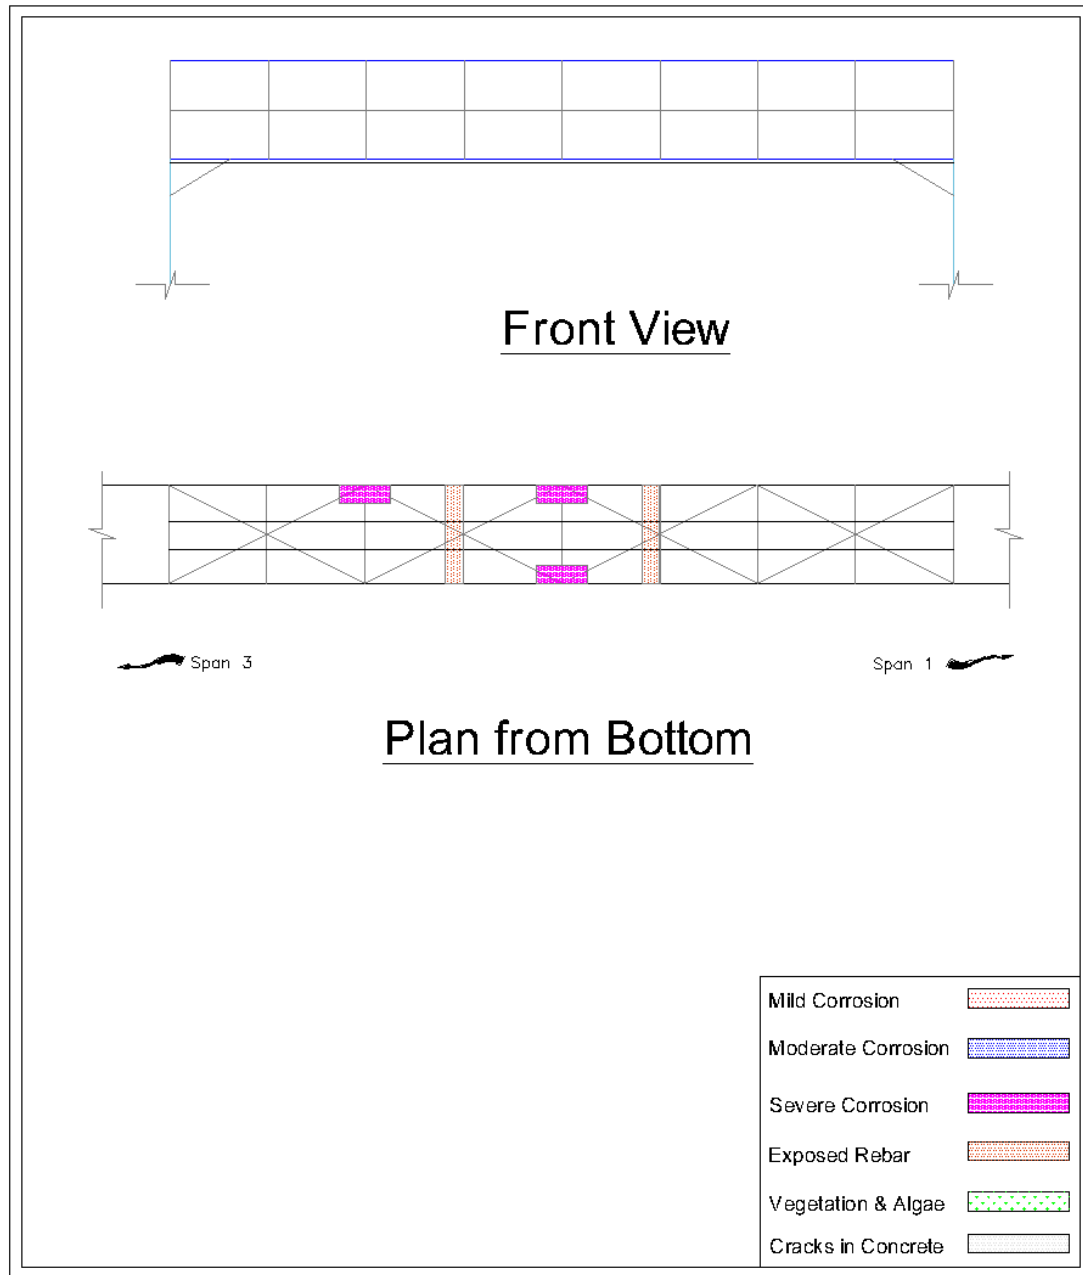
**Fig 2.6:** Locations of Deteriorations in Span-2

- Structural members are in fair condition, displaying mild corrosion for top chord members, verticals, diagonals, and bottom chord members steel concrete joint. Severe corrosion in gusset plate connection bottom diagonal members to bottom chord member. (locations are marked in figures below).
- Precast slab panels are deteriorated reinforced is exposed at deck level. (*Photographs of the same can be seen in fig 2.7-2.8*)

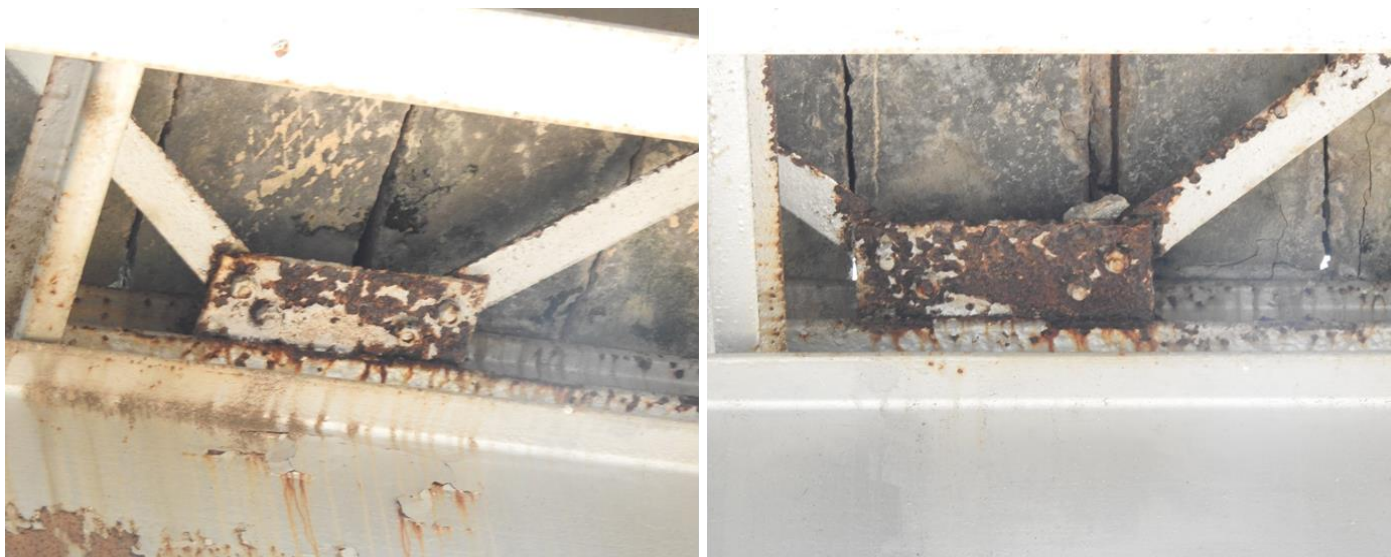
**Fig 2.7:** Sever corrosion of gusset plate

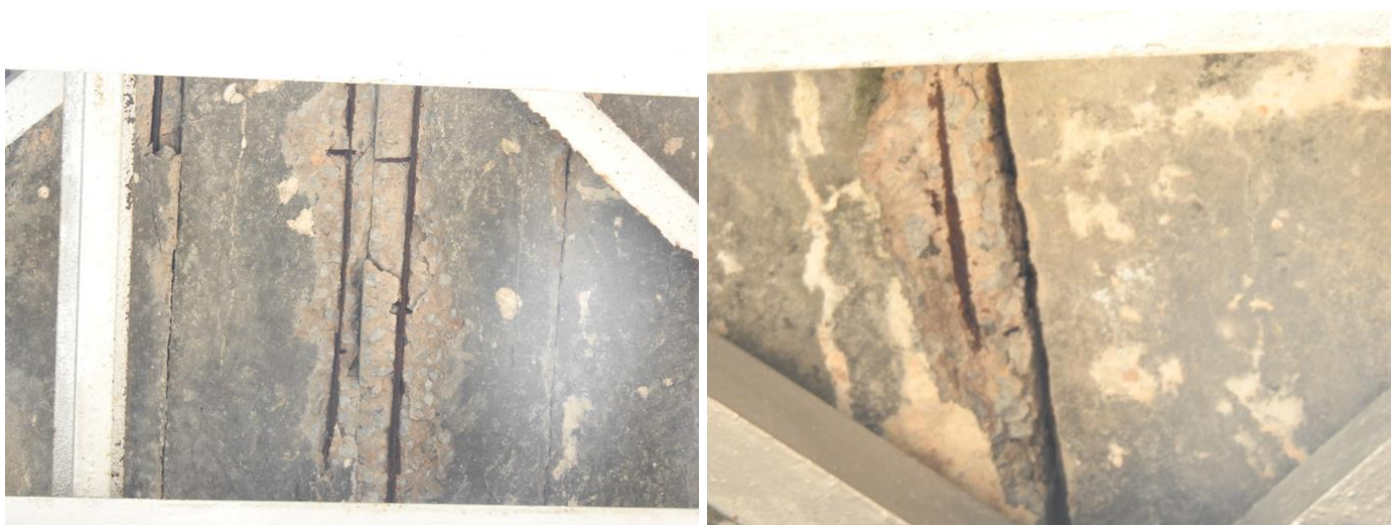
**Fig 2.8:** Exposed reinforcement in precast slab panels in span 2

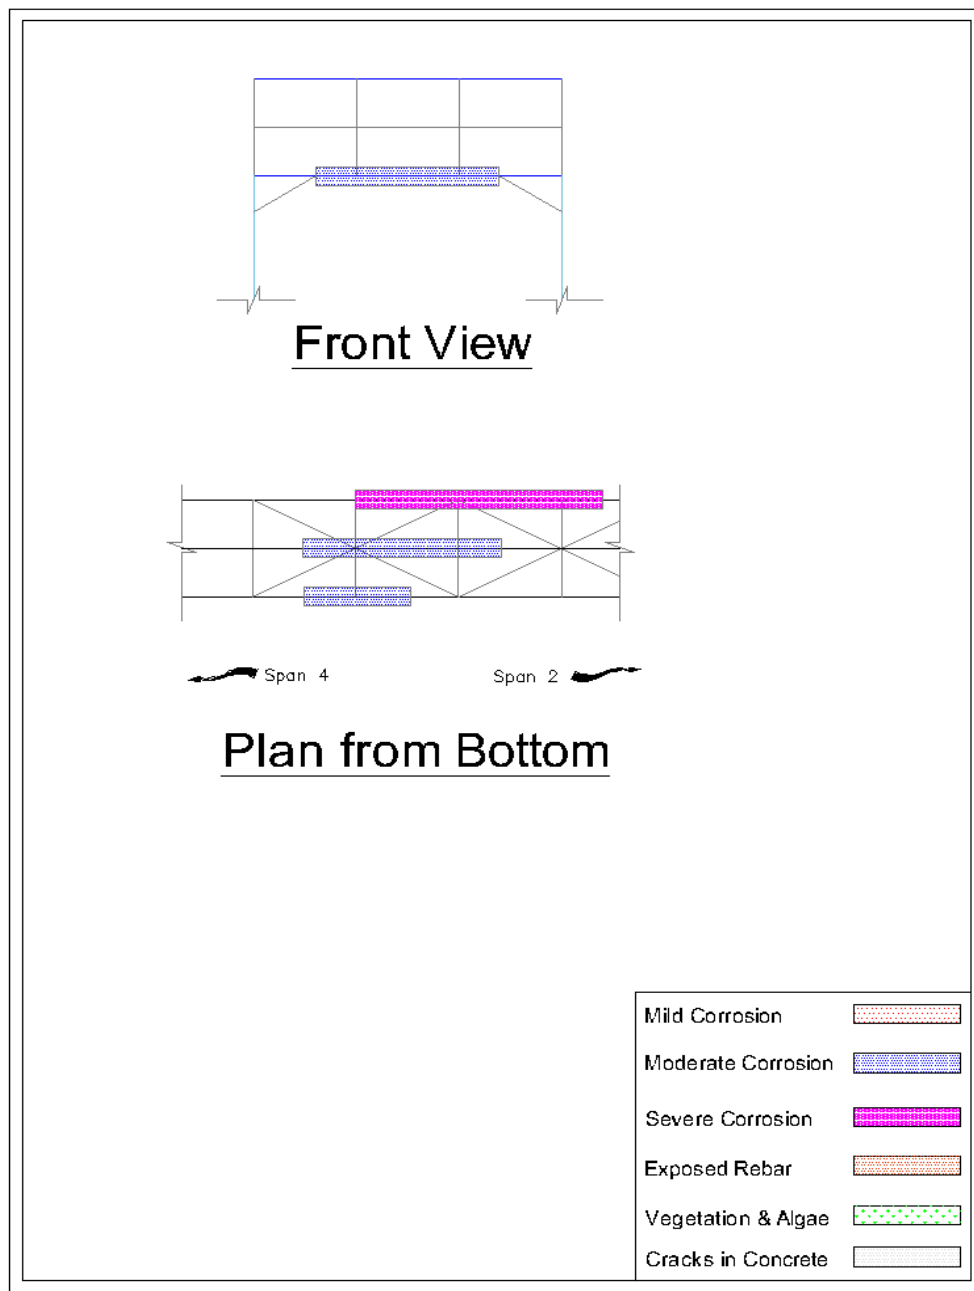
**Fig 2.9:** Locations of Deteriorations in Span-3

- Structural members are in fair condition, displaying mild corrosion for top chord members, verticals, diagonals. Severe corrosion for bottom chord members steel concrete joint and gusset plates connecting diagonal members to bottom chord member. Moderate corrosion for floor beam. (locations are marked in figures below) (Photographs of the same can be seen in **fig 2.10**)

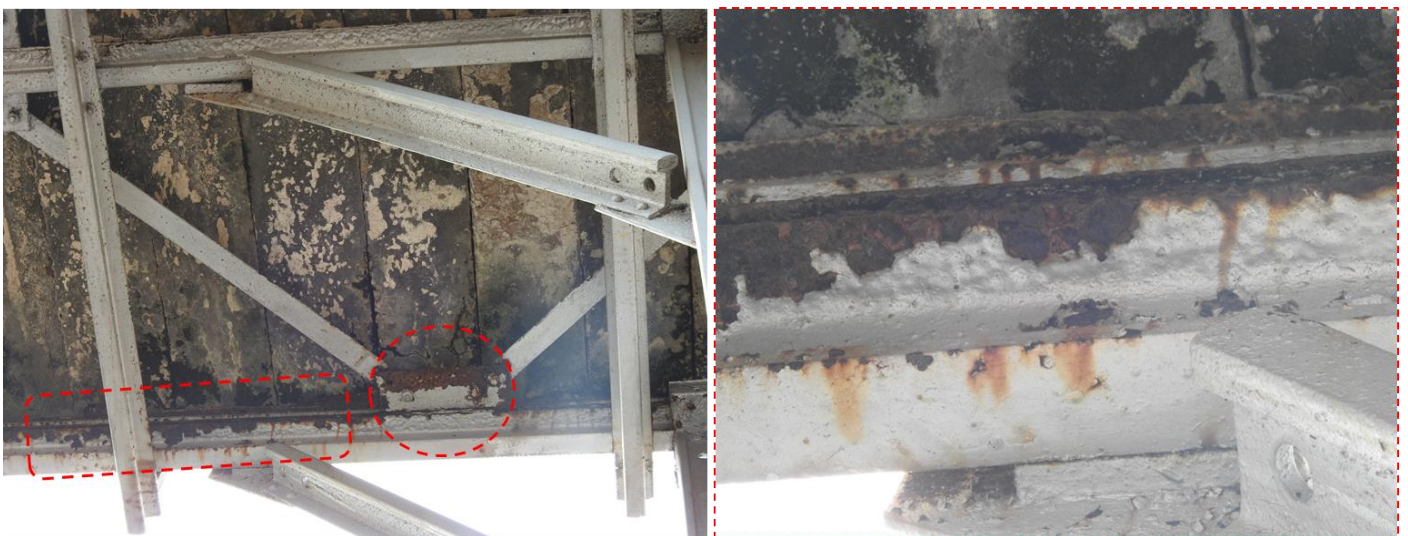
**Fig 2.10:** Sever corrosion of gusset plate and bottom chord member at steel concrete joint
