# Third Party Audit of ROB's and FOB's of SCR

## INSPECTION OF FOB AT ANAKAPALLE RAILWAY STATION

**Final Report**  
SEPTEMBER | 2020

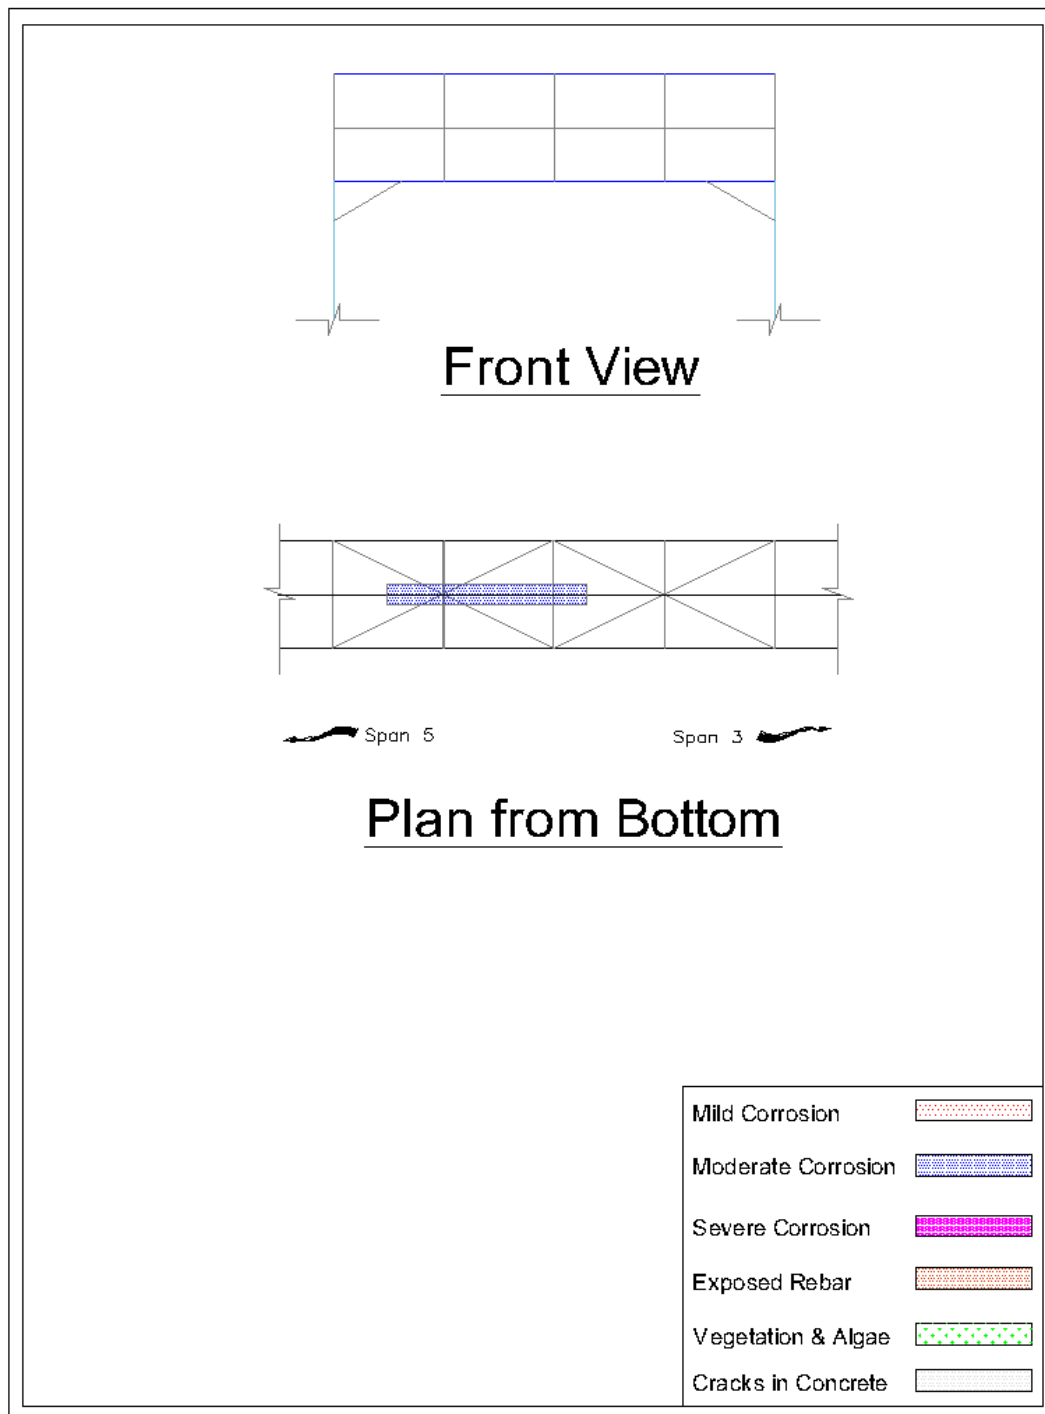
**Fig 2.11:** Locations of Deteriorations in Span-4

- Structural members are in fair condition, displaying mild corrosion for top chord members, verticals, diagonals, and gusset plates. Moderate corrosion for bottom chord members along steel concrete joint. (locations are marked in figures below) (Photographs of the same can be seen in **fig 2.12**)

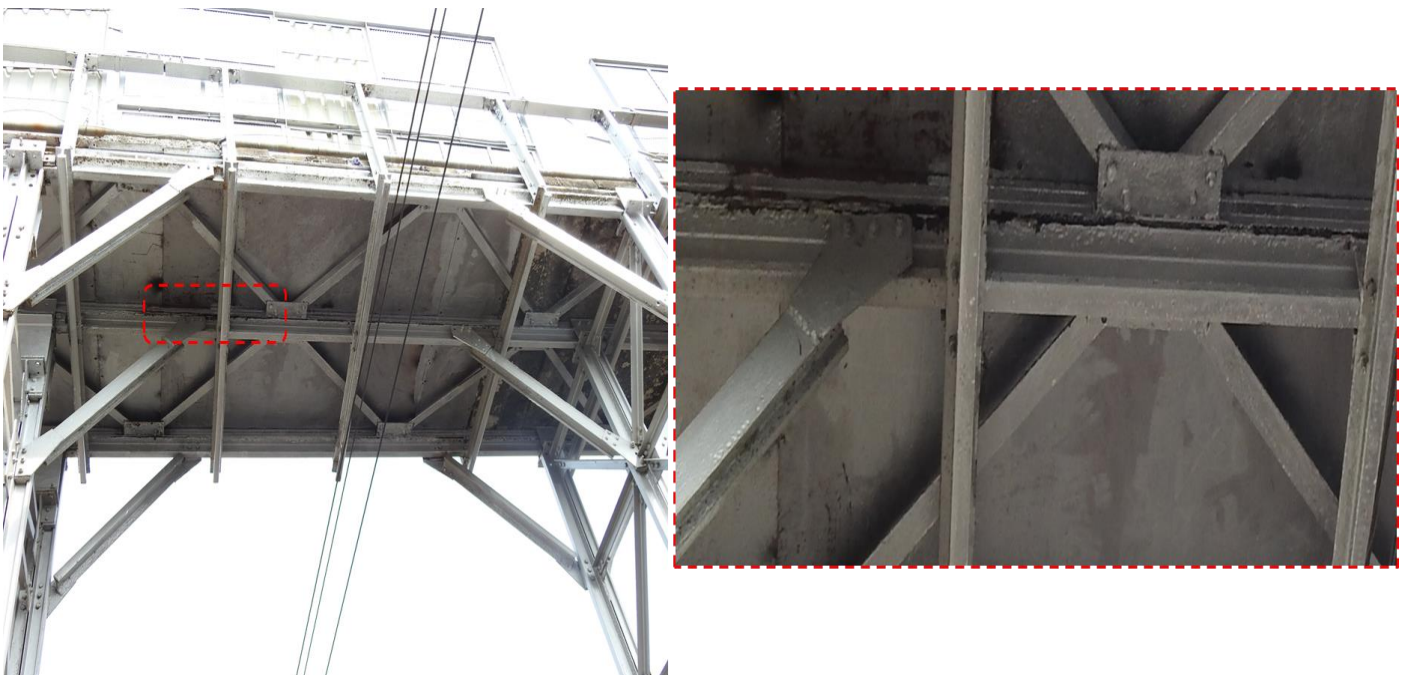
**Fig 2.12:** Moderate corrosion of floor beam in span 4

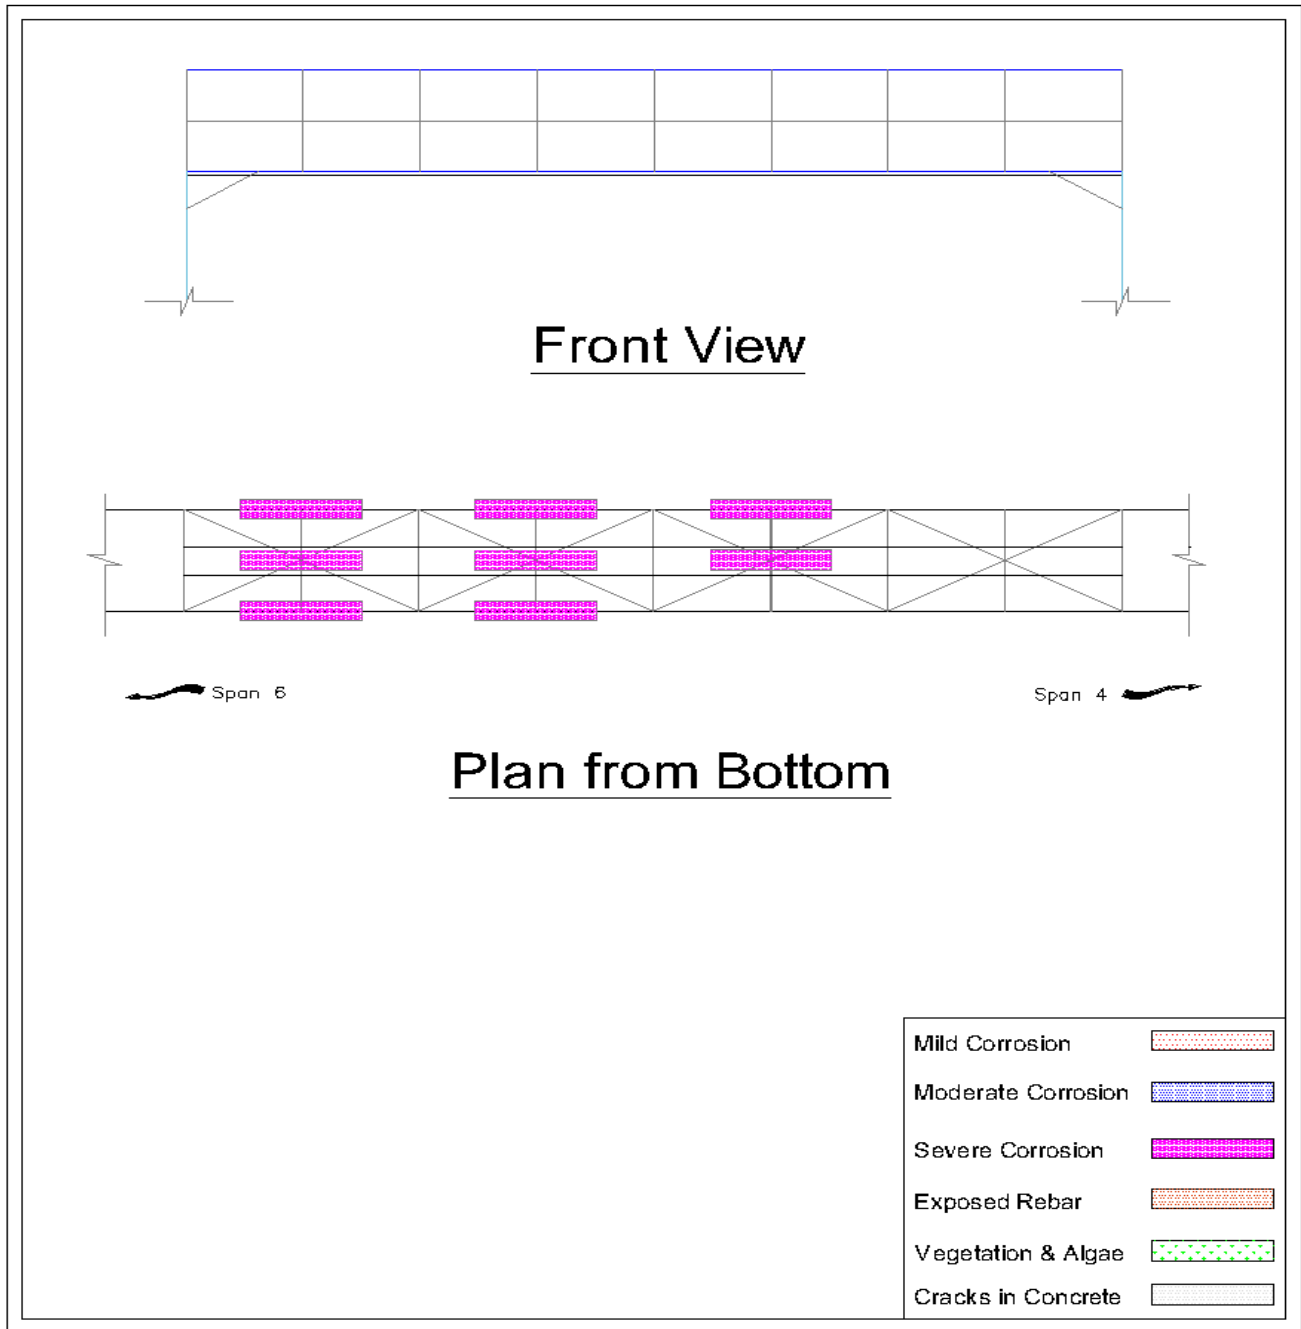
**Fig 2.13:** Locations of Deteriorations in Span-5

- Structural members are in fair condition, displaying mild corrosion for top chord members, verticals, diagonals and Severe corrosion in bottom chord members steel concrete joint and gusset plate connection bottom diagonal members to bottom chord member. (locations are marked in figures below) (Photographs of the same can be seen in **fig 2.**)

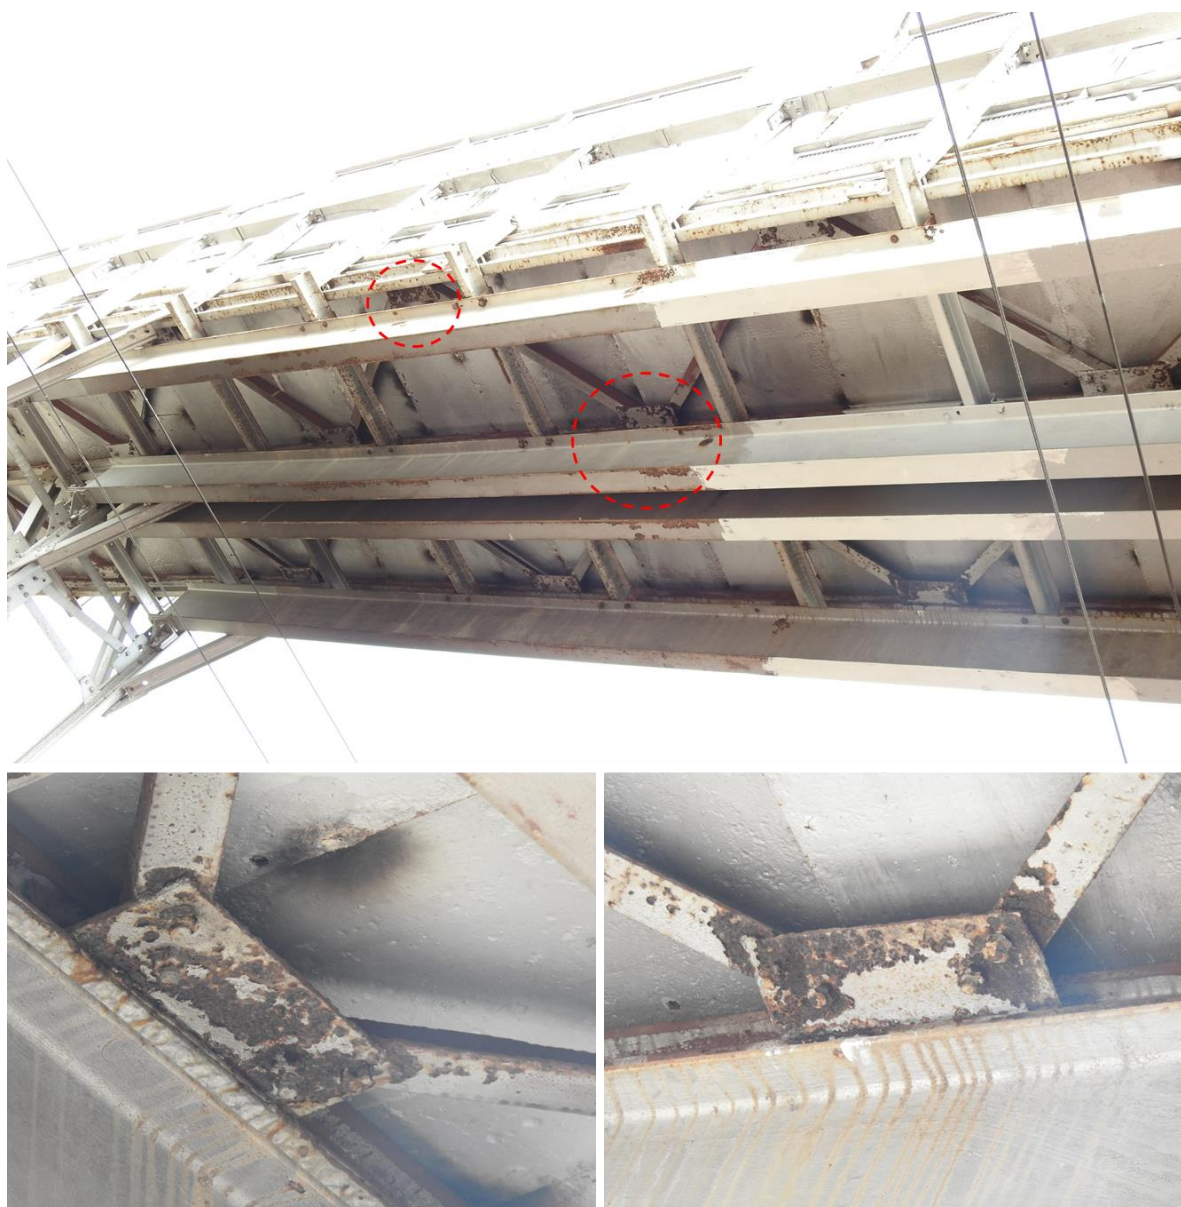
**Fig 2.14:** Corrosion of gusset plate and bottom chord members

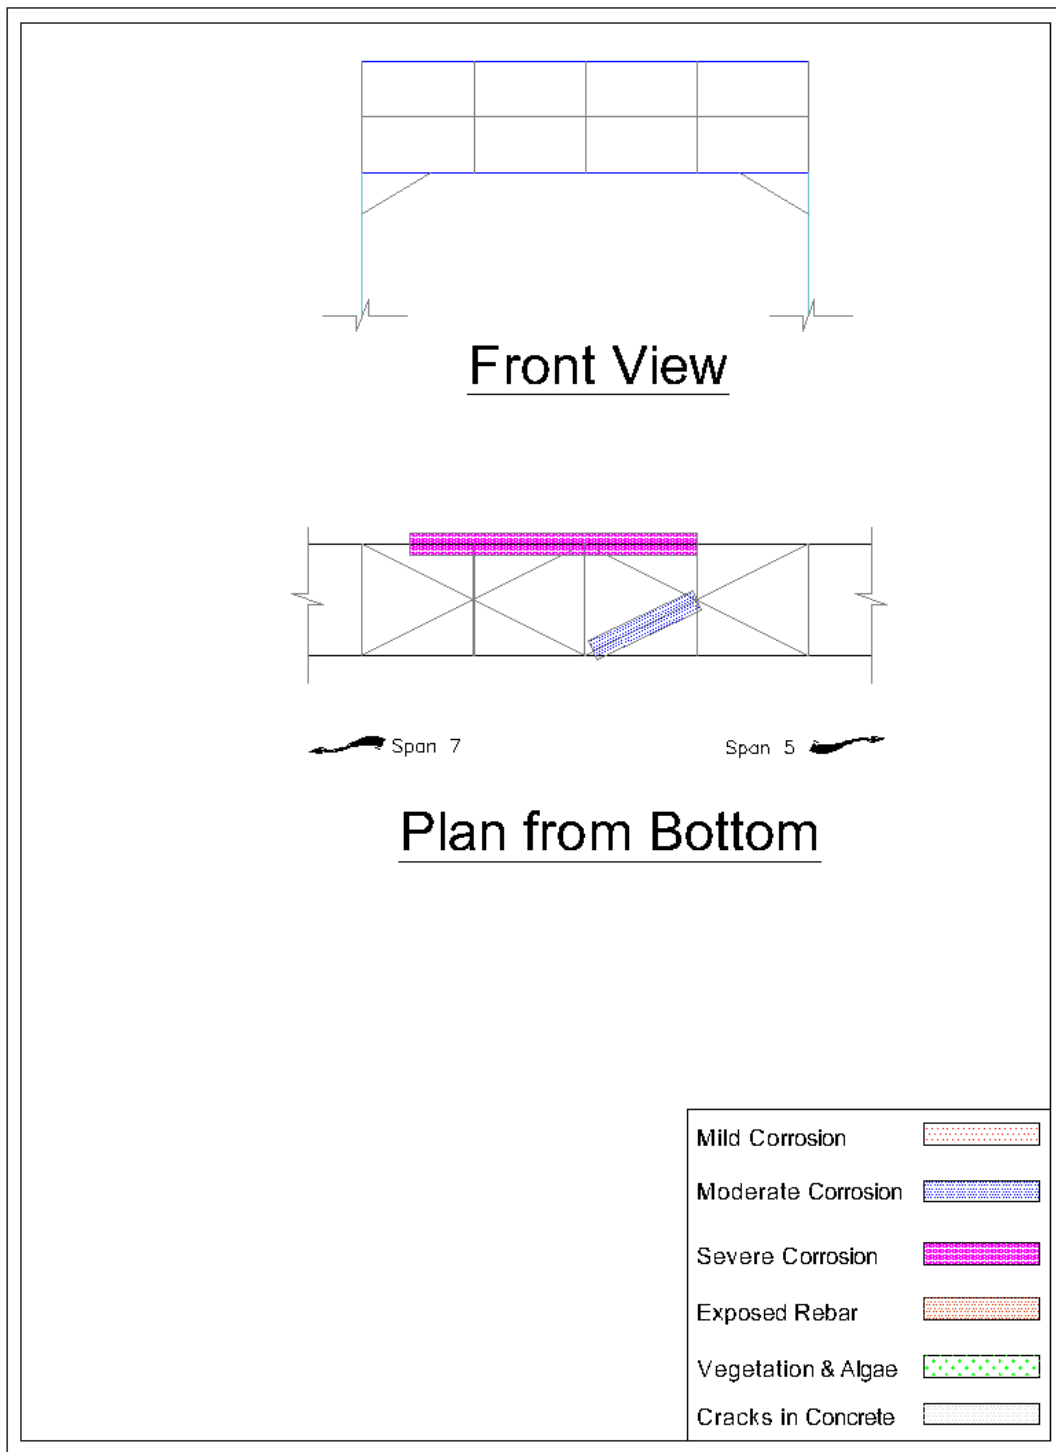
**Fig 2.15:** Locations of Deteriorations in Span-6

- Structural members are in fair condition, displaying mild corrosion for top chord members, verticals, diagonals and Severe corrosion in bottom chord members steel concrete joint and Moderate corrosion in bottom diagonal members to bottom chord member. (locations are marked in figures below)  
(Photographs of the same can be seen in **fig 2.16**)

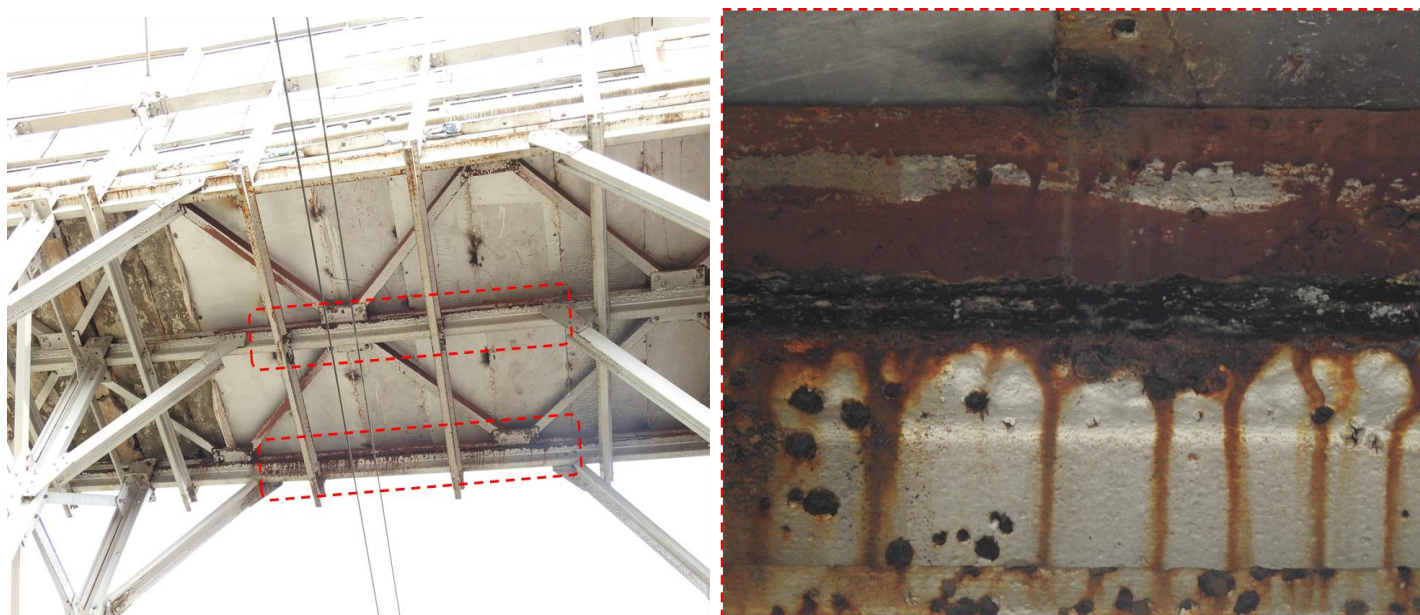
**Fig 2.16:** Corrosion of bottom chord members

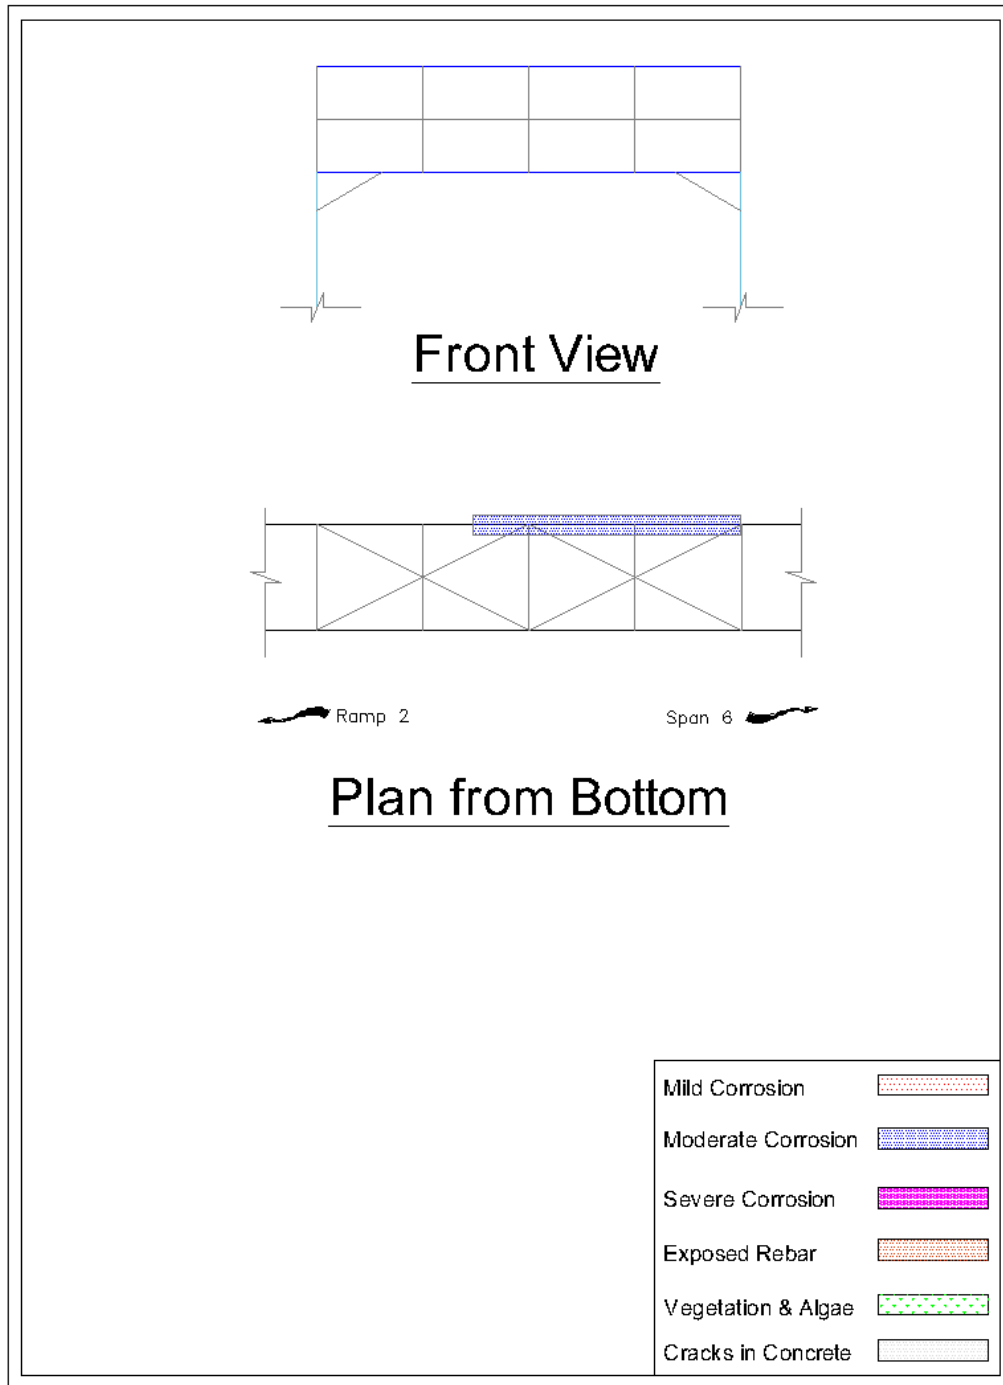
**Fig 2.17:** Locations of Deteriorations in Span-7

- Structural members are in fair condition, displaying mild corrosion for top chord members, verticals, diagonals, and Moderate corrosion in bottom chord members steel concrete joint. (locations are marked in figures below) (*Photographs of the same can be seen in **fig 2.18***)

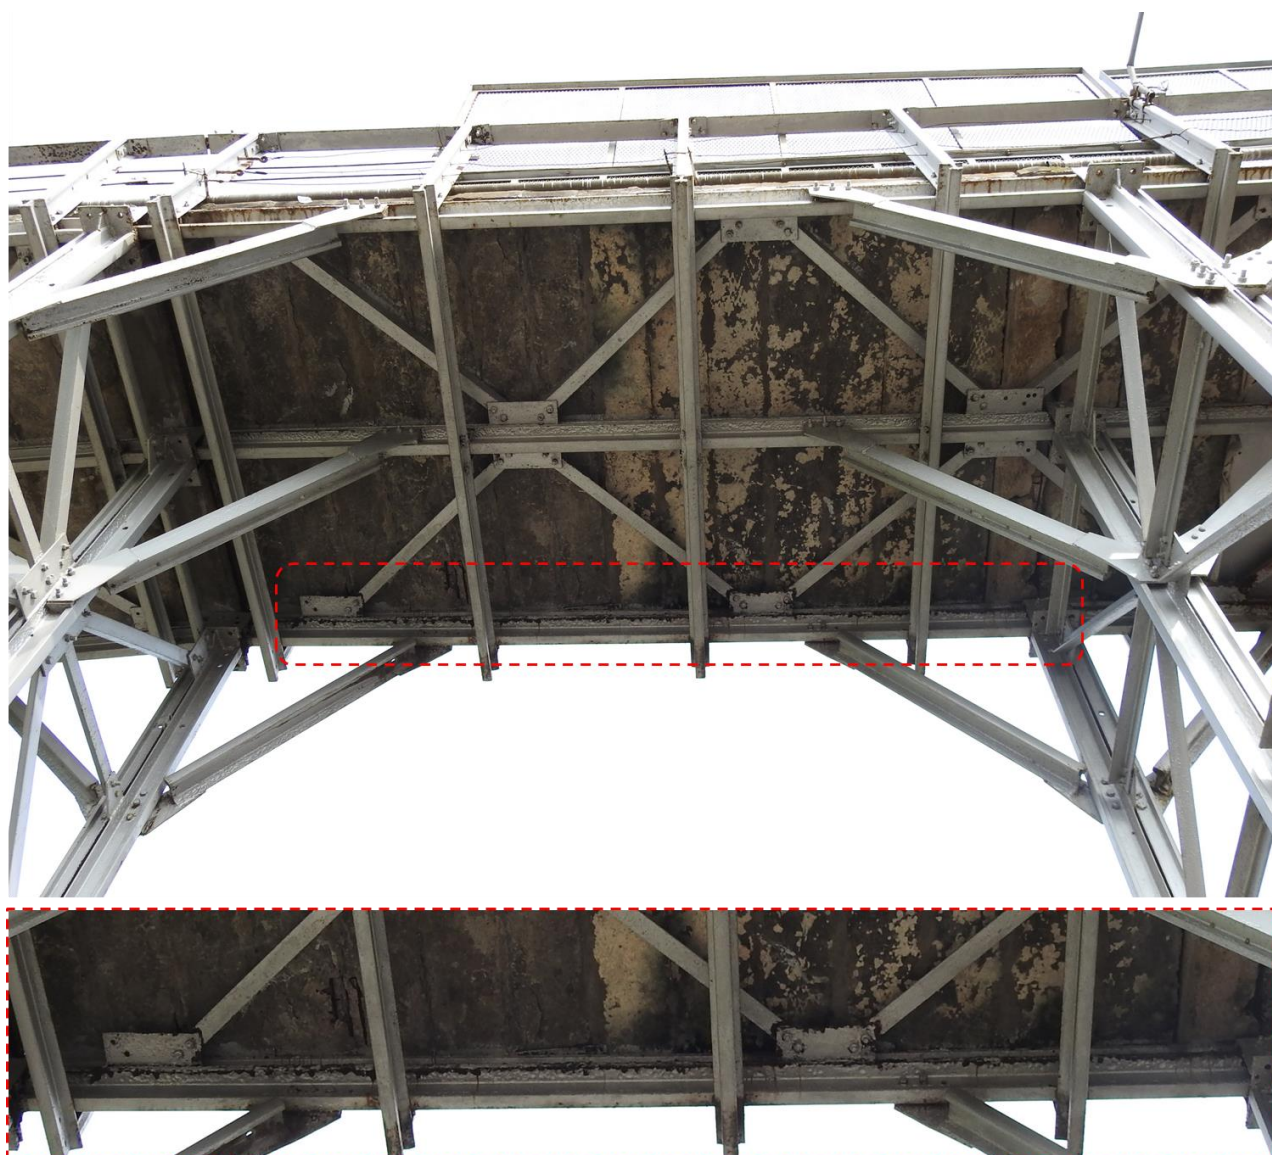
**Fig 2.18:** Corrosion of bottom chord members

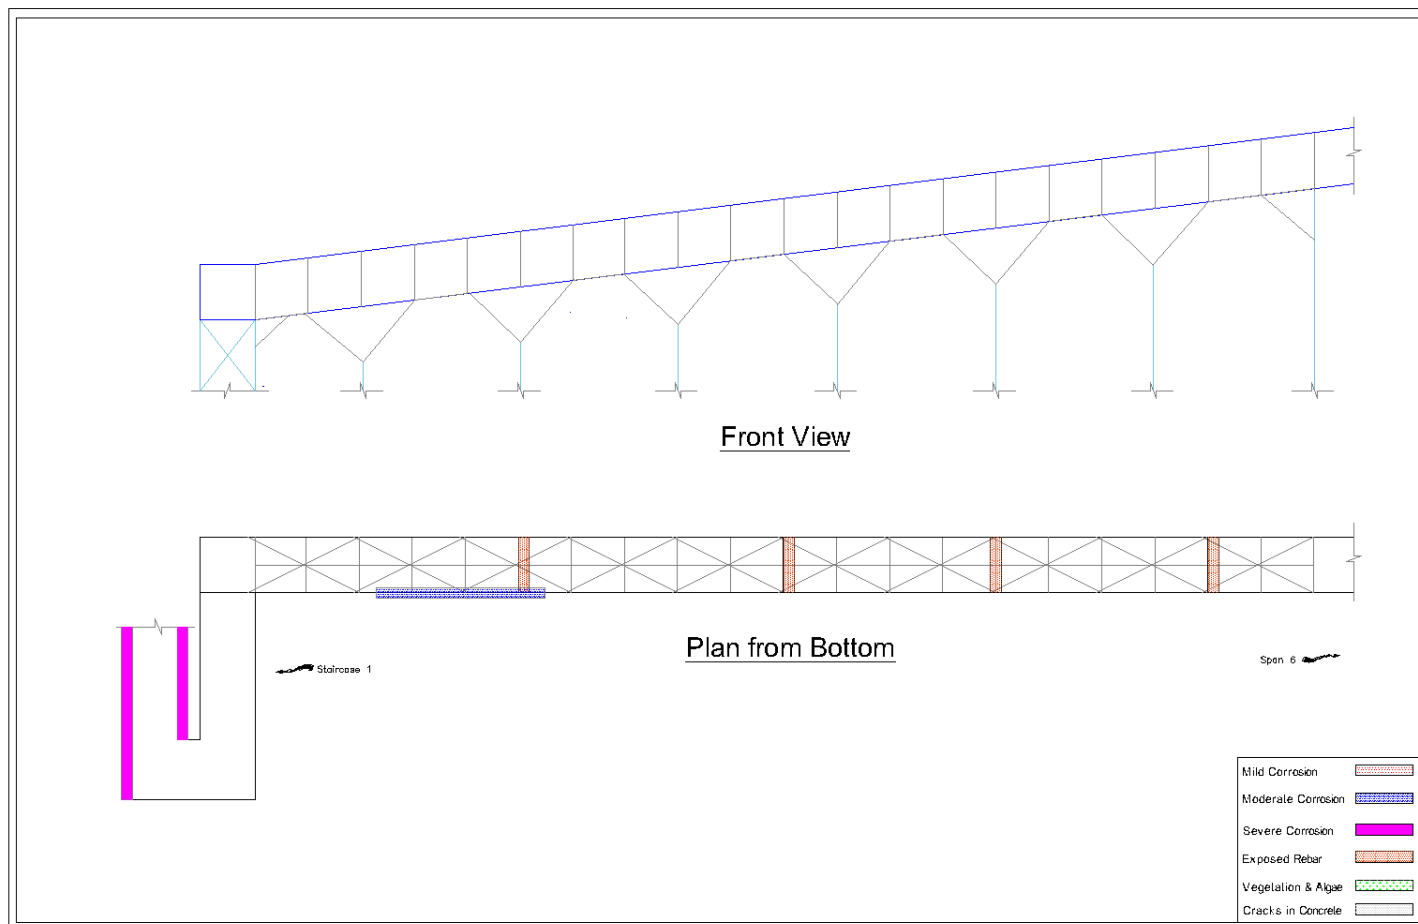
**Fig 2.19:** Locations of Deteriorations in Ramp-2

- Structural members are in fair condition, displaying mild corrosion for top chord members, verticals, diagonals, and Moderate corrosion in bottom chord members steel concrete joint. (locations are marked in figures below)
- Exposed reinforced pre-cast slab panels and sever corrosion in bottom chord member supporting ramp flight. (Photographs of the same can be seen in **fig 2.20**)

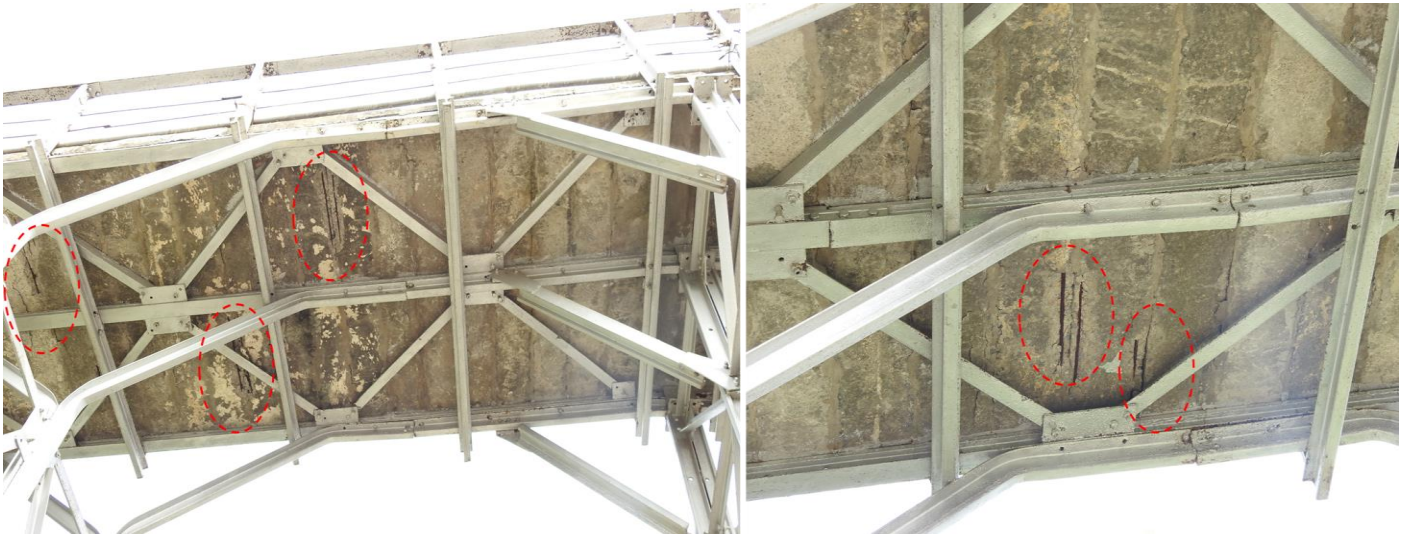
**Fig 2.20:** Exposed reinforced Pre-cast slab panels

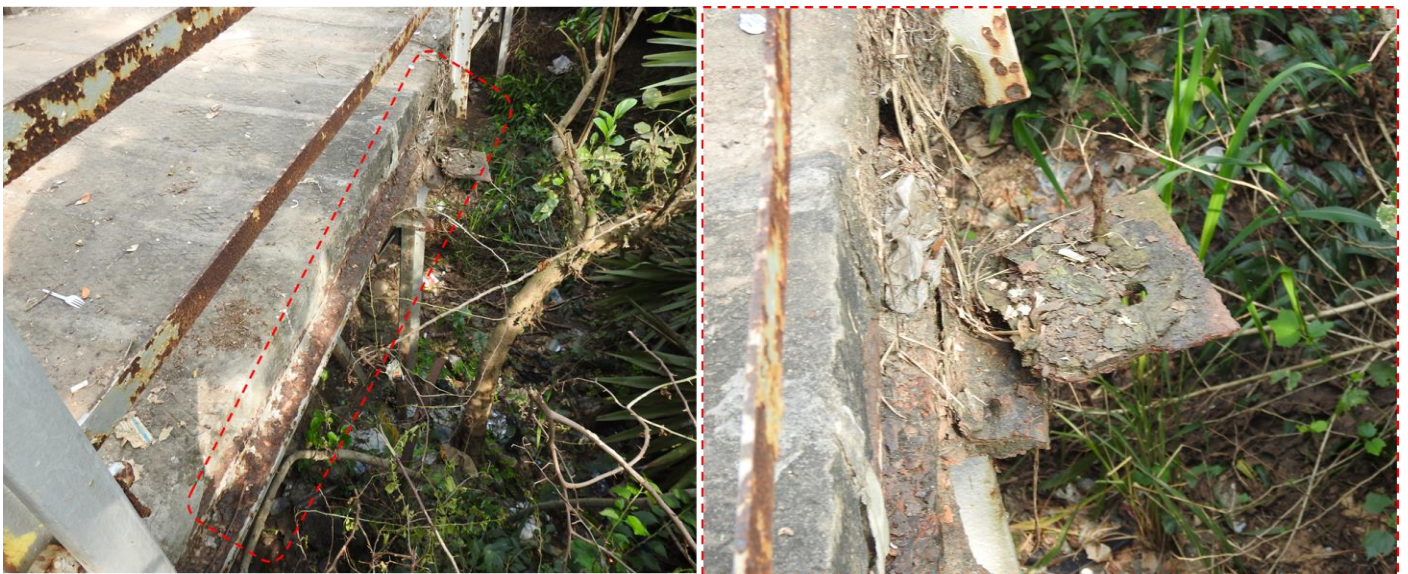
**Fig 2.21:** Severe corrosion in floor beam supporting flight of ramp

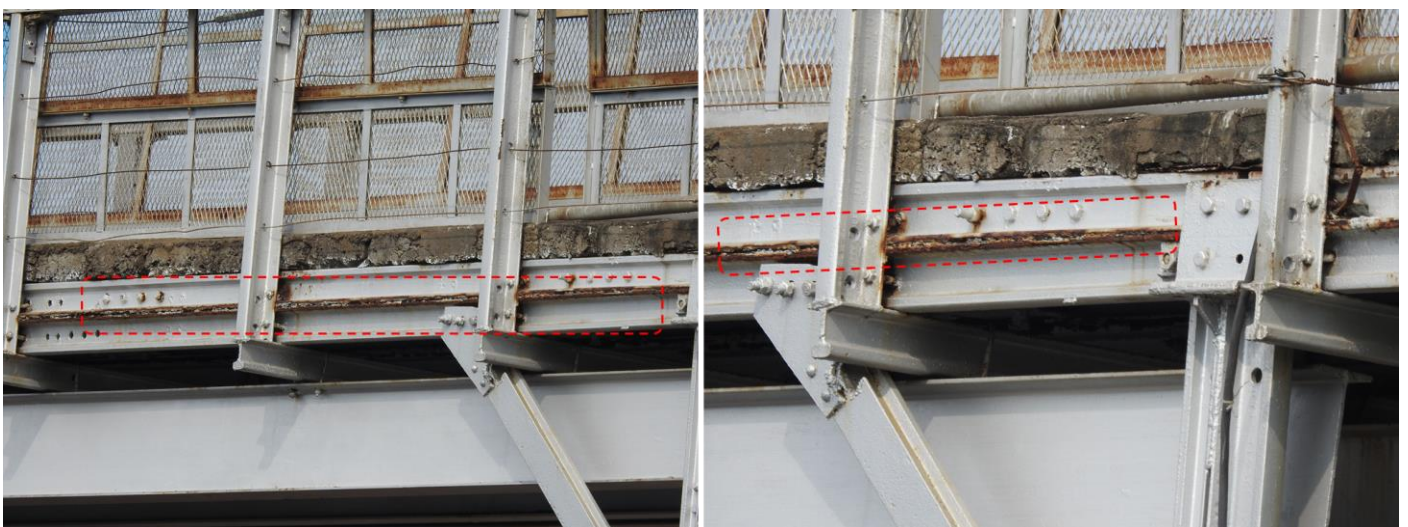
**Fig 2.22:** Moderate Corrosion in bottom chord member
