## Third Party Audit of ROB's and FOB's of SCR

### INSPECTION OF FOB AT ELAMANCHILI RAILWAY STATION

**Final Report**  
SEPTEMBER | 2020

| <b>Name of the Project</b> | : | VISUAL INSPECTION OF FOB AT ELAMANCHILI RAILWAY STATION |

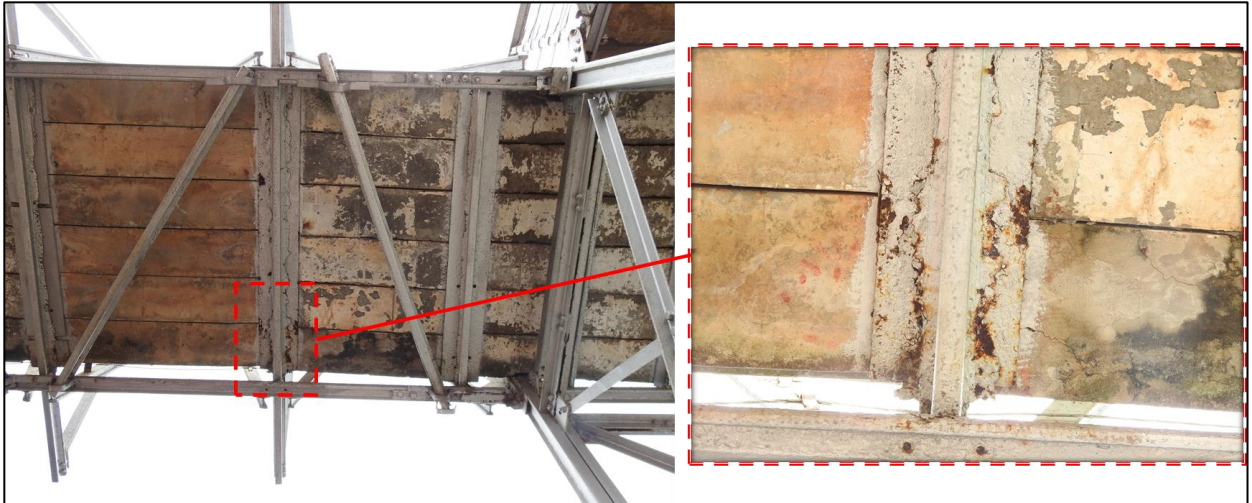
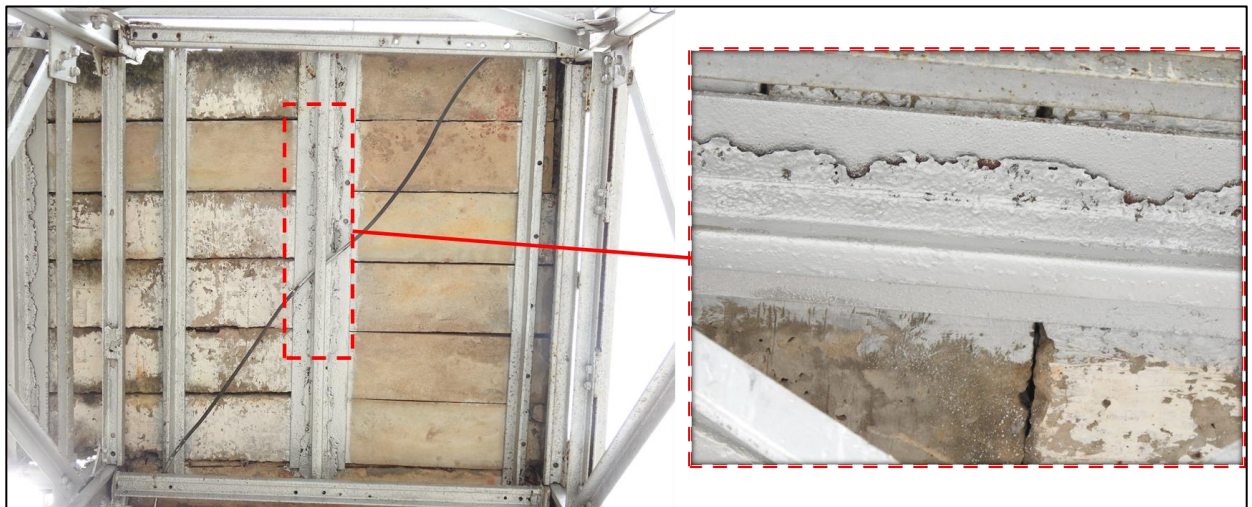
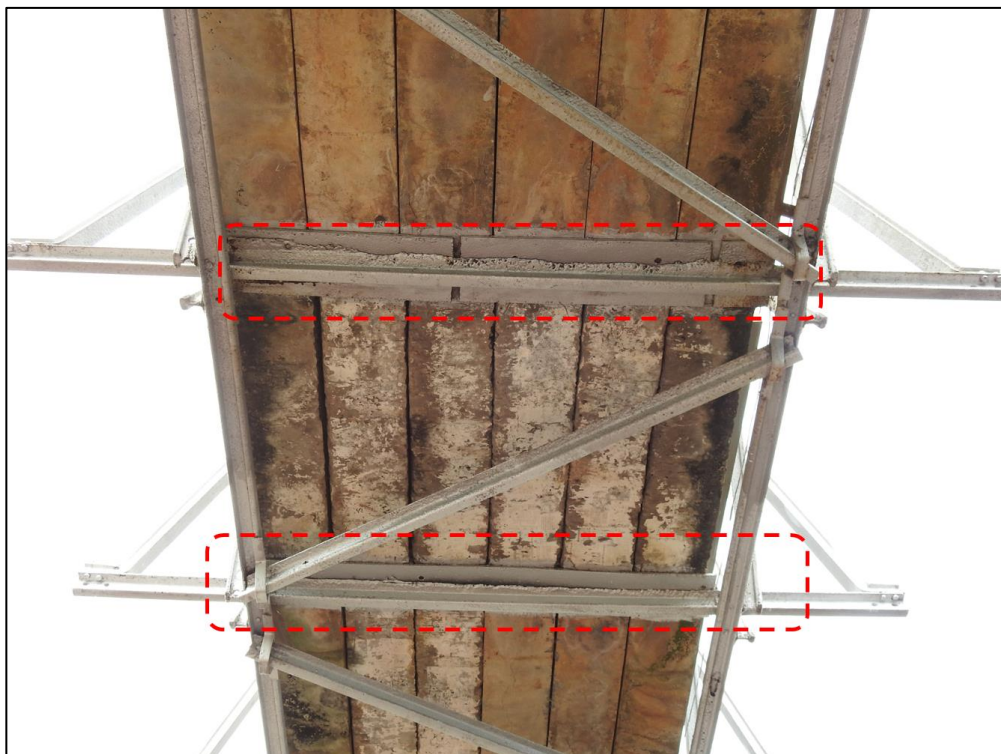
✓ Corrosion of floor beams along the span of FOB, coated with silver oxide paint.

Corrosion of Floor beam coated with silver oxide paint

| SIGNS OF DISTRESS, DEFORMATION IN BRIDGES | | | |
|---|---|---|---|
| | Rust straining/ corrosion | Floor Beams and staircase landing beam | Corrosion is observed at all the joints & floor beams of FOB and staircase landing beam |

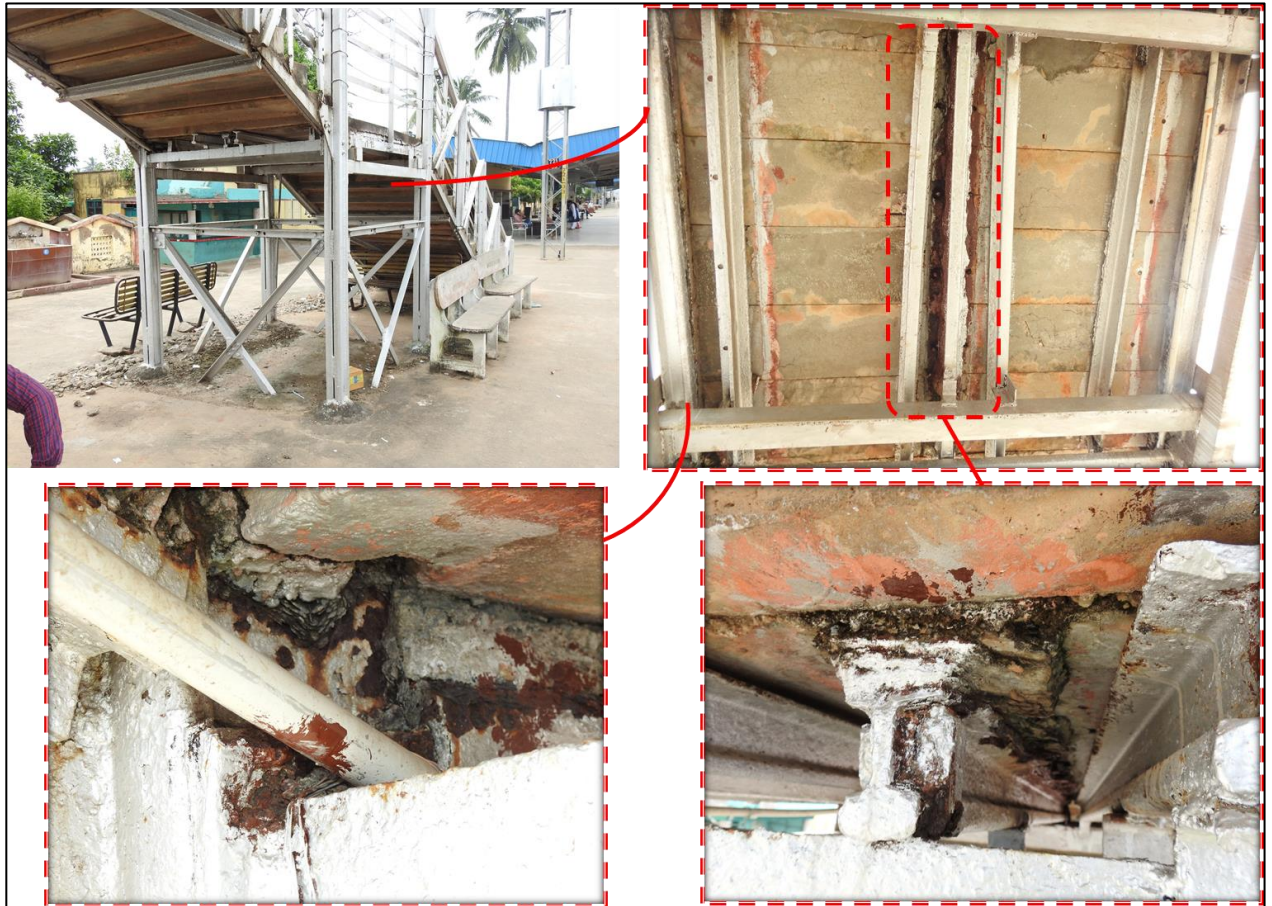
(a) Corrosion of floor beam and stringer beam in staircase-1

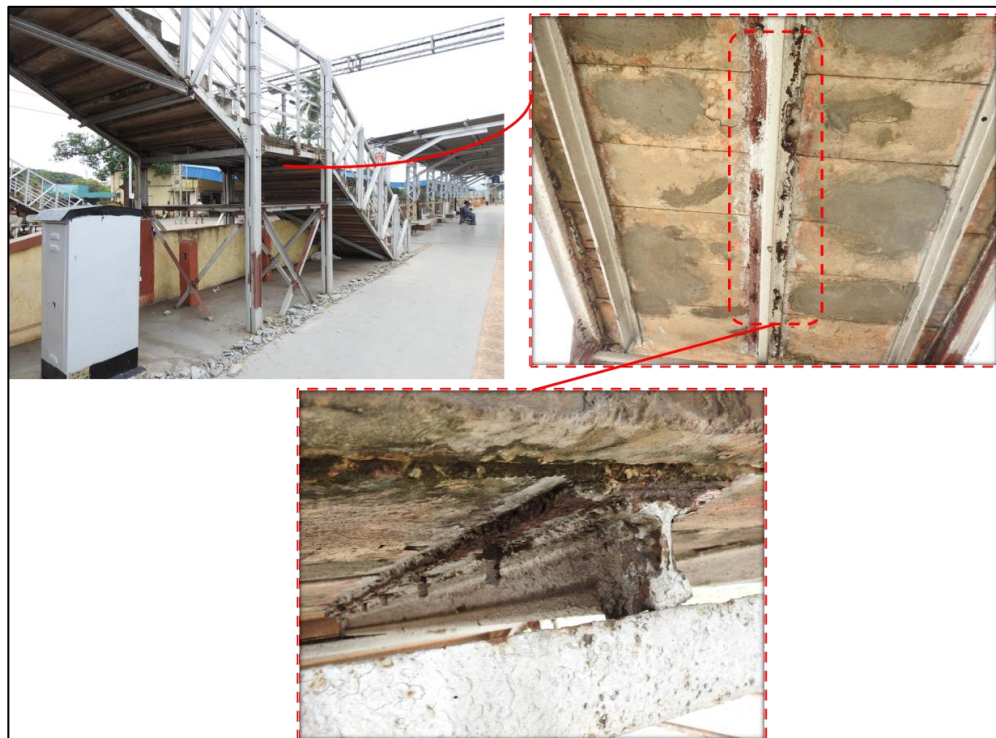
(b) Corrosion of floor beam in staircase-2

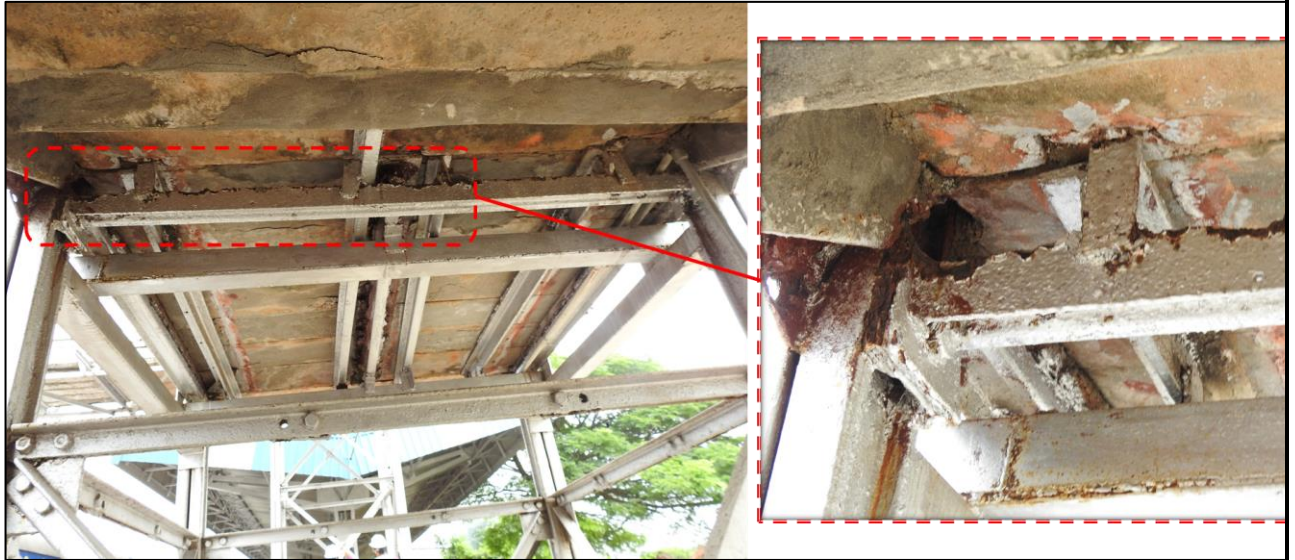
(c) Corroded angle section in staircase -1

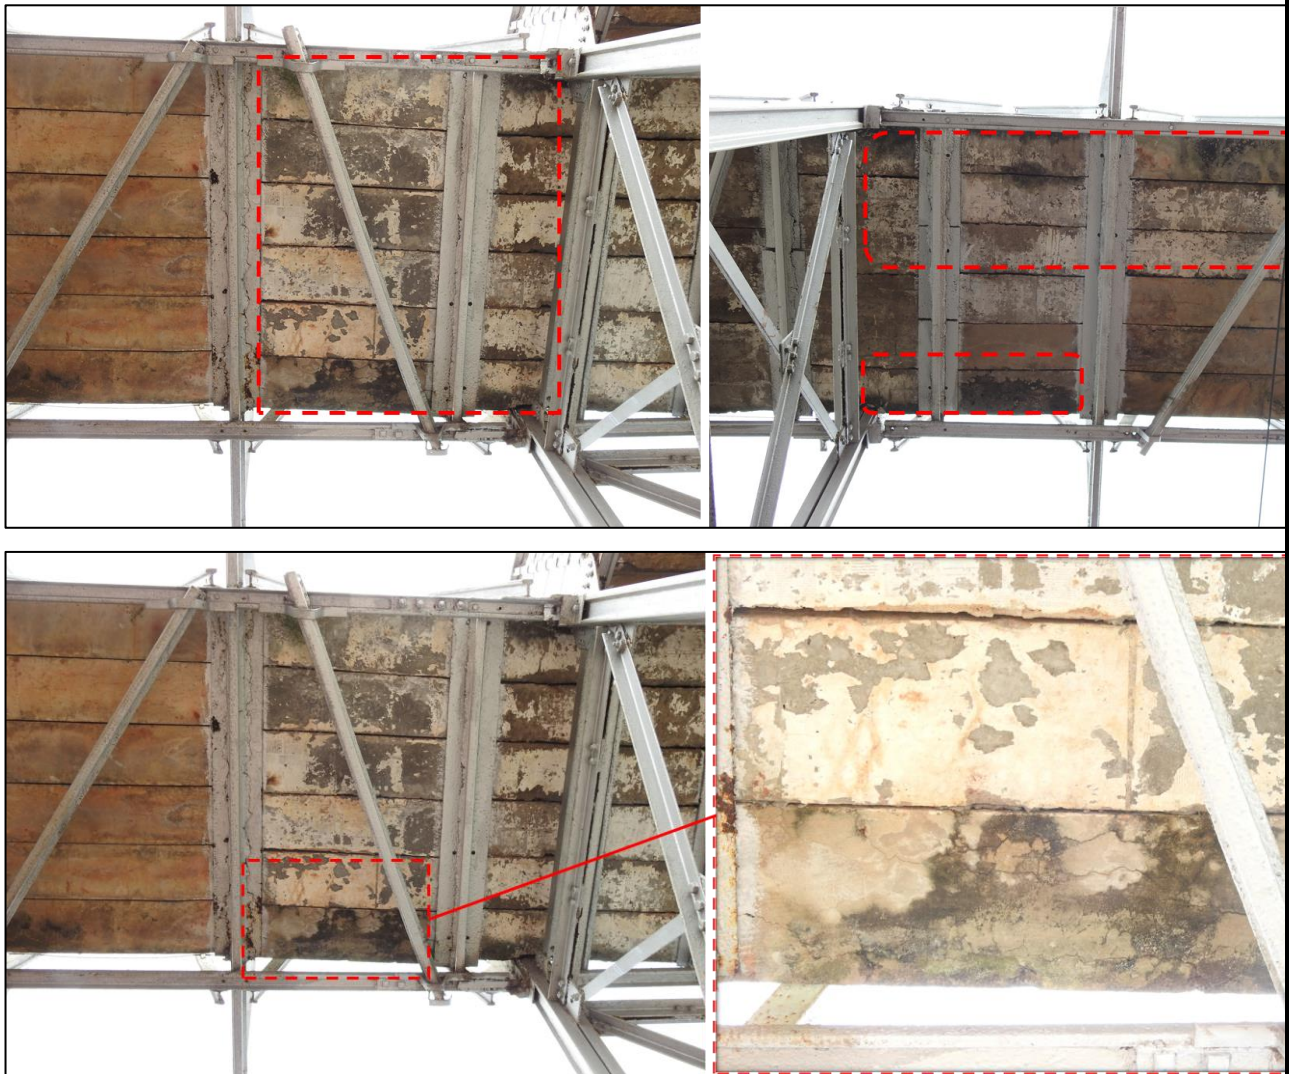
✓ Leaching and cracks observed in slab panels

(a) Leaching and cracks in slab panels

| SIGNS OF DISTRESS, DEFORMATION IN BRIDGES | | | |
|---|---|---|---|
| | Cracking in RCC components | Slab panels | Cracks are observed in Pre-cast RCC slab panels of Staircase & Main Slab. |

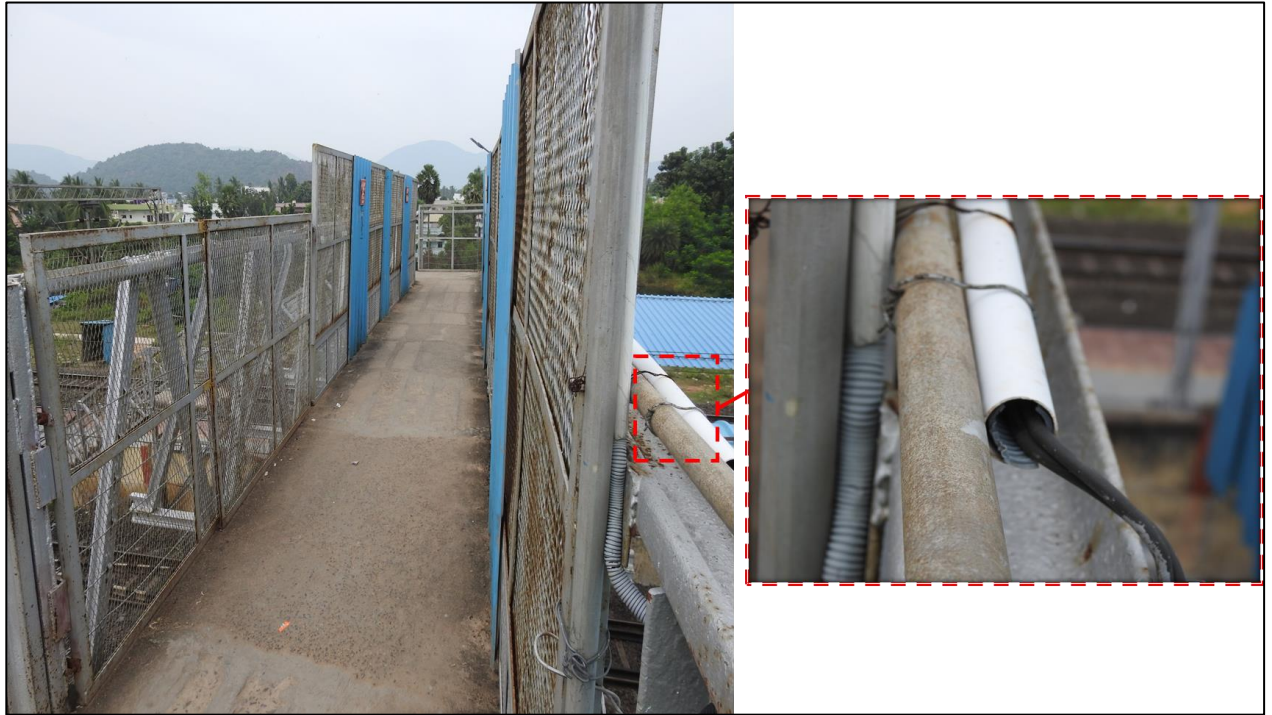
| 1.2 IDENTIFICATION OF LOADS ON BRIDGE | | |
|---|---|---|
| | | a. Cables are protected with 2-inch HDPE pipe. (Refer <b>fig :1.2</b> )<br>b. No Roof Truss is provided. |
| | | No additional wearing coats. (Refer <b>fig :1.2</b> )<br>Fence made of galvanized wire of 2 mm gauge and 2 mm galvanized sheet is used above OHE Line on both side of pathway is used for passengers Protection. (Refer <b>fig :1.2</b> ) |

**Fig 1.2:** FOB pathway, protective screen and Additional loads of PVC pipes

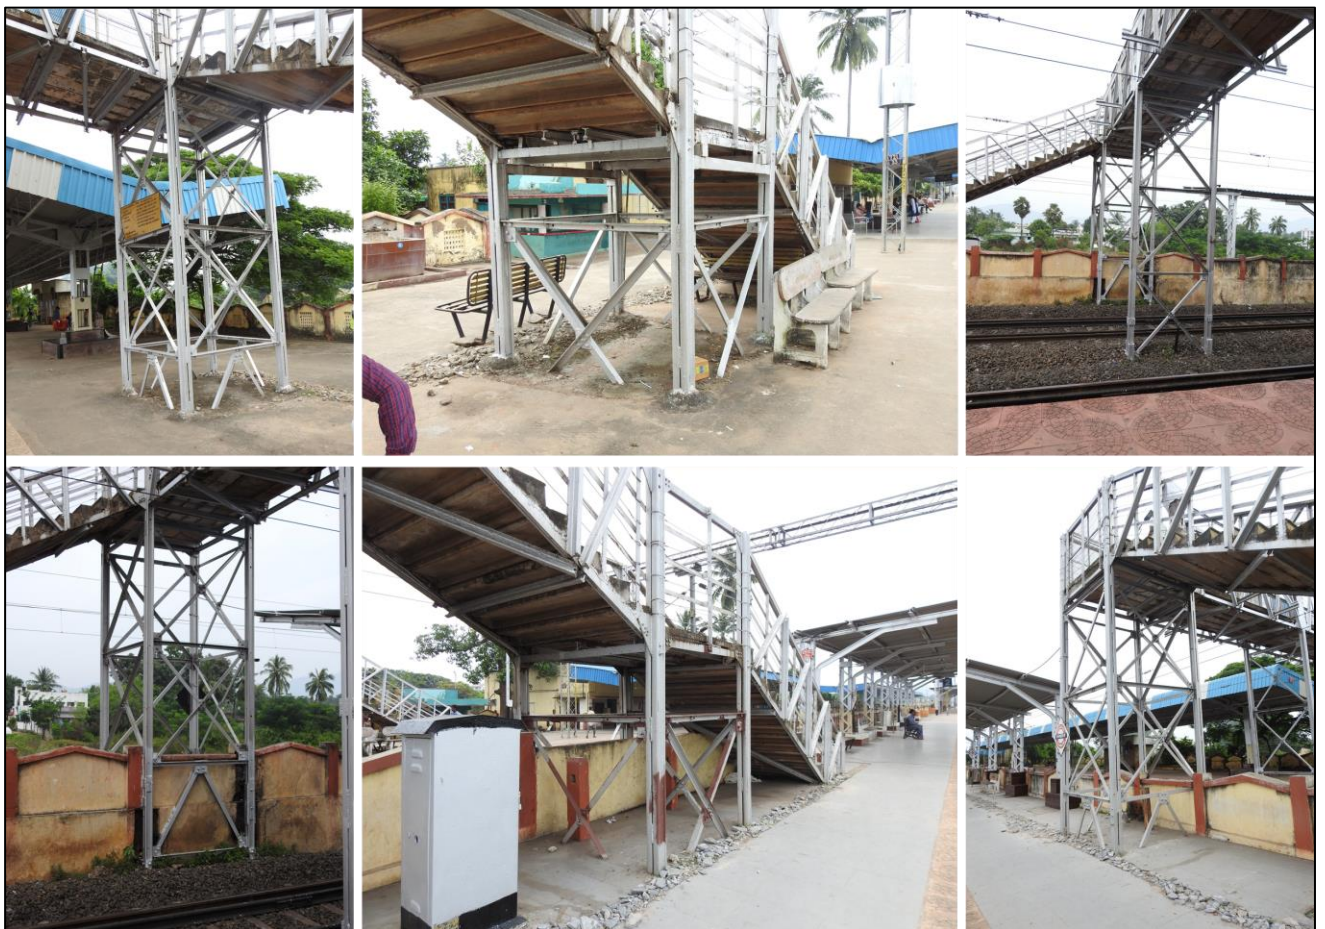
| | Type/Shape of Column section | Rail Sections | a. Trestles & Stanchion Columns are 65 x 135 x 135 (Head x Height x Base) bull headed Rail sections.<br>b. Cross Bracings in Stanchions are 65 x 65 x 8 mm Angles are used. (Refer <b>fig :1.3</b> ) |

**Fig 1.3:** Trestles and Stanchion column sections details

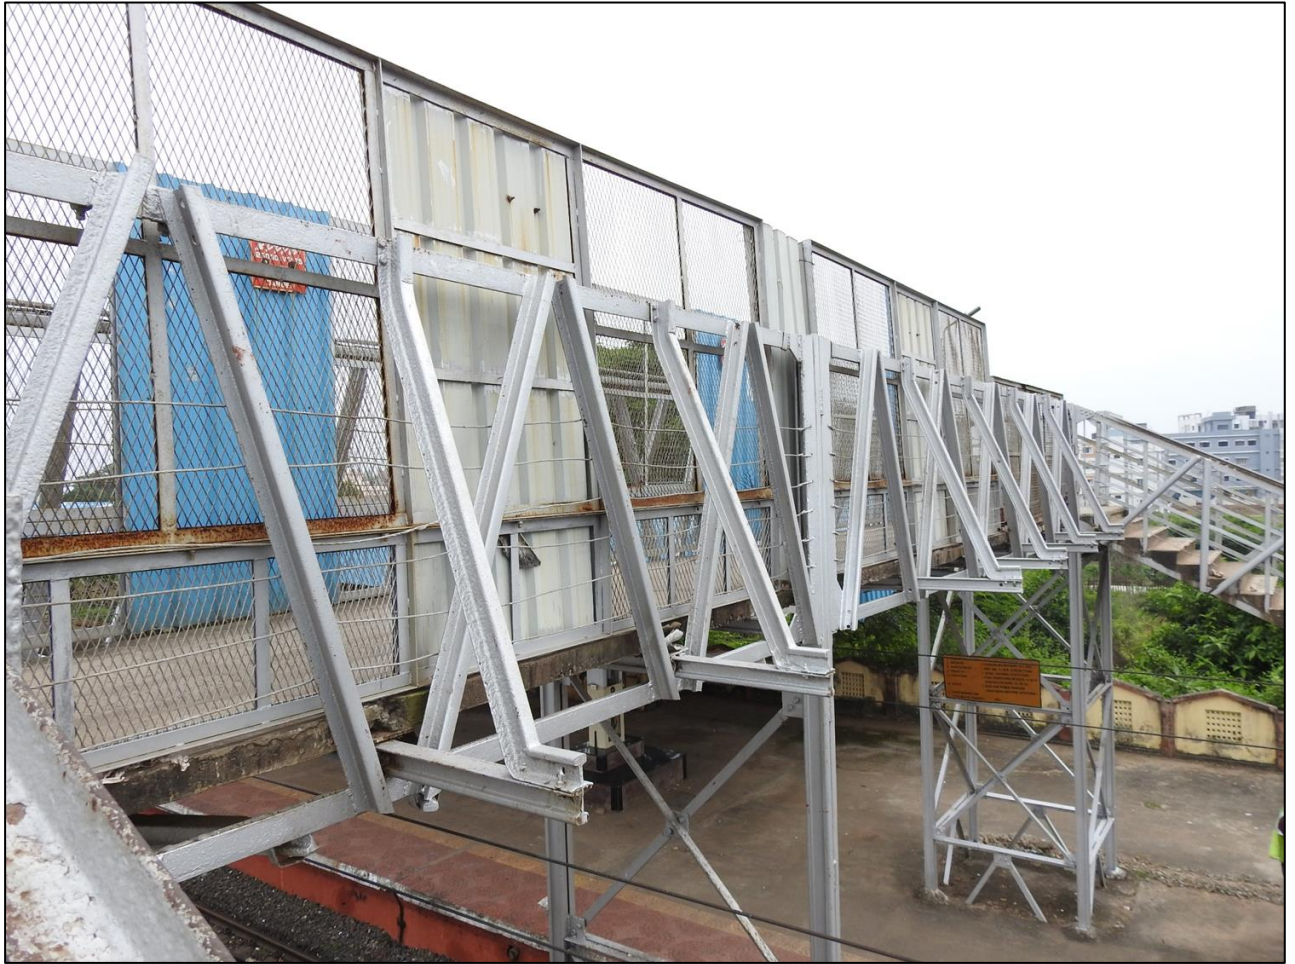
| 1.3 STRUCTURAL SYSTEM OF THE BRIDGE | | |
|---|---|---|
| | | a) Top Chord & Bottom Chord members are 45 x 80 x 80 (Head x Height x Base) Rail sections<br>b) 45 x 80 x 80 (Head x Height x Base) Rail sections are used as vertical members.<br>c) 45 x 80 x 80 (Head x Height x Base) Rail sections are used as Floor beams.<br>d) 45 x 80 x 80 (Head x Height x Base) Rail sections are used as Bracings. (Refer <b>fig :1.4</b> ) |

***Fig 1.4:*** Arrangement of truss

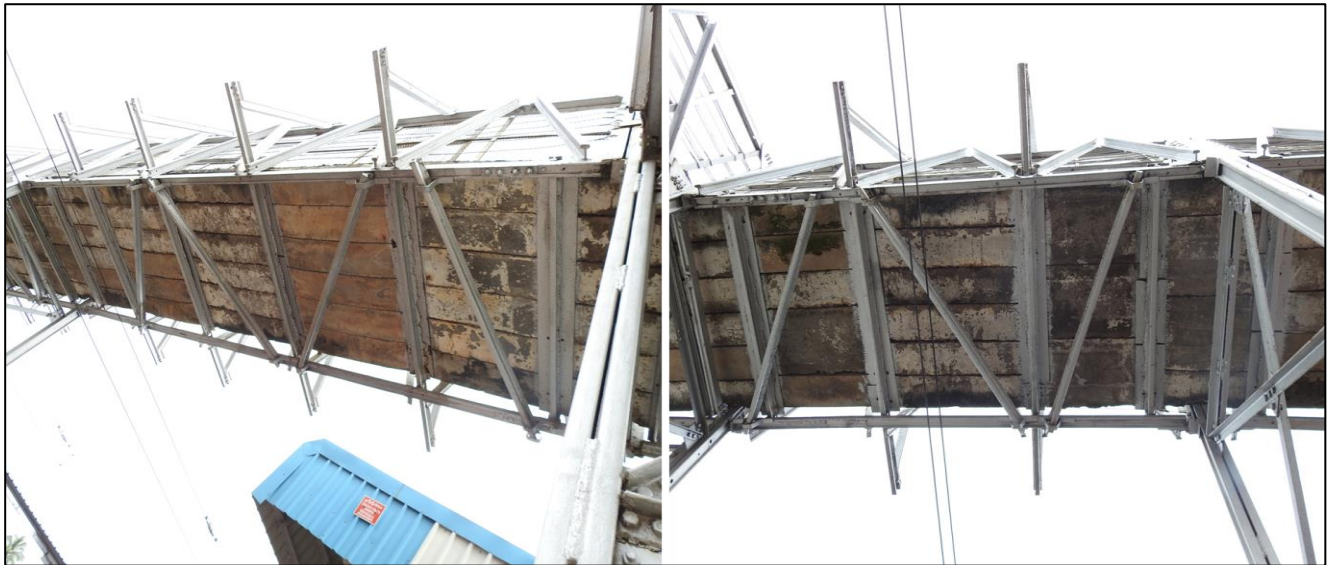
| | Material of Slab | Pre-cast slab panels for Spans | a. Pre-cast Reinforced concrete slab panels are used for floor slab of 100 mm thick, RCC slab panels are resting on Floor Beam members. (Refer <b>fig :1.5</b> ) |

***Fig 1.5:*** Bottom view of FOB

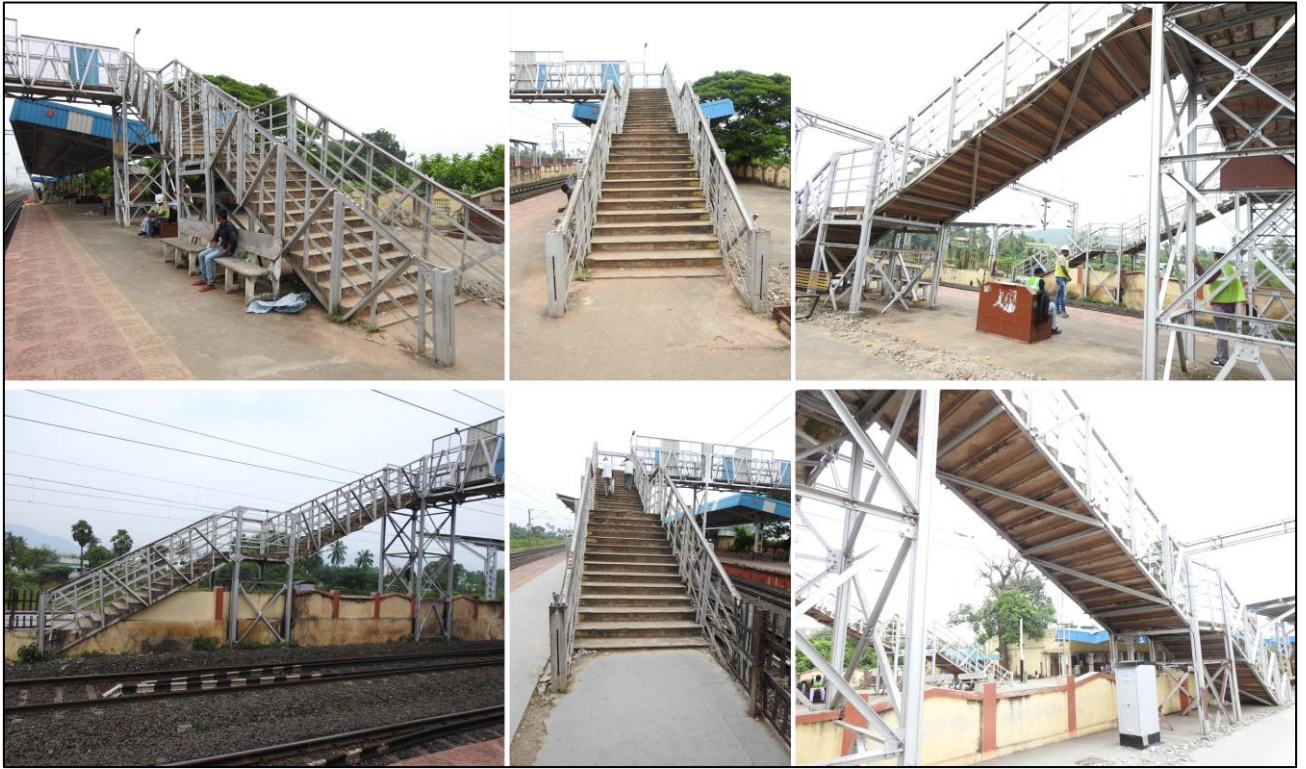
| | Number of Staircase | 2 No's | Staircase is observed as Precast RCC Slab panels supported on 45 x 45 x 80 (Head x Height x Base) Stringer Beams on both sides. (Refer <b>fig :1.6</b> ) |

**Fig 1.6:** Staircase details

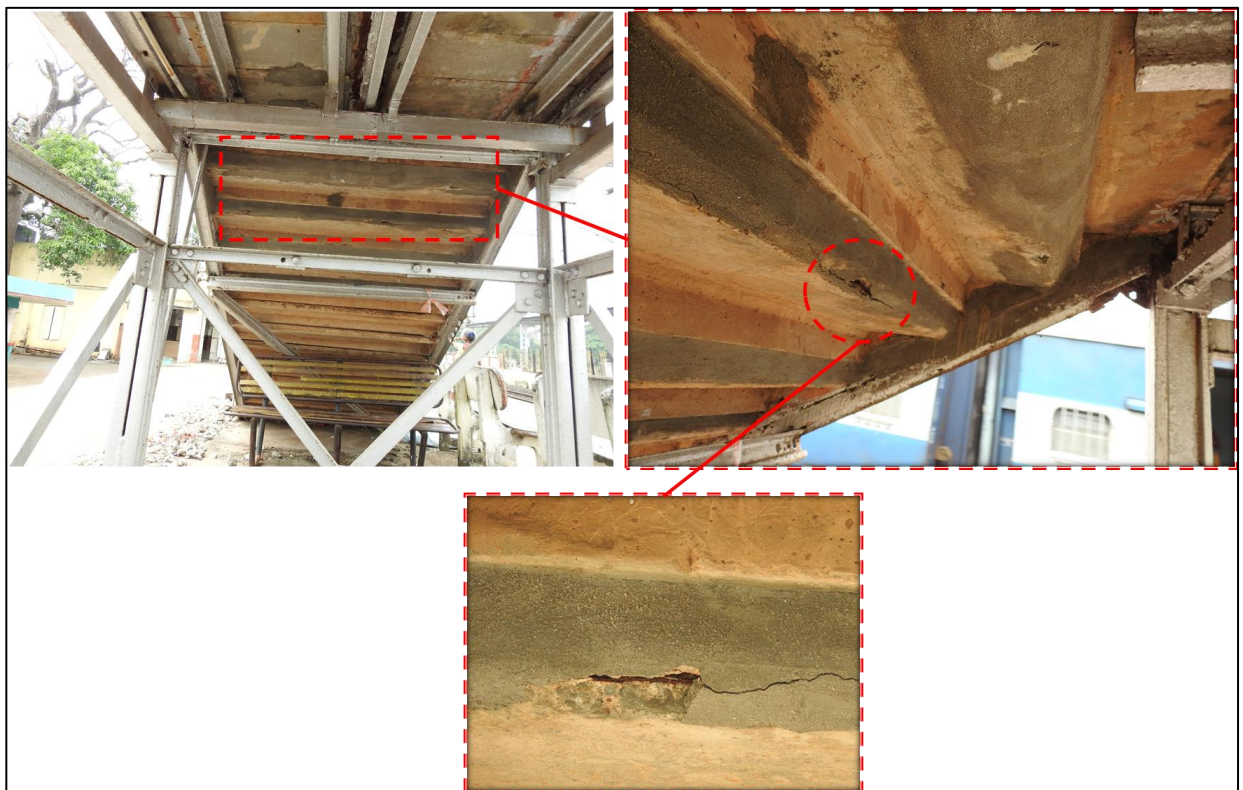
**Fig 1.7:** Patch work and reinforcement exposed in staircase -1

Reinforced cement concrete Slab at Deck level and some precast panels in staircase are observed with exposed rebar in many locations.

**Methodology for patching:** Hand applied Mortar (Patching) repair is performed to restore small areas where sound concrete is damaged by spalling, scaling and/or impact. This method of repair is generally applied using trowel and require minimum or formworks. The patch thickness is limited to a maximum of 100 mm depth of hollow surface. Hand applied Mortar repair is classified into two types considering defective area and surface. Hand applied Mortar

- a) **Type - A** is applicable to surfaces without exposed rebar is having defective widths of up to 300mm and depths of up to 50 mm.
- b) **Type - B** is for surfaces with exposed rebar, with defective widths between 300 mm and 600 mm, and up to 100 mm depths.

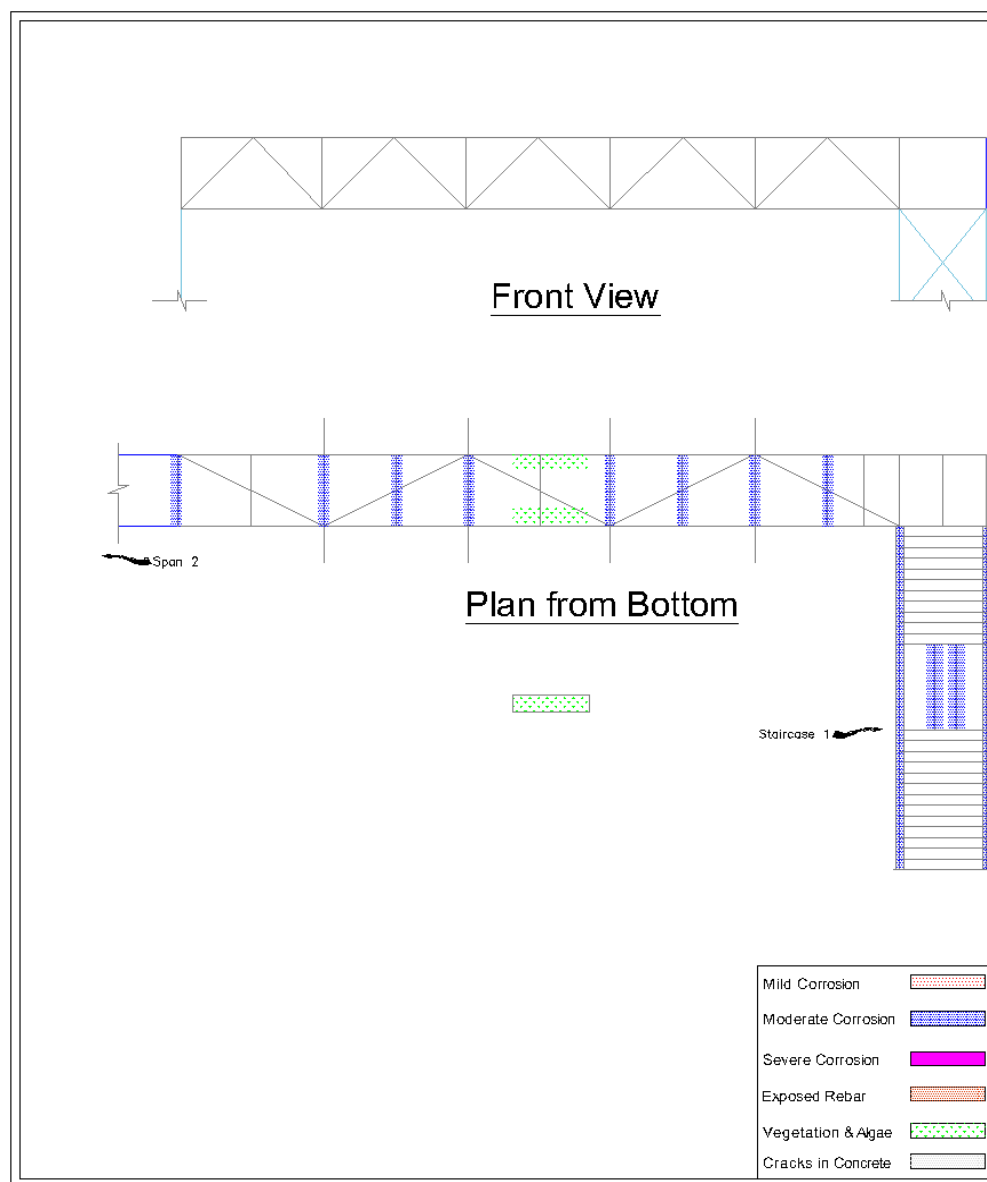
**Fig 2.1:** locations of deterioration and bottom view of span-1

- Structural members are in fair condition, displaying mild corrosion for top chord members, verticals, diagonals, and gusset plates, moderate corrosion for floor beams and staircase stringer beam along steel concrete joint. (Locations are marked in figures below).

- Algae formation is observed along steel concrete joint on outer surface at deck level. Moderate corrosion in floor beams in staircase mid landing Staircase 1 and precast slab panels are deteriorated reinforced is exposed in flights and staircase at deck level. (Photographs of the same can be see in **fig 2.3-2.7**)

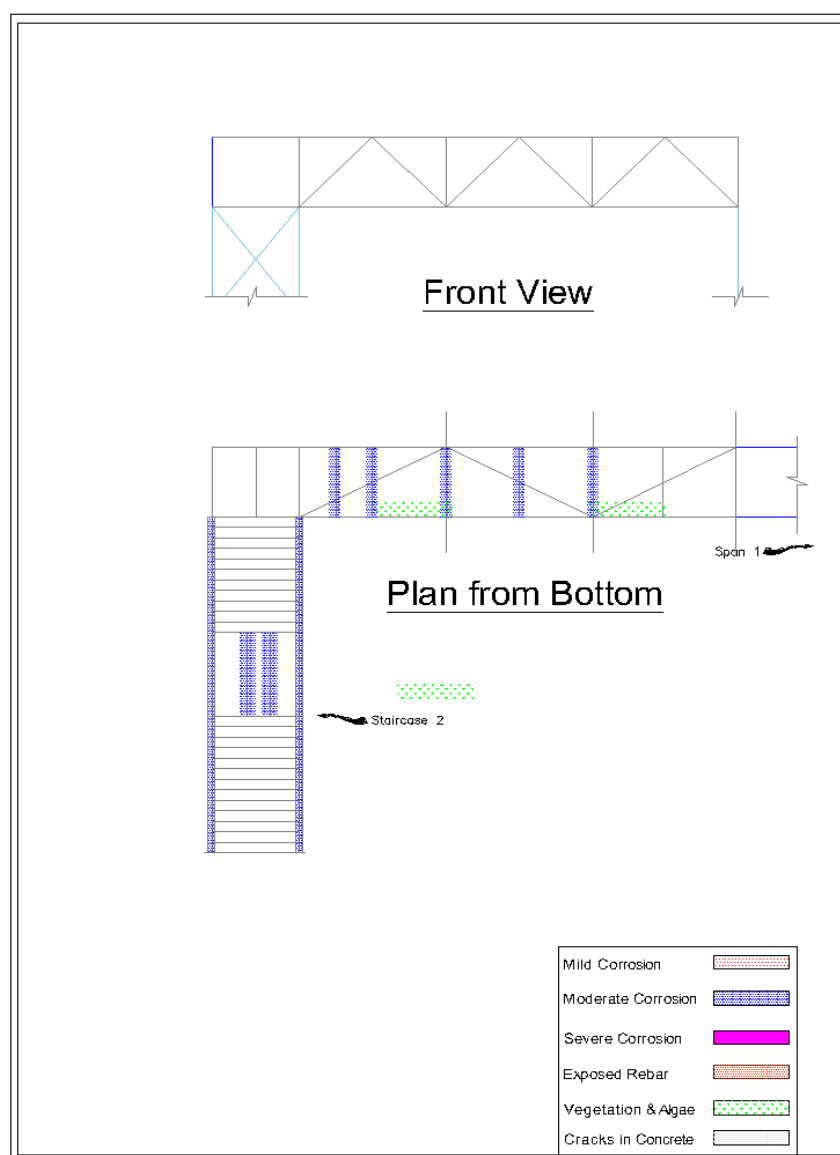
**Fig 2.2:** locations of deterioration and bottom view of span-2

- Structural members are in fair condition, displaying mild corrosion for top chord members, verticals, diagonals, and gusset plates, moderate corrosion for floor beams and staircase stringer beam along steel concrete joint. (Locations are marked in figures below).
- Algae formation is observed along steel concrete joint on outer surface at deck level. Moderate corrosion in floor beams in staircase mid landing Staircase 2 and precast slab panels are deteriorated reinforced is exposed in flights and staircase at deck level. (Photographs of the same can be see in **fig2.3-2.7**)

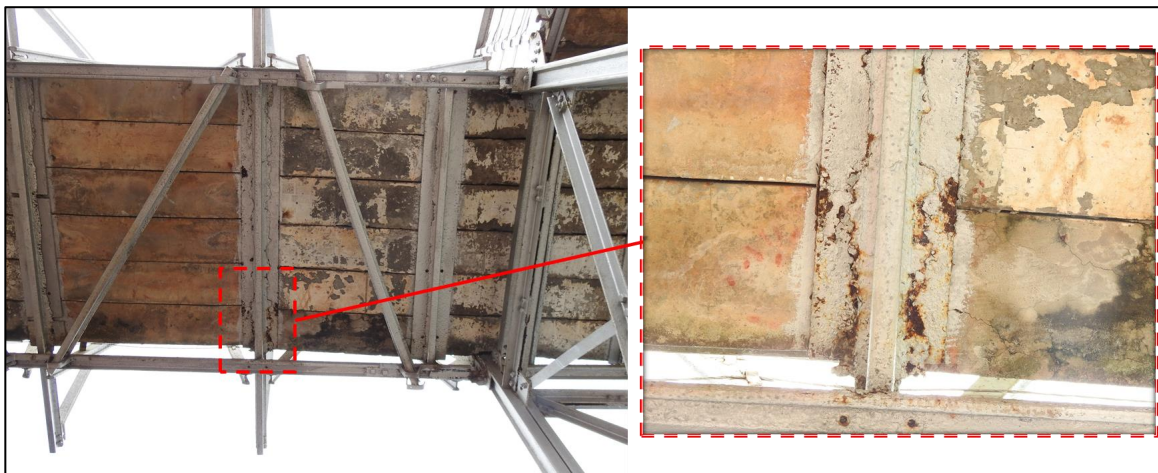
**Fig 2.3:** Corrosion of Floor beam

- If the paint condition is identified as Grade-1, aluminum paint shall be applied with a similar shade.
- Where condition of paint is evaluated as Grade-2 special anticorrosion paint shall be applied to restrict corrosion from progressing further.
- When the condition of the member is observed to be in Grade – 3, which might have occurred due to environmental conditions or age of the structure. In such cases section loss is calculated by using caliper where it is accessible and UPV at one accessible

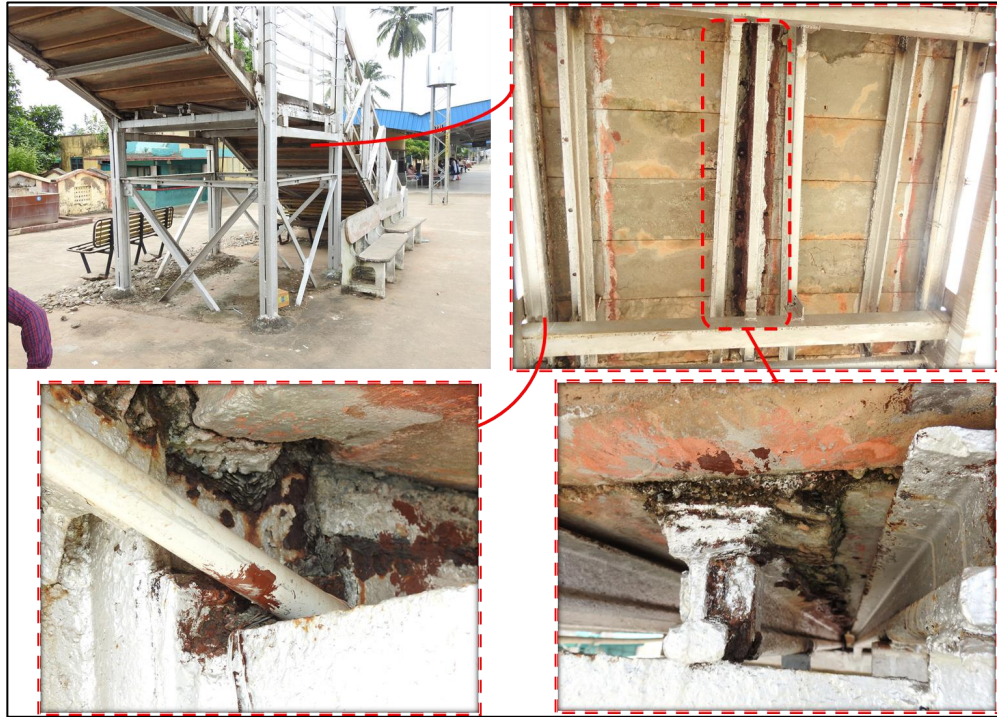
**Fig 2.4:** Corrosion of floor beam and stringer beam in staircase-1

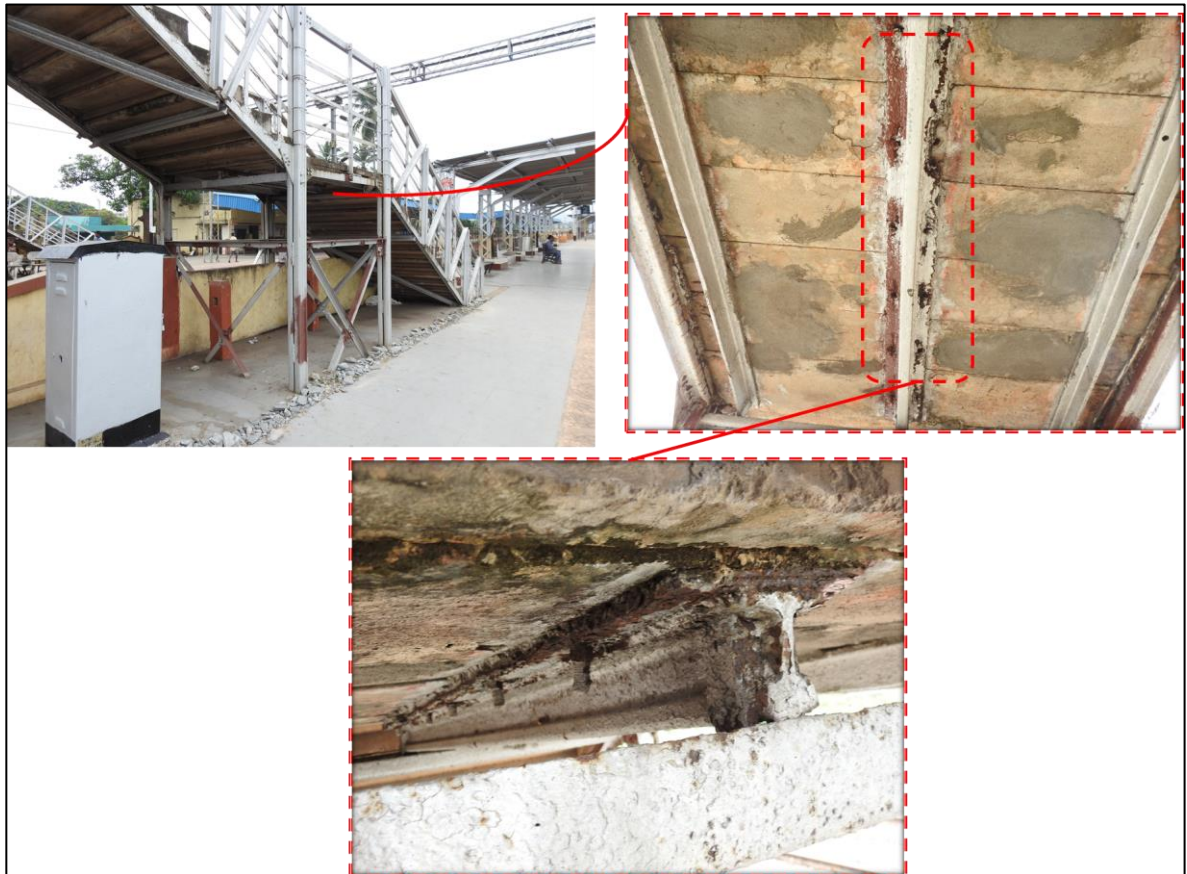
**Fig 2.5:** Corrosion of floor beam in staircase-2

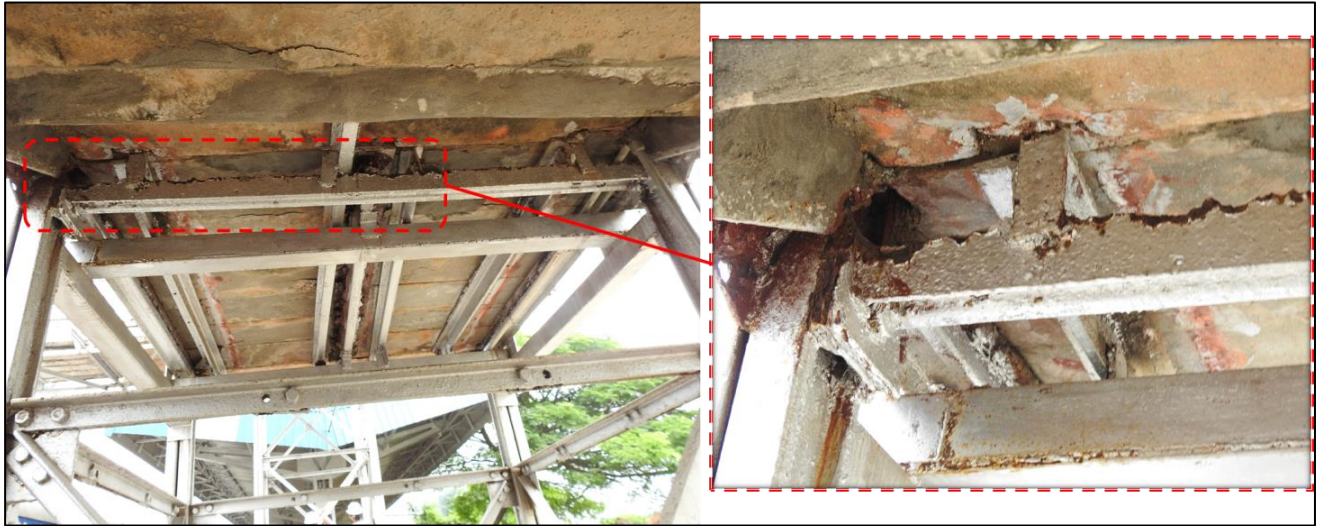
**Fig 2.6:** Corroded angle section in staircase -1

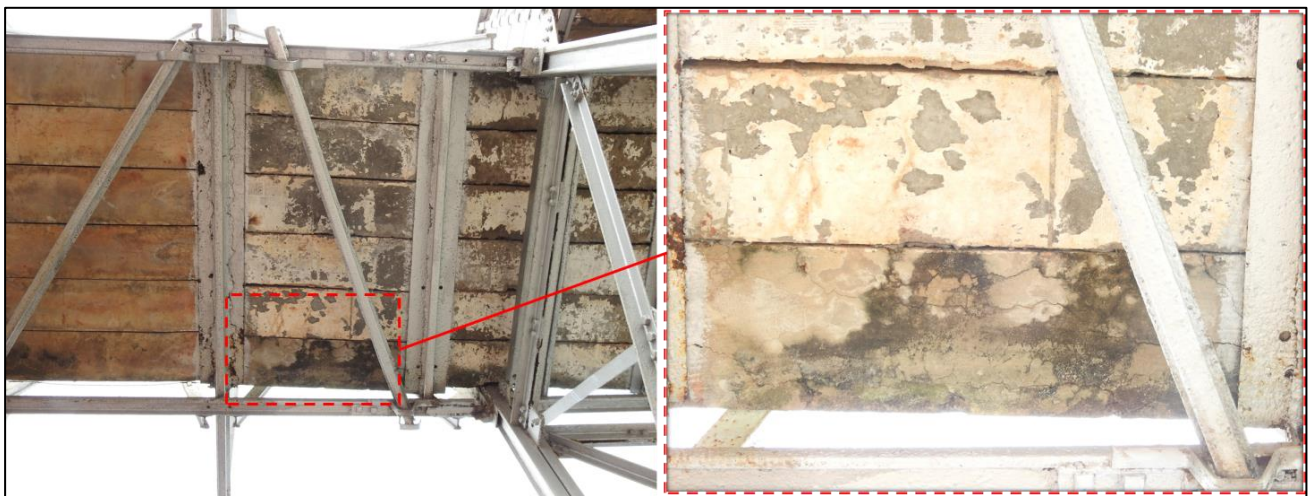
**Fig 2.7:** cracks in slab panels
