## Third Party Audit of ROB's and FOB's of SCR

### INSPECTION OF FOB AT BITRAGUNTA (B) RAILWAY STATION

**Final Report**  
SEPTEMBER | 2020

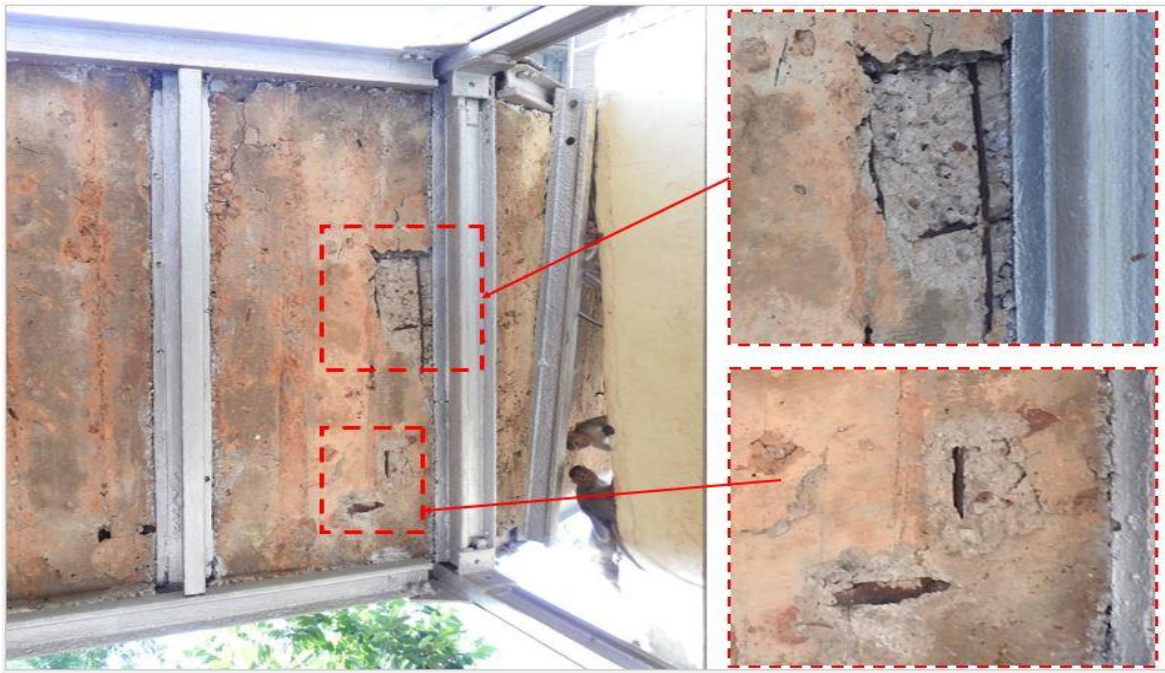
a) Reinforcement exposed at Staircase-1 of Main landing

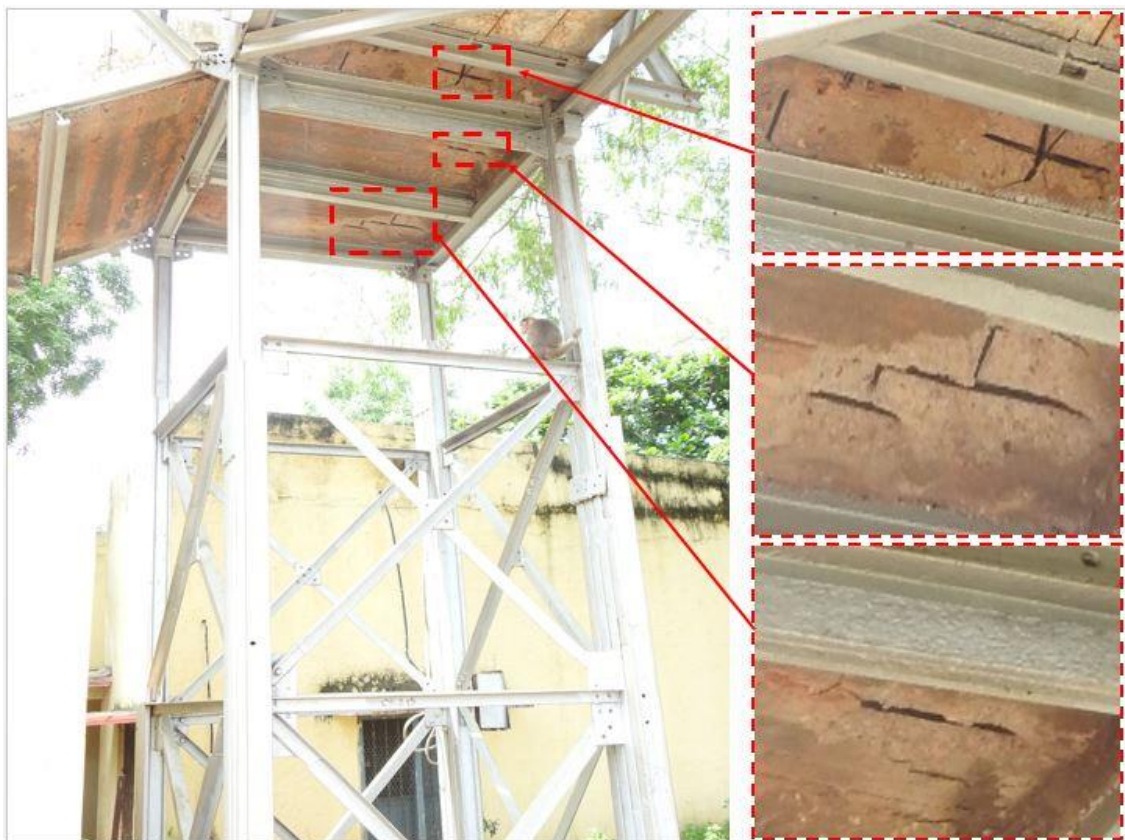
b) Reinforcement exposed at Staircase-1 of Main landing

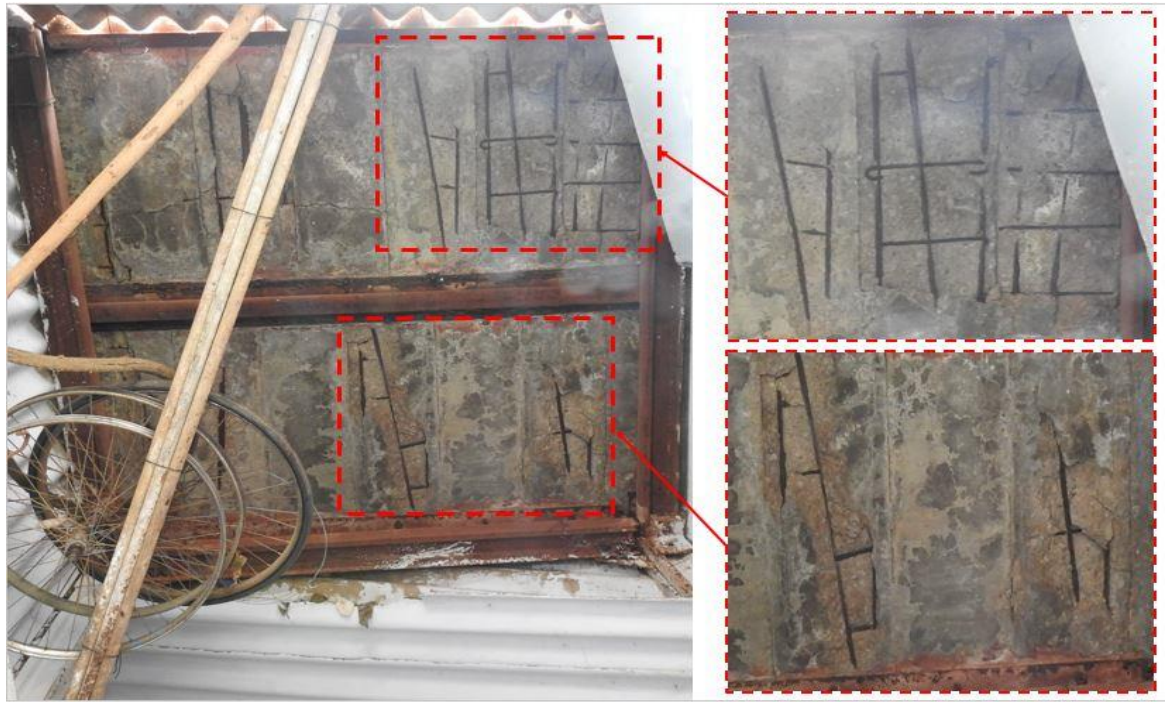
c) Spalling observed at Mid landing of Staircase-2

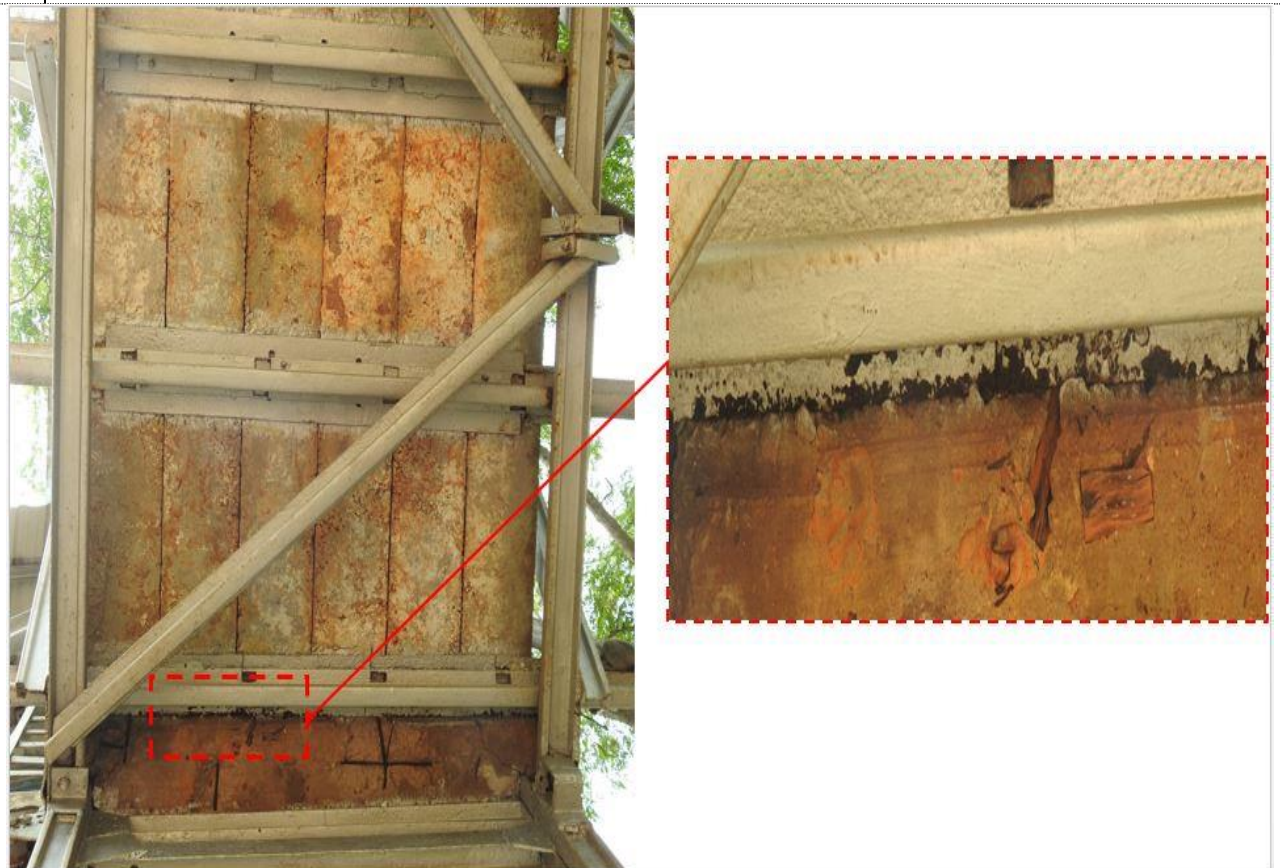
a) Corrosion observed at floor beams in Span-1

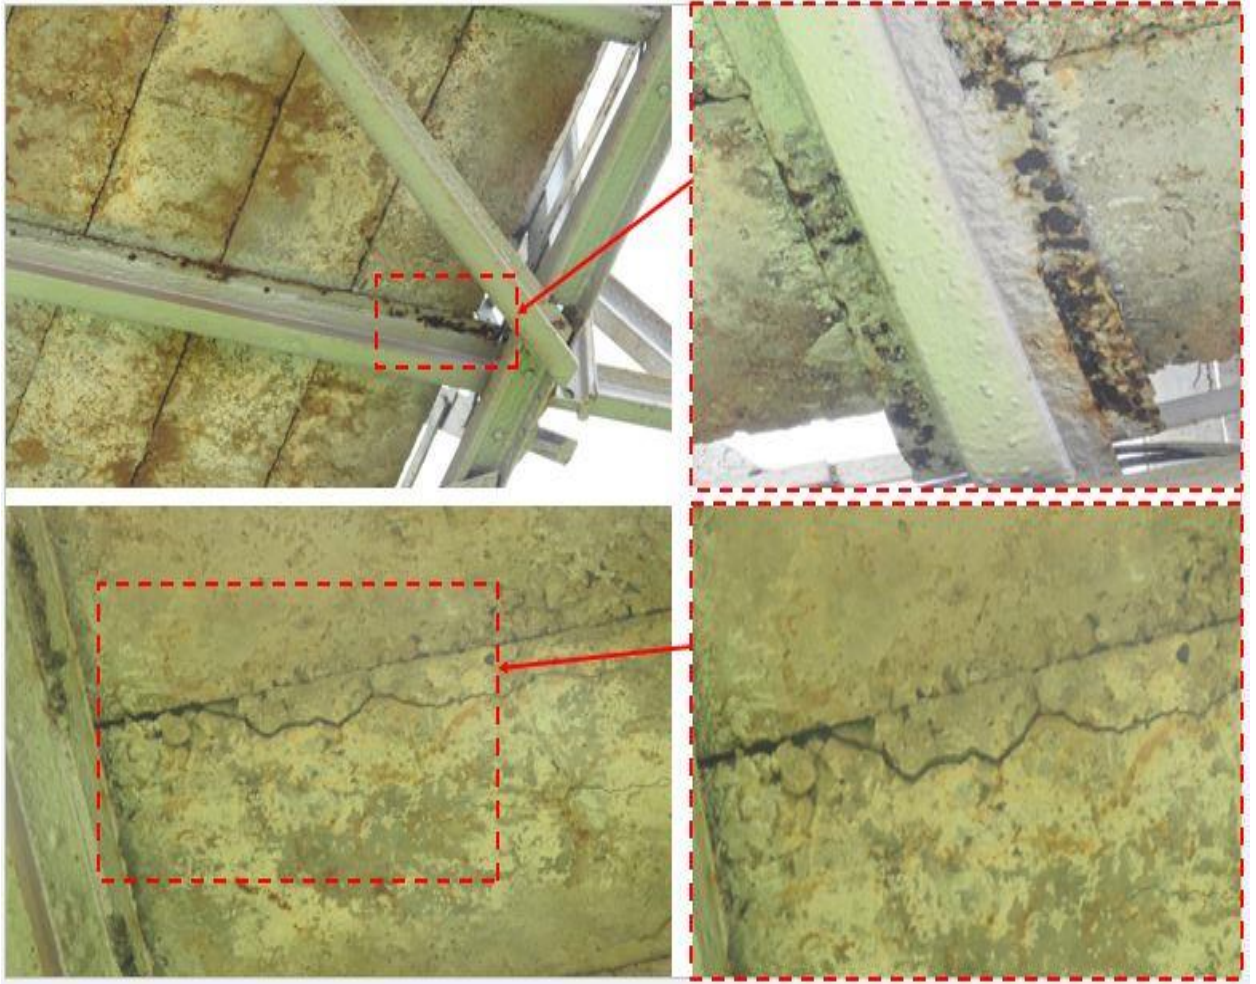
b) Corrosion observed at Bottom chord joints of Span-1

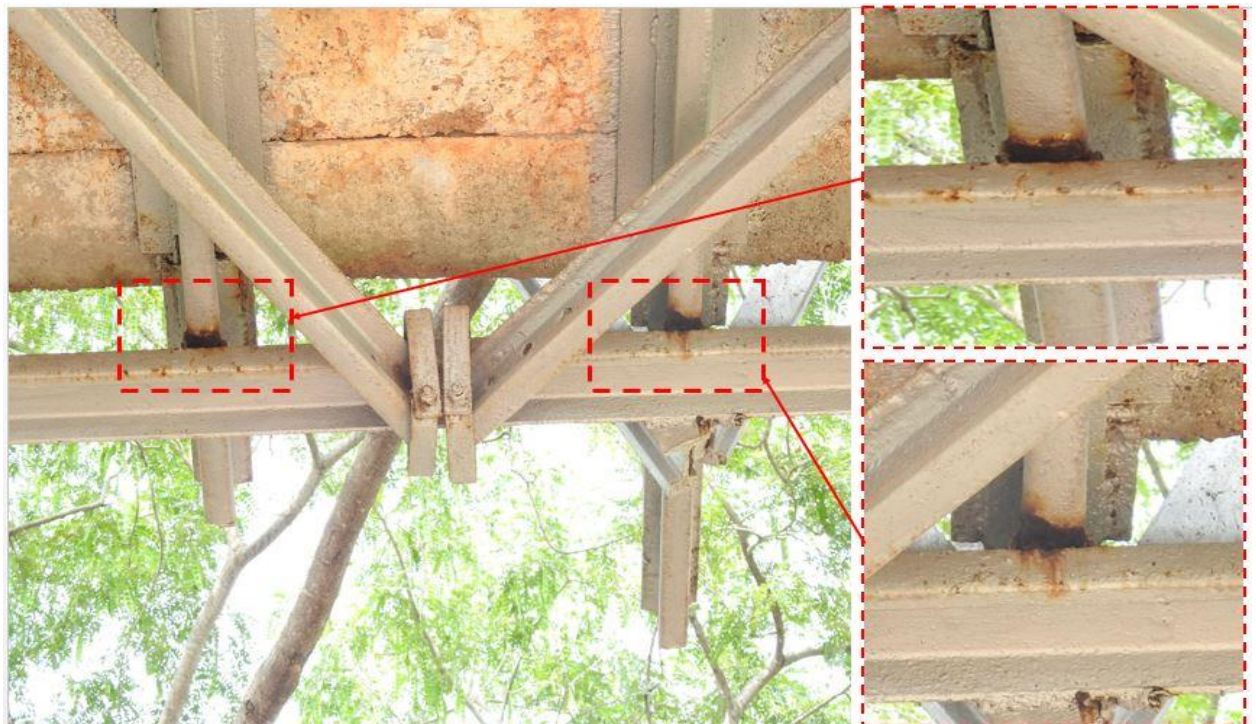
c) Corrosion & cracks observed at Span-3

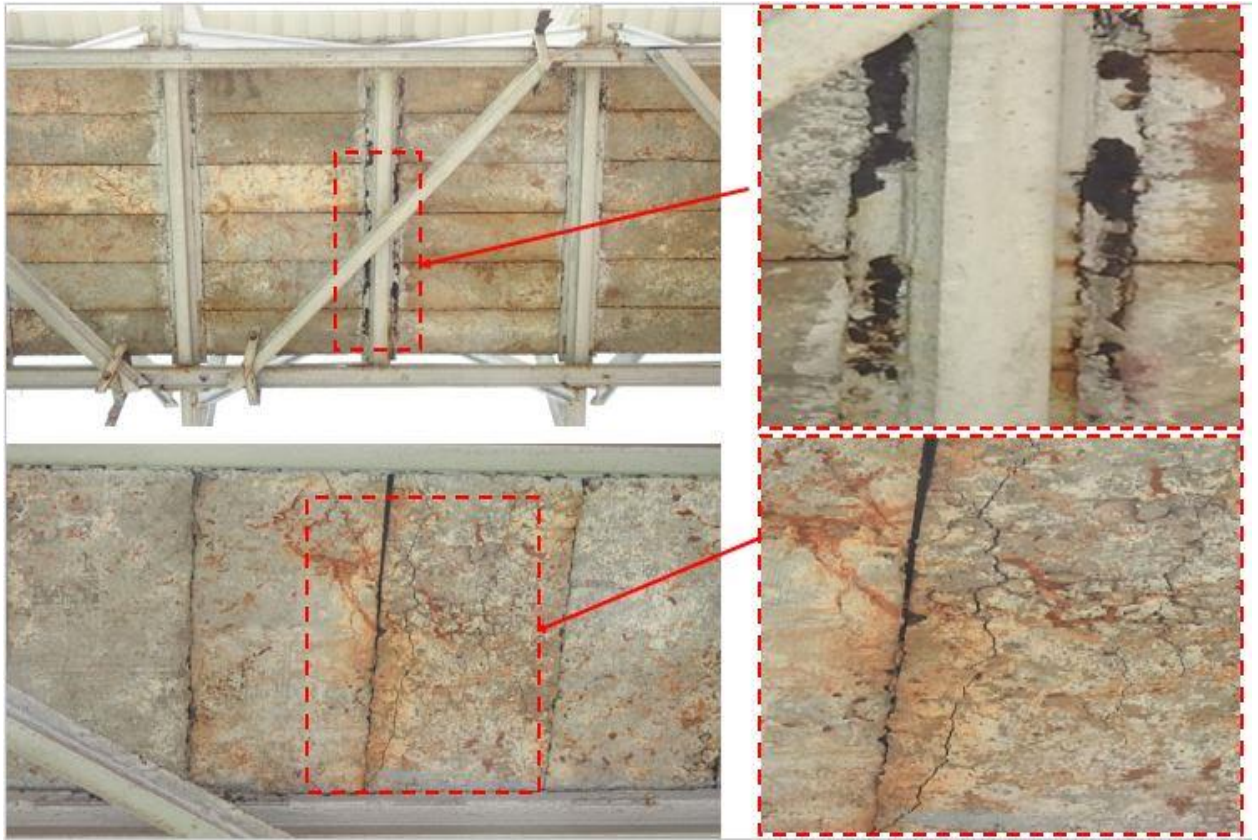
d) Corrosion & cracks observed at Span-4

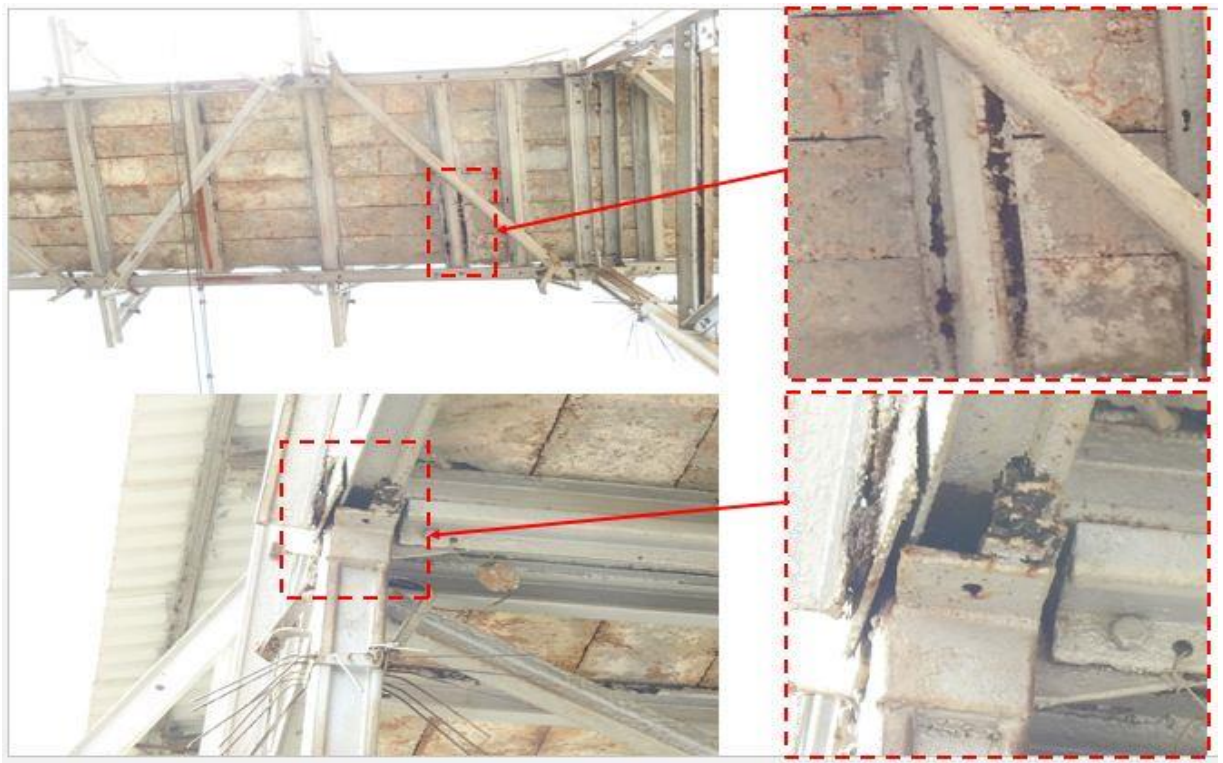
e) Corrosion observed at Floor beams and joints in Span-5

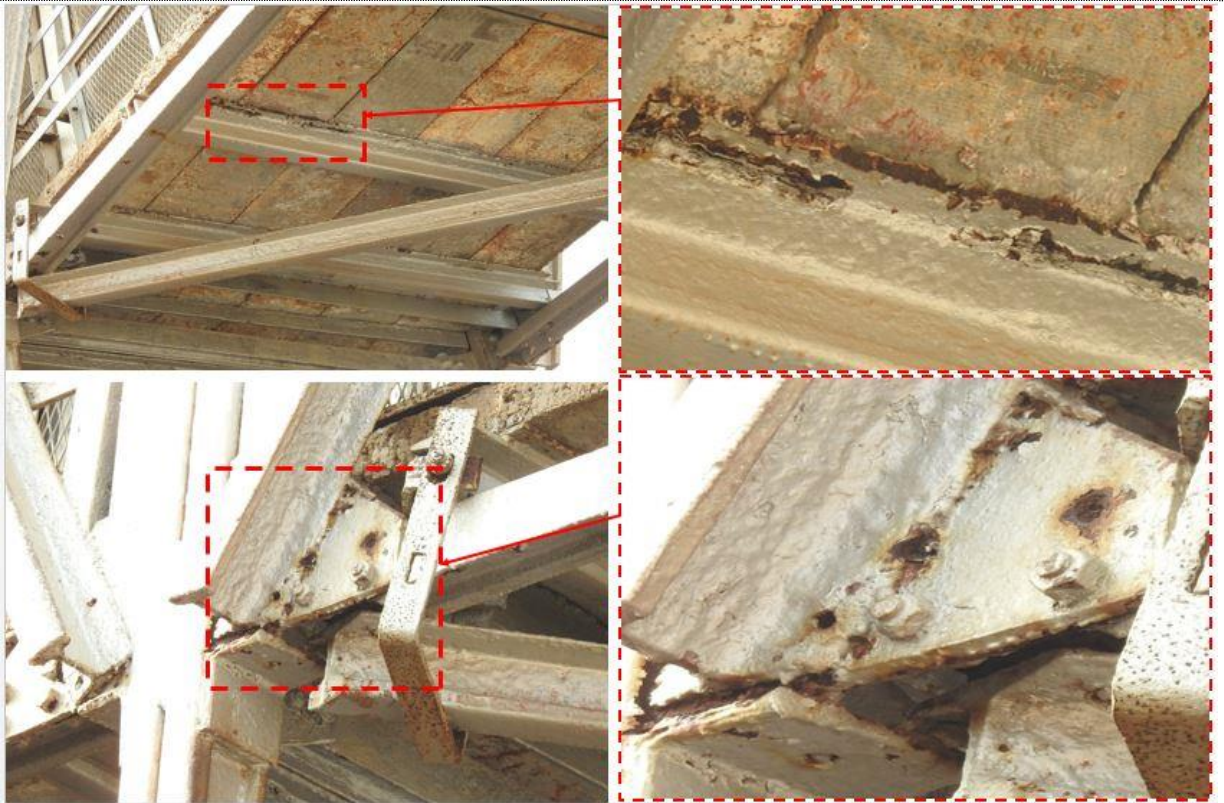
f) Corrosion observed at Floor beam & cleat angles of Span-6

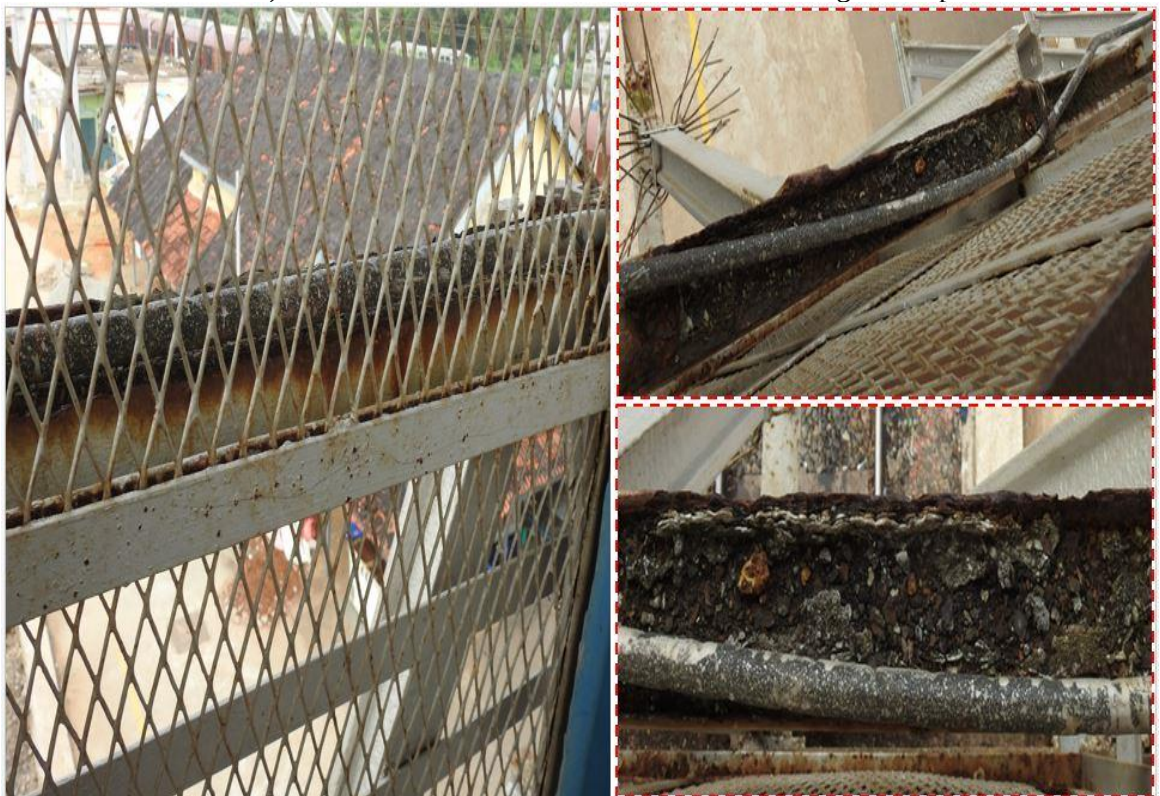
g) Corrosion observed at Top chord of Span-6

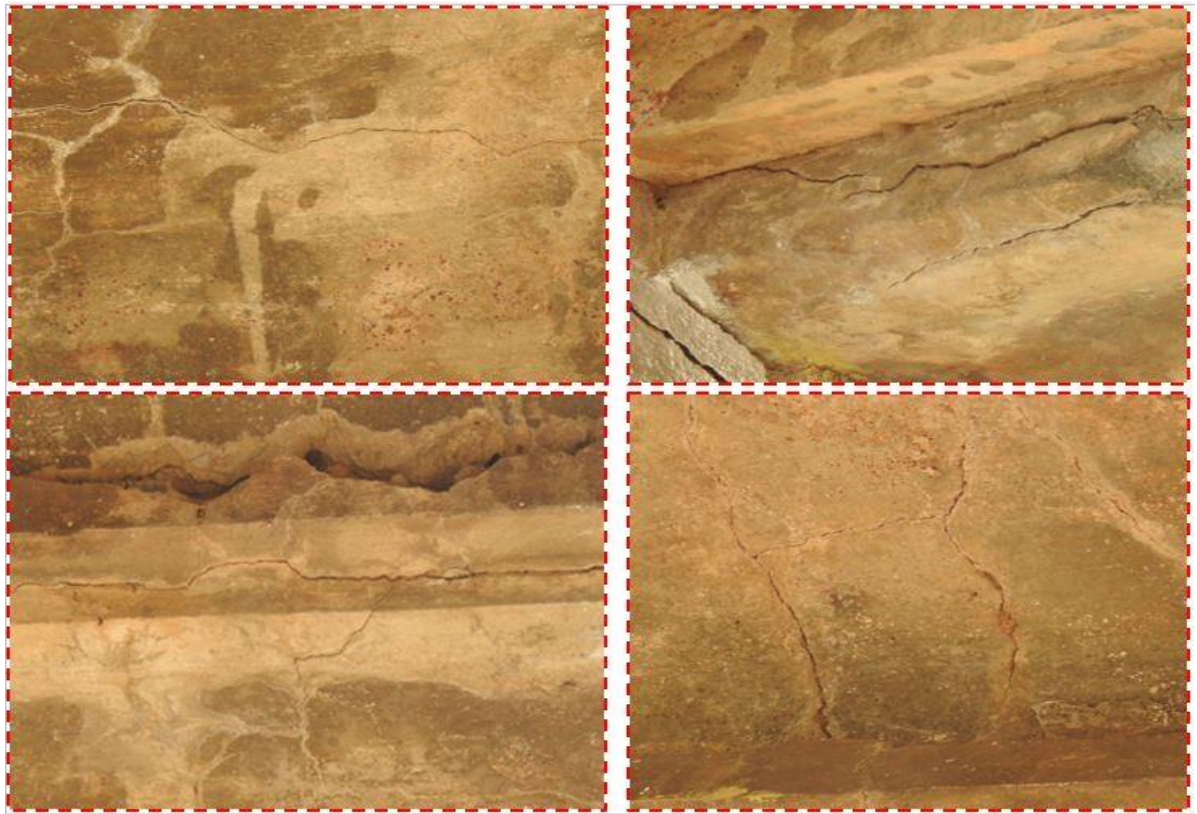
h) Cracks observed at Flight-1 of Staircase-2

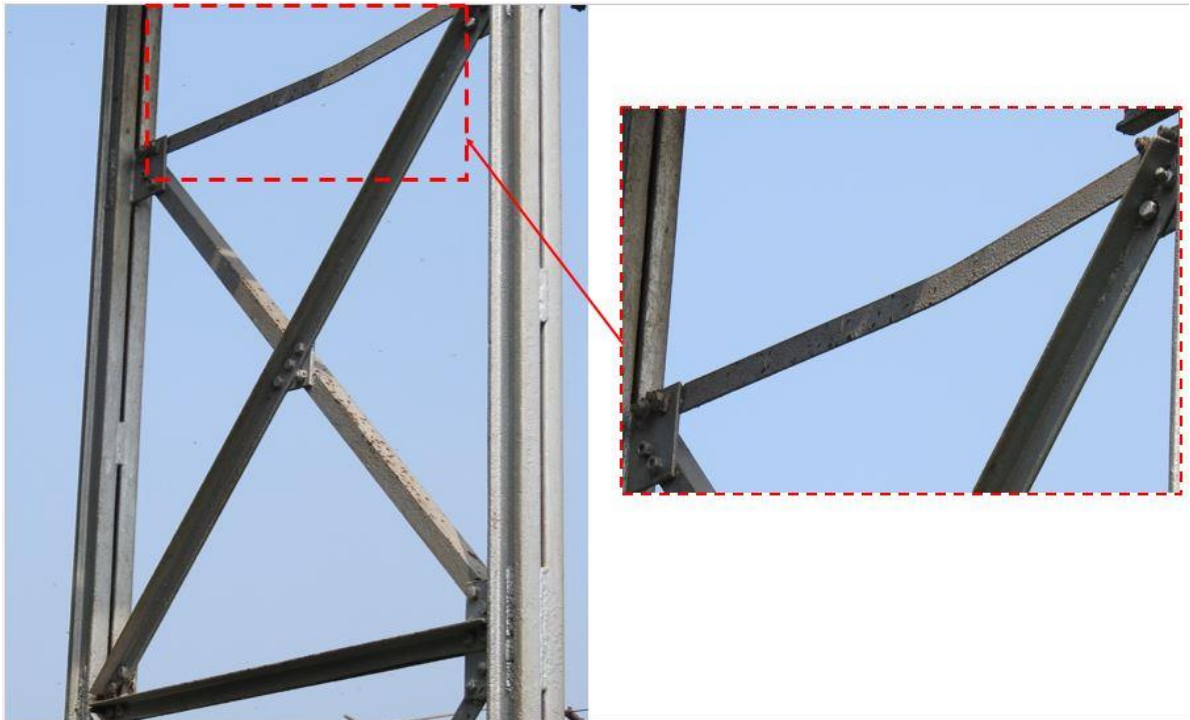
i) Deformation in Horizontal bracing of Stanchion-2

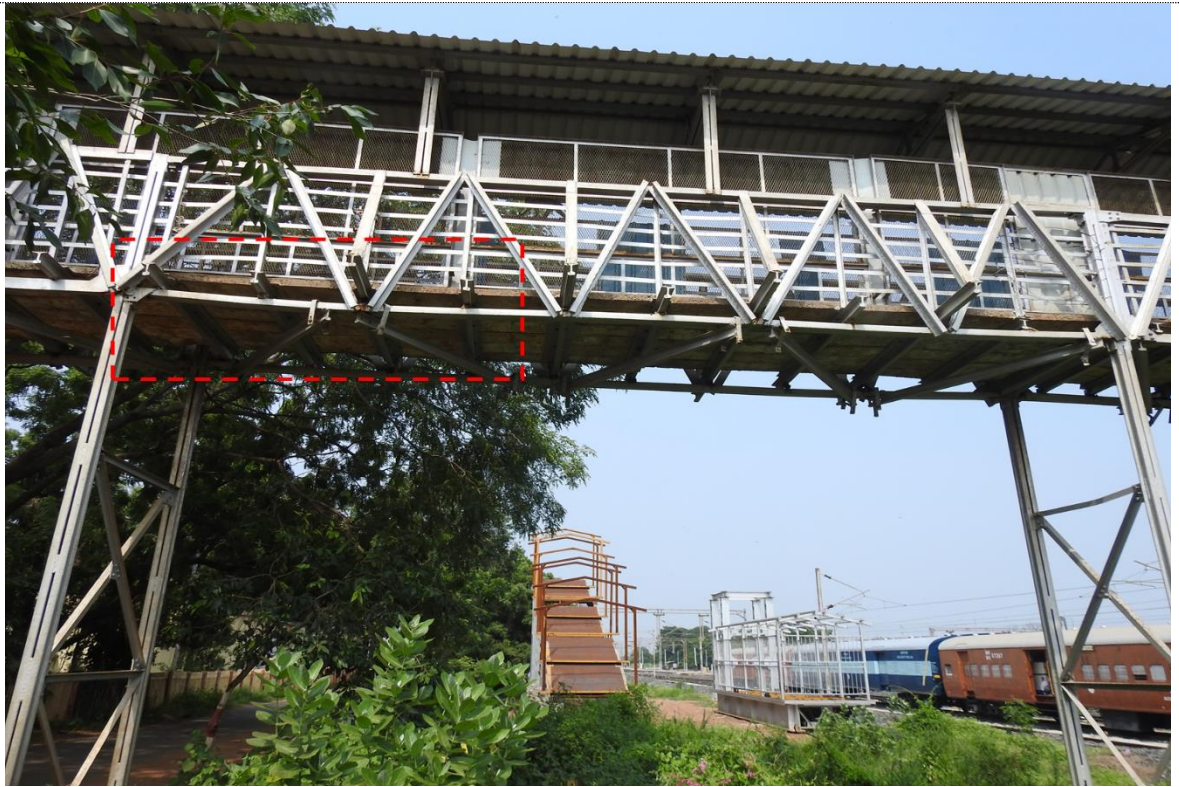
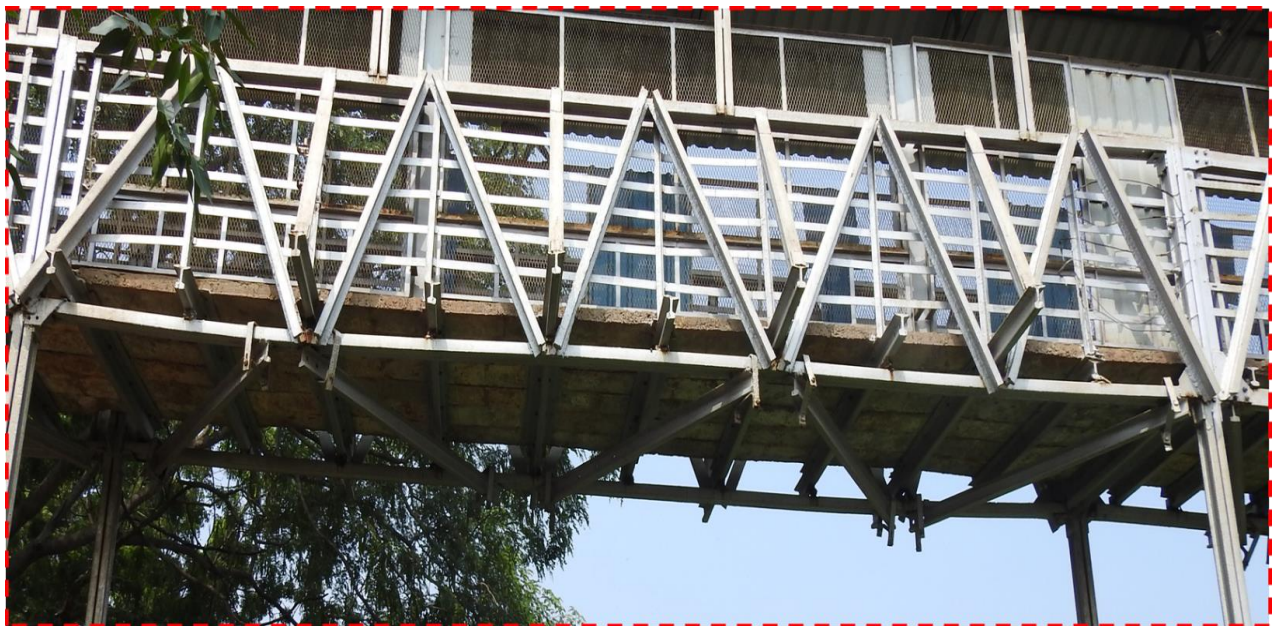
j) Deformation observed in Bottom chord of Span-2

| SIGNS OF DISTRESS/DEFORMATION IN BRIDGES | | | |
|---|---|---|---|
| | Deformation in steel members | Bottom chord of span 2 | Deformation observed in bottom chord of span-2 near the support & horizontal ties of stanchion-2 |

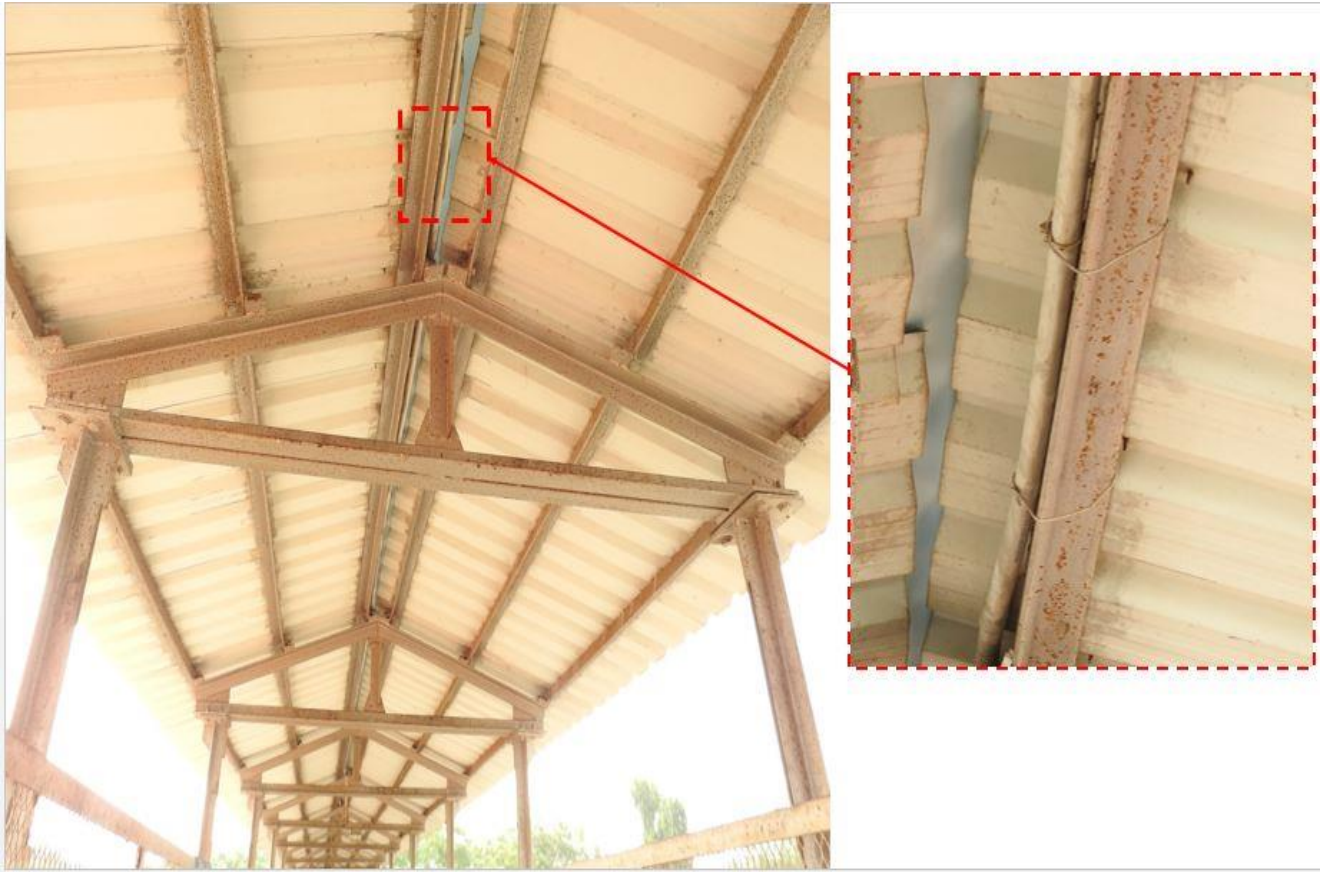
**Fig 1.8:** Additional loads of PVC pipes

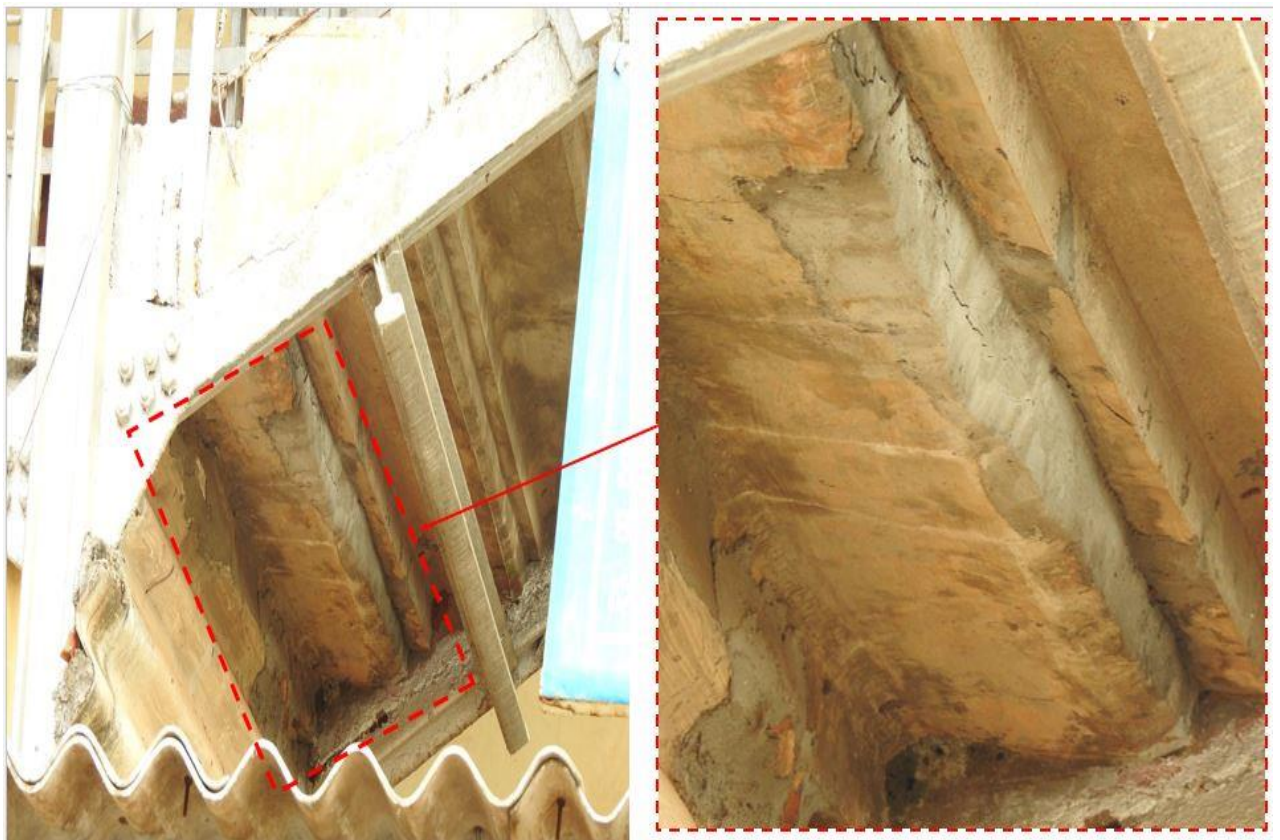
**Fig 1.11:** Patch work observed at Staircae-2

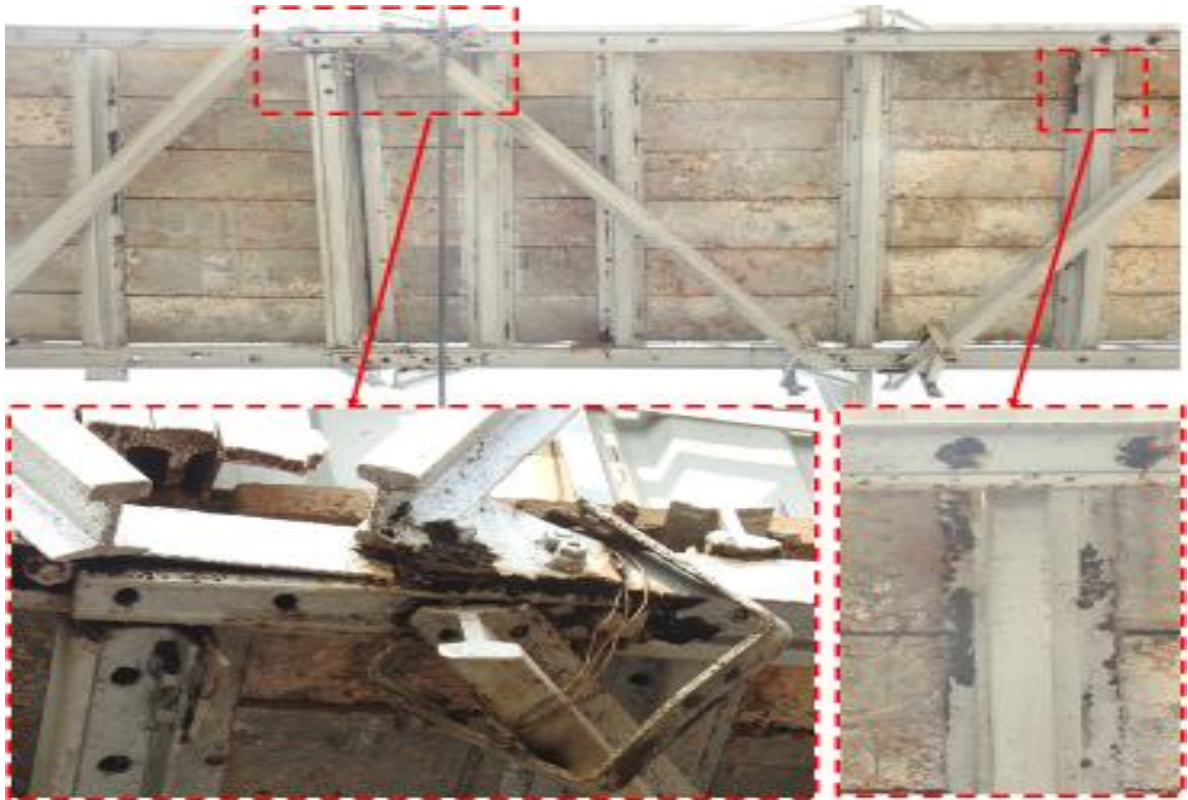
**Fig: 1.14** Corroded joints and floor beam

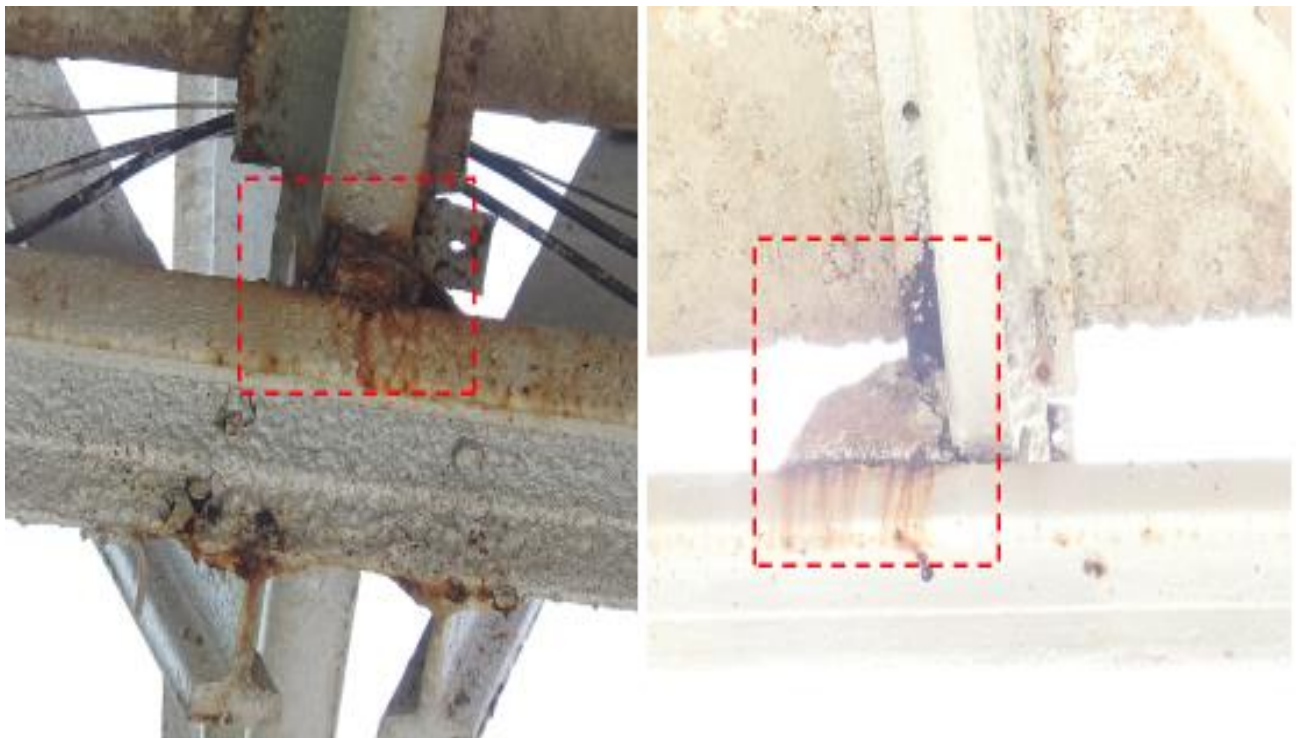
**Fig: 1.15** Rusty steel joints

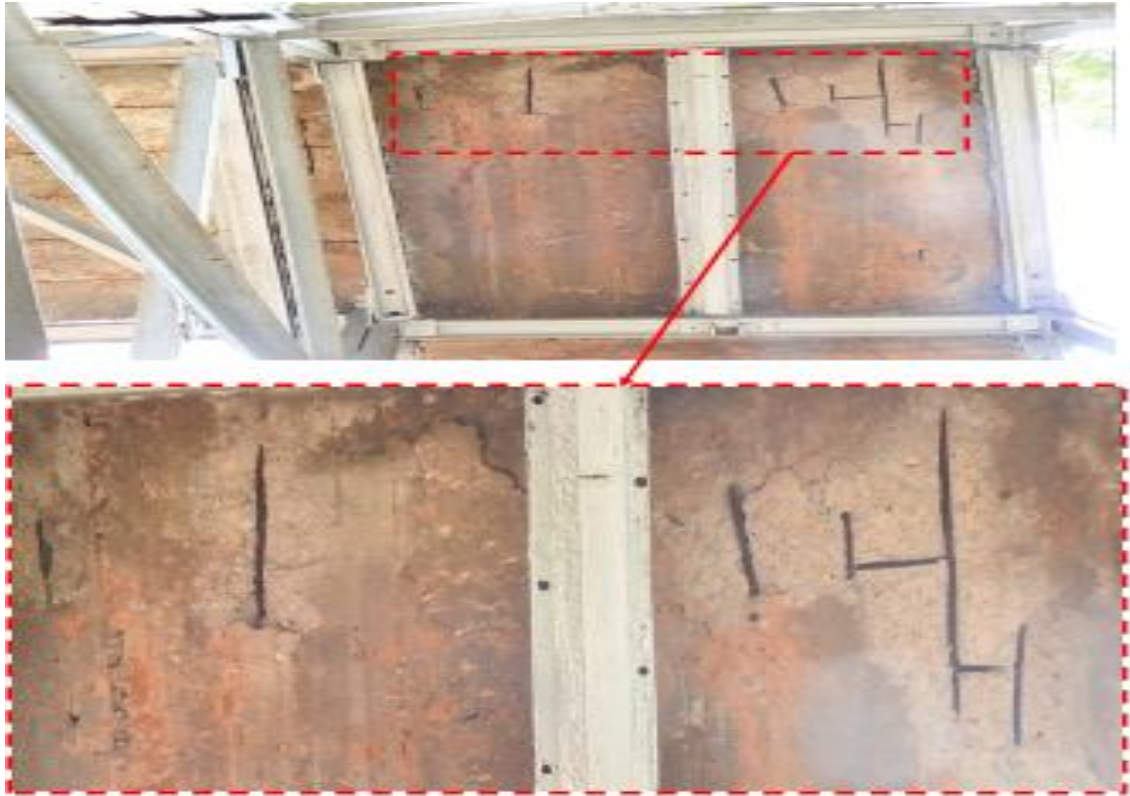
**Fig: 1.16** Damaged panels observed at mid – landing of Staircase-1

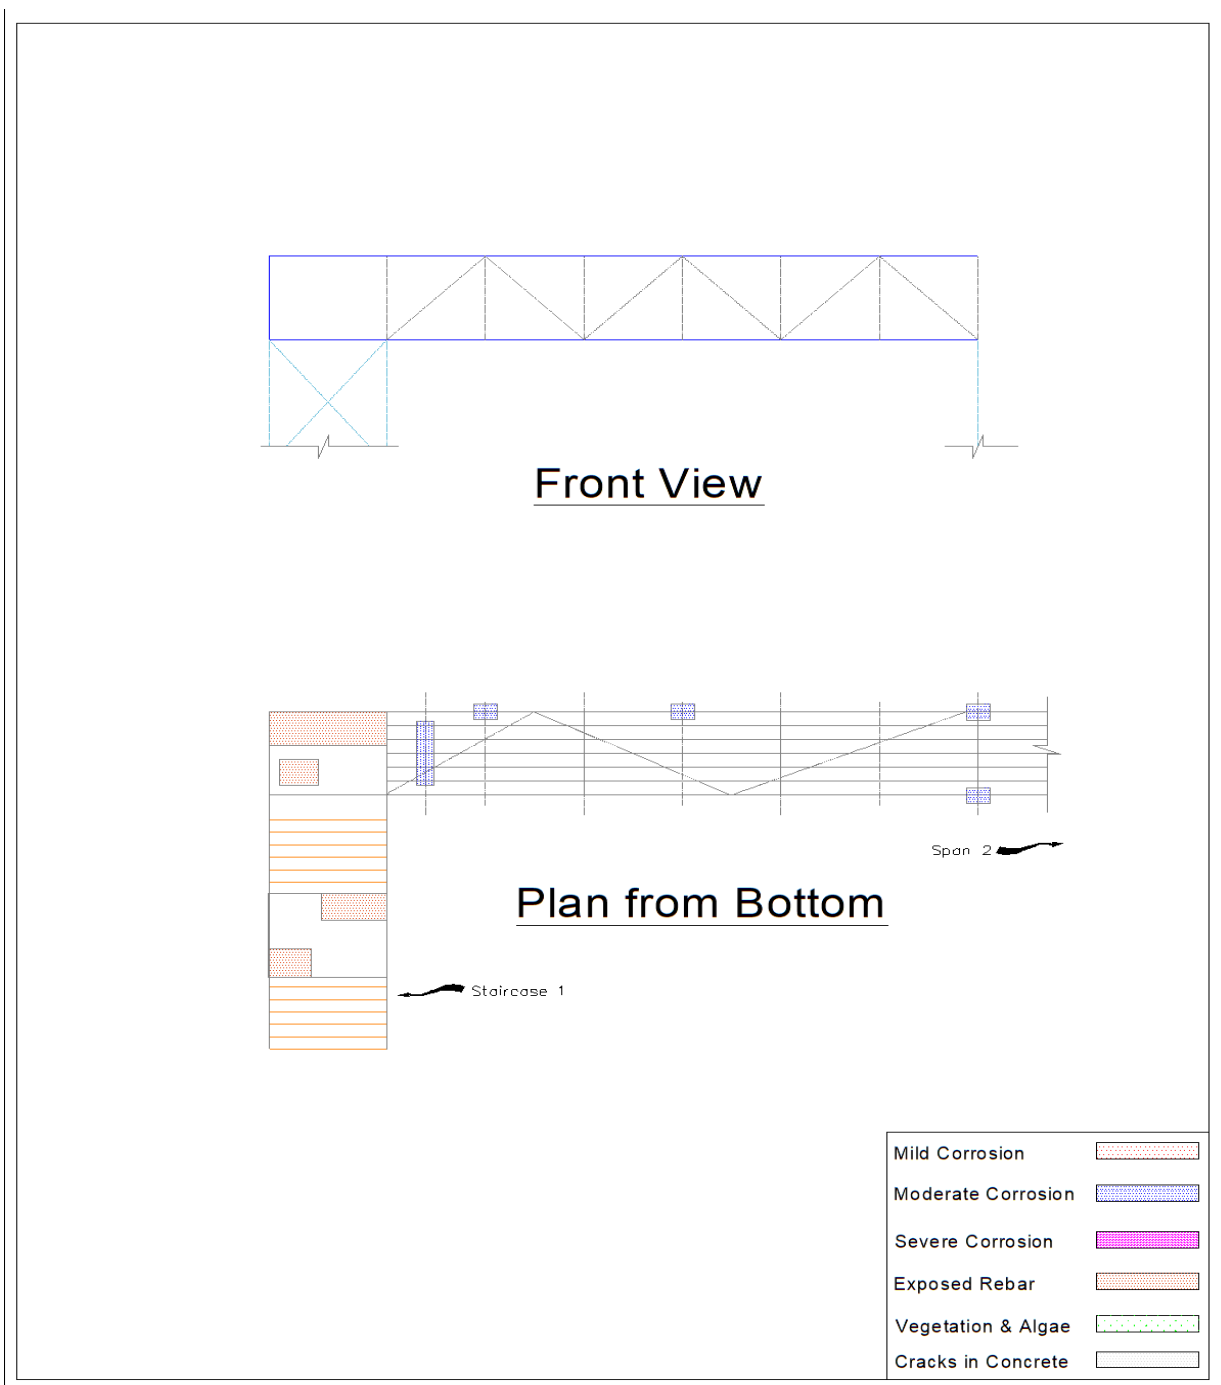
**Fig 2.1:** Locations of Deteriorations in Span 1

- Structural members are in fair condition, displaying mild corrosion for top chord members, verticals, diagonals, gusset plates, bottom chord members, and staircase stringer beam along steel concrete joint. (locations are marked in figures below).
- Staircase 1 precast slab panels are deteriorated reinforced is exposed in staircase RCC landing slab at deck level. (Photographs of the same can be see in **fig 2.2-2.3**)

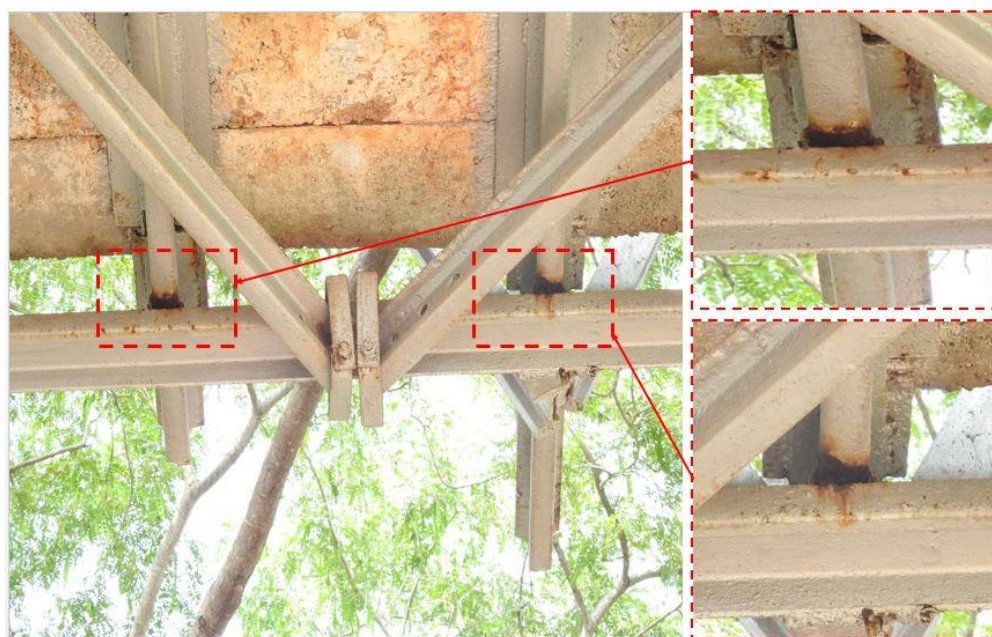
**Fig 2.3:** Corrosion at floor beam and bottom chord joint

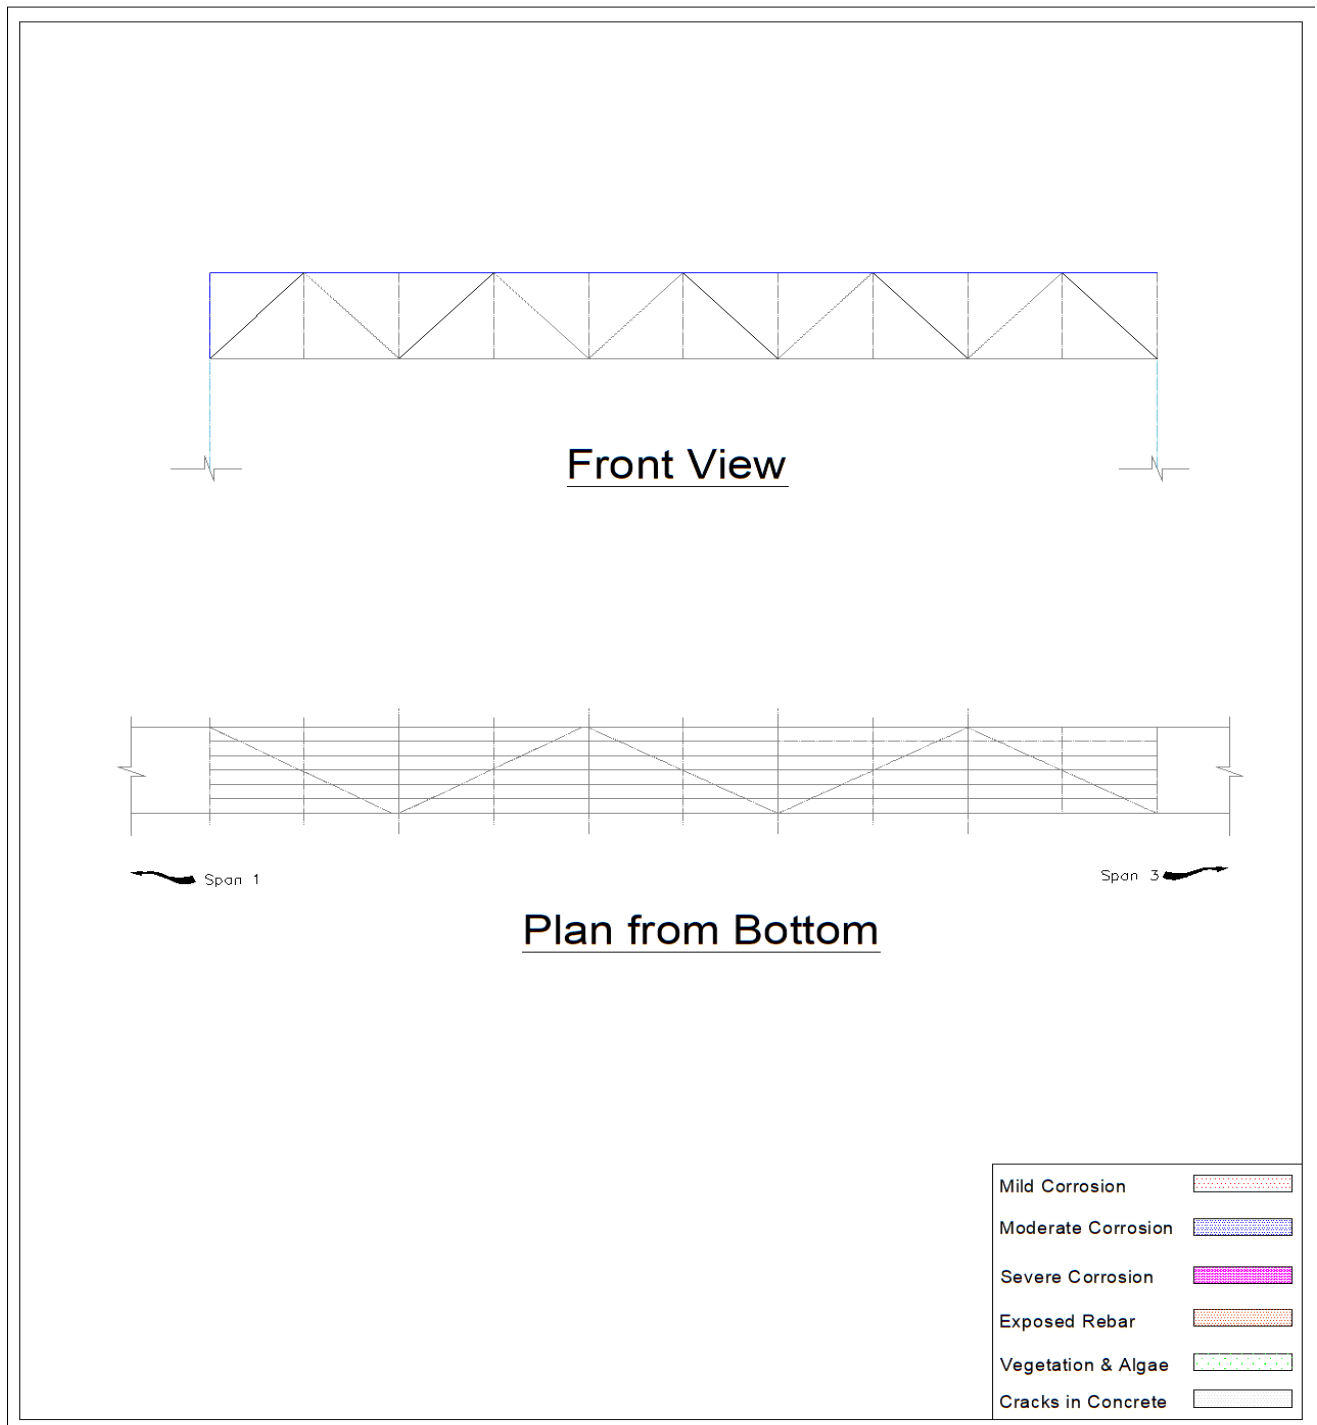
**Fig 2.4:** Locations of Deteriorations in Span 2

- Structural members are in fair condition, displaying mild corrosion in Top and Bottom chord members, verticals, floor beams and diagonals.
