## Third Party Audit of ROB's and FOB's of SCR

### INSPECTION OF FOB AT BITRAGUNTA (B) RAILWAY STATION

**Final Report**  
SEPTEMBER | 2020

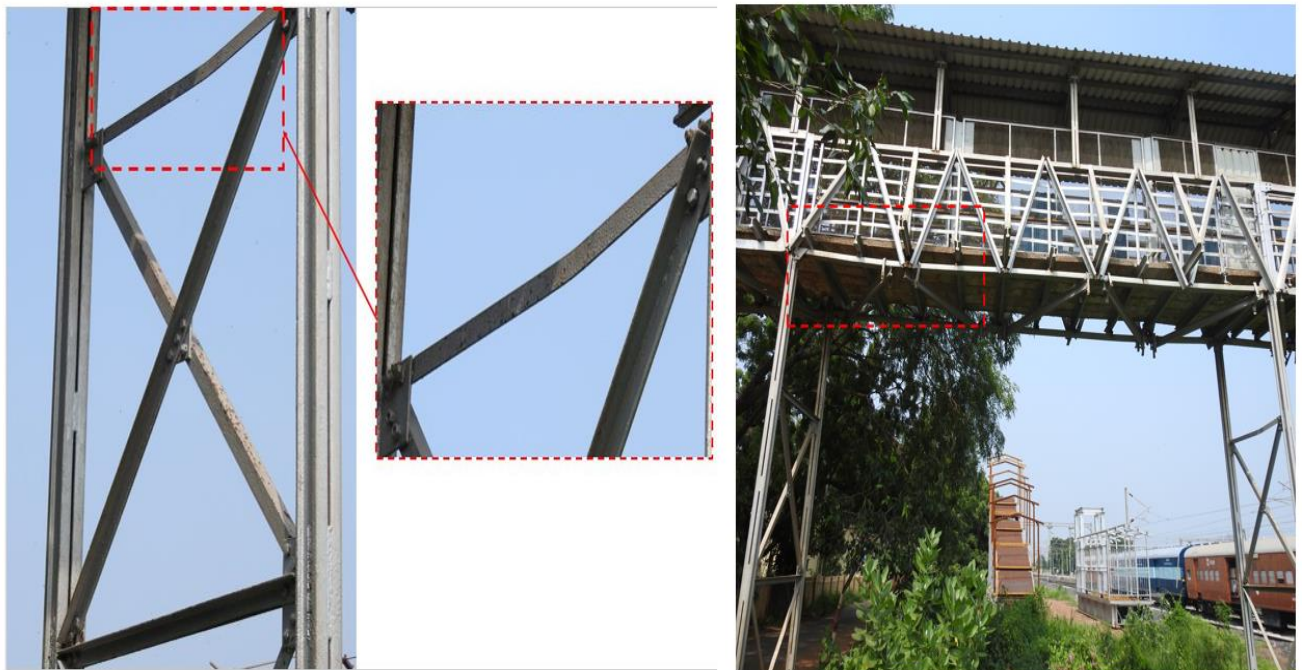
**Fig 2.5:** Deterioration locations of Horizontal bracing of stanchion 2 and Bottom chord of Span-2.

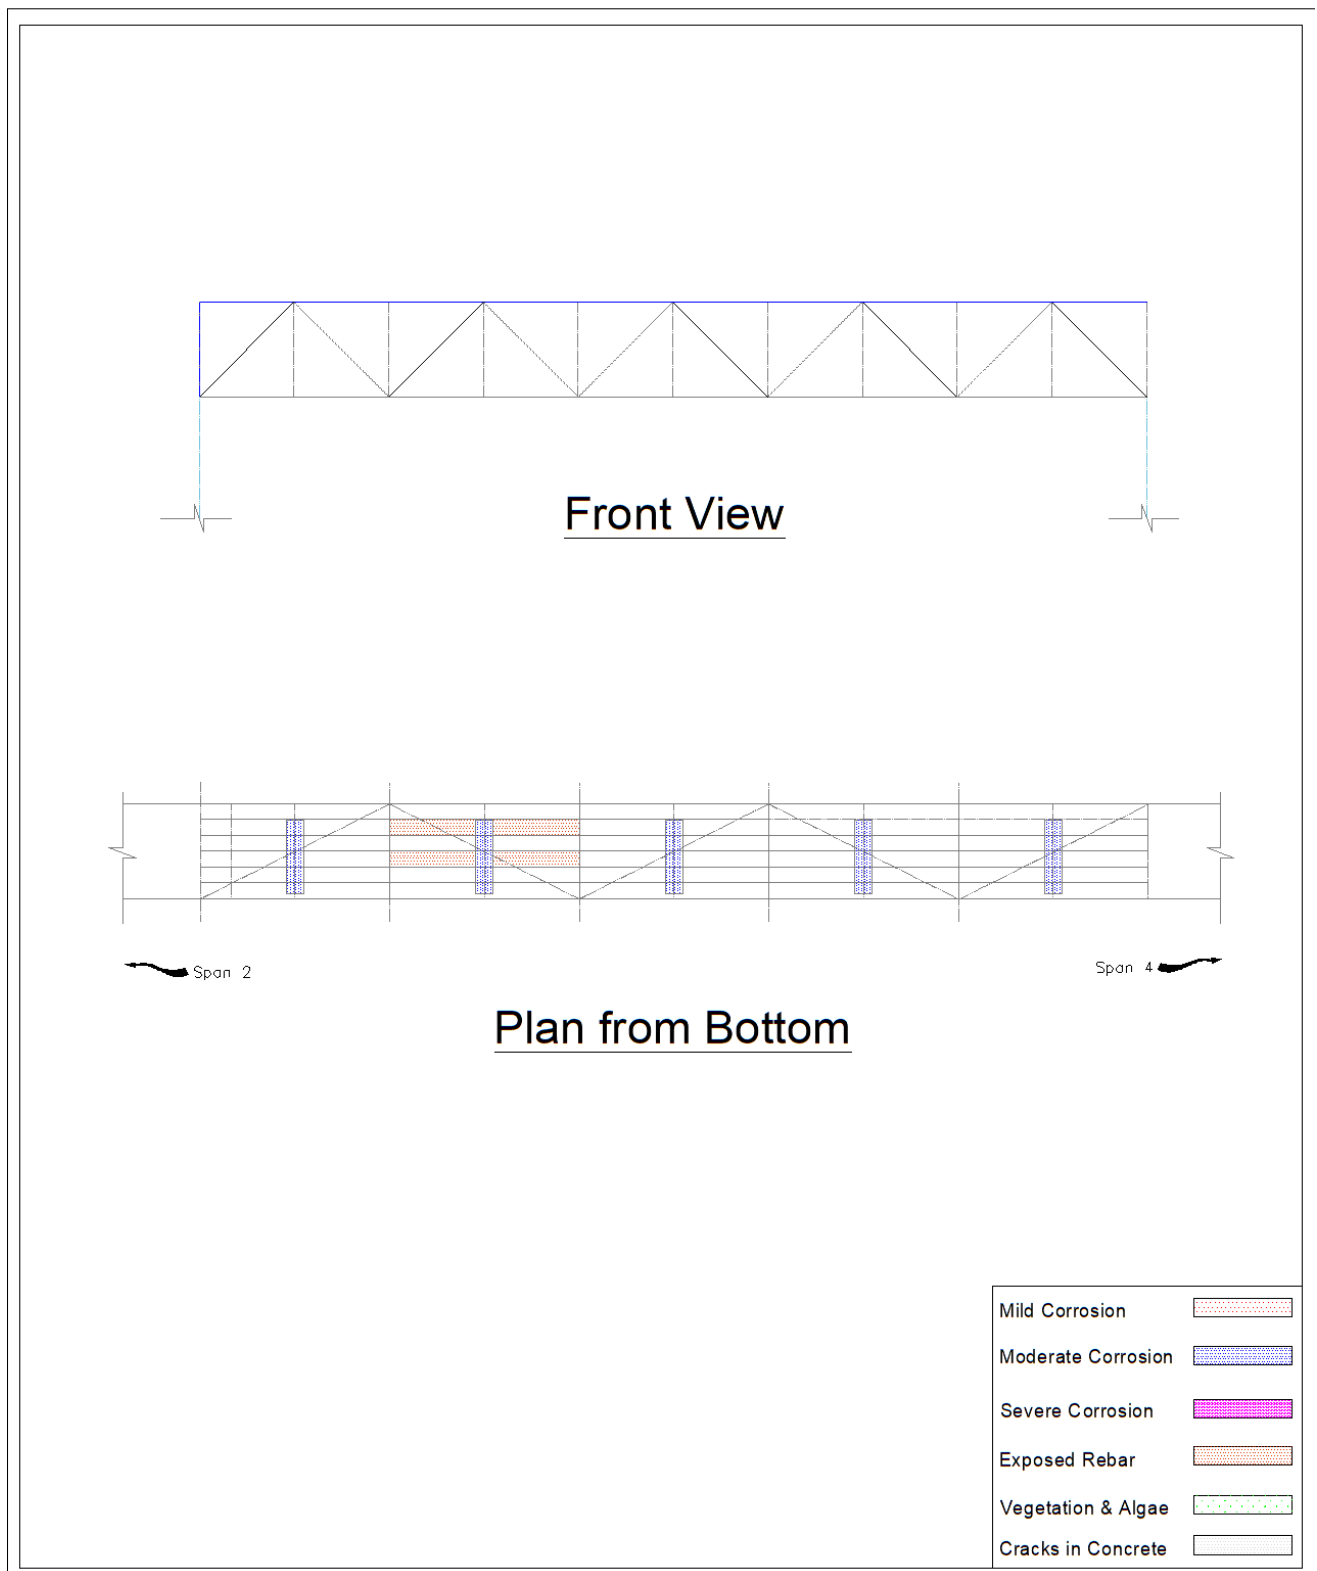
**Fig 2.6:** Locations of Deteriorations in Span 3 and staircase 3

- Structural members are in fair condition, displaying mild corrosion for top chord members, verticals, diagonals, gusset plates, bottom chord members, and moderate corrosion of floor beams.
- Deterioration of Precast RCC panels at deck level

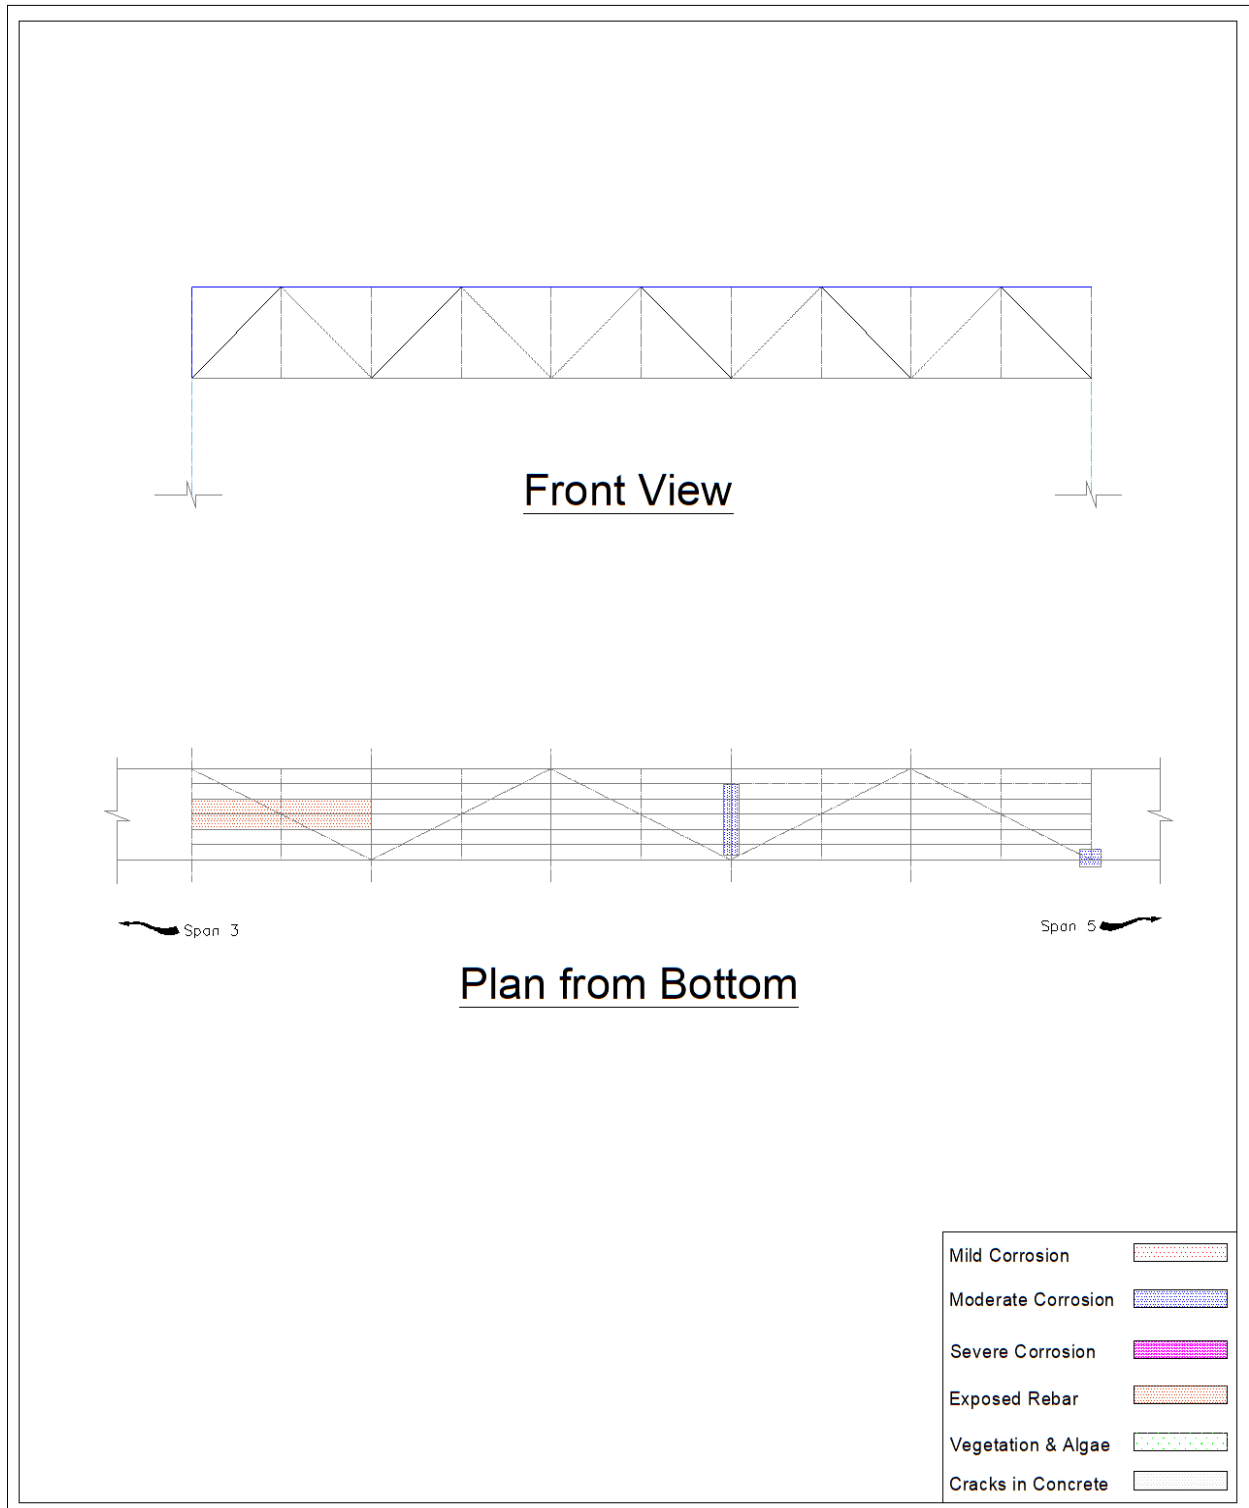
**Fig 2.8:** Locations of Deteriorations in Span 4

- Structural members are in fair condition, displaying mild corrosion for top chord members, verticals, diagonals, gusset plates, bottom chord members, and moderate corrosion of floor beams.
- Deterioration of Precast RCC panels at deck level

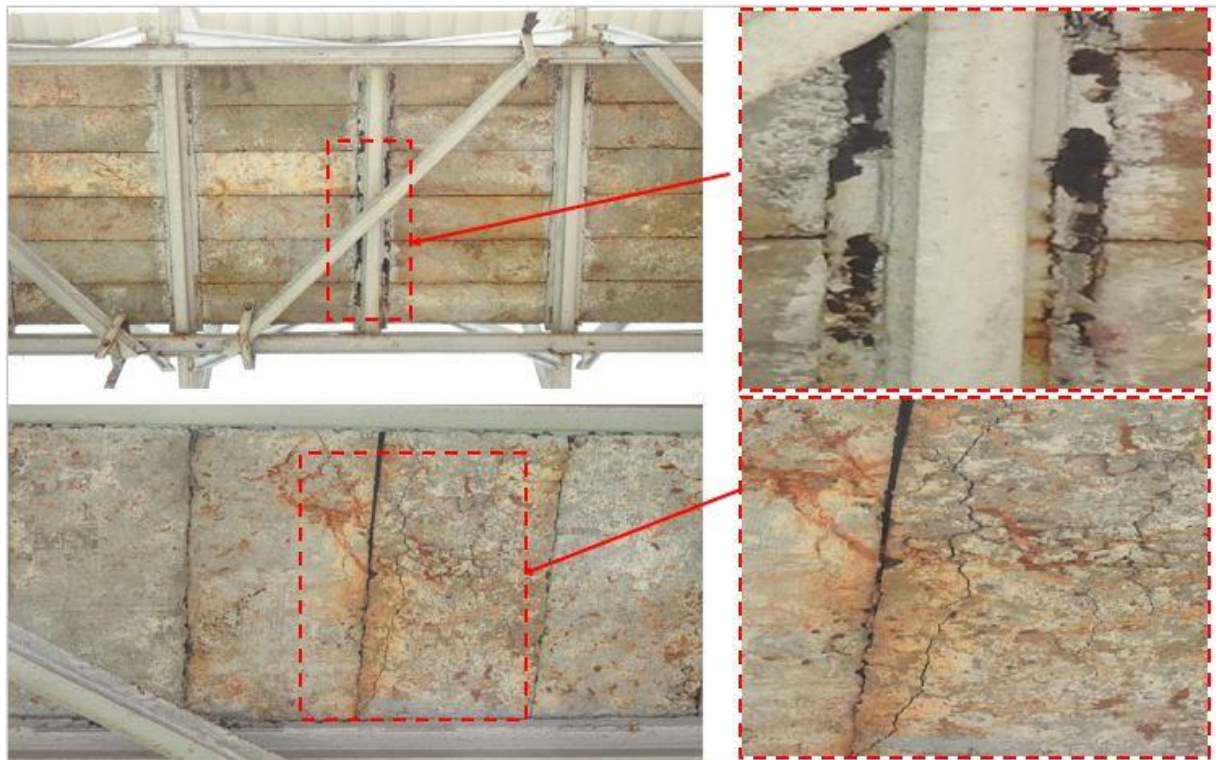
**Fig 2.9:** Floor beam corrosion and cracks in slab panels

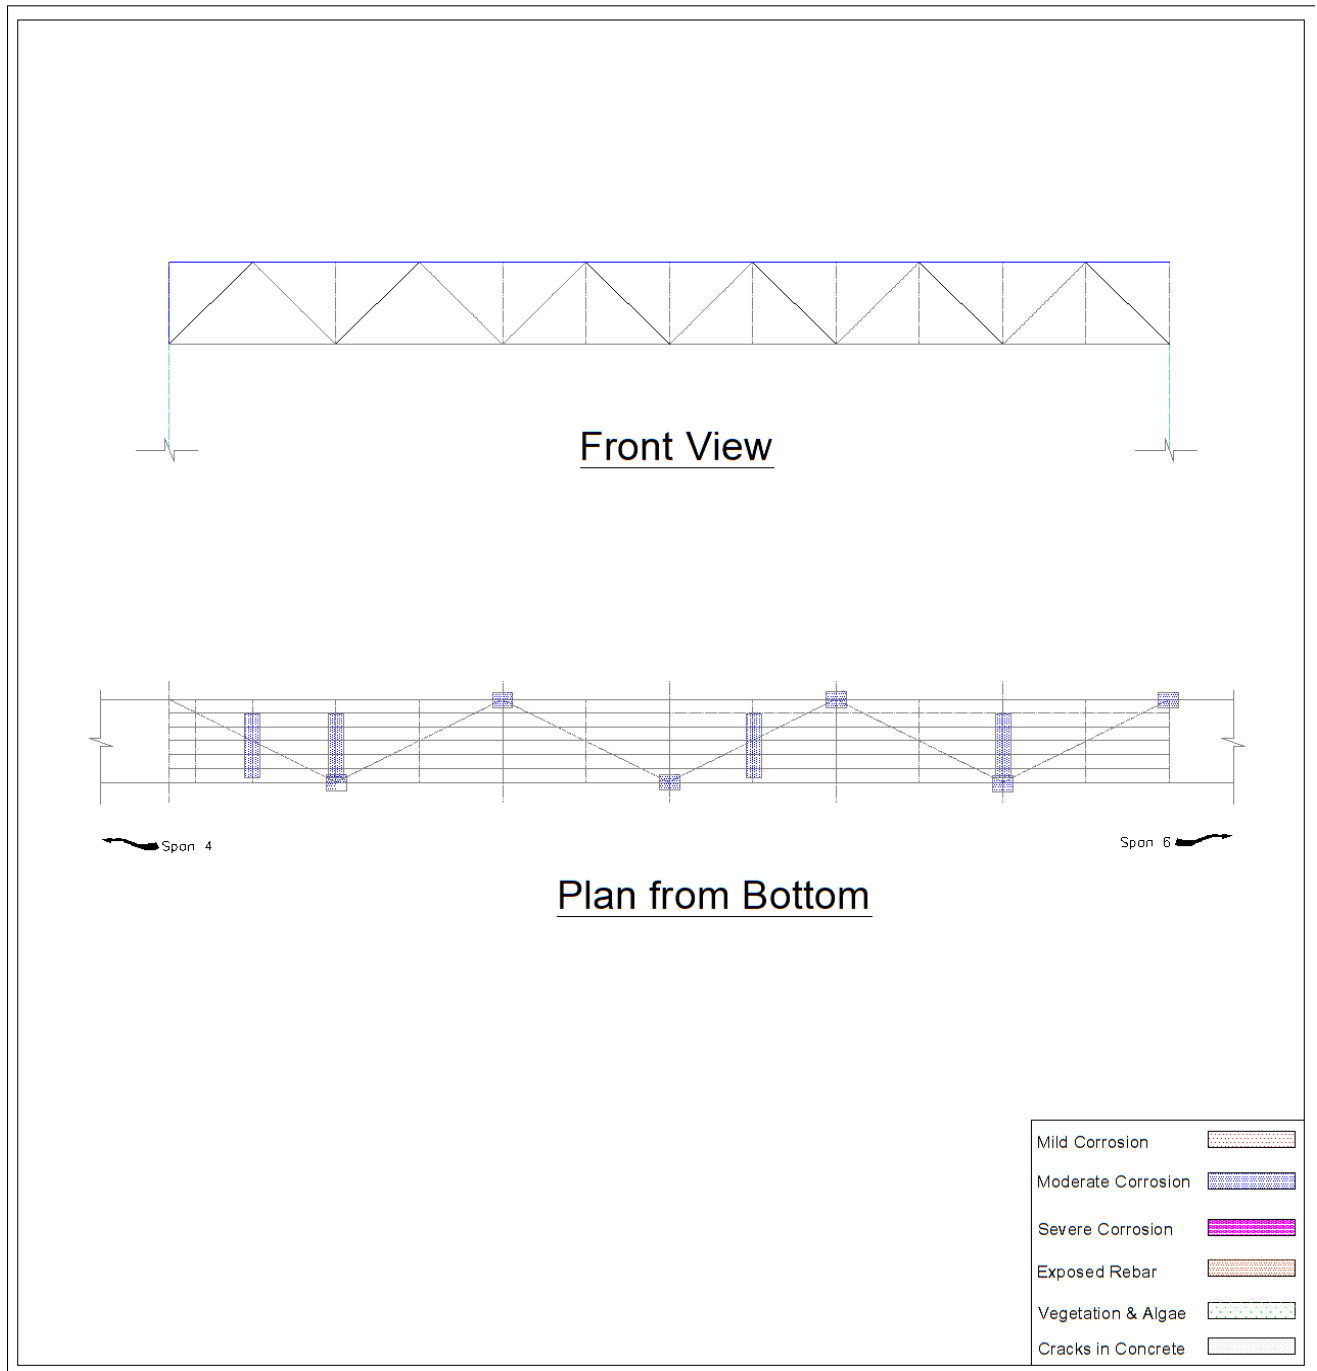
**Fig 2.10:** Locations of Deteriorations in Span 5

- Structural members are in fair condition, displaying mild corrosion for top chord members, verticals, diagonals, gusset plates, bottom chord members, and moderate corrosion of floor beams and at joints.

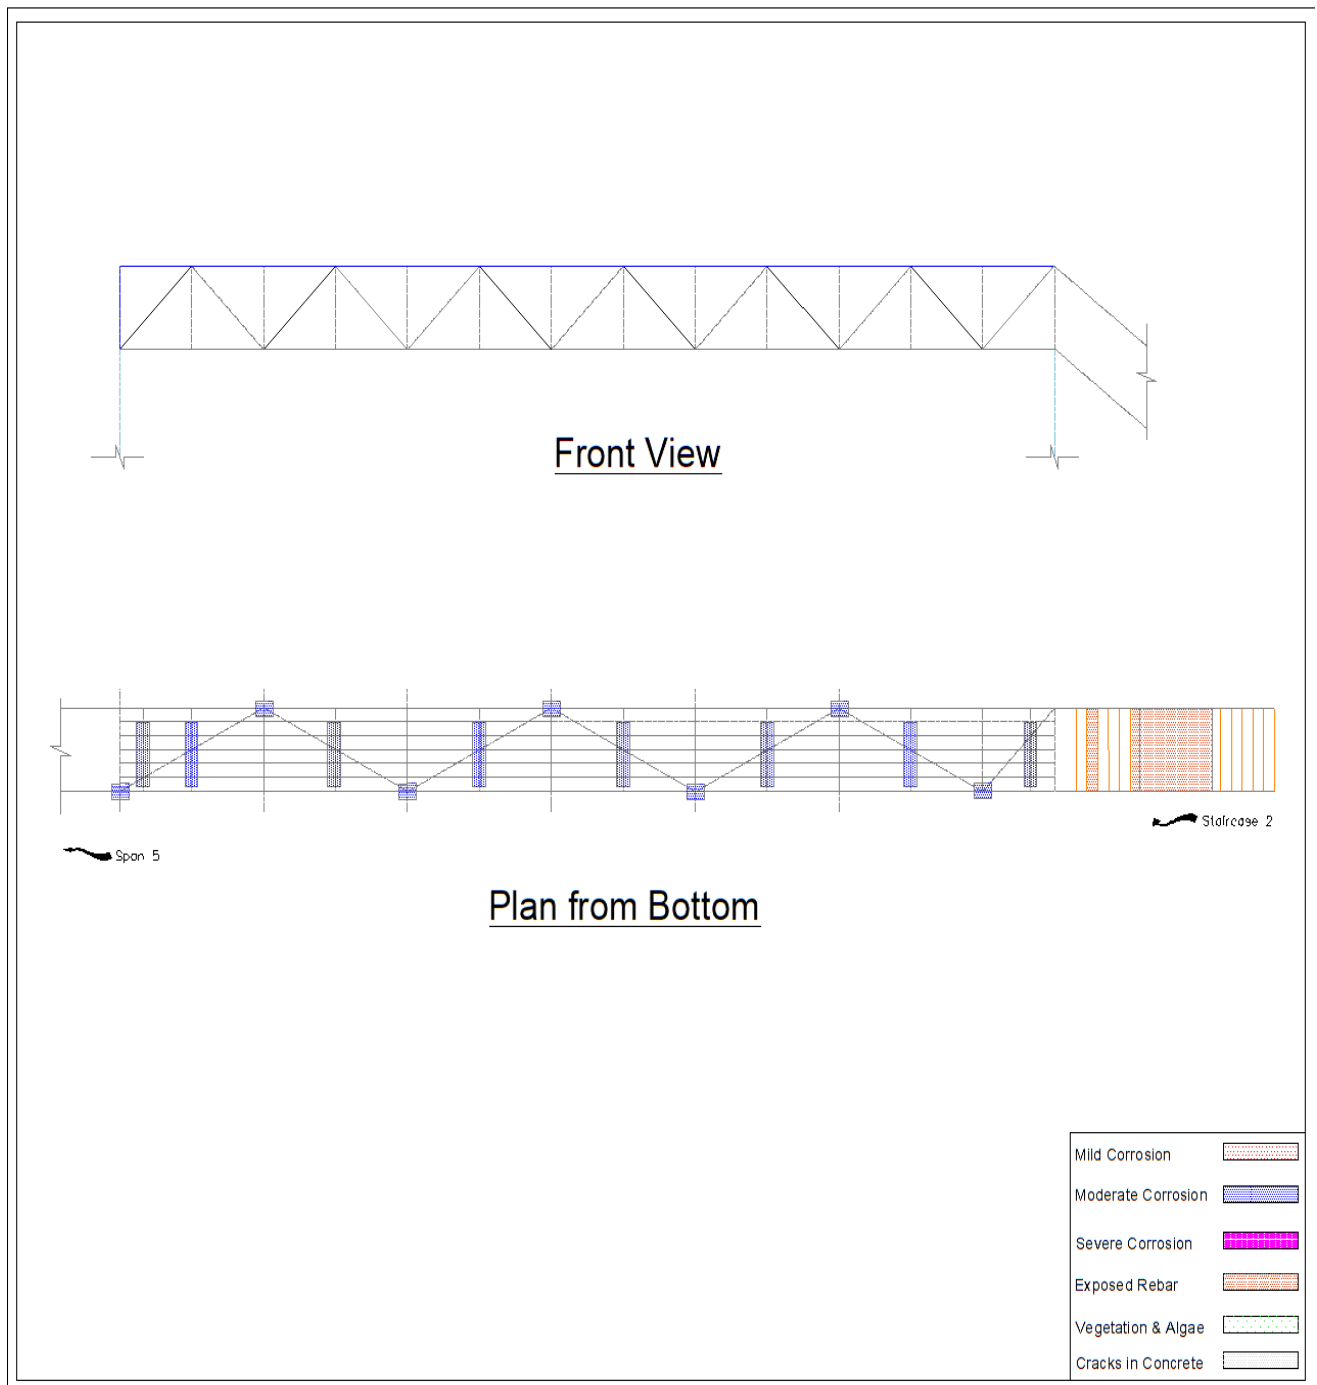
**Fig 2.12:** Locations of Deteriorations in Span 6

- Structural members are in fair condition, displaying mild corrosion for verticals, diagonals, gusset plates and moderate corrosion of floor beams, Top and Bottom chord members.
- Deterioration of Precast RCC panels at deck level and reinforcement exposure is also observed in Staircase landing.

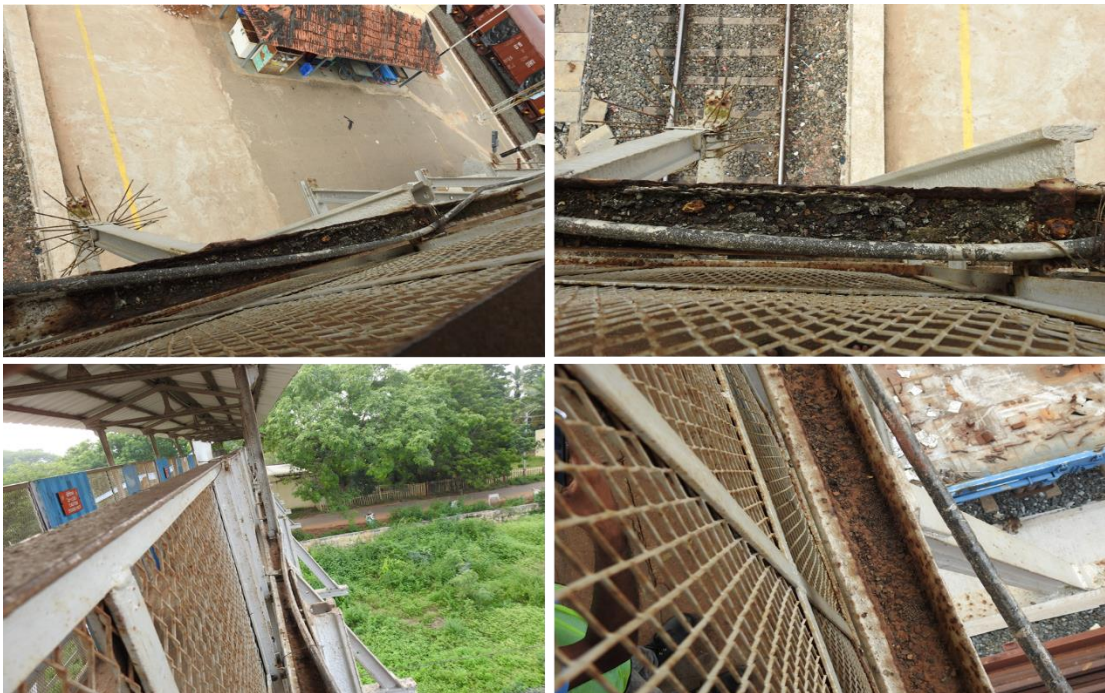
**Fig 2.13:** Locations of Corrosion observed at top chord members

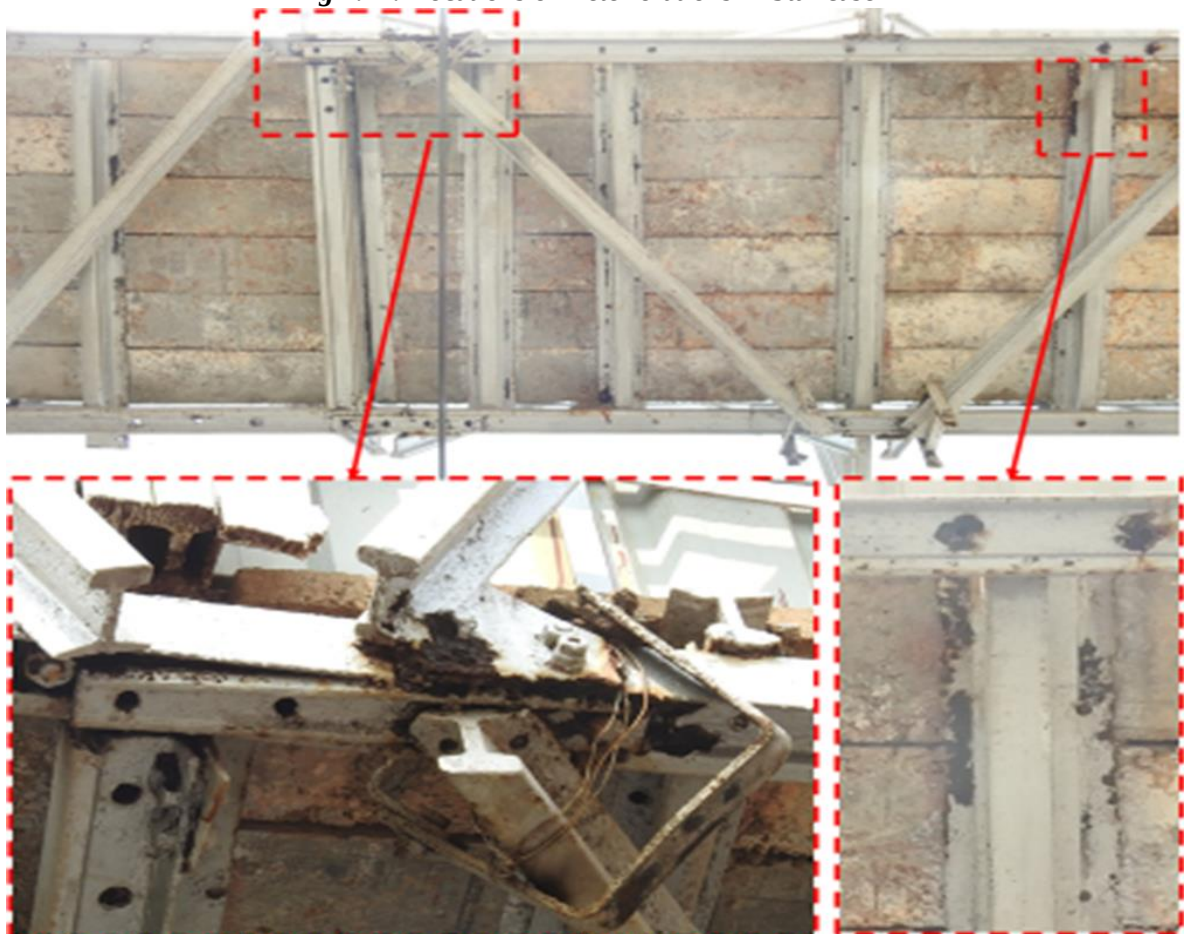
**Fig 2.15:** corrosion of floor beams and Bottom chord.
