## Third Party Audit of ROB's and FOB's of SCR

### INSPECTION OF FOB AT REPALLE RAILWAY STATION

**Final Report**  
SEPTEMBER | 2020

| <b>Name of the Project</b> | : | VISUAL INSPECTION OF FOB AT REPALLE RAILWAY STATION |

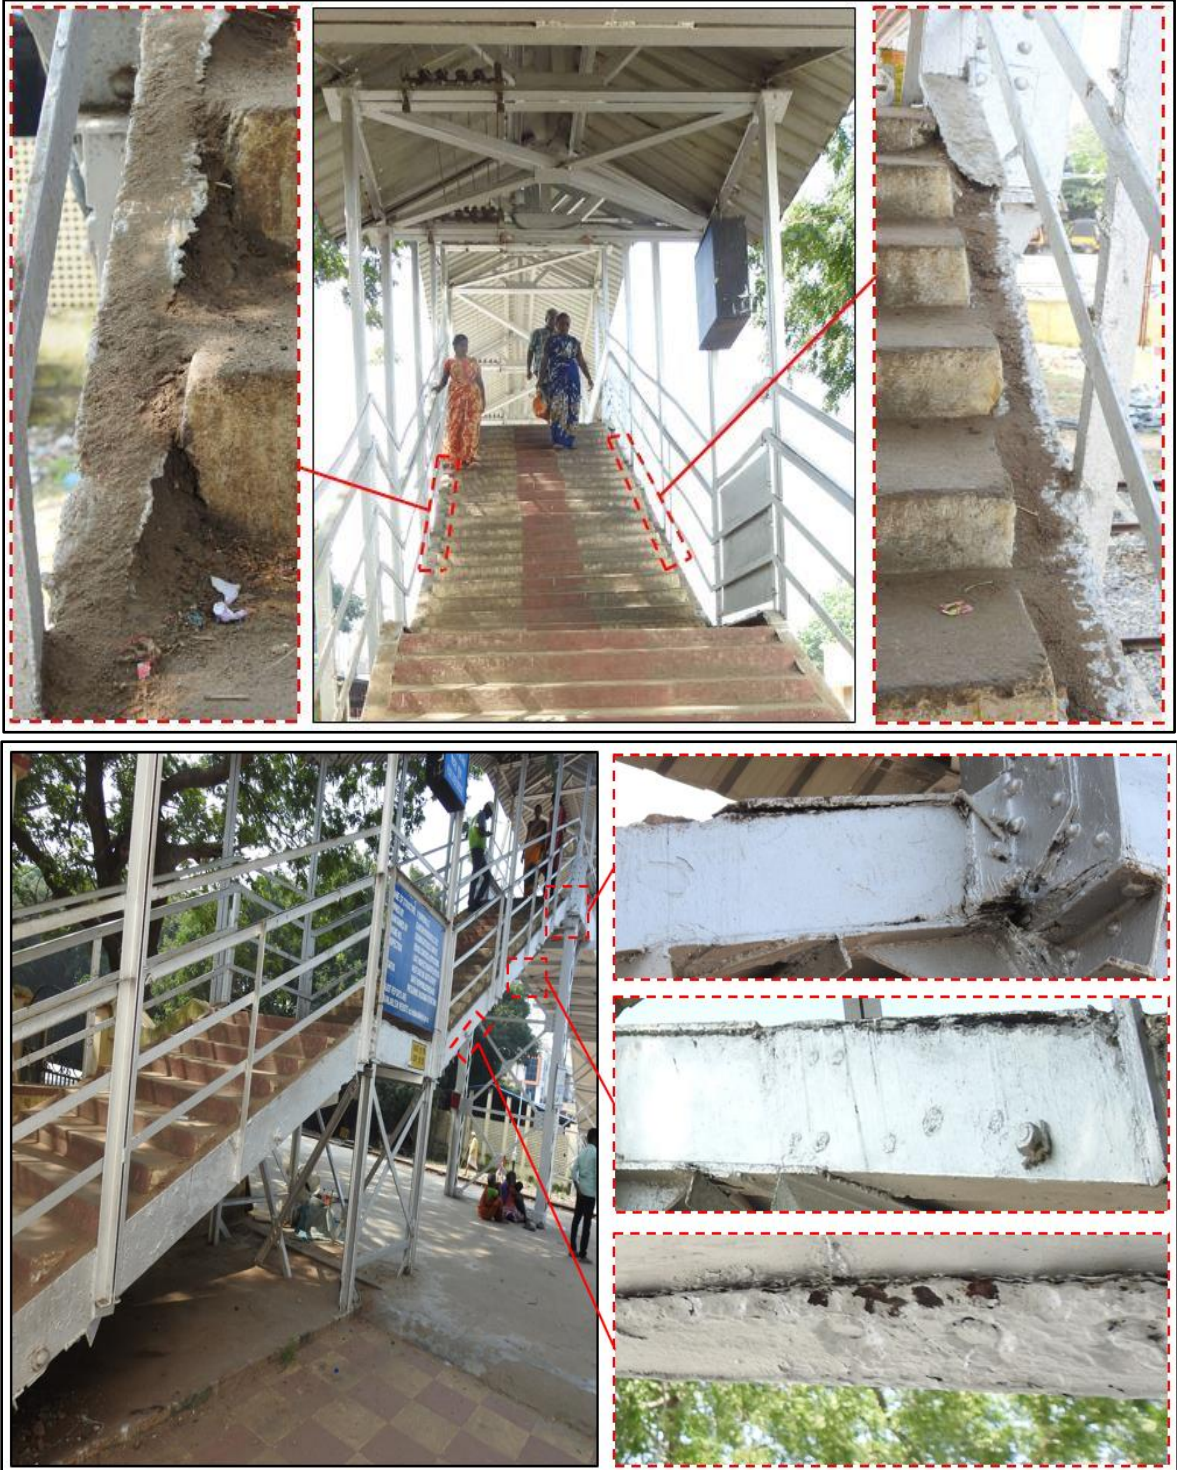
a) Corrosion observed at Staircase 1 Stringer beam

- c) Replacement of damaged members or severely corroded members, staircase stinger beam at staircase-1 and staircase-2. Cleat angles connecting Stanchion and Staircase and Gusset plate.

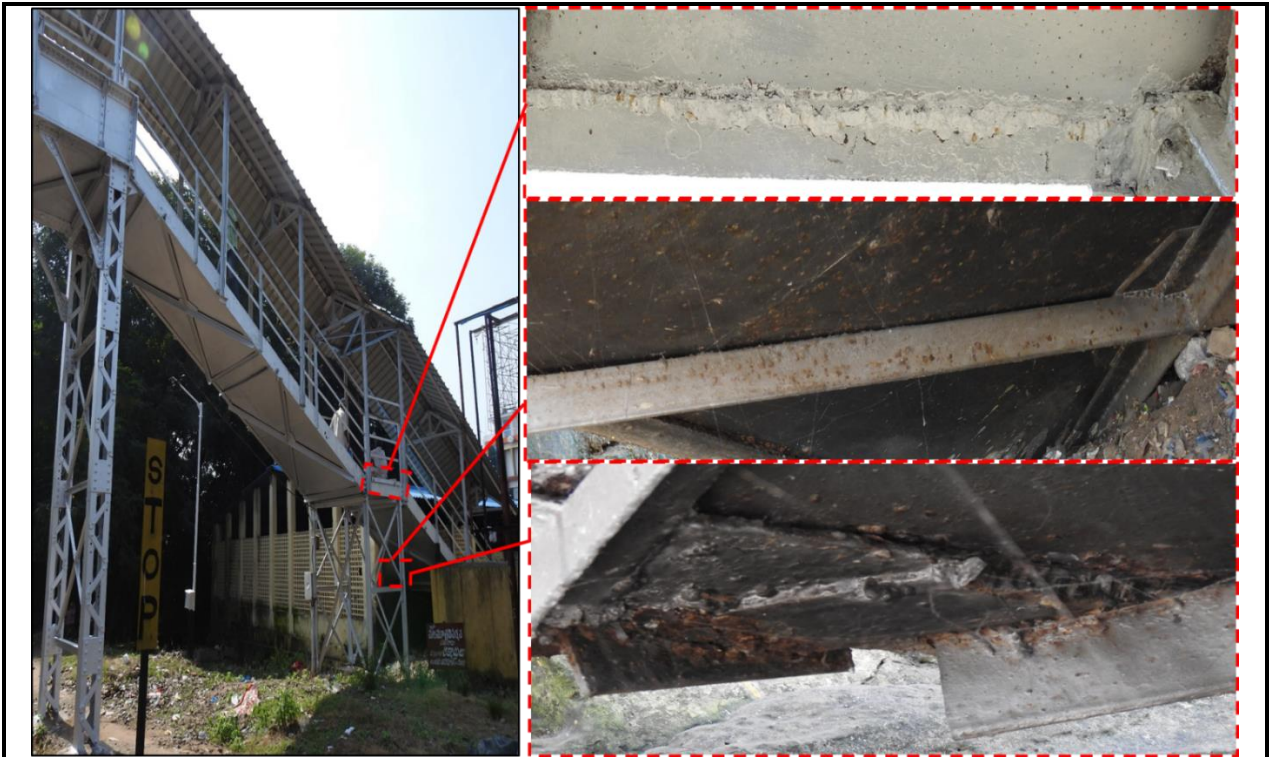
b) Corrosion observed at Staircase 2 Stringer beam and Corrosion of cross bracing

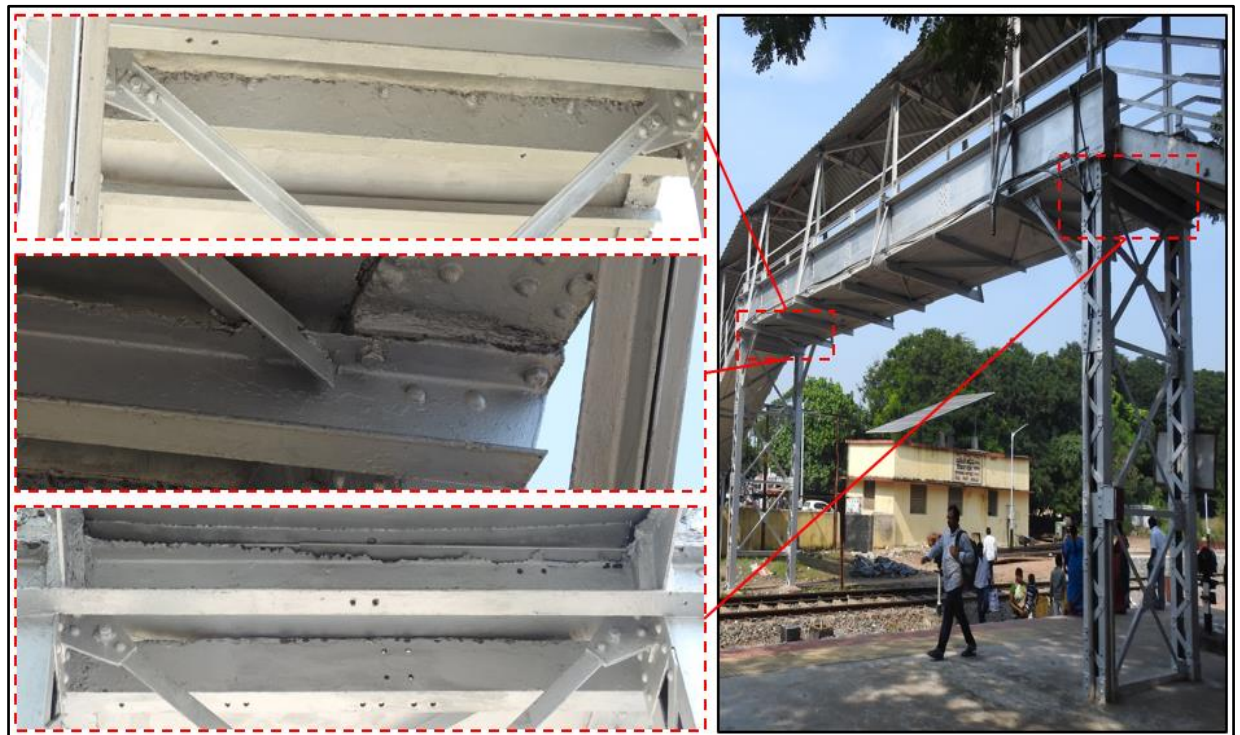
a) Corrosion observed at floor beams of FOB

| SIGNS OF DISTRESS, DEFORMATION IN BRIDGES | | | |
|---|---|---|---|
| | Corrosion | Floor level | Corrosion is observed the Floor Beams of FOB. (Refer <b>Part 1.4(b)</b> ) |

- a) Cleaning of debris immediately to avoid deterioration of concrete and steel members.
  - b) Anti-corrosion treatment for Grade-1 and Grade-2 highlighted corrosive members for floor beams.

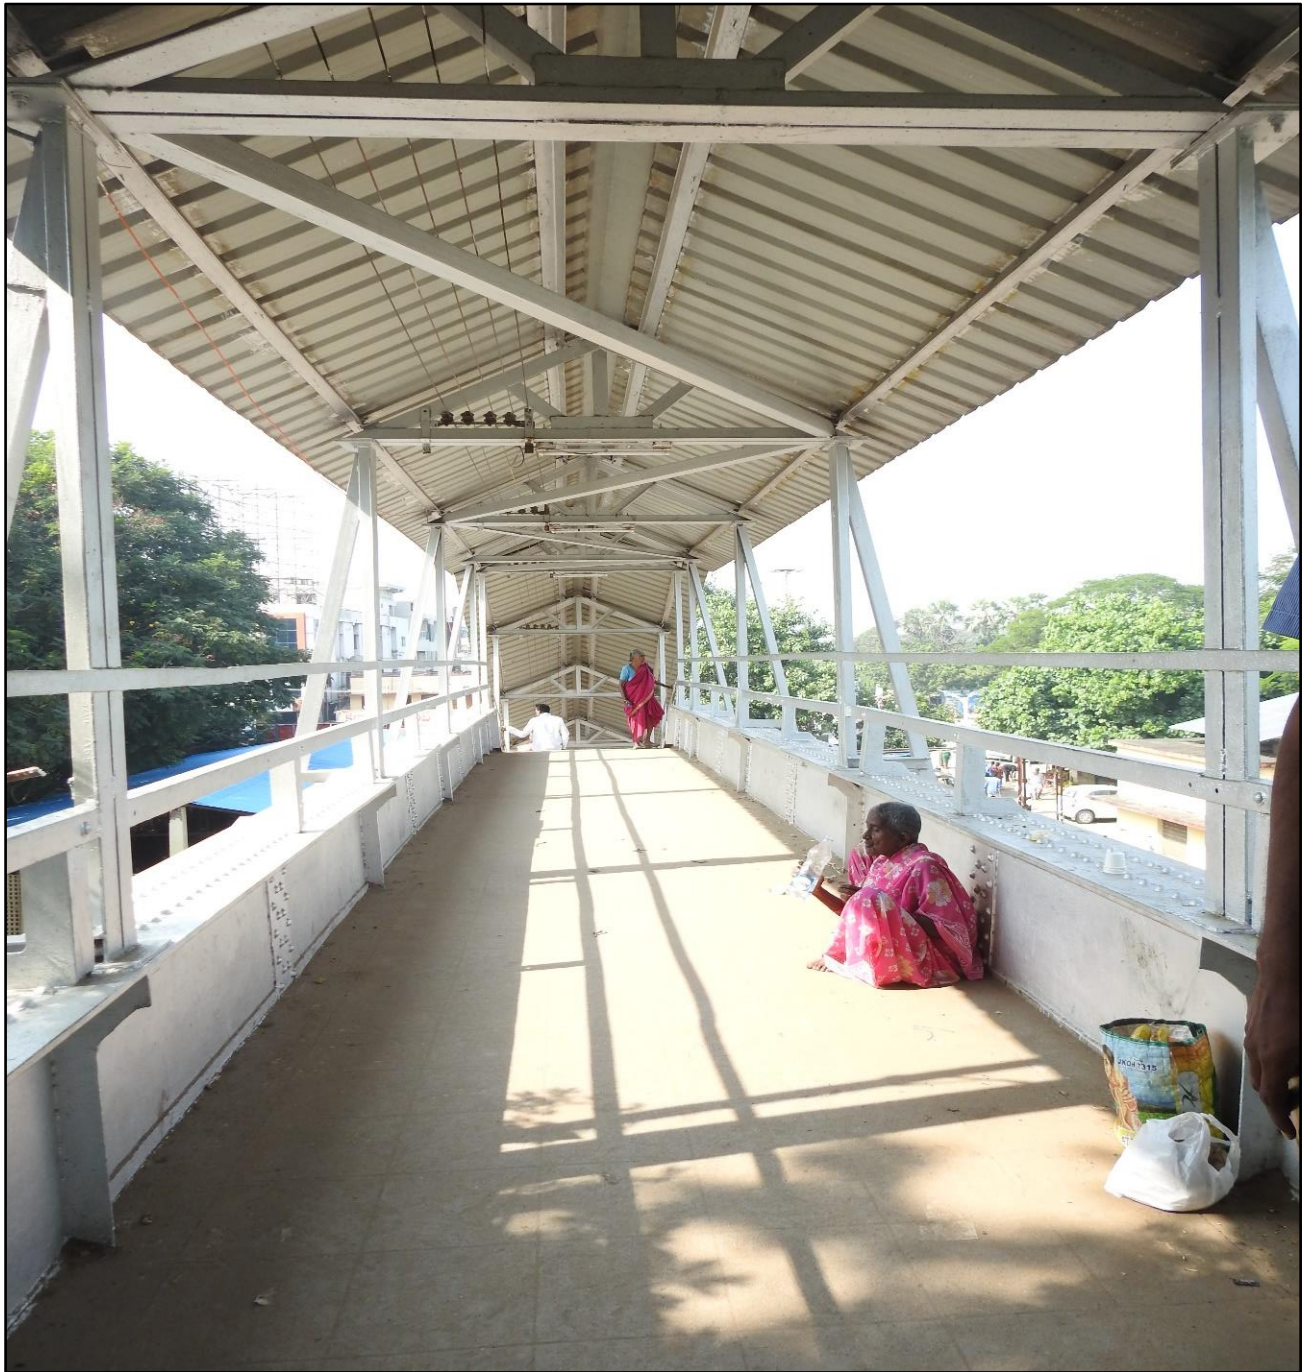
| | Thickness of Slab | 200 mm | b. CC flooring is laid on the top of the Floor slab. (Refer <b>fig : 1.2</b> ) |

***Fig 1.2:*** Pathway, Steel Railing of FOB

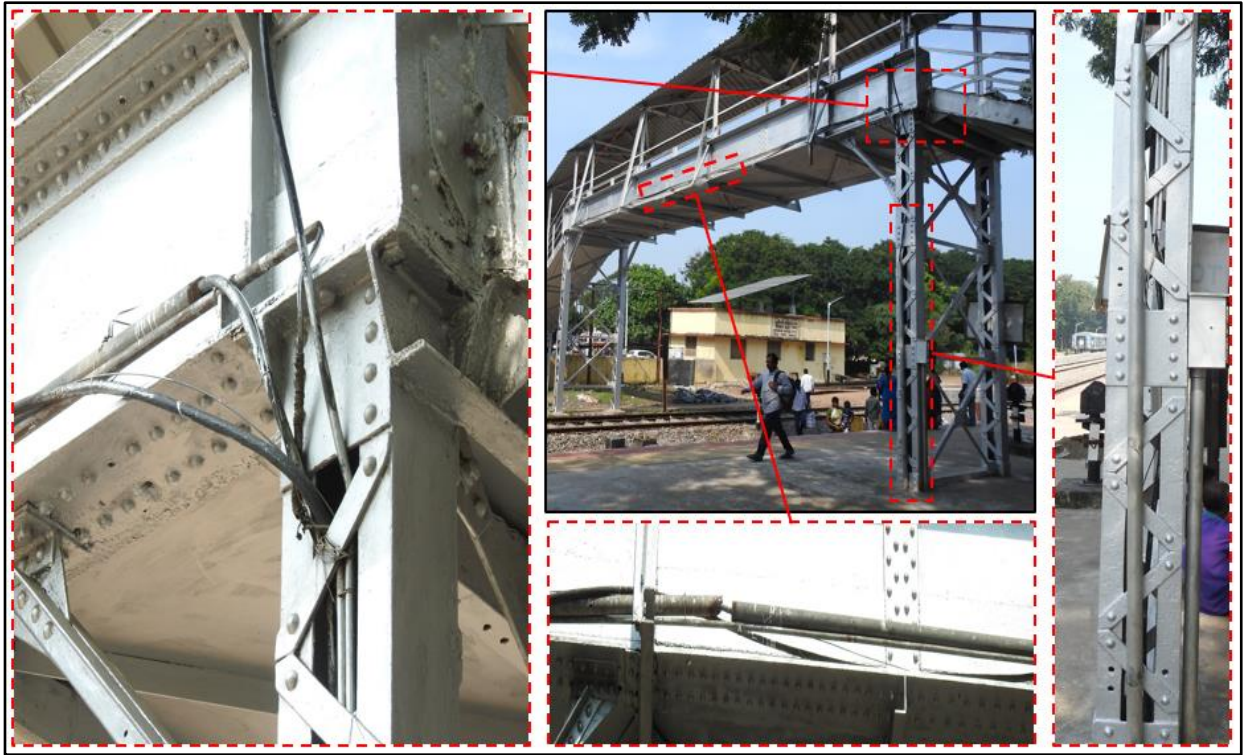
| 1.2 IDENTIFICATION OF LOADS ON BRIDGE | | | |
|---|---|---|---|
| | a) Pipeline - Utilities | Yes | a. 1-inch, 2-inch GI pipes and 1-inch HDPE pipe of 3 No's are supported along the length of girder and 1.5-inch GI pipe is supported on Stanchions and Mid landing. (Refer <b>fig :1.3</b> )<br>b. King post Truss is used as Roof truss (Refer <b>fig :1.9</b> )<br>c. Insulated Electrical Lines are Supported on Roof Truss. (Refer <b>fig :1.9</b> )<br>d. Steel Metal Sheet is used for Roof (Refer <b>fig: 1.1</b> ) |

**Fig 1.3:** Additional loads of HDPE, GI pipes

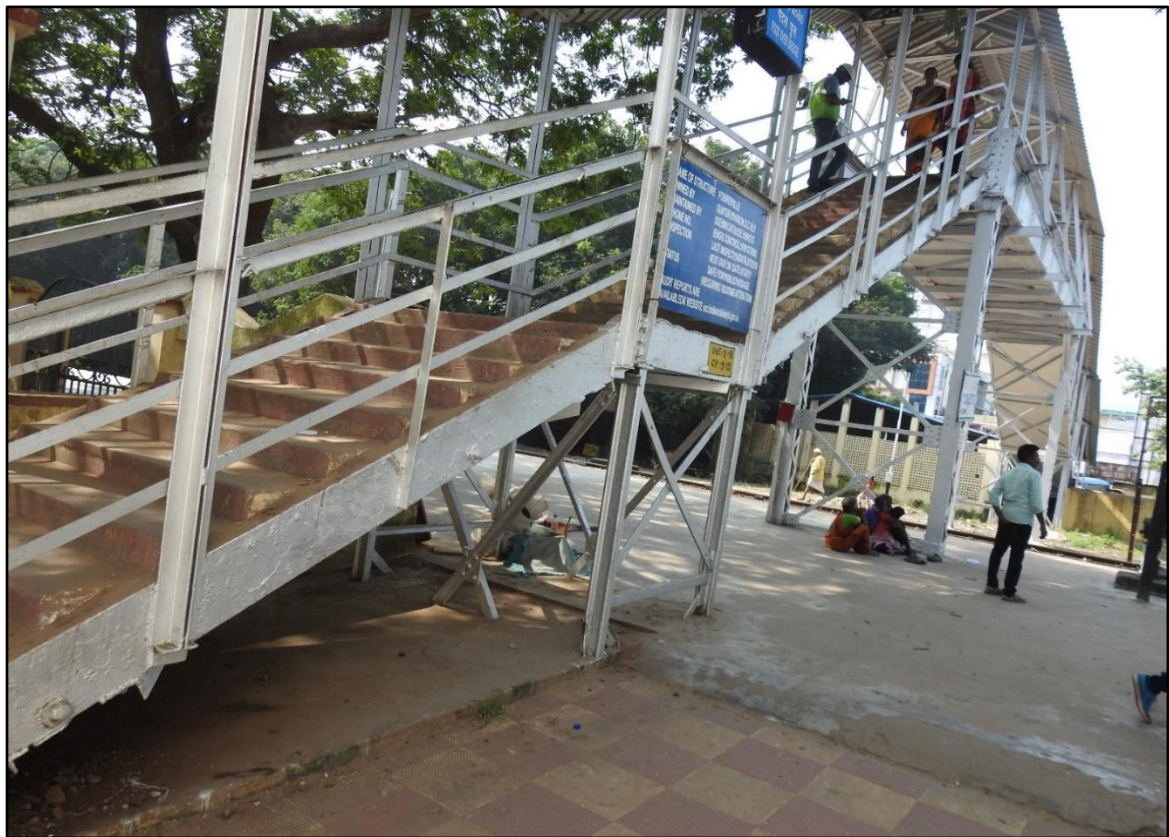
| | Type of Parapet Railing | Steel railing | Staircase is provided with railing on both sides using 65 x 50 x 10 angle section and 45 x 10 mm M.S flats are used. (Refer <b>fig : 1.6</b> ) |

**Fig 1.6:** Railing Details

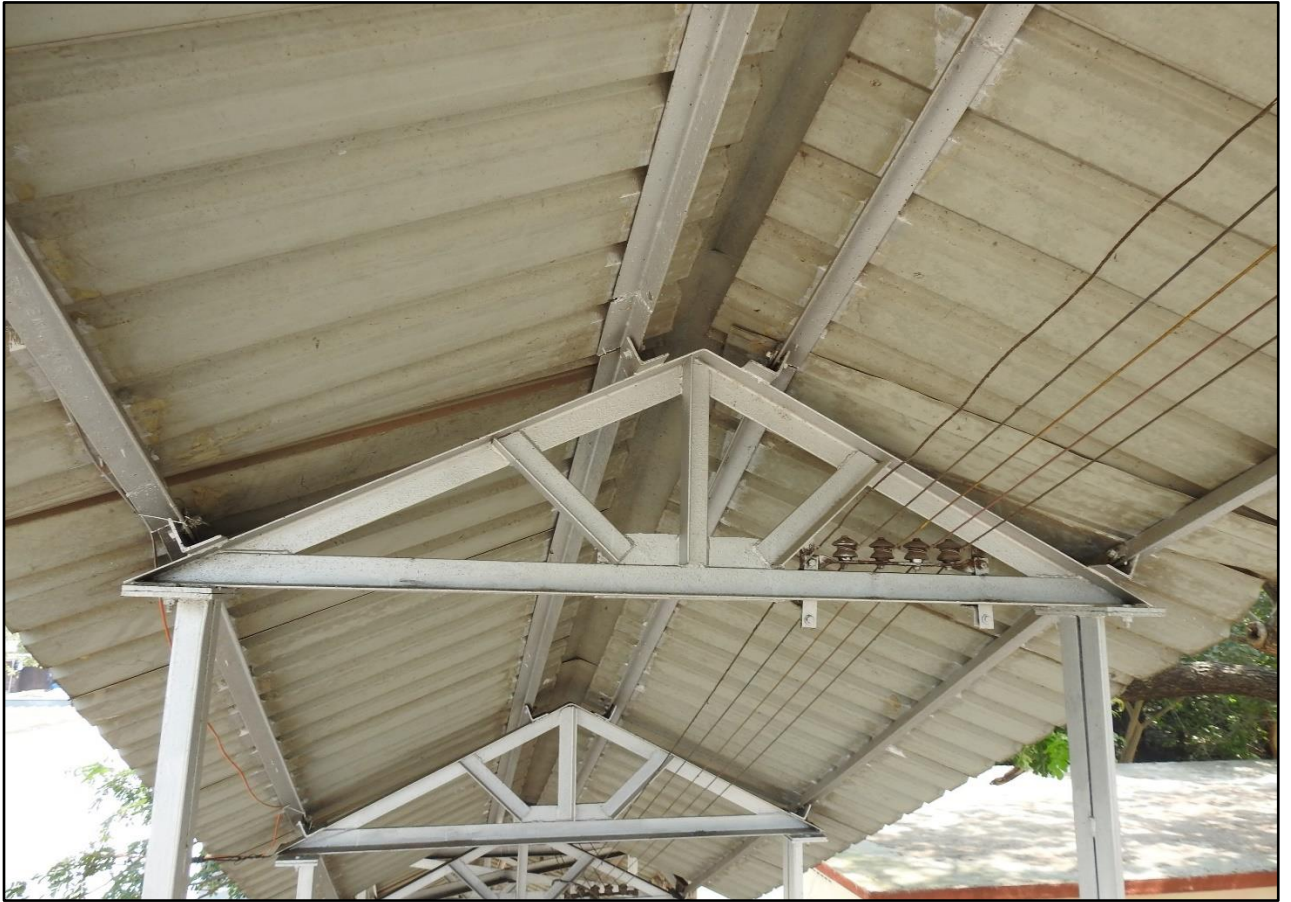
| 1.3 STRUCTURAL SYSTEM OF THE BRIDGE | | | |
|---|---|---|---|
| | Element of roof truss section | Angle section | King post Truss of 75 x 75 x 8 mm Angles are used as Roof truss supported with bracings of 65 x 65 x 8 mm Angle section (Refer <b>fig : 1.9</b> ) |

***Fig 1.9:*** Insulated Electrical lines on Roof truss

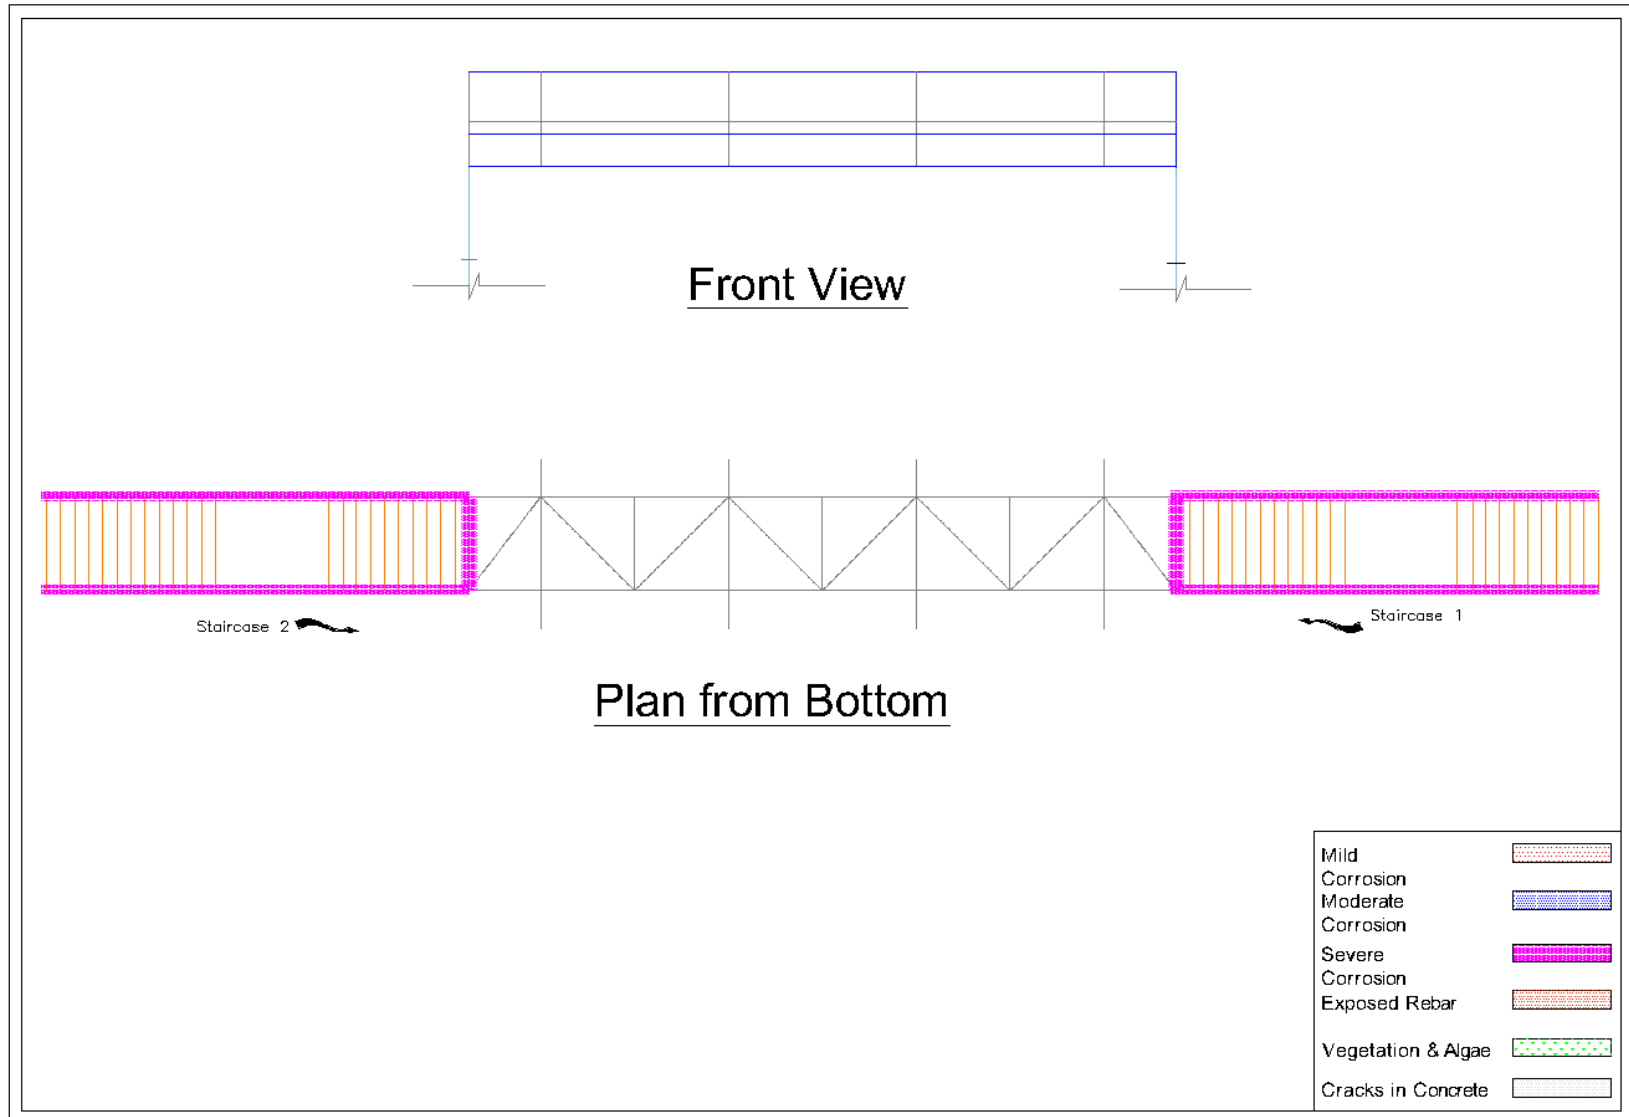
**Fig: 2.1** locations of deteriorations and bottom view of FOB

- Structural members are in fair condition, displaying mild corrosion for top chord members, verticals, diagonals, and bottom chord members and **severe corrosion** for staircase stringer beam along steel concrete joint in staircase-1 and staircase-2 (locations are marked in figures).  
(Photographs of the same can be see in **fig 2.2-2.4**)

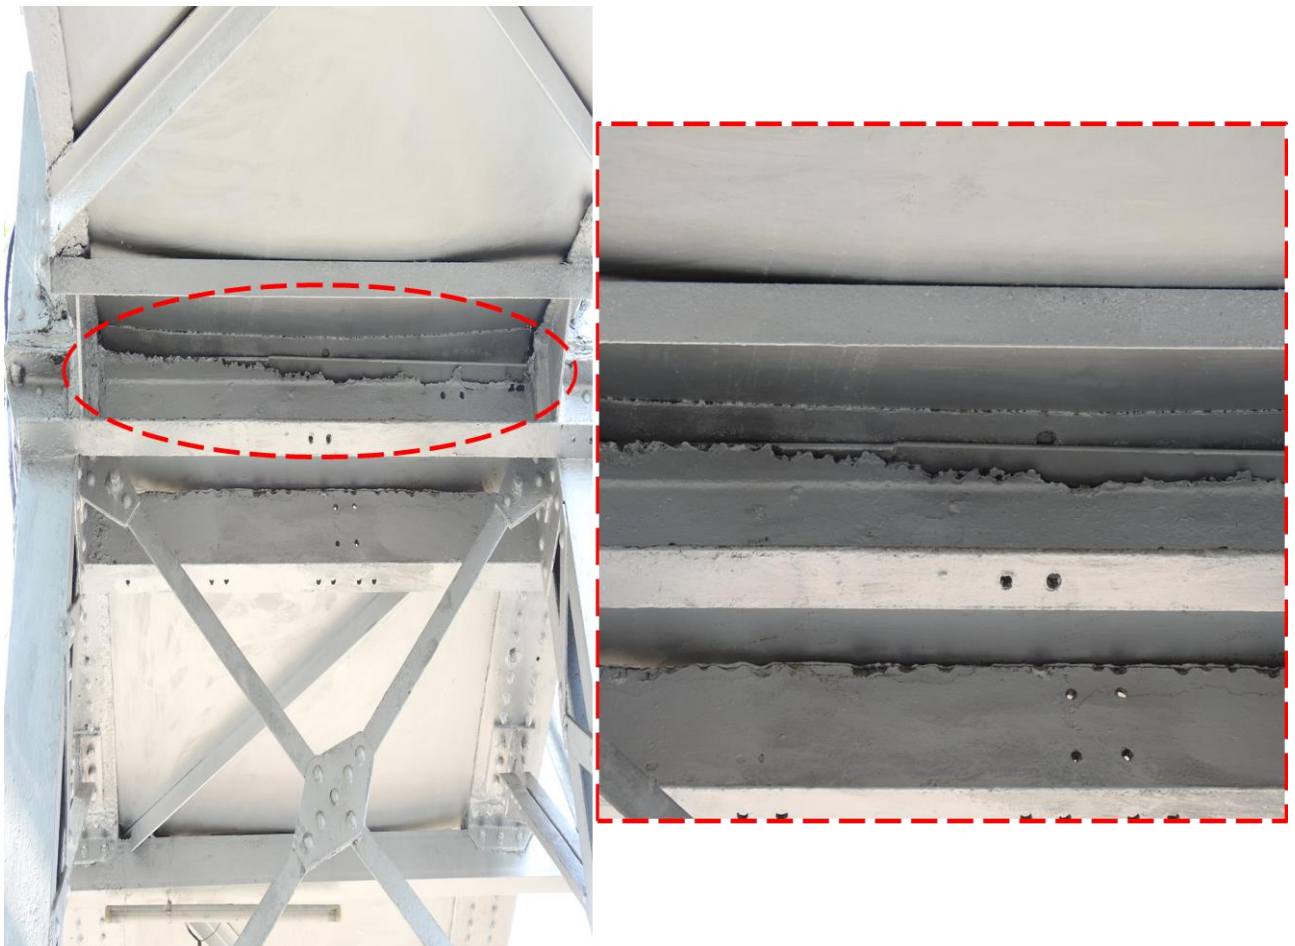
| Span 1 | Mild Corrosion | Moderate Corrosion | Sever Corrosion | Remark |
|---|---|---|---|---|
| Floor Beams/ Cross Girders | ✓ | | | |

**Fig: 2.2** Corrosion of Floor beam

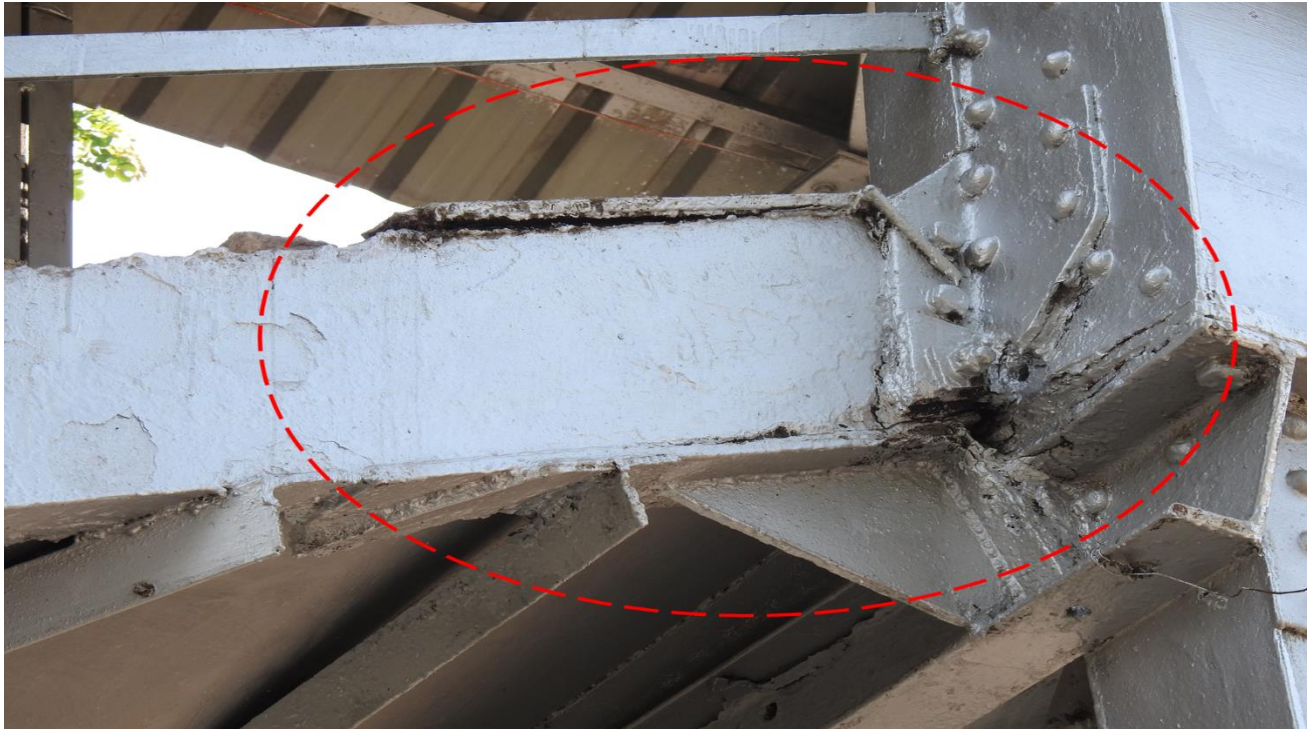
**Fig: 2.3** Corrosion of joints

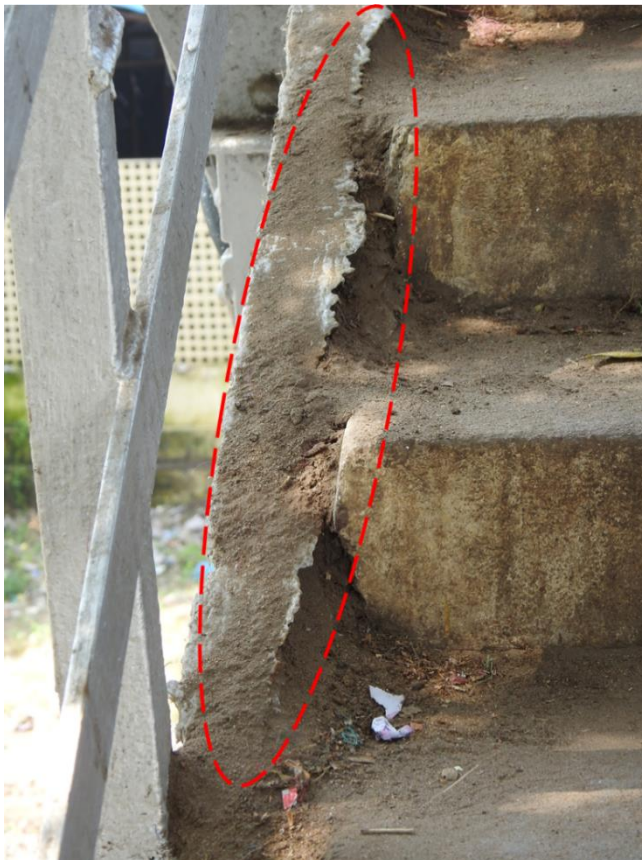
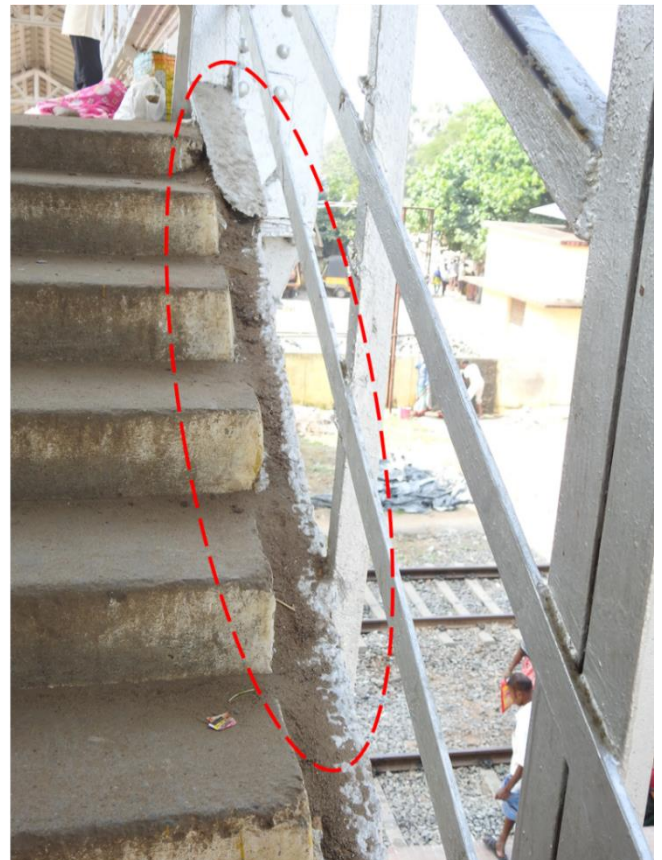
**Fig: 2.4** Corrosion of Stringer beams
