# Third Party Audit of ROB's and FOB's of SCR

## INSPECTION OF FOB AT KACHIGUDA RAILWAY STATION

**Final Report**  
SEPTEMBER | 2020

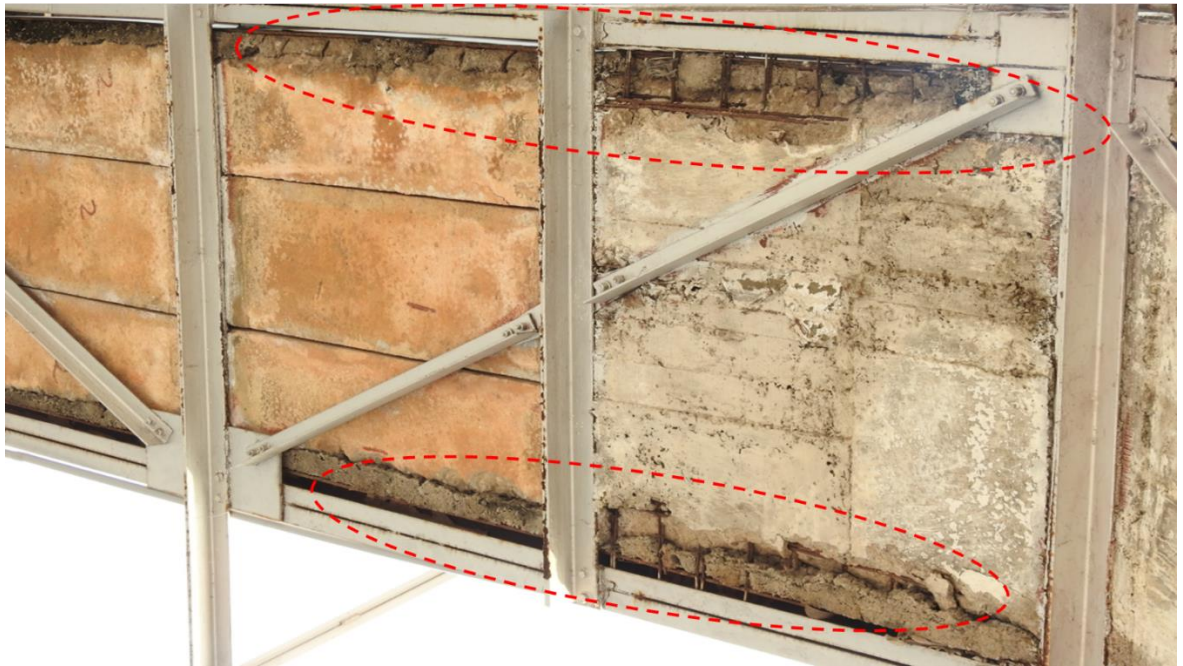
(a) Spalling and reinforcement exposure in span 1

| SIGNS OF DISTRESS, DEFORMATION IN BRIDGES | | | |
|---|---|---|---|
| | Spalling | Slab panels | spalling and exposed reinforcement is observed at the bottom of slab in span 1,3,4 and Slab and Bottom chord joints (Refer <b>Part 1.4 – 1.4(a)</b> ) |

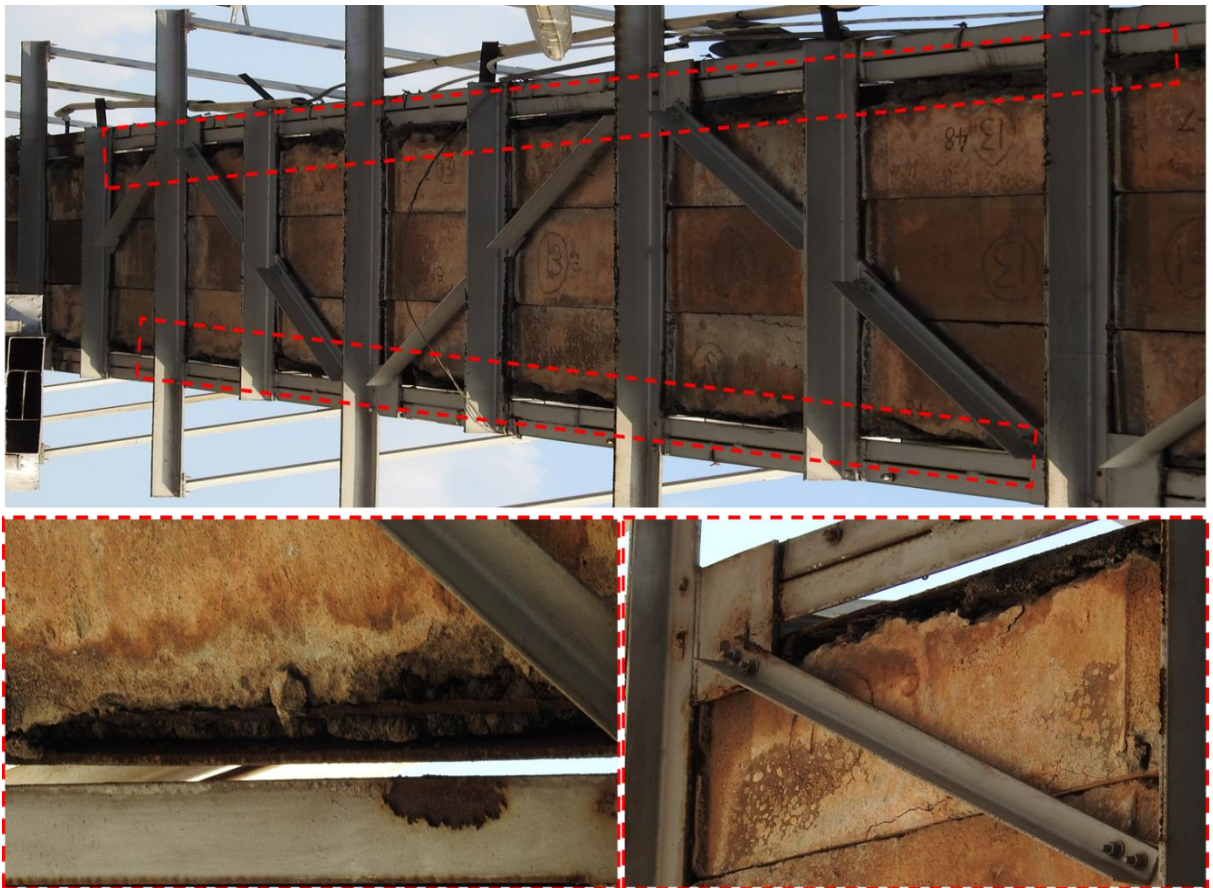
(b) Spalling at bottom chord and slab panels connecting joint along the length of FOB

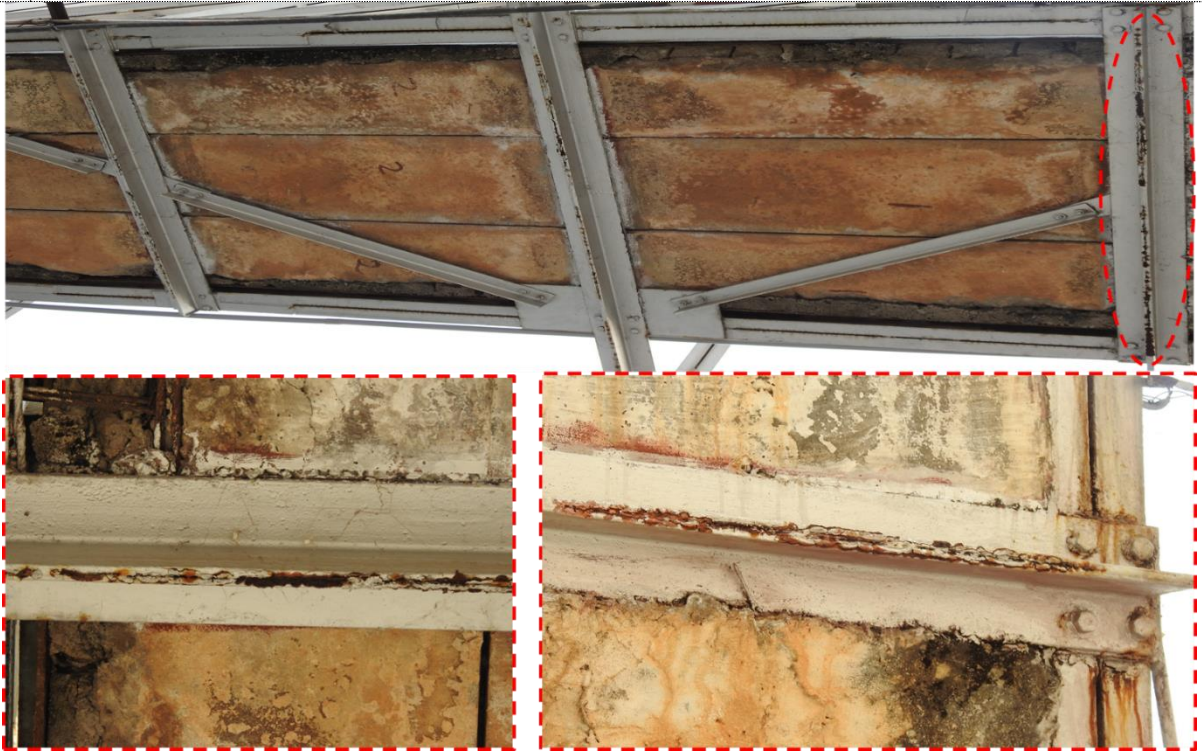
(a) Corrosion of Floor and bottom chord beams at span 1

| SIGNS OF DISTRESS, DEFORMATION IN BRIDGES | | | |
|---|---|---|---|
| | Extent of Corrosion | Floor beams | corrosion is observed at floor beams and joints (Refer <b>Part 1.4 – 1.4(b)</b> ) |

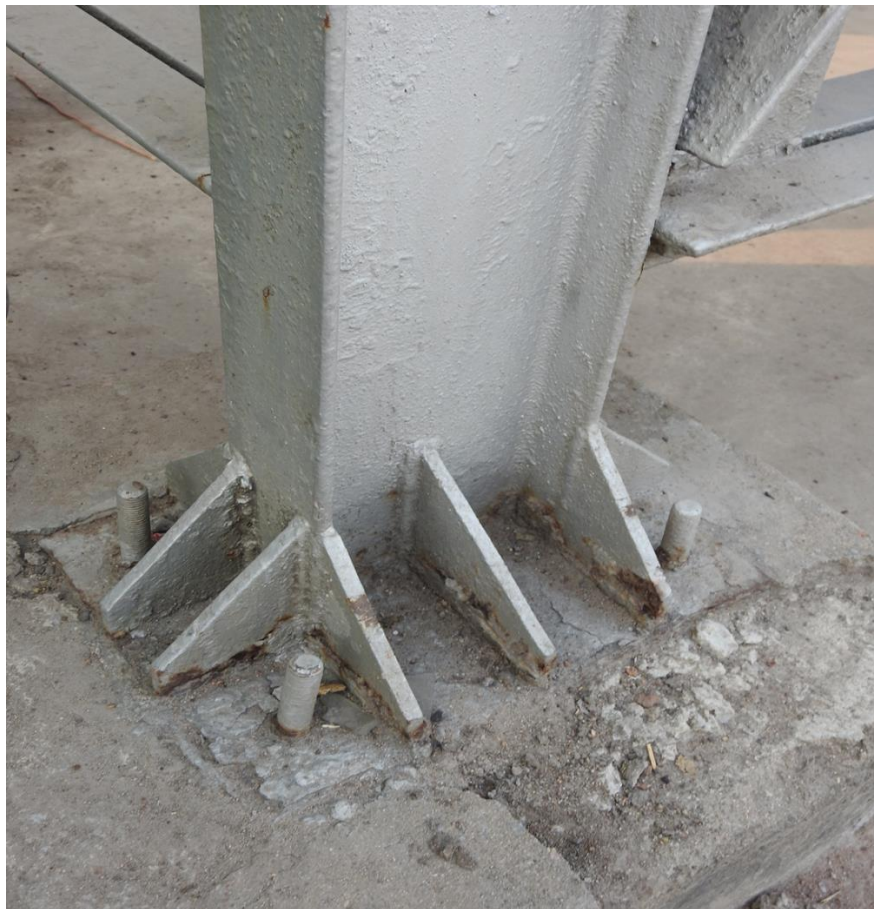
(b) Corrosion of Base plate at Trestle 1

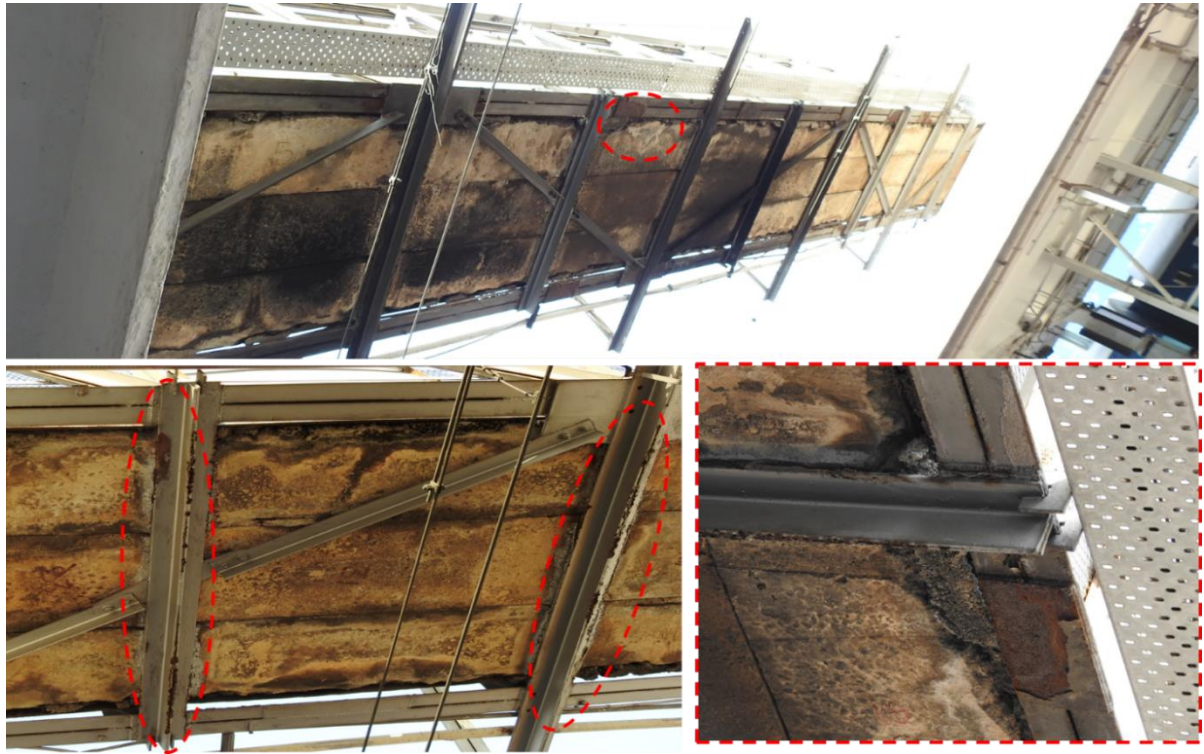
(c) Corrosion of floor beams and Bottom chord members in span 2.

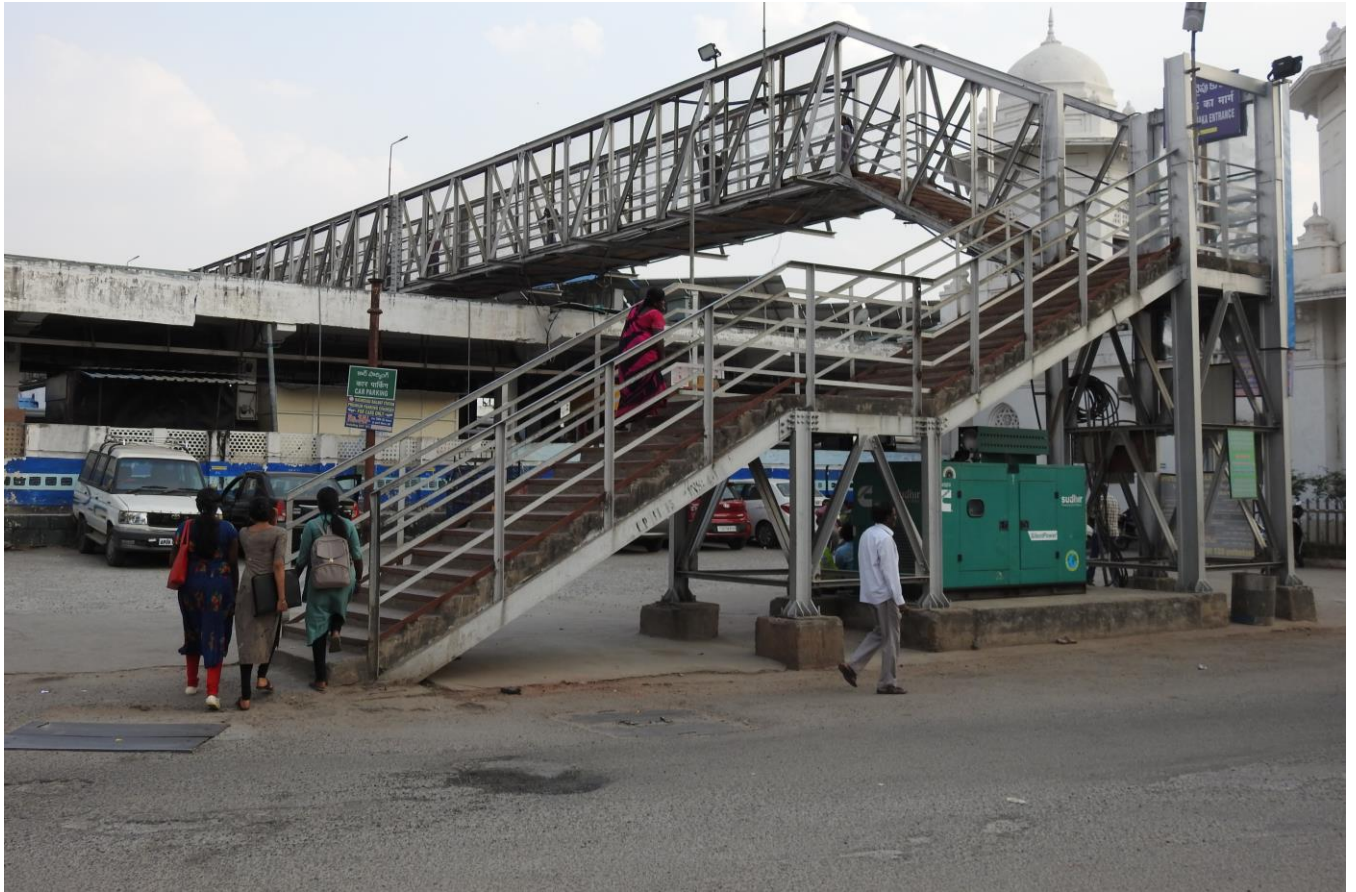
**Fig1 8:** Staircase details

| | Number of Staircase | 2 no's | <p>Staircase steps are observed as RCC slab, Steps are supported on stringer beams of ISMB 250 section, horizontal members of ISMB 150 and diagonal bracings with 65 x 65 x 8mm angle sections. (Refer <b>fig :1.8</b>)</p> |

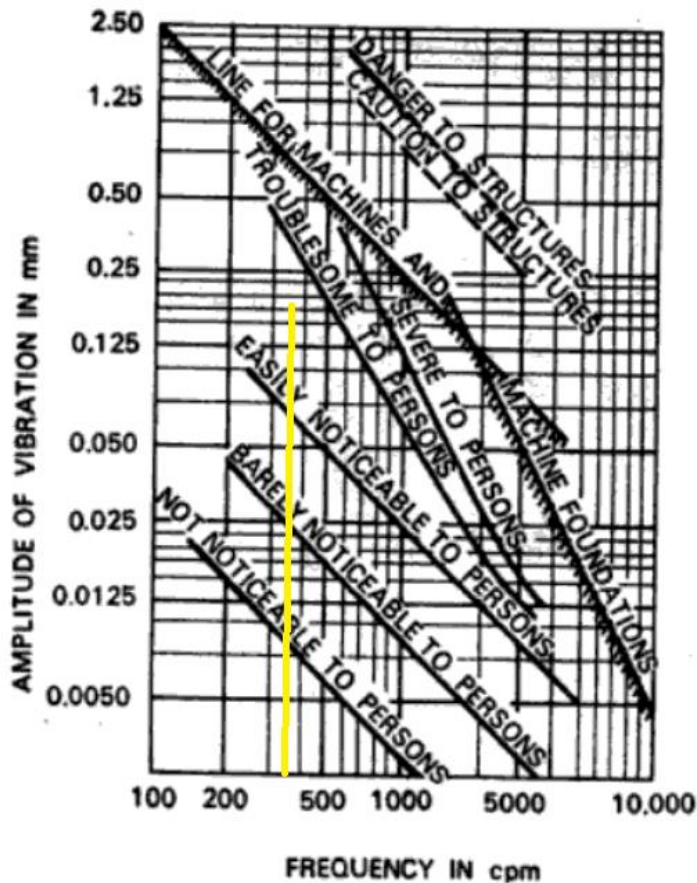
**Fig. 1.4:** Allowable Limits for Vertical Vibration Amplitudes (After Richart, F. E., Jr. *et al.*, *Vibration of Soils and Foundations*, Prentice-Hall Inc., New Jersey, USA, 1970; with permission).

Based on the vibration analysis carried out the structure is undergoing vibrations in permissible limit of vibrations. (Frequency observed is 366 cpm and maximum amplitude observed during the test time of complete 3hrs is 0.1425 mm)

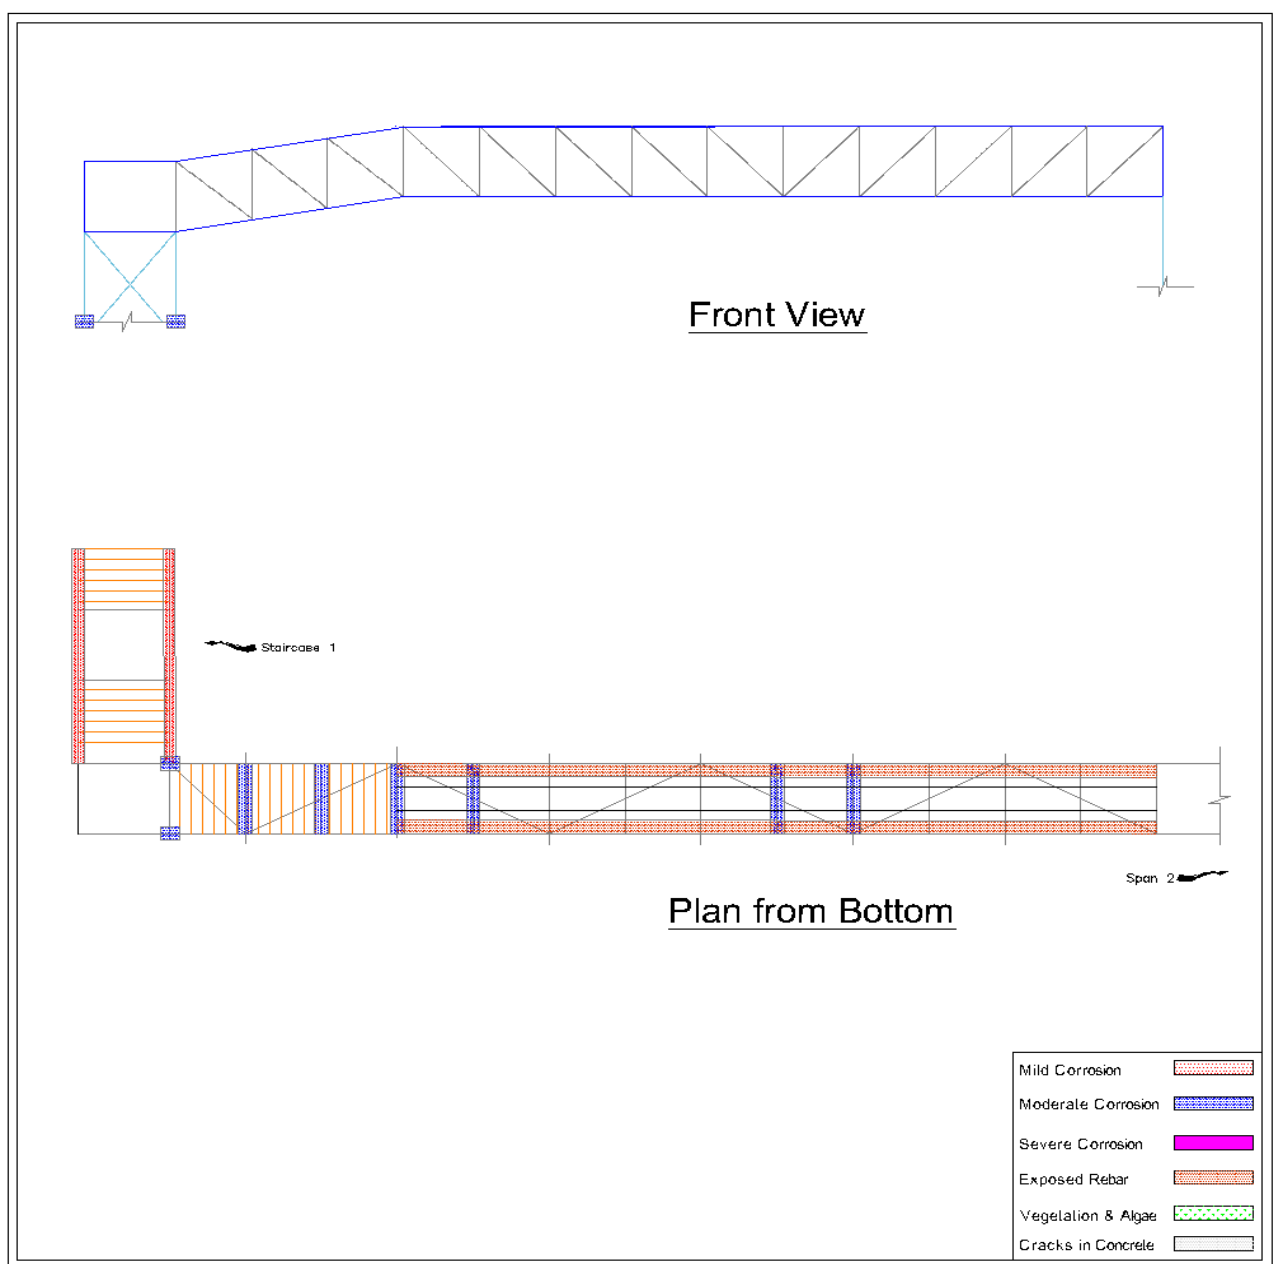
**Fig 3.1:** Locations of deteriorations and bottom view of span-1

- Structural members are in fair condition, displaying mild corrosion for top chord members, verticals, diagonals, gusset plates and bottom chord members. Moderate corrosion for staircase stringer beam along steel concrete joint and floor beams (locations are marked in figures below).
- Exposed reinforcement in RCC slab panels at pathway of span-1. (Photographs of the same can be see in **fig3.2-3.4**)

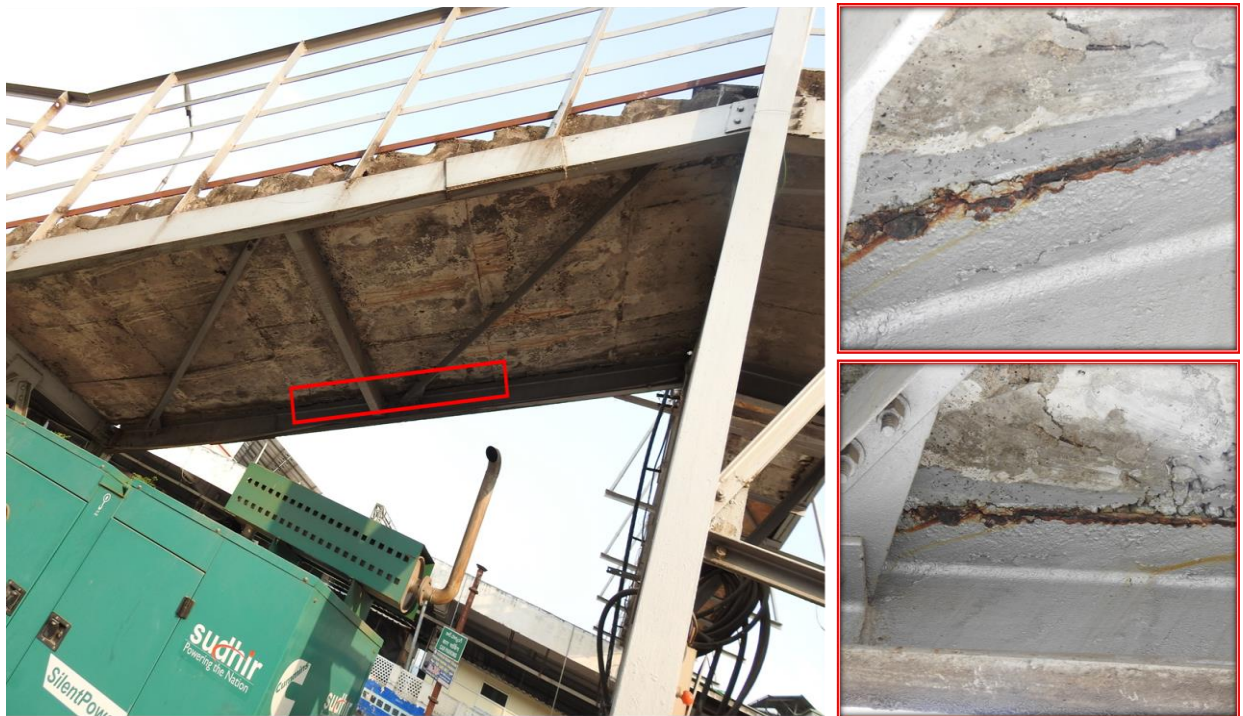
**Fig 3.2:** Corrosion of stinger beam near steel concrete joint at span-1

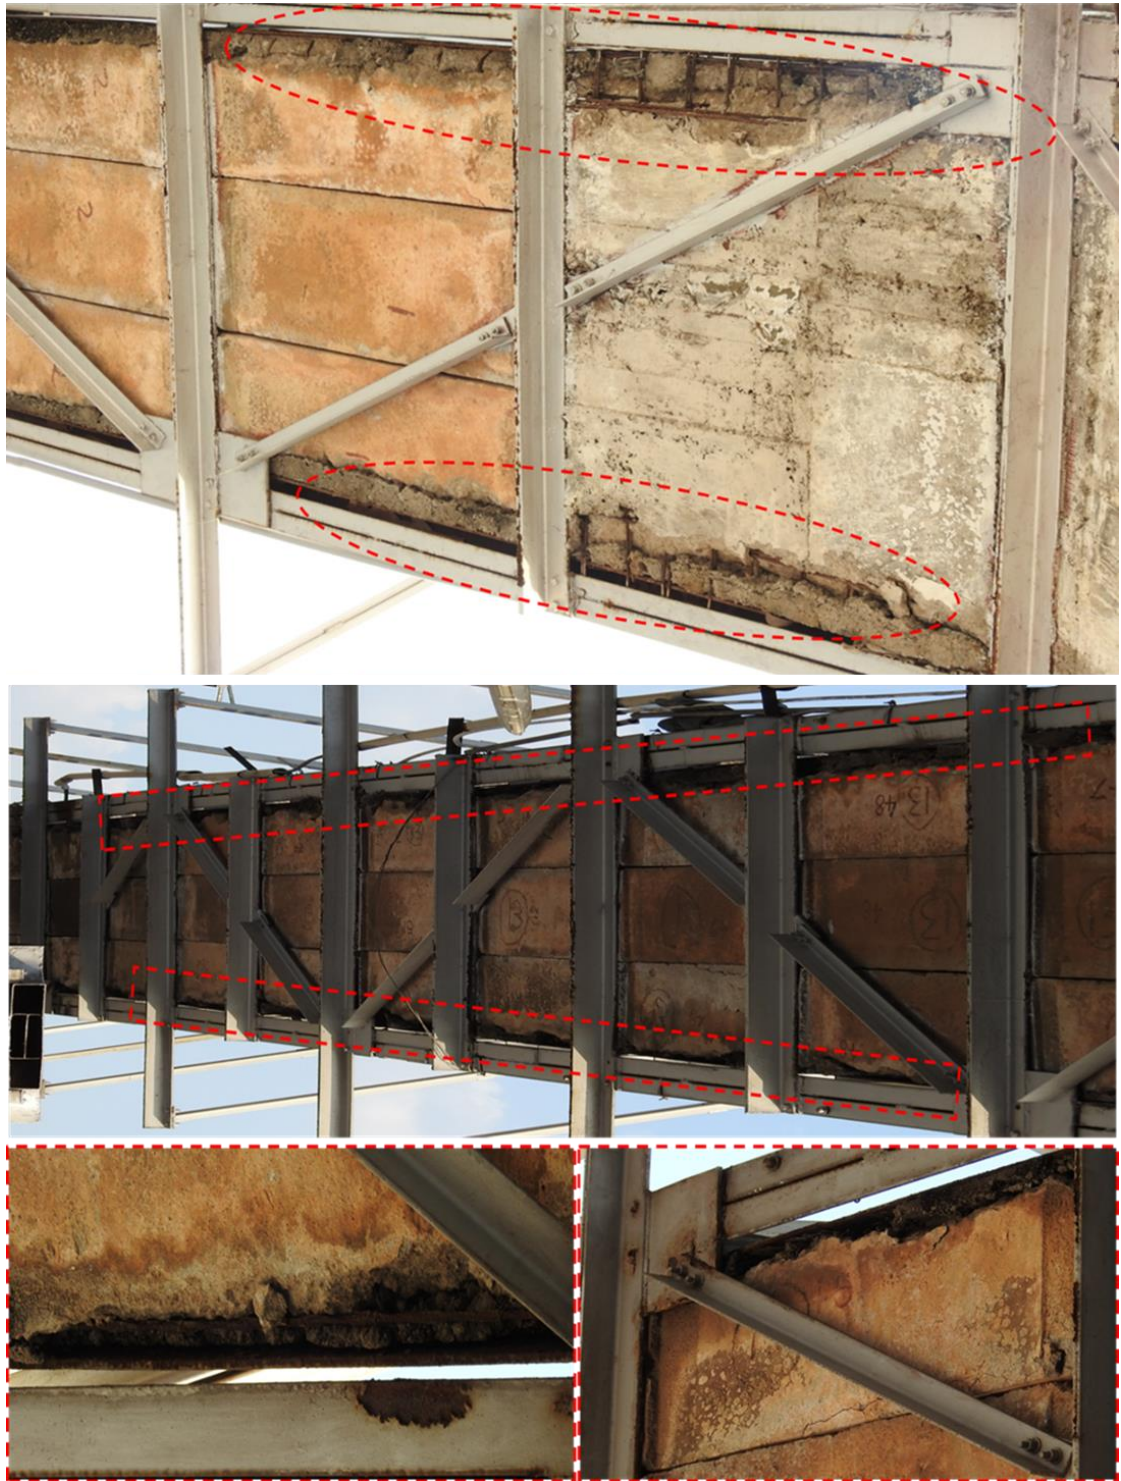
**Fig 3.3:** Exposed reinforcement in slab panels at span-1

- c) Replacement of damaged and exposed precast slab panels at span-1, span-2 span-3.
  - d) Anti-corrosive treatment for splice joint in span-2.
  - e) Replacement of bolts in span-5.

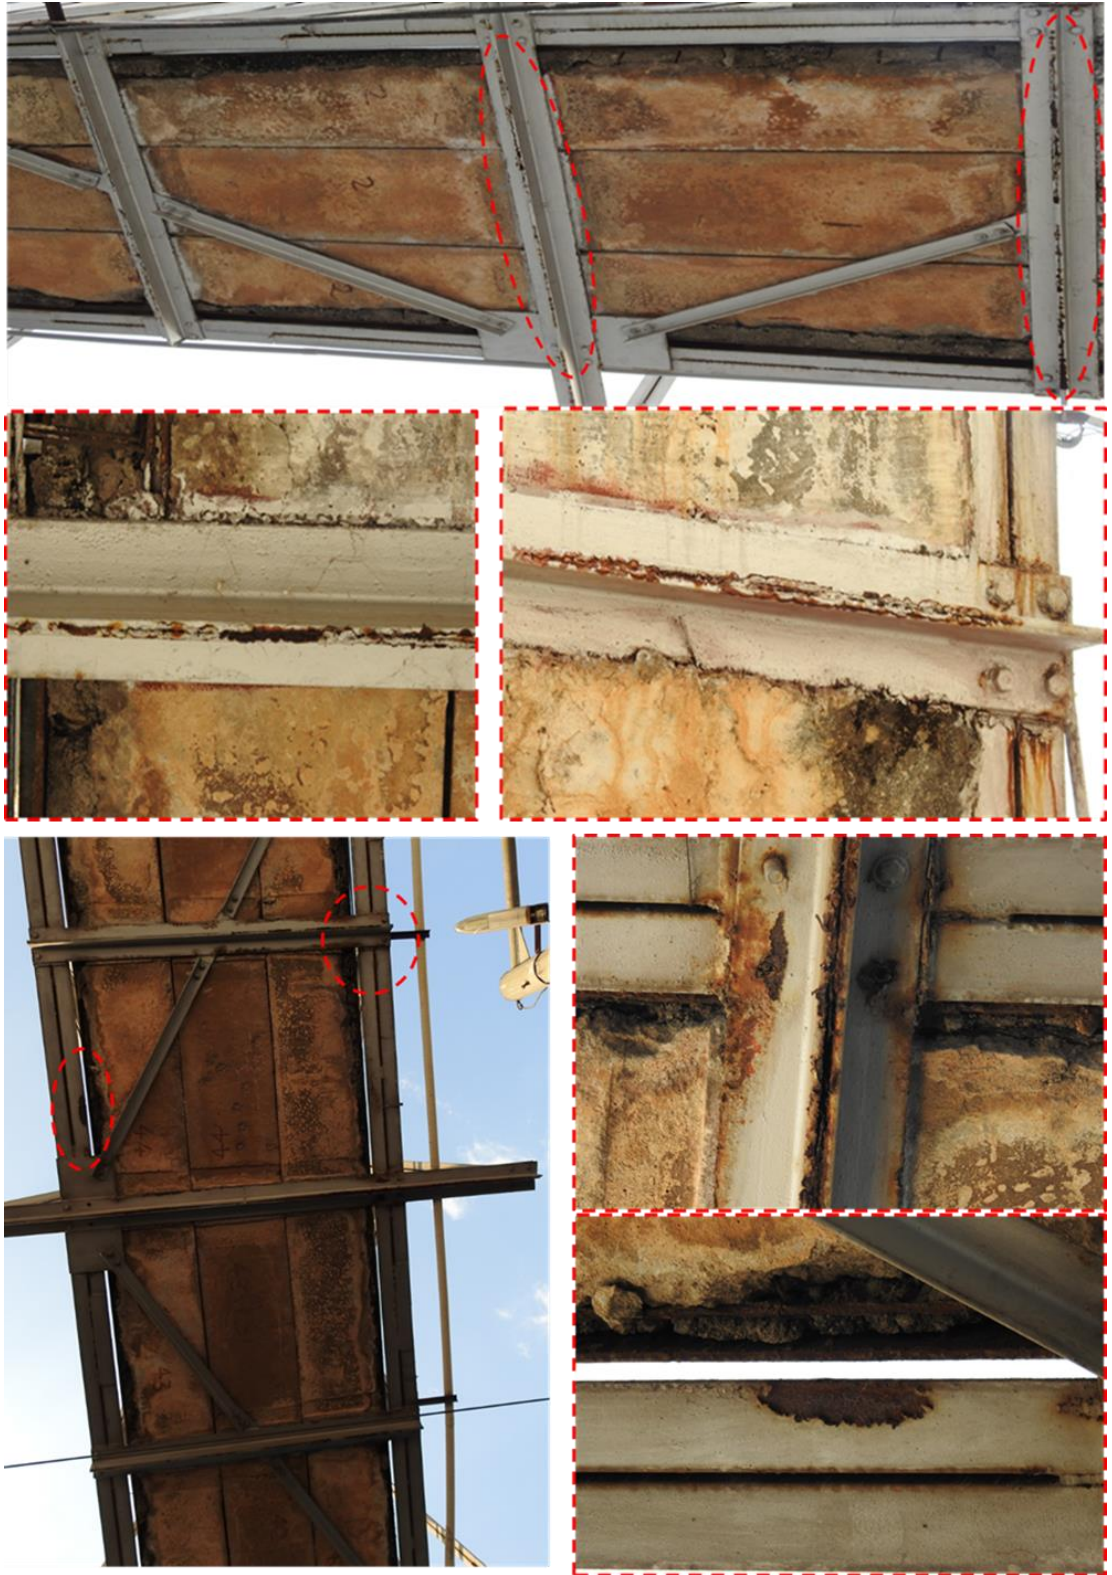
*Fig 3.4:* corrosion of floor beams in span-1

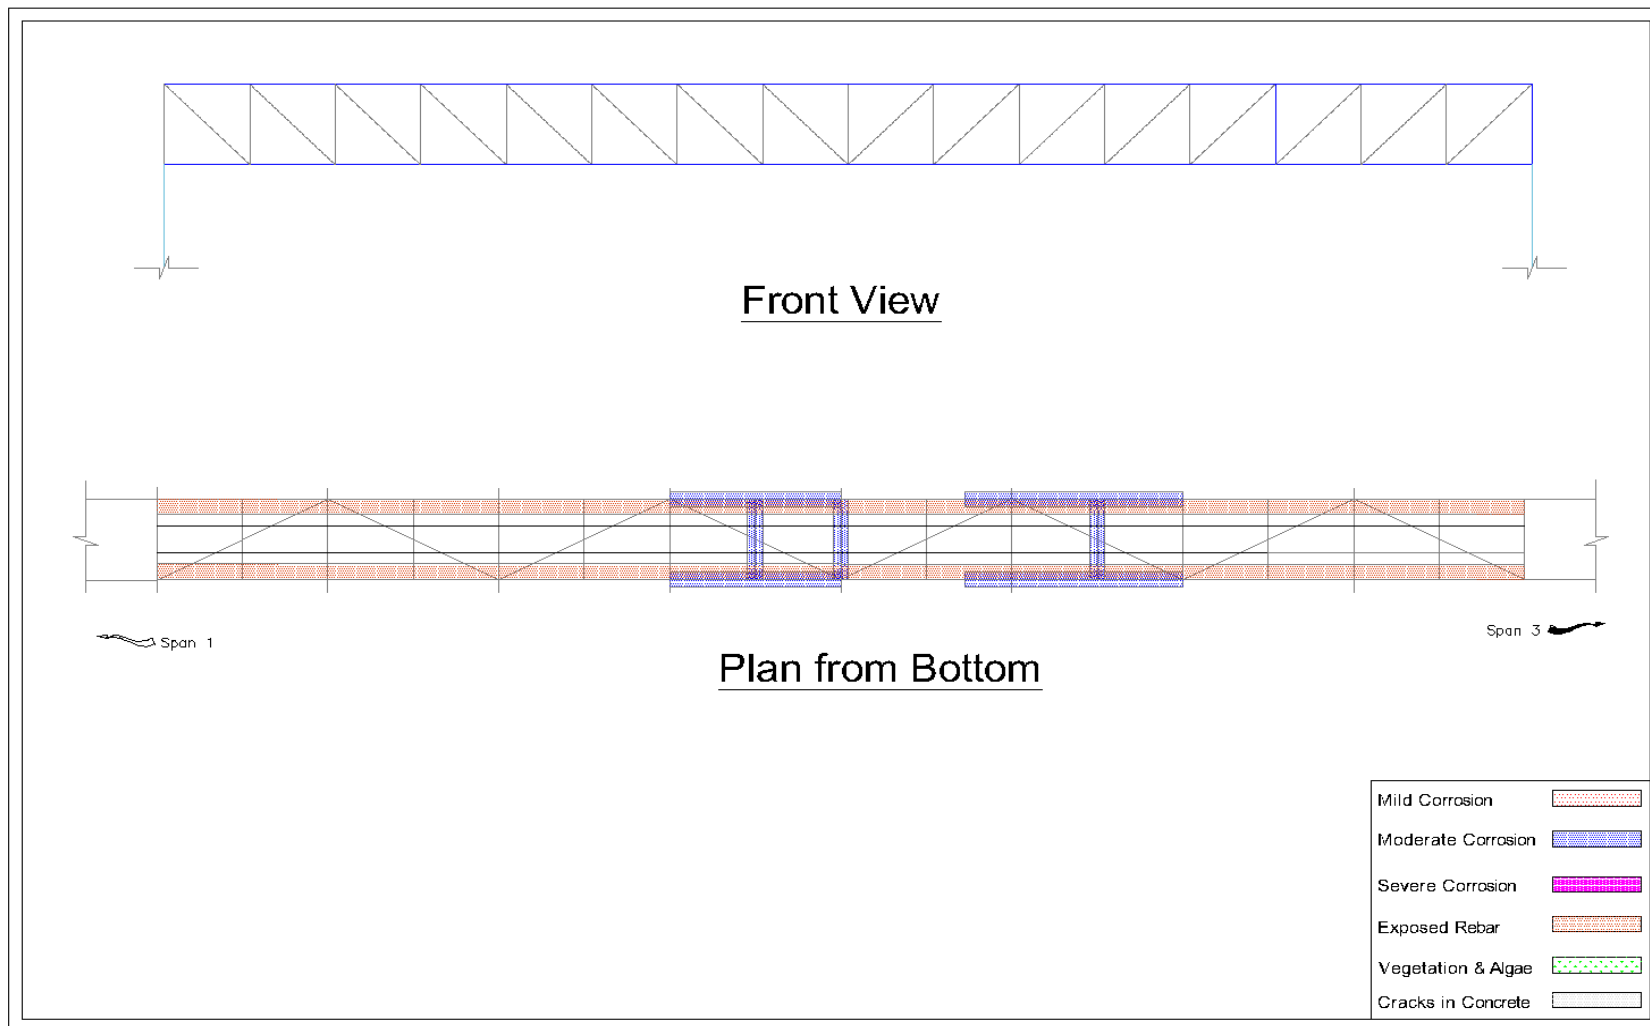
**Fig 3.5:** Locations of deteriorations and bottom view of span-2

- Structural members are in fair condition, displaying mild corrosion for top chord members, verticals, diagonals, gusset plates. Moderate corrosion for floor beams and bottom chord and moderate corrosion at splice joint. (Locations are marked in figures below).
- Exposed reinforcement in RCC slab panels at pathway of span-2. (Photographs of the same can be see in **fig 3.6-3.7**)

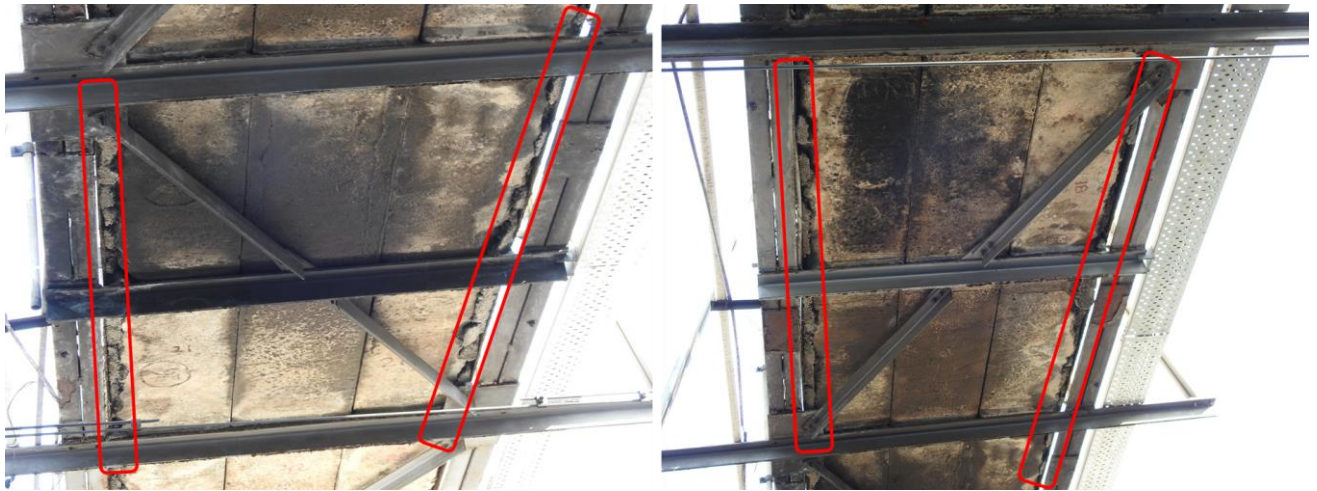
**Fig 3.6:** Exposed reinforcement in slab panels at span-2

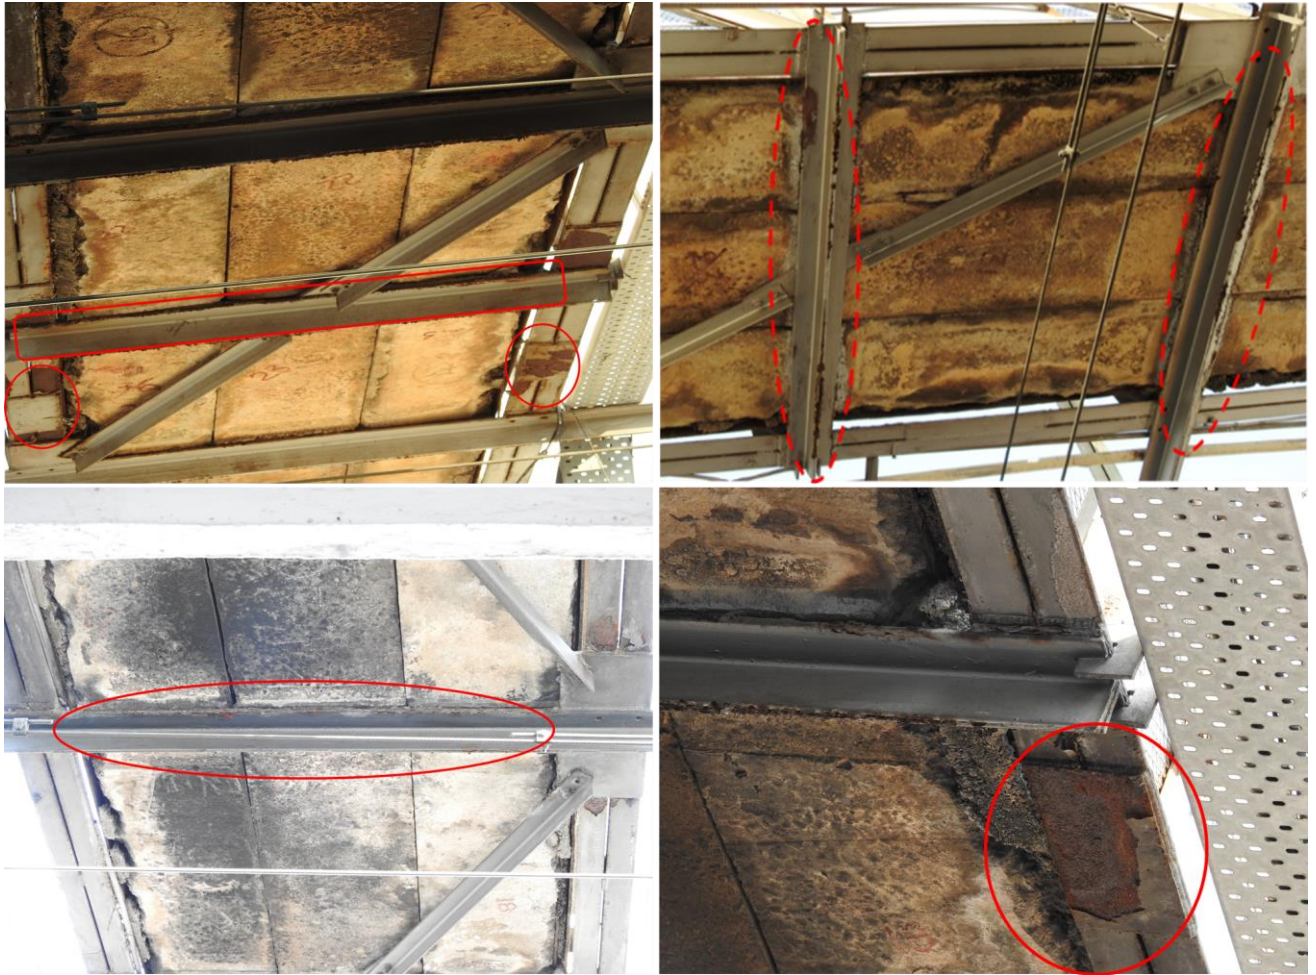
**Fig 3.7:** corrosion of floor beam, bottom chord and splice joint in span-2

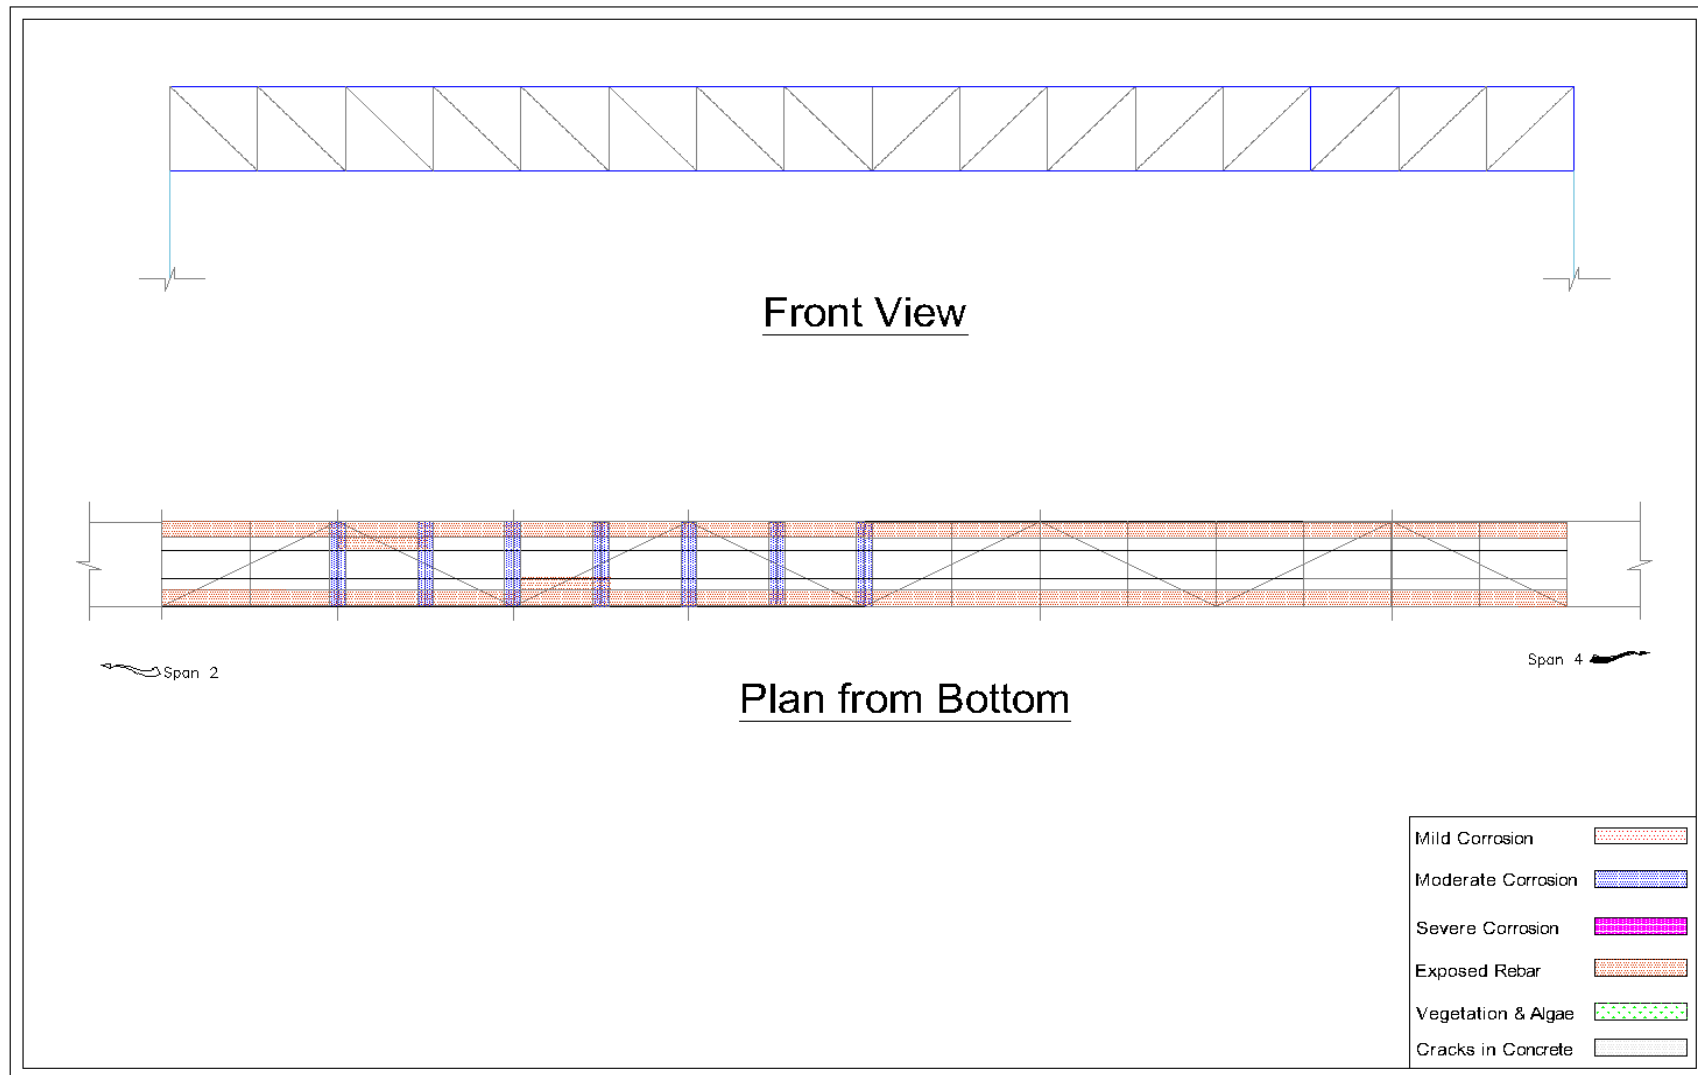
**Fig 3.8:** Locations of deteriorations and bottom view of span-3

- Structural members are in fair condition, displaying mild corrosion for top chord members, verticals, diagonals, gusset plates. Moderate corrosion for floor beams and bottom chord. (Locations are marked in figures below).
- Exposed reinforcement in RCC slab panels at pathway of span-3. (Photographs of the same can be see in **fig 3.9-3.10**)

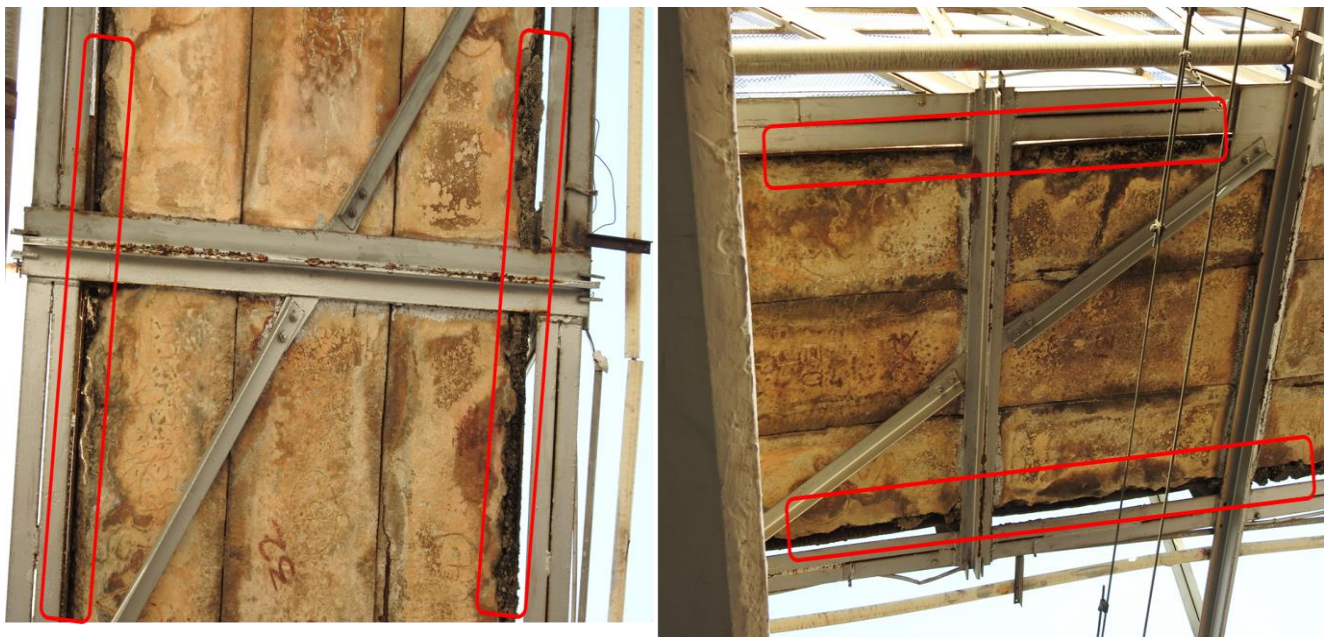
**Fig 3.9:** Exposed reinforcement in slab panels at span-3

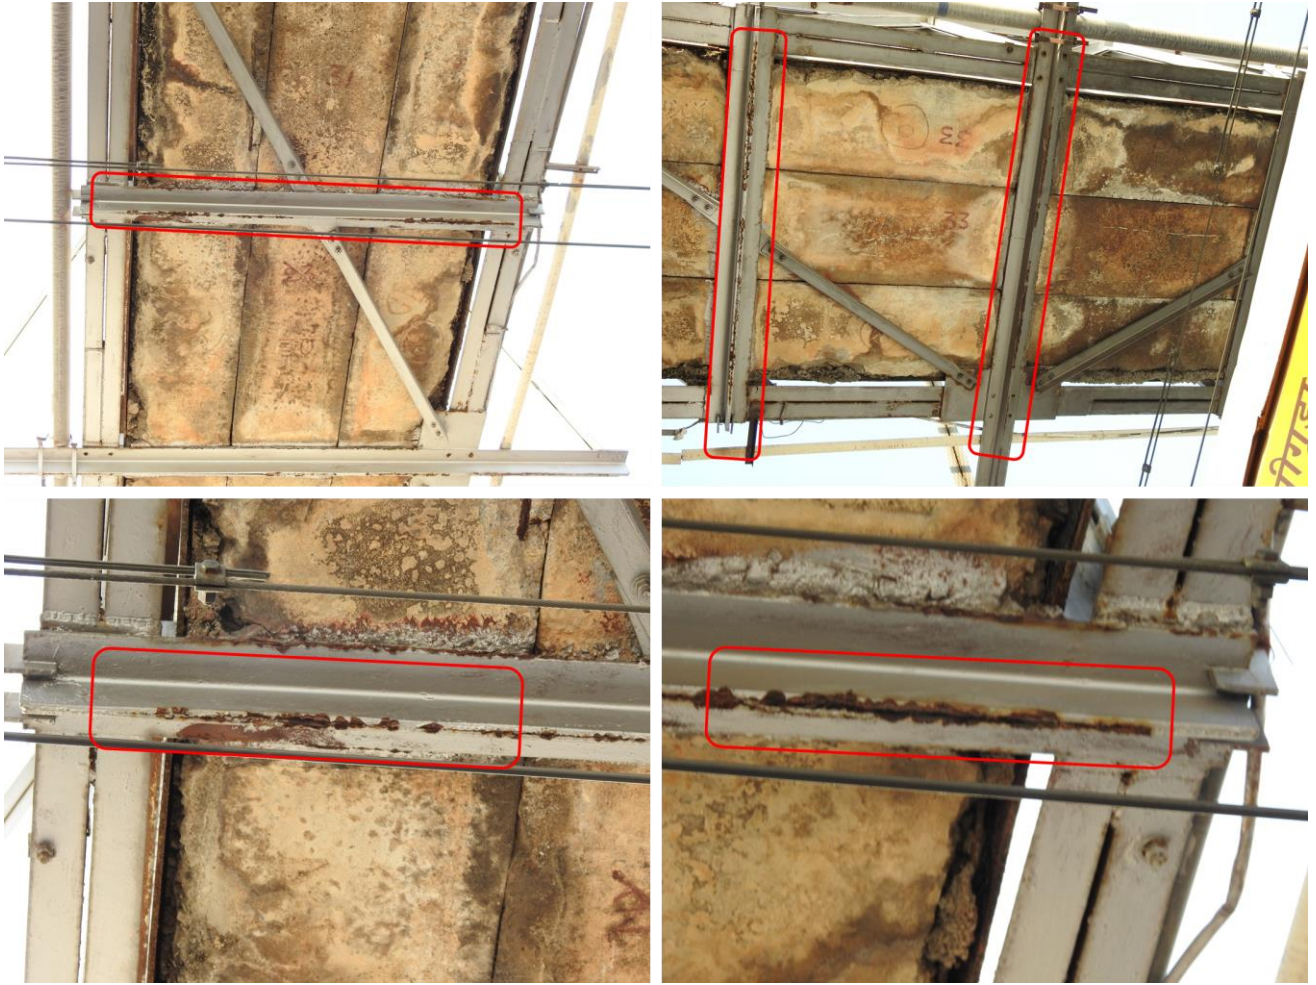
**Fig 3.10:** corrosion of floor beam in span-3

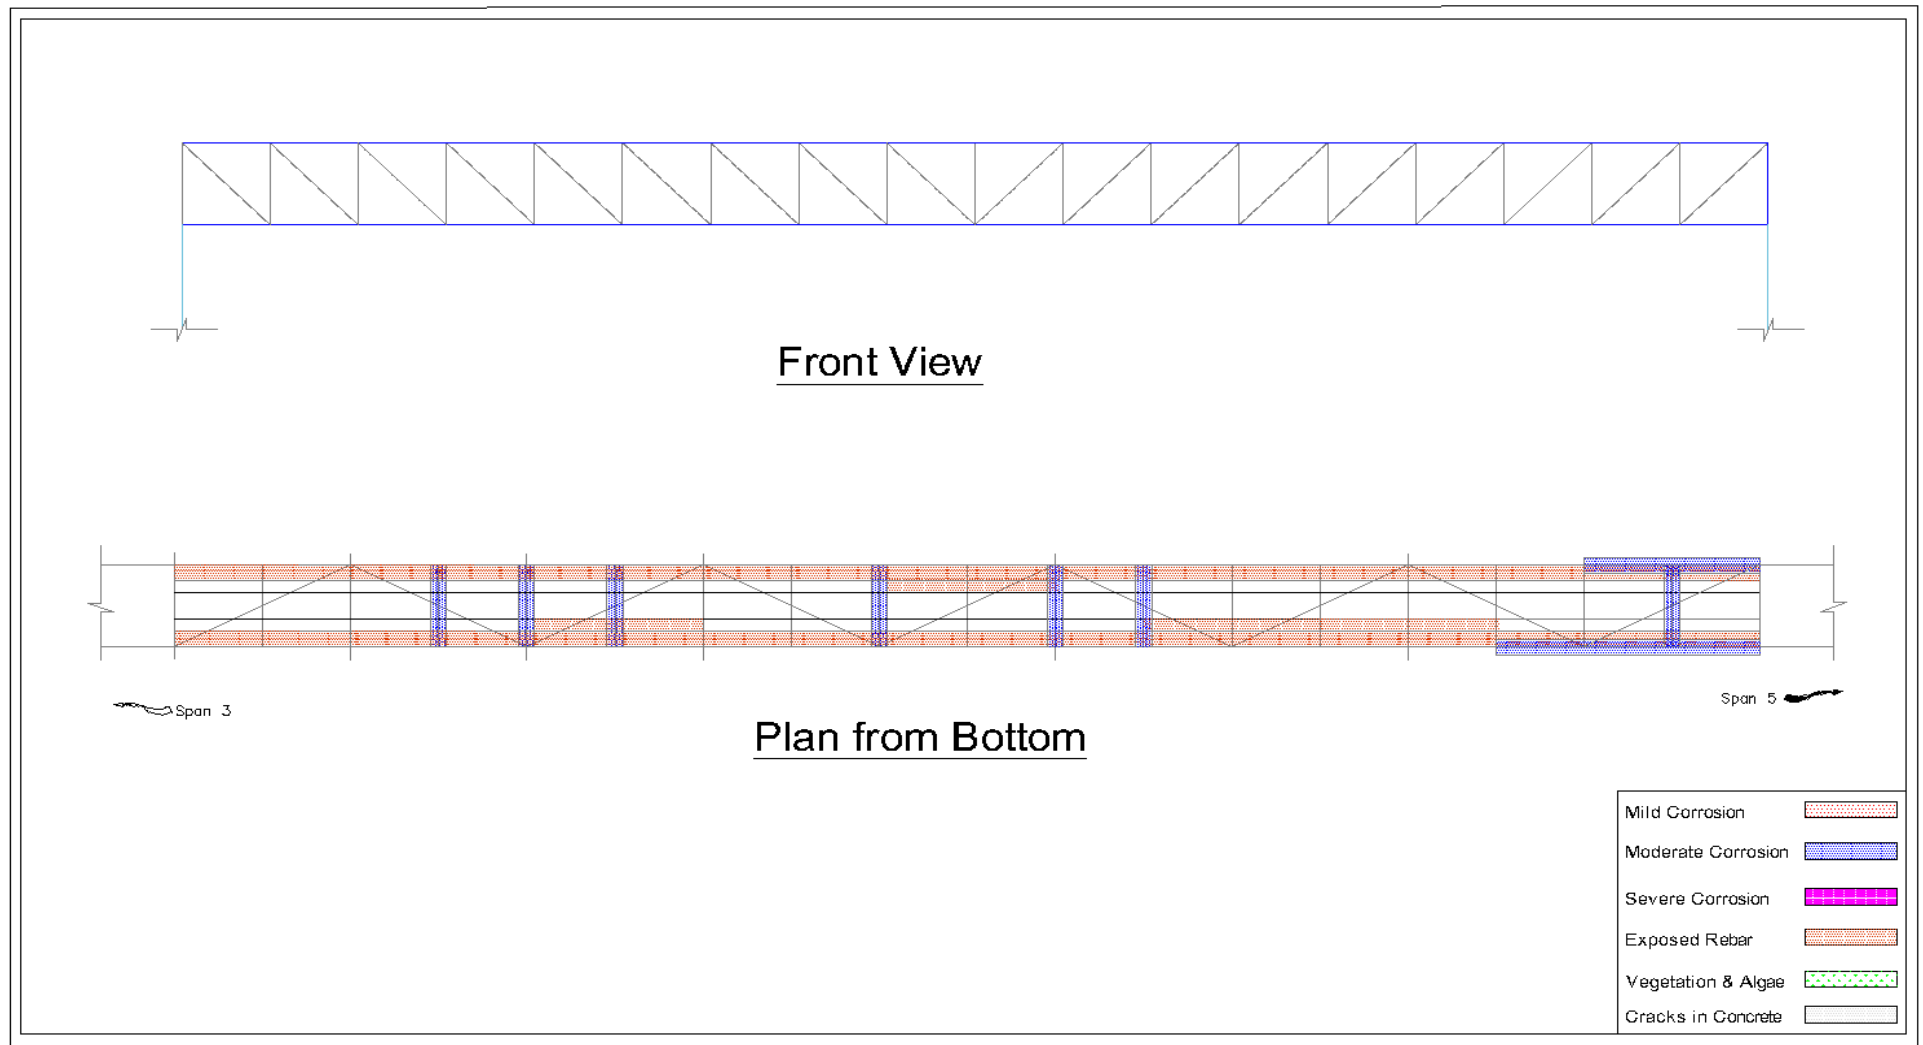
**Fig 3.11:** Locations of deteriorations and bottom view of span-4

- Structural members are in fair condition, displaying mild corrosion for top chord members, verticals, diagonals, gusset plates. Moderate corrosion for floor beams and bottom chord. (Locations are marked in figures below).
- Exposed reinforcement in RCC slab panels at pathway of span-4. Moderate corrosion of Sacrificial plate and missing diagonal in span-4 (Photographs of the same can be see in **fig 3.12-3.14**)
