# Third Party Audit of ROB's and FOB's of SCR

## INSPECTION OF FOB AT KACHIGUDA RAILWAY STATION

**Final Report**  
SEPTEMBER | 2020

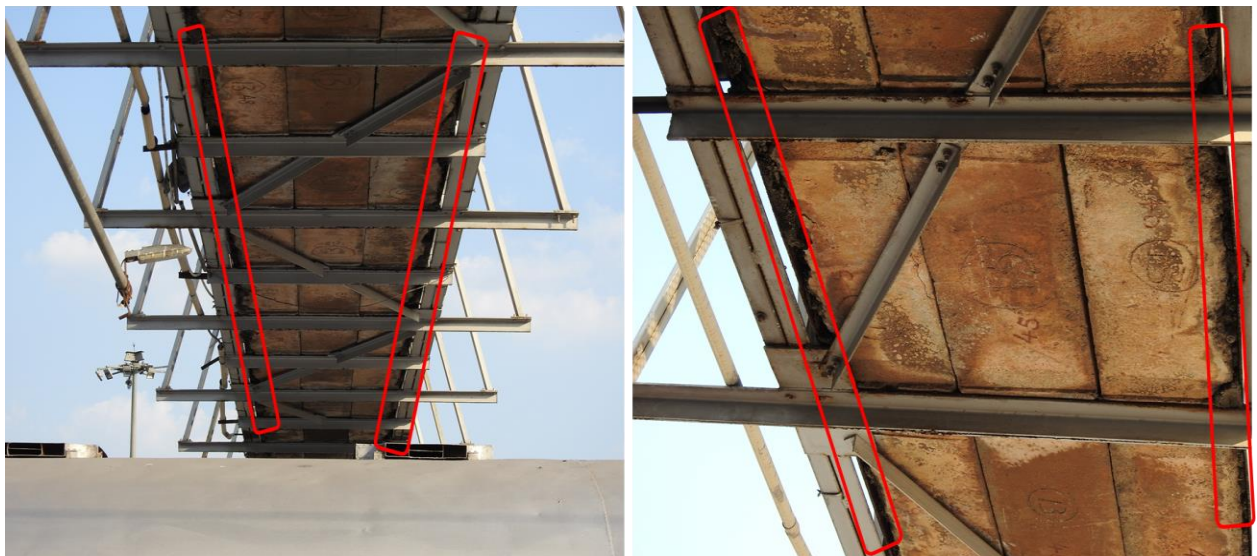
- Structural members are in fair condition, displaying mild corrosion for top chord members, verticals, diagonals, gusset plates. Moderate corrosion for floor beams and bottom chord. (Locations are marked in figures below).
- Exposed reinforcement in RCC slab panels at pathway of span-4. Moderate corrosion of Sacrificial plate and missing diagonal in span-4 (Photographs of the same can be see in **fig 3.12-3.14**)

**Fig 3.12:** Exposed reinforcement in slab panels at span-4

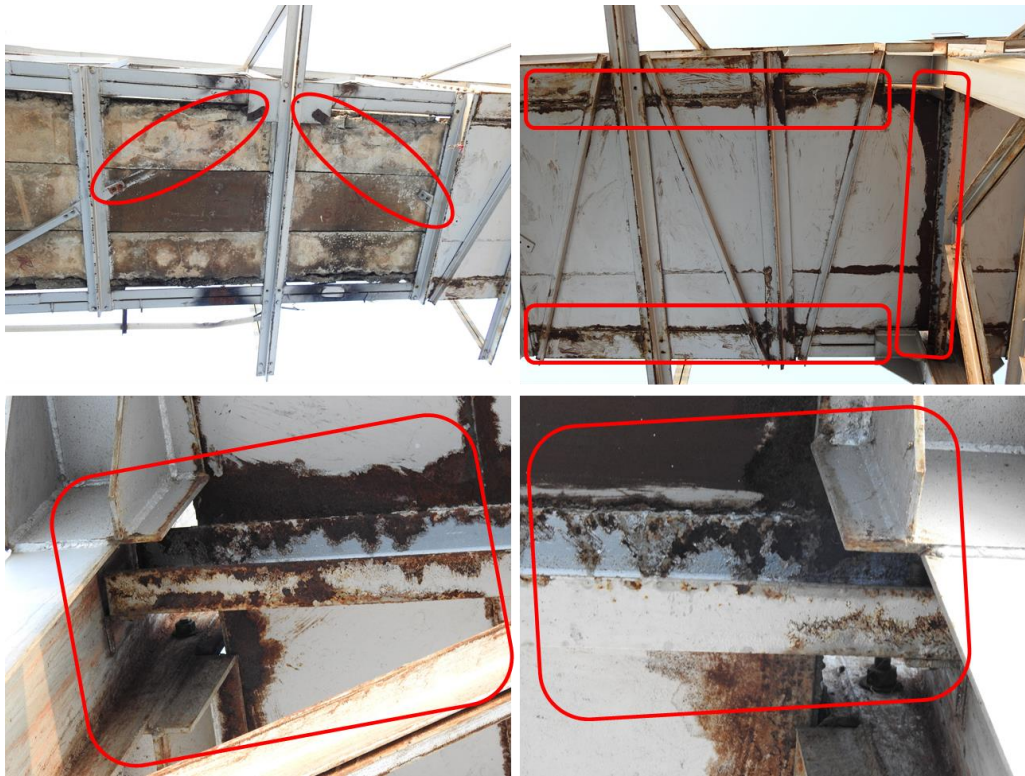
**Fig 3.13:** corrosion of floor beam and sacrificial plate and missing diagonal

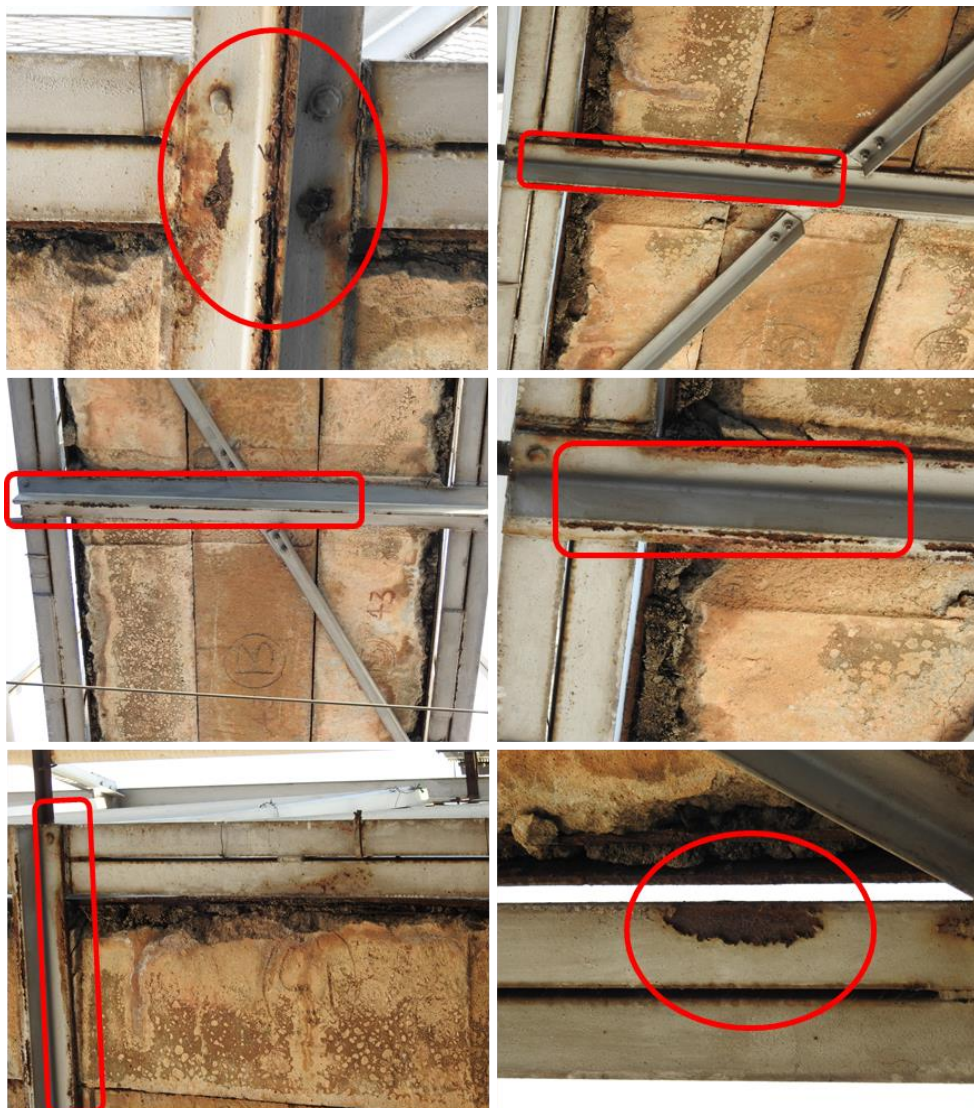
**Fig 3.14:** Corrosion of floor beams and bottom chord in span-4

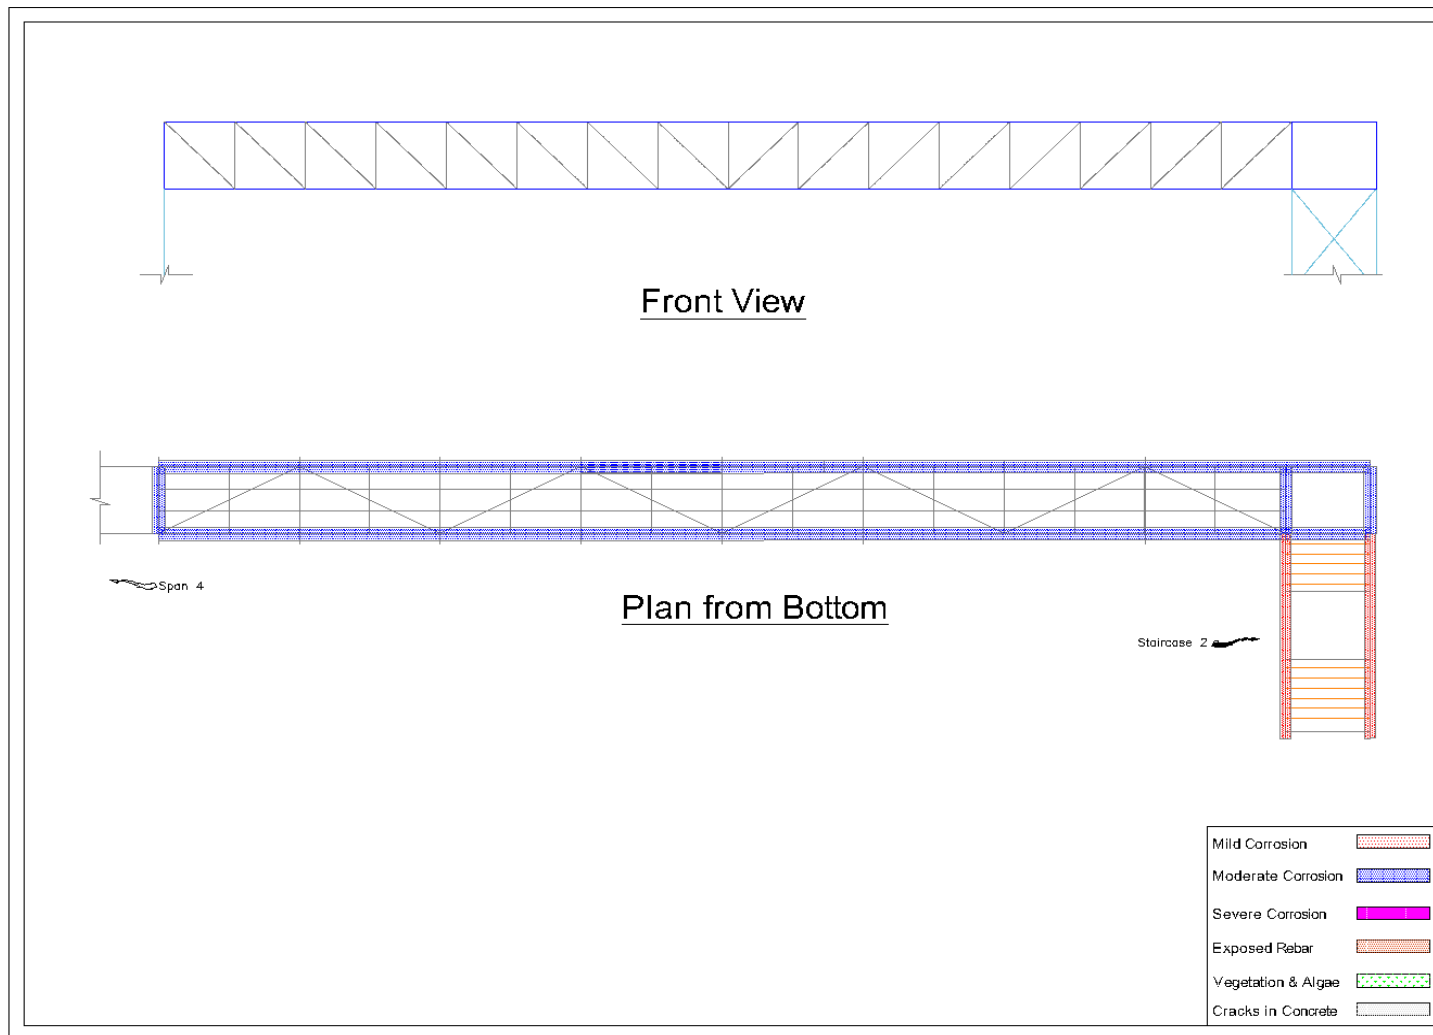
**Fig 3.15:** Locations of deteriorations and bottom view of span-5

- Structural members are in fair condition, displaying mild corrosion for top chord members, verticals, diagonals, gusset plates. Moderate corrosion for bottom chord and staircase stinger beam at staircase-2. (Locations are marked in figures below).
- Moderate corrosion of sacrificial plate in span-4. (Photographs of the same can be see in **fig 3.16-3.18**)

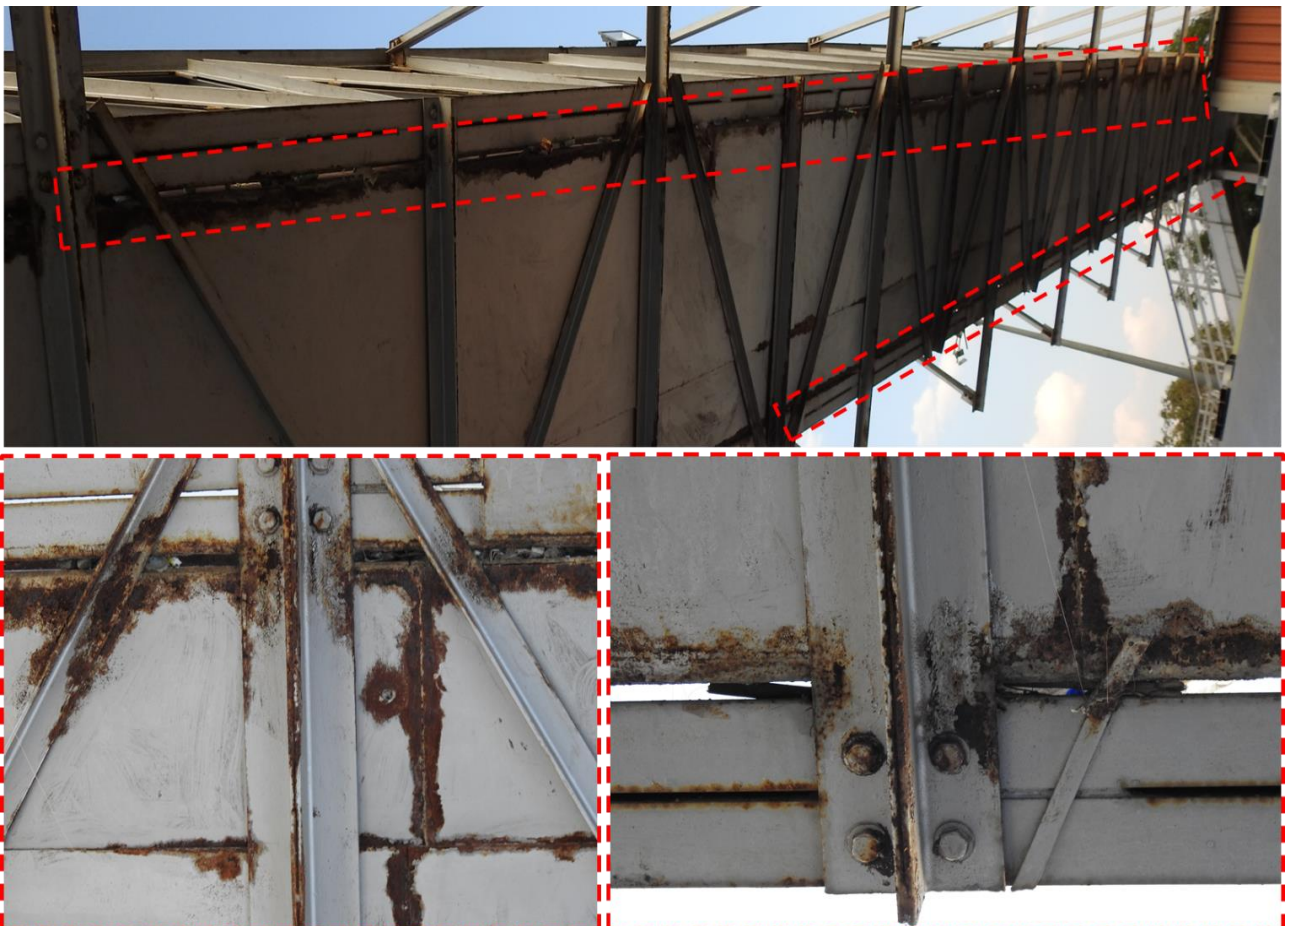
**Fig: 3.16** corrosion of floor beam, joints and sacrificial plate and bottom chord joints

- c) Replacement of damaged and exposed precast slab panels at span-1, span-2 span-3.
  - d) Anti-corrosive treatment for splice joint in span-2.
  - e) Replacement of bolts in span-5.

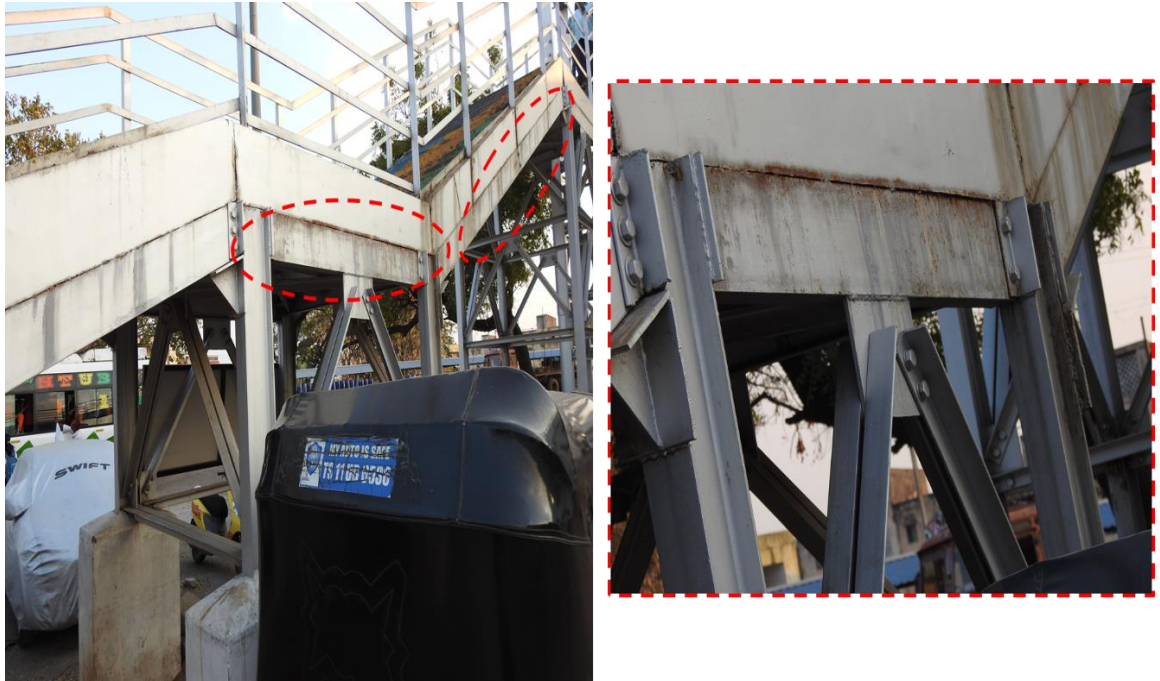
**Fig: 3.17** Corrosion of Stinger beam at staircase-2

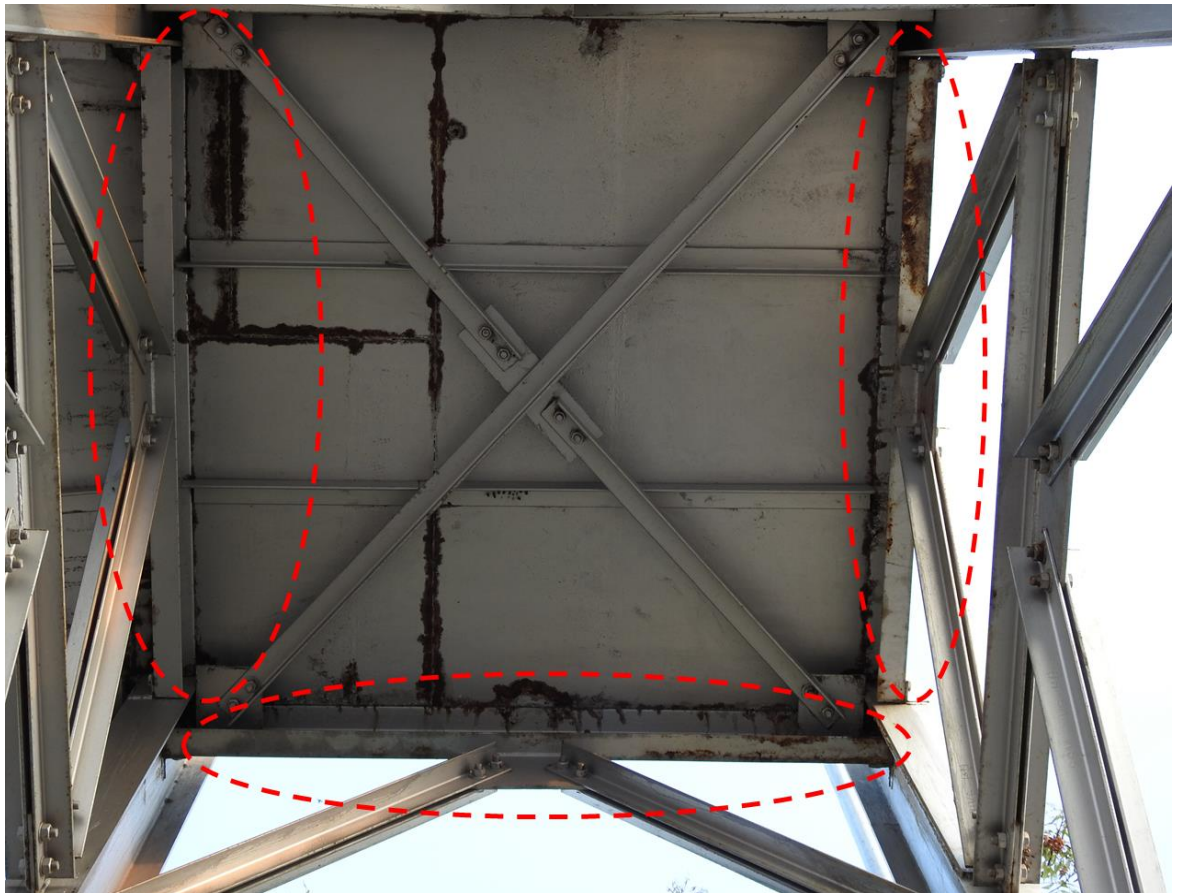
**Fig: 3.18** corrosion of floor beams at Main landing of Trestle 2
