## Third Party Audit of ROB's and FOB's of SCR

### INSPECTION OF FOB AT MALKAJGIRI RAILWAY STATION

**Final Report**  
SEPTEMBER | 2020

| <b>Name of the Project</b> | : | VISUAL INSPECTION OF FOB AT MALKAJGIRI RAILWAY STATION |

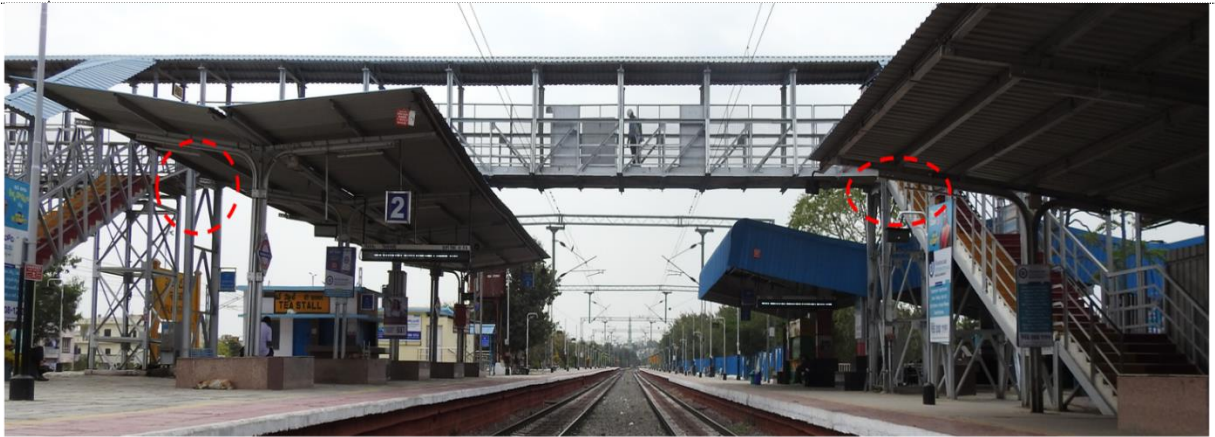
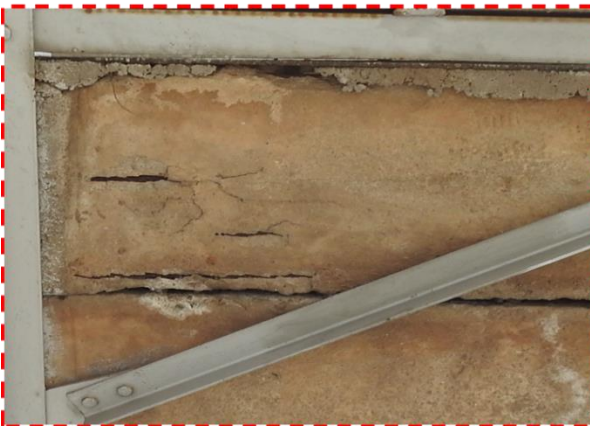
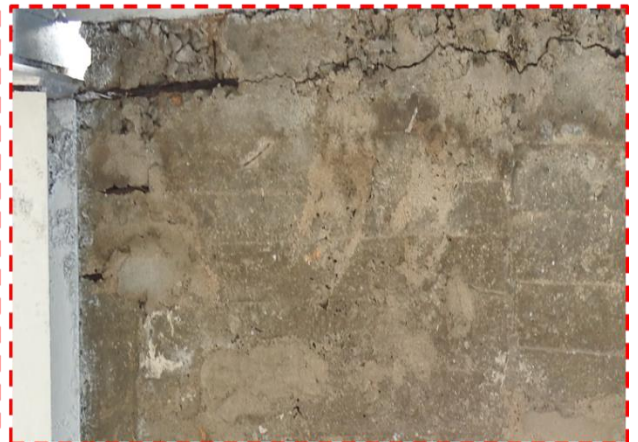
- a. ✓ Spalling and Reinforcement exposure of RCC slab observed along the 1<sup>st</sup> span of FOB

Spalling and reinforcement exposure in span 1

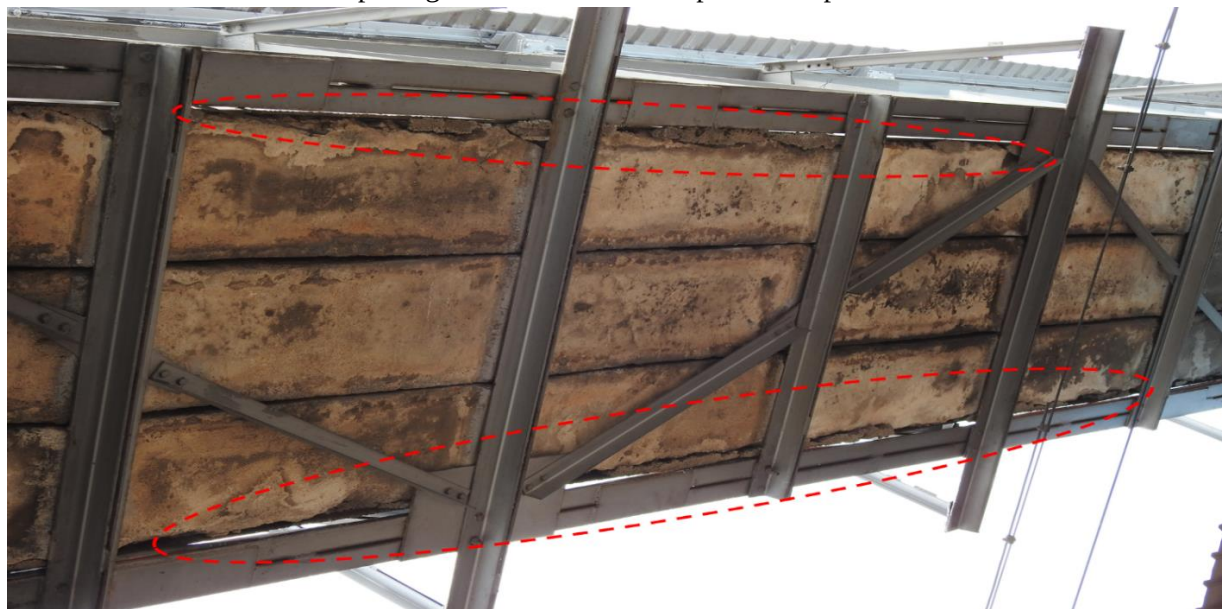
Spalling at bottom chord and slab panels connecting joint

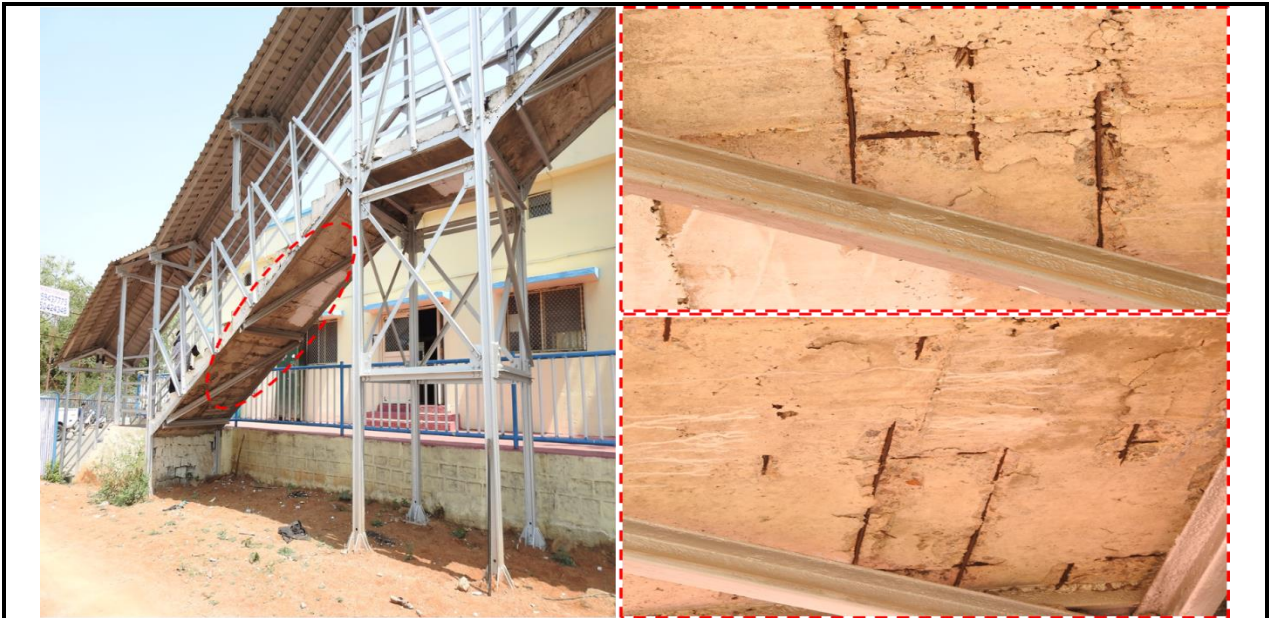
Spalling at stair case 3

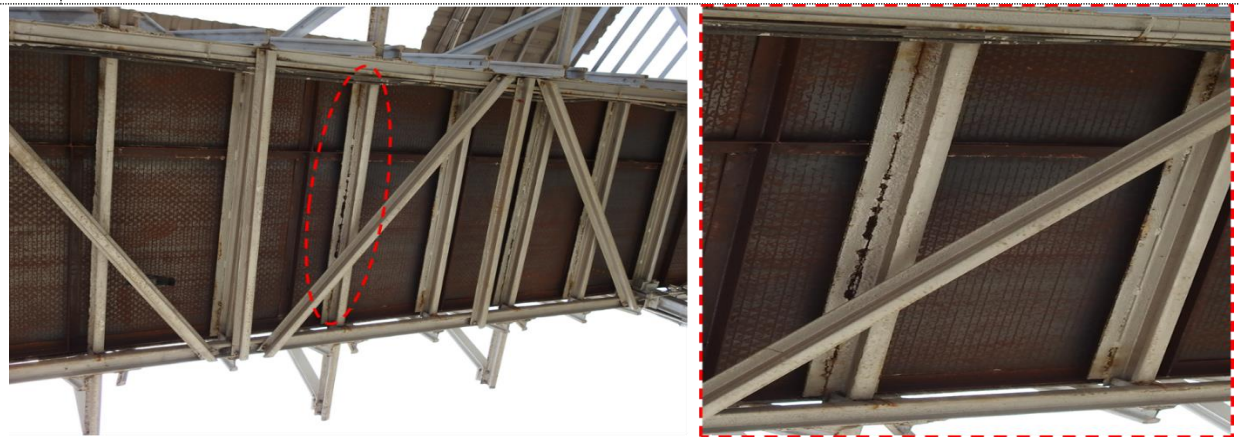
b. ✓ Corrosion is observed floor beams of span 2

Corrosion of Floor beams

| SURVEY OF SIGNS OF DISTRESS, DEFORMATION IN BRIDGES | | | |
|---|---|---|---|
| | Extent of Corrosion | Floor beams | Slight corrosion is observed at floor beams of span 2 (Refer <b>Part 1.4 – 1.4(b)</b> ) |

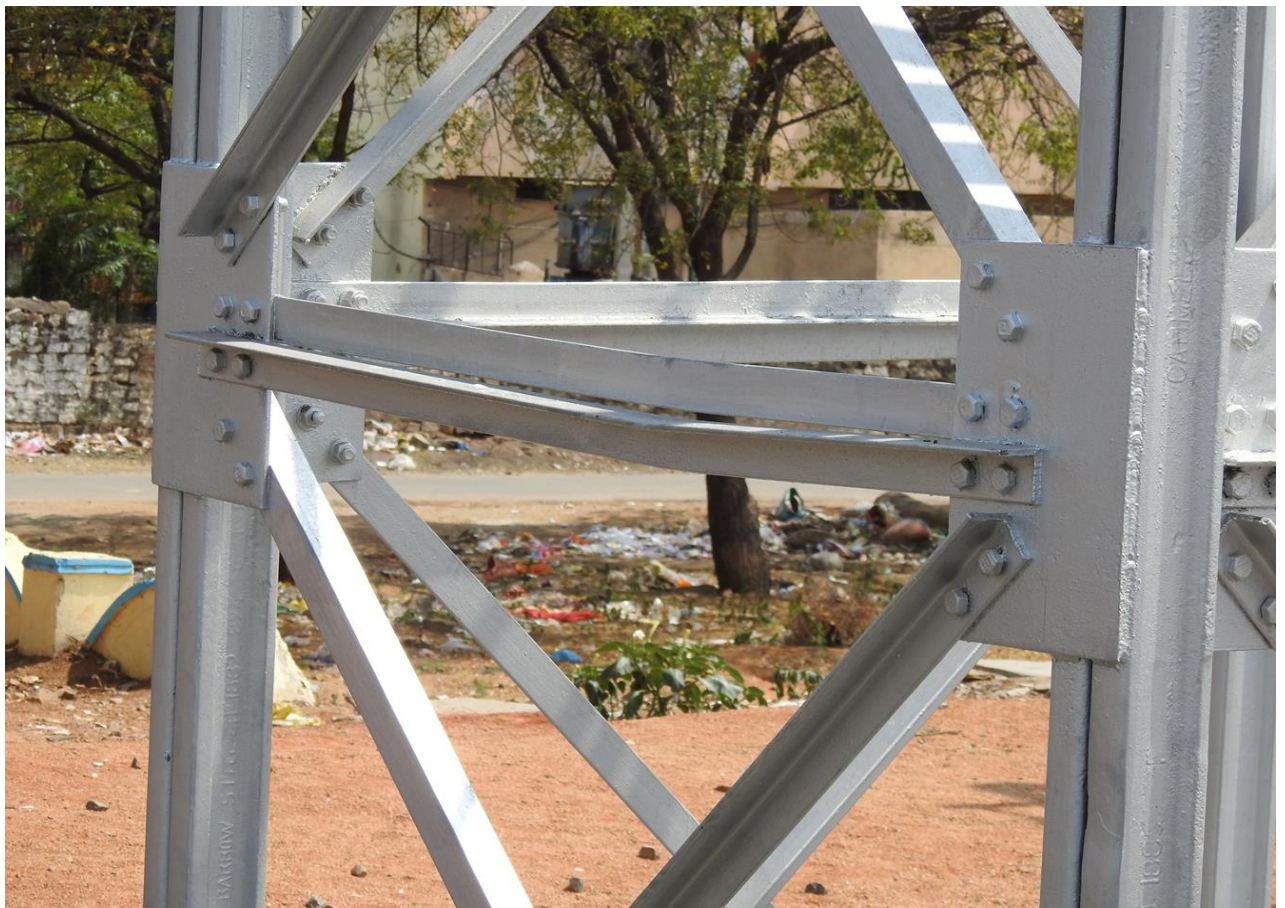
**Fig 1.8:** Deformation of bracings at trestle 4

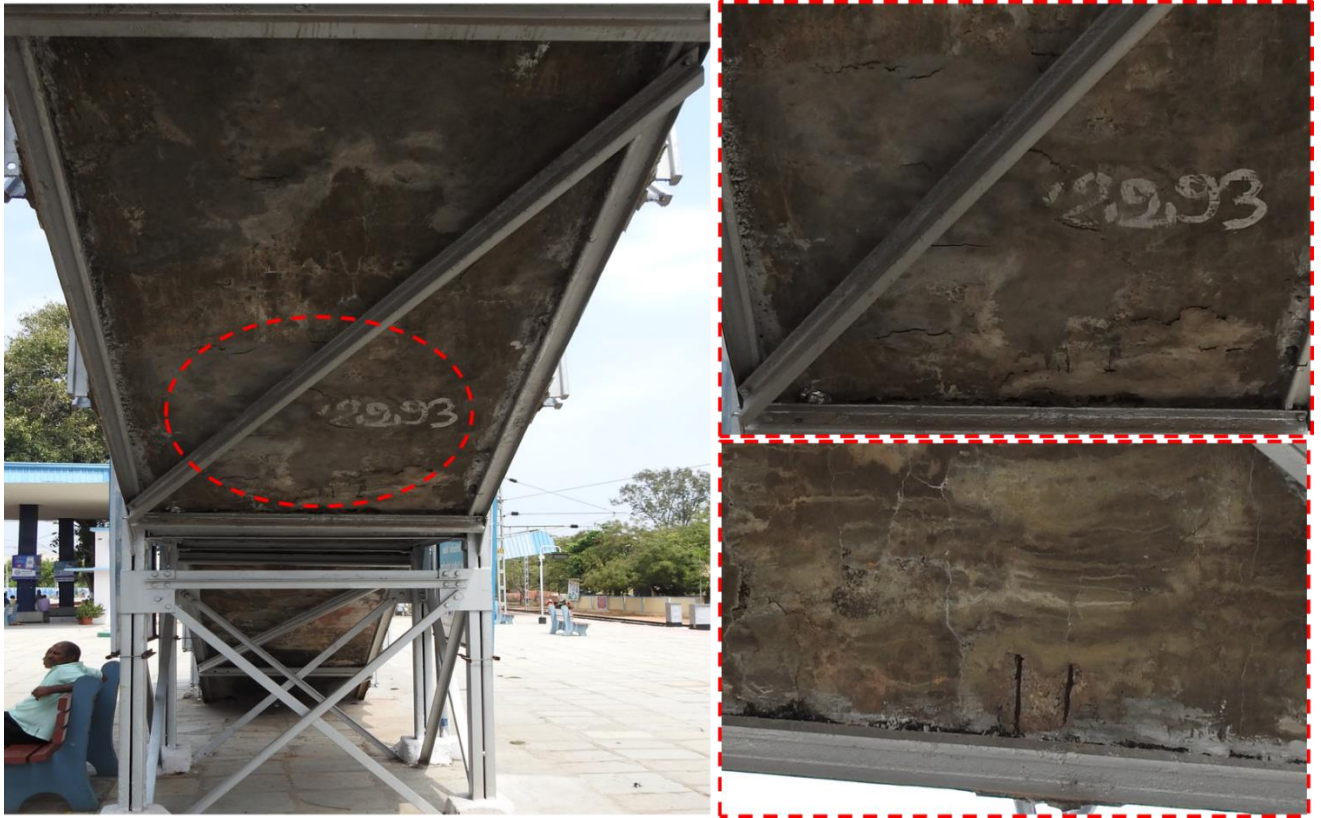
**Fig 1.9:** Patch work observed at staircase 2

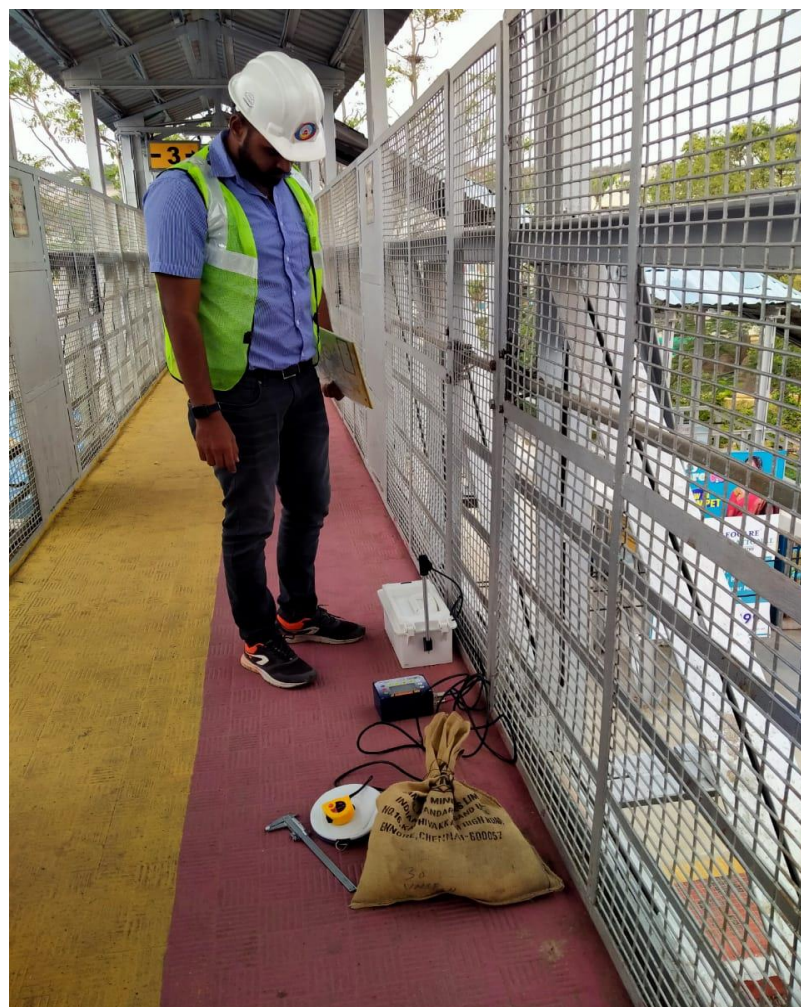
**Fig 1.10:** Vibration Test at Malkajgiri FOB

Based on the vibration analysis carried out the structure is undergoing vibrations in permissible limit of vibrations. (Frequency observed is 252 cpm and maximum amplitude observed during the test time of complete 2hrs is 0.5106 mm)

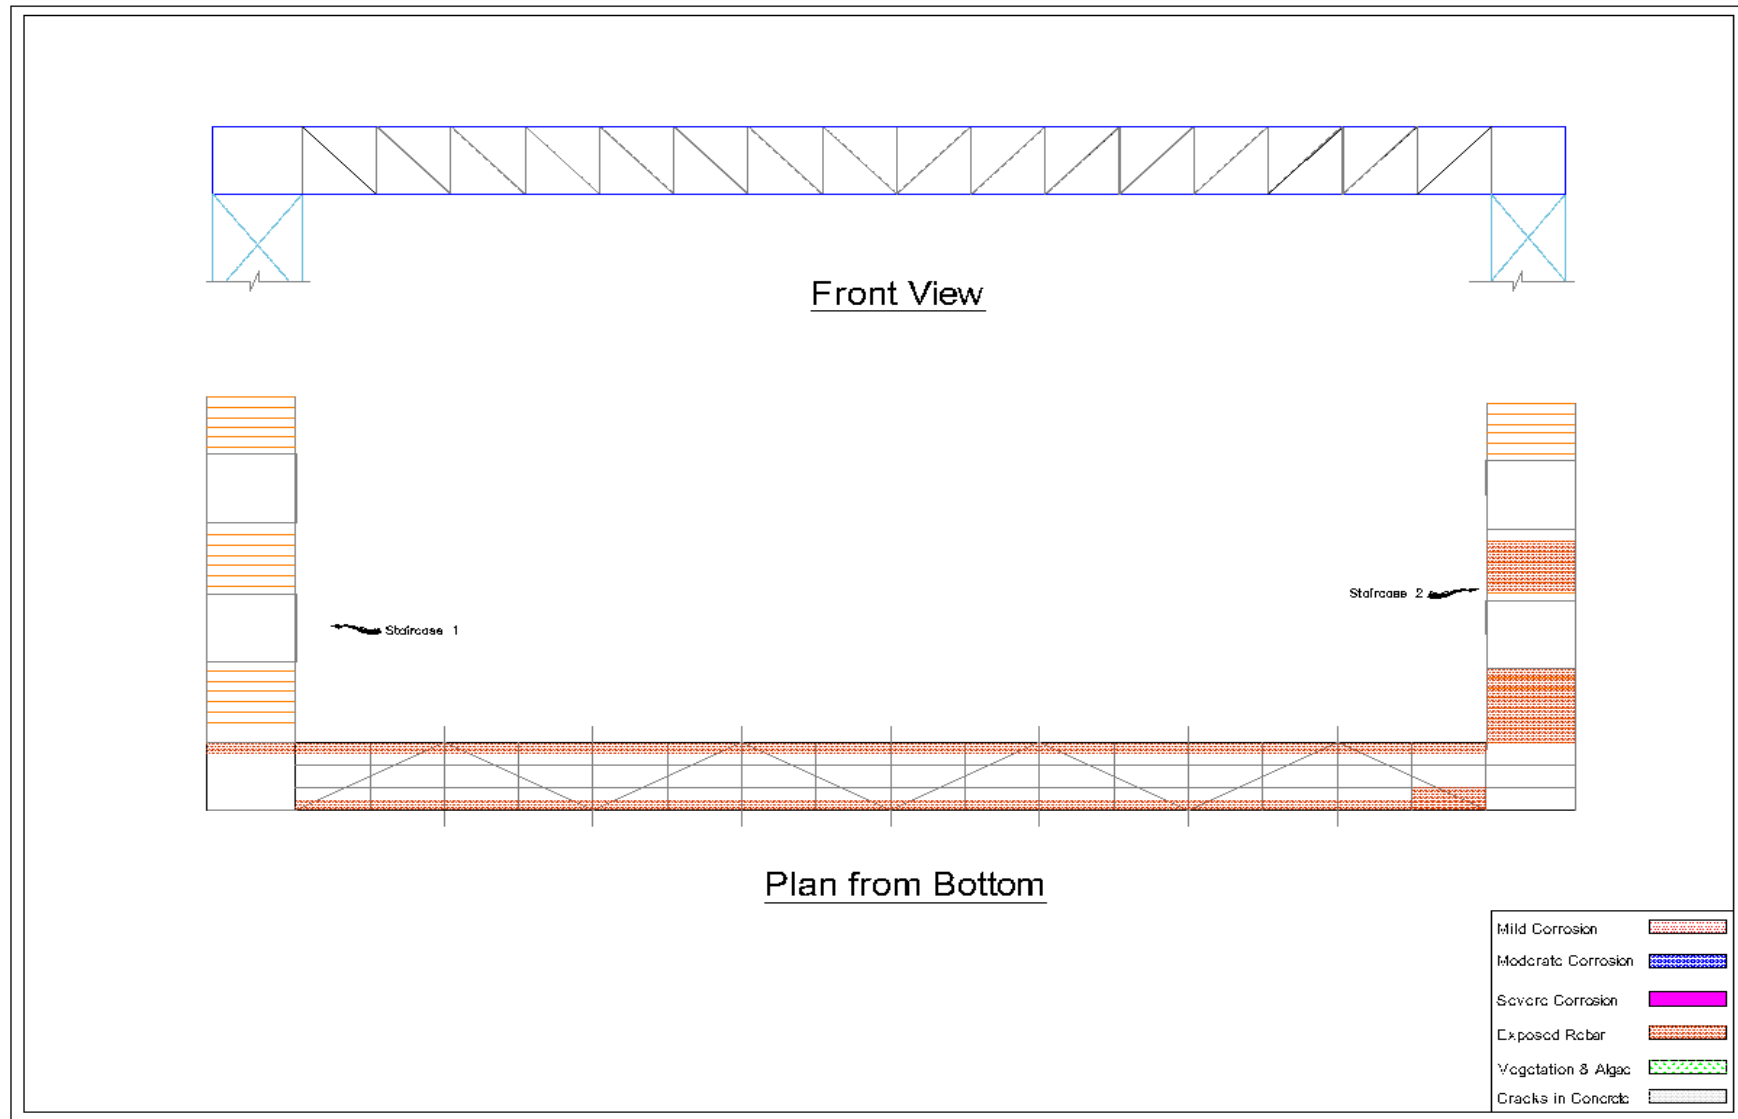
**Fig 3.1:** Locations of deteriorations and bottom view of Span-1

- Structural members are in fair condition, displaying mild corrosion for top chord members, verticals, diagonals, gusset plates, bottom chord members and staircase stringer beam along steel concrete joint. (locations are marked in figures below).
- Staircase 1 reinforced is exposed in flights and staircase RCC mid landing slab at deck level.  
(Photographs of the same can be see in **fig 3.2-3.3**)

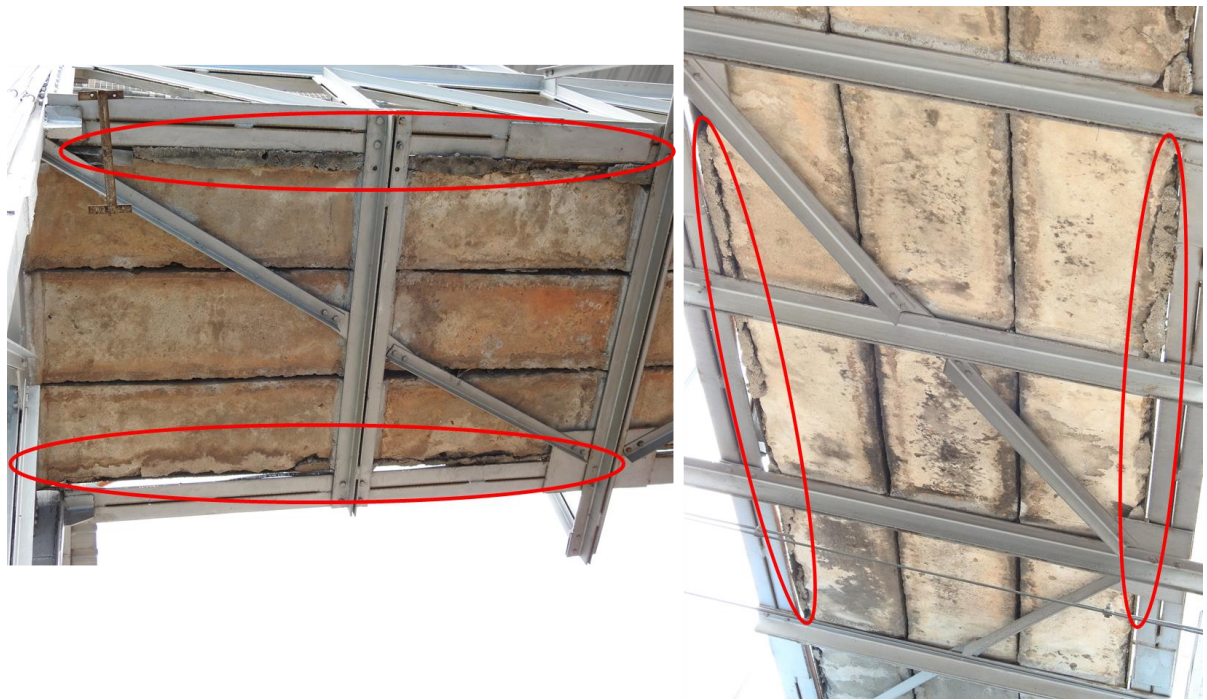
**Fig 3.2:** Exposed reinforcement and patchwork in slab panels at span-1

**Methodology for patching:** Hand applied Mortar (Patching) repair is performed to restore small areas where sound concrete is damaged by spalling, scaling and/or impact. This method of repair is generally applied using trowel and require minimum or formworks. The patch thickness is limited to a maximum of 100 mm depth of hollow surface. Hand applied Mortar repair is classified into two types considering defective area and surface. Hand applied Mortar

- a) **Type - A** is applicable to surfaces without exposed rebar is having defective widths of up to 300mm and depths of up to 50 mm.
- b) **Type - B** is for surfaces with exposed rebar, with defective widths between 300 mm and 600 mm, and up to 100 mm depths.

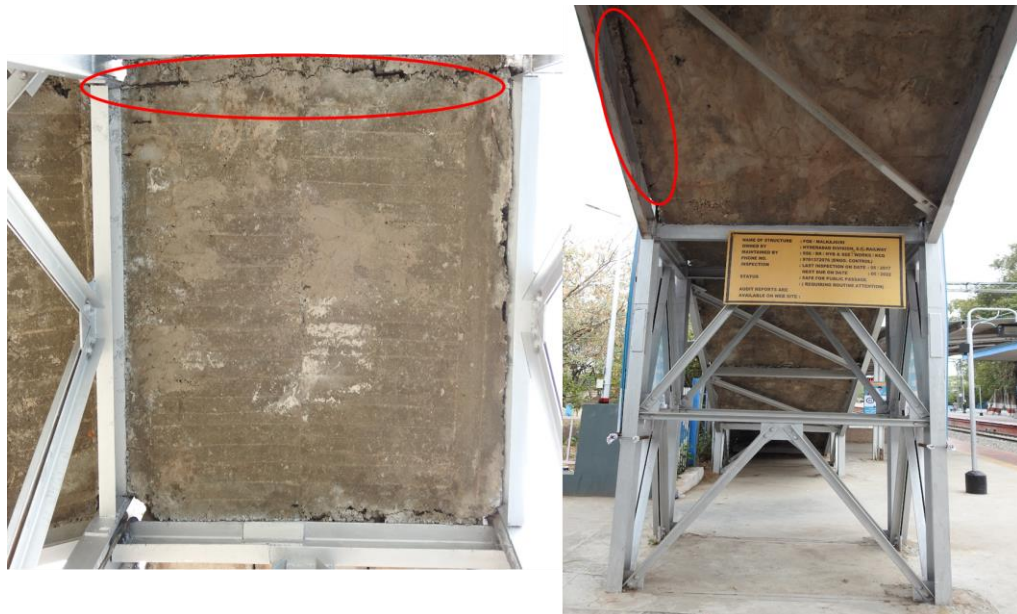
**Fig: 3.3** Exposed reinforcement in mid landing and flight of staircase-1

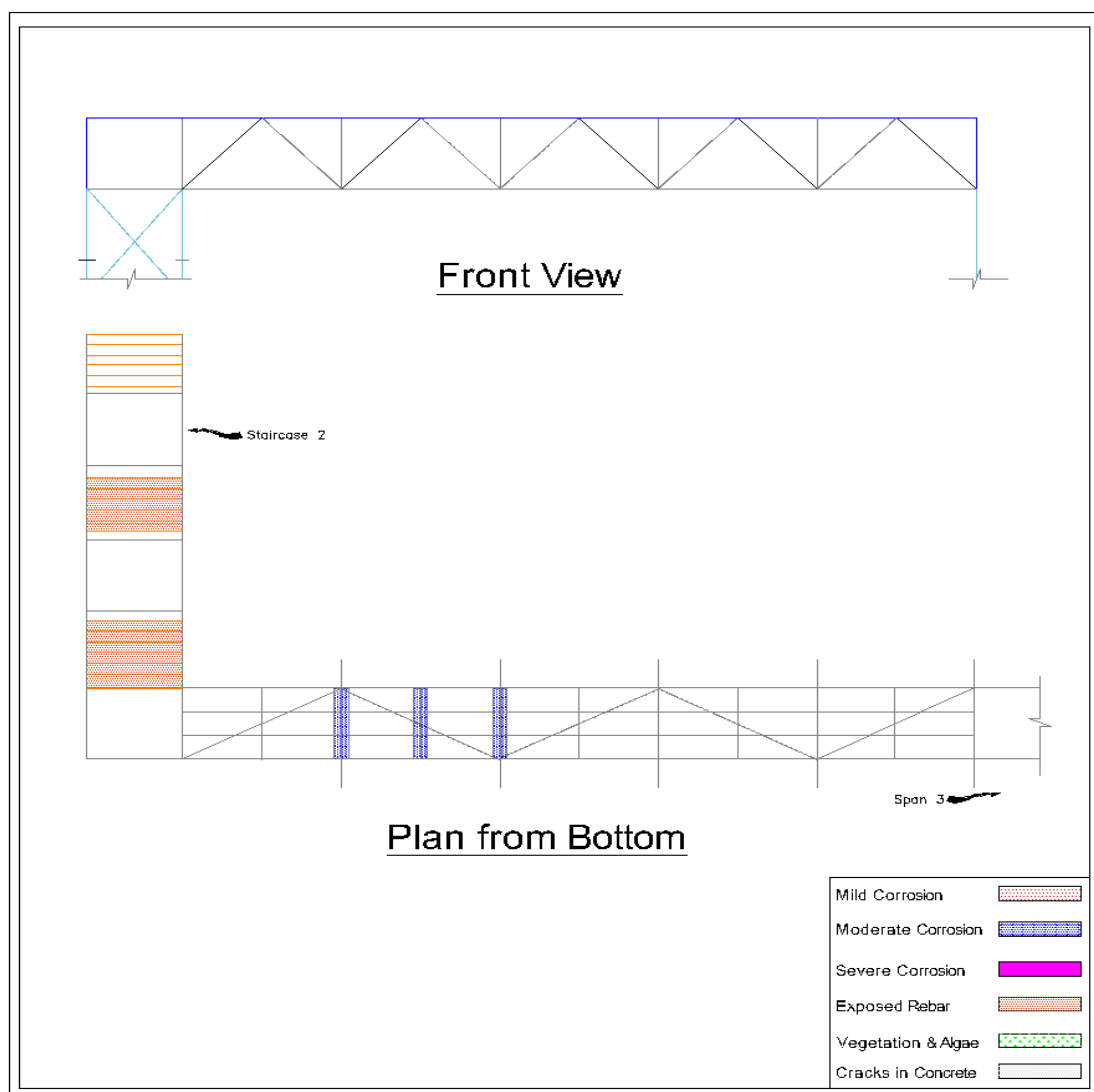
**Fig: 3.4** Locations of deteriorations and bottom view of span-2

- Structural members are in fair condition, displaying mild corrosion for top chord members, verticals, diagonals, gusset plates, bottom chord members and staircase stringer beam along steel concrete joint. (locations are marked in figures below).
- Staircase 2 reinforced is exposed in flights and staircase RCC mid landing slab at deck level.  
(Photographs of the same can be see in **fig 3.5-3.6**)

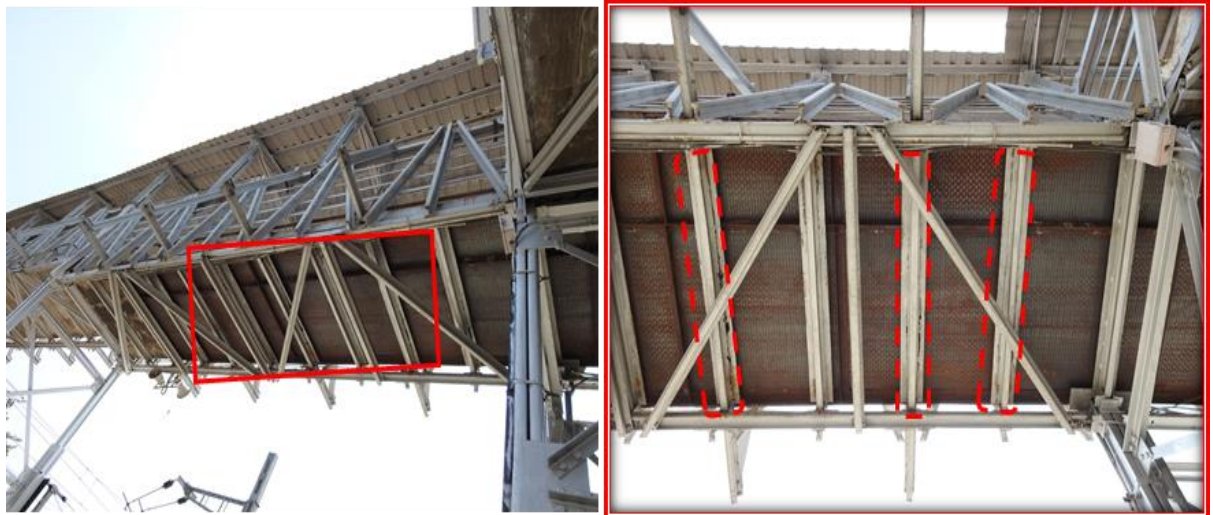
**Fig: 2.5** Corrosion of floor beams in span-2

- If the paint condition is identified as Grade-1, aluminum paint shall be applied with a similar shade.

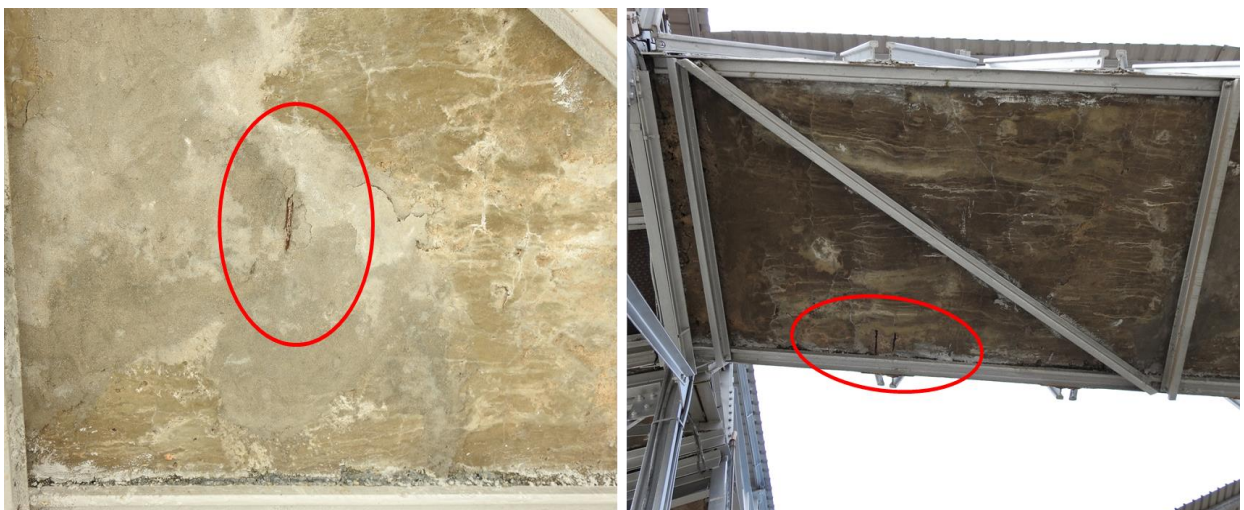
**Fig: 3.6** Exposed reinforcement in flight of staircase-2

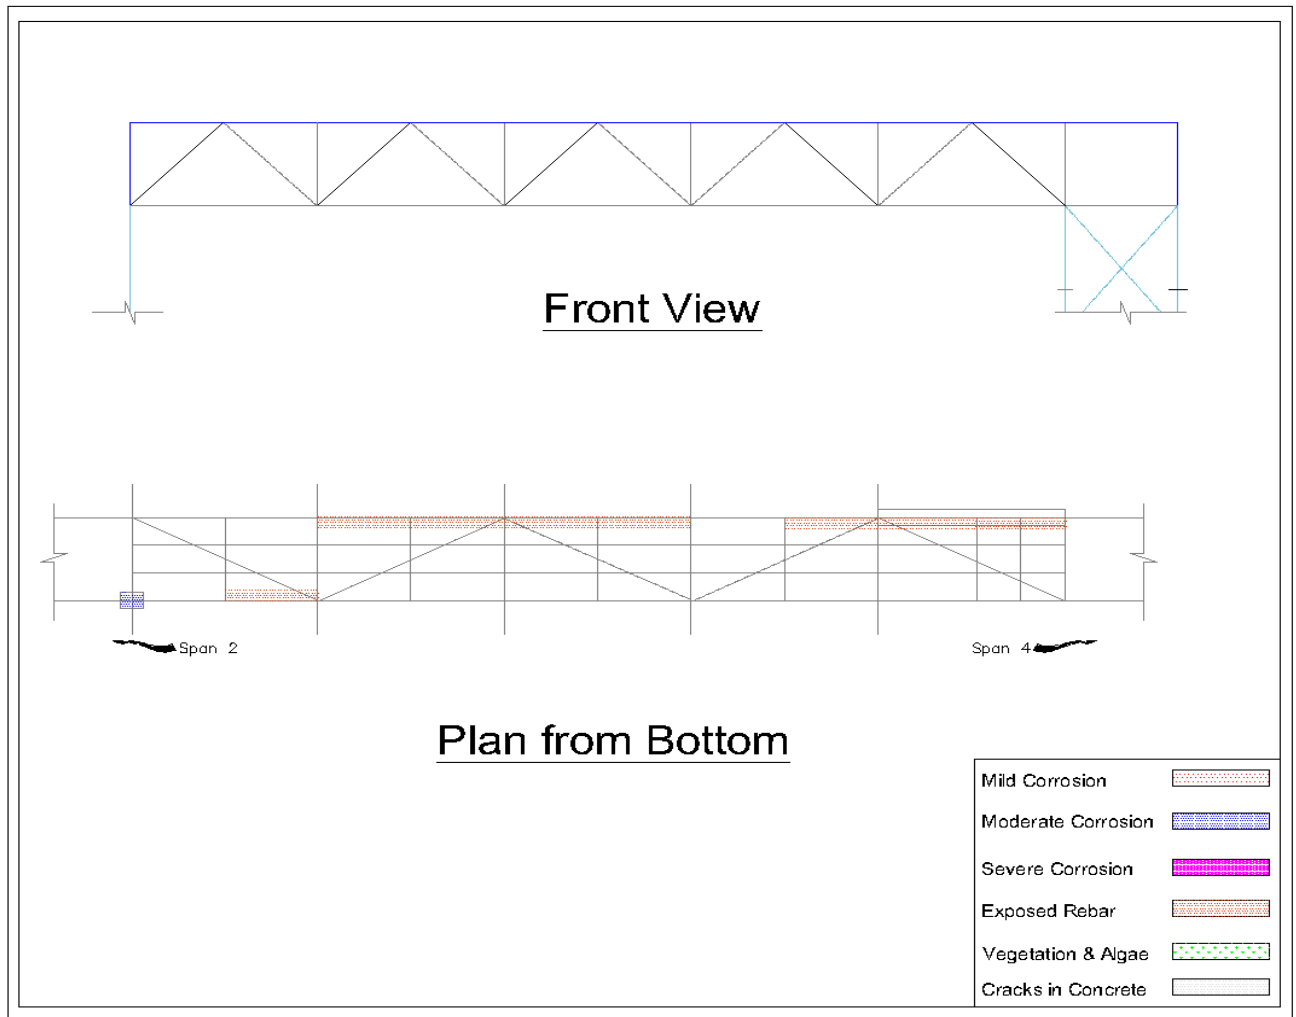
**Fig: 3.7** Locations of deteriorations and bottom view of span-3

- Structural members are in fair condition, displaying mild corrosion for top chord members, verticals, diagonals, gusset plates, bottom chord members and staircase stringer beam along steel concrete joint. (Locations are marked in figures below). (Photographs of the same can be seen in **fig:3.8**)

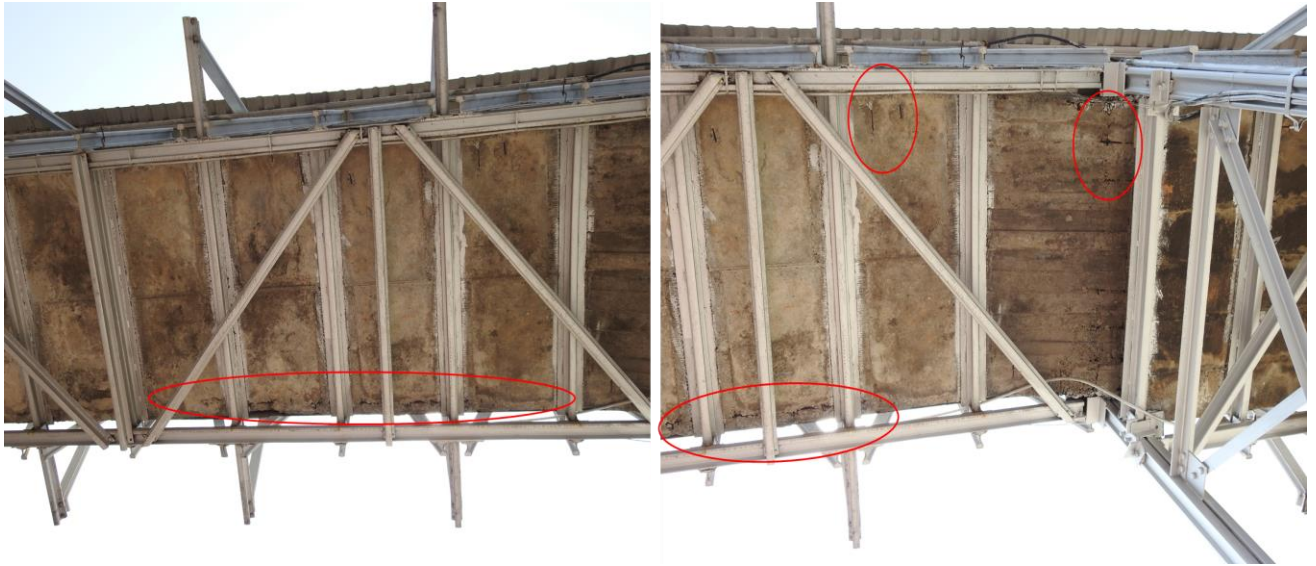
**Fig: 3.8** Exposed reinforcement in pathway of span-3

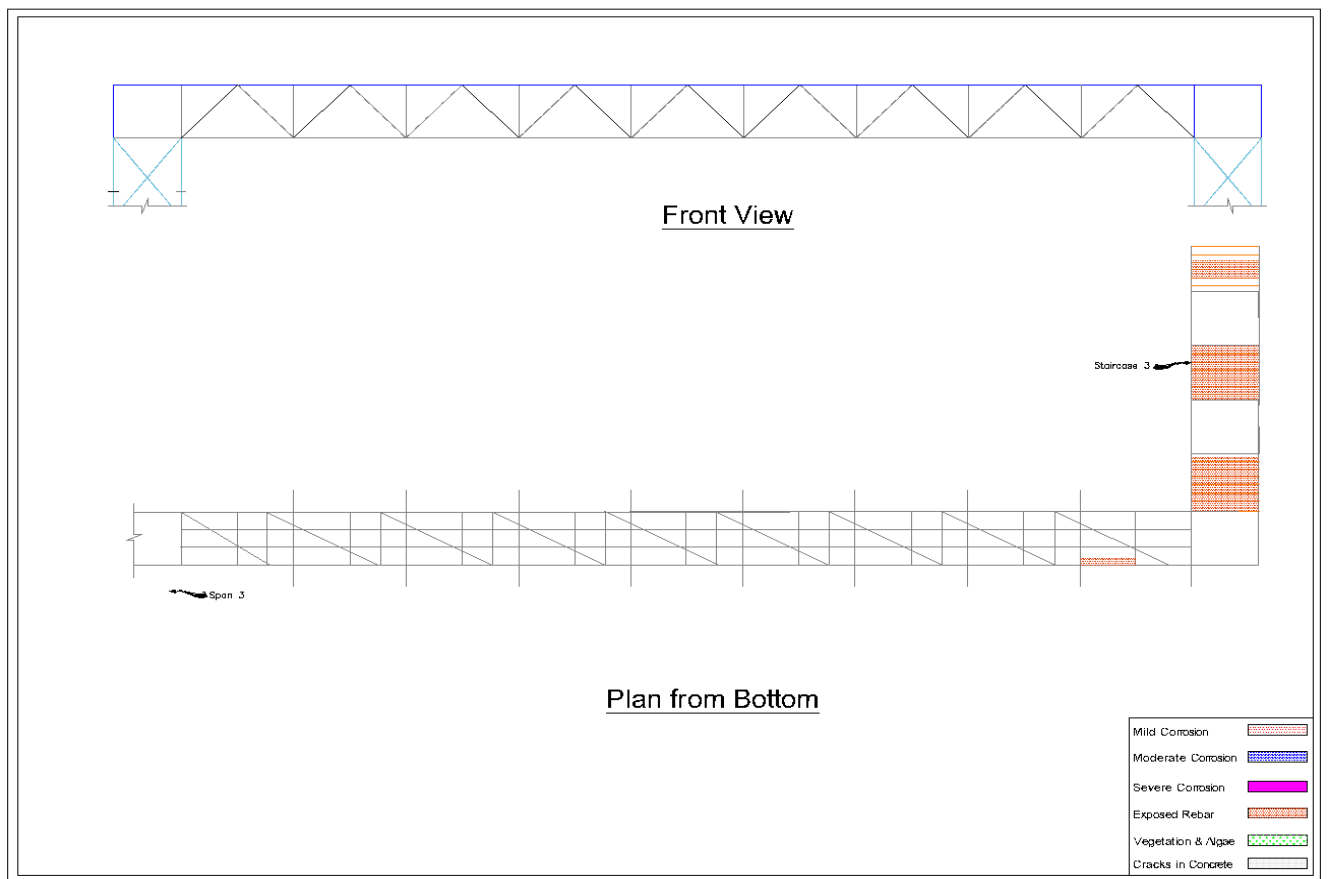
**Fig: 3.9** Locations of deteriorations and bottom view of span-4

- Structural members are in fair condition, displaying mild corrosion for top chord members, verticals, diagonals, gusset plates, bottom chord members and staircase stringer beam along steel concrete joint. (locations are marked in figures below).
- Staircase 3 reinforced is exposed in flights and staircase RCC mid landing slab at deck level.  
(Photographs of the same can be see in **fig3.10**)

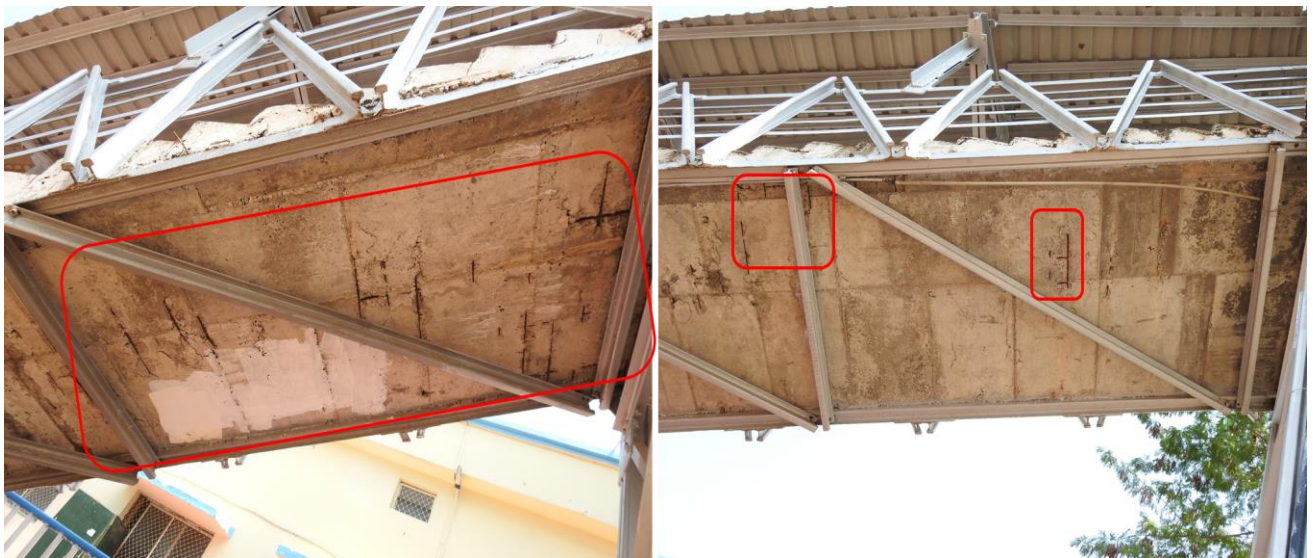
**Fig: 3.10** Exposed reinforcement in staircase-3
