## Third Party Audit of ROB's and FOB's of SCR

### INSPECTION OF FOB AT FALAKNUMA RAILWAY STATION

**Final Report**  
SEPTEMBER | 2020

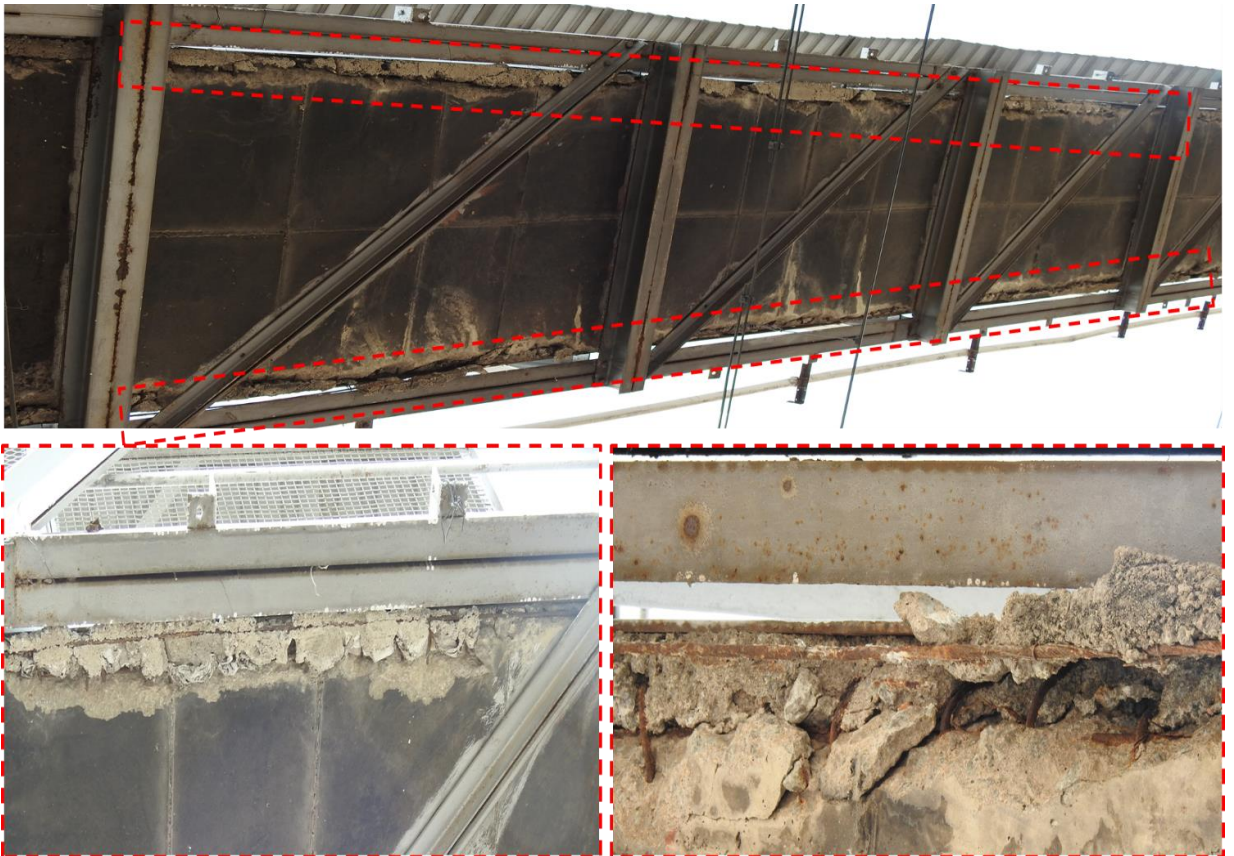
- a. ✓ Spalling and Reinforcement exposure of RCC slab observed along the 1<sup>st</sup> span of FOB

Spalling and reinforcement exposure

| SIGNS OF DISTRESS, DEFORMATION IN BRIDGES | | | |
|---|---|---|---|
| | Spalling | RCC slab | Spalling and exposed reinforcement is observed at the bottom of slab in span 1 and at stair case slab. (Refer <b>Part 1.4 – 1.4(a)</b> ) |

Reinforced cement concrete Slab at Deck level and some precast panels in staircase are observed with exposed rebar in many locations. *(Photographs of the same can be see in **fig 3.4**)*

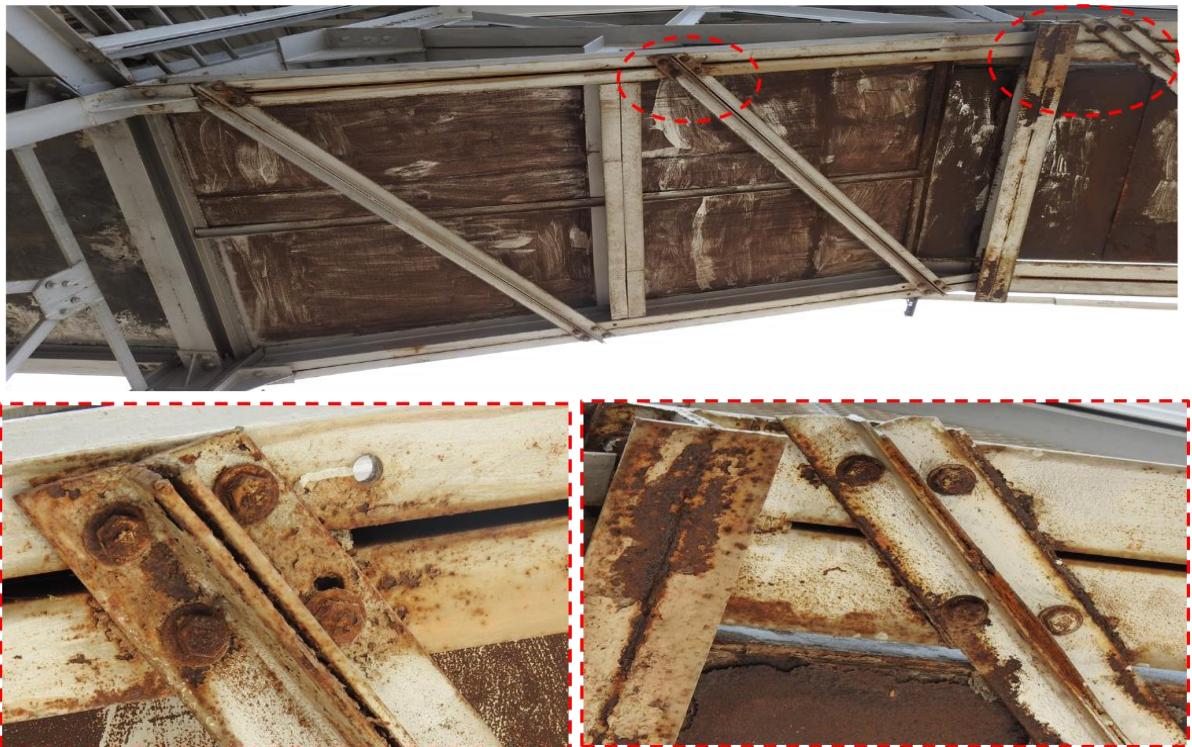
- b. ✓ Corrosion is observed in joints of Floor beams and bottom main chord member and slight corrosion is observed at stringer beam joints

Corrosion observed in Floor beams joints of span 2

| SIGNS OF DISTRESS, DEFORMATION IN BRIDGES | | | |
|---|---|---|---|
| | Extent of Corrosion | Joints | corrosion is observed at bolted joint connecting Floor beams, bracings and bottom chord members(Refer <b>Part 1.4 – 1.4(b)</b> ) |

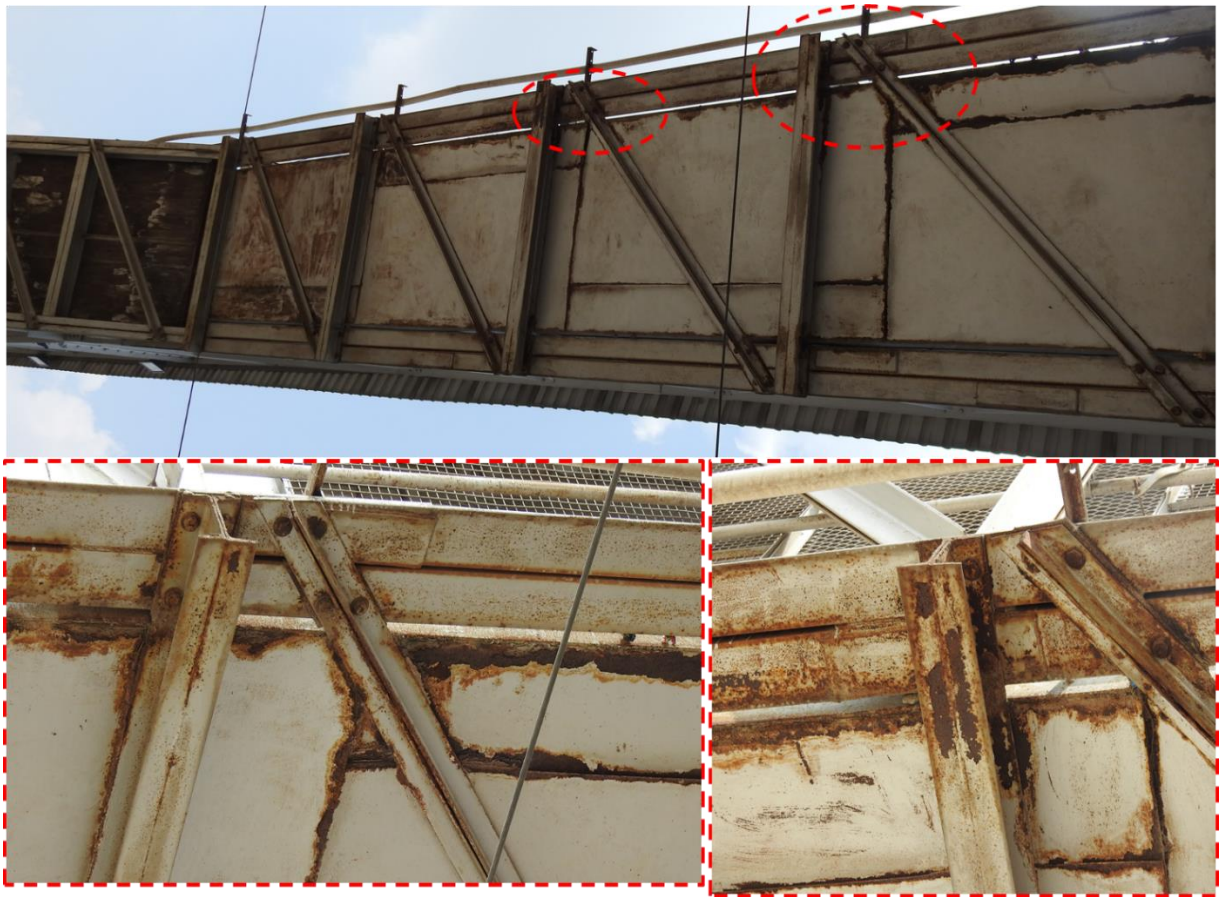
Corrosion of floor beam joints of span 3

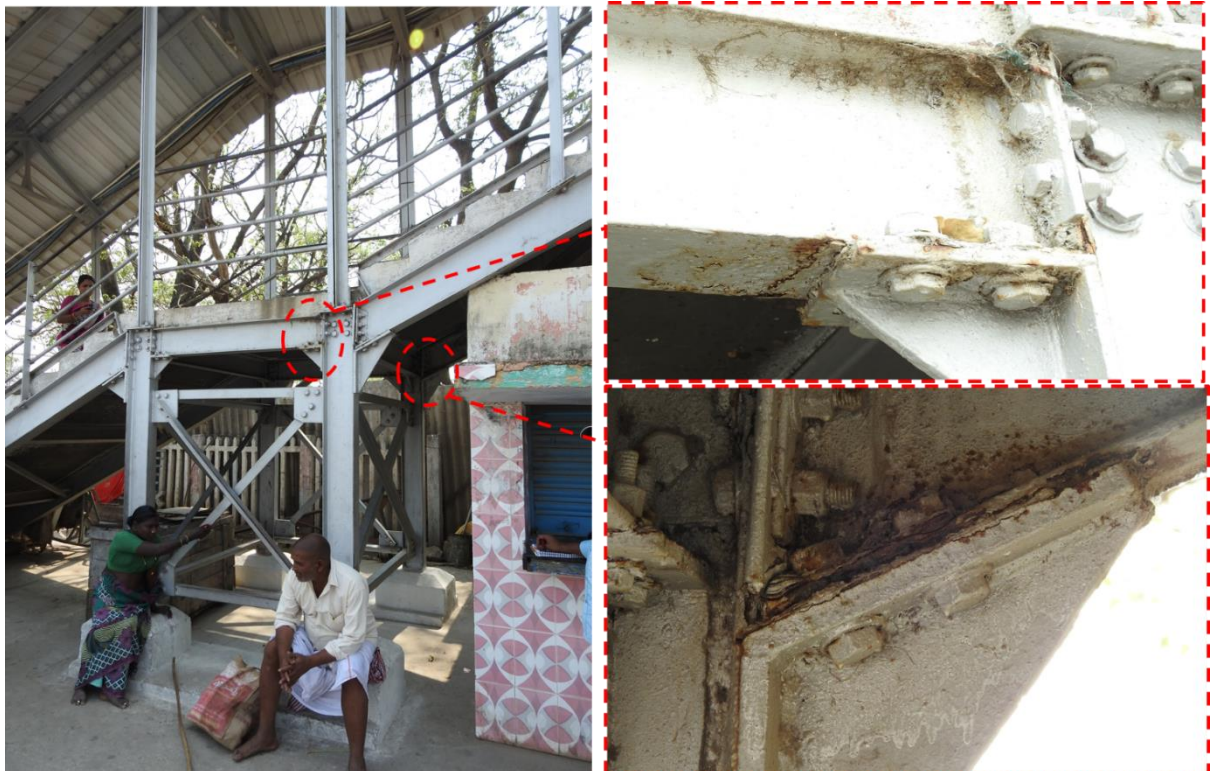
Corrosion at mid landing beam column joint.

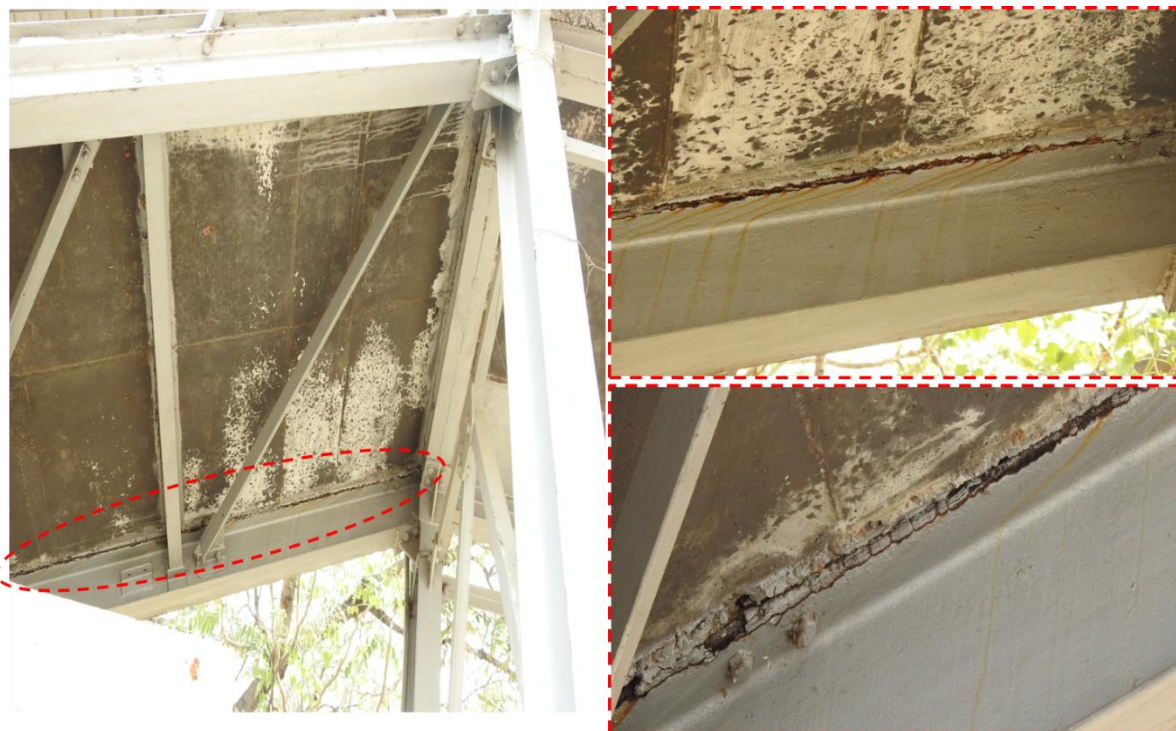
corrosion observed at Stringer beam (steel concrete joint)

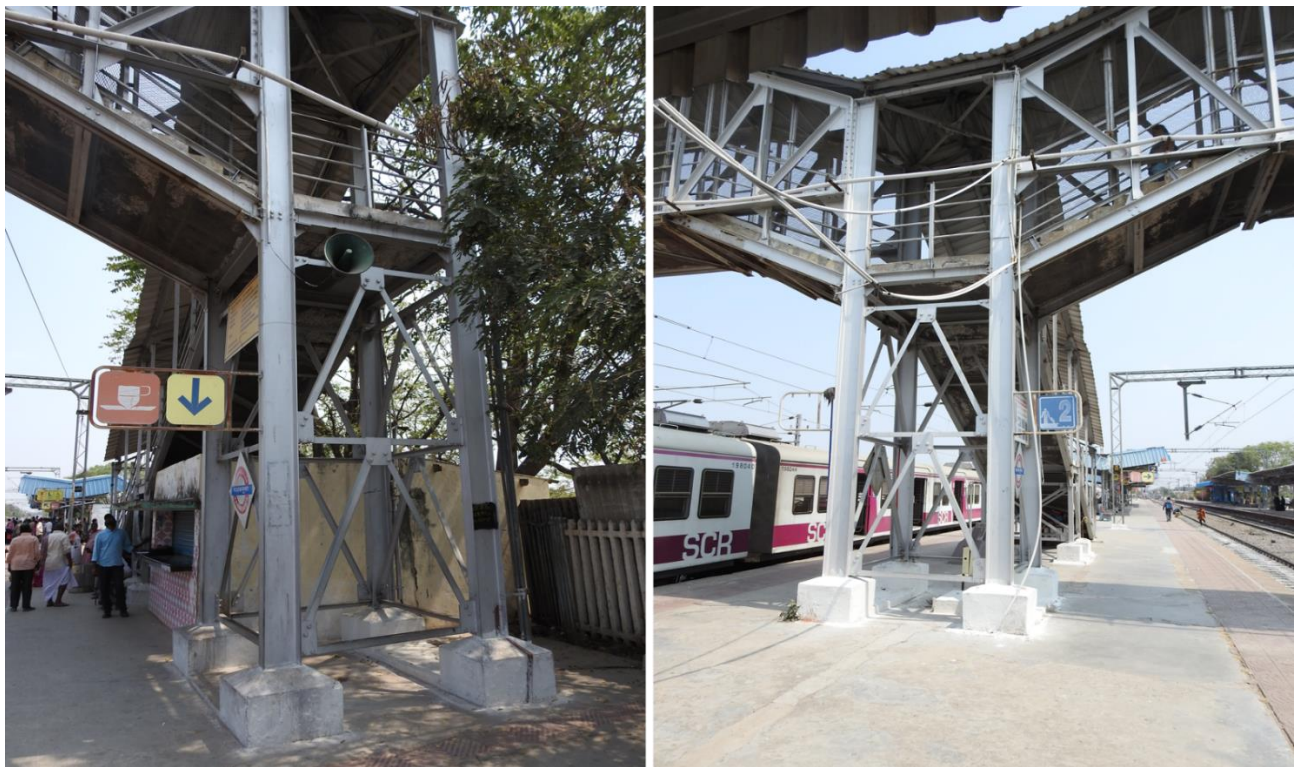
**Fig 1.2:** Trestles details

| 1.3 STRUCTURAL SYSTEM OF THE BRIDGE | | | |
|---|---|---|---|
| | Trestles Connection Details | | Trapezoidal Concrete encasement is observed below vertical supports (Refer <b>fig :1.2</b> ) |

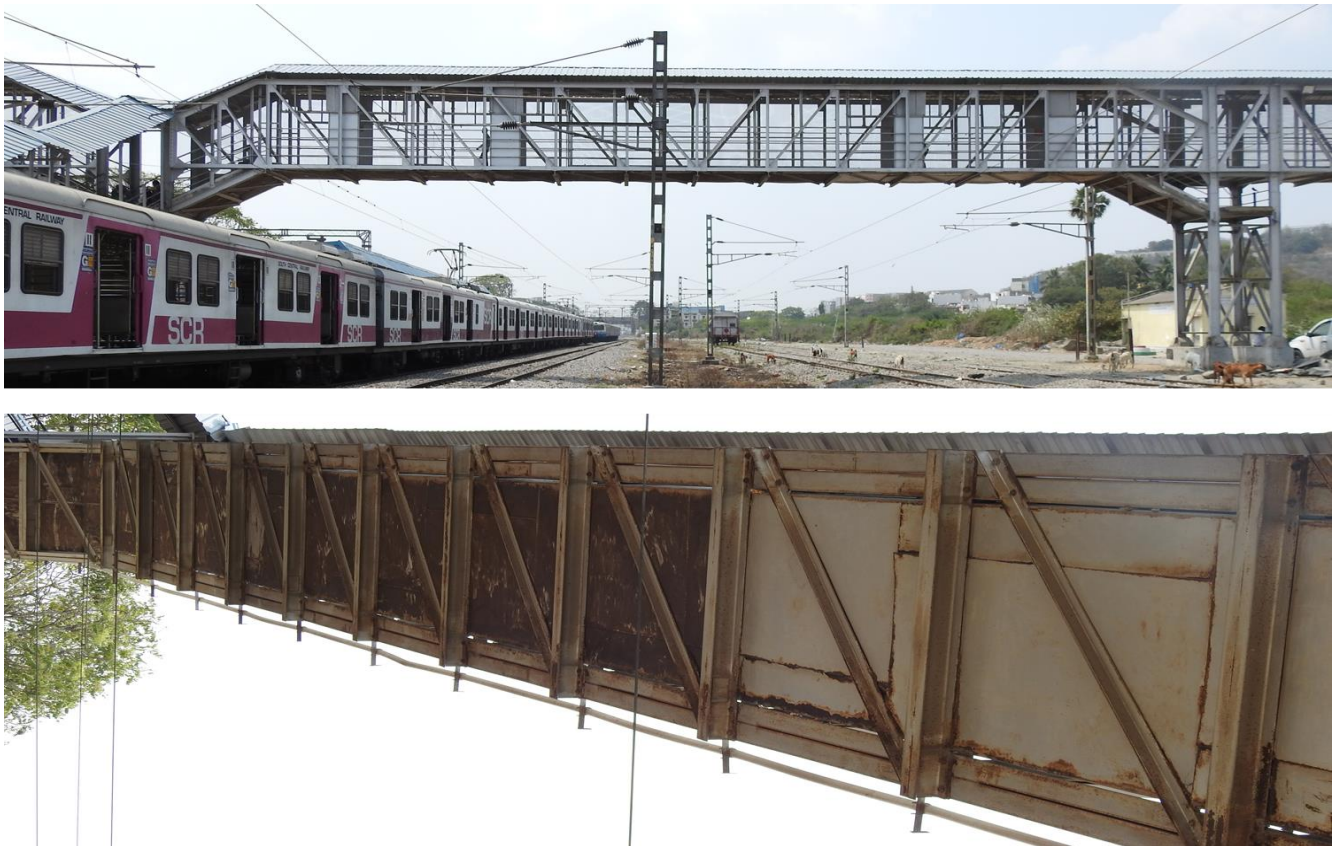
**Fig 1.4:** Front view and bottom view of span 2

| SIGNS OF DISTRESS, DEFORMATION IN BRIDGES | | | |
|---|---|---|---|
| | Rust straining | Bottom chord members | Rusting is observed at all over the bottom chord members of FOB. (Refer <b>Part 1.4 – 1.4(b), Fig 1.4</b> ) |

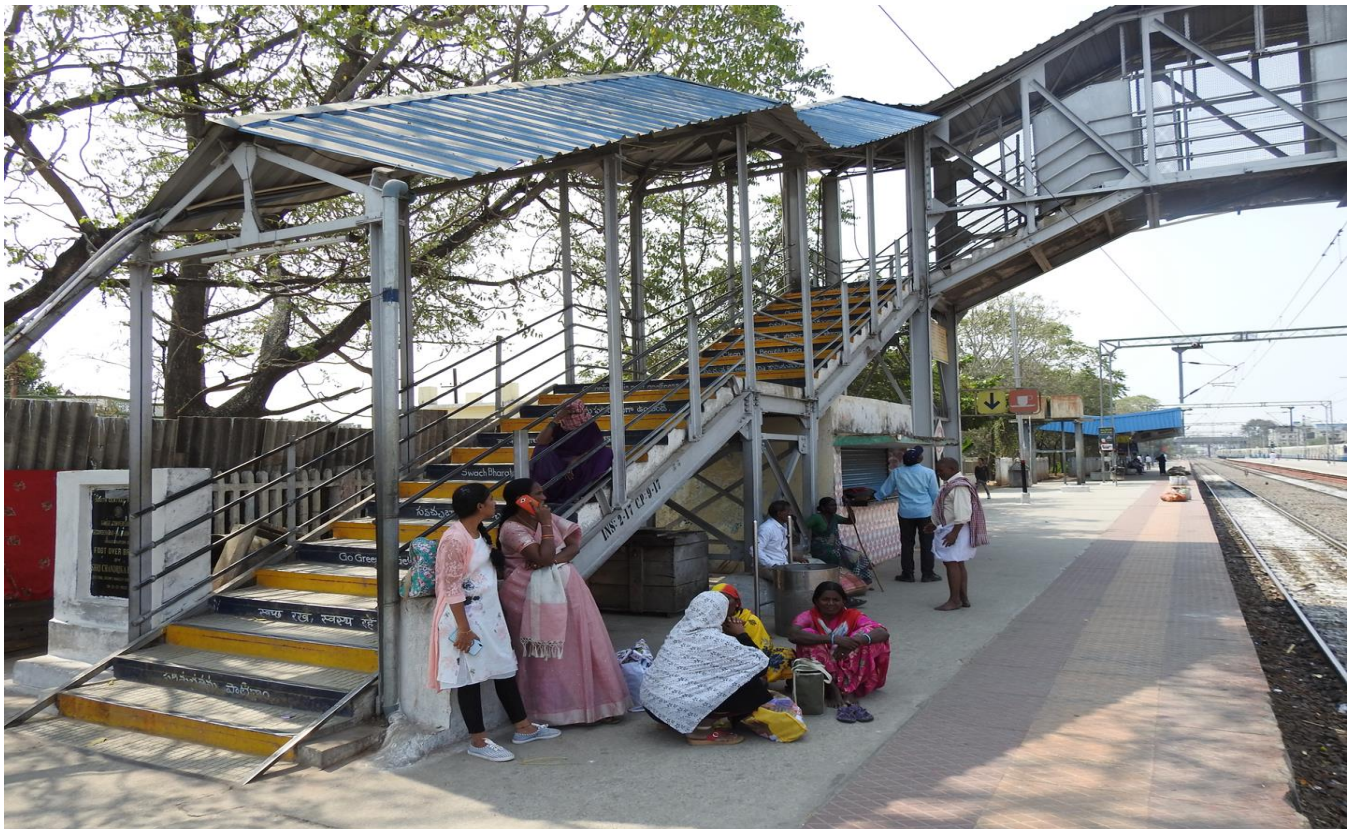
**Fig 1.6:** Staircase details

| | Number of Staircase | 3 no's | Staircase steps are observed as<br>RCC slab, Steps are supported on<br>stringer beams of ISMB 250<br>section, horizontal members of<br>ISMB 150 and diagonal bracings<br>with 65 x 65 x 8mm angle sections.<br>(Refer <b>fig :1.6</b> ) |

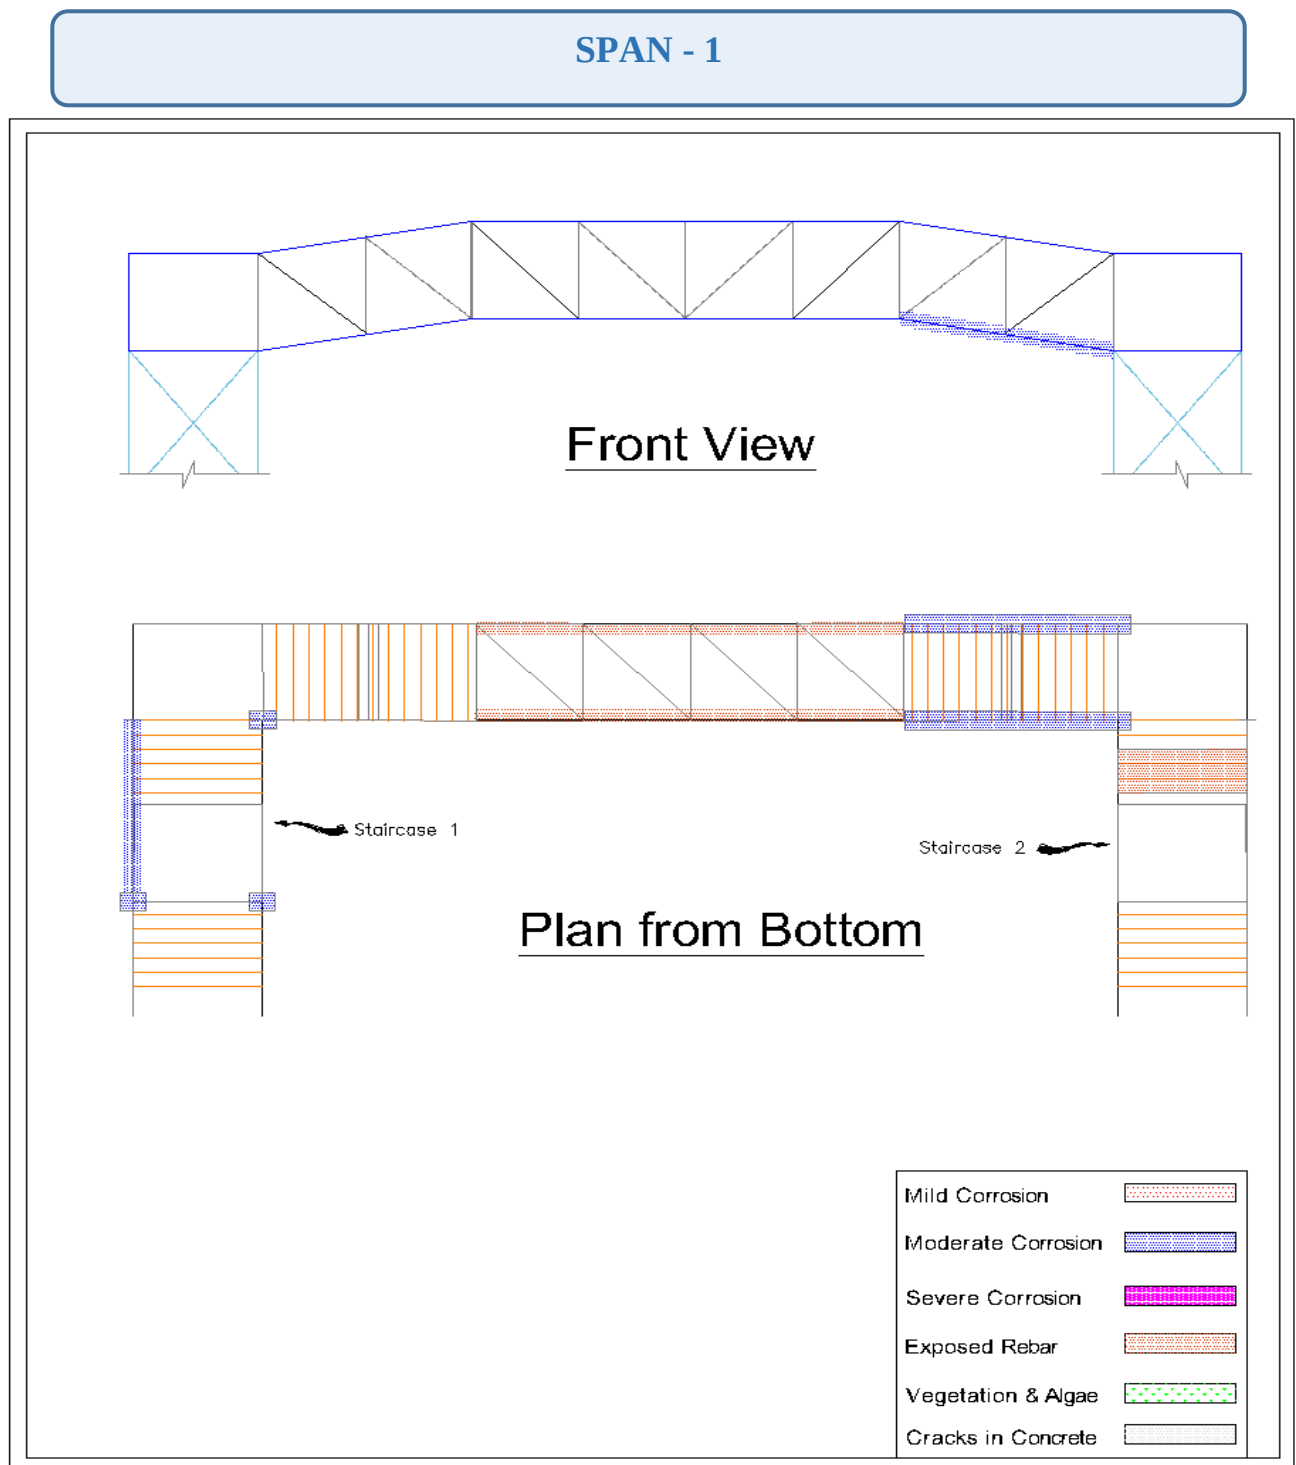
**Fig: 3.1** Locations of deteriorations and bottom view of span-1

- Structural members are in fair condition, displaying mild corrosion for top chord members, verticals, floor beams, diagonals and bottom chord members, moderate corrosion for stinger beams. Moderate corrosion of joints near stinger beam and column connection (locations are marked in figures below).
- Exposed reinforcement in pathway slab near at deck level. (Photographs of the same can be see in **fig3.2-3.4**)

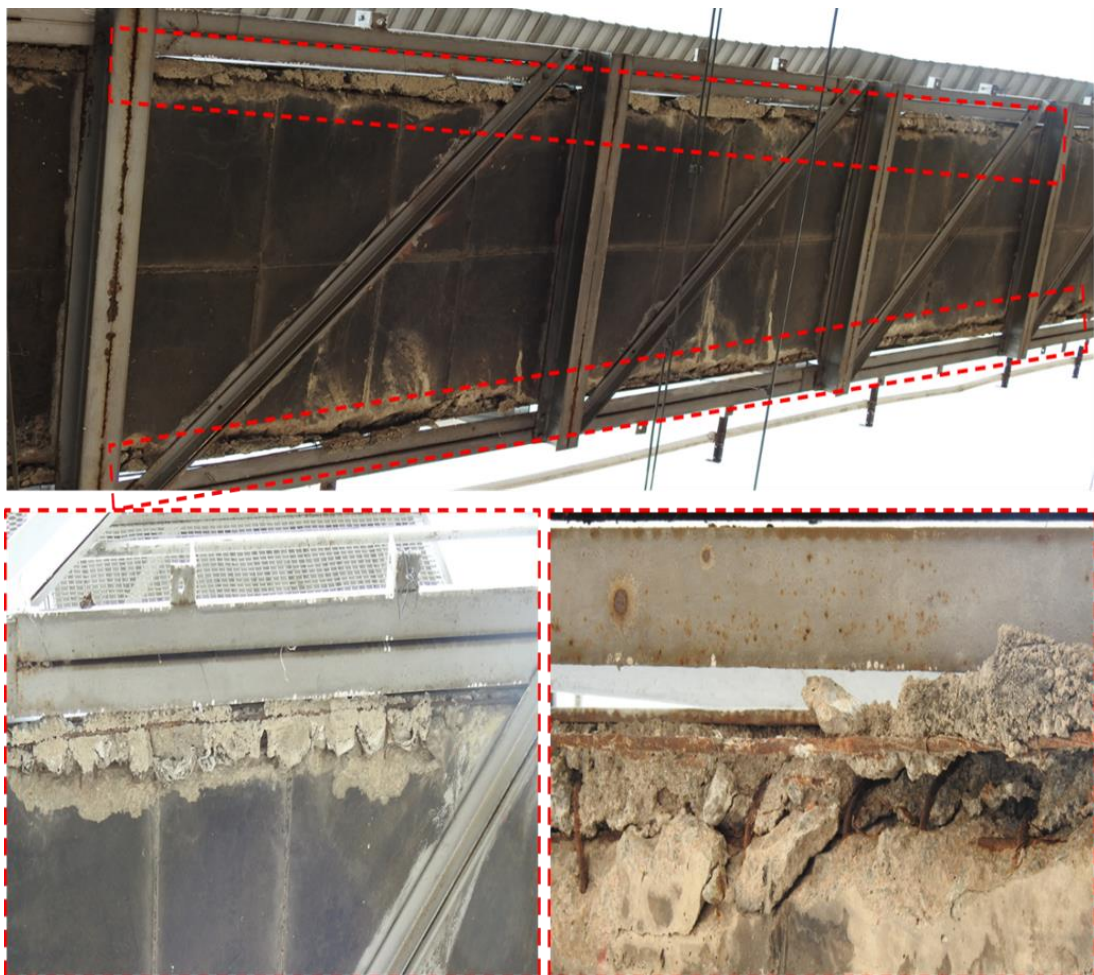
**Fig: 3.2** Exposed reinforcement in slab at pathway of span-1

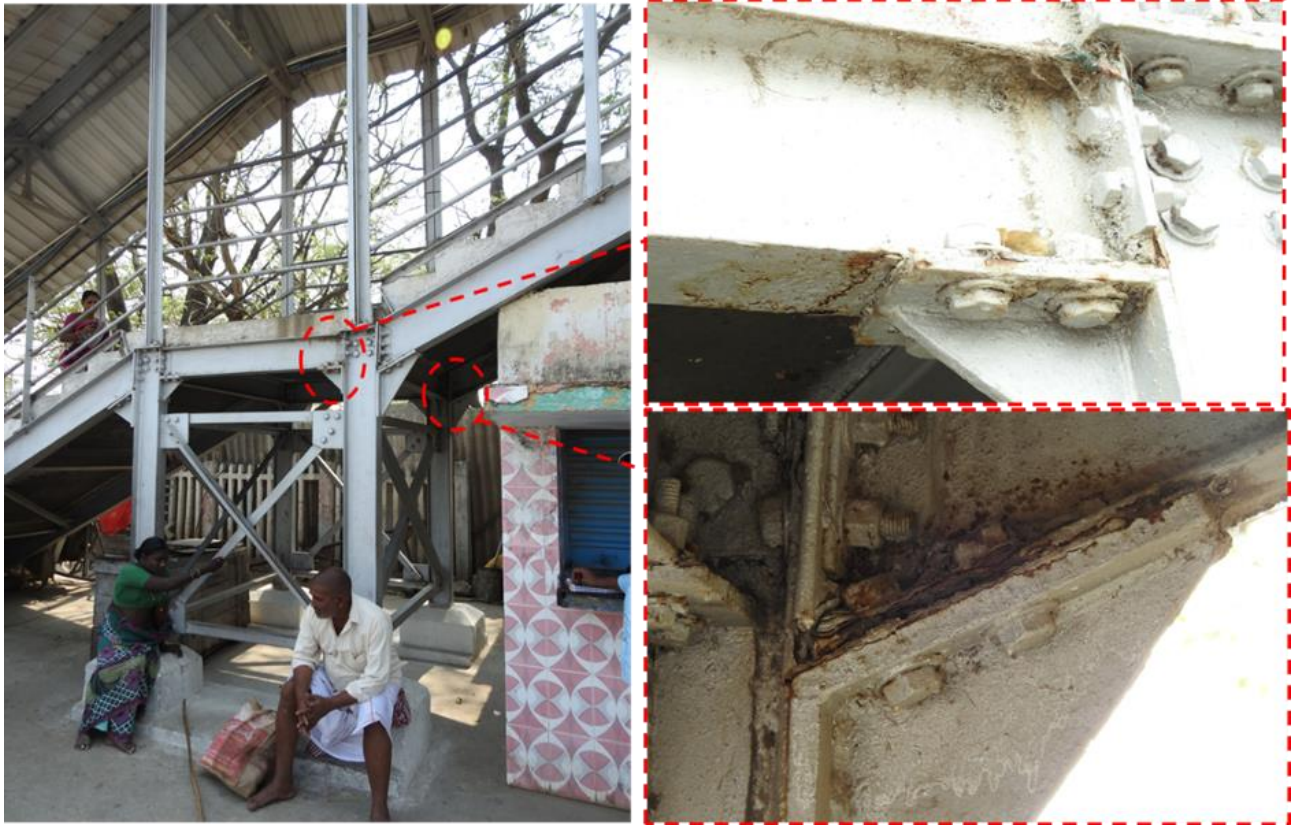
**Fig: 3.3** Corrosion of bolts near beam column joint at span-1

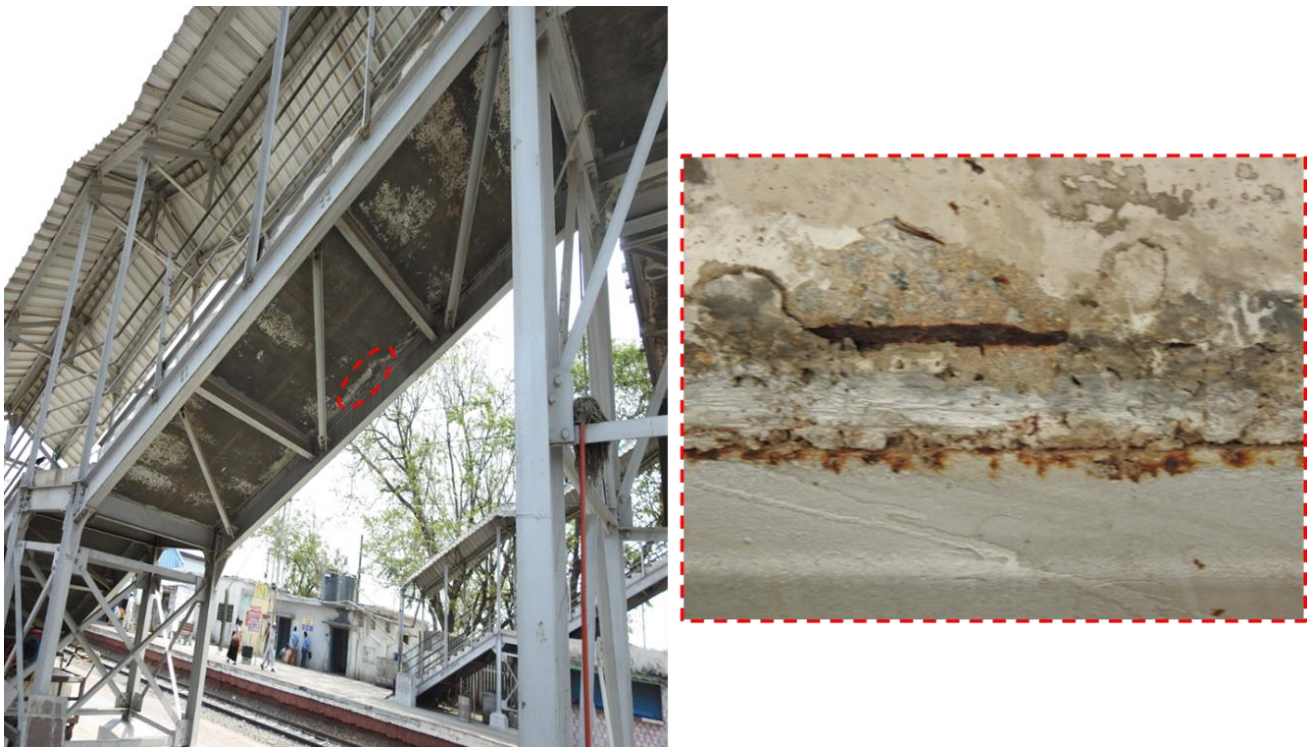
**Fig: 3.4** spalling and exposed reinforcement at staircase-2

**Methodology for patching:** Hand applied Mortar (Patching) repair is performed to restore small areas where sound concrete is damaged by spalling, scaling and/or impact. This method of repair is generally applied using trowel and require minimum or formworks. The patch thickness is limited to a maximum of 100 mm depth of hollow surface. Hand applied Mortar repair is classified into two types considering defective area and surface. Hand applied Mortar

- a) **Type - A** is applicable to surfaces without exposed rebar is having defective widths of up to 300mm and depths of up to 50 mm.
- b) **Type - B** is for surfaces with exposed rebar, with defective widths between 300 mm and 600 mm, and up to 100 mm depths.

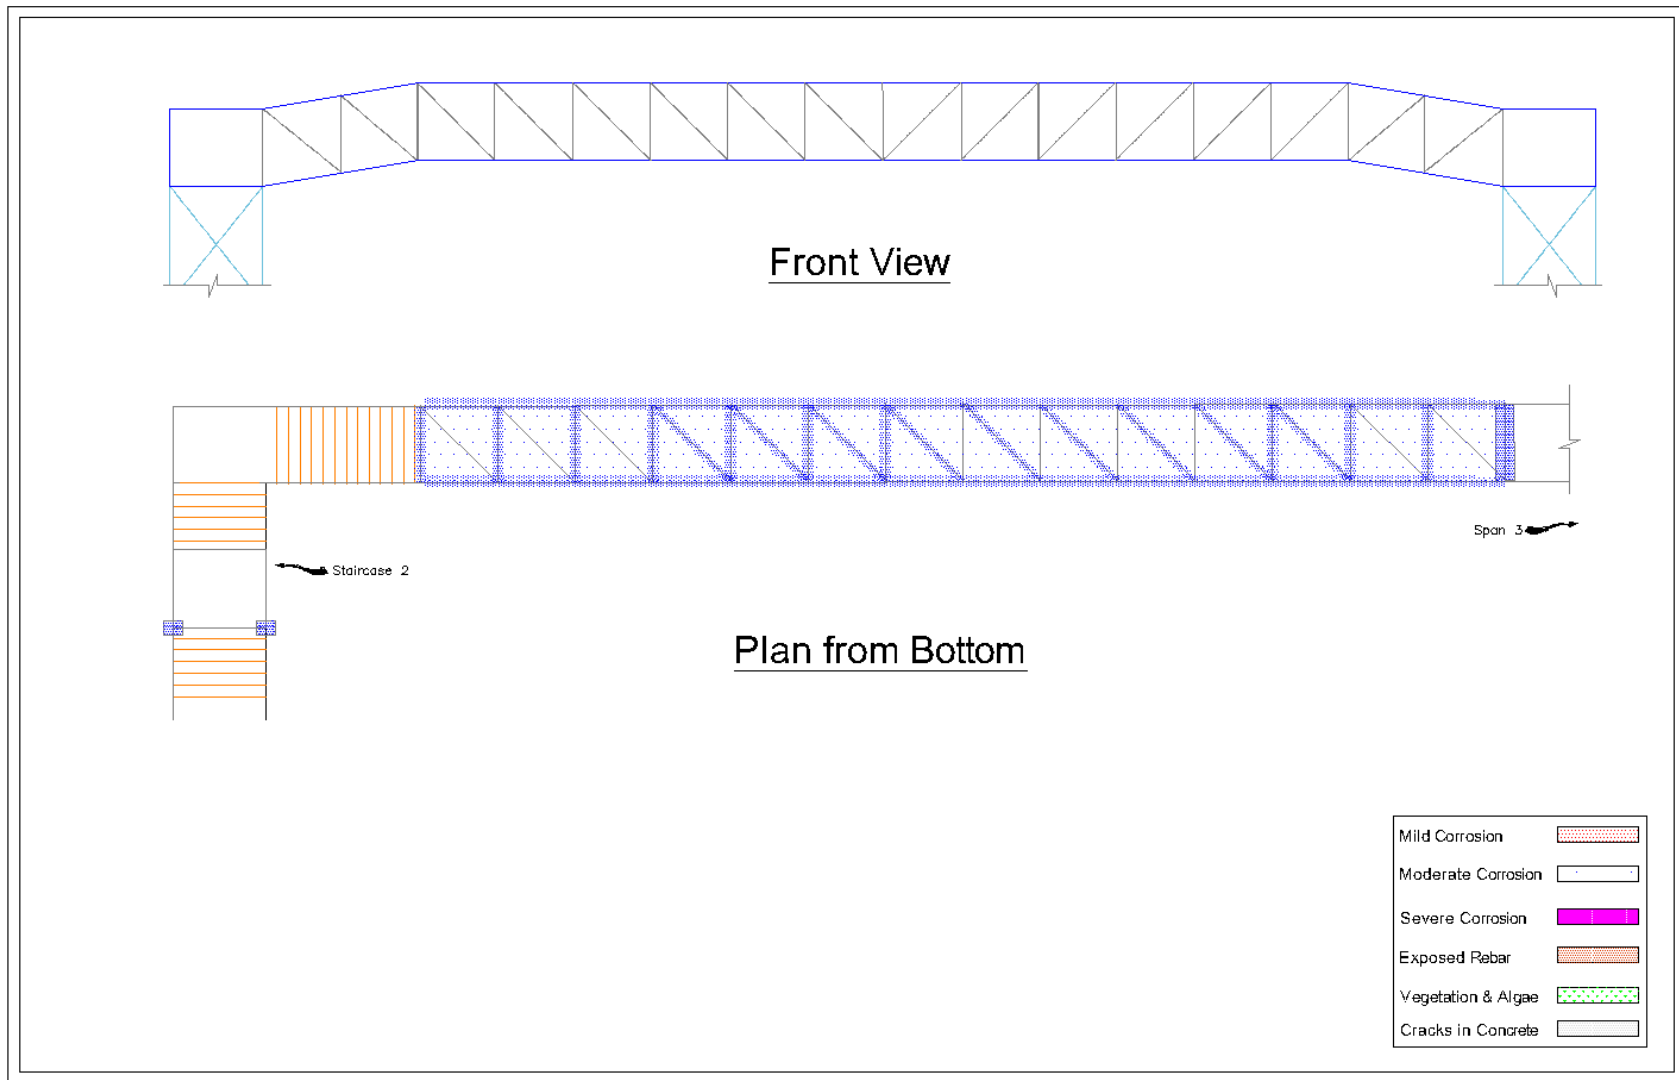
**Fig: 3.5** Locations of deteriorations and bottom view of span-2

- Structural members are in fair condition, displaying mild corrosion for top chord members, verticals and moderate corrosion for floor beams, diagonals and bottom chord members. Moderate corrosion of joints connecting diagonals to bottom chord. (Locations are marked in figures below).
- Moderate corrosion of sacrificial plate is observed all over the pathway of span-2. (Photographs of the same can be see in **fig3.6-3.8**)

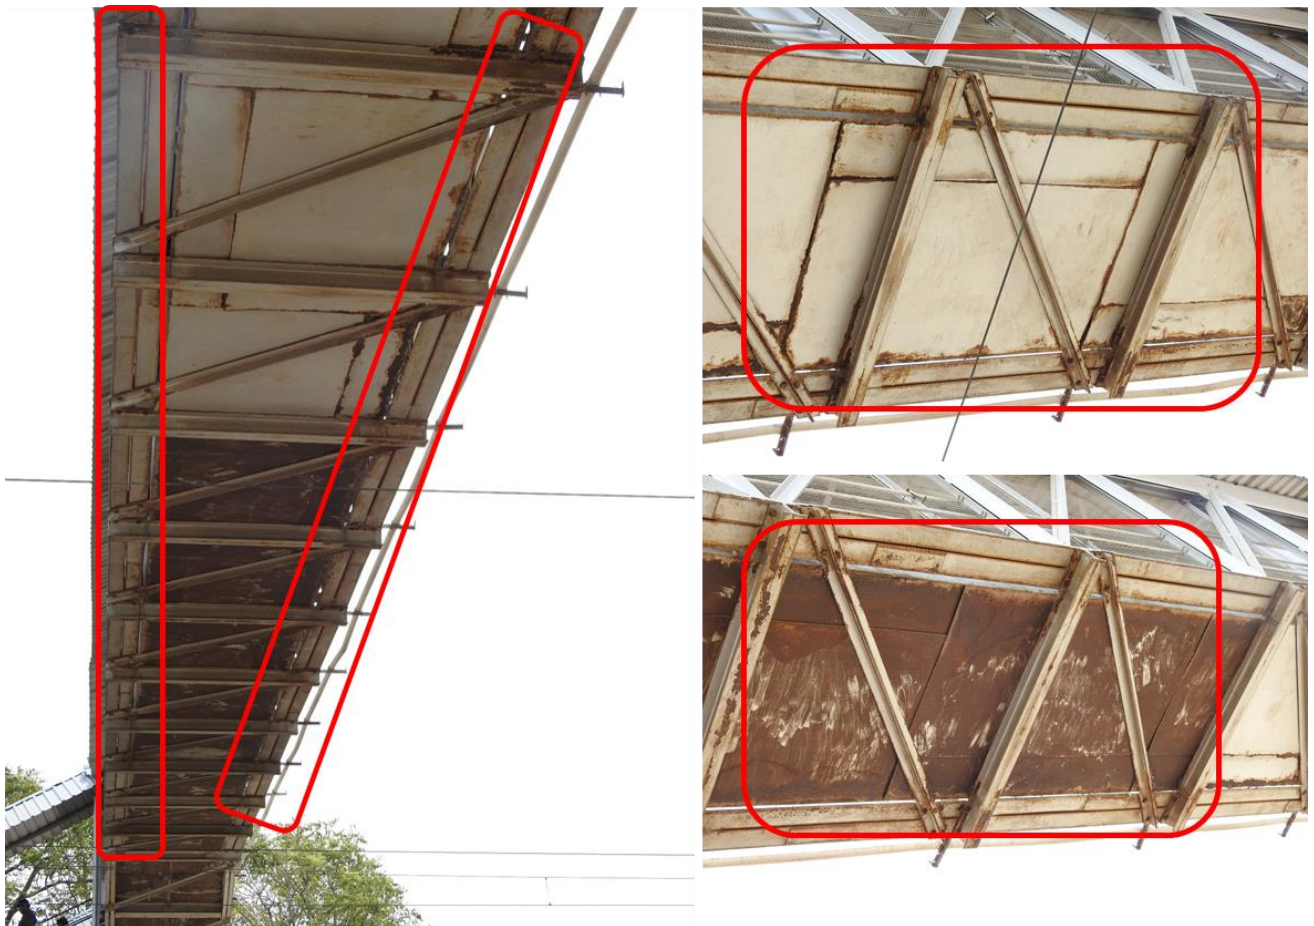
**Fig: 3.6** corrosion of bottom chord and sacrificial plate at span-2

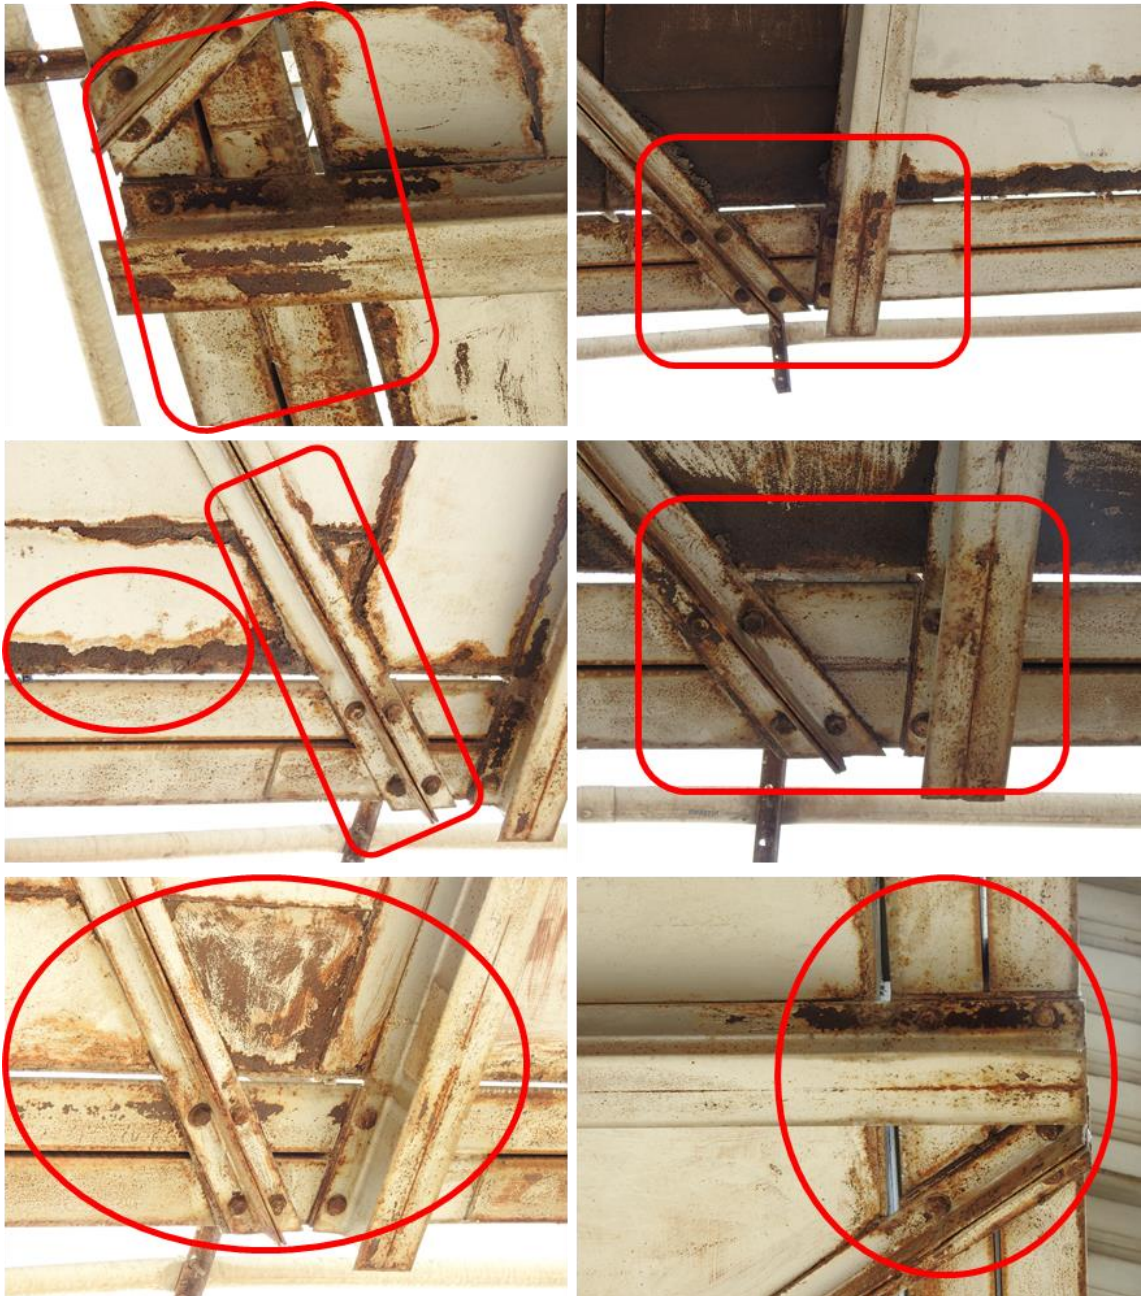
**Fig: 3.7** corrosion of diagonals, floor beams at span-2

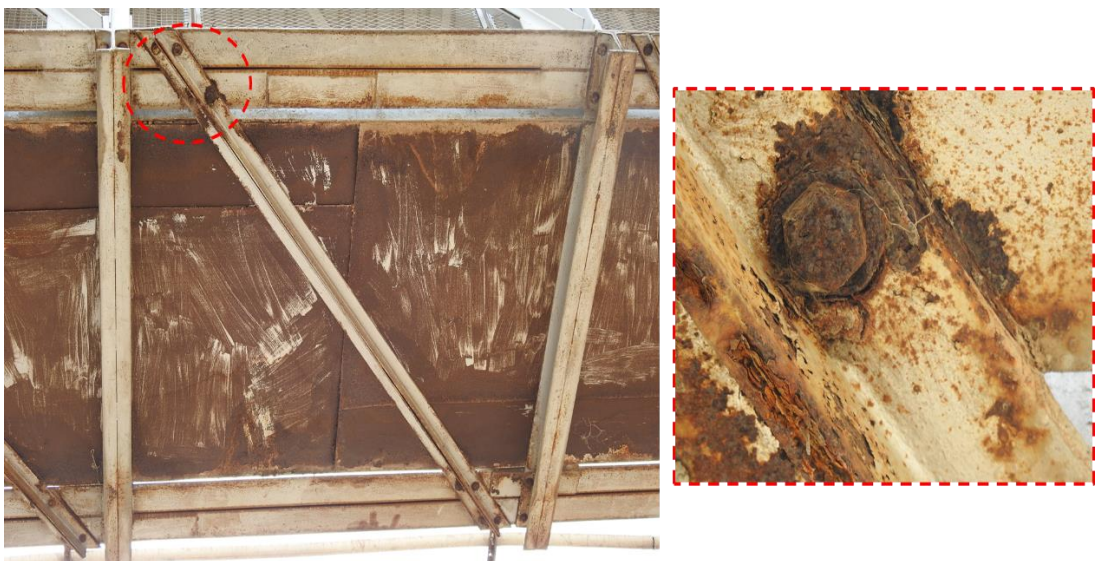
**Fig: 3.8** corrosion of bolts at span 2

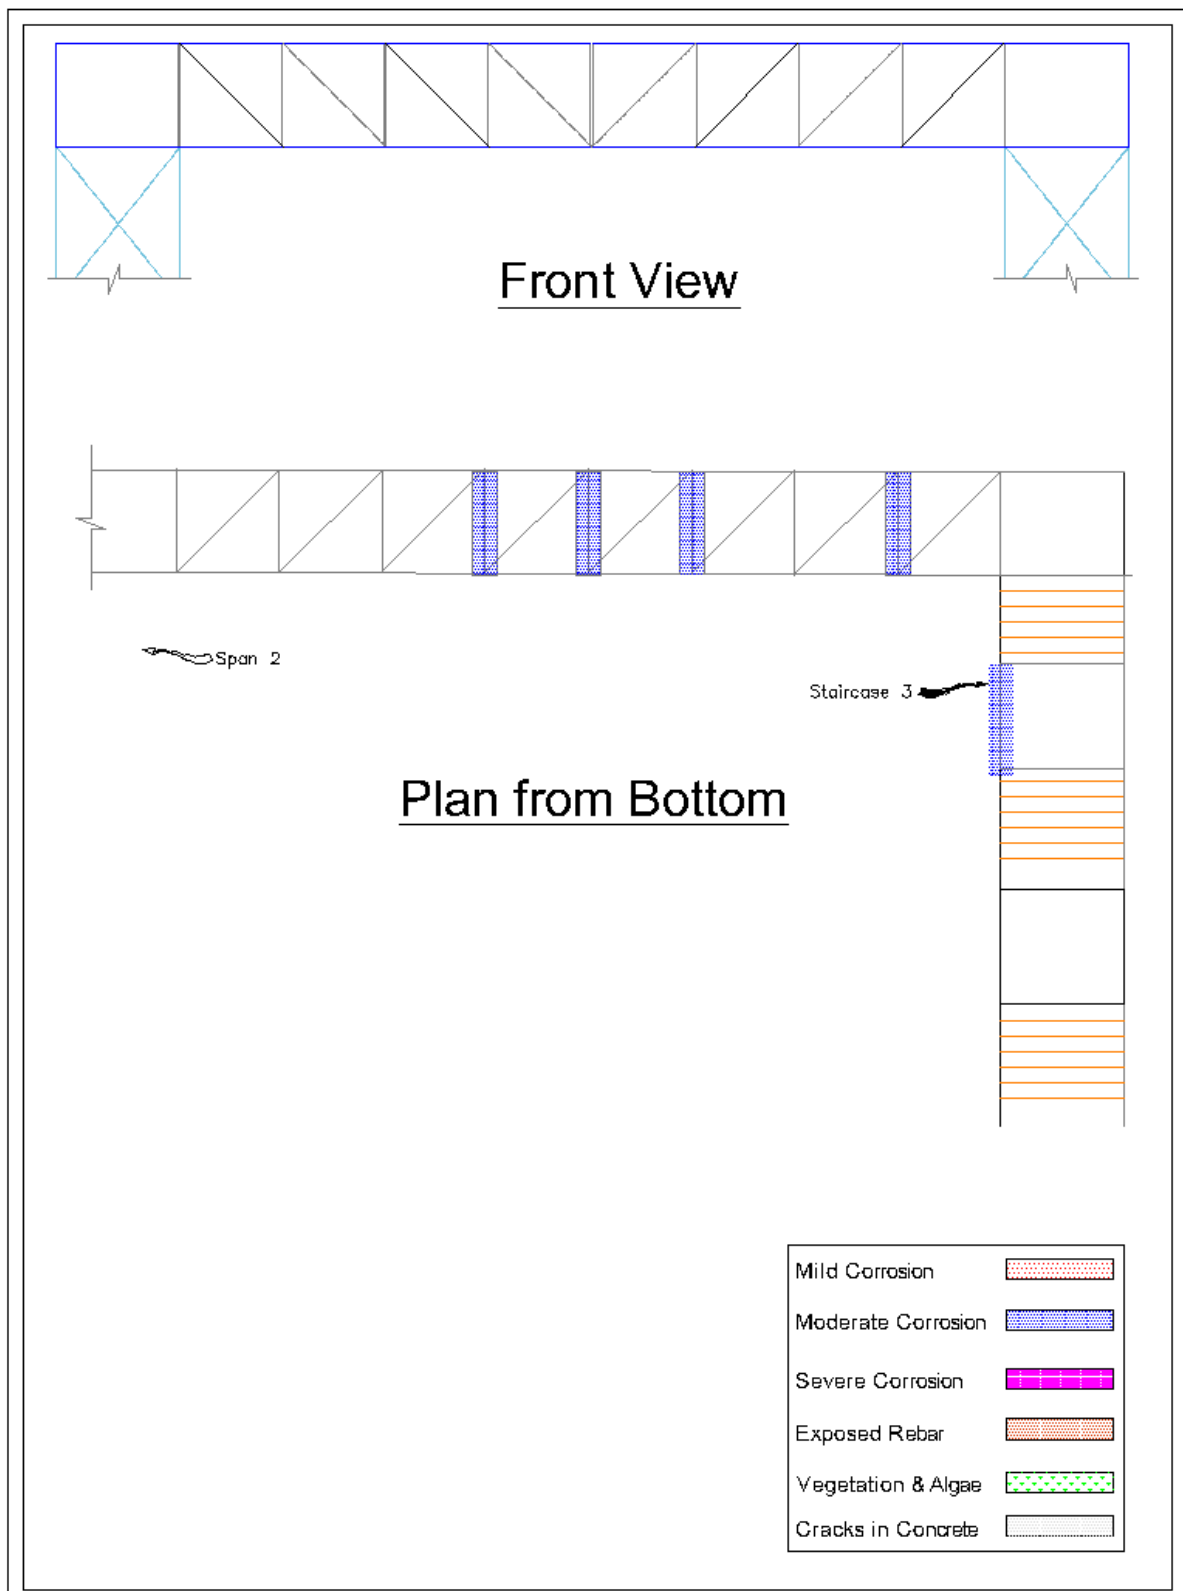
**Fig: 3.9** Locations of deteriorations and bottom view of span 3

- Structural members are in fair condition, displaying mild corrosion for top chord members, verticals and moderate of bottom chord members, diagonals, and floor beams. (locations are marked in figures below).
- Moderate corrosion of sacrificial plate in span-2 (Photographs of the same can be see in **fig 3.10-3.11**)

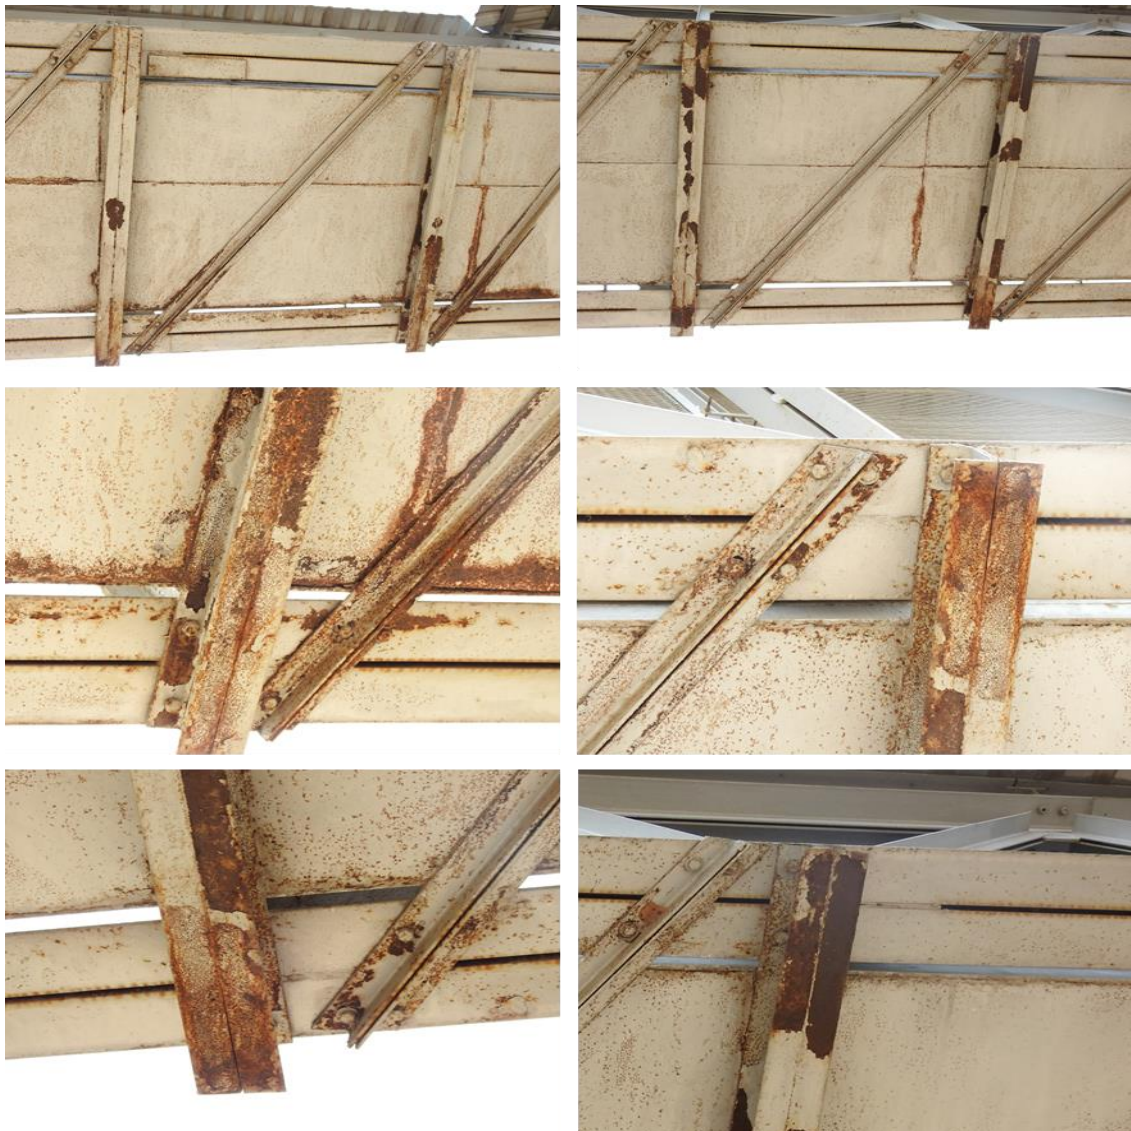
**Fig: 3.10** Corrosion of floor beams, diagonals and bolts at span-3
