## Third Party Audit of ROB's and FOB's of SCR

### INSPECTION OF FOB AT FALAKNUMA RAILWAY STATION

**Final Report**  
SEPTEMBER | 2020

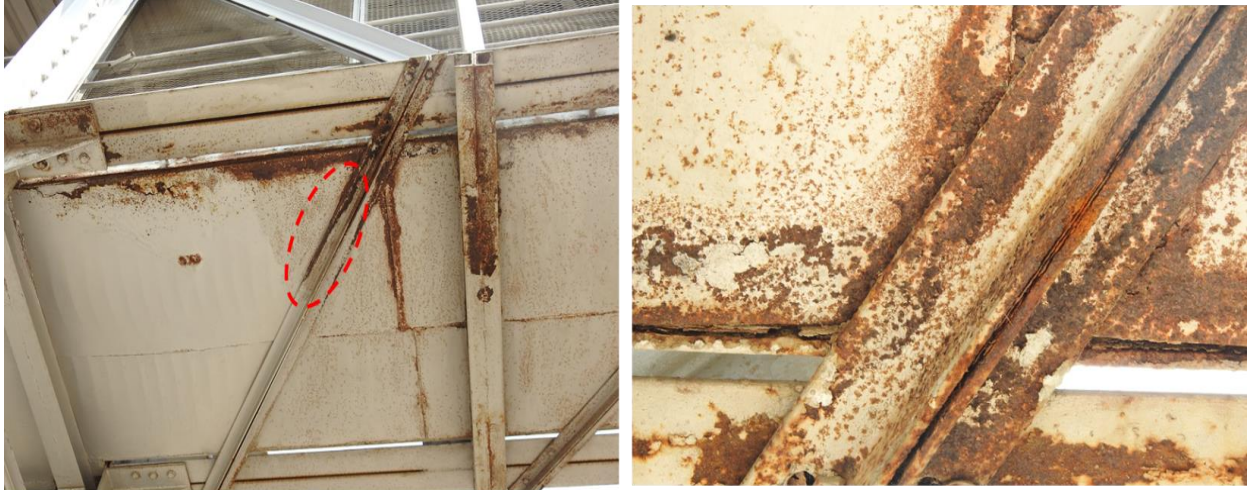
- Structural members are in fair condition, displaying mild corrosion for top chord members, verticals and moderate of bottom chord members, diagonals, and floor beams. (locations are marked in figures below).
- Moderate corrosion of sacrificial plate in span-2 (Photographs of the same can be see in **fig 3.10-3.11**)

**Fig: 3.11** Corrosion of diagonal and sacrificial plate at span-3
