# Third Party Audit of ROB's and FOB's of SCR

INSPECTION OF ROB NO. 7A NEAR LAKDIKAPUL RAILWAY STATION

**Final Report**  
SEPTEMBER | 2020

| Name of the Project | : | INSPECTION OF ROB (7A) NEAR LAKDIKAPUL RAILWAY STATION |

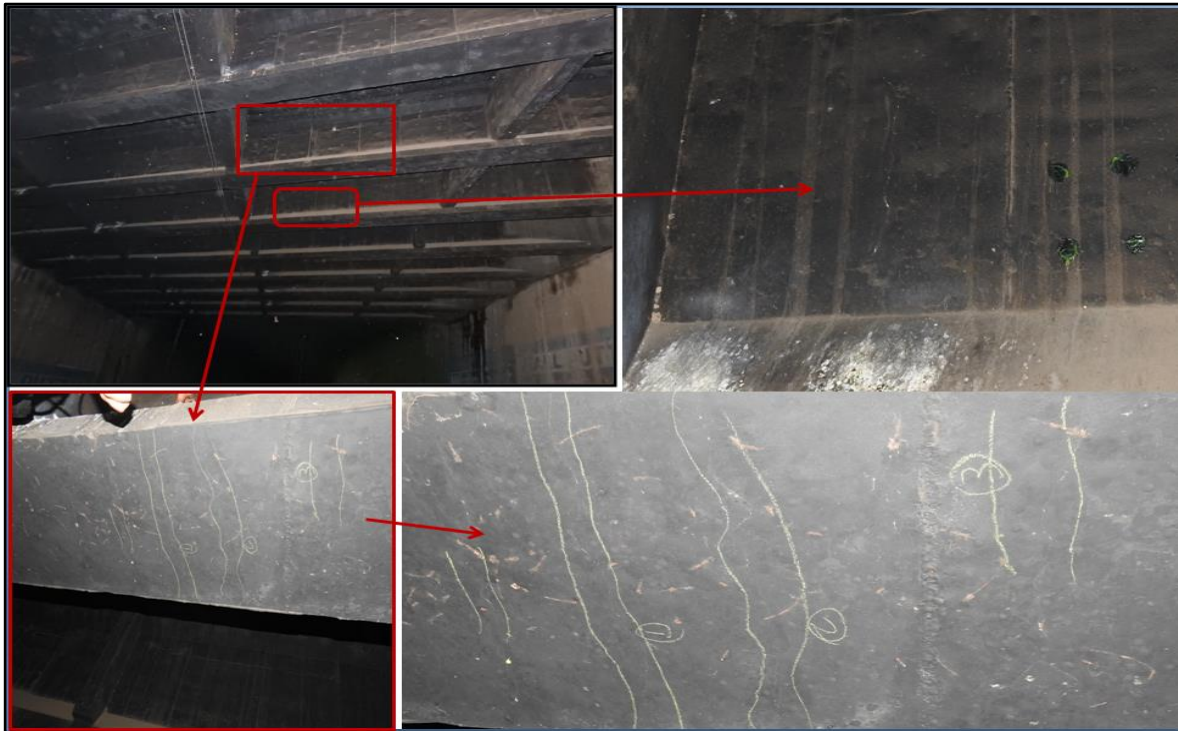
Fig.1

| | Condition of Girder | | Structural cracks have been observed in mid span of the girders (Refer Fig-1) |

- ✓ Structural Cracks have been observed in the Mid spans of Longitudinal Girders.

During the detailed visual observation at bottom of Deck slab on the above said locations and the following observations are made, spalling and Reinforcement exposure was noticed at overhang portion of deck slab (**Refer** Fig 2,3,4/ page 5,6,7) and is effected with dampness, Structural cracks were noticed at Main girder (**Refer** Fig 1/ page 5).

So, Shotcrete and Grouting should be done at all the spalled concrete locations, and Injection Grouting should be done at Crack locations.

- a) Epoxy Grouting of the Cracks observed at the Girders.
  - b) Shotcreting of the Spalled concrete locations after the application of Anti corrosive paint for exposed rebars with Minimal deterioration.

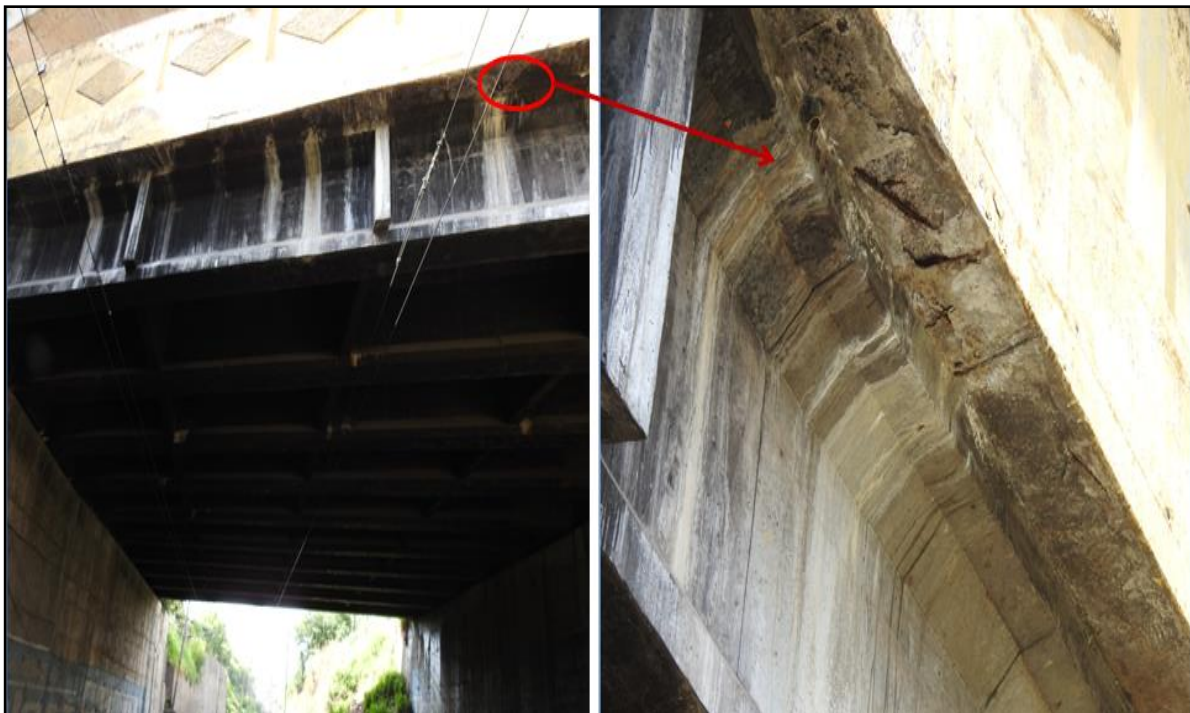
Fig.2

| | Condition of Slab from Bottom | | Spalling & Reinforcement exposure has been observed. (Refer Fig-2) |

- ✓ Spalling and Reinforcement exposure is observed at the bottom of slab.

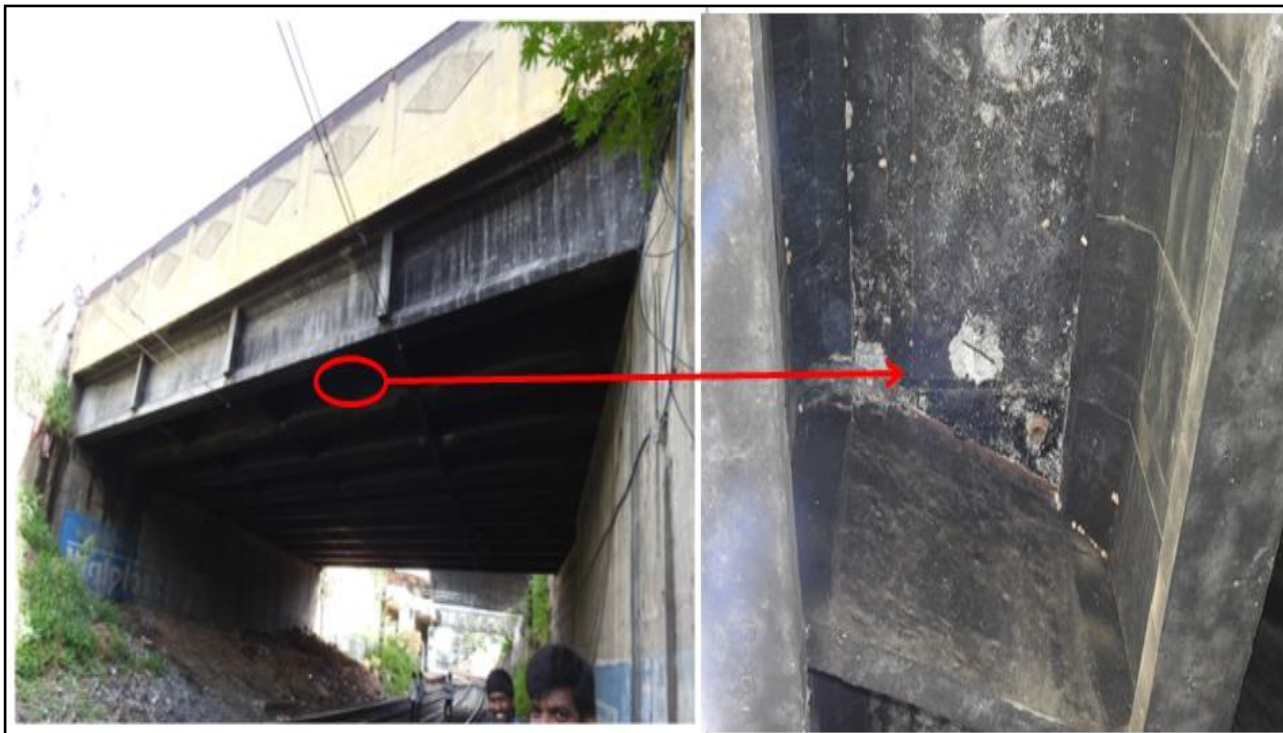
Fig.3

✓ Corrosion and Spalling observed near Drainage Spout

- c) Replacement of the distressed bearings.
  - d) Extension of the drainage spouts pipe so that the surrounding concrete should not be deteriorated.

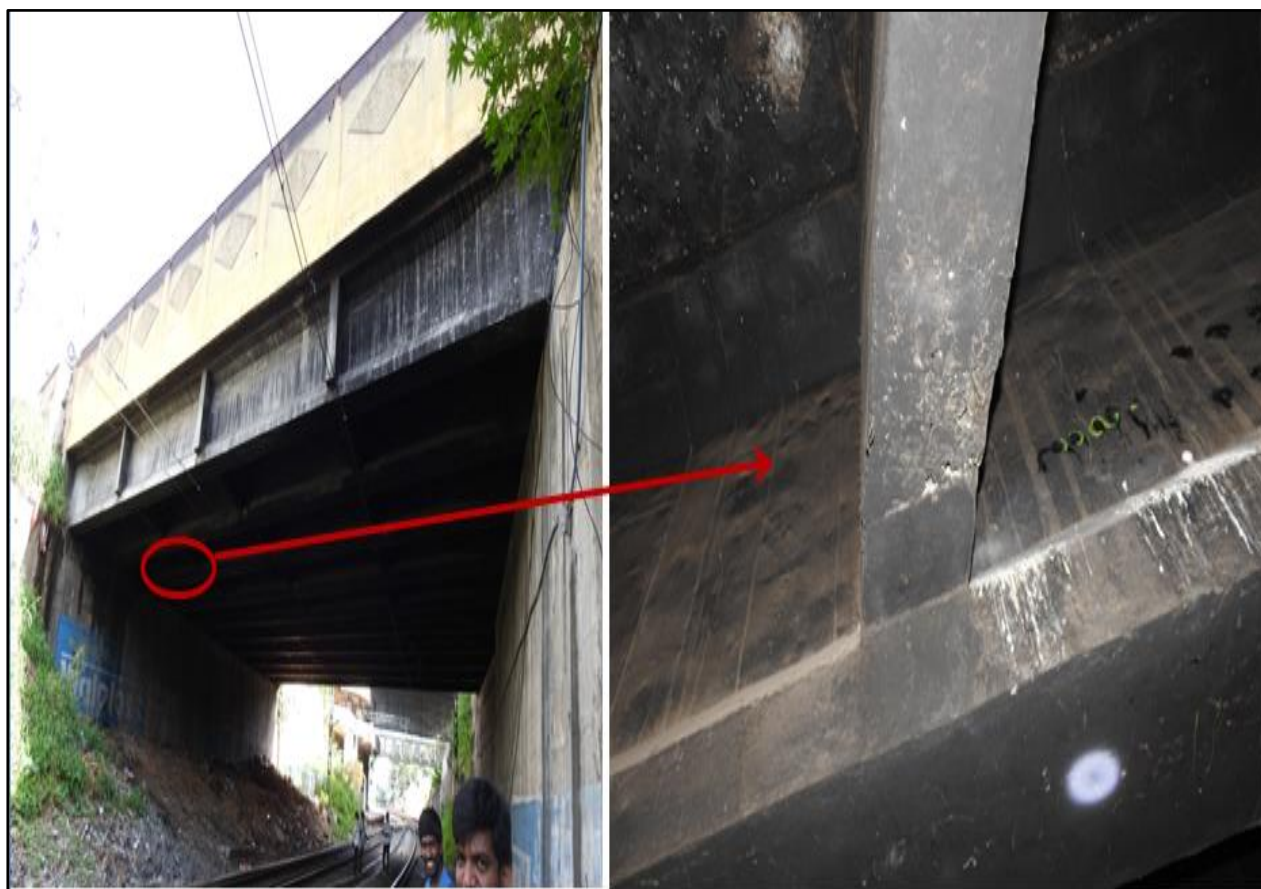
Fig.4

| | Condition of Secondary Girder | | Distresses are observed near main & secondary Girder junctions (Refer Fig-4) |

✓ Cracks are observed in the secondary girders.

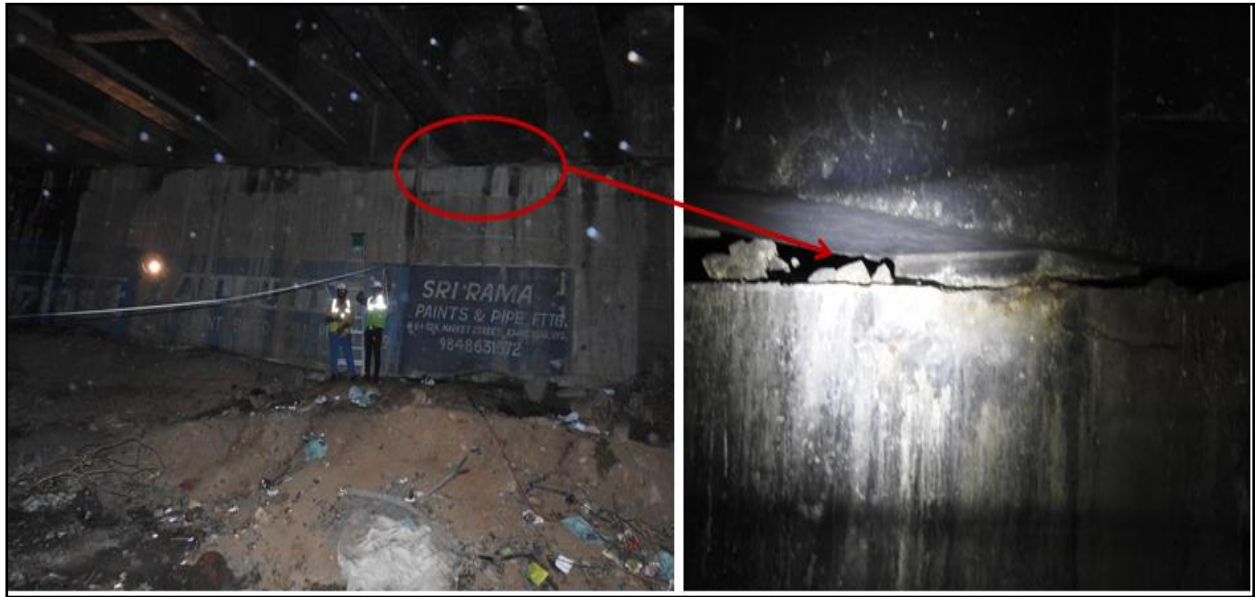
Fig.5

| | General condition<br>(Check Corrosion, cleanliness, seizing of plates silting, accumulations of dirt in case of submersible bridges) | | All the bearings are in distressed condition |

1.3.5 ✓ Distresses are found in the Elastomeric Pad bearings.

The distresses are observed on almost all the bearings (**Refer** Fig.5/ Page 7) of the bridge on the above said locations i.e. bearings have been settled down. So, all the distressed bearings should be replaced for proper functioning and increase in service life of bridge.

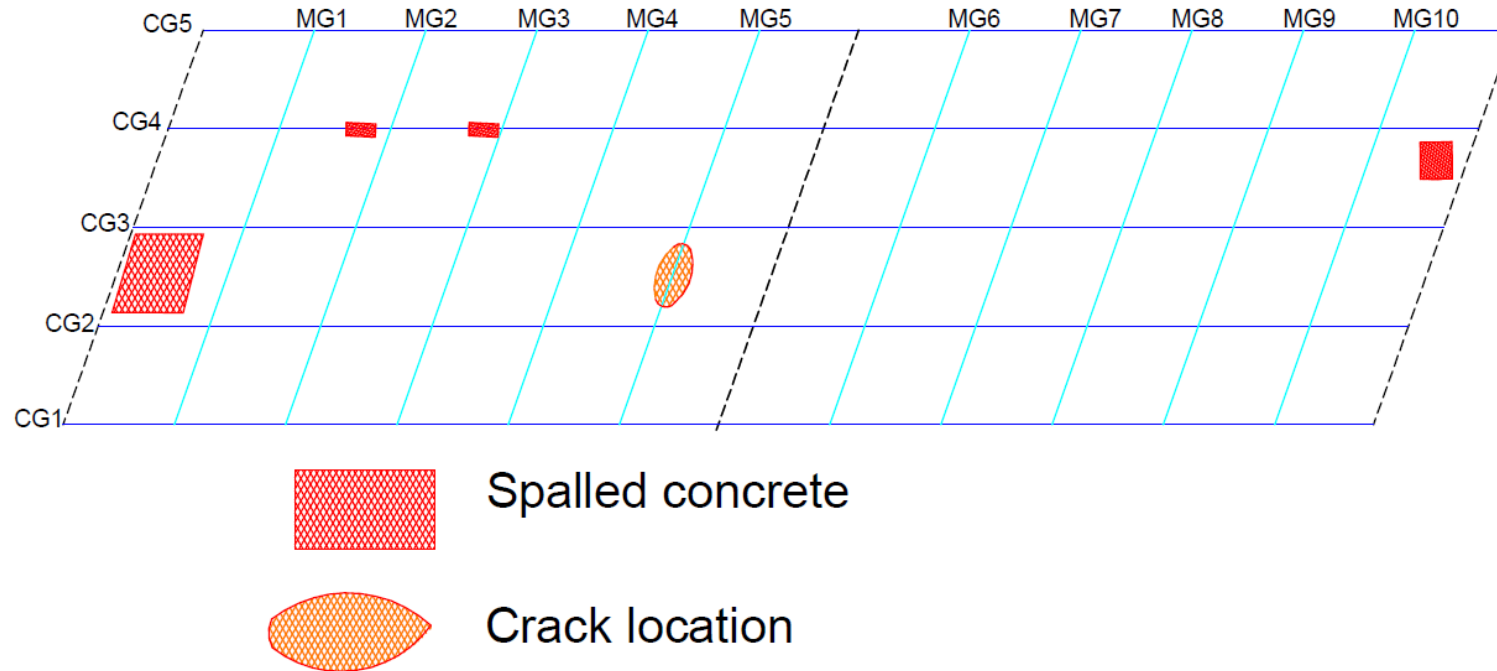
Fig 7.1 Bottom view of Deck slab with Spalled concrete and Crack locations

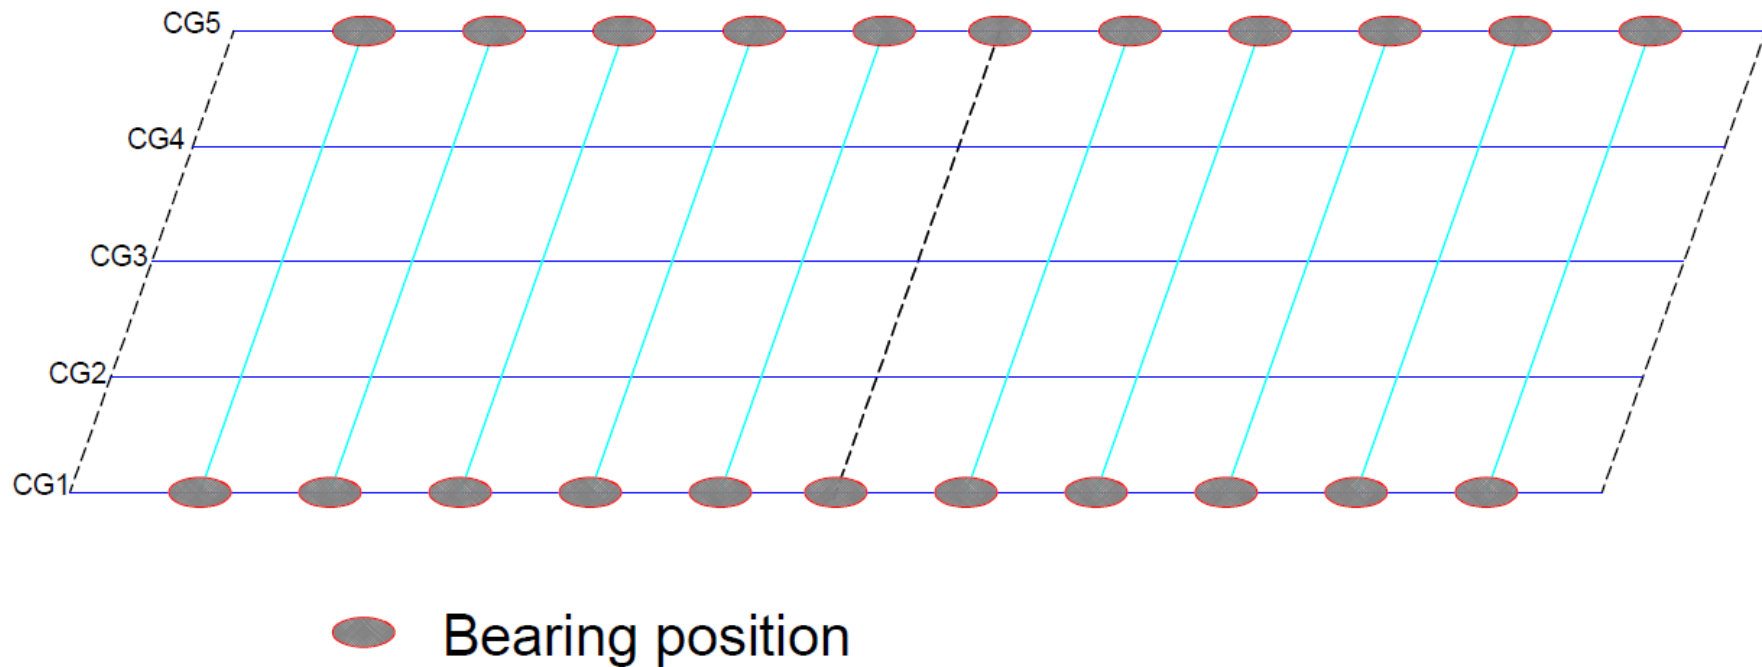
Fig 7.2 Bottom view of Deck slab with Elastomeric bearing locations
