## Third Party Audit of ROB's and FOB's of SCR

**INSPECTION OF ROB NO. 254B NEAR METTUGUDA**

**Final Report**  
**SEPTEMBER | 2020**

| <b>Name of the Project</b> | <b>:</b> | <b>VISUAL INSPECTION OF ROB - (254B)</b> |

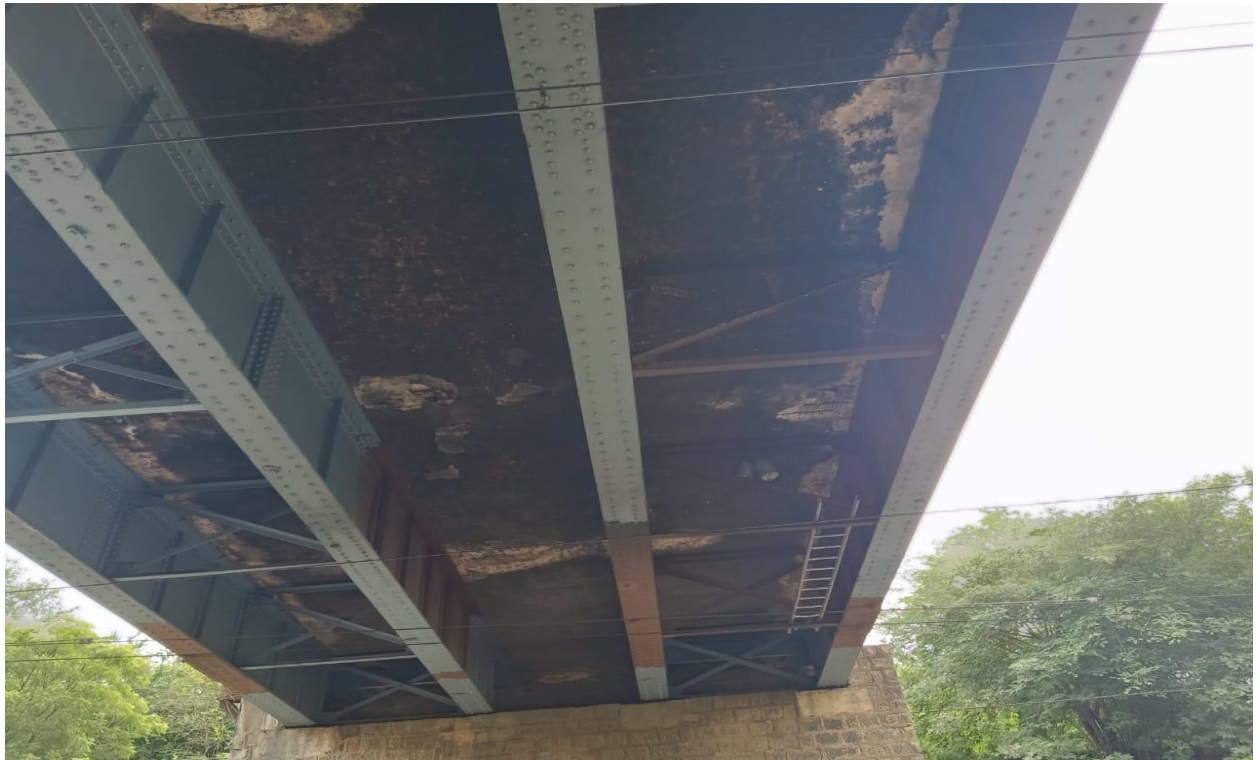
**Fig:1.2** Bottom view of Slab

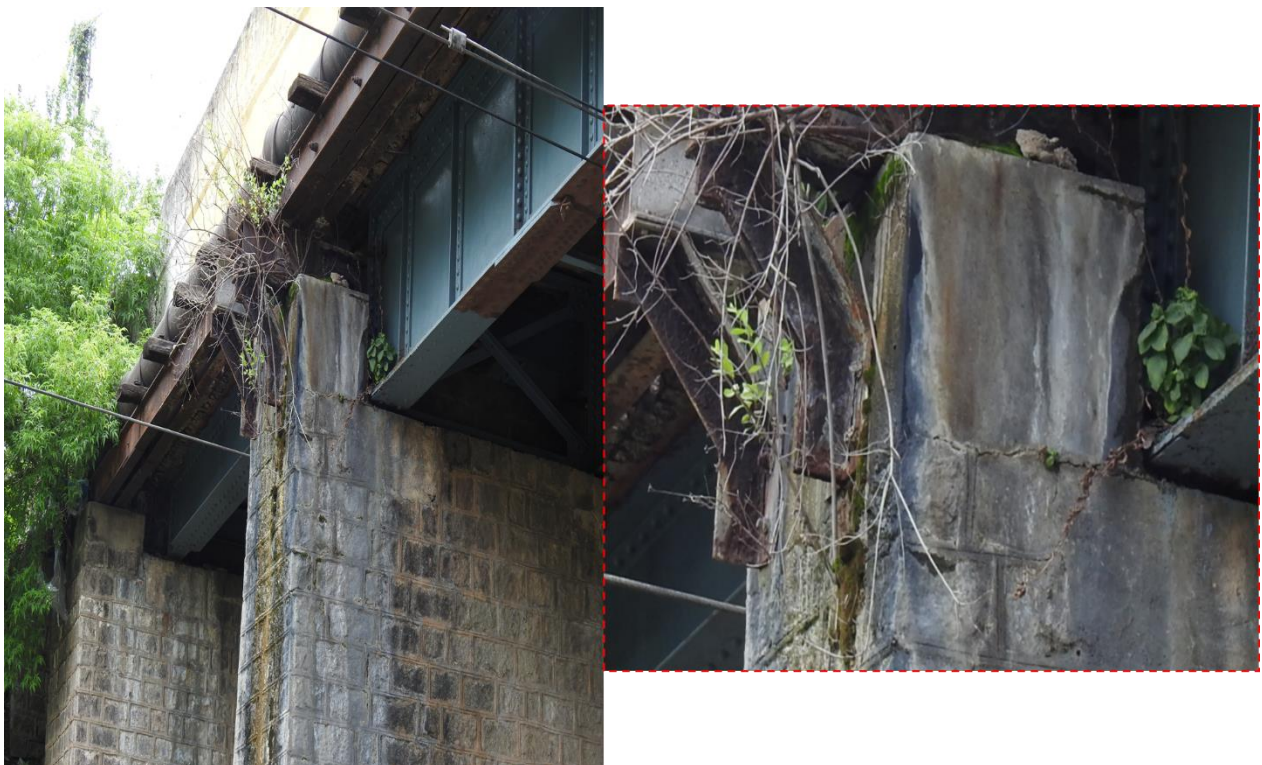
| 1.2 STRUCTURAL SYSTEM OF THE BRIDGE | | | |
|---|---|---|---|
| | Type (Shape) | wall | Leaching and Algae formation and vegetation growth has been observed on piers. |

| 1.3 SURVEY OF SIGNS OF DISTRESS, DEFORMATION IN BRIDGES | | | |
|---|---|---|---|
| | Cracking in RCC components | Pier cap | cracks are observed at pier cap ( <i>Refer Fig:11</i> ) & Pier ( <i>Refer Fig:3</i> ) |

**Fig: 1.3** Vegetation, algae growth, leaching, and cracks observed at Piers

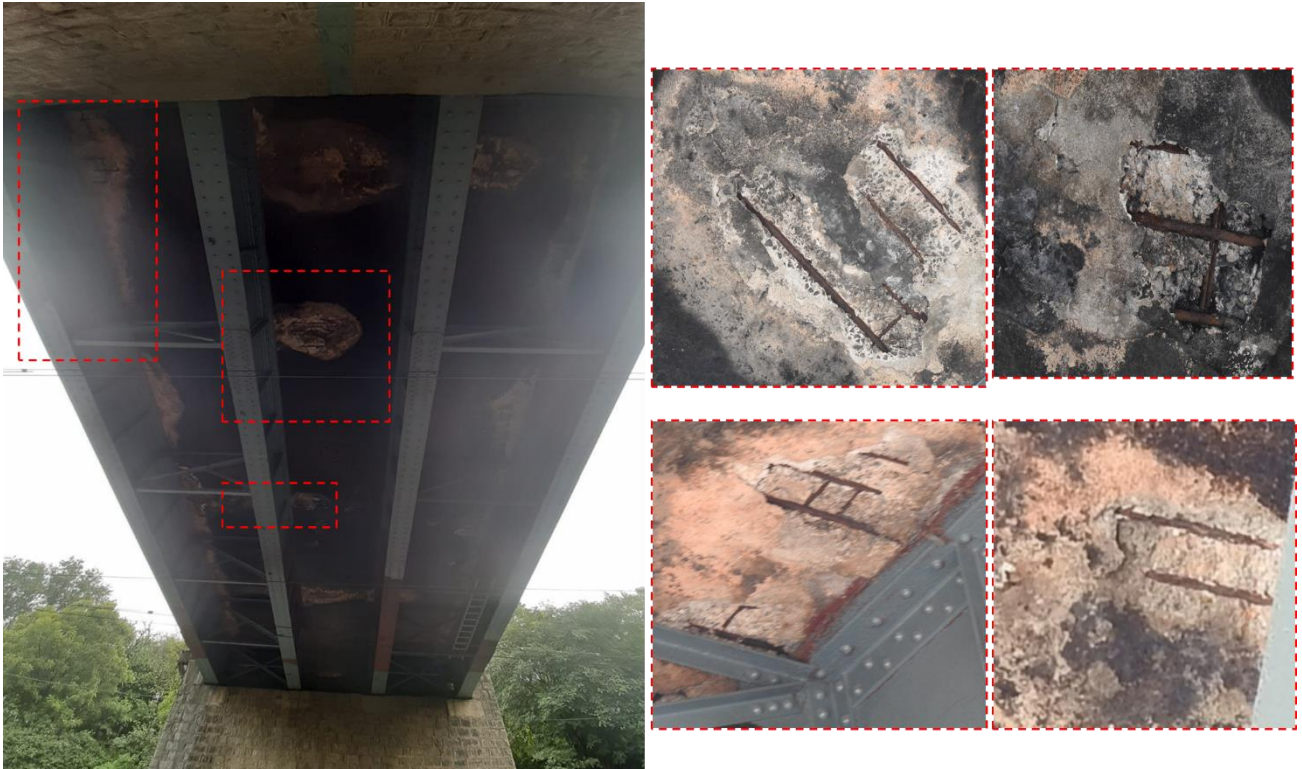
| | Condition of Slab from Bottom | Distresses Found | Spalling & Reinforcement exposure has been Observed. (Refer Fig:4, 5) |

| 1.3 SURVEY OF SIGNS OF DISTRESS, DEFORMATION IN BRIDGES | | | |
|---|---|---|---|
| | Spalling | Slab | Spalling is observed in Slabs. ( <i>Refer Fig:4, 5</i> ) |
| | Reinforcement Exposure | Slab | Reinforcement Exposure is observed in Slabs ( <i>Refer Fig:4,5,7</i> ) |

**Fig:1.4** Exposed reinforcement observed in span 2

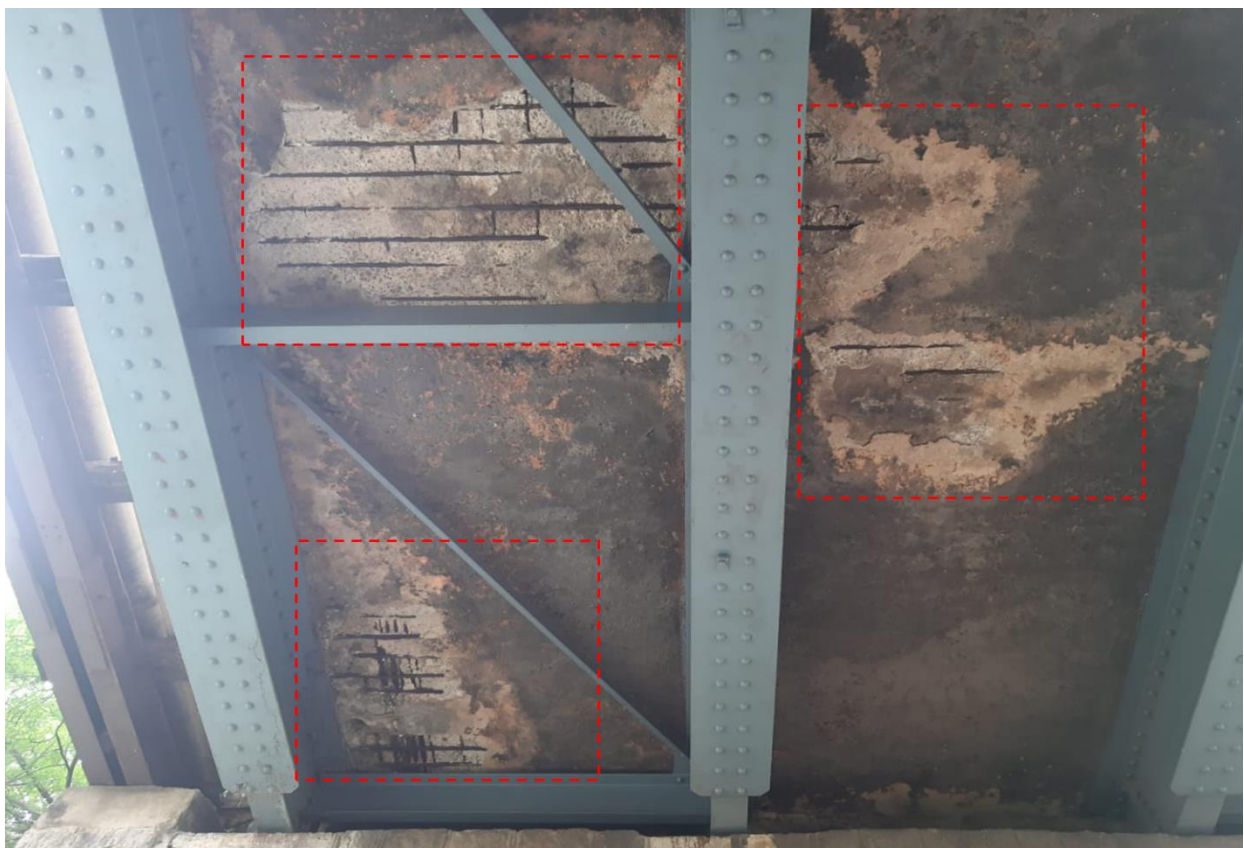
**Fig: 1.5** Exposed reinforcement observed in span 3

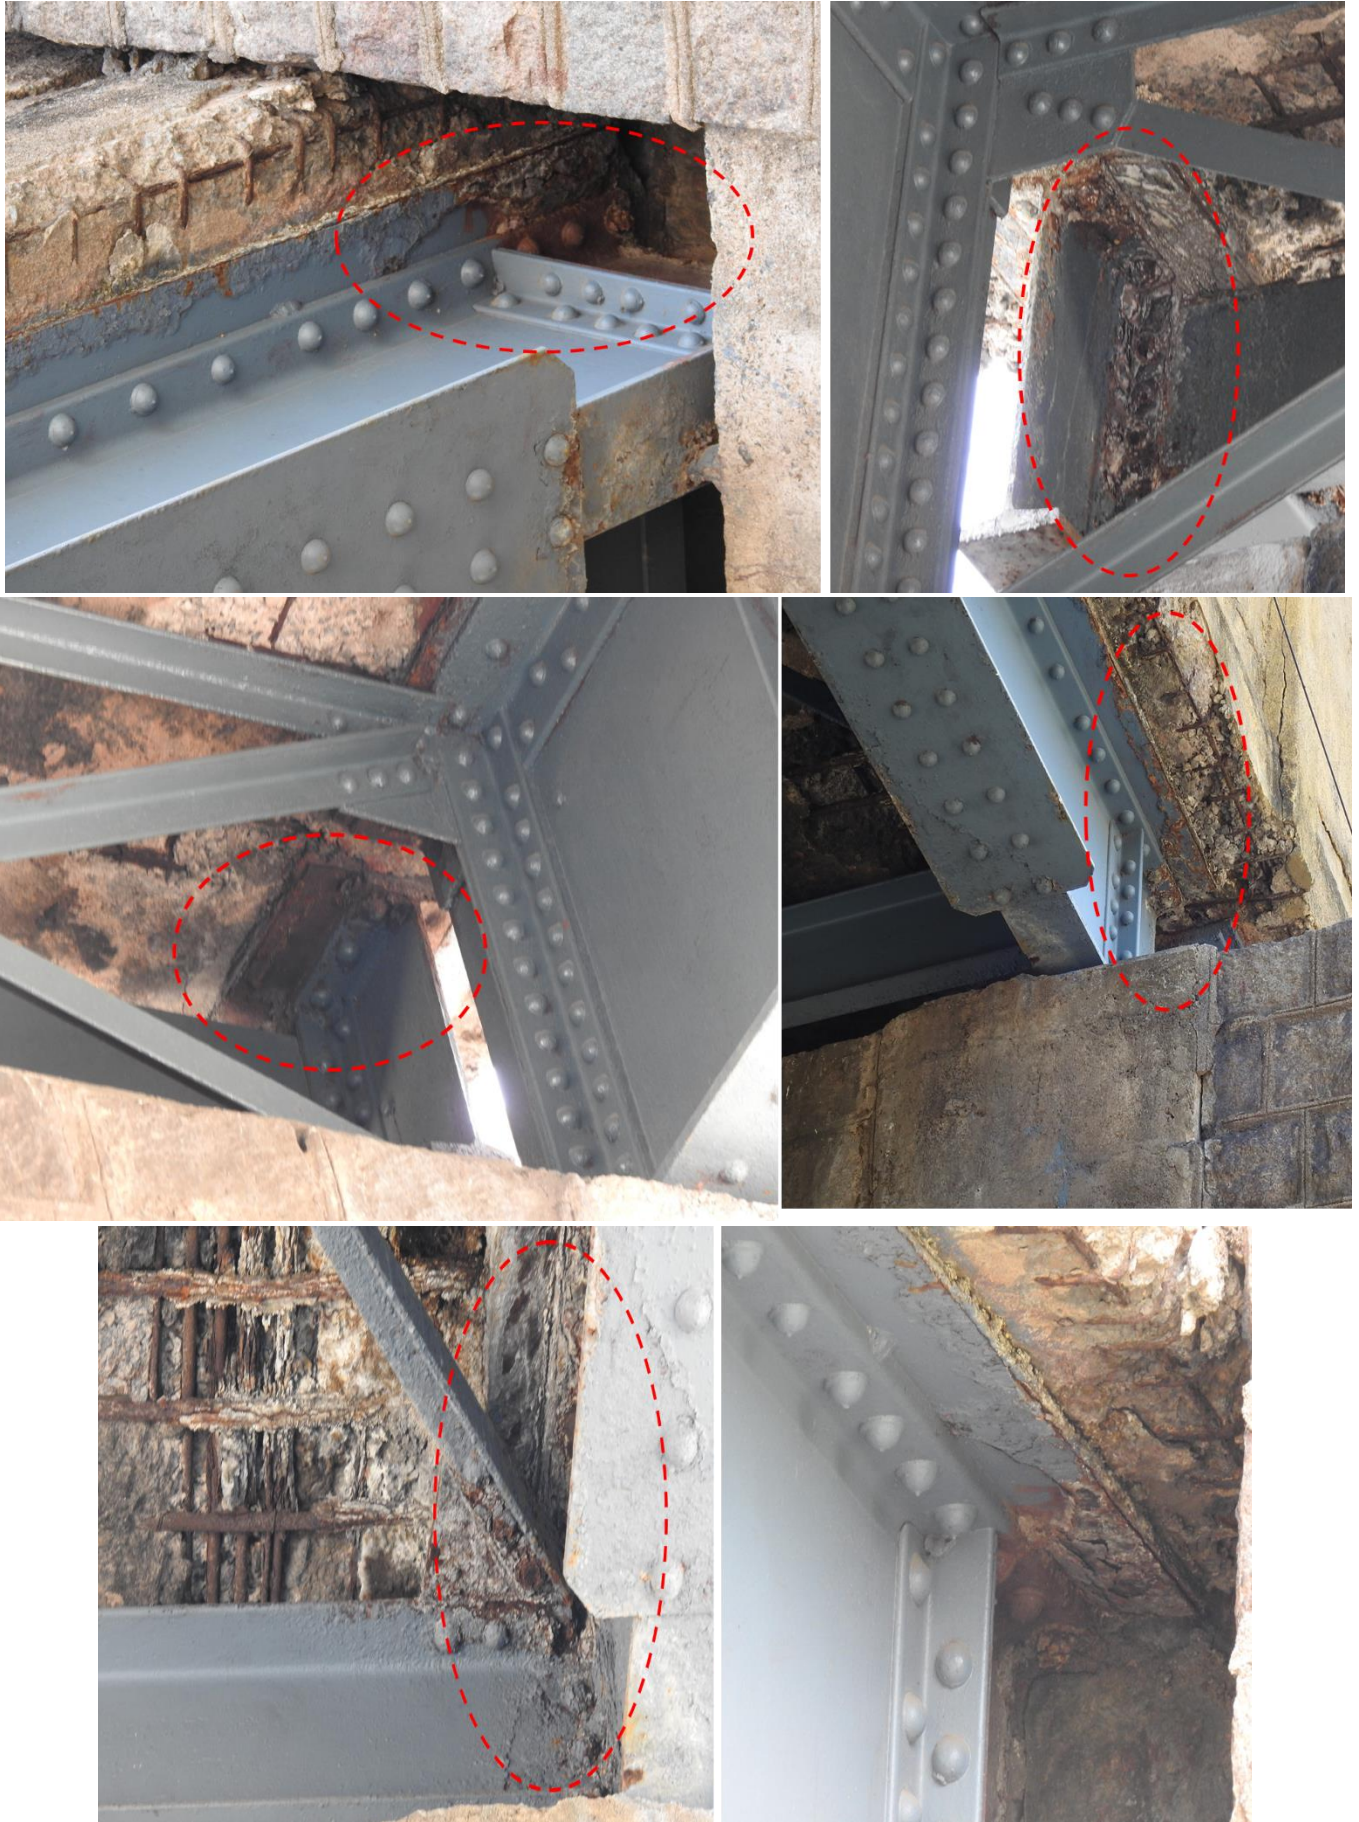
| | Condition of Girder | Distresses Found | corrosion is observed in along steel concrete joint (Refer Fig:6) |

| 1.3 SURVEY OF SIGNS OF DISTRESS, DEFORMATION IN BRIDGES | | | |
|---|---|---|---|
| | Corrosion | Girder | Corrosion is observed at steel concrete joints of ( <i>Refer Fig:6</i> ) |

**Fig: 1.6** Corrosion observed at steel concrete joint, severe damage observed at rivet head

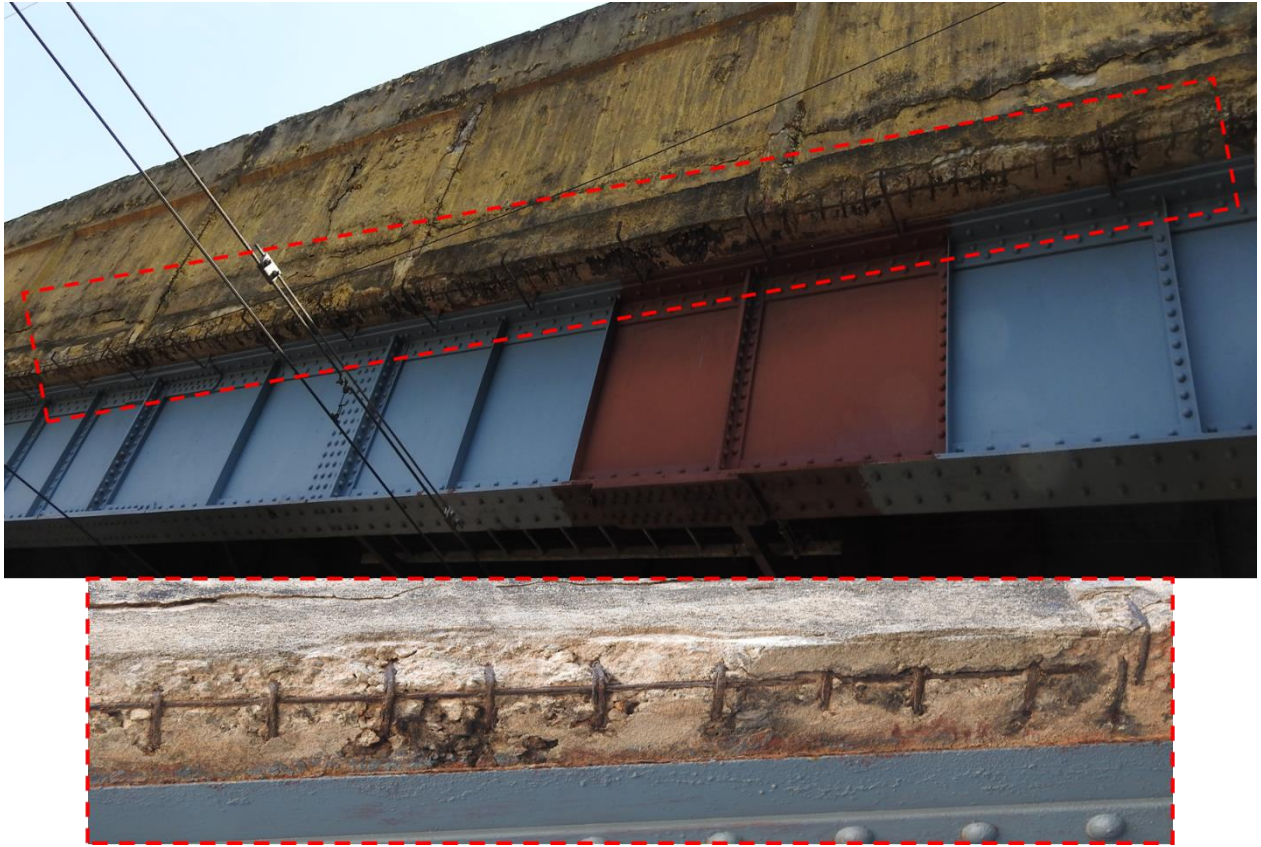
**Fig: 1.7** Spalling and reinforcement exposed at overhang portion of slab due to less cover

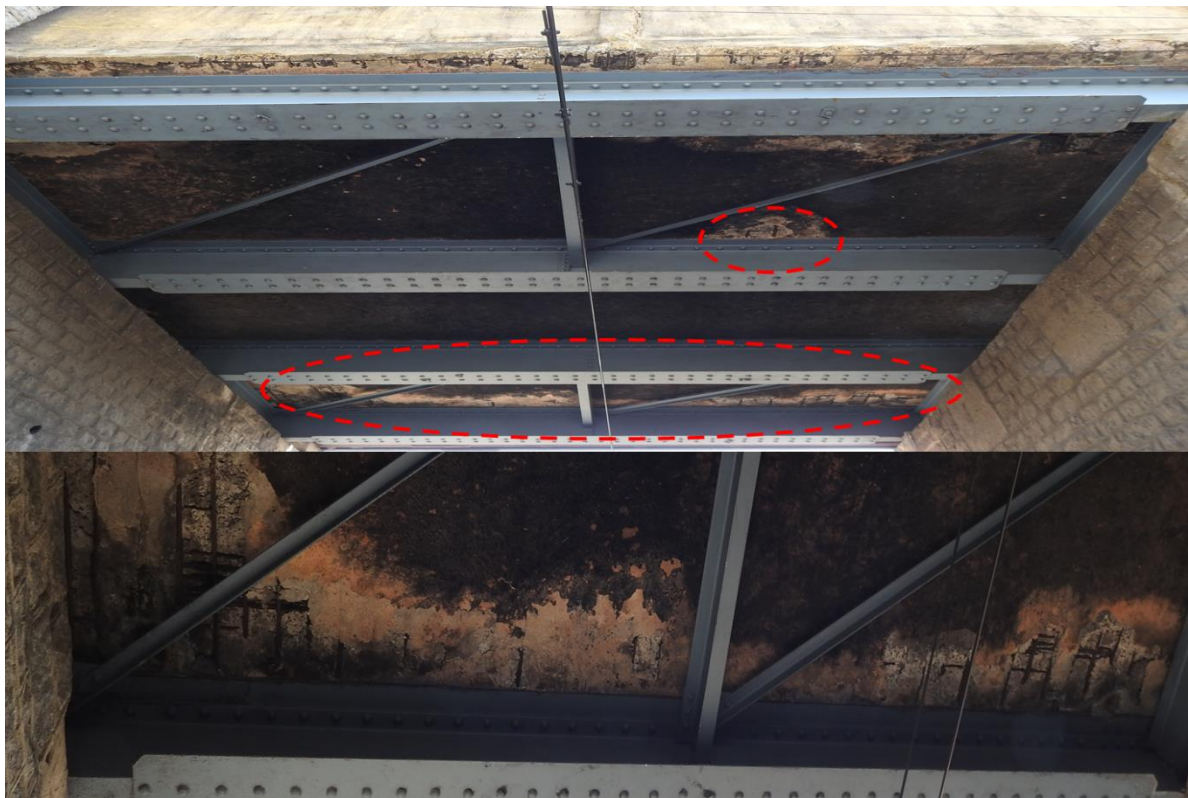
**Fig: 1.8** Spalling and reinforcement exposed at span 1

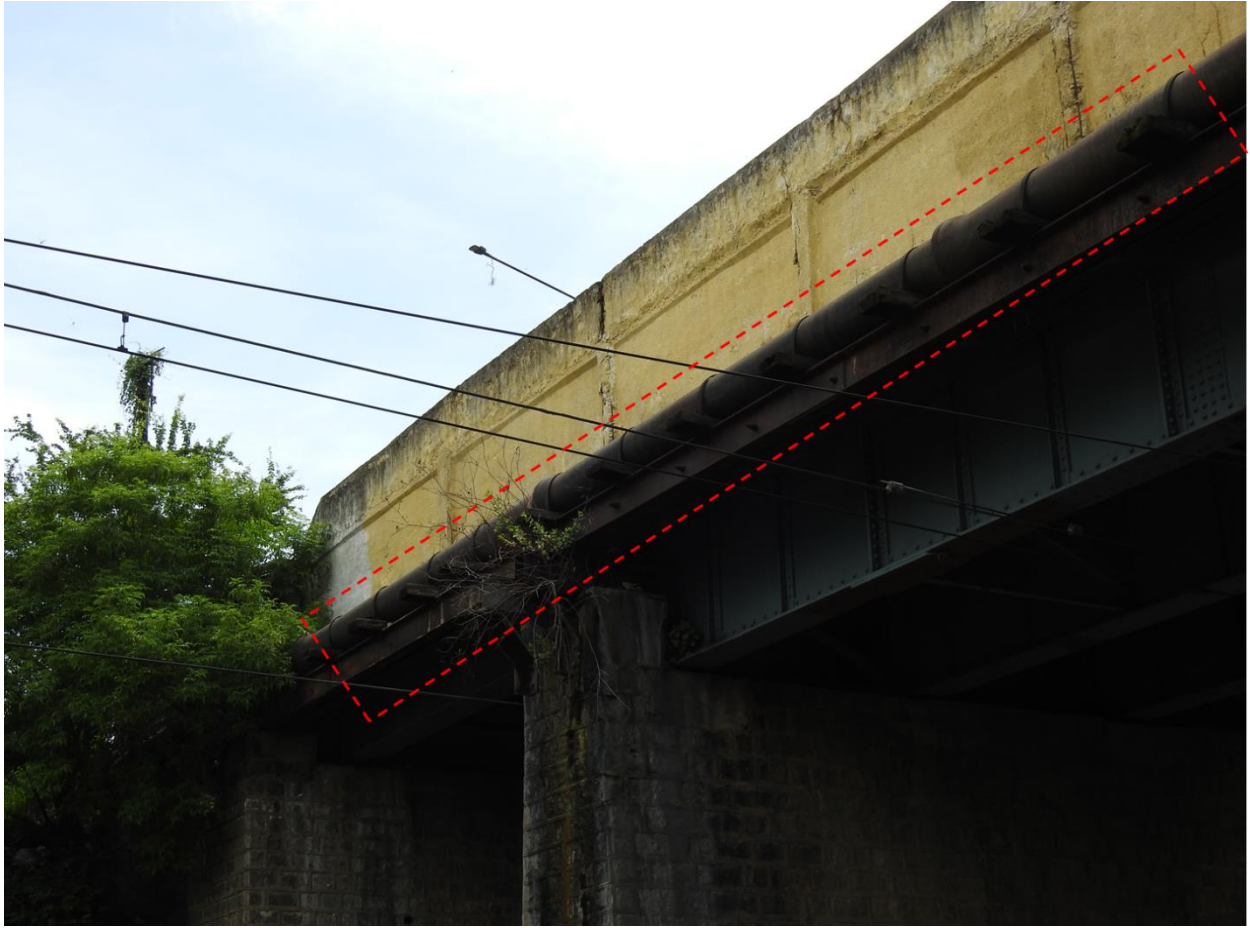
**Fig: 1.9** Additional load of utility is observed

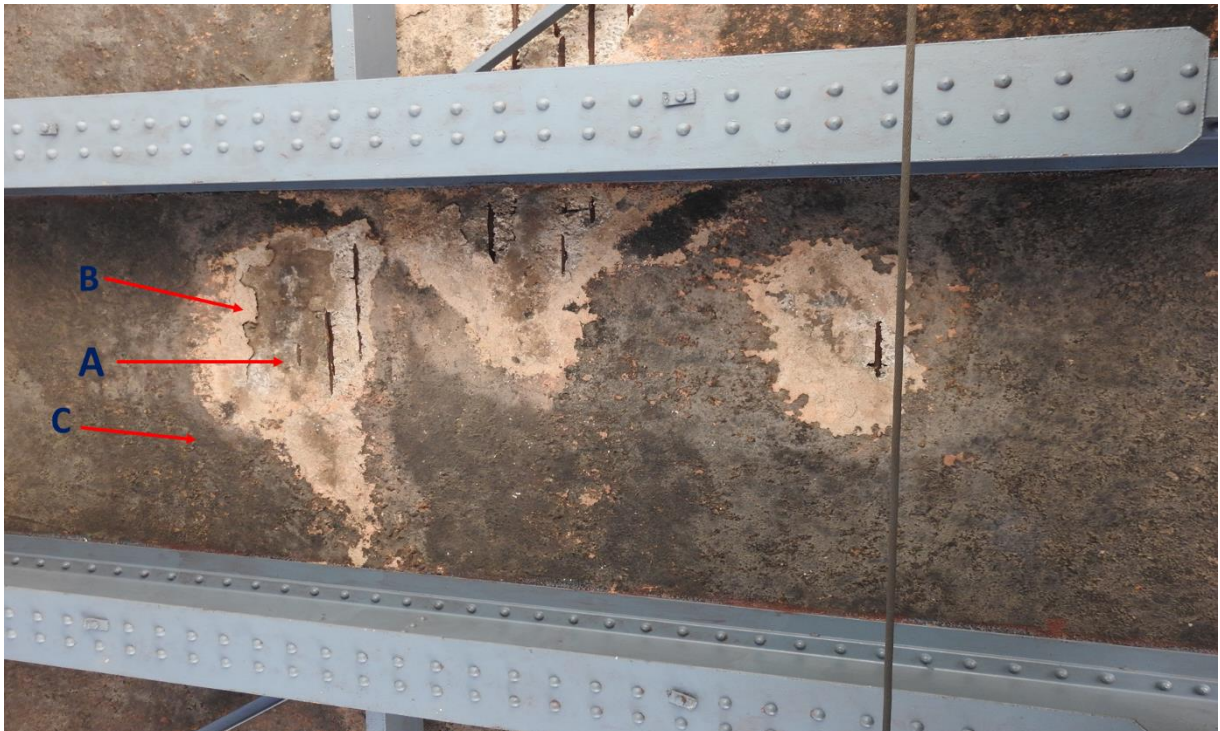
**Fig:1.10** Patch work observed (A- original concrete, B-old patch work, C-new patch work)

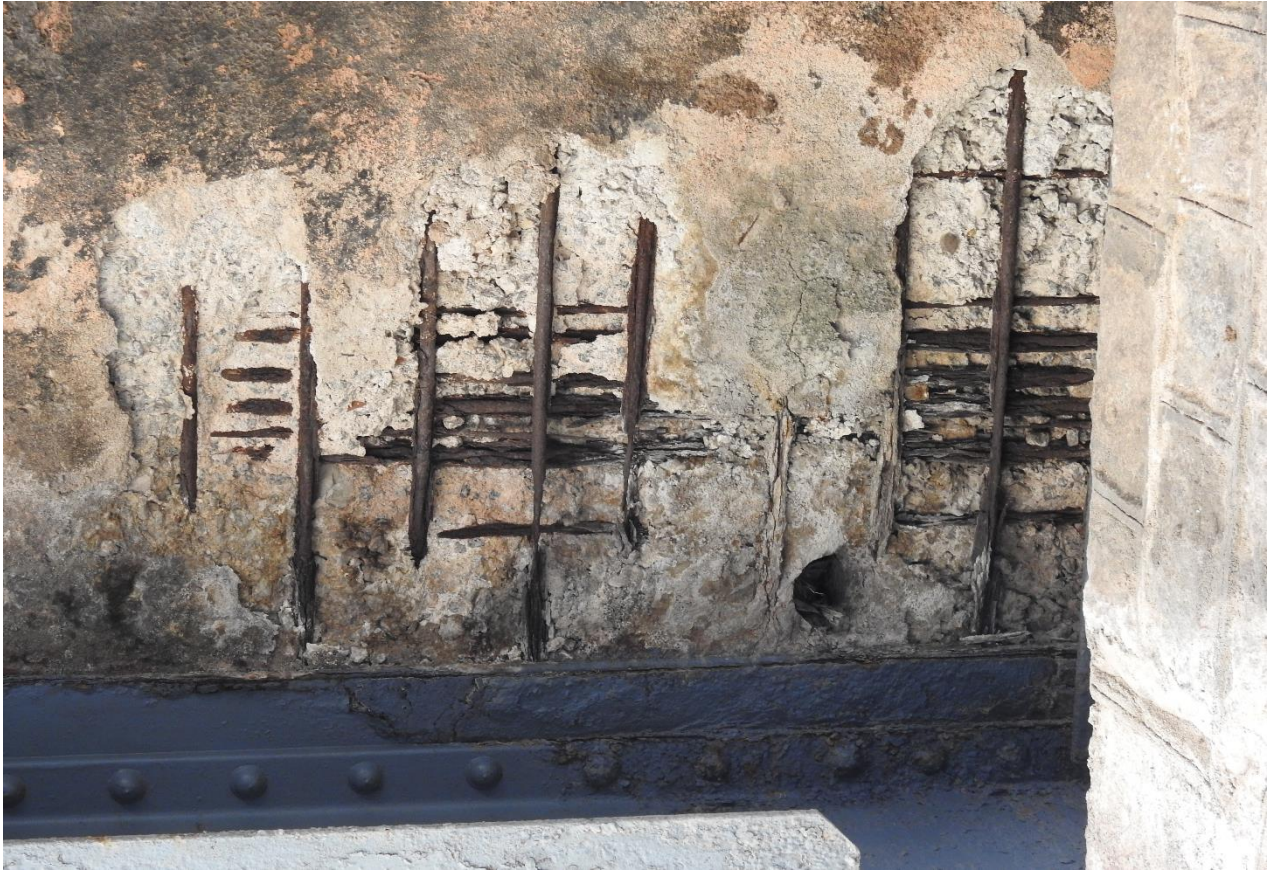
**Fig: 1.11** Exposed reinforcement due to improper drain

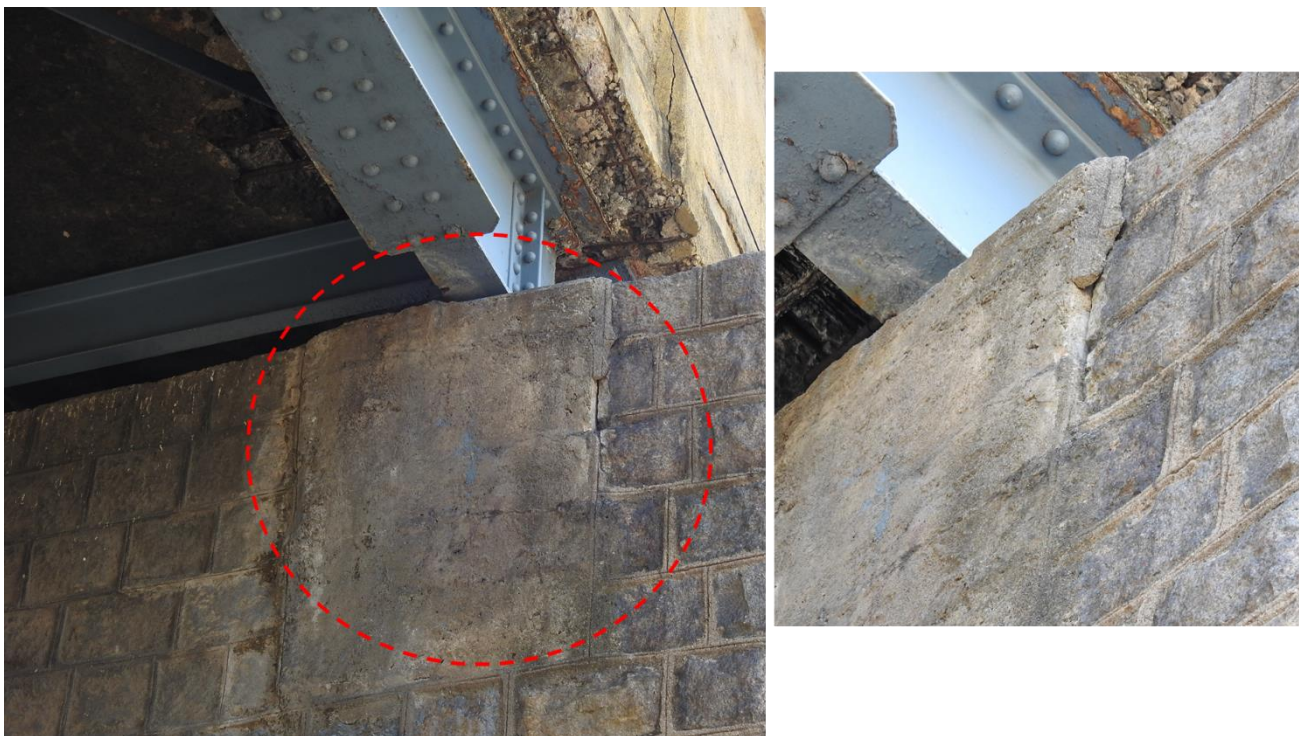
**Fig: 1.12** pointing failure observed at the bed block

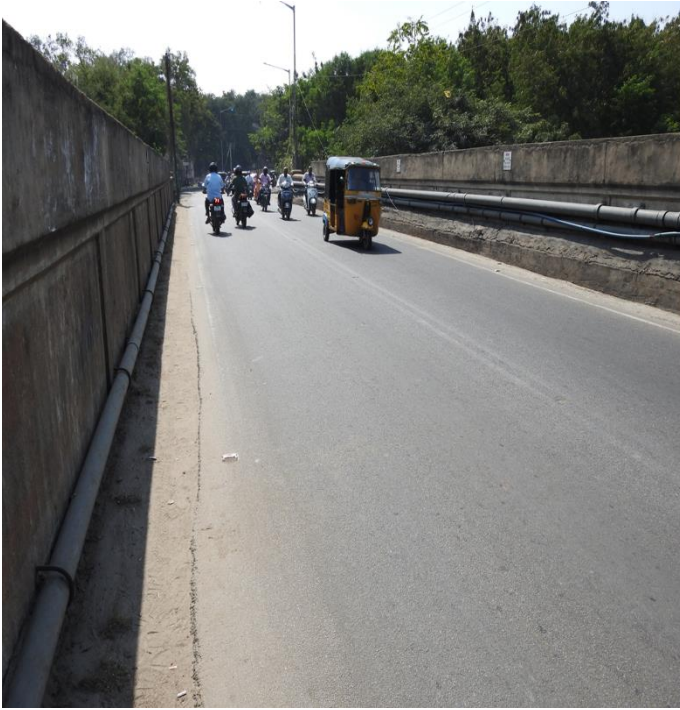
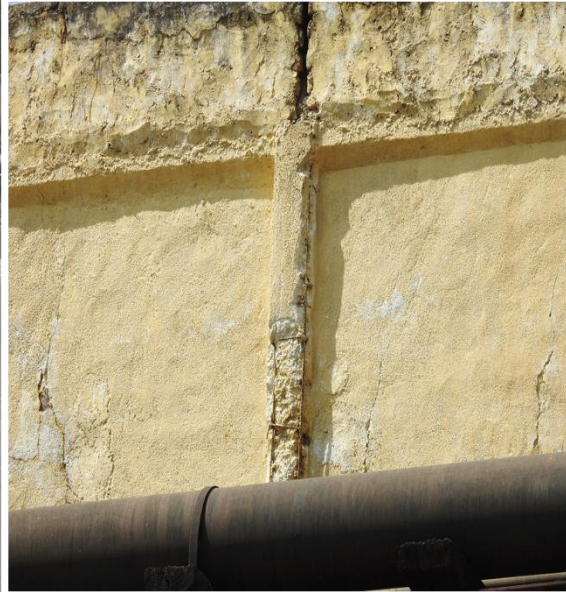
***Fig: 1.13*** Cracks on parapet wall

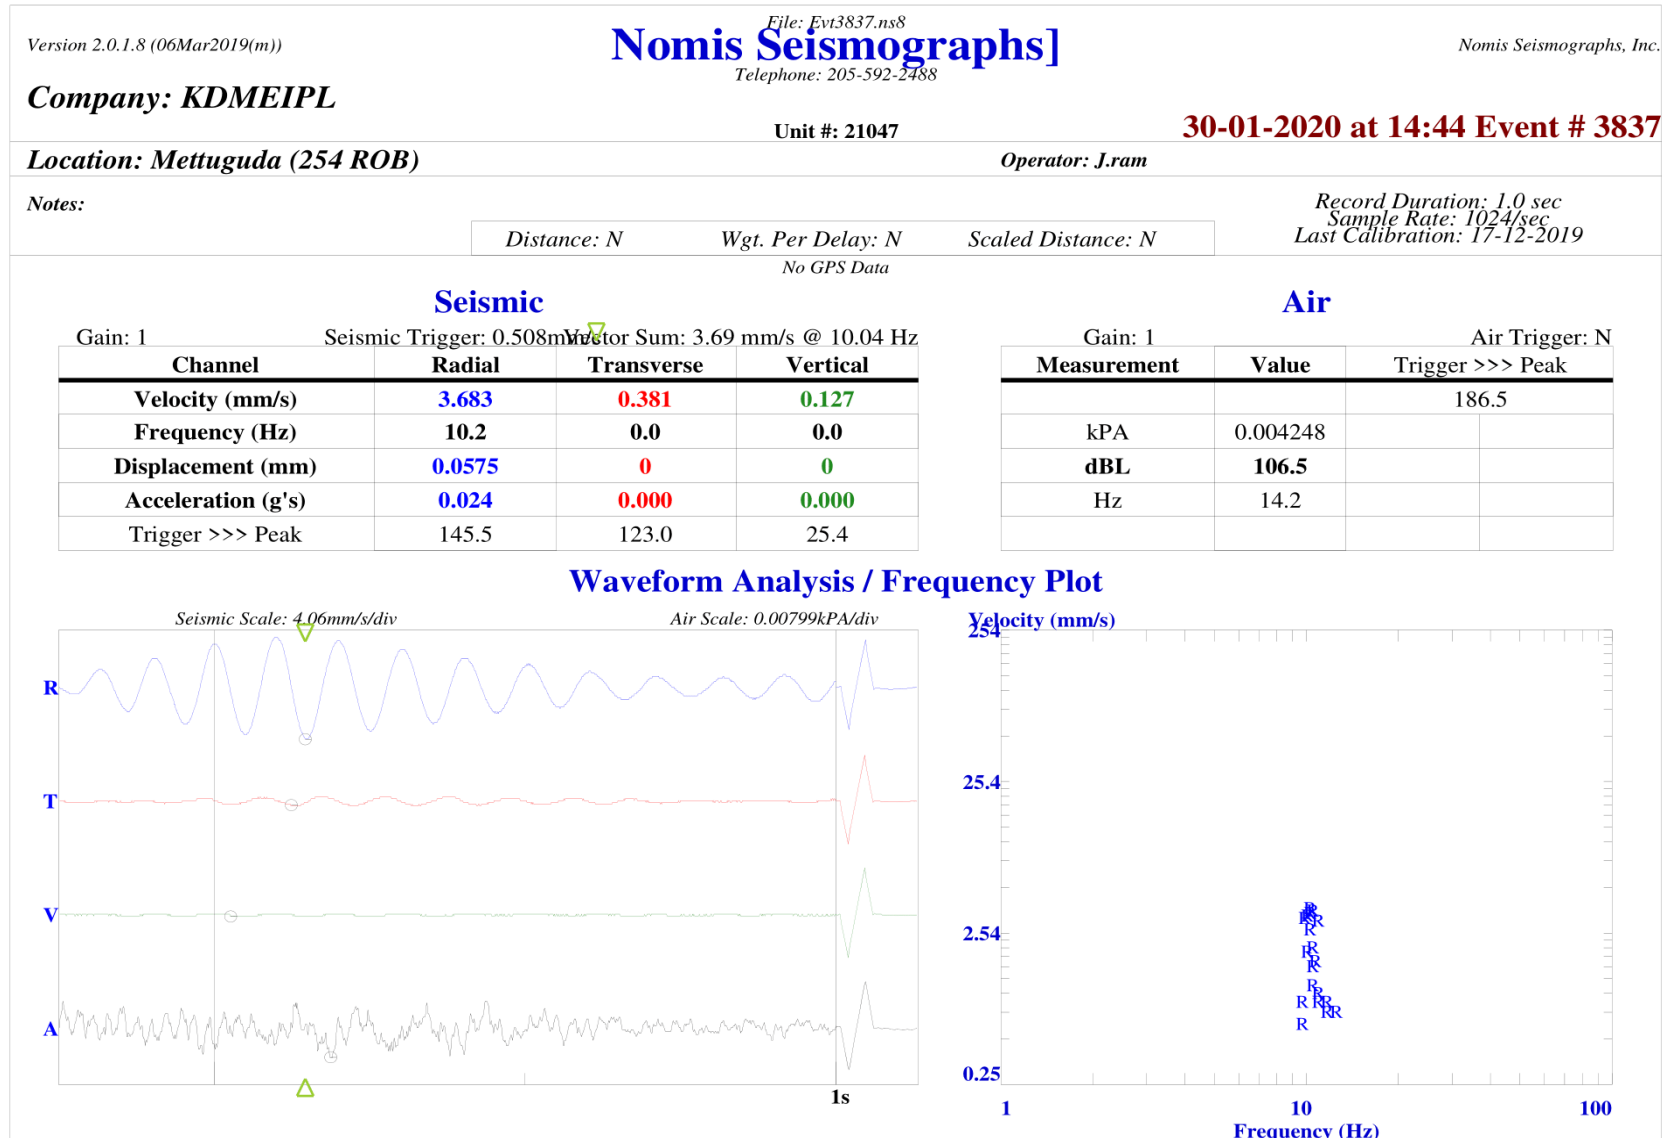
Based on the vibration analysis carried out the structure is in permissible limit of vibrations. (Frequency observed is 300 cpm and maximum amplitude observed during the test time of complete 3hrs is 0.0575 mm)

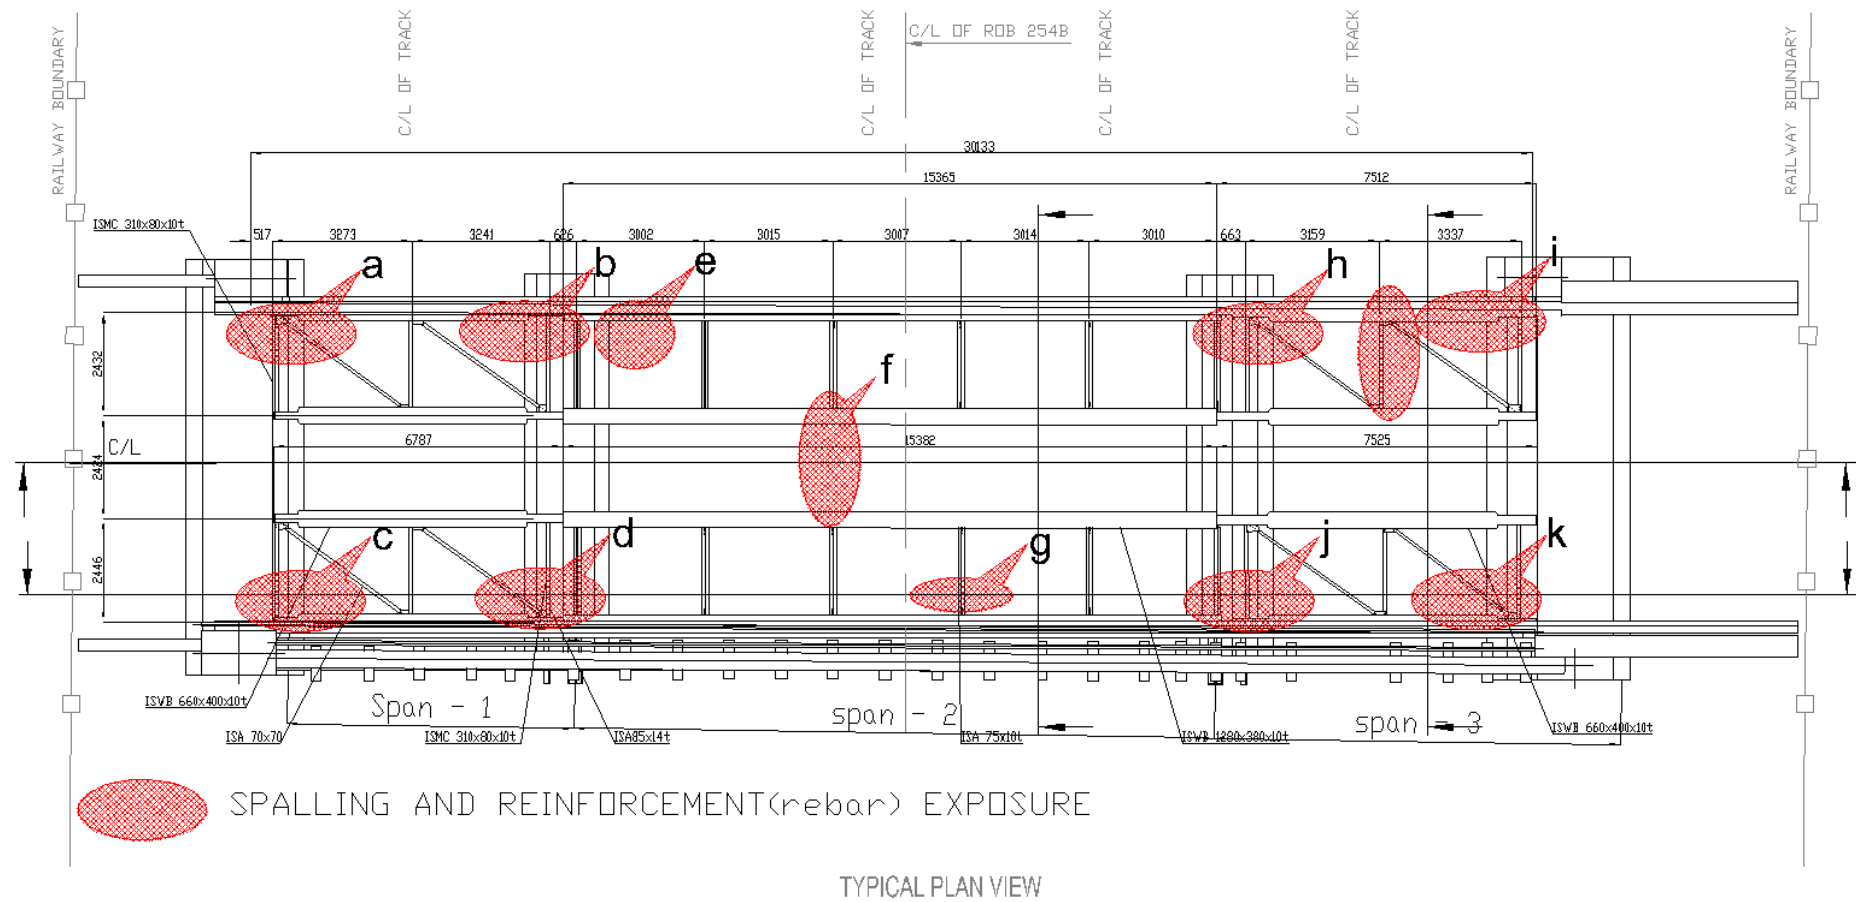
**Fig 3.1:** Bottom view of slab deck with reinforcement exposed (damaged) locations

During the detailed visual observation, is made of Deck slab on the above said locations and the following observations are made, excessive spalling was noticed in span 1, 2 & 3 in majority of the deck slab is affected with dampness, rebar corrosion and cracks were noticed at the steel concrete joints.

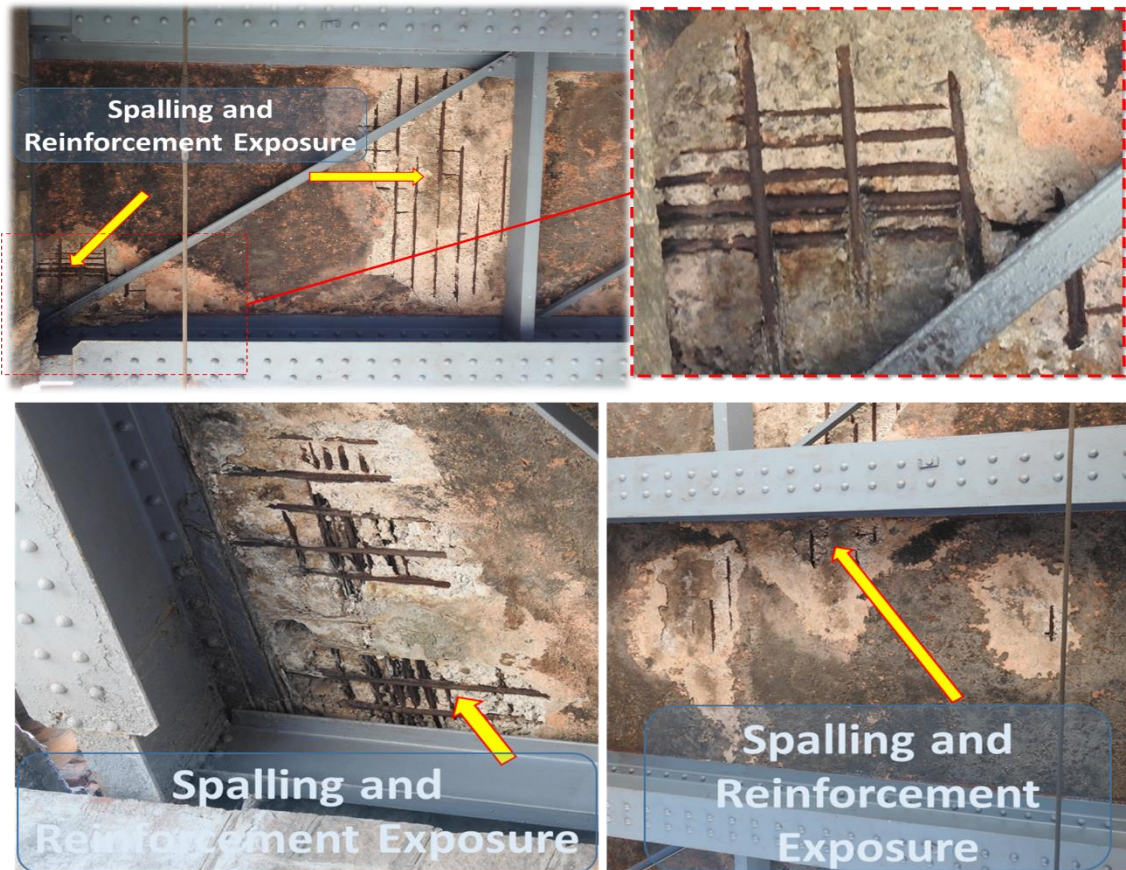
**Fig 3.2:** Damage locations identified in span 1 at “a, b, c & d”

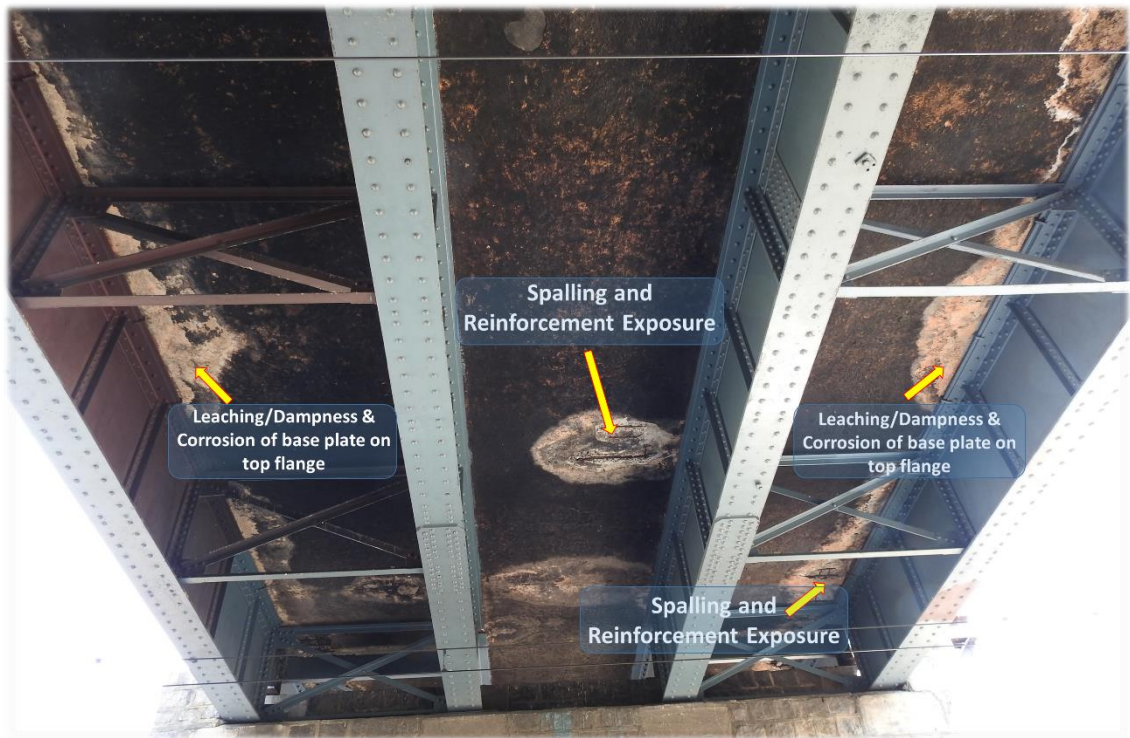
**Fig 3.3:** Damage locations identified in span 2 at “e, f & g”

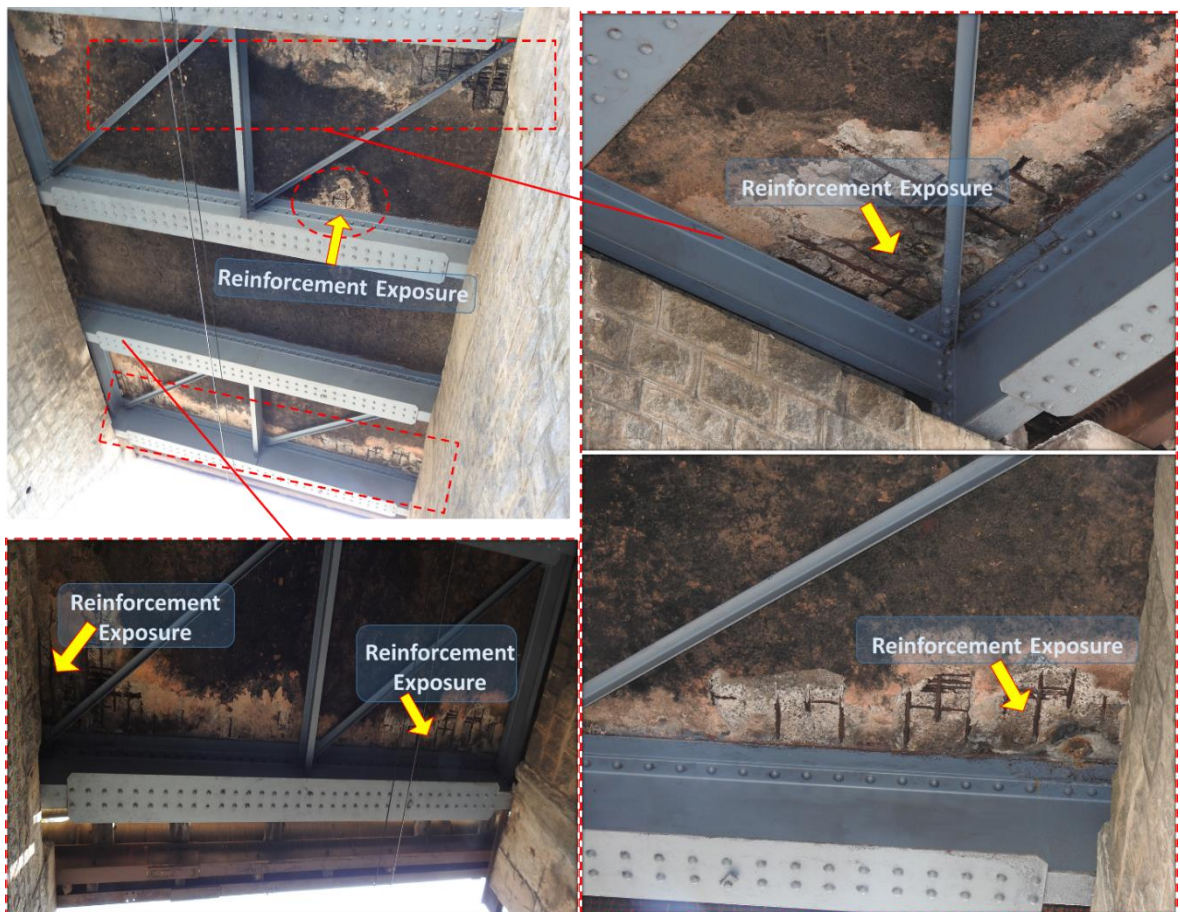
**Fig 3.4:** Damage locations identified in span 3 at “h, I, j & k”

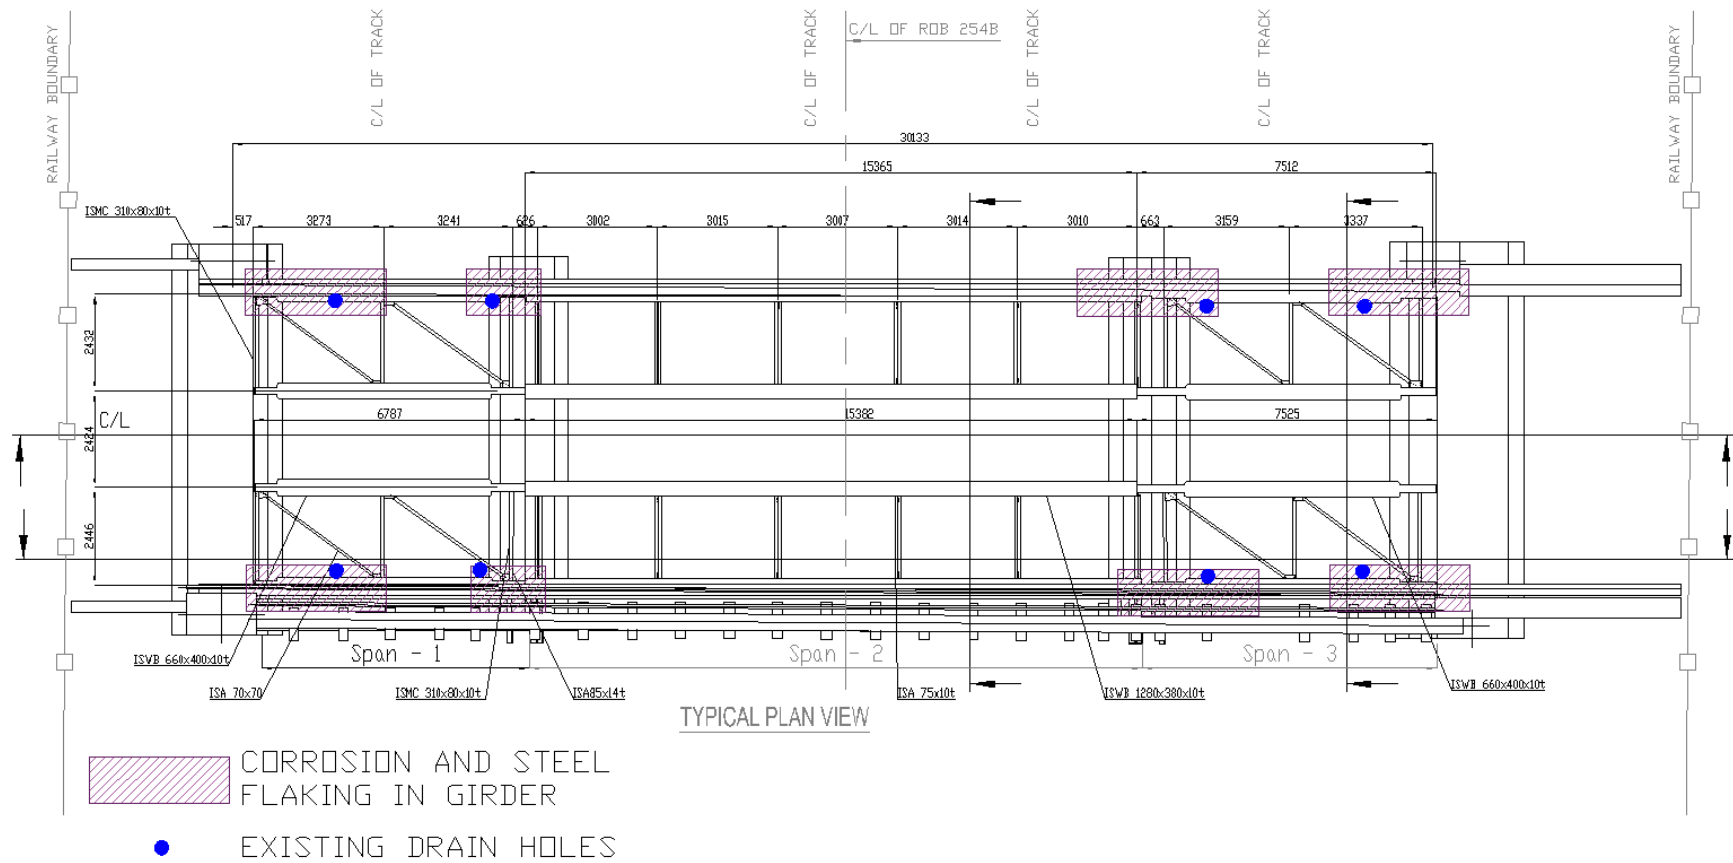
**Fig 3.5:** Bottom view of slab deck with Steel girder exposed (damaged) locations

A detailed visual observation is made on steel girders on the above said locations and the following observations are made, excessive corrosion and steel flaking was noticed in span 1, & 3 near drain holes and supports. Near steel concrete joints cover plate on the girders and angular bracing members connected with rivets are damaged.

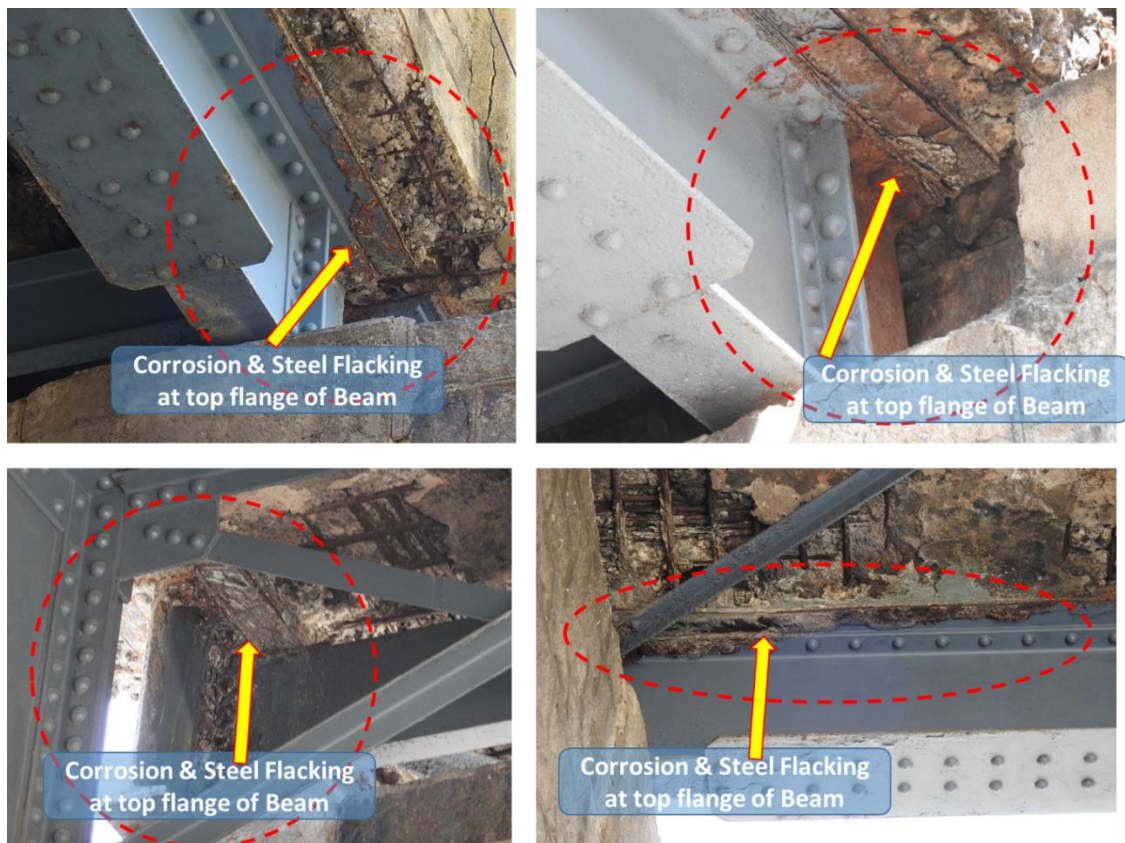
Corrosion and steel flaking observed near support

**Fig 3.6:** Damaged locations identified in span 1 and 3
