## Third Party Audit of ROB's and FOB's of SCR

**INSPECTION OF ROB NO. 254B NEAR METTUGUDA**

**Final Report**  
**SEPTEMBER | 2020**

| <b>Name of the Project</b> | <b>:</b> | <b>VISUAL INSPECTION OF ROB - (254B)</b> |

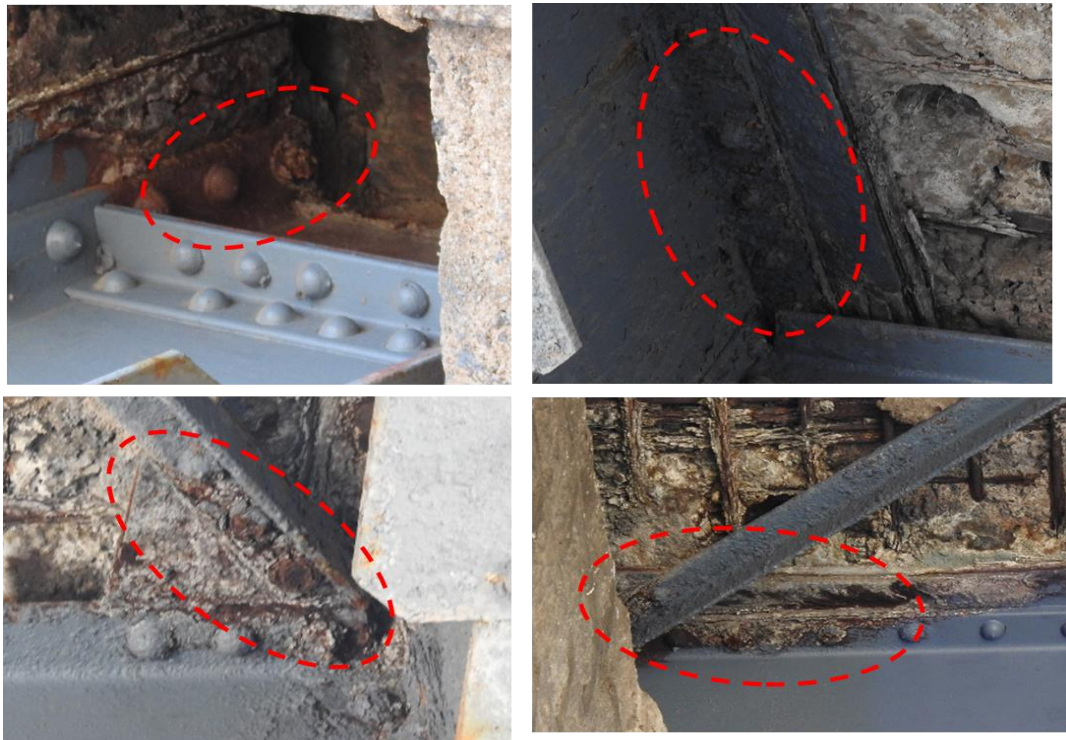
**Fig 3.7:** Rivet Damaged locations identified in span 1 and 3

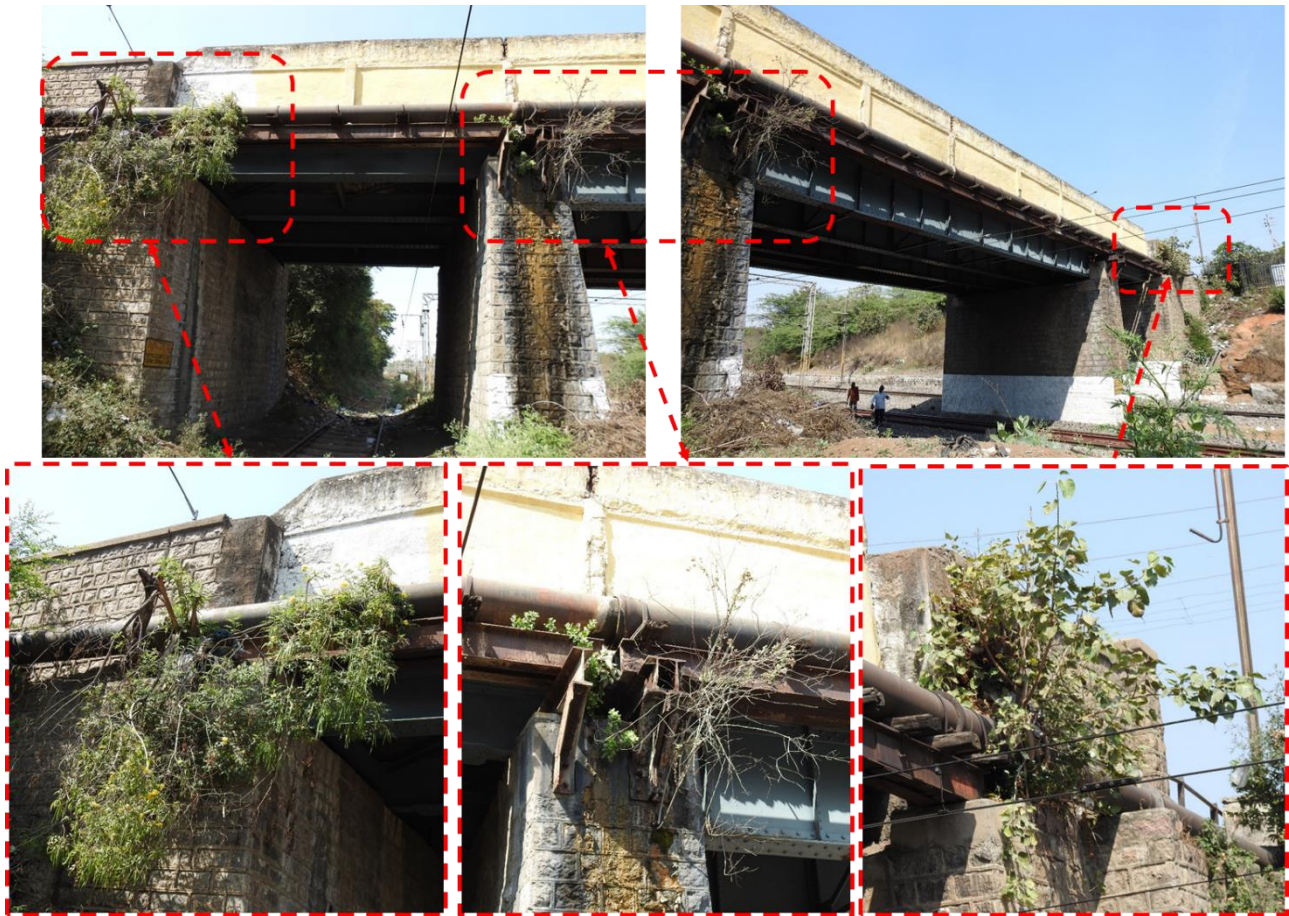
**Fig 3.8 :** Vegetation observed on the top of the pier (abutment wall)

These shall be removed from the components of the bridges as well as from near the bridges if it is found that they affect the soundness of the structure in course of time.
