# Third Party Audit of ROB's and FOB's of SCR

INSPECTION OF ROB NO.117/A NEAR RAGHAVAPURAM RAILWAY STATION

**Final Report**  
SEPTEMBER | 2020

**Name of the Project** : VISUAL INSPECTION OF ROB-117/A

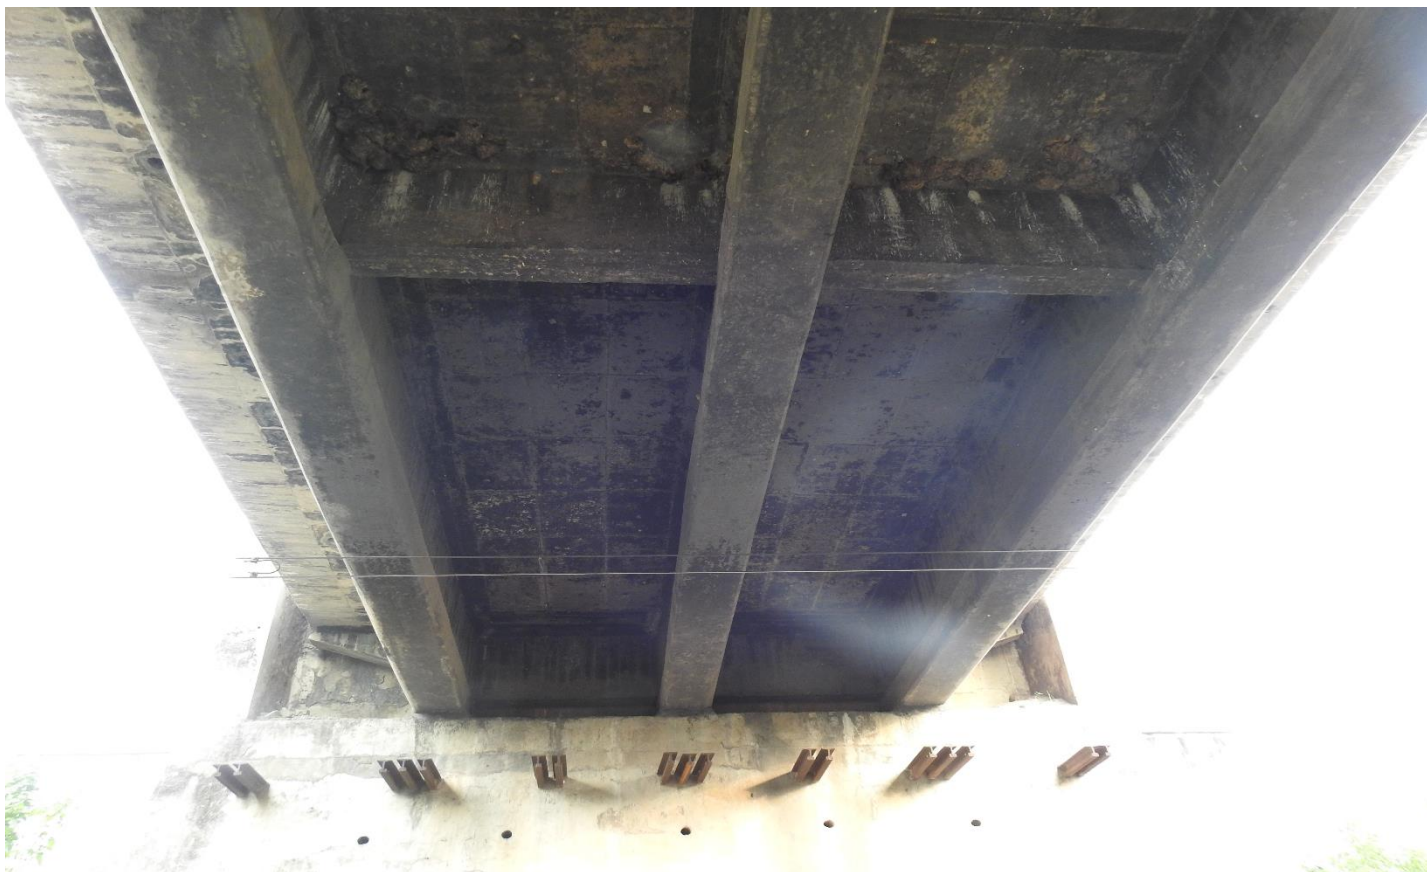
| | Condition of Slab from Bottom | | Leaching and vegetation growth observed. (Refer Fig-3,) |

**Fig: 3** Bottom view, Leaching observed

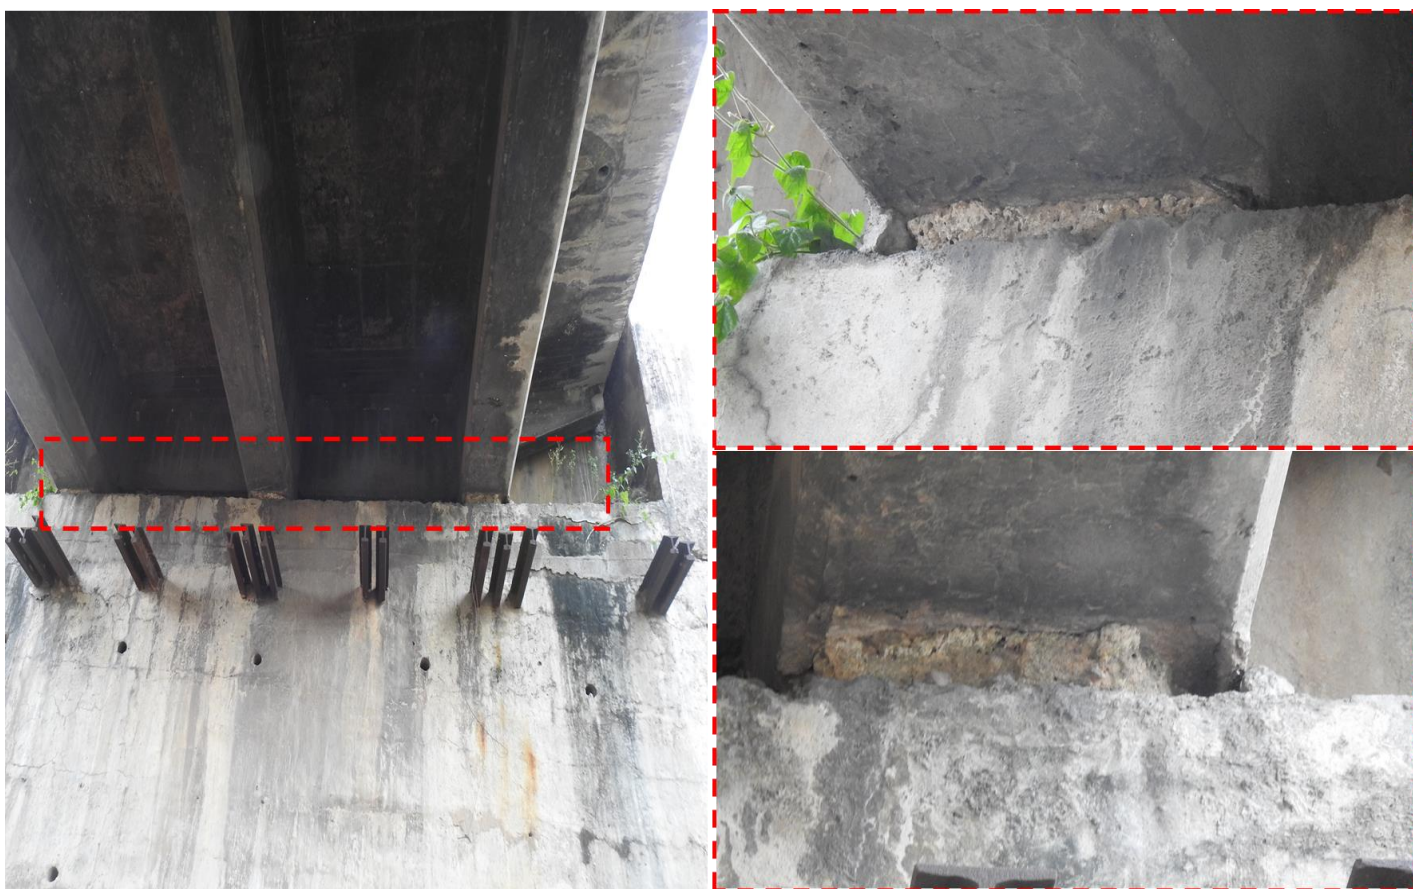
| PART 1.2 STRUCTURAL SYSTEM OF THE BRIDGE | | | |
|---|---|---|---|
| | Type of Bearings | | Bearings are covered with mortar ( <b>Refer Fig-4,5</b> ) |

**Fig 4:** Bearings at Abutment 1

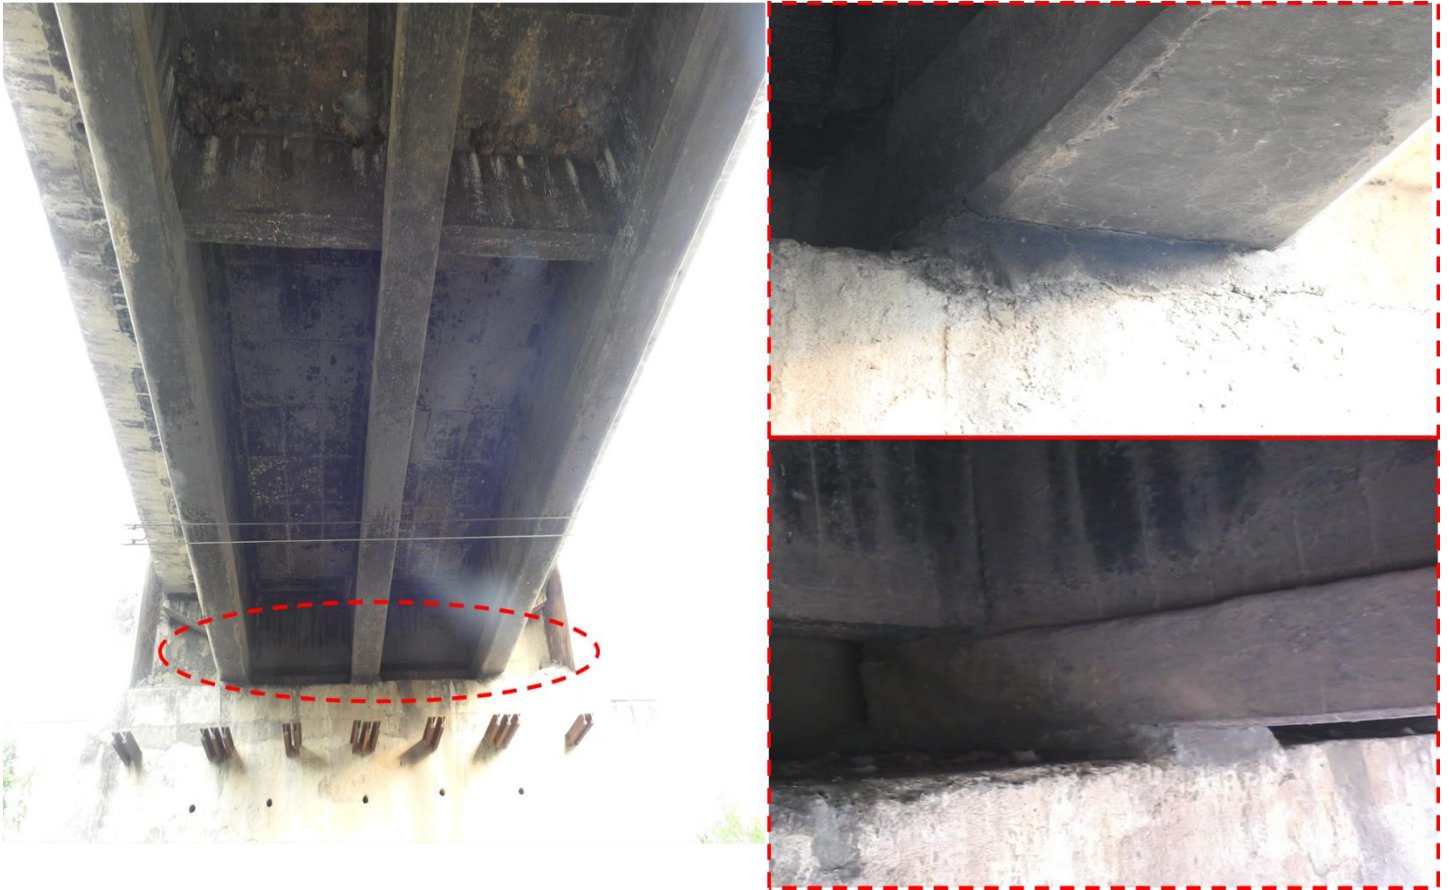
**Fig 5:** Bearings at Abutment 2

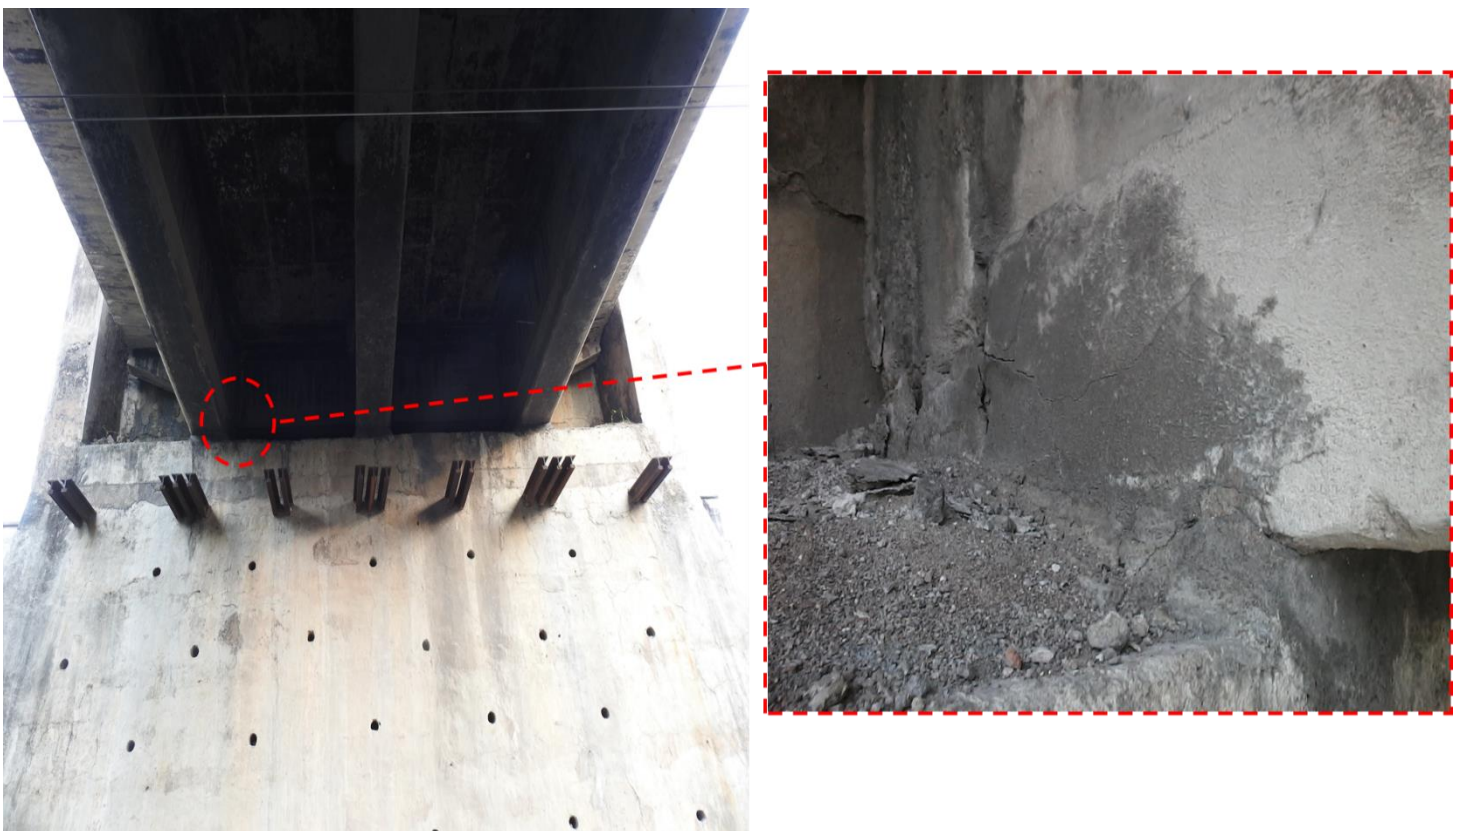
**Fig 6:** Spalling and crack at main girder resting location

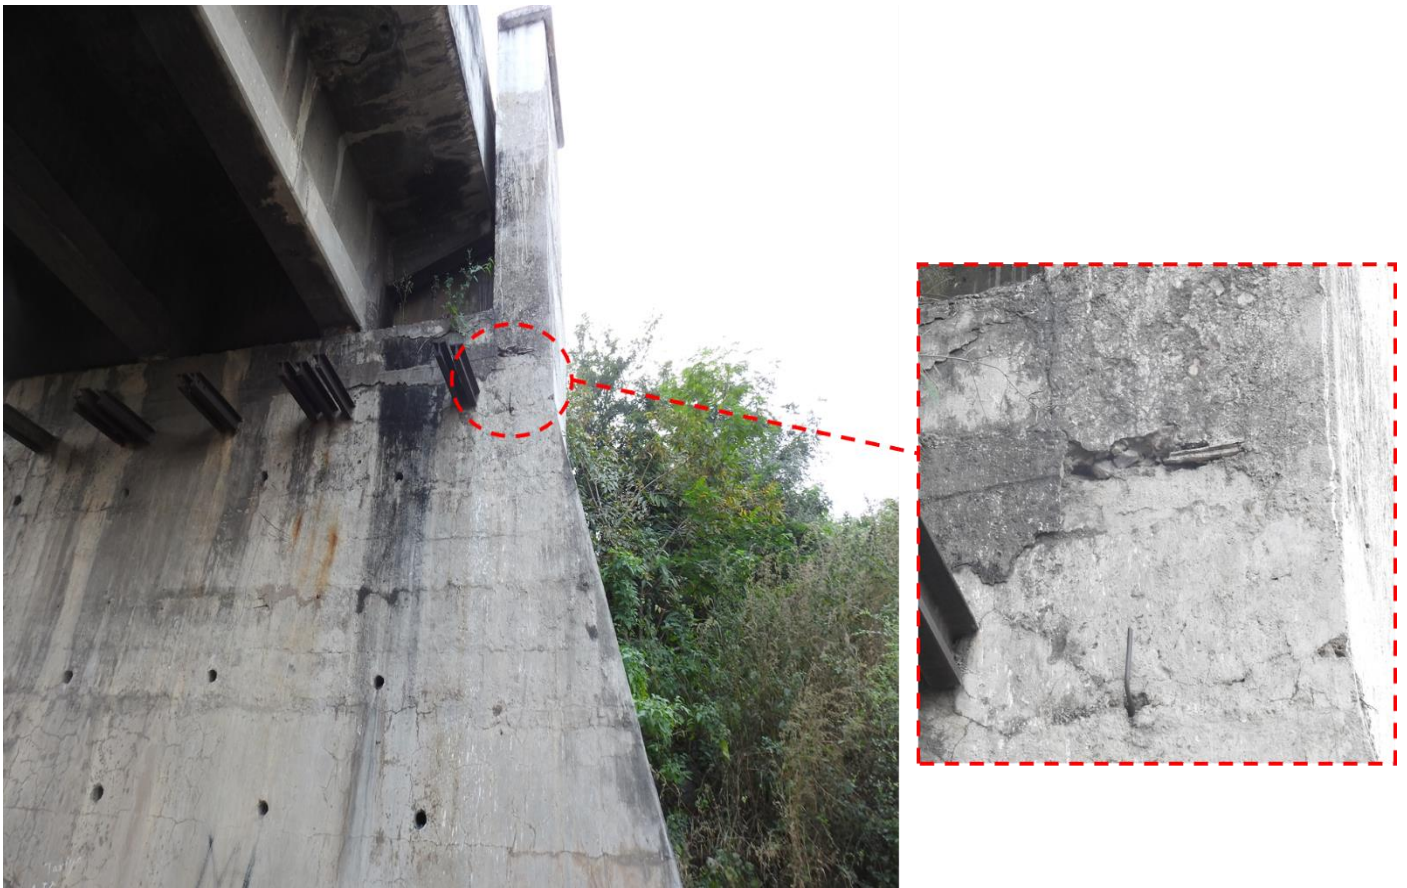
| | Condition of Secondary Girder | | Minor spalling observed. (Refer Fig-7) |

**Fig 7:** Minor Spalling, leaching at Abutment

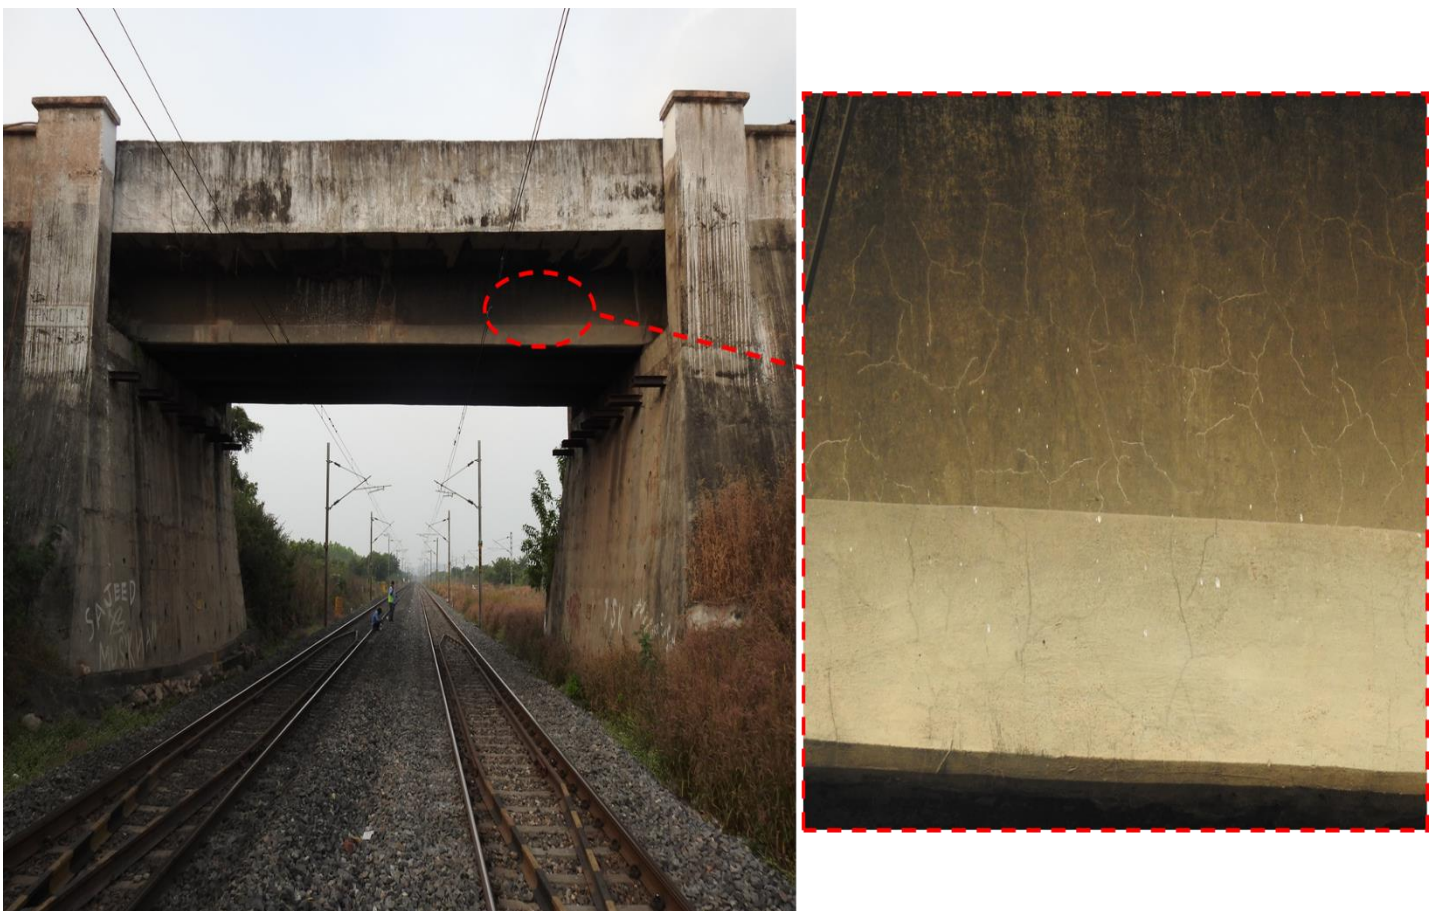
**Fig 8:** shrinkage cracks at main girders

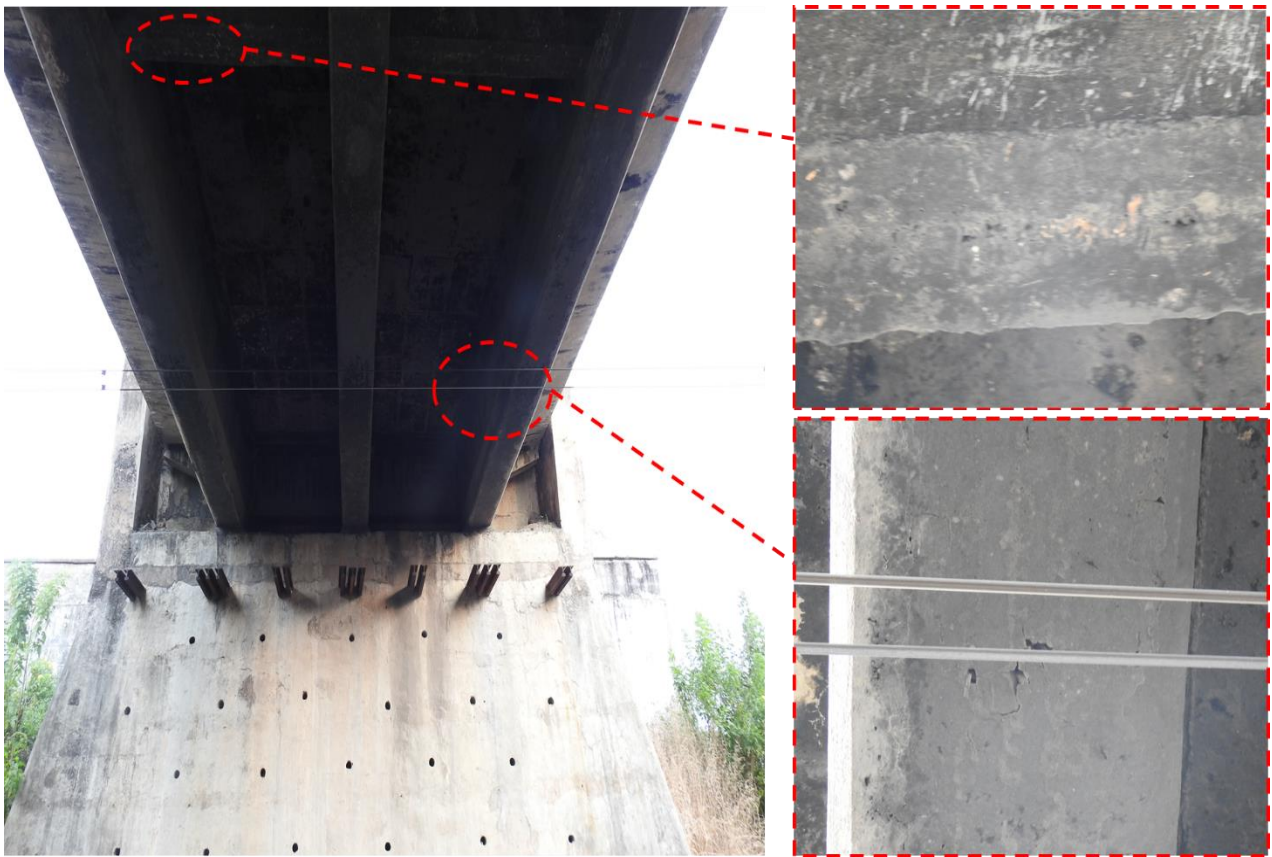
**Fig 9:** Minor spalling at secondary and main girder

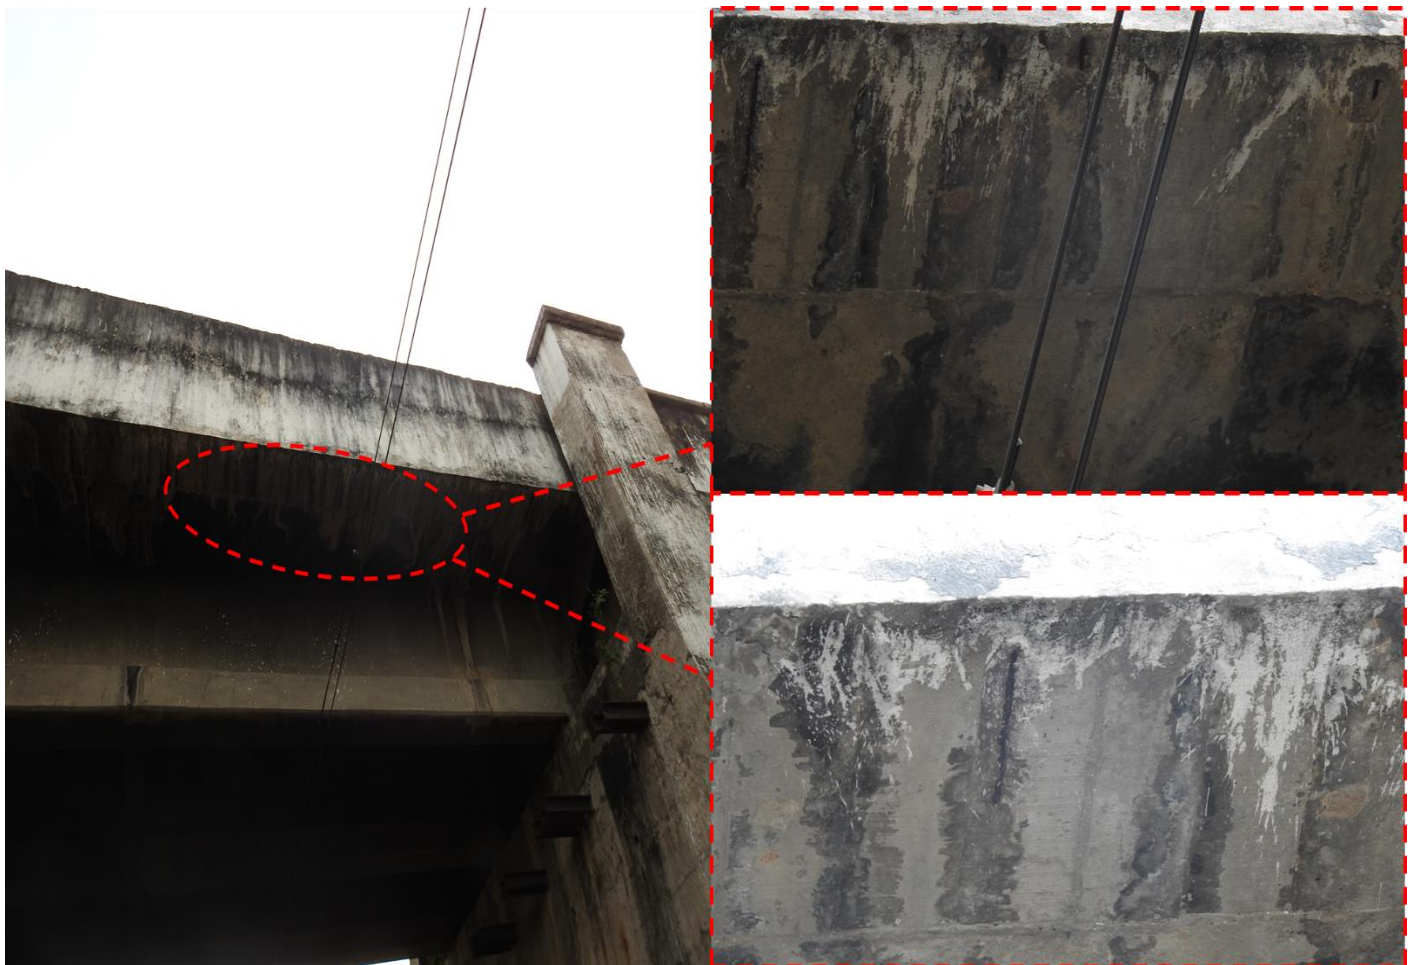
**Fig 10:** Spalling at Overhang Slab portion

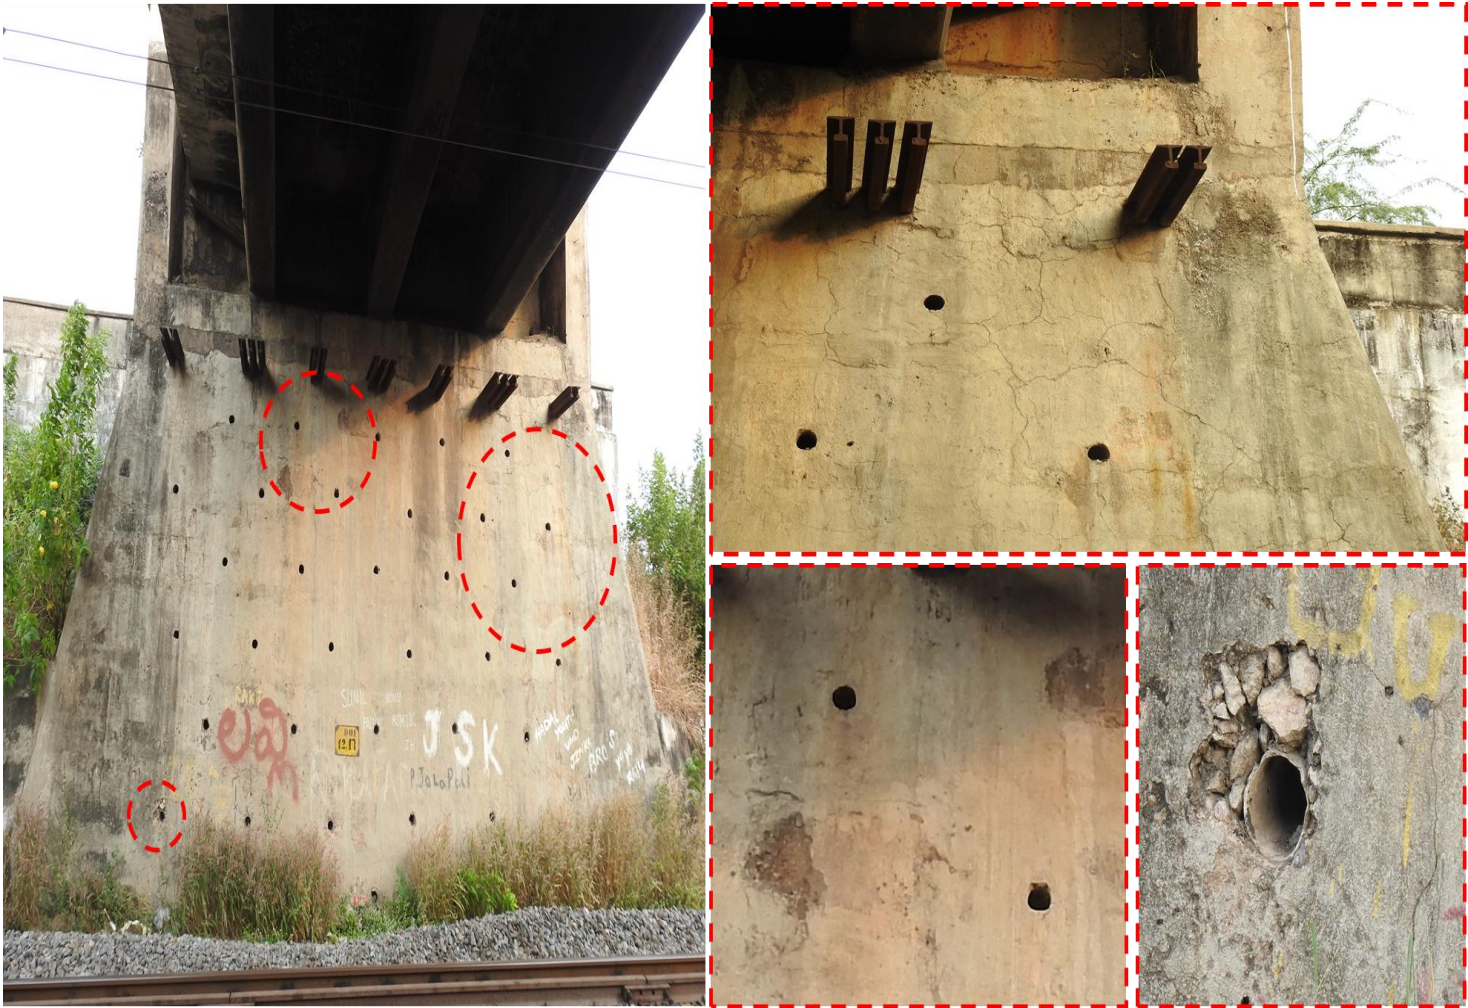
**Fig 11:** Shrinkage cracks and minor spalling at Abutment 1

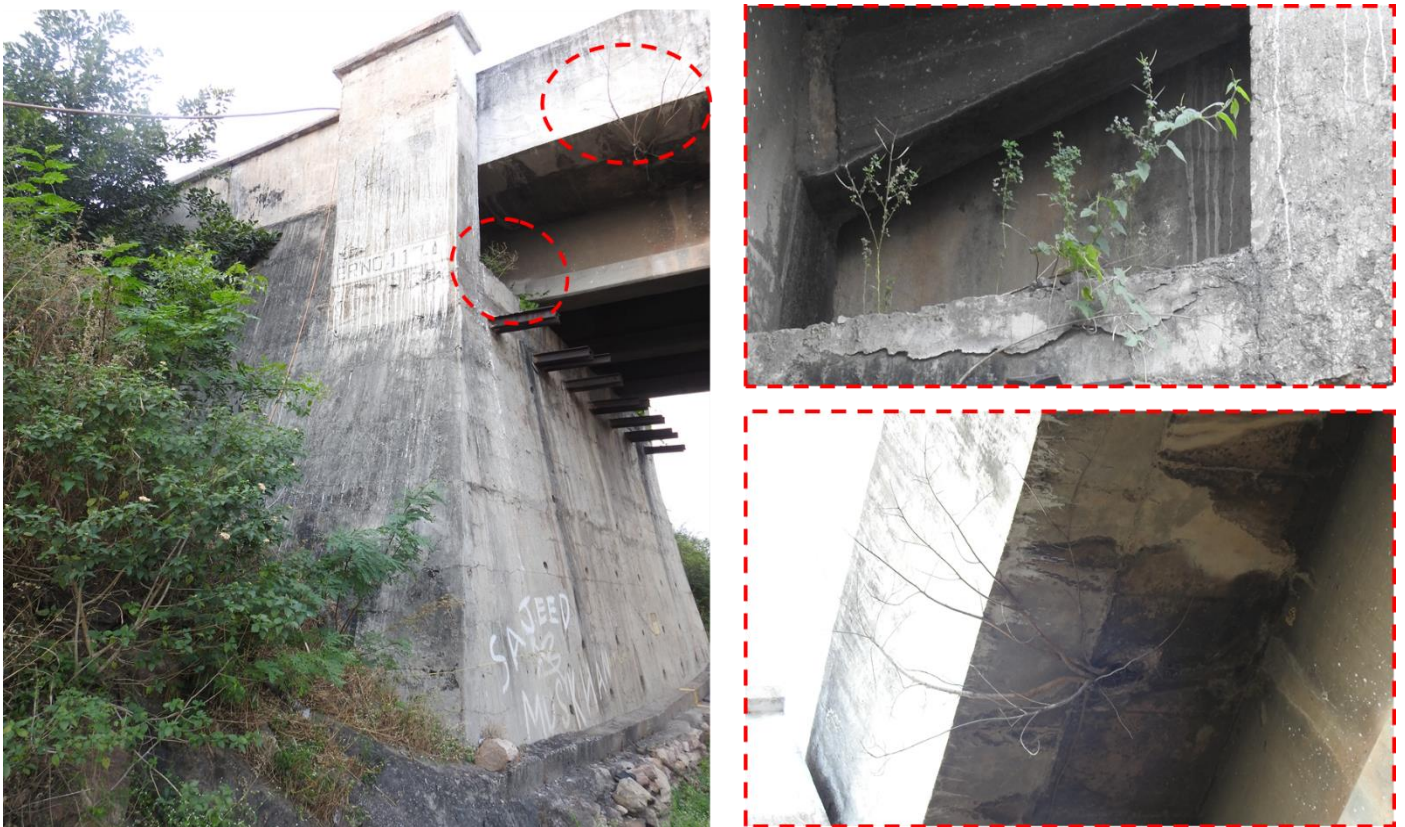
**Fig 12:** Vegetation observed at abutment and Drainage spouts

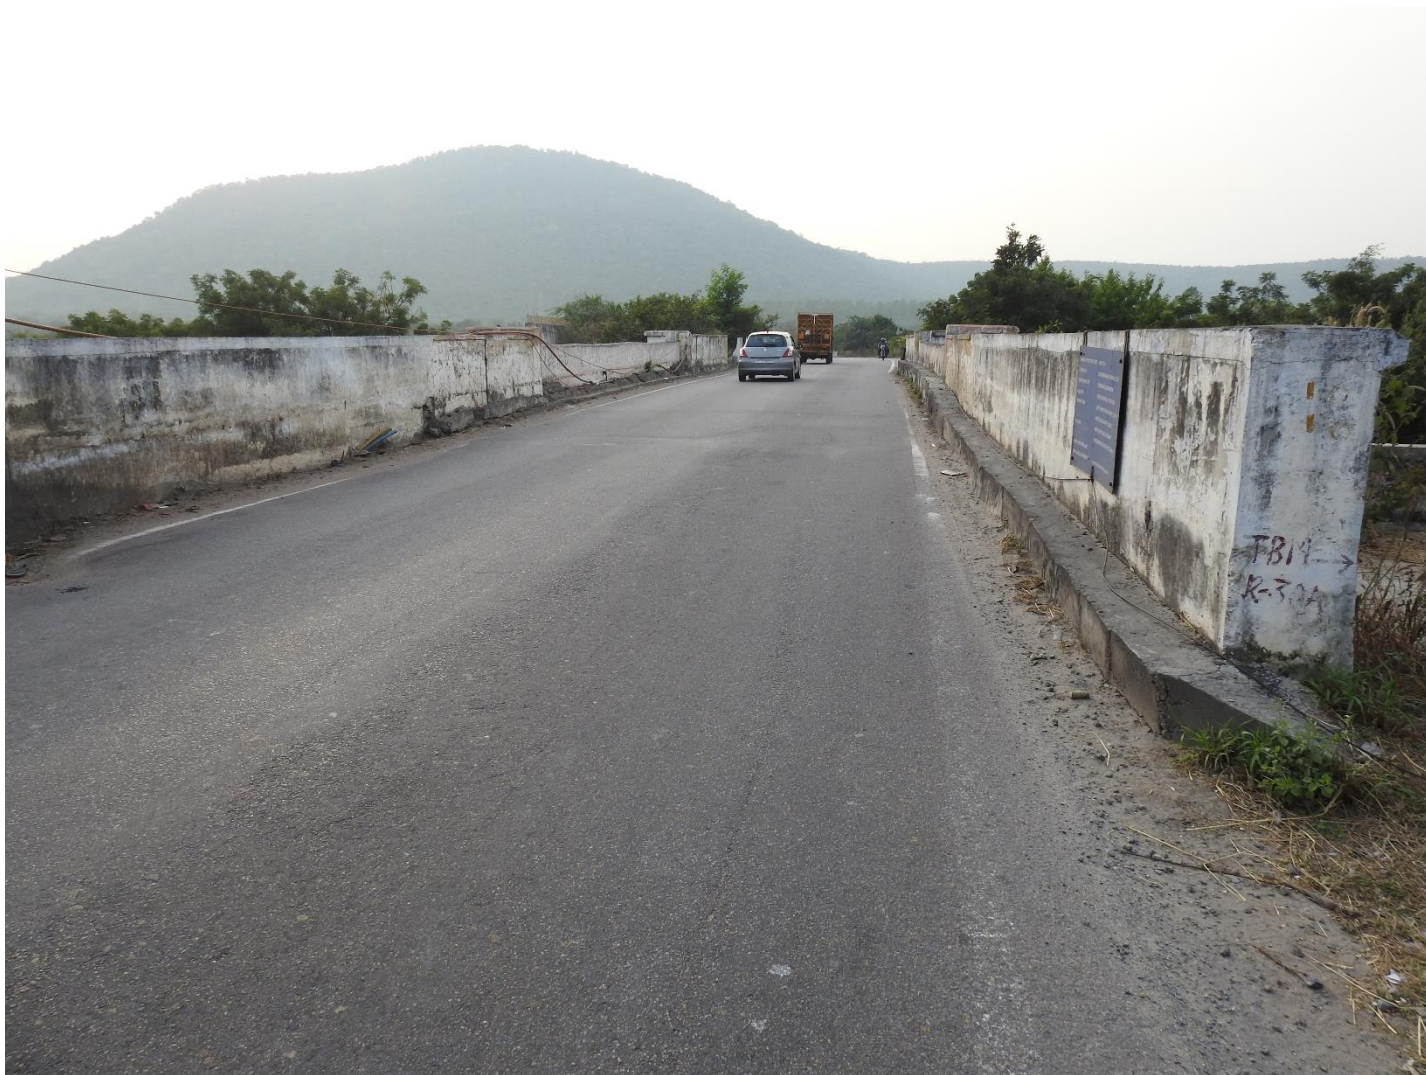
| | Condition of Flooring/Wearing Coat | | Good condition (Refer Fig-13) |
| | Condition of Wall/Railing | | No Accidental hit marks are observed on wall (Refer Fig-13) |

***Fig 13:*** Wearing coat & Parapet wall

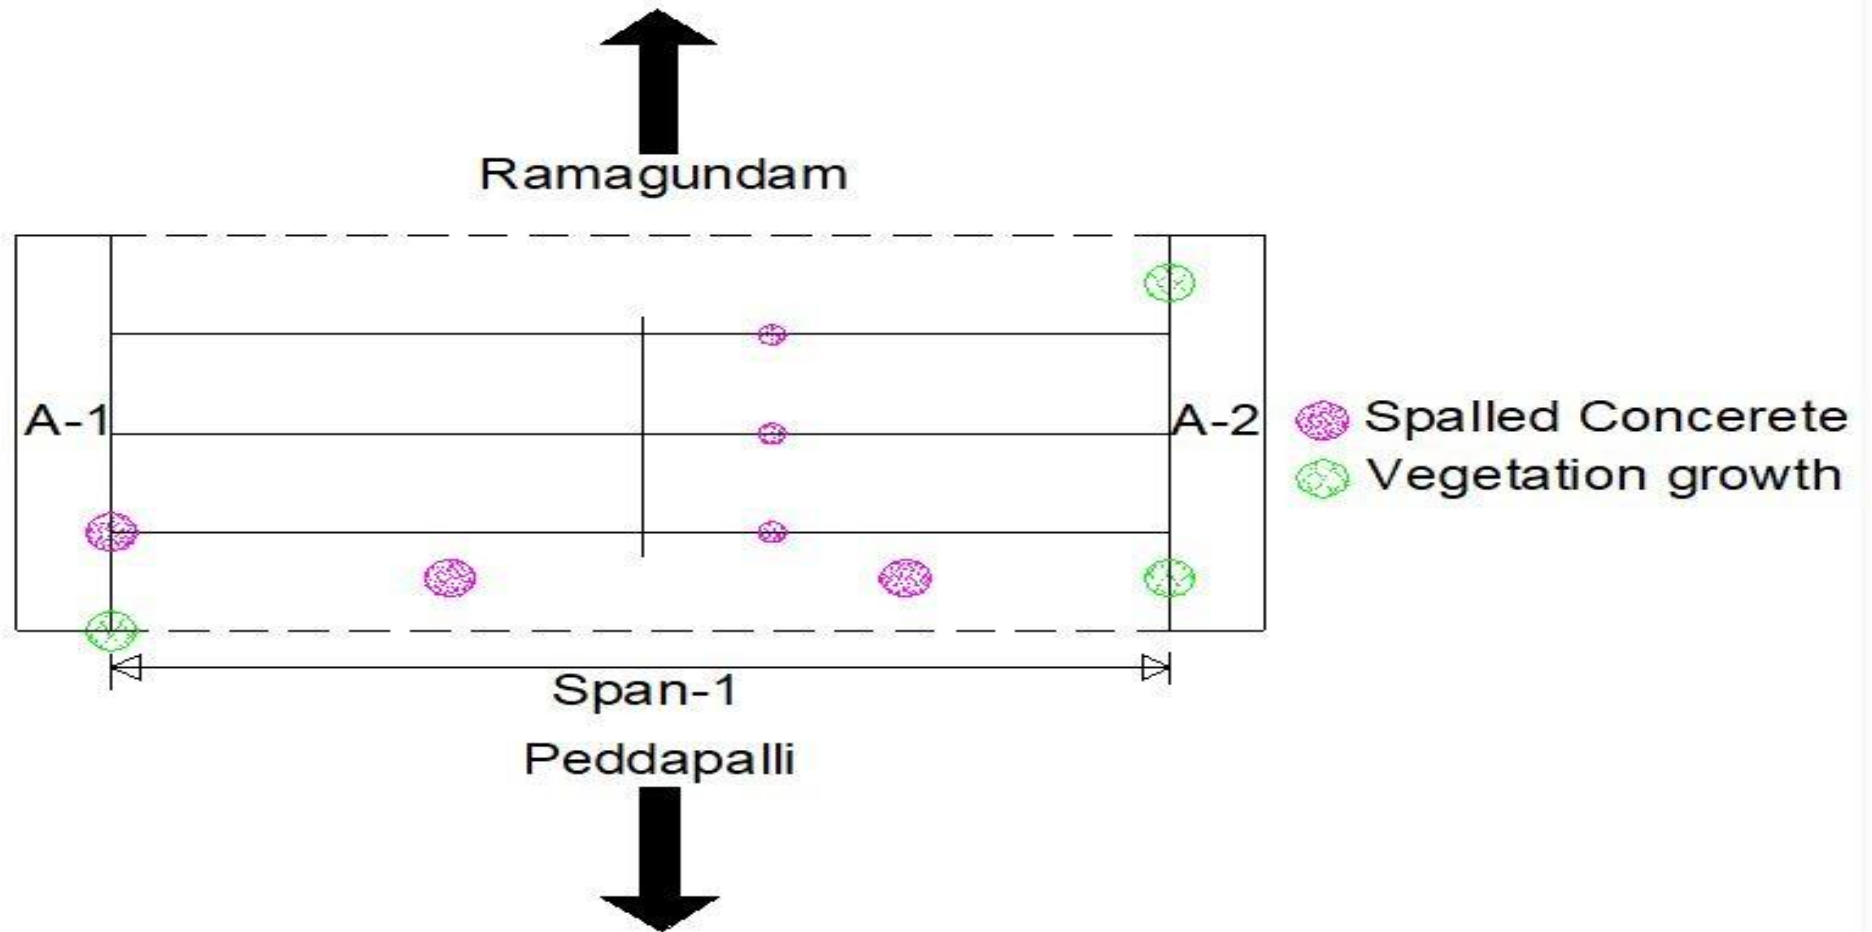
**Fig: 14** Bottom view of ROB with damaged locations

The detailed visual observation of ROB, the following observations are made. Minor Reinforcement exposure observed at overhang portions of ROB. Spalling of concrete at Girder resting locations. Vegetation growth is also observed at abutments and drainage spouts.

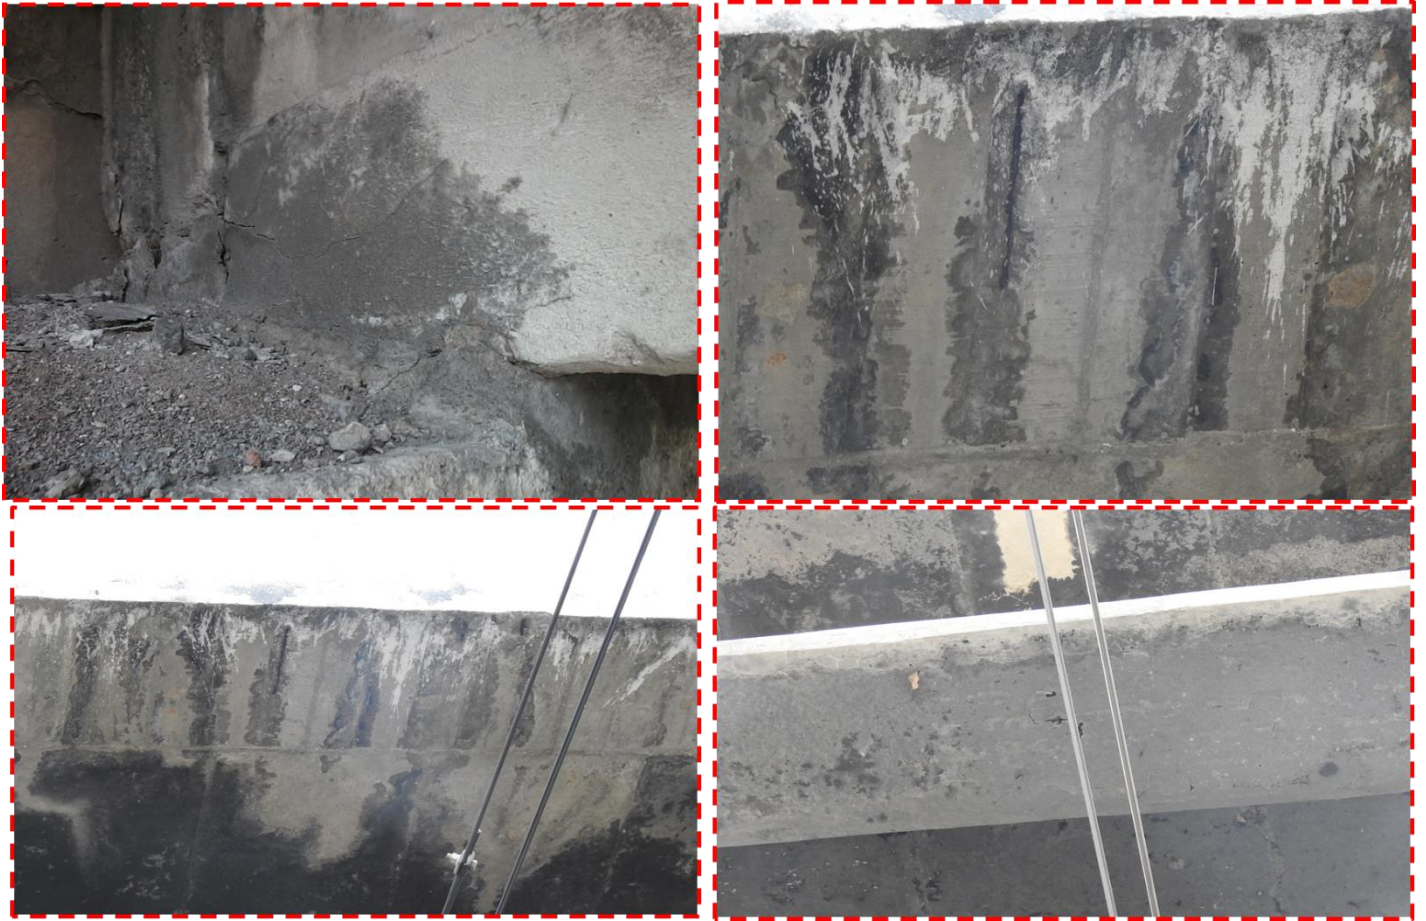
**Fig: 15** Spalling of concrete at girders and overhang slab portion

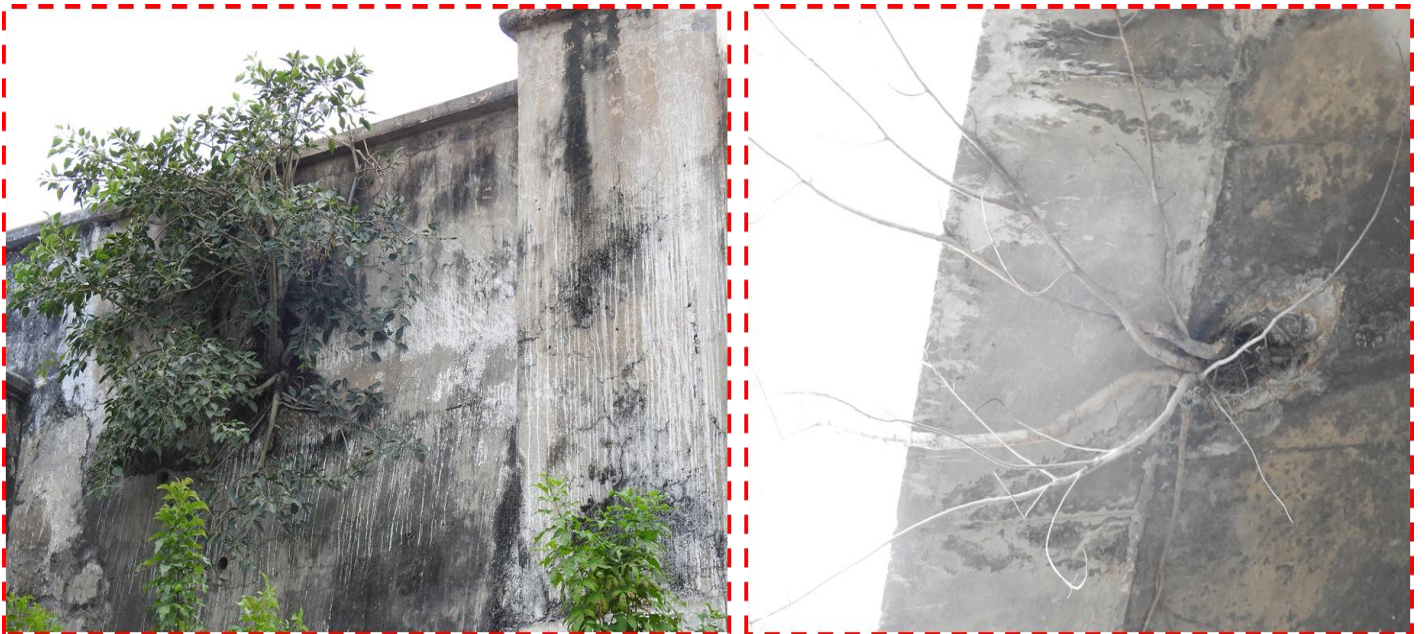
**Fig: 16** Vegetation growth at abutments and slab
