## Third Party Audit of ROB's and FOB's Of SCR

**INSPECTION OF ROB NO. 561A AT CHITTOOR RAILWAY STATION**

**Final Report**  
**SEPTEMBER | 2020**

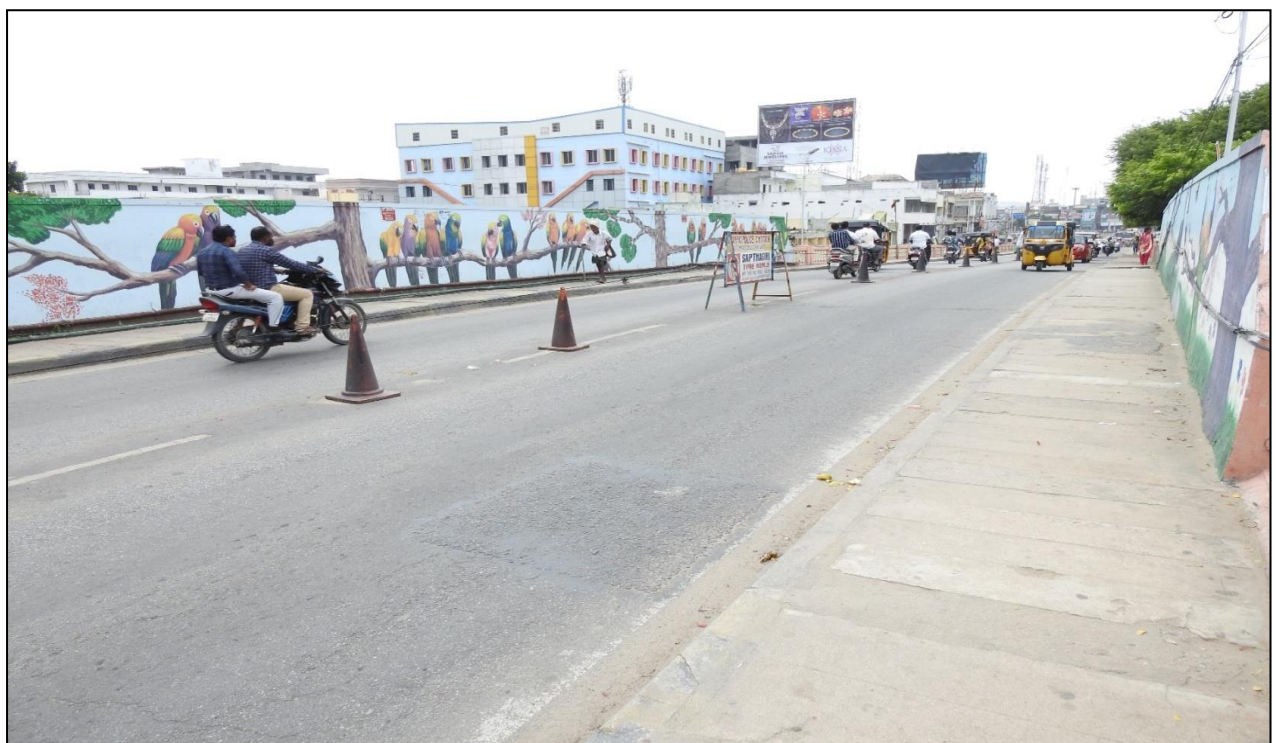
| | Condition of Flooring/Wearing Coat | Fair | (Refer Fig-3) |

**Fig 3:** Top View of the bridge / Condition of wearing course

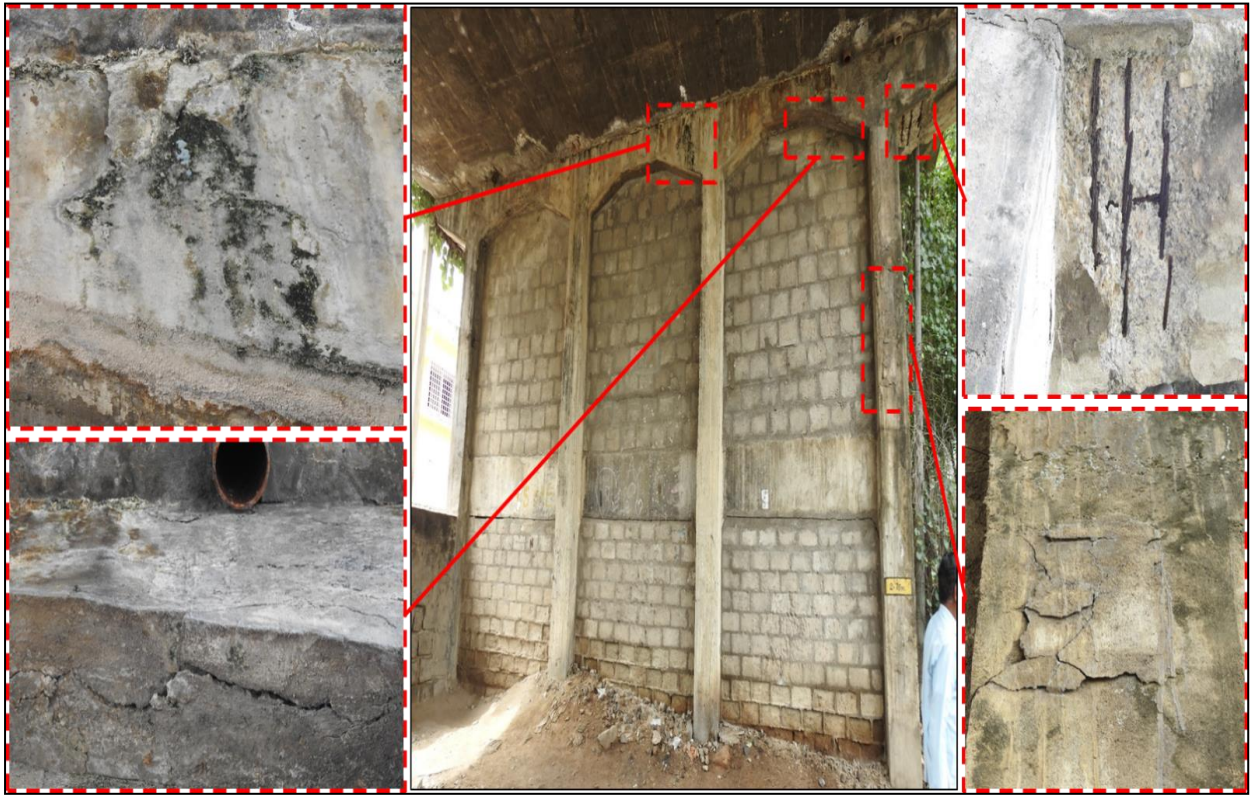
| PART 2 STRUCTURAL SYSTEM OF THE BRIDGE | | | |
|---|---|---|---|
| | Pier Diameter/Dimension | | Cracks, Spalling, Reinforcement exposure and Leaching are observed at Pier caps & columns.<br><br>... (Refer Fig:4, 5, 6 & |

**Fig 4:** Cracks, Spalling & Reinforcement exposure observed in Pier-1

- Based on visual inspections and NDT Testing and its interpretations following recommendations were made:
  - a) Epoxy Grouting of cracks observed at girders, pier columns and slab.

- b) Jacketing of the severely cracked columns should be done
  - c) Application of Anti corrosive paint for exposed rebars with Minimal deterioration

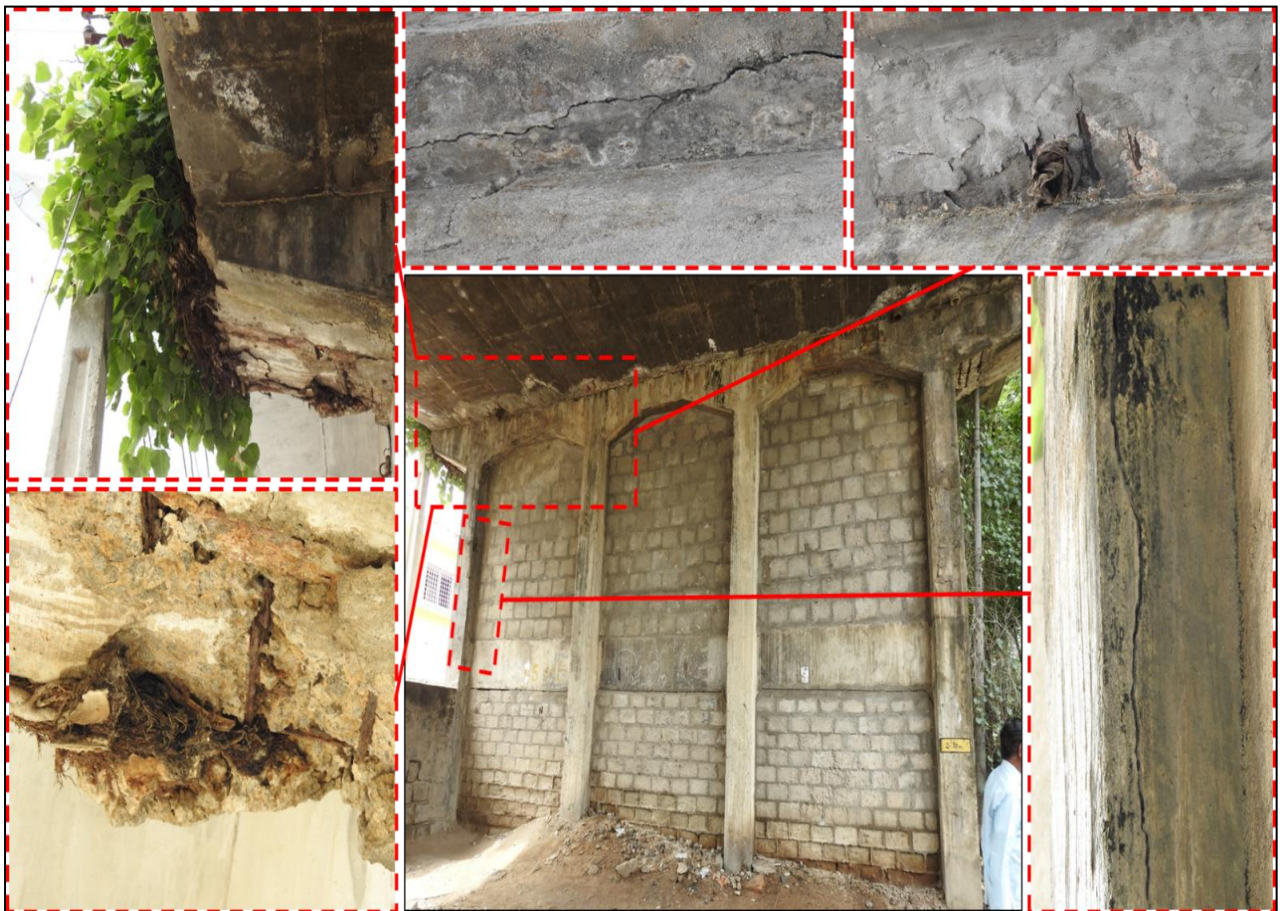
**Fig 5:** Cracks, Vegetation & leaching observed on Pier-1

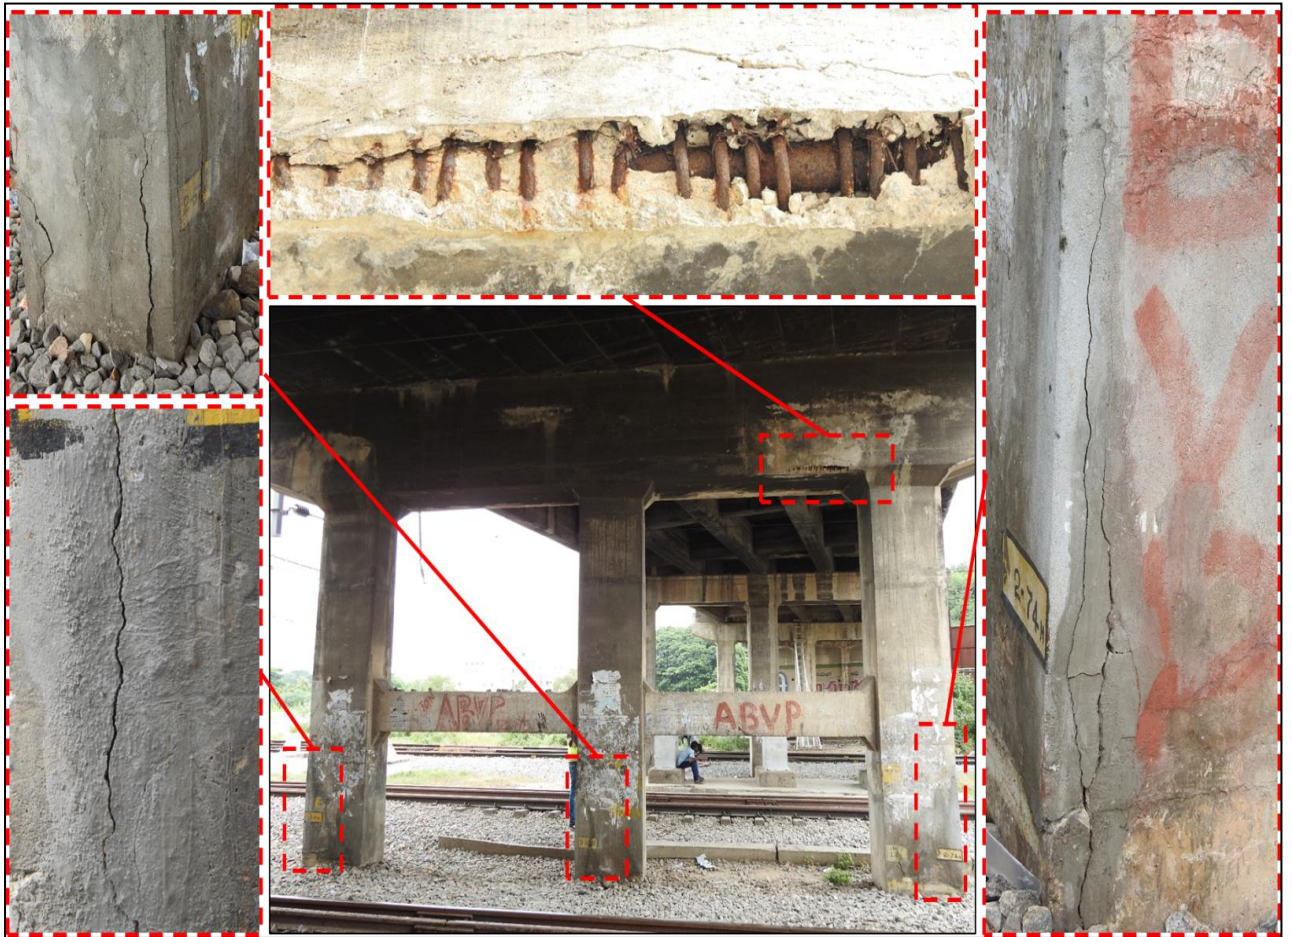
**Fig 6:** Cracks, Spalling & Reinforcement exposure observed in Pier-2

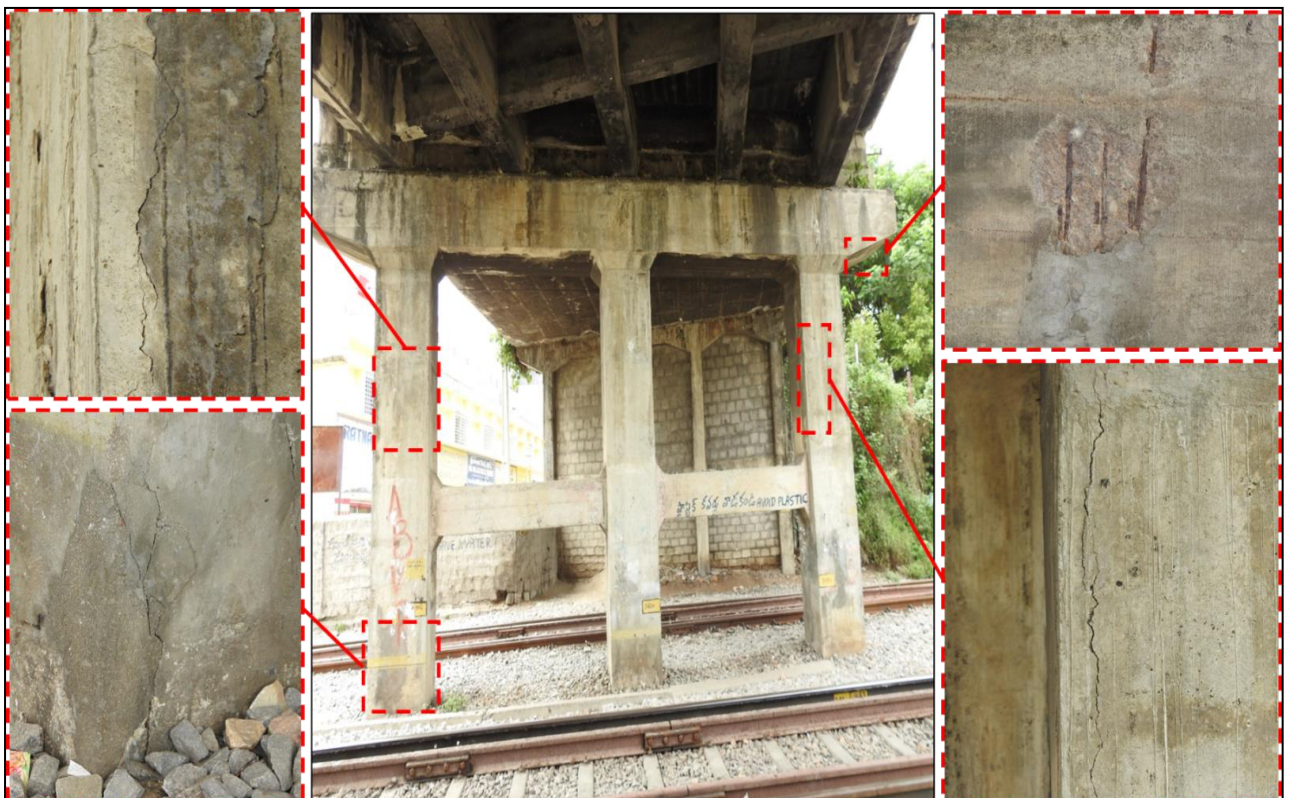
**Fig 7:** Cracks, Spalling & Reinforcement exposure observed in Pier-2

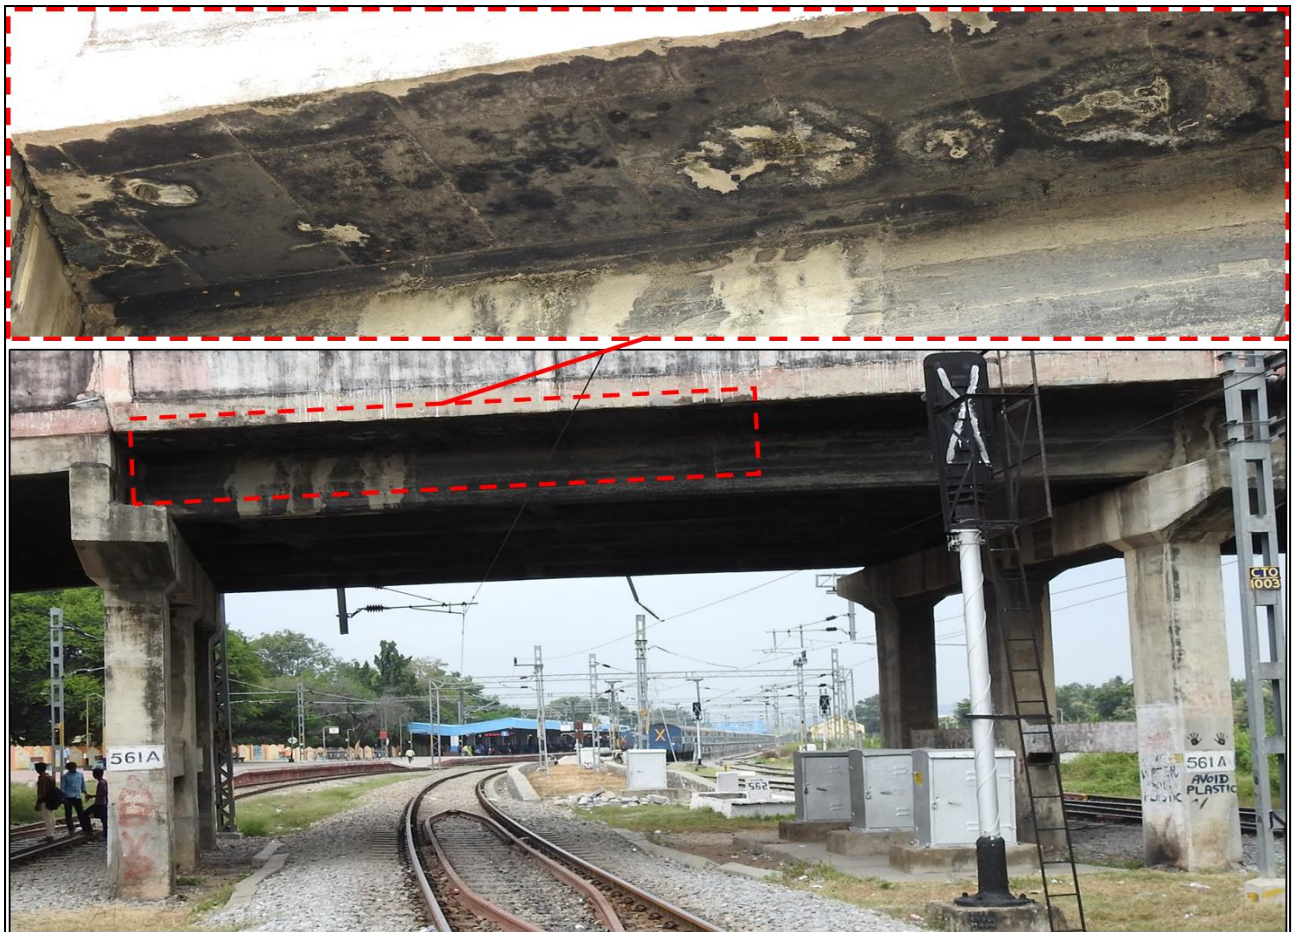
**Fig 8:** Leaching at overhang portion of Slab of Span-2

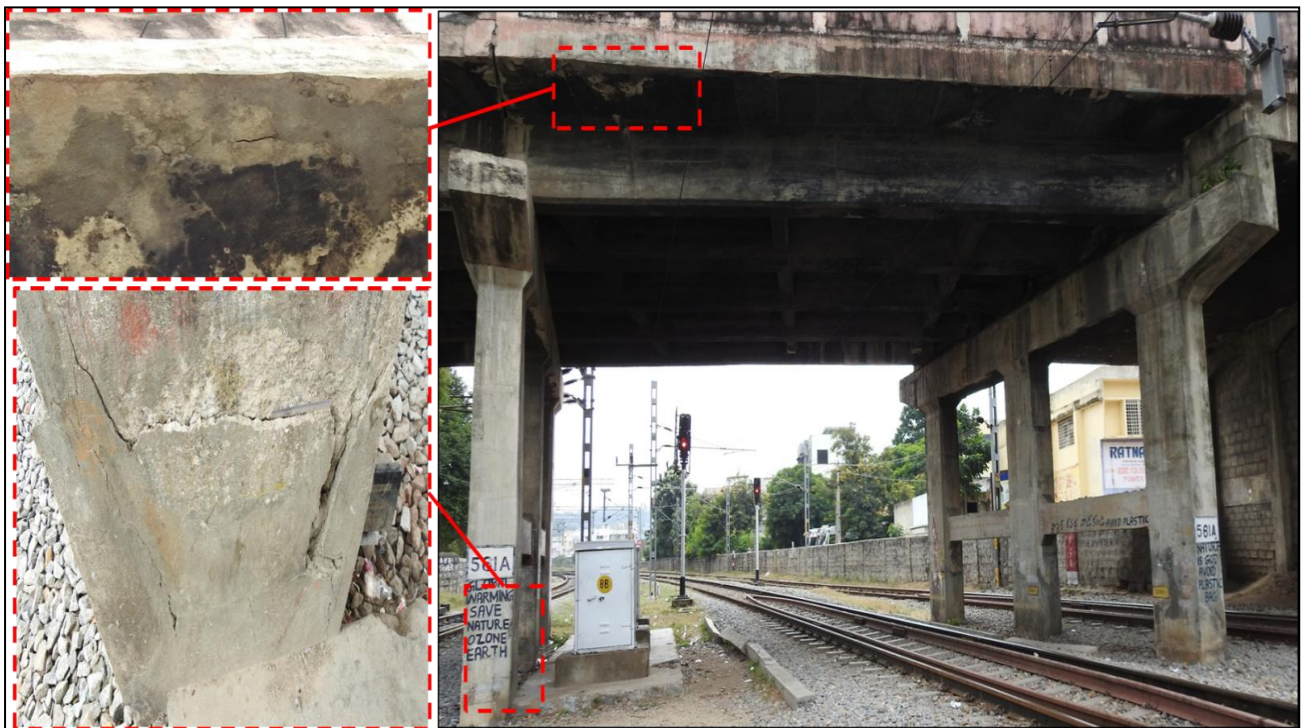
**Fig 9:** Cracks at overhang portion of slab and spalling at Pier-3 column

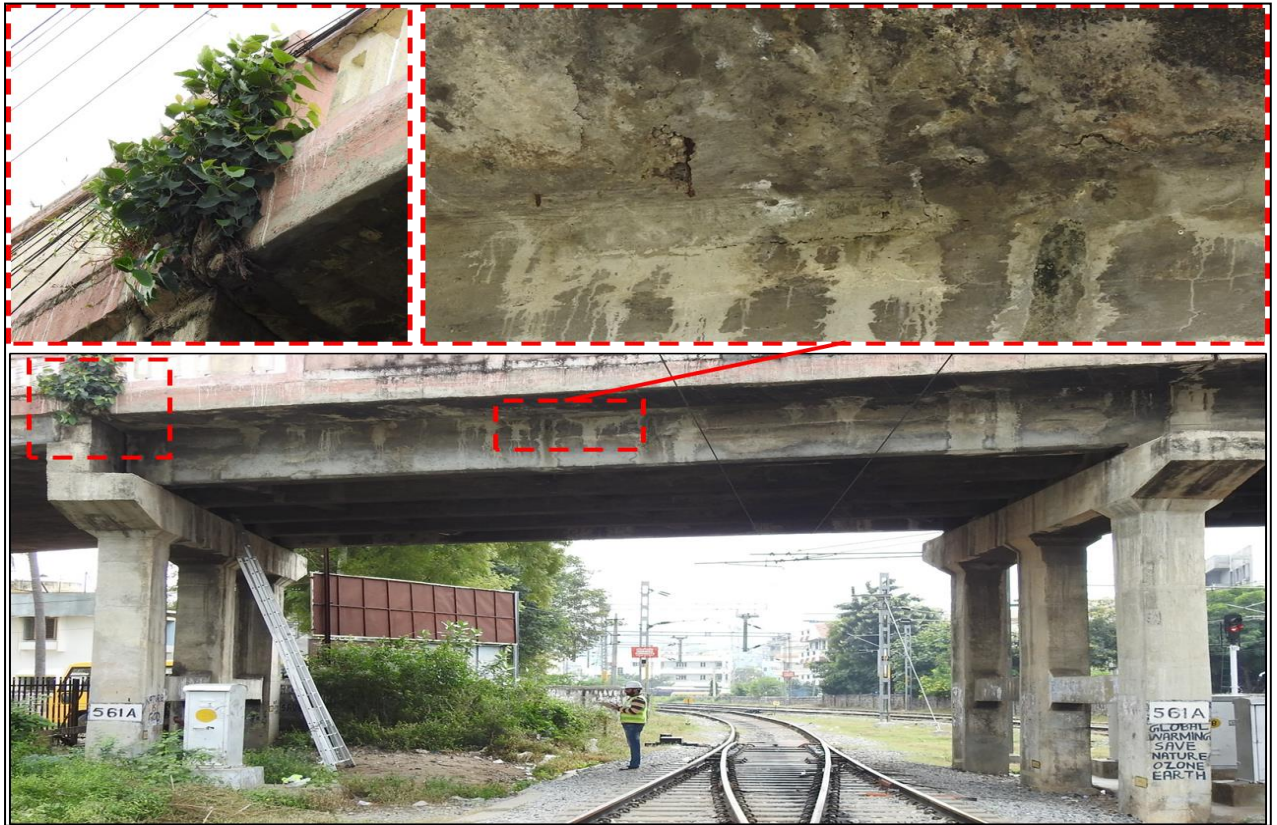
| | Condition of Girder | Distresses Found | Honey combing, Cracks & Spalling has been observed. (Refer Fig:10, 12 & 13) |

**Fig 10:** Vegetation at Expansion joint & Spalling at Girder and Slab of Span-3

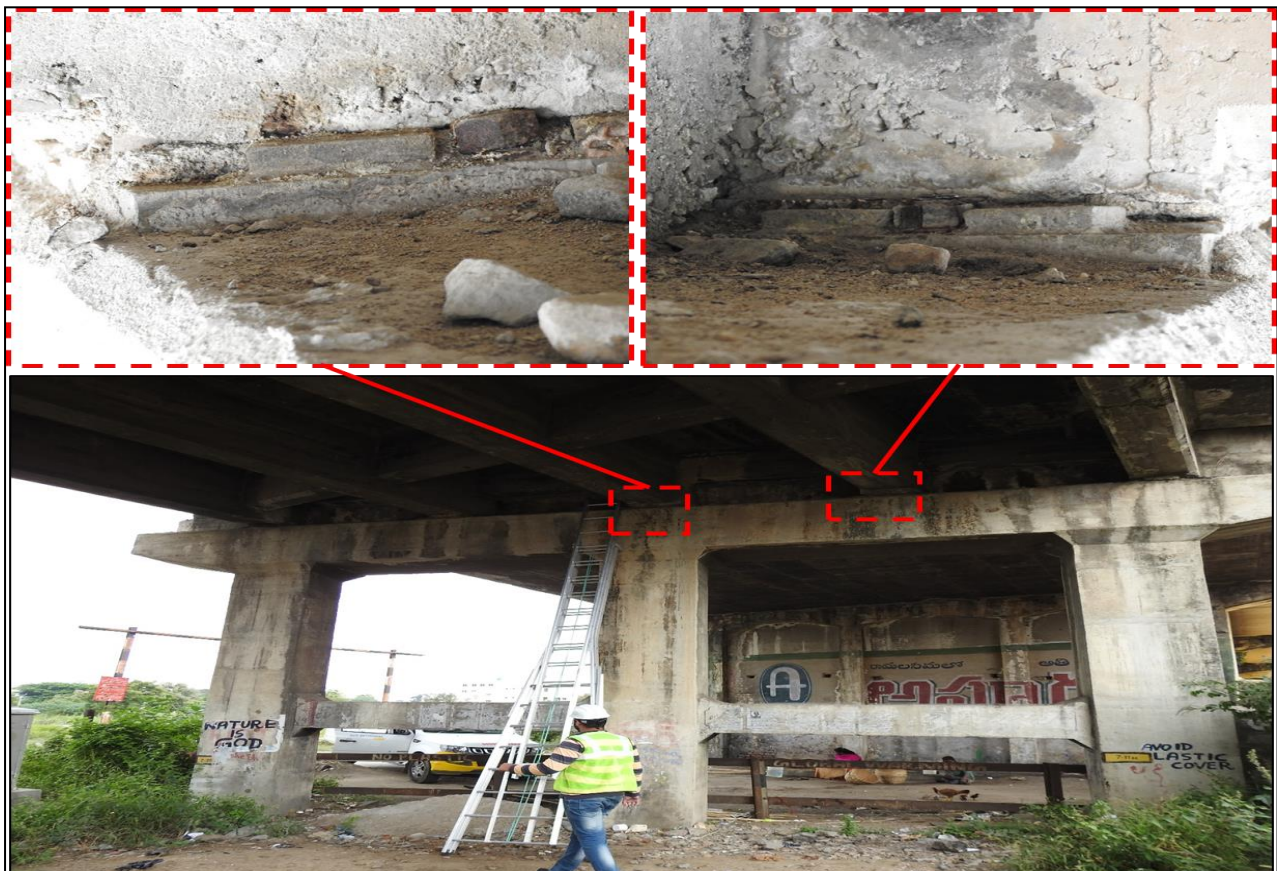
| | General condition<br>(Check Corrosion, cleanliness, seizing of plates silting, accumulations of dirt in case of submersible bridges) | | Debris accumulated at bearings |

**Fig 11:** Debris accumulated at Bearings

- d) Replacement of severely Corroded bars in slab and Shotcreting of the deteriorated concrete
  - e) Clearing of accumulated debris.

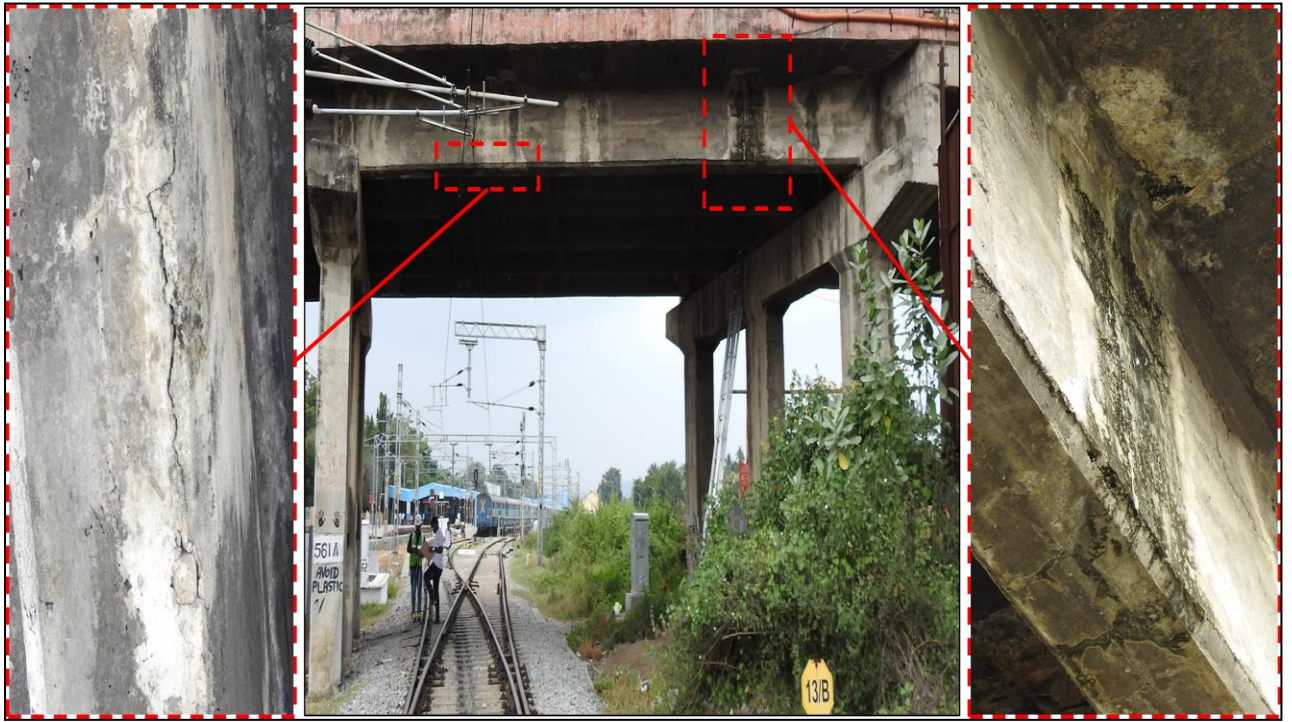
**Fig 12:** Spalling & Seepage observed at Exterior girder of Span-3

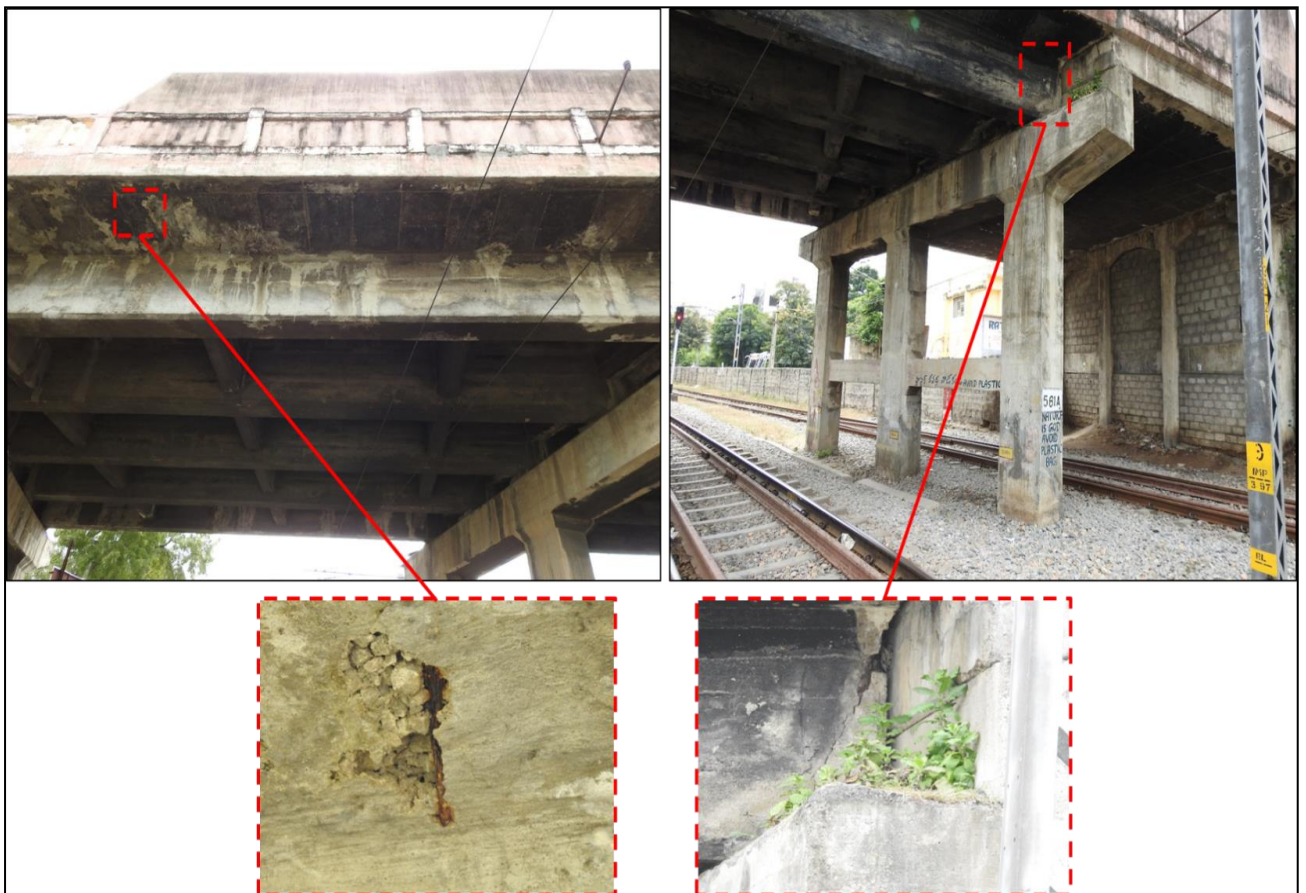
**Fig 13:** Spalling, Vegetation & Reinforcement exposure at Girder & Slab

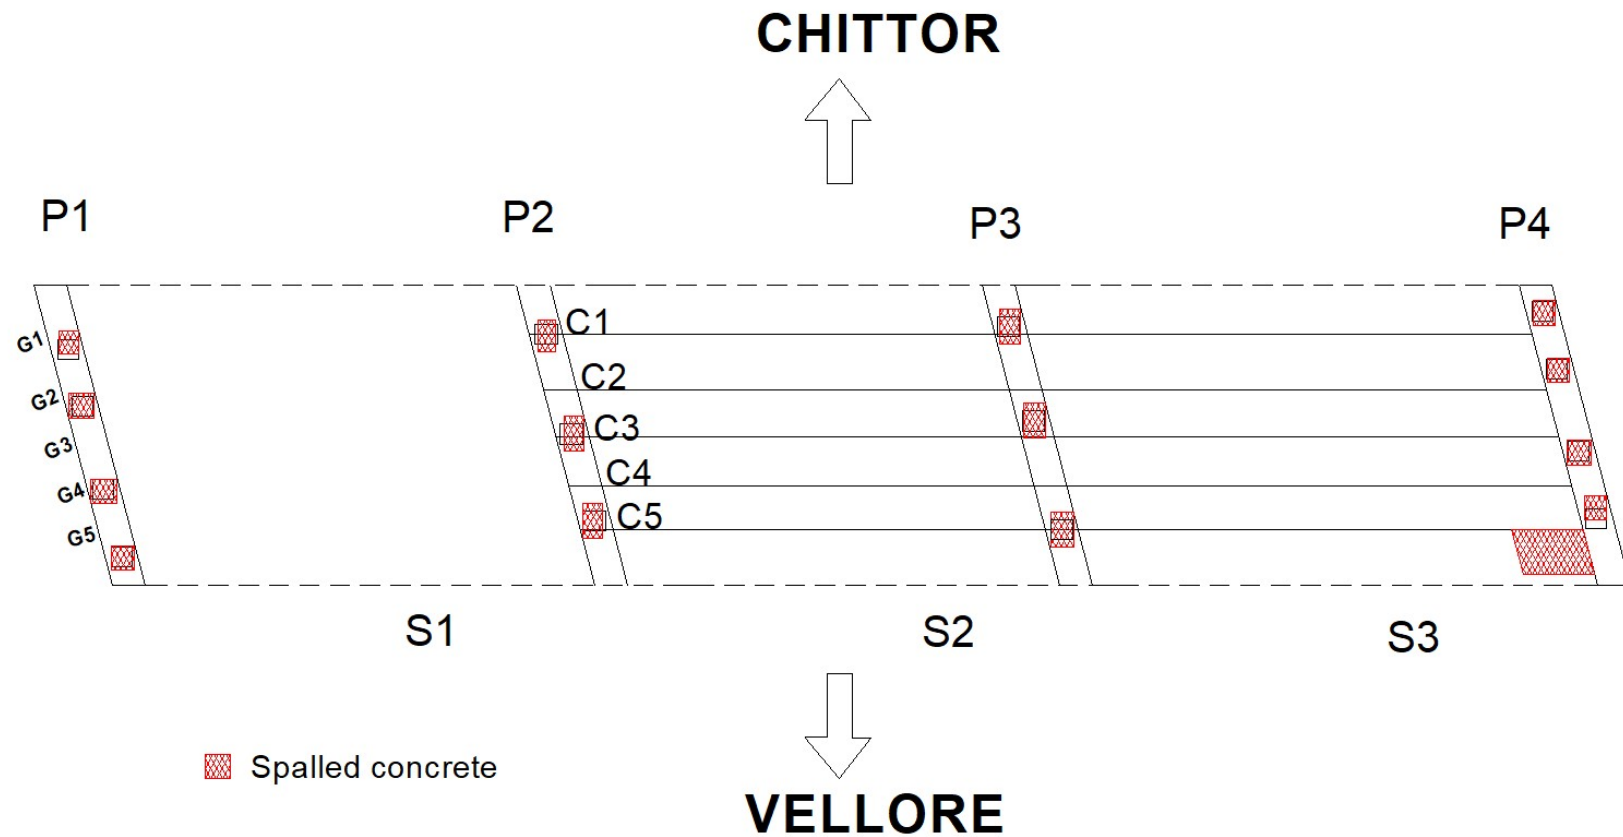
**Fig: 18** Bottom view of ROB with damaged locations

The detailed visual observation of ROB, the following observations are made. Major Spalling and Reinforcement exposure are observed at Deck slab and piers as shown in the above figure, Corrosion is seen in the exposed rebars of the Slab, Major Structural cracks are observed at almost all the columns of the pier.

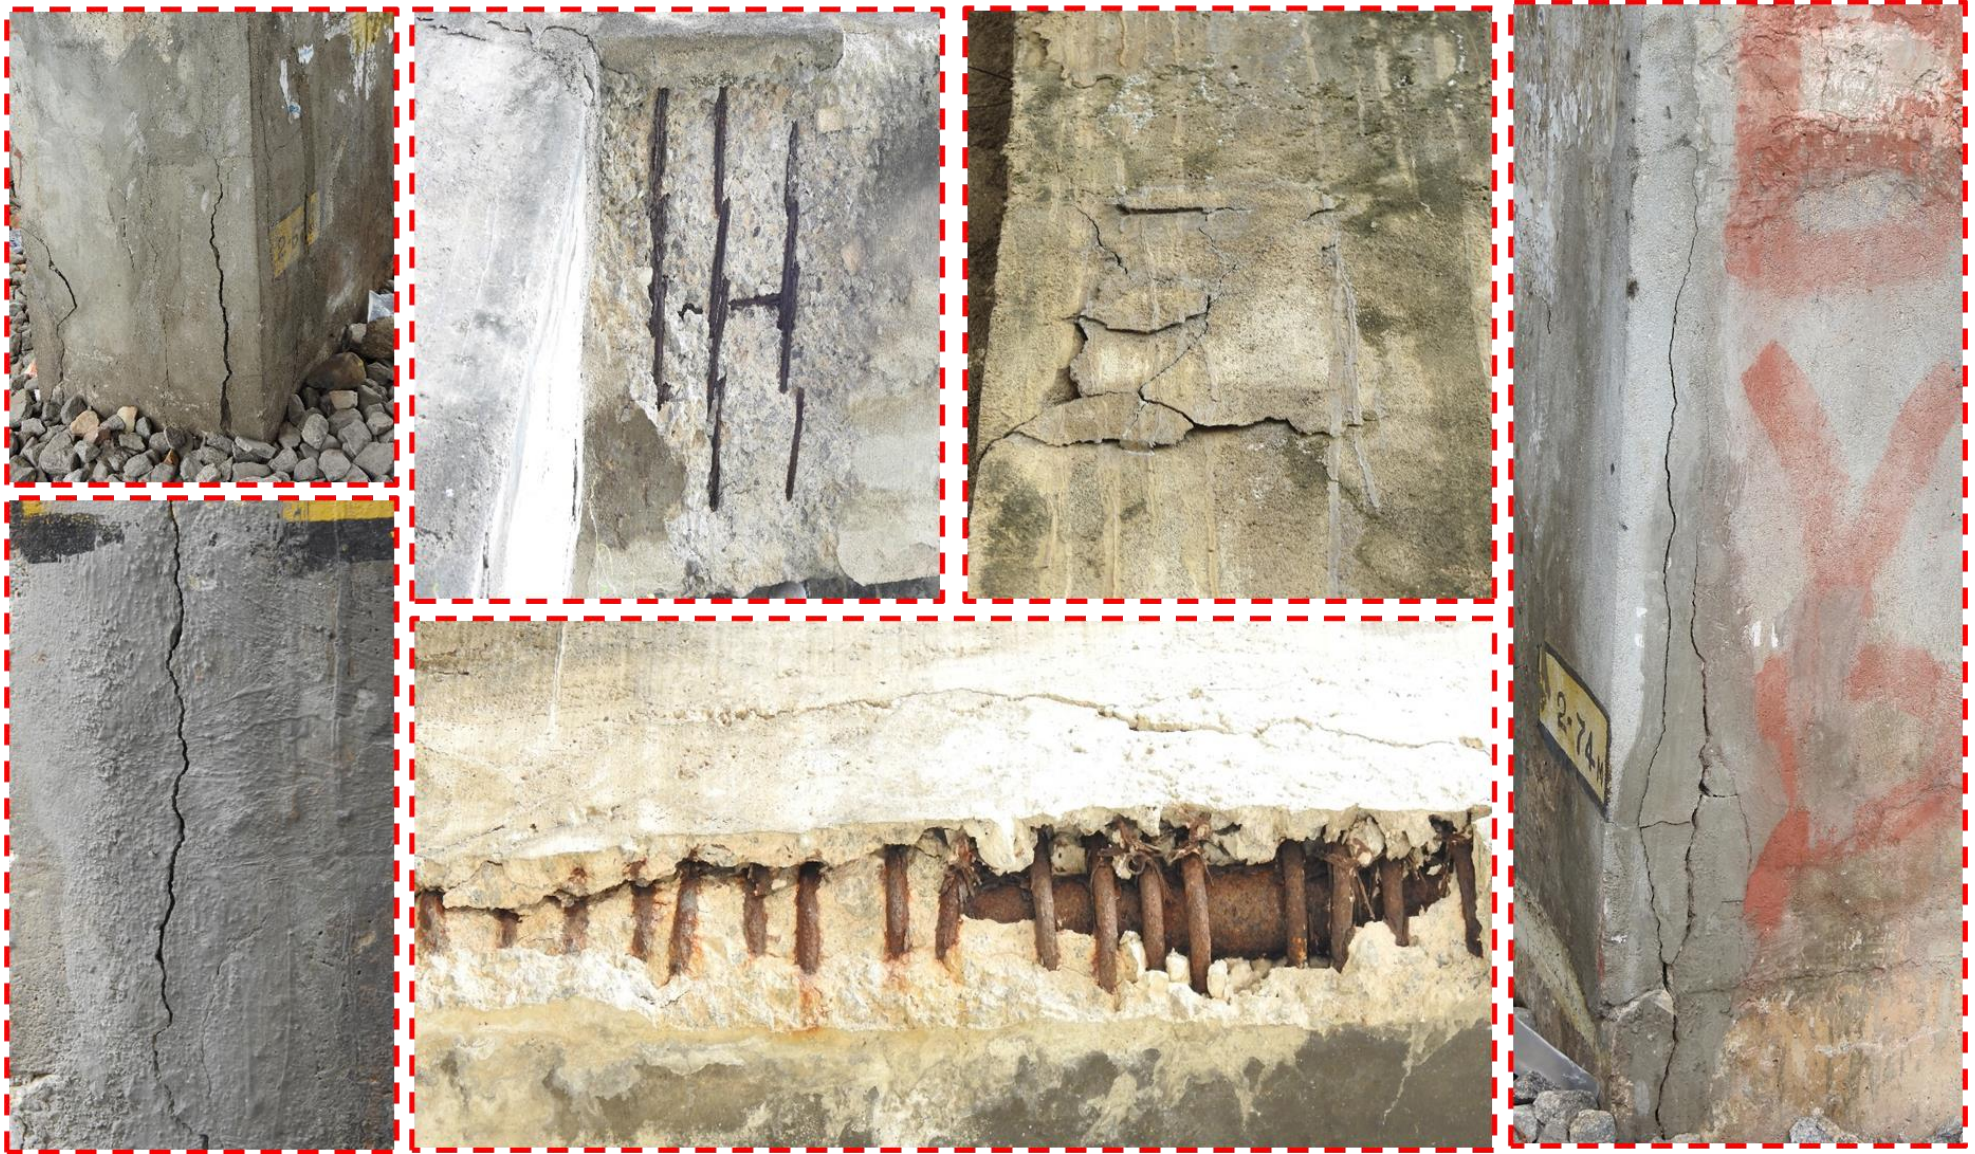
**Fig: 19** Major Cracks at Columns and Reinforcement exposure.

- c) Half-cell potential test shows that the Rebar is in Intermediate risk of Corrosion.
  - d) Crack width test shows that the observed cracks at Pier columns are major structural cracks (>0.3mm)
