# Third Party Audit of ROB's and FOB's Of SCR

INSPECTION OF ROB NO.295A NEAR KOMMALAPUDI RAILWAY STATION

**Final Report**  
SEPTEMBER | 2020

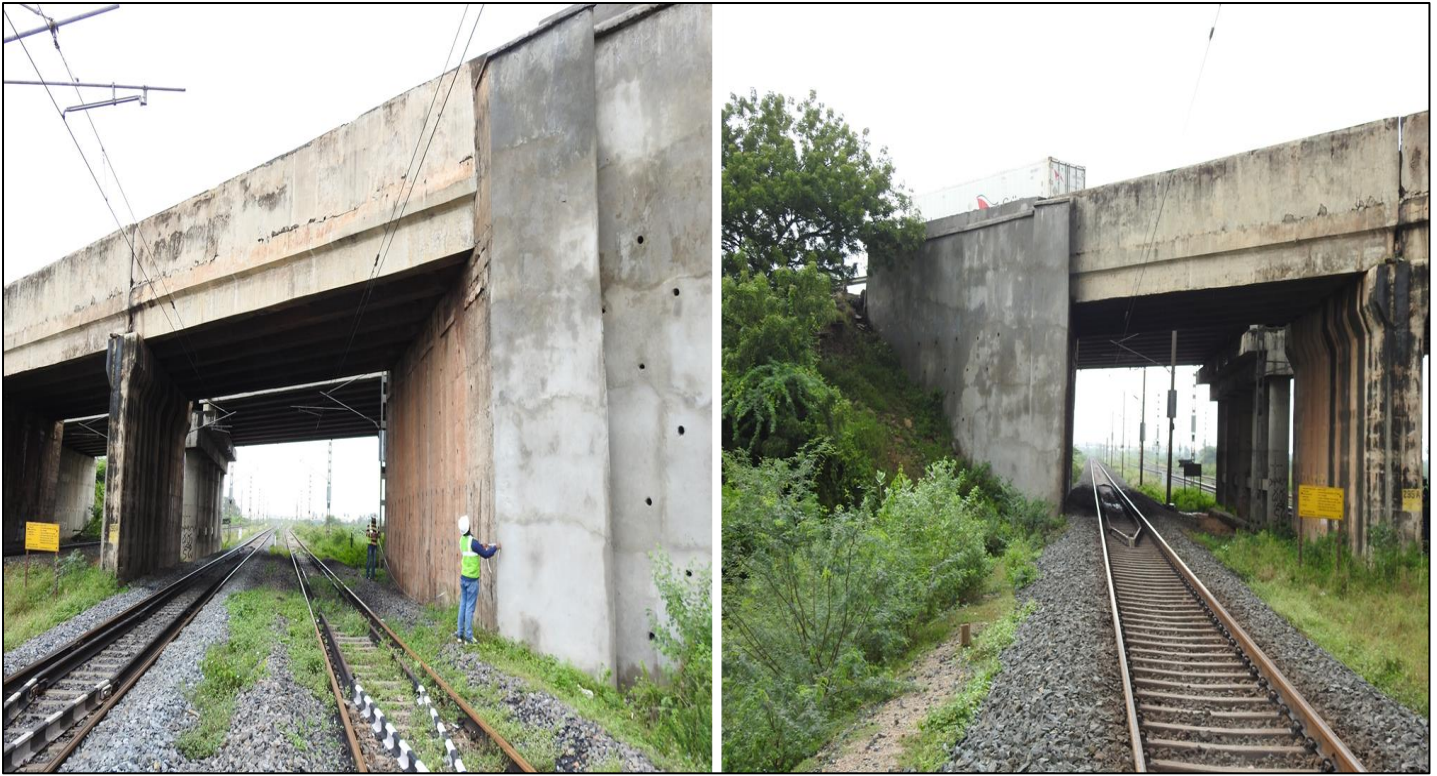
**Fig: 2** View of Abutments (A1 and A2)

| PART 1.2 STRUCTURAL SYSTEM OF THE BRIDGE | | | |
|---|---|---|---|
| | Condition (Crack, Settlement, Scour, Tilting, Steel Corrosion, Strains, and other damages etc...) | | Cracks, Spalling, Honeycombing, Reinforcement exposure are observed at Abutment |

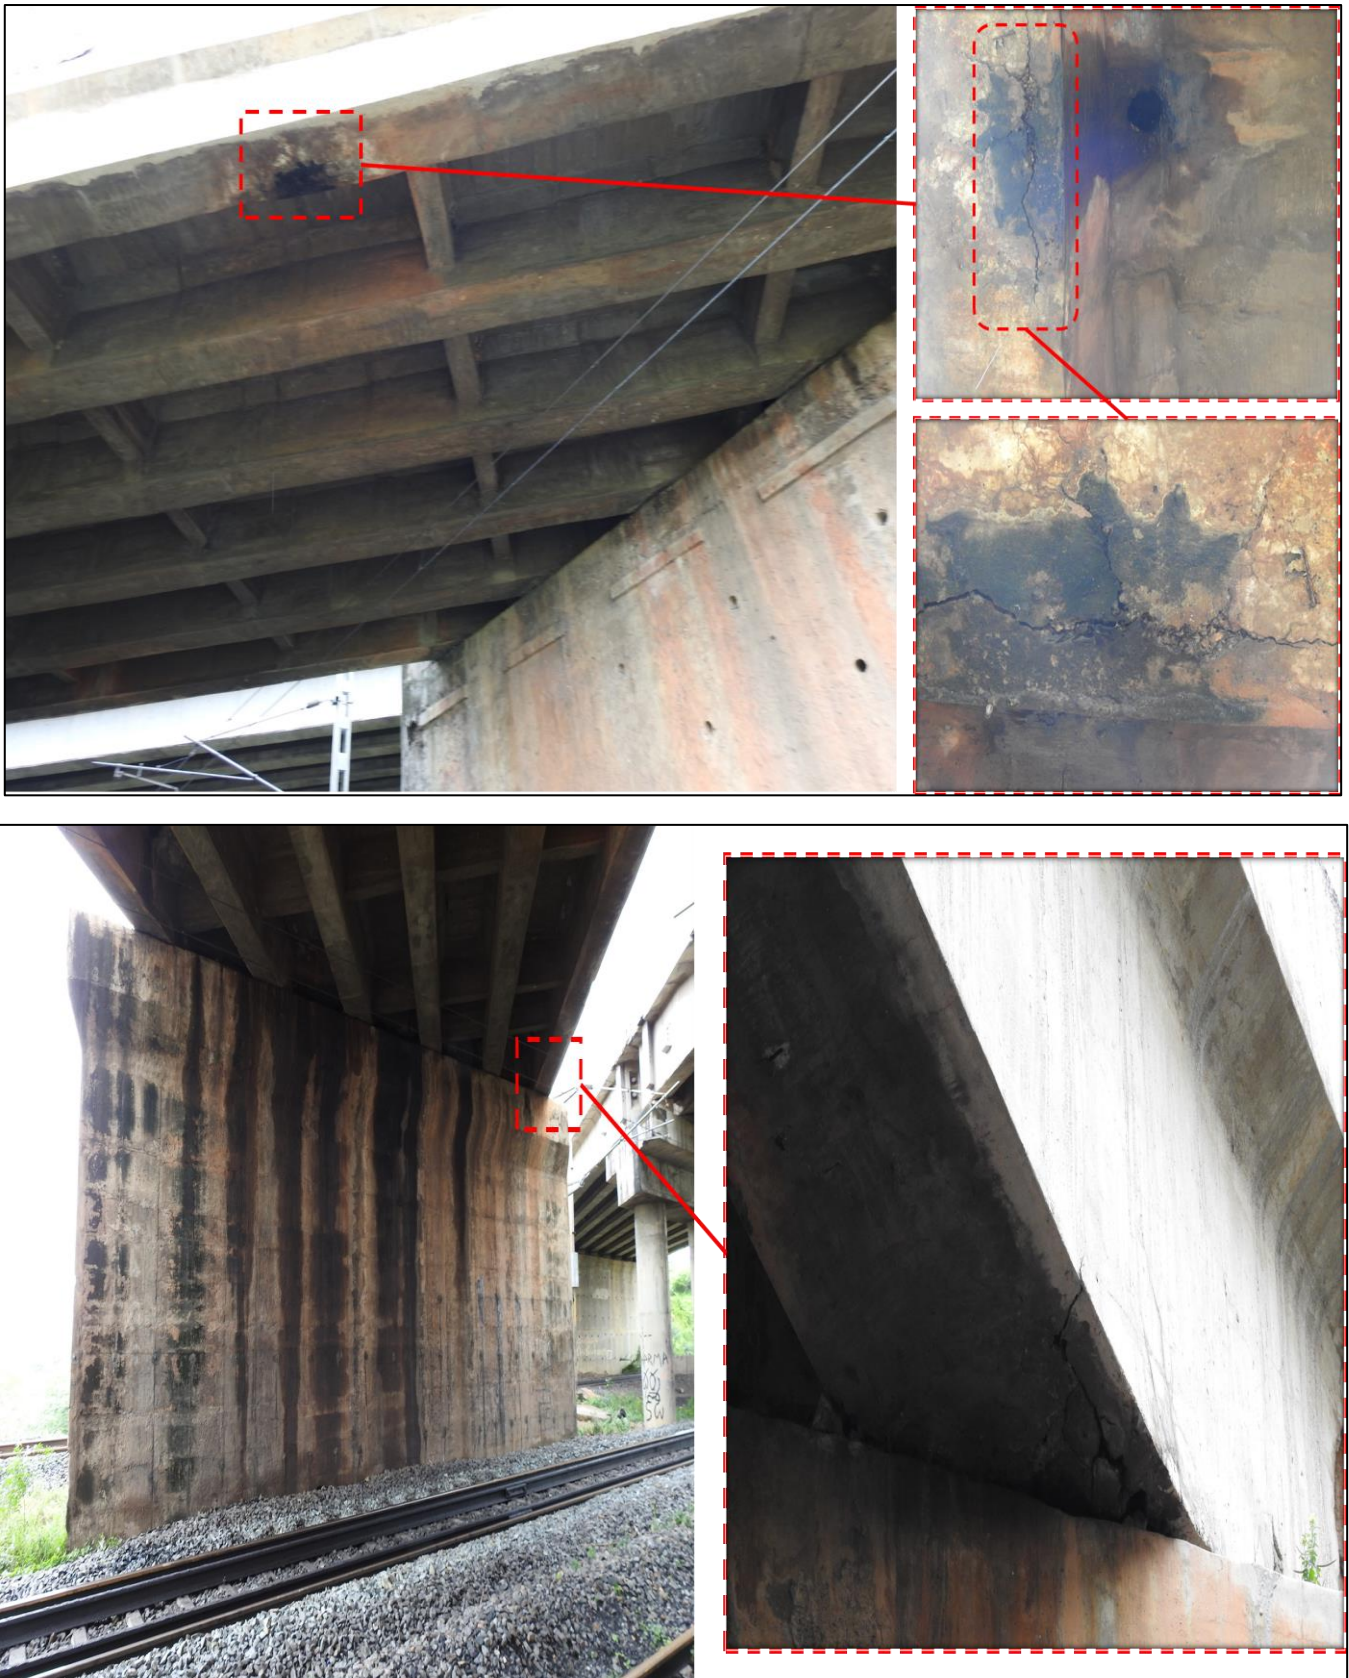
| | Condition of Girder | Distresses Found | Cracks, Spalling, Reinforcement exposure has been observed <b>(Refer Fig-4 &amp; 5)</b> |

**Fig 4:** Cracks observed in Exterior girder

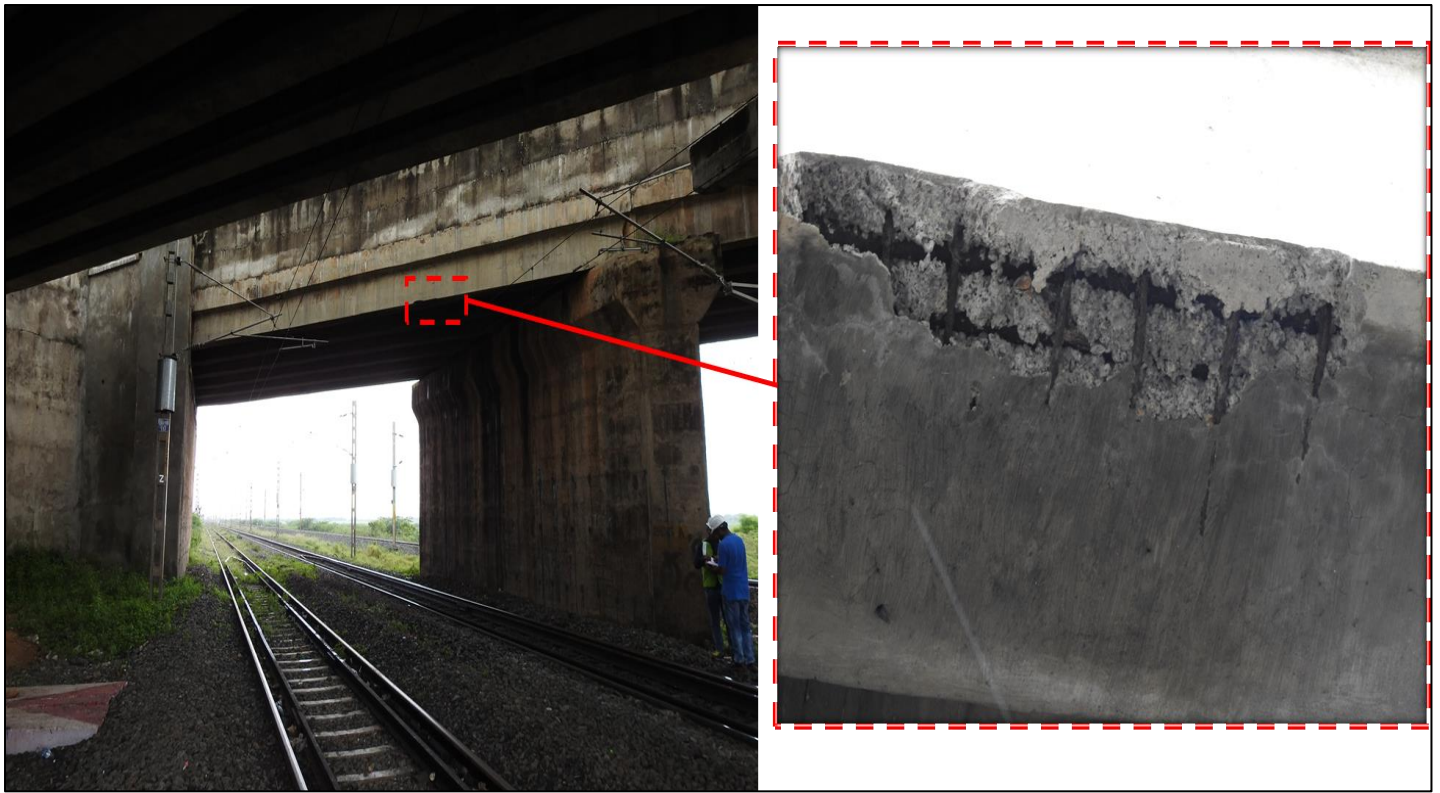
**Fig 5:** Reinforcement exposed in exterior girder

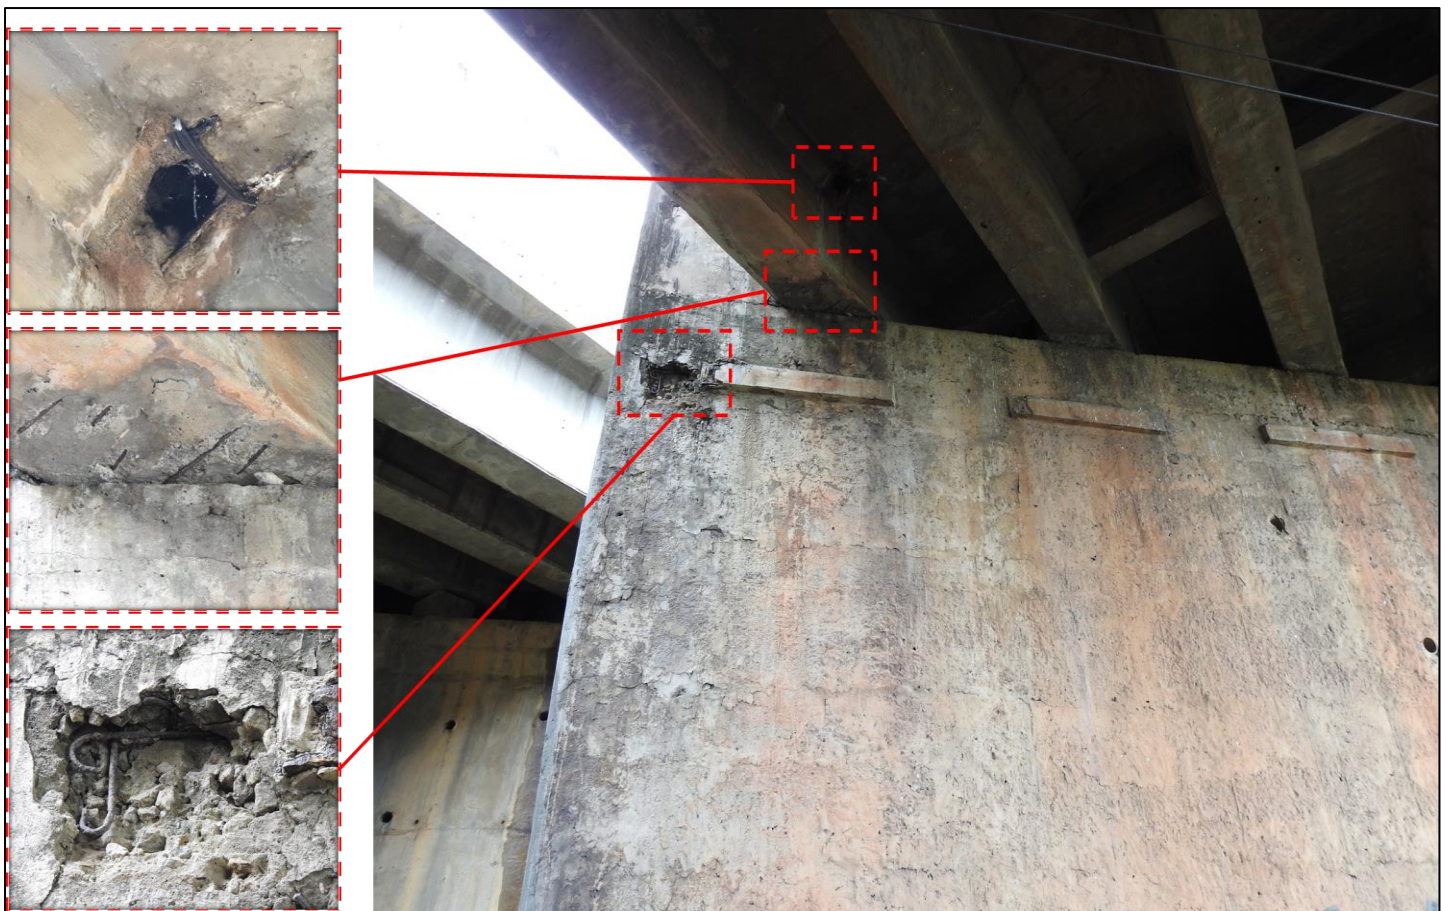
**Fig 6:** Reinforcement exposed in exterior girder, pier and slab at drainage spout

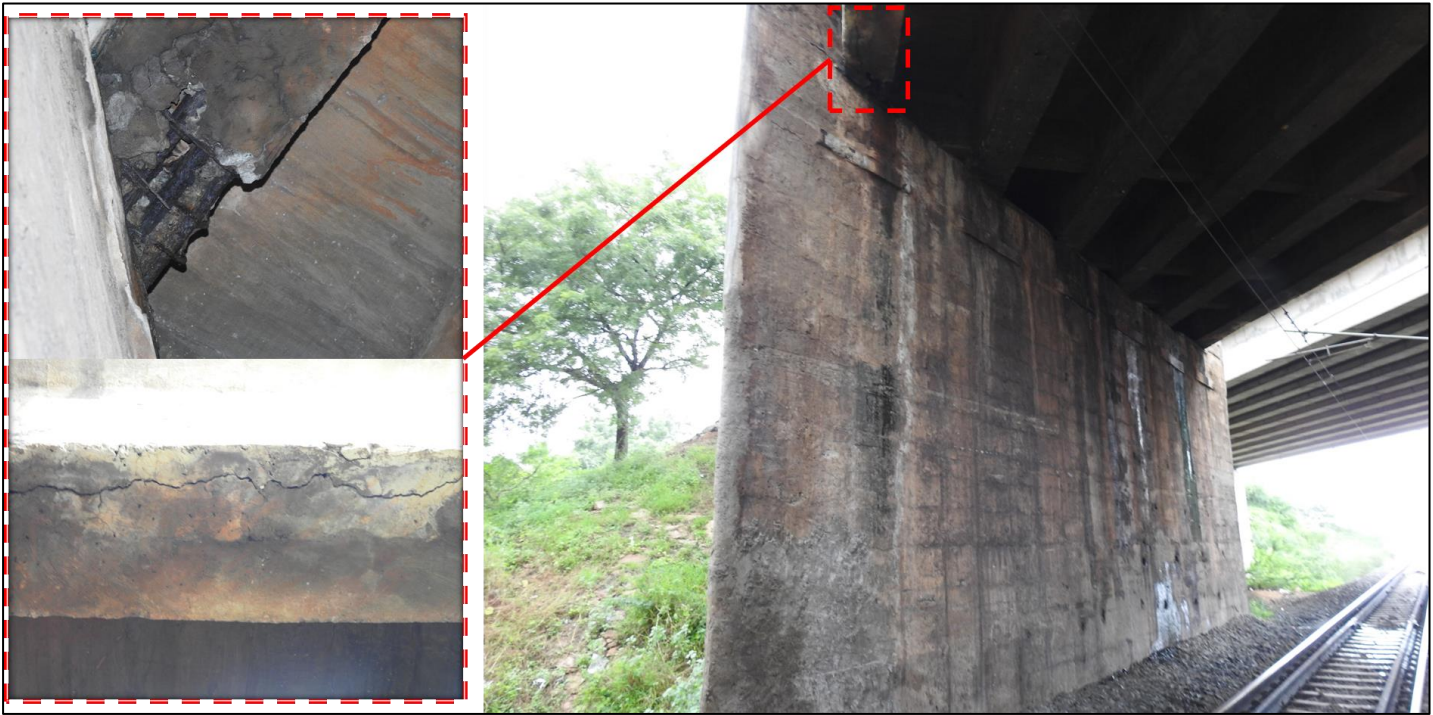
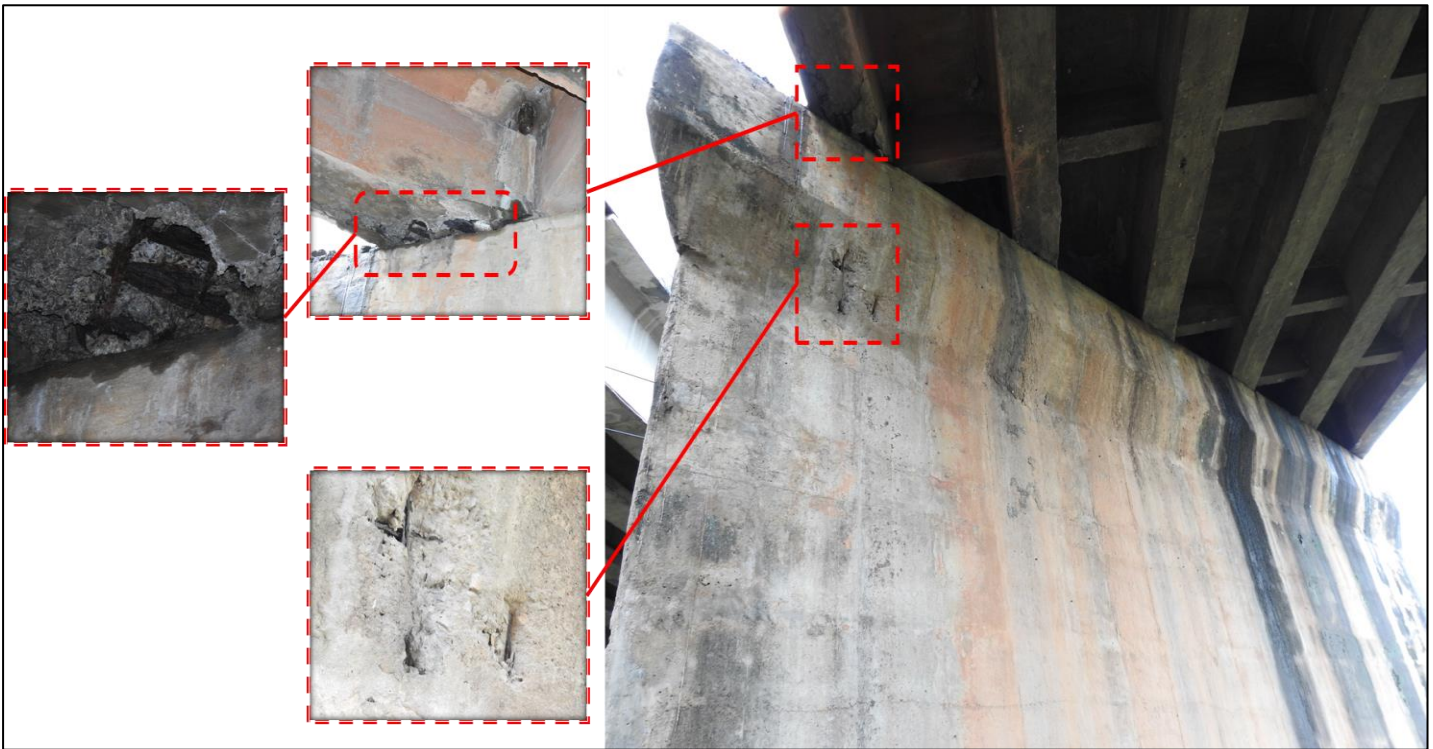
**Fig 7:** Reinforcement exposed, Leaching and cracks at girder end and Pier haunch

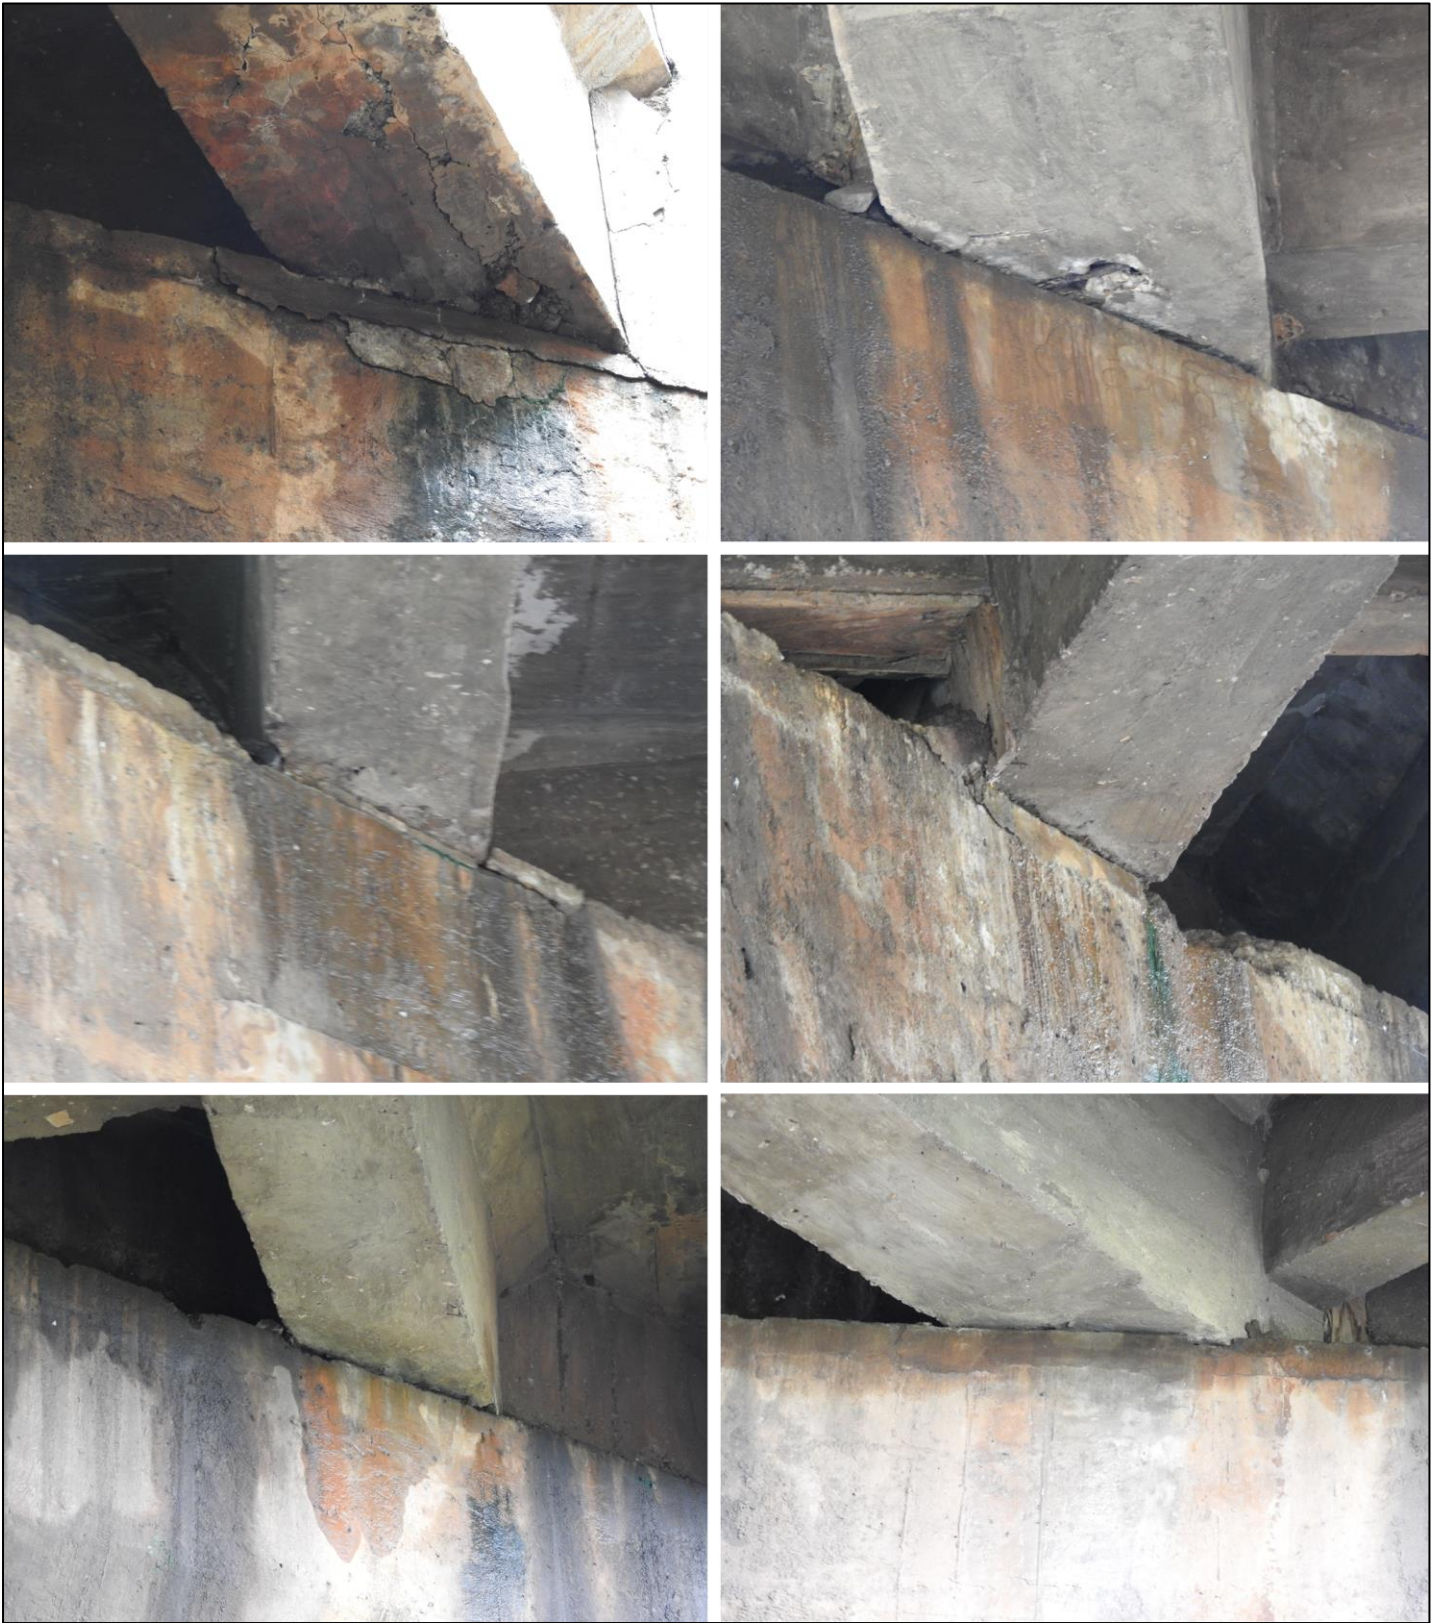
**Fig 8:** Distresses observed at Bearings

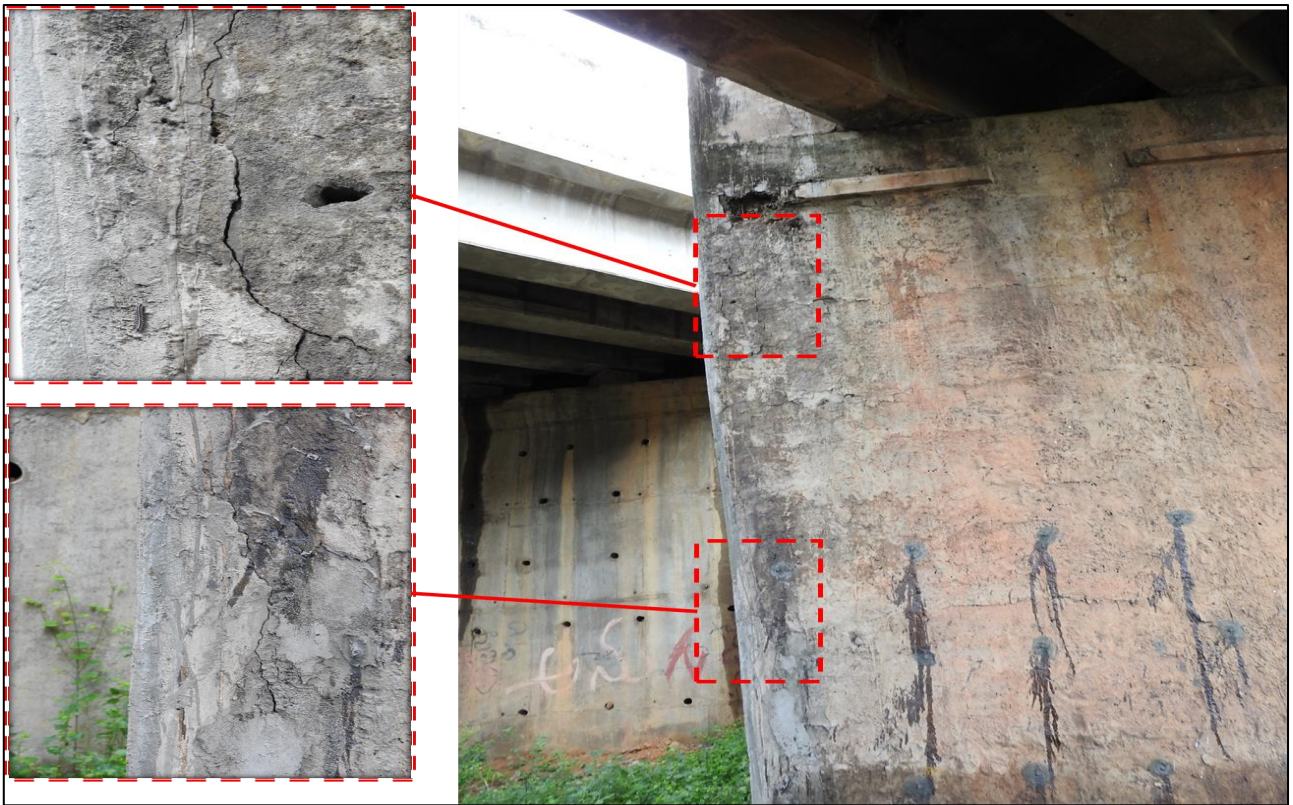
| PART 1.2 STRUCTURAL SYSTEM OF THE BRIDGE | | | |
|---|---|---|---|
| | Type (Shape) | Wall | Cracks, Spalling, Reinforcement exposure has been observed on Pier. |

**Fig 9:** Cracks observed on pier

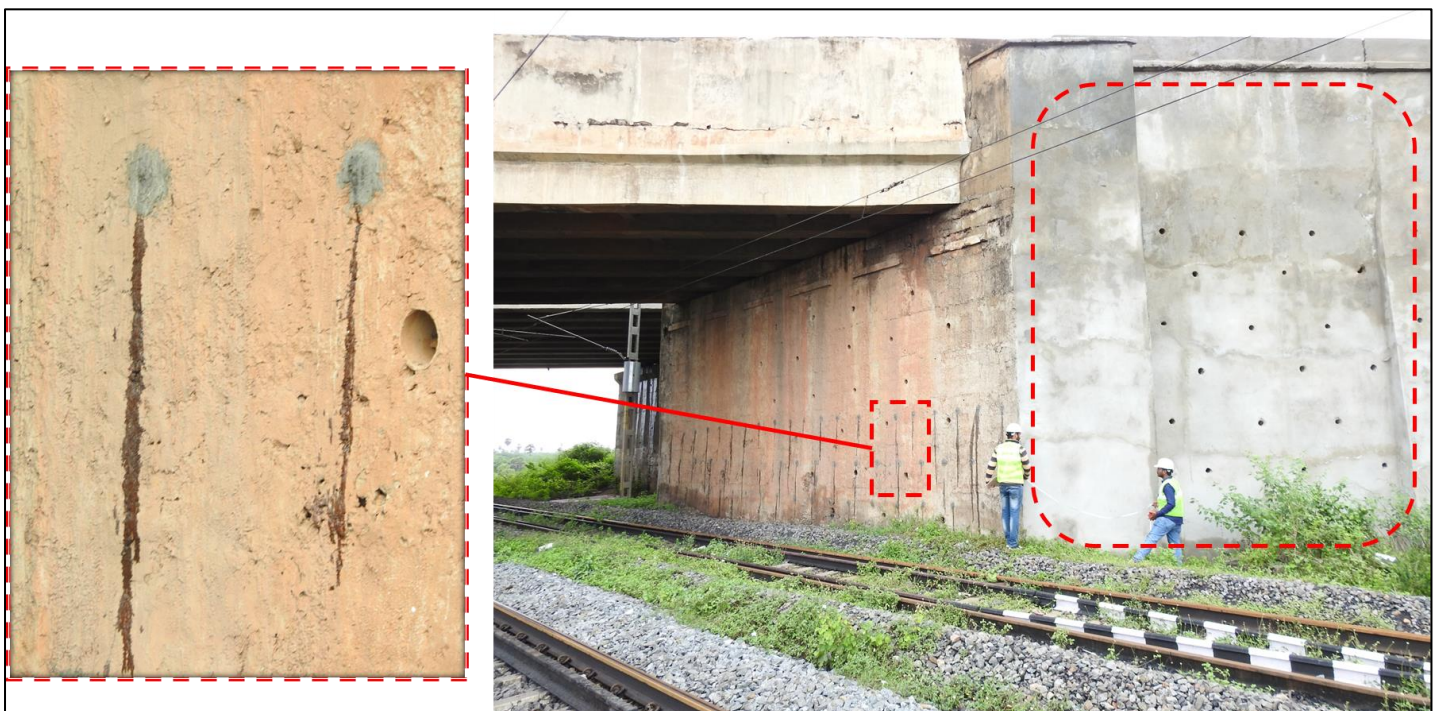
**Fig 10:** Epoxy grouting on Abutment & newly constructed retaining wall

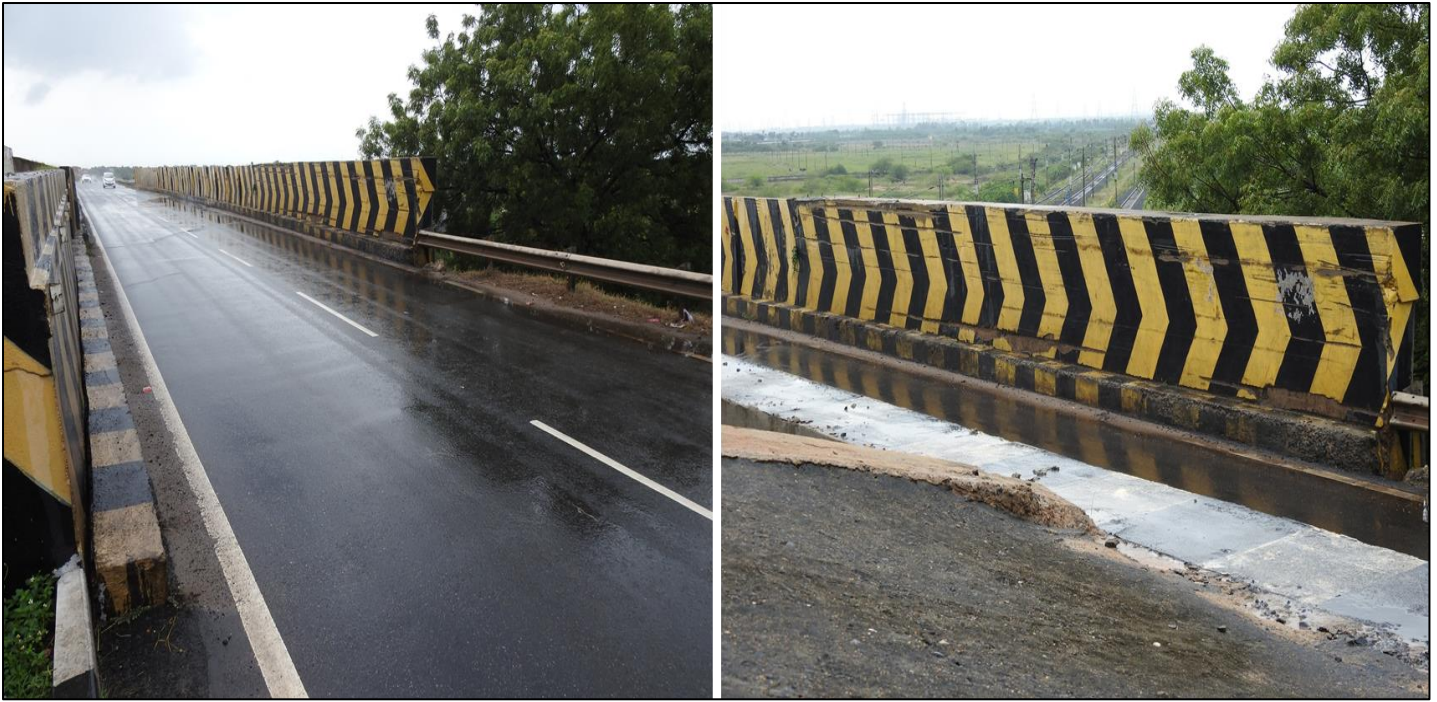
| | Condition of Wall/Railing | | Accidental hit marks are observed on Crash Barrier as Bridge is Narrow <b>(Refer Fig-11)</b> |

***Fig 11:*** Wearing Coat condition & Accidental hitting marks on Crash Barrier.

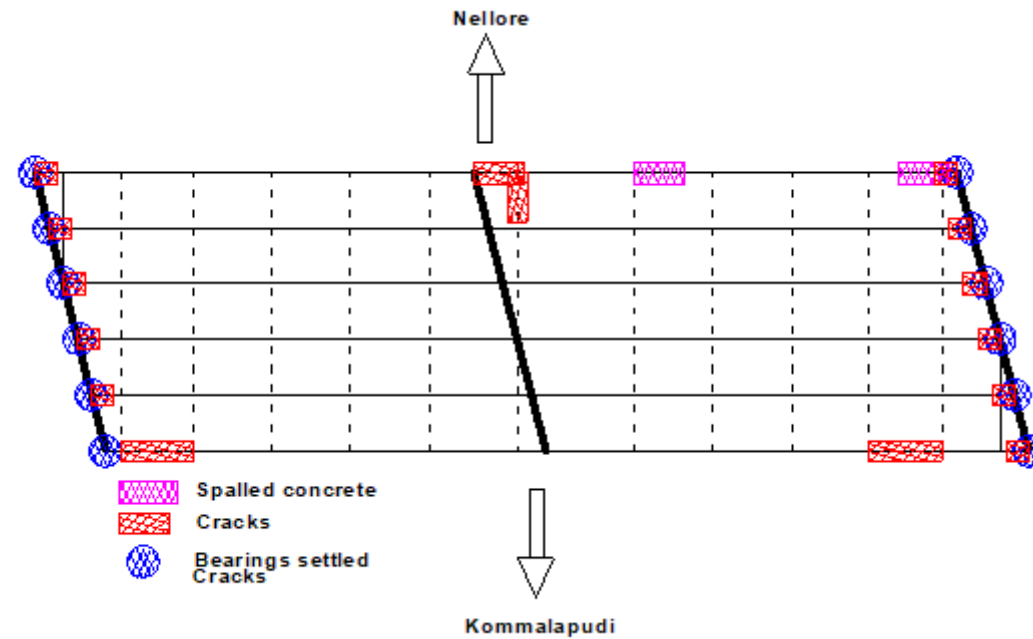
**Fig: 12** Bottom view of ROB with damaged locations

The detailed visual observation of ROB, the following observations are made spalling of concrete and cracks observed and bearings are setteled.(Refer **fig 4,5,6,7,8**)

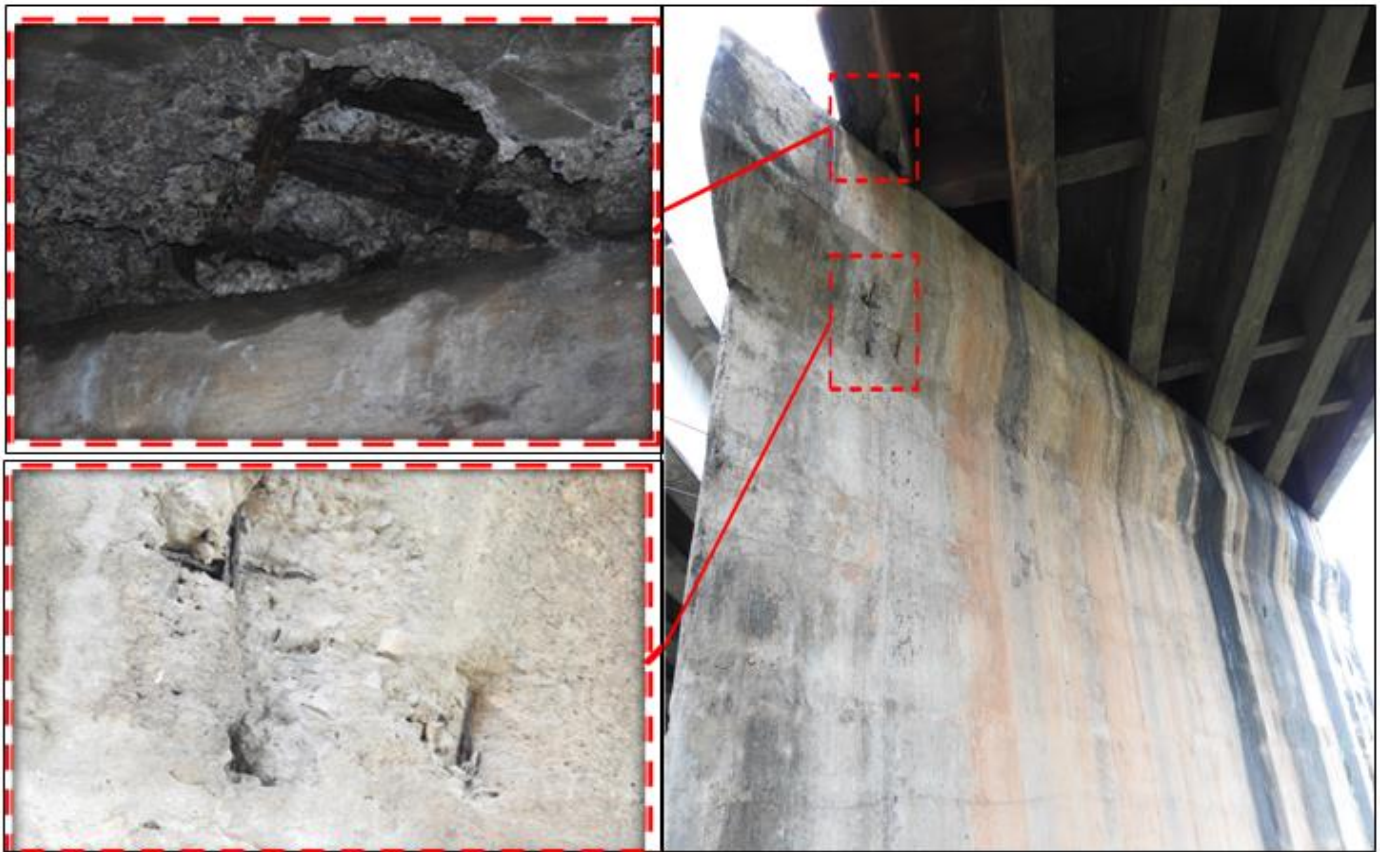
**Fig 13:** Reinforcement exposed at girder end and Pier haunch

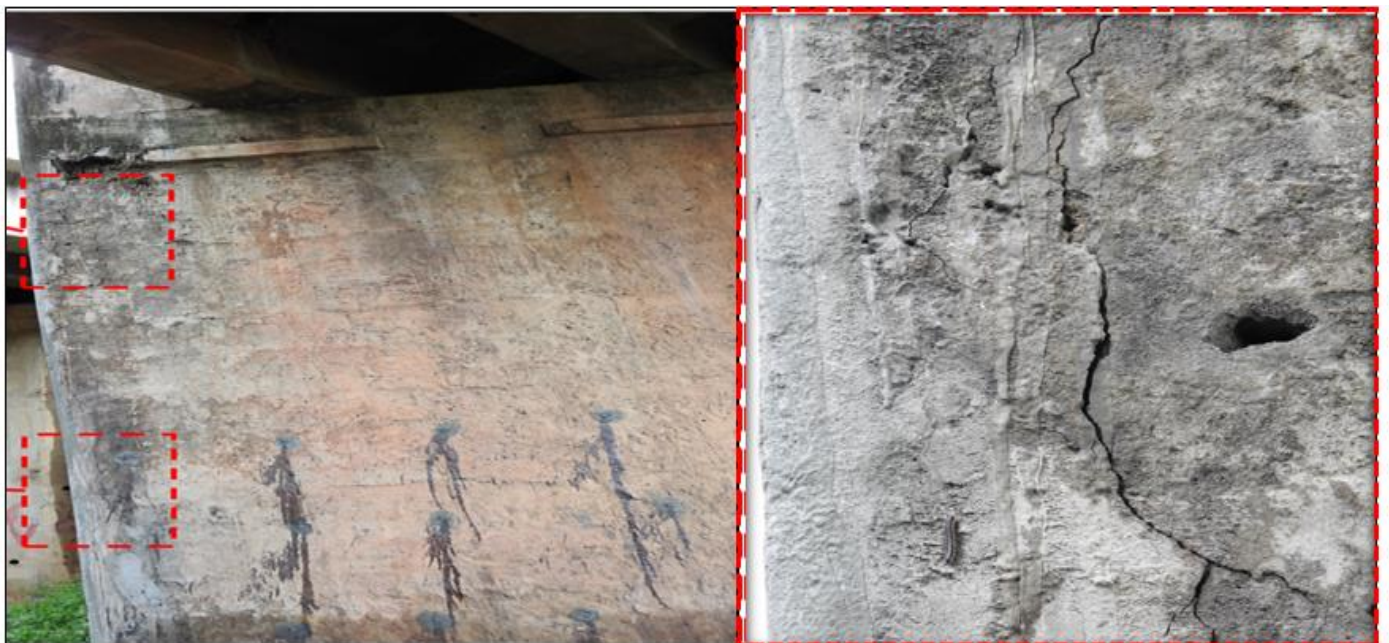
**Fig 14:** cracks observed at Abutment.

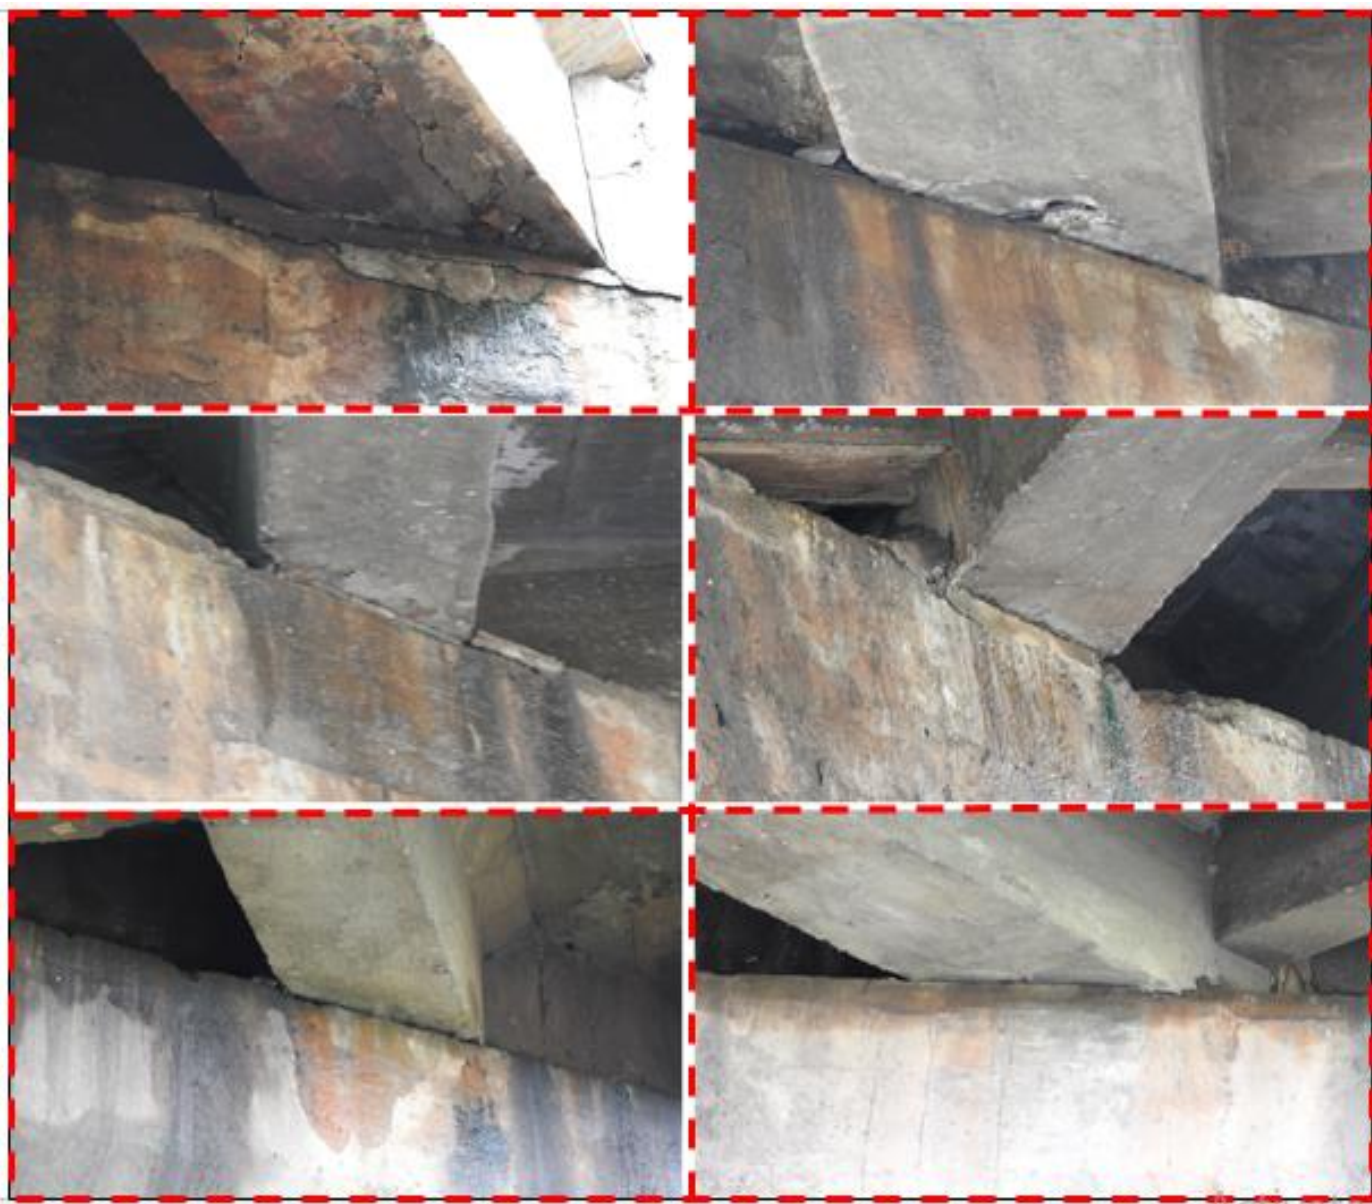
***Fig 15:*** Bearings settled.

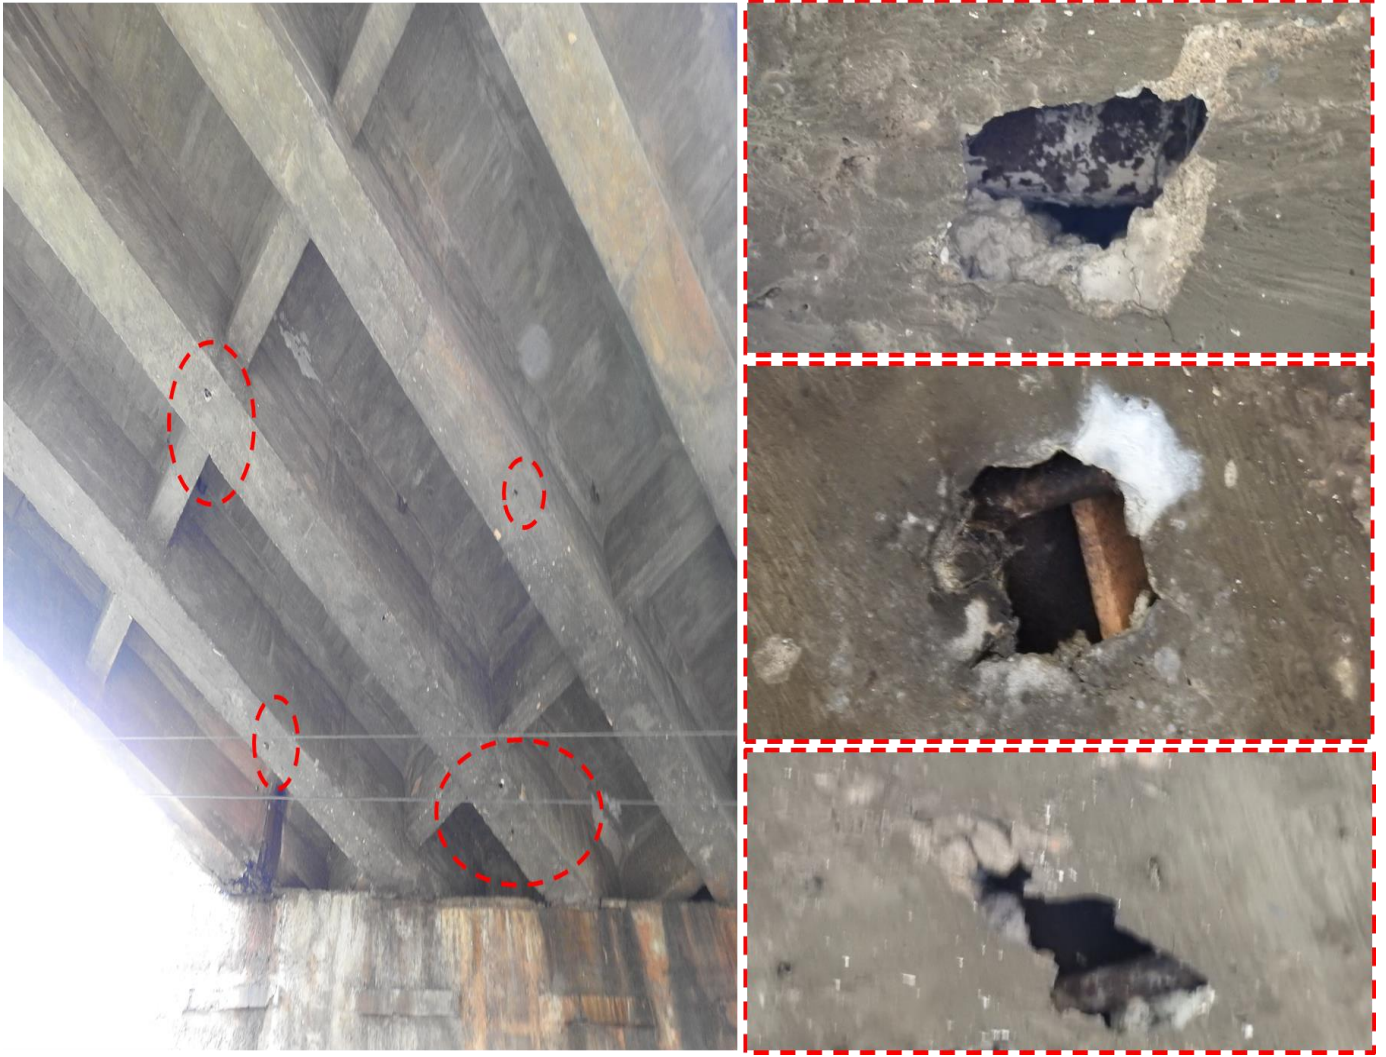
**Fig 16:** Minor spalled concrete holes on main girder.
