# Third Party Audit of ROB's and FOB's Of SCR

**INSPECTION OF ROB NO. 660A NEAR TENALI RAILWAY STATION**

**Final Report**  
**SEPTEMBER | 2020**

**Name of the Project** : VISUAL INSPECTION OF ROB 660A  
**Location** : NEAR TENALI RAILWAY STATION (396/12-15)  
**Location Co-ordinates** : 16°14'18.0"N 80°38'29.3"E  
**Date of Inspection** : 29th NOVEMBER, 2019  
**Date of NDT** : 31<sup>st</sup> Aug 2020

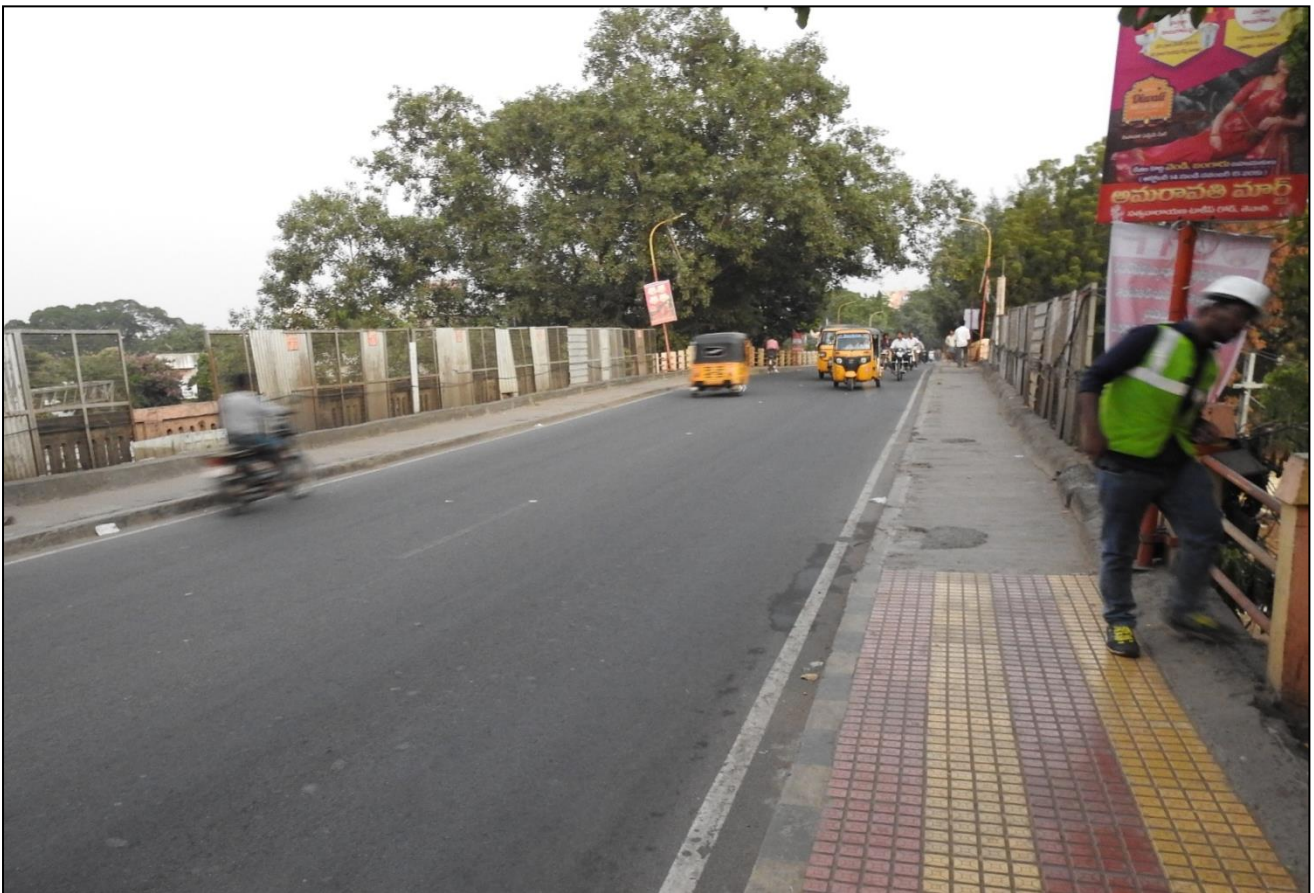
| | Condition of Flooring/Wearing Coat | Fair | <b>(Refer Fig: 3)</b> |

**Fig: 3** Top view of the Bridge / Condition of Wearing coat

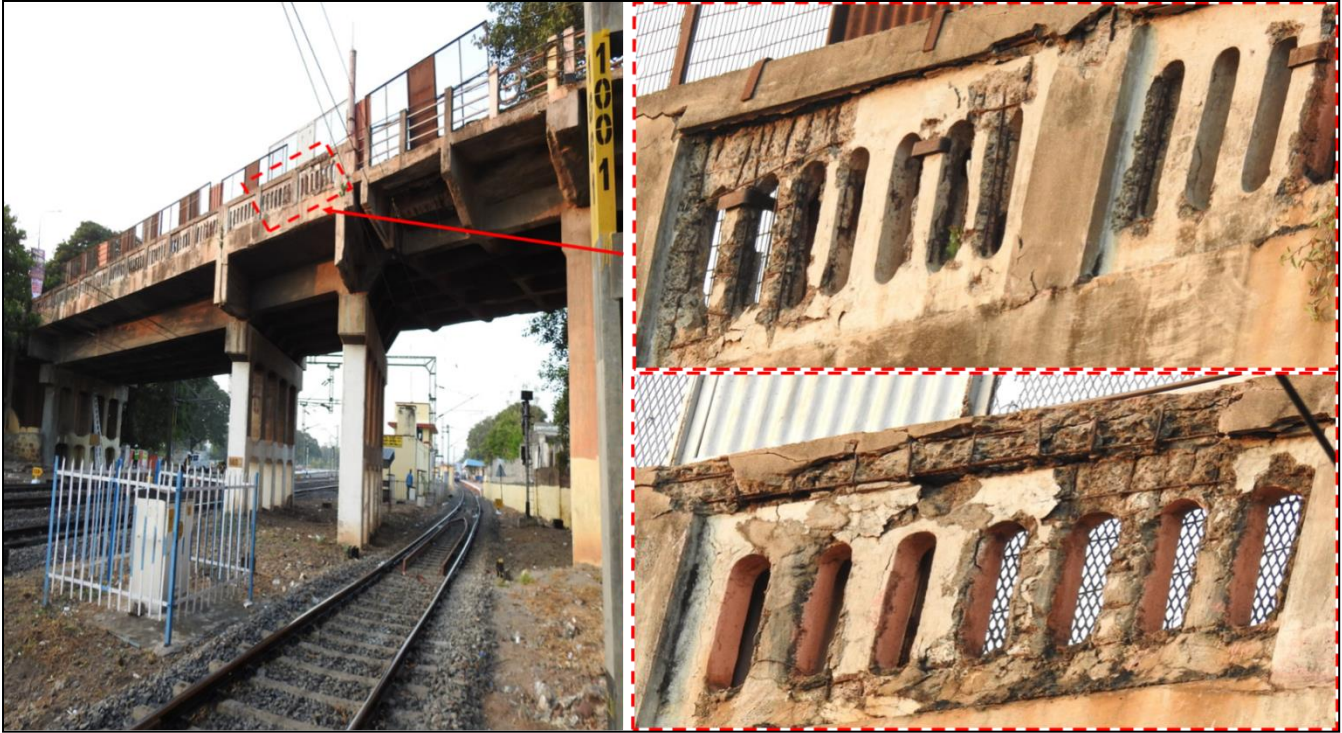
| | Condition of Wall/Railing | | Spalling, Reinforcement exposure, cracks has been observed <b>(Refer Fig:4)</b> |

**Fig: 4** Condition of parapet wall / Railing

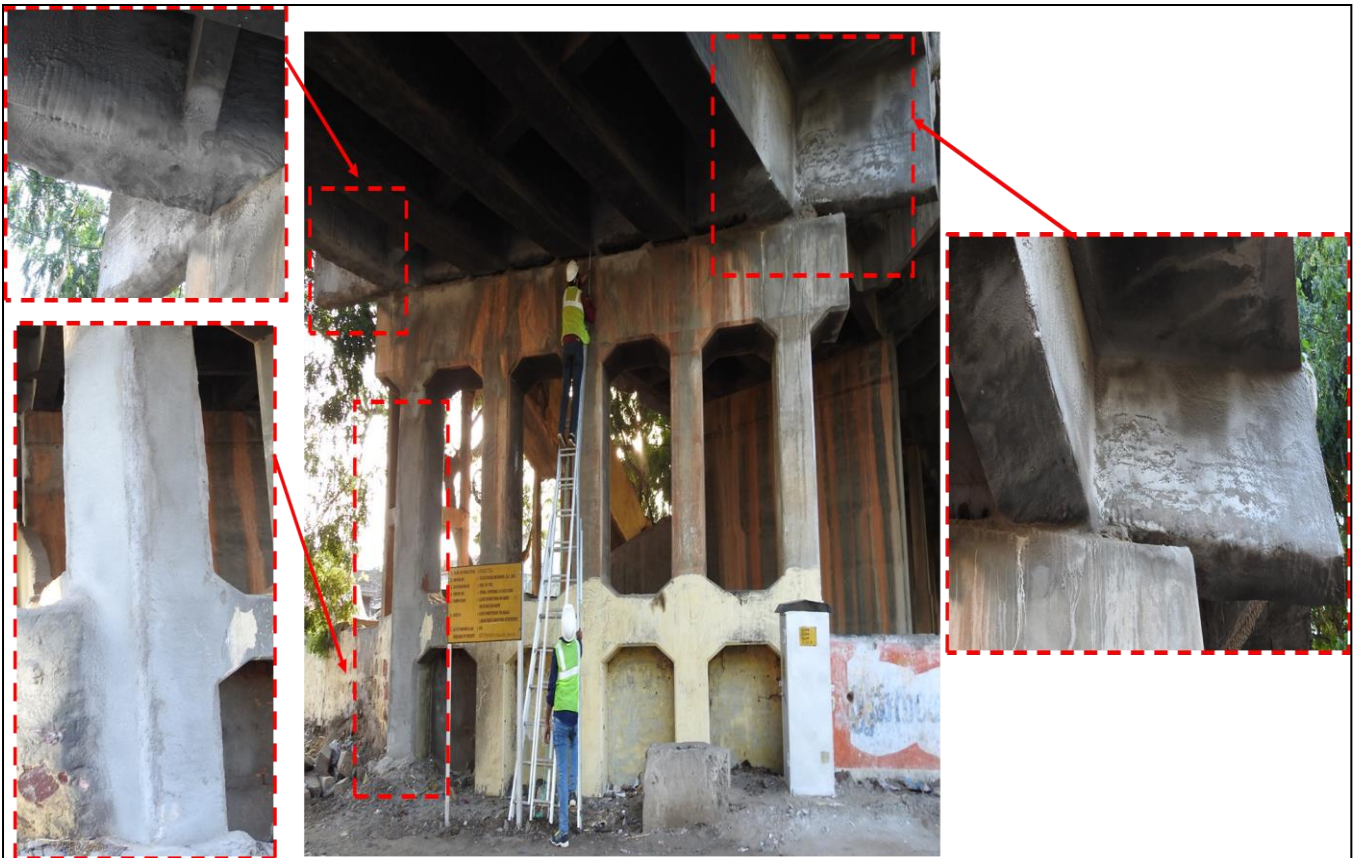
| PART 2 STRUCTURAL SYSTEM OF THE BRIDGE | | | |
|---|---|---|---|
| | Type (Shape) | Portal Type | Cracks & Spalling has been observed on Pier.<br><br>Patching done.<br><br>... (Refer Fig: 5, 6 & 13) |

**Fig 5:** Shotcreting observed in pier-1 columns & Girders

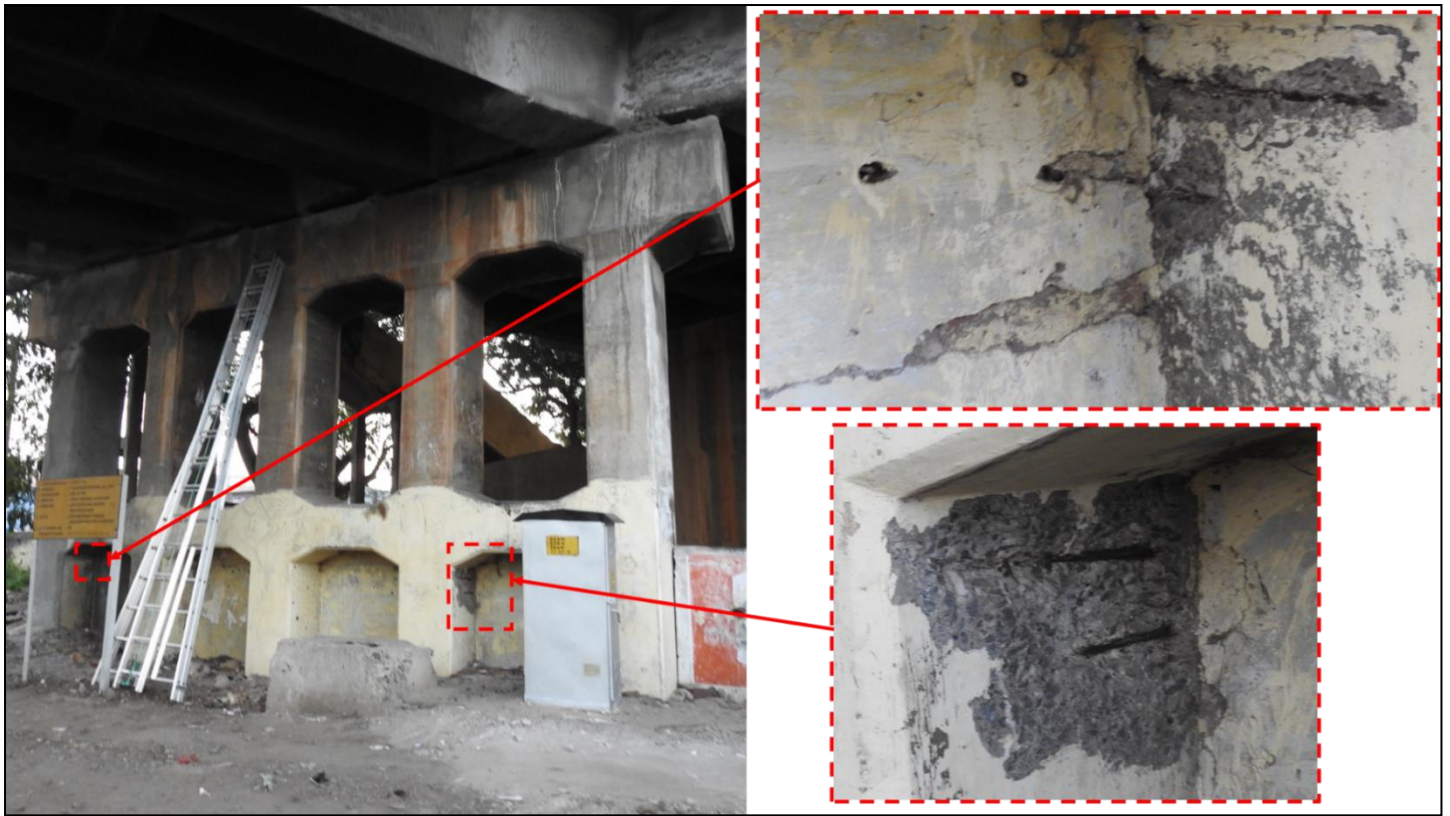
**Fig 6:** Reinforcement exposure observed in pier-1 columns

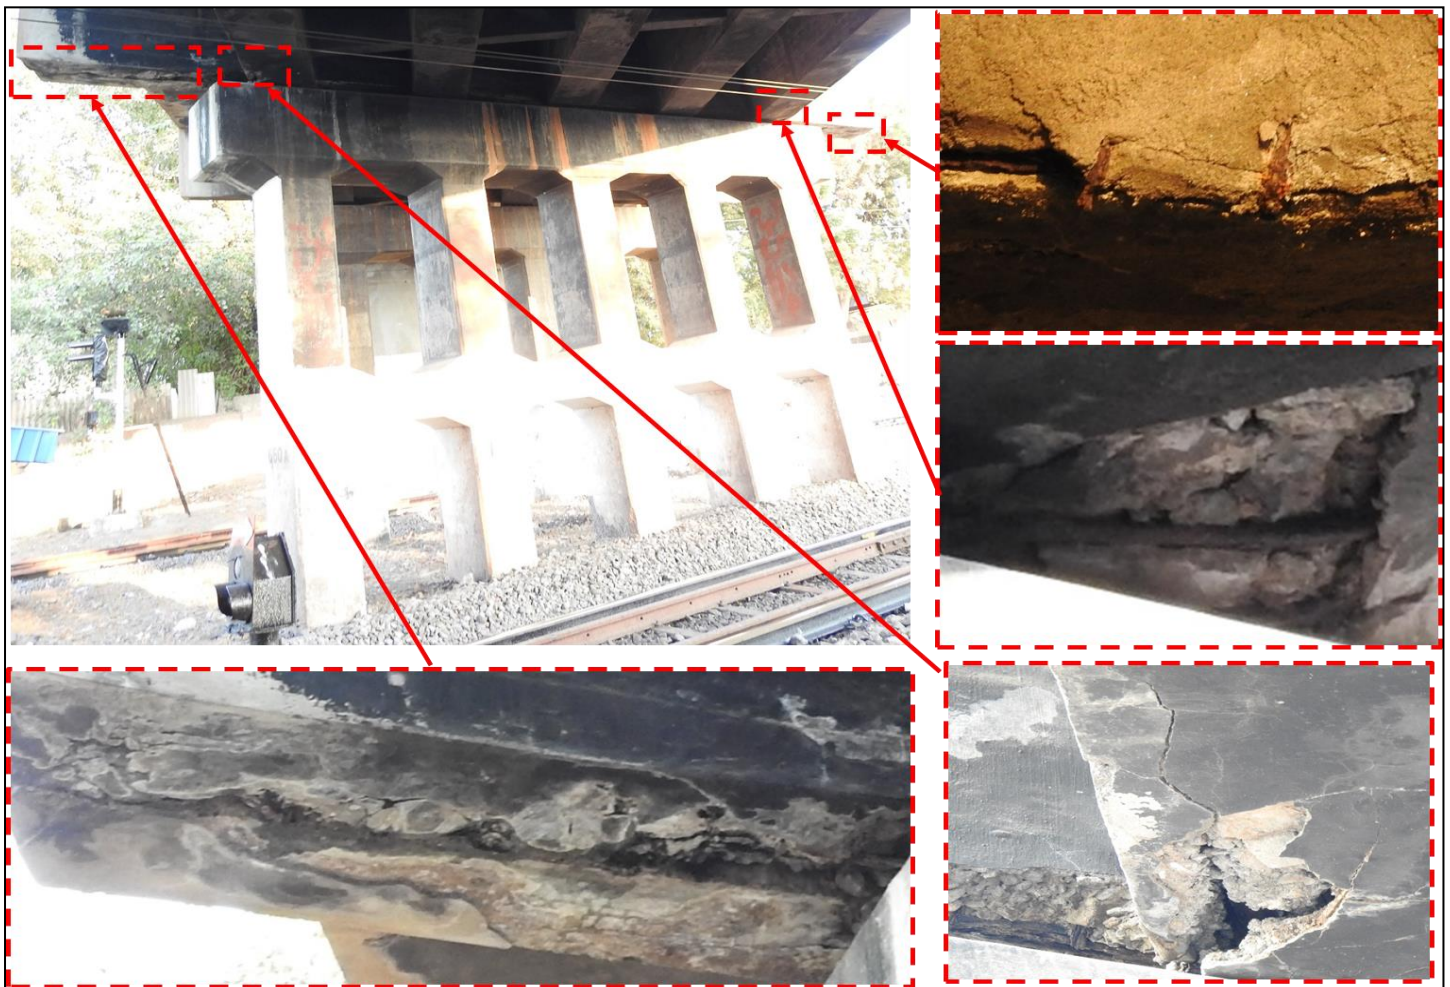
| | Condition of Girder | Distresses Found | Spalling, Patching, Repairing has been observed <b>(Refer Fig: 7)</b> |

**Fig 7:** Reinforcement exposure & Spalling observed on Longitudinal & Cross girders of Span-1

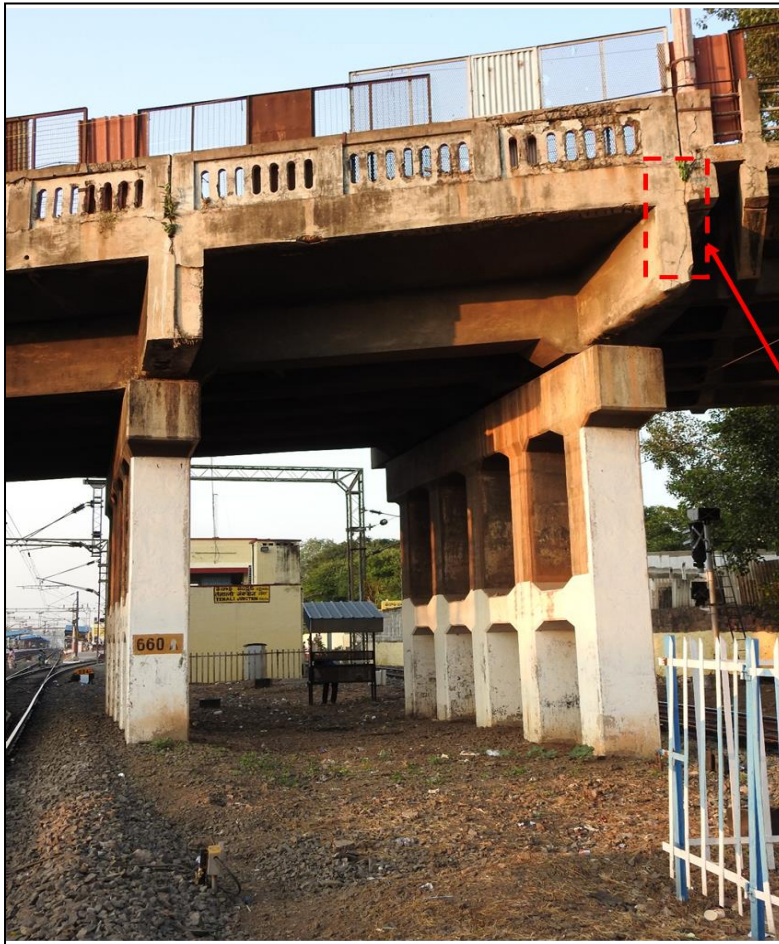
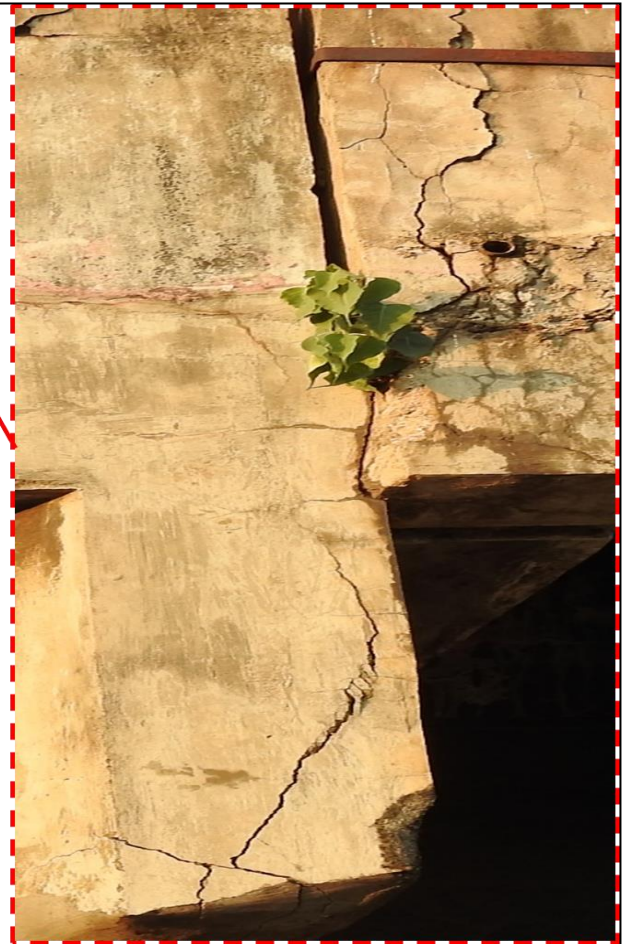
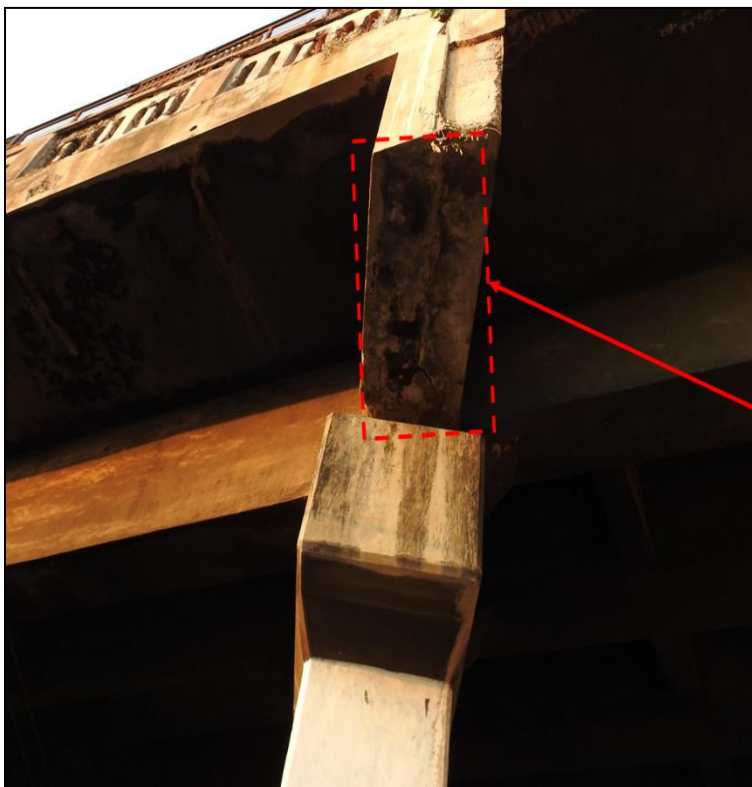
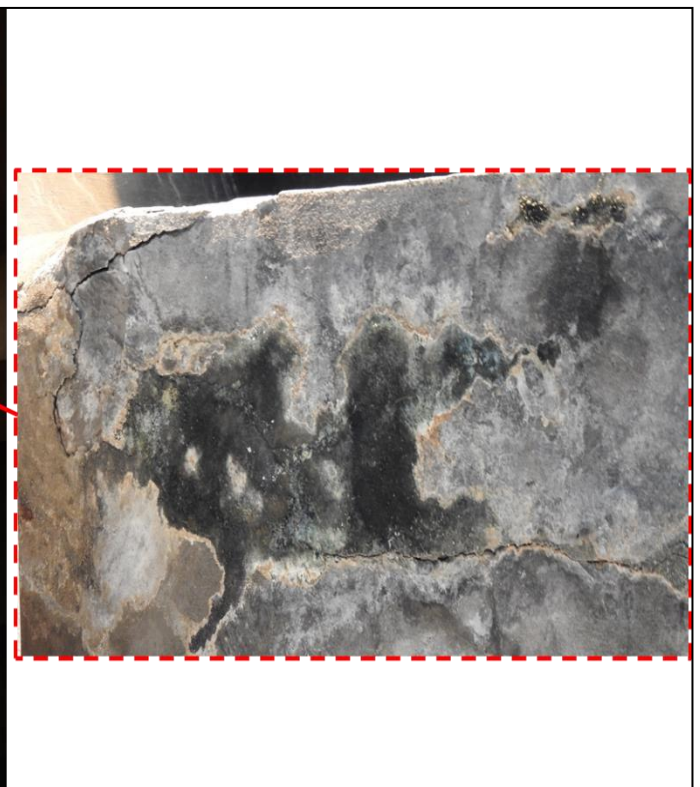
| | Condition of Secondary Girder | Distresses Found | Repair works done. <b>(Refer Fig: 8, 9 &amp; 10)</b> |

| | Defects | Location | Notes |
|--|---|---|---|
| | Cracking in RCC components | Slabs & Piers | Cracks are observed at ends of the Cross Girders. |

**Fig 8&9:** Severe cracks & Vegetation observed in end of the cross girders

- Based on visual inspections and NDT Testing and its interpretations following recommendations were made:
  - a) Epoxy Grouting of cracks observed at Slab, piers, and cross girders.

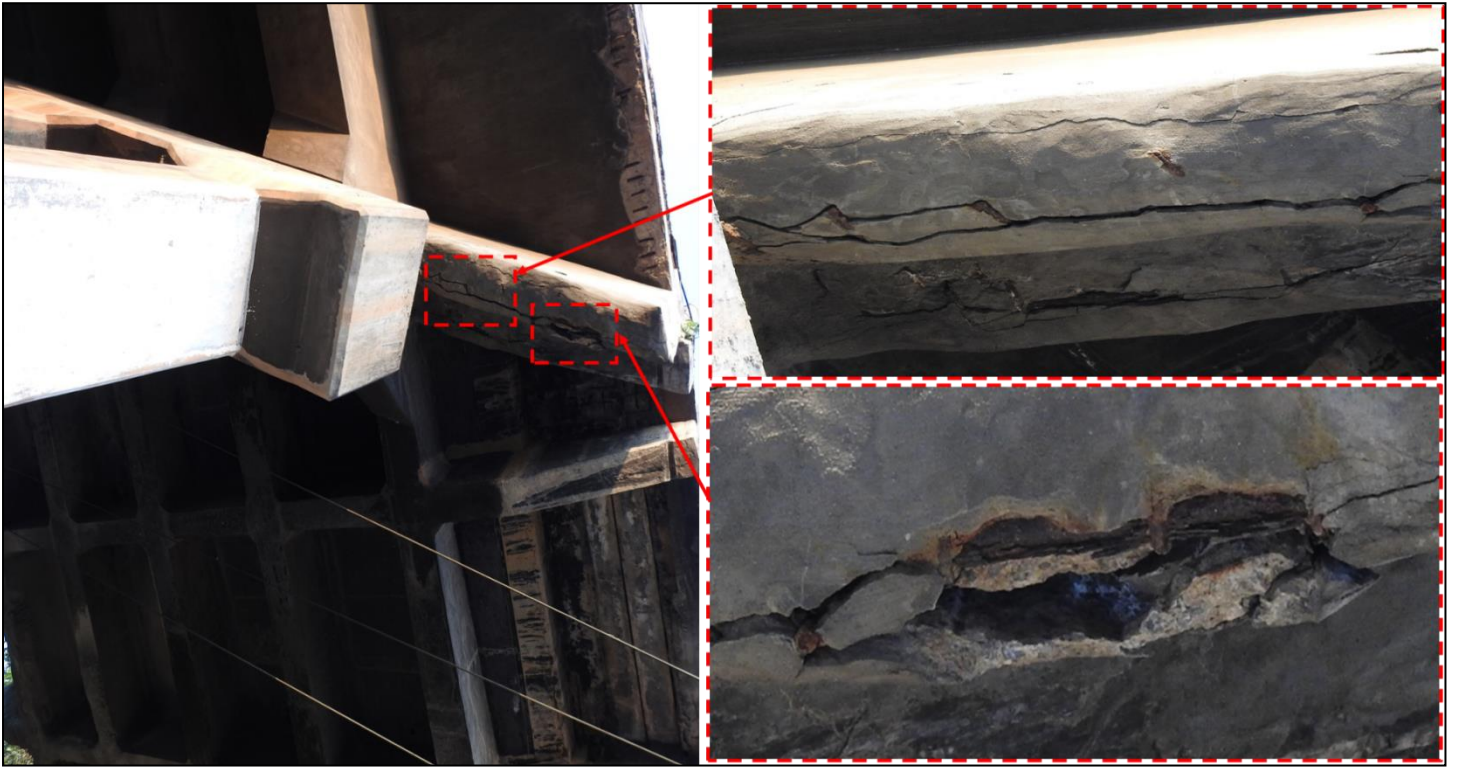
**Fig 10:** Severe Spalling & Reinforcement exposure observed at over hanging portion of cross girder in pier 2

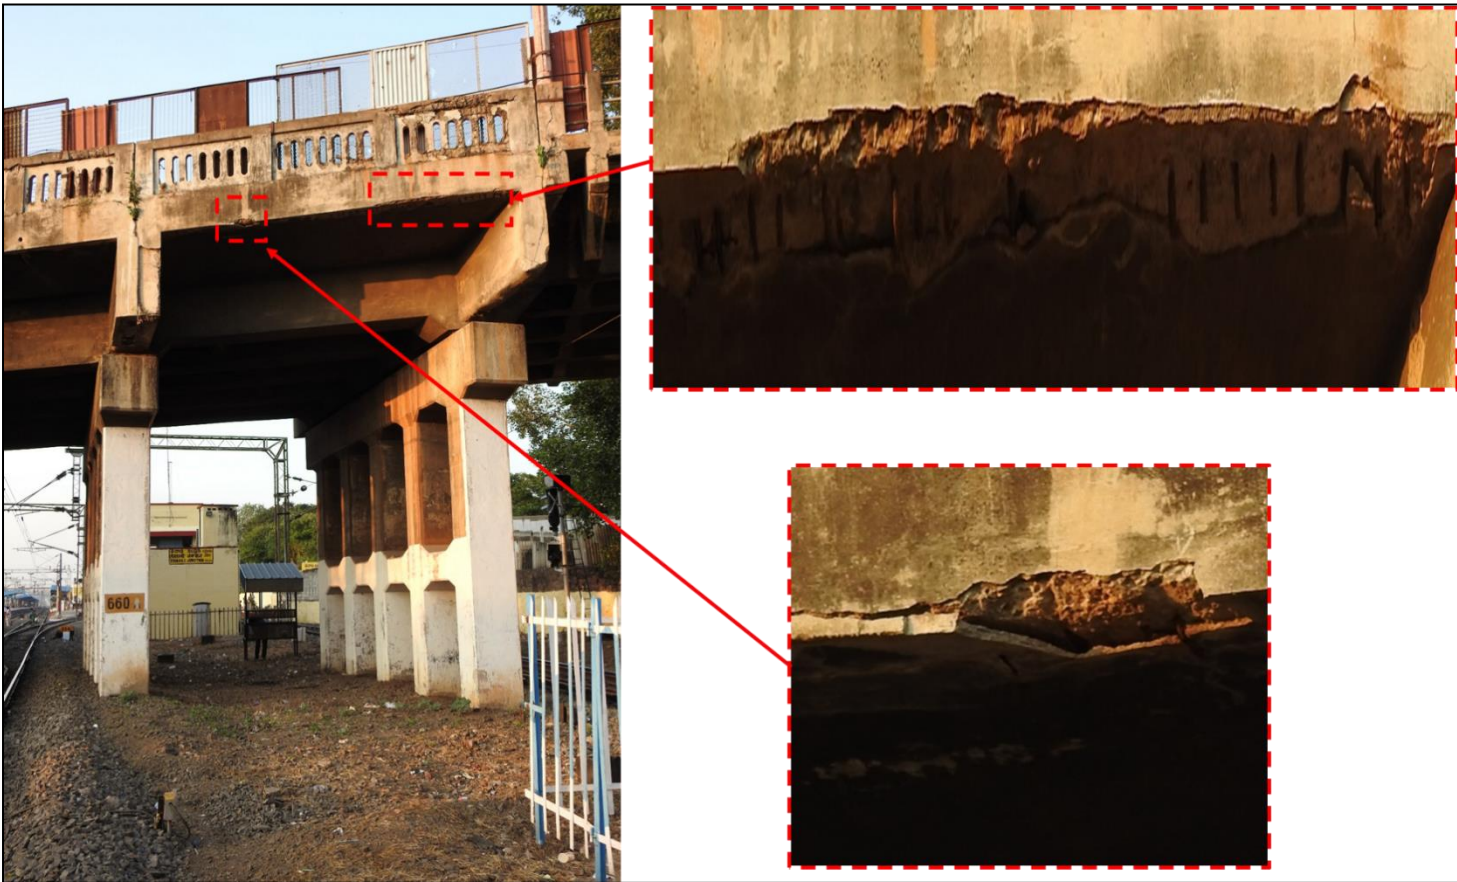
**Fig 11:** Spalling & Reinforcement exposure observed at over hanging portion of slab in Span-2

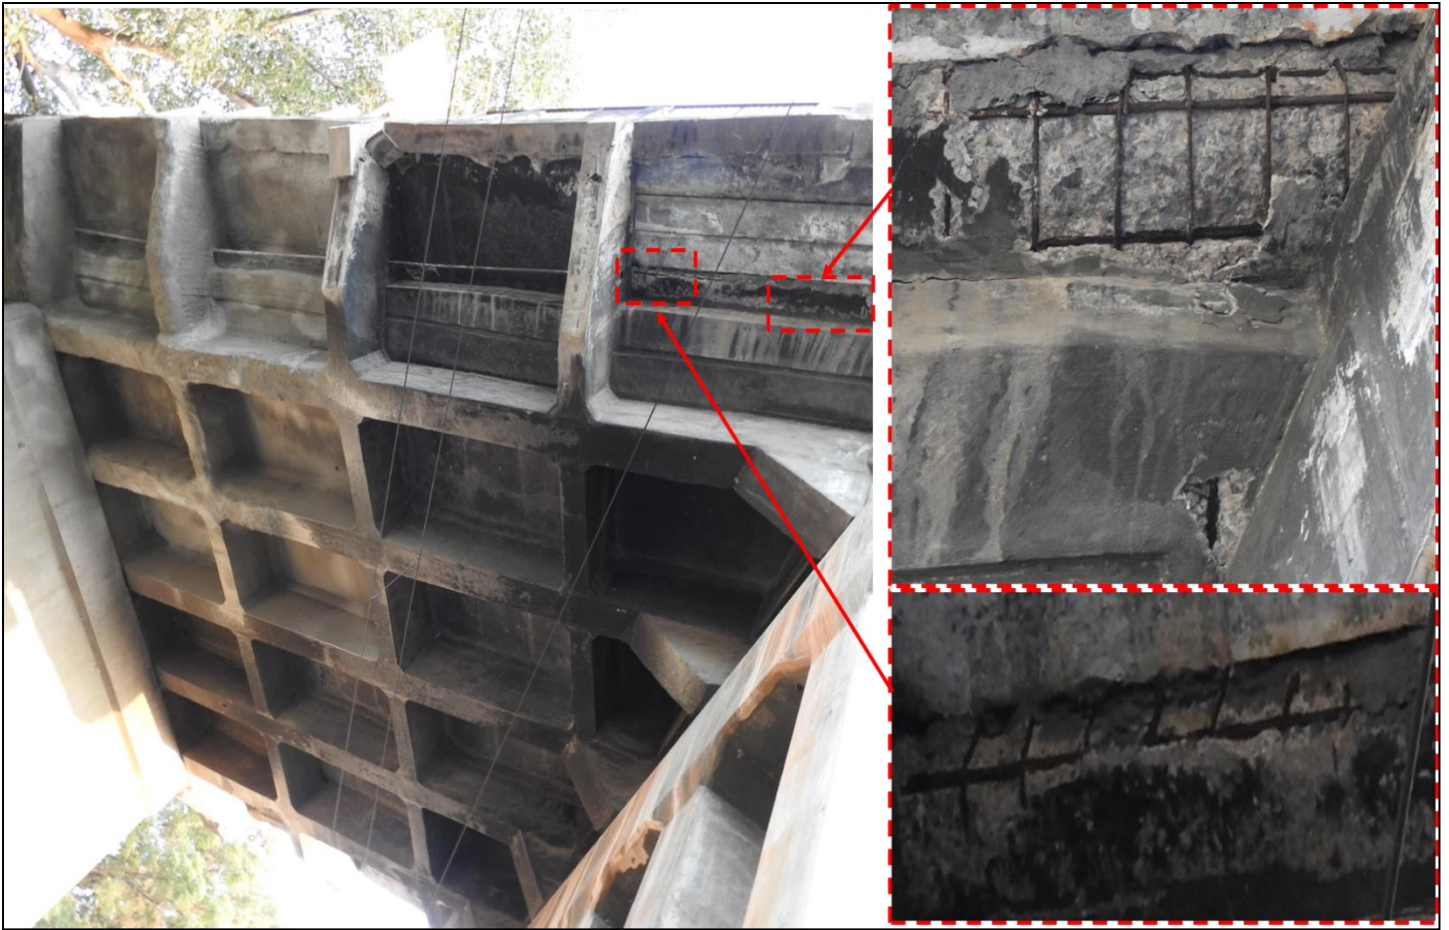
**Fig 12:** Reinforcement exposure observed at Slab of Span-3

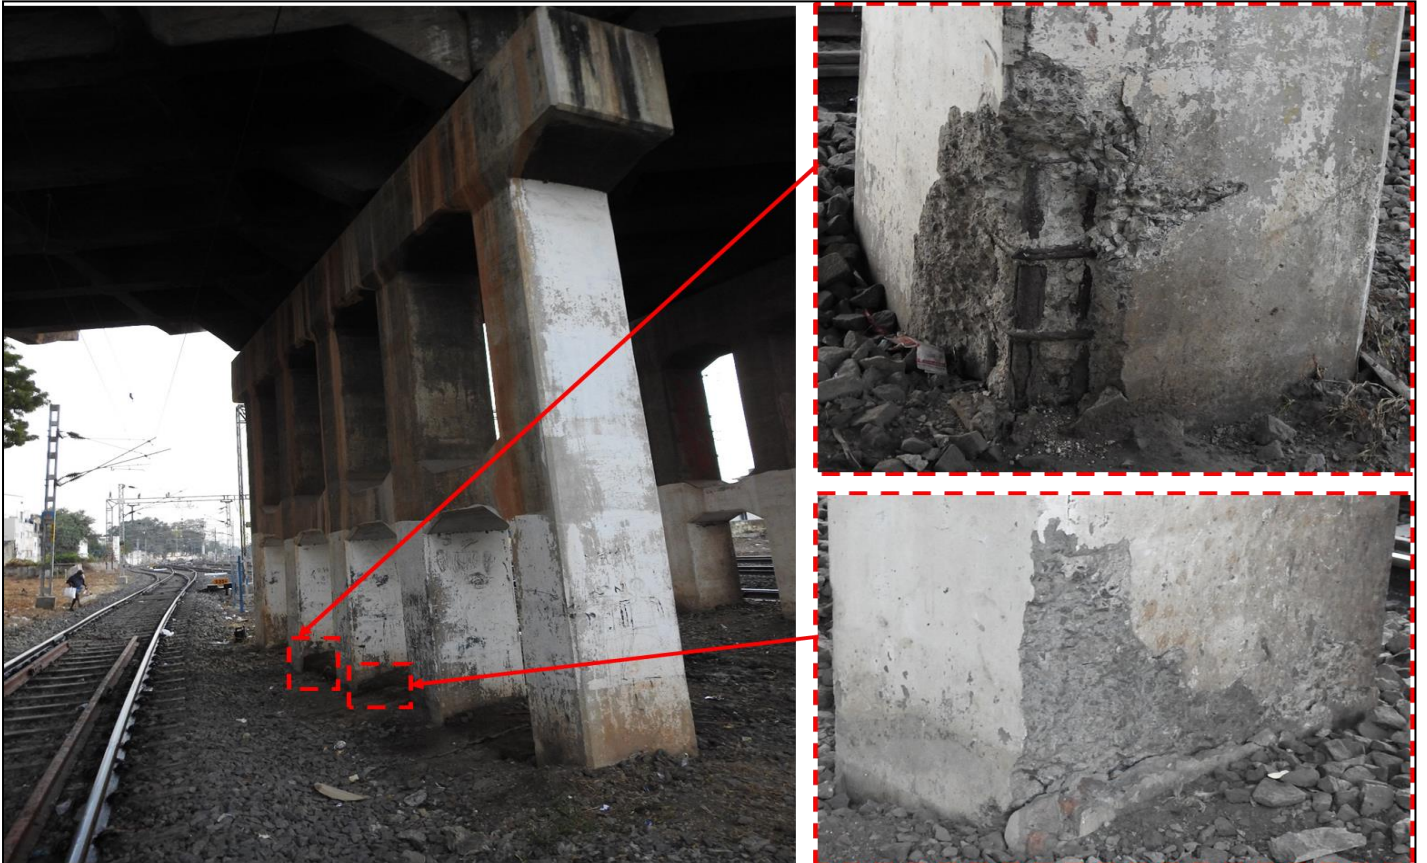
**Fig 13:** Reinforcement exposure & Spalling observed at columns of Pier-3

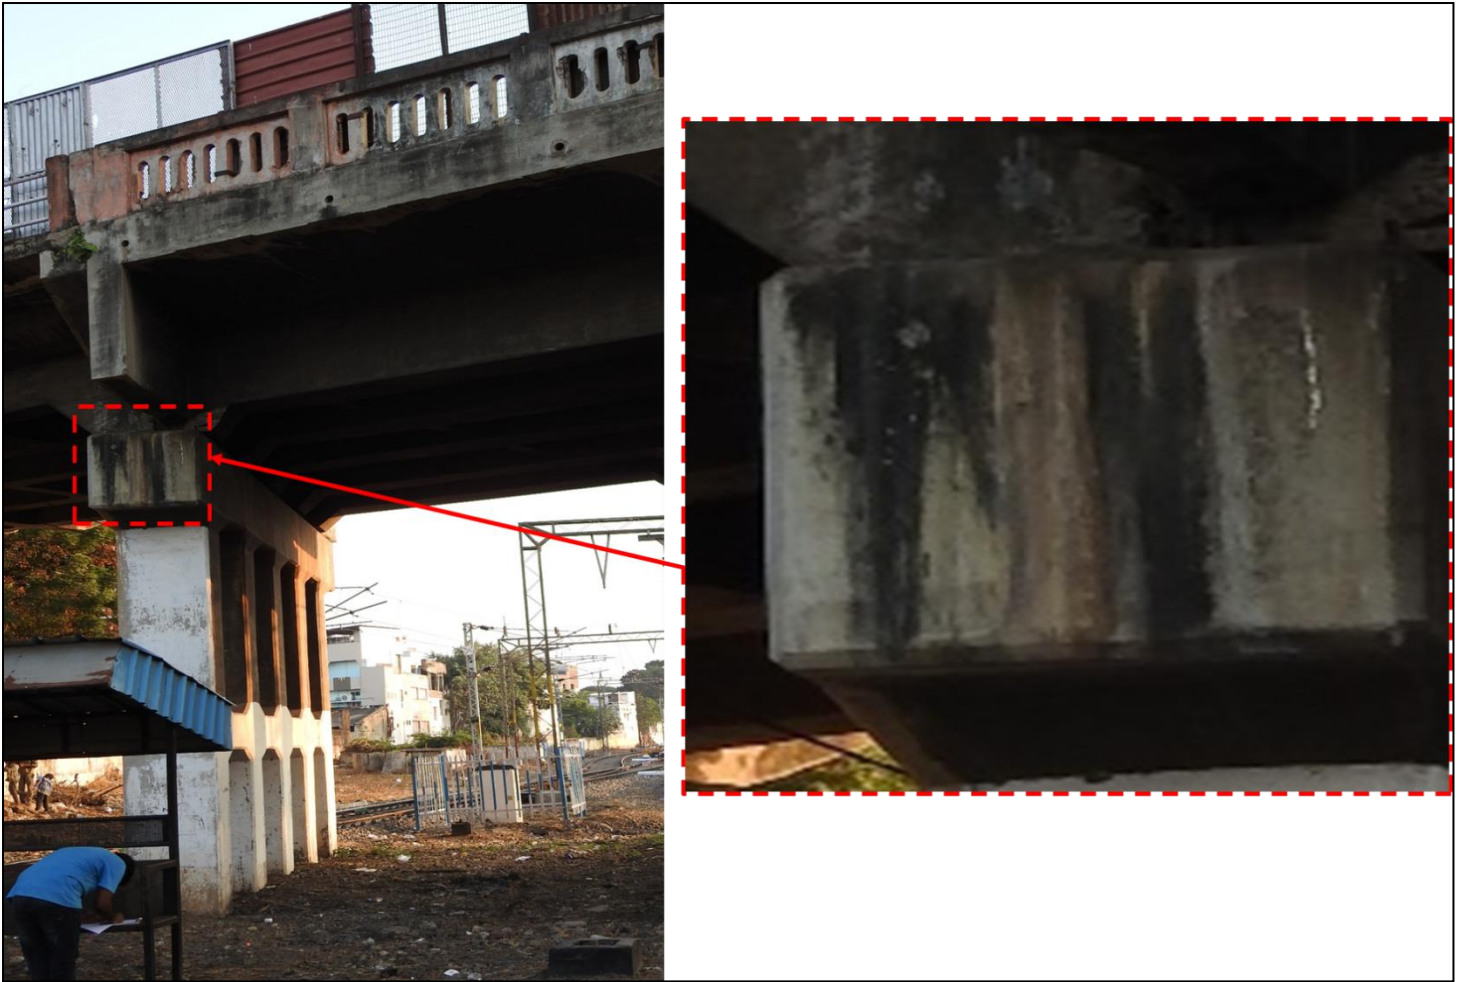
**Fig 14:** Leaching observed at Pier-3 cap

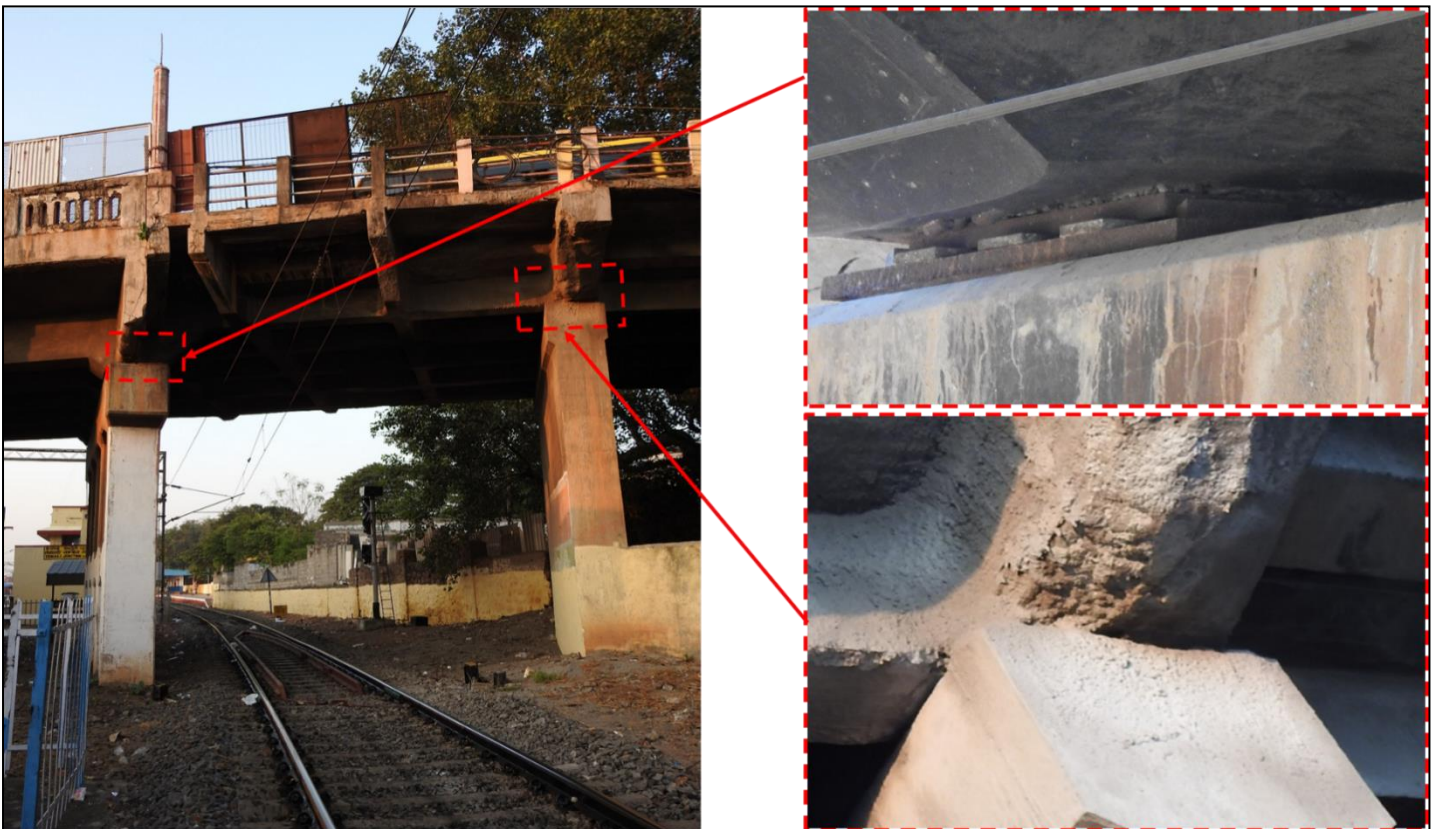
| | General condition (Check Corrosion, cleanliness, seizing of plates silting, accumulations of dirt in case of submersible bridges) | | Debris accumulated at all bearings and filled with Mortar. <b>(Refer Fig: 15)</b> |

**Fig 15:** Debris accumulated at bearings of Span-2 and filled with Mortar at Span-3

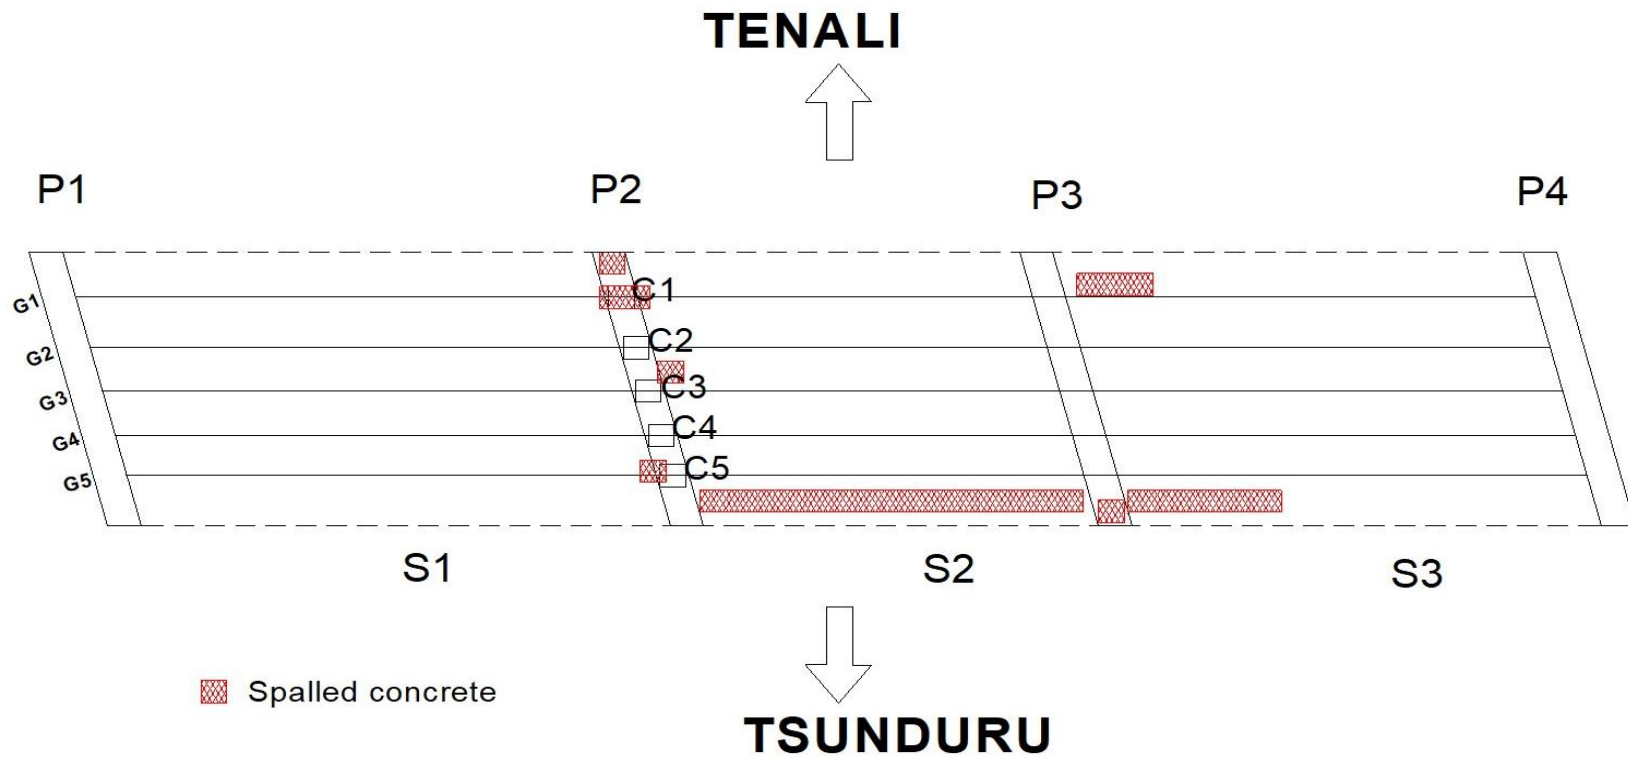
**Fig: 19**Bottom view of ROB with damaged locations

The detailed visual observation of ROB, the following observations are made. Major Spalling and Reinforcement exposure are observed at Deck slab, overhang portions and piers as shown in the below figure, Corrosion is seen in the exposed rebars of the Slab.

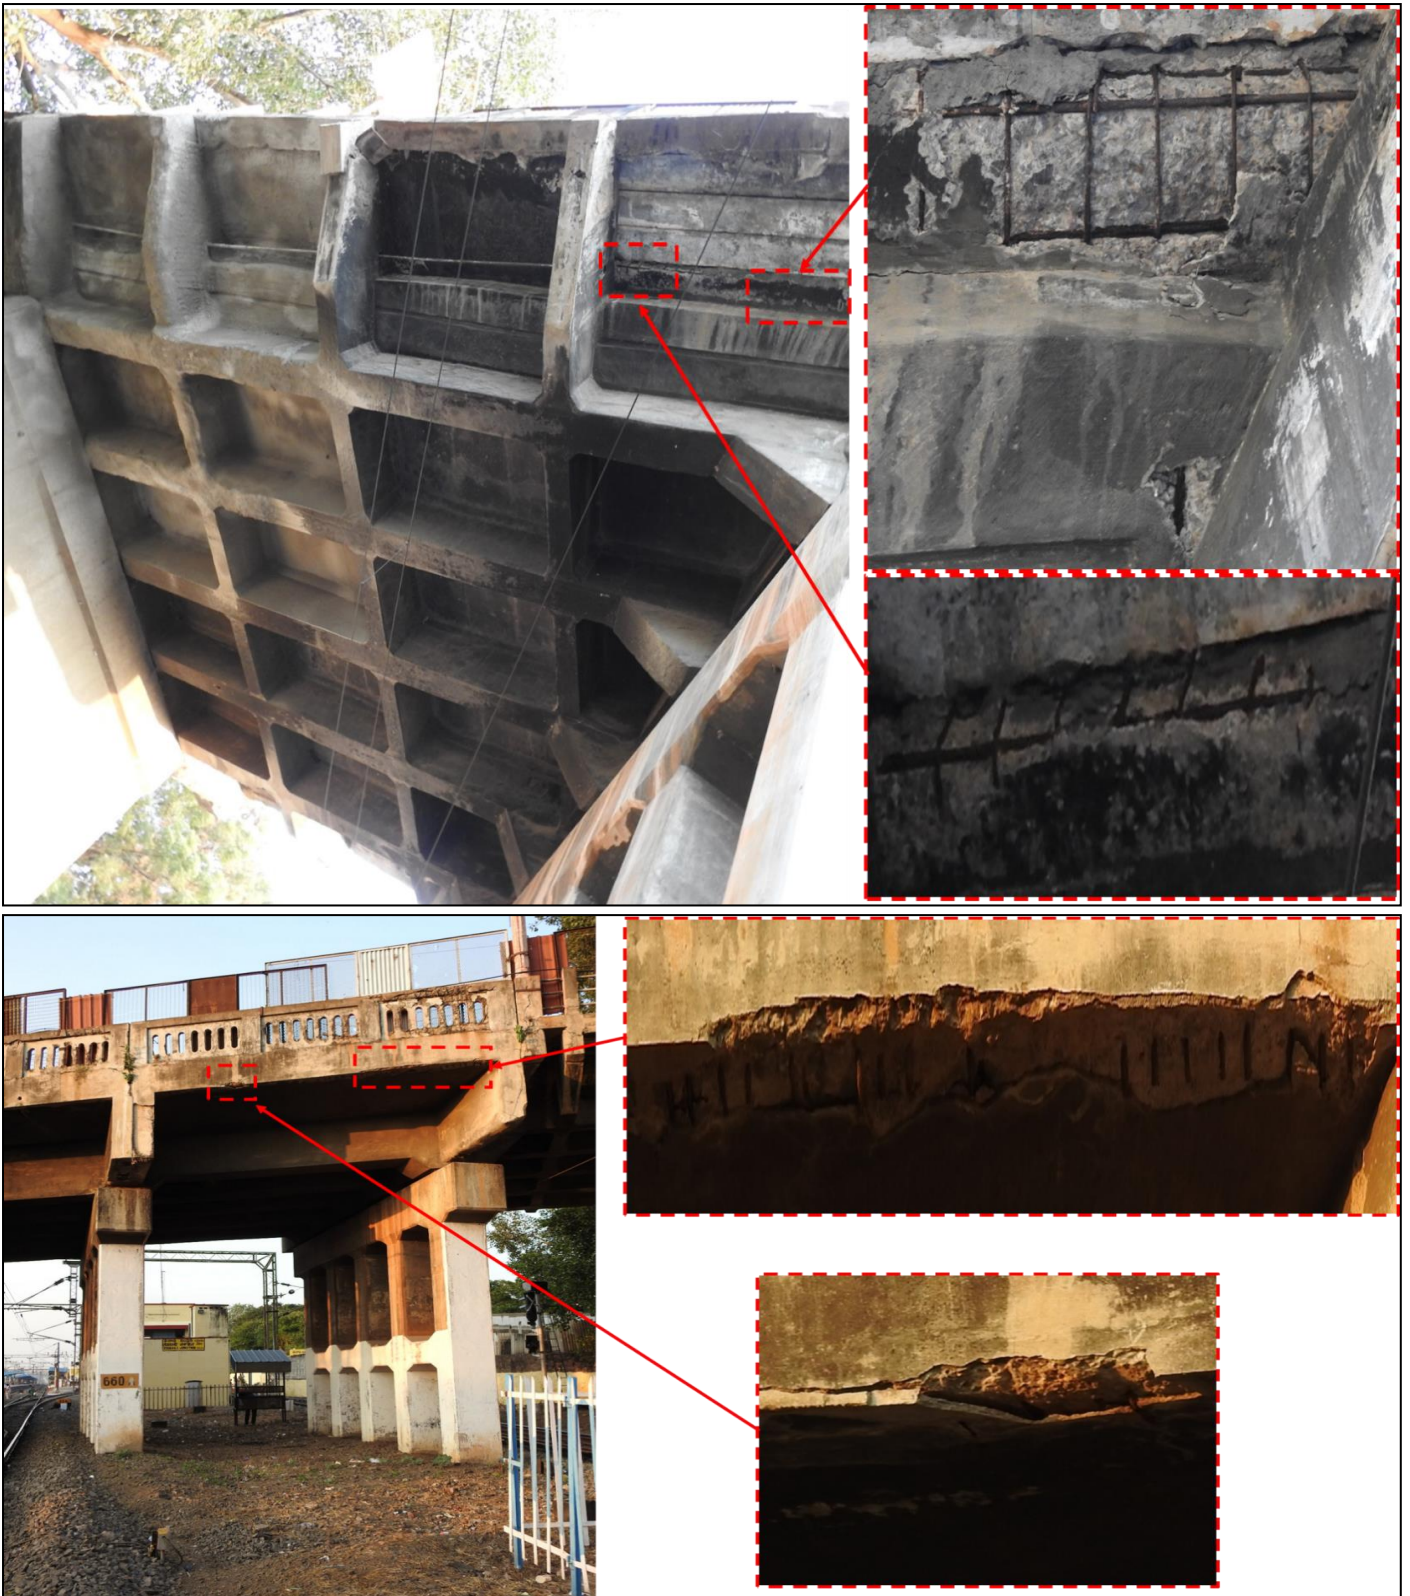
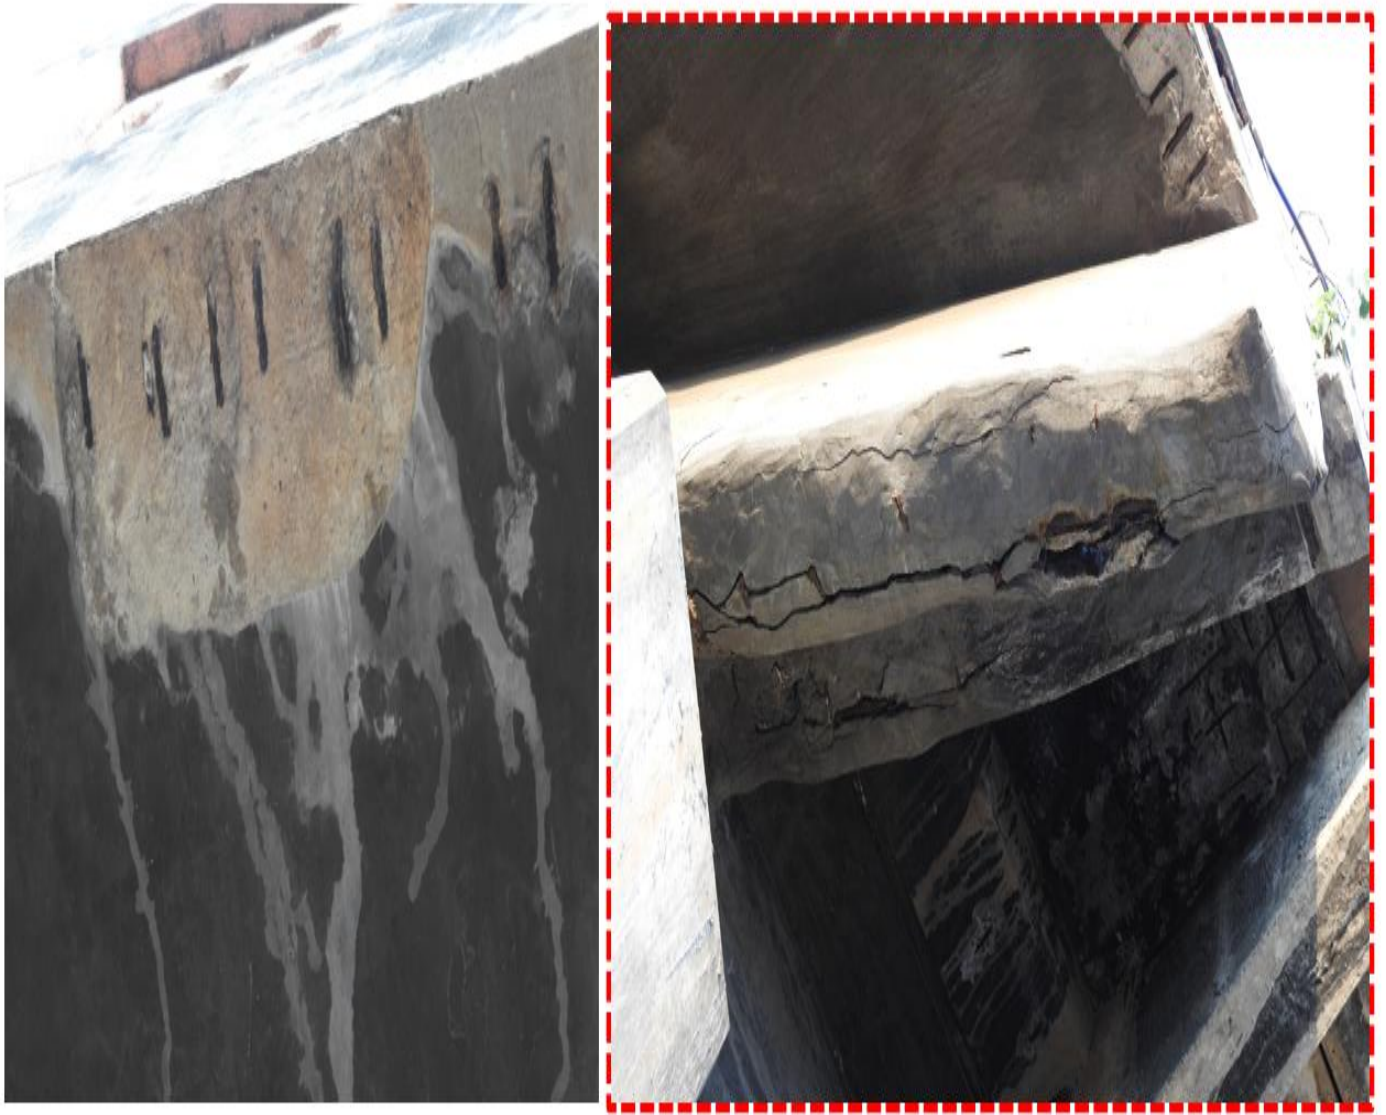
**Fig: 20** Deterioration of Reinforcement and Major spalling of Deck slab.

- b) Application of Anti corrosive paint for exposed rebars with Minimal deterioration
  - c) Replacement of severely Corroded bars in slab and Shotcreting of the deteriorated concrete
