# Third Party Audit of ROB's and FOB's Of SCR

INSPECTION OF ROB NO.251 NEAR GODAVARI RAILWAY STATION

**Final Report**  
SEPTEMBER | 2020

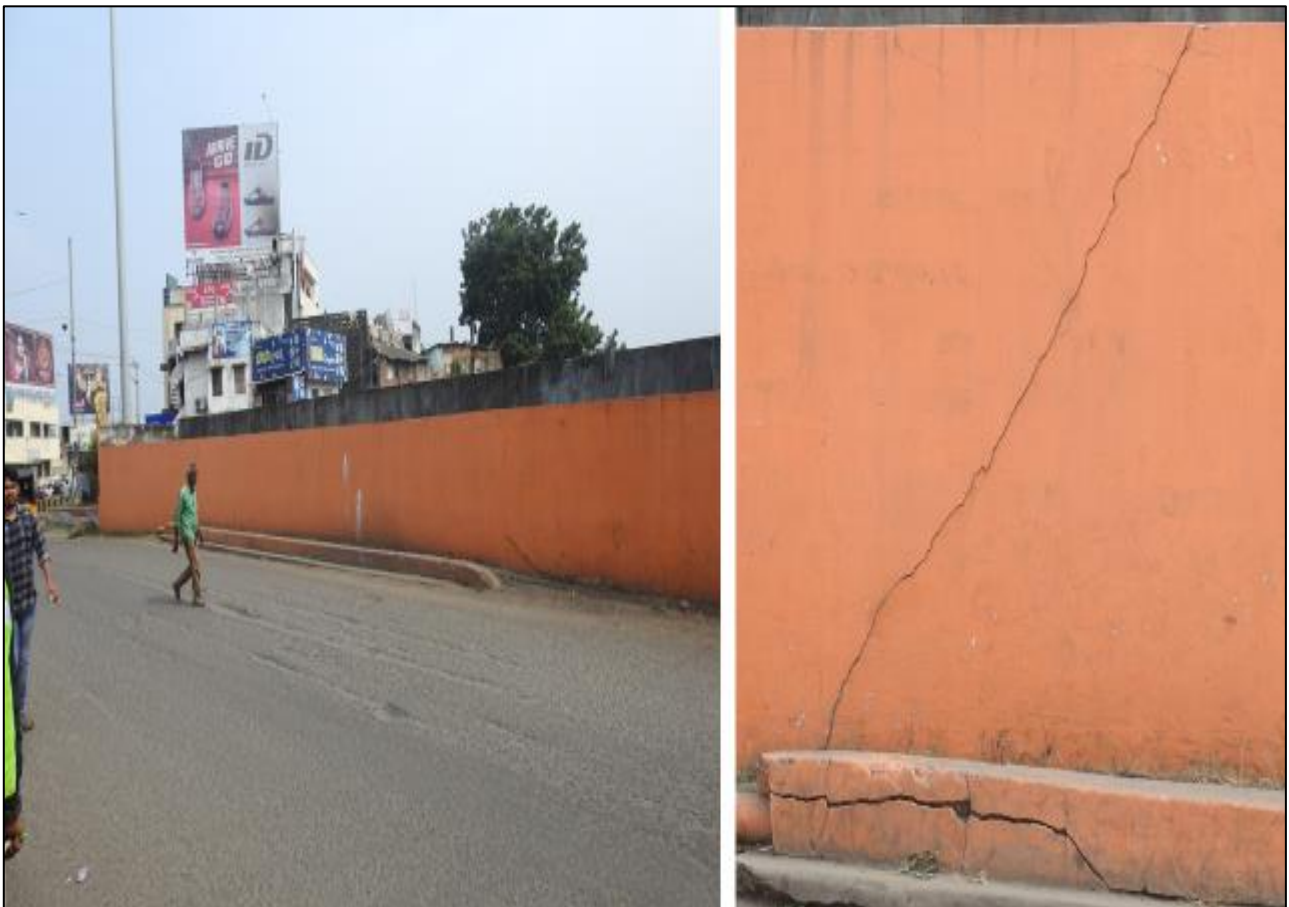
| | Condition of Slab from Top | | Not visible, as covered with wearing coat (Refer <b>Fig-3</b> ) |
| | Condition of Wall/Railing | | cracks are observed on Parapet wall. (Refer <b>Fig-3</b> ) |

**Fig: 3** Wearing coat & cracks observed on parapet wall

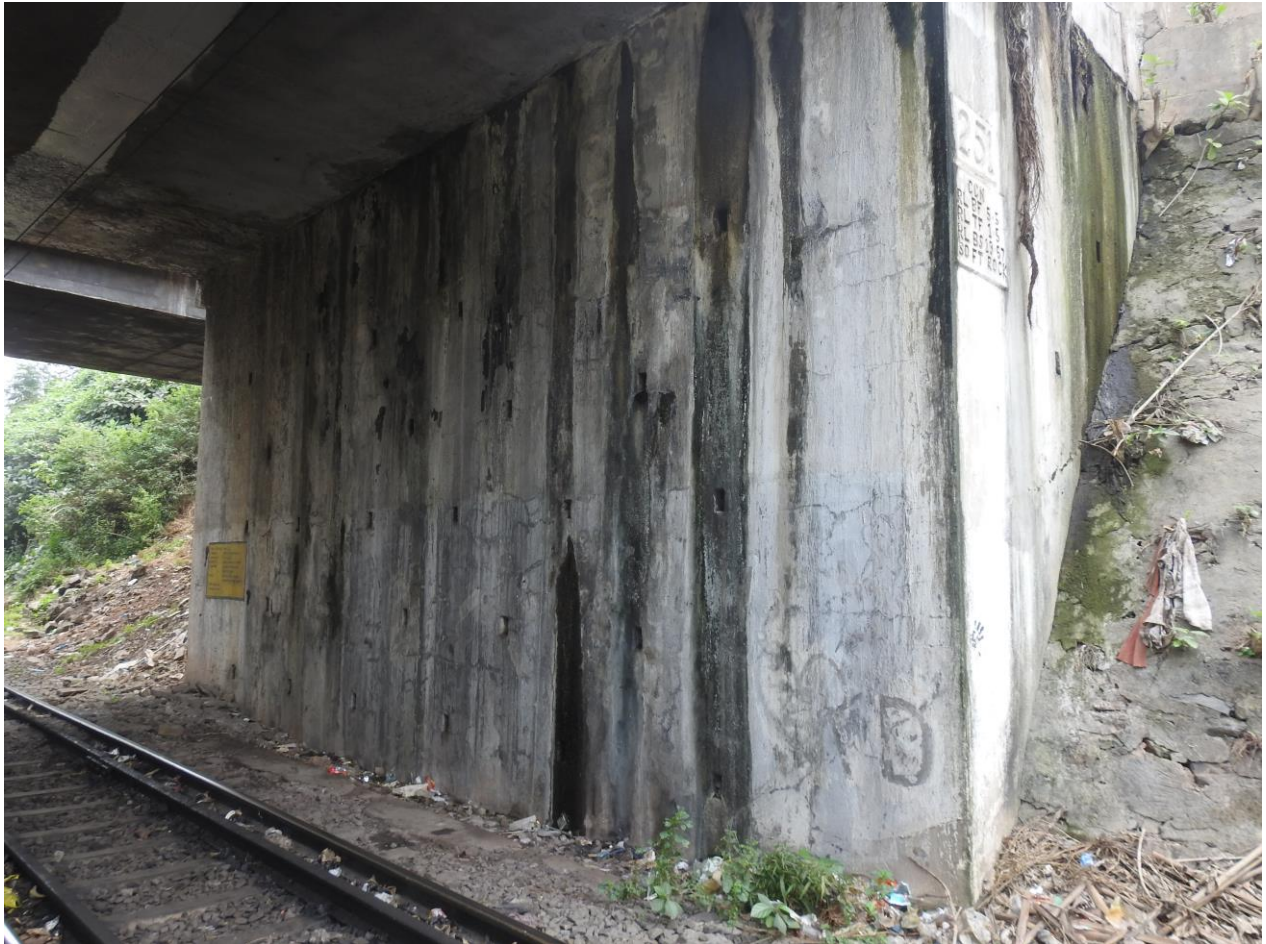
| PART 1.2 STRUCTURAL SYSTEM OF THE BRIDGE | | | |
|---|---|---|---|
| | Condition (Crack, Settlement, Scour, Tilting, Steel Corrosion, Strains and other damages etc...) | Distresses Found | Shrinkage Cracks and Leaching is observed<br>Water seepage is observed at abutments due to the flow of drain over ROB (Refer <b>Fig- 4, 15</b> ), |

**Fig: 4** Water seepage at abutment

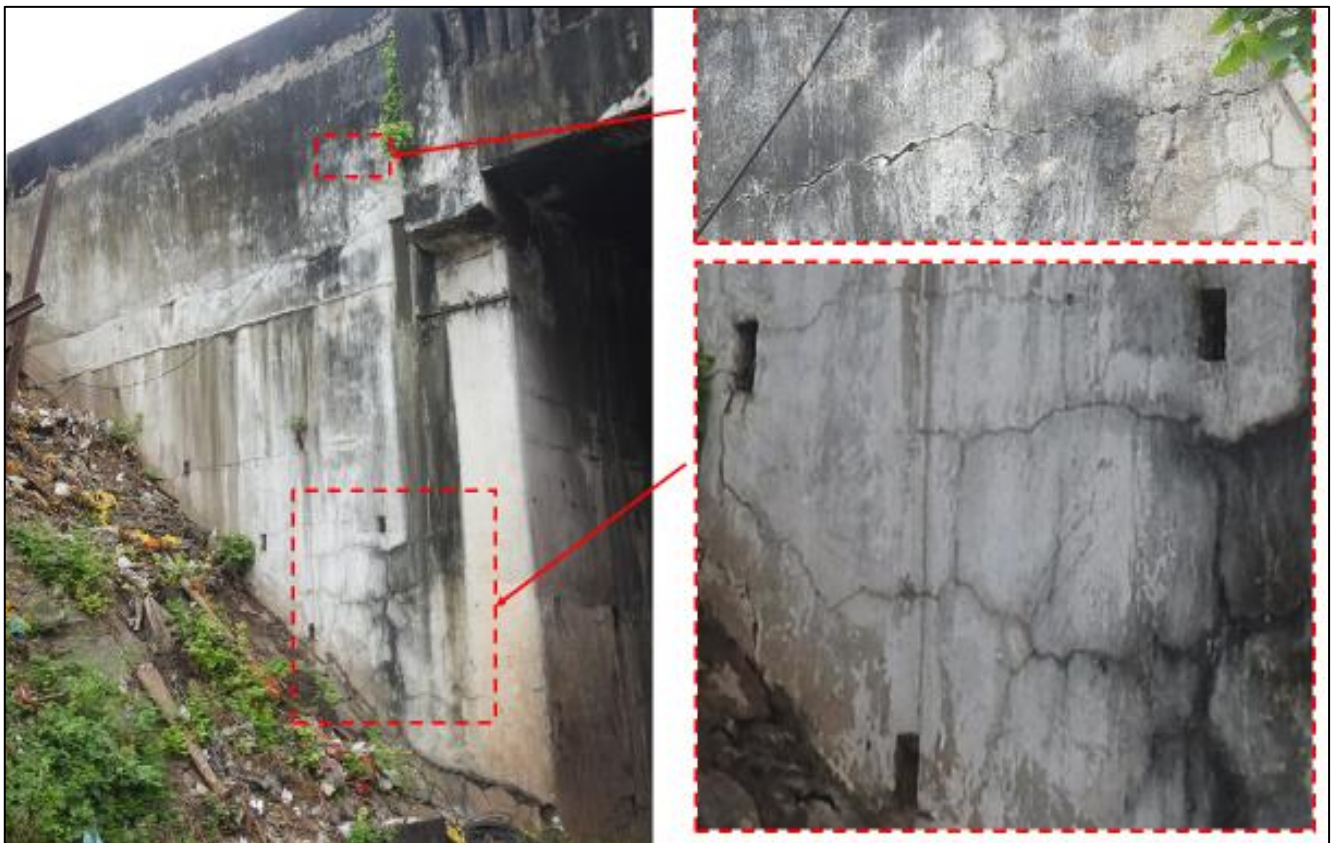
**Fig: 5** Cracks observed at Abutment 1

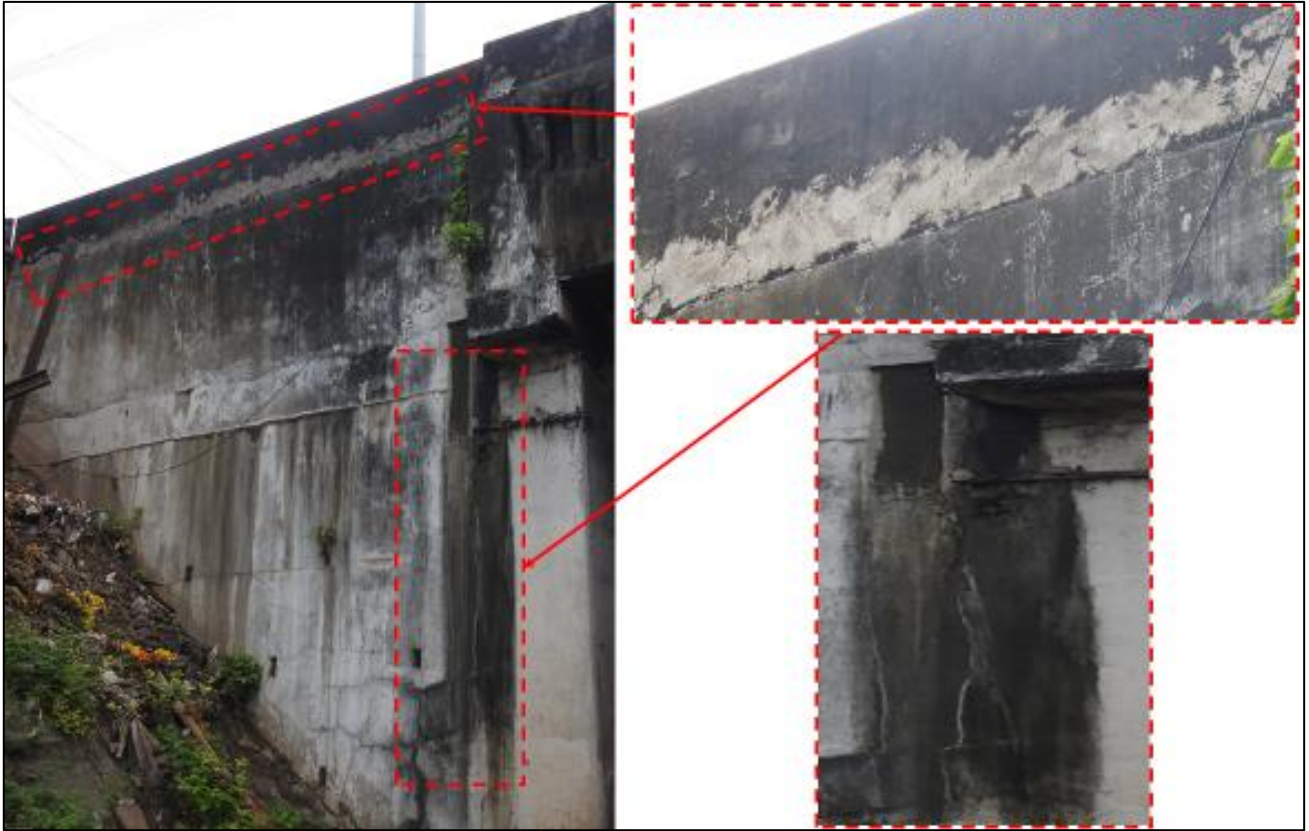
**Fig:6** Patch work & Leaching observed at Abutment-1

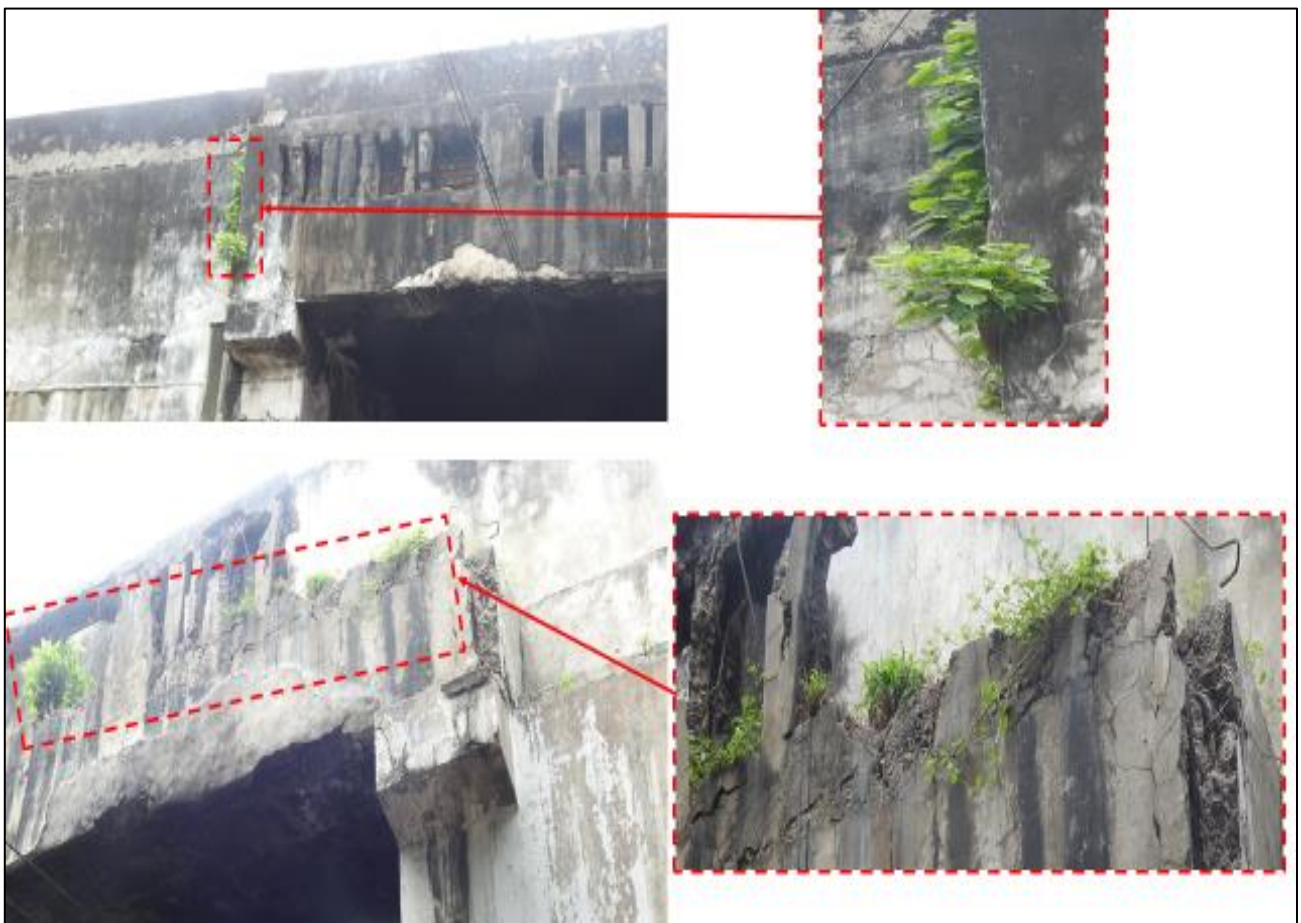
**Fig 7:** Vegetation growth observed at Abutment-1

- d) Clearing of Vegetation growth immediately to avoid deterioration of concrete.

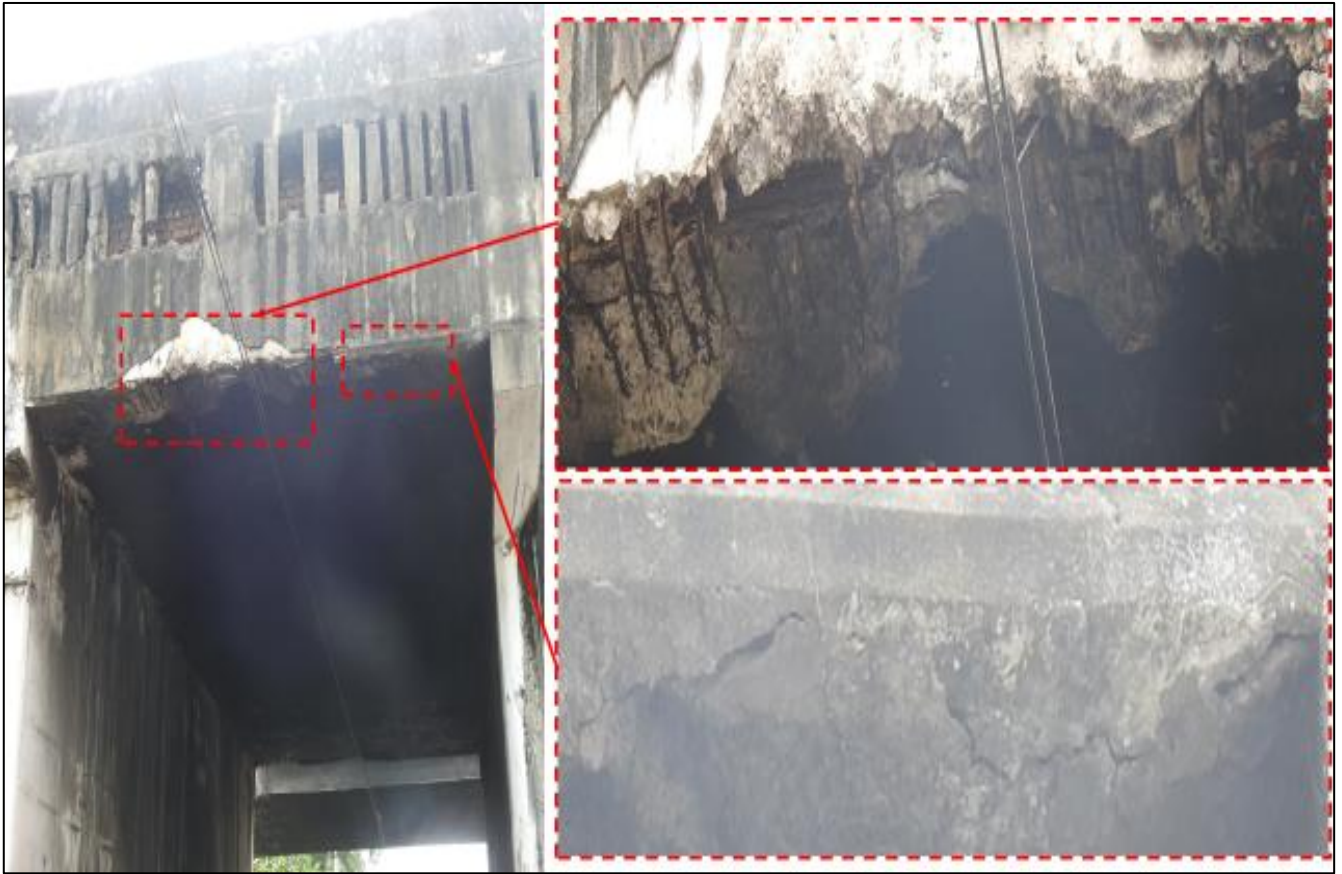
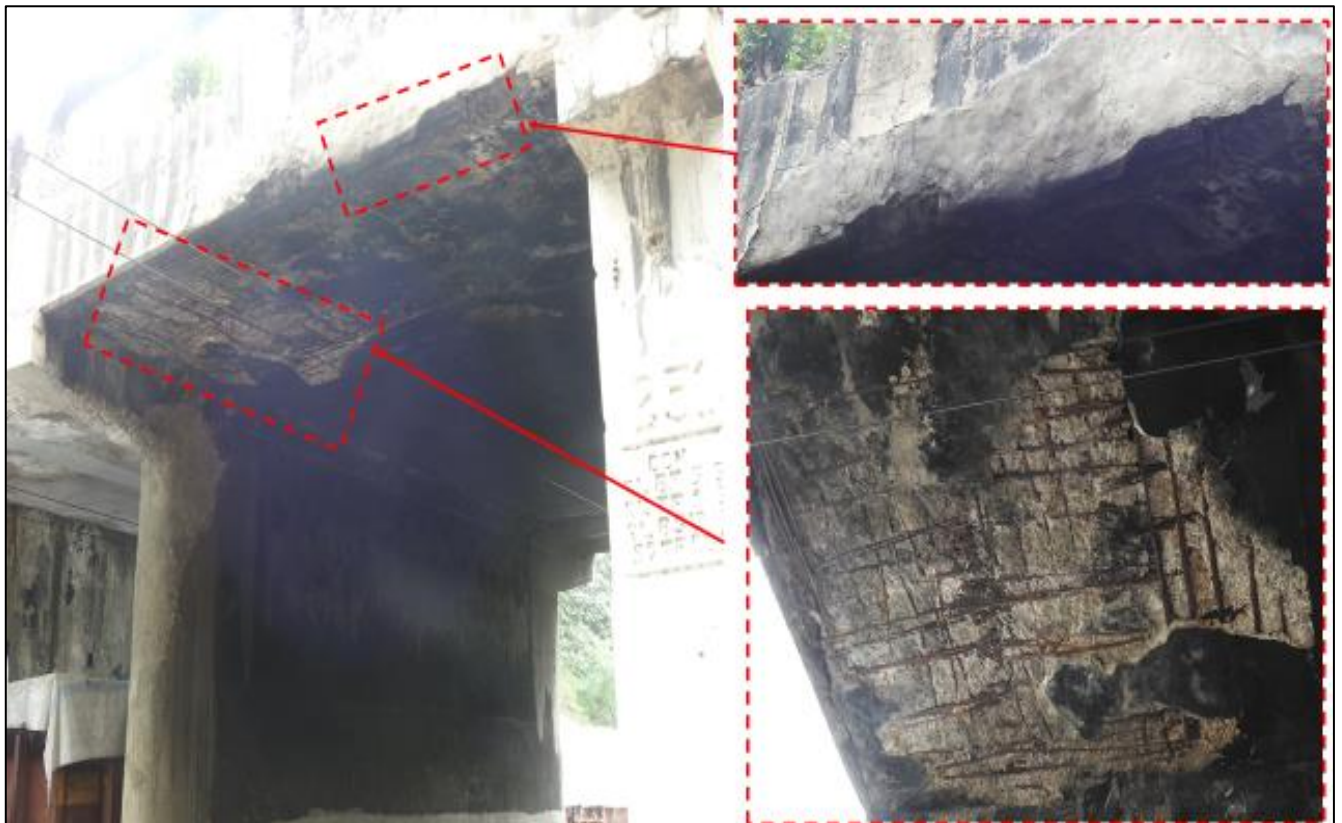
**Fig 8:** Reinforcement exposure & Spalling observed at Span-1

- b) Application of Anti corrosive paint for exposed rebars with Minimal deterioration
  - c) Replacement of severely Corroded bars in slab and Shotcreting of the deteriorated concrete

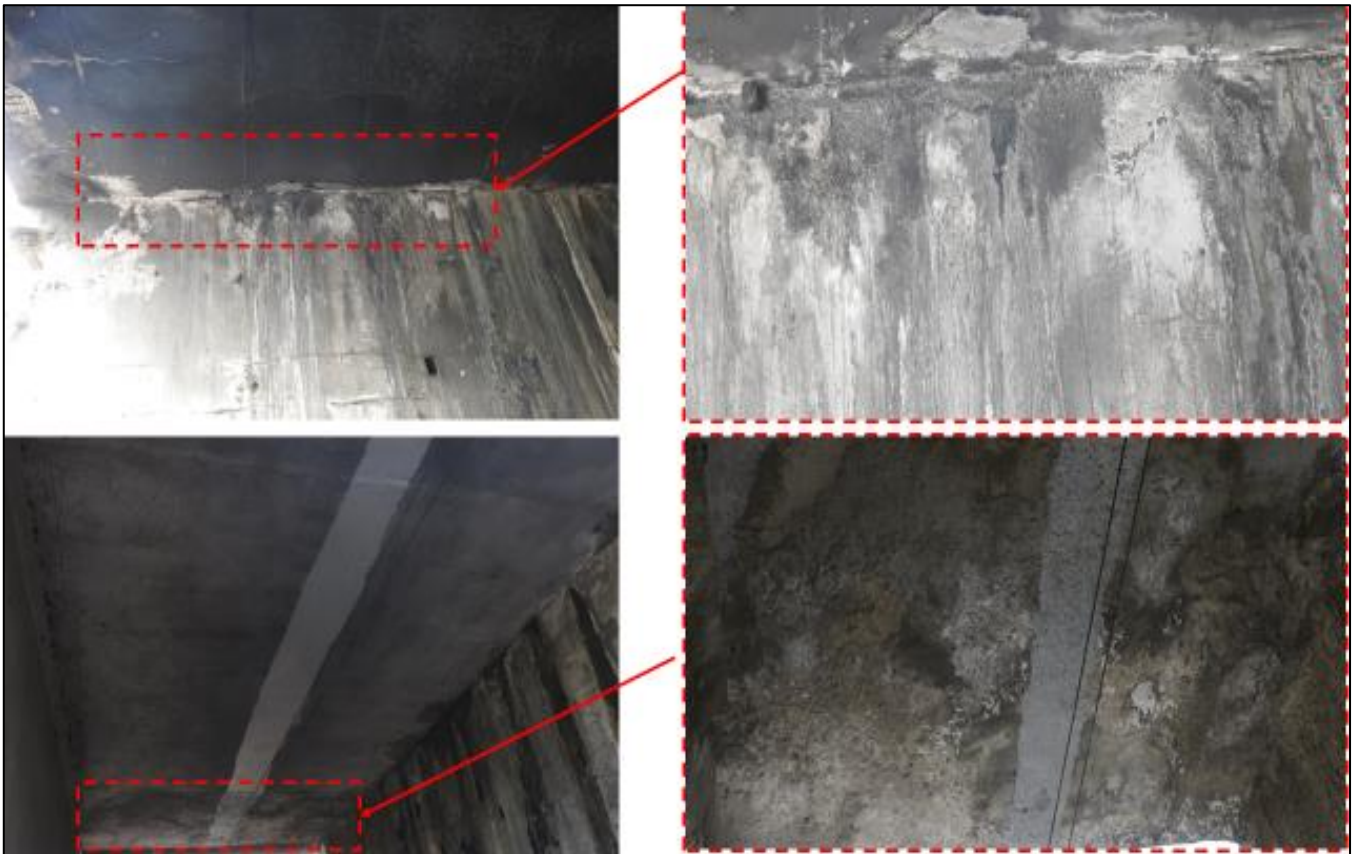
**Fig 9:** Leaching observed on Slab – 1 & Slab-2

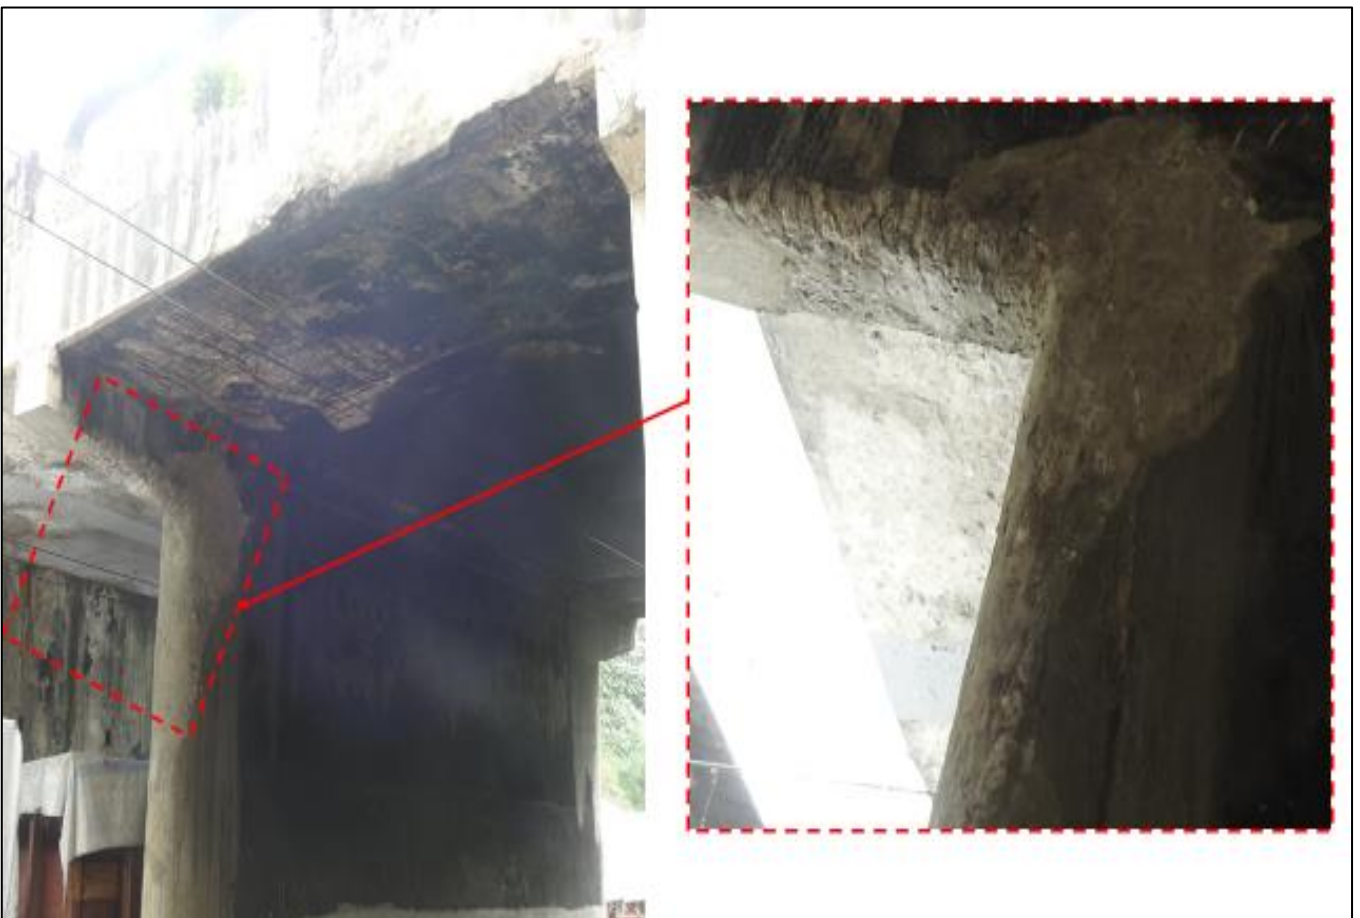
**Fig 10:** Cracks & Spalling observed at Pier

- Based on visual inspections and NDT Testing and its interpretations following recommendations were made:
  - a) Epoxy Grouting of cracks and complete Jacketing of the pier wall should be done

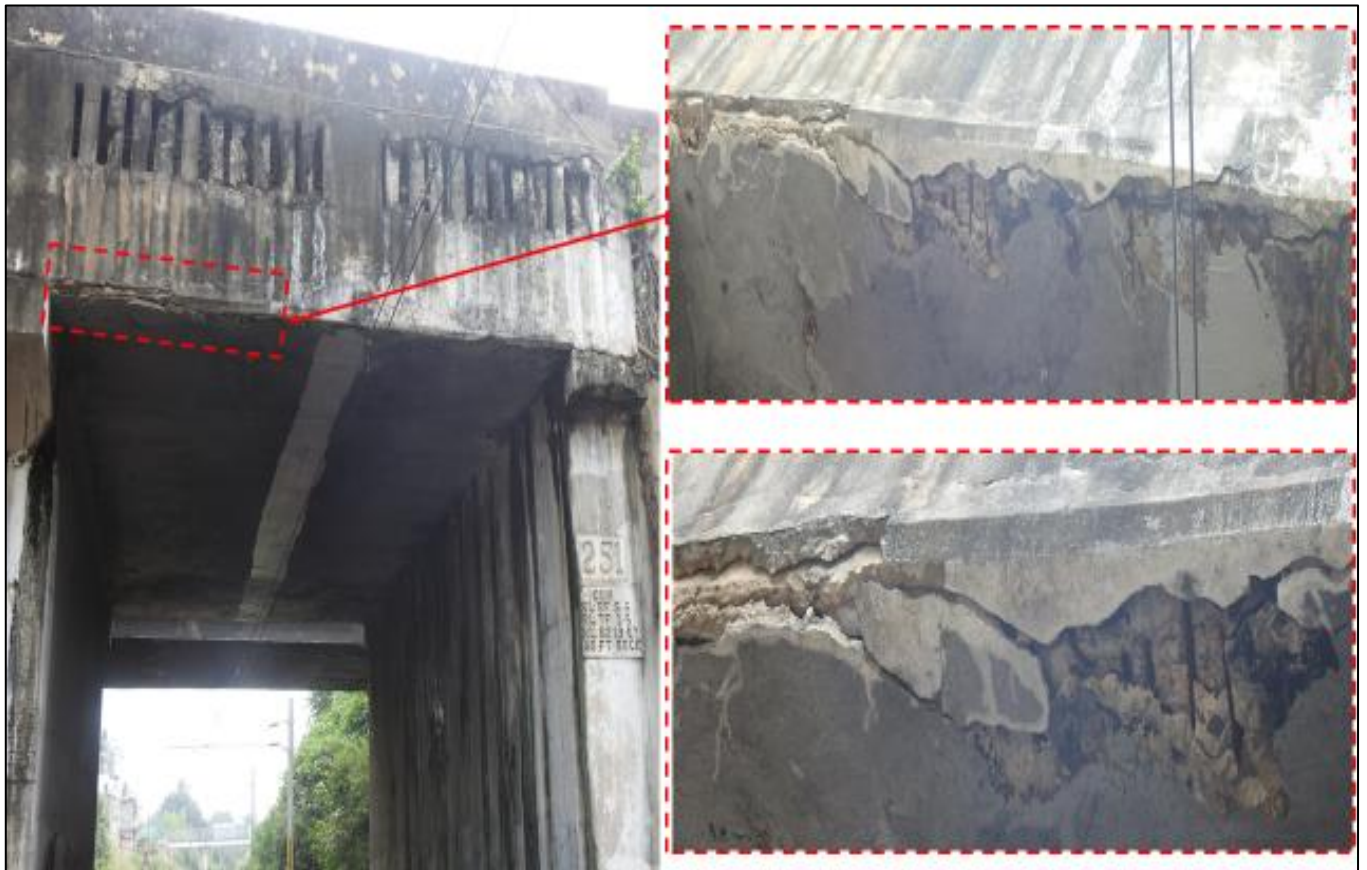
**Fig 11:** Reinforcement exposure observed at Span-2

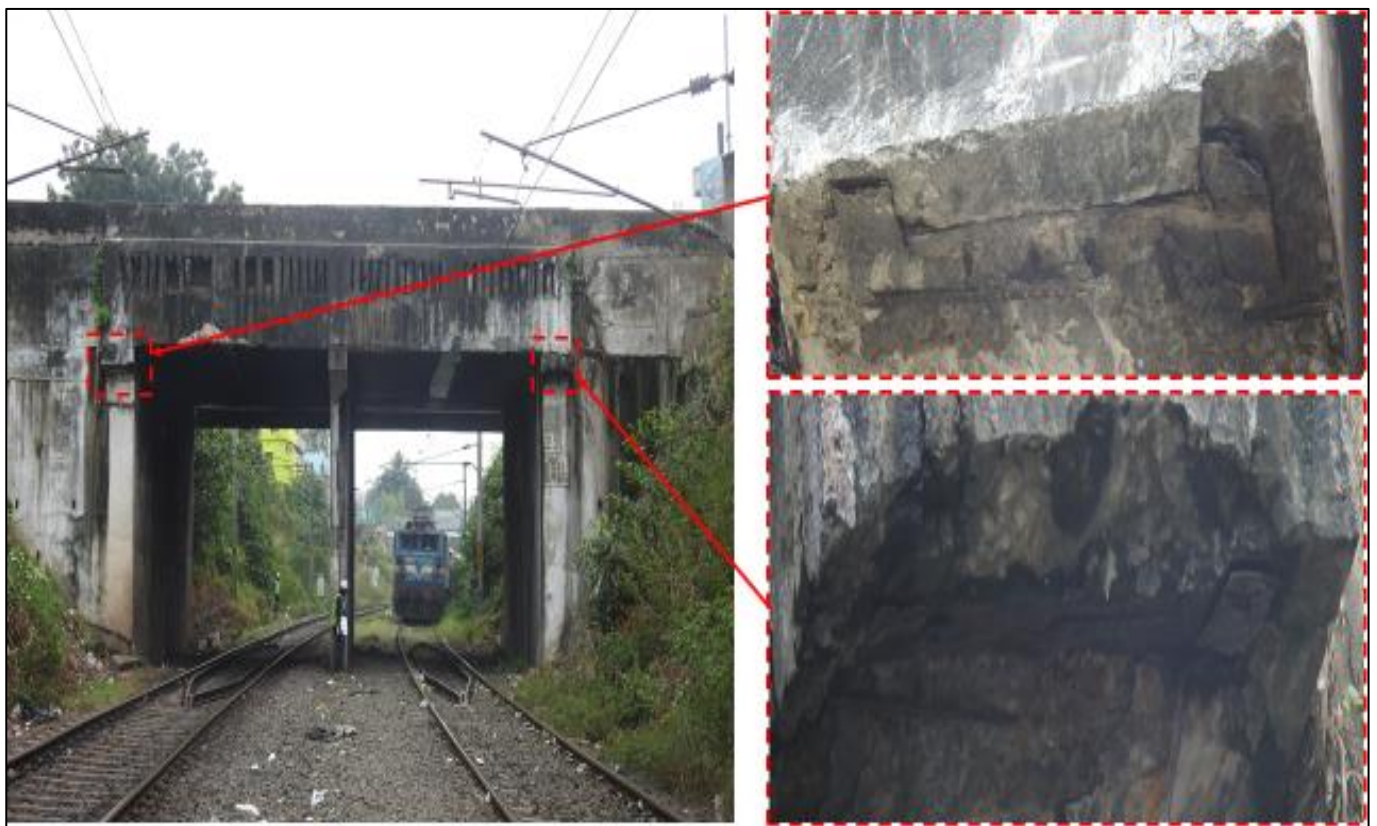
**Fig 12:** Spalling observed at both Abutment Pier caps

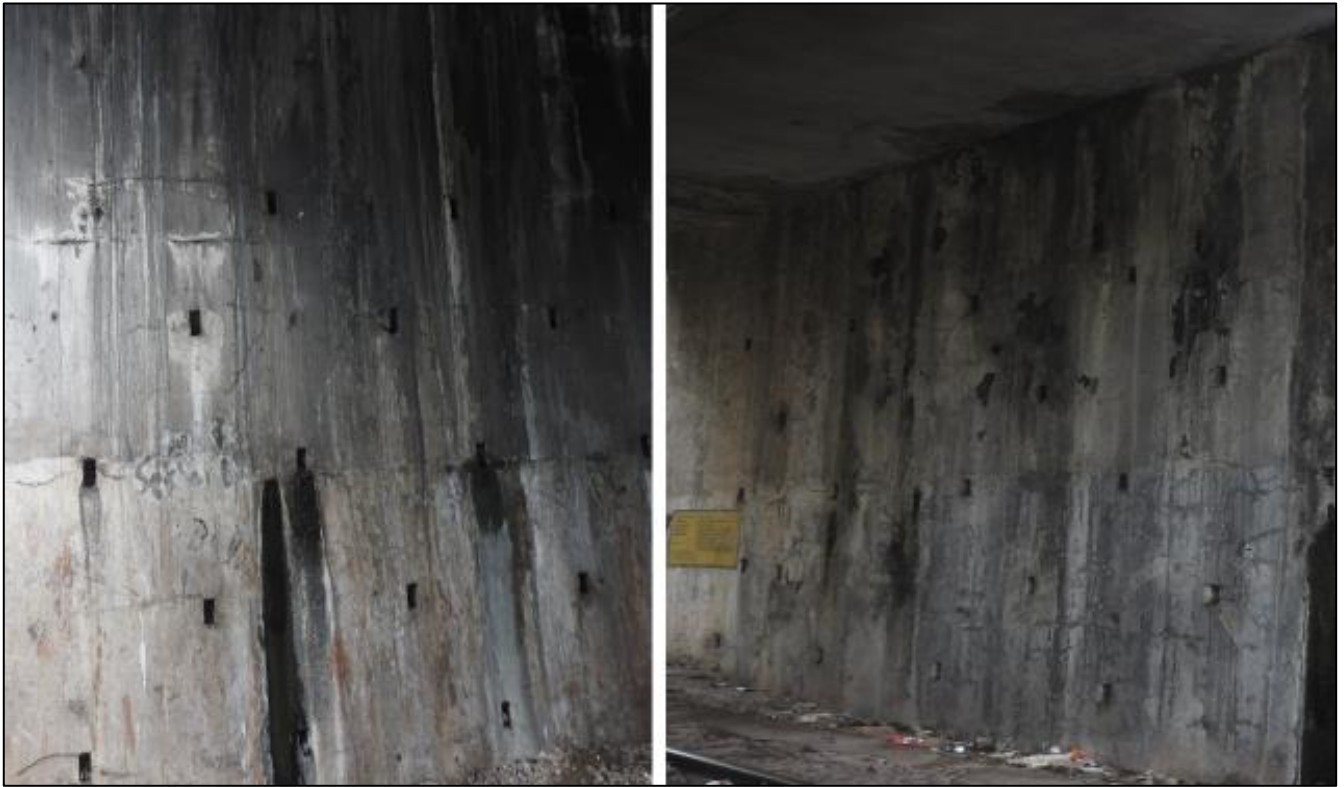
**Fig 13:** Shrinkage cracks observed on A1 & A2 Abutments

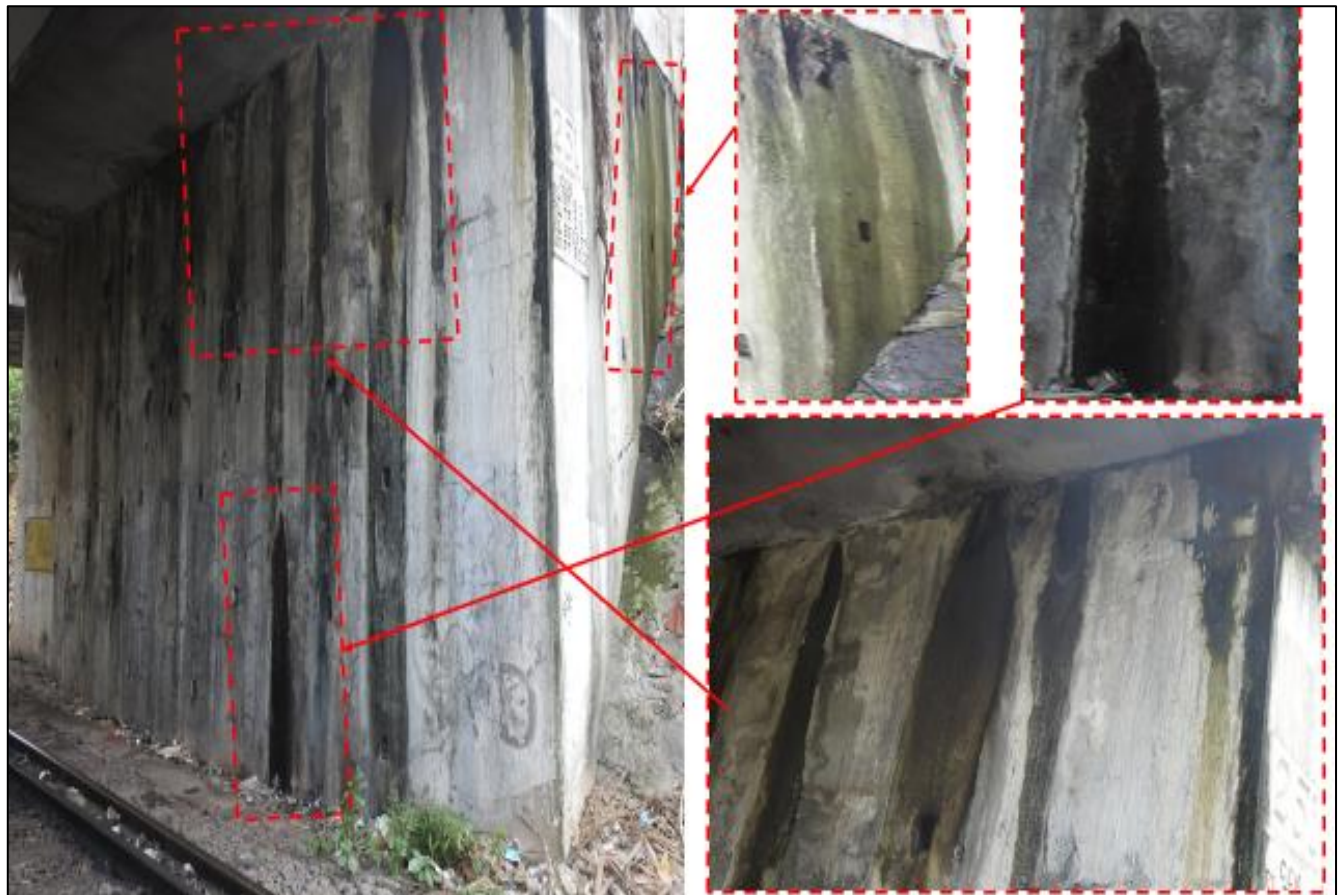
**Fig 14:** Algae observed on Abutment-2

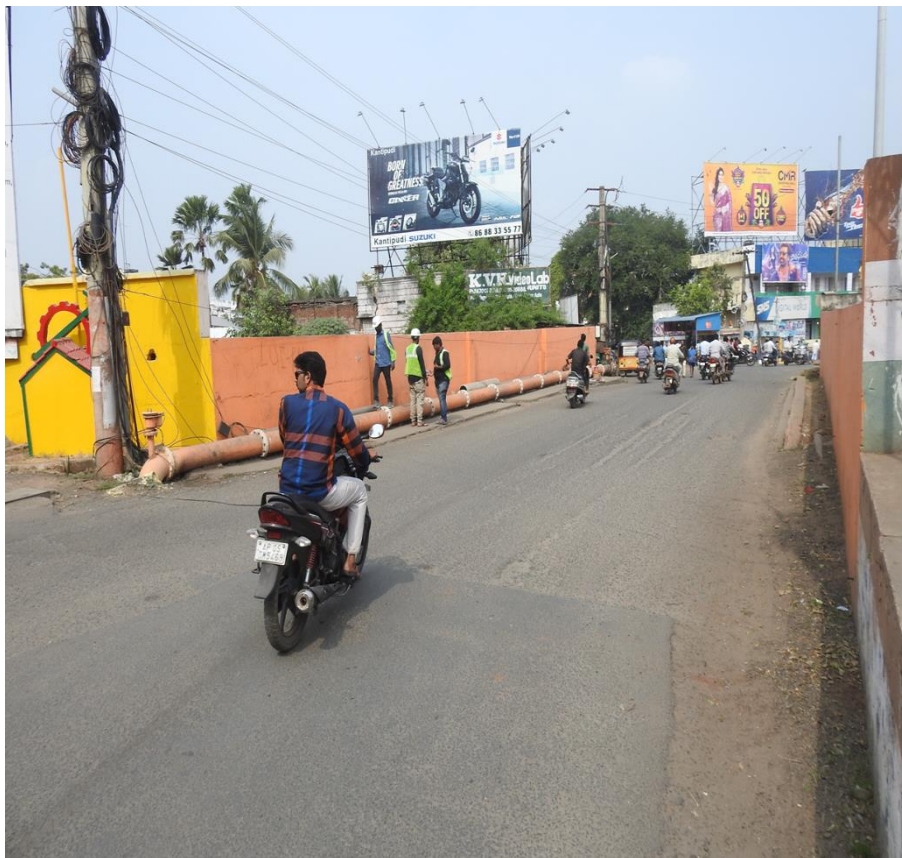
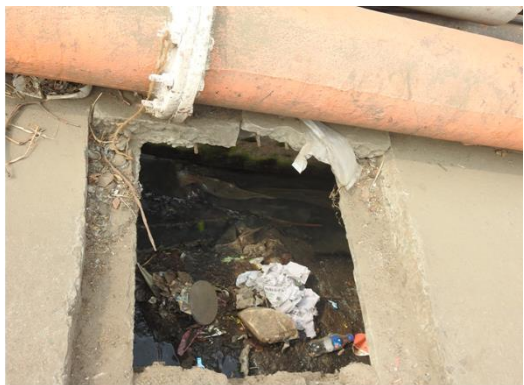
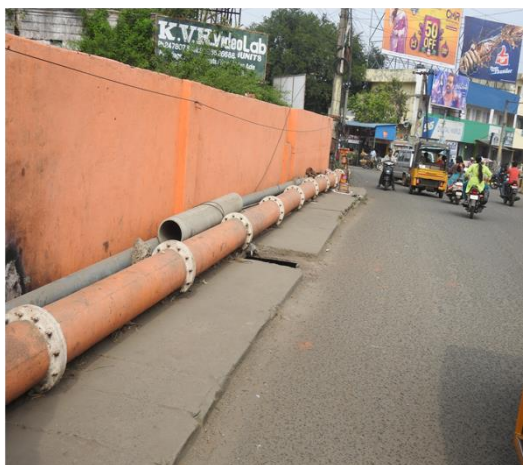
***Fig 15: Wearing coat and drain at ROB***

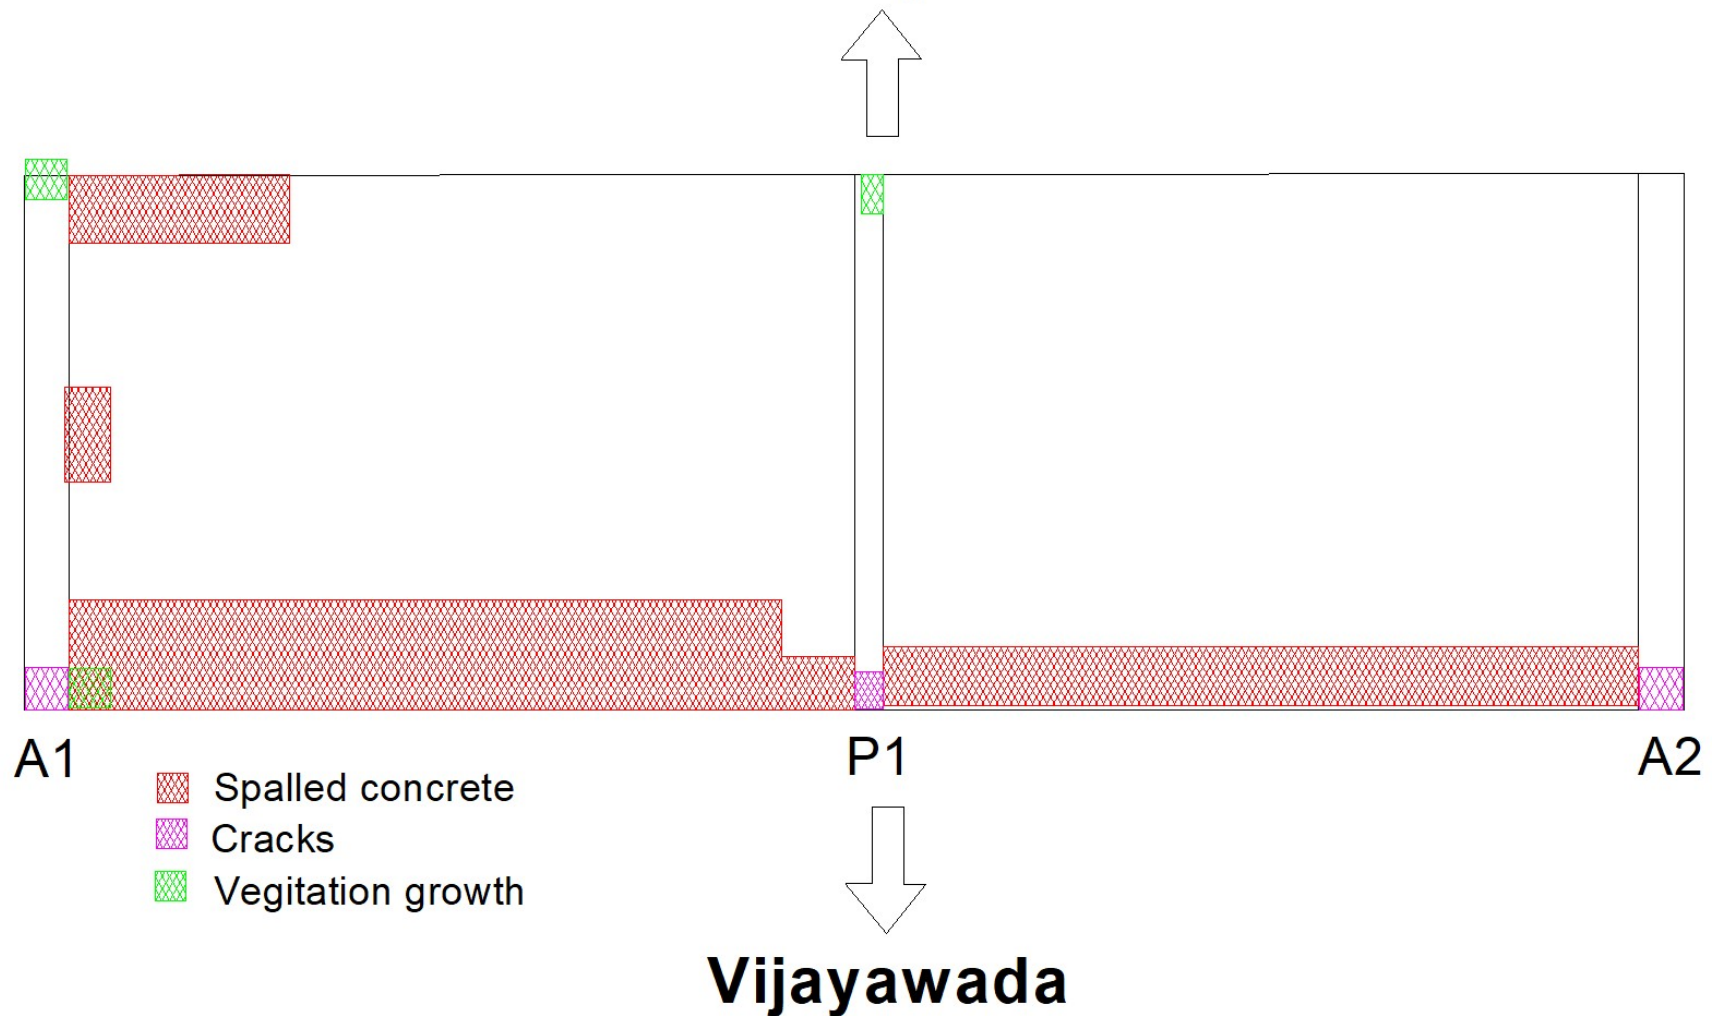
**Fig: 19 Bottom view of ROB with damaged locations**

The detailed visual observation of ROB, the following observations are made. Major Spalling and Reinforcement exposure are observed at Deck slab as shown in the above figure, Corrosion is seen in the exposed rebars of the Slab. Cracks have been observed at Abutments and Pier cap, Vegetation growth is also observed.

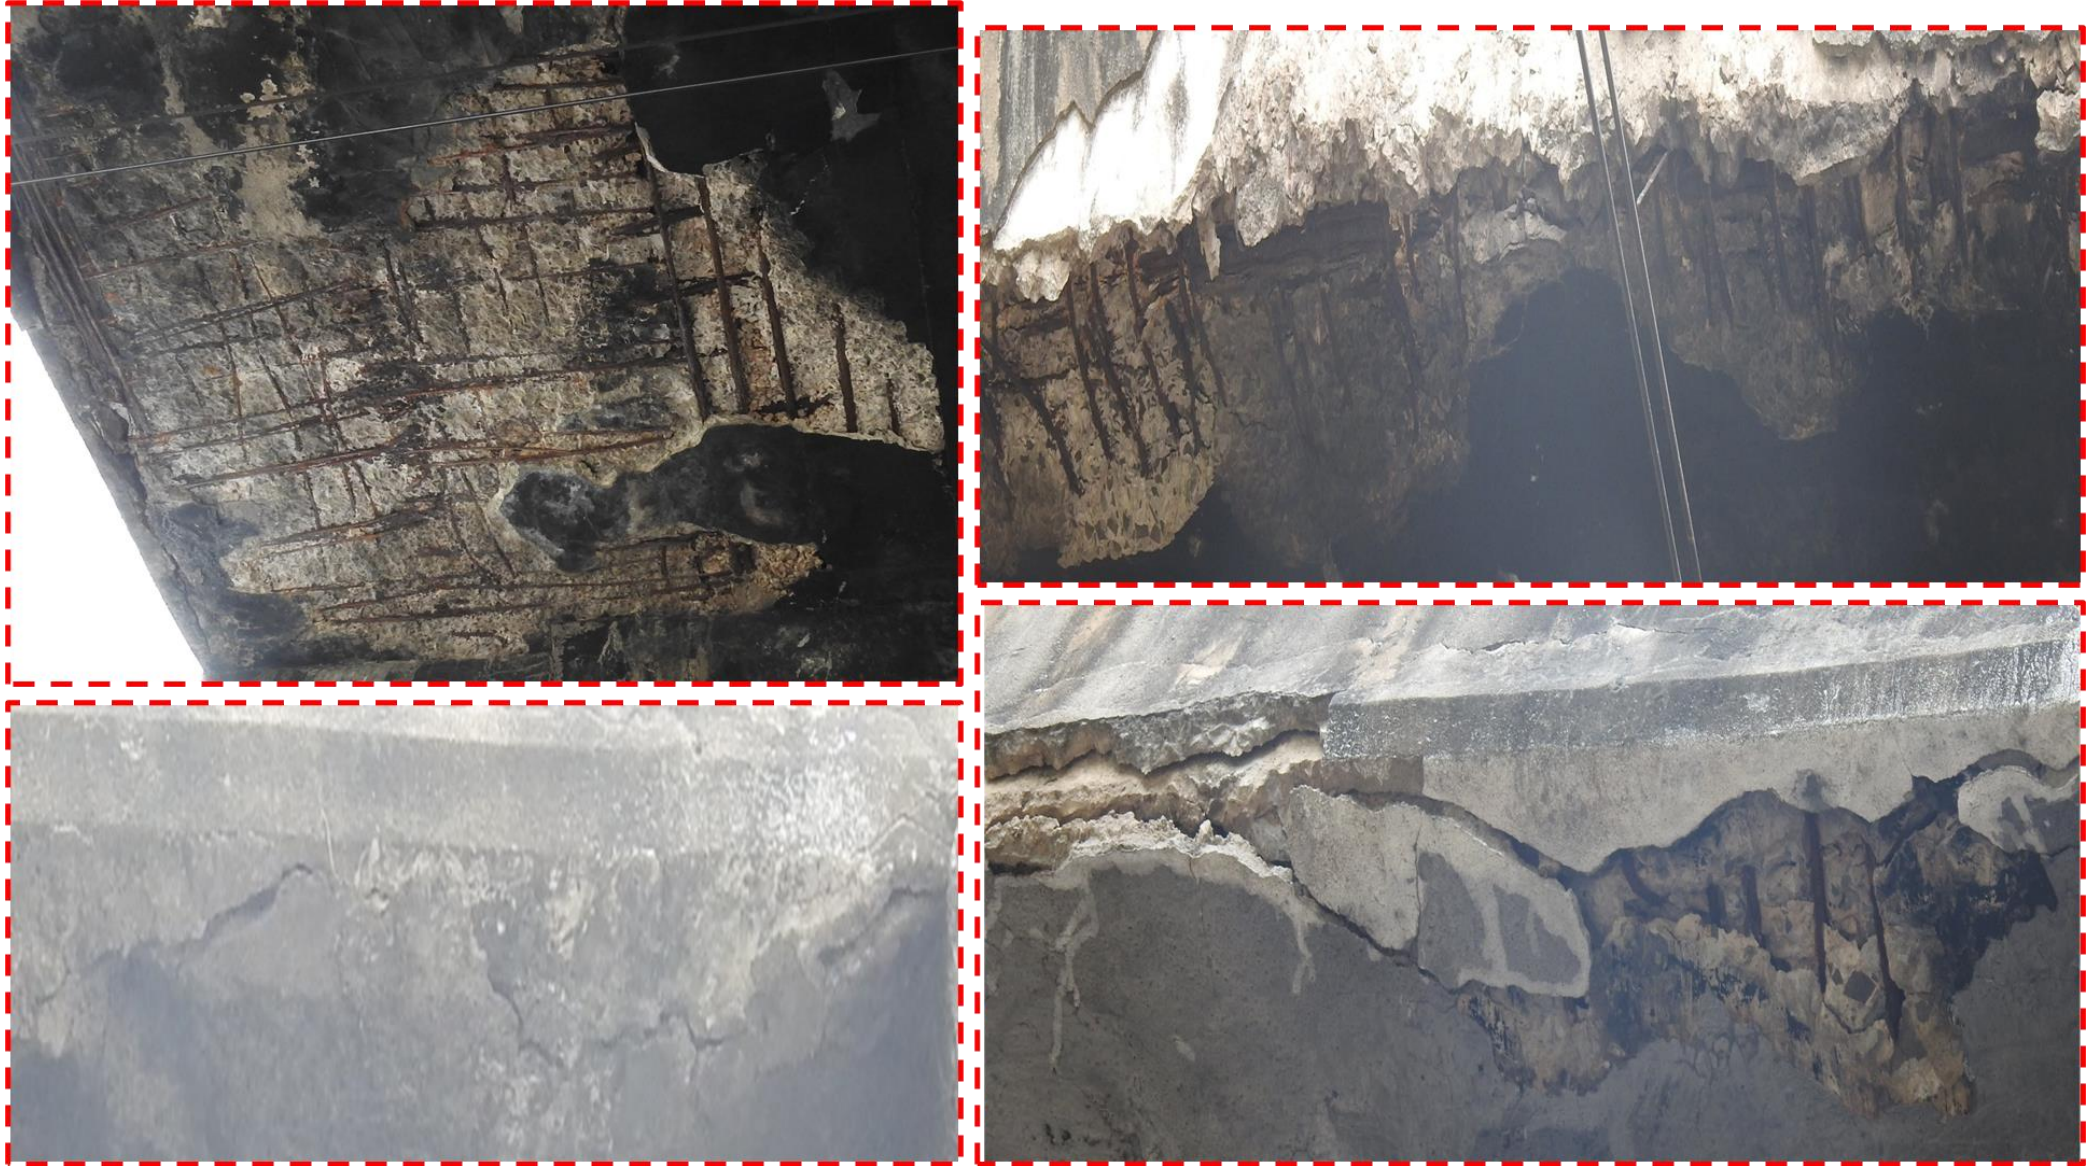
**Fig: 20** Deterioration of Reinforcement and Major spalling of Deck slab.
