GOVERNMENT OF INDIA
MINISTRY OF RAILWAYS
(Railway Board)

No.2017/CE-IV/RUB/88

Sub: Prevention of water logging at subways/RUBs.

A Supplement to Guidelines on Waterlogging and drainage problem in RUBS/Subways issued by Railway Board vide letter No. 2017/CE IV/RUB/88 dated 22.04.2020

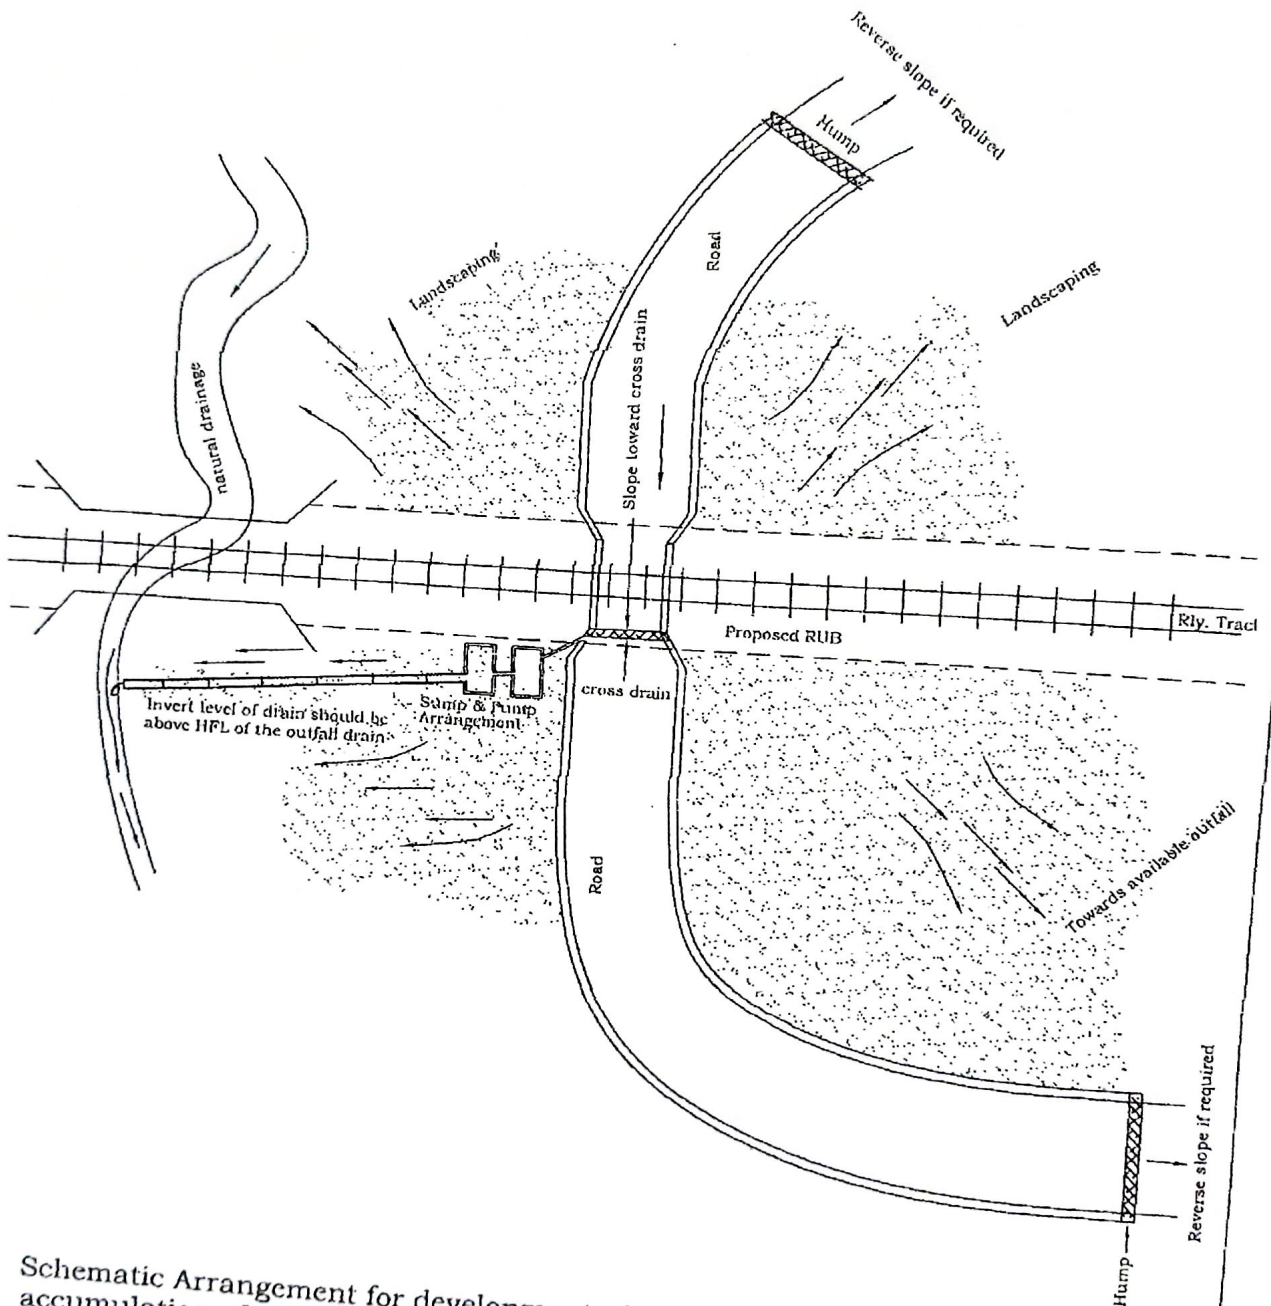
5.	Ingress of water from openings left in retaining wall.	Leftover openings should be filled up & sealed properly with Cement/Epoxy grouting.
6.	Ingress of water due to water logging behind the Retaining wall as earth filling/levelling of surface was not done properly after construction of the wall	Low lying surface behind the Retaining wall should be landscaped suitably so that water does not get accumulated (Annexure-I).

Schematic Arrangement for development of surrounding area to prevent accumulation of water.

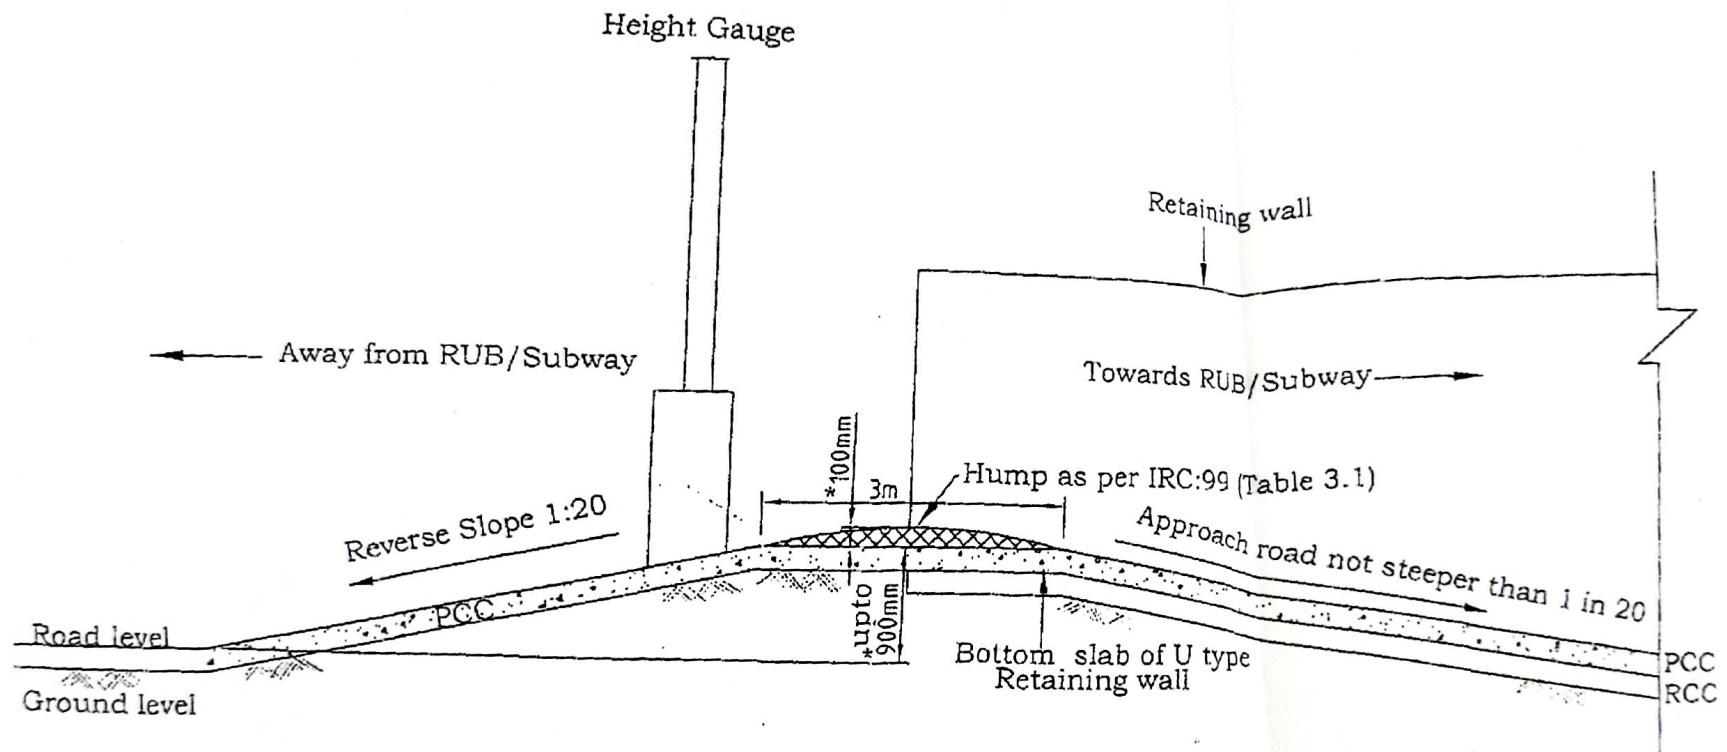
8.	Improper/low height hump and non-provision of reverse slope at the end of retaining wall. Overflow of water over hump.	As per site condition, raised hump with/without reverse slope may be provided. Retaining wall should continue along the approach slope up to the hump or from where reverse slope starts (Annexure-II).

Schematic Arrangement for Reverse slope with Hump
