| <b>Name of the Project</b> | : VISUAL INSPECTION OF FOB/ PF-1 - PF-2 AT NECKLACE ROAD RAILWAY STATION |

## VISUAL INSPECTION OF STEEL FOOT OVER BRIDGE

### PART 1 GENERAL INFORMATION AND OBSERVATION

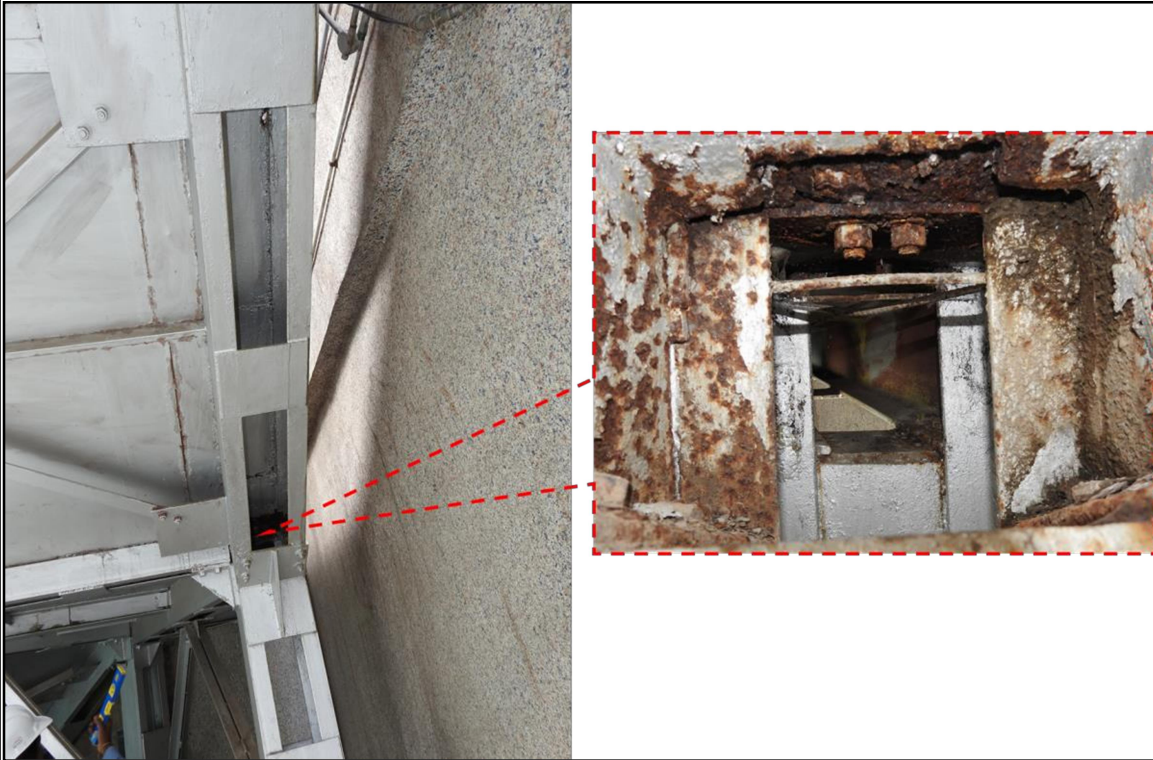
- 4.1 ✓ Corrosion is observed in double channel sections at staircase at PF 2 (Inside the joint)

Corrosion observed at Channel built-up section

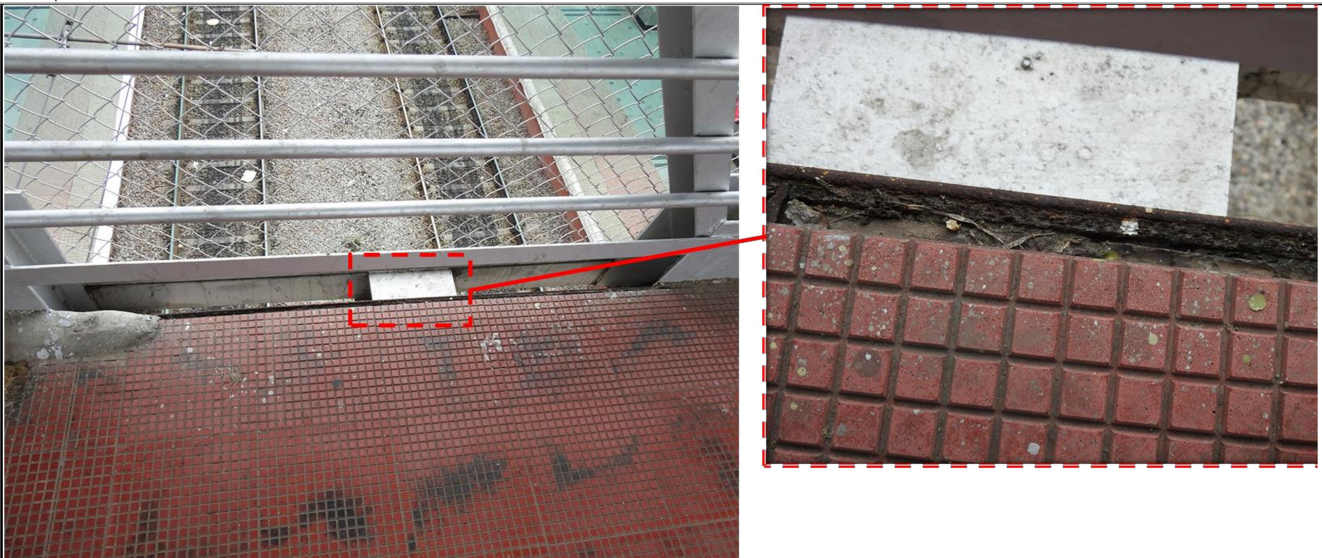
- 4.2 ✓ Corrosion is observed at tie members (Double channel section) along the span of FOB

Corrosion observed at slab resting  
area & tie member

| PART 4 SURVEY OF SIGNS OF DISTRESS, DEFORMATION IN BRIDGES | | | |
|---|---|---|---|
| | Extent of Corrosion | | Corrosion is observed along the span of FOB in slab resting area |
| | Corrosion at steel-Concrete joint | Tie members of clear span | Corrosion is observed at steel concrete joint |

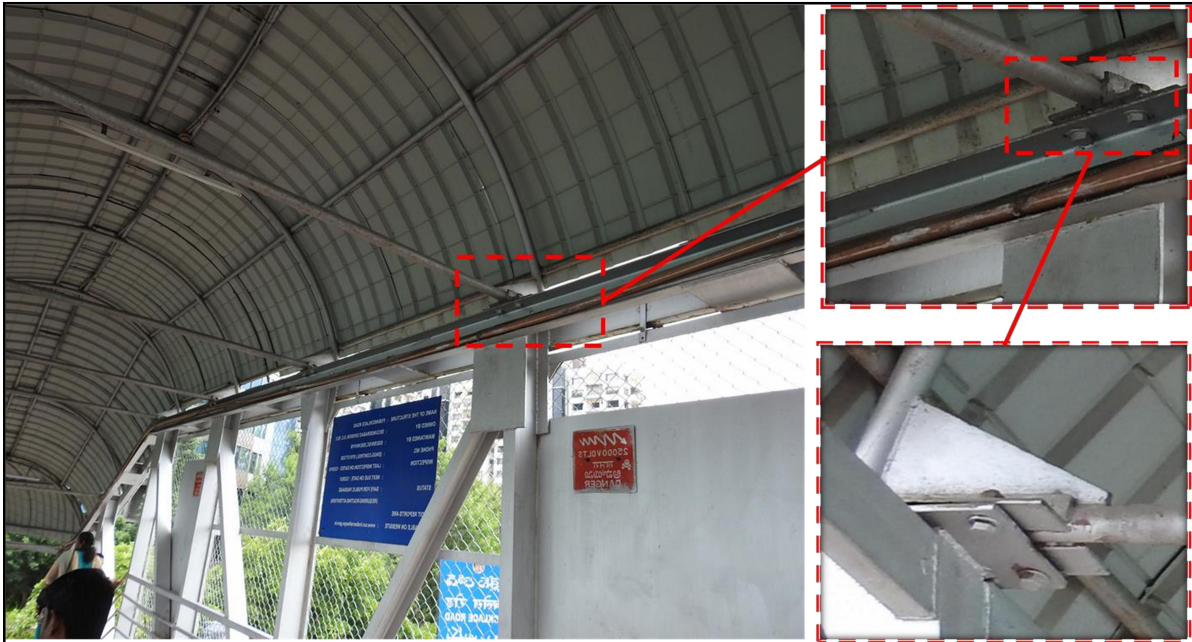
**Fig 1:** Electrical Cables, Roof truss and Roof sheet and bolted connection

| PART 2 IDENTIFICATION OF LOADS ON BRIDGE | | | |
|---|---|---|---|
| | b) Cables | Yes | Cables are protected with 1-inch dia HDPE pipe<br>(Refer <b>fig :1</b> )<br>1-inch Hollow circular sections are used (truss member)<br>(Refer <b>fig :1</b> )<br>Steel Metal Sheet is used for Roof (Refer <b>fig :1</b> ) |

| PART 3 STRUCTURAL SYSTEM OF THE BRIDGE | | | |
|---|---|---|---|
| | Element of roof truss section | Semi-circular truss supported with hollow pipes | 1-inch Semi-circular truss are used for roof truss, supported on 1-inch Tie Members using welded joints. (Refer <b>fig :1</b> ) |

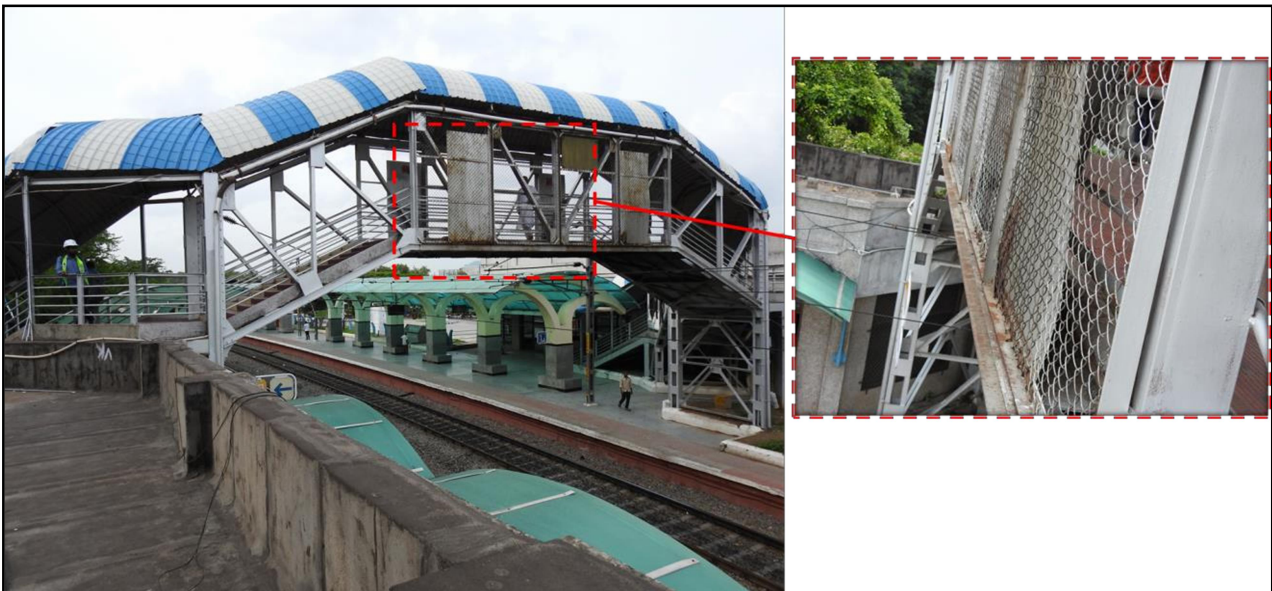
**Fig 2:** Protective screening mesh for passengers

| PART 2 IDENTIFICATION OF LOADS ON BRIDGE | | | |
|---|---|---|---|
| | b) Provision of protective screen for passengers | Yes | Chain link fence made of Galvanized wire of 2 mm gauge and 2 mm Galvanized sheet is used above OHE Line on both side of pathway is used for Protection. Mesh frame is supported with angular and MS flats.<br>(Refer <b>fig :2</b> ) |

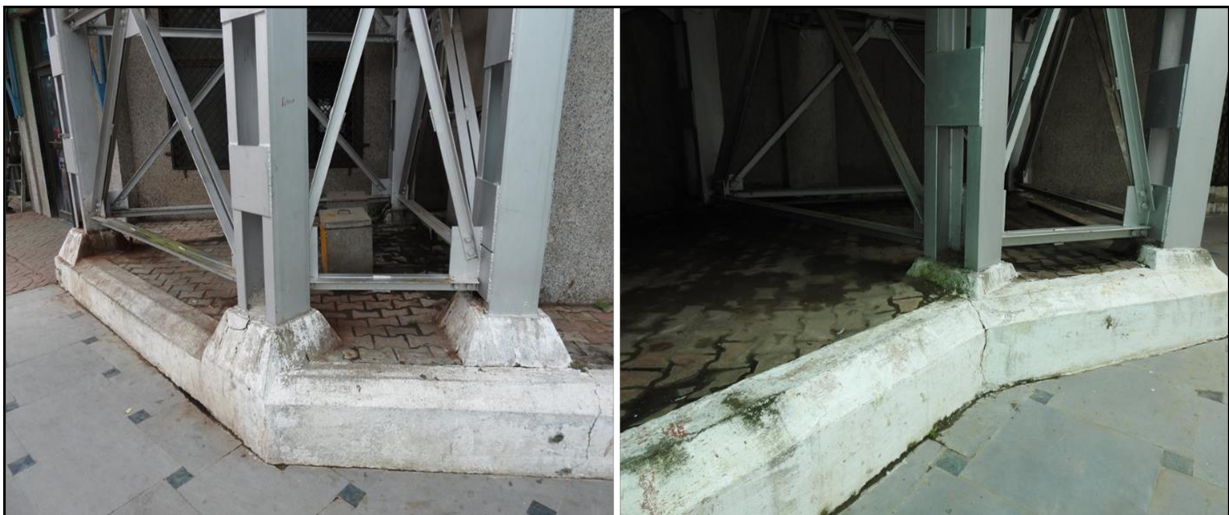
**Fig 3:** Trestles and their protection with concrete encasement

| PART 3 STRUCTURAL SYSTEM OF THE BRIDGE | | | |
|---|---|---|---|
| 3.2 | <b>Pedestal/Base plate details</b> | Not visible | Trapezoidal concrete encasement is observed at platform level for vertical supports (Refer <b>fig: 3</b> ) |

| | Type/Shape of Column section | Channel Section | a. Truss supported on ISMC 250 double channel section<br>b. Supported with angular bracings of 75x 75 x 8 mm<br>c. 10 mm thick gusset plate is used. (Refer <b>fig :3 and 6</b> ) |

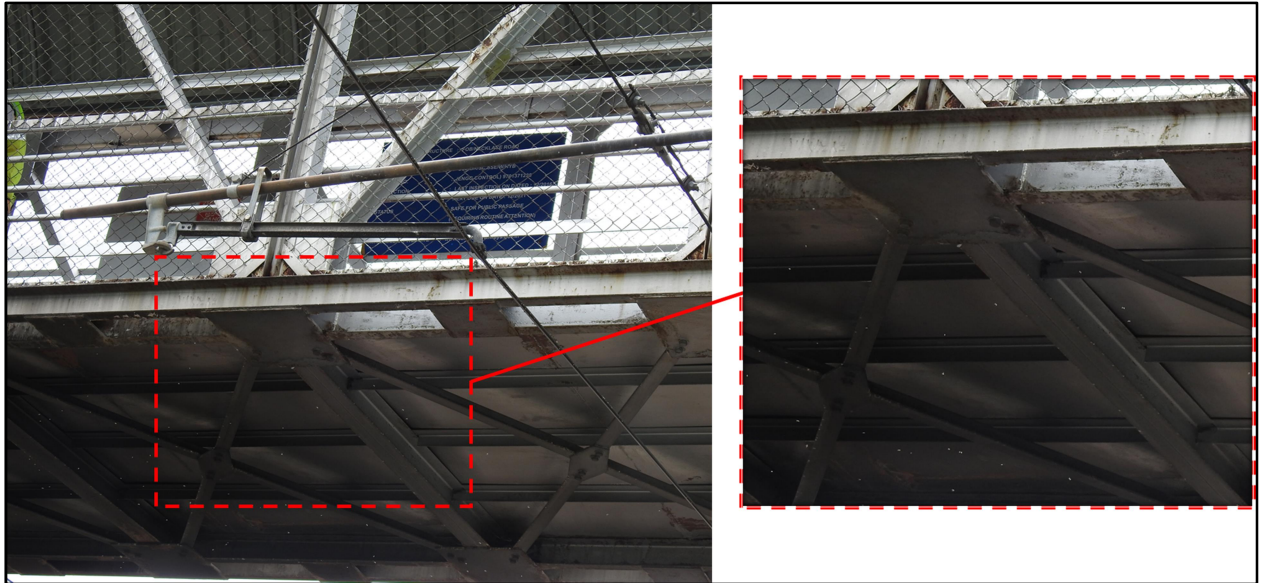
***Fig 4: Tie members and secondary girders with bracings***

| | Height of Truss (H) | 2.75 m | b. Truss supported on ISMC 250 double channel section<br>c. Diagonal bracings of ISMC 150<br>d. Angular bracings of 75x 75 x 8 mm are supported for base slab. (Refer <b>fig :4 and 5</b> ) |

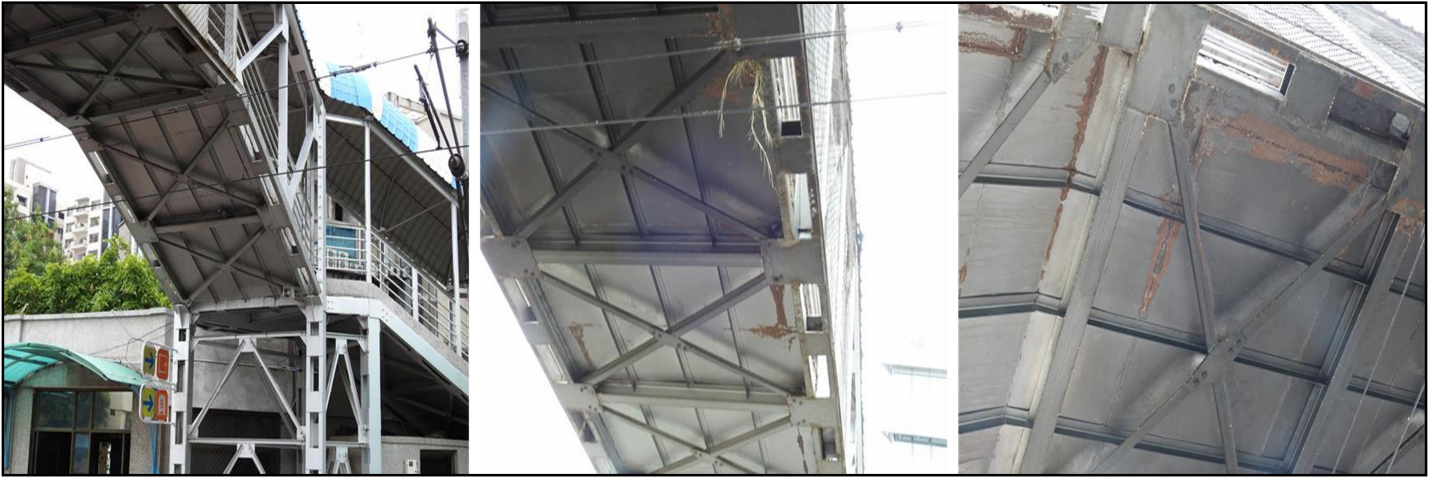
**Fig 7:** Rusting of sacrificial plate

- a) From visual inspection, Slight rusting is observed at in the sacrificial plate of RCC slab.
- b) Internal corrosion is observed in staircase tie members.

| | Material of Slab | RCC | a. RCC slab casted in-situ supported on sacrificial plate.<br>b. Chequered tiles flooring used<br>c. RCC slab is supported by angles and secondary girders of ISMC150 (Refer <b>fig :7</b> ) |

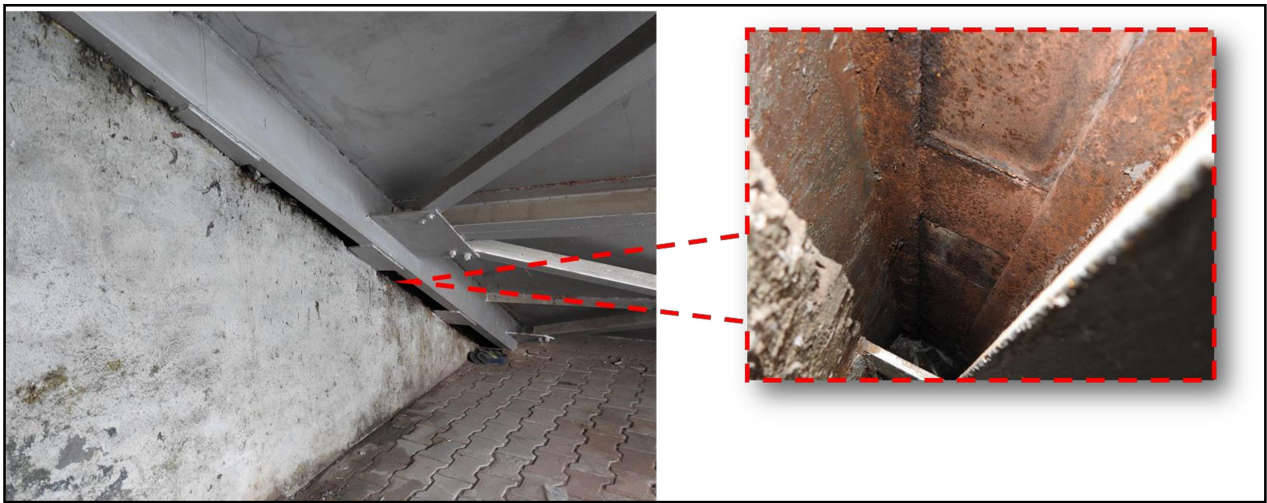
**Fig 8:** Rusting of Channel section at staircase

| | Number of Staircase | 2 no's | Staircase steps are RCC slab cast-in situ. Waist slab is supported on ISMC 250 Channel using cleat Angles. Staircase Landing 3 m wide is supported on Vertical and Horizontal Angular Members. (Refer <b>fig :7&amp;8</b> ) |

| PART 4 SURVEY OF SIGNS OF DISTRESS, DEFORMATION IN BRIDGES | | | |
|---|---|---|---|
| | Rust straining | Staircase supported channel section | Rusting is observed at joints of FOB at double channel section (Refer <b>Fig 8 and 9</b> ) |

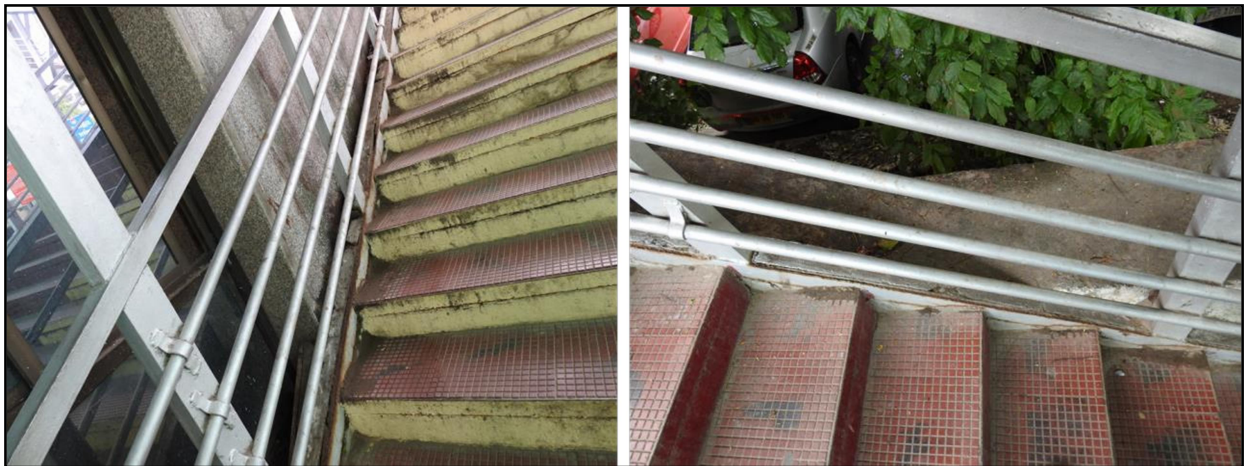
**Fig 9:** Rusting of staircase supporting channels on both sides

| | Type of Parapet Railing | Steel railing | Stair case is provided with Railing on both sides of one-meter height using Angular and Hollow Circular sections. (Refer <b>fig :9</b> ) |
