Third Party Audit of ROB's and FOB's of SCR

INSPECTION OF FOB AT BITRAGUNTA (A) RAILWAY STATION

Final Report

SEPTEMBER | 2020

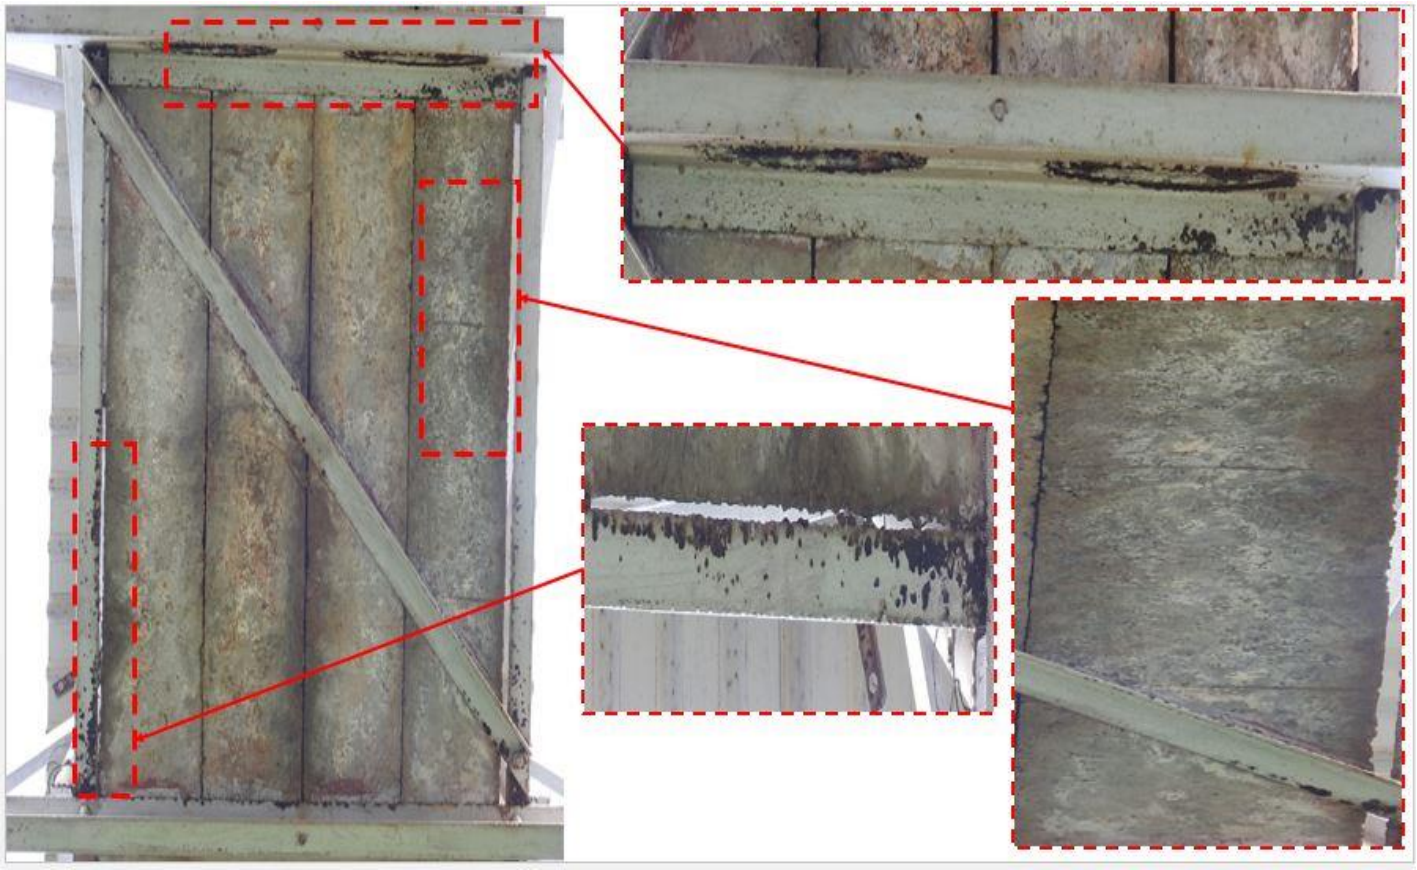
a) Reinforcement exposed and cracks observed at Staircase-1

b) Reinforcement exposed and cracks observed at Staircase-2

c) Reinforcement exposed at Staircase-3 of slab panels

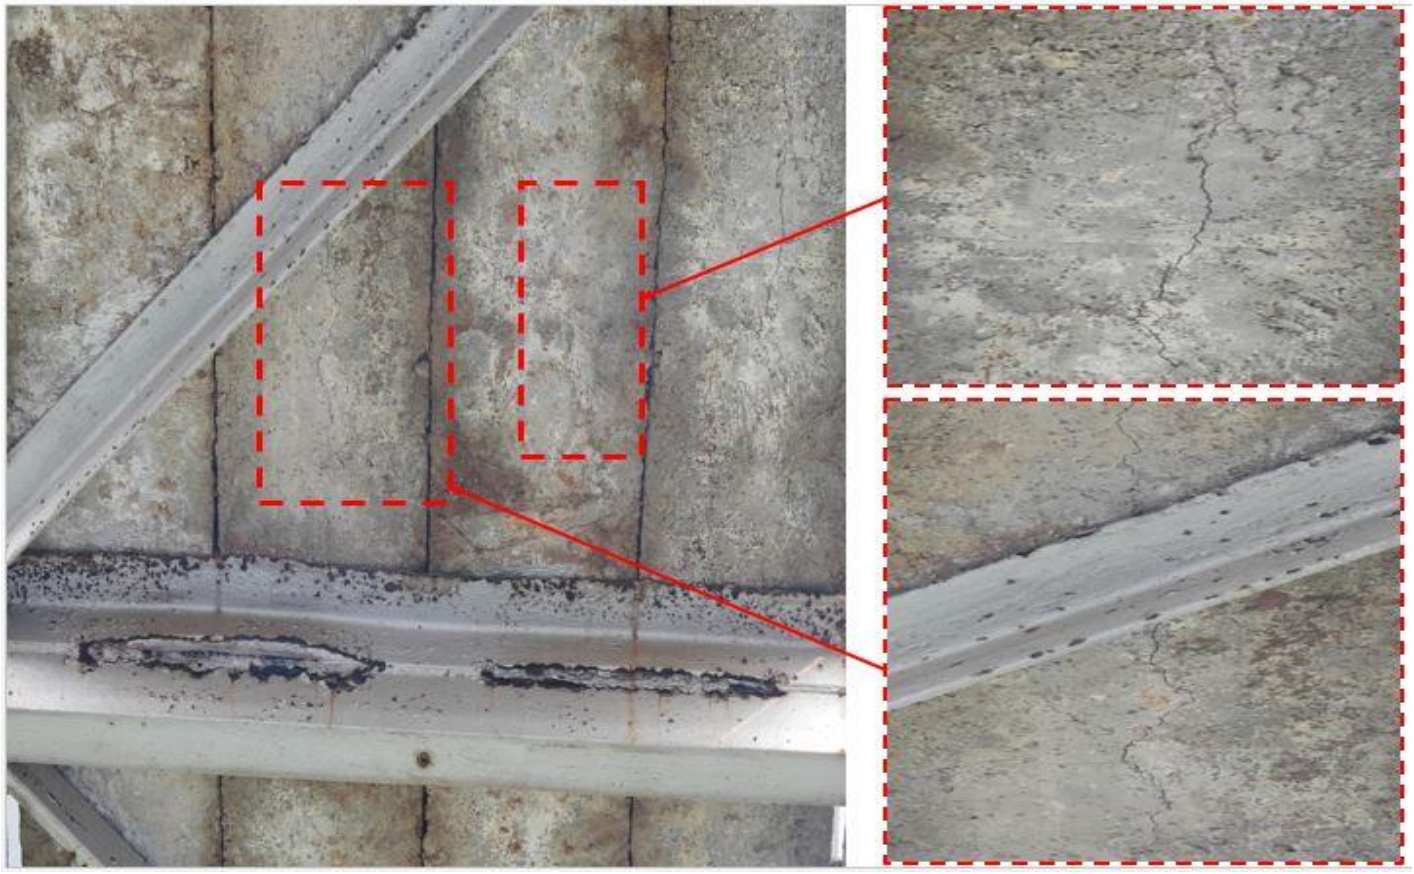
d) cracks observed at Span-2 Floor slab

e) Cracks observed at Span-6 Floor slab

f) Cracks observed at slab panels of Span-9

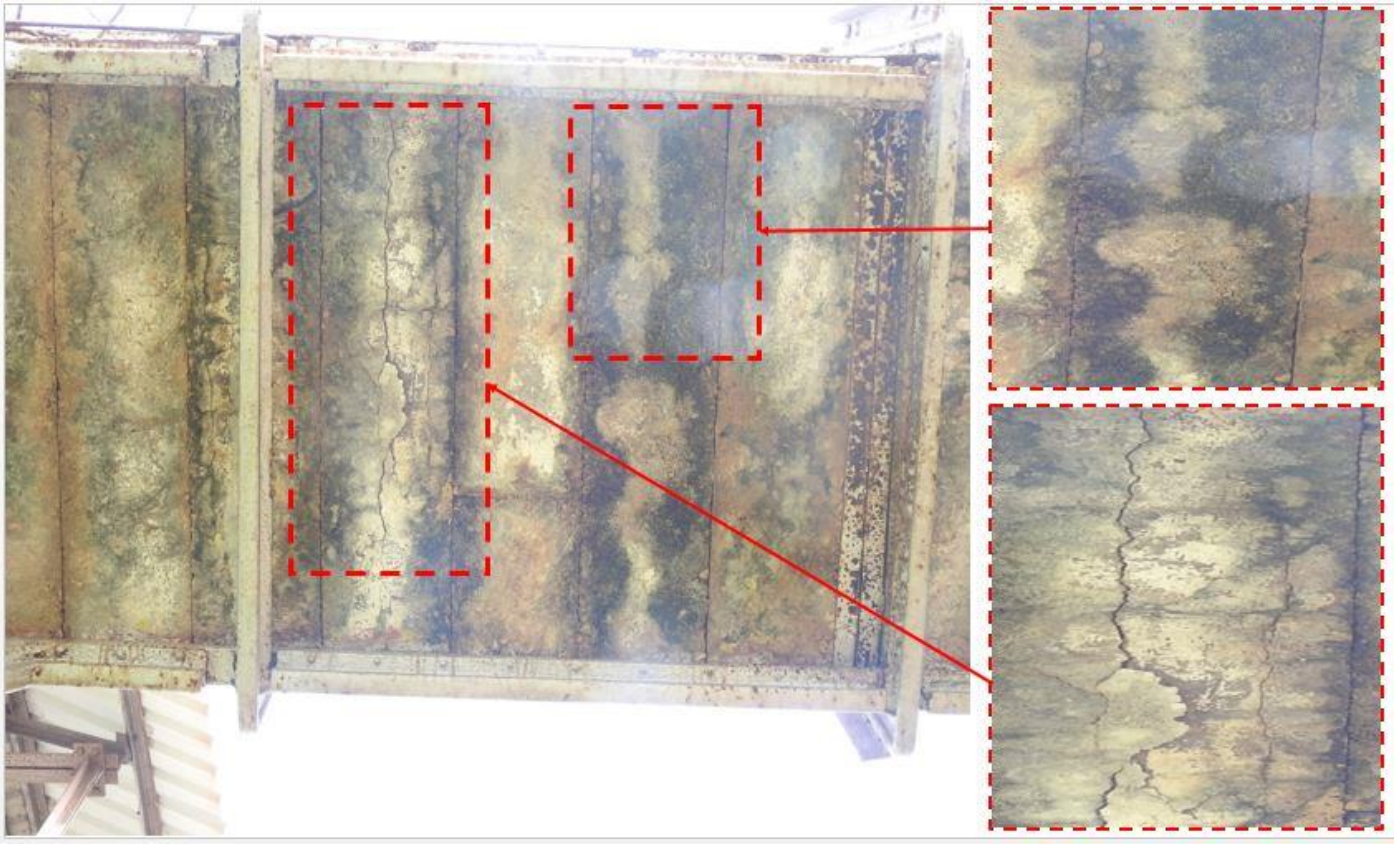
g) Cracks observed at bottom chord and floor beam, leaching at slab panels of Span-10

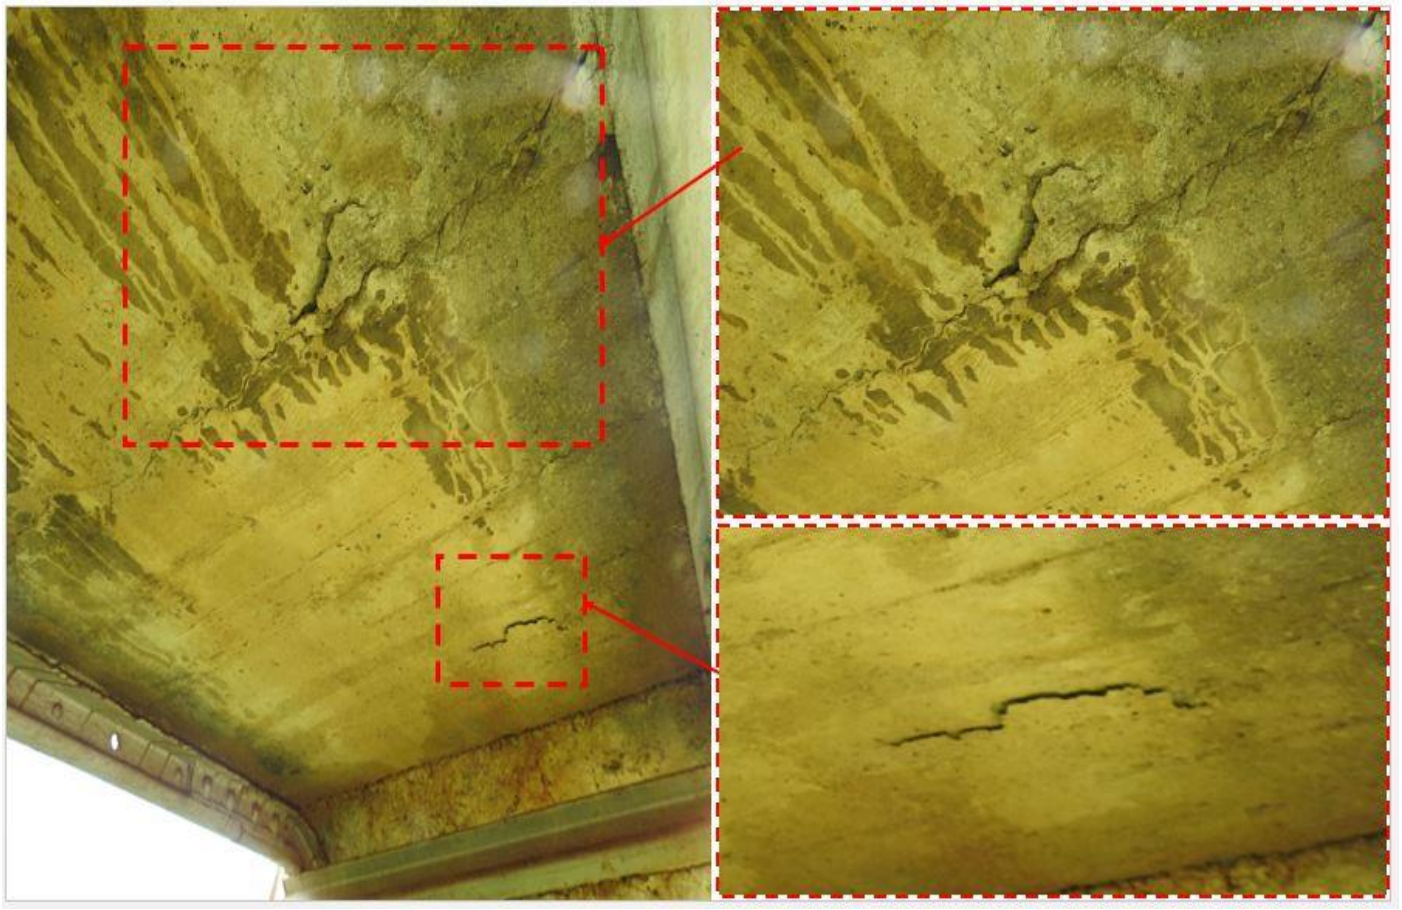
h) Cracks observed at Span-11

i) Cracks and Leaching observed at Span-1

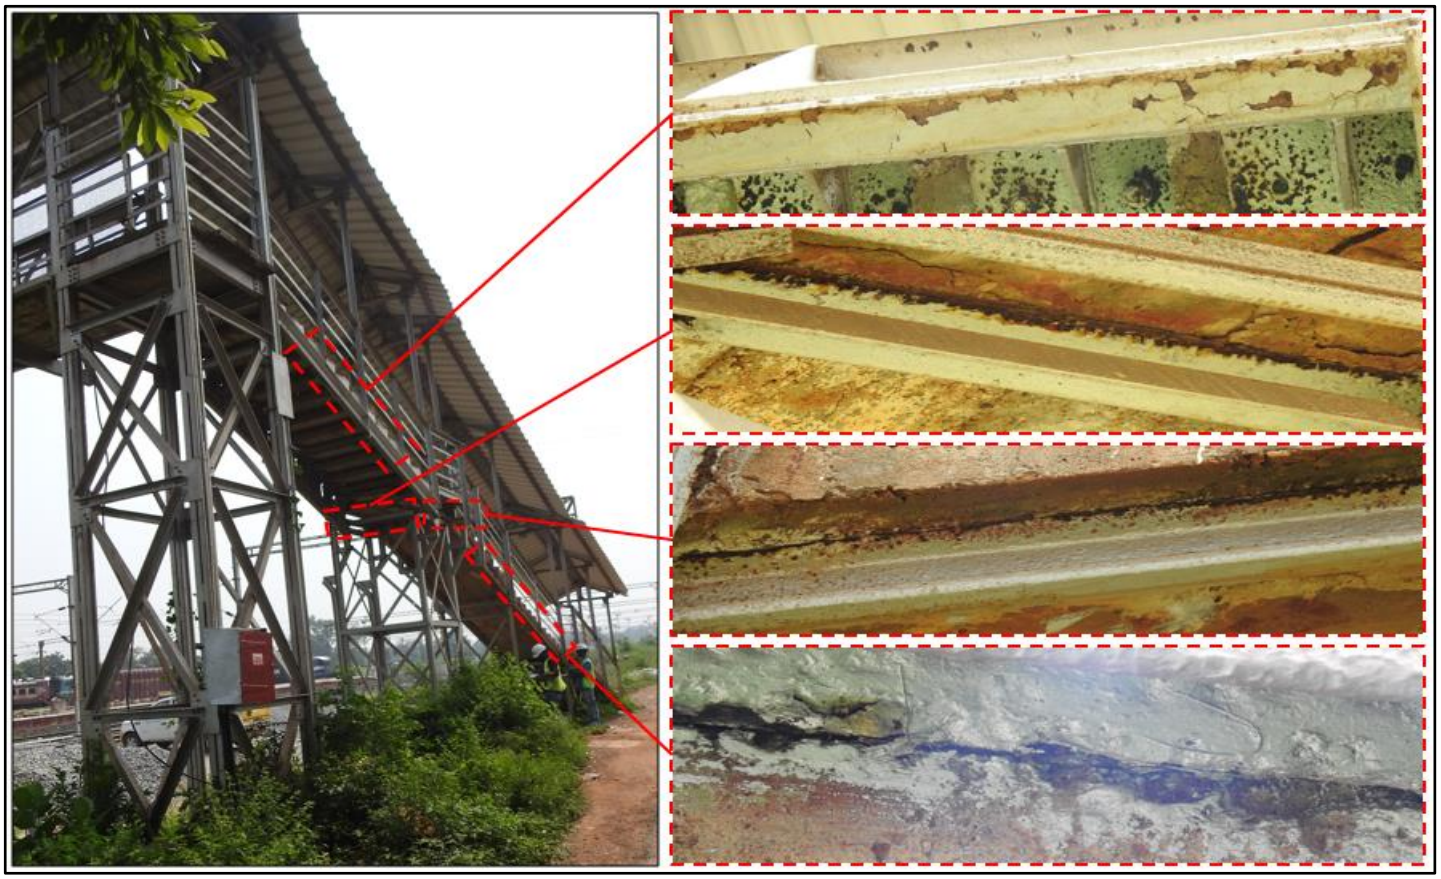
I. Patch Work observed at staircase 2

II. Spalling observed at Staircase-4

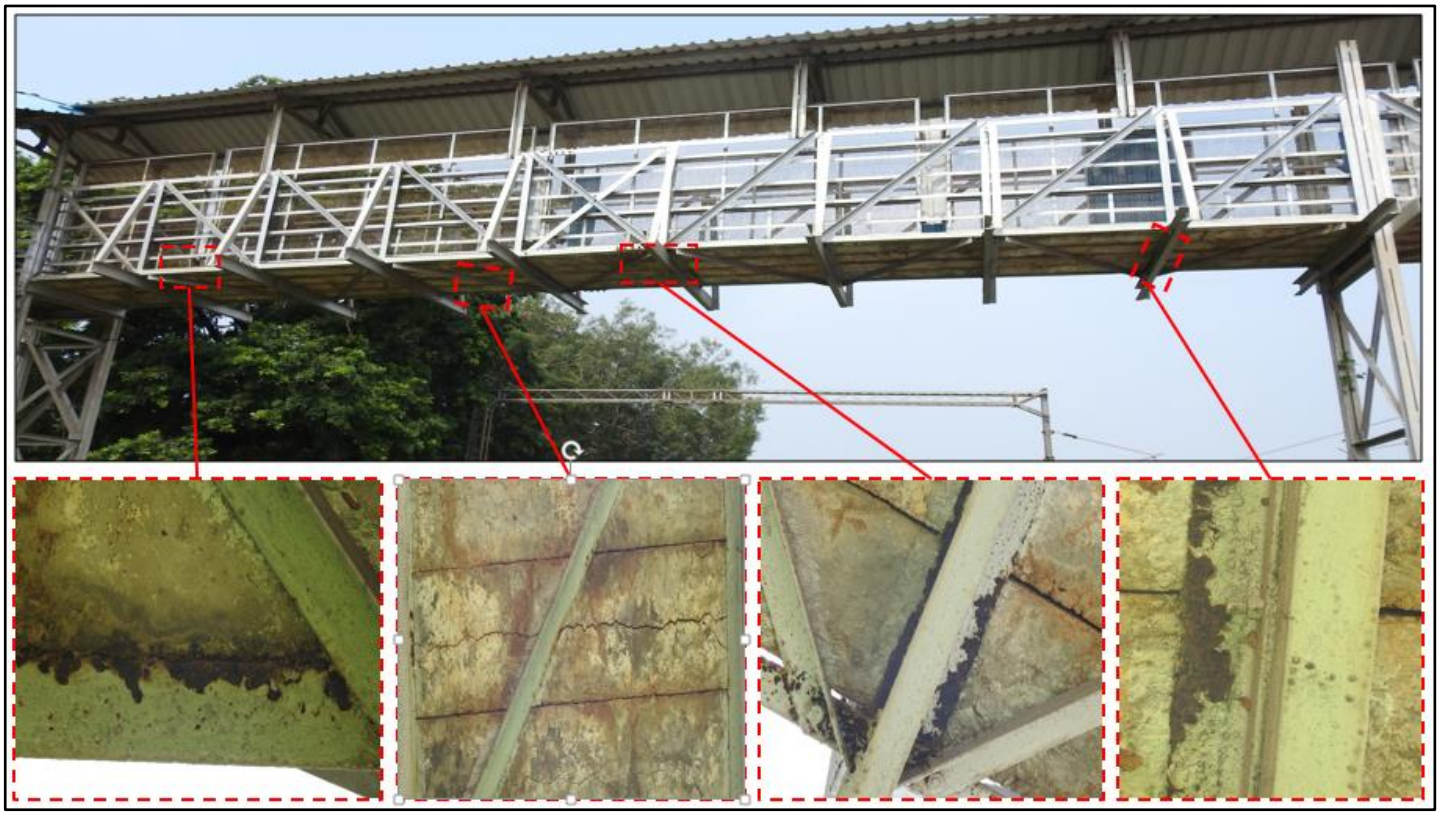
a. Corrosion observed at Stairase-1 Stringer beams and tie beams

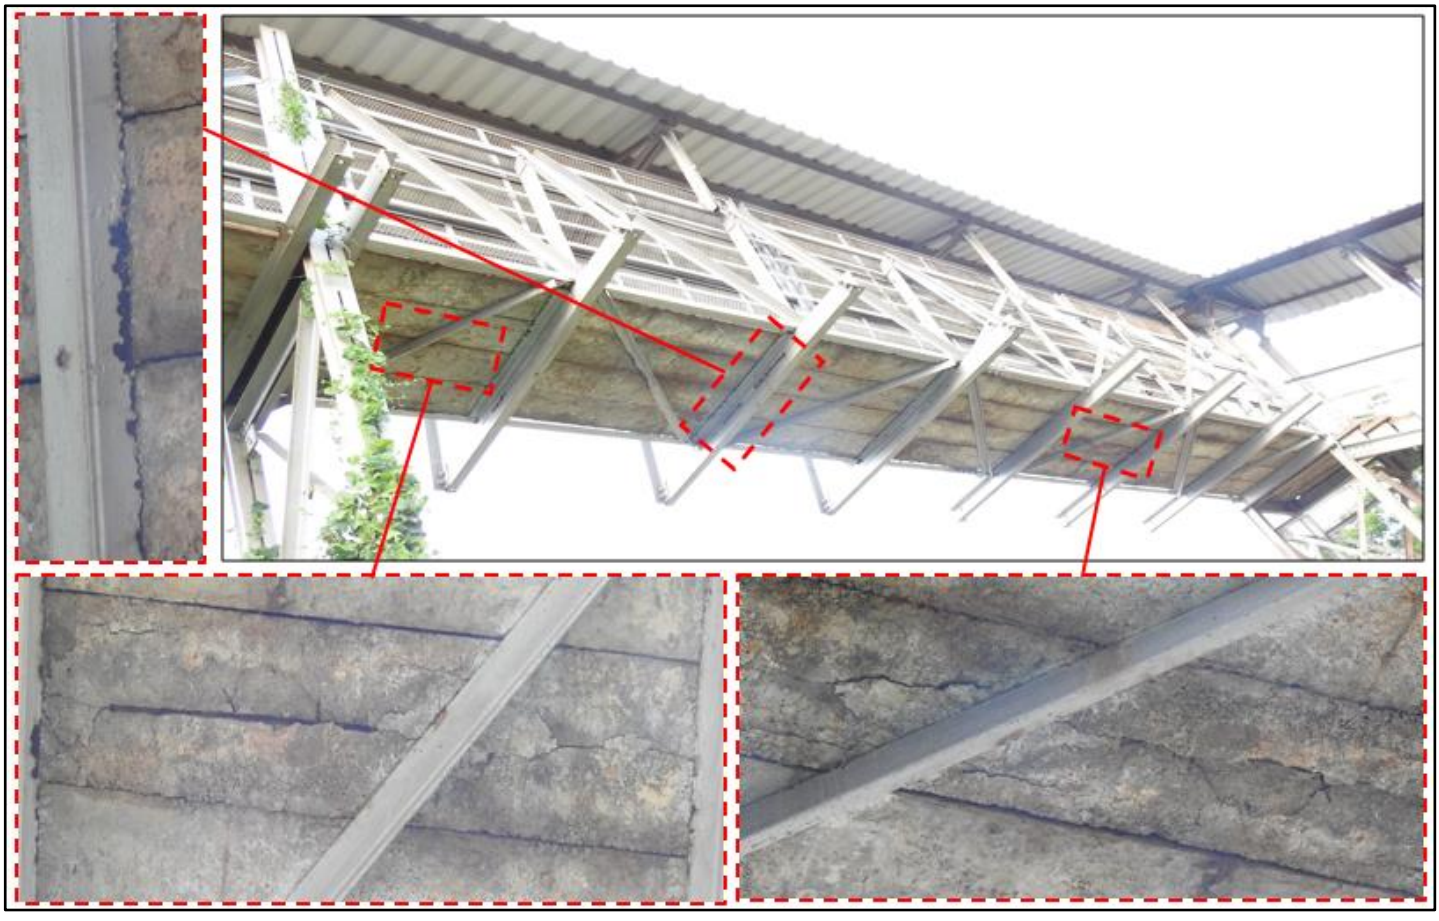
b. Corrosion observed at Stairase-2 Stringer beams and Floor beams

c. Corrosion observed at Span-1 floor beams and bottom chord

d. Corrosion observed at Span-2 floor beams and bottom chord

e. Corrosion observed at Span-3 floor beams and bottom chord

f. Corrosion observed at Span-4 floor beams and bottom chord

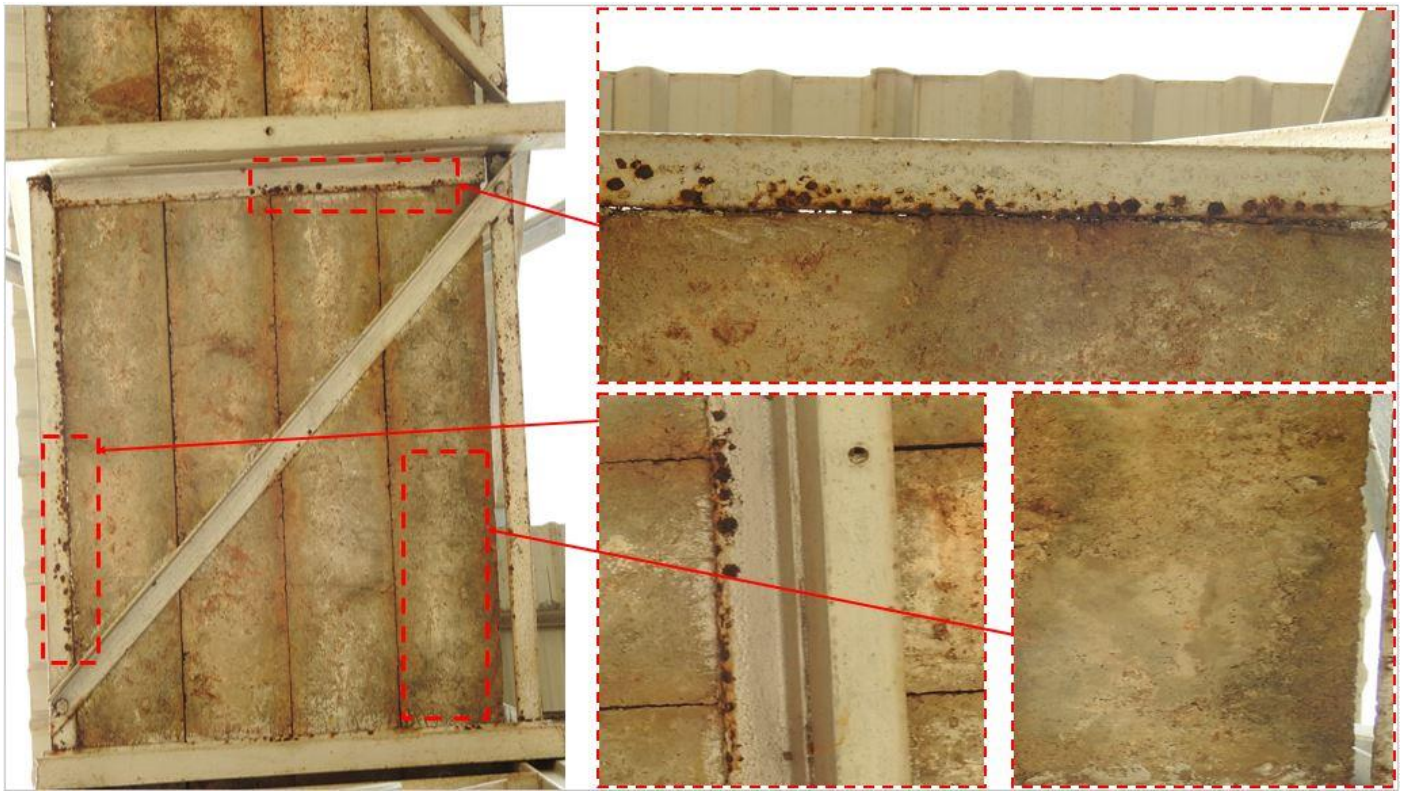
g. Corrosion observed at Span-5 floor beams and bottom chord

i. Corrosion observed at Span-6 floor beams and bottom chord

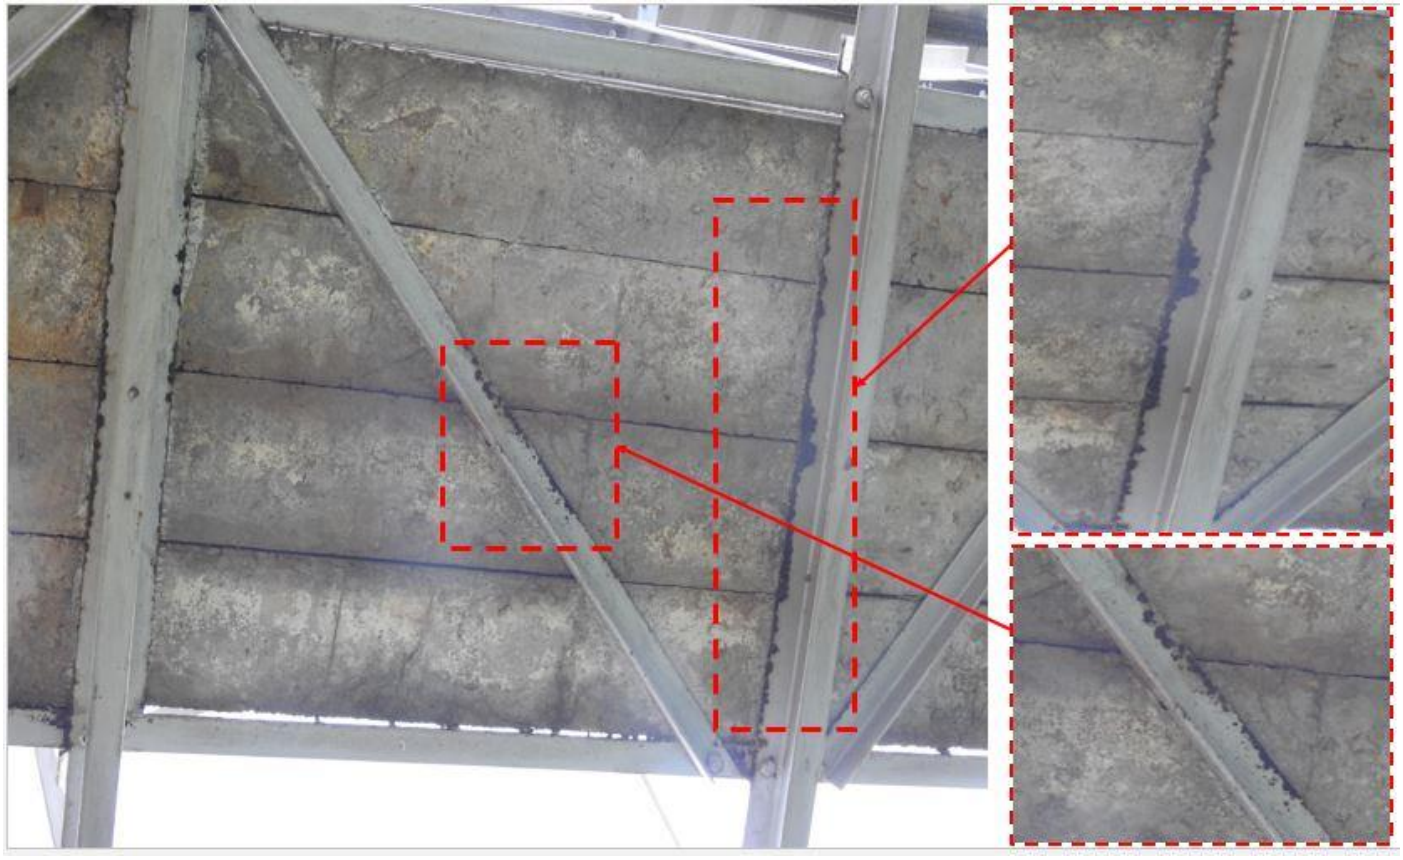
i. Corrosion observed at Span-7 floor beams, Reinforcement exposed and spalling

j. Corrosion observed at Span-8 of bottom chord, floor beam & leaching at slab panel

k. Cracks and corrosion observed at Span-9

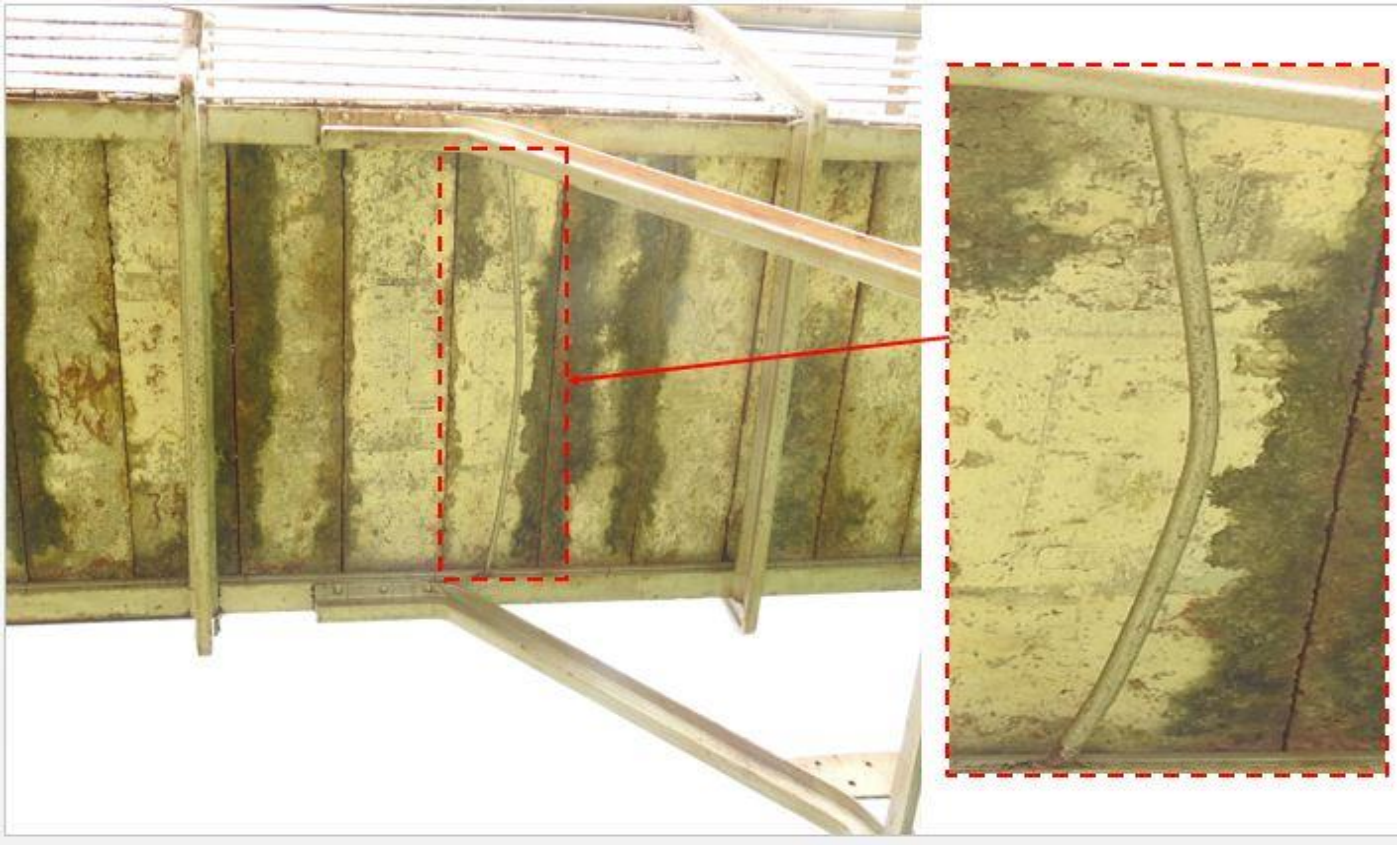
l. Corrosion observed at Span-10 of slab panels

m. Corrosion observed at Floor beam and bracing of Span-11

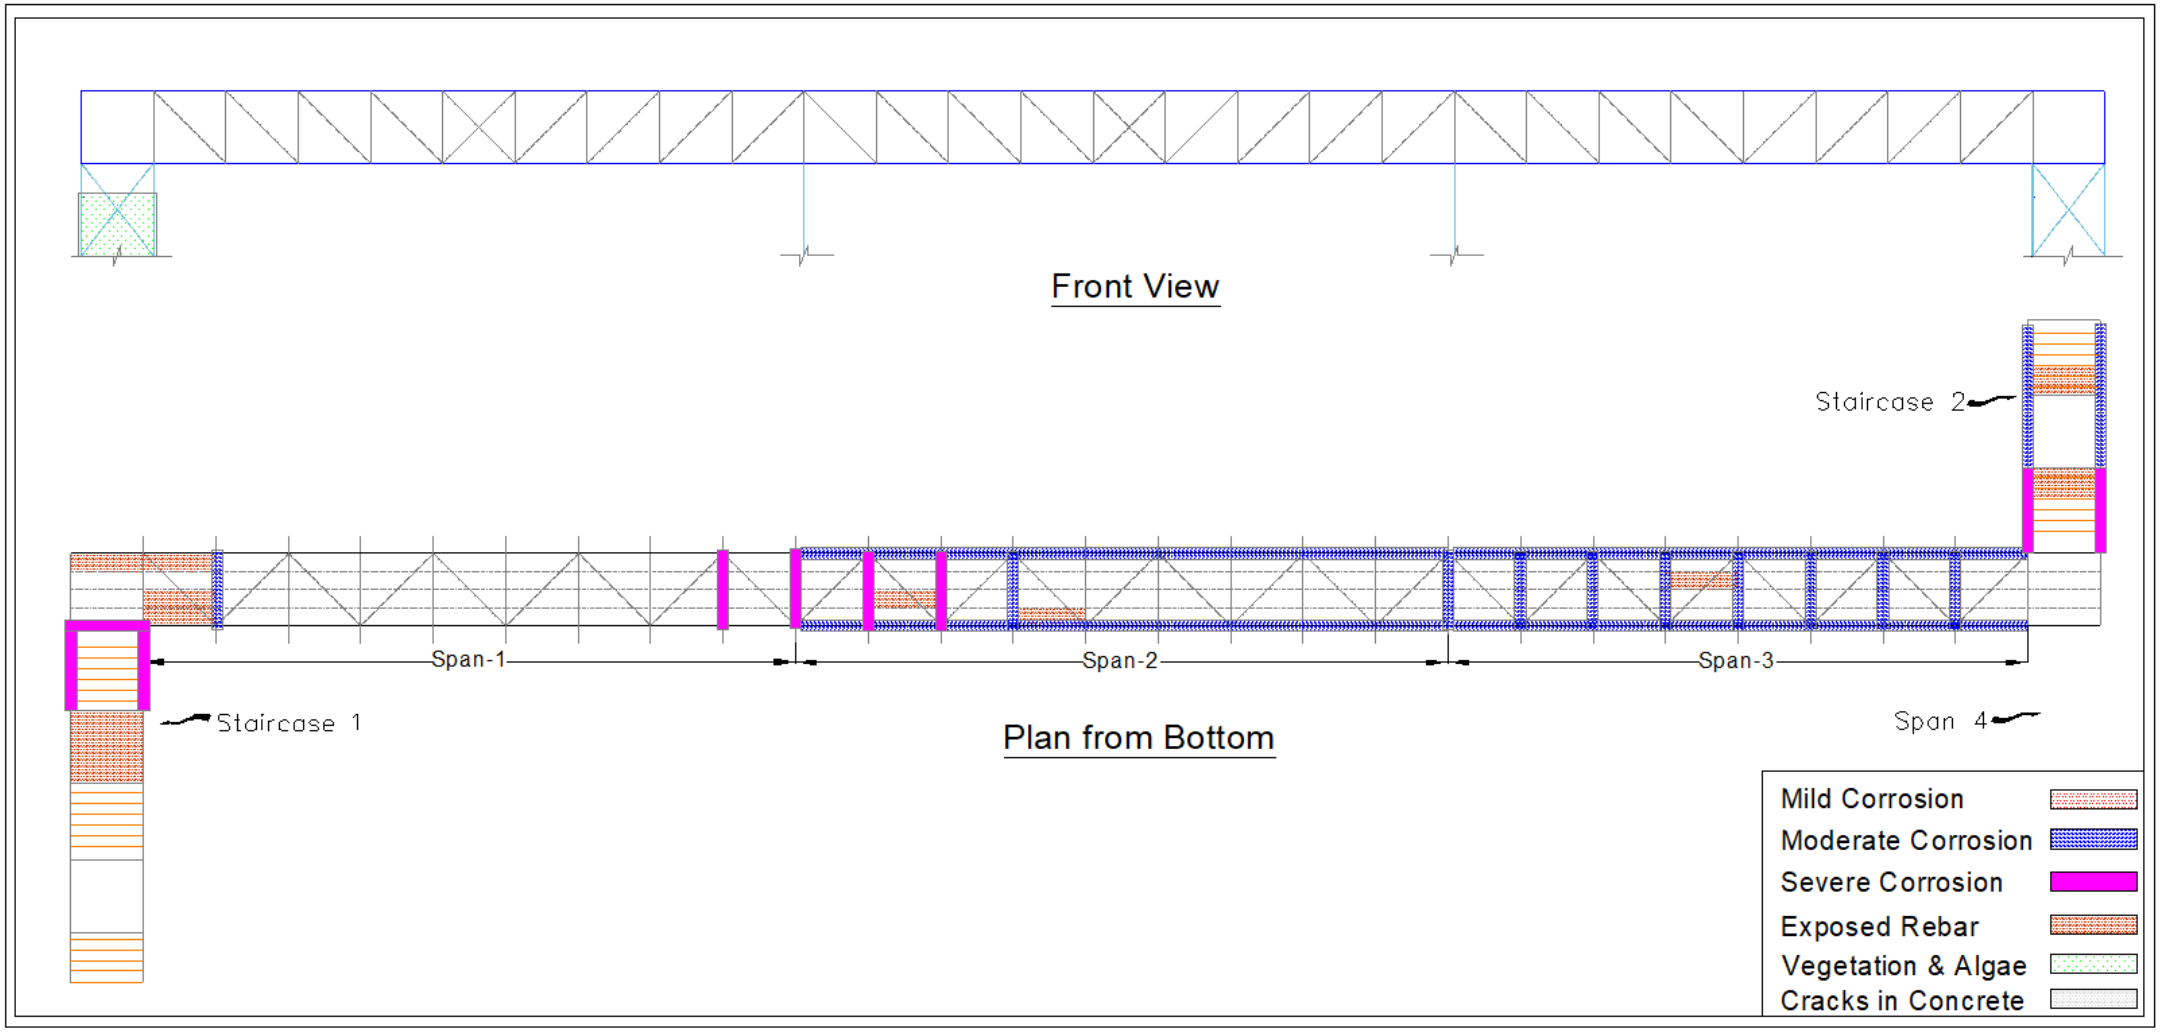
Fig 2.1: Locations of Deteriorations in Span 1, 2 & 3.

- Structural members are in fair condition, displaying mild corrosion for top chord members, verticals, diagonals, and gusset plates, moderate to Severe corrosion for bottom chord members, Floor beams, Gusset plates and staircase stringer beam along steel concrete joint.
- Precast slab panels are deteriorated Cracks are observed in deck level, *(Photographs of the same can be seen in **fig 2.2-2.7**)*

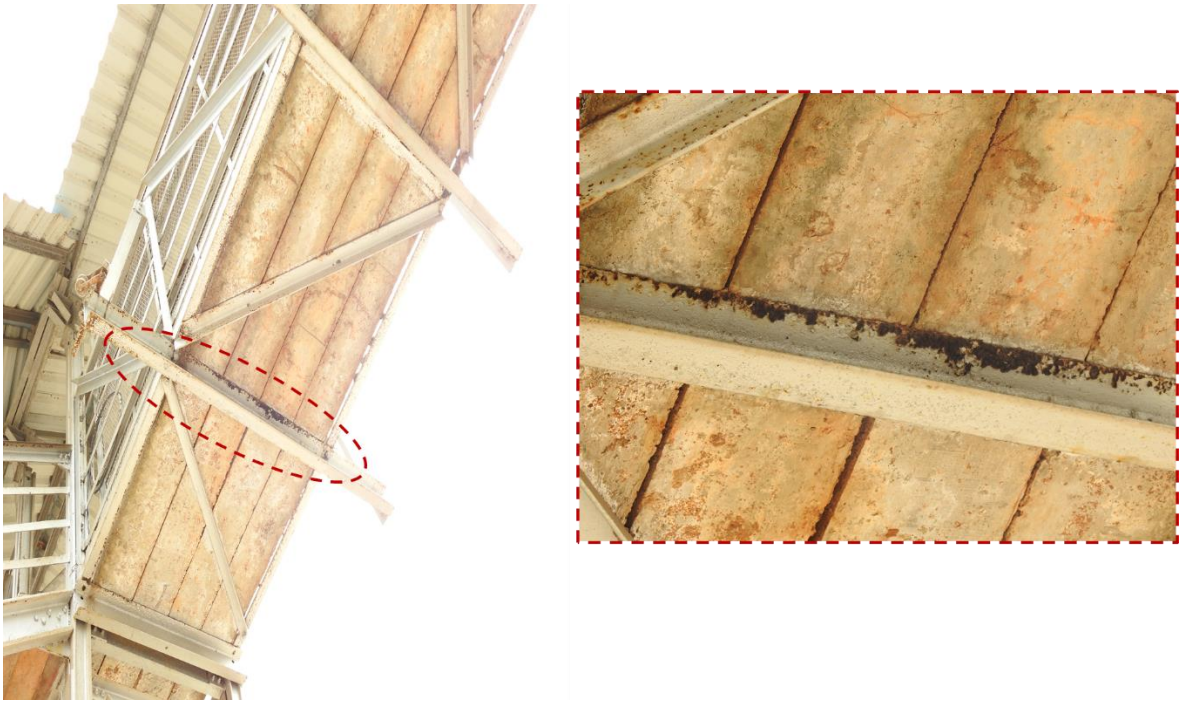
Fig 2.2: Locations of corrosion near floor beams

Fig 2.3: Locations of moderate corrosion near floor beams of span 2

Fig 2.4: Locations of moderate corrosion at cleat angles of staircase

Fig 2.5: Locations of Deteriorations at slab panels

Fig 2.6: Locations of deteriorations at stringer beam of Staircase

Fig 2.7: Locations of Deteriorations at gusset plates

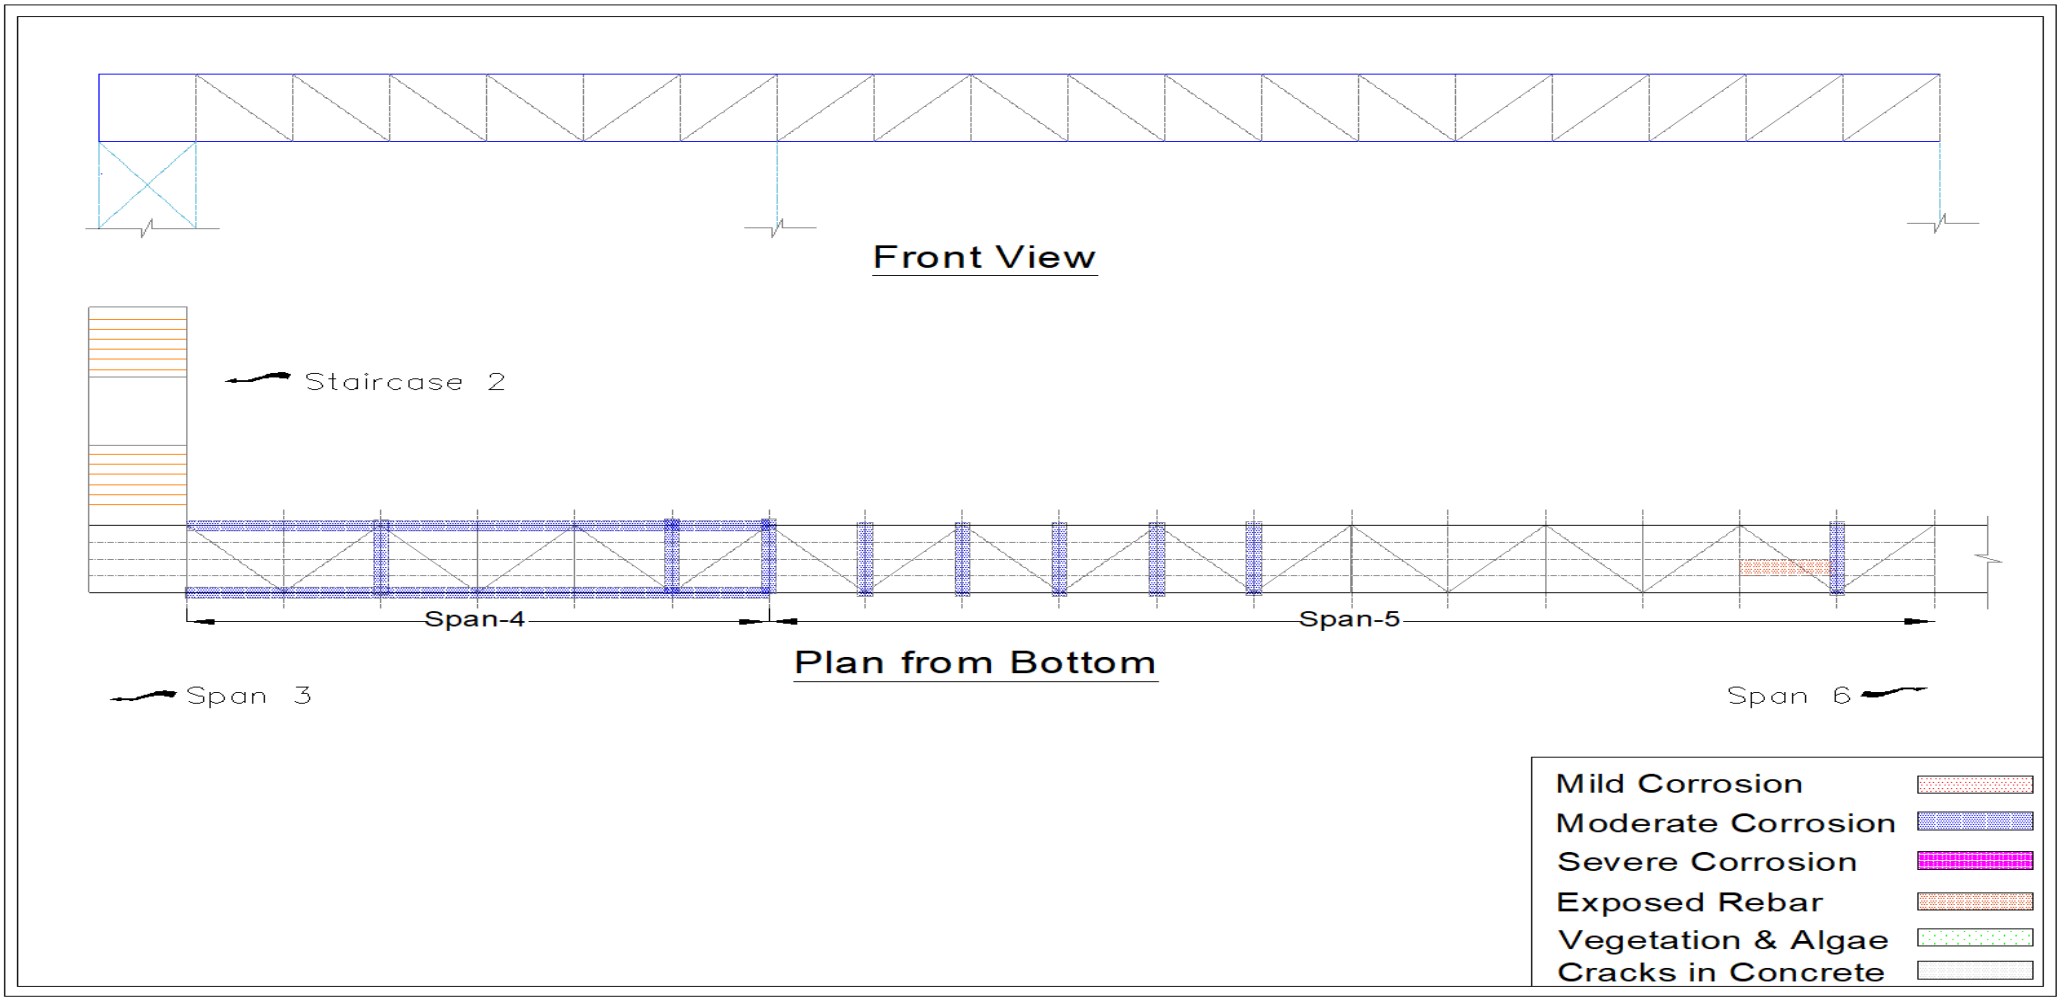
Fig 2.8: Locations of Deteriorations in Span 4 & 5

- Structural members are in fair condition, displaying mild corrosion for top chord members, verticals, diagonals, and gusset plates, Moderate corrosion for bottom chord members, Floor beams.
- Precast slab panels are deteriorated cracks observed at deck level, *(Photographs of the same can be seen in **fig 2.11**)*

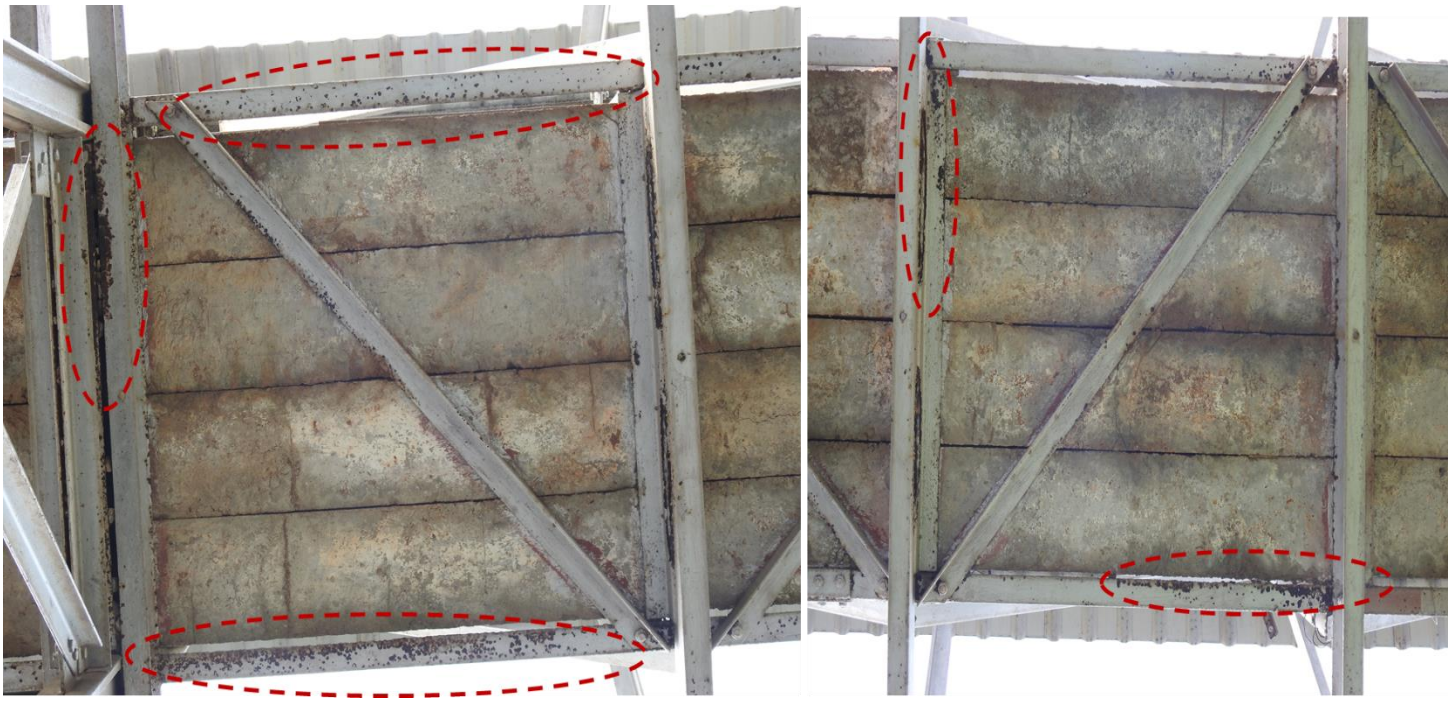
Fig 2.12: Locations of Deteriorations in bottom chord and floor beams of Span 5

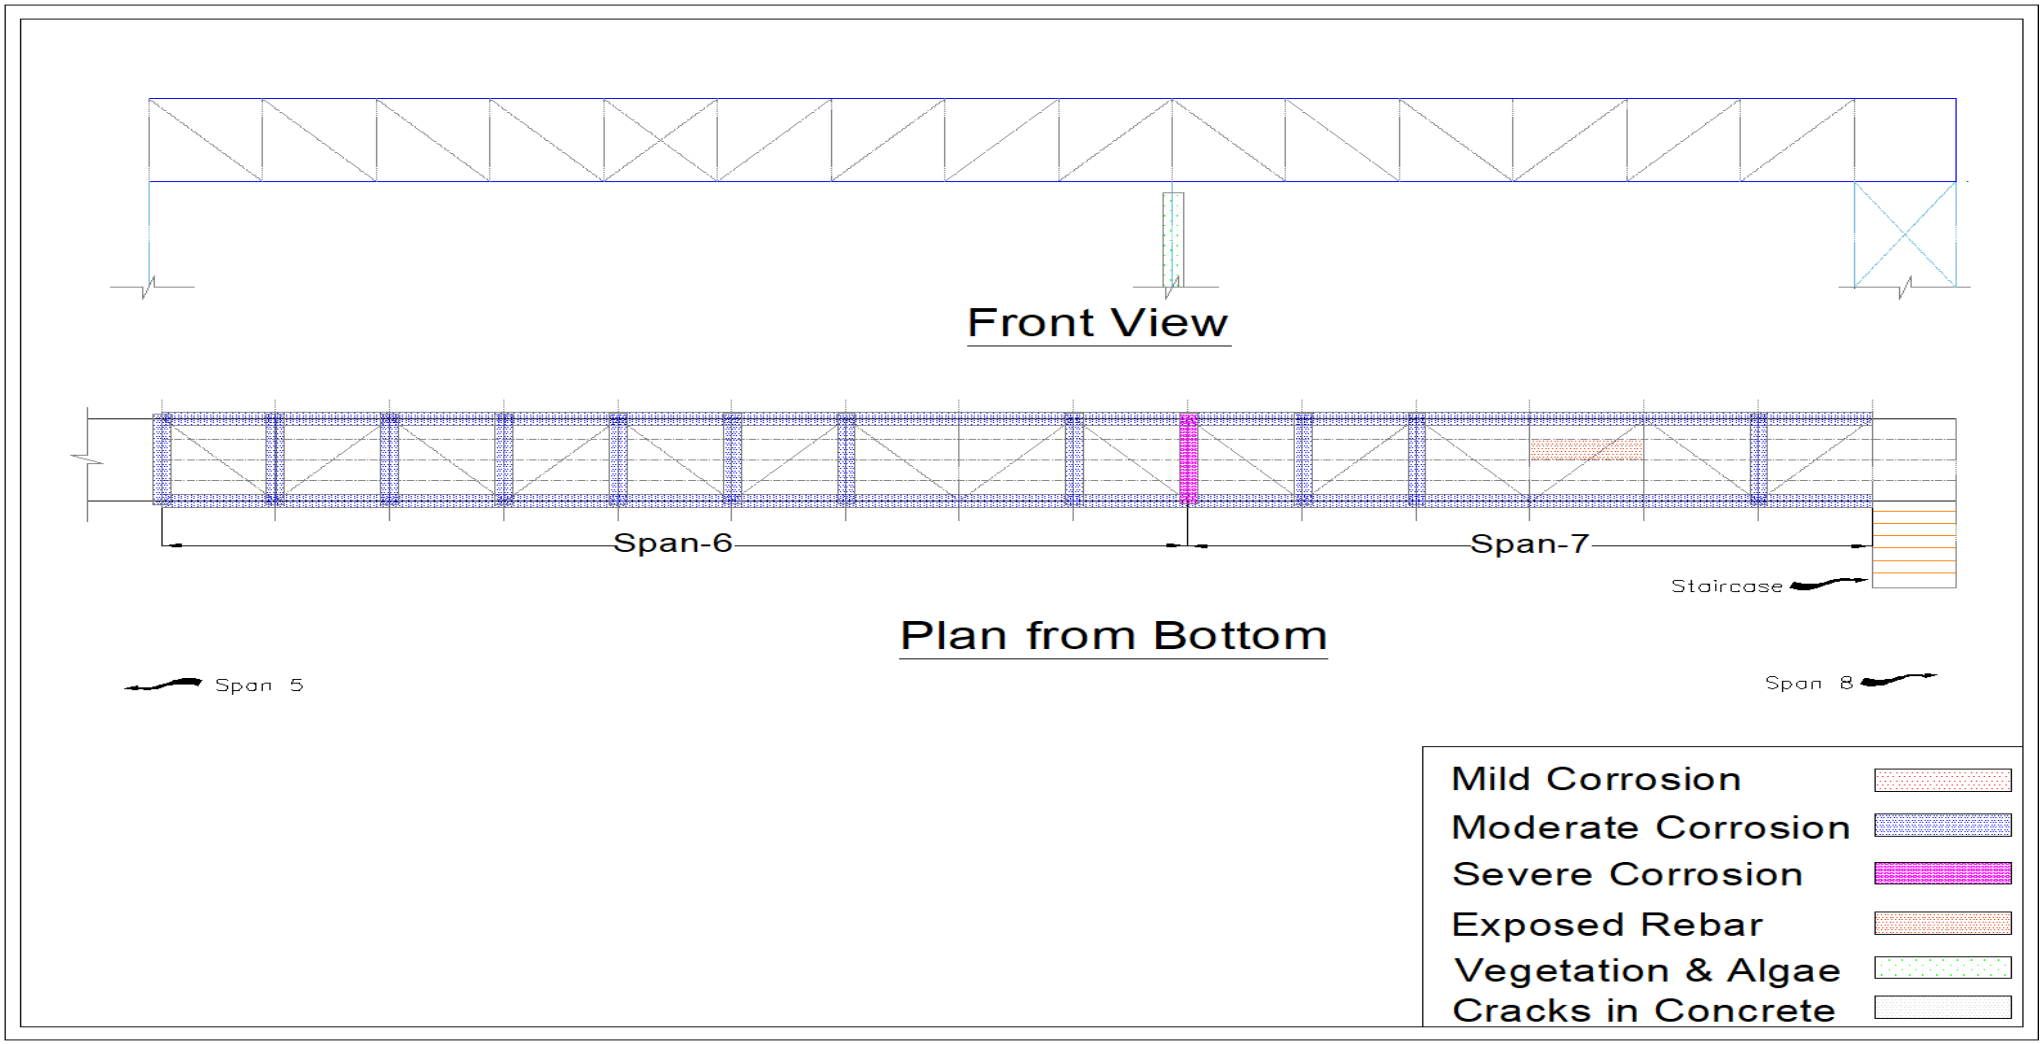
Fig 2.13: Locations of Deteriorations in Span 6 & 7

- Structural members are in fair condition, displaying mild corrosion for top chord members, verticals, diagonals, and gusset plates, moderate corrosion for bottom chord members and severe corrosion of floor beams.
- Precast slab panels are deteriorated reinforcement is exposed in deck level,
- Vegetation observed at stanchions.
