Third Party Audit of ROB's and FOB's of SCR

INSPECTION OF FOB AT BITRAGUNTA (A) RAILWAY STATION

Final Report

SEPTEMBER | 2020

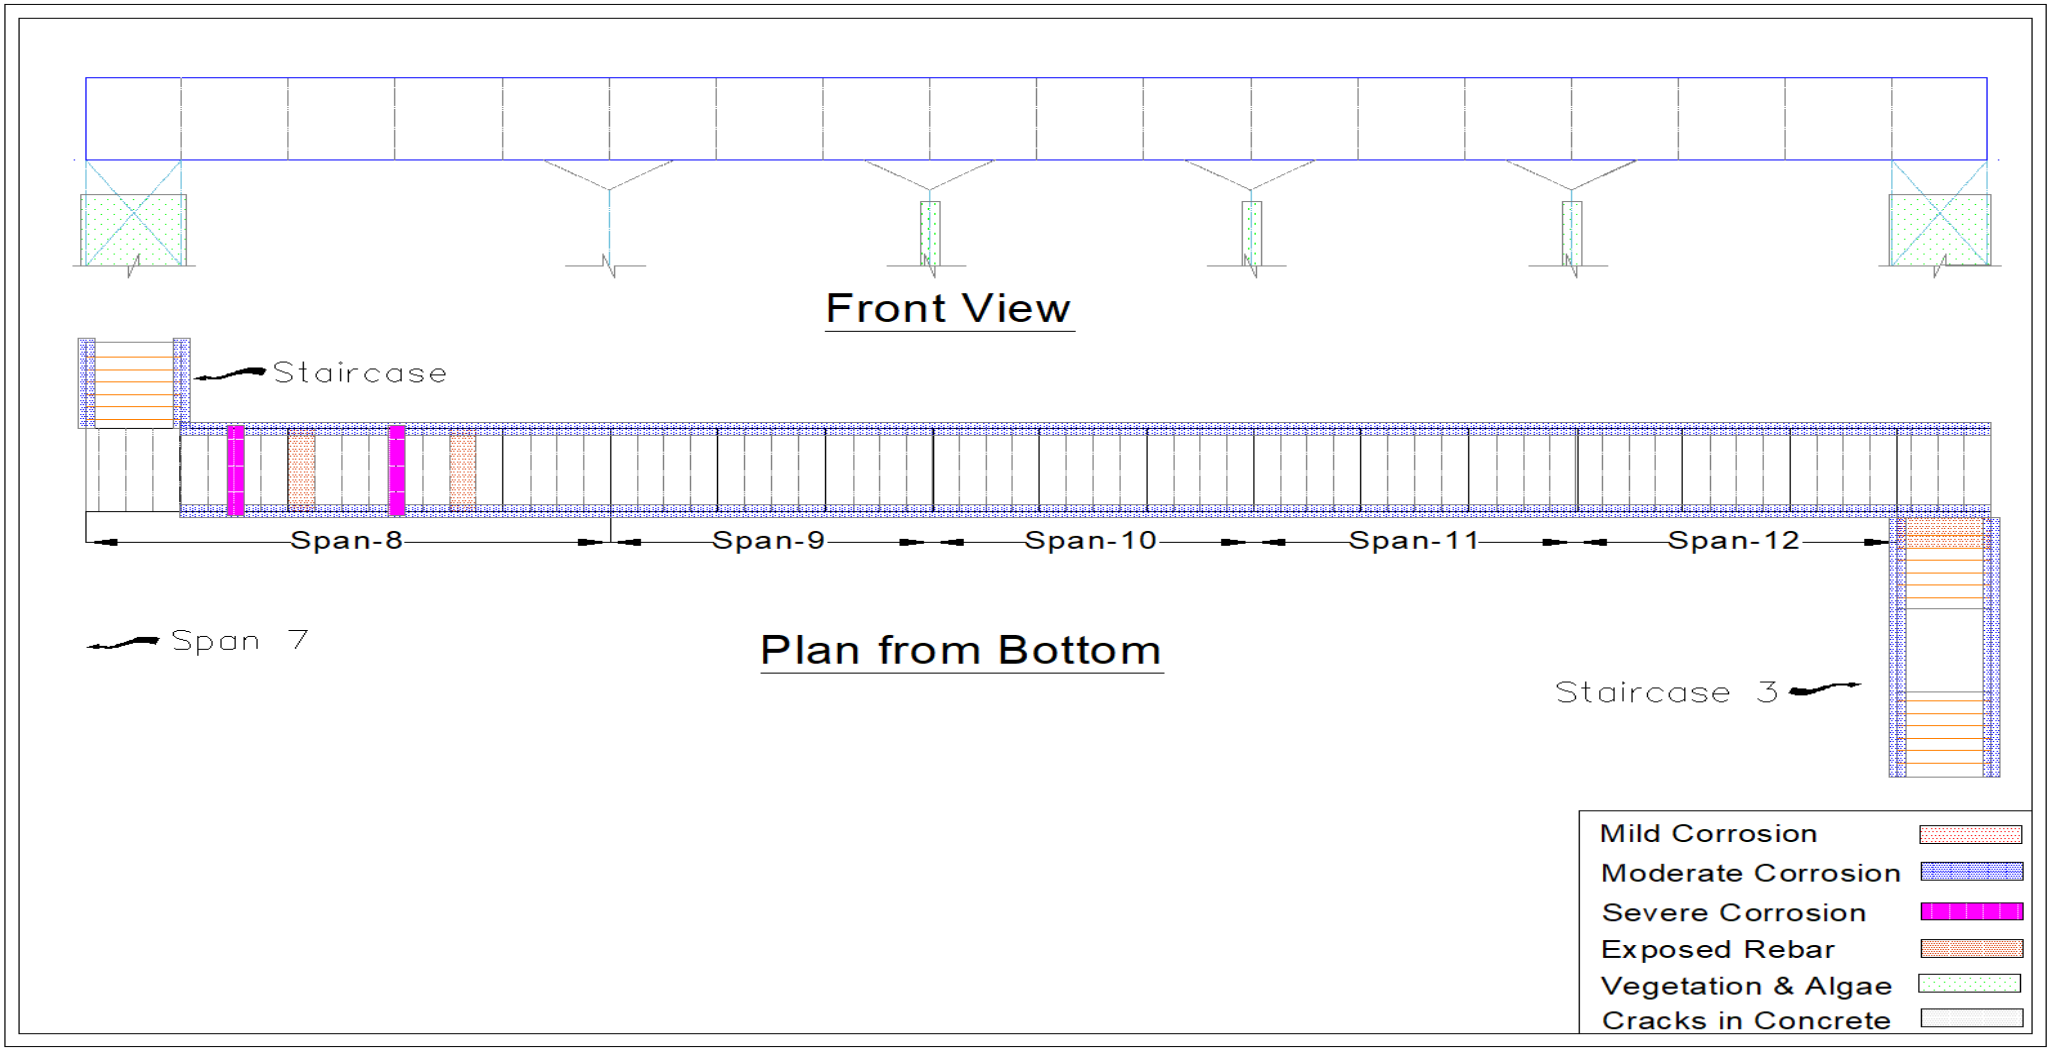
Fig 2.16: Locations of Deteriorations in Span 8, 9, 10, 11 & 12

- Structural members are in fair condition, displaying mild corrosion for top chord members, verticals, diagonals, and gusset plates, moderate corrosion for bottom chord members and at steel concrete joint at staircase. Severe corrosion of floor beams
- Precast slab panels are deteriorated cracks are observed at deck level, *(Photographs of the same can be see in **fig 2.17**)*
- Vegitation growth observed at stanchions

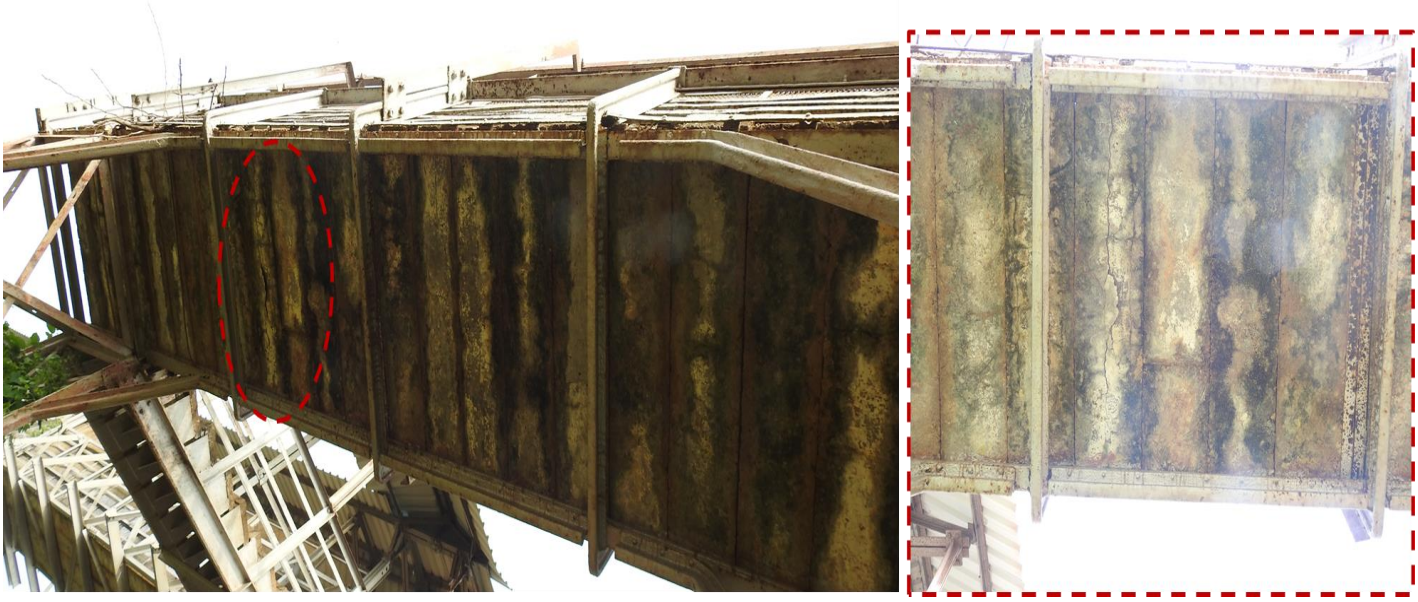
Fig 2.17: Locations of Deteriorations at precast slab panels

Fig 2.18: Locations of corrosion in floor beams

Fig 2.19: Locations of Deteriorations in bottom chord members

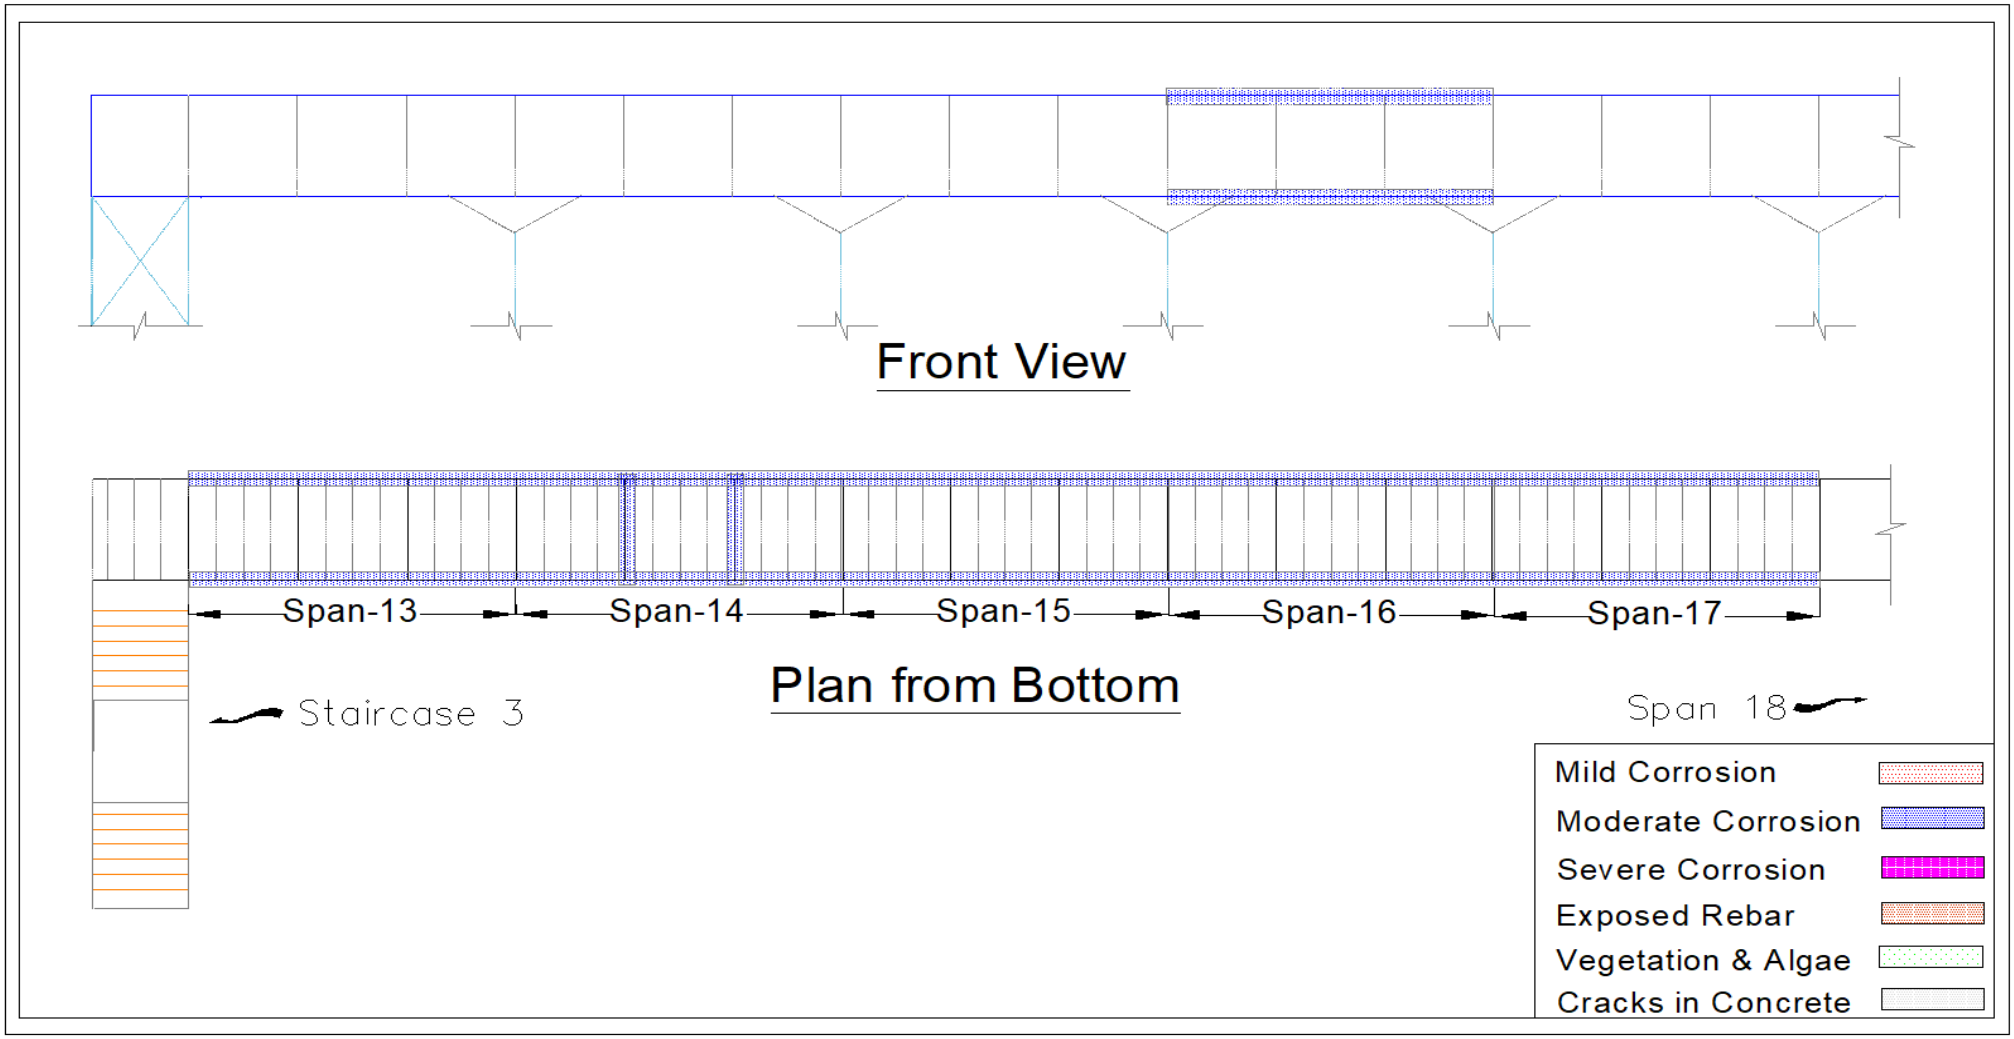
Fig 2.20: Locations of Deteriorations in Span 13, 14, 15, 16 & 17

- Structural members are in fair condition, displaying mild corrosion for top chord members, verticals, diagonals, and gusset plates, moderate corrosion for bottom chord members floor beams.
- Precast slab panels are deteriorated; cracks are observed at deck level.
- Corrosion is also observed at bracings and columns of stanchions

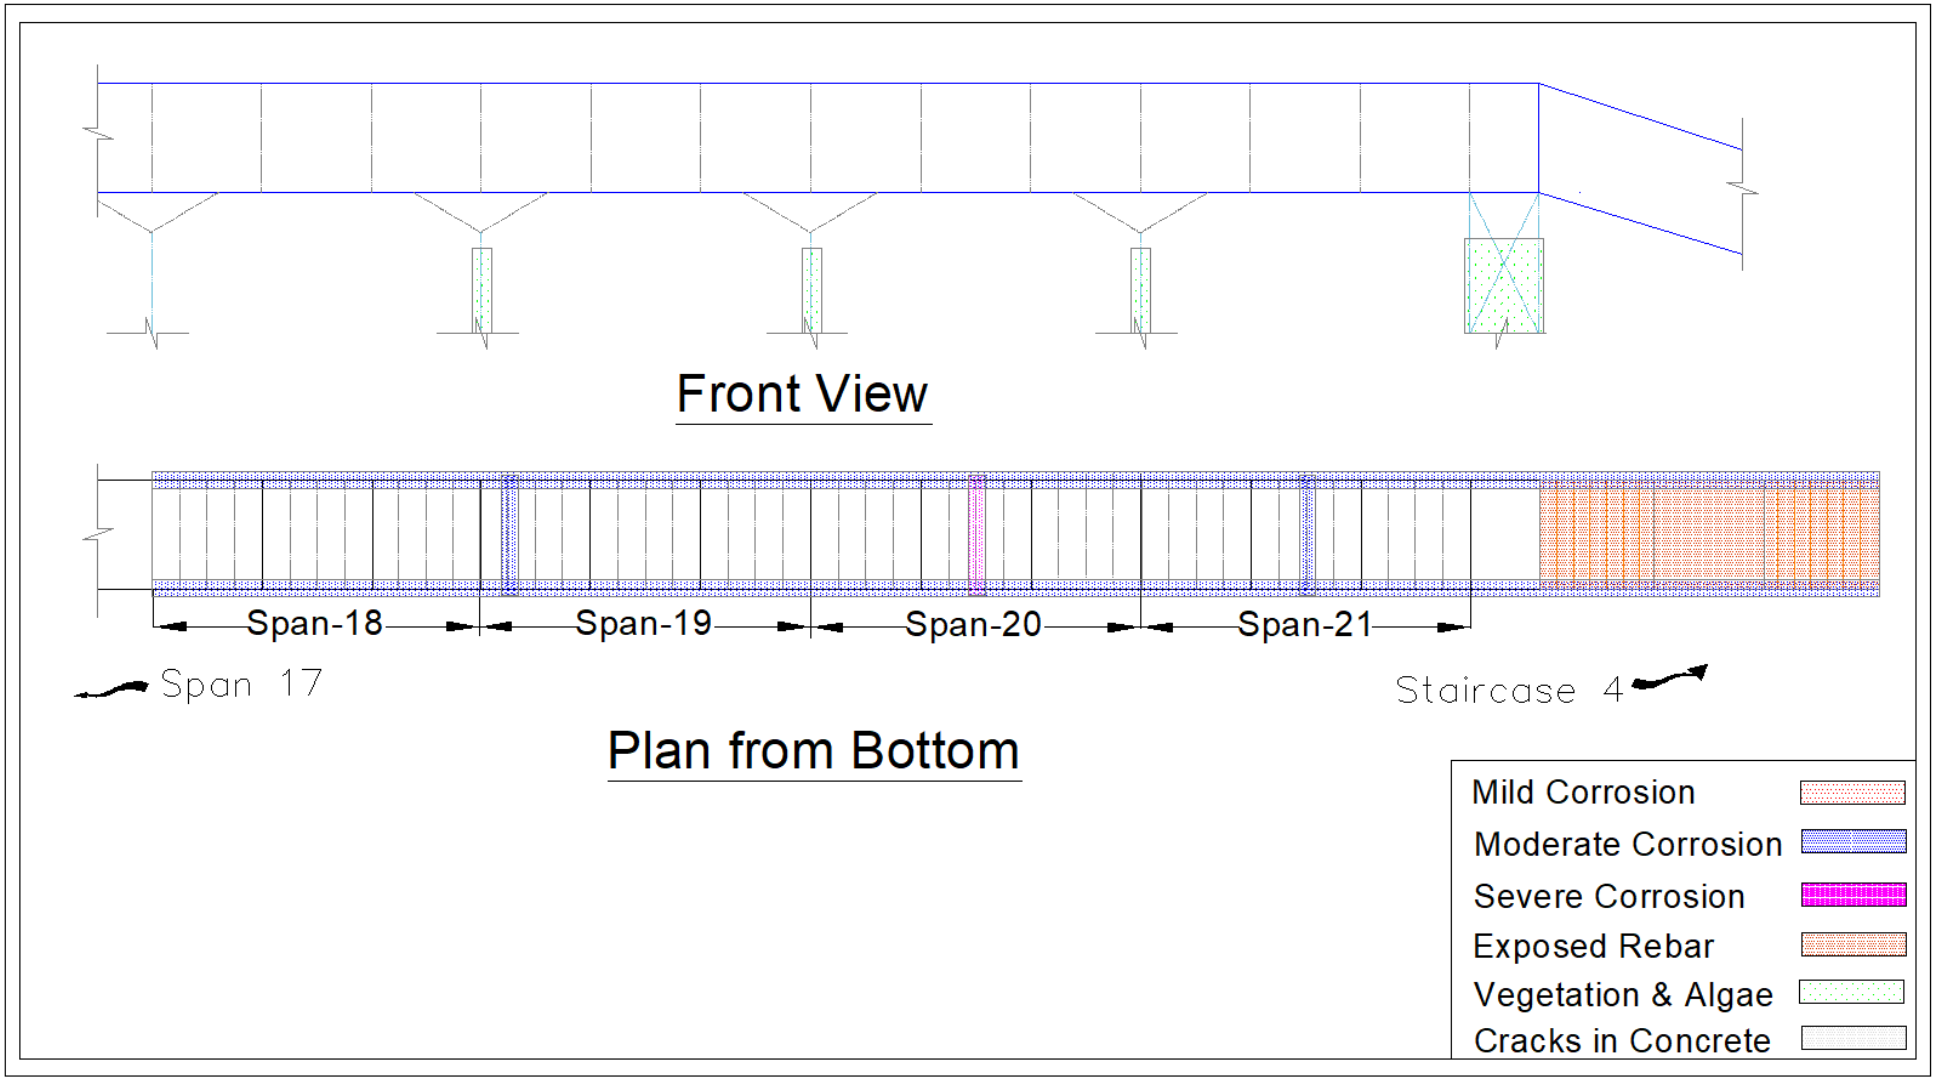
Fig 2.23: Locations of Deteriorations in Span 18, 19, 20 & 21.

- Structural members are in fair condition, displaying mild corrosion for top chord members, verticals, diagonals, and gusset plates, moderate corrosion for bottom chord members, floor beams and Stringer beams of Staircase
- Precast slab panels are deteriorated reinforcement is exposed in deck level and Staircase. *(Photographs of the same can be seen in **fig 2.26 and 2.27**)*
- Deformations are observed in tie bars connecting bottom chord members.
- Severe vegetation growth is observed at Stanchions and staircase.
